RESTORATION PROJECT OF ÇARBOĞA AND YENİGÜN HOUSES IN
ŞİRİNCE, İZMİR

A THESIS SUBMITTED TO
THE GRADUATE SCHOOL OF APPLIED AND NATURAL SCIENCES
OF
THE MIDDLE EAST TECHNICAL UNIVERSITY

JANUARY 2004

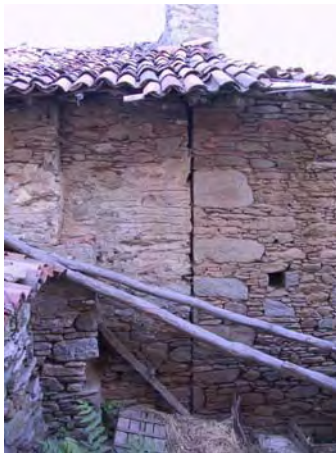
Figure 3.8 West elevation of Yenigün House

The eaves project 24 cm from the elevation. There are missing boards and tiles in the eaves. On the parts of the walls below the parts of the eave that are damaged, it is observed that the mortar has begun to disintegrate and that there are empty joints between the stones. Also at lower parts of the walls near the ground there are empty joints.

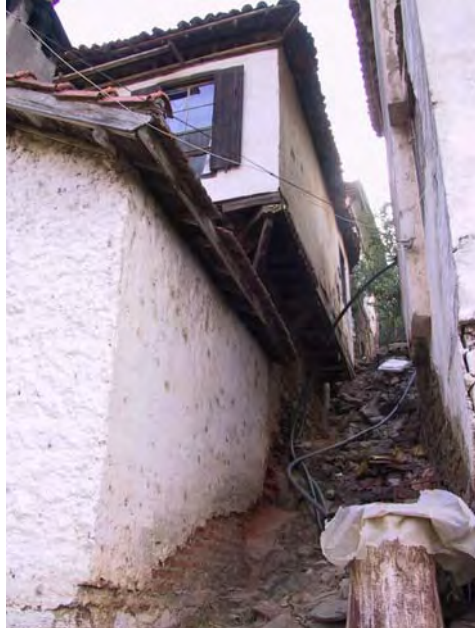
Figure 3.9 North elevation of Yenigün House

At the lower edge of the timber frame part there is a 20cm timber band. The eave projects 38cm from the timber frame wall. There is no covering beneath it. There are cracks on the plaster over timber frame wall near the window. At some parts the plaster is missing and the wood lath is visible beneath.

At the upper parts of the ground floor wall there are traces of plaster. The plaster is missing on the lower parts of the wall. Empty joints and erosion of stone can be seen at the lower parts of the wall.

North elevation of G03 space is 3.74m wide and it is in brick masonry covered with lime plaster. At the east corner it is 2.9m high. It has a pitched roof covered with French tiles. On the lower part of the wall in a band of approx. 65cm the plaster is missing. At the lowest part of the wall near the ground there is erosion of bricks.

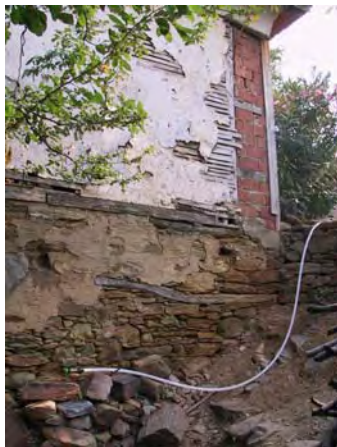
Figure 3.13 North elevation of Çarboğa House

In the fabric of the ground floor wall there is a single timber tie beam approx. 2.25m long. It does not correspond to any architectural element. On the upper parts of the ground floor wall pointing is applied at the joints of stones with lime plaster. The pointing is missing at the lower parts of the wall. There is erosion of stone at the lowest part of the wall near the ground.

The wall of G04 space of Çarboğa House is in rubble stone masonry without mortar. It is covered with a sloped roof where there are over and under tiles.

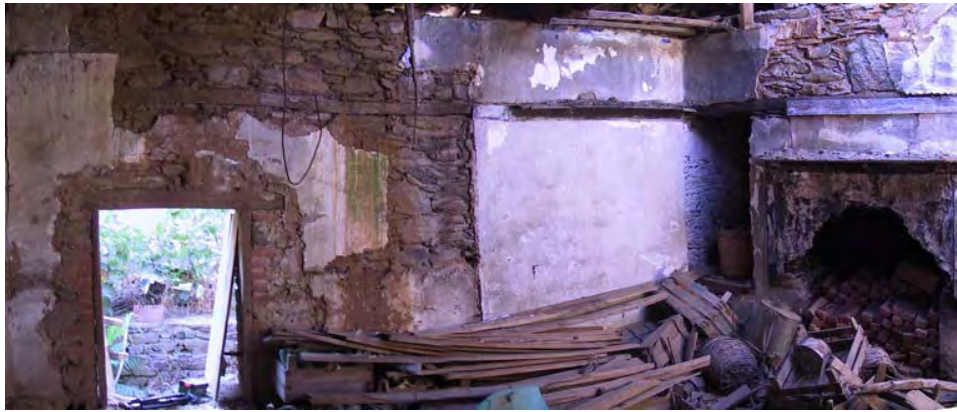
Figure 3.22 West wall of F05 space in Yenigün House

On the west wall near the south corner there is the door. On the north half of the wall 2 m above ground level there is a “sergen” shelf. This shelf has a different profile than the one in F02 space and it is ornamented. On the north wall, at the west corner there is an opening with a timber shutter measuring 0.62m by 1.31m connecting the space with F01. From the side of F01, timber boards are nailed on the shutter to cancel the connection. Next to this opening is a fireplace. On the east corner of this wall there are a vertical and a horizontal joint defining an area of a *b m. (this part of the wall corresponds to the fireplace on F03 space on the other side of the wall). On east wall there are two W2 type windows. Above the windows there is a 10 cm wide “sergen” shelf.

On the south wall, at east corner there is a third W2 type window. At the place corresponding to the level difference on the floor, there is a vertical trace on the on the west wall. To the south of the trace the plaster is partly missing.

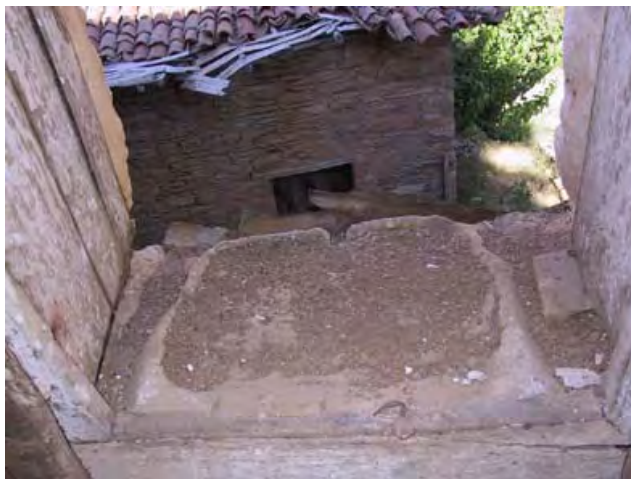
Figure 3.25 Window of F04 space of Çarboğa House

The floor is covered with lime mortar similar to the floor of F03 space. An approx. 60 cm part of the floor covering near the west wall is missing and the beams carrying the floor are visible below. These beams are attached to the concrete lintel between the brick and stone masonry walls.

The ceiling cover is missing and the roof construction is visible above.
