RESTORATION AND REVITALIZATION PROJECT OF HOUSE NO 1 in  
ZENGINLER DISTRICT BUYUK CIKMAZ - ANTAKYA

A THESIS SUBMITTED TO  
THE GRADUATE SCHOOL OF NATURAL AND APPLIED SCIENCES  
OF  
MIDDLE EAST TECHNICAL UNIVERSITY

MAY 2008

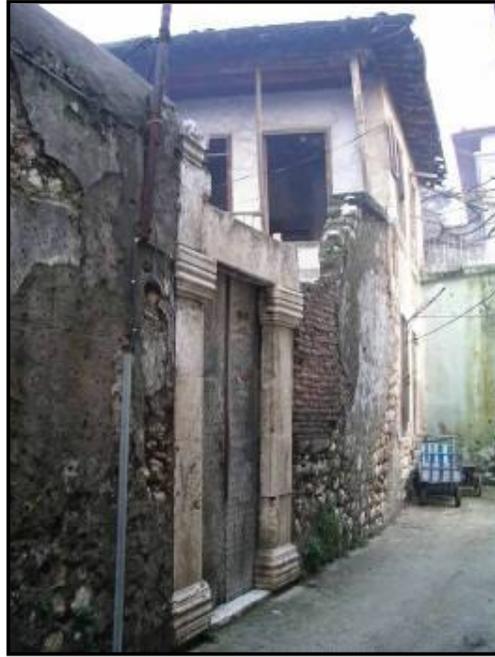
**Figure 2:** South-West Façade (author April, 2003)

The highest point of the façade is +7.50m level from the ground level at the north-west mass and +8.16m level at the south-east mass. The height of the courtyard wall is irregular owing to partial collapses and repairs. The highest level of the courtyard wall is +4.22m from the ground level and the lowest level is 2.69m from the ground at the right side of the entrance wall.

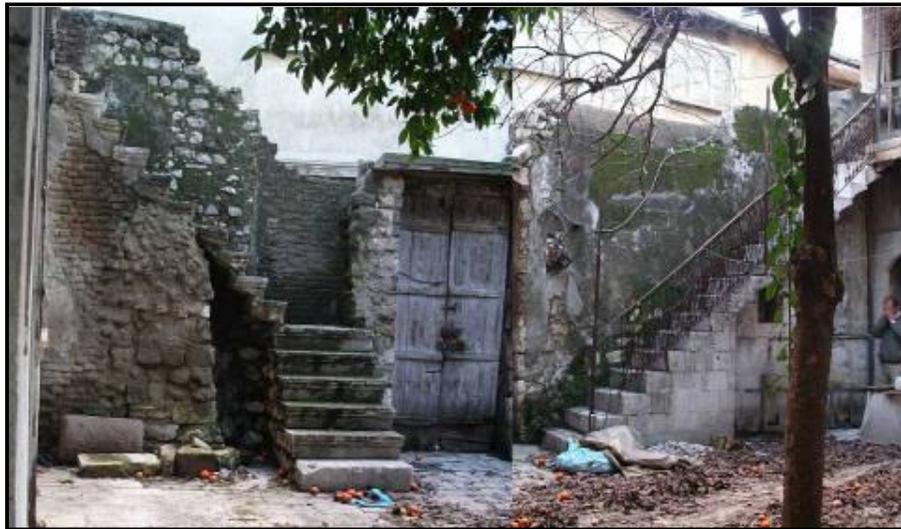
The south-west façade of the courtyard which is composed of courtyard wall is almost 10m in length. The highest points of the façade are +2.72m at right side and +2.58m at left. Partial collapses can be observed especially at the mid parts of the wall. At those parts, the height of wall decline +1.00m level.

**Figure 6:** South-west Façade of the Courtyard (author April, 2003)

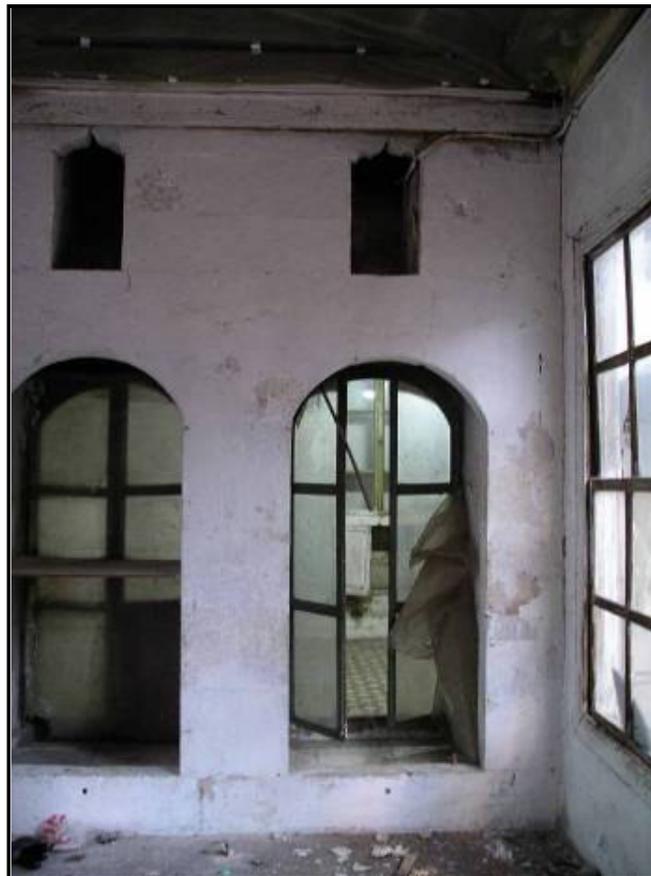
The entrance door of the room is on the left edge of the north-west wall. There is a door wing which seems not to be original because its dimension, material and combination with the door frame. There is timber shelving (N-PD) next to door which includes four shelves. The shelving has been limited with two timber frames which extend from the door to the corner of the wall. The rest of the surface is lime plastered and lime-washed except the area below the timber frame. The lime plastered surface has been lost at this part.

**Figure 12:** Space GF03 (author April, 2003)

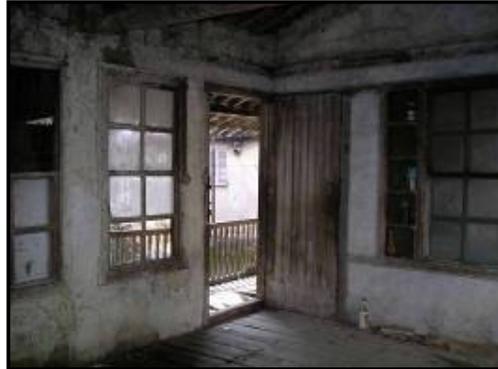
The floor is of timber floorboards. It is at 1.74m level. The level increases towards the north-west wall up to 1.64m level. There are two holes on the floor because of a probable decay of the material.

**Figure 25:** Space FF06 (author April, 2003)

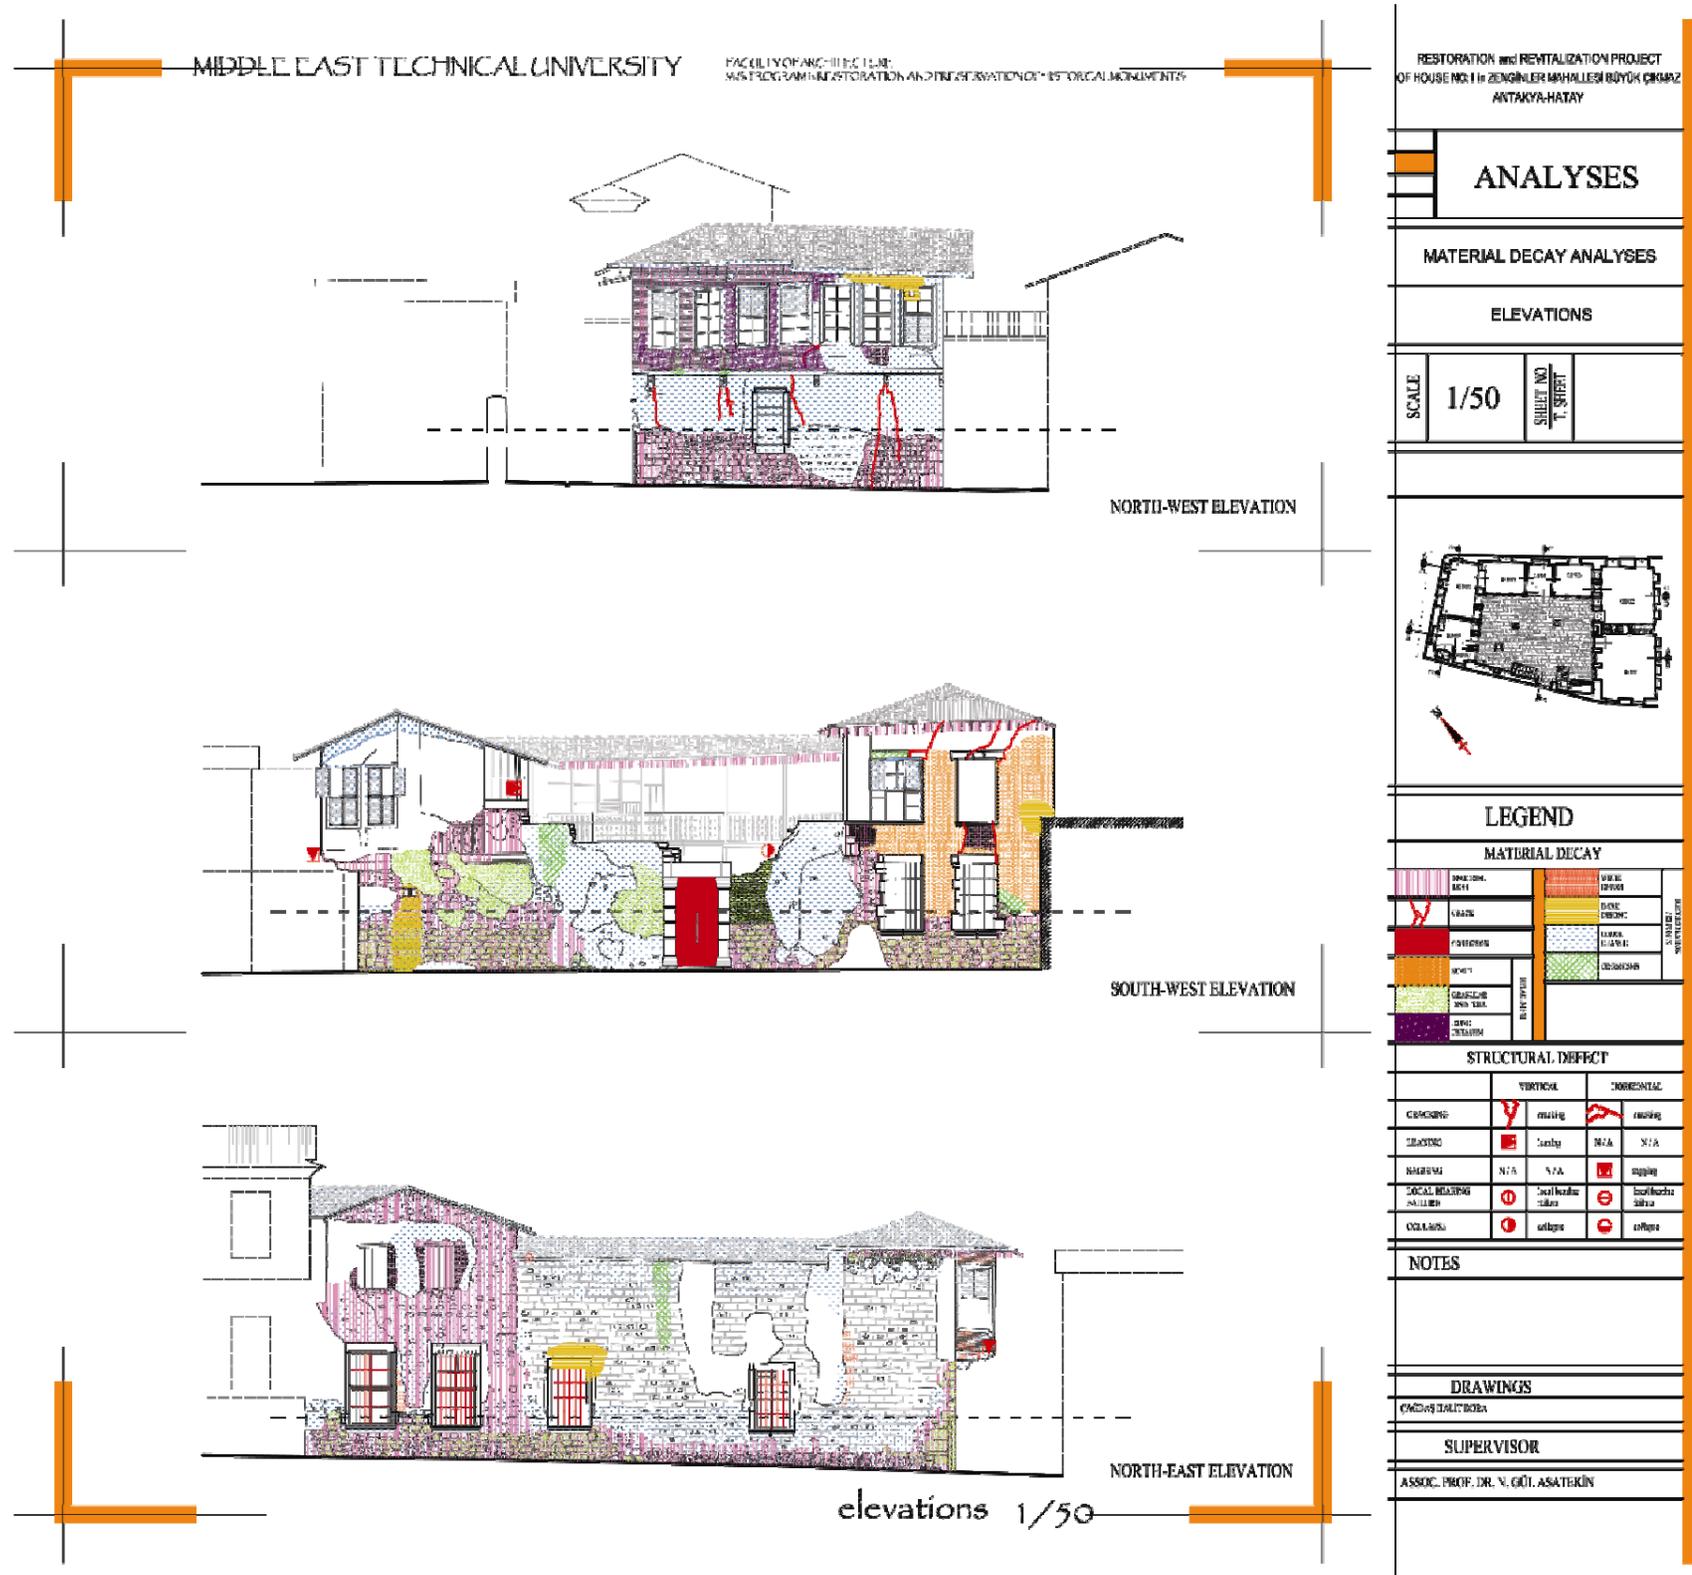
Illustration 31: Material Decay Analyses - Elevations

The roof tiles have been broken or have been lost on the roof structure.

Some parts of the courtyard wall at south west and the roof structure have partially collapsed.

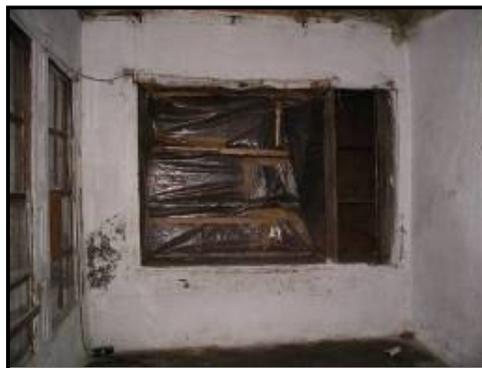
**Evidence:** The peculiar details and inadequate connections of the cupboard placed on the stone masonry separated from the other space with a thin frame covered by using wood laths from one side.

**Figure 35:** Cupboard in Space GF05 (author April, 2003)

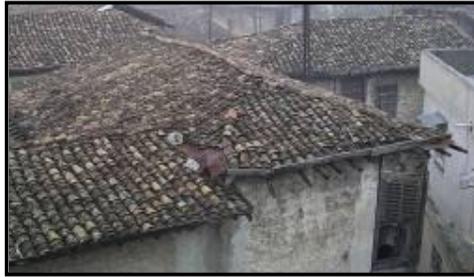
**Evidence:** Use of inadequate materials and peculiar connection with the other mass indicate the alteration.

**Figure 47:** The Roof Construction of North-west Mass (author April, 2003)

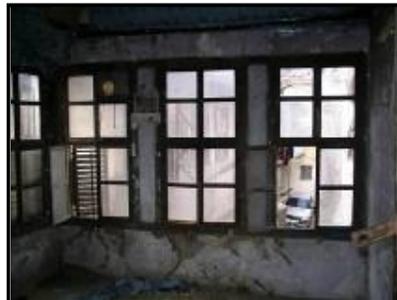
**Evidence:** The inadequate openings of the windows indicate the alteration.

**Figure 48:** The Four Winged Windows of First Floor (author April, 2003)

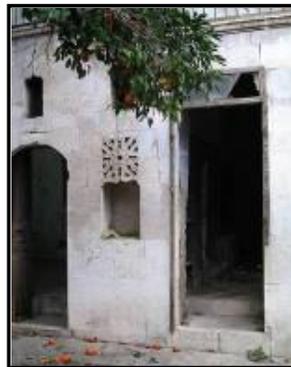
**Evidence:** Use of inadequate technique of fitting the door wing and the different dimensions with different form of the opening show the alteration.

**Figure 50:** The Door of Space GF01 (author April, 2003)

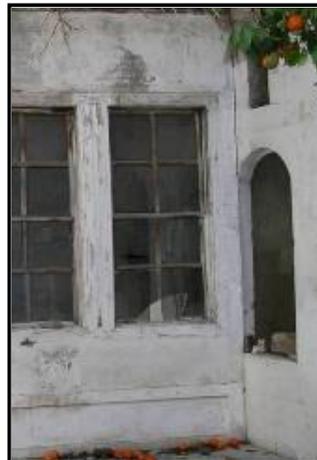
**Evidence:** The peculiar connections of the mass with both other two either on ground floor or at the roof level, the window and closed top window openings of GF02 space which inadequately are in GF03 space at present time, different details of the architectural elements are some of the indicators of the change.

**Figure 56:** The Corner of North-east and South-east Masses (author April, 2003)

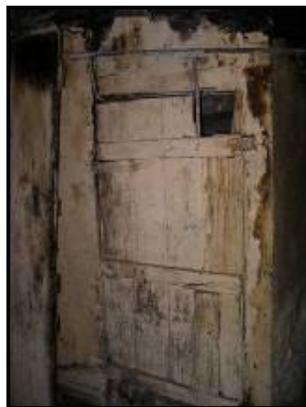
**Evidence:** The peculiar connections of the walls, the level difference between the GF07 which one of the door opens out, the different details of the door from the others in the building, the jerry-built partition walls which do not lead to the ceiling and the inadequate connection between the kitchen and the toilette are some of the indicators of the change.

**Figure 58:** The Door between GF08 and GF07 Spaces (author April, 2003)

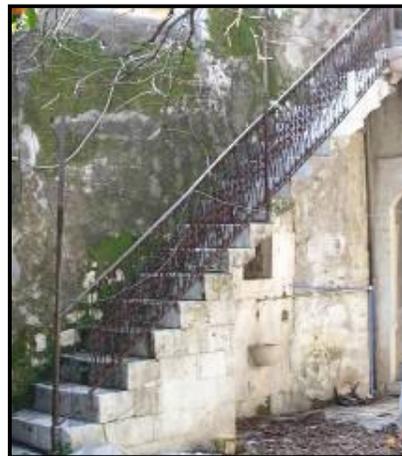
**Evidence:** The details of the iron balustrade indicate the change.

**Figure 70:** The Iron Balustrade of the Staircase (author April, 2003)

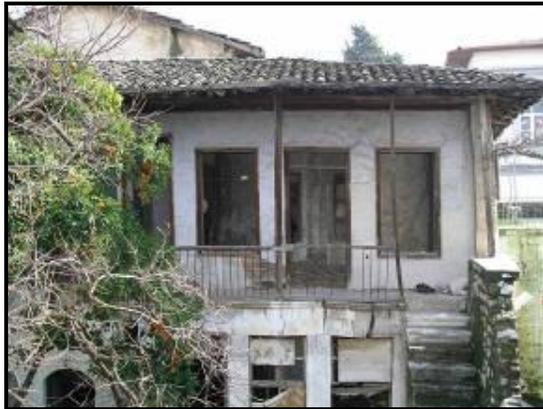
**Evidence:** The openings, the traces of the hinges and in some circumstances, the remains of the elements indicate the changes.

**Figure 79:** The Missing Door and Window Wing at First Floor (author April, 2003)

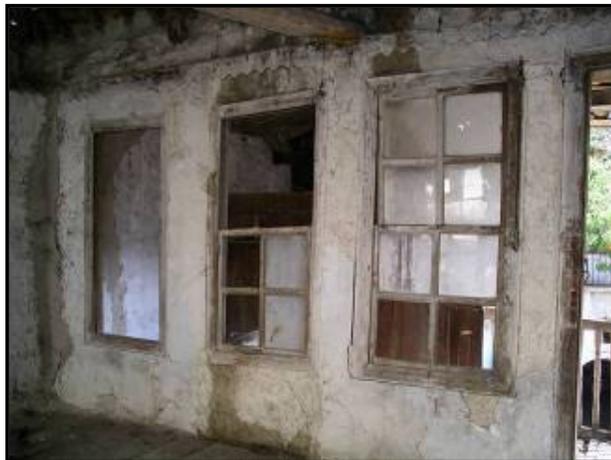
**Figure 80:** The Missing Door and Window Wing at FF06 Space (author April, 2003)
