A PROPOSAL FOR PRESERVATION AND REHABILITATION OF
YENİ GALLE PAZARI HANI (FORMER ALİ PAŞA KERVANSARAYI)
AND ITS IMMEDIATE SURROUNDING
IN BURSA

A THESIS SUBMITTED TO
THE GRADUATE SCHOOL OF NATURAL AND APPLIED SCIENCES
OF
MIDDLE EAST TECHNICAL UNIVERSITY

MAY 2008

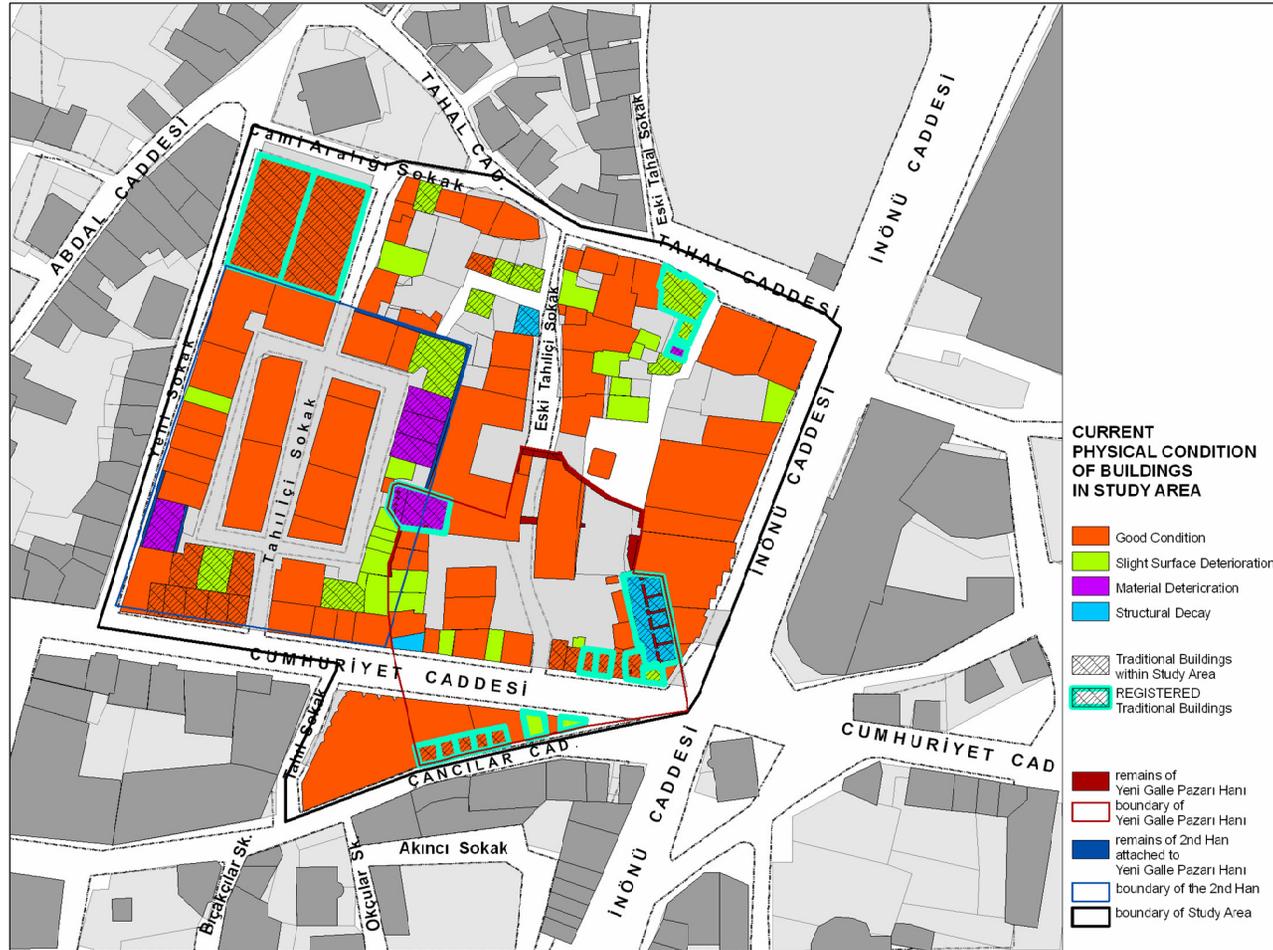
Figure 2. 41 : Current Physical Condition of Buildings in Study Area

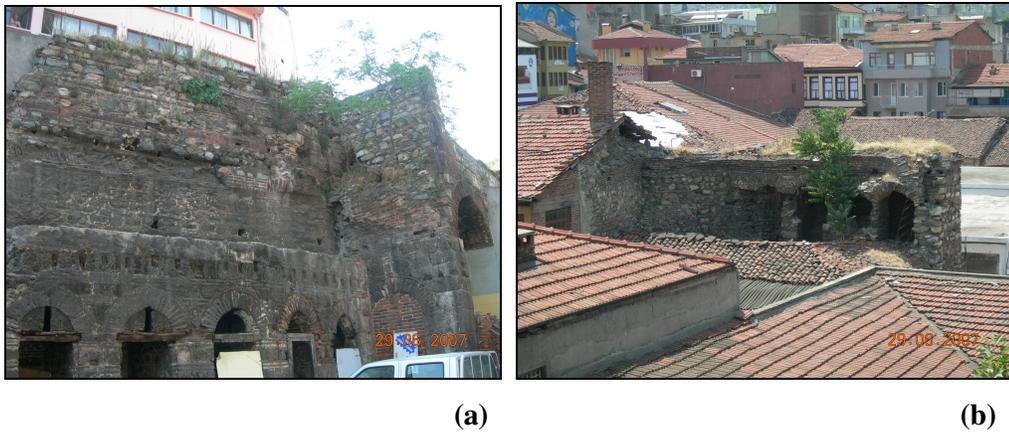
Figure 2. 49 : (a) the remains of the vaults at the back wall of Y.G.P.H. (b) small rooms on the upper storey of Y.G.P.H.

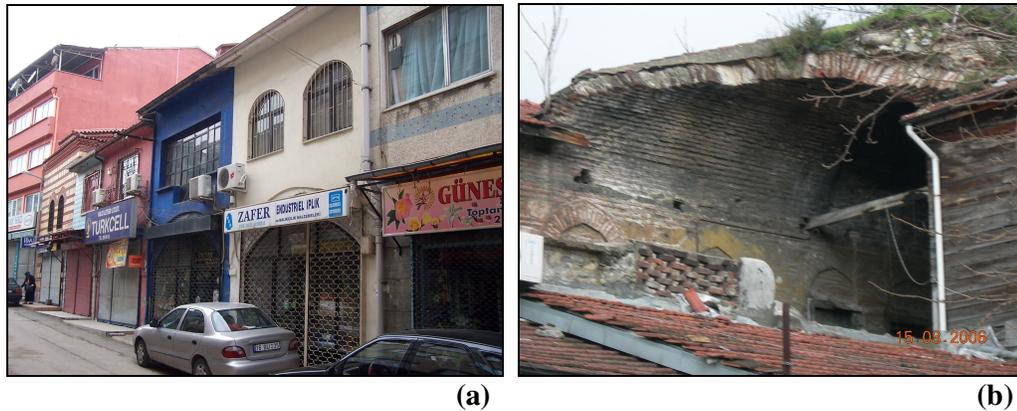
Figure 2. 50 : (a) Five small units of Y.G.P.H. at the south of Cumhuriyet Street (b) partially collapsed vault at the PART I of Y.G.P.H.

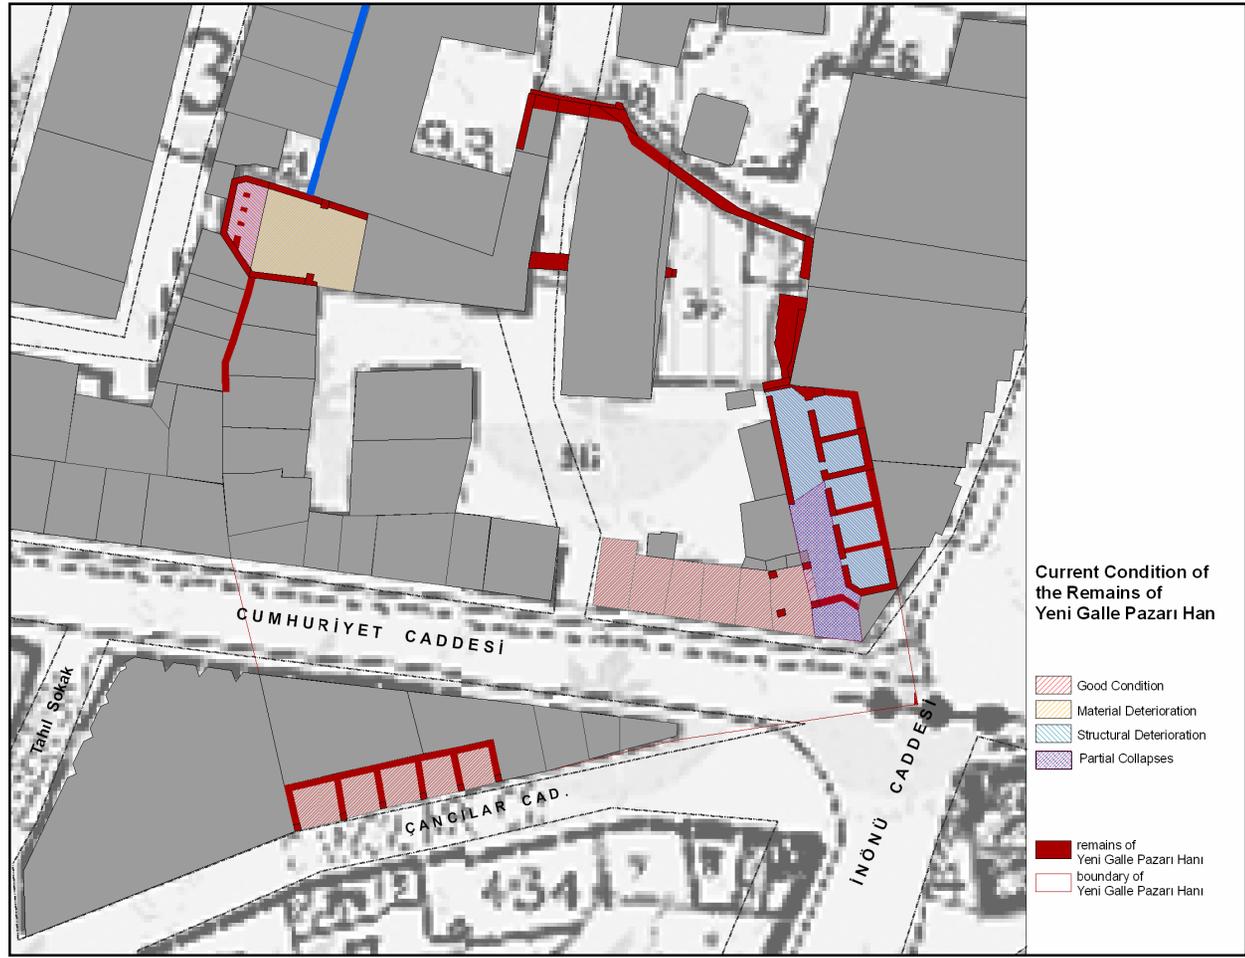
Figure 2. 51 : Current Condition of the Remains of Y.G.P.H.

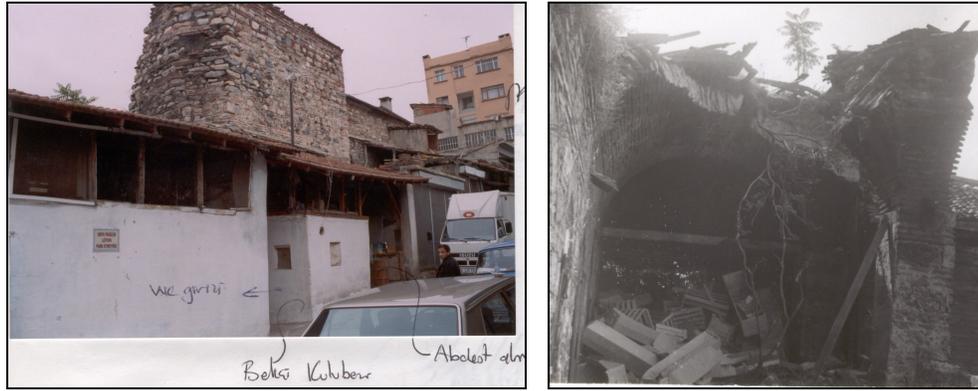
Figure 2. 57 : (a) new reinforced concrete buildings attached to the walls of Y.G.P.H. **(b)** the structural deformation at the column of the vault

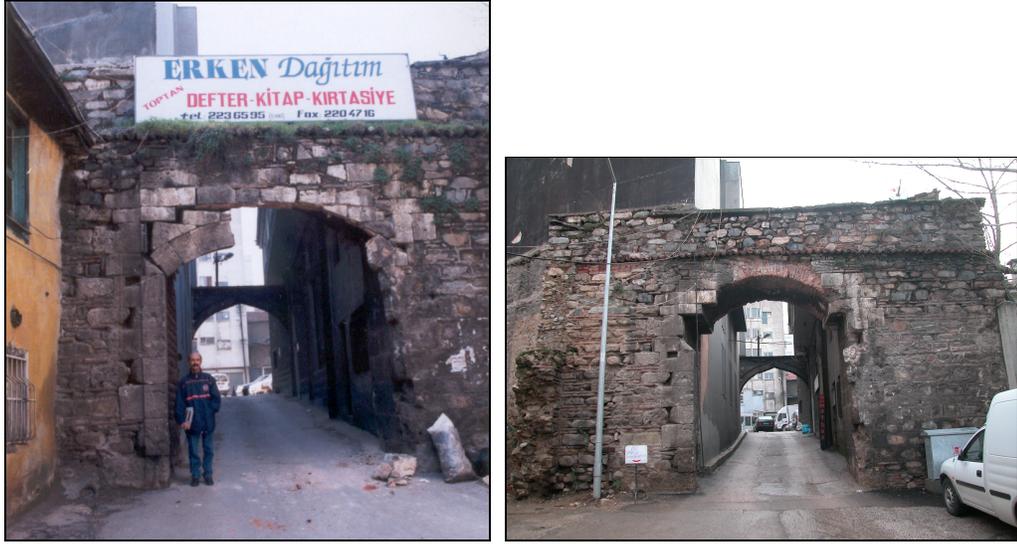
Figure 2. 58 : (a) the status of the north gate of Y.G.P.H. in 1995 (b) the current status of the north gate of Y.G.P.H. (2007)
