NON-DESTRUCTIVE EXAMINATION OF STONE MASONRY HISTORIC  
STRUCTURES – QUANTITATIVE IR THERMOGRAPHY AND  
ULTRASONIC TESTING

A THESIS SUBMITTED TO  
THE GRADUATE SCHOOL OF NATURAL AND APPLIED SCIENCES  
OF  
MIDDLE EAST TECHNICAL UNIVERSITY

SELEN AKEVREN

FEBRUARY 2010

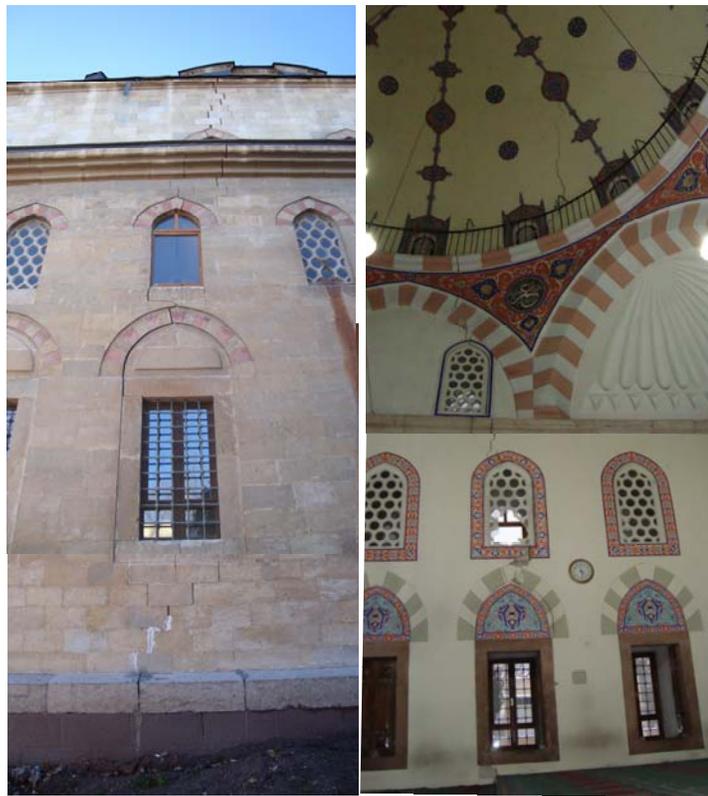
Figure 3.2 The exterior (at the left) and interior views (at the right) of crack on the east wall of structure.

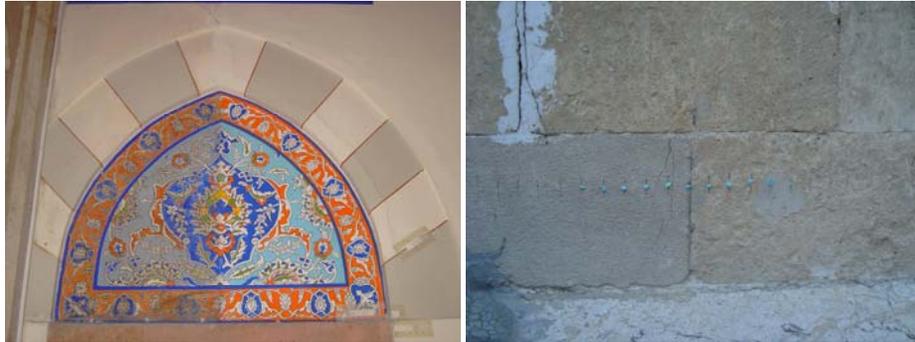
Figure 3.3 Interventions on wall paintings (at the left) and on exterior wall surfaces (at the right)

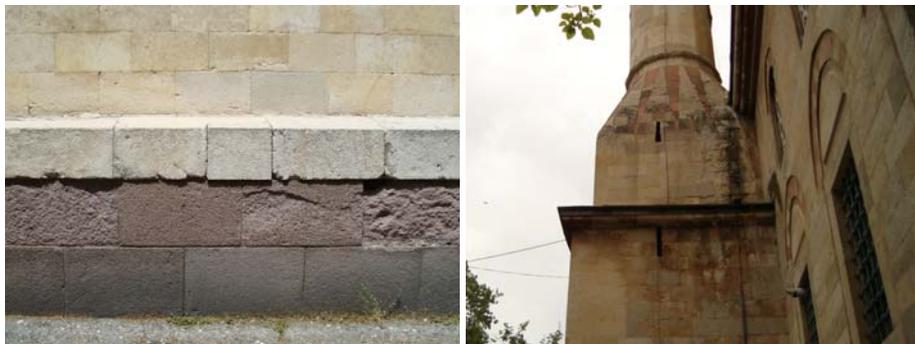
Figure 3.4 Partial view of deteriorations; material loss (at the left) and dampness problem (at the right)

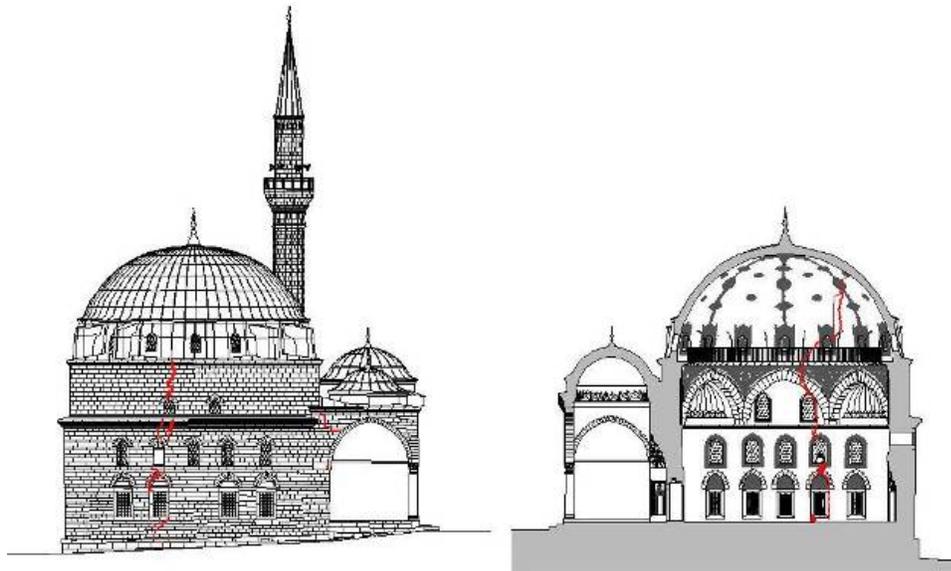
Figure 4.1 The exterior and interior elevations of the east façade, showing the route of the structural crack (in red) due to the differential settlement of the clayey ground.

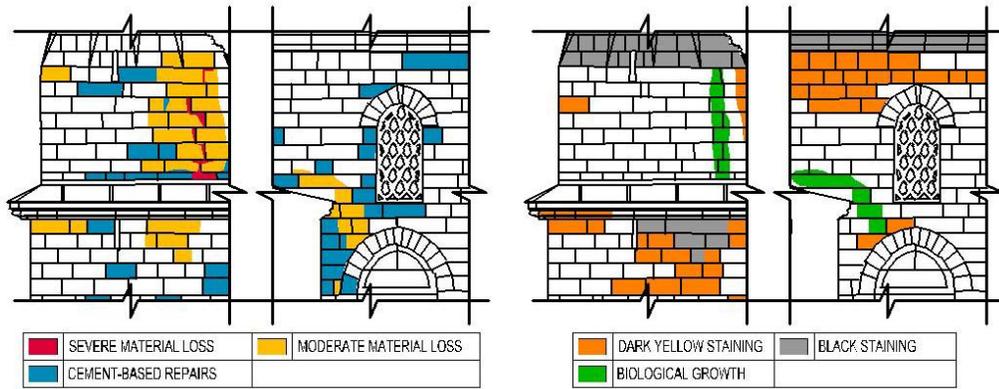
Figure 4.3 Partial elevation drawings for the exterior wall surfaces defined in Figure 4.2 showing the mappings of material loss and cement based repairs (at the left) and discoloration and deposits (at the right).

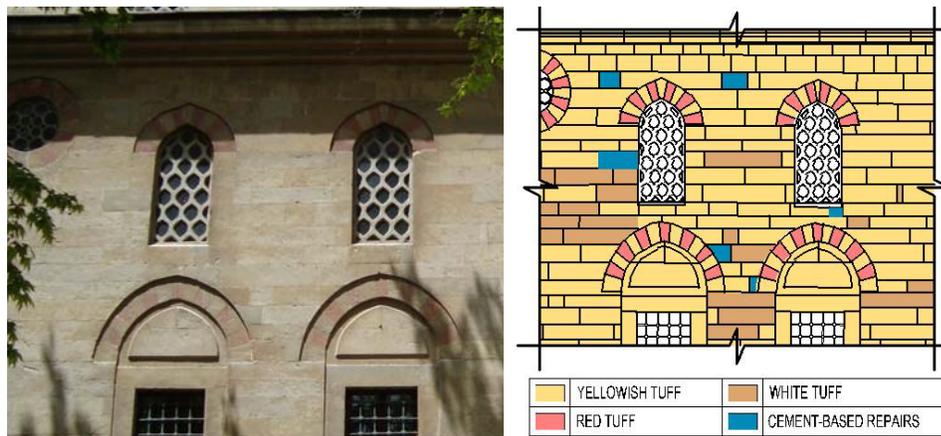
Figure 4.4 Partial view of exterior wall surface on south elevation (at the left) and mapping of selected region (at the right) showing the distribution of yellowish tuff, white tuff and red tuff on exterior wall surface together with the cement-based repairs.

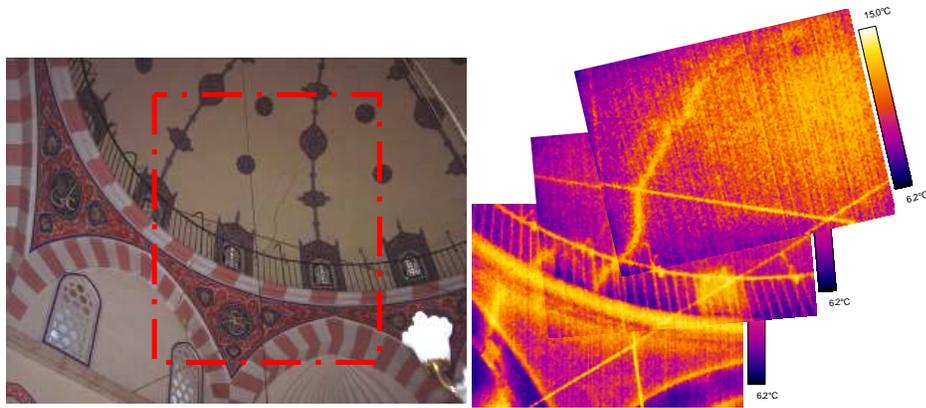
Figure 4.5 View of the structural crack passing through the transition elements and dome (at the left) and IR image of the selected region: The route of crack in IR images as a warmer wide path while it could not be followed clearly by eye.

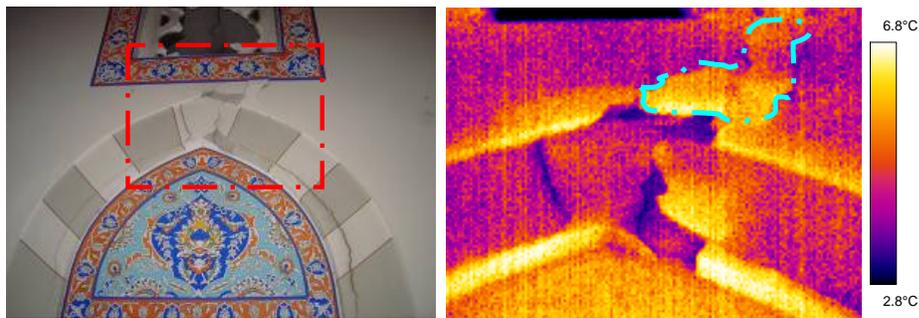
Figure 4.6 Partial view of the structural crack on the east wall (at the left) and the IR image of the selected region (at the right): The detached surfaces as warmer patches with heterogeneous temperature distribution while the deepest cracks were the coldest path in IR image.

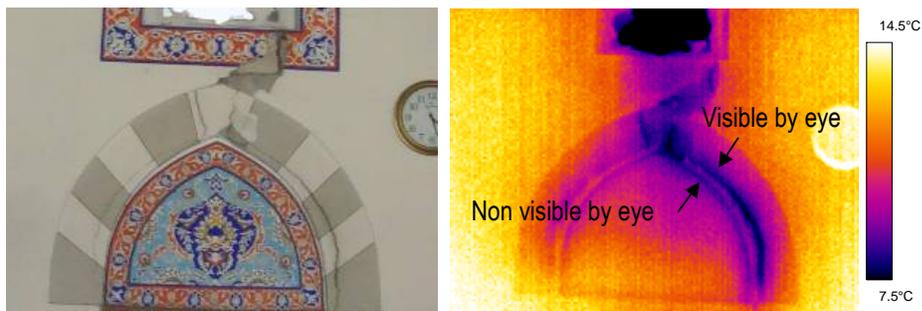
Figure 4.7 Partial view of the same region shown in Figure 4.6 taken eleven months later (at the left) and its IR image (at the right): The detached surfaces were lost (follow the blue circled area in Figure 4.6). The deepest crack following the arch was observed to have the coldest path. The non-visible deepest crack hidden behind the plaster layer was also detected in the IR image as the next colder path.

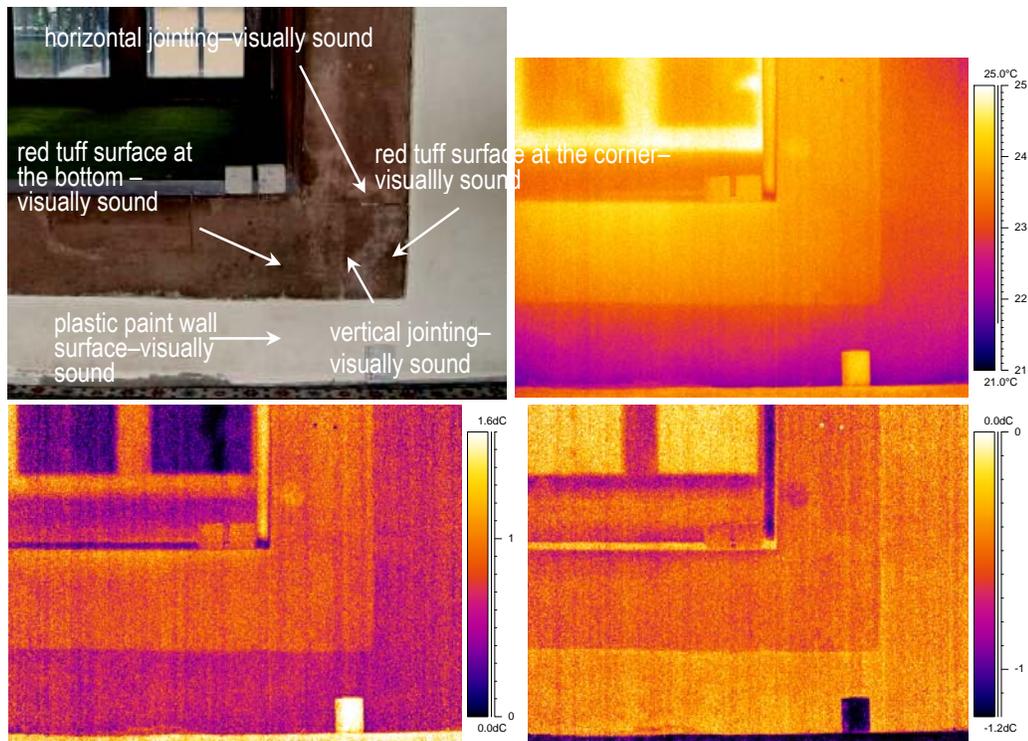
Figure 4.8 Partial view from the right bottom of window opening at the east side of the structure (at the top left), its IR image (at the top right); and the differential IR images of the heating period (at the left bottom) and the cooling period (at the right bottom).

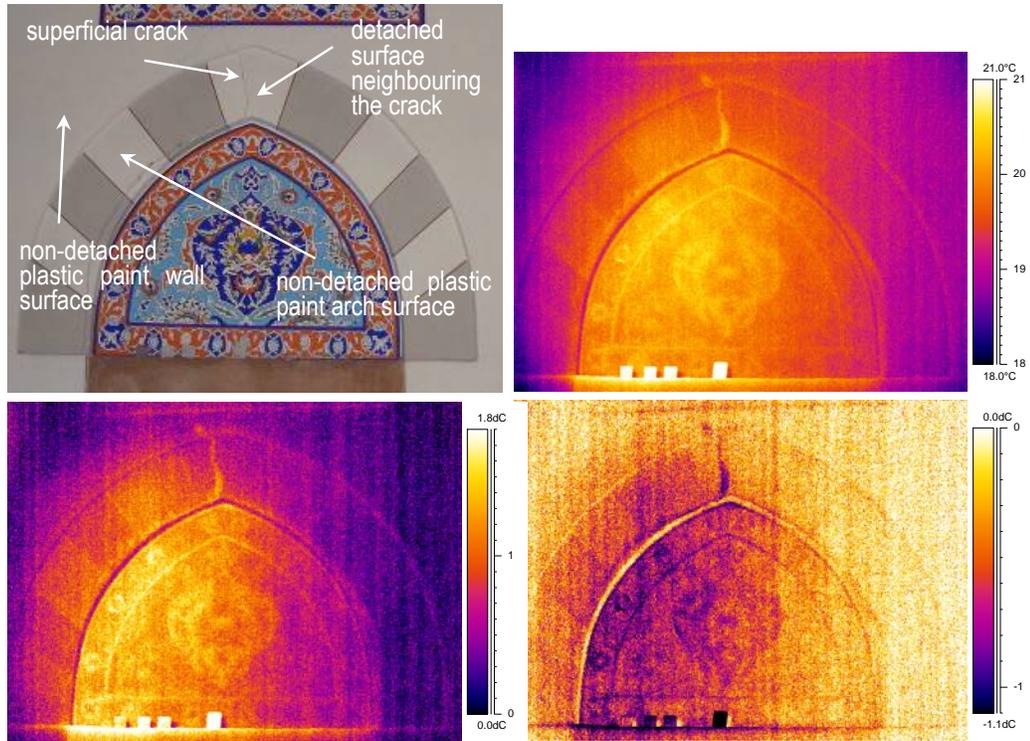
Figure 4.11 Partial view from a window arch located at the south of the structure (at the top left), its IR image (at the top right); and the differential IR images of the heating period (at the left bottom) and the cooling period (at the right bottom).

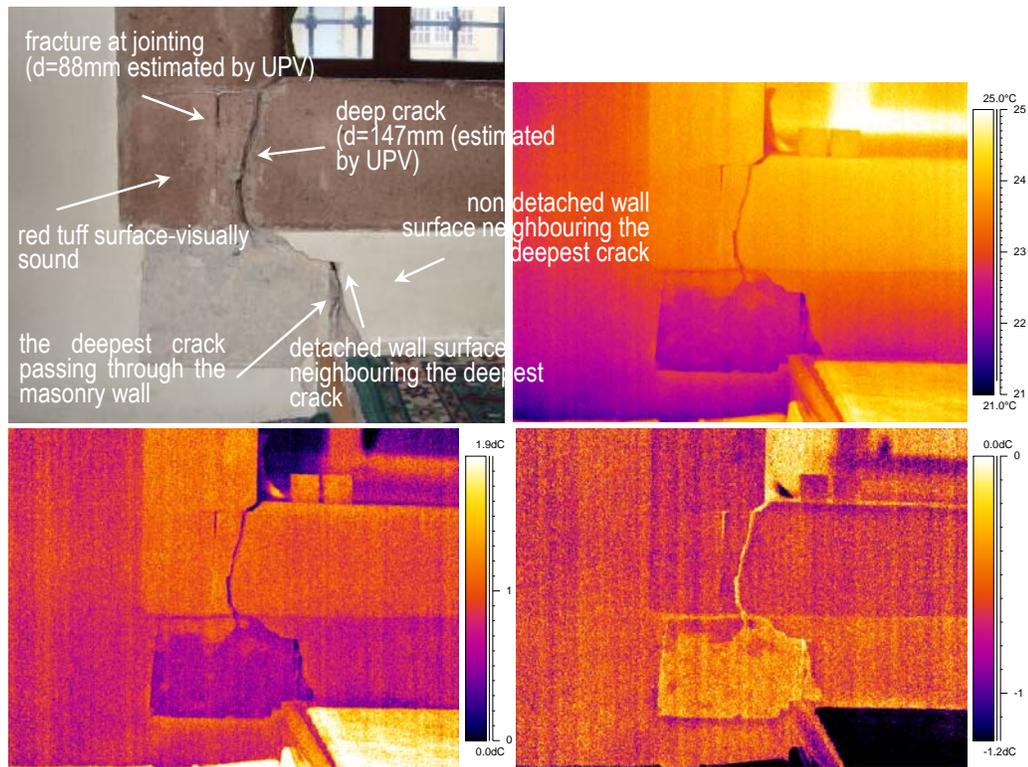
Figure 4.14 Partial view from the left bottom of window opening at the east side of the structure (at the top left); its IR image (at the top right); and the differential IR images of the heating period (at the left bottom) and the cooling period (at the right bottom).

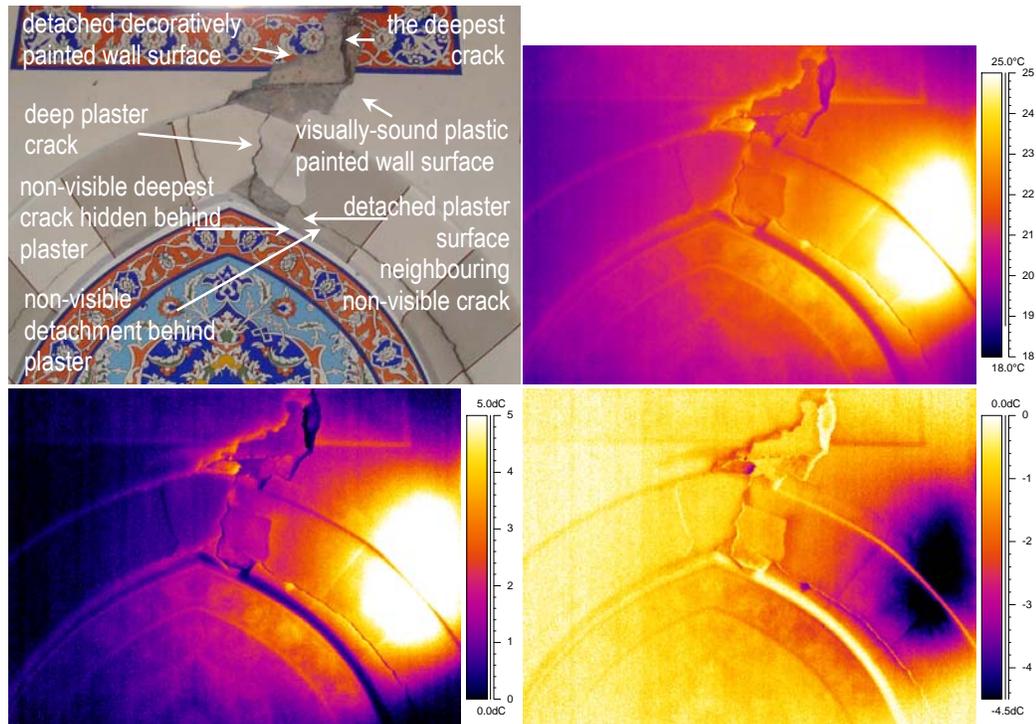
Figure 4.19 Partial view from a window arch located at the east of the structure (at the top left), its IR image (at the top right); and the differential IR images of the heating period (at the left bottom) and the cooling period (at the right bottom).

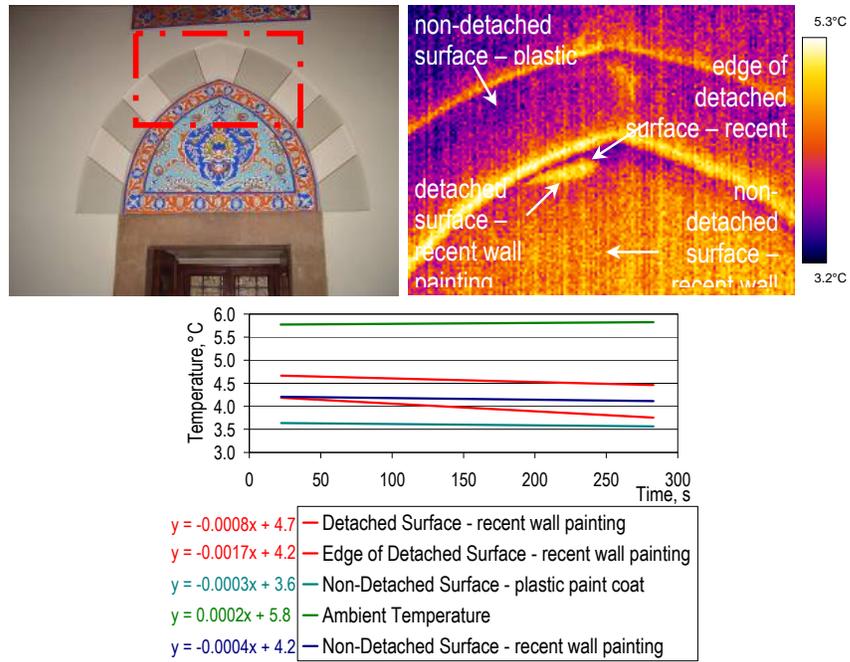
Figure 4.26 Partial view from a window at the west side of the structure (at the top left), the IR image of selected region (at the top right), and the surface temperature curves versus time during the cooling period (at the bottom): Non-visible detached surface, which was detected in the IR image as a warmer patch, cooled down faster than the non-detached surfaces while the fastest cooling was observed at the edge of the detachment. The wall surfaces were colder than the ambient temperature while the plastic paint coated surfaces were the coldest.

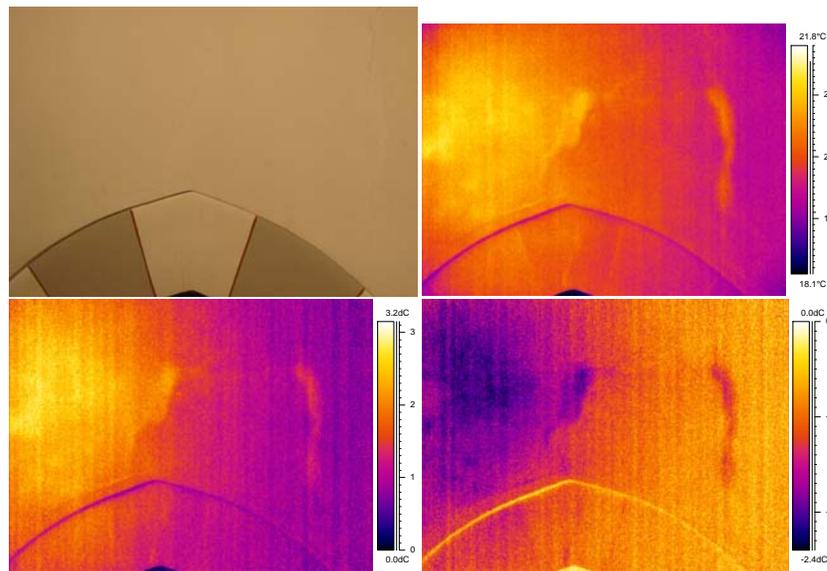
Figure 4.27 Partial view from the wall surface of second floor at the north side of the structure (at the top left), its IR image (at the top right); and the differential IR images of the heating period (at the left bottom) and the cooling period (at the right bottom).

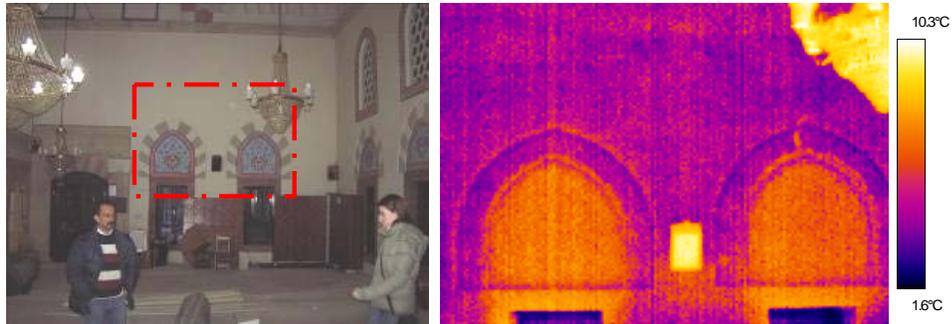
Figure 4.29 Partial view from the north wall of the structure (at the left) and the IR image of the selected region: The decoratively-painted wall surfaces were slightly warmer than the plastered wall surfaces coated with white plastic paint

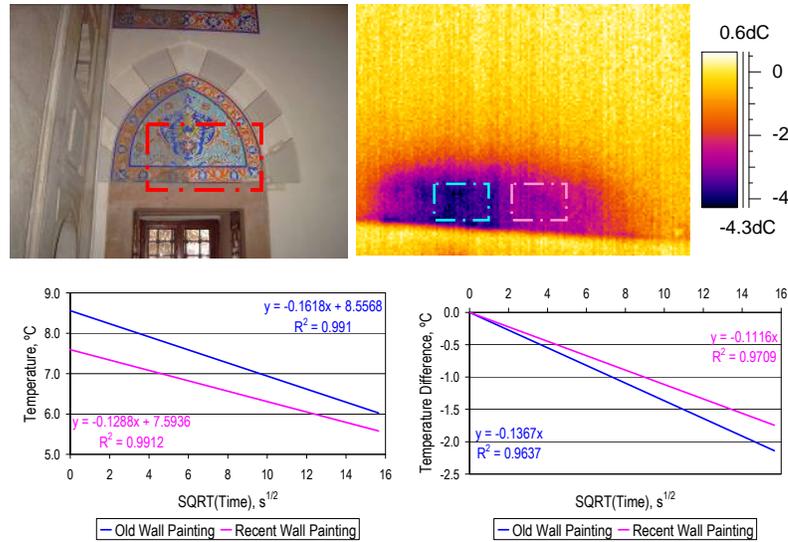
Figure 4.31 Partial view of old and recent wall paintings on the south wall (at the top left), the differential IR image of the selected region during the cooling period (at the top right), the linear fitting of surface temperatures and temperature difference versus square root of time during the cooling period (at the bottom): the old wall painting surfaces cooled down faster than the recent wall painting surfaces.

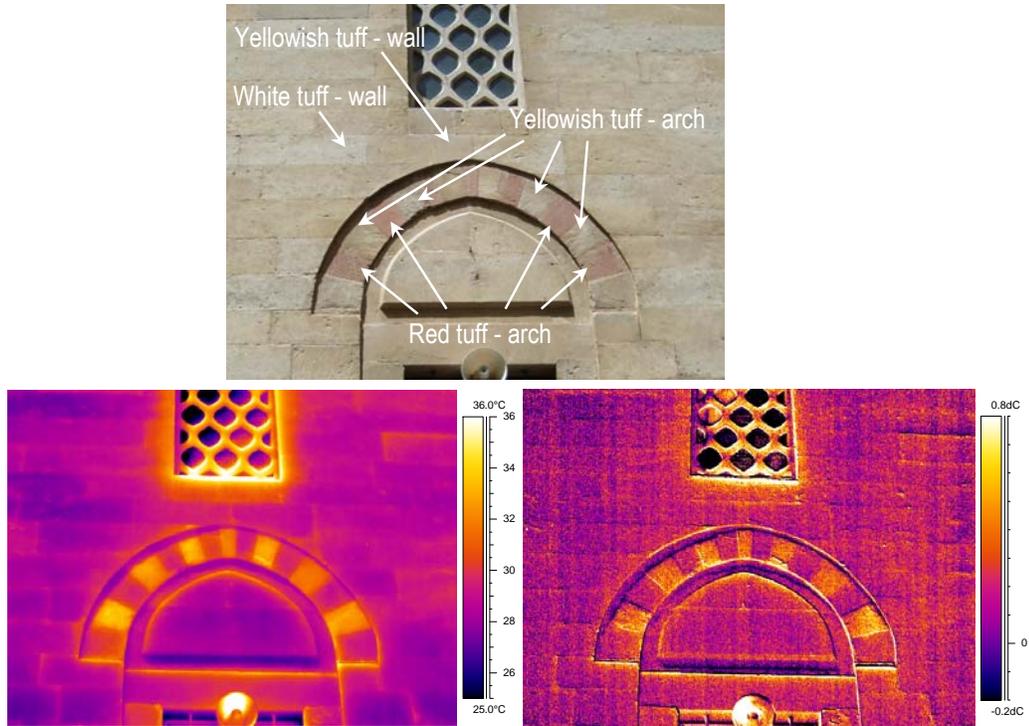
Figure 4.32 Partial view of exterior wall surfaces at south side (at the top), its IR image (at the left bottom); and the differential IR image of the heating period (at the right bottom).

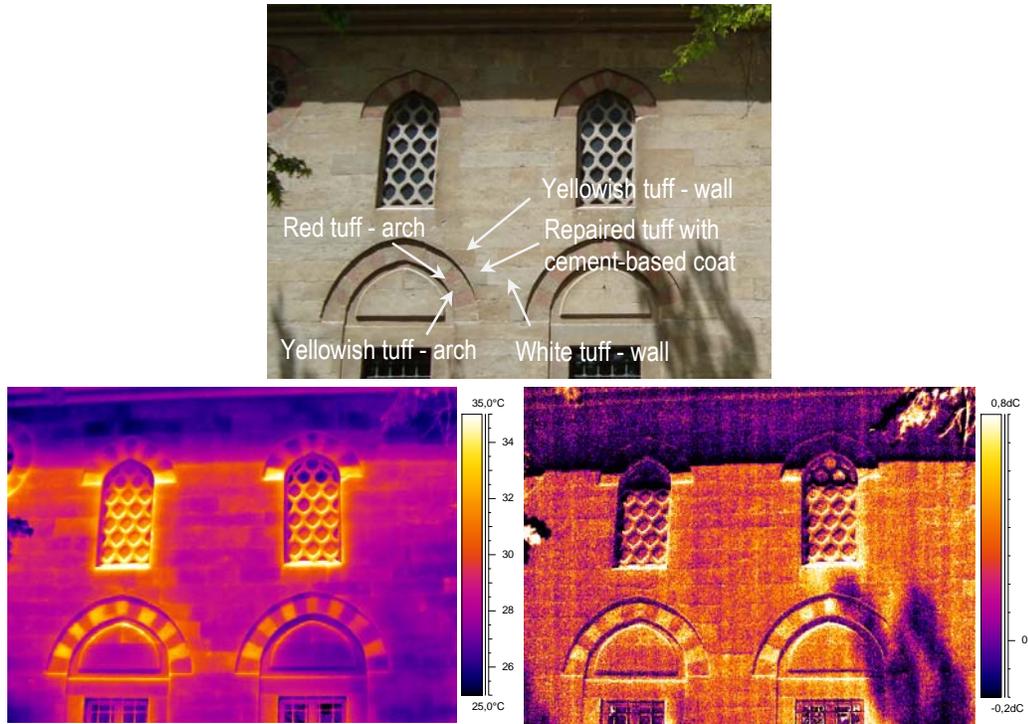
Figure 4.34 Partial view of exterior wall surfaces at south side (at the top), its IR image (at the left bottom); and the differential IR image of the heating period (at the right bottom).

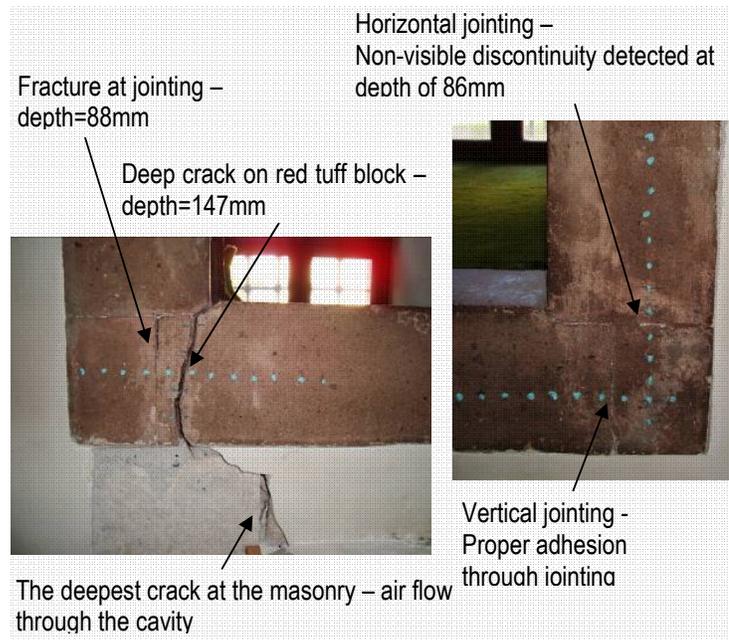
Figure 4.40 The close views of structural cracks and jointings on red tuff blocks at the left and right bottom corners of window niche examined *in-situ* by using QIRT and ultrasonic testing.
