VERNACULAR TIMBER HOUSES OF UZUNGÖL:
EXAMINING / ANALYZING THEM IN THEIR RE-FUNCTIONING PROCESS

A THESIS SUBMITTED TO
THE GRADUATE SCHOOL OF NATURAL AND APPLIED SCIENCES
OF
MIDDLE EAST TECHNICAL UNIVERSITY

IN PARTIAL FULFILLMENT OF THE REQUIREMENTS
FOR
THE DEGREE OF MASTER OF SCIENCE
IN
RESTORATION IN ARCHITECTURE

FEBRUARY 2012

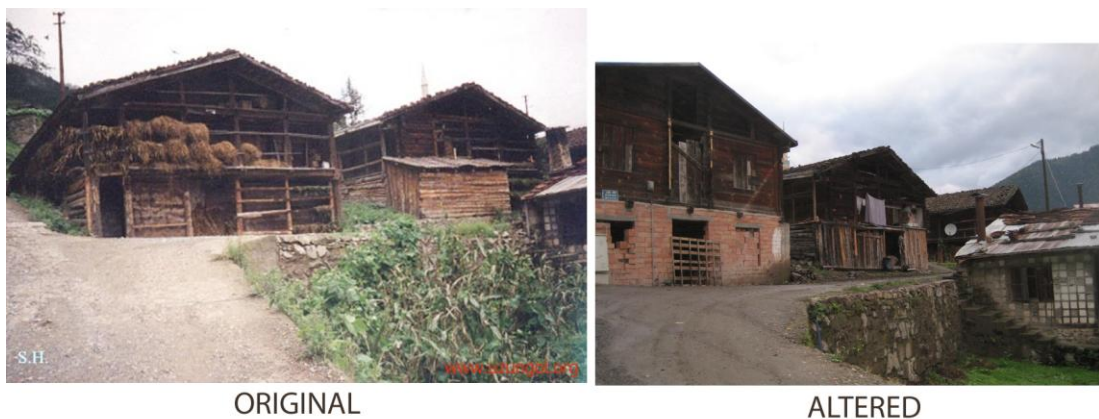
Figure 43, Original and Altered View of Some Vernacular Houses in the Study Area

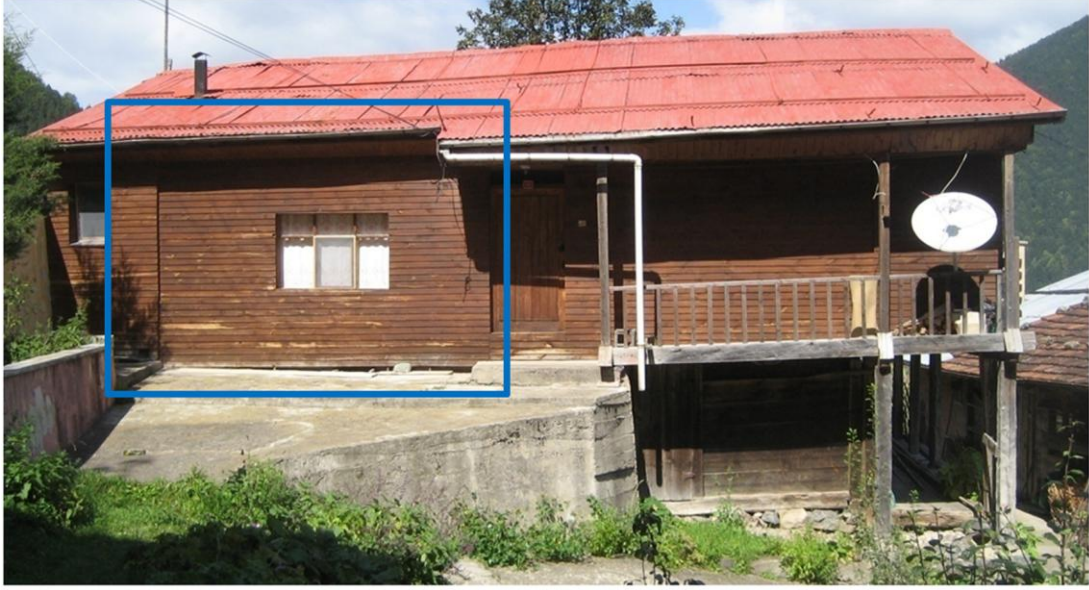
According to the analyze of the façade coverings that is made of new timber in the study area after the evaluation of materials used, structural system and taken information from the occupants, it is considered that type of additions have been applied in the last 10 years.

Figure 50, Addition of New Timber Covering to the Façade

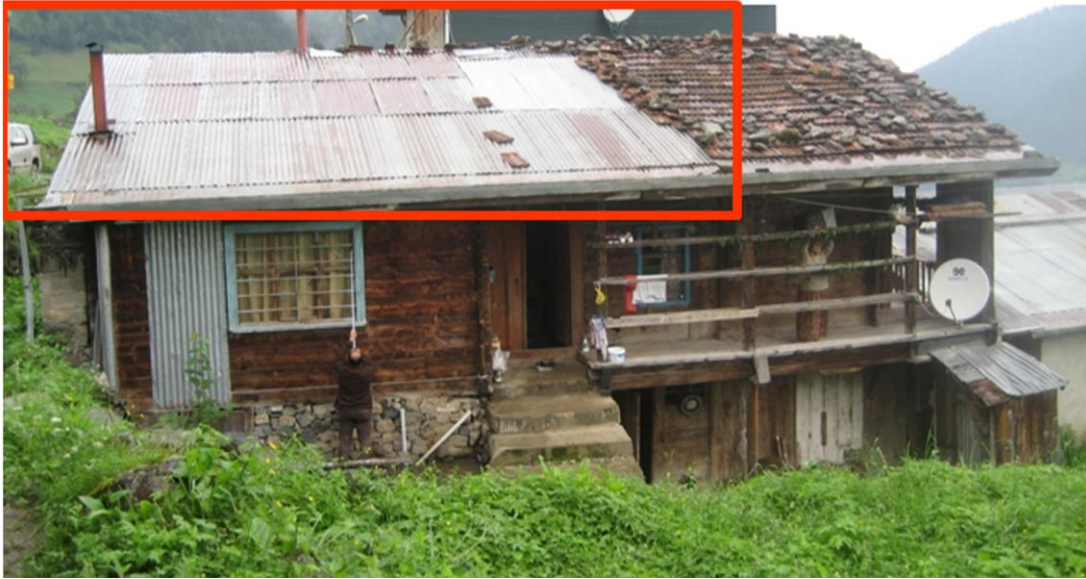
In some of the houses, it is seen that some tiles at roofs have been removed in the study area (see Figure 53). Type of removed tiles is over&under tile (mission tile or alaturca tile) in the buildings. The number of roof tile removals in all removals places a big amount that the number of application is 14 and the total number of removals is 17. In this type of intervention, there are two different situations seen at the buildings. At first one, the roof tiles are removed and original roof is covered with corrugated metal panel. At the second one, the removal of some tiles is for a repair at a certain section at roof. According to the analyze of the removing of a part of the tiles at roofs in the study area after the evaluation of the condition of the remaining tiles, the condition of the corrugated metal sheet that is an alternative covering material under the tiles and taken information from the occupants, it is considered that type of removals have been applied in the last 5 years.

Figure 53, Removal of Some of Roof Tiles

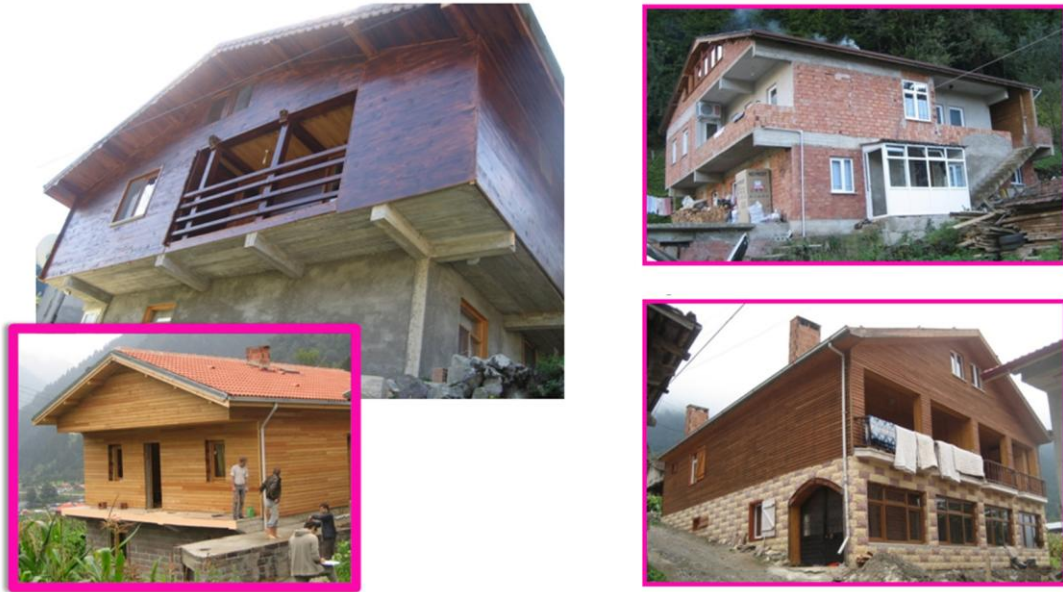
According to the analyze of the reconstruction of the buildings in the study area after the evaluation of materials used, structural system and taken information from the occupants, it is considered that type of alteration has been applied in the last 5 years.

Figure 54, Alteration of Whole Building

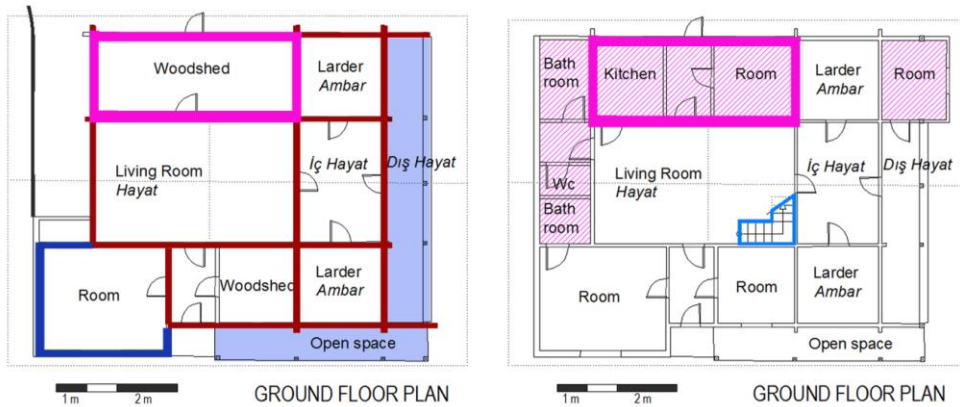
According to the analyze of the alteration of woodsheds that have been divided and arranged as one kitchen and one room in the study area after the evaluation of materials used, structural system and taken information from the occupants, it is considered that type of alterations have been applied in the last 10 years.

Figure 55, Alteration of the Space that Woodshed has been Turned into a Kitchen and a Room

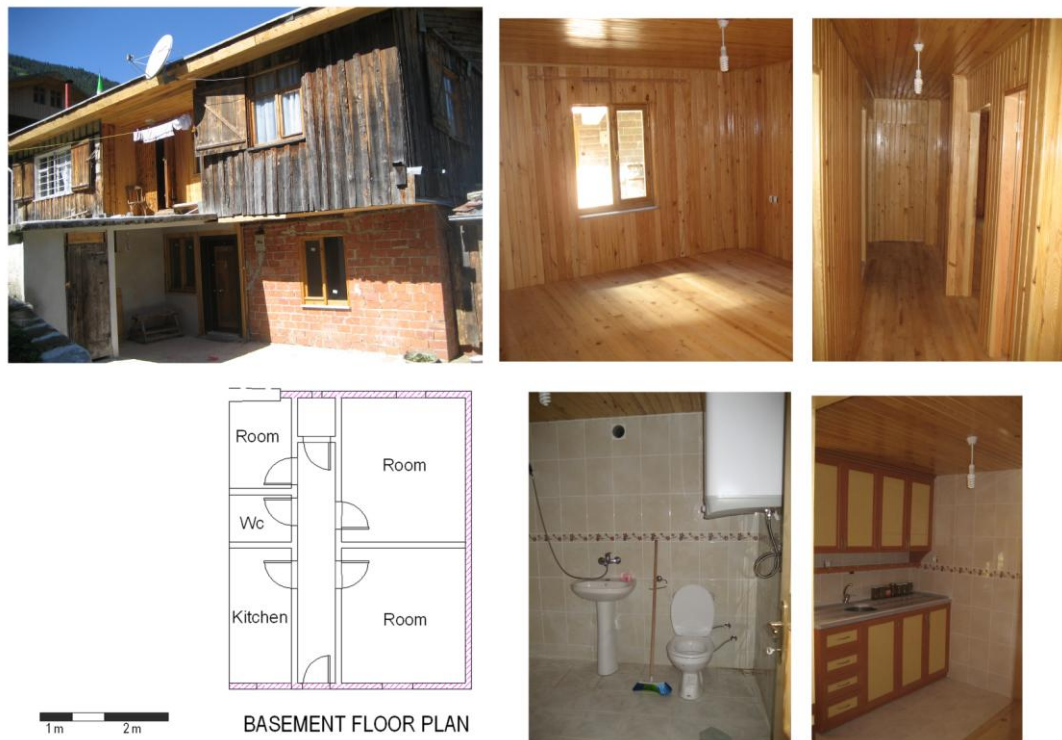
Figure 62, Alteration of Space that Basement Floor Spaces have been Re-Arranged as Living Spaces or Accommodation Units.

In the 5 of the space alterations applied to the houses in the study area, it is seen that the spaces, which functioned originally as stable and woodshed at the basement floor, have been rearranged and turned to living spaces or accommodation units (see Figure 62). Preserved the outer boundaries of the basement floor, it is seen that the original structural system has been replaced with reinforced concrete frame at the basement floor⁶¹. At the new basement floor, the spaces have been refunctioned as additional living spaces or as accommodation units depending on the necessities. The altered spaces have window additions at the outer facade walls in order to benefit from daylight. No façade order is considered in positioning the windows. According to the analysis of these space alterations in the basement floor spaces in the study

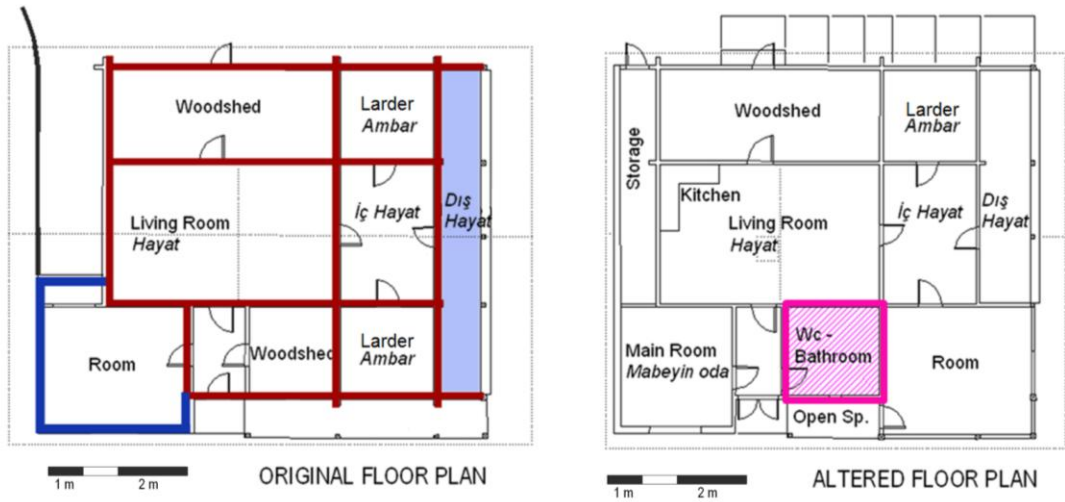
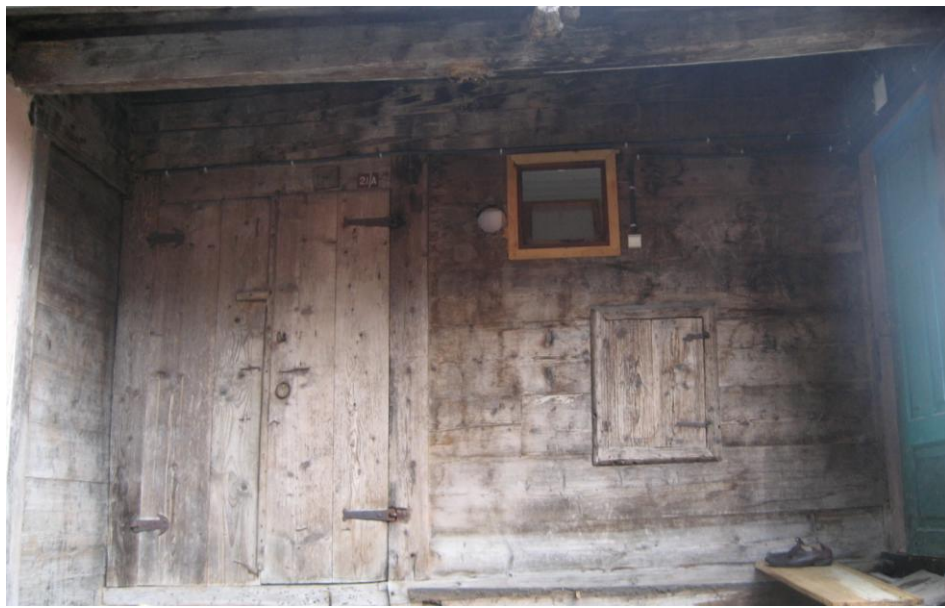
According to the analysis of these space alterations, after the evaluation of materials used, positioning and taken information from the occupants, it is considered that type of additions have been applied in the last 5 years.

Figure 63, Alteration of Space that Woodshed has been Re-Arranged as Wet Spaces

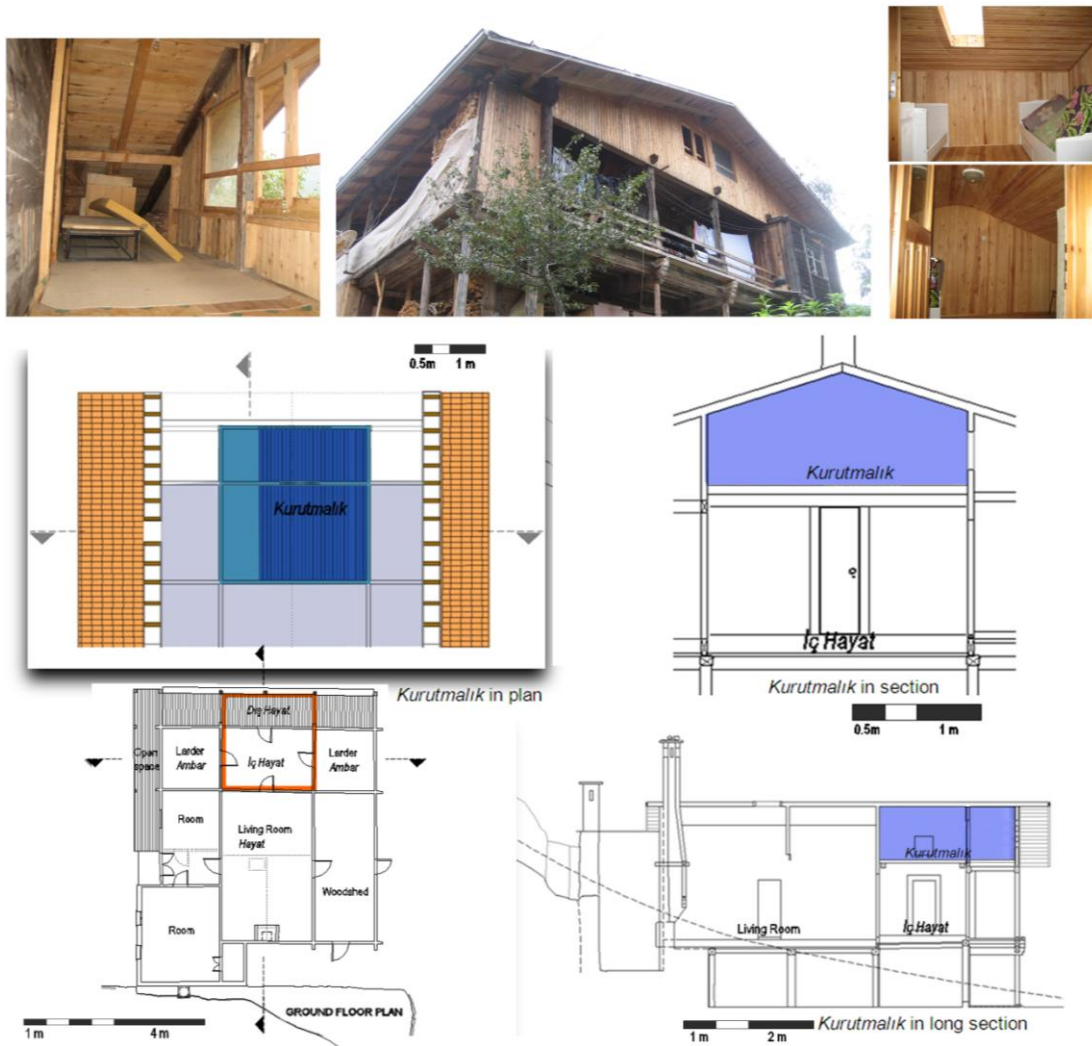
Figure 65, Alteration of Space that *Kurutmalık* has been Re-arranged and Turned to a Room.

According to these space analysis in the study area, after the evaluation of materials used, structural system and taken information from the occupants, it is considered that type of alterations have been applied in the last 5-10 years.

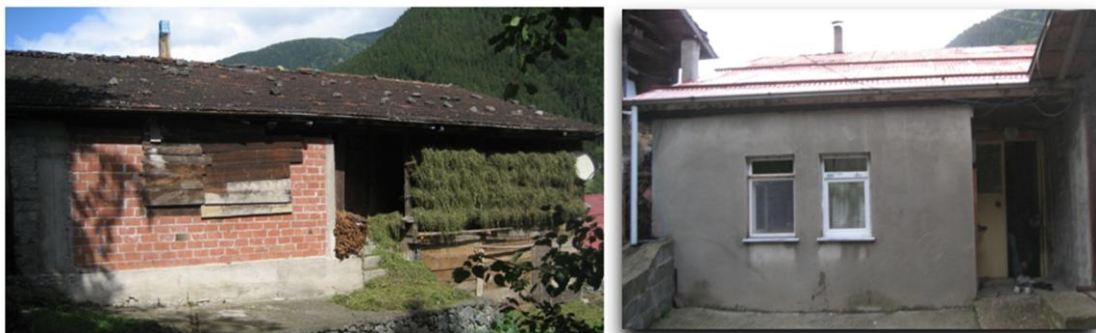
According to the analysis of the renewals of some sections of the houses in the study area; after the evaluation of materials used, structural system and taken information from the occupants, it is considered that type of alterations have been applied in the last 5 years.

Figure 68, Replacement of the Original Parts of the Building With Reinforced Concrete System Brick Wall

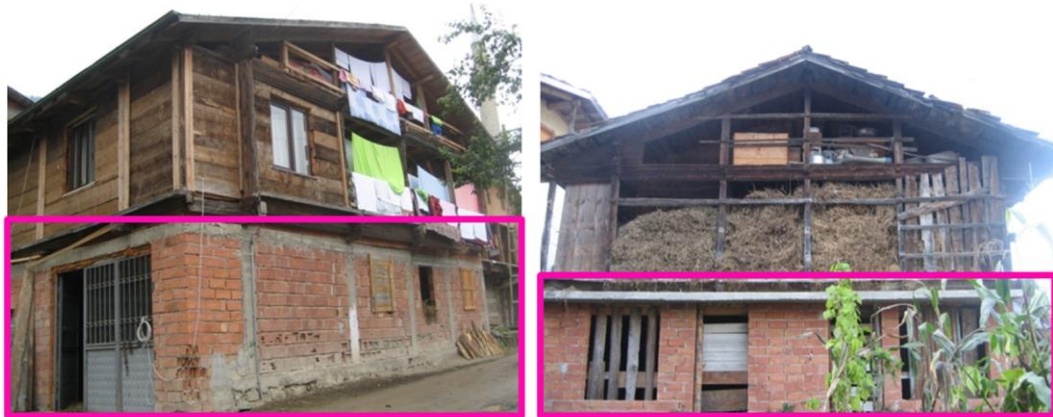
According to the analysis of the renewal of the structural system at the basement floor in the study area, after the evaluation of materials used, structural system and taken information from the occupants, it is considered that type of alterations have been applied in the last 5 years.

Figure 69, Alteration of the Masonry System of the Basement Floor With Reinforced Concrete System Brick Wall

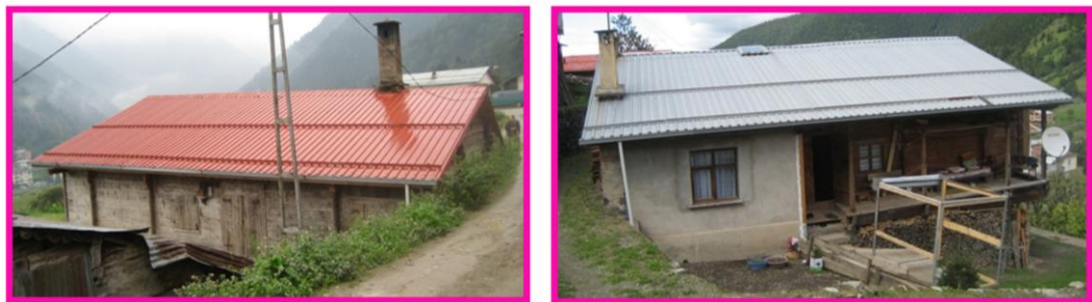
According to the analysis of the alterations of some roofs in the study area, after the evaluation of materials used, structural system and taken information from the occupants, it is considered that type of additions have been applied in the last 5 years.

Figure 71, Renewal of the Roof With New Material

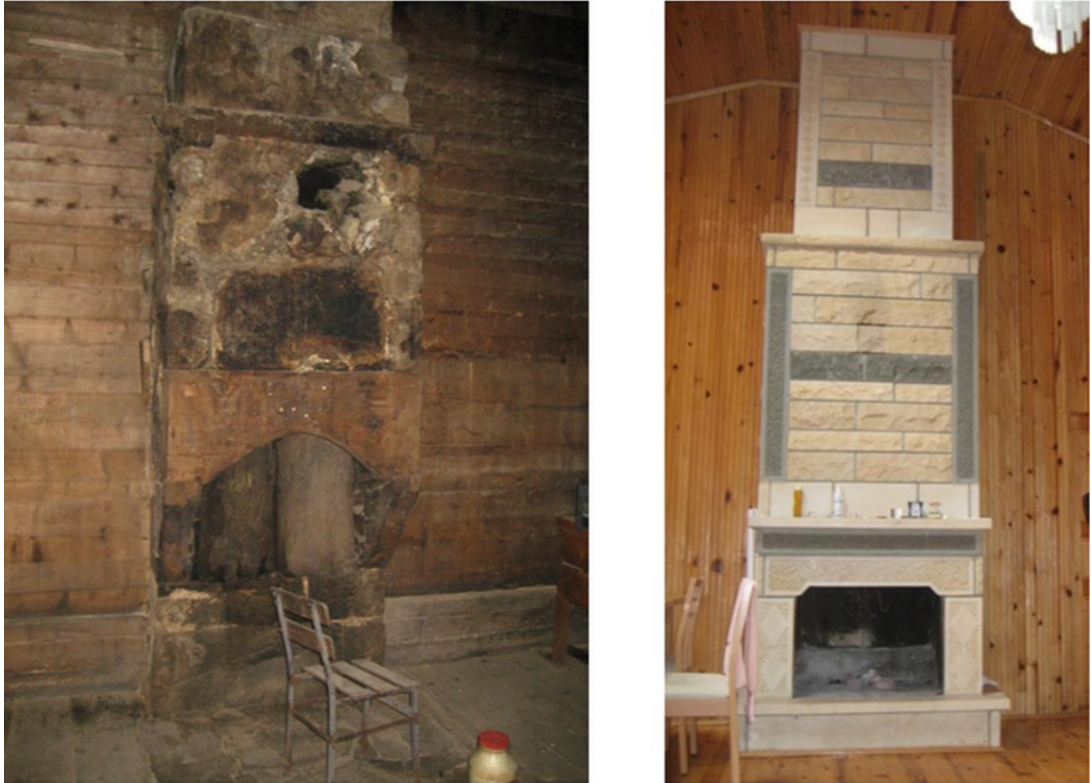
Figure 72, Replacement of the Original Fireplace With New One

In the 4 of the architectural element alterations applied to the houses in the study area, it is seen that the original fireplace in the living space (*hayat*) has been renewed (see Figure 72). The original fireplaces have been completely renewed with using new material preserving original location and original dimensions. Fire places are masonry bond of brick and are covered with artificial stone. The altered fireplaces are used differently in function from the original. No cooking is at the new ones, but heating.

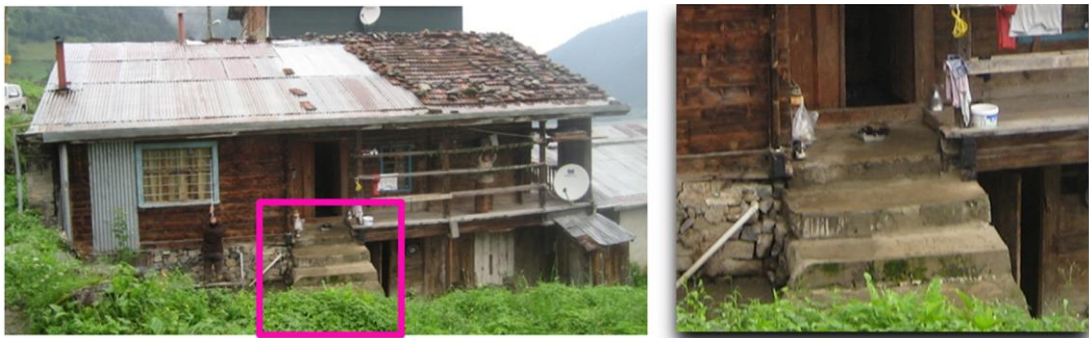
According to the analysis of the architectural element alterations in the study area, after the evaluation of materials used, structural system and taken information from the occupants, it is considered that type of alterations have been applied in the last 20 years.

Figure 73, Replacement of the Original Stone Based Stair With Concrete One

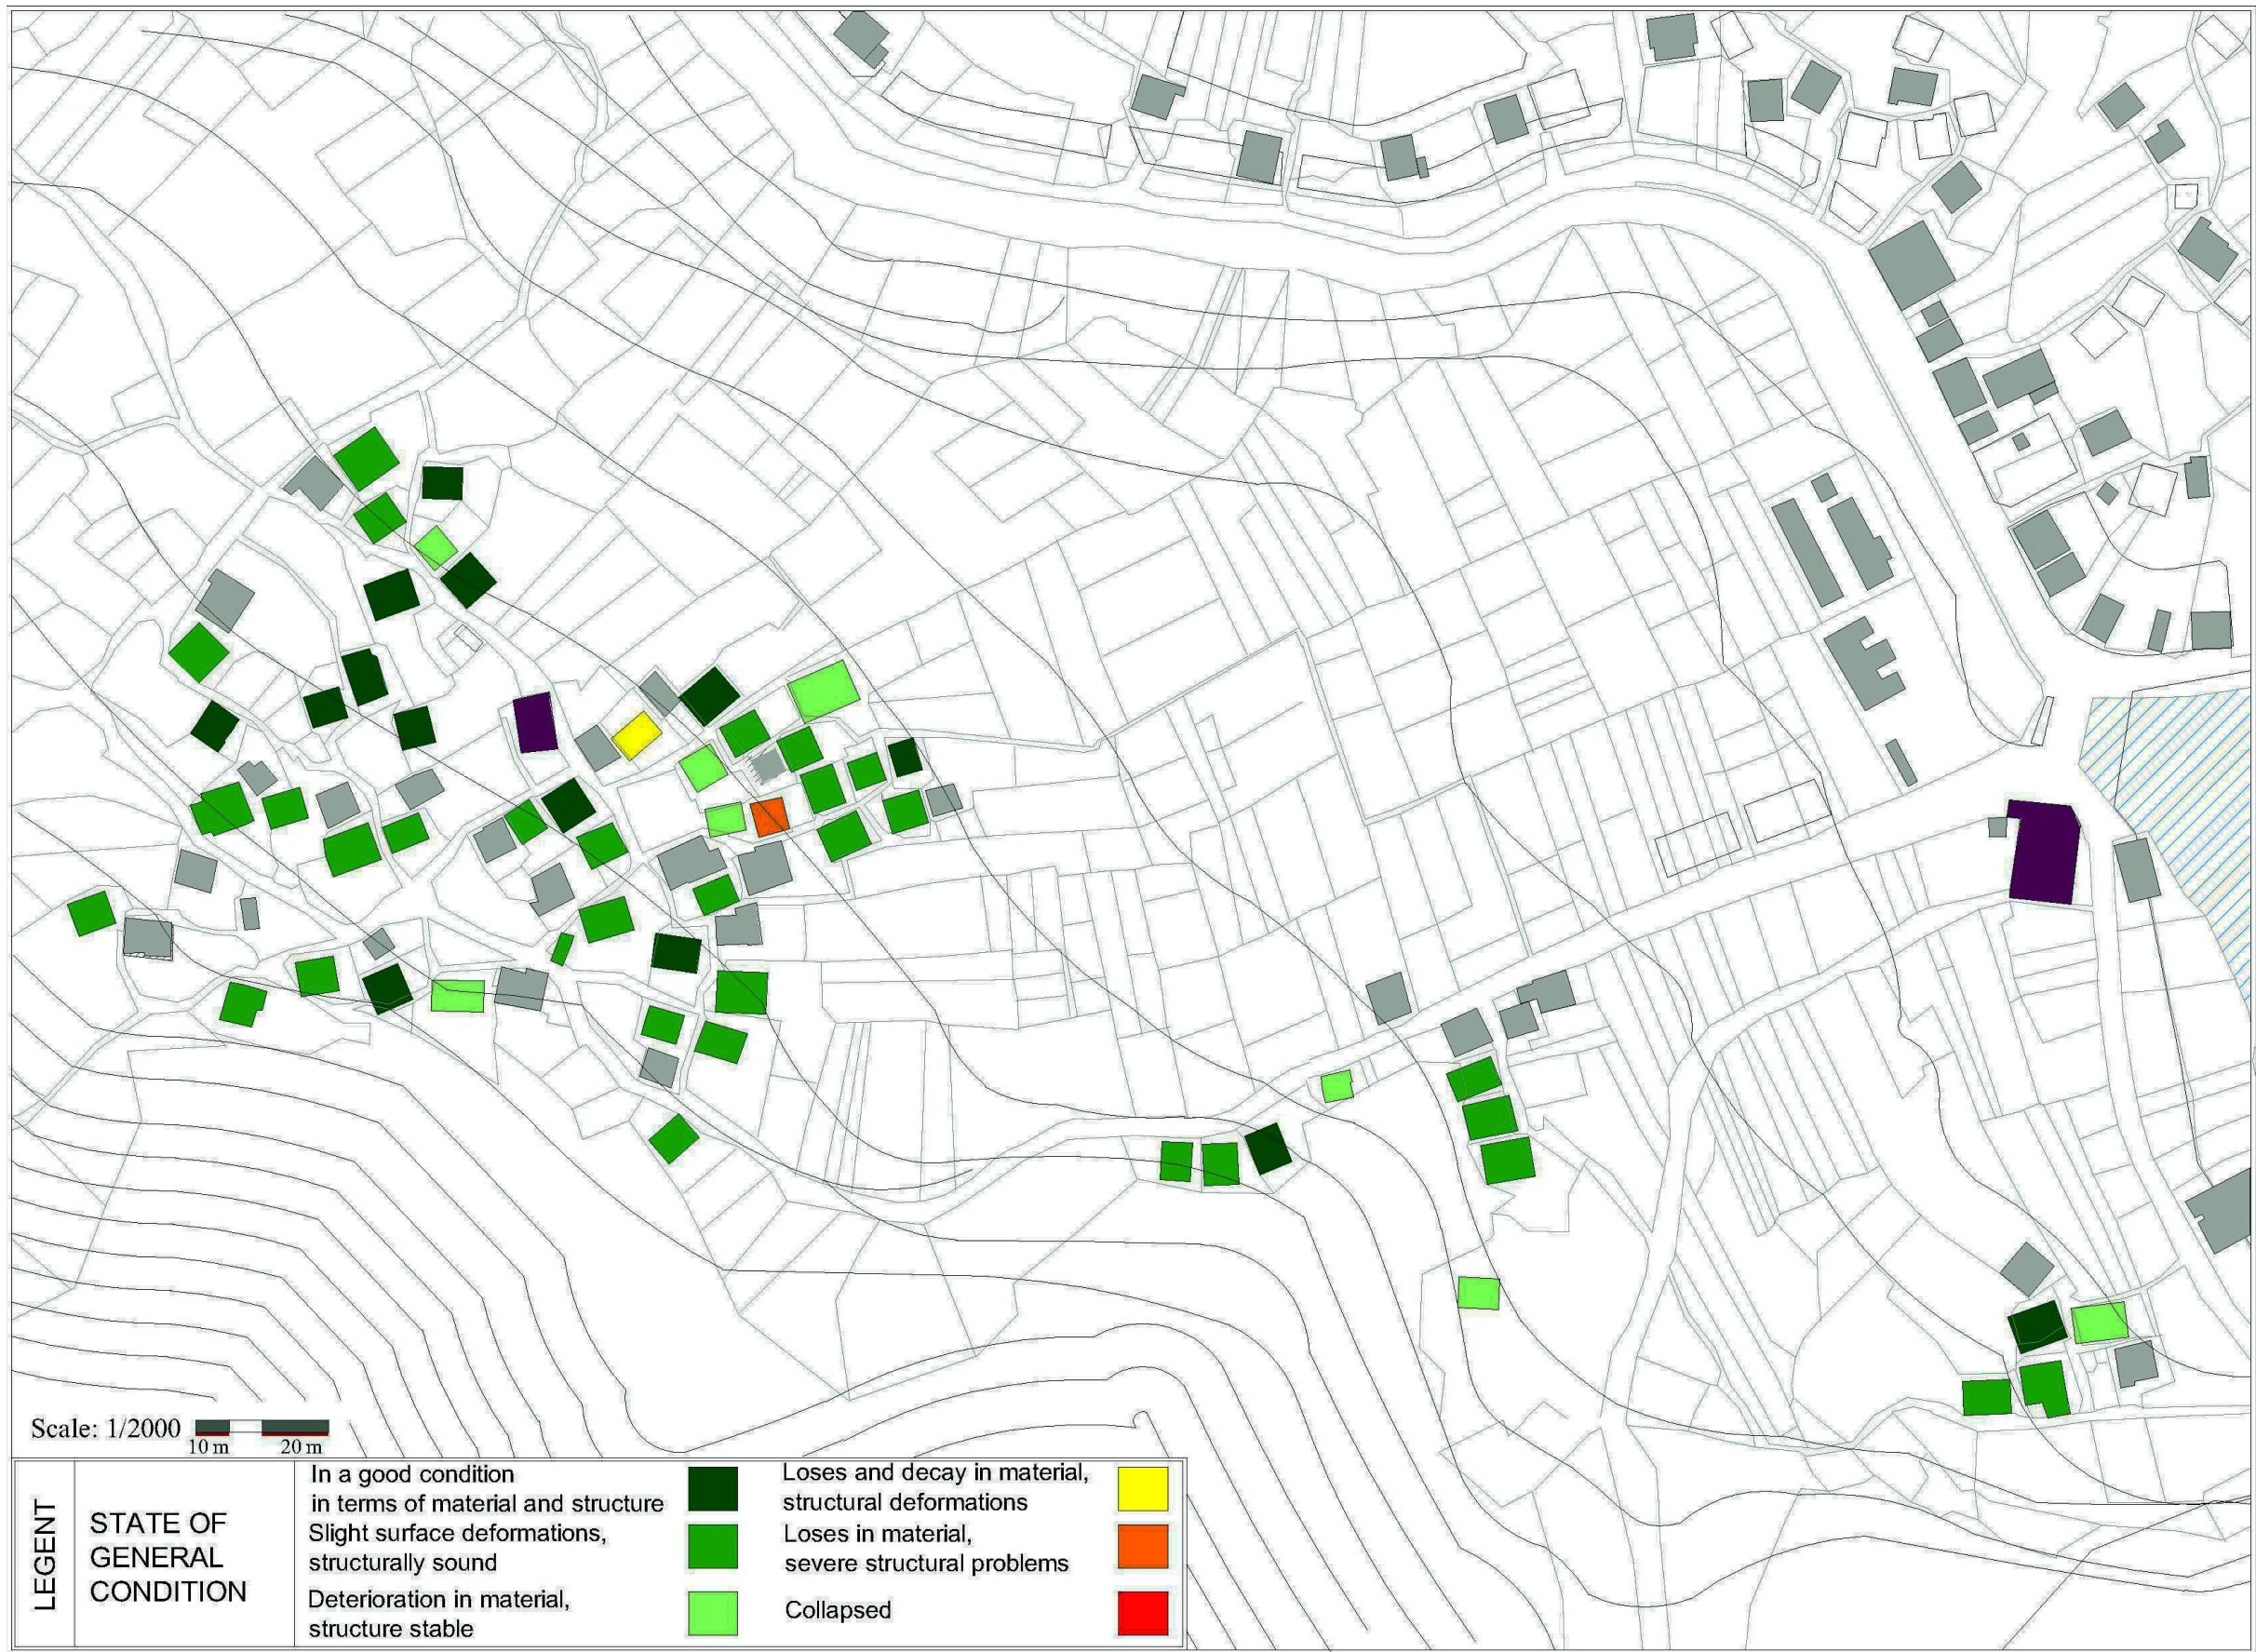
Figure 141, General Condition of the Buildings in the Study Area
