CONSERVATION PROPOSAL OF AN EARLY REPUBLIC PERIOD BUILDING:
ATATÜRK ORMAN ÇİFTLİĞİ HAMAMI

A THESIS SUBMITTED TO
THE GRADUATE SCHOOL OF NATURAL AND APPLIED SCIENCES
OF
MIDDLE EAST TECHNICAL UNIVERSITY

BÜŞRA KUL

FEBRUARY 2012

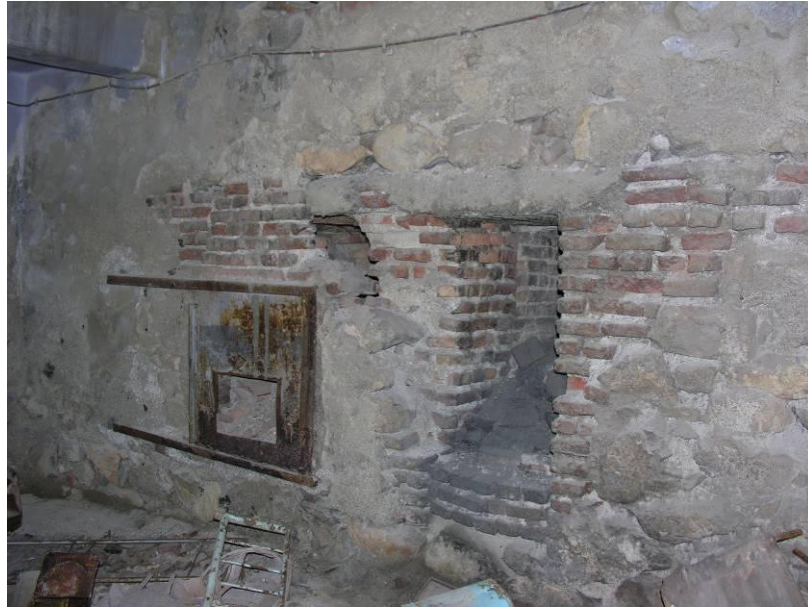
It's seen that the space next to "sıcaklık" was designed to place heating and water system mechanism. The place of the water tank can be observed today. Also it can be seen that there is a canal embedded in slab in which hot air is transferred. On the other hand, a radiator type heating system can also be observed by traces on wall surfaces. In that respect, it can be said that these two system were being used together.

Figure 19 - Heating system, canals going through the slab of "sıcaklık" space (author,2011)

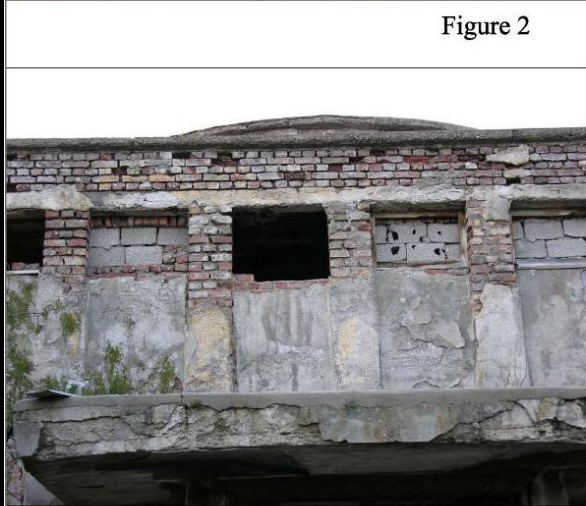
<p data-bbox="931 1650 1020 1677">Figure 3</p>	<p data-bbox="1074 963 1513 1415">There are structural problems, material loss and deterioration on surface. The stair in front of the entrance is broken from three part and the covering terracotta finishing is detached from several parts(Figure 2). Also the side walls of the entrance stair are partially collapsed from upper courses. Infilling of the openings, plaster loss, window and door frame loss and loss of some brick courses are the types of material losses that are determined on this facade.(Figure 1,2,3) Detachment of plaster layers can also be seen especially on surfaces at first floor level. At the south side of the projected part, concrete window sills are deformed and broken at some parts.</p>

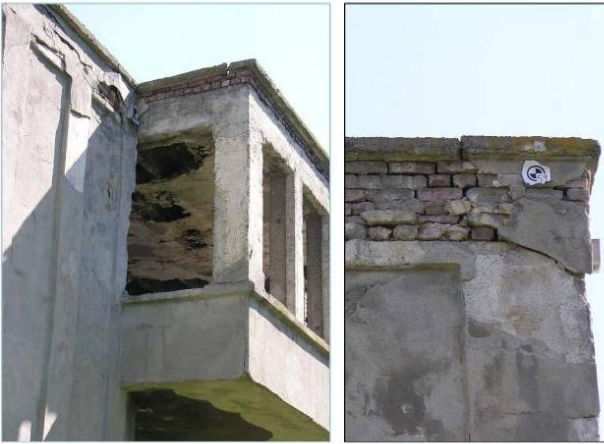
<p data-bbox="1703 1661 1792 1688">Figure 6</p> <p data-bbox="1970 1661 2059 1688">Figure 7</p>	<p data-bbox="2122 821 2561 1050">Loss of plaster and detachment of plaster are the problems that are expanded on whole surface. At the north side of the projected part concrete window sills are deformed and broken at some parts. Also a brick course of parapet is lost above projected parapet and loss of plaster above parapet can be observed.</p>

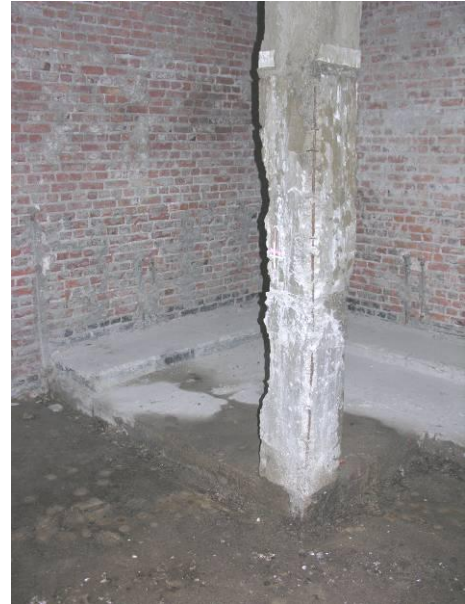
Figure 52 - Fragmentation and corrosion problem of the column (author,2010)

Main problem of the columns today is fragmentation and as a result corrosion of reinforcing bars. (Figure 51,52)

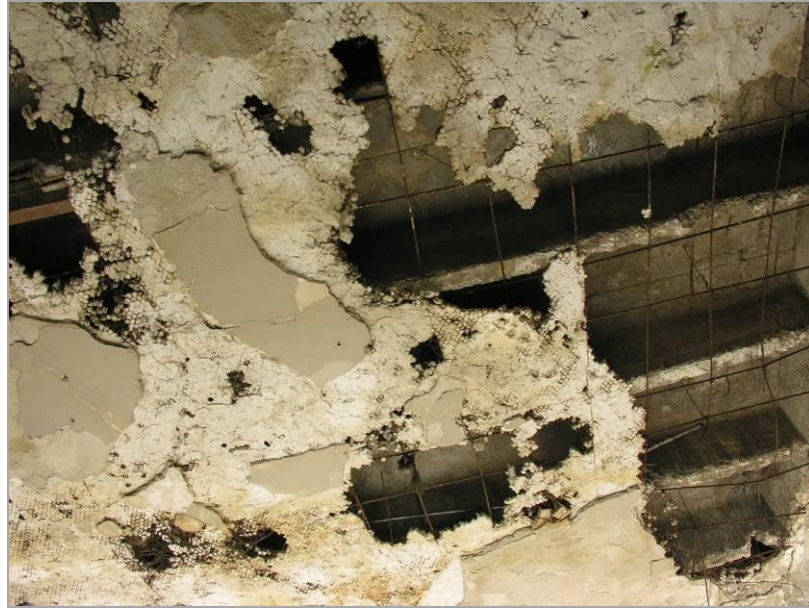
Figure 60 –Suspended ceiling in space F-02(author,2010)

The suspended ceiling in space F-02 is formed by using pebble aggregated mortar over a metal hexagon gauze and hanged on ceiling with wire mesh reinforcement and metal bars. (Figure 60)This can be seen as an early application of a suspended ceiling and an innovation considering the time period that Hamam was constructed.

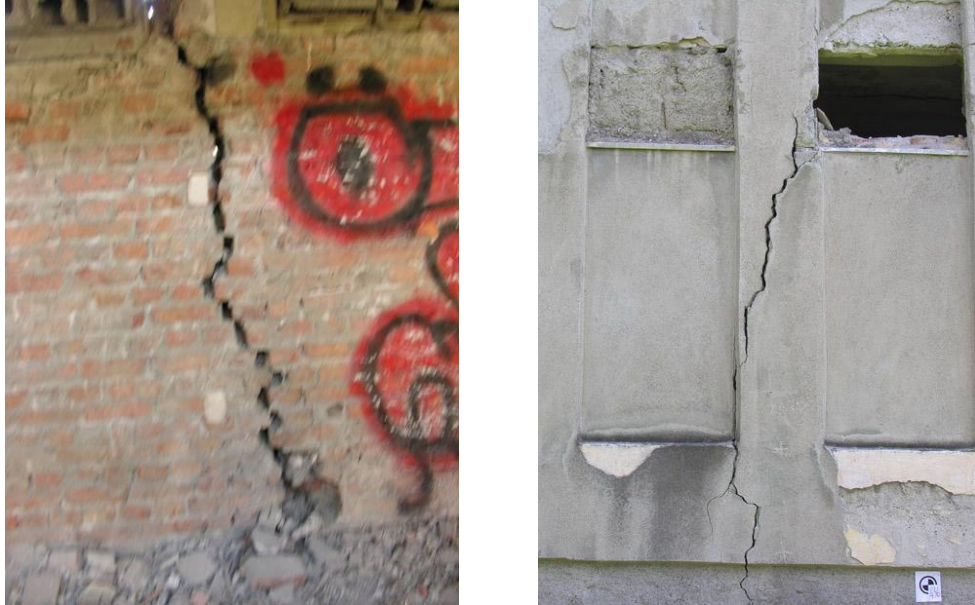
Most serious problem of the Hamam is the structural problems. There are structural cracks in space G-01 starting from basement and continues through +2.00 m level at east and west walls. (Figure 76)The crack also continues on ground, through axis of the cracks on walls. It is probably caused by different settlement due to ground level differences in basement floor. The building also forced in South side and structural crack and micro cracks can be seen in South wall of space G-01. Deformation of brick courses can be seen in parapet at the North side and upper niches in space G-03.

Figure 76 - Structural Crack on east wall both at outer and inner surfaces(author, 2010)

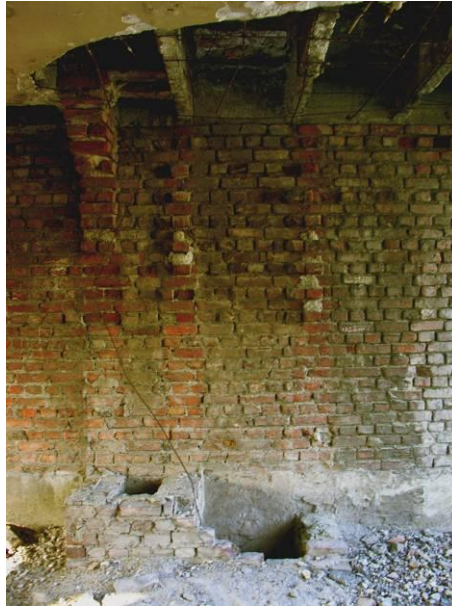
Figure 77- Demolished chimney in space F-02(author, 2010)

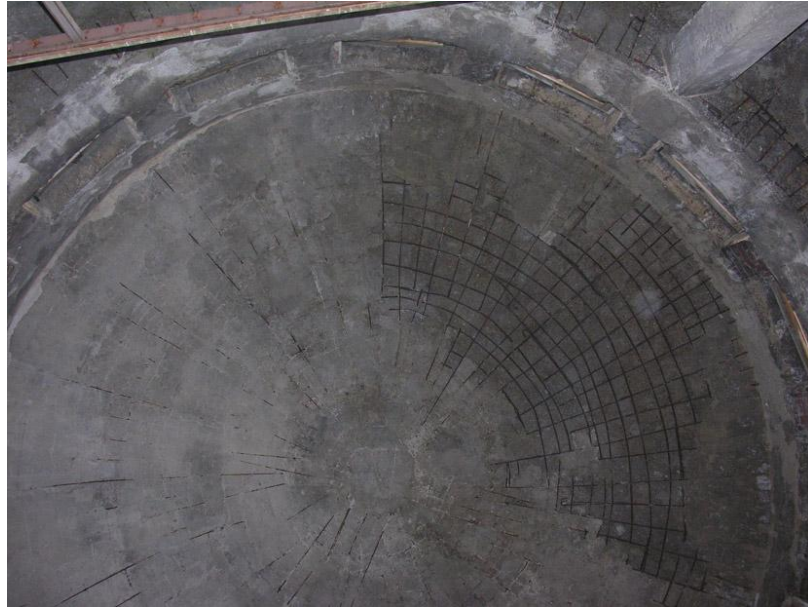
Main problem of the space is fragmentation of concrete. The dome's iron structure has revealed out due to fragmentation of concrete. The same problem can be observed on columns. (Figure 5,6)

Figure 78 - Concrete fragmentation on dome over space G-01 and F-01(author, 2010)

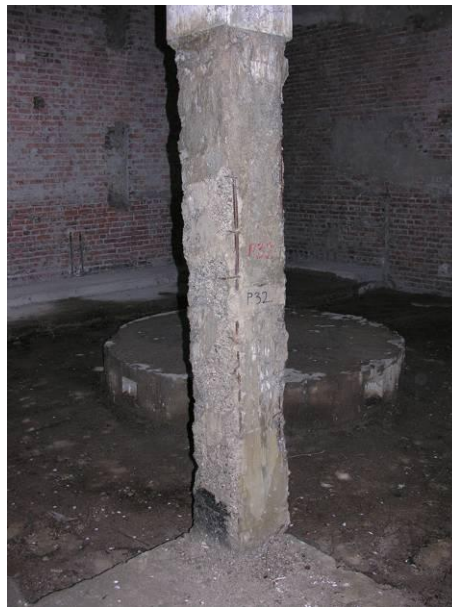
Figure 79 Concrete fragmentation problem in columns(author, 2010)

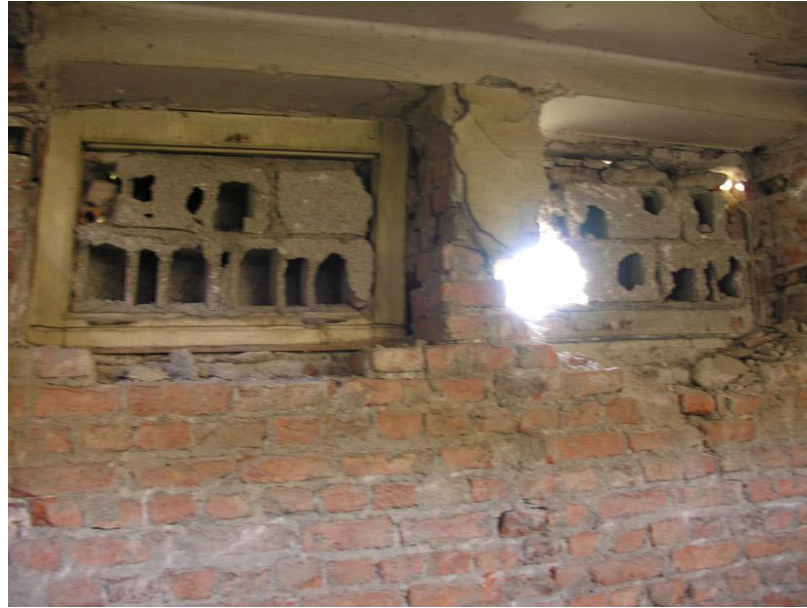
For windows and doors, timber frames and glass lost is determined. (Figure 80) The iron bars in reinforced concrete columns, domes and the railings are corroded .Metal buckling can be seen in railings

Figure 80 - Plaster lost, later infills, timber frame work and glass losses(author, 2010)
