DEFINING CONSERVATION PRINCIPLES FOR  
THE BREWERY OF ATATURK FOREST FARM

A THESIS SUBMITTED TO  
THE GRADUATE SCHOOL OF NATURAL AND APPLIED SCIENCES  
OF  
MIDDLE EAST TECHNICAL UNIVERSITY

IN PARTIAL FULFILLMENT OF THE REQUIREMENTS  
FOR  
THE DEGREE OF MASTER OF SCIENCE IN RESTORATION  
IN  
ARCHITECTURE

FEBRUARY 2013

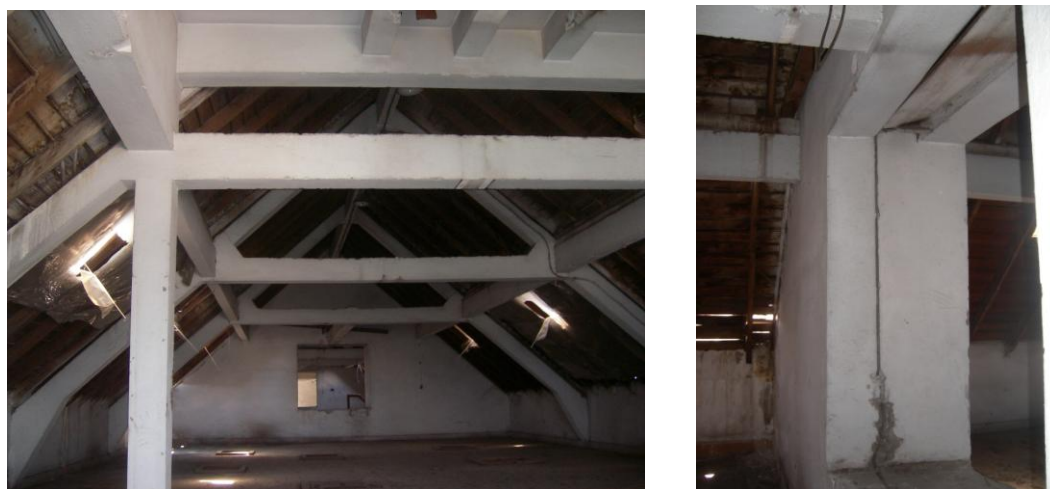
**Figure 56.** Combination of reinforced concrete and timber construction system on roof floor (left) and the dilatation showing the place of 1947 dated addition (right) (Source: Author)

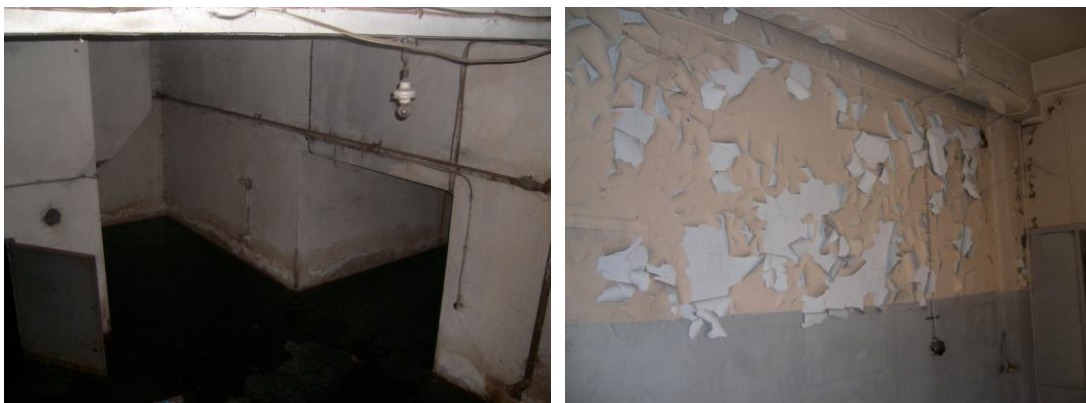
**Figure 57.** The water accumulation on basement floor due to drainage problems and the deformations on painted surface. (Source: Author, 2012)

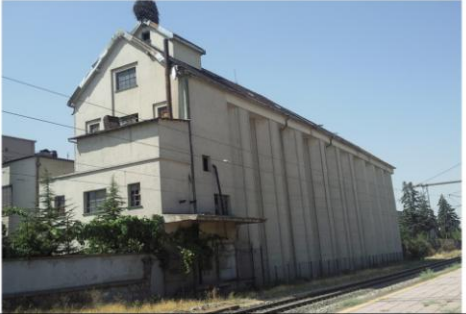
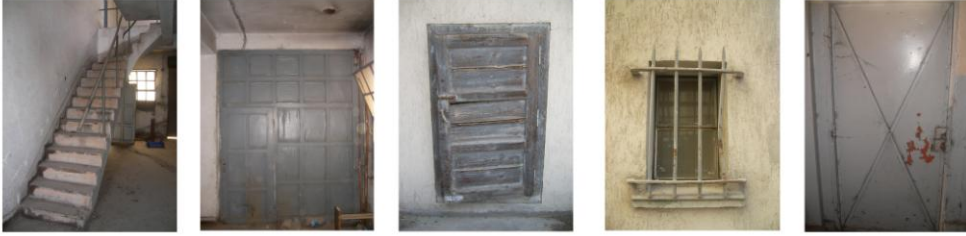
Figure 58. Inventory number 3: The silo building

CONSTRUCTION DATE: 1937		
NUMBER OF STOREY: 5 + 1 BASEMENT FLOOR		
ORIGINAL FUNCTION: SİLO		
CURRENT FUNCTION: NOT USED		
STRUCTURAL SYSTEM: REINFORCED CONCRETE FRAME SYSTEM WITH BRICK INFILL		
ROOF TYPE: GABLE ROOF WITH INTERLOCKING TILES	KEY PLAN	 
FINISHINGS OF THE FLOORS: LEVELING CONCRETE, TIMBER CLADDING CERAMIC TILE		
FINISHINGS OF THE WALLS: PLASTER, PLASTIC DYE , CERAMIC TILE		
DATES OF PERIOD ADDITIONS: 1947, 1976		
STRUCTURAL CONDITION: SLIGHT STRUCTURAL PROBLEMS WITH MATERIAL DETERIORATIONS ON FACADES		
CONDITION OF CHANGE: GENERALLY CONSERVED WITH ITS PERIOD ADDITIONS		
EXTERIOR PHOTOGRAPHS

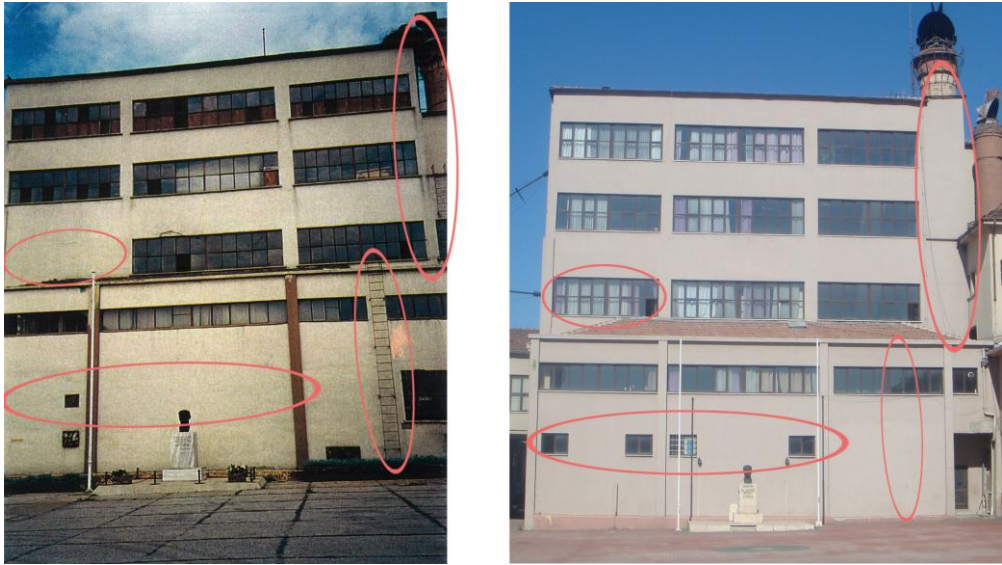
**Figure 63.** Photographs of west façade of the malt building which were taken before repairs in 2001 (left) and today (right) (Sources: TTA Archive and author)

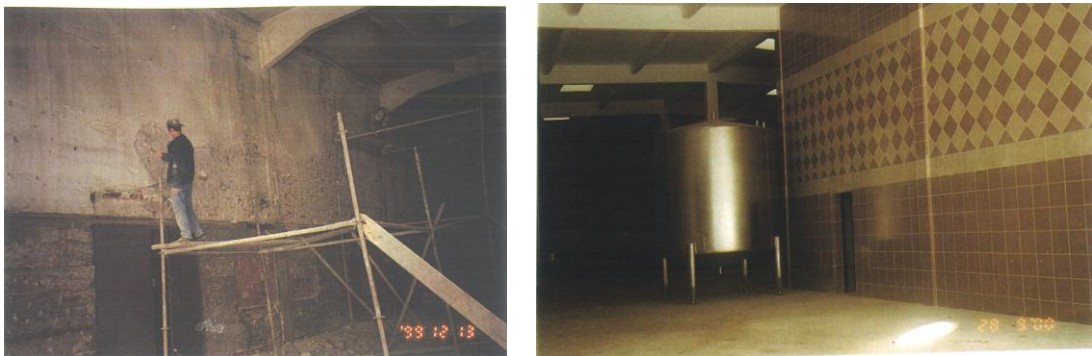
**Figure 73.** The inner walls of the beer filling building before and after the repairs made in 2001 (Source: TTA Archive)

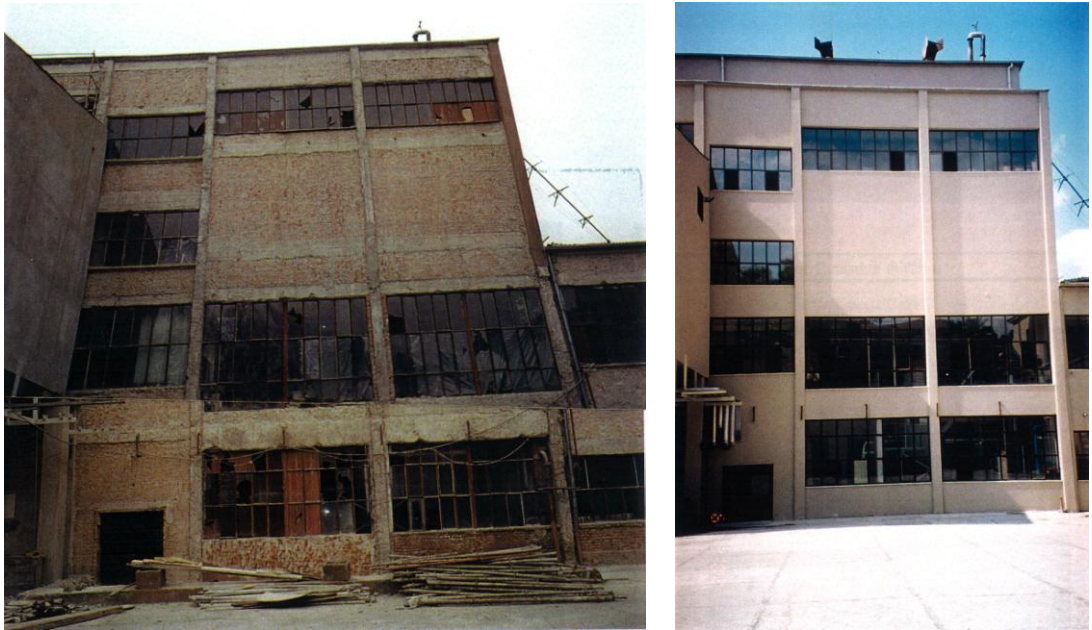
**Figure 83.** Photographs of the south façade of the boiling and fermentation building which were taken before (left) and after (right) the repairing in 2001 (Sources: TTA Archive)

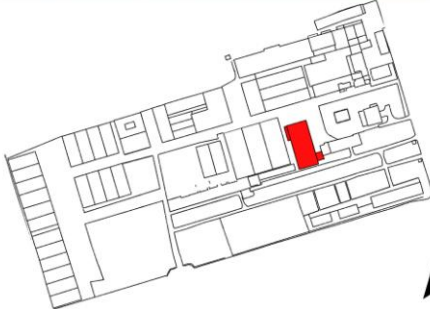
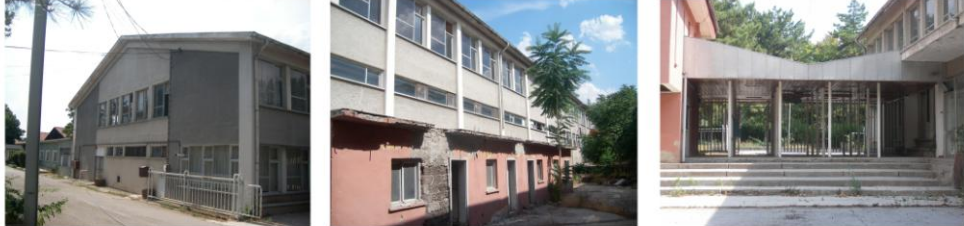
FINISHINGS OF THE FLOORS: MOSAIC		
FINISHINGS OF THE WALLS: LIME PLASTER		
DATES OF PERIOD ADDITIONS: -		
STRUCTURAL CONDITION: THERE ARE NO SEVERE STRUCTURAL PROBLEMS AND MATERIAL DETERIORATIONS		
CONDITION OF CHANGE: ORIGINAL MASS, PLAN SCHEME, MATERIALS AND FACADE ORGANIZATIONS ARE CONSERVED		
EXTERIOR PHOTOGRAPHS

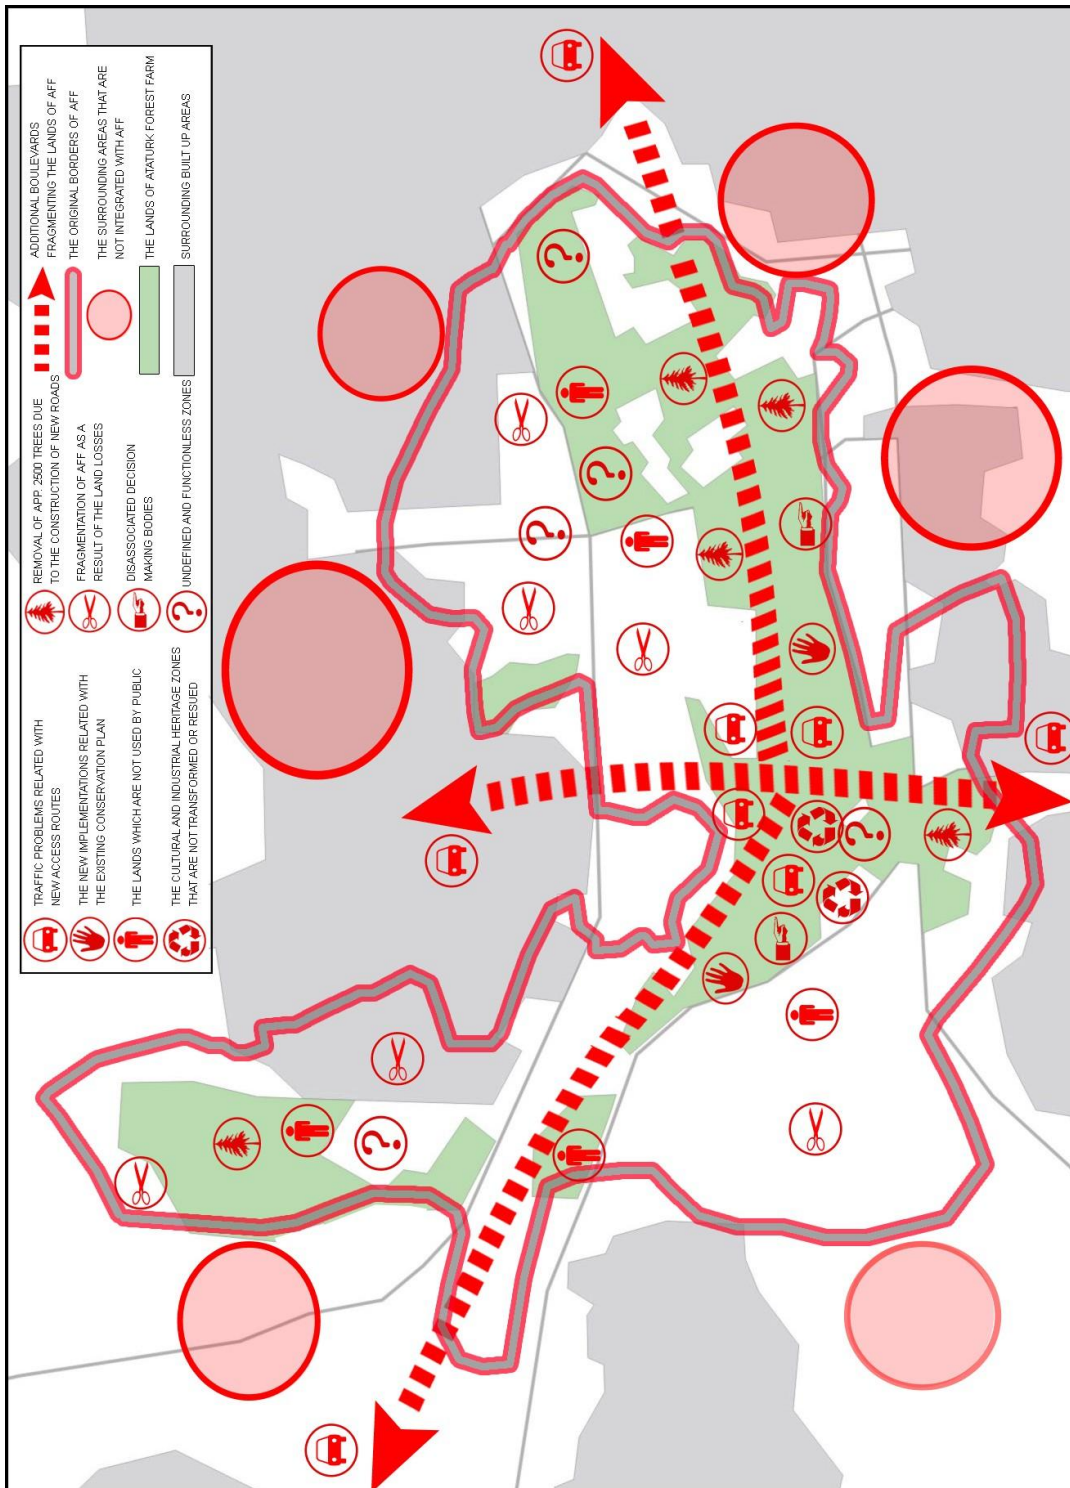
**Figure 119.** The problems of Ataturk Forest Farm in urban scale

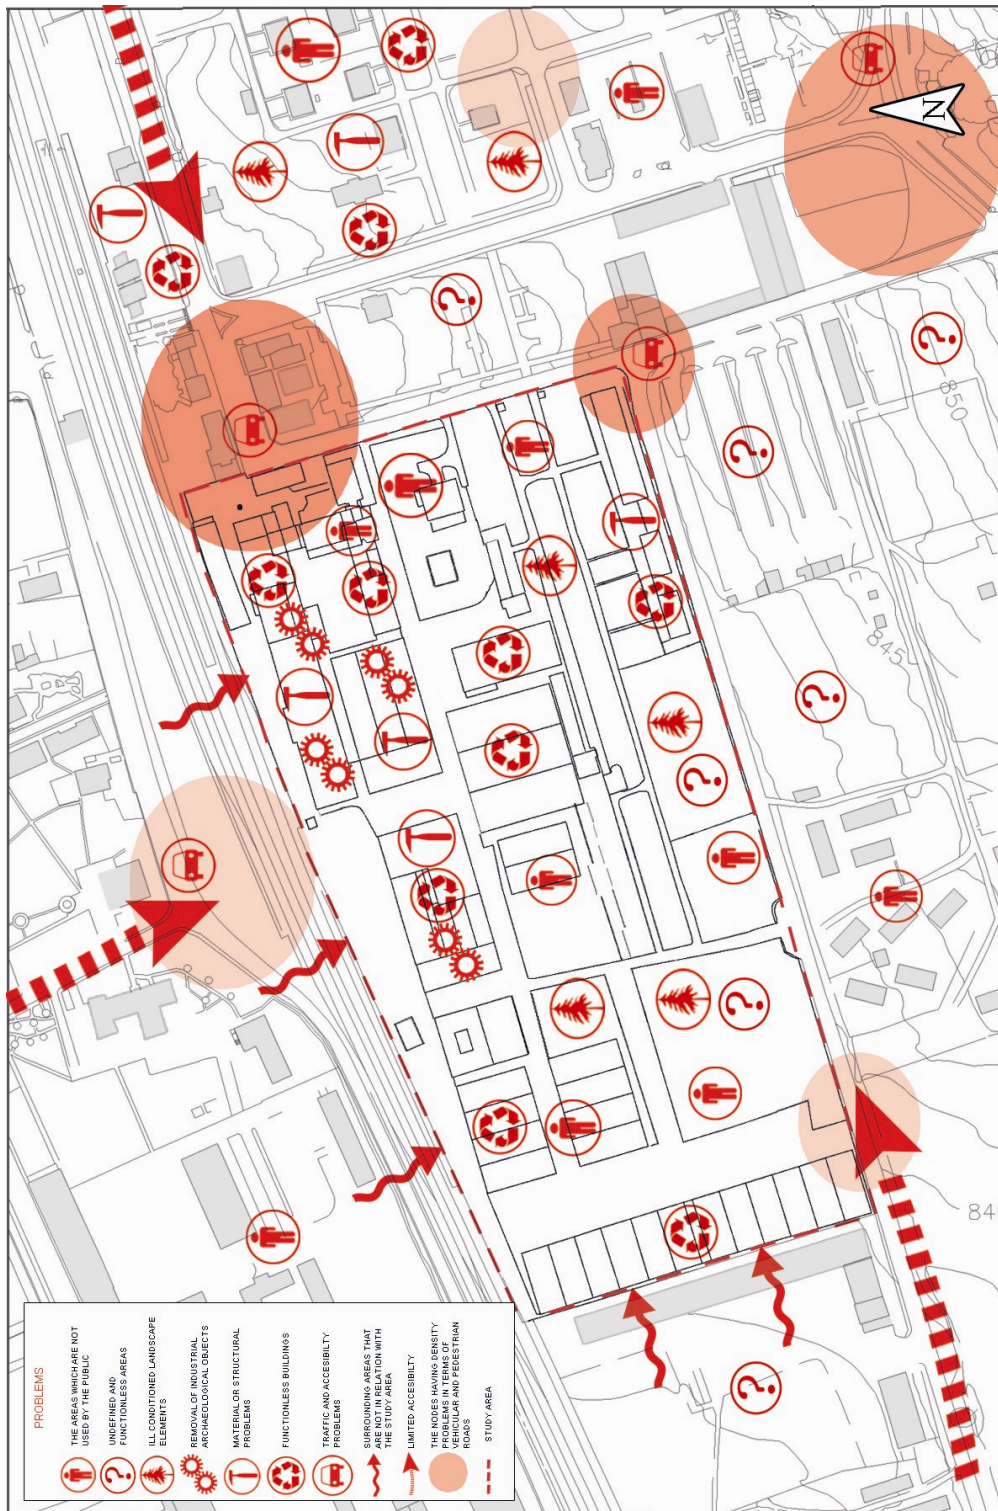
**Figure 120.** The problems of the brewery of Ataturk Forest Farm with its surrounding environment
