INTEGRATING THE RUM CHURCHES IN SAMSUN INTO DAILY LIFE

A THESIS SUBMITTED TO THE GRADUATE SCHOOL OF NATURAL AND APPLIED SCIENCES OF MIDDLE EAST TECHNICAL UNIVERSITY

MELDA AYDAN

JANUARY 2016

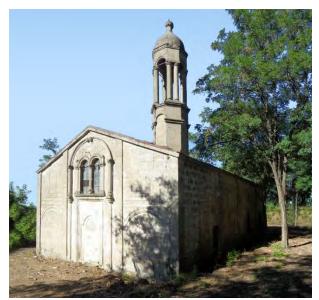
Figure 57: Antyeri Church – West and South Façade (Author, 2013)

There exists an octagonal bell tower with a bulbous dome at the south-west corner of the building. It is certain that there was another one in the north-west corner (See Figure 63 and Figure 64). In addition, the inner part of the tower can be seen inside, symmetrically to the existing one.

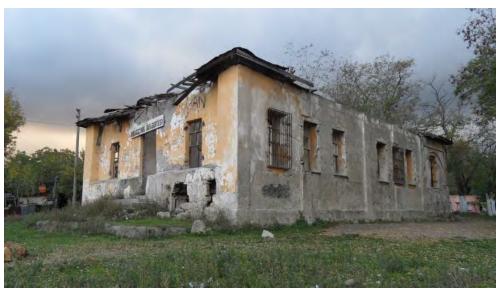
Figure 84: Aşağıçinik Church – East and North Façade (Author, 2013)

Since the roof of the building was demolished, there is no clue about the substructure. However, considering the height of the building and the fact that there is not any trace of a vault or a springing arch, it may be possible that upper part of the building had collapsed or been removed intentionally and appropriately. In order to understand how a church with a semi-closed Narthex looks like, Mesudiye Church in Ordu can be studied (See Figure 96, Figure 97). In addition, the photograph of Yolağzı Church in Giresun can give an idea about the general look of these kinds of churches (See Figure 95).

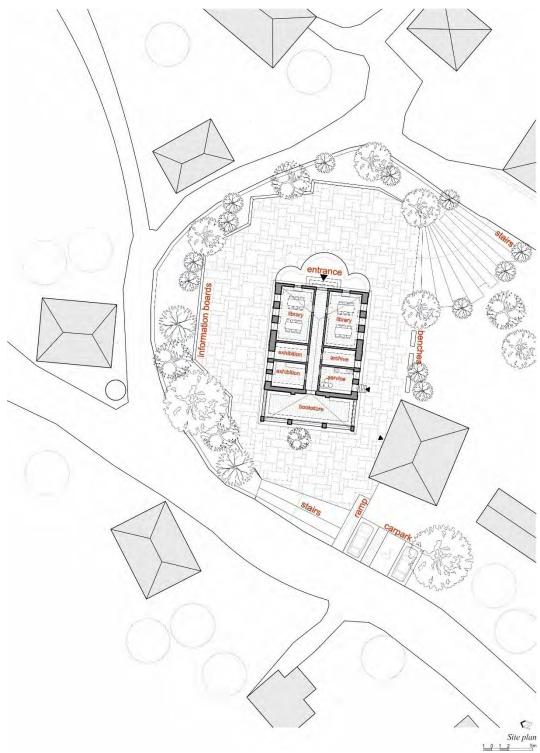
Figure 167: Site plan proposal for Aşağıçinik Church

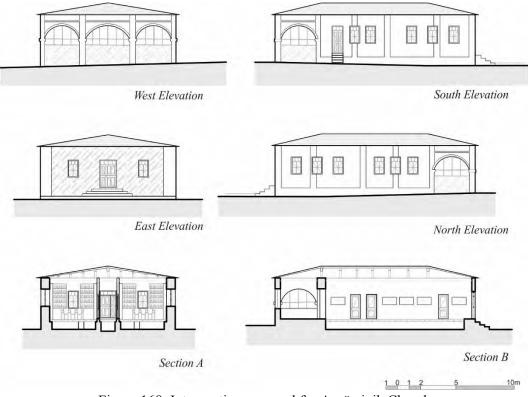
Figure 168: Intervention proposal for Aşağıçinik Church
