CONSERVATION AND REVITALIZATION PROPOSALS FOR
ESKİŐEHİR SUGAR FACTORY SOCIAL FACILITIES AREA

A THESIS SUBMITTED TO
THE GRADUATE SCHOOL OF NATURAL AND APPLIED SCIENCES
OF
MIDDLE EAST TECHNICAL UNIVERSITY

MERVE YILDIZ

FEBRUARY 2016

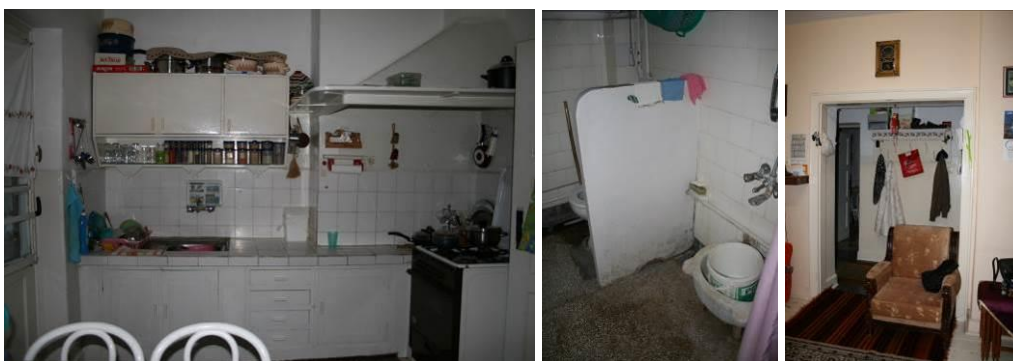
Figure 3.27: Examples of alterations and removal in Employee Dwelling Type 1

In terms of structural and material condition, all of the three buildings of Employee Dwelling Type 1 are in good condition and only need maintenance of timber architectural elements and floor coverings.

Plan scheme and façade organization of the buildings are totally conserved. On the other hand, alteration is seen only in joinery and finishing materials. For instance, ceramic wall coverings are added to the kitchens and bathrooms, while vinyl floor covering is added to the kitchens. In addition, removal of door wings of living room is seen at one of the housing unit.

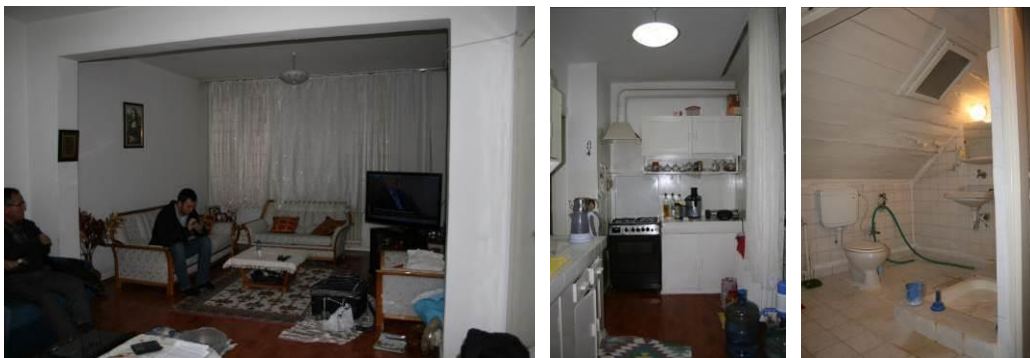
Figure 3.34: Examples of removal and alterations in Employee Dwelling Type 3

In terms of structural and material condition, buildings in Employee Dwelling Type 3 are in good condition and only need maintenance of timber architectural elements and floor coverings.

Plan scheme and façade organization of the building is mostly changed due to the mass addition at the south side of the building. Besides, wall in between living and dining rooms are removed and these two rooms are used as a single space. In addition, alteration is also seen in joinery and finishing materials. For instance, ceramic floor and wall coverings are added to the wet spaces and vinyl floor covering is added to the rooms and halls in both ground and first floors.

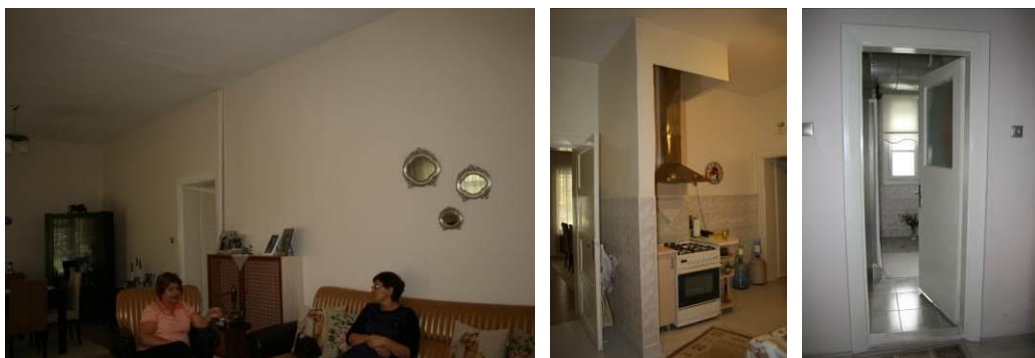
Figure 3.38: Examples of removal and alterations in Employee Dwelling Type 4

In terms of structural and material condition, buildings in Employee Dwelling Type4 are in good condition and only need maintenance of timber architectural elements and floor coverings.

Plan schema and façade organization of the building is changed due to the mass addition at the entrance. Besides, wall in between living and dining rooms is removed and these two rooms are used as a single space. Wall of kitchen is also removed and space is enlarged. In addition, alteration is also seen in joinery and finishing materials. For instance, all of the timber floor coverings are replaced with laminated floor coverings and ceramic floor and wall coverings are added to the halls and wet spaces.

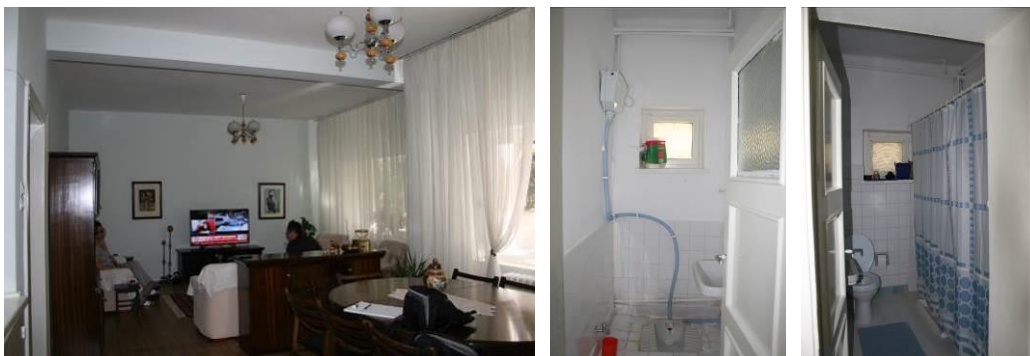
Figure 3.42: Examples of removal and alterations in Employee Dwelling Type 5

In terms of structural and material condition, buildings in Employee Dwelling Type 5 are in good condition and only need maintenance of timber architectural elements and floor coverings.

Plan scheme and façade organization of the building is partly changed due to the wall removal in between sofa and living room. With the removal these two rooms are used as a single space. In addition, alteration is also seen in joinery and finishing materials. For instance, rooms and halls are covered with linoleum and ceramic floor and wall coverings are added to the wet spaces.

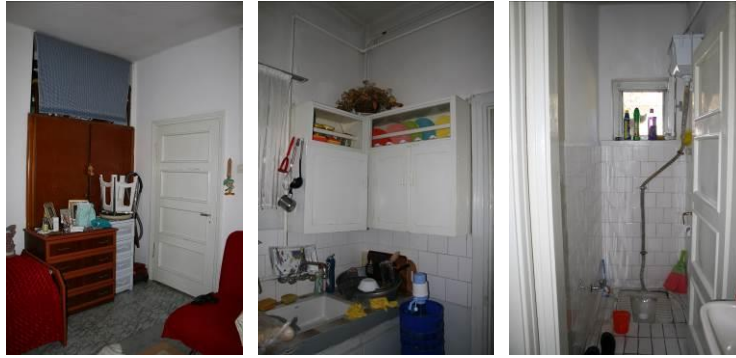
Figure 3.46: Examples of alterations in Employee Dwelling Type 6

In terms of structural and material condition, buildings in Employee Dwelling Type 6 are in good condition and only need maintenance of timber architectural elements and floor coverings.

Plan scheme and façade organization of the buildings are totally conserved. On the other hand, alteration is seen only in joinery and finishing materials. For instance, ceramic wall coverings are added to the kitchens and bathrooms, while vinyl floor covering is added to the rooms and kitchens. In addition, some of the built-in cupboards are renewed in bedrooms.

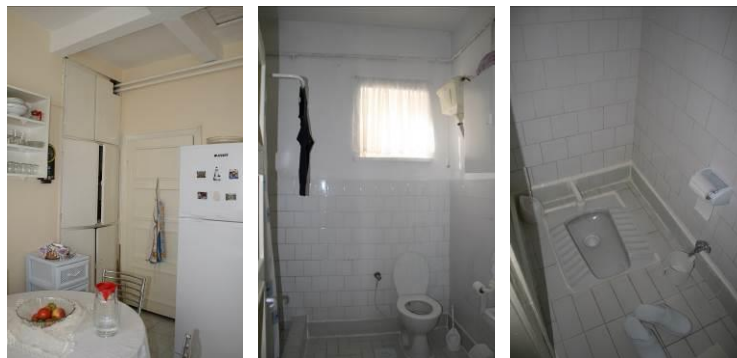
Figure 3.50: Examples of alterations in Employee Dwelling Type 7

In terms of structural and material condition, buildings in Employee Dwelling Type 7 are in good condition and only need maintenance of timber architectural elements and floor coverings.

Plan scheme and façade organization of the buildings are partly changed. Walls of cellar and hall next to it are removed and kitchen is enlarged. On the other hand, alteration is seen only in joinery and finishing materials. For instance, ceramic wall coverings are added to the kitchens and bathrooms, while vinyl floor covering is added to the rooms and kitchens.

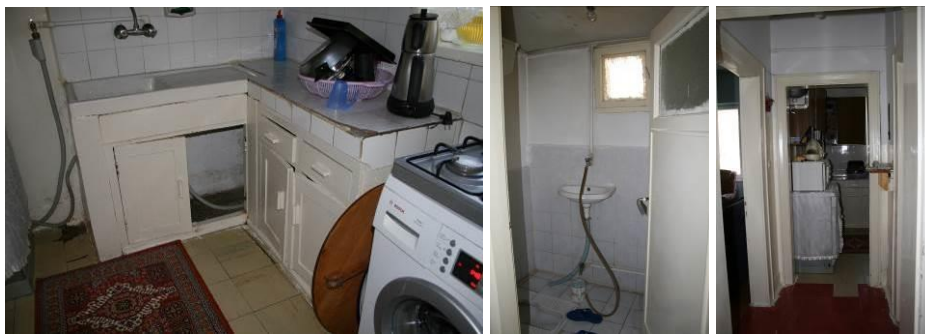
Figure 3.54: Examples of alterations in Employee Dwelling Type 8

In terms of structural and material condition, buildings in Employee Dwelling Type 8 are in good condition and only need maintenance of timber architectural elements and floor coverings.

Plan scheme and façade organization of the building is mostly changed due to the mass addition as wet space at the north-east corner of the building. In addition, alteration is also seen in joinery and finishing materials. For instance, ceramic wall coverings are added to the kitchens and wet spaces, while vinyl floor covering is added to the rooms and kitchens.

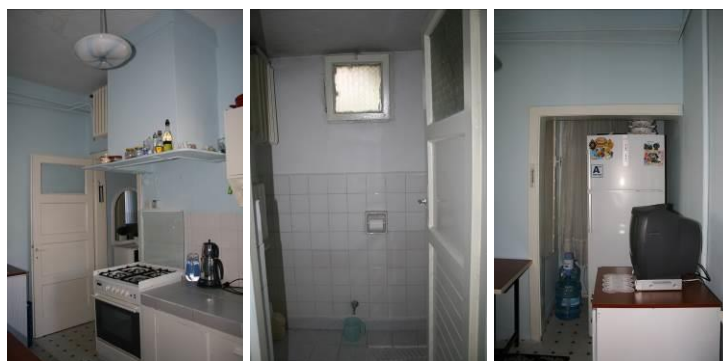
Figure 3.58: Examples of alterations in Employee Dwelling Type 9

In terms of structural and material condition, buildings in Employee Dwelling Type 9 are in good condition and only need maintenance of timber architectural elements and floor coverings.

Plan scheme and façade organization of the building is mostly changed due to the mass addition as wet space at the north-west corner of the building. In addition, alteration is also seen in joinery and finishing materials. For instance, ceramic wall coverings are added to the kitchens and wet spaces, while vinyl floor covering is added to the rooms and kitchens.

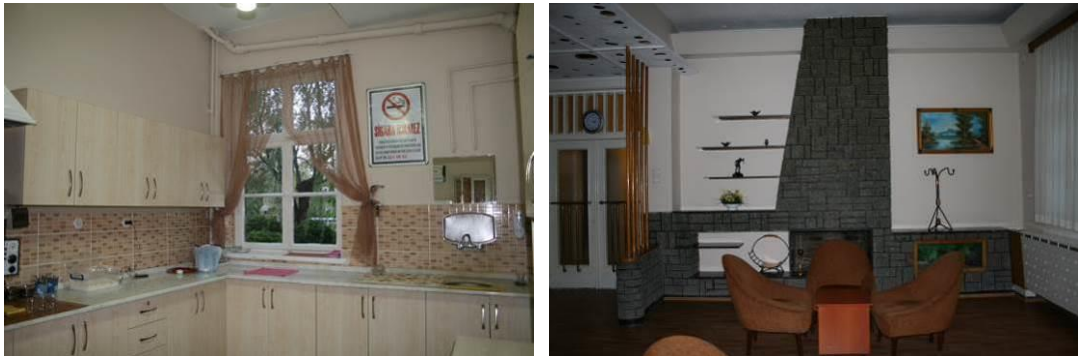
Figure 3.62: Examples of alterations in Old Guesthouse

In terms of structural and material condition, the building of Old Guesthouse is in good condition and only need maintenance of timber architectural elements and floor coverings.

Plan schema and façade organization of the building is mostly conserved. Except from addition of wet spaces to the guest rooms, there are not any spectacular changes seen in plan schema. On the other hand, alteration is seen only in joinery and finishing materials. For instance, ceramic floor and wall coverings are added to the common wet spaces, laminated flooring is added to lounge and guest rooms and a fireplace is constructed at the north wall of the lounge.

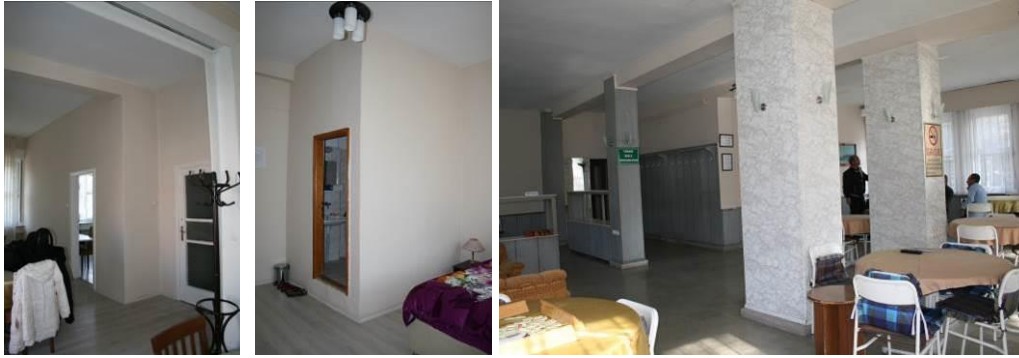
Figure 3.66: Examples of alterations in New Guesthouse

In terms of structural and material condition, the building of New Guesthouse is in good condition and only needs maintenance of timber architectural elements and floor coverings.

Plan schema and façade organization of the building is mostly changed. Due to the fact that function of the building is transformed into a guesthouse, wet spaces are added to almost most of the rooms in ground and first floors. Besides, removal of interior walls is seen according to the spatial needs occurred in the time of transformation. Moreover, at south façade in ground floor level an entrance arrangement with stairs is applied later on. On the other hand, alteration in joinery and finishing materials is seen like almost all of the buildings in the settlement.

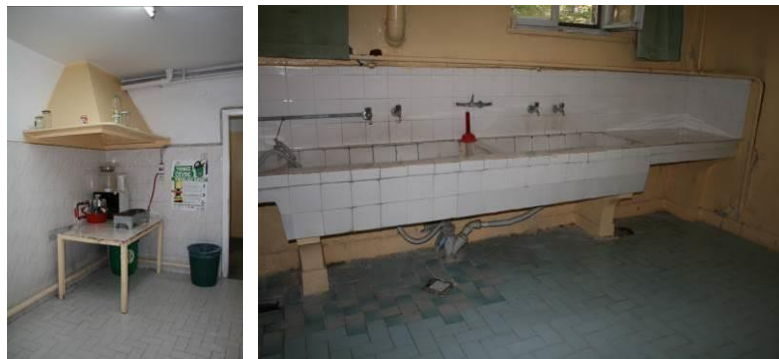
Figure 3.70: Examples of alterations in Girl's Dormitory

In terms of structural and material condition, the building of Girl's Dormitory is in good condition and only needs maintenance of timber architectural elements and floor coverings.

Plan scheme and façade organization of the building are totally conserved. On the other hand, alteration is seen in joinery and finishing materials. For instance, ceramic floor and wall coverings are added to the wet spaces and service spaces.

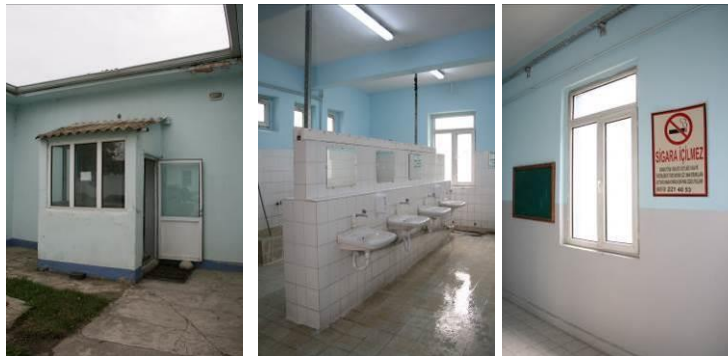
Figure 3.74: Examples of alterations in Worker's Pavilion

In terms of structural and material condition, the buildings of Worker's Pavilions are in good condition and only need maintenance of timber architectural elements and floor coverings.

Plan schema and façade organization of the buildings are mostly conserved. Except from removal of a wall at south-west part of the building, not any spectacular change is seen in plan schema. Besides, entrance halls are added just in front of the main entrance doors. On the other hand, alteration is seen in joinery and finishing materials. For instance, ceramic floor and wall coverings are added to the common wet space and all of the timber windows of the building is changed with PVC ones.

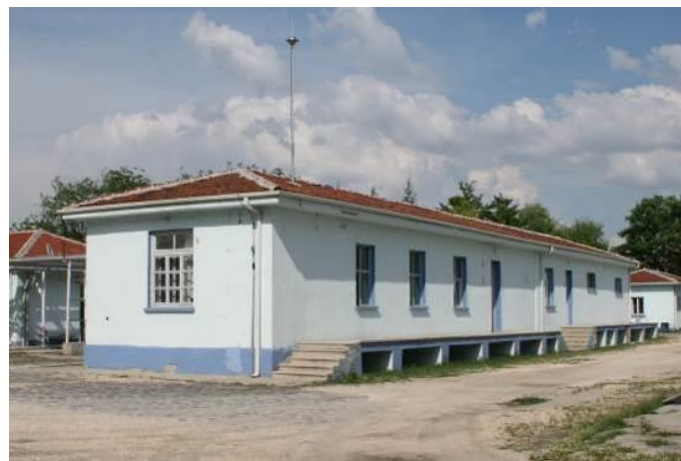
Figure 3.77: South-west façade of Milk House

In terms of structural and material condition, the building of Milk House is in bad condition due to the fact that basement floor have material and structural problems and immediately needs an extensive intervention. In addition, ground floor of the building needs maintenance of timber architectural elements and floor coverings.

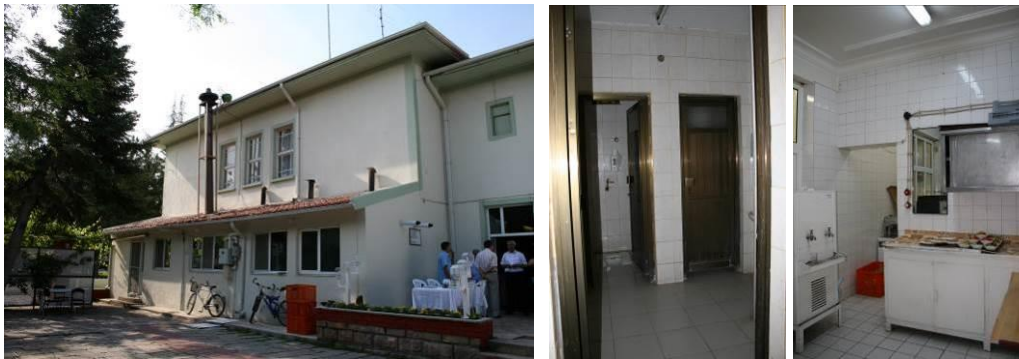
Figure 3.82: Examples of mass addition and alterations in Restaurant

In terms of structural and material condition, the building of Restaurant is in good condition and only need maintenance of timber architectural elements and floor coverings.

Plan schema and façade organization of the building is mostly conserved. Except from enlargement of service spaces with an addition of mass to the west corner of the south façade, there are not any spectacular changes seen in plan schema. On the other hand, alteration is seen only in joinery and finishing materials. For instance, ceramic floor and wall coverings are added to the common service and wet spaces.

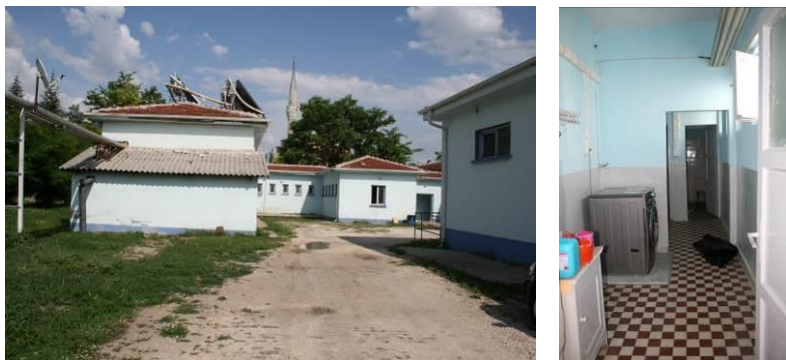
Figure 3.89: Examples of mass addition and alterations in Laundry

In terms of structural and material condition, the building of Service Type 1 is in good condition and only need maintenance of timber architectural elements and floor coverings.

Plan schema and façade organization of the building is mostly conserved. Except from addition of mass to the west façade, there are not any spectacular changes seen in plan schema. On the other hand, alteration is seen only in finishing materials. For instance, ceramic floor and wall coverings are added to the common wet space.

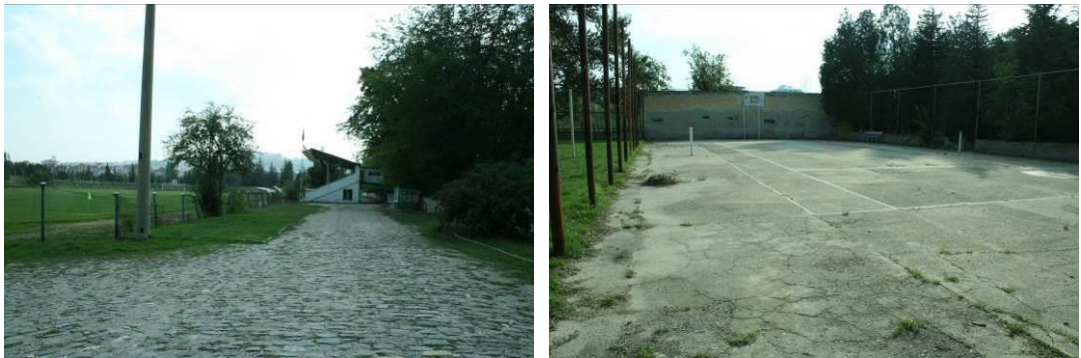
Figure 3.113: Sport areas in the Social Facilities Area

Second sport area in the settlement locates east side of the Playground Type 1. There is a small football field at west and a basketball field at west both of which have dimension of 36 x 16 meters. Basketball field is also used as tennis court temporarily. On the other hand, sport area is neglected and in a bad condition nowadays.

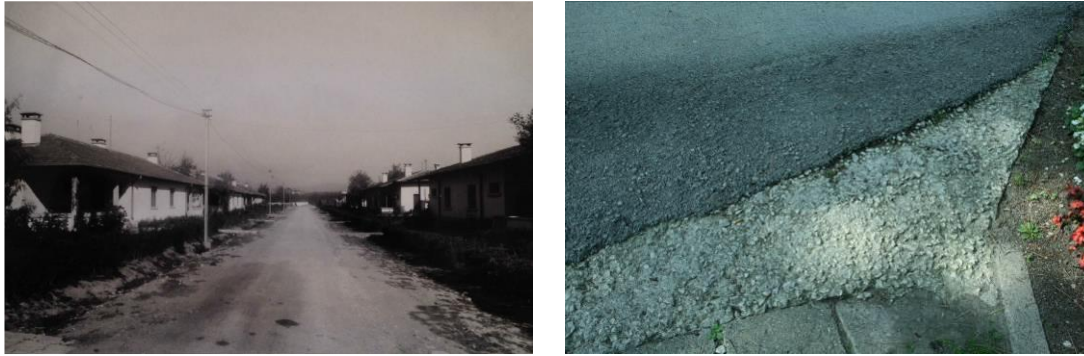
Figure 3.114: Original compact earth pavement and rough concrete pavement layers

Today, vehicle roads are all covered by asphalt. With the help of old photographs and traces found in the area, original covering materials under the asphalt layer are determined. According to the photographs derived from Eskişehir Sugar Factory archives, original vehicle roads are seen as compact earth pavement. In between compact earth and asphalt layers, rough concrete is seen in some parts of the roads today.
