**THE RESTORATION PROJECT OF
THE OLD AGRICULTURAL BANK BUILDING
IN MERSIN**

**A THESIS SUBMITTED TO
THE GRADUATE SCHOOL OF NATURAL AND APPLIED SCIENCES
OF
MIDDLE EAST TECHNICAL UNIVERSITY**

NİDA NAYCI

JANUARY 2005

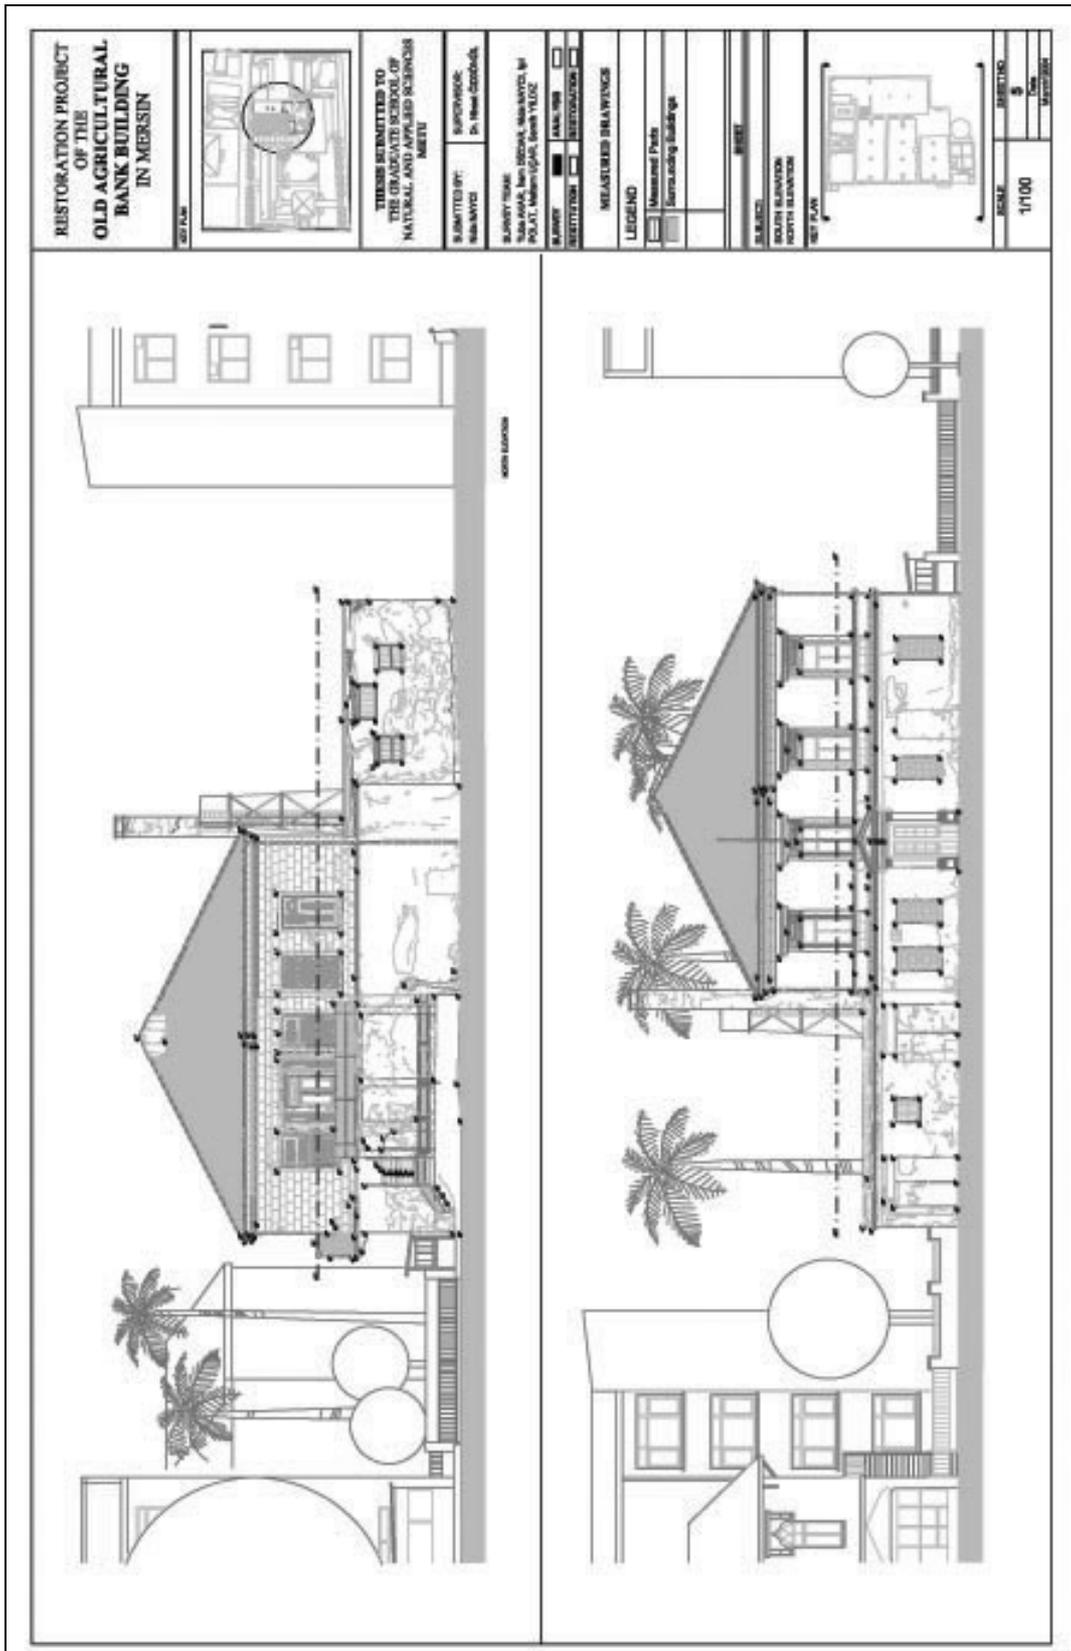
Drawing 2.5 North and South Elevations

The whole north facade of the main building is out of cut stone masonry wall. It is plastered and painted in white color except from the window sills, which are left unpainted and the entrance door, which is painted in dark brown. The main problem observed in the north façade of the main building is rising damp problem which rises until 1.50 m above the ground level. Around the openings there are detachments in plaster finishing in flaking forms. On the cut stone window and door sills and horizontal jails, there is black crust deposition due to the atmospheric pollution.

The main problem observed in the south façade of the building is contour scaling in plaster material especially on the east portion of the ground floor. On the rest of the plaster finishing there is granular to crumbly disintegration of plaster material. The rising damp problem can be visualized on the ground floor level. There is oxidation problem observed in the metal grills and balustrades. The timber door and window elements have been suffering from tiny cracks occurred due to the exposure to UV lights and swelling and shrinkage cycles

of the timber material. On the east portion of the terrace, there is a local destruction of the stone masonry wall in order to install the clean water pipes, which has resulted with material loss in structural scale. In the RC beams and columns of the terrace there are structural cracks and flaking problem in the concrete material.

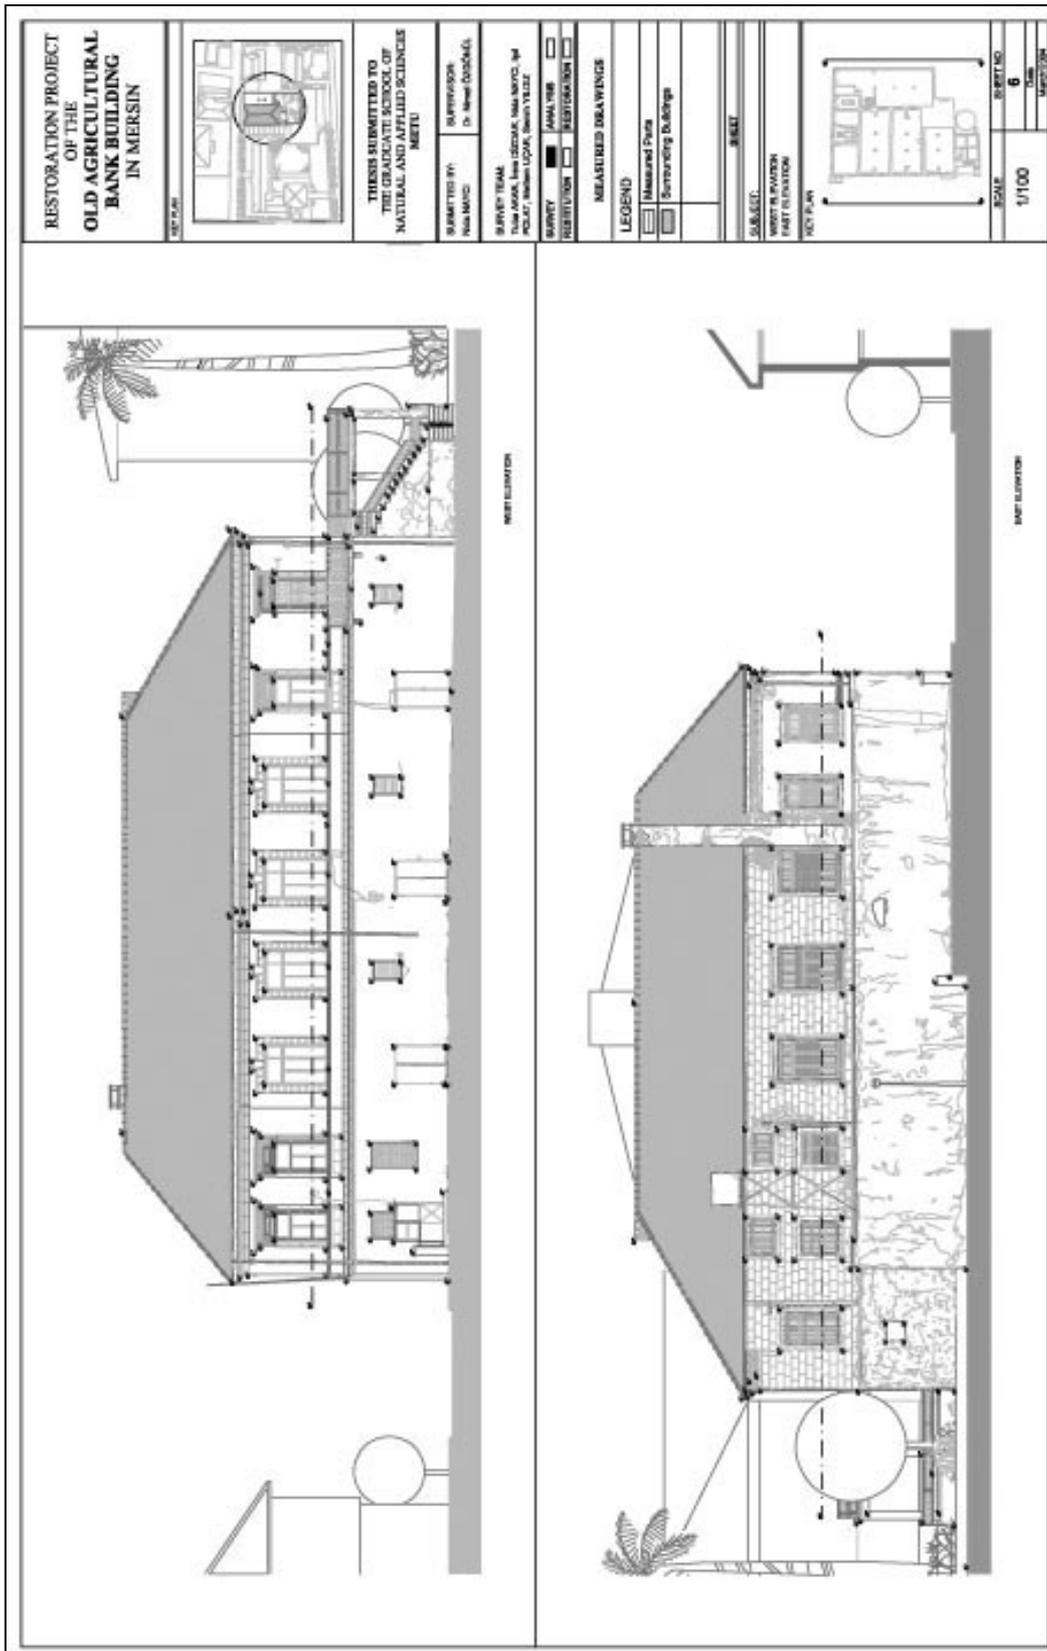
Drawing 2.6 East and West Elevations

The main problem observed in the west façade is blind detachment of the cement plaster from the stone masonry walls especially in mid portion of the building. There is black deposition on the cut stone surfaces of the window sills and roof cornice. There are material loss as contour flaking and structural cracks in RC elements of the terrace.

The east façade is the most decayed façade of the building (Figure 2.9). There is granular to crumbly disintegration of stone material which is has paint finishing. The water on the terraced superstructure of the depot buildings collects on the meeting point of the east façade of the main building since there isn't appropriate drainage system of the terrace. This causes serious material loss on the stone and plaster materials of the east façade. There is macro vegetation observed on the east façade due to damp problem. One of these macro vegetations has caused saw type structural crack on the stone masonry wall. On the cut stone surfaces of the roof cornice and window sills, there is black deposition problem due to atmospheric pollution.

The main problem observed on the east façade of the depot building is detachment of cement plaster from the stone masonry wall. The sallination and dampness areas can be visualized on the surface. On the south portion of the stone masonry wall there is a serious structural crack, which has caused by a macro vegetation growth.

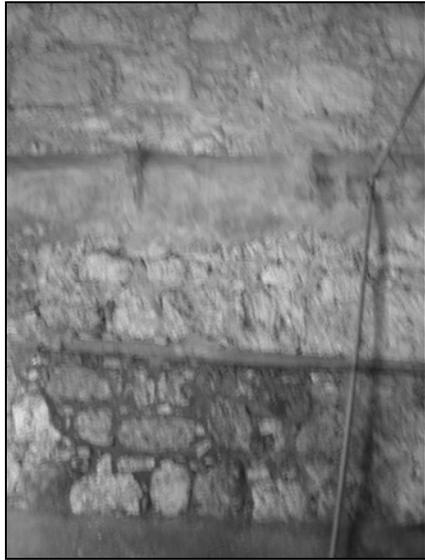
Figure 2.28 Weatherings on masonry elements Figure 2.29 Weatherings on east façade

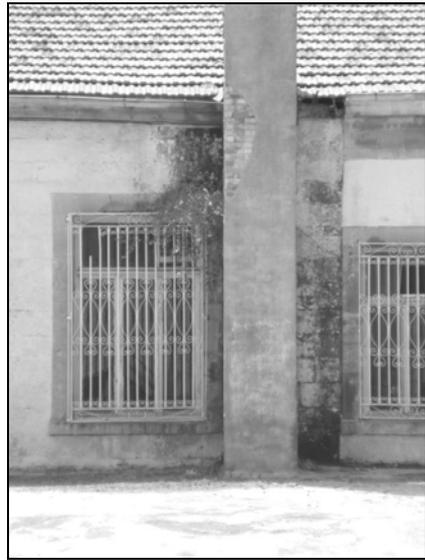
The results of inadequate construction details harm the east of the main building most. The construction of the depot building adjacent to the main building wall causes dilatation problems between the two buildings. Moreover, inadequate slope of the terrace of the depot building collects water in the intersection of the terrace roof and east wall of the main building. These cause detachments in the plaster and disintegration of the stone as well as supply suitable conditions for the growth of macro plants in the joints of the east wall. They cause structural cracks.
