**RESTORATION PROJECT OF İBRAHİM ŞAHİN HOUSE IN
SOĞUKPINAR DISTRICT, BEYHAMAM STREET, NO 41, TOKAT**

**A THESIS SUBMITTED TO
THE GRADUATE SCHOLL OF NATURAL AND APPLIED SCIENCES
OF
MIDDLE EAST TECHNICAL UNIVERSITY**

**IN PARTIAL FULFILLMENT OF THE REQUIREMENTS
FOR
THE DEGREE OF MASTER OF SCIENCE
IN
RESTORATION
IN
ARCHITECTURE**

The subject of thesis is to prepare the restoration project of a traditional Anatolian dwelling in Tokat.

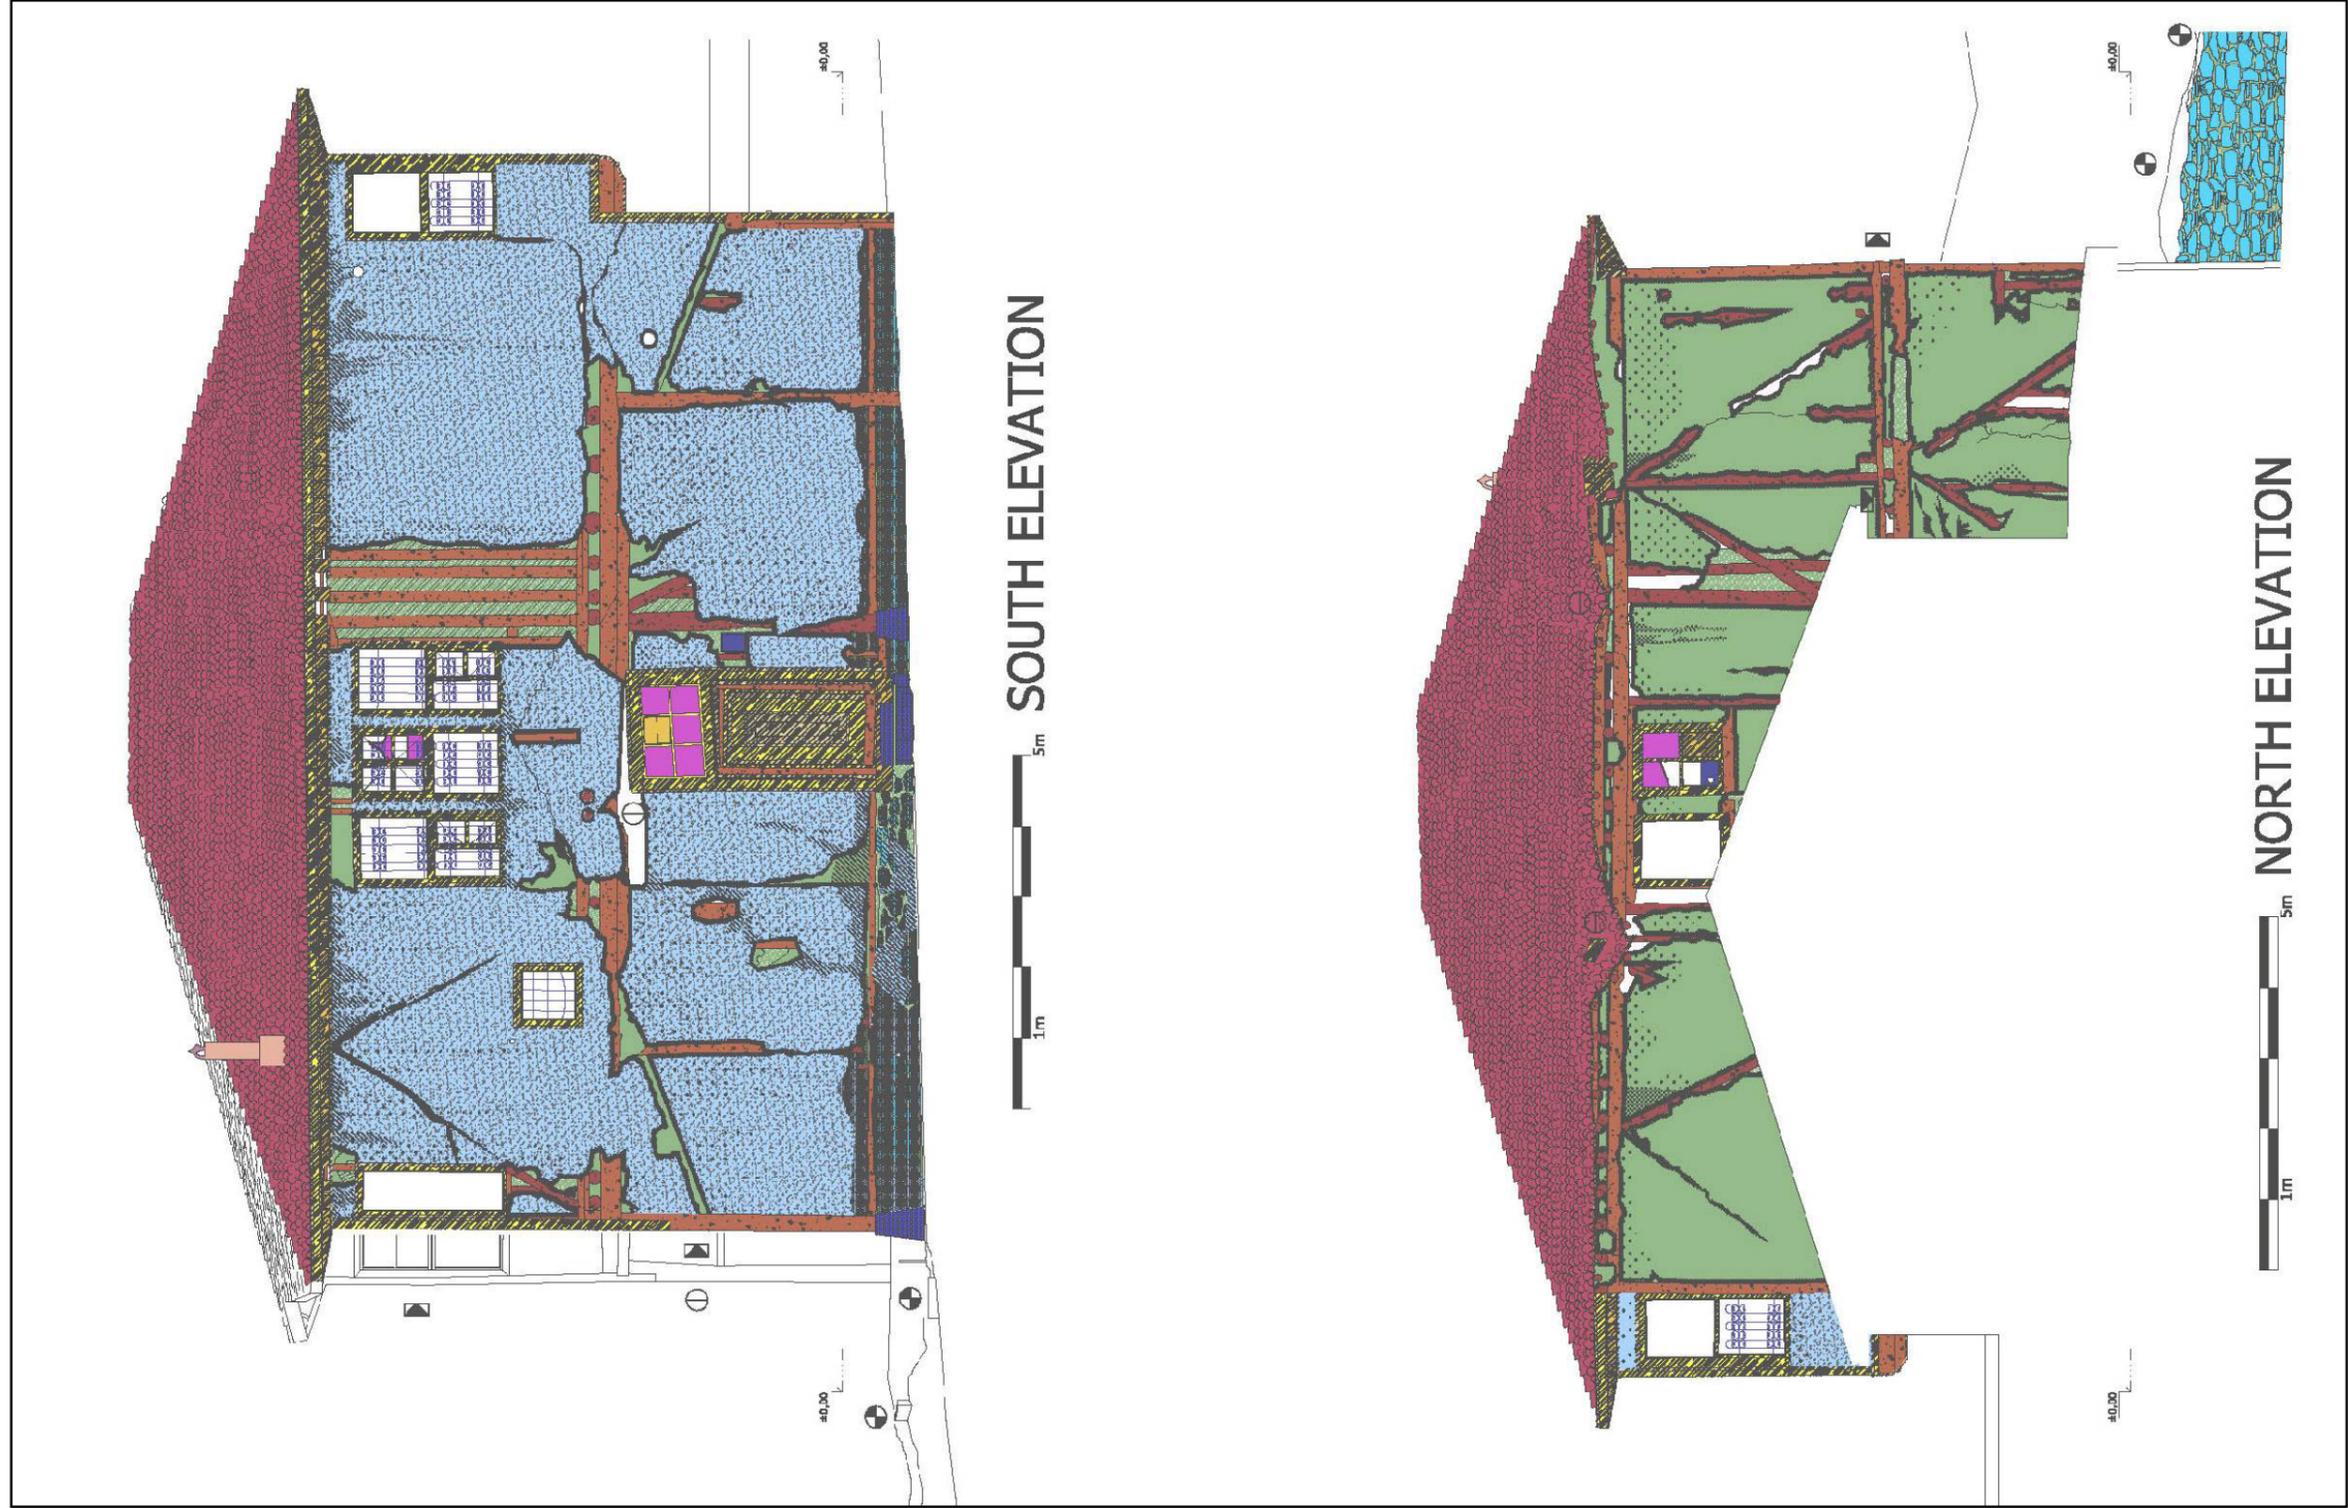
Figure 86: Analysis of Material Deter. and Str. Defects: South and North Façades: 1/100 (Presented in 1/50 at Jury)

Deposits can be seen as white and dark colors on the building material. *White deposit* is generally seen at stone masonry walls of west and south façades up to 1-1.5 m from ground level. Possible cause of the deterioration is the salt driven by the rising damp. White deposit can also be seen on some walls related with the flowing of lime based material by a leakage problem, as seen especially at the ceiling and east wall of space Z08. On the other hand *dark deposit* is seen in black or dark gray color especially at the bottom parts of first floor walls possibly related with accumulation of dirt. It can also be seen at top levels of outer walls under eaves and interior walls under window openings. This may possibly be related to the flowing of rusted wood dusts due to the rain penetration. Another reason of this type of problem is smoke. This type of deposit can be seen inside the walls of fireplaces and chimneys.

Granular disintegration is seen generally on outer plasters and on mortars due to the direct touch of rain water. Related problem on masonry walls seems to cause loss of jointing material. For outer plasters, granular disintegration is accompanied by detachments as scales. For indoor spaces as being assigned to a wet space use, especially mud plastered walls of space Z08 can be given as an instance.

At stone steps of basement floor and south entrance, *abrasion* problem is observed. Some of the outer stone masonry walls have again this problem accompanied by flaking. Here the problem is possibly related to the rising damp and direct touch of rain water.

Smells of decay, reddish dust, fibrous texture, color change are the indicators of *microbiological growth* on timber. Whitening on small areas on timber is probably related to this problem. Under some window openings blue-green froth like formations are followed, i.e. 108 windows. This problem is also observed on north part of the stone masonry wall of west elevation. It is probably because of a possible wet space use at the related area. The south elevation facing WC space has the same type of problem as well.

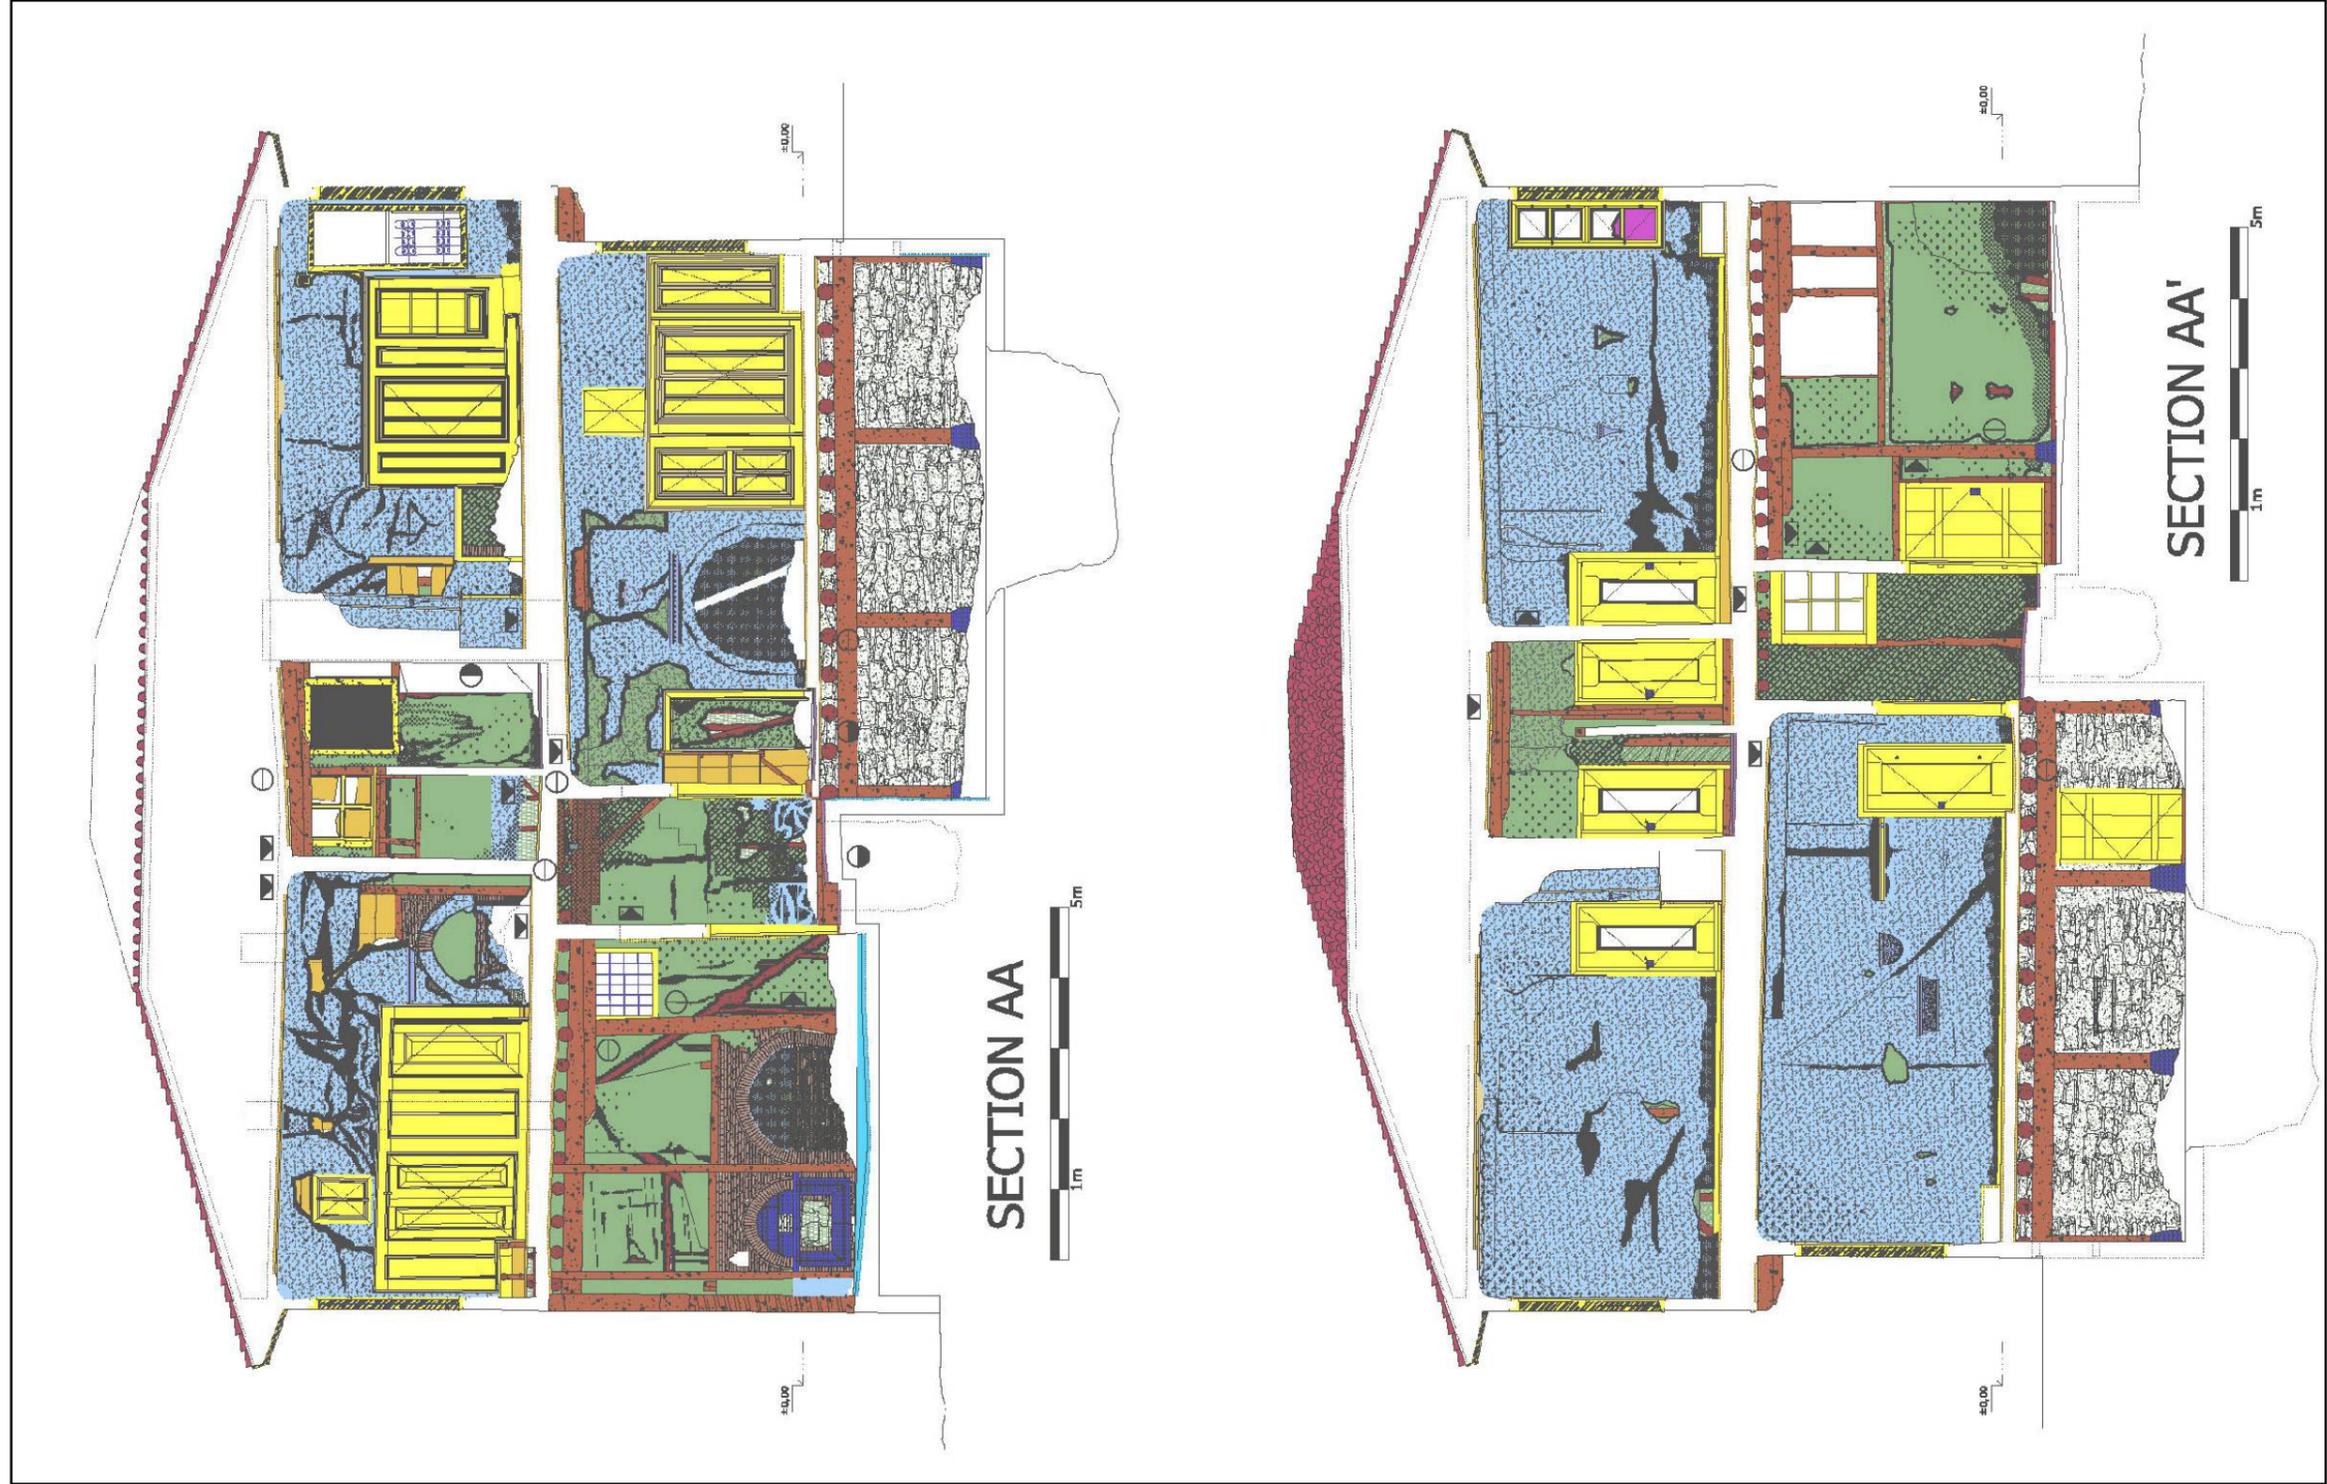
Figure 88: Analysis of Material Deter. and Str. Defects: Sections AA, AA':1/100 (Presented in 1/50 at Jury)

Structural problems are followed as cracks, bending and leaning problems, local bearing failures and as collapses. Structural cracks are mostly seen at junction points of vertical and horizontal surfaces and at corners of spaces.

One of the most definite problems in the building is observed at the northwest corner of the dwelling, namely room Z05 and room 103. Due to a possible earthquake the massive brick masonry fireplace unit located inside Z05, pushed and broke the contiguously placed timber post. The deformation was probably intensified by the unbalanced weight distribution caused by the fireplace unit of room 103. This situation results with the sagging and leaning problems of the structural elements of space 103.
