# CONSERVATION OF LIGHTHOUSES AS A PART OF MARITIME HERITAGE: THE CASE OF LIGHTHOUSES IN AEGEAN COAST, TURKEY

## A THESIS SUBMITTED TO THE GRADUATE SCHOOL OF NATURAL AND APPLIED SCIENCES OF MIDDLE EAST TECHNICAL UNIVERSITY

SEPTEMBER 2019

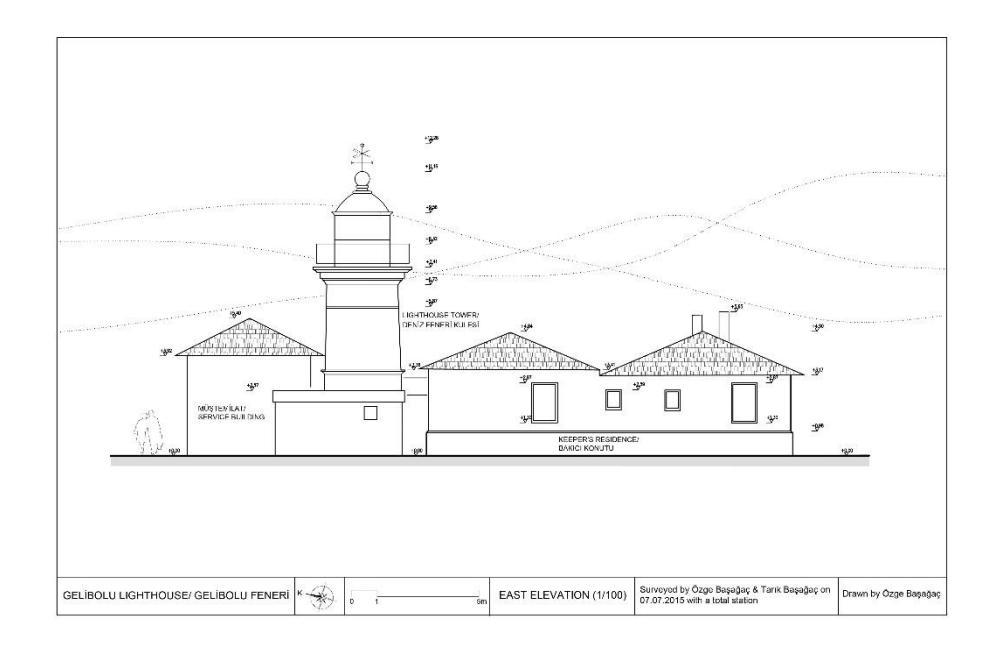
All of the buildings located within the lot of the Gelibolu Lighthouse are in good condition without any material or structural problems.

Figure 3.12. East (Sea) elevation of Gelibolu Lighthouse, service building and storage (Author, 2015)

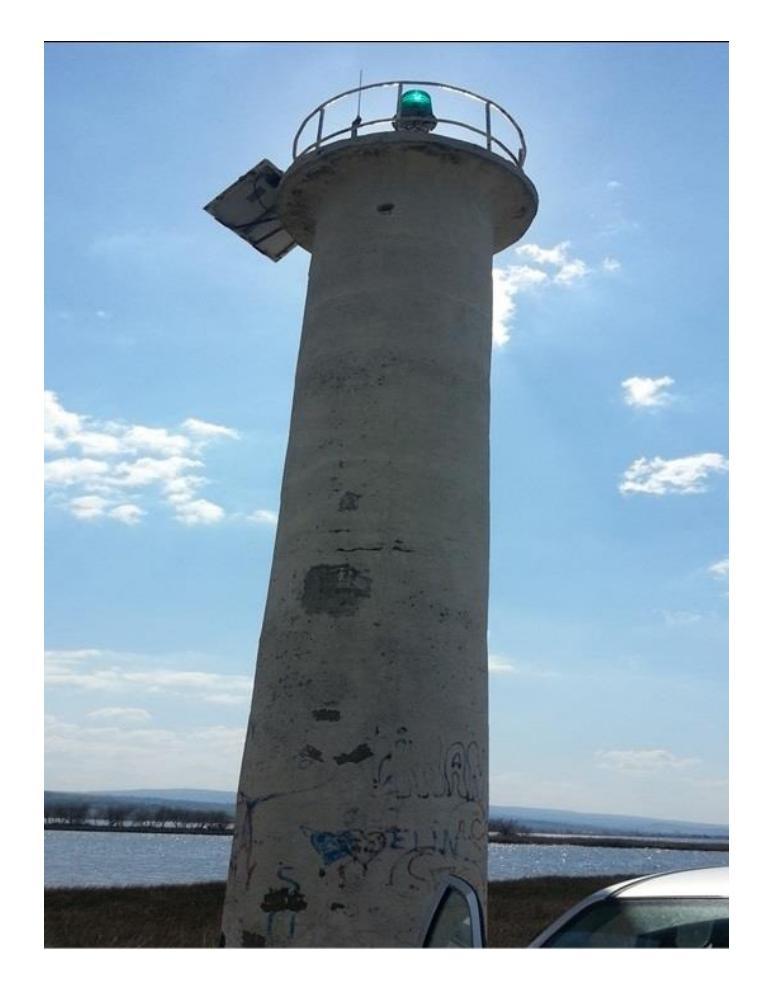
The lighthouse is vandalized with graffiti frequently. There is a structural crack on the tower, starting from the foundation and going up. The cycle of wetting with sea water and drying under harsh sun is a strong weathering process for the lighthouse. The ground of the lighthouse is also prone to erosion/ decay due to rising sea water and frequent flooding.

Figure 3.17. Çardak Lighthouse (KEGM, Kıyı Emniyeti Genel Müdürlüğü, 2012)

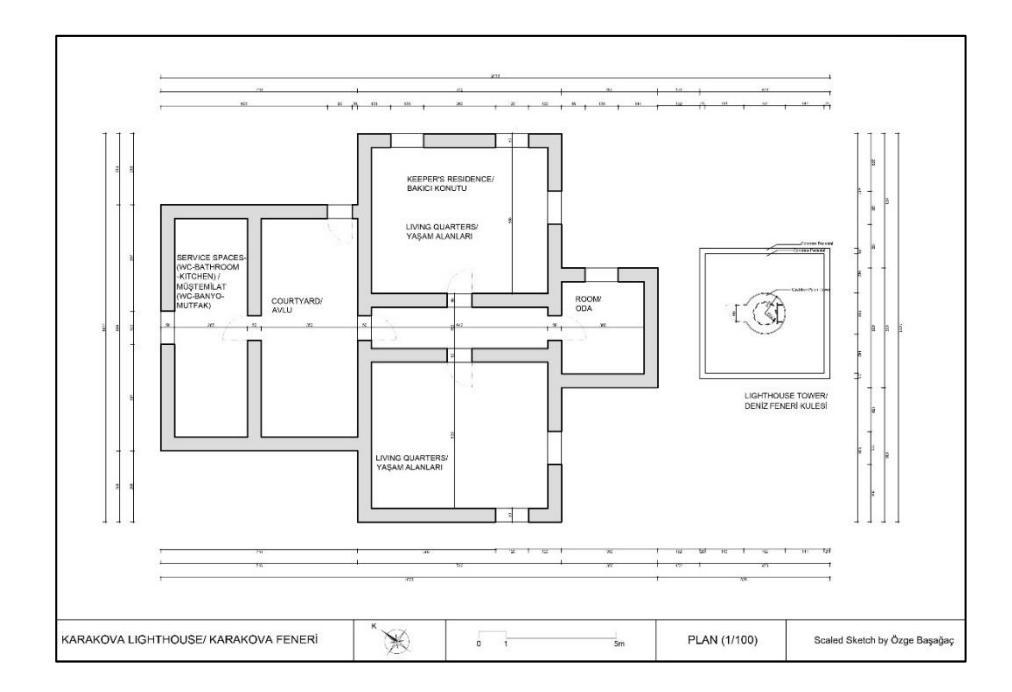
Figure 3.22. Sketch Plan of Karakova Lighthouse (Author, 2015)

The light keeper's house is abandoned now. The roof had partially collapsed yet the eave line is visible, and the full height of the roof is seen at certain points. It has a T shaped plan. The entrance is through the courtyard which has the rooms on one side and service spaces on the other. The keeper's residence is plastered and painted white. The timber window frames are also seen. The remains of the masonry pedestal of the original metal light pole is observed on the roof.

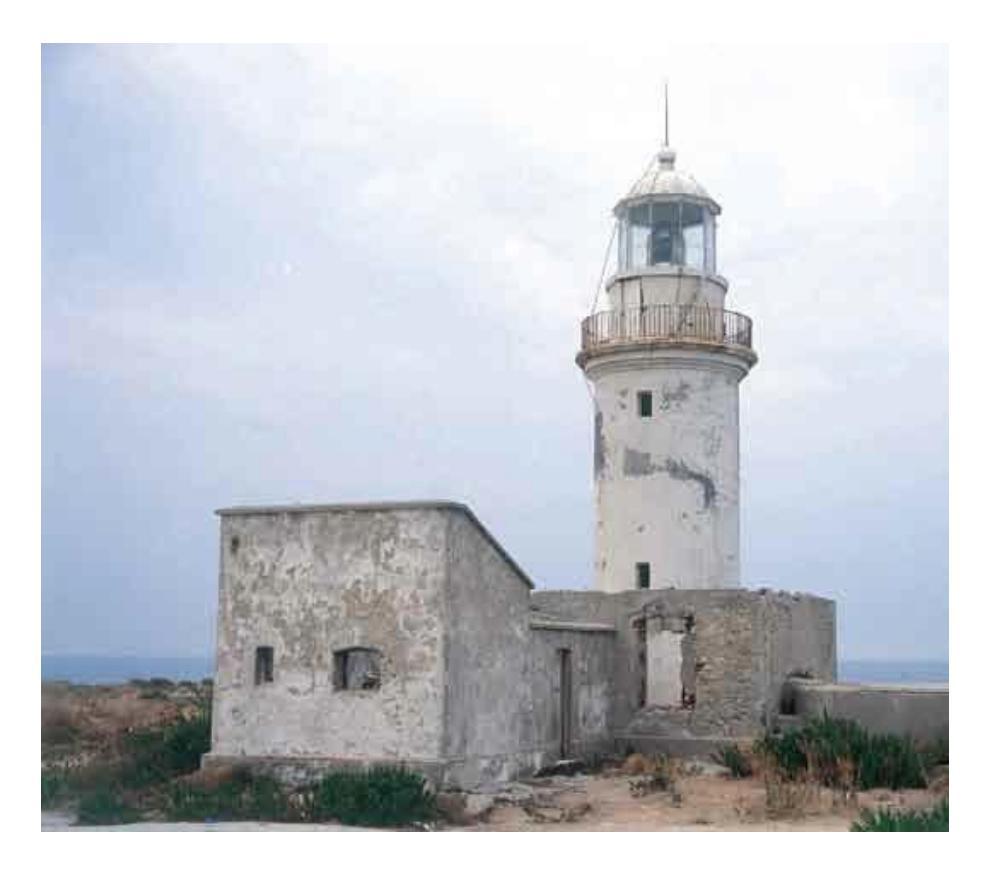
Figure 3.101. Polente Lighthouse before restoration in 2008 (Toroslu, 2008)

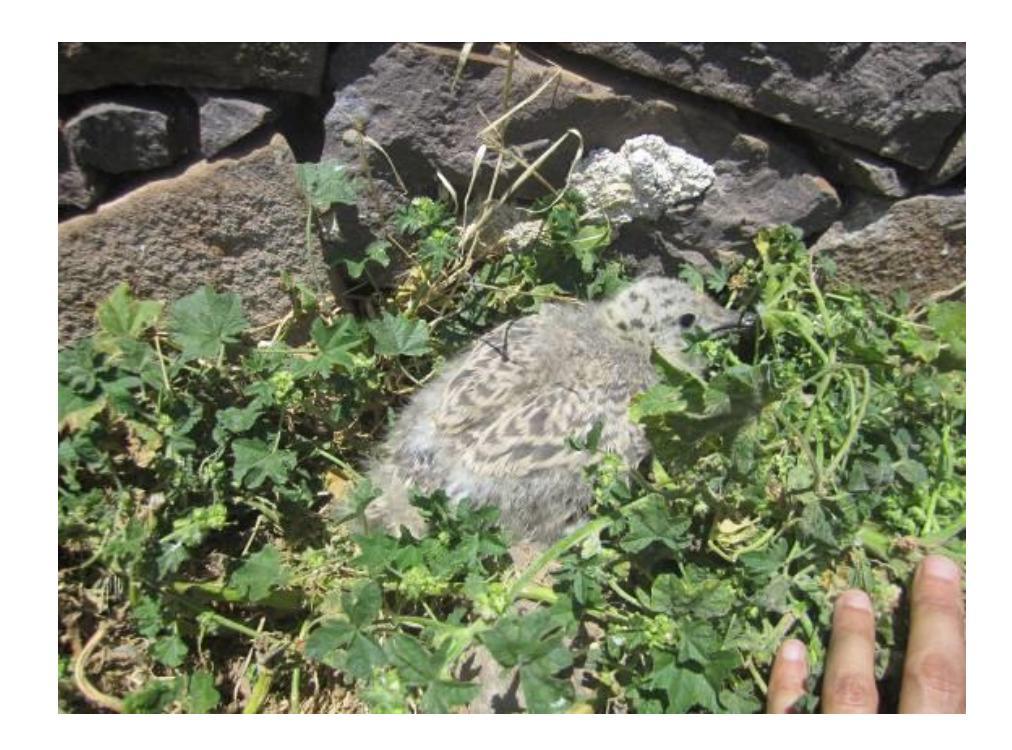
Figure 4.9. Seagull chicks nestled inside the ruins of the Oğlak Island Lighthouse walls and floors (Author, May 2014)
