A PROPOSED MODEL FOR UNDERSTANDING THE IMPACTS OF CLIMATE  
CHANGE ON TANGIBLE CULTURAL HERITAGE

A THESIS SUBMITTED TO  
THE GRADUATE SCHOOL OF NATURAL AND APPLIED SCIENCES  
OF  
MIDDLE EAST TECHNICAL UNIVERSITY

EMİNE GİZEM BAŞKAN

JANUARY 2016

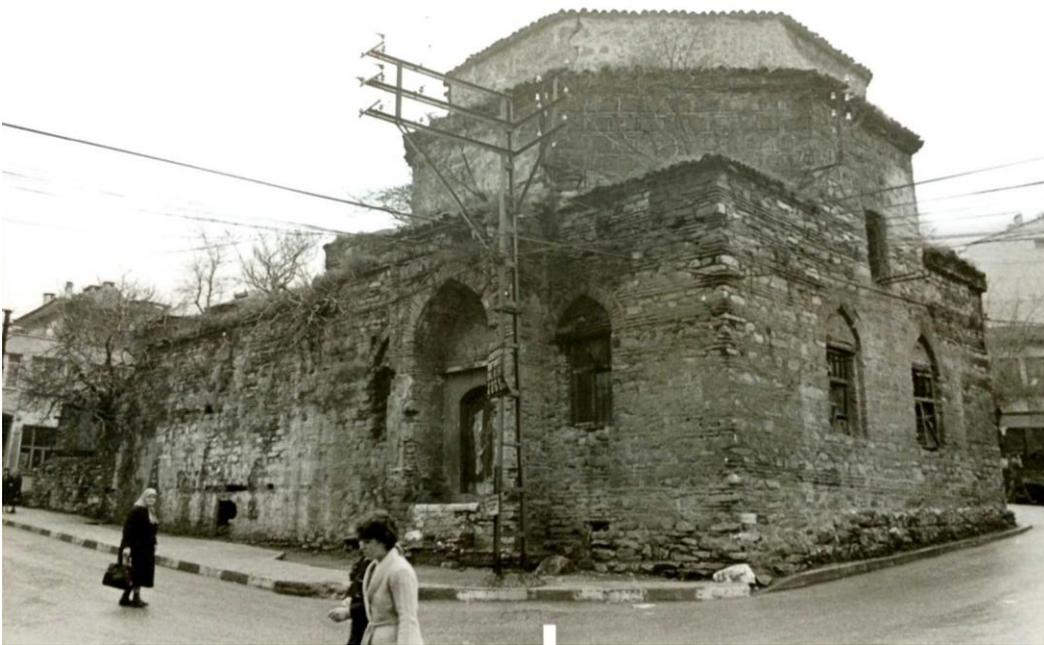
**Figure 5.24.** Material loss, biologic growth, blackening, soiling, and decayed pantiles were seen on the eastern facade of the building.

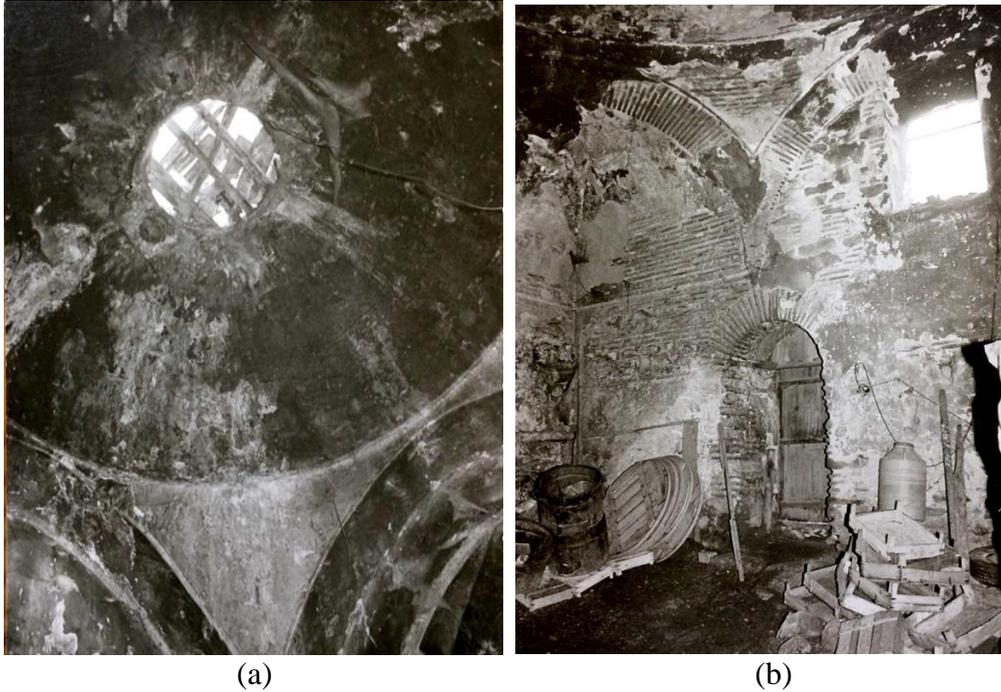
(a) (b)  
**Figure 5.25.** The collapsed roof lantern at the top of the dome (a) causing the rainwater leakage and the damage inside of the building as shown in (b).  
(Source. Bursa – CNHPRB, 1984)

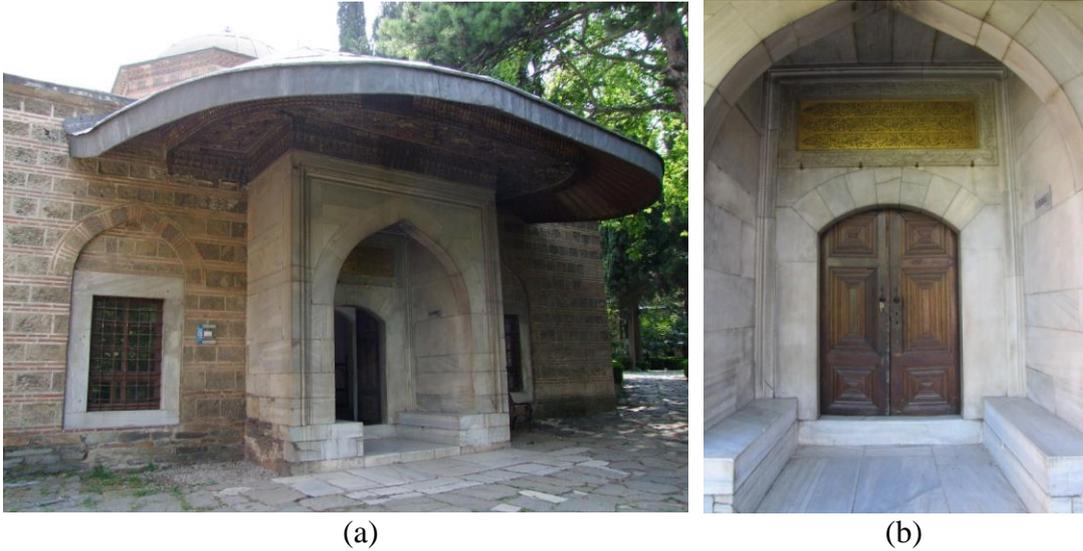
**Figure 5.31.** The exterior views (a) and (b) showing blackening and biological growth (algae) on the canopy and the portal.  
(Source. D2 Tasarım Mimarlık, 2010)

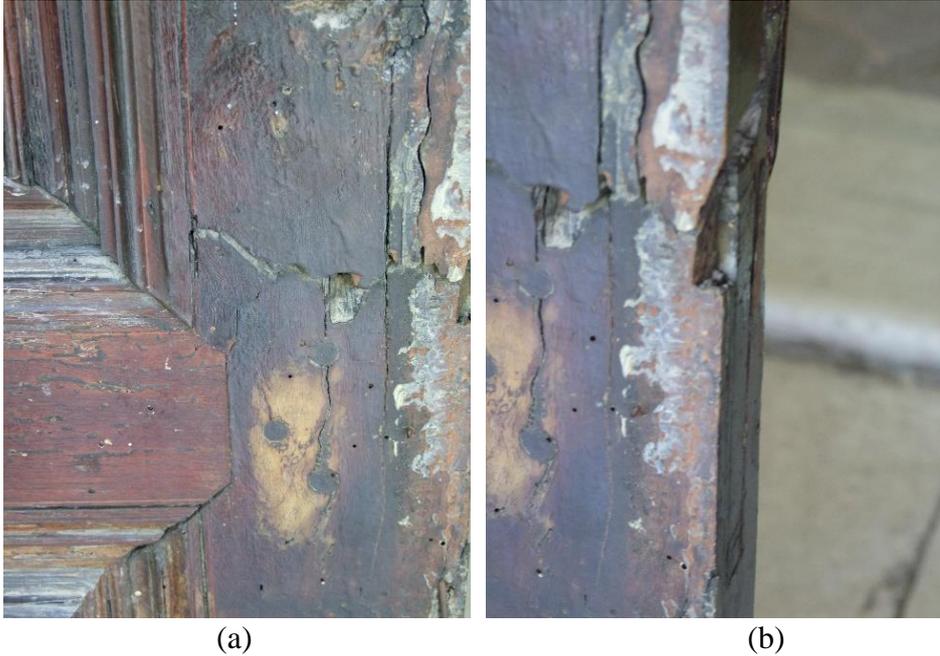
(a) (b)  
**Figure 5.38.** Both (a) and (b) showing the details of decayed wooden entrance door.  
(Source. D2 Tasarım Mimarlık, 2010)

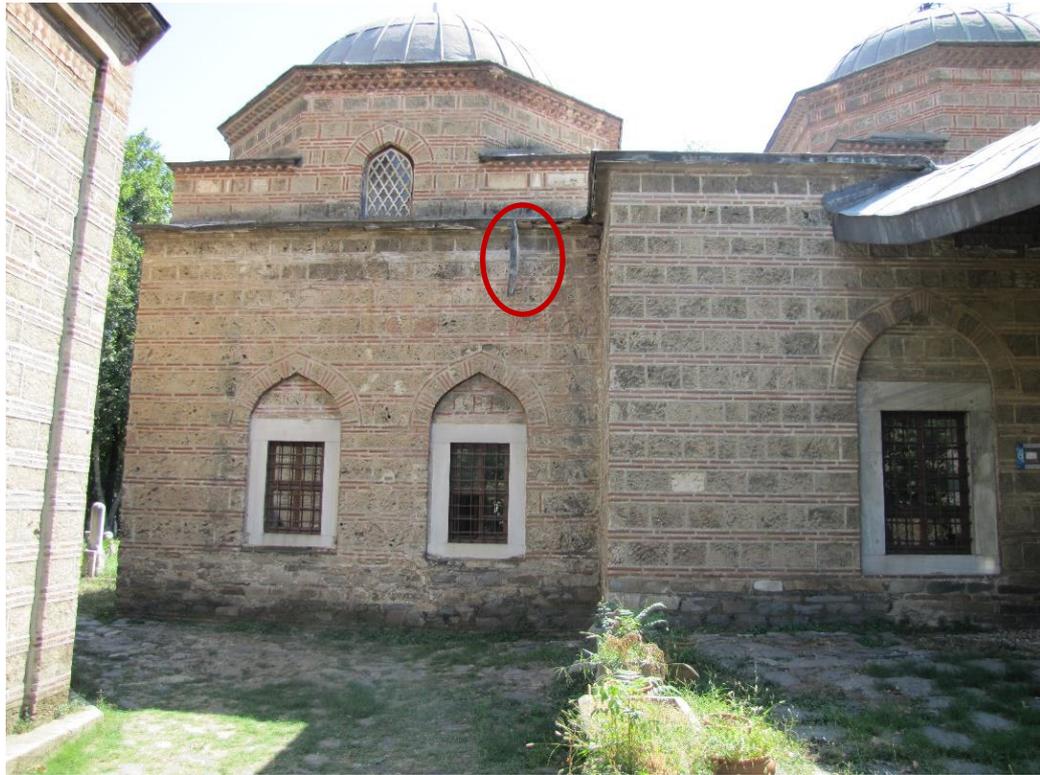
**Figure 5.39.** Damaged lead sheets, which caused penetrating damp to inside, accumulation of dirt and black streaks, were seen on the north facade of the *Şehzade Alaaddin Tomb*.  
(Source. D2 Tasarım Mimarlık, 2010)

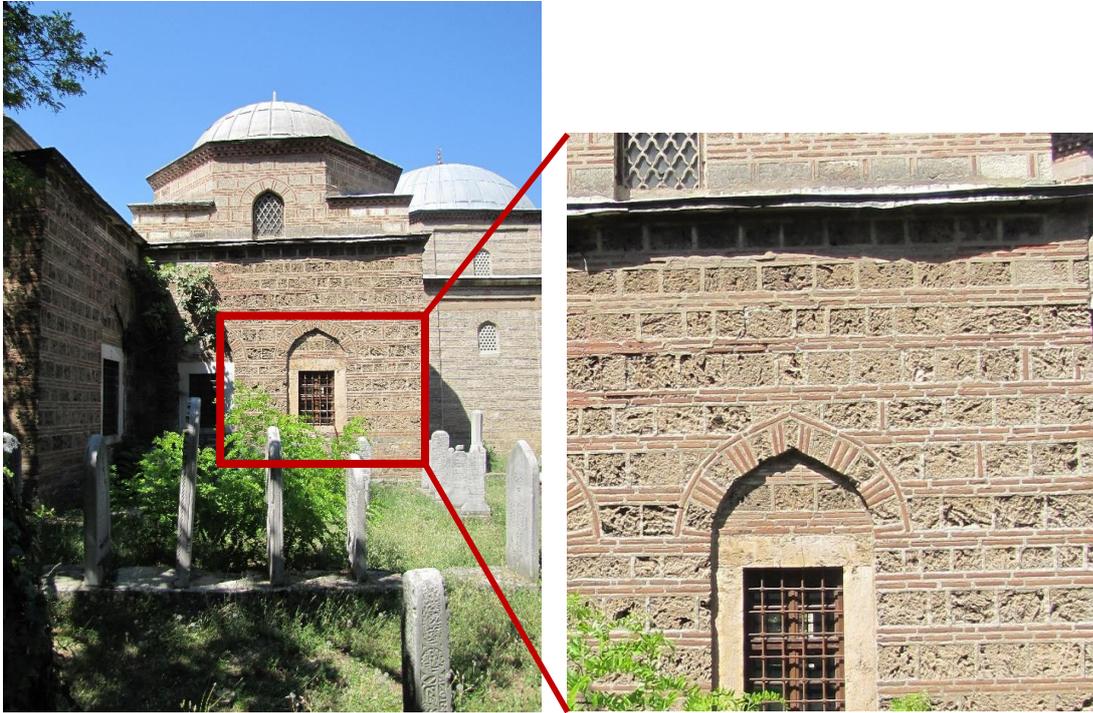
**Figure 5.41.** Surface erosion is clearly observed on the south facade of the *Şehzade Alaaddin Tomb*.

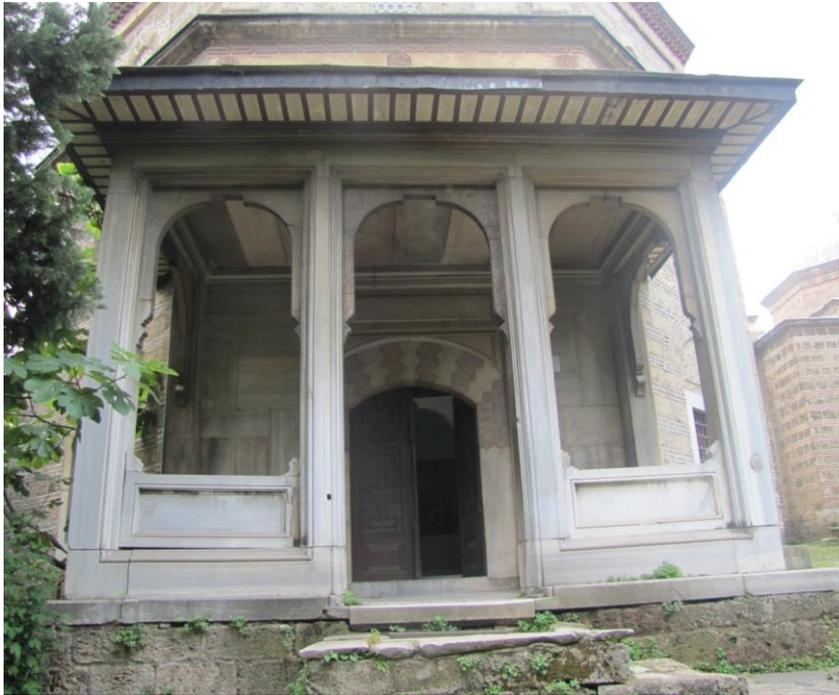
**Figure 5.49.** Excessive soiling was easily observed on marble sections of the portico.  
(Source. D2 Tasarım Mimarlık, 2010)

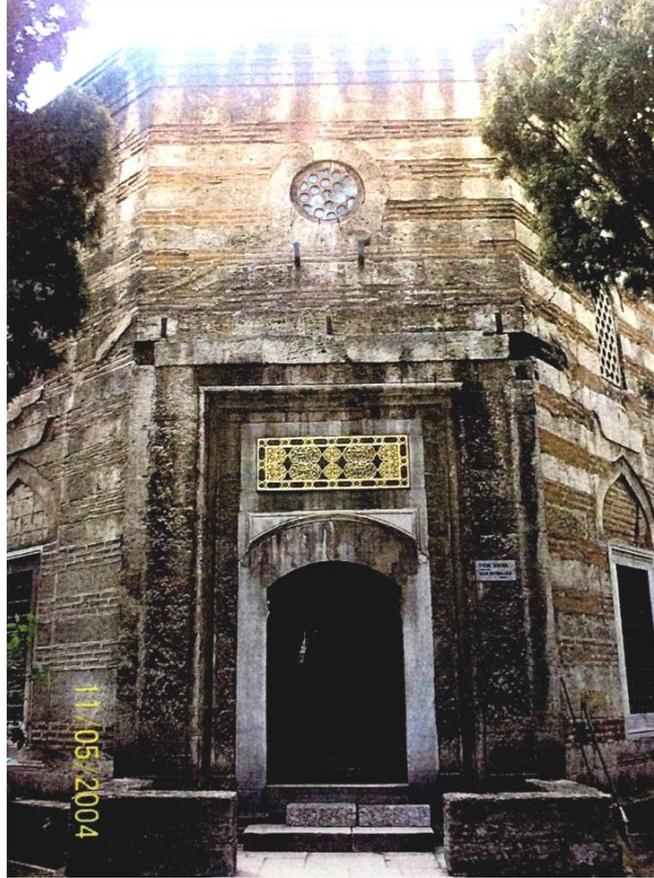
**Figure 5.53.** Missing entrance canopy caused excessive blackening and soiling on the portal. Besides, surface erosion and material loss were also seen at the facades.  
(Source. Bursa – CNHPRB, 2004)

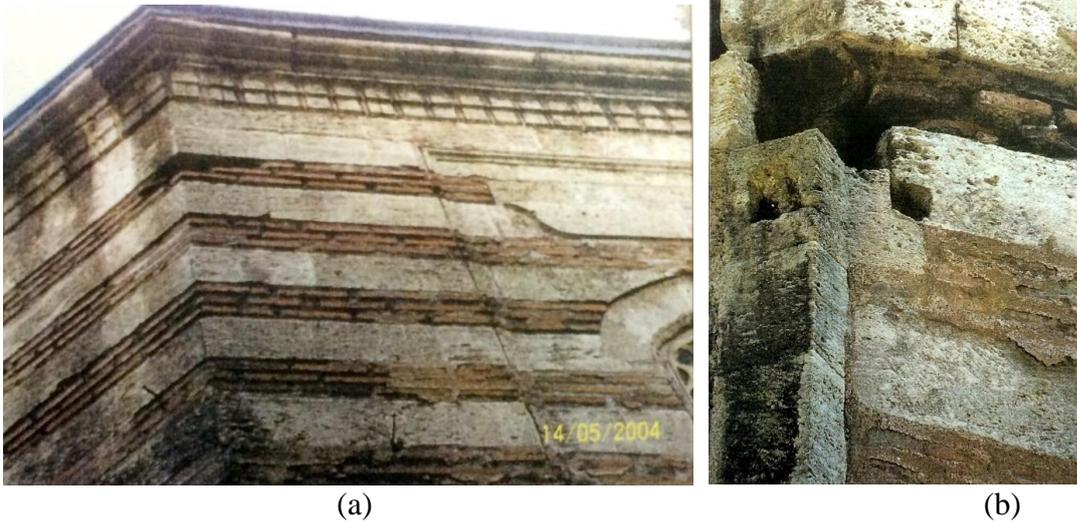
**Figure 5.54.** The photos showing (a) deformed lead sheets on the eaves; blackening on the moulding; and material loss, especially bricks; and (b) material loss (bricks and stones).

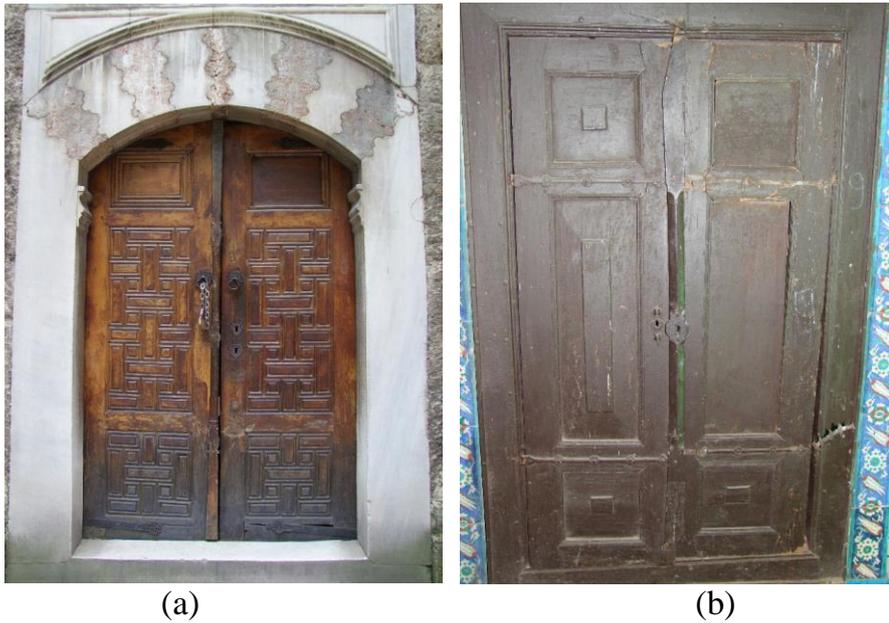
**Figure 5.59.** Both photos displaying the deteriorated wooden entrance door from outside and inside, and greening and darkening on the marble parts of the portal.  
(Source. D2 Tasarım Mimarlık, 2010)

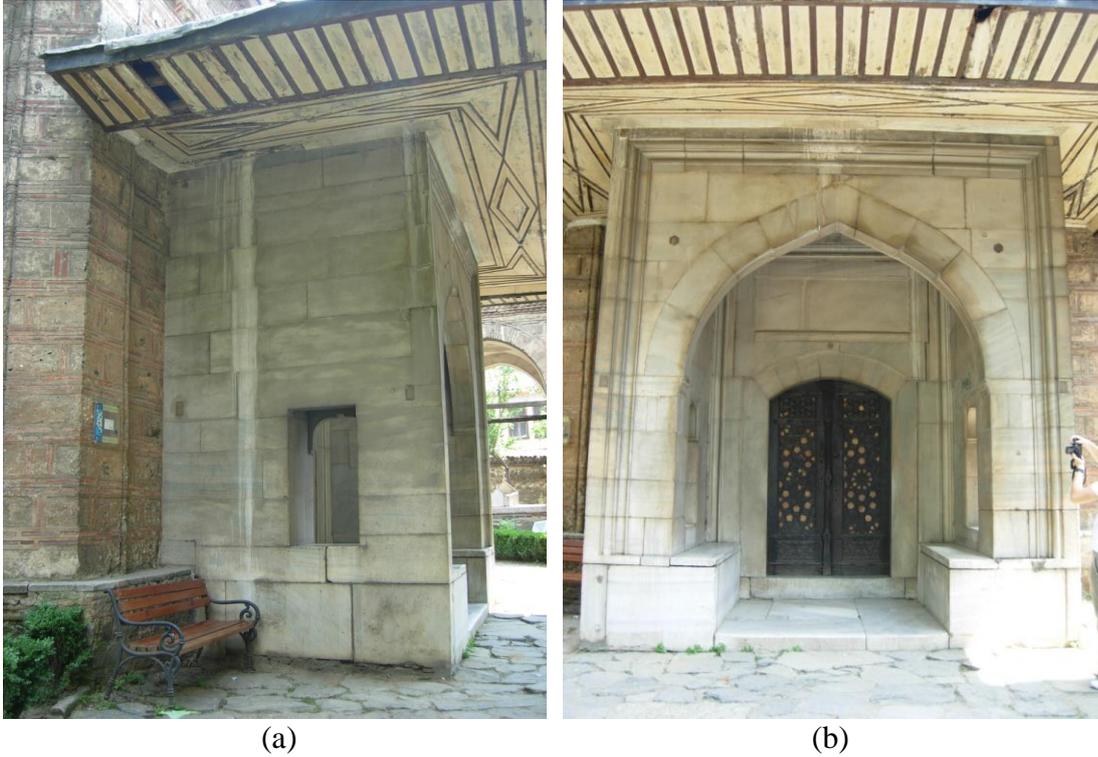
**Figure 5.62.** Both (a) and (b) showing soiling on the marble parts and the deteriorated woodwork of the portico.  
(Source. D2 Tasarım Mimarlık, 2010)

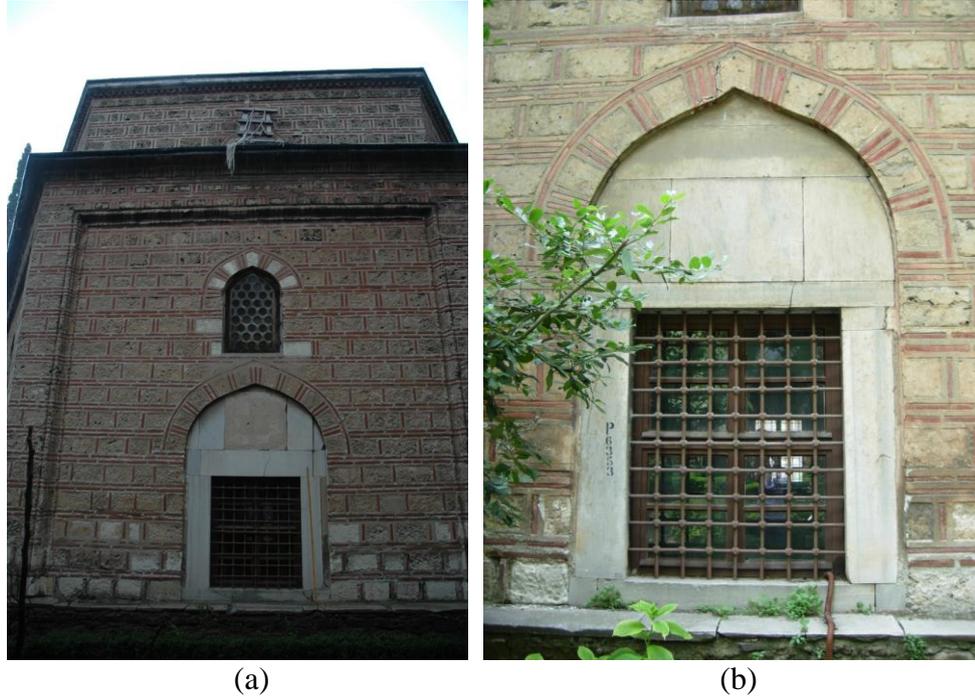
**Figure 5.63.** Both (a) and (b) showing blackening, and eroded stone and brickworks.  
(Source. D2 Tasarım Mimarlık, 2010)

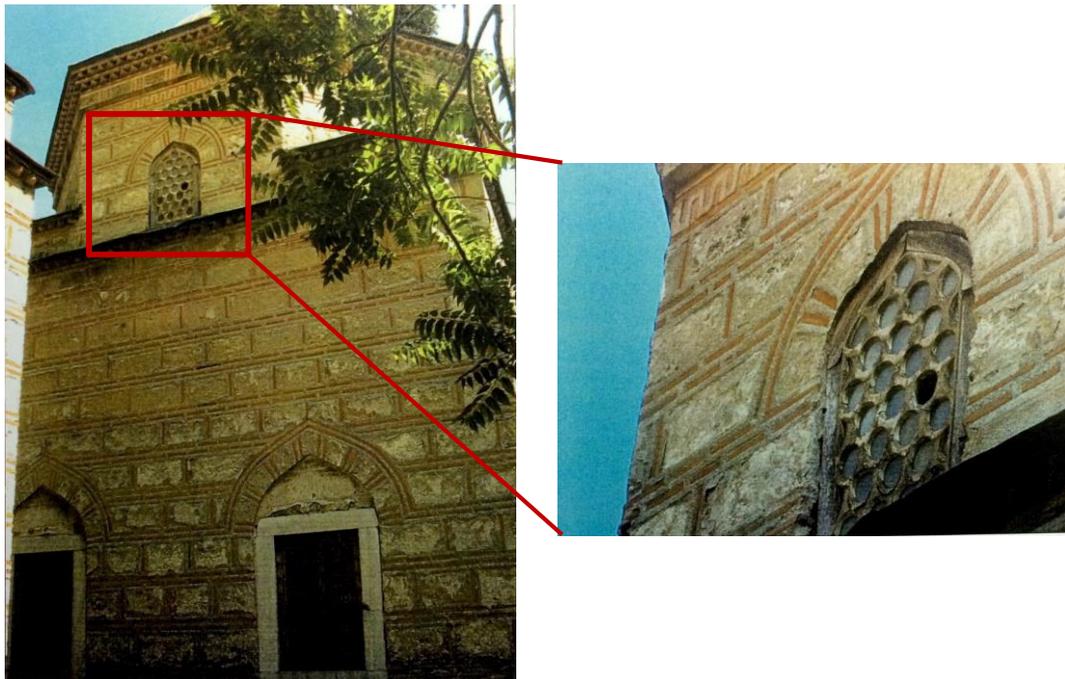
**Figure 5.69.** The photos showing the spalling lime mortar, which covered the surfaces of stone courses, and the deteriorated gypsum framed exterior window. (Source. Bursa – CNHPRB, 2004)

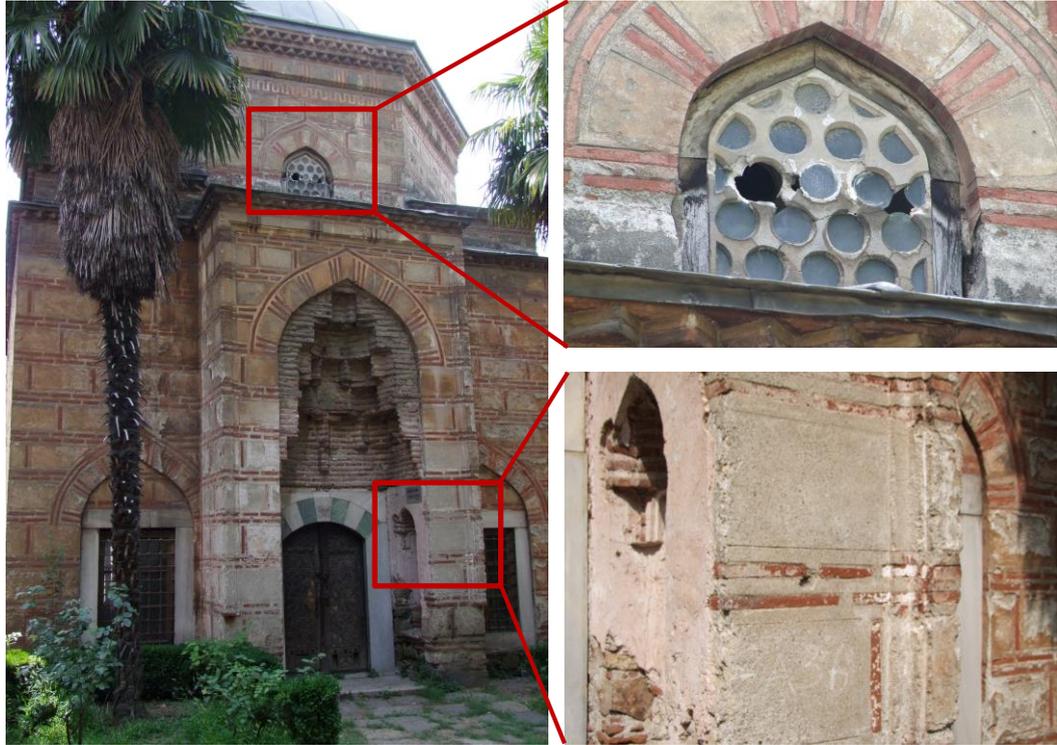
**Figure 5.71.** The photos showing the details from the problematic sections of the tomb, such as detached brick courses, broken gypsum framed exterior window and bell jars, and poor repointing.  
(Source. D2 Tasarım Mimarlık, 2010)

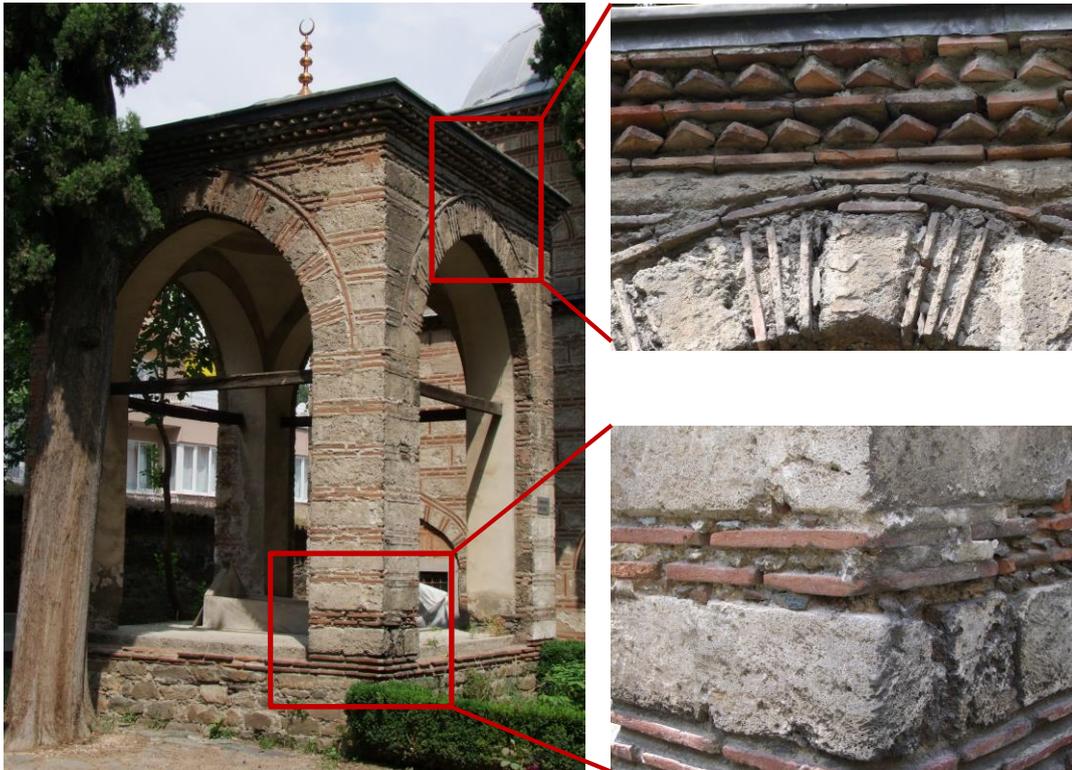
**Figure 5.74.** Deteriorated brick and stone courses, and mortar joints.  
(Source. D2 Tasarım Mimarlık, 2010)

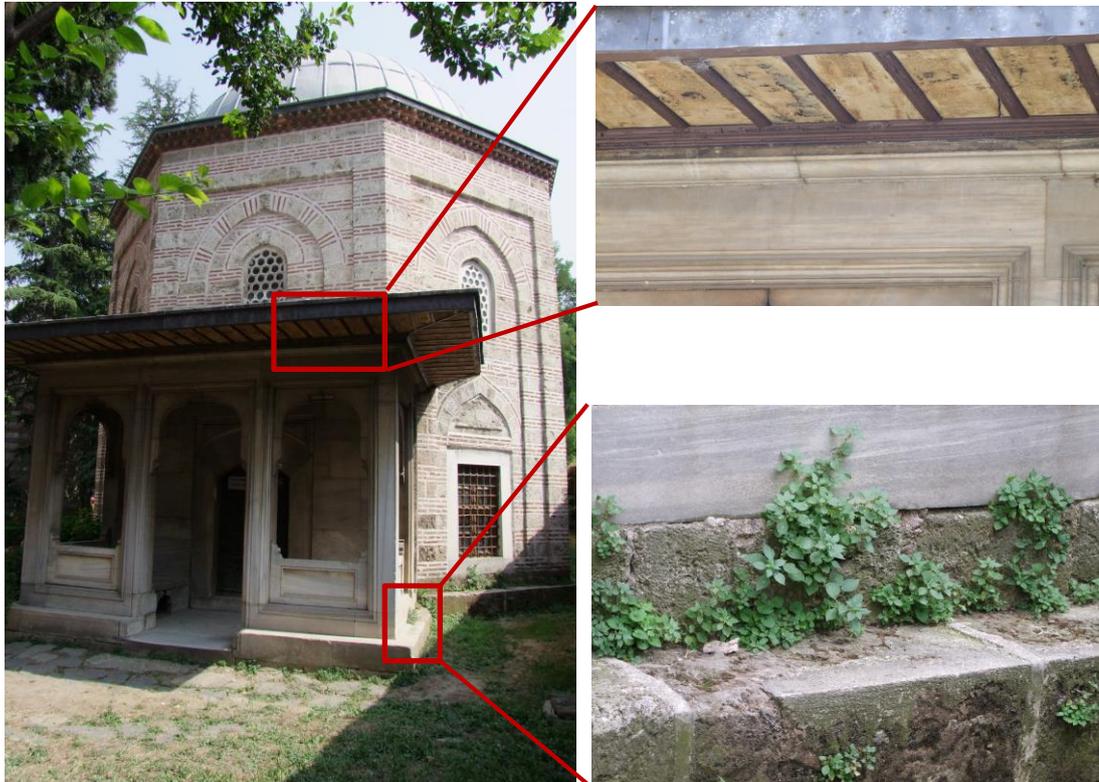
**Figure 5.77.** The photos showing the decayed wooden parts of the canopy and the biological growth on the plinth.  
(Source. D2 Tasarım Mimarlık, 2010)

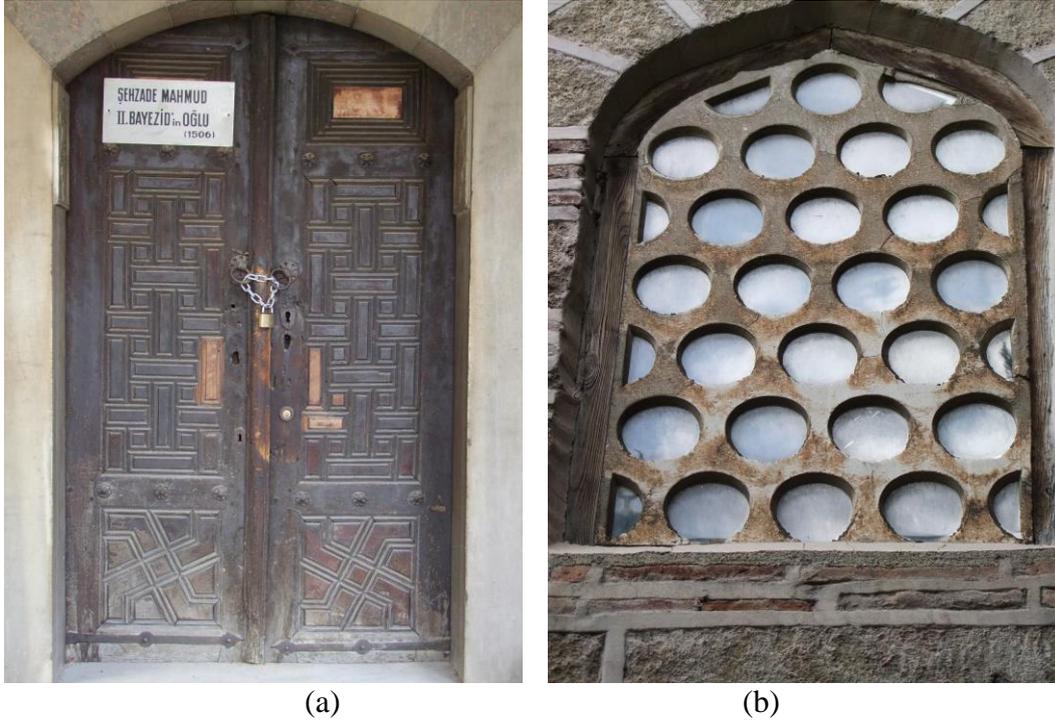
**Figure 5.78.** The photos showing (a) the decayed wooden door, and (b) the discolored gypsum framed exterior window.  
(Source. D2 Tasarım Mimarlık, 2010)

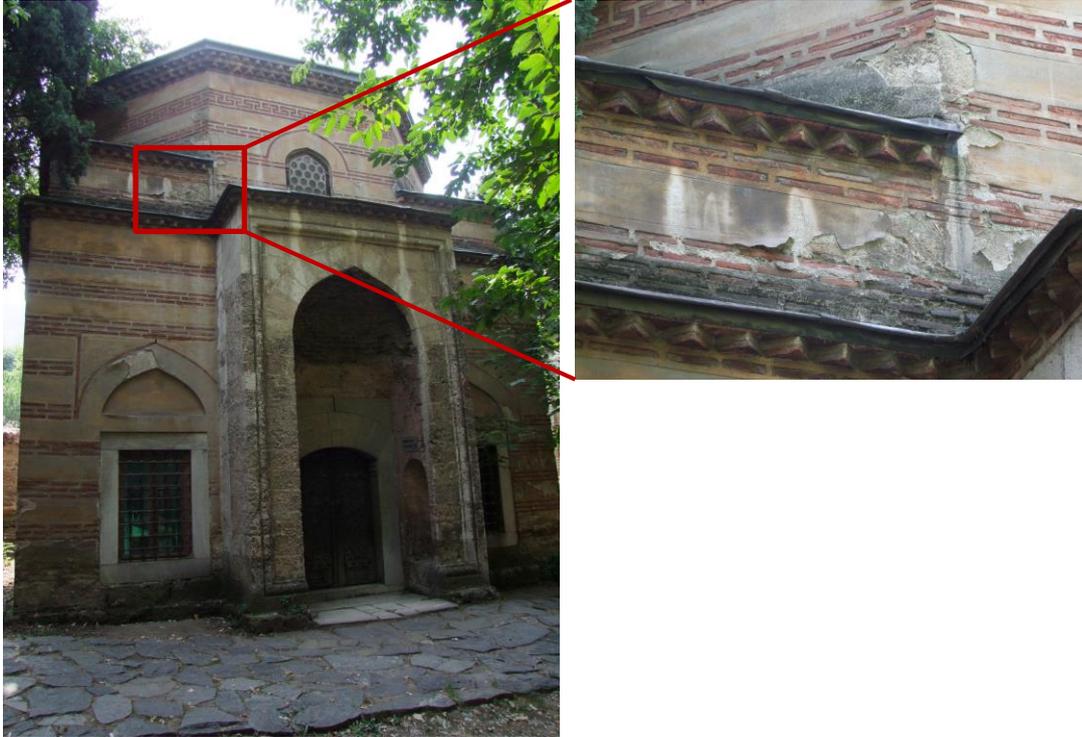
**Figure 5.81.** The photos showing the deformed lead sheets covering the eaves, dark patches and blackening on the facades.  
(Source. D2 Tasarım Mimarlık, 2010)

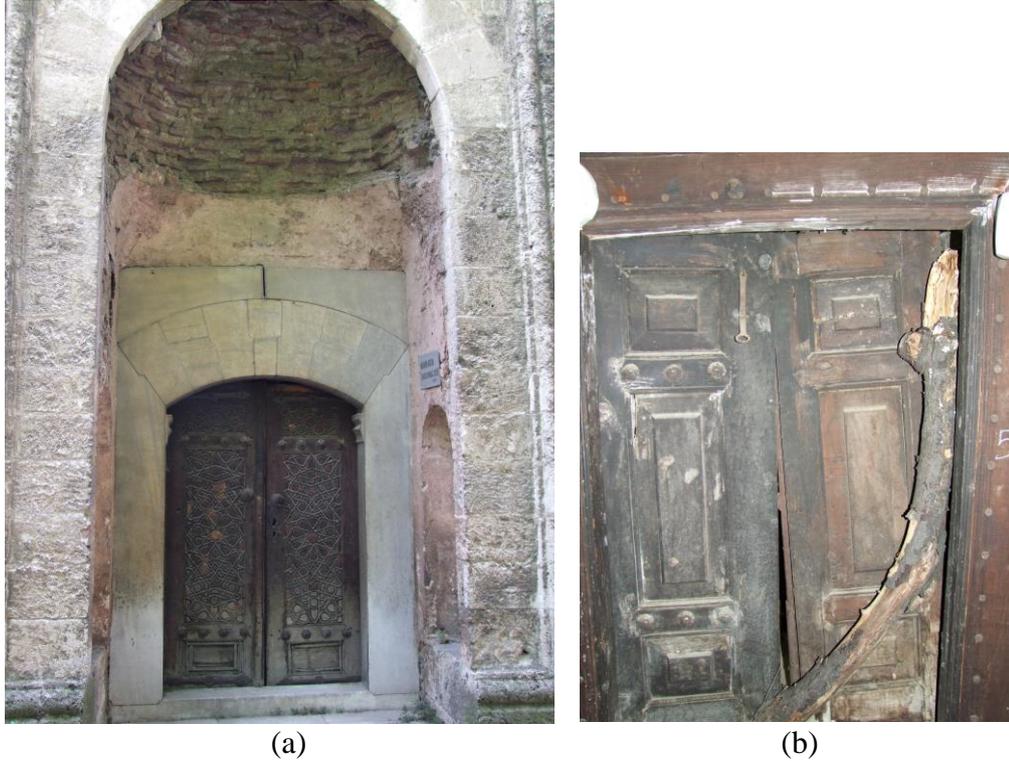
**Figure 5.82.** The photos showing (a) deteriorated brick courses, decayed wooden door and soiling on the portal, and (b) the decayed wooden shutter.  
(Source. D2 Tasarım Mimarlık, 2010)

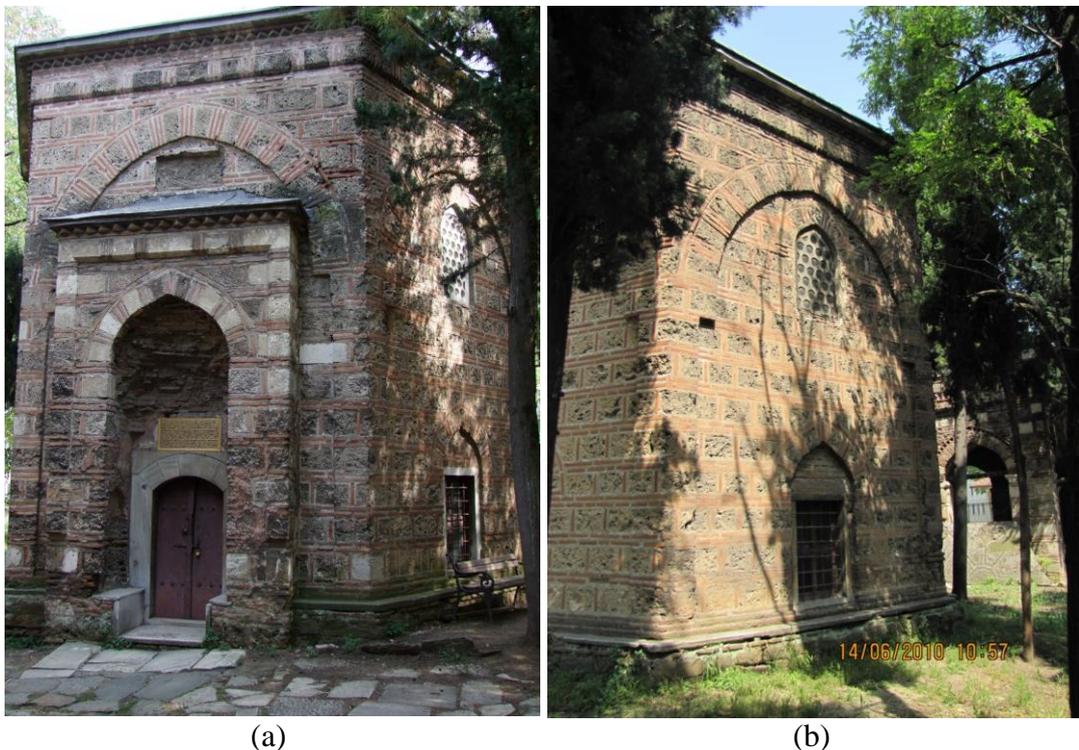
**Figure 5.83.** The photos (a) and (b) showing the erosion of both brick-stone courses and mortar joints, excessive blackening and algae growth in the facades.  
(Source. D2 Tasarım Mimarlık, 2010)

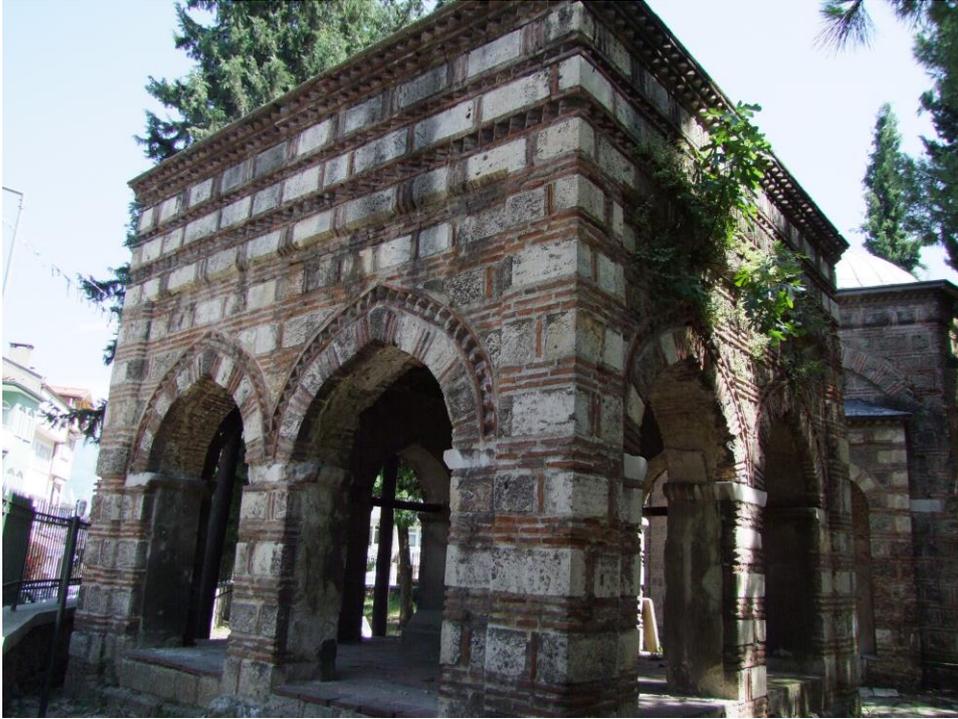
**Figure 5.84.** The photo showing the northern and western facades of the tomb. The deteriorated brick and stone courses, eroded mortar joints and blackening were identified.

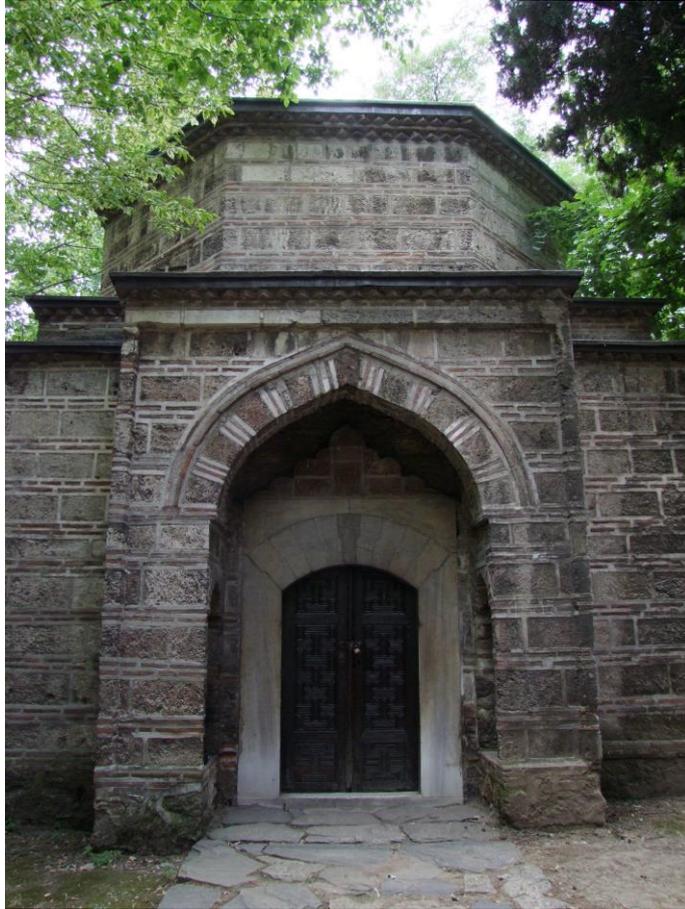
**Figure 5.85.** The photo showing blackening and algal growth on the facades.  
(Source. D2 Tasarım Mimarlık, 2010)

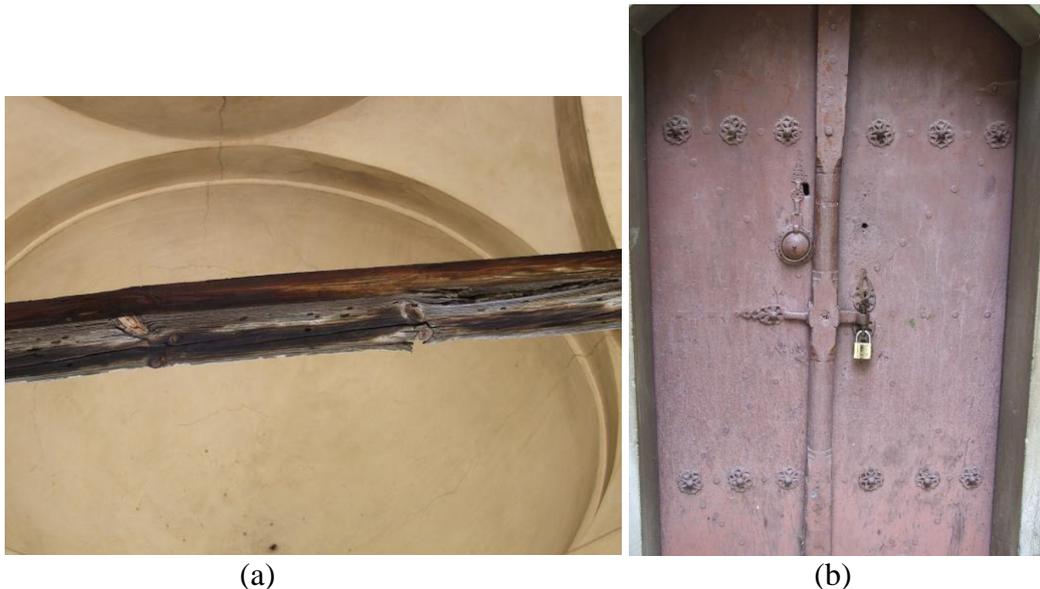
**Figure 6.22.** The photos showing (a) the cracks in the bonding timber of the tomb of Gülbahar Hatun, and (b) adhesion of the paint layer in patches on the timber door of Hüma Hatun (taken by the author).

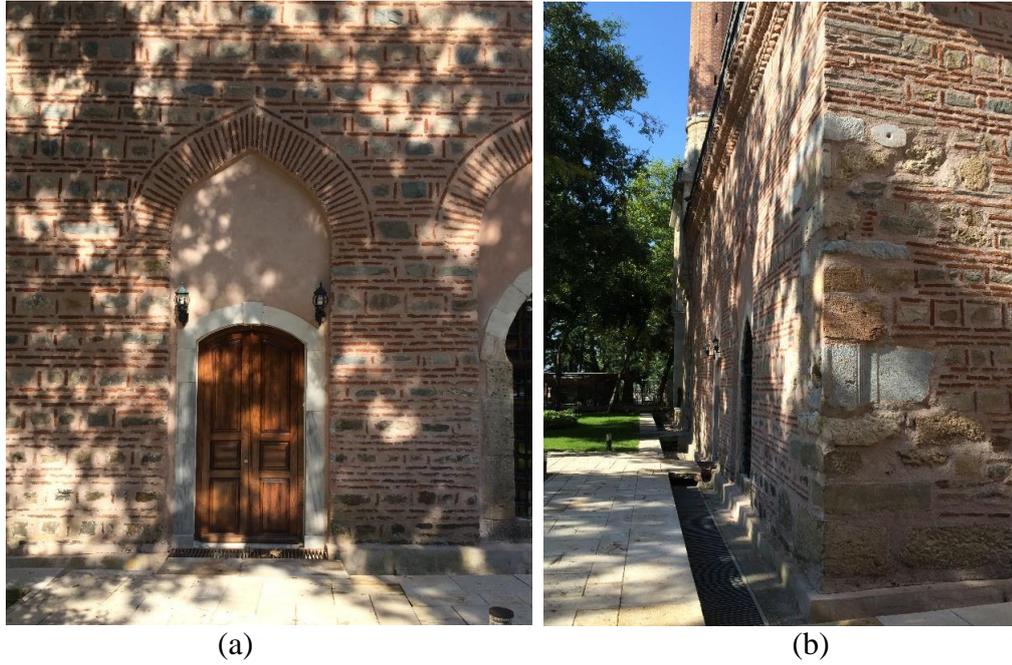
**Figure 6.25.** (a) The faint green stains and the line of dampness on the west facade of the mosque in August 2014; and (b) the open drainage system (taken by the author).

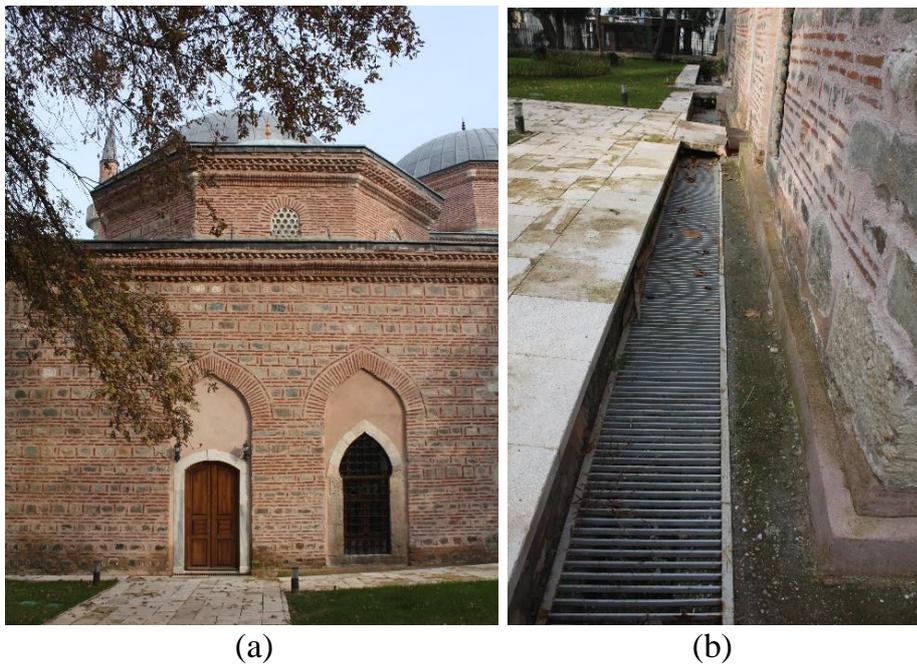
**Figure 6.26.** Damp and green areas are more significant in both photos (a) and (b) taken in November 2014 (taken by the author).

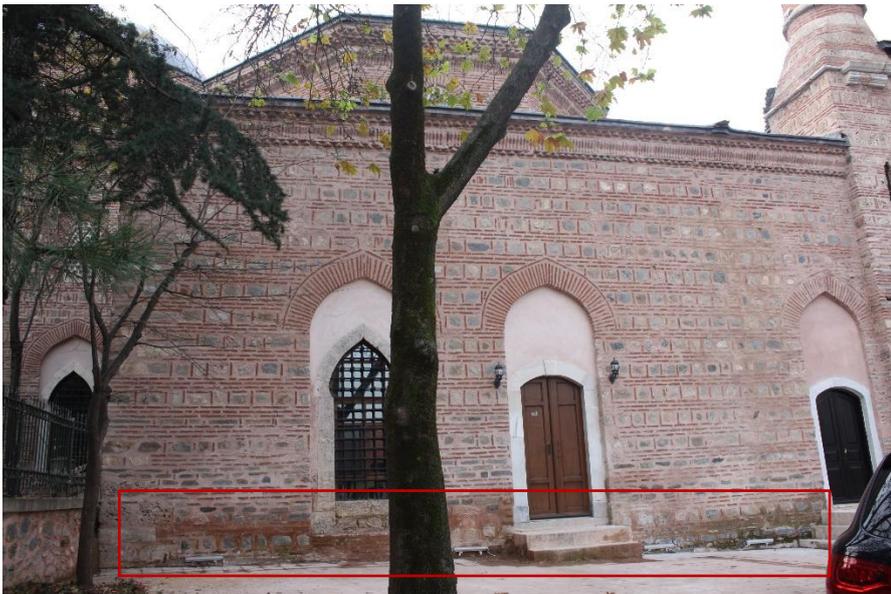
**Figure 6.27.** Wet areas and deposit of water-soluble salts on the lower parts of the masonry are similar to the condition before restoration on the east facade (taken by the author).

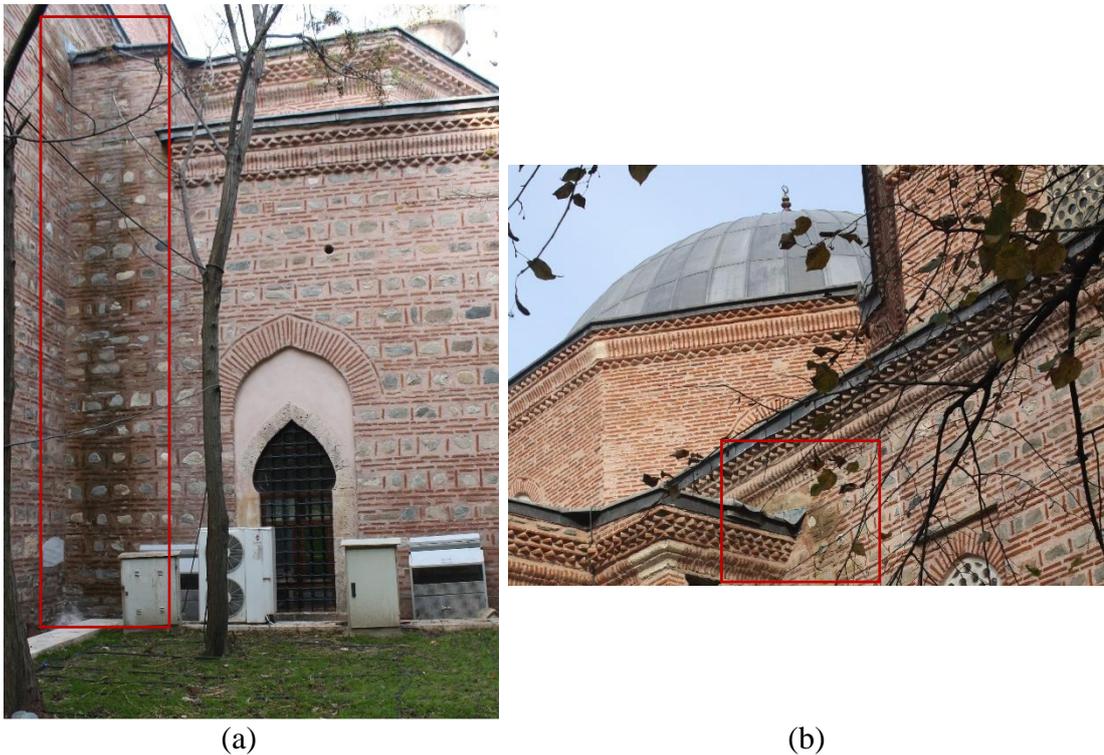
**Figure 6.28.** Occurring of dampness and biological growth on the facades due to the flow of water over the specific area after the restoration project (taken by the author in November 2014)

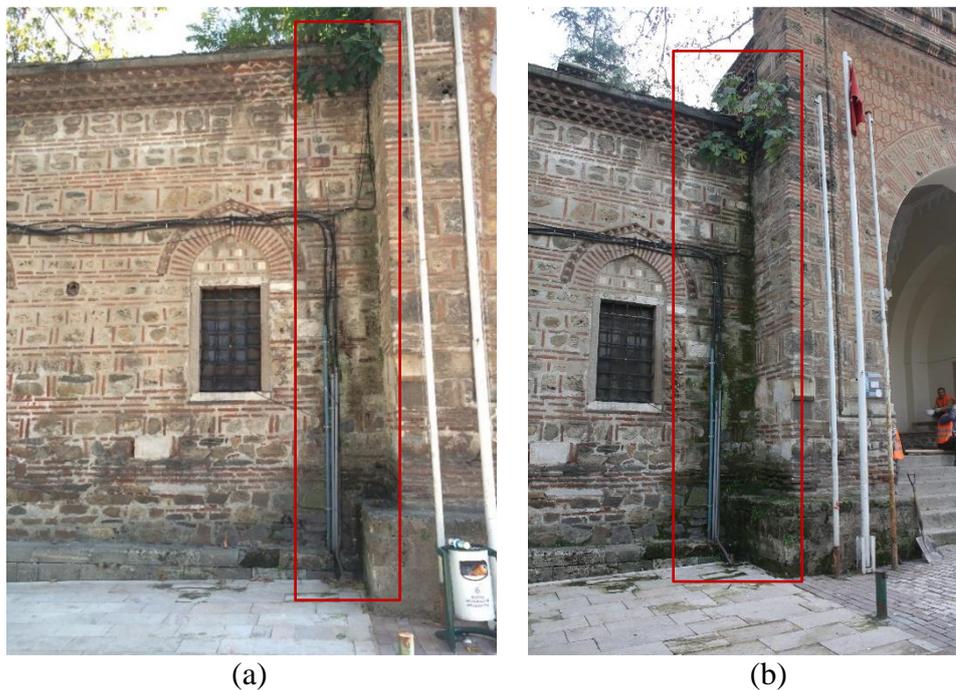
**Figure 6.29.** The difference between (a) August (dry season) and (b) November (wet season) in terms of the intensity of greening on the surface (taken by the author).

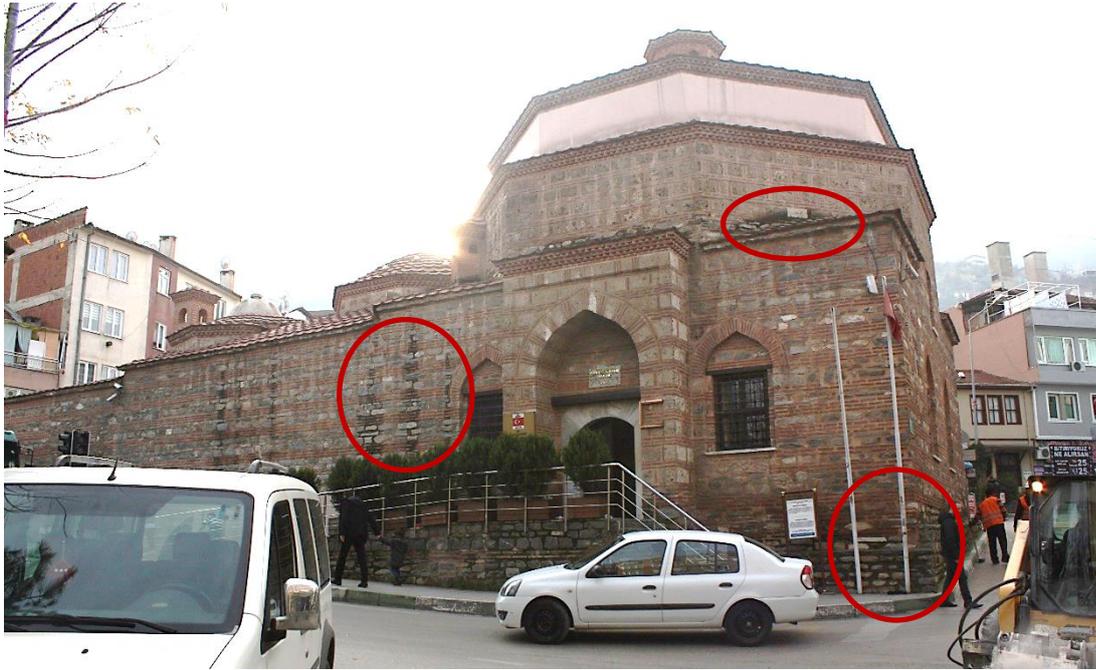
**Figure 6.33.** The red circles indicating the different areas suffering from dampness, blackening and biological growth (taken by the author).

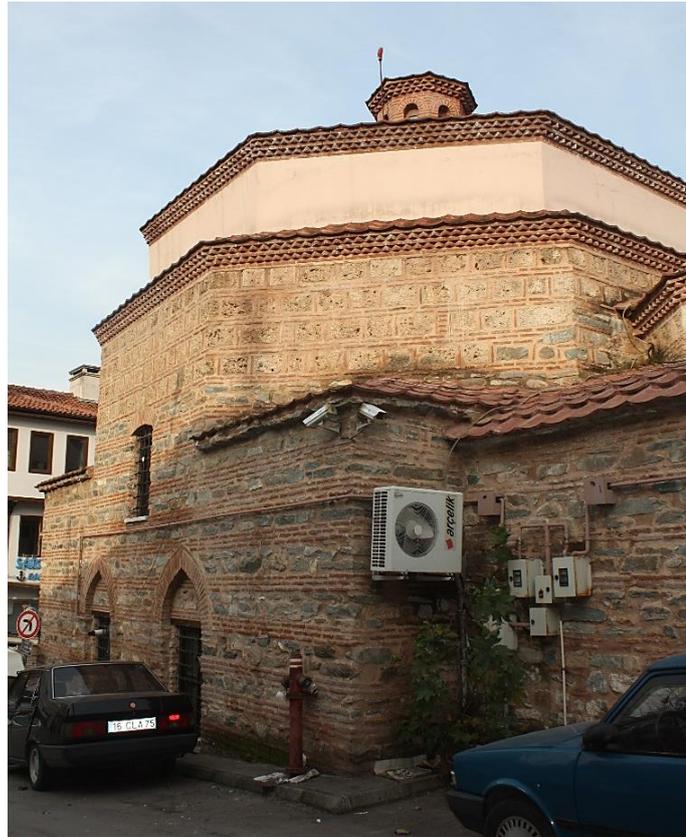
**Figure 6.34.** The re-growth of the woody root plant at the junction of the walls (taken by the author).

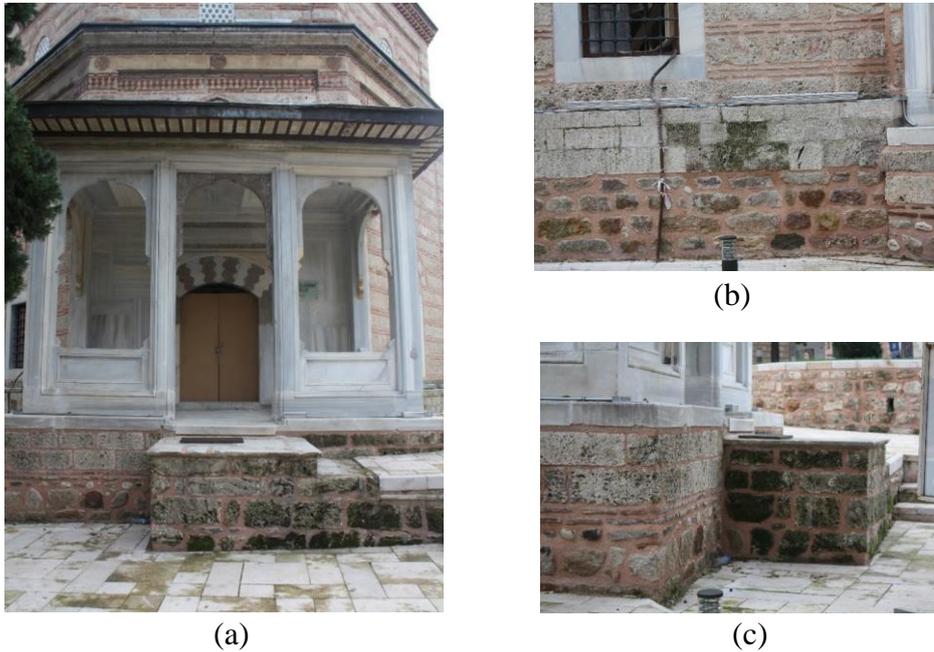
**Figure 6.41.** The photos show the dampness and biological growth problems on *küfeki* stones of the stairs in front of the portico and the plinth (taken by the author).
