A PROPOSED MODEL FOR UNDERSTANDING THE IMPACTS OF CLIMATE  
CHANGE ON TANGIBLE CULTURAL HERITAGE

A THESIS SUBMITTED TO  
THE GRADUATE SCHOOL OF NATURAL AND APPLIED SCIENCES  
OF  
MIDDLE EAST TECHNICAL UNIVERSITY

EMİNE GİZEM BAŞKAN

JANUARY 2016

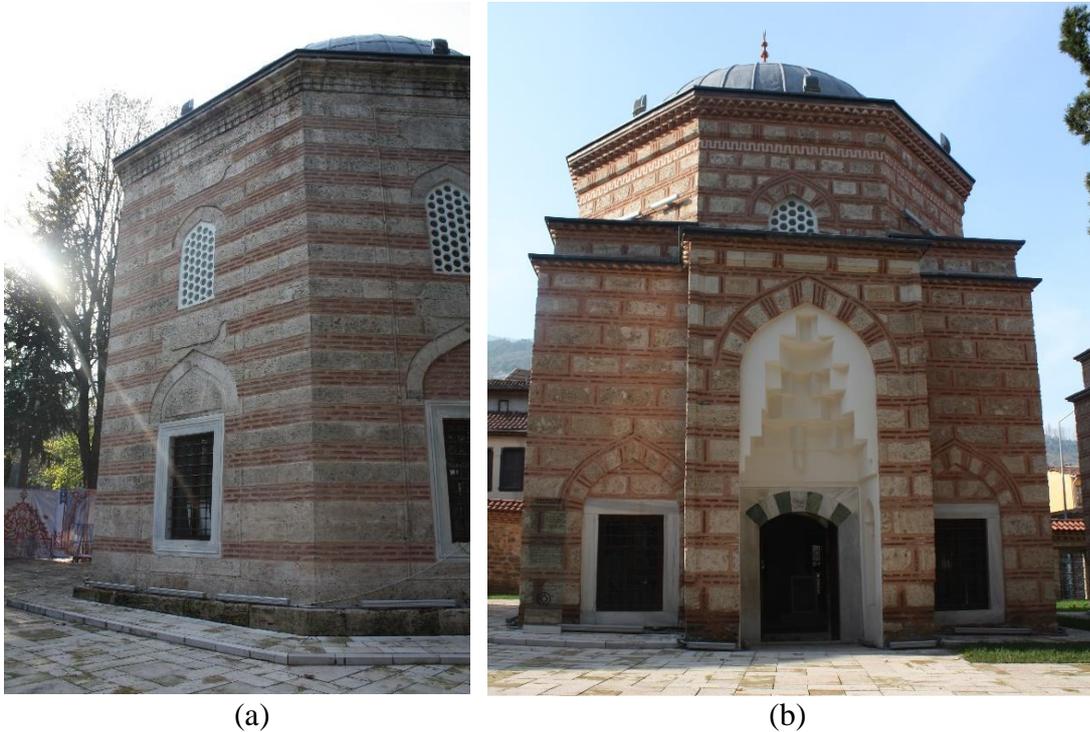
**Figure 6.44.** (a) Greening on the lower surfaces of the Tomb of Şehzade (Prince) Mustafa indicating the presence of excessive moisture; and (b) darker patches on the lower level of the walls of Gülruh Sultan Tomb corresponding to areas of persistent damp (taken by the author).

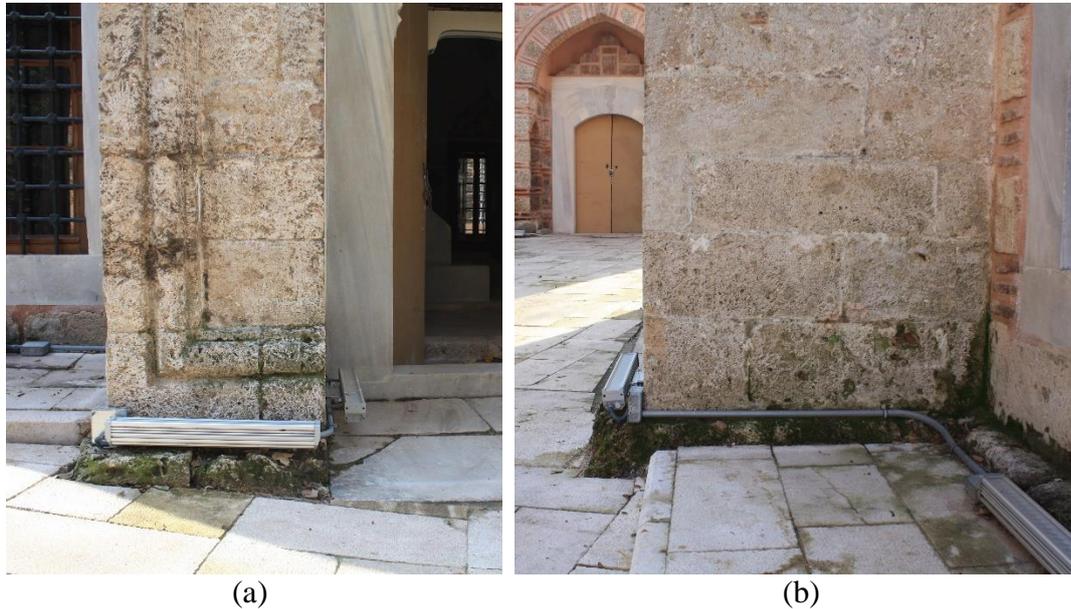
**Figure 6.47.** The photos displaying the colonization on damp areas of the lower levels of the walls in the Tomb of Mükriime *Hatun* (taken by the author).

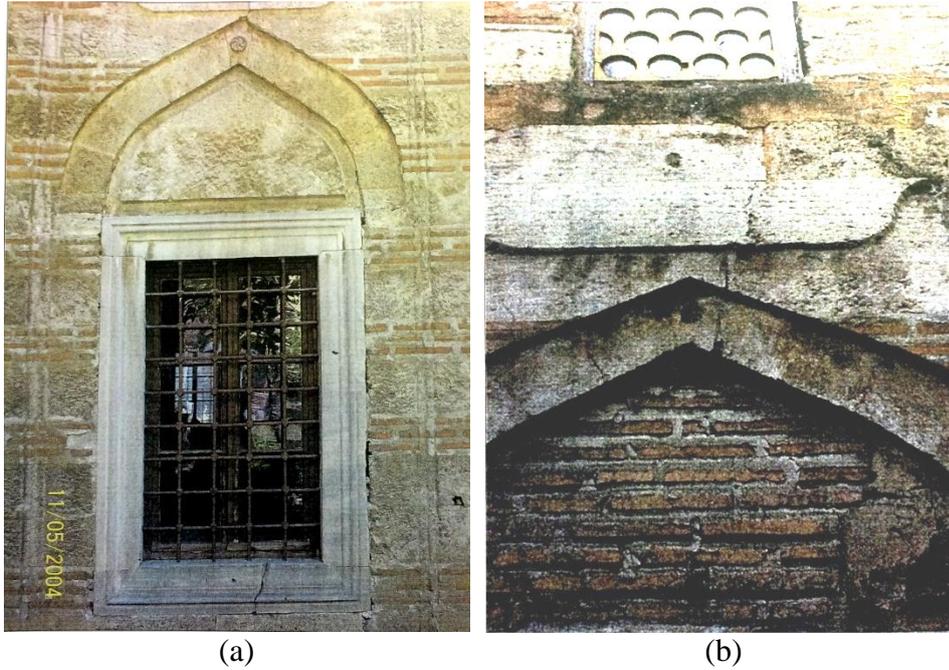
(a) (b)  
**Figure D.17.** Both (a) and (b) show the cracks in different parts of the building, especially around the windows.  
(Source. Bursa-CNHPRB, 2004)
