**DOCUMENTATION AND EXAMINATION OF HISTORIC  
BUILDING MATERIALS FOR THE PURPOSE OF CONSERVATION: CASE  
STUDY, PART OF THE WALLS AT THE CITADEL OF ANKARA**

**A THESIS SUBMITTED TO  
THE GRADUATE SCHOOL OF NATURAL AND APPLIED SCIENCES  
OF  
MIDDLE EAST TECHNICAL UNIVERSITY**

**JANUARY 2005**

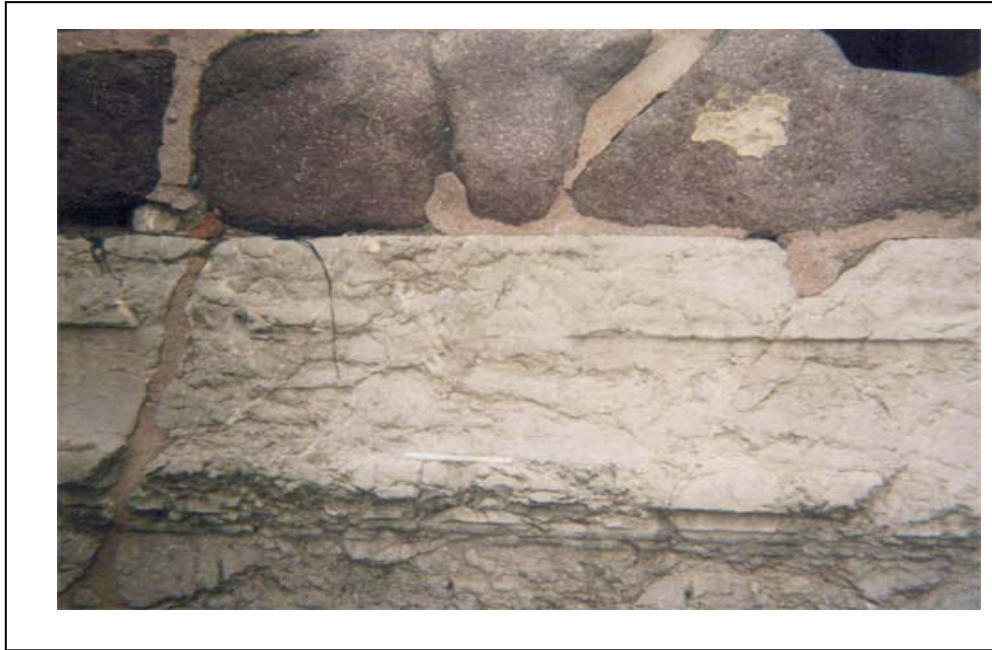
**Figure 3.1** A view from west elevation at Gençkapı Gate; material loss and detachment as scales on marble surfaces

Visual analyses was done according to procedure given in section 2.1. It showed that, the stone walls of Gençkapı Gate had some deterioration forms as material loss, alveolization, detachments as scales, discoloration and salt deposition on the stone surfaces

(Fig. 3.1-3.2). The most severe decay was found especially on the marble stones on the west elevation (Fig. 3.1). In the upper part of the north elevation, alveolar weathering and salt deposition were observed (Fig. 3.2).

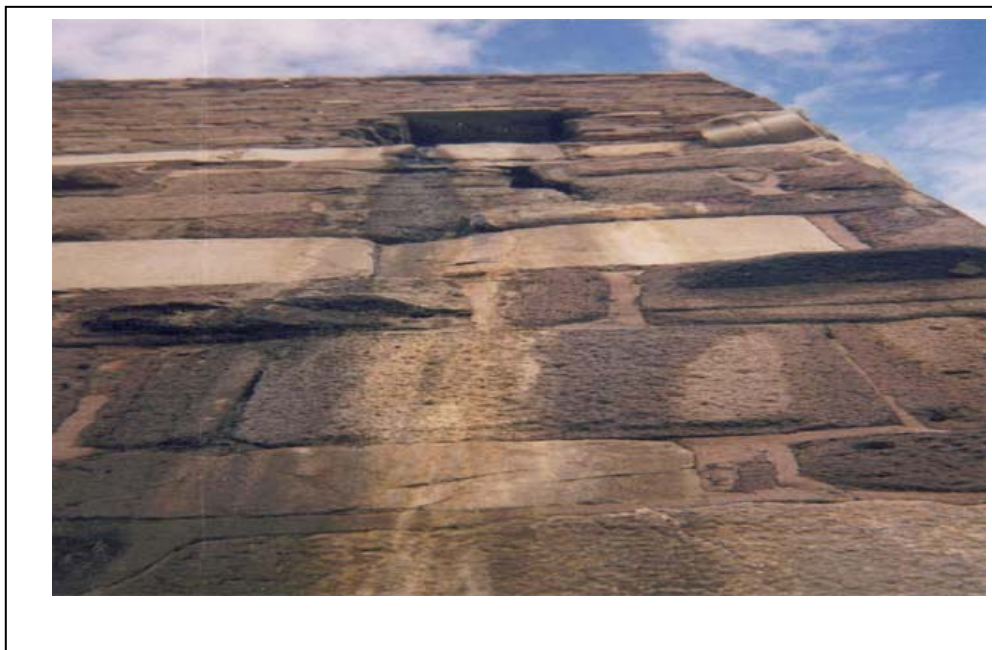
**Figure 3.2** A view from north elevation at Gençkapı Gate; salt depositon and alveolar weathering on the andesite surface
