VALUE ASSESMENT FOR DEFINING THE CONSERVATION
PRINCIPLES FOR *KAYSERİ SÜMERBANK BEZ FABRİKASI*

METU 2007

A THESIS SUBMITTED TO
THE GRADUATE SCHOOL OF NATURAL AND APPLIED SCIENCES
OF
MIDDLE EAST TECHNICAL UNIVERSITY

IN PARTIAL FULFILLMENT OF THE REQUIREMENTS
FOR
THE DEGREE OF MASTER OF RESTORATION
IN
ARCHITECTURE

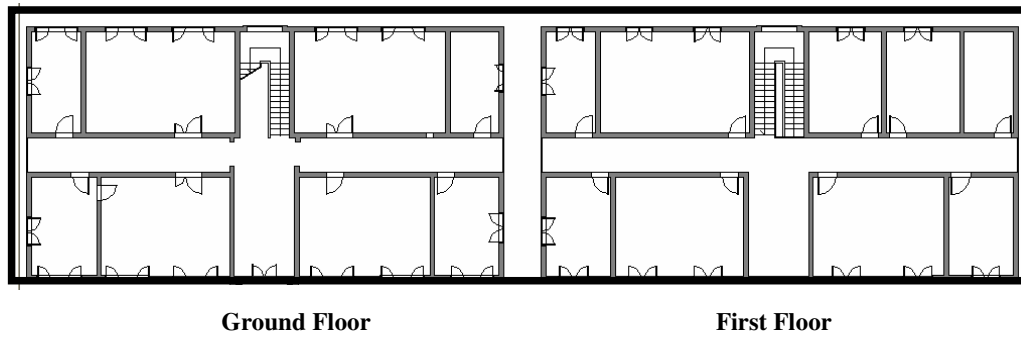
Fig. 13: Administration Building Plans (2006)

Entrance is enabled by a huge gate in the middle of the building. Plan scheme and aspects are symmetrical. There is upstairs right against entrance. Corridors, main entrance gate and stairs are in the center of the building shaped as cross. There are offices on the west and east of the corridor in the middle of the building in south-north directions. There are windows for lightening in north and south ends of the corridor. Similar plans are used for both floors. Internal walls are cement plastered and painted and floor covering is timber. Windows and doors are woodwork.

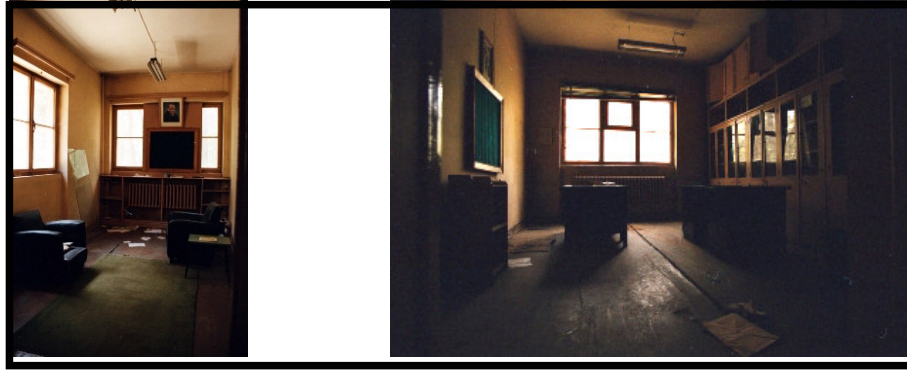
Fig. 15: Interior Photo of Building (2005)

Administrative building is not in use today. It is neglected like the whole factory. However there is no general significant deterioration. There are not any structural problems. The deformation stems from not being used and being neglected. Architectural timber elements need care or renewal. It is necessary to adapt the building which has conveniences of the year 1935 to the present conditions, especially wet spaces need renewal.

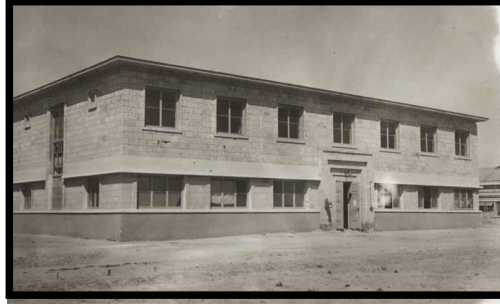
Fig. 17: Elevation Photo of Administration Building in 1938⁶³

There is not any change in plan scheme or façade organization of the administrative building of the factory built in 1935. It has been maintained and repaired for modification such as paint renewal, varnishing wood elements. It can be seen in original plan designs and photos of front elevation shows that no changes are done.

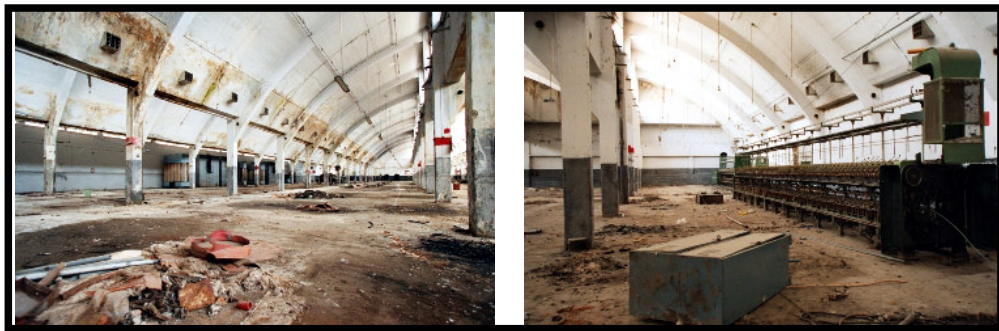
Fig. 18: Interior Photo Of Production Building (2005)

There are various units in the building because of being multifunctional. The most important among them is the main aerodrome used for weaving. Entrance to the unit is enabled from south and east of the building. Entrance is not directly connected to work place but it is connected to dressing rooms. Weaving workshop is reached from there. Sunlight is carefully used for lightening and an upper blanket system is used for this purpose. Upper blanket of work places is provided by connecting semicircular beams to columns.

Large volumes were done with pitched beam system. Modernist way of design was able to be seen on technical accessories hidden in construction. Mechanical systems (air conditioning, heating, lightening) were solved in the details of column beam connections. In addition to the wide workshops with weaving looms, there were lots of places for other purposes in the building.

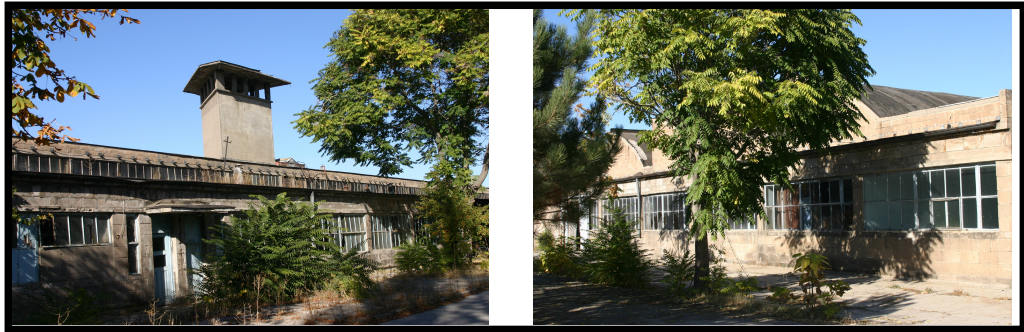
Fig. 20: South and West Elevation Photo Of Production Building(2006)

The most important elevation of the building is west façade. Water storage is in this façade. As the highest unit of the production building with a height of nearly 20 meters. There are the gates for raw material and in this elevation. Weaving looms and other equipment has been sent out from west elevation. Many walls are deformed because of this process.

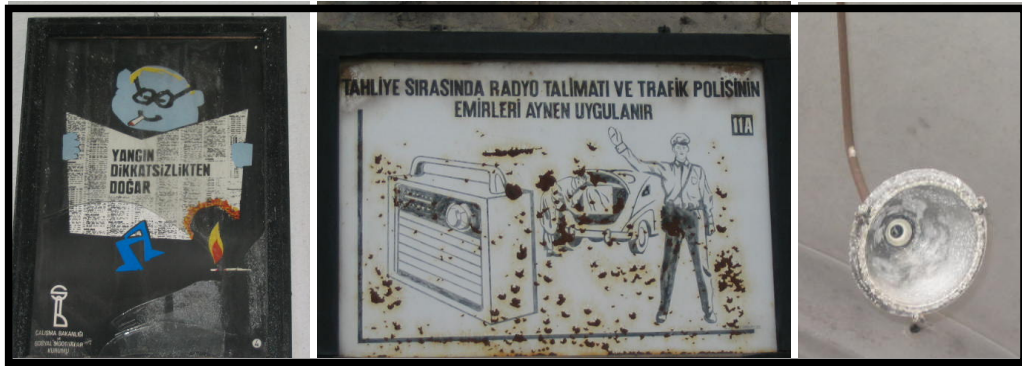
Fig. 22: Technical Details (2006)

Exteriors of the building are chopped stone. Interiors are cement plastered and painted. Architectural elements like doors and windows are wood. Doors for material entrance are metal. Building has lots of unique details those reveal working conditions of those days. Details like lightening elements, working discs, fire system, and water distribution are original and can be perceived in construction system. Some weaving looms and technical production equipment are in the building.

The building is deformed because of not being used for a long time and discharging. Some walls collapsed during the materials were being taken. It has been looted and lots of doors and windows are broken. Damp problem is occurred because of the roof. There are moisture problem in the connections of roof and windows which lead water in and on the walls and internal surface of the roof paled, molded

and plaster was damaged. Timber elements are deformed. Particularly doors and windows need repair and renewal.

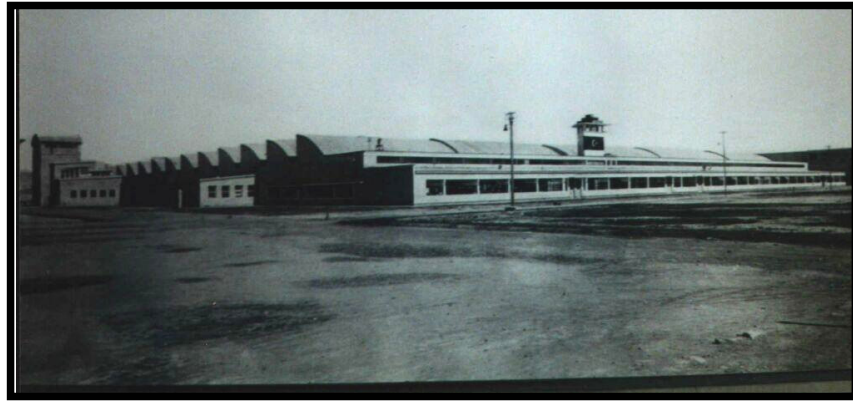
Fig. 23: South and West Elevation Photo Of Production Building in 1935⁶⁵

There is no change in plan scheme and façade organization of the building constructed in 1935. In 2002 north elevation and the first block on north has been renewed. Other changes are for alterations such as painting or repairing leaking roof surfaces.

There are original photographs of the production building. Much knowledge about façade organization can be got from those photographs.

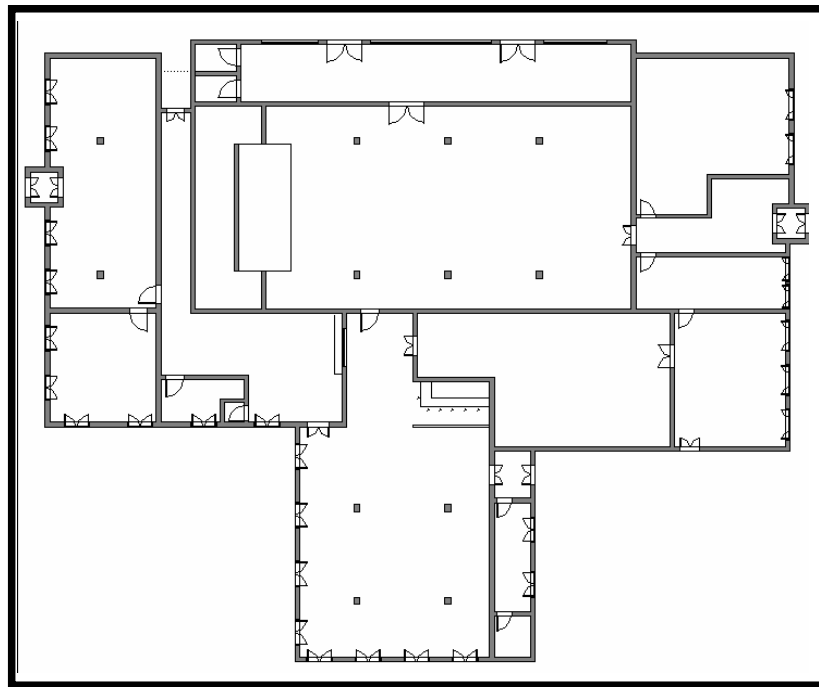
Fig. 25: Plans of Theater and Clubhouse (2006)

Local and ball hall building is in the south of the factory area, on the west of administrative building. The multifunctional building's dimensions are approximately 43mx37m. The general plan type can be described as two accreted rectangles.

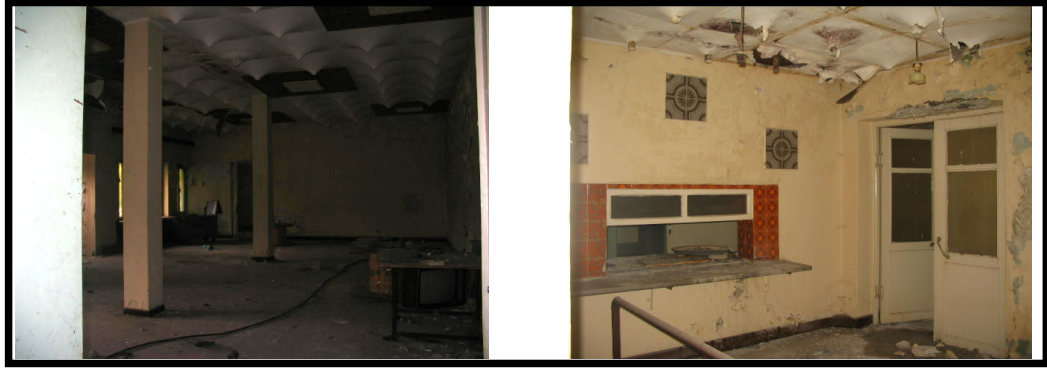
Fig. 26: Club house

The building has lots of functions. These are theatre, clubhouse, game hall and service units of these; kitchen, wet spaces and theatre backstage. Building has lots of entrances and exits. Clubhouse's and game hall's main gate is in a narrow corridor from east façade. There are also two doors enabling entrance to lobby to the theatre from east façade. There are game halls in the north of the corridor main gate opens to. There are two game halls in different dimensions through east west façade. There is an entrance door and four rectangular formed windows are on the middle

axis of the north wall of the rectangular formed major game hall in east. There is a door to the small game hall on the west wall. There are square formed windows; two on each north and west façades of the small hall.

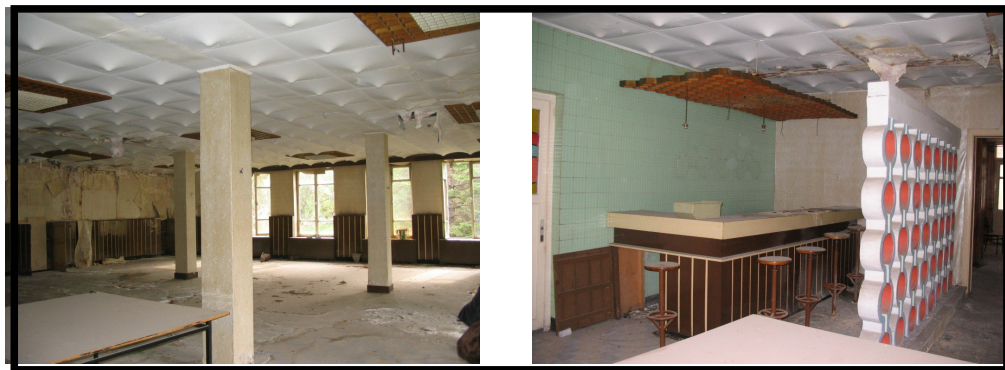
Fig. 28: Club house and Bar (2006)

There are dressing rooms and showers for workers on the south of small hall. Dressing room opens to the corridor which main entrance gate opens to. There is a service window and a door enabling entrance to main hall in the south end of this corridor. Main hall is the place for weddings, banquets and balls. It is nearly formed square. There are four carrier columns in the middle. Lightening is enabled by four square formed windows on the north and west walls. Administration units are on the south, kitchen is on the south east of the main hall. There is a door opening to the theatre on the east wall. There is an original bar on the south east of main hall and on the east of kitchen. Dividing element and furnishing reveal the impact of modernism.

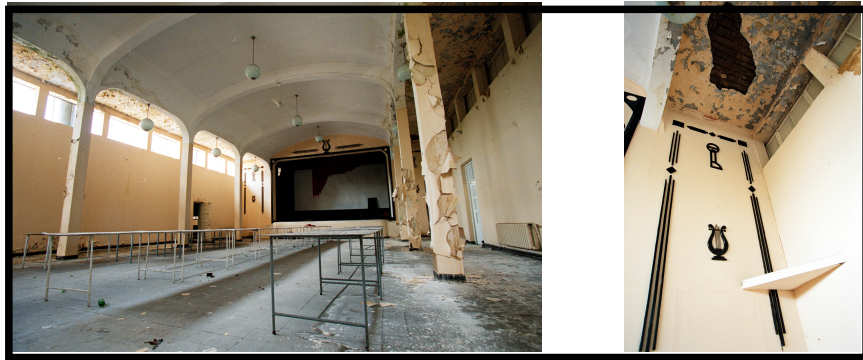
Fig. 29: Theater (2006)

Ball hall (theater) is a square formed place on the east of main hall. There are six carrier columns. It is the widest and highest part of the building. Stage and backstage are in the north of the place. Administrative offices are in the south. The place is illuminated by windows at the top. Lobby is on the east of the theatre. Lobby constitutes the east façade of the building. There are wet spaces in the north of the lobby.

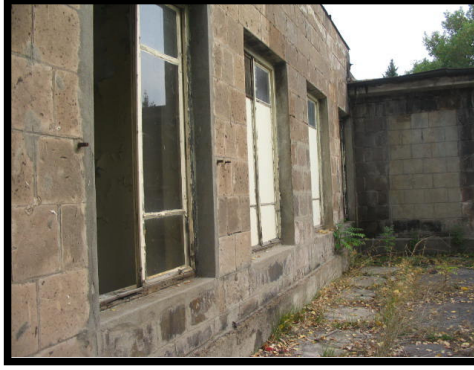
Fig. 30: East Elevation

Façade setup is considerably dramatic. It is formed of two rectangular parts intersecting one another. Its façade is stone covered as the other buildings and one color of stones is used. The east façade is the place of theatre lobby and it is completely transparent and in the middle of the façade. On the right and left of this transparency there are dead walls. There are offices on the south façade. There are wide rectangular formed windows for lightening and the doors opening to offices. Service entrance of the kitchen is also on this façade. The most important façade according to organization is the east façade. The main hall of the clubhouse is in this part. The rectangular formed illumination windows cause the balance of solid and void . The north façade is the place of game halls. The rectangular windows used in general and especially in the part of clubhouse are also present in this part. There is a door to the game hall for entrance and exit.

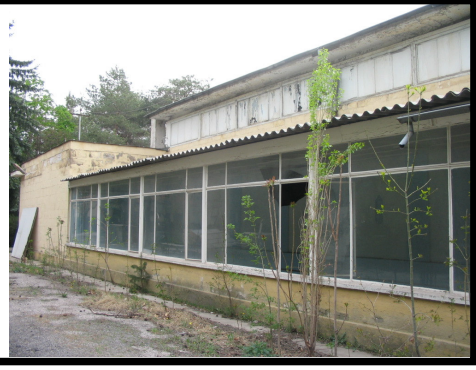
Fig. 31: West Elevation(2006)

There are no structural deformations but material is deformed considerably. There are distensions, falls, pales and molds especially on the ceilings of game halls, main hall and theatre. The dampness caused roof damage ceilings of the halls. Building is lack of care because of being out of usage. It can be seen on the timber doors and windows. There are damages of seen in the clubhouse and theatre as in all of the other buildings of the factory.

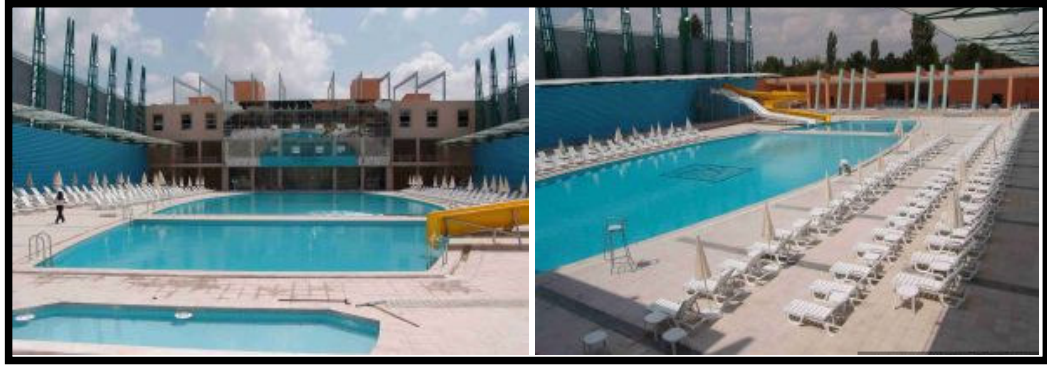
Fig. 34: Swimming Pool (2006)

Neither football field nor swimming pool is used for different functions from purpose; however, they are both reorganized for current comfort conditions. Dressing rooms and a public gallery are added to football field. Furniture and technical accessories of swimming pool are renewed and a small pool for children is constructed. Sports center, administrative building and dressing rooms are built on its south. Catering facilities are between factory and swimming pool on the north of the pool.

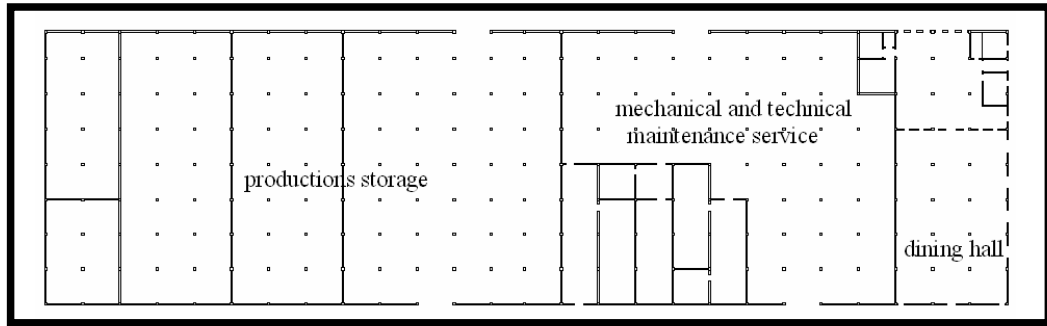
Fig. 40: Production Storage Plan (2006)

Warehouses and foundry are three separate buildings on the west of main production building. The southerly one of the buildings is the storage of the productions. It has a rectangular plan with the dimensions of approximately 43mX133m and 8m height. There is storage in the south, mechanical and technical maintenance service in the middle and workers' dining hall in the north of the building. It is a single story building constructed in reinforced concrete system.

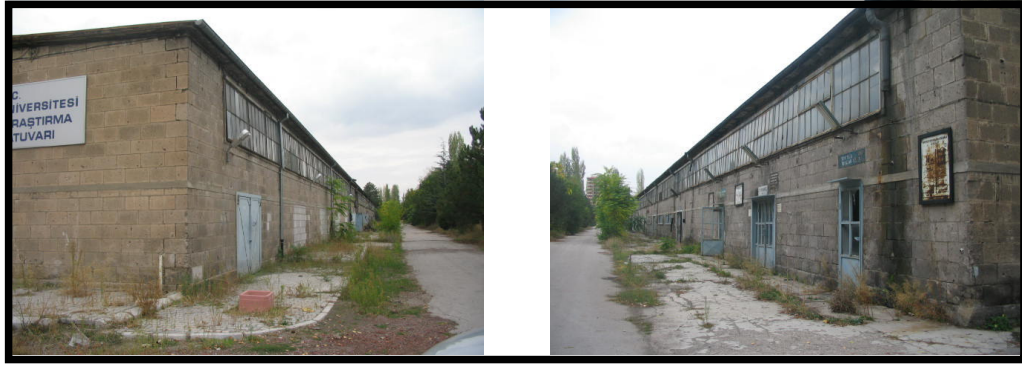
Fig. 41: Elevation of Warehouse (2006)

The storage unit is used as earthquake research center of Erciyes University today. In the southern façade of storage there is a door for entrance.. A new door is designed for this unit being stucked to the original material and dimension. There are band windows beginning from 5 meters height and ending under roof. Lightening is supplied by windows. Entrance to storage is provided from southern and eastern façades. Entrance and exit to the service in the middle is also in eastern façade.

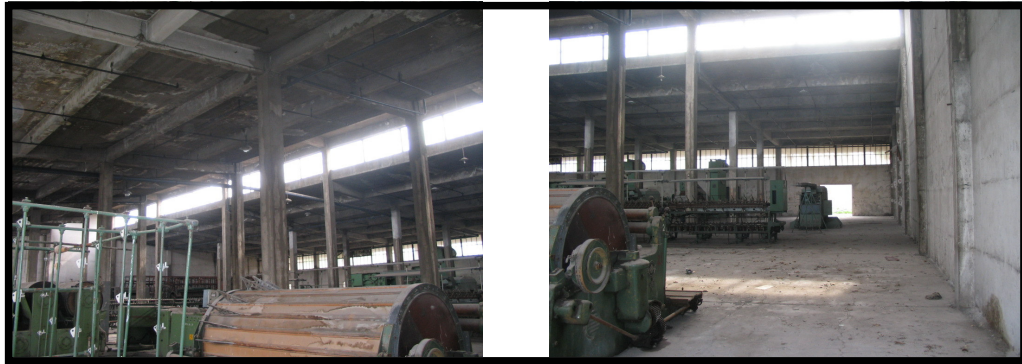
Fig. 42: Interior of Warehouse (2006)

The storage was built in reinforced concrete system and its façade is stone covered. Illumination elements are band windows. There are dormer windows in atelier unit in the middle of the building. Although it is almost empty there are still some Russian made machines in atelier.

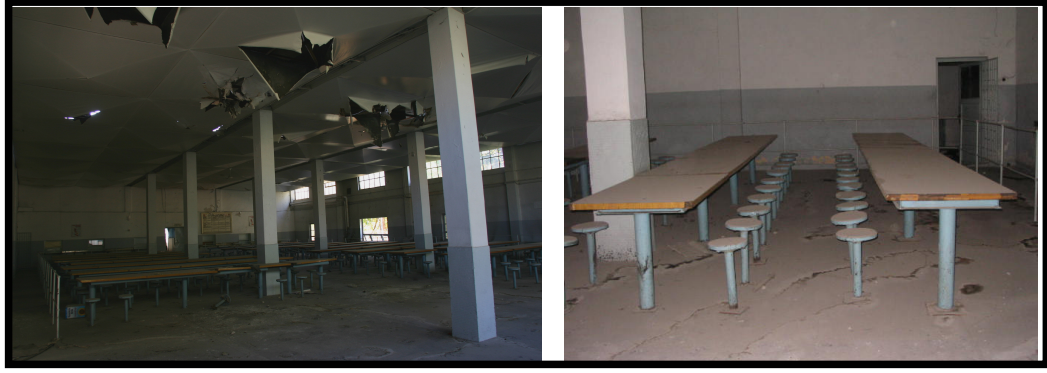
Fig. 43: Interior of diner hall (2006)

The most unique and deluxe unit of the storage is workers' dining hall. It consists of dining hall, kitchen and wet spaces. A special suspended ceiling was used in dining hall. Dining tables and chairs are Russian design of 1935. Kitchen is on the west of the dining hall. The place is specially designed with its dining bell, chairs, kitchen chimney and wet spaces.

Deformations are nearly same as the other buildings. The deformations are because of not being used and cared for. Erciyes University supported maintenance and repair for the unit used as earthquake research center. Those are for modification. There are no changes in plan scheme and façade organization. There are deformations because of patching in mechanical and technical maintenance unit. Walls collapsed during the machines were being carried away. Deformations are more clear in the dining hall. There are flows and droppings on the suspended ceiling. Lack of care is the moisture problem in the dining hall. Surface abrasion is clear especially in the kitchen.

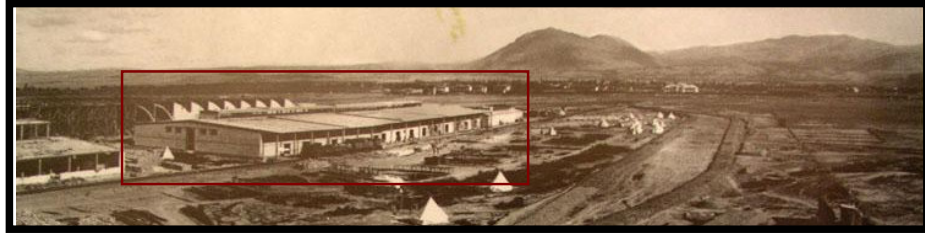
Fig. 44: Photo of Warehouse in 1935

The production storage was built in 1935 with the factory. Iron road comes into the storage in order to charge the products which would be delivered to other cities. There are no changes in structure damaging façade organization. Changes were all done for the sake of maintenance and repair.

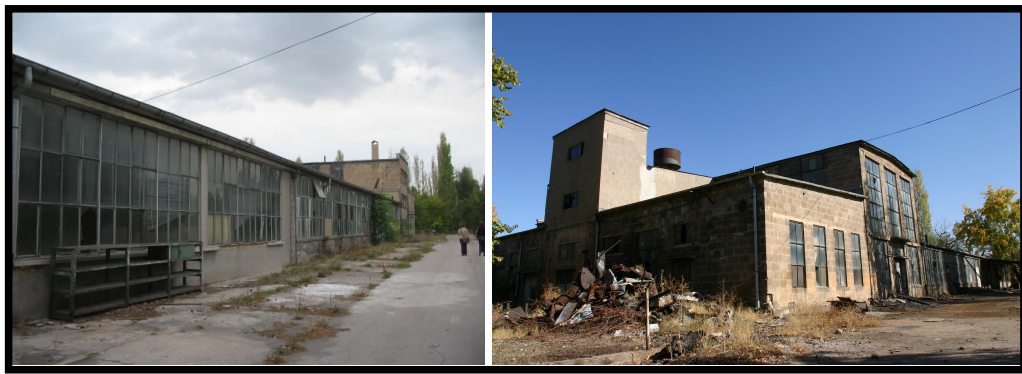
Fig. 45: Elevation of Iron Foundry (2006)

It has a rectangular plan with the dimensions of 68mX40m. The workshop and maintenance unit is single story and offices in the north of the building are double story. Foundry unit is single story but it has the height of a double story. Maintenance and repair unit is in the middle. Illumination is supplied by dormer windows. Workshops are in the west, offices are in the east of the building. Foundry is in the north.

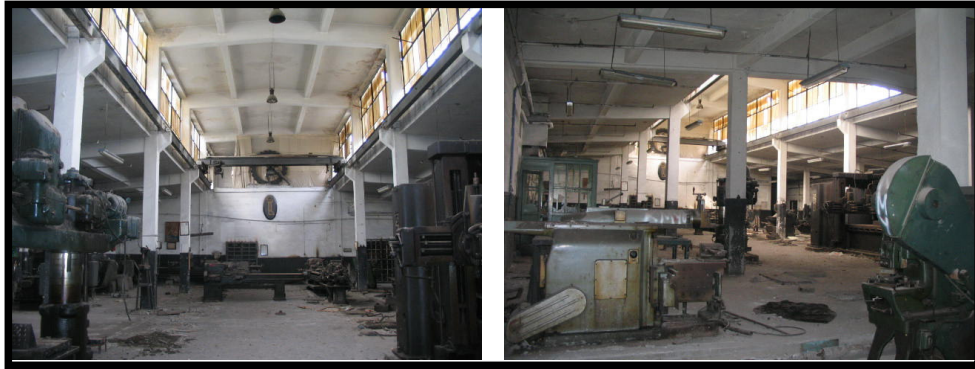
Fig. 47: Interior of Iron Foundry (2006)

Passing to offices can be by the door in the east. That corridor also enables to pass to foundry. Offices are attainable from eastern façade and foundry is attainable from northern façade. Foundry unit is the most technical part of the building reserved with its all elements. There are many original technical details.

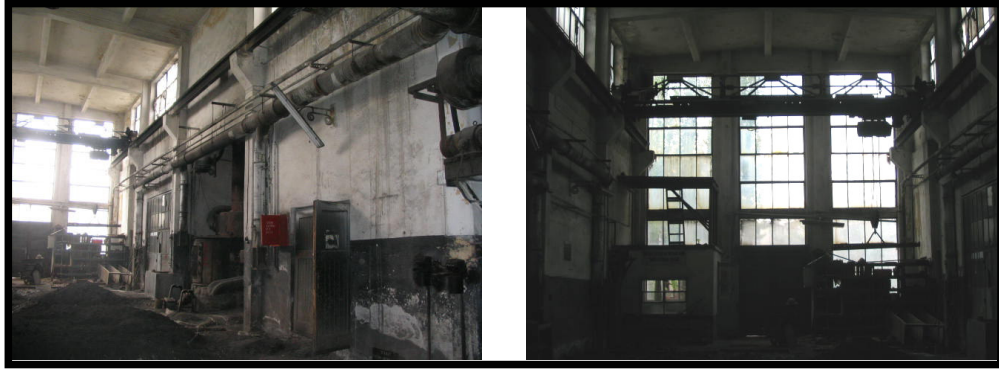
Fig. 48: Interior of Iron Foundry (2006)

Its façade is different from the rest. Illumination is supplied by rectangular formed windows in the offices. There are wide transparent surfaces in eastern façade especially in the office unit. There are perpendicular band windows in both floors in the north of this façade. Foundry is in the northern façade. In contrast to eastern façade it is nearly a dead surface. Façade activation is enabled with different floor heights and solid-void rate. There are band windows in the north of western façade like in the east. It has the same characteristics with eastern façade along.

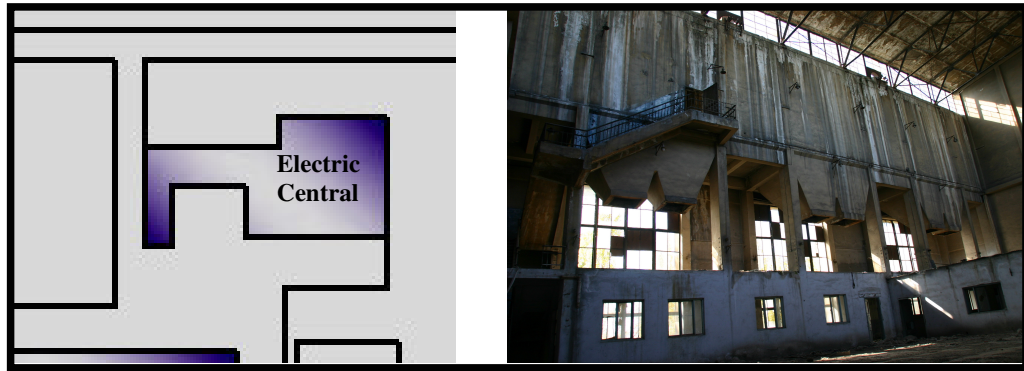
Fig. 51: Electric central plan in Site plan and Interior Photo of Building (2006)

Electric central is on the north east of foundry. It has differences in façade organization plan type from other structures in the area. Reinforced concrete system and steel system are used together. There is a huge risk for the steel parts of the building because of corrosion. Entrance is prohibited for this reason.

Electric central has the dimensions of approximately 70mX40m. Plan type can be described as the union of rectangles of different dimensions. Square formed main part is the place in the north of the building where electricity was produced. Steel truss system was used in this very wide and high part. Technical details for electricity production were used.

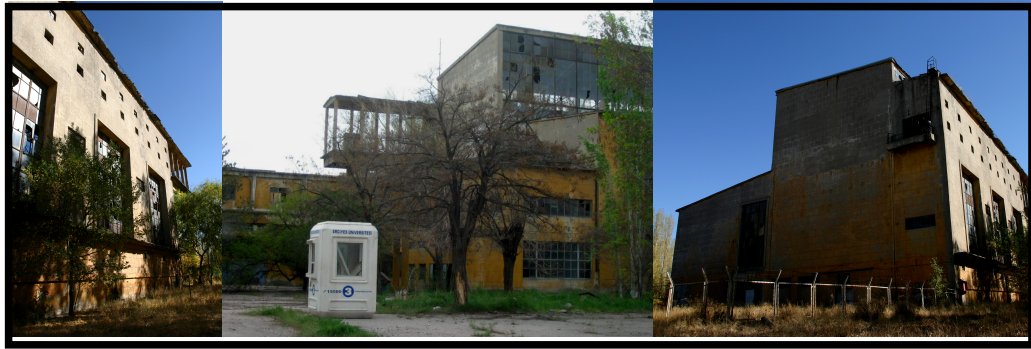
Fig. 53: Elevation of Electric Central (2006)

Central building also differs from the others with its façade. It takes attention with its bridge coupler on the columns in entrance façade. Main entrance is from eastern façade. Eastern façade is the place of offices and laboratories. There are wide windows beginning in basement. Behind this part there is the production unit.

There are coal storages in the southern façade's basement. Perpendicular rectangular windows were used for lightening of the first floor. There are square windows in the part of the building under eaves. Western façade of the central is the most solid façade of the building. There is just a perpendicular band window in north. The most important façade of the building is the eastern one that contains main entrance gate.

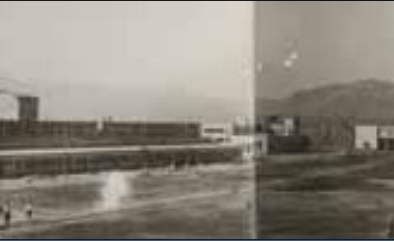
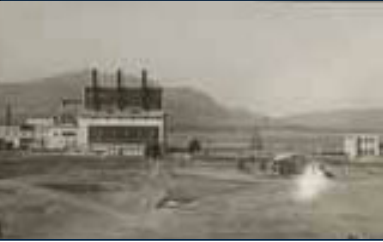
Table 20: Electric Central in 1935

<p><u>Desinged by:</u> Russian Architects</p> <p><u>Construction date:</u> 1935</p> <p><u>Constructed by :</u> Abdurrahman Naci Bey</p> <p><u>Structural System:</u> Reinforced Concred System</p>

- * Electric central is on the north east of foundry.
- * It has differences in façade organization plan type from other structures in the area.
- * Reinforced concrete system and steel system are used together. There is a huge risk for the steel parts of the building because of corrosion. Entrance is prohibited for this reason.
- * Electric central has the dimensions of approximately 70mX40m.
- * Plan type can be described as the union of rectangles of different dimensions.
- * Square formed main part is the place in the north of the building where electricity was produced. Steel truss system was used in this very wide and high part. Technical details for electricity production were used.

- * Electric Central structure, which is reinforced concrete system, is in good condition. But steel structure is in bad condition.
- * Other deformations are nearly same as the other buildings. The deformations are because of not being used and cared for.
- * There are no changes in plan scheme and façade organization.
- * There is problem in structure elements specially in metal bearing elements. It was deteriorated by people who were despoil. Also it has problem on ceiling. It is formed by moisture
- * Interior wall finishing;
 - * plaster and wash are in bad condition because disrepair.
 - * but this deterioration is not severe. It can be solved by maintenance.
- * Architectural elements specially;
 - * windows, doors and floor covered are also needed repaired.

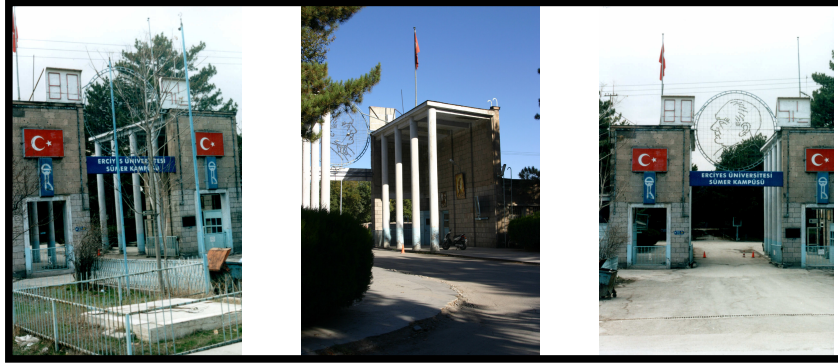
Fig.56: Entrance (2006)

Entrance gate is one of the most charming parts of the factory. It is the signal of the hugeness of the area behind it rising on columns. It resembles a triumphal arch and can be described as the symbol of modernization and industrialization. There are Atatürk's relief and emblem of Sümerbank in the middle of the gate which was built in column and beam system reinforced concrete.

Damages on the entrance gate, in the security unit and hospital are generally because of the material used. There are some flows and color changes on the walls and ceilings of the hospital. There are deformations in architectural elements because of not being used and lack of care.

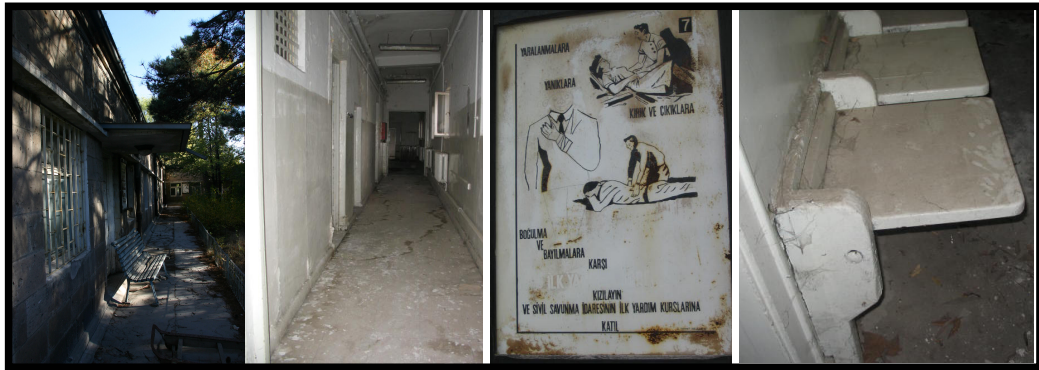
Fig. 57: Interior of Hospital (2006)

Hospital is on the south. Although SSK was using the place as a polyclinic it is not being used today. Entrance is enabled from the interior of the factory, the western façade. Plan has the dimensions of nearly 36mX22m. It is the union of two rectangles as the letter L. there are patient rooms, consulting rooms, operating room and drugstore. It is built a single storey building, built in reinforced concrete system.

SSK made lots of changes in the hospital. However the changes were not related to the plan scheme and façade organization. Floor covering and architectural elements were renewed.

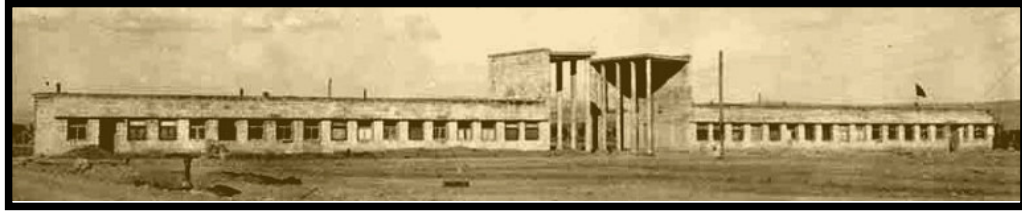
Fig. 58: Entrance and Hospital in 1935

The greatness of the main gate is much like a symbol of the greatness of the factory's aim. The hospital on the south reveals that the area was not only used for economy and manufacture but also show that social development could be done by the factory. Infirmary where surgeries and births were held in those times was turned into a polyclinic serving for the society of Kayseri.
