AN INVESTIGATION ON THE WATER SUPPLY AND DRAINAGE
SYSTEMS OF HISTORICAL TURKISH BATHS

A THESIS SUBMITTED TO
THE GRADUATE SCHOOL OF NATURAL AND APPLIED SCIENCES
OF
MIDDLE EAST TECHNICAL UNIVERSITY

IN PARTIAL FULFILLMENT OF THE REQUIREMENTS
FOR
THE DEGREE OF MASTER OF SCIENCE, IN BUILDING SCIENCE
IN
ARCHITECTURE

SEPTEMBER 2008

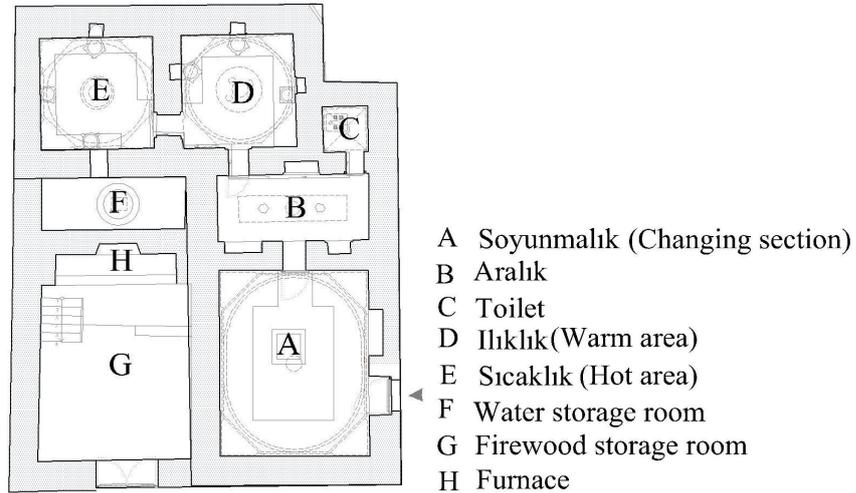
Figure 2.1. An example of a historical Turkish bath: Hacı Hamza Menzil Hamamı, in Çorum.

In historical Turkish baths there are mainly three sections: changing section, bathing section and service section. These sections were explained under respective headings. The plan of a typical historical Turkish bath was given in Figure 2.1.

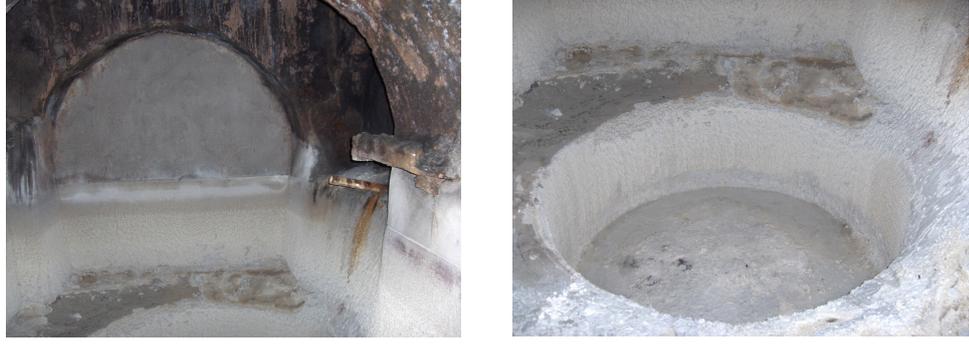
Figure 2.2 A view of the water storage room with brick barrel vault covering above and concave boiler below in Yıldırım Beyazıt Hamamı in Mudurnu, Bolu.
Source : Archives of the Author

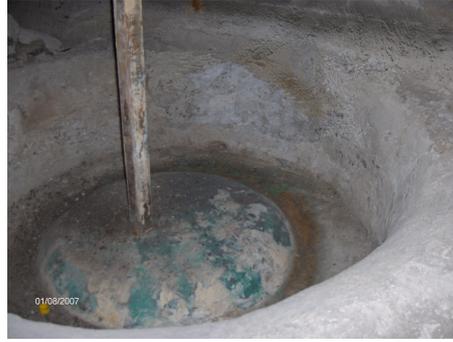
Figure 2.3 A view of the water storage room in Paşa Hamamı, in Beypazarı, Ankara. *Source : Archives of the Author*

Hot and cold water storage rooms; firewood storage room and furnace together with the hypocaust section (*cehennemlik*) constitute the service section of the hamams. Water storage rooms are the spaces where water needed for the cleaning purpose is stored. The hot water storage rooms are generally covered with pointed or barrel vaults. Examples of water storage rooms are photographed in the fieldwork during the study (Figures 2.2, 2.3 and 2.4).

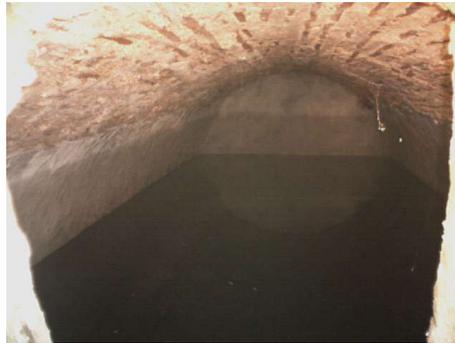
Figure 2.4 A view of the water storage room in Yalı Hamamı, in Tekirdağ.
Source: Archives of The General Directorate of Pious Foundation, 2008

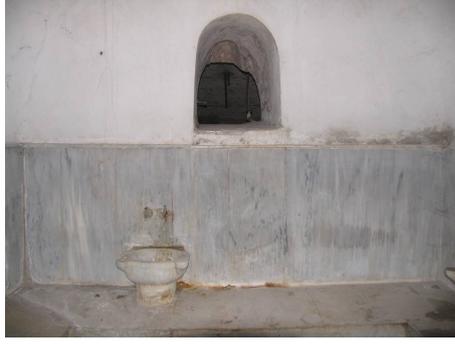
Figure 2.5 A view of observation window in Paşa Hamamı, in Beypazarı, Ankara.
Source : Archives of the Author

In the study of Önge (1995) it was stated that in order to control amount of water in these rooms, to benefit from the vapor heated there and to be able to do necessary repairs in these rooms, a window opening called as “*observation window*” is located in one of the iwans or halvets of hot area adjacent to the water storage room of the bath (Figures 2.5 and 2.6).

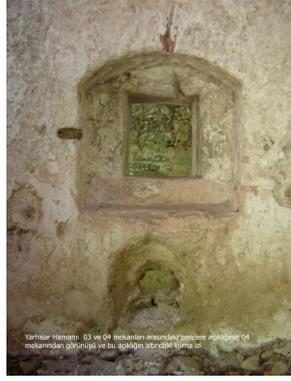
Figure 2.6 A view of observation window in Yarhisar Köyü Hamamı, in Bursa.
Source: Archives of The General Directorate of Pious Foundation

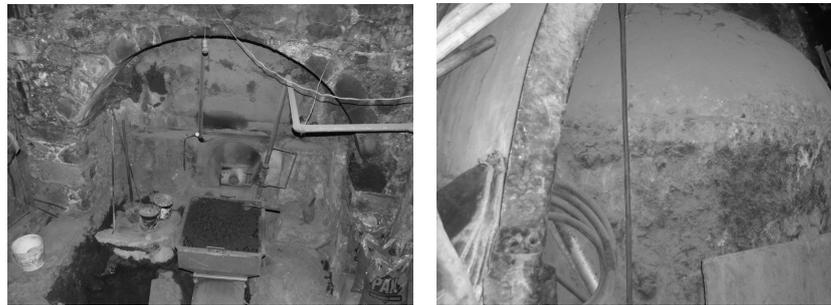
Figure 2.7 Views of furnace section in Şengül Hamamı, in Ulus, Ankara. *Source : Archives of the Author*

bath is stored. Furnace is the part in fire wood storage room in which the heating of hot water storage room and bathing spaces take place. In this part, there is generally an arched opening in the form of a fireplace opens outside for lighting the fire. Just over the fireplace, in the middle, there is mostly a concave copper boiler for heating water in the water storage room by the fire in the furnace, which is photographed in various examples during fieldwork of the study (Figures 2.7 and 2.8)

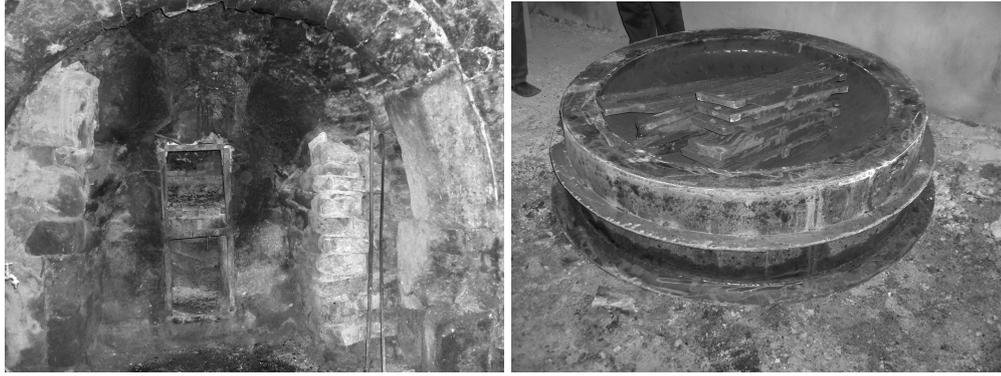
Figure 2.8 Views of furnace section in Yıldırım Beyazıt Hamamı in Mudurnu, Bolu.

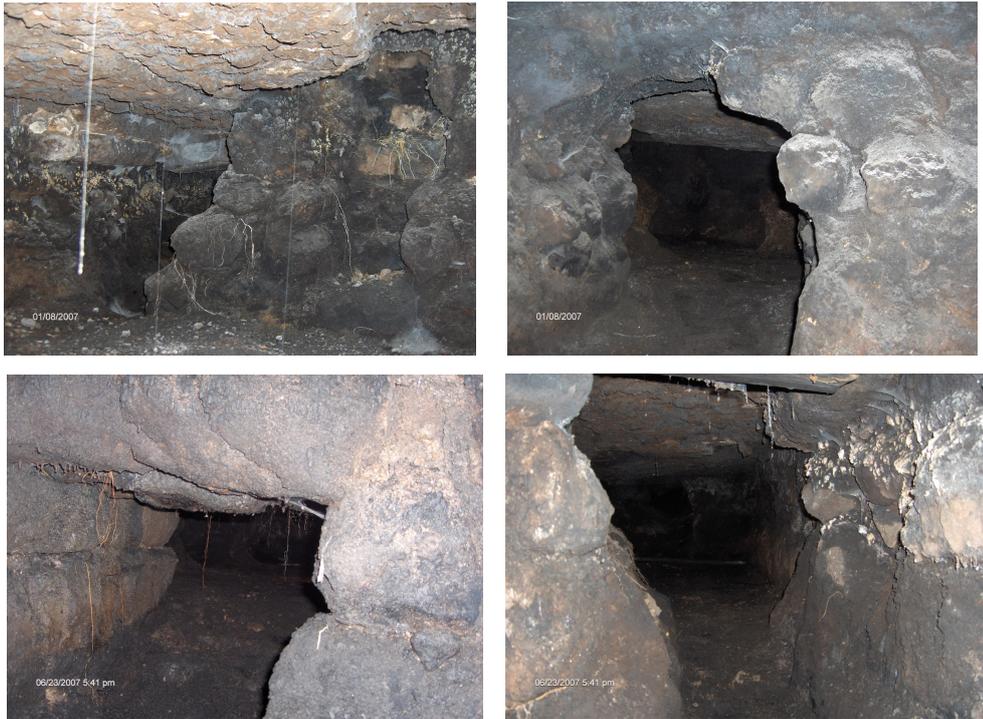
Figure 2.9 Views of hypocaust section (*cehennemlik*) in Paşa Hamamı, in Beypazarı, Ankara.

Önge (1995) further explains that, the bathing section of the bath is generally heated by the circulation and dispersion of flame (*alev*) and smoke (*duman*) that result from the burning up of firewood inside the furnace. This circulation and dispersion take place inside the *cehennemlik*, all through the underground of hot and warm area of bathing section, examples of which photographed during the fieldwork of the study are given in Figures 2.9, 2.10 and 2.11.

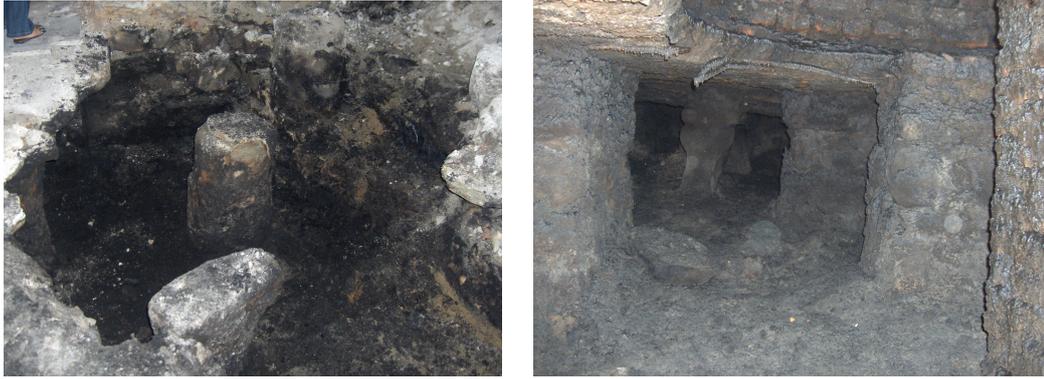
Figure 2.10 Views of the hypocaust section in Yıldırım Beyazıt Hamamı, in Mudurnu, Bolu.

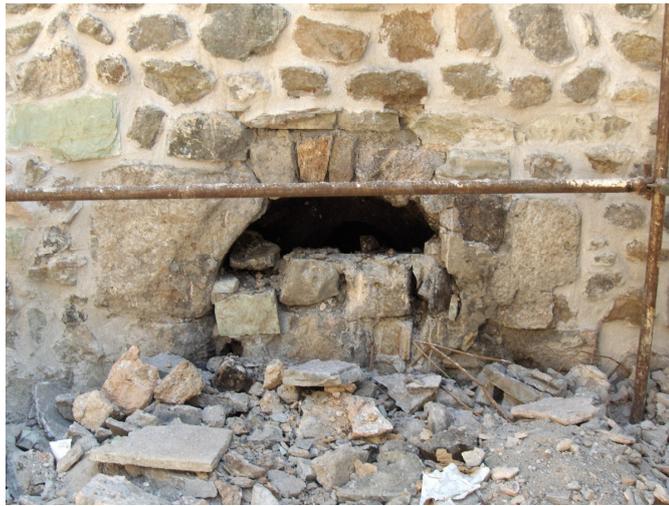
Figure 2.11 A view of the entrance part to the hypocaust section in Yıldırım Beyazıt Hamamı, in Mudurnu, Bolu.

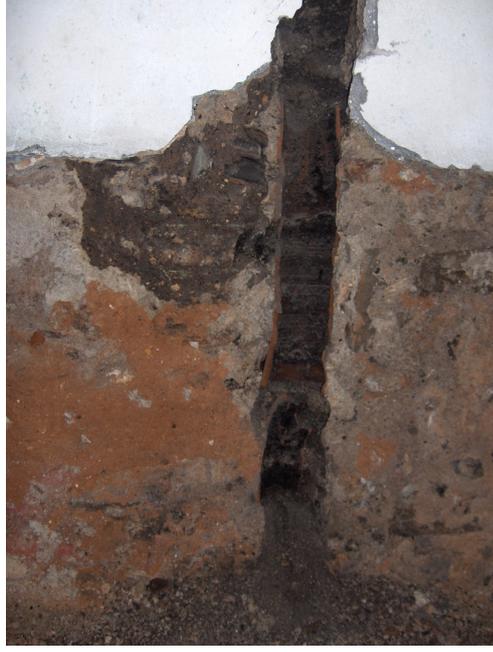
Figure 2.12 A view of *tüteklik* rising inside the wall up to the roof in Yıldırım Beyazıt Hamamı, in Mudurnu, Bolu.
Source : Archives of the Author

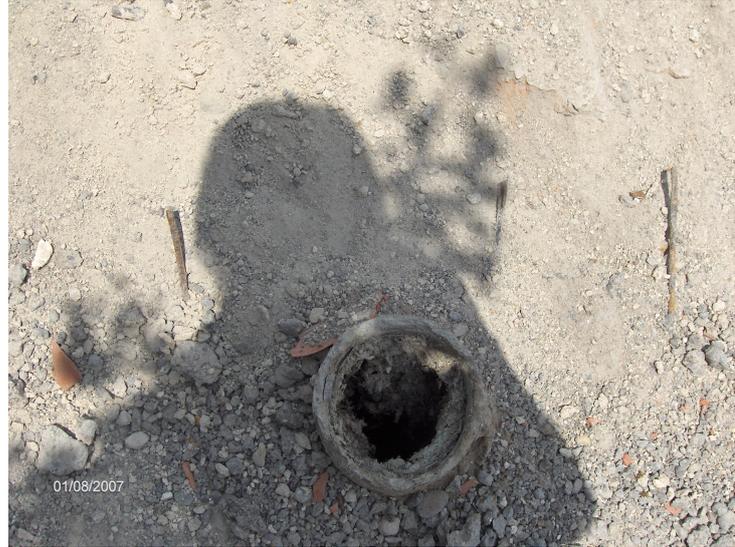
Figure 2.13 A view of *tüteklik* in Paşa Hamamı, in Beypazarı, Ankara.
Source : Archives of the Author.

Temizsoy, *et al.* (2003) states that, there are vertical stacks, called as *tüteklik*, which are the parts of service section designed to support and interrelate hot water supply system in the baths. Vertical stacks (*tüteklik*) are constructed as a hole inside the massive rubble stonewalls but there are terracotta vertical pipes (*künk*) inside them (Figures 2.12 and 2.13). Besides heating, *tüteklik* on the exterior walls provides control of heat loss or transfer while ones on the interior walls keep hot water circulating at a certain temperature inside the bath.

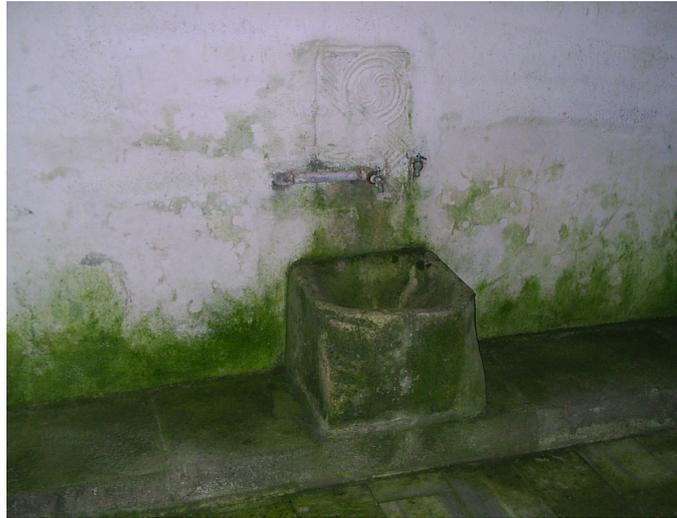
Figure 2.14 A view of a stone basin in tepidarium section of Yıldırım Beyazıt Hamamı, in Eskiçağa, Bolu.

İpekoğlu, *et al.* (2004) explains that basins are generally in circular, semi-circular, semi-octagonal or in such similar forms some of which with geometrical or muqarnas decorations (Figures 2.14, 2.15 and 2.16). Önge (1995) claims that the terracotta pipes which are also called *merbah* or *pöhrenk* are placed along the walls of bathing section (Figure 2.17). The author defines those pipes as cylindrical in form and one end is larger than the other to be connected to each other. One end is approximately 9cm, the other is 13cm in diameter, 1.5cm in thickness and 25-38cm in length. They are embedded with a waterproof mortar called *lökiin* along the walls Önge (1981) further claims that, in historical Turkish baths, these terracotta pipes are usually connected to the *maslak* or *makse*, which is in the form of a perforated stone coffer placed in a niche in the height of a person in the wall of the water storage room.

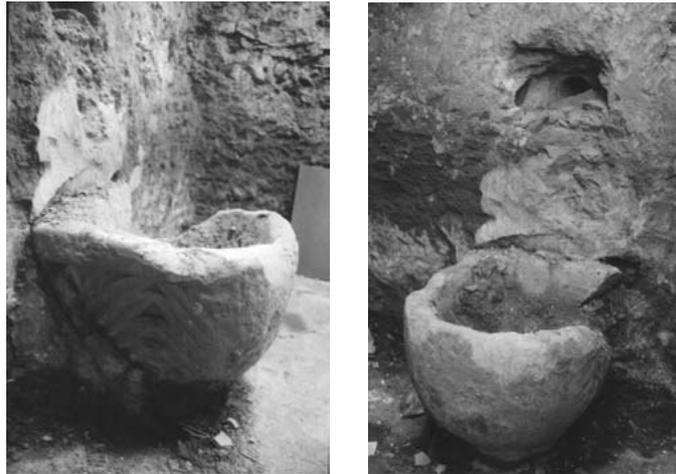
Figure 2.15 A view of a basin in Çukur Hamam
Source: Temizsoy, et al., 2003, pp.8

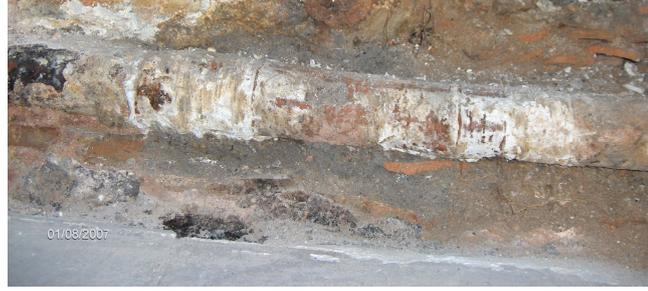
Figure 2.17 A view of a terracotta pipe in Paşa Hamamı, in Beypazarı, Ankara.
Source: Archives of the Author

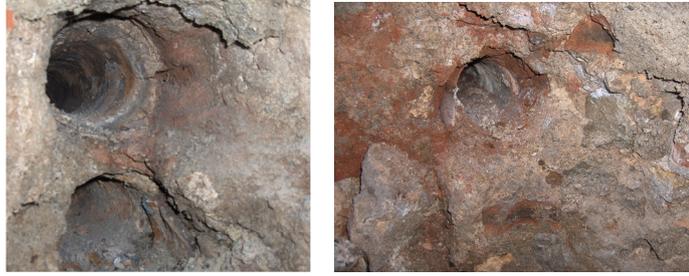
Figure 2.18 Terraces of terracotta pipes observable as the horizontal bant on the wall of Yıldırım Beyazıt Hamamı in Mudurnu, Bolu.
Source: Archives of the Author

Önge (1981) explains that, the terracotta pipes could be either in two rows both for hot and cold water or in one row only for hot water according to the necessity or the size of the bath. From the field observations the author concludes that only hot water run through the taps of bathing section in most of the historical baths between 12th and 15th century even in the 16th century. In Paşa Hamamı, in Beypazarı, Ankara; in Şengül Hamamı, in Ulus, Ankara; in Yıldırım Beyazıt Hamamı, in Mudurnu, Bolu; in Yarhisar Köyü Hamamı, in Bursa; in Çukur Hamam, in Manisa, and in Kamanlı Hamamı, in Urla, İzmir terracotta pipes are placed in two rows both for hot and cold water (Figures 2.18, 2.19 and 2.20), while as İpekoğlu, *et al.* (2004) states, in Büyük Hamam and Küçük Hamam, in Seferihisar; in Kaleiçi Hamamı, in Sığacık and in Özbek Hamamı, in Düzce terracotta pipes are placed in one row for hot water only.

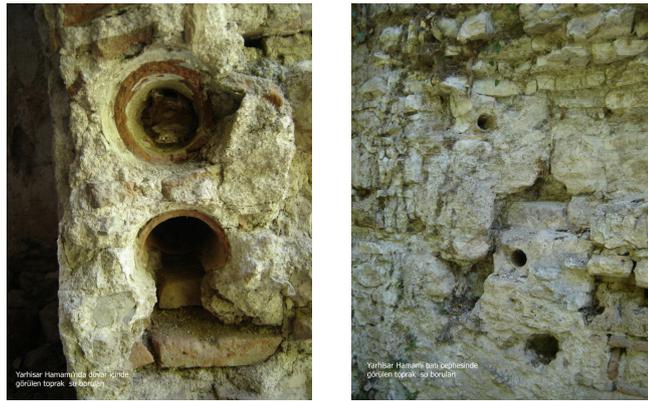
Figure 2.19 Terracotta pipes arranged in two rows on top of each other carrying hot and cold water Yarhisar Köyü Hamamı, in Bursa.
Source: Archives of The General Directorate of Pious Foundations, 2008

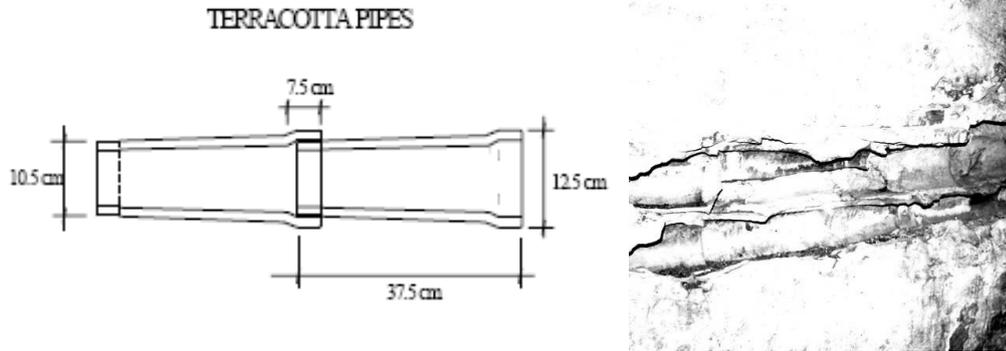
Figure 2.20 Detail of terracotta pipes arranged in two rows in Kamanlı Hamamı, in Urla, İzmir.

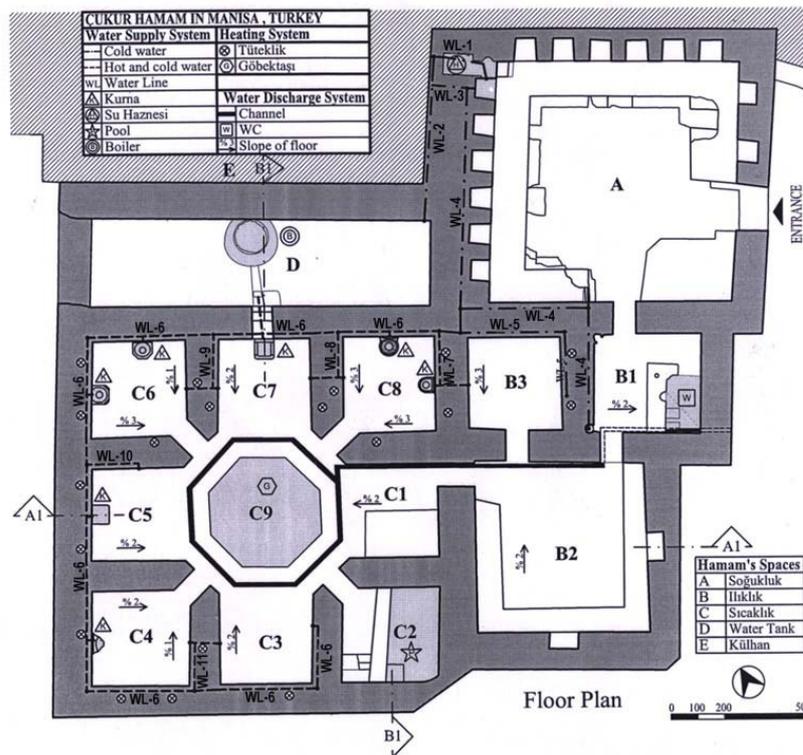
Figure 2.22 Plan of Çukur Hamam showing the hot and cold-water terracotta pipelines which carry water in two lines at a certain slope with a gravity arrangement.
 Source: Temizsoy, et al., 2003, pp.4

In an investigation pertinent to the service systems of historical Turkish baths, a 14th century *Beylikler* period hamam, Çukur Hamam, in Manisa was examined in terms of its original water supply system, surface water drainage system and heating system (Temizsoy, *et al.* (2003). In this study, both hot and cold water supply systems of the structure were analysed, in terms of their original slopes and levels. The authors found that in Çukur Hamam, a certain slope was used to carry the water by terracotta pipes and gravity was used for the distribution of water. In the study the terracotta pipes on the walls were observed to be arranged in two lines parallel to each other to carry hot and cold water where hot water pipe line was below the cold water pipe line as shown in Figure 2.21. Both hot and cold water pipe lines were found to have separate stoppers. The hot and cold-water supply system and wastewater discharge system of Çukur Hamam is given in Figure 2.22.

In another study, Temizsoy, et al. (2003) examined the surface water discharge system in *Çukur Hamam*. The authors found that the wastewater was directed towards the wastewater channels by means of inclined floor surfaces with the slope arrangement of 2% or 3% from caldarium to tepidarium as shown in Figure 2.22.

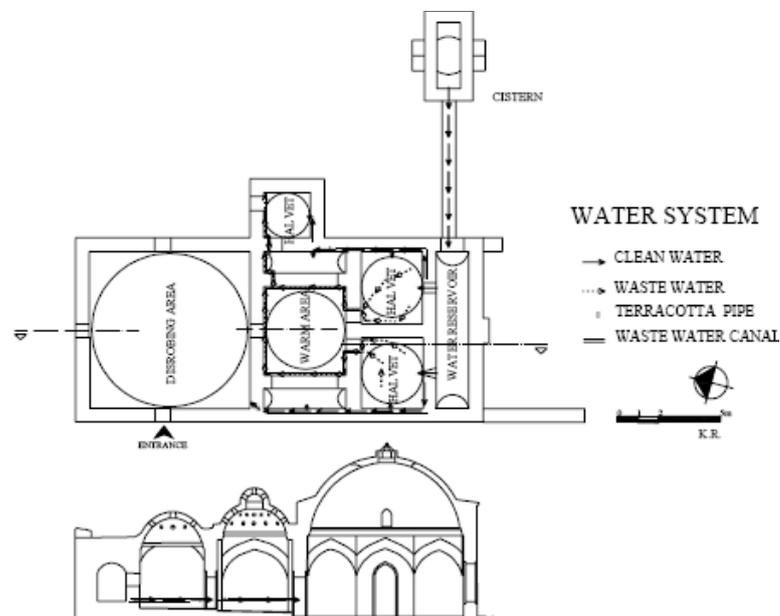
Figure 2.23 Plan and section drawings of Düzce Hamamı showing the water supply system of the structure.

In another study, İpekoğlu, *et al.* (2004) investigated the water distribution system in a group of Ottoman baths. In that study the authors found that the cold water could be distributed to the bathing spaces after collecting in a cold-water storage room or it could be distributed by terracotta pipes without collecting in a cold-water storage room. In the first case, after collection of clean water in cold-water storage room sufficient quantity was transmitted to the hot water storage room and the rest was distributed to the bathing spaces by terracotta pipes. The authors observed such an arrangement in a double bath in Urla, İzmir. In the second case, clean water was brought to the hot water storage room from the cistern or well either by stone channels or terracotta pipes at the upper level of the hot water storage room. In this arrangement, cold water supplies of both the hot water storage room and the bath were directly transmitted to the taps running in the basins and to the fountain. The authors observed such an arrangement in Ulamiş, Düzce and Kamanlı Hamamları (Figure 2.23).

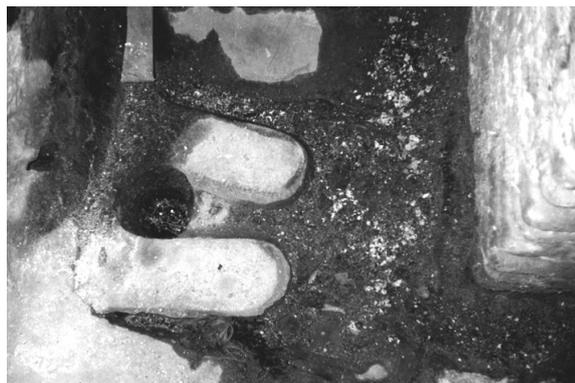
Figure 2.27 A view of the waste water collection and discharge system in Büyük Hamam, in Seferihisar.

İpekoğlu, *et al.* (2004) explains that the open channels; arranged on the floors of the caldarium and tepidarium sections of the baths, toilets; discharging the waste water collected through these channels to the outside, floor drains and the outlets constitute the waste water collection and discharge system of historical Turkish baths. The authors further explain that the open wastewater channels are generally located along the walls and/or along the bottom edges of the elevated platforms, which are generally covered with marble. The waste water is directed towards these channels with the help of the inclined floor arrangements of the bathing spaces and discharged either from the toilet or from the corner of the one wall of the structure to the outside (Figure 2.27).

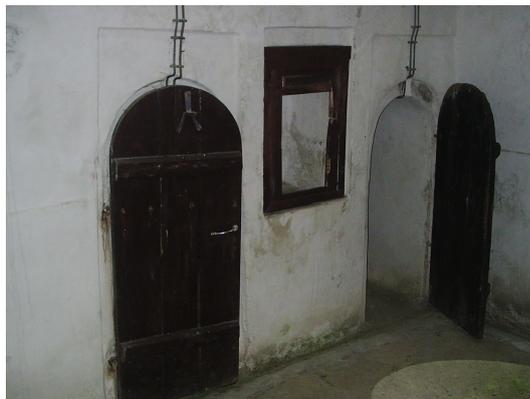
Figure 2.28 A view of waste water collection and discharge channels in Yıldırım Beyazıt Hamamı, in Eskiçağa, Bolu. *Source : Archives of the Author*

In a field observation of the author, Yıldırım Beyazıt Hamamı, in Eskiçağa, Bolu was examined in terms of its wastewater collection and discharge system. In that structure waste water coming from the two *halvet* of caldarium section and from the tepidarium section was observed to be transmitted to the outlet located on the west wall of tepidarium section and from there discharged to the outside of the structure.

On the other hand, the wastewater collected on the elevated platform of the caldarium section was directed towards the toilet with a slope arrangement of 2% and discharged from a floor drain located in the toilet. It was found that the dimensions of waste water channels were not the same all through the bath, such that, their dimensions were observed to vary in the range of 7.5-15cm in width and 7-8cm in depth. It was also found that there was a slope arrangement in the bath to direct the wastewater to the wastewater collection channels. At floor level of *halvet* sections, the wastewater was found to be directed towards the caldarium where there was a central wastewater collection system along the wall edges (Figure 2.28). These channels were observed to collect wastewater by means of a slope arrangement varying in the range of 1-3%. However, the slopes in tepidarium were found to be 2 %.

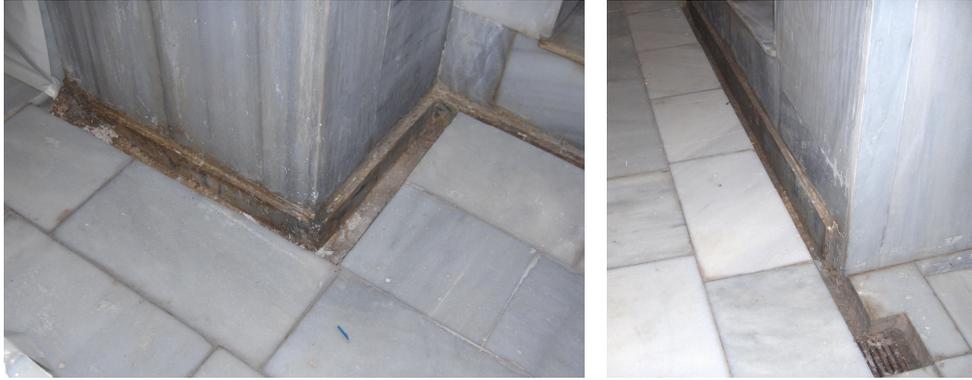
Figure 2.29 Views of wastewater collection and discharge channels and floor drain in Paşa Hamamı, in Beypazar, Ankara
Source: Archives of the Author

In another field observation, wastewater collection and discharge system of Paşa Hamamı, in Beypazarı, Ankara was investigated. In this structure the wastewater was observed to flow from the elevated platforms to the lower levels, and then, it was directed towards the open channels surrounding the wall edges of caldarium section. Their dimensions were observed to vary in the range of 6-12cm in width and 7-20cm in depth. The wastewater collected in these channels was discharged by means of a floor drain with the dimensions of 16.5cm x 19.5cm in width to depth, located in the middle of entrance of the caldarium section (Figure 29).

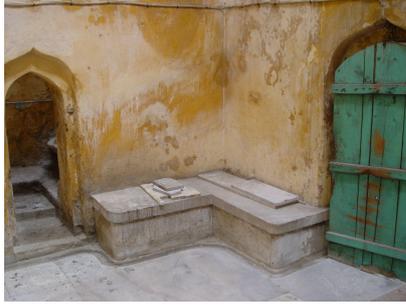
Figure 2.30 Wastewater channels in Tekirdag, Yalı Hamam.
Source: Archives of The General Directorate of Pious Foundations, 2008

In Yalı Hamamı, in Tekirdağ the open wastewater channels were observed to be arranged along the bottom edges of the elevated platforms and along the wall edges of the caldarium and tepidarium sections (Figure 2.30).

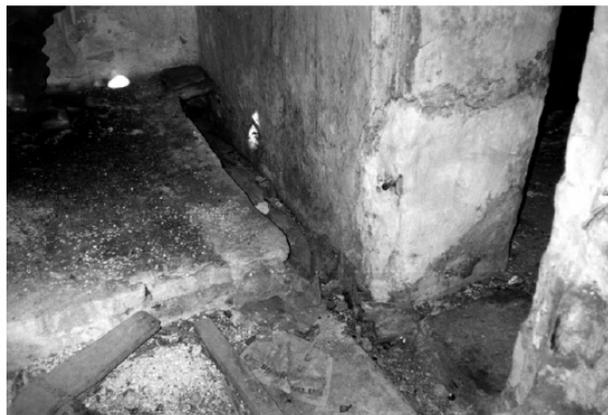
Figure 2.31 A view of waste water collection and discharge channels in Özbek Hamamı, in Urla, İzmir.
Source: İpekoğlu, et al., 2004, pp.6

As seen in Figure 2.31, İpekoğlu, *et al.* (2004) investigated Özbek Hamamı, in Urla, İzmir and observed that waste water coming from *halvet*, was separately transmitted to the channels lying along the bottom edges of the elevated platforms in the caldarium section and sent to the outside from the corner of one wall. Also as seen in Figure 2.32, in Kamanlı Hamamı, in Urla, İzmir, the authors observed that, the wastewater coming from *halvets* was discharged through the open channels in the main space of the caldarium and was carried from the corner of one wall of the tepidarium to the outside.

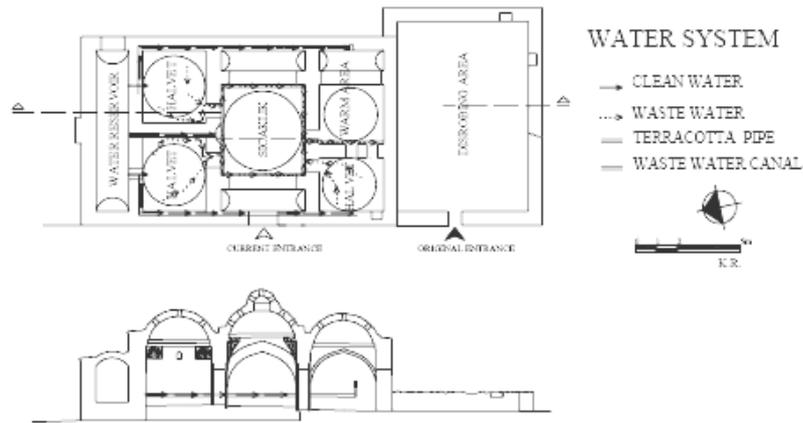
Figure 2.32 – Analyses of the wastewater collection and discharge system in Kamanlı Hamamı, in Urla, İzmir
 Source: İpekoğlu, et al., 2004, pp.6

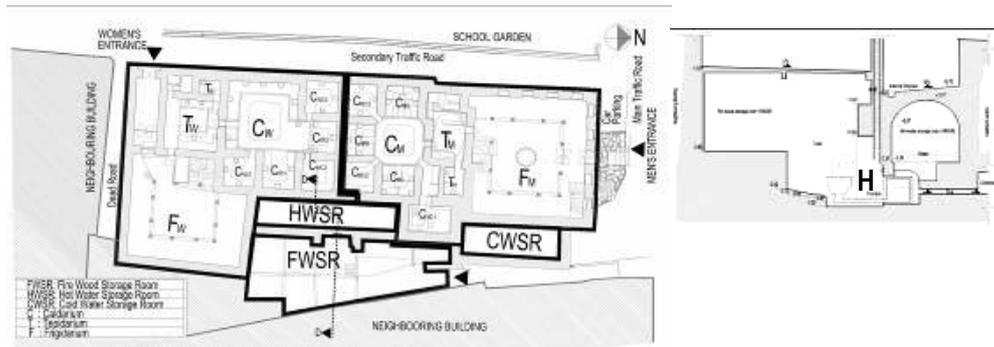
Figure 3.3 Plan of Şengül Hamamı showing the sections for women and men's parts and the section DD showing the locations of furnace and hot water storage room.

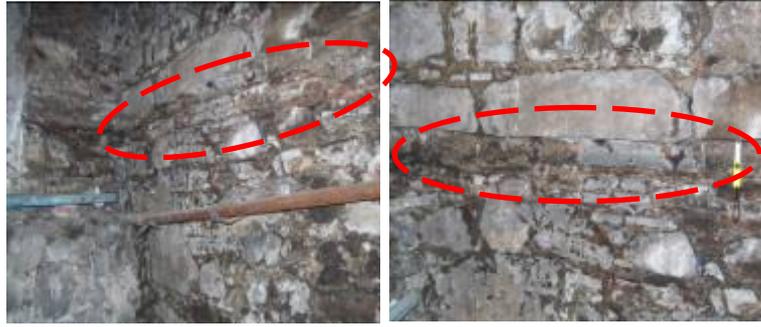
Figure 3.4 Views of the traces of the historical terracotta piping in Şengül Hamamı, running at the west wall of the firewood storage room.
Source : Archives of the Author

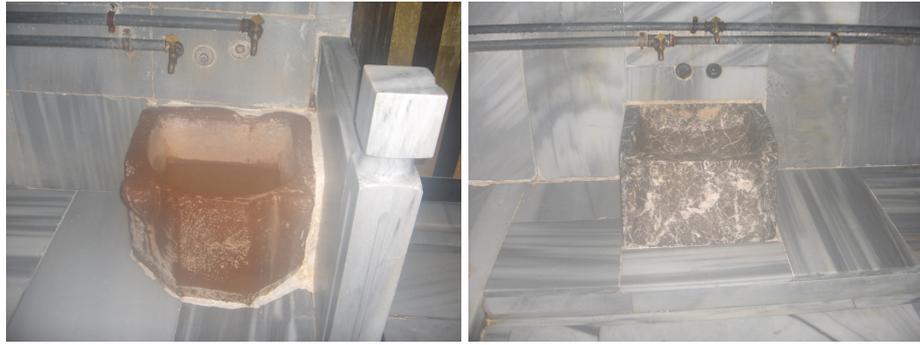
Figure 3.5 Views of the stoppers belonging to the old water supply system located close to the level of present piping system.
Source : Archives of the Author

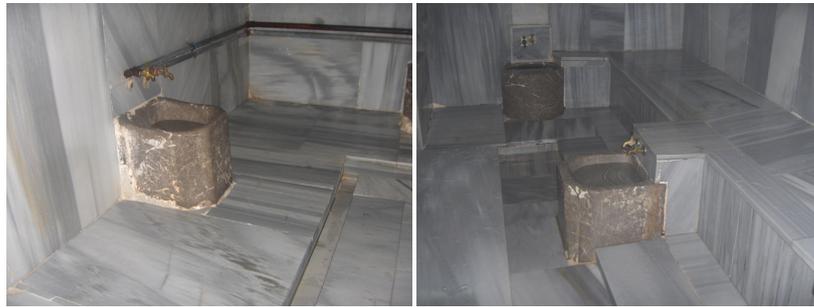
Figure 3.6 Views of wastewater collection and discharge system in Şengül Hamamı.

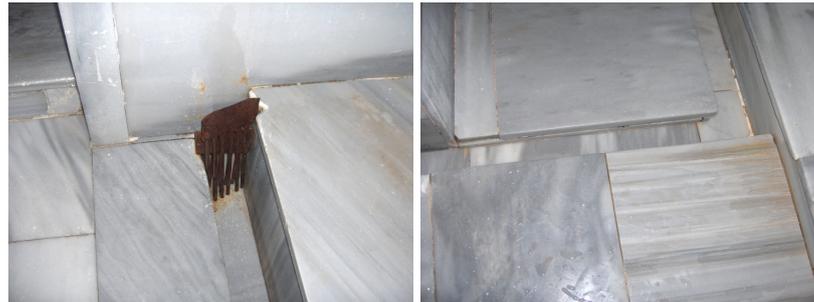
Figure 3.7 Views of waste water channels and of floor drains in Şengül Hamamı.

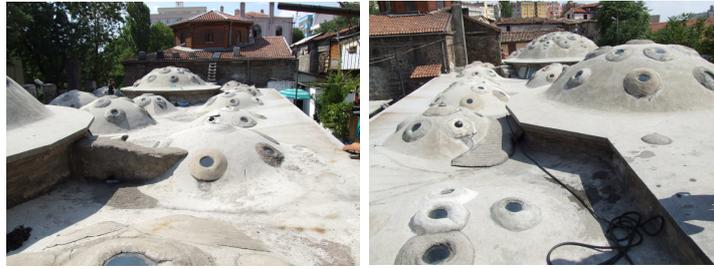
Figure 3.8 General views of the mesh-reinforced concrete roof above the caldarium and tepidarium sections.

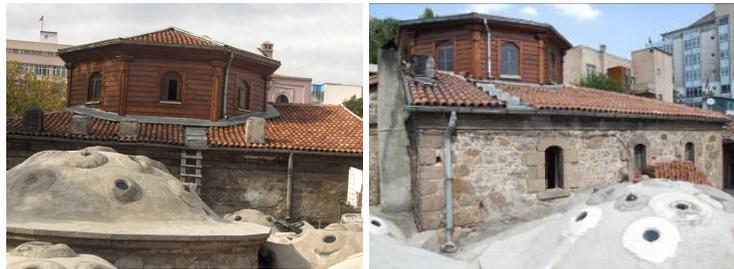
Figure 3.9 Views of the pitched roof, A1, over the frigidarium of women's part (at left) and the pitched roof, A2, over the frigidarium of men's part (at right) with their discharge components: gutters and downpipes *Source: Archives of the Author.*

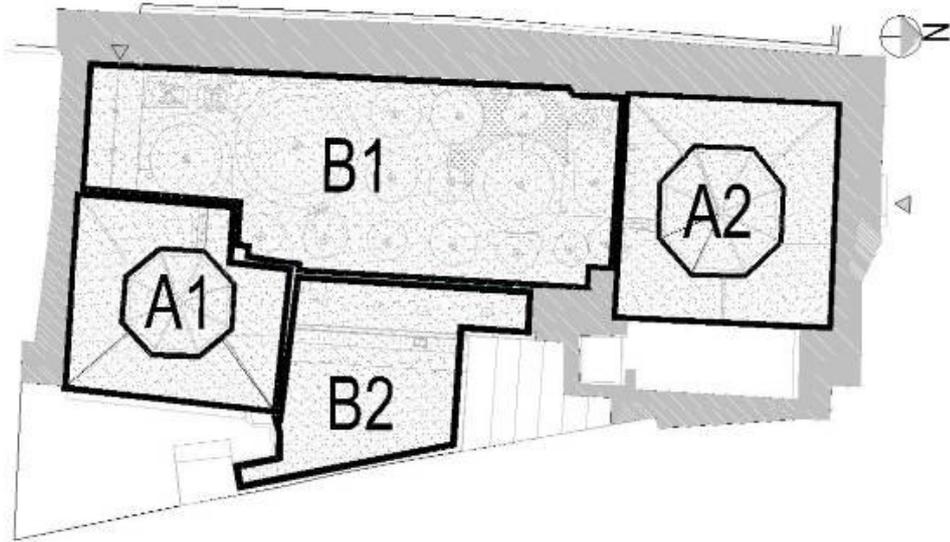
Figure 3.10 Plan of the building, showing the roof areas under study and immediate grounds: **A1**–timber pitched roof covered with roof tiles above the women’s frigidarium section; **A2**–timber pitched roof covered with roof tiles above the men’s frigidarium section; **B1**–mesh-reinforced concrete roof above the caldarium and tepidarium sections; **B2**–mesh-reinforced concrete roof above the hot water storage room and the fire wood storage room; **Grey-shaded areas**–immediate grounds of the building.

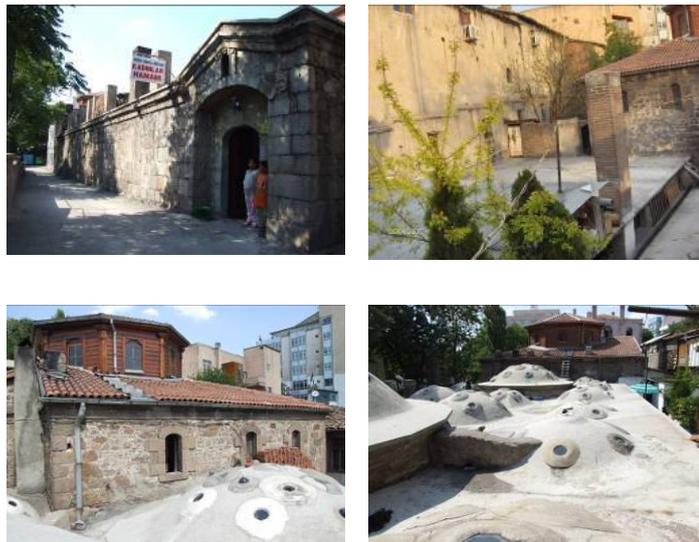
Figure 3.11 Views of the building, showing the roof areas under study.

The roof areas under study were presented in Figure 3.10. These areas were composed of four roof areas; A1, A2, B1 and B2, having different geometry and drainage systems (Figure 3.10). The roofs A1 and A2 were pitched roofs similar with each other, consisted of two parts; the four-sided pitched roof covering the square area and the lantern roof at its top. A peripheral drainage system was provided by means of zinc eaves gutters and fourteen down pipes, some of which discharge water directly onto the concrete-clad roof, B1 (Figure 3.11).

The roof B1 was a low-slope roof including domes, configured to provide peripheral drainage, with flows from elevated interior edges to lower exterior ones, and then, to waterspouts located at the eaves level along the west side of the roof (Figure 3.11). There were nine spouts, with similar dimensions, serving this roof area.

The roof B2 was a flat roof configured to provide an internal drainage, with flows towards an internal gutter located at the middle of the roof area (Figure 3.11). The water collected in the gutter was discharged through a grilled outlet located at its north end, and then, carried by a drain line (buried in the garden) to the rainwater drainage network (buried under the street) (Figure 3.12).

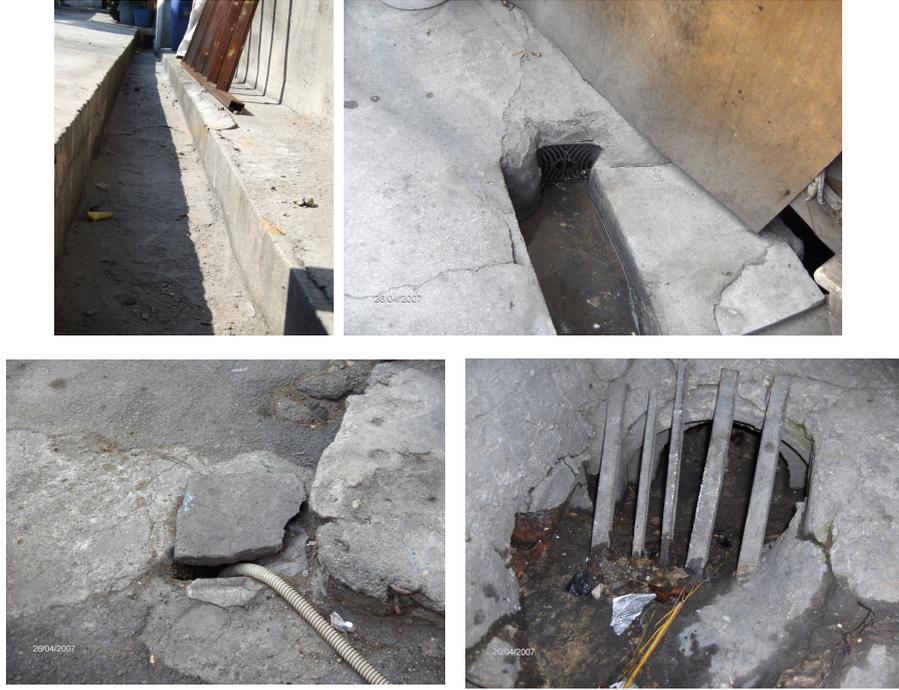
Figure 3.12 Views of the interior gutter and the drain discharging water from concrete clad flat roof, B2 and view of the drain line (buried in the garden) towards the drainage network (buried under the street).

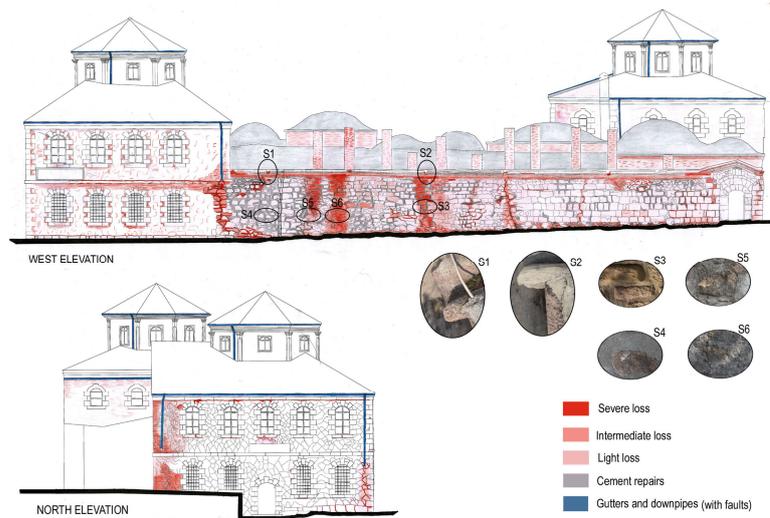
Figure 4.1 Elevations showing the distribution of the severe material loss at the north and west façade of the building. *S1, S2, S3, S4, S5 and S6 show the location of material samples taken from the west façade.* The severe loss and detachment on surfaces was observed together with white staining and salt deposits, especially at the lower parts of the rainwater pipes at both sides of the façade and stone courses at the top, underneath the eaves gutter.

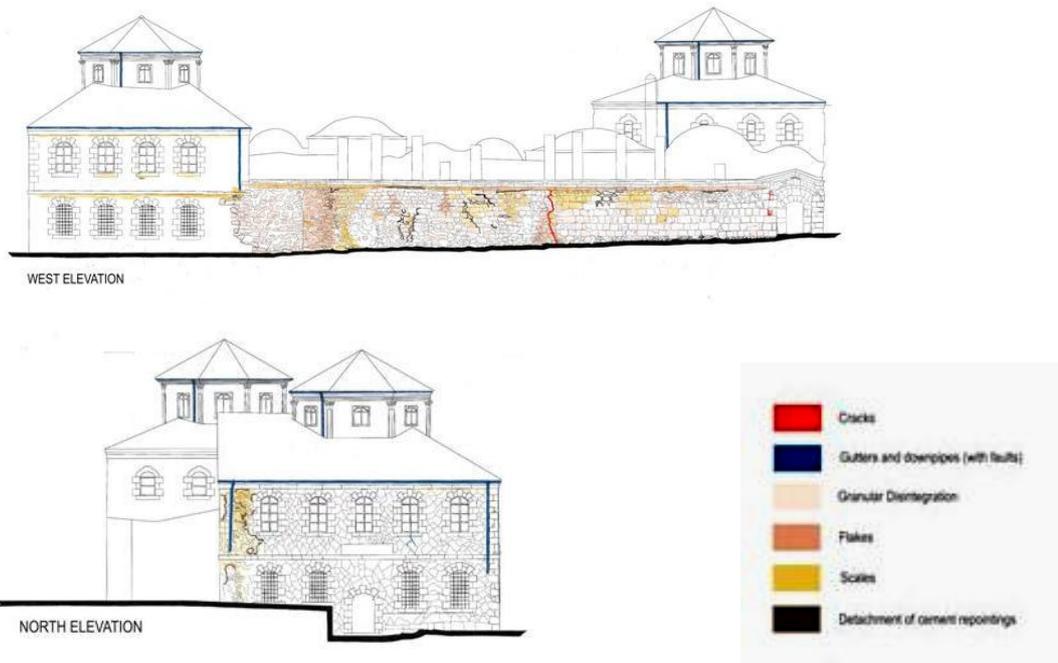
Figure 4.2 Elevations showing the distribution of the material detachment and cracks at the north and west façade of the building.

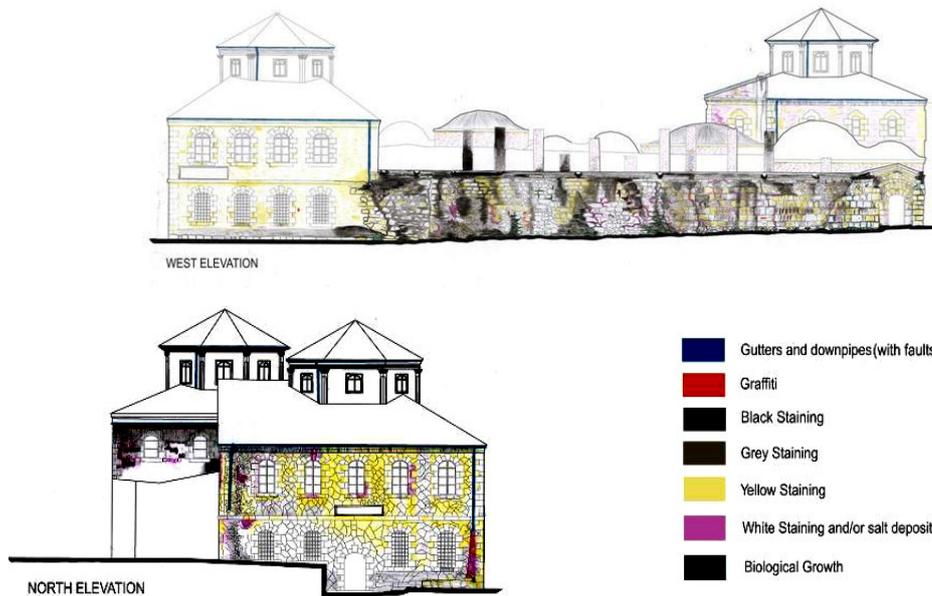
Figure 4.3 Elevations showing the distribution of discoloration and deposits on surfaces of the north and west façade of the building.

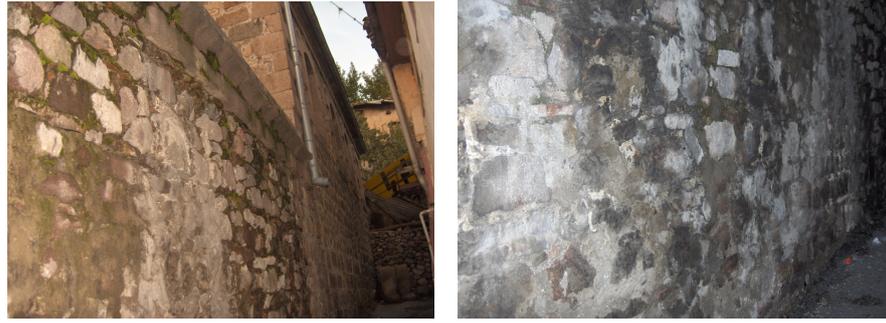
Figure 4.4 Views of biological growth as active deterioration zones together with white staining and/ or salt deposition & material loss in relation with cement repointing on surfaces of the south façade of the building.

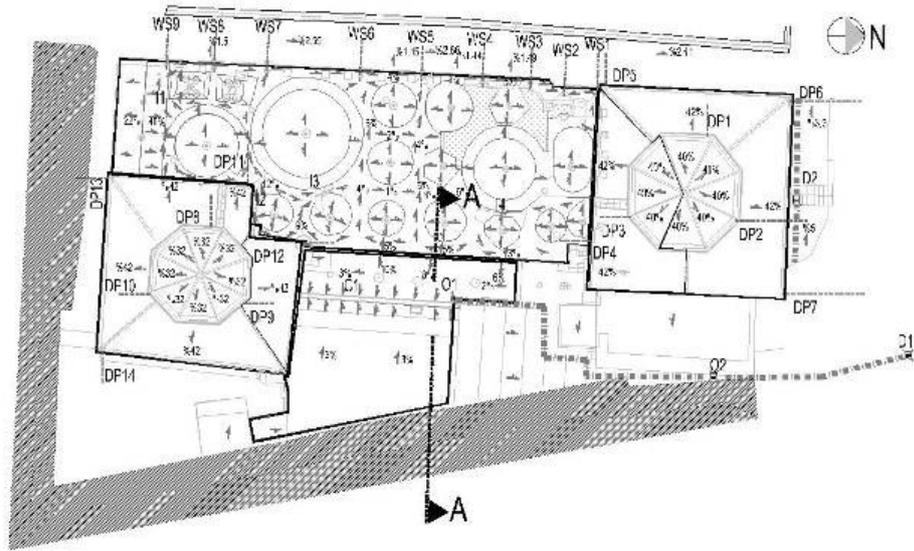
Figure 4.5 The map showing the direction and extent of surface slopes on the roofs of Şengül Hamamı and its immediate periphery.
 Source: Archives of The General Directorate of Pious Foundations, 2008

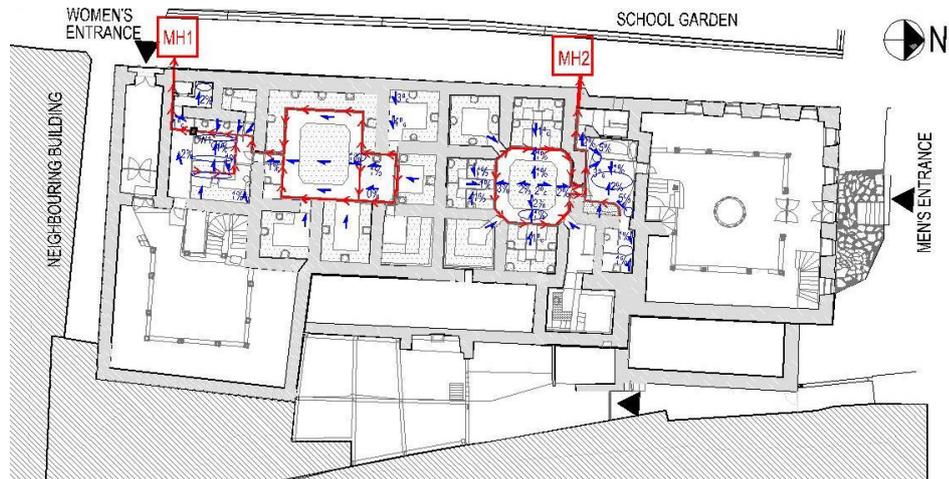
Figure 4.6 The map showing the water flow pattern of the waste water discharge channel towards the manholes and the surface gradients of floors.
 Source: Archives of The General Directorate of Pious Foundations, 2008

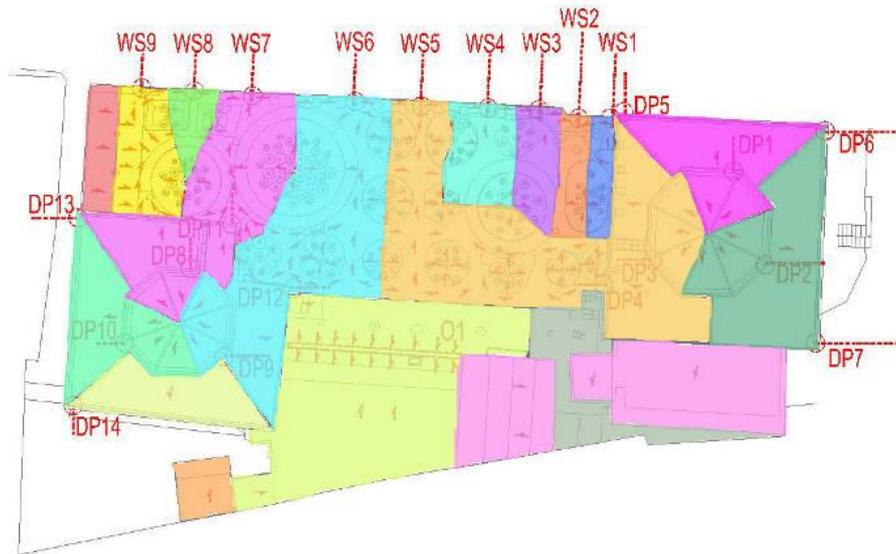
Figure 4.7 The roof map of the as-is case, showing the uneven distribution of discrete effective areas feeding the individual discharge components.

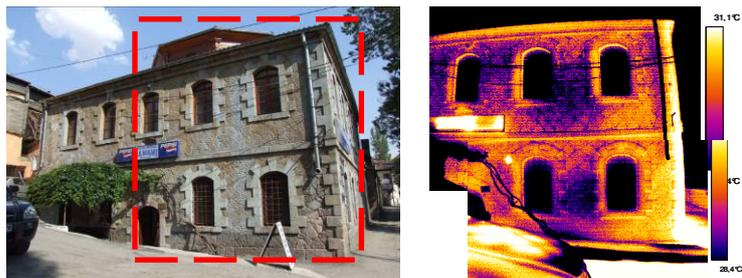
Figure 4.8 The infrared image of the selected region at the north façade, showing the severe material loss as warmer areas and the detachments which were not observed visually as colder areas, both suffering from the roof drainage faults.

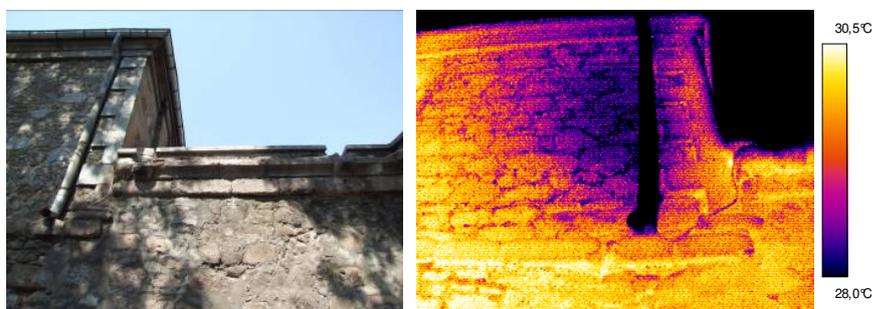
Figure 4.9 The infrared image of the selected region in which the detached areas close to the rainwater down pipes were detected as colder areas.

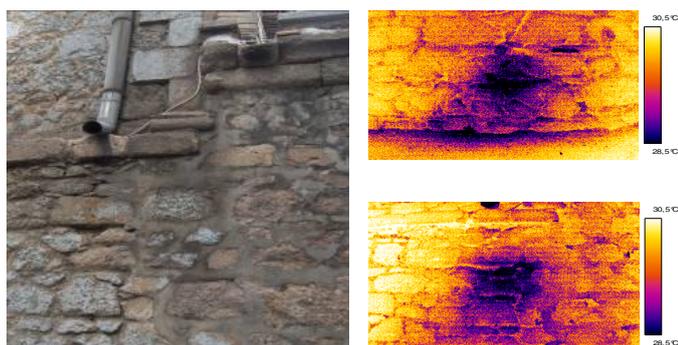
Figure 4.10 The infrared image of the selected region in which the lower parts of the wall corresponding to the axis of the down pipe and the water spouts were found to be cold and damp

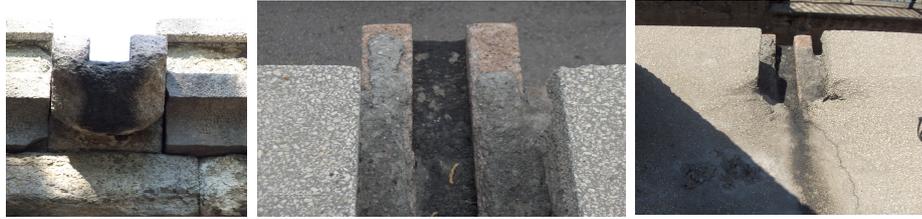
Figure 4.11 The front and top views of the original water spout, WS6, having flow dimensions of 10cm x 7cm in width to depth, respectively.

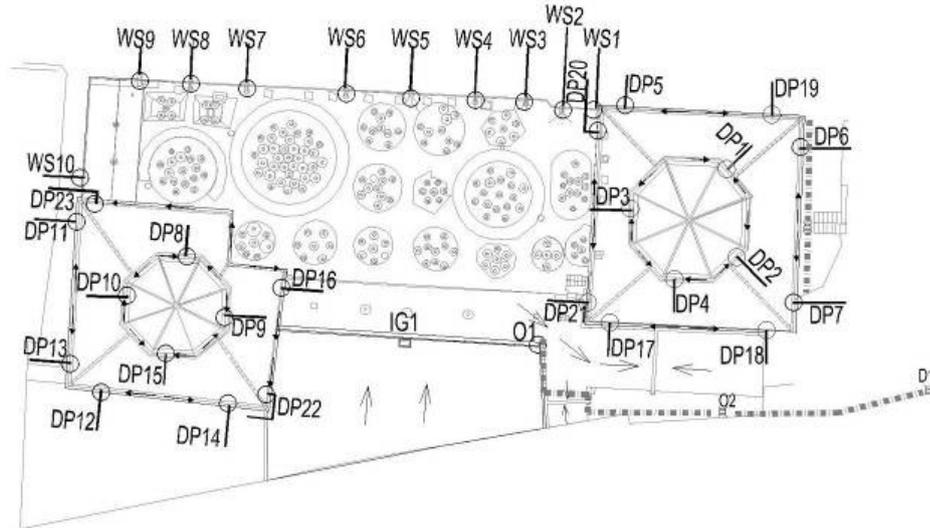
Figure 4.12 The roof map of the ideal case showing the location of each individual discharge component.

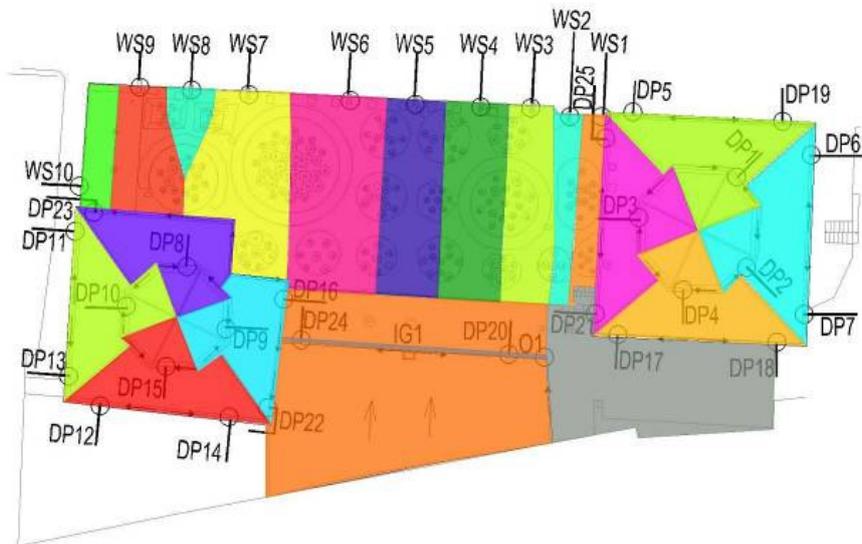
Figure 4.13 The ideal roof map showing the discrete effective areas feeding individual discharge component which provides an even rainwater loading for each component.
