AN INVESTIGATION ON THE WATER SUPPLY AND DRAINAGE
SYSTEMS OF HISTORICAL TURKISH BATHS

A THESIS SUBMITTED TO
THE GRADUATE SCHOOL OF NATURAL AND APPLIED SCIENCES
OF
MIDDLE EAST TECHNICAL UNIVERSITY

IN PARTIAL FULFILLMENT OF THE REQUIREMENTS
FOR
THE DEGREE OF MASTER OF SCIENCE, IN BUILDING SCIENCE
IN
ARCHITECTURE

SEPTEMBER 2008

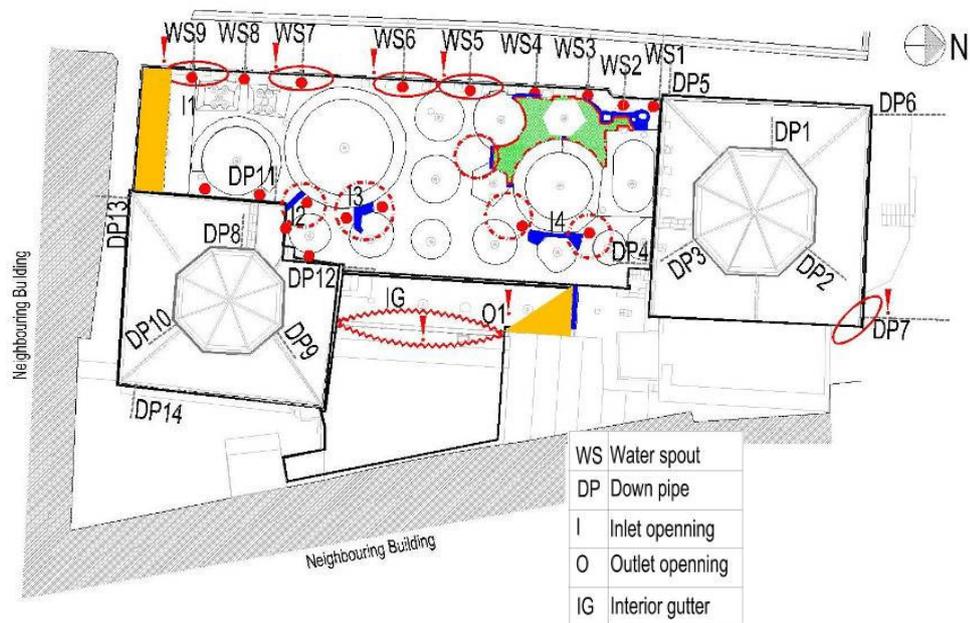
Figure 4.14 The map showing the faults of the roof drainage system and their location.

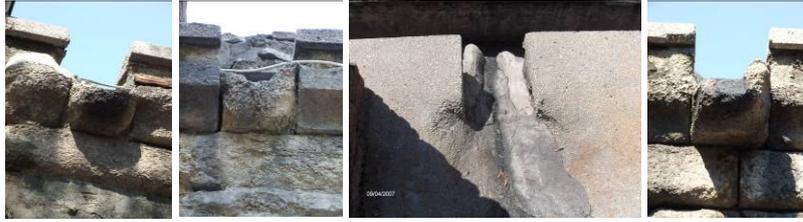
Figure 4.15 Views of the spouts, WS1, WS4, WS5 and WS7 (from left to right, respectively) showing the severely deteriorated sluiceways due to cement-based mortar repairs.

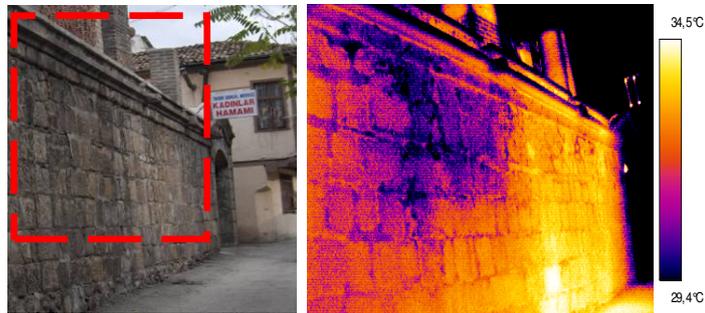
Figure 4.16 The infrared image of the selected region in which the darker areas indicate the damp zones at the upper parts of the wall due to the overflowing from the roof eaves level between the spouts WS6 and WS7; severe material loss together with salt deposits and biological growth overlap with the colder areas.

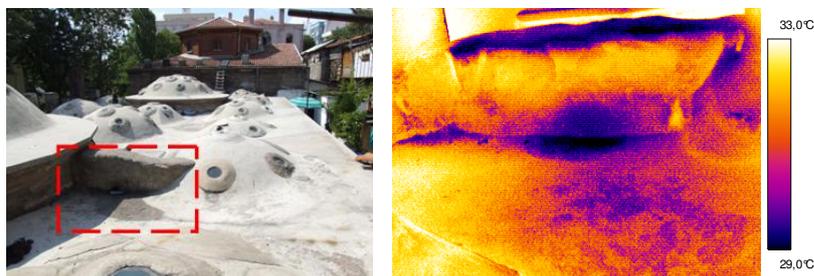
Figure 4.17 The infrared image of the parapet cutting the water flow and causing soil/dirt accumulation in front of its outlet; the gradual decrease of surface temperatures towards the outlet exhibited the potential for absorbing and retaining rainwater.

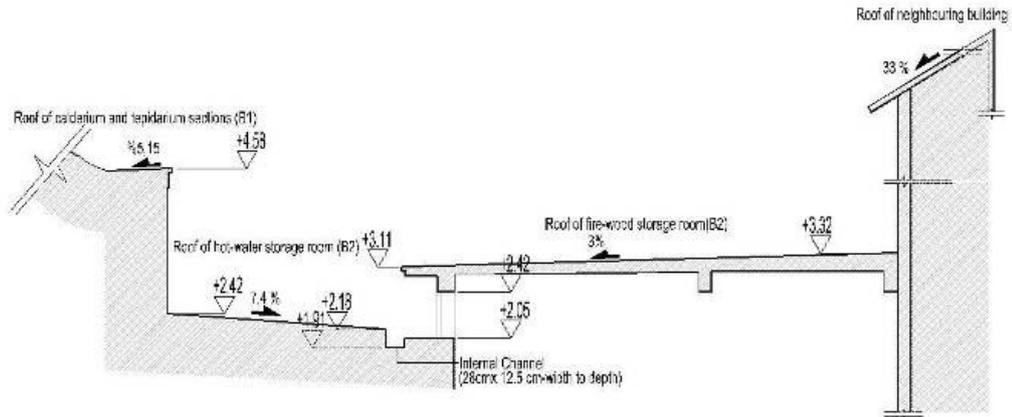
Figure 4.18 The cross section A-A from the roof B2 showing the roof slope arrangement towards the interior gutter and additional rainwater loading from the neighboring building.

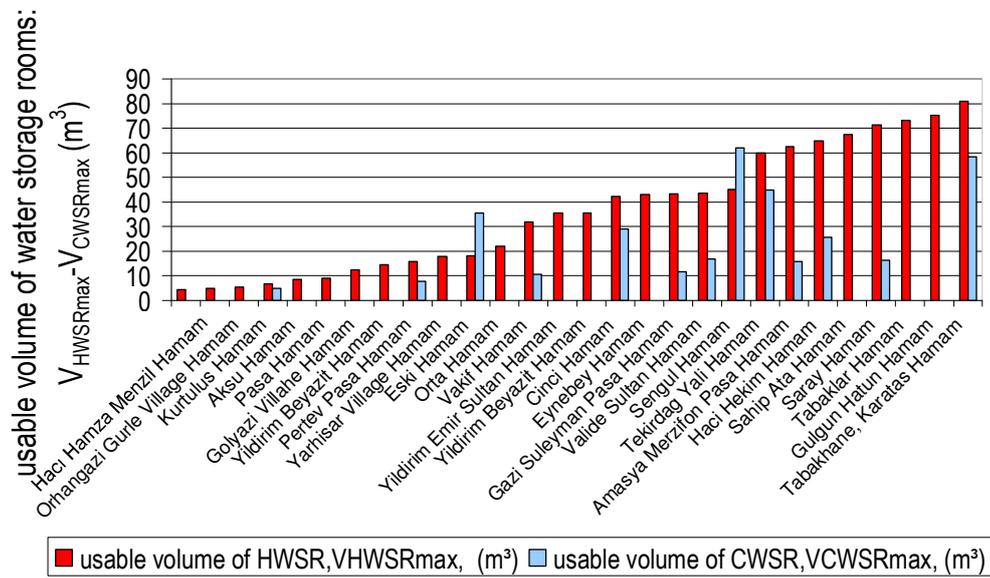
Figure 4.19 The chart showing the maximum hot water storage capacities, $V_{HWSRmax}$, and cold water storage capacities, $V_{CWSRmax}$, of historical baths.

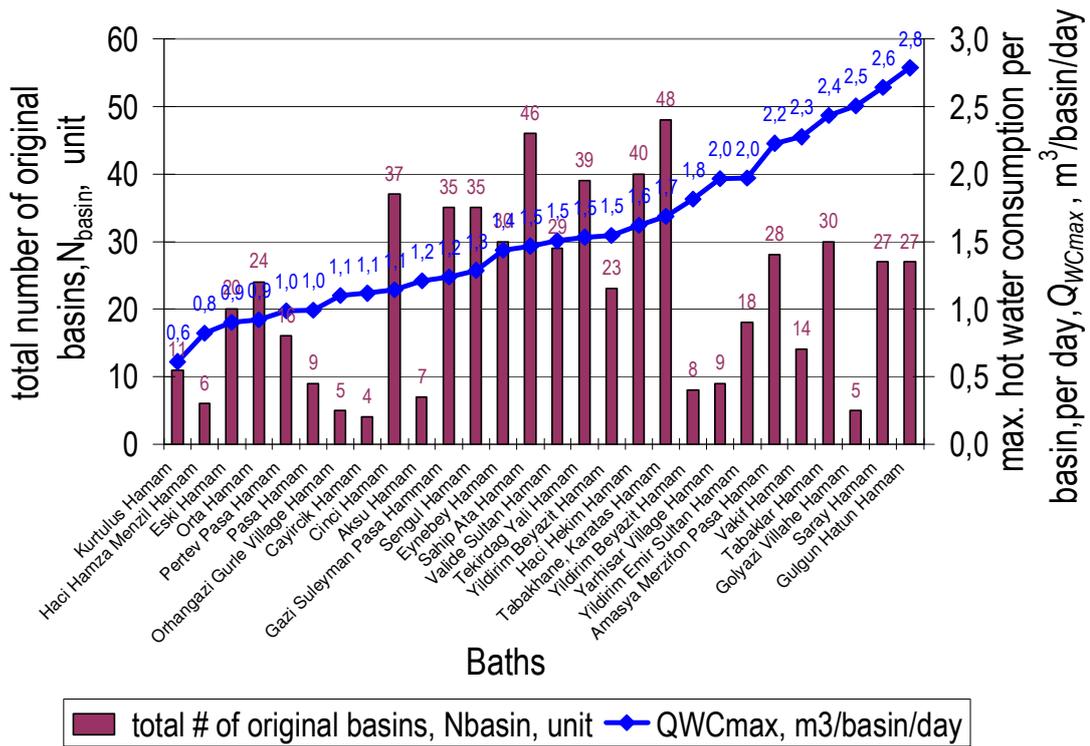
Figure 4.20 The chart showing the Q_{WCmax} values versus number of original basins, N_{basin} , for each historical bath; the Q_{WCmax} varied in the range of 0.61-2.78 $m^3/basin/day$.

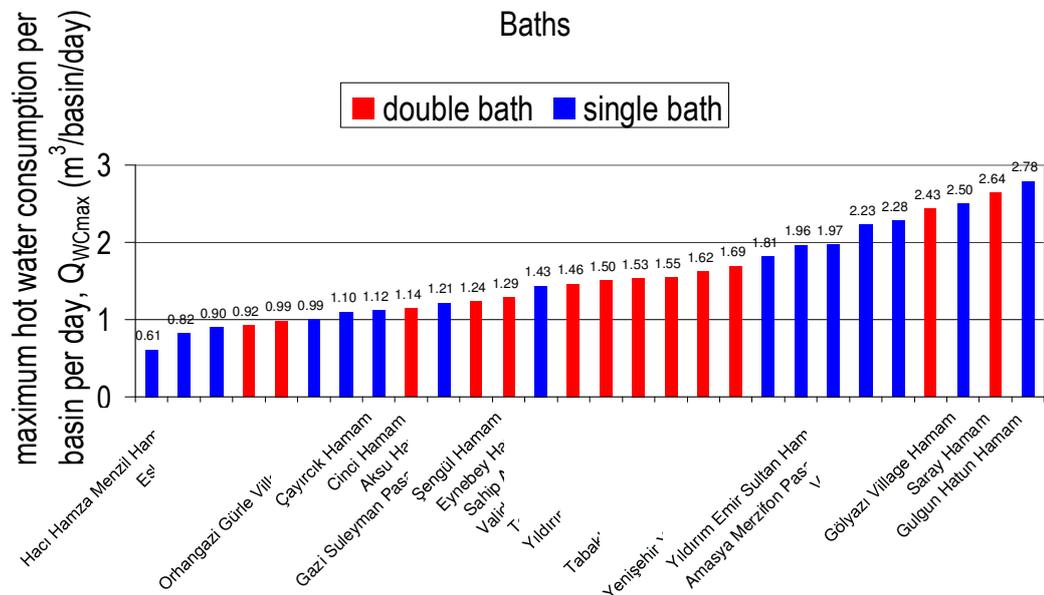
Figure 4.21 The chart showing Q_{WCmax} values versus the type of historical baths; there is not a visible effect of type of the bath to the Q_{WCmax} value.

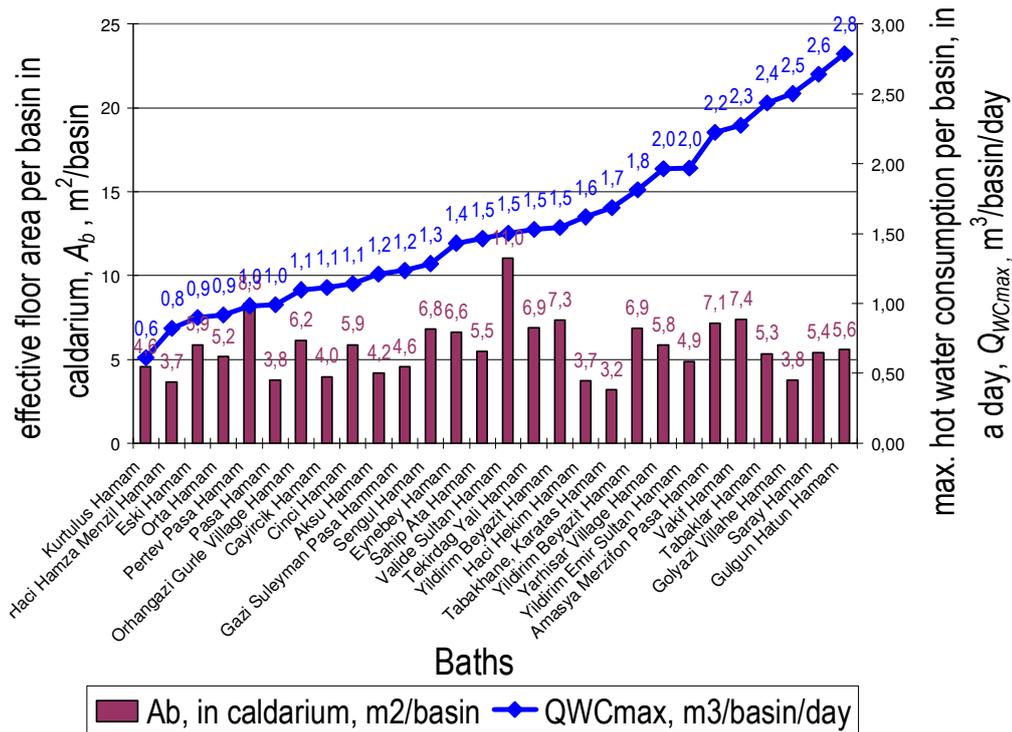
Figure 4.22 The chart showing the Q_{WCmax} as a function of A_b , showing that there is not a visible effect of A_b in the increase of Q_{WCmax} of the bath.

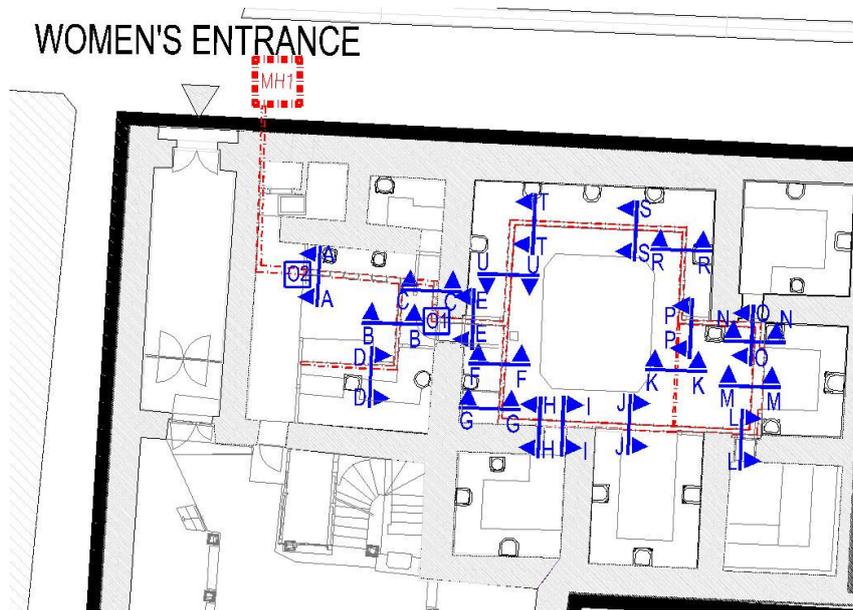
Figure 4.23 The map showing the direction and name of the sections taken from the wastewater discharge channels in caldarium and tepidarium sections of the women's part in Şengül Hamamı.

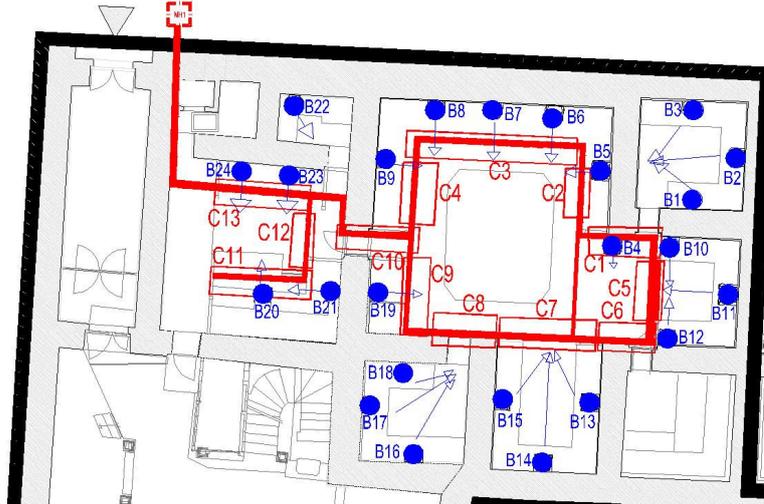
Figure 4.24 The map showing the name of the basins feeding each channel in caldarium and tepidarium sections of the women's part in Şengül Hamamı.
