IN-PLANE SEISMIC STRENGTHENING OF BRICK MASONRY WALLS
USING RE-BARS

A THESIS SUBMITTED TO
THE GRADUATE SCHOOL OF NATURAL AND APPLIED SCIENCES
OF
MIDDLE EAST TECHNICAL UNIVERSITY

OCTOBER 2008

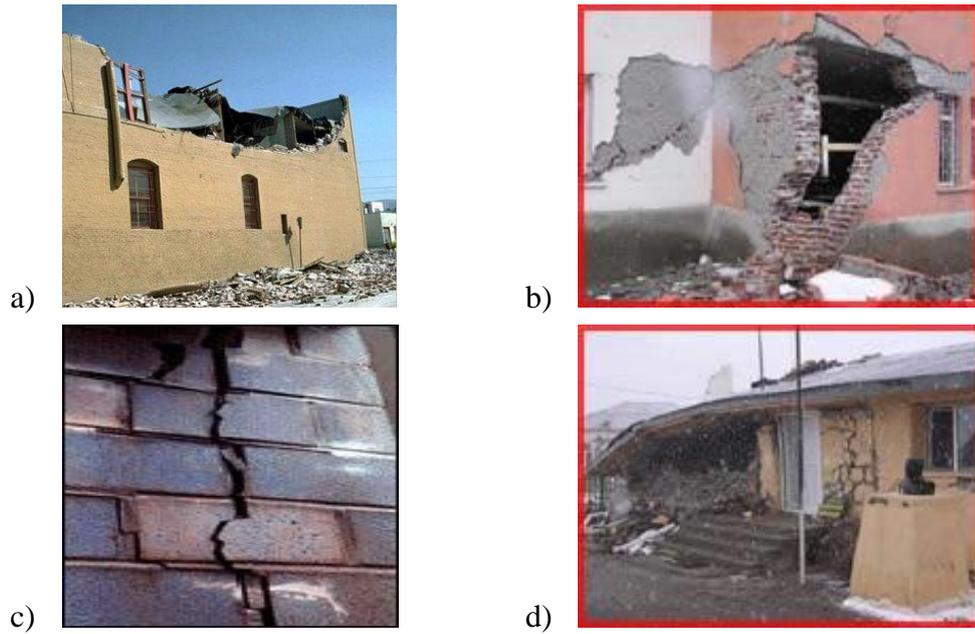
Figure 1.1 a) Out of plane failure, b) Corner opening, c) Vertical cracks, d) Roof falling

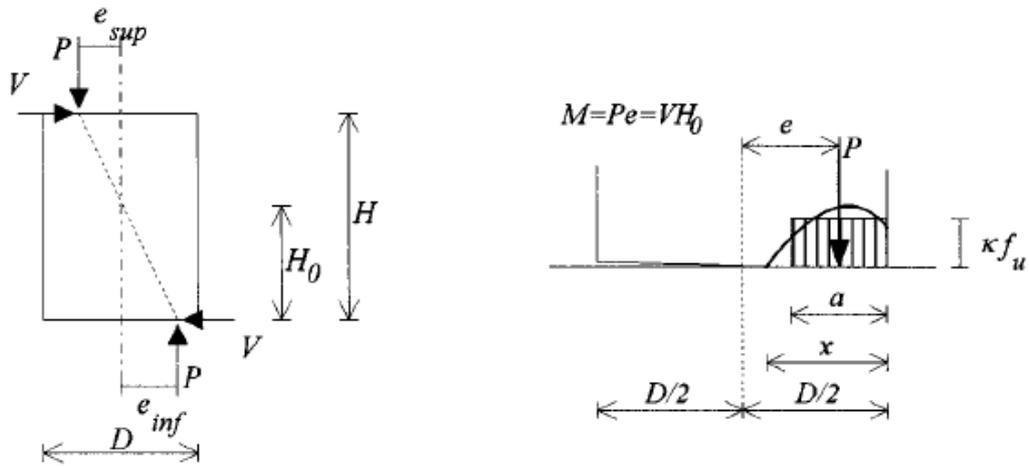
Figure 1.4 Assumptions for rocking strength evaluation of a wall failing with crushing at the base corner

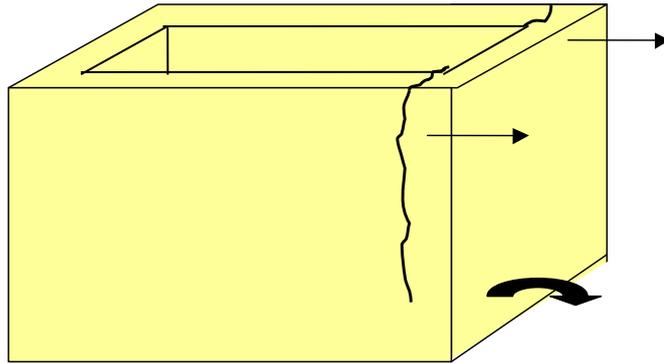
Figure 2.1 Out of plane collapse of URM wall

Weaker connections of URM walls at intersections may fail in tension forming vertical cracks and lead to out-of-plane collapses. Separation of the wall at the orthogonal joints is followed by total collapse of the wall (Figure 2.1, Figure 2.2).

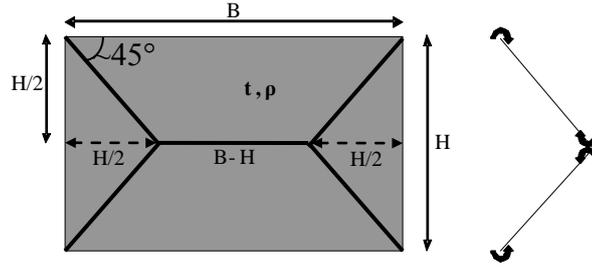
Figure 2.3 Assumed failure lines on the wall

When the bond between slabs and the walls is strong enough then the wall is forced to blow out due to its own mass and inertia. As a result, wall behaves as if it is supported from the edges continuously. Using low quality mortar between the bricks or too small wall thickness may also cause this type of failure. Failure of the wall follows the pattern similar to the yield line theory (Figure 2.3).

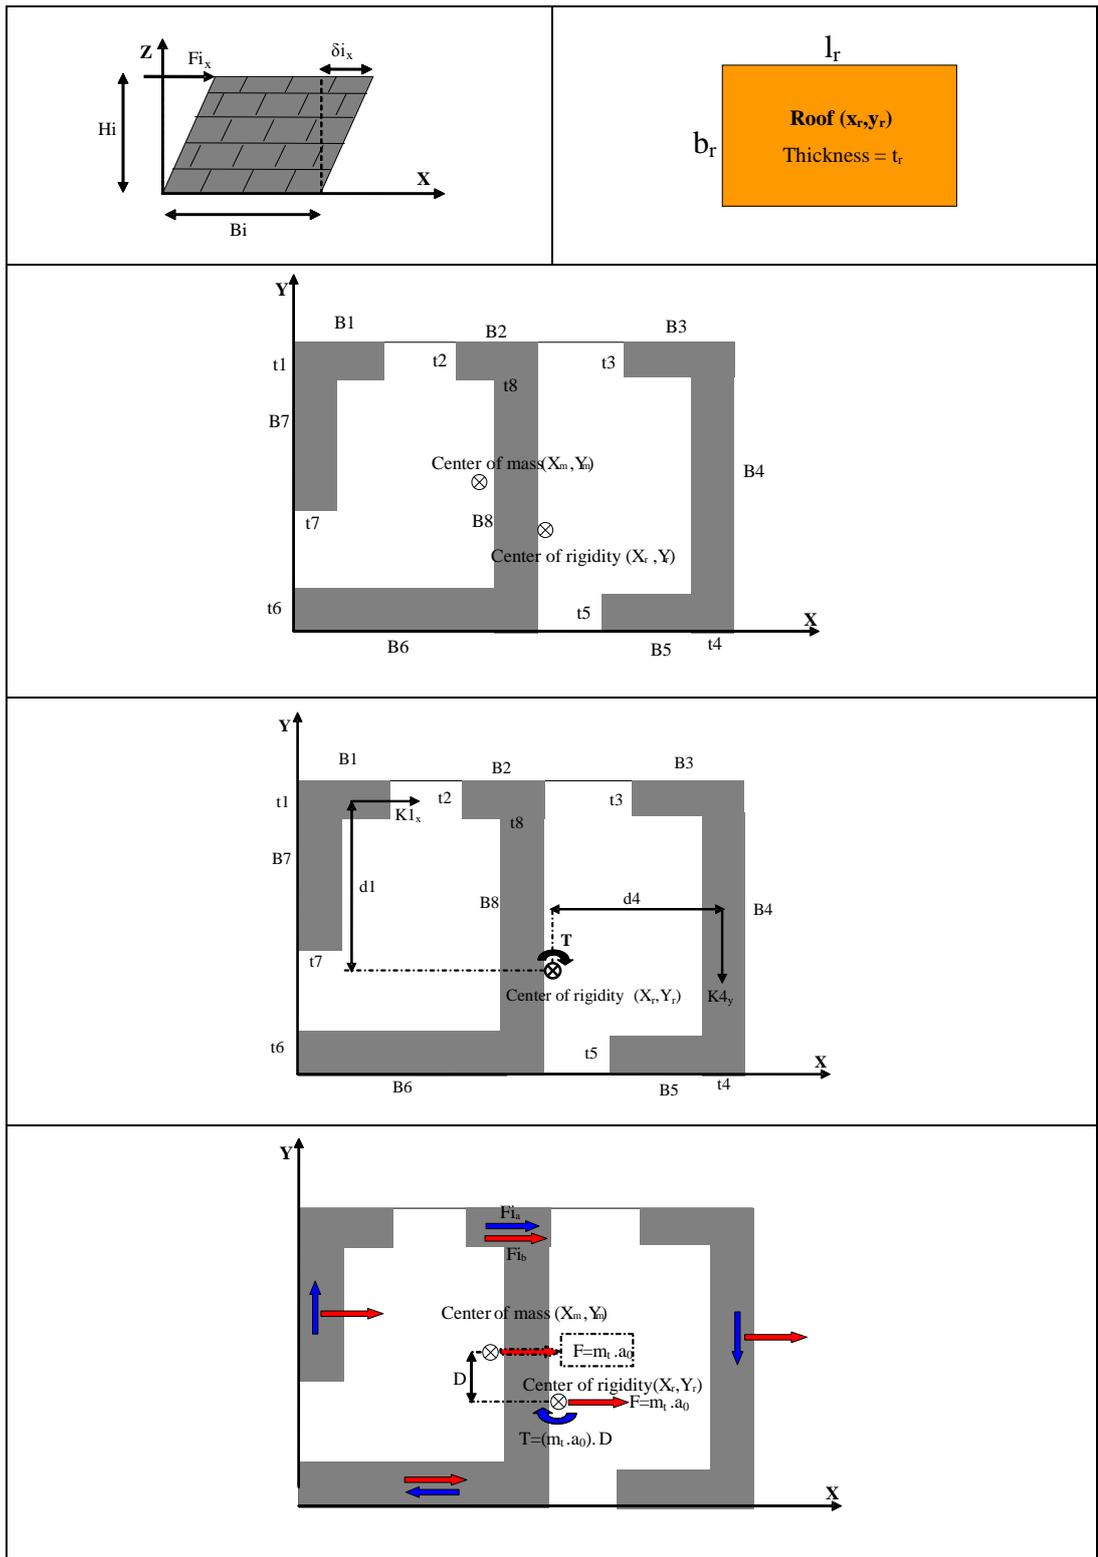
Figure 2.4 Distribution of earthquake demand force through the walls

Earthquake demand on the structure is calculated by taking response spectrum coefficient $S(T_1)$ as 2.5 and structural behavior (reduction) factor 'R' as 2.0 as stated in section 5.2.1 of "Specification for Structures to be Built in Disaster Areas-2007". The importance factor '(I)' is assumed to be 1.0. The earthquake demand as a lateral force acting at the mass center is distributed to the wall segments assuming a rigid diaphragm as shown in Figure 2.4 and through the calculations listed below;

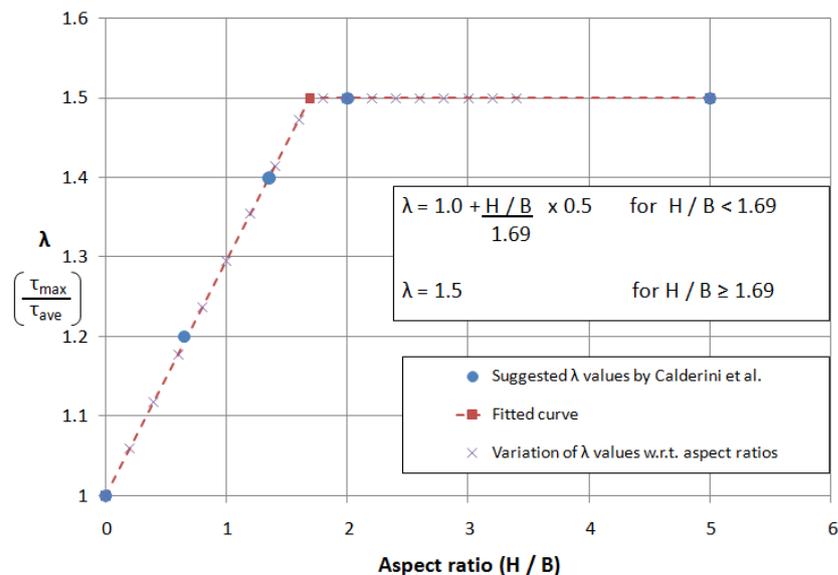
Figure 2.6 λ vs. aspect ratio graph and developed formulation for λ value

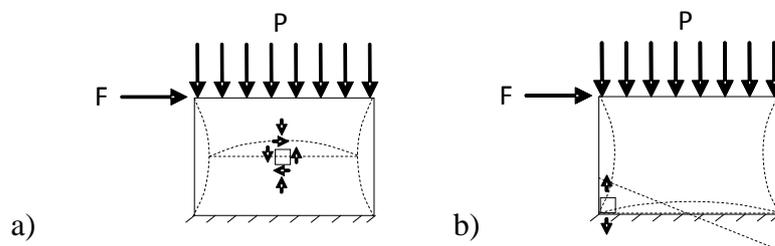
Figure 2.7 a) Diagonal shear cracking, b) rocking of vertically loaded free to rotate wall

The in-plane failure mechanisms are affected by the boundary conditions and aspect ratio of the walls. If a small house with one or two wall segments in the same axis is considered, the top edges of the walls may be accepted as free to rotate, similar to a cantilever beam (Figure 2.7). On the other hand, if the slab is continuous over numerous wall segments, the top edges of the walls can be accepted as ‘restrained’ against rotation. In Figure 2.7 a), failure is assumed as diagonal shear cracking starting from the center of the wall which has the maximum shear stress due to narrowing of the effective shear area. Shear stress on infinitely small element at the center of the wall can be obtained by increasing the average shear stress value with shear stress distribution factor (λ) represented in Figure 2.6. Principal tensile stresses on that element can be obtained using Mohr circle as shown in Figure 2.8. Eqns. (2.22) and (2.23) were derived for diagonal shear failure of a one end fixed other end free-to-rotate masonry wall. Flexural failure (rocking motion) of the wall is represented in Figure 2.7 b) where rocking motion is assumed to be triggered by the tensional failure of base corner of the wall. It is also assumed that infinitely small element at the base and edge of the wall (wall corner) has only principal tensile stresses with zero shear stress for the shown orientation. The derivation of the assumed in-plane capacity of the wall towards rocking motion is given in eqns. (2.24) and (2.25). When eqns. (2.23) and (2.25) are compared for $P=0$, the critical ratio of H/B is found to be 0.175, which would determine the failure mechanism between diagonal shear and rocking. Usually, P is not zero and H/B ratio is well above 0.175. For the walls that have low level of P force and high H/B ratios, the failure is governed by the rocking motion.

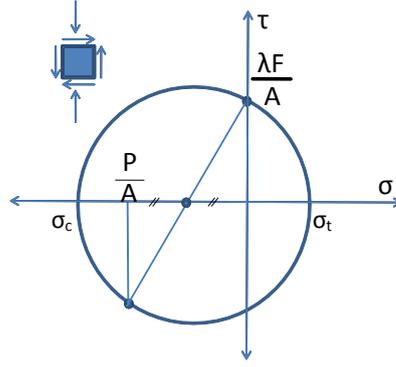
Figure 2.8 Mohr circle related to Figure 2.7 a)

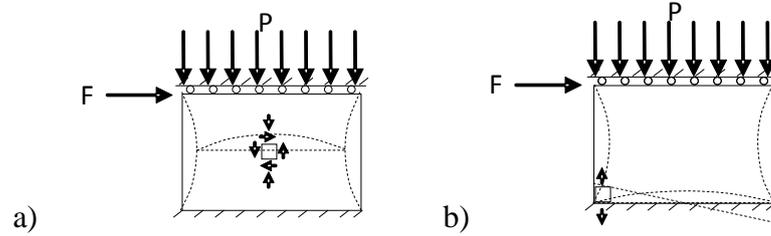
Figure 2.9 a) Diagonal shear cracking, b) rocking of vertically loaded upper edge restrained wall

wall results in lower moments at the bottom of the wall, which causes lower principal tensile stresses on the infinitely small element at the base corner of the wall. Eqns. (2.26) and (2.27) represents the assumed rocking capacity of the wall.

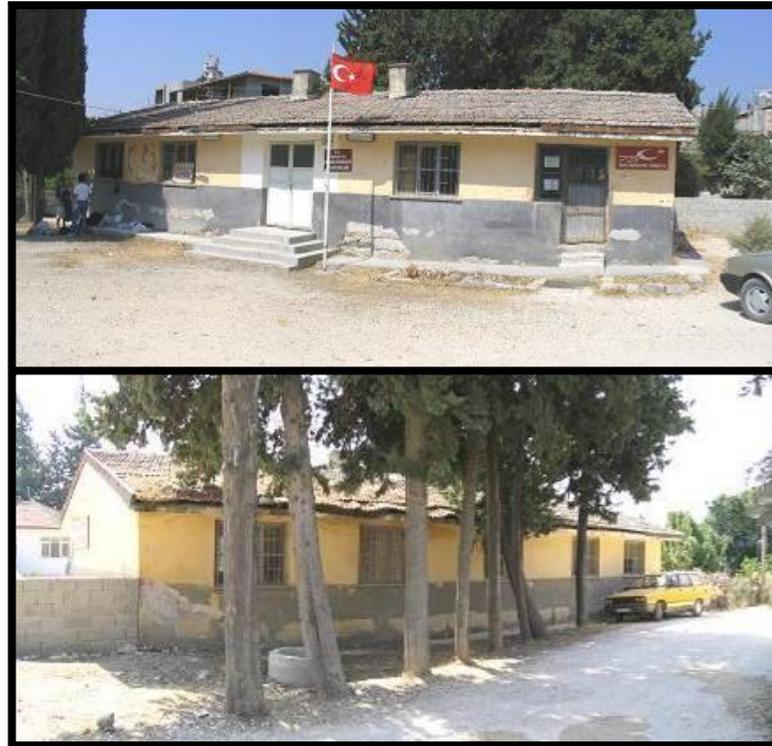
Figure 2.10 General view of example house

A single storey URM house was selected as the case study for the evaluation part using macro based excel program. The house is placed in Antakya, Turkey (Figure 2.10) and has 7.5 m width, 17.5 m length, and 2.4 m wall height. To define the wall layout in the program, walls are defined as lines between wall corners and window–door openings (Figure 2.11).

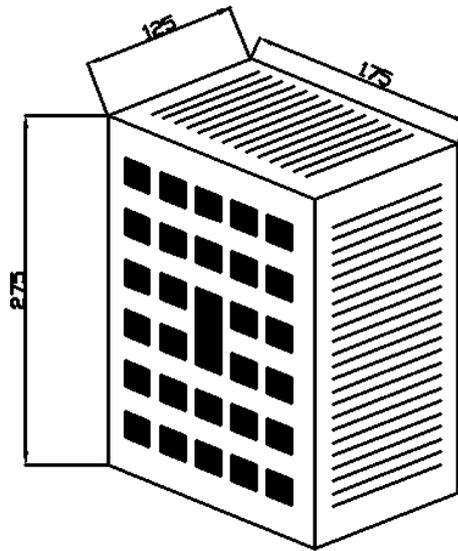
Figure 3.2 Dimensions of the brick used in tests, (in mm)

Three 125 mm x 175 mm x 275 mm bricks were used with a void ratio of 60% (Figure 3.2). Brick was placed in the testing machine and loaded in the direction of the holes. For the displacement measurement, a Linear Variable Displacement Transducer (LVDT) was placed in the same direction. Average force displacement curve is obtained for the vertical compressive loading of the brick (Figure 3.3). Approximate vertical load carrying capacity of the bricks was found to be 330 kN as given in the graph. When the vertical load carrying capacity of a brick is divided by the total cross sectional area (including holes according to “Specification for Structures to be built in Disaster Areas-2007”), ultimate compressive stress is approximately found to be 6.86 MPa.

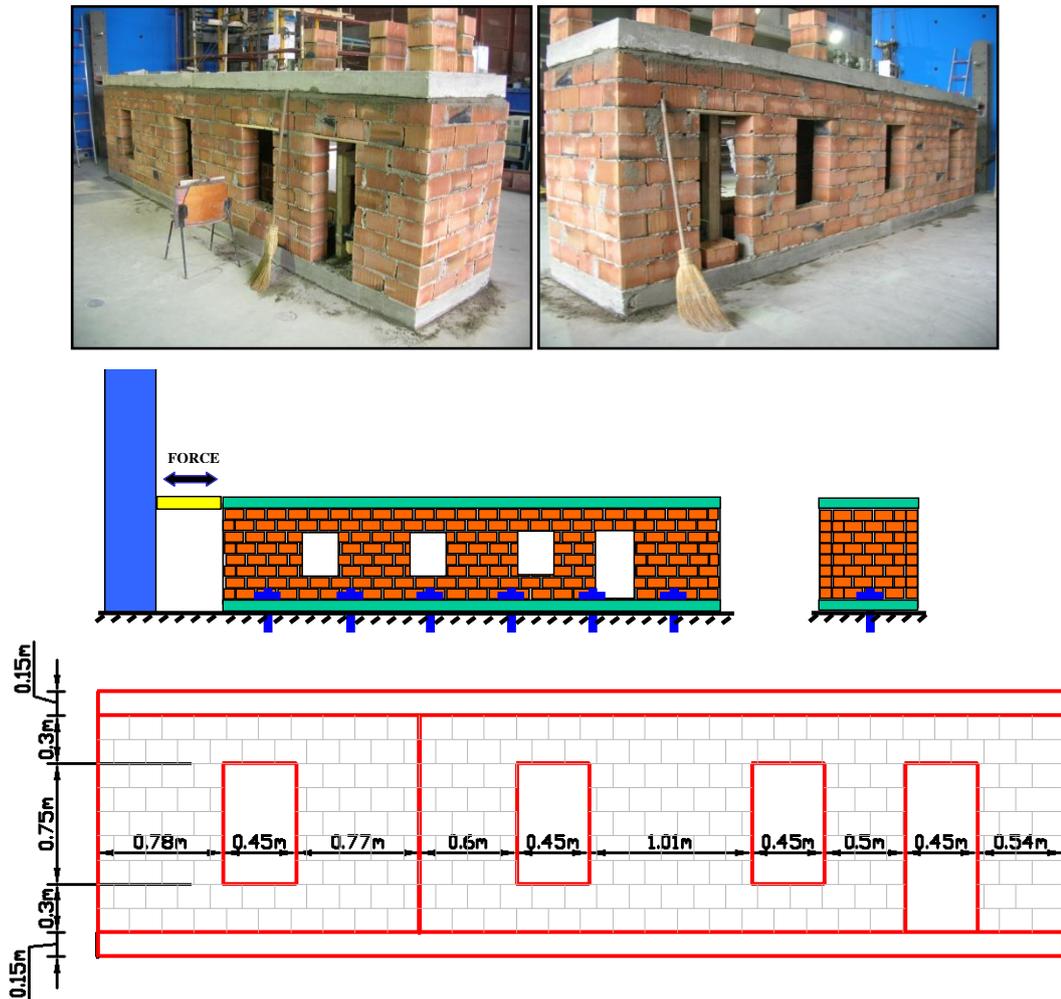
Figure 4.1 Half-scale brick masonry house test specimen

innovative approach using spring boxes were proposed to retain the post-tensioning force on the rebars, which can be easily lost due to cracking of the walls or yielding of the post-tensioning rebars. General behavior after strengthening was approximately predicted using simple relationships for design of strengthening on actual houses using the proposed technique. Dimensions of the wall parts and a general view from the test house are given in Figure 4.1.

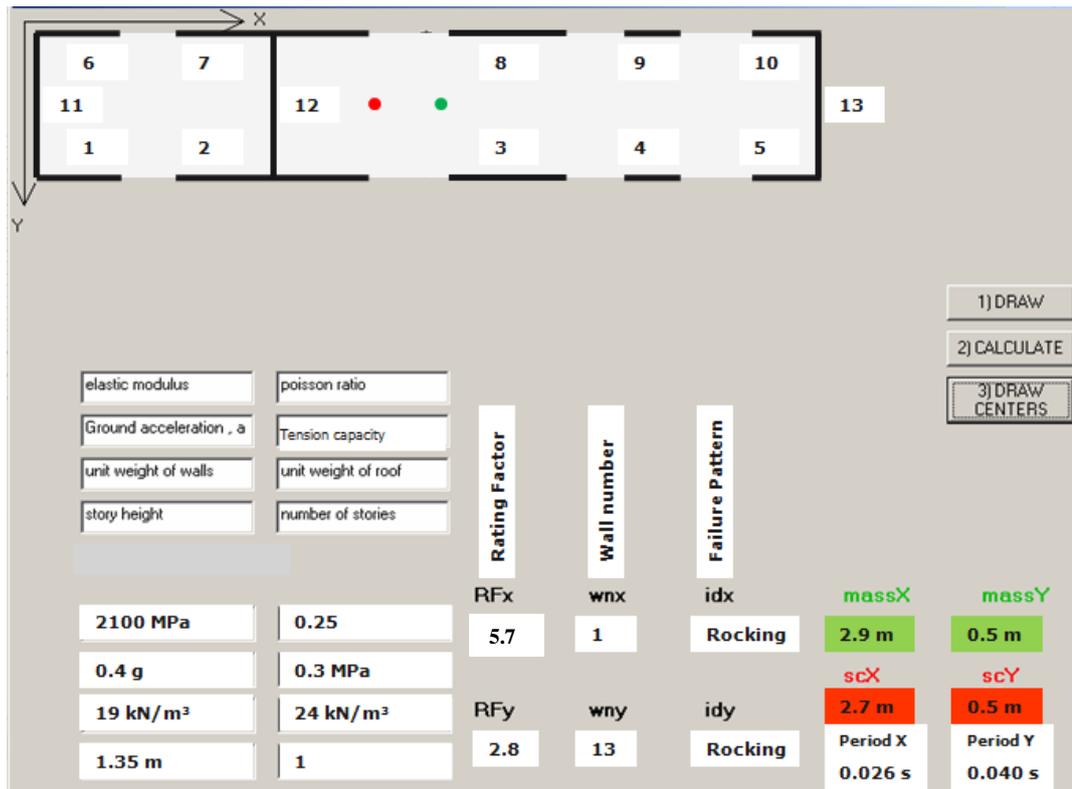
Figure 4.2 Results of test house on macro based excel program

Number 1 wall exhibits a rocking failure due to eqn. (2.27). Although number 1 wall fails in flexure it continues to carry vertical loads and horizontal force. Redistribution takes place between the other walls until all of the walls fail. Post-cracking strength of the wall was assumed to be zero; although, the cracked wall would continue to carry some amount of lateral force.

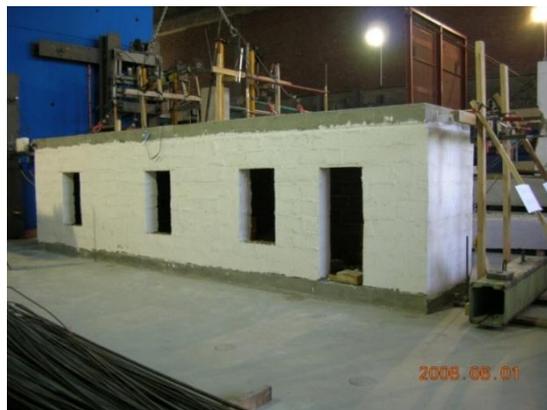
Figure 4.3 Original unstrengthened test specimen

Half-scale test house (Figure 4.3) was loaded to failure in its original condition without any strength improvement. Distribution of lateral load in accordance with the stiffness of each wall was considered before the test in order to analytically approximate an in-plane lateral load carrying capacity. The numbering of wall segments is given in Figure 4.2 and related data is presented in Table 4.1. Thickness of mortar joint was assumed as 120 mm and elastic modulus was taken as 2100 MPa.

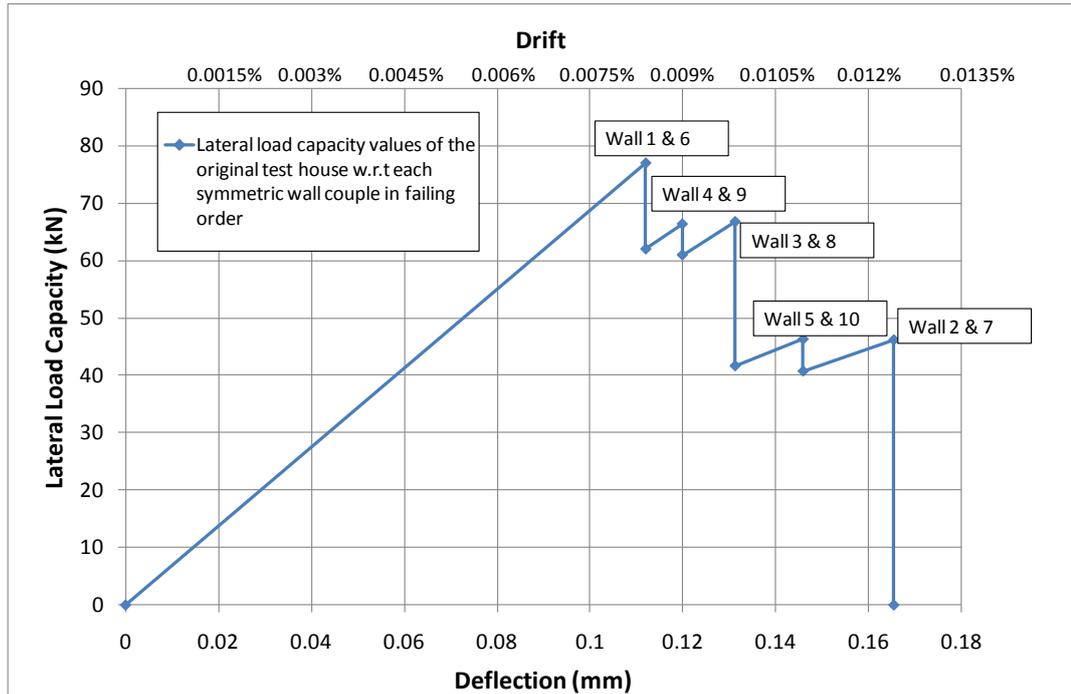
Figure 4.4 Analytically fit capacity curve of unstrengthened test house

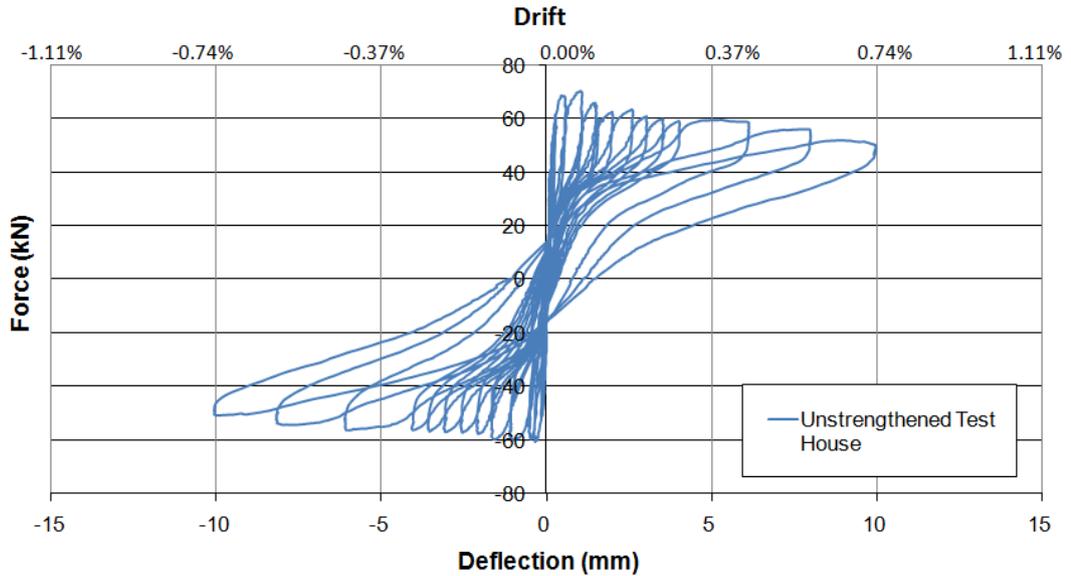
Figure 4.5 Force vs. Deflection graph of the first test

Unstrengthened URM house specimen test was performed with increasing reversed cyclic loading until the first crack has formed. Initial loading step started from 10 kN and increased systematically with about 10 kN increments. Lateral force has reached to its ultimate value of 68 kN at around 0.42 mm (0.031%). The lateral force approached to about 50 kN plateau as the displacements are further increased (Figure 4.5). The forces approaching to a constant value is deemed to be due to a static equilibrium position as all of the walls were cracked in flexure (rocking mode) and the weight of the ceiling was supported by the lateral force. Assuming the diagonally formed compression struts are all inclined 45 degrees, the lateral force should have been equal to the weight of the ceiling, which is 32 kN. Since the test was stopped before excessive damage to the structure, the lateral force is expected to further decrease if the test was continued on until heavy damage.

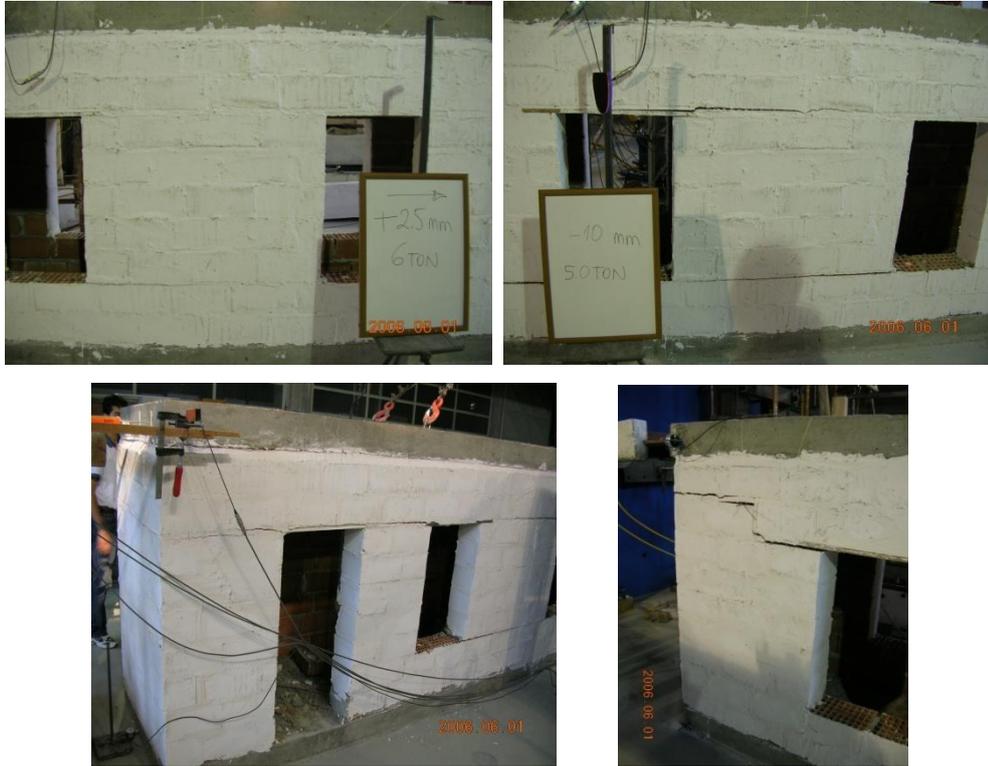
Figure 4.6 Cracks on the first specimen

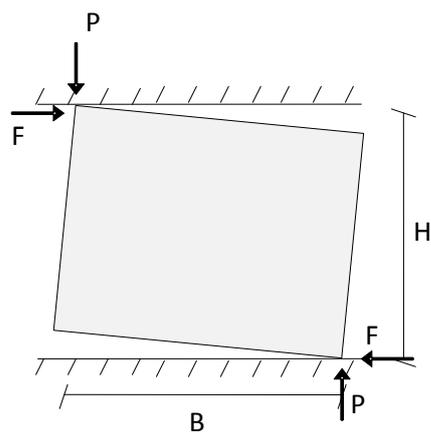
Figure 4.7 Horizontal constant force developing at the corner of rocking walls

which has failed in the rocking mode, was calculated as a function of the vertical dead load acting on each wall as shown in Figure 4.7.

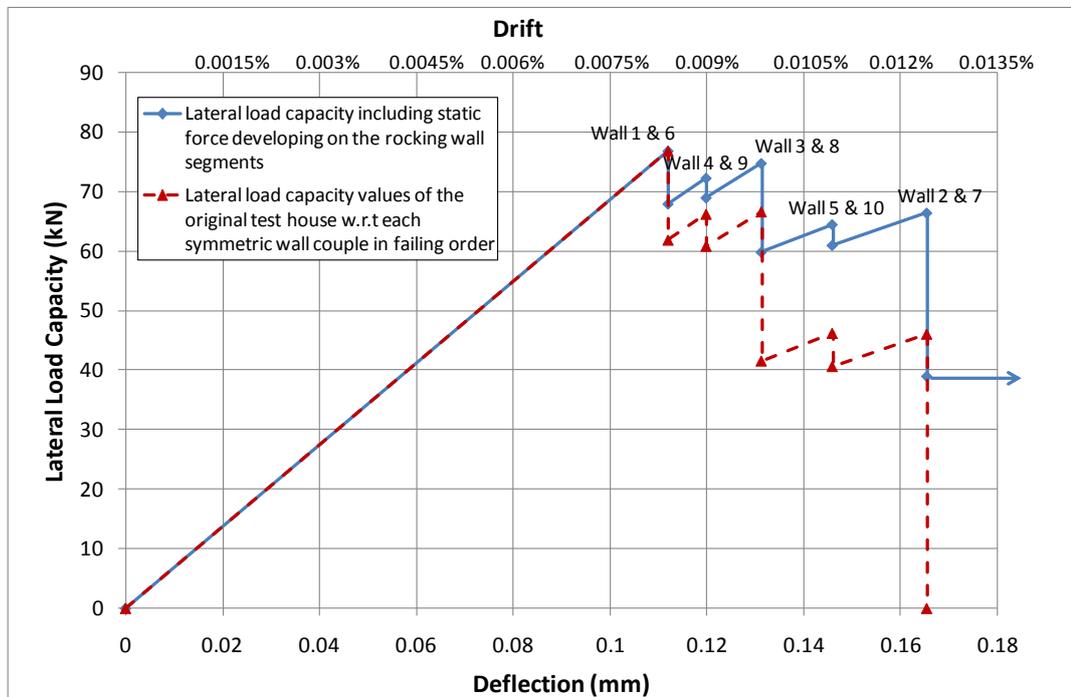
Figure 4.8 Analytically obtained load-deflection graphs of unstrengthened test house

The comparison of the analytically obtained load-deflection graphs are compared in Figure 4.8. The curve obtained by considering static equilibrium of the walls that were cracked in rocking motion differs in the nonlinear range and has a constant remaining lateral force of about 40 kN as all of the walls have cracked and lost their stiffness.

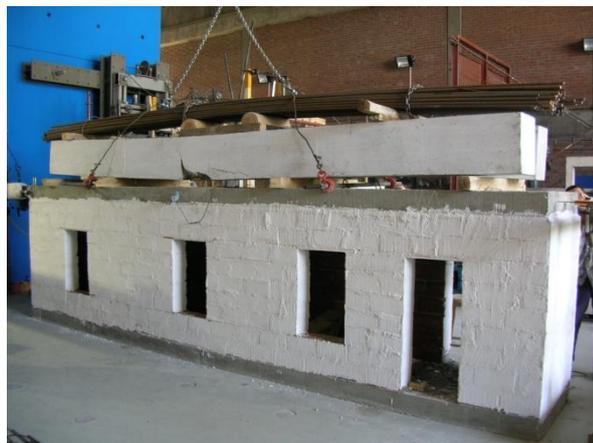
Figure 4.9 Second test with 50 kN of weight above the house

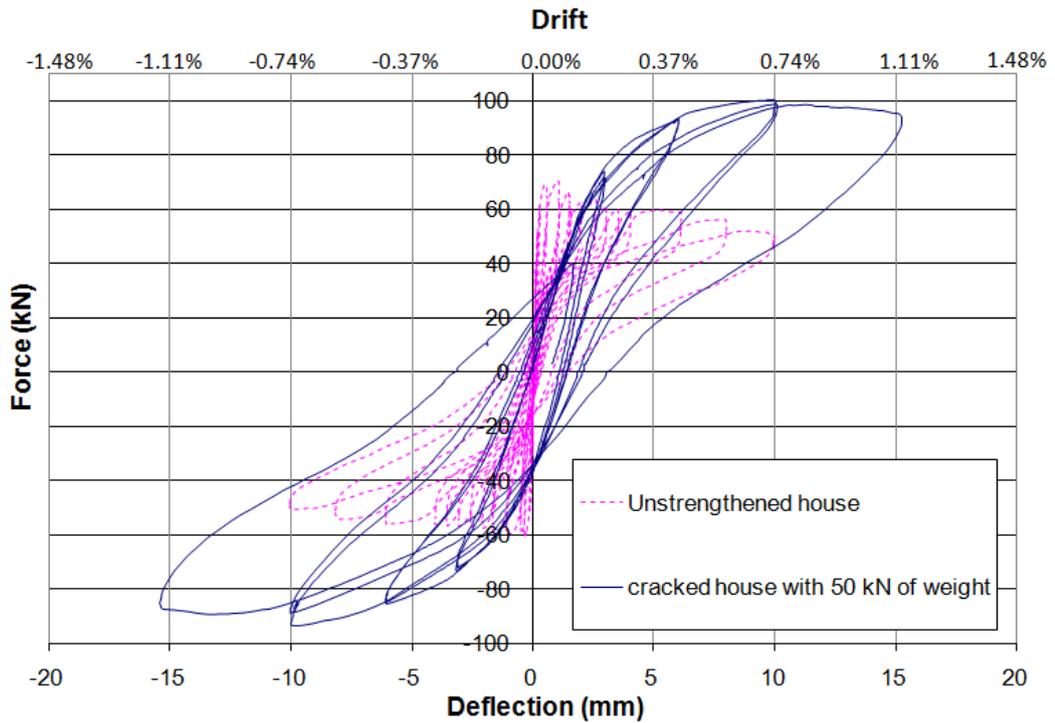
Figure 4.10 Force vs. Deflection graph of the second test

The displacement – load capacity curve was also obtained for the house with 50kN weight on the roof as shown in Figure 4.11. The initial stiffness degradation is shown with a dashed line since the walls were already cracked. The ultimate remaining capacity of the wall after all crack formations has obtained as about 100 kN as in Figure 4.10.

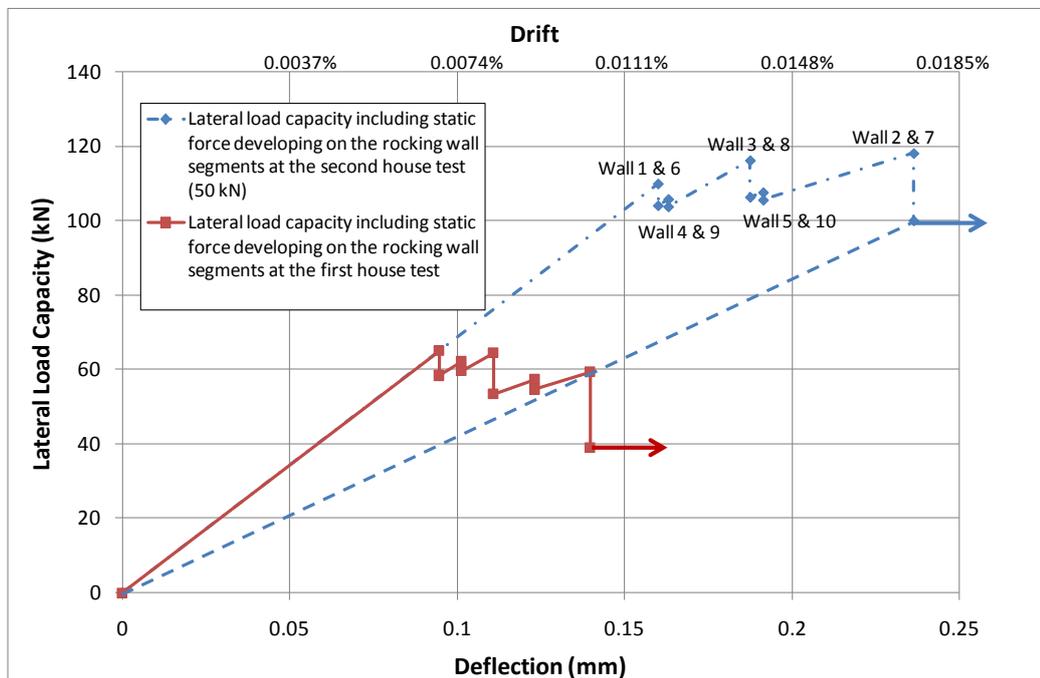
Figure 4.11 Analytically obtained capacity curves of the first and second tests (cracked + 50kN DL)

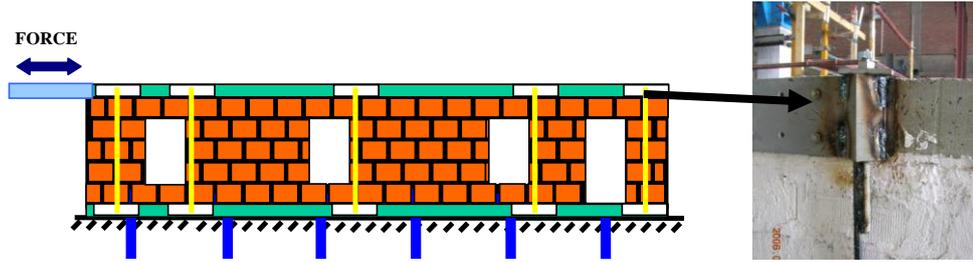
Figure 4.12 Setup of the third test

Post-tensioning bars located in the vertical direction were used to apply vertical force of about 20 kN on each bar for a total of 200 kN. Considering the 5000kg of mass generated 50 kN in the vertical direction, the applied force was about 4 times the former test. The maximum capacity have reached to about 250 kN, which is about 4 times the original capacity of 68 kN and about 2.5 times the 100 kN capacity with 5000 kg mass on the ceiling (Figure 4.13).

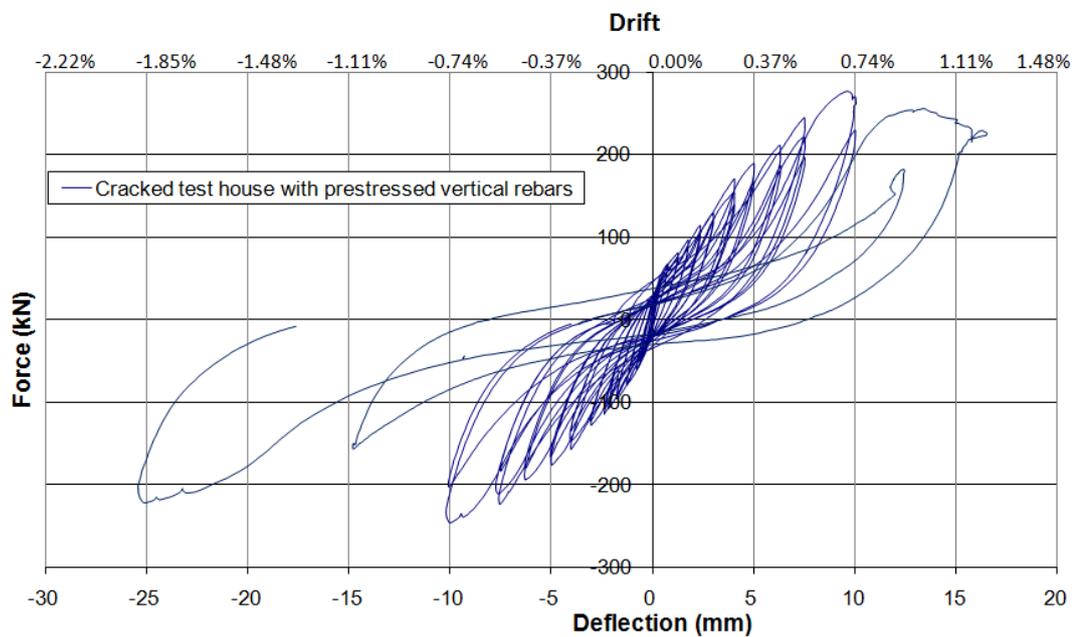
Figure 4.13 Force vs. Deflection graph of the third test

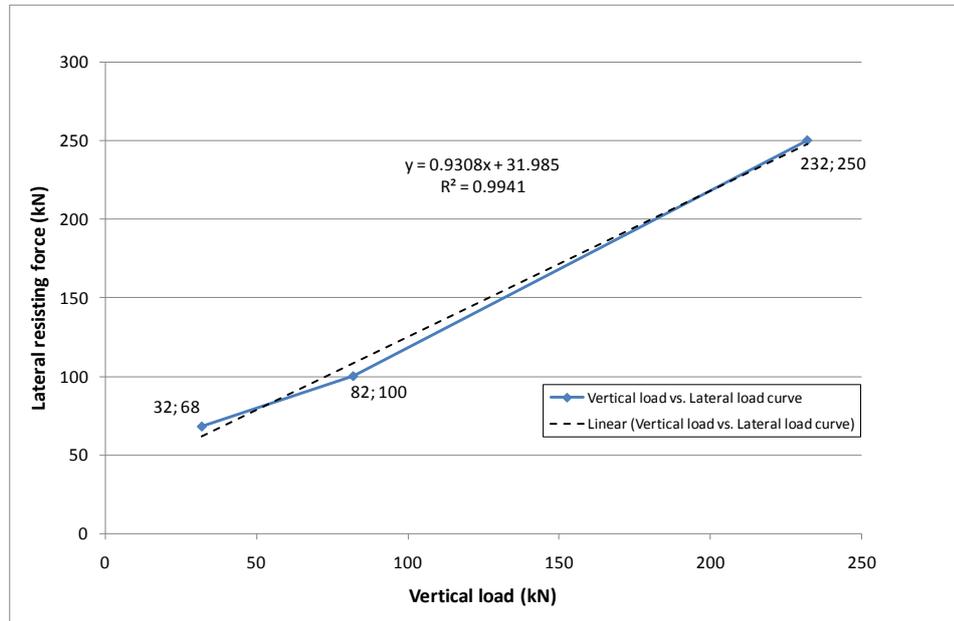
Figure 4.14 Capacity increase on the test house against vertical load application

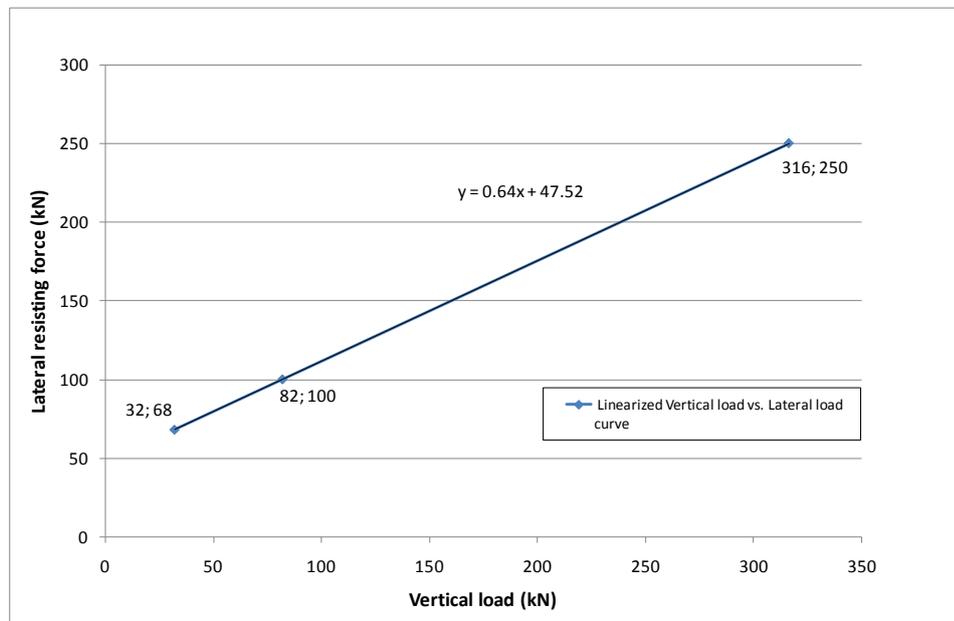
Figure 4.15 Linearized capacity increase against vertical load application

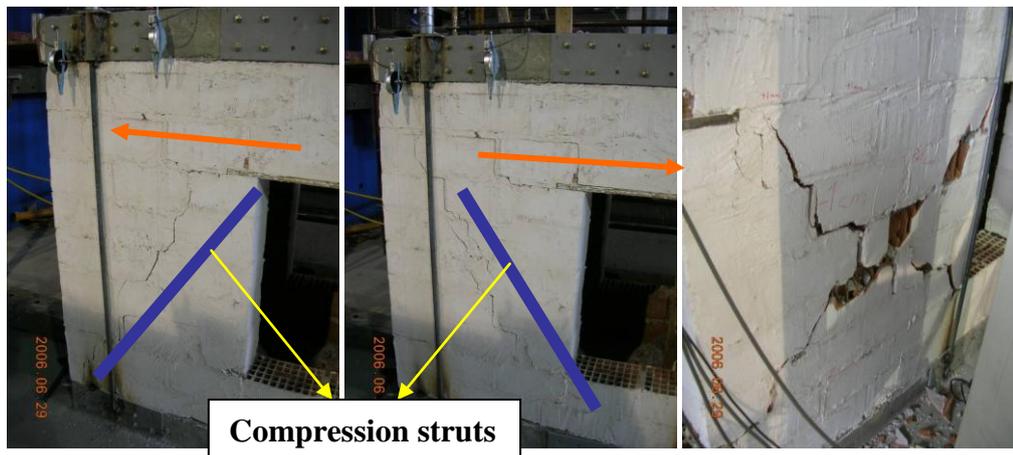
Figure 4.16 Diagonal shear cracks on vertically post-tensioned cracked house

Crushing of the mortar joints due to larger compressive stresses during the test, has resulted in losing the initial post-tensioning of the vertical rebars which led to opening of the already existing flexural cracks. During the third test, re-application of post-tensioning force on the vertical rebars prevented the wall piers from rotating and caused them to crack diagonally as shown in Figure 4.16. As a result of loosening of the rebars during the test, bolts were tightened two times during the testing which indicated the need for a mechanism to tighten relaxing rebars during loading. A spring-box system was developed for the next rounds of tests to prevent premature loss of post-tensioning force. Details about the spring box based post-tensioning is given in the following sections.

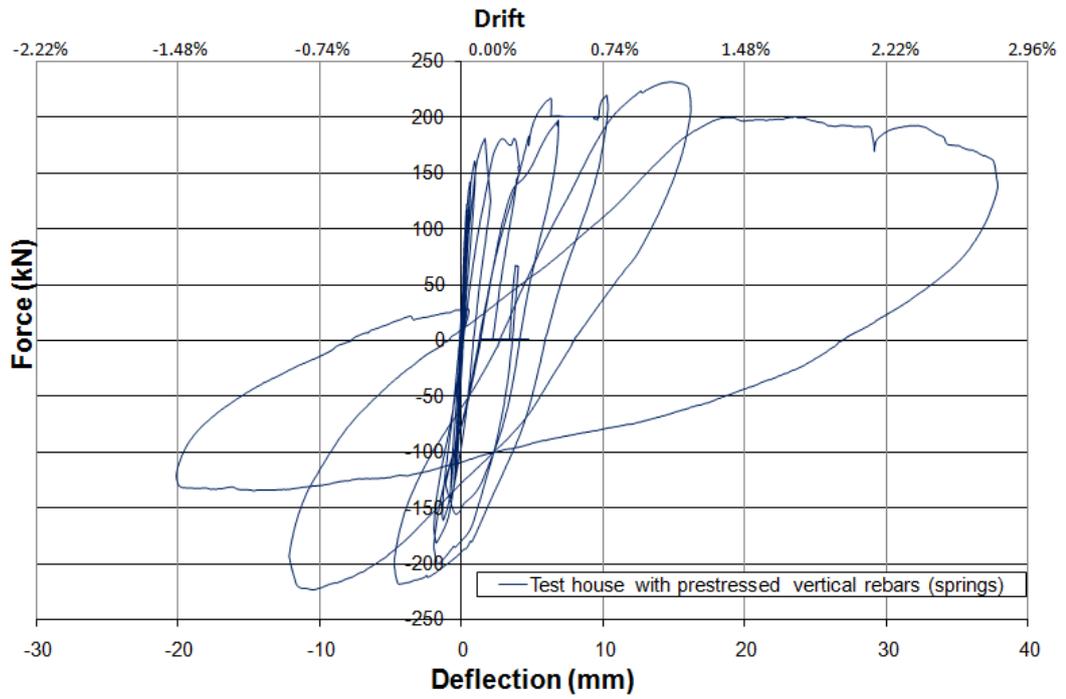
Figure 4.18 Force vs. Deflection graph of the fourth test

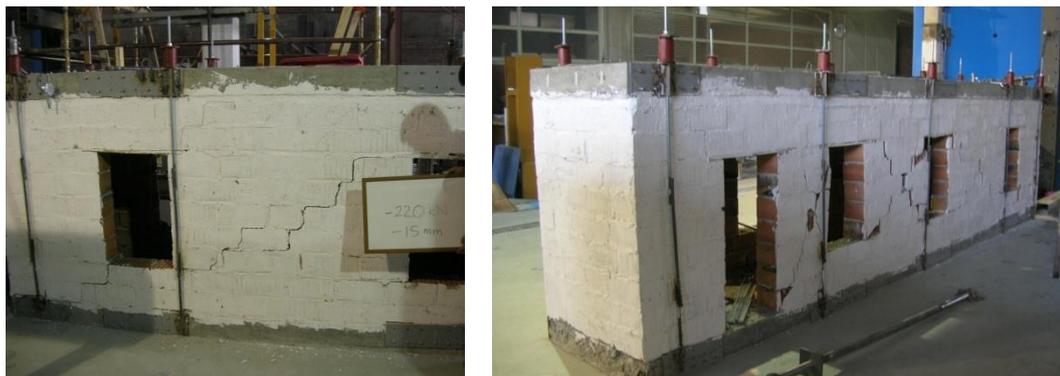
Figure 4.20 Cracks on the fourth test

cracks were observed at the walls numbered as 2, 3, 7 and 8 as in Figure 4.20. Remaining walls exhibited rocking failure due to higher aspect ratios.

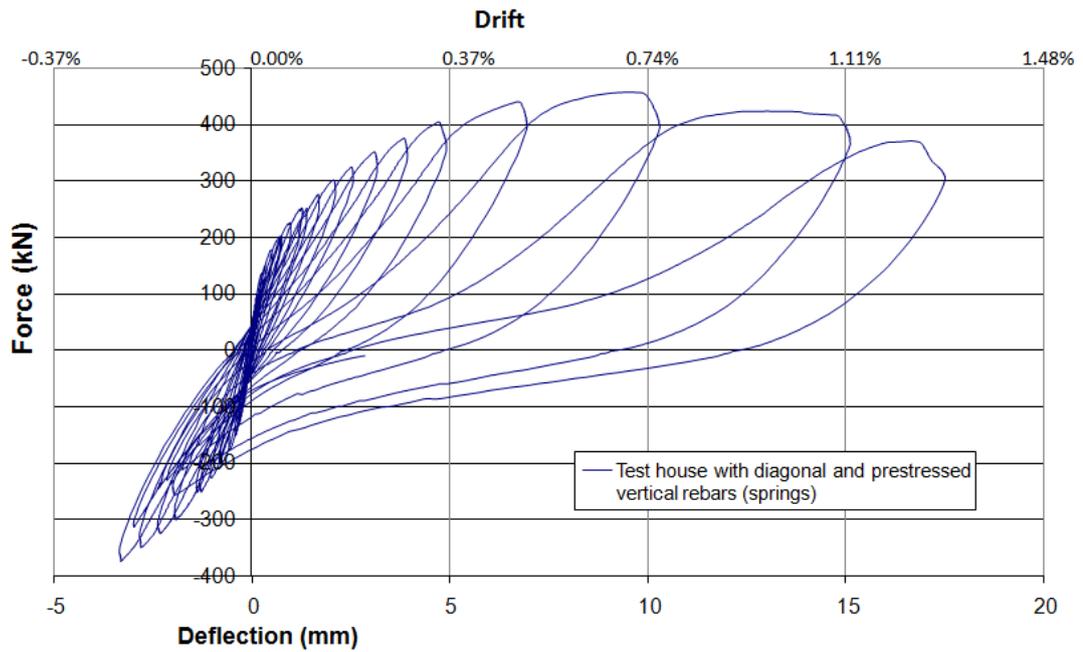
Figure 4.22 Force vs. Deflection graph of the fifth test

The test setup was prepared using a single hydraulic piston that would pull and push the slab level. The reinforcement placed inside the ceiling slab was welded to a horizontally placed loading beam which was connected to the hydraulic piston. The fifth test house, which had diagonal braces, could not be fully loaded in the pulling (tension) direction since the actuator – slab connection was separated due to excessive force. The house was loaded in pushing direction only beyond its ultimate capacity which has been recorded as 450 kN; a value that is about 6.6 times the original capacity (68 kN) (Figure 4.22). Diagonal braces were yielded while vertical braces remained in their elastic range.

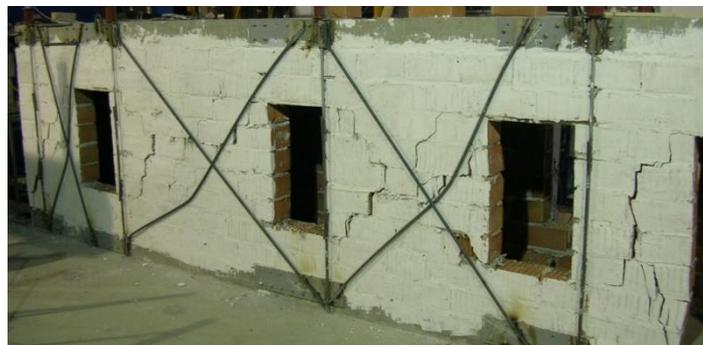
Figure 4.23 Cracks on the fifth test

During the test, additional vertical forces were developed on the ceiling slab due to the vertical component of the forces in the diagonally placed rebar. Combined effect of the vertical post-tensioning and vertical component of the diagonal member forces, the rocking mode was suppressed and the walls have failed in diagonal shear cracking (Figure 4.23). Buckling of diagonal rebars during alternating loading directions verified the yielding – elongation of the diagonal rebars.

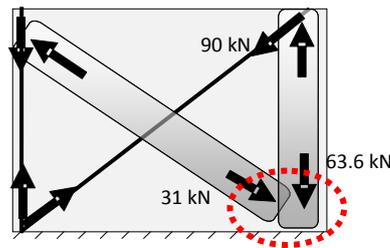
Figure 4.24 Force distribution on compression struts at the ultimate stage of the fifth house test

The ultimate capacity of the third test house was measured as about 450 kN. The diagonal bars were placed with about 45° angle and ½ ratio for B/H in the first bay. The yielding stress was accepted as 450 MPa and $\phi 16$ mm bars yielded at 90 kN axial force. The horizontal component of all rebars on both sides of the house turns out to be 335 kN leaving about 115 kN for the load carried by the diagonal compression struts developing inside the wall segments. The failure was predominantly due to corner crushing; therefore, the crushing capacity of the corner bricks were calculated as 63.6 kN coming from the diagonal bar (vertical compression strut) and 31 kN generated by the diagonal compression strut (Figure 4.24). The vector combination of load in the range of 90 kN acting on a corner brick would be used for the future design applications of strengthening.

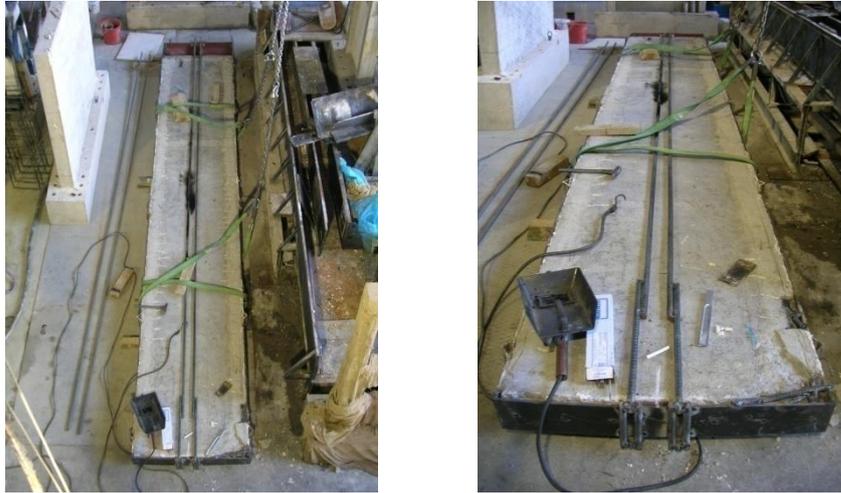
Figure 4.25 Strengthening of the slab

to welding two ends on the bolted plates have generated a post tensioning stress of about 190 MPa (~38 kN) considering losses due to support plate movement.

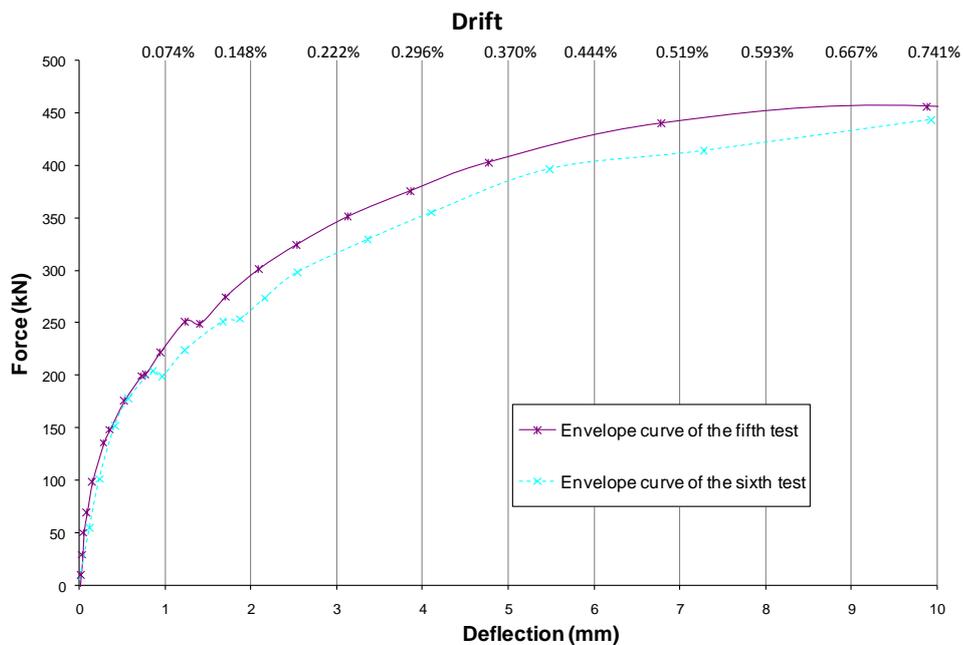
Figure 4.27 Pre-cracking regions of the fifth and sixth tests

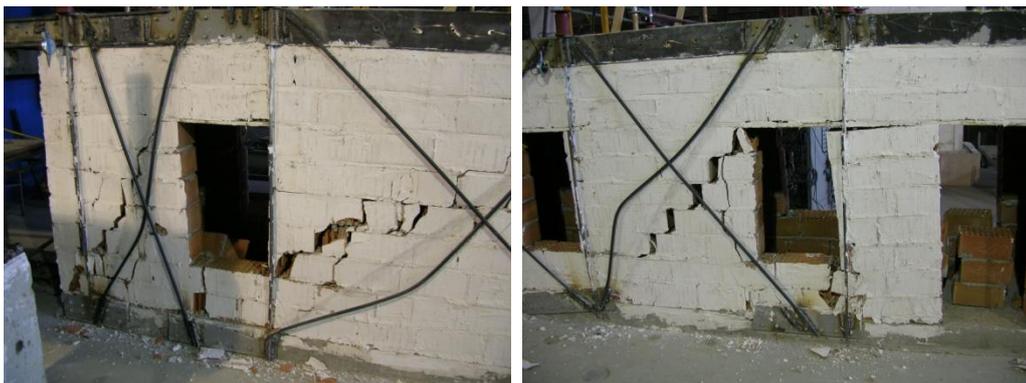
Figure 4.29 Cracks on the sixth test

The load – deflection graph of the sixth house test house was obtained in tension and compression directions as shown in Figure 4.28. As expected, the ultimate load carrying capacity of the sixth test did not change in pushing direction and obtained as about 450 kN. Comparison of the initial load – deflection envelope curve of the 5th and 6th tests should show that the 6th test would perform better in the pre-cracking region. However, since the bar got extremely hot when welded to the steel plate, the overall temperature on the bars might be compatible, which has resulted in similar behaviors in the 5th and 6th tests (Figure 4.27). The response of the structure at higher deformations was similar since the diagonally placed rebars have yielded and lost their pre-tensioning force (Figure 4.29).

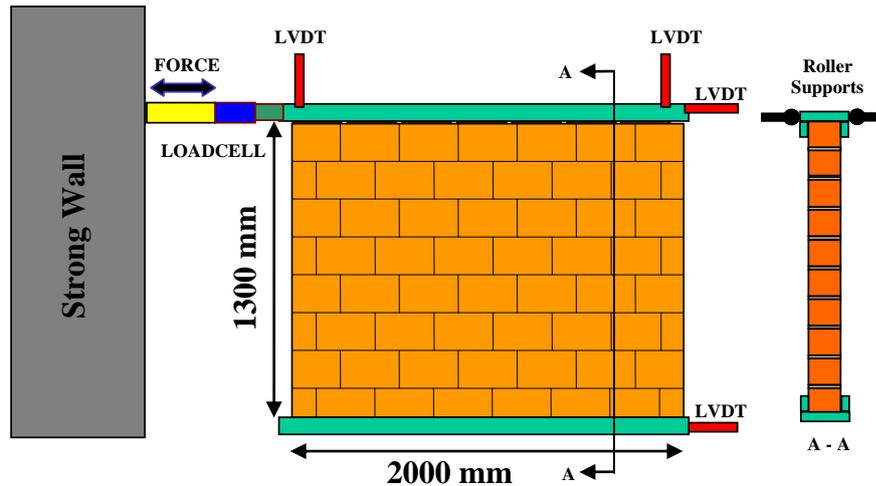
Figure 5.1 General test setup of the wall tests

The strengthening studies included application of vertical post-tensioning of the wall using vertical rebars and strength improvement provided with diagonal rebars. Spring boxes were also used for the enhancement of the post-ultimate behavior of the test walls. General behavior and ultimate strengths of the test walls were predicted using the equations derived in Chapter 2 (Eqns. (2.23) and (2.25)) and they were compared with the ones expressed in literature by Tomazevic[4] and Magenes&Calvi[3].

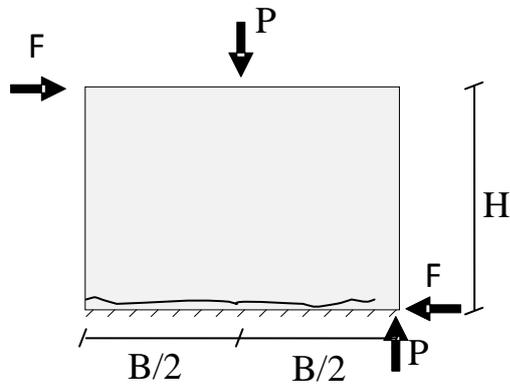
Figure 5.2 Force distribution on the cracked wall

$$F = P \times \frac{B}{2H} \quad (5.1)$$
