IN-PLANE SEISMIC STRENGTHENING OF BRICK MASONRY WALLS
USING RE-BARS

A THESIS SUBMITTED TO
THE GRADUATE SCHOOL OF NATURAL AND APPLIED SCIENCES
OF
MIDDLE EAST TECHNICAL UNIVERSITY

OCTOBER 2008

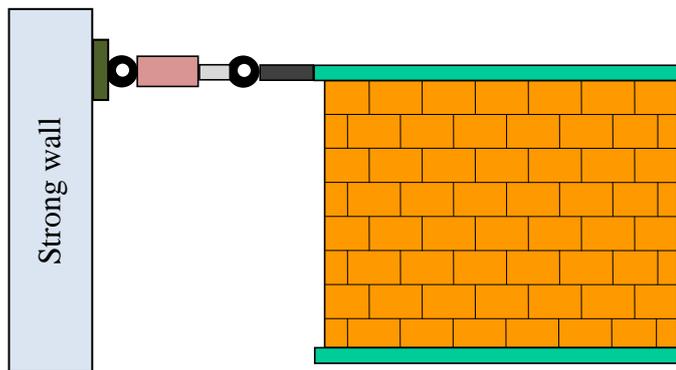
Figure 5.3 Schematic setup of the first test

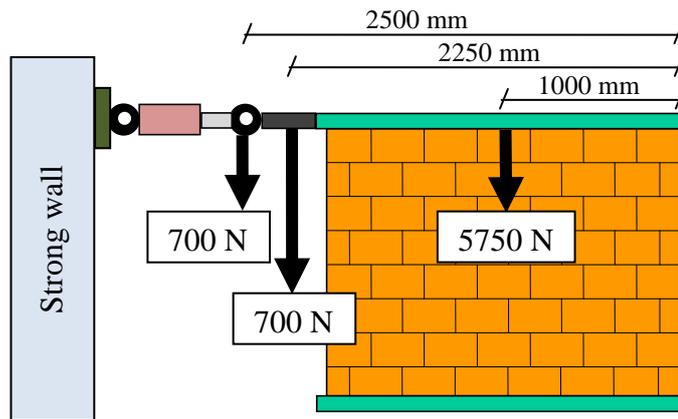
Figure 5.4 Vertical loads on the first test wall

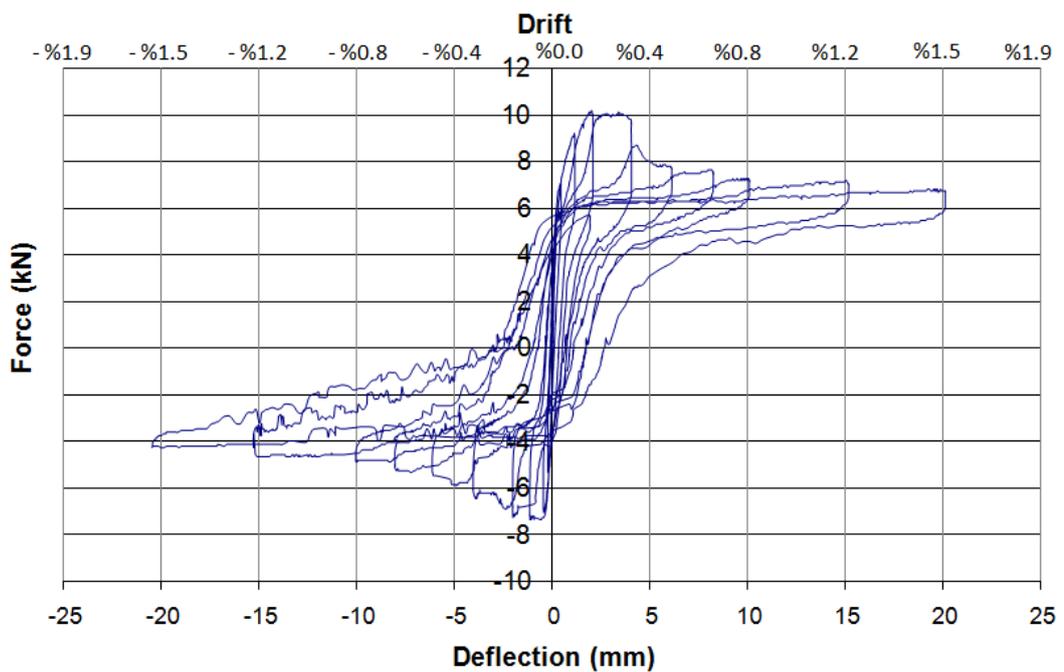
Figure 5.5 Force-Deflection graph of the first test

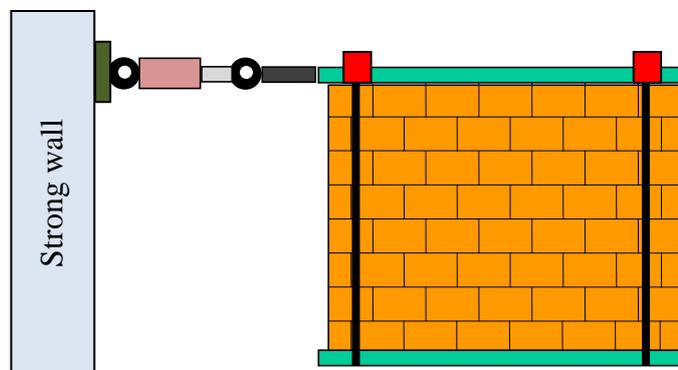
Figure 5.6 Schematic setup of the second test

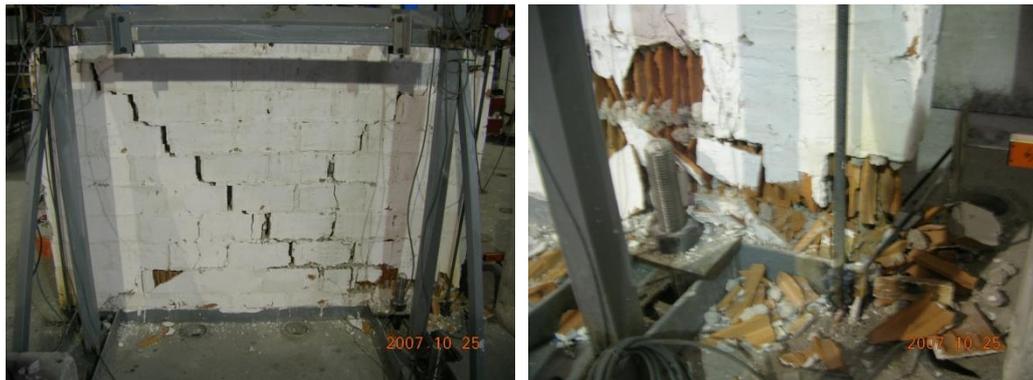
Figure 5.7 Deformed wall in the second test

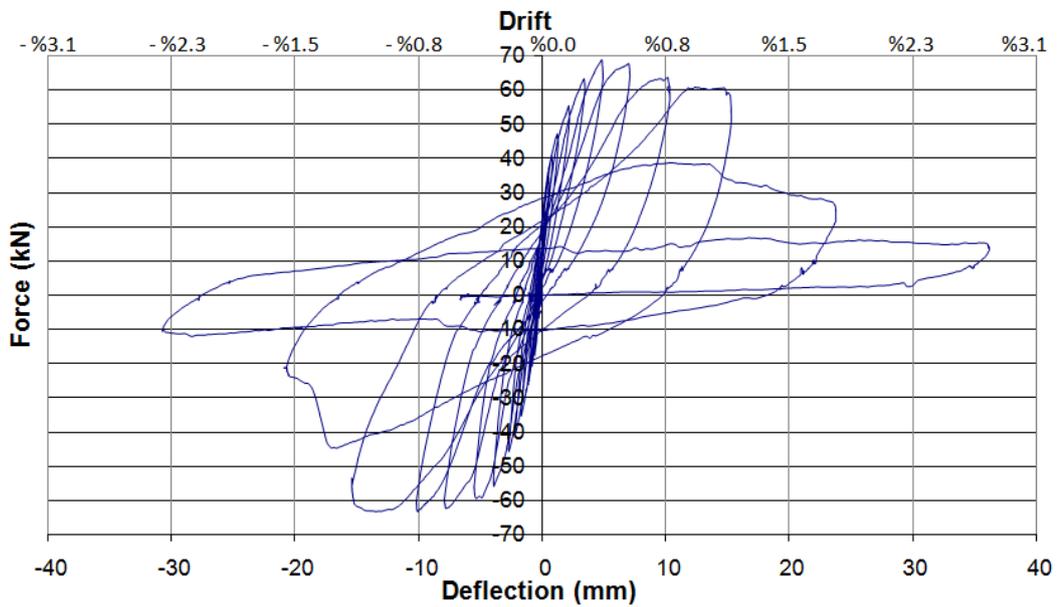
Figure 5.8 Force-Deflection graph of the second test

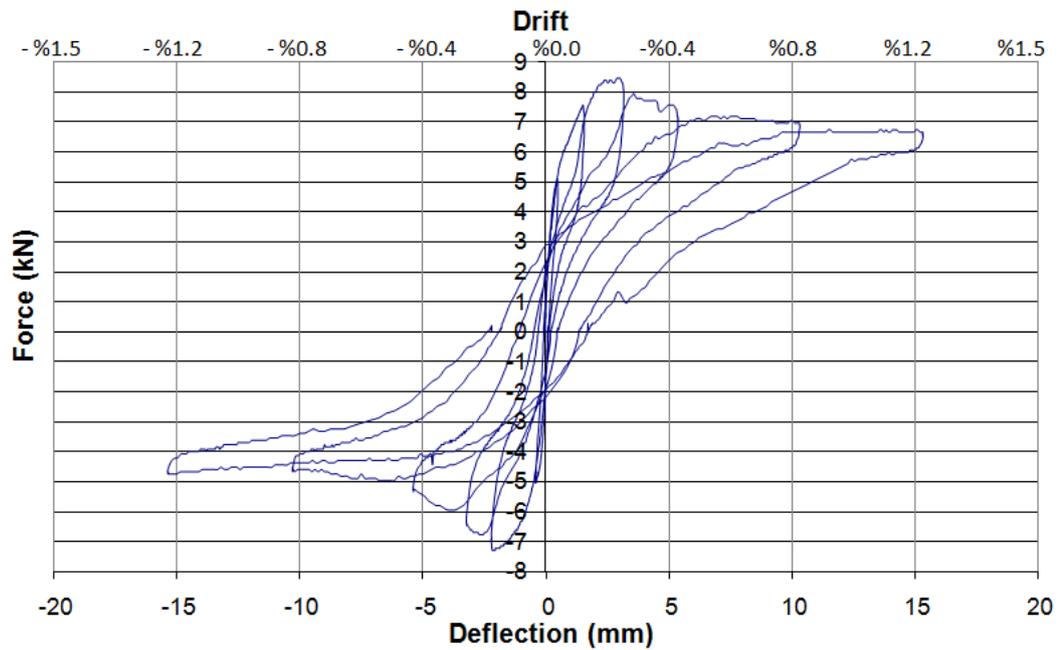
Figure 5.9 Force-Deflection graph of the third test

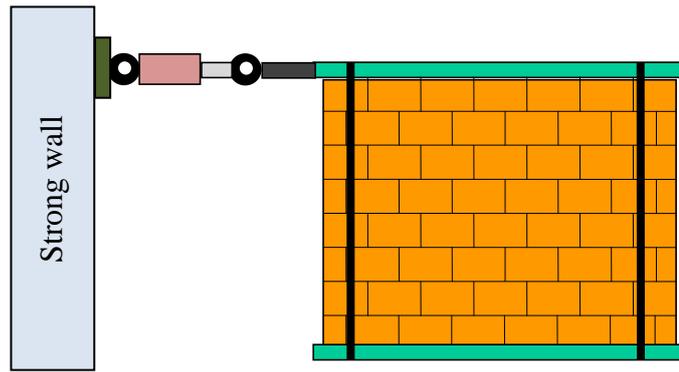
Figure 5.10 Schematic setup of the fourth test

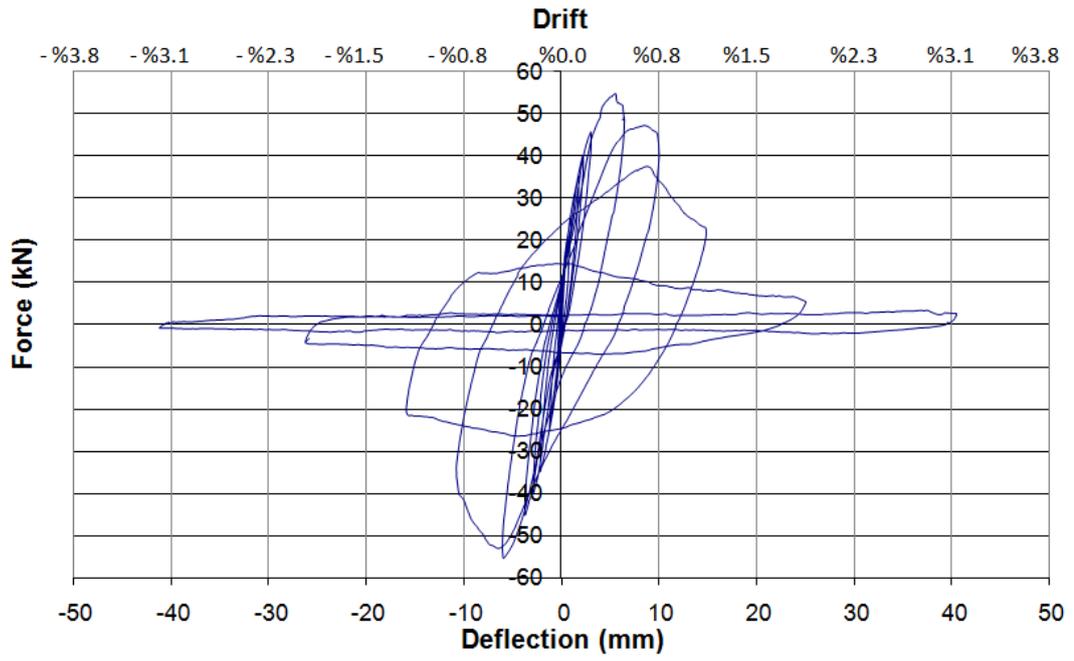
Figure 5.11 Force-Deflection graph of the fourth test

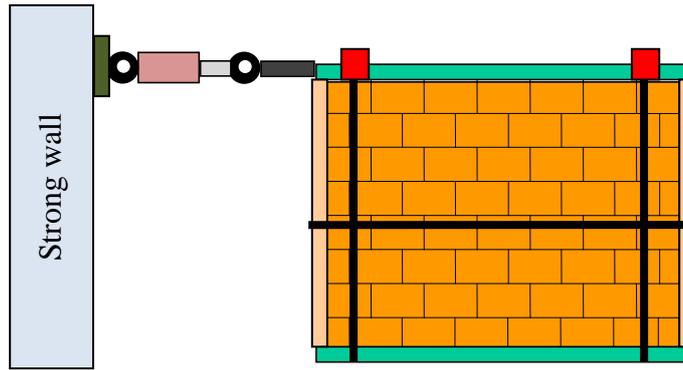
Figure 5.14 Schematic setup of the fifth test

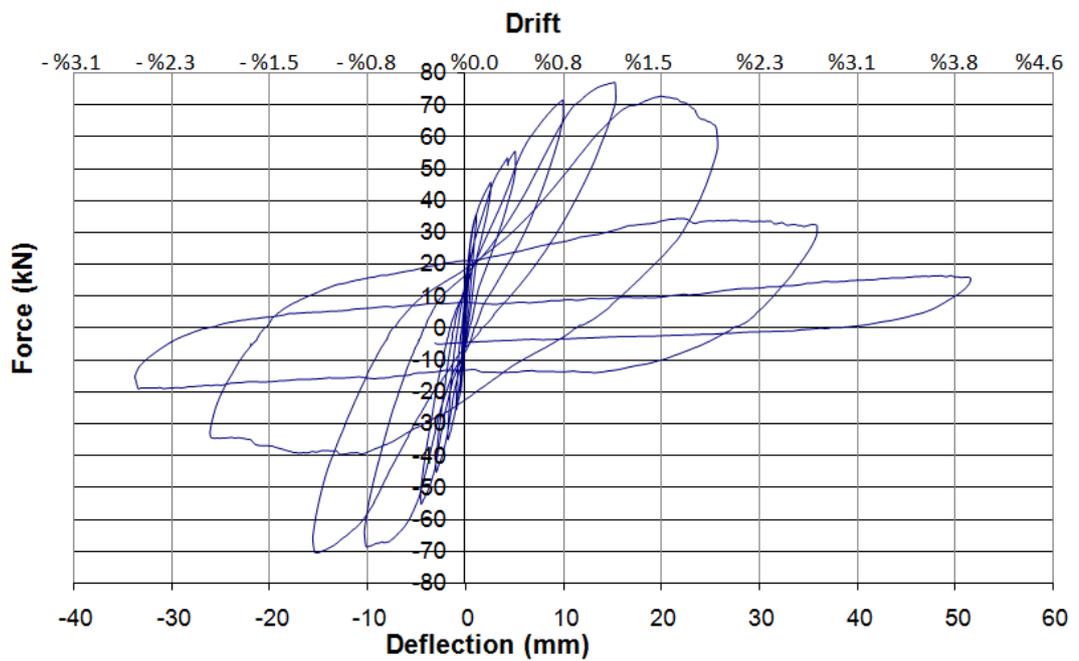
Figure 5.16 Force-Deflection graph of the fifth test

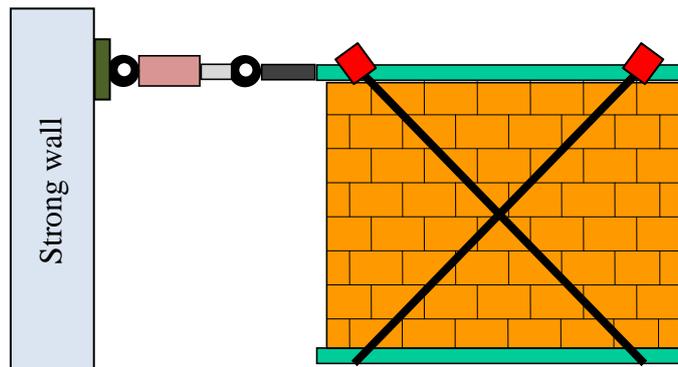
Figure 5.17 Schematic setup of the sixth test

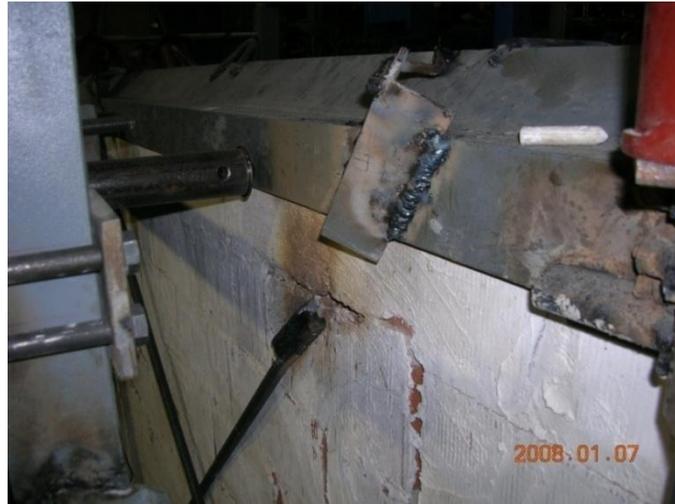
Figure 5.18 Failure at the diagonal rebar during the sixth test

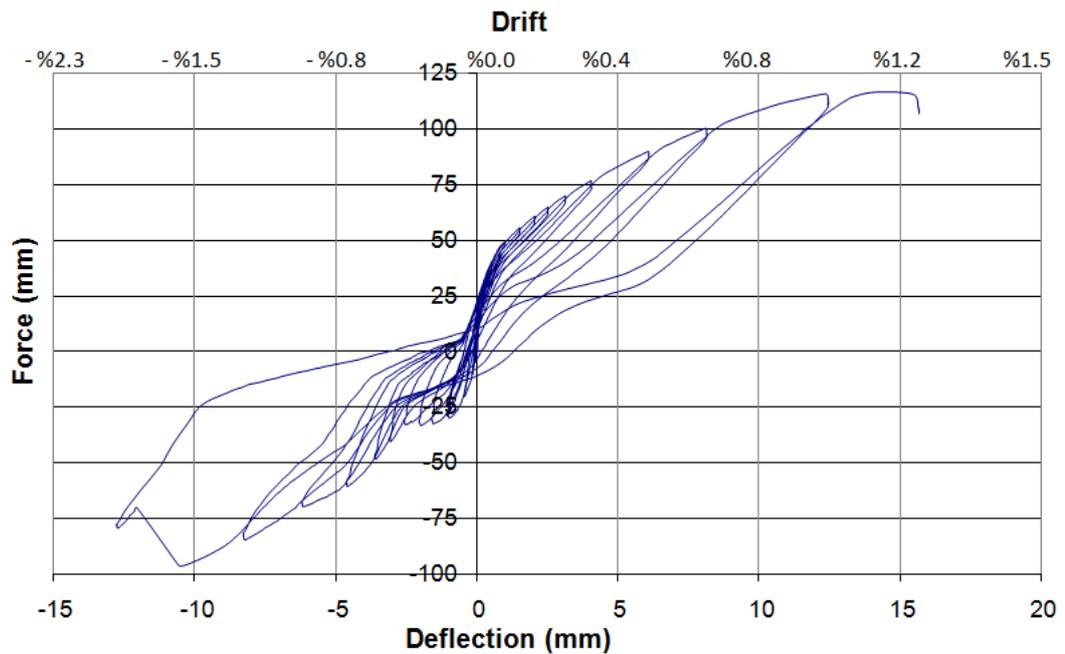
Figure 5.19 Force-Deflection graph of the sixth test

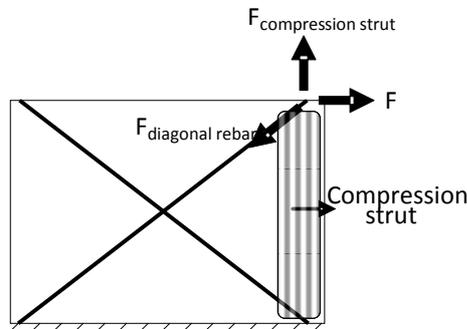
Figure 5.20 Bracing forces at the seventh test

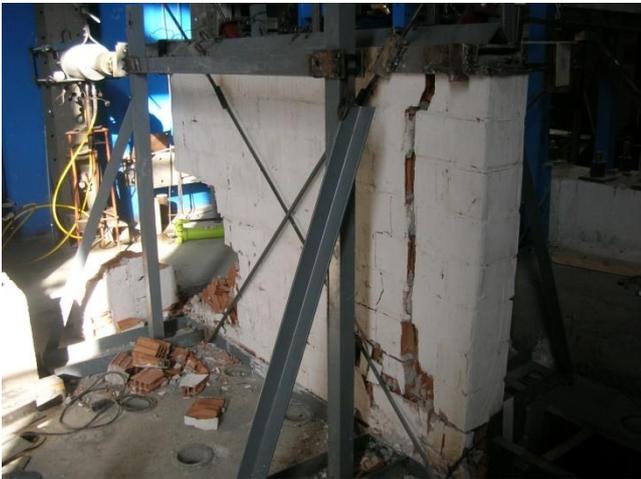
Figure 5.21 Deformed wall in the seventh test

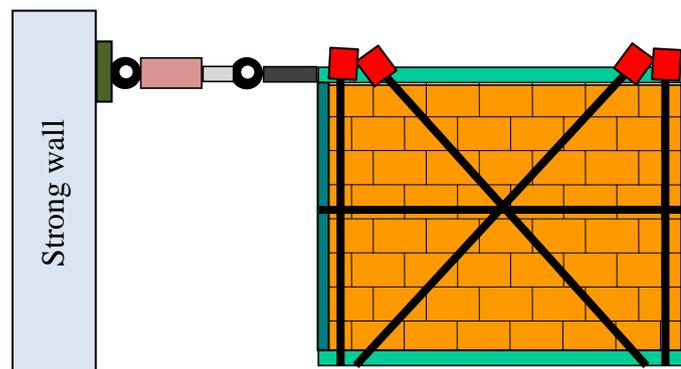
Figure 5.23 Schematic setup of the eighth test

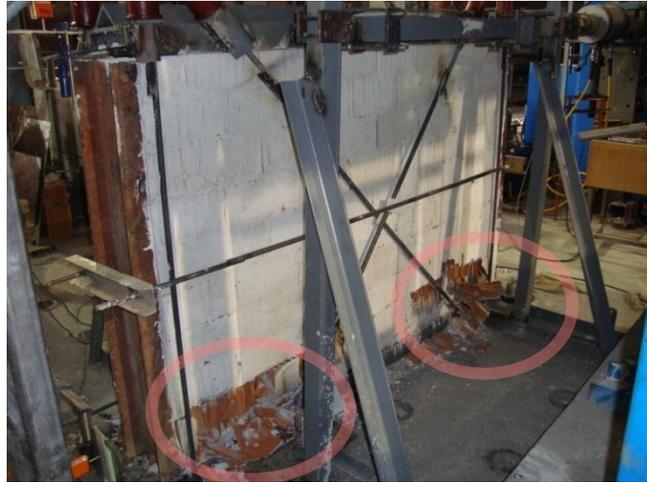
Figure 5.24 Deformed wall in the eighth test

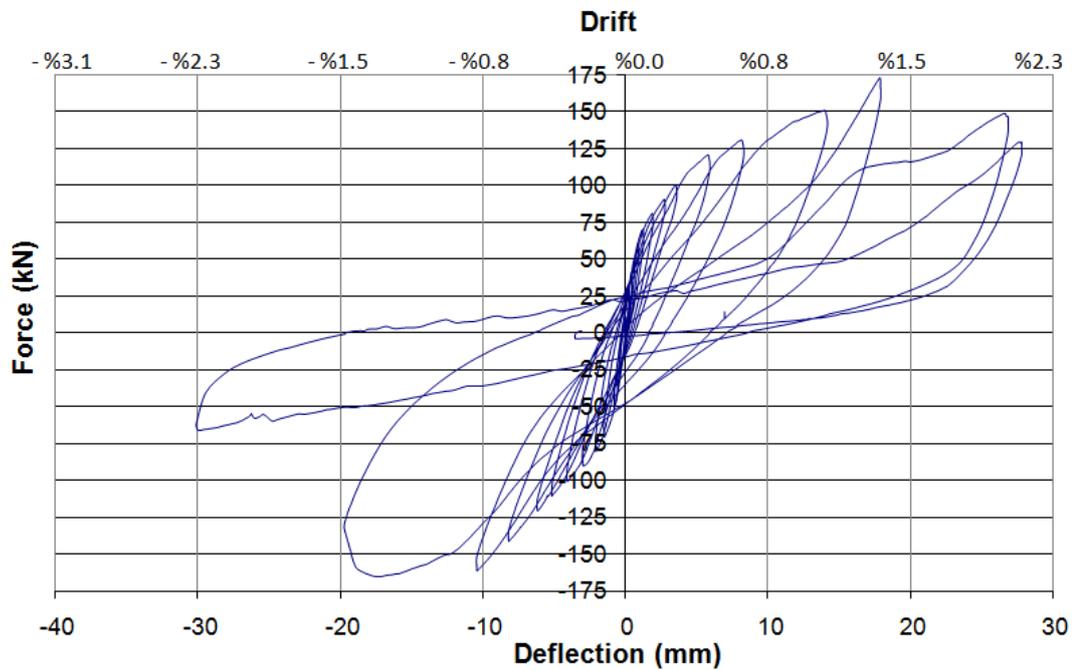
Figure 5.25 Force-Deflection graph of the eighth test

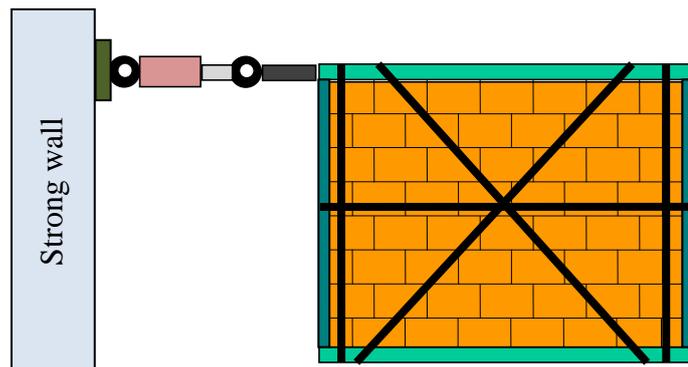
Figure 5.27 Schematic setup of the ninth test

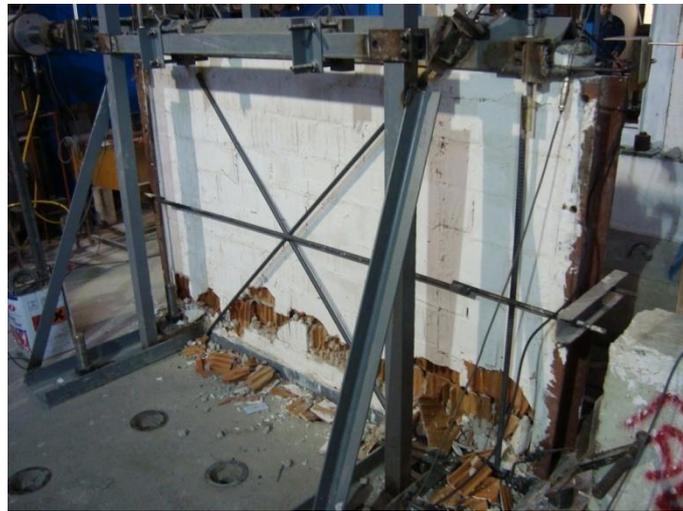
Figure 5.28 Deformed wall in the ninth test

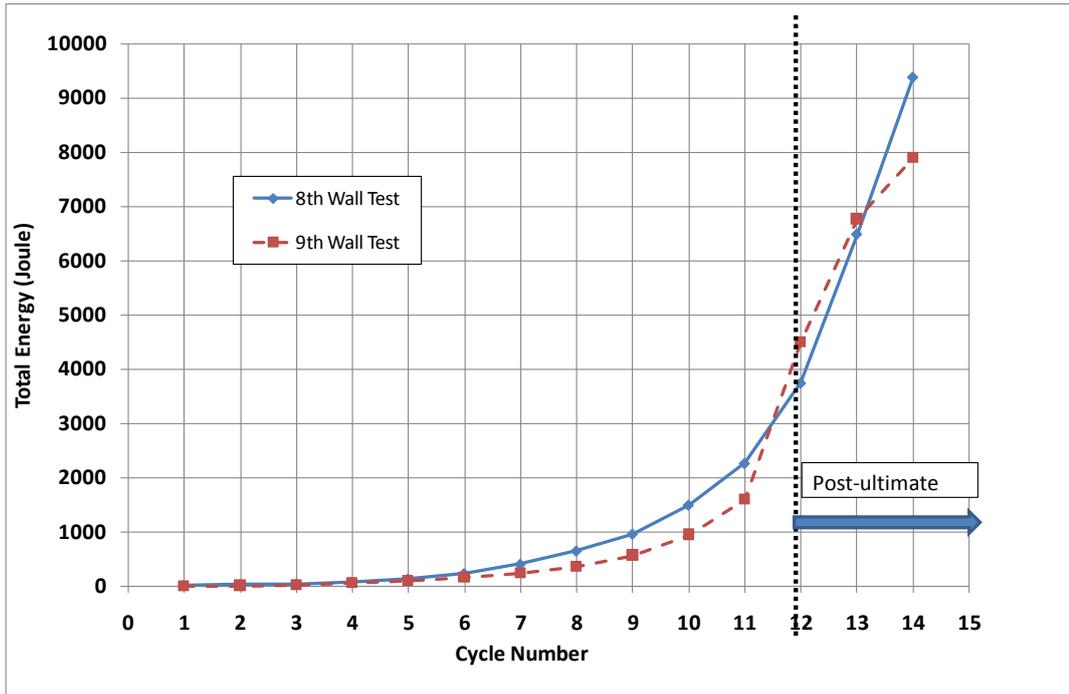
Figure 5.31 Comparison of energy dissipation characteristic of the 8th and 9th tests

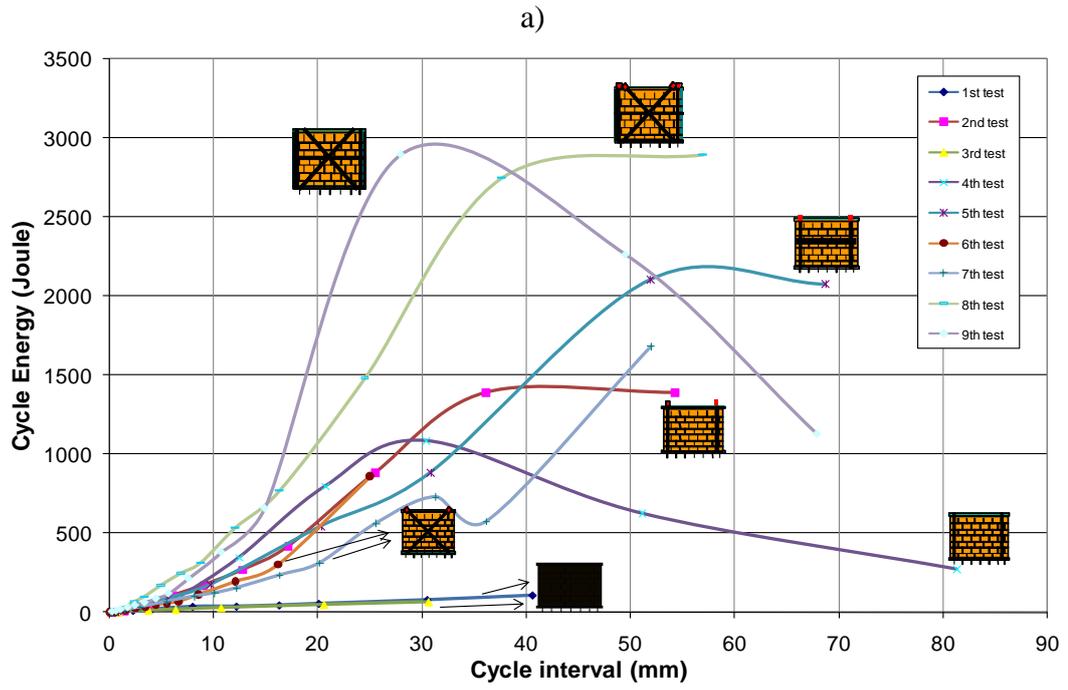
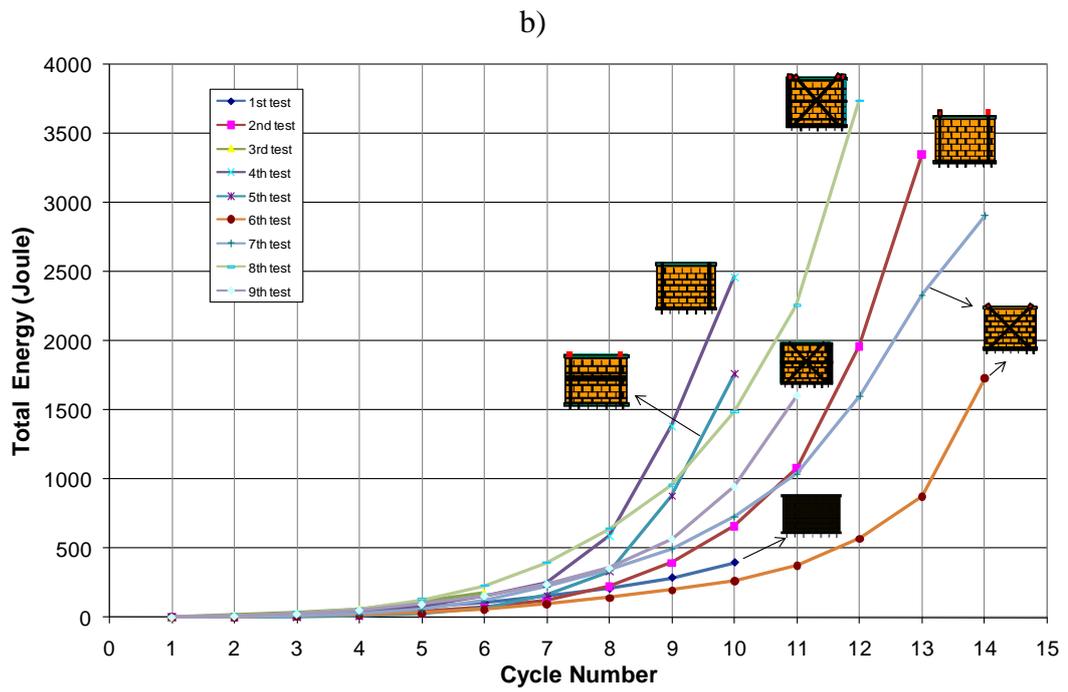
Figure 6.4 Energy Dissipation versus Total Deformation Curves of rebar post-tensioned brick masonry wall tests

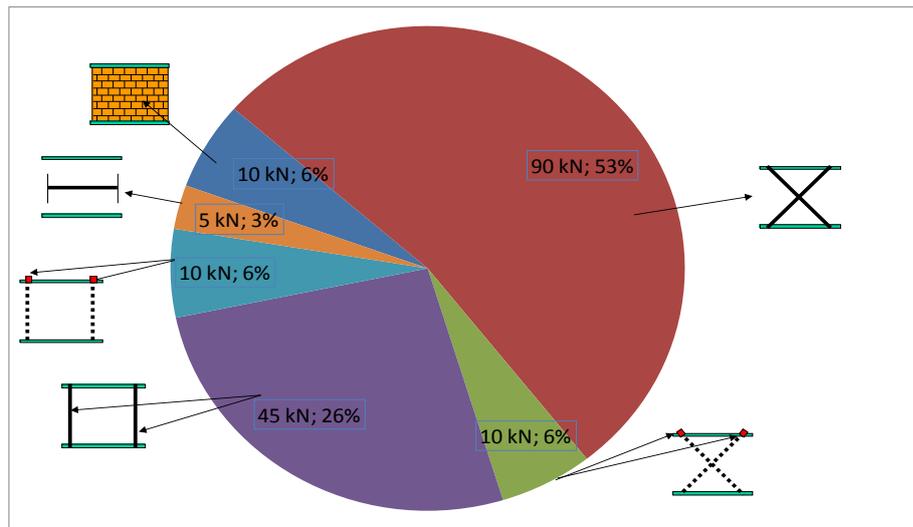
Figure 6.6 Capacity increment participation of test components

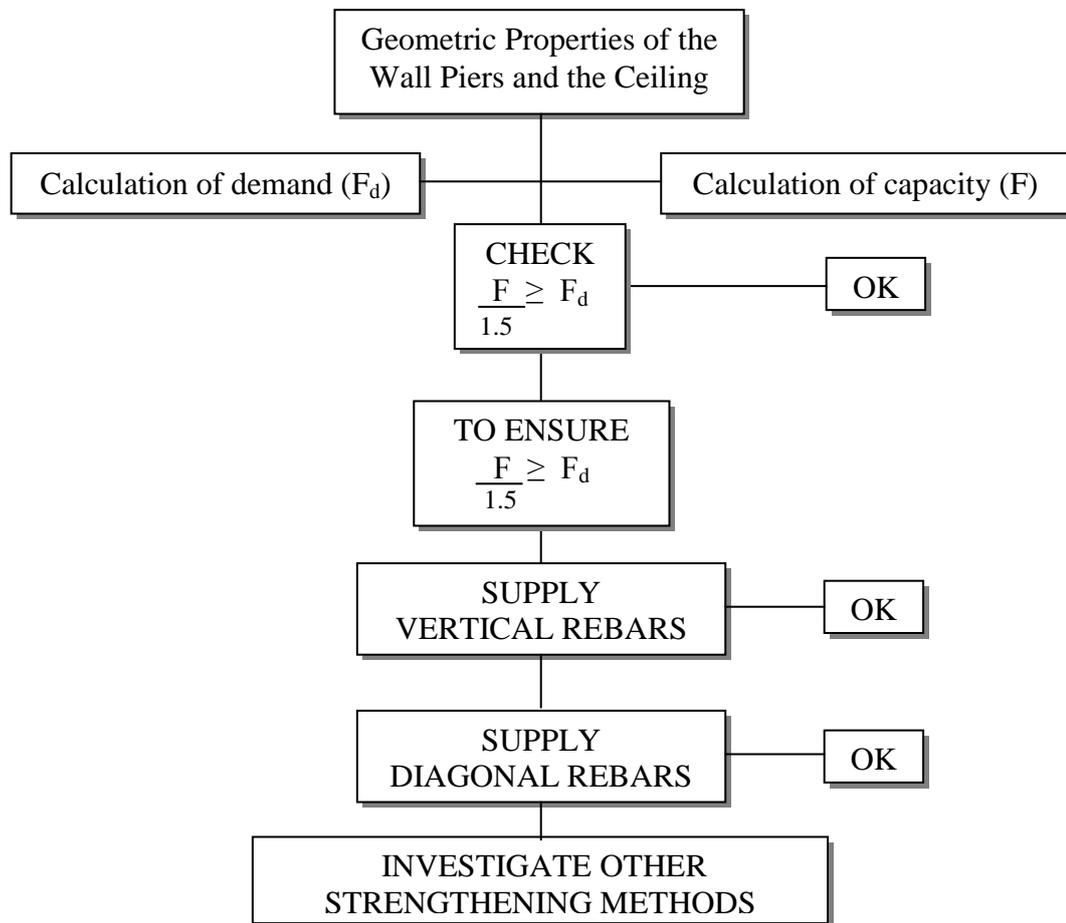
Figure 6.7 Strengthening procedure for single storey brick masonry houses

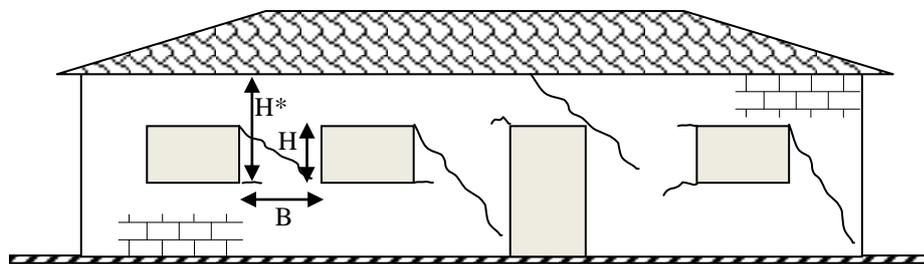
Figure 6.8 Possible crack patterns on a generic URM house
