**DETERMINATION OF THE ROCK MASS CHARACTERISTICS AND  
SUPPORT SYSTEMS OF THE NEW ULUS TUNNEL, ANKARA**

**IN PARTIAL FULFILLMENT OF THE REQUIREMENTS  
FOR  
THE DEGREE OF MASTER OF SCIENCE  
IN  
GEOLOGICAL ENGINEERING**

**DECEMBER 2008**

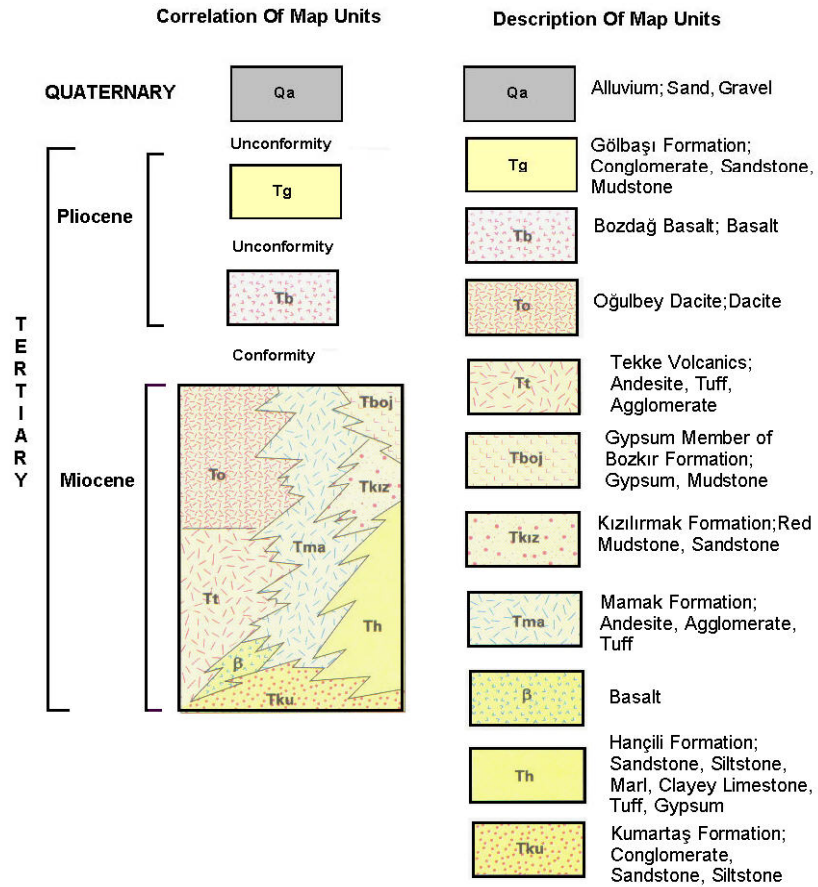
Figure 2.1 Geological map of the close vicinity of the study area (MTA, 1/100000 Scale Geological Map, Ankara Sheet)

According to the report of MTA (1997), the geological feature exposed at the site is named as Mamak formation (Tma). The formation involves andesite, agglomerate and tuff. Agglomerates are white, gray and partly red colored and consist of andesite, dasite and basalt blocks which are embedded within a tuffaceous matrix. Some distinct beddings are observed within agglomerates. The tuffs intercalated with agglomerates are in various colors and thin bedded. Yellowish-white volcanic breccias include various sized angular andesite pebbles. A slight bedding generated by conglomerate-tuff intercalation is observed. Although there are white and highly weathered parts exposed in the vicinity, andesites are generally gray-pink colored. In addition to the joints, flow structures on the andesites are seen in the close vicinity. Mamak formation shows transition to Kumartaş Formation and positiones laterally to Tekke volcanics and Hançili Formation. The formation is overlain by Bozdağ Basalts. It is accepted as Late Miocene aged as the units it positiones laterally. (Akyürek et al., 1997)

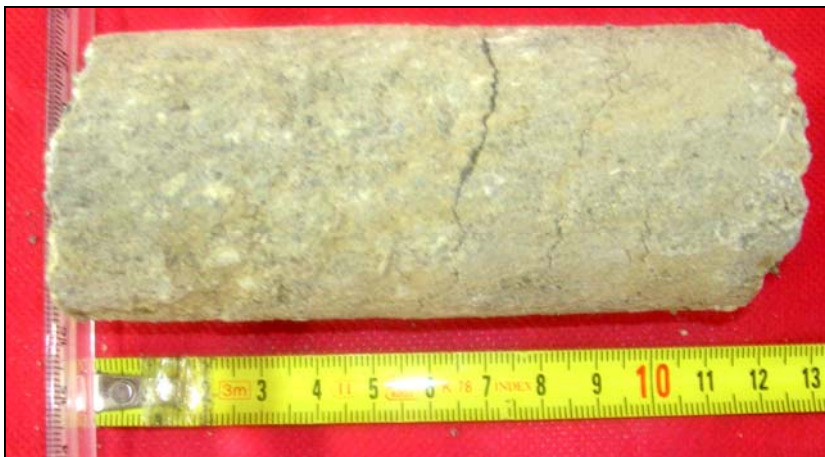
Figure 2.4 The photograph of the core sample taken from BH-1.

Since this borehole is located near the entrance portal, the borehole data were used to identify the entrance portal's geological structure. The sample benefitted in this petrographical analysis is a piece of the core taken from the depth between 42.00 and 43.00 metres.

Despite the fact that BH-1 does not coincide the tunnel route, the depth from which the core was taken represents the the tunnel elevation. The photograph of the core specimen used for the analyses is given in Figure 2.4. Additionally, the results of petrographical analysis of the speciemen are tabulated in Table 2.1.

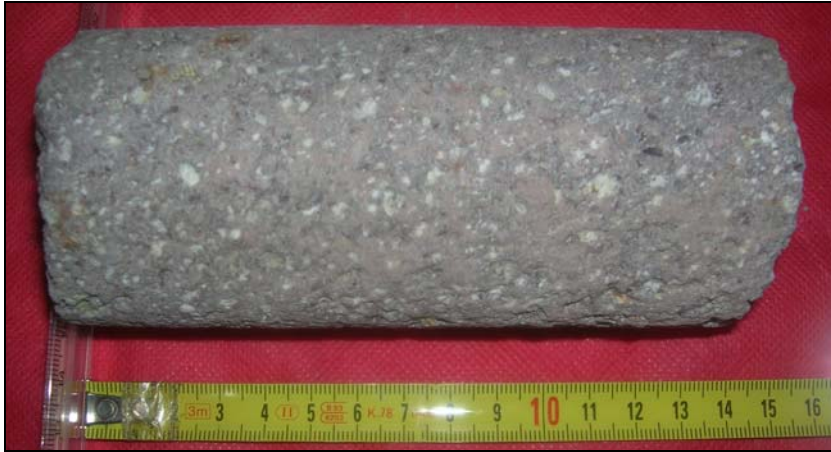
Figure 2.8 The photograph of the core sample taken from BH-2.

The second borehole was located on the left tube near the entrance portal. The core sample shown in Figure 2.8 was obtained from the tunnel elevation; between 36.60-36.76 m.

As seen in the figure, the pink colored specimen has aphanitic porphyry texture. The core has a length of 16 cm. The vesicles are clearly seen on the surface of the specimen. The petrographical analysis results of the specimen are given in Table 2.2. Moreover, the photomicrographs of the baked biotite crystal (Figure 2.9), the plagioclase and biotite crystals (Figure 2.10) and baked hornblende phenocryst (Figure 2.11) are illustrated below.

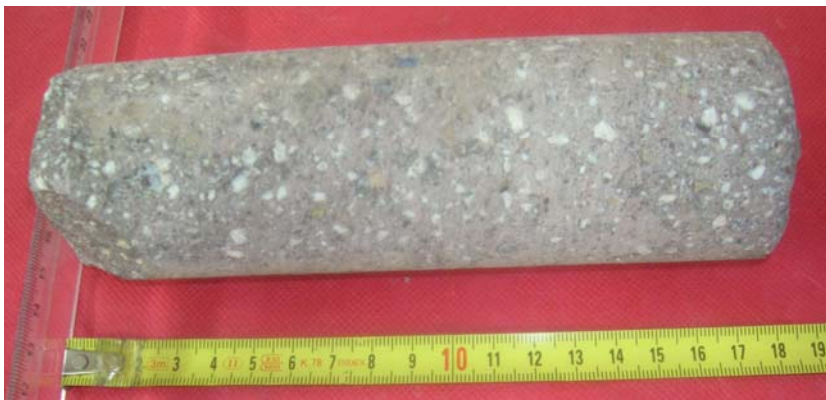
The specimen was taken from the depth between 36.00 and 36.18 m at BH-3. As seen from Figure 2.12, the 19 cm long core sample has surface staining. The petrographical analysis results of the specimen are given in Table 2.3.

Figure 2.12 The photograph of the core sample taken from BH-3.

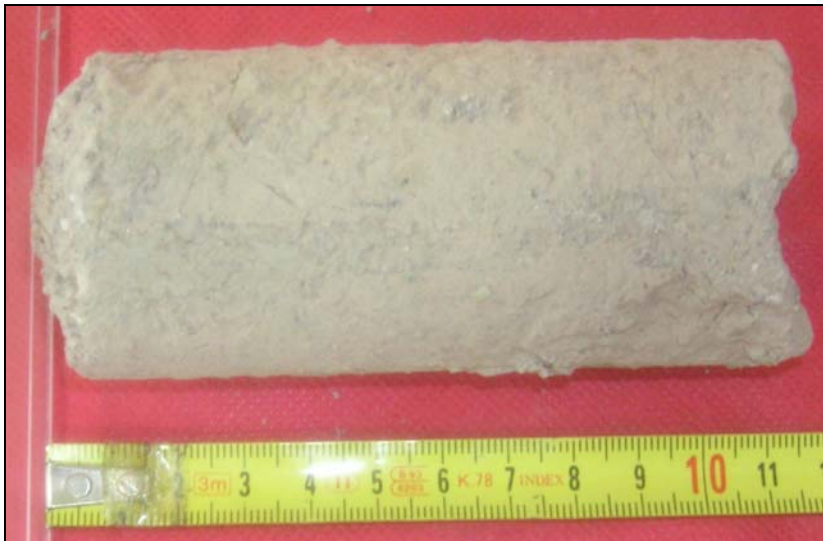
The specimen was obtained from the tunnel elevation, at the depths of 17,50-17,65 m within BH-4 (Figure 2.15). In table 2.4, the results of petrographical analysis are given.

Figure 2.15 Photograph of altered core sample taken from BH-4.

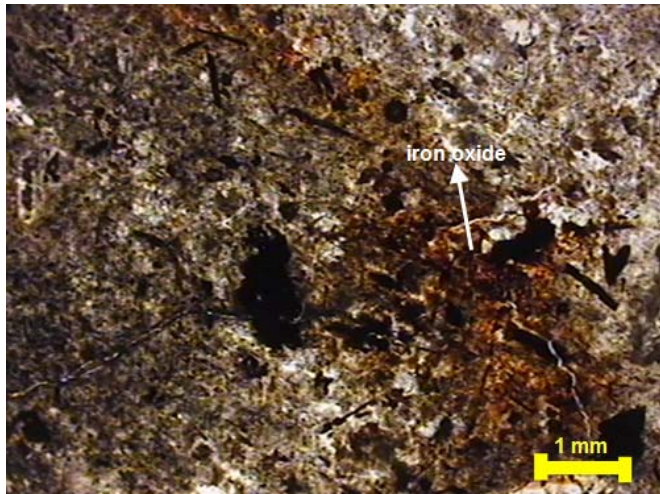
Figure 2.17 Thin section of the core specimen taken from BH-4.

Furthermore, the photomicrographs of the quartz phenocryst (Figure 2.16) and thin section of core specimen taken from BH-4 (Figure 2.17) are illustrated below. In Figure 2.17, apart from the alteration, the reddish-brown ironoxide is clearly seen under analyser out position.

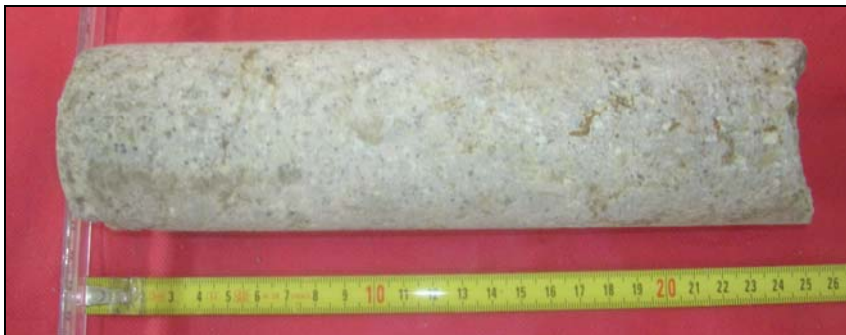
Figure 2.18 The photograph of the core sample taken from BH-7.

The specimen was obtained from the tunnel elevation, at the depths of 78,00-79,00 m within BH-7 (Figure 2.18). The results of petrographical analysis of the specimen are tabulated in Table 2.5. Additionally, the flow texture (Figure 2.19), baked biotite (Figure 2.20) crystals and plagioclase phenocrysts with pseudomorph quartz crystal are illustrated.

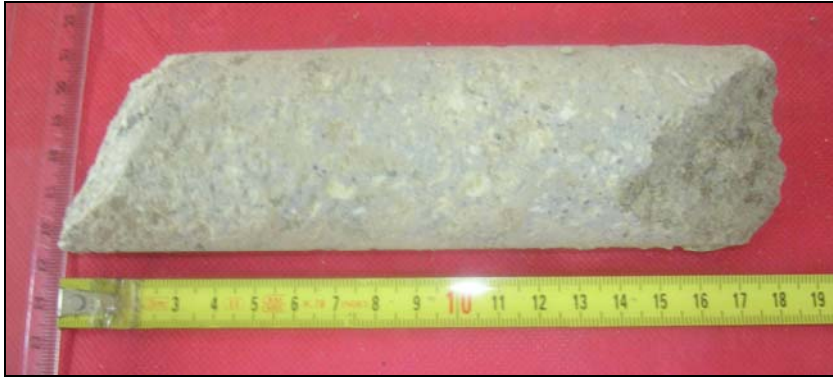
Figure 2.22 The photograph of the core sample taken from BH-8.

The specimen was obtained from the tunnel elevation, at the depths of 34.60-34.80 m of BH- 8 (Figure 2.22).

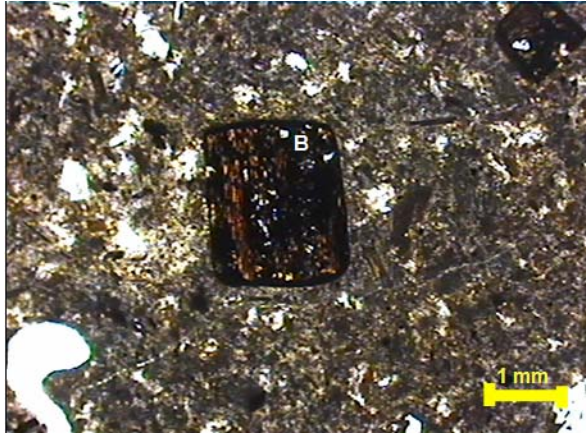
Figure 2.23 The thin section view of the baked biotite (B) crystal is seen in altered matrix under analyser in position.

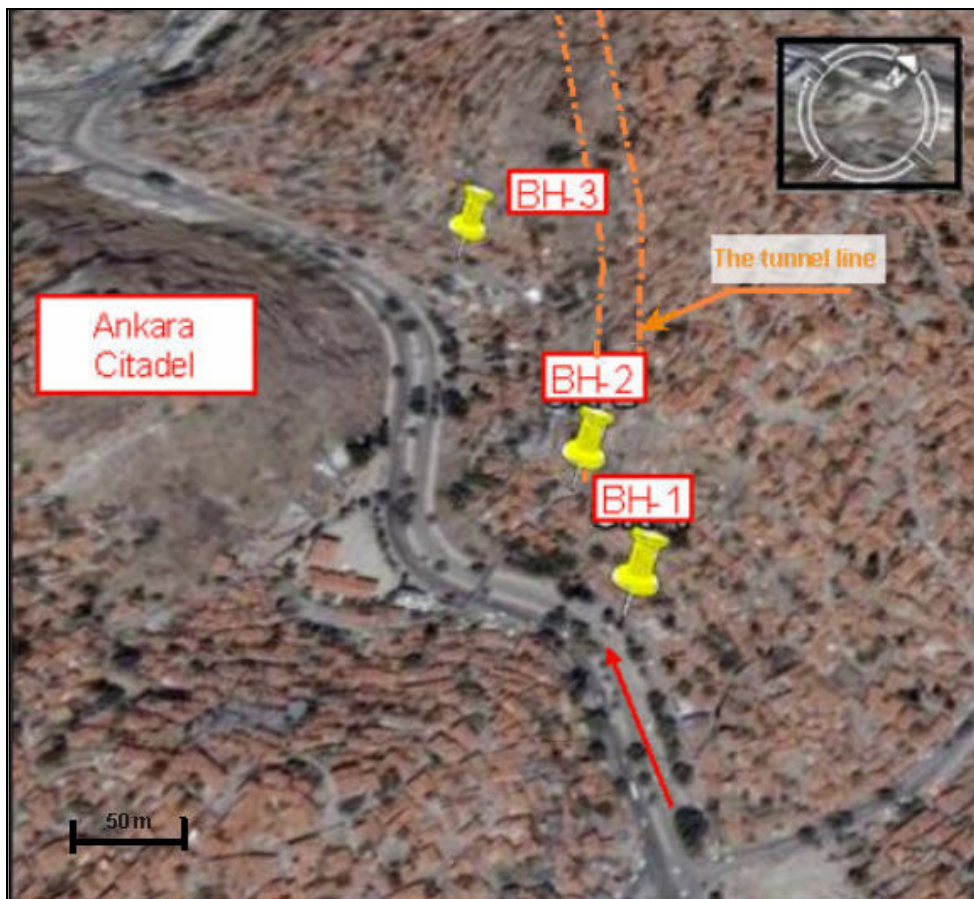
Figure 2.24 GoogleEarth screen (2008) showing the locations of BH-1, BH-2 and BH-3.

Starting from the entrance portal's close vicinities the observations were achieved on the upper parts of the hill. The GoogleEarth view of the locations of BH-1, BH-2 and BH-3 is given in Figure 2.24.

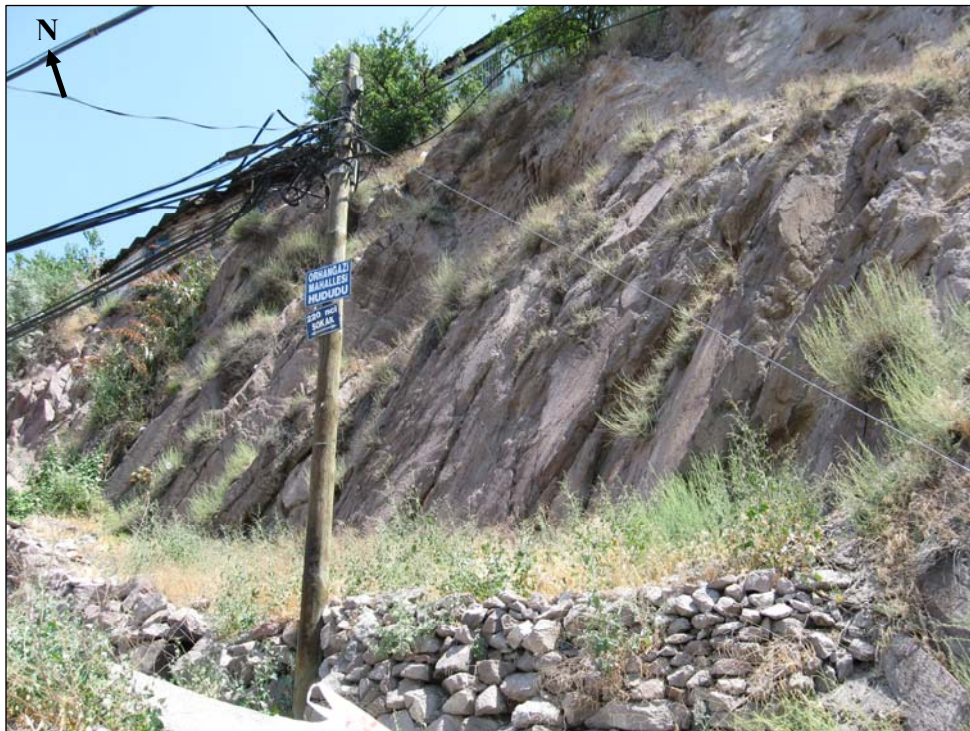
Figure 2.25 The flow structures of andesites located on the upper parts of the hill near B-1 and BH-2.

The flow structure of andesites observed on the upper parts of the hill near B-1 and BH-2 is presented in Figure 2.25. The discontinuity conditons are given in the scan-line survey forms in Appendix A. In general, the discontinuity surfaces are rough and the apertures are mostly filled with clay. Additionally, the surfaces are moderately weathered. In Figure 2.26, another vision of the andesites at the upper parts of the hill, near BH-1 and BH-2 is given.

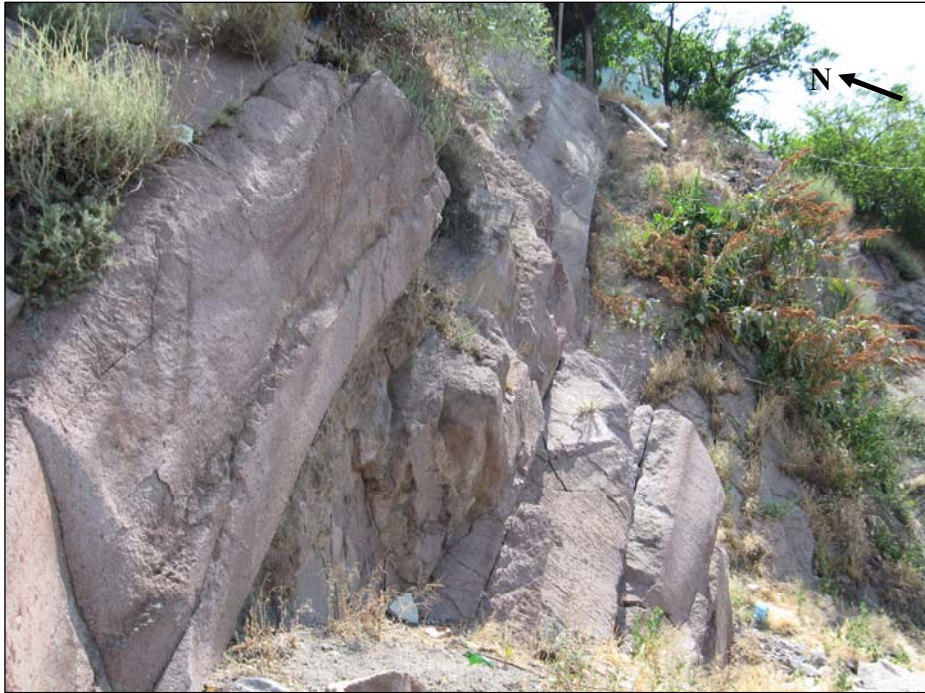
Figure 2.26 The appearance of the andesites exposed at the upper parts of the hill, near BH-1 and BH-2

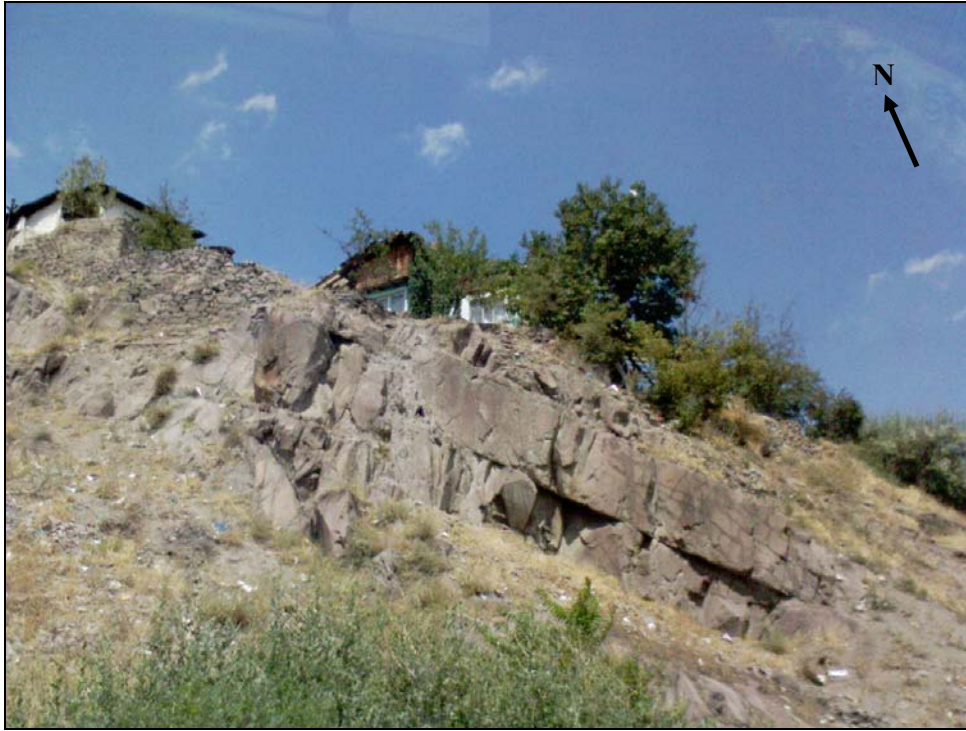
Figure 2.27 A view of the andesites exposed near BH-3

The pink andesites exposed near BH-3 are jointed and the discontinuity surfaces are moderately weathered. The spacings between the discontinuity surfaces range between 20-80 cm. A general view of the andesites studied at the site is presented in Figure 2.27. The properties of the discontinuities are defined in the scan-line survey chart given in the Appendix A.

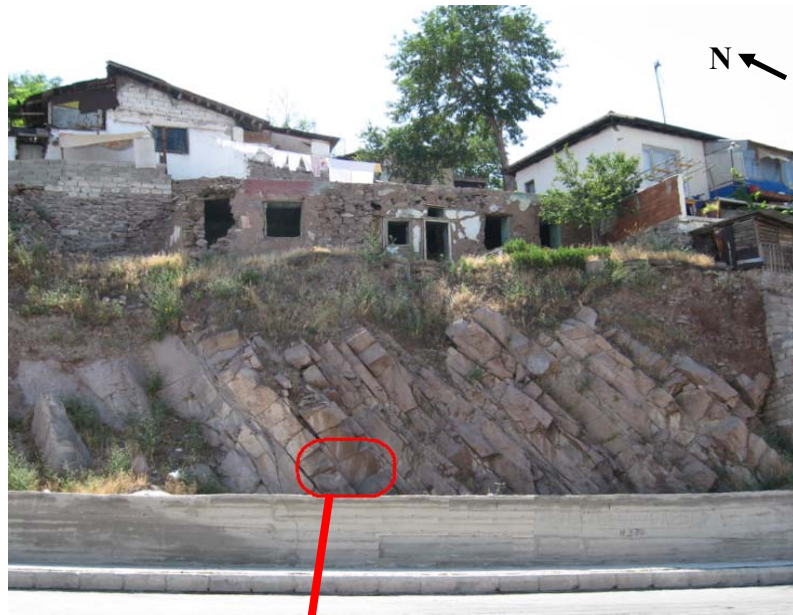
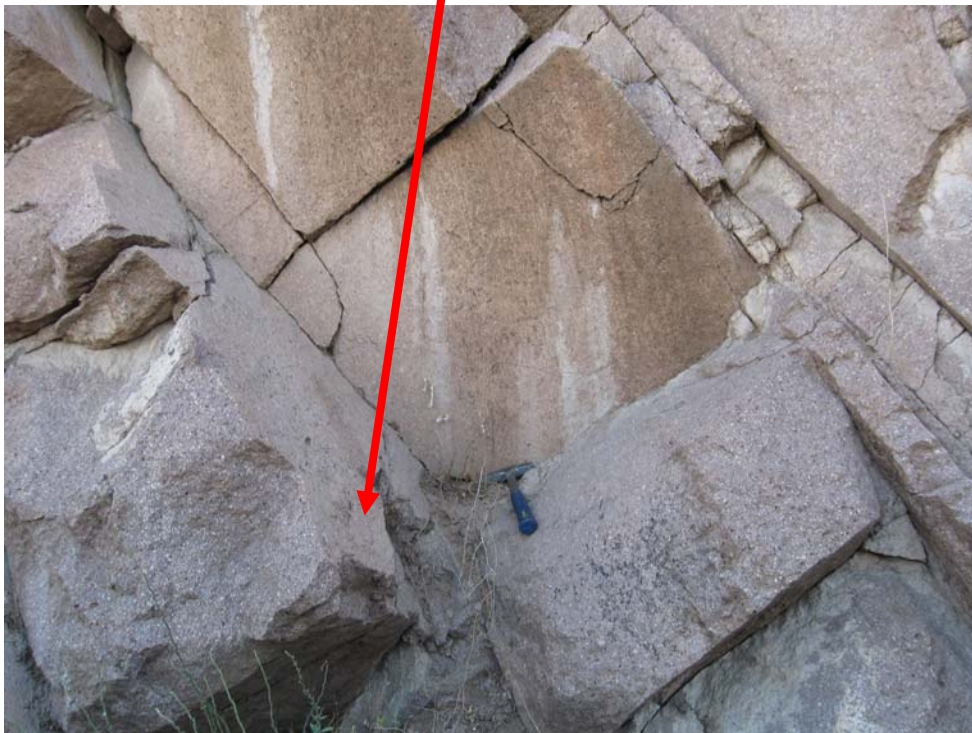
Figure 2.29 The studied andesites near BH-5.

As seen in the photographs (Figure 2.29), the andesites are pink colored and have vesicles covering the surfaces. The constituents composing the cementation material could not be observed since they are not visible. Big white minerals seen both on the rock faces and in fresh parts are supported by small grain sized minerals that can not be detected by macroscopic surveys. The texture is aphanitic porphyry and the visible big white crystals are sodium riched plagioclases (Figure 2.30).

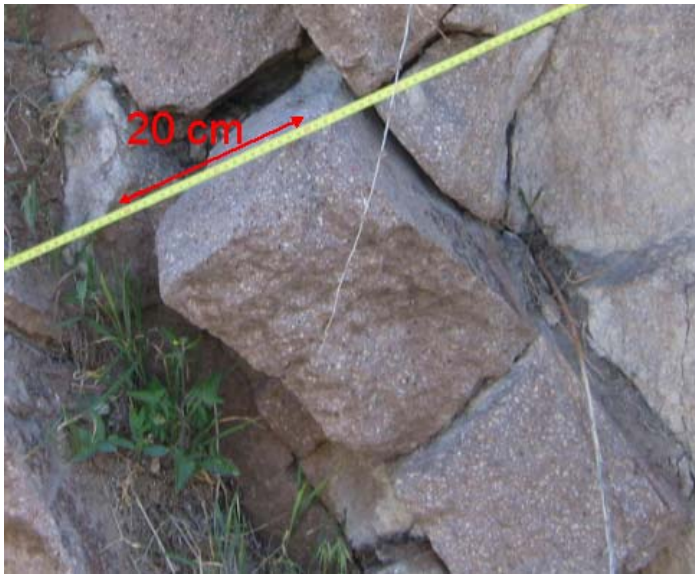
Figure 2.30 Aphanitic porphyry textured andesites (White crystals seen on the surface are plagioclase crystals).

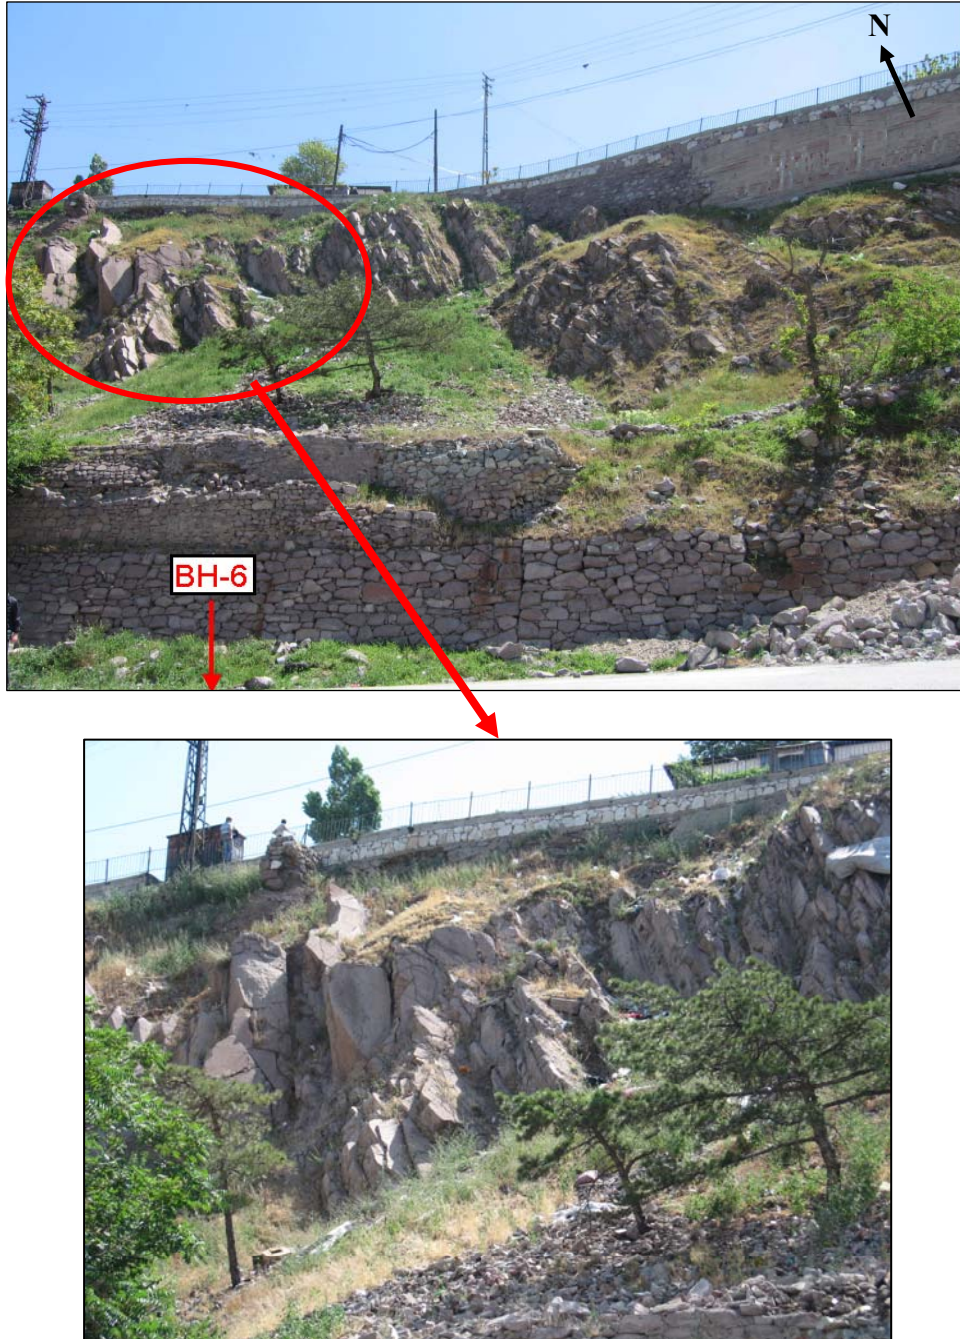
Figure 2.31 The photograph of the andesites located at km: 0+880; near BH-6.

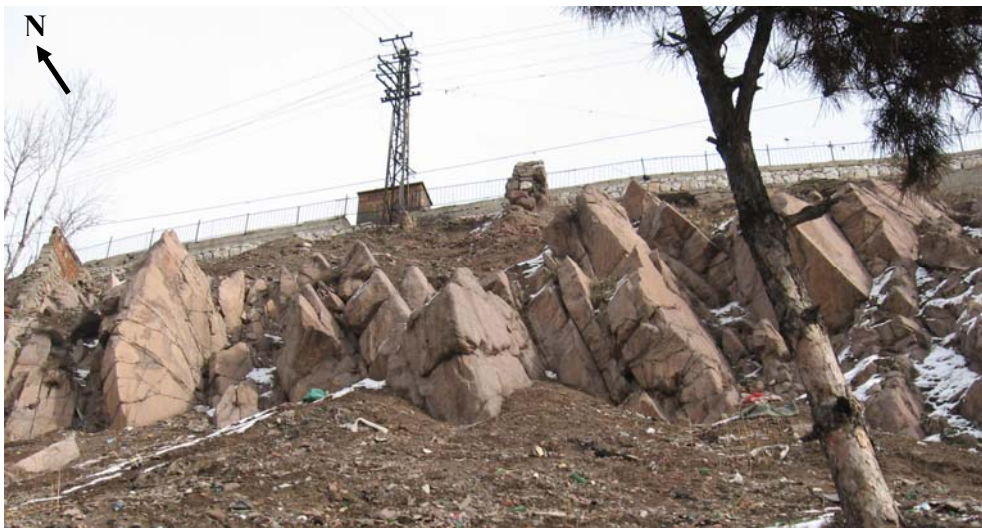
Figure 2.32. The andesites at km:0+840, near the BH-6.

The unit examined near BH-6 is the continuation of the andesites previously studied at BH-5. The elevation of the studied andesites is 920 m. Although the geological unit is the same, the discontinuity orientations and degree of weathering differ than those of andesites observed at BH-5. Most of the exposed parts of the pink andesites are fractured and moderately weathered. Big and branchy type of joints covers the intact rock masses (Figure 2.32). Clay constitutes the infilling material of these joints.

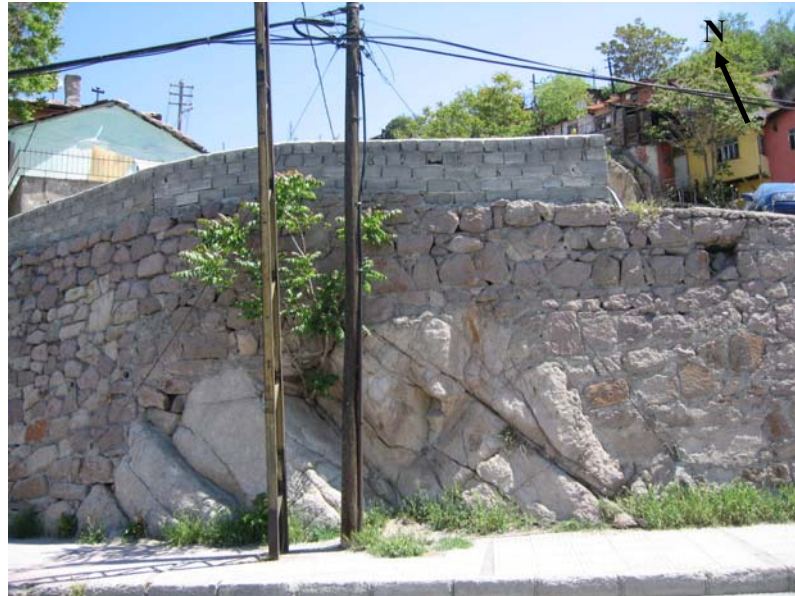
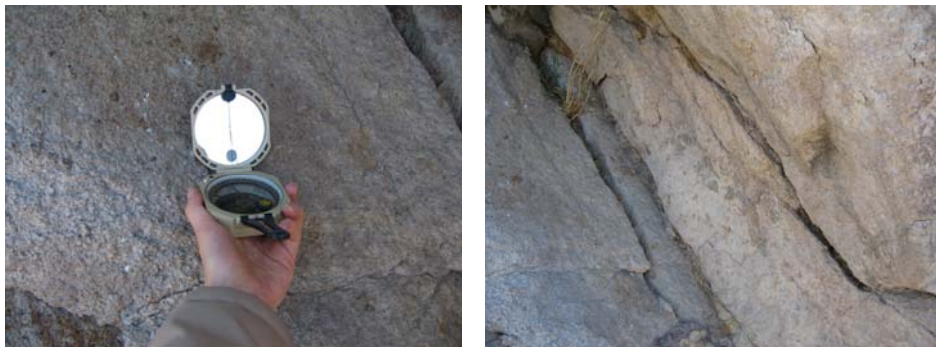
Figure 2.33. The kaolinized andesites with clay infillings.

At lower elevations of the hill (860 m) more kaolinized andesites crop out under the artificial structures. These andesites show up in dirty white color. Moreover it is hard to differentiate them from the concrete at some places. In Figure 2.33, photographs of the kaolinized andesites are given.

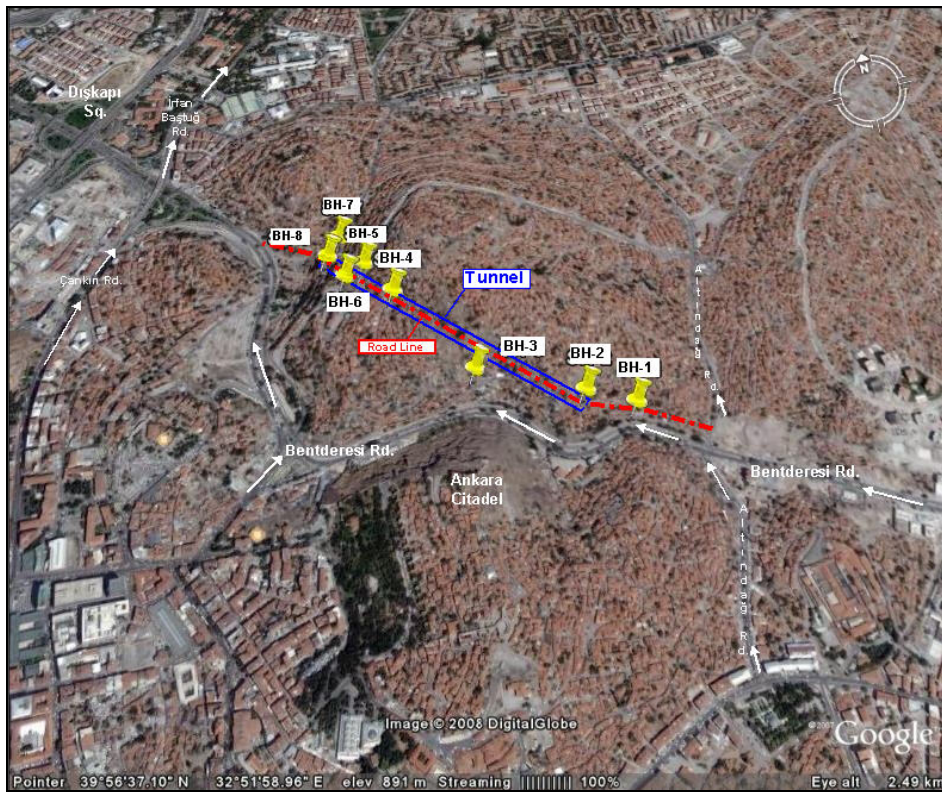
Figure 3.1 A satellite image acquired from Google Earth (2008). The red dash line represents the planned road line as the blue line shows the tunnel.

The drillings were aimed to cut the tunnel elevation to reveal the region surrounding the tunnel. The software acquired satellite image showing locations of boreholes is given in Figure 3.1.

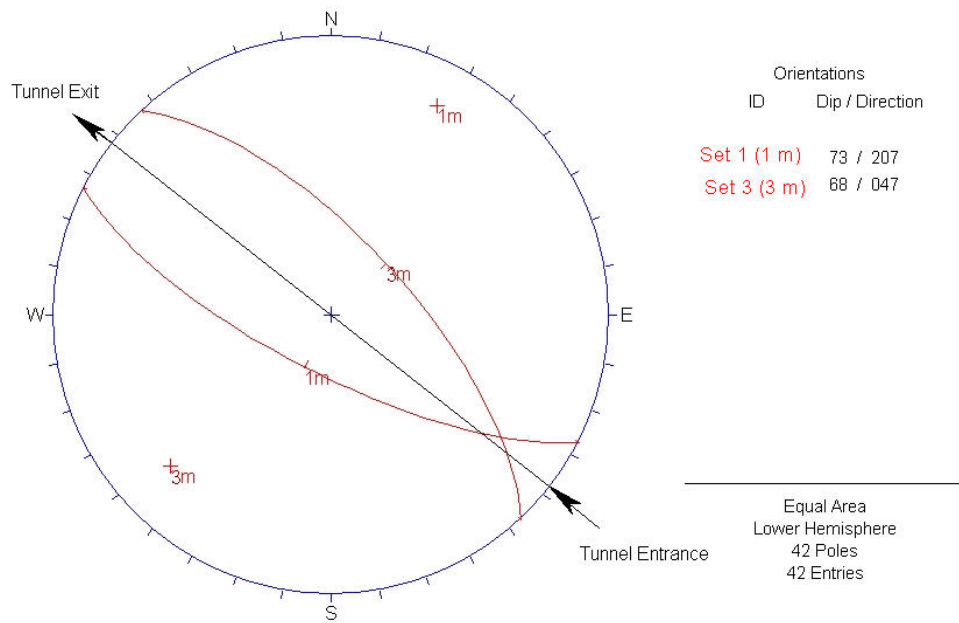
Discontinuity Set	Dip	Dip Direction
Set 1	73	207
Set 3	68	047

Figure 3.5. The orientations of major discontinuity sets at km:0+100-0+200

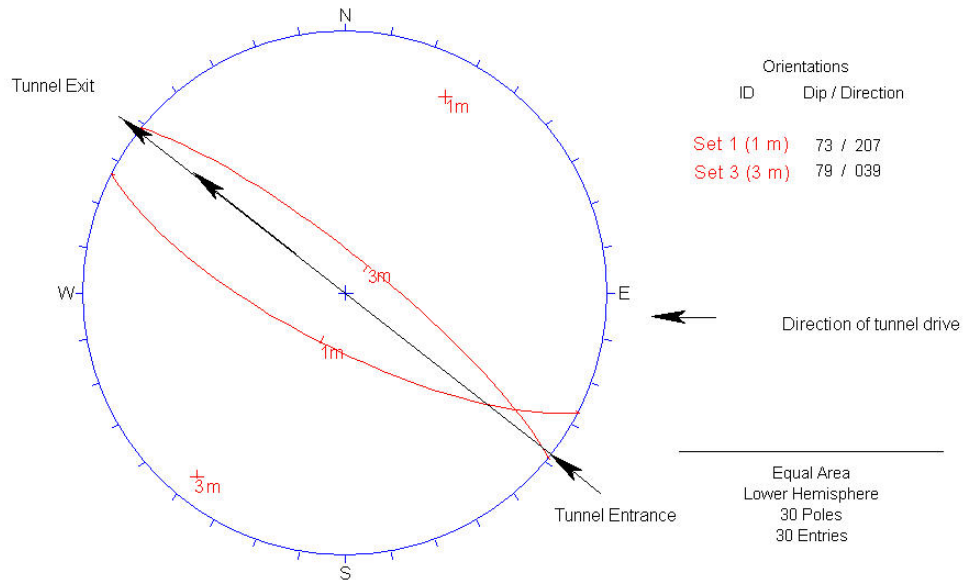
Discontinuity Set	Dip	Dip Direction
Set 1	73	207
Set 3	79	039

Figure 3.6. Orientation of major discontinuity sets at km:0+200-0+300

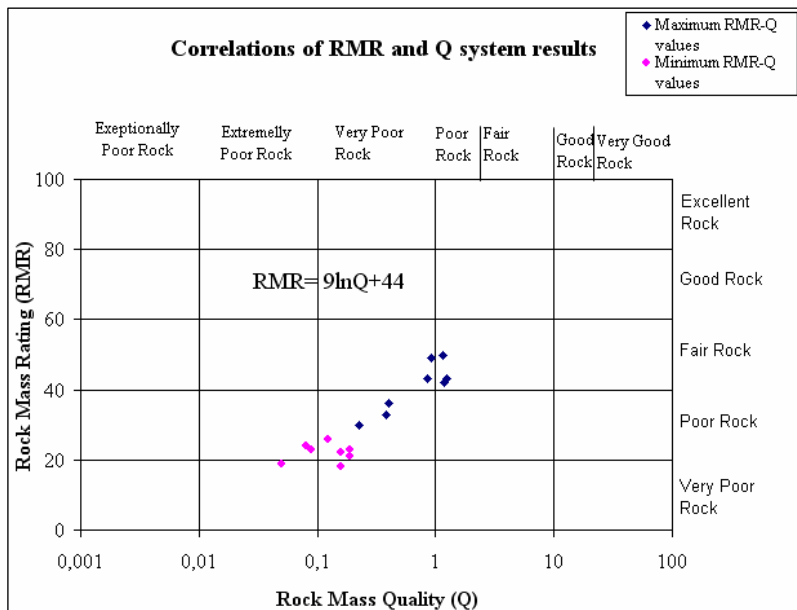
Figure 3.13 The correlation of classification results of RMR and Q systems

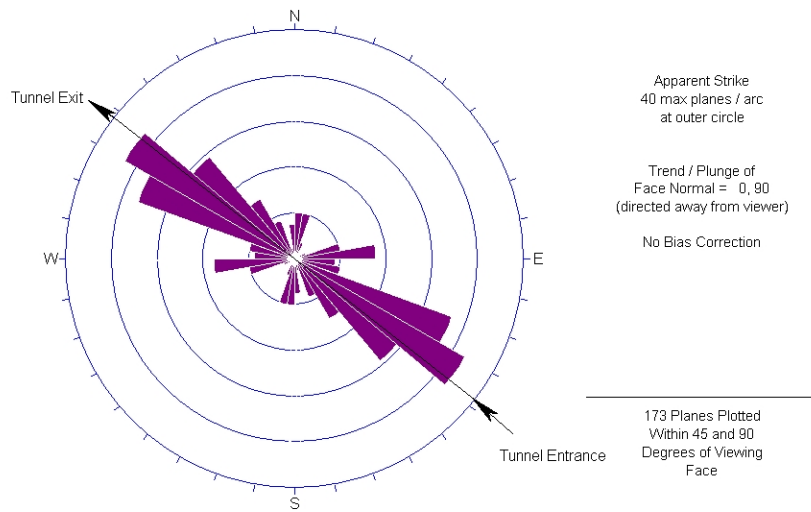
Figure 4.4 The Rosette diagram showing the trends of discontinuities

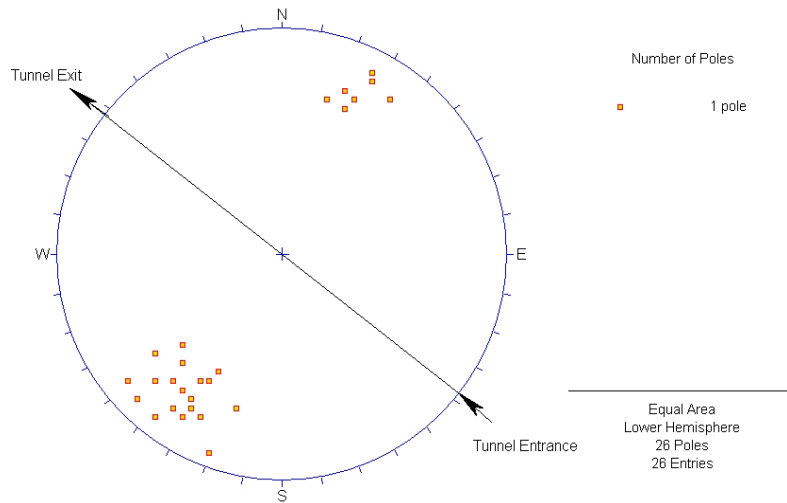
Figure 4.14 Pole concentration of discontinuities at km:0+900

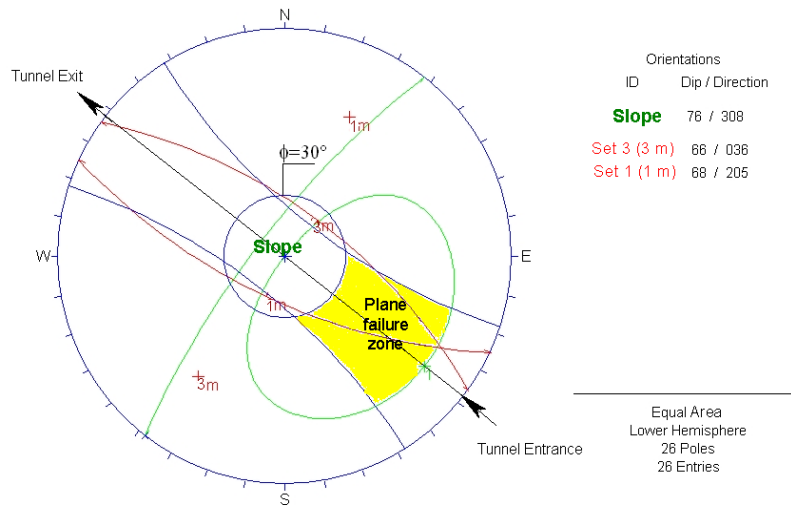
Figure 4.17 Plane failure analysis for the exit portal slope face
