THERMAL PERFORMANCE ASSESSMENT OF HISTORICAL TURKISH
BATHS

A THESIS SUBMITTED TO
THE GRADUATE SCHOOL OF NATURAL AND APPLIED SCIENCES
OF
MIDDLE EAST TECHNICAL UNIVERSITY

PINAR (KIRMIZIDAĞ) ÇİÇEK

SEPTEMBER 2009

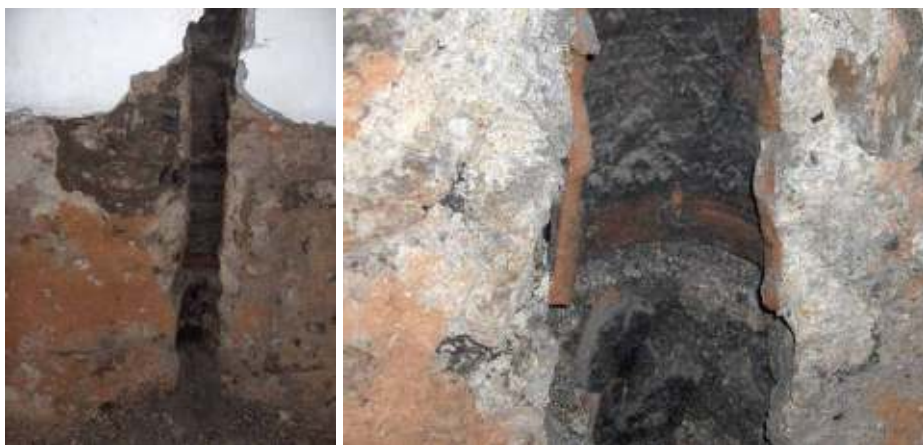
Figure 2.5 Views of terracotta draft chimneys (*tüteklik*) rising inside the wall up to the roof in Yıldırım Beyazıt Hamamı in Mudurnu, Bolu (Source: *Archives of Gülşen Dişli*).

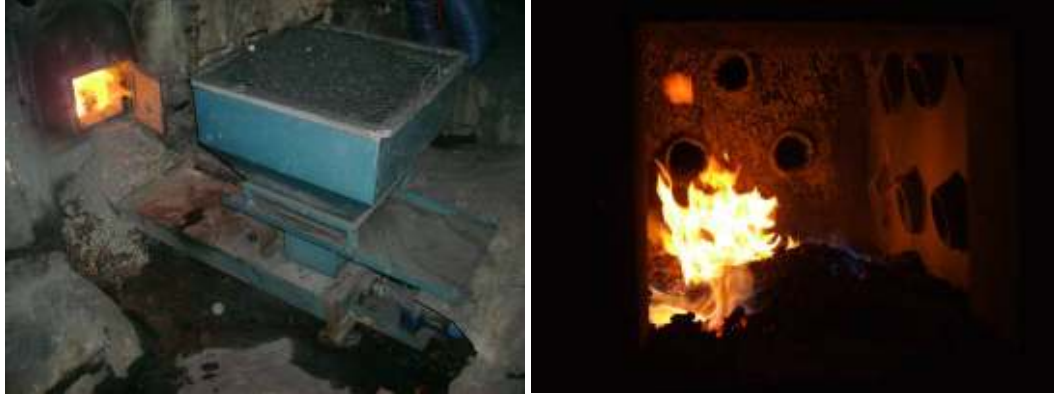
Figure 3.2 Views of the furnace in Şengül Hamamı (Source: Archives of the Author and Gülşen Dişli)

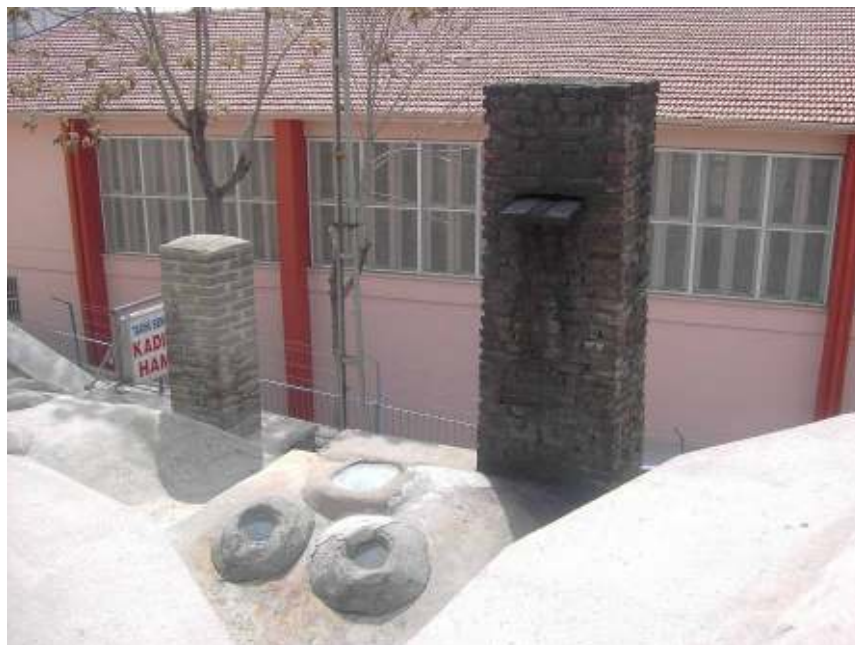
Figure 3.6 View of two draft chimneys; one out of use (on the left) and one with a damper mechanism to open and close the top (on the right) on the roof of Şengül Hamamı (Source: Archives of Author)

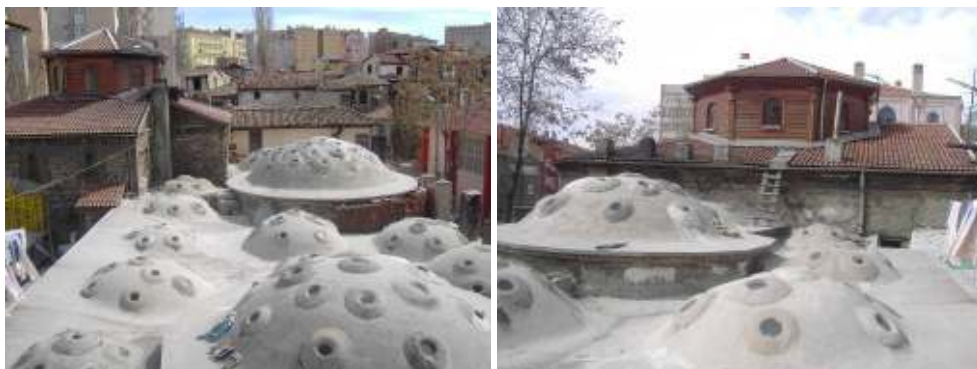
Figure 3.8 Views of Şengül Hamamı's roof covered by an 8 cm-thick mesh-reinforced concrete layer (Source: Archives of the Author)

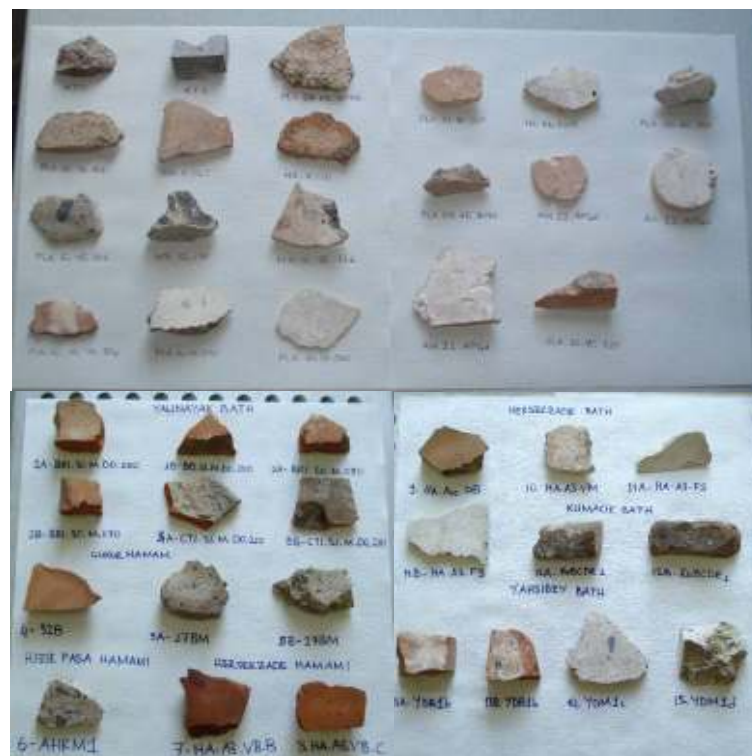
Figure 3.11 Samples of historic brick, stone, brick and stone mortar, interior and exterior plasters collected from the historical baths belonging to the same period with Şengül Hamamı.

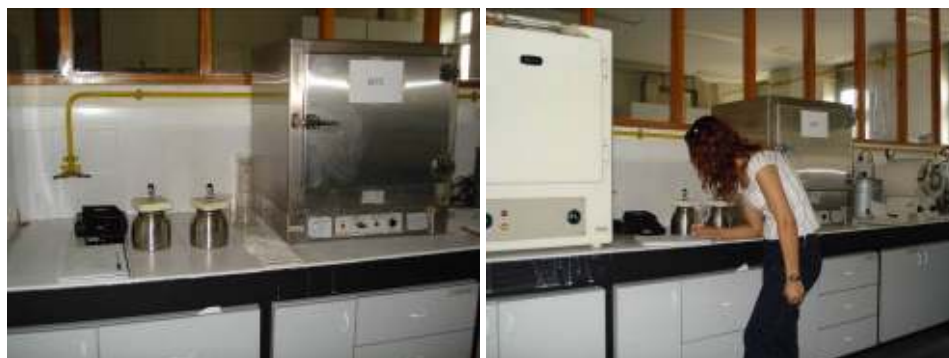
Figure 3.13 Photographs showing the experimental setup for the determination of specific heat capacity values of historic samples.

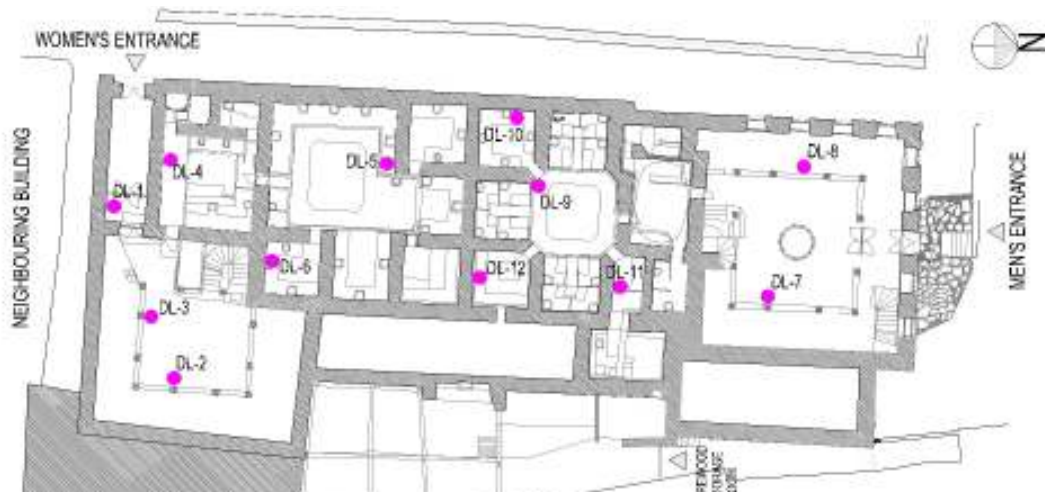
Figure 3.14 Plan showing the distribution of data loggers in different parts of Şengül Hamamı (Source: Archives of the General Directorate of Pious Foundations, 2008; produced by the author).

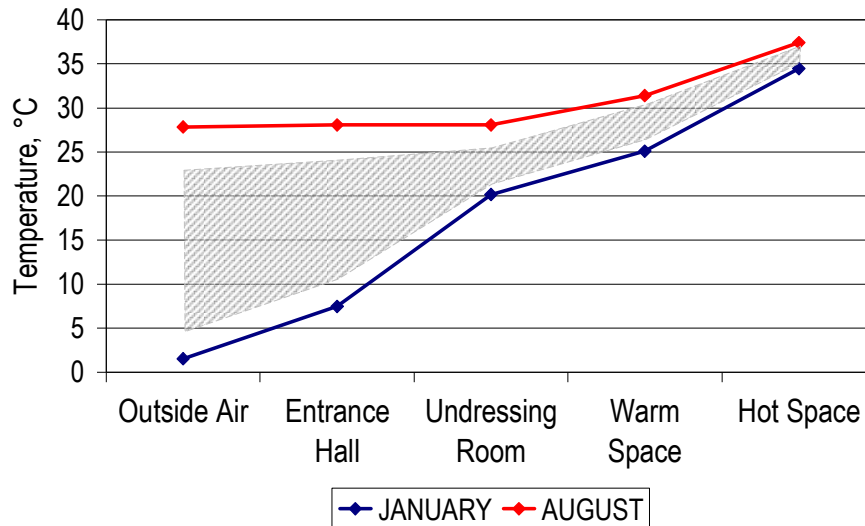
Figure 4.3 The monthly means of ambient temperatures, showing the gradual increase in temperature between the spaces, starting from the outside air to the entrance hall, then to the undressing room, and to the warm and hot bathing spaces of the women's part.

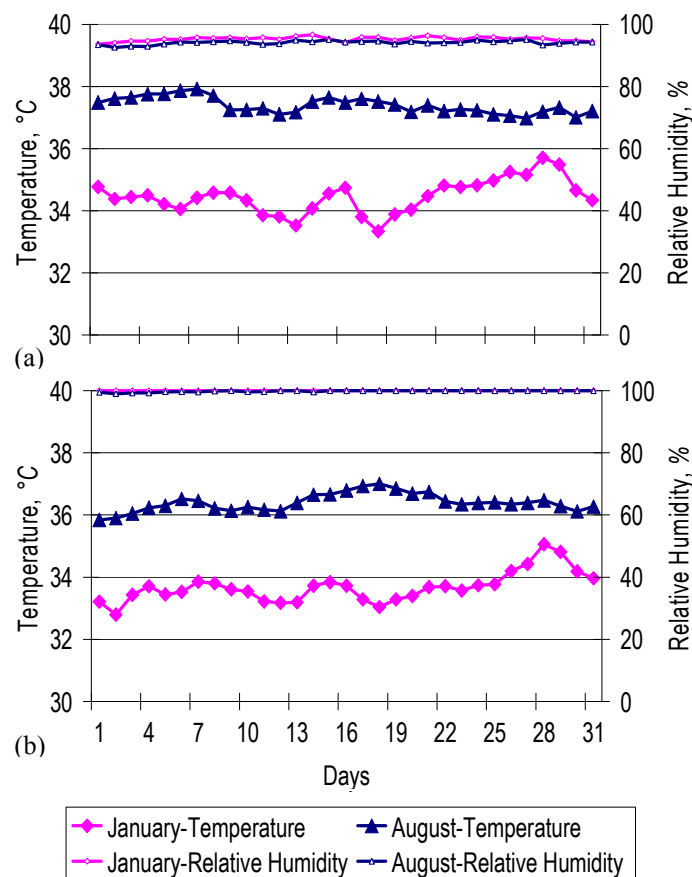
Figure 4.5 The daily means of ambient temperature and relative humidity at women’s and men’s hot spaces in January and August; showing the interior ambient temperature differences of $2.9^{\circ}\text{C} \pm 0.7^{\circ}\text{C}$ and $2.7^{\circ}\text{C} \pm 0.6^{\circ}\text{C}$ measured between the months of August and January at women’s (a) and men’s (b) hot spaces, respectively, while the humidity conditions were remained the same.

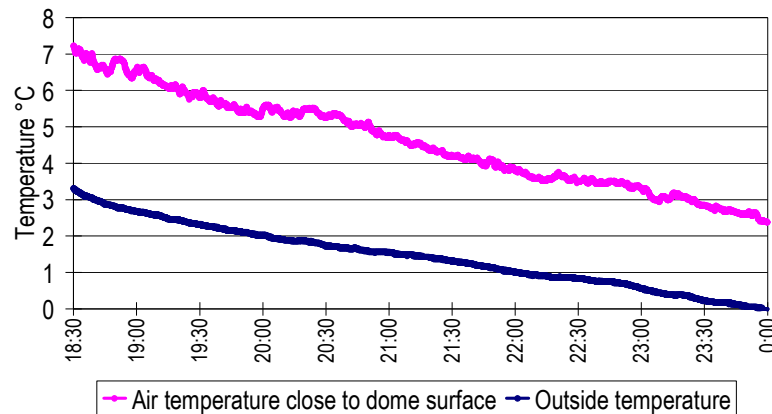
Figure 4.6 The curves of air temperature close to the exterior dome surface and outside air temperature for a period of three-and-a-half hours in February at night, showing that the air temperature close to the dome surfaces was warmer than the outdoor temperature with a temperature difference of $3.1^{\circ}\text{C} \pm 0.5^{\circ}\text{C}$.

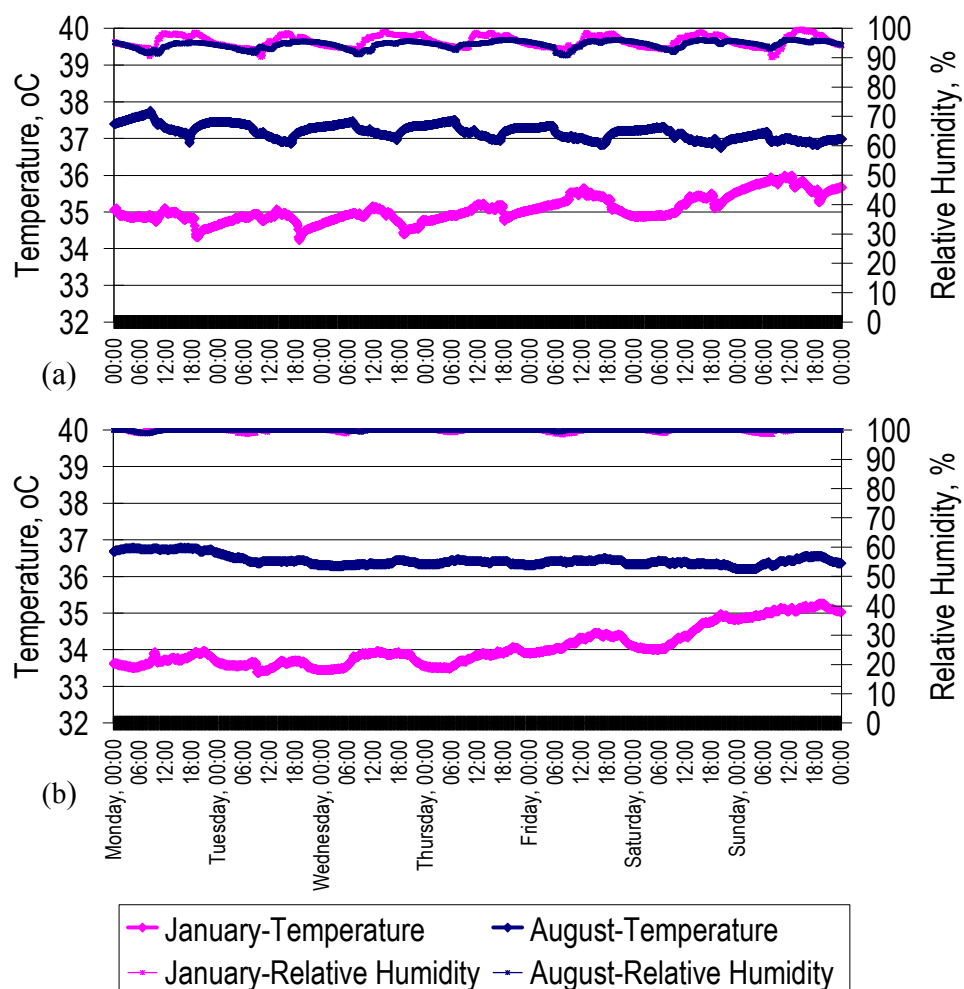
Figure 4.7 The daily temperature and relative humidity fluctuations at the women’s and men’s hot spaces for a period of one week in January and August; showing the daily ambient temperature fluctuations in the range of $0.72^{\circ}\text{C}\pm 0.12^{\circ}\text{C}$ and $0.57^{\circ}\text{C}\pm 0.16^{\circ}\text{C}$ in the women’s hot space (a) and in the range of $0.56^{\circ}\text{C}\pm 0.20^{\circ}\text{C}$ and $0.23^{\circ}\text{C}\pm 0.09^{\circ}\text{C}$ in the men’s hot space (b) in January and August, respectively.

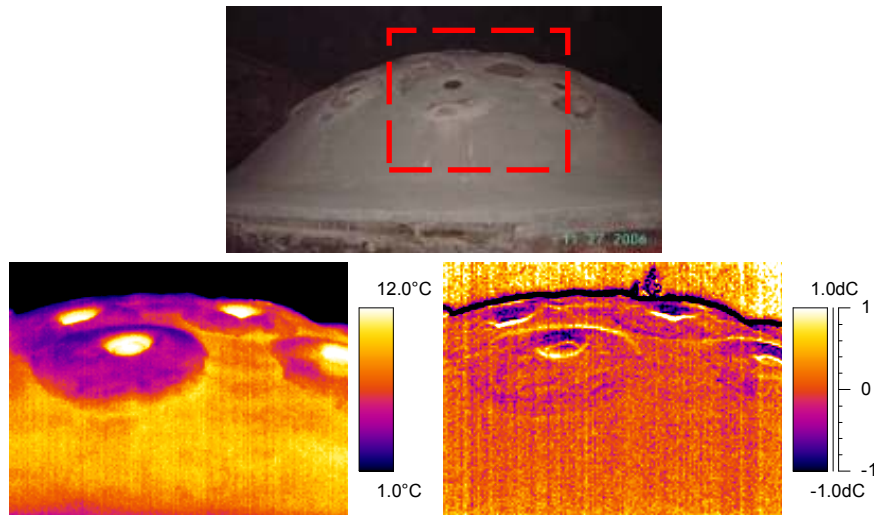
Figure 4.9 The IR image taken from the north side of the dome of the women's hot space at outdoor ambient air conditions of 10.7°C and 40%RH in November; and its differential IR image (at bottom right), that is the temperature difference between the last and first IR images in the sequence, showing the heat loss from the concrete-clad dome surfaces with $\Delta T=+0.2^{\circ}\text{C}$ in 322s during the cooling period at night.

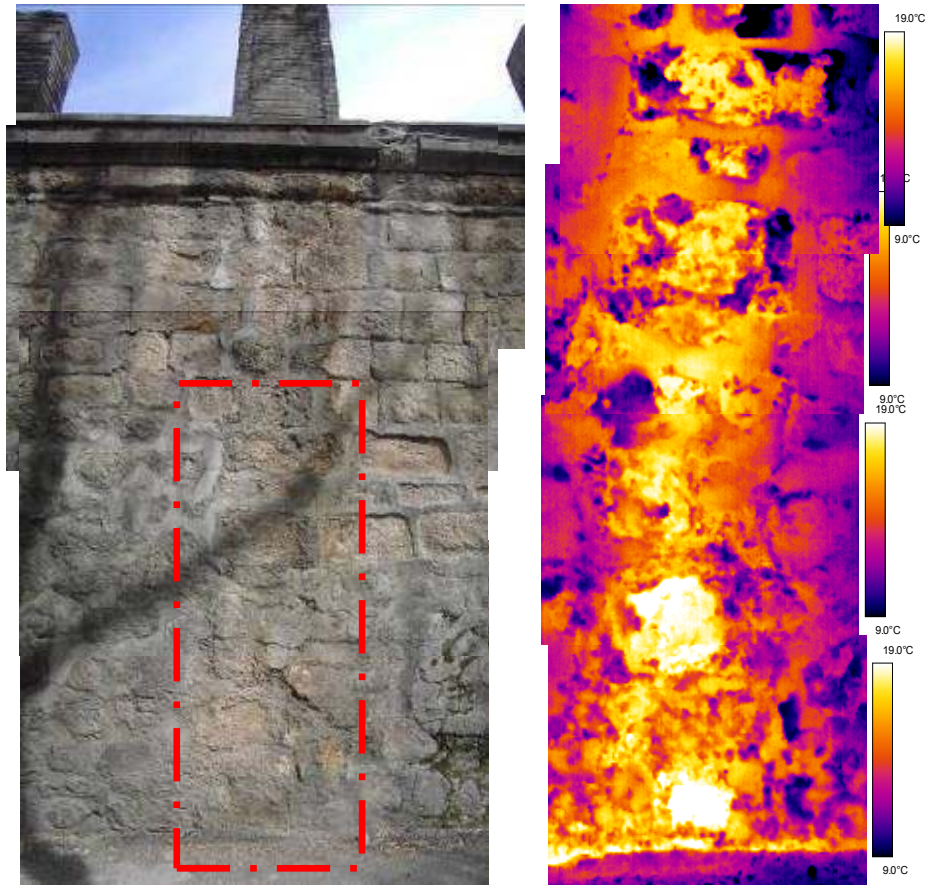
Figure 4.11 A partial view from the west wall of men's hot space on the axis of chimney and its IR image showing that surface temperatures of the wall were warmer than the ambient temperature of 2.8°C in February, at night, with a temperature difference of 12.5°C.

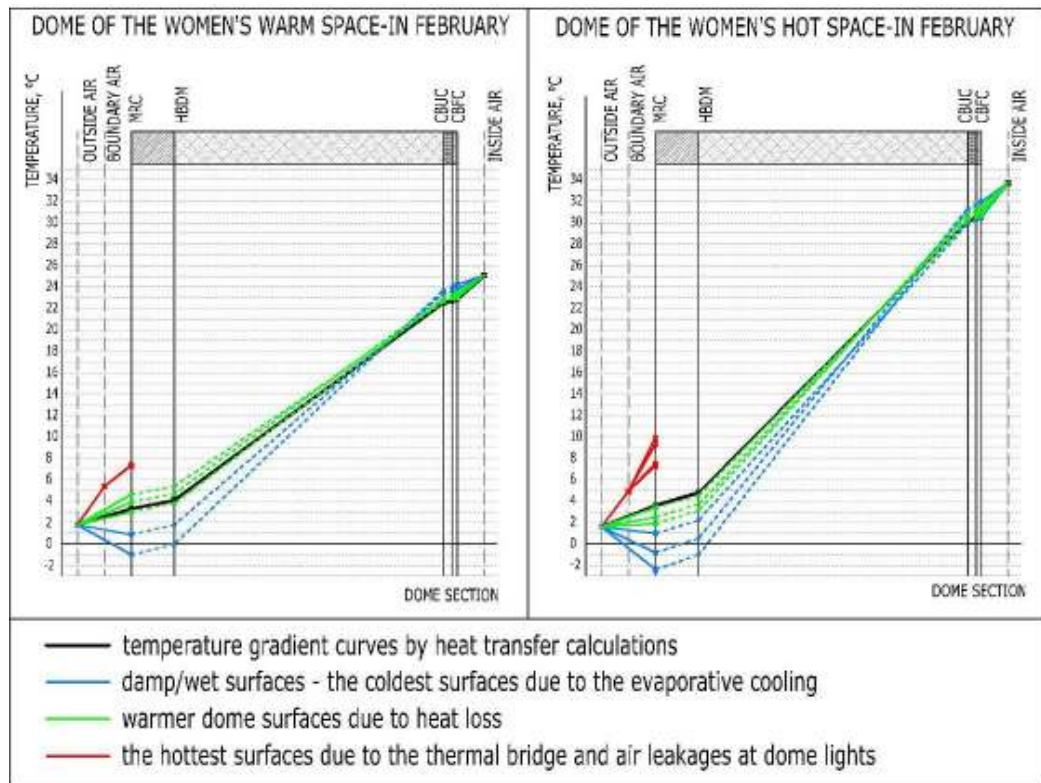
Figure 4.18 Sections through the domes of the women's warm (at left) and hot (at right) spaces, showing temperature gradients through each component calculated according to the thermal conductance and thickness of each layer (lines in black); and heat flow curves produced according to the real surface temperatures measured at inside and outside surfaces of the dome structures.

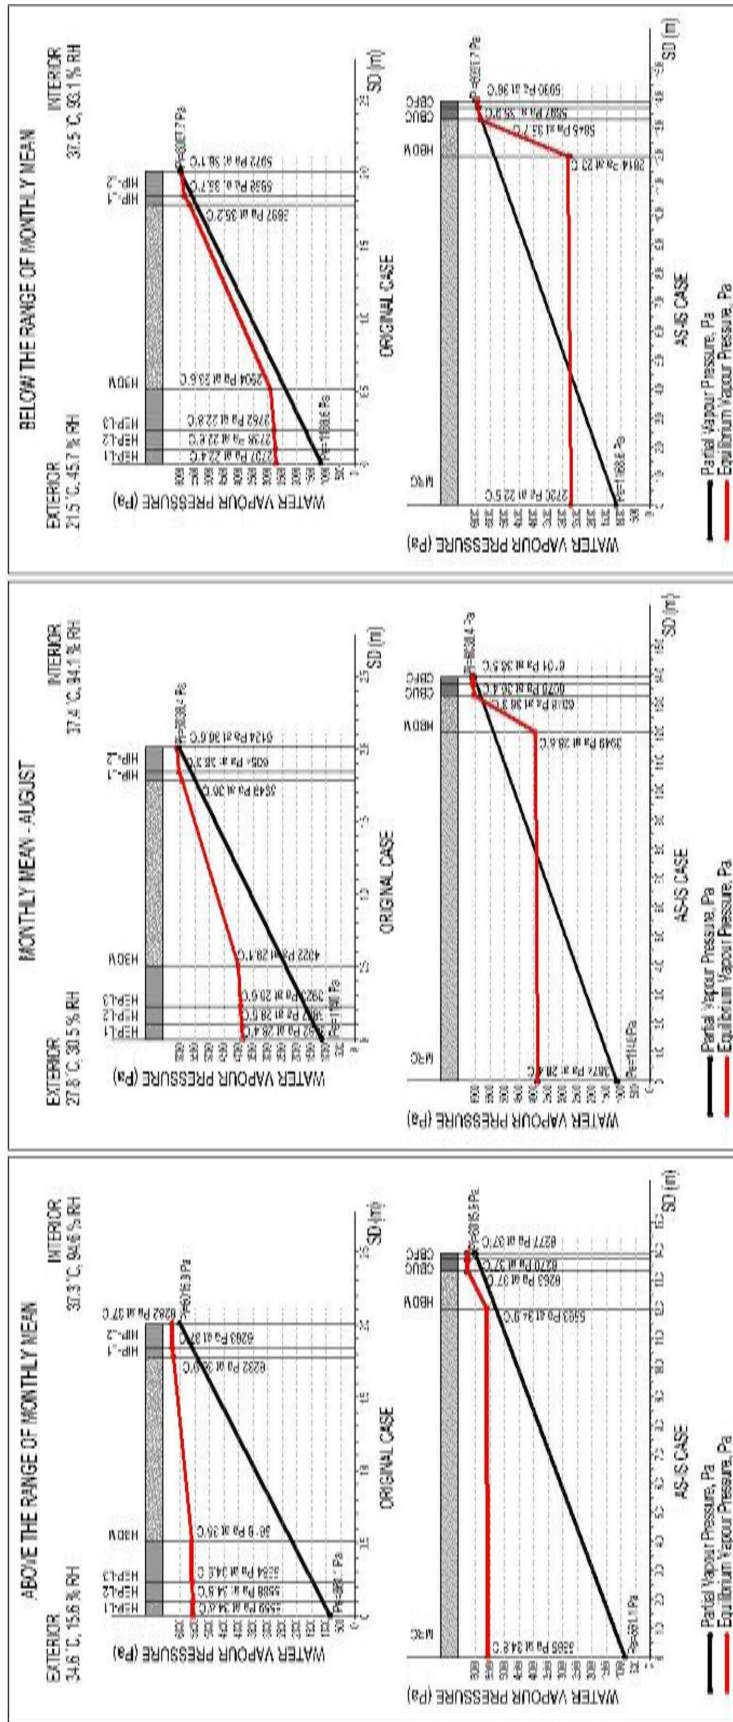
Figure D.8 The partial vapour pressure distribution analyses of the dome section of women's hot space in *ORIGINAL* (at top) and *AS-IS* (at bottom) cases for the monthly-mean temperature and RH values of August (in middle), together with those for above (at left) and below (at right) the range of monthly means.

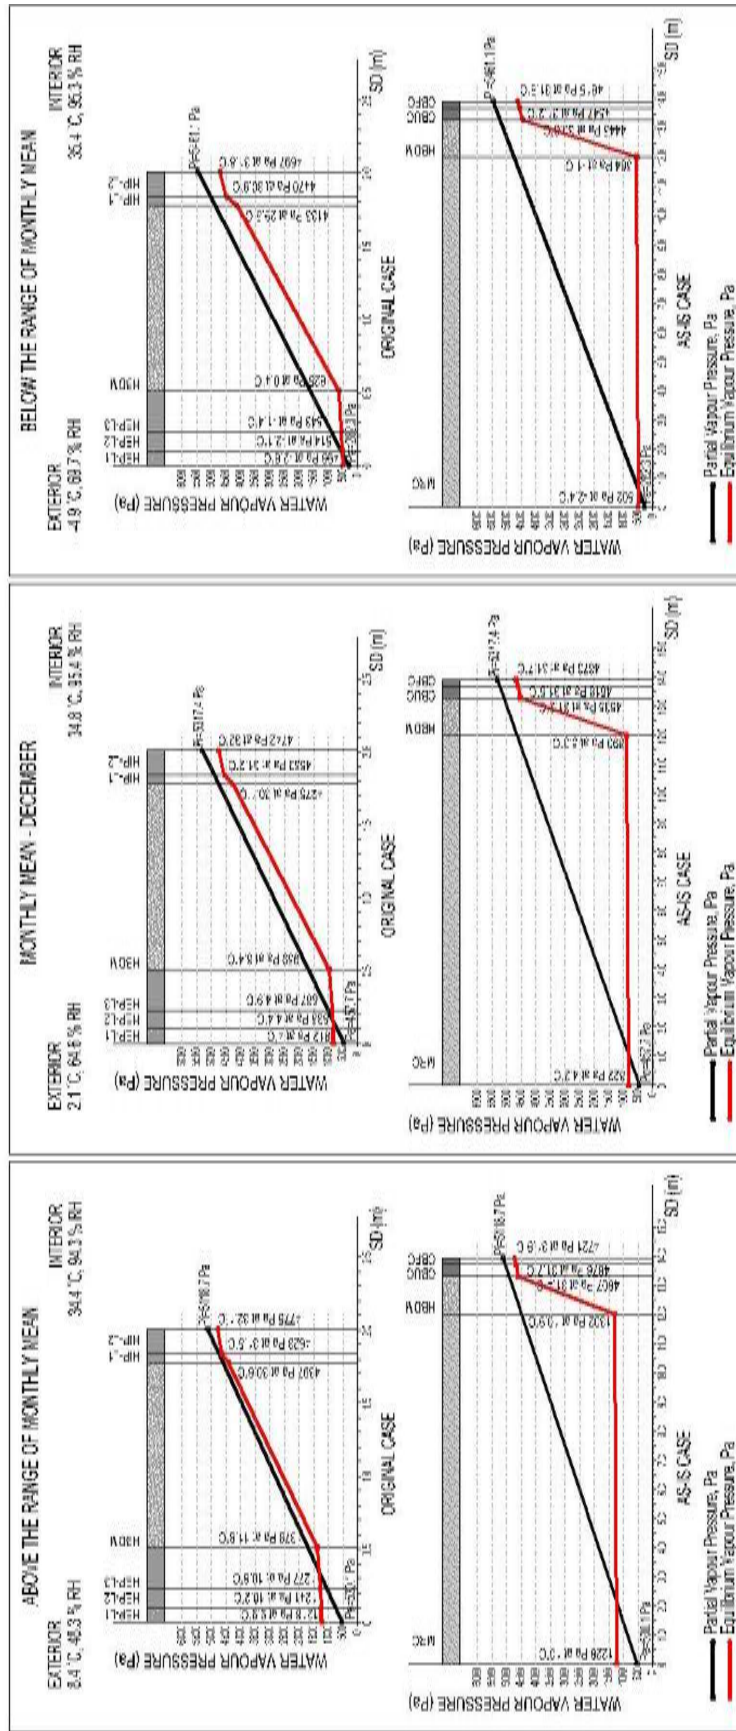
Figure D.12 The partial vapour pressure distribution analyses of the dome section of women's hot space in *ORIGINAL* (at top) and *AS-IS* (at bottom) cases for the monthly-mean temperature and RH values of December (in middle), together with those for above (at left) and below (at right) the range of monthly means.
