EVALUATION OF SEISMIC RESISTANCE OF TRADITIONAL  
OTTOMAN TIMBER FRAME HOUSES

A THESIS SUBMITTED TO THE GRADUATE SCHOOL OF NATURAL  
AND APPLIED SCIENCES  
OF  
MIDDLE EAST TECHNICAL UNIVERSITY

YASEMİN DİDEM AKTAŞ

AUGUST 2011

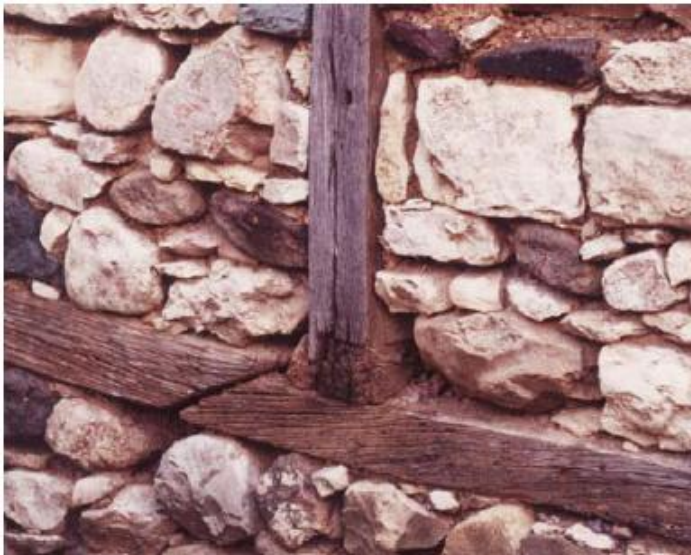
Figure 27: Chamfered joint in the base beam of a house in Yalova (Aksoy and Ahunbay; 2005)

In addition to the nailed connections, single housing or mortise and tenon joints can also be observed (Kuban, 1995: 243), especially in the connections between base beams with each other, posts at the edges with base beams, upright elements with their caps, floor beams and projection supports, and those in the roof (Aksoy and Ahunbay, 2005: 53). For examples of such connections, please see (Figure 27-Figure 32).

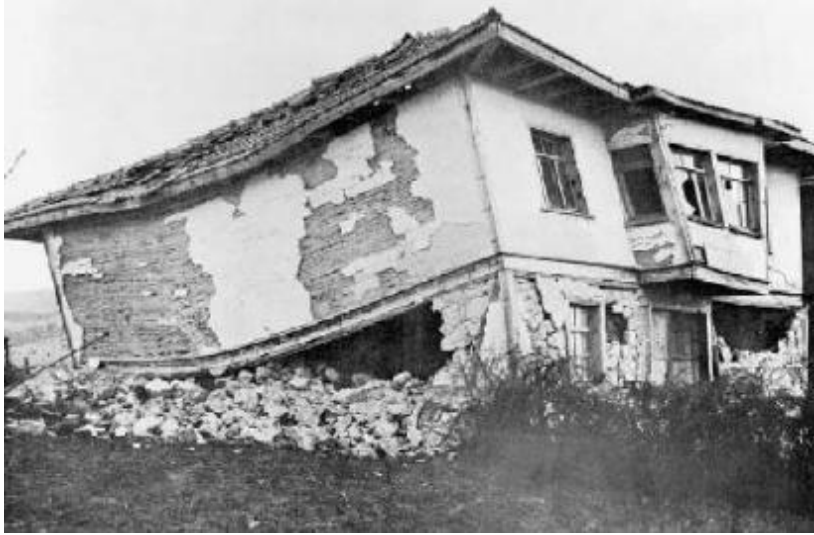
Figure 36: An example showing the destroyed masonry ground floor in Iğdiş Village after 1970 Gediz Earthquake (after Şahin-Güçhan, 2007a)

Similarly, according to the observations made by Şahin-Güçhan (2007a), in the 1970 Gediz Earthquake, the most affected parts of the damaged timber structures were masonry sections like the exterior walls of ground floor, service walls and chimneys. Even in the case that loosening of infill materials occurred, the timber frame remained intact (Figure 36). *Bağdadi* constructions performed better than the ones with masonry infill. The modification of ground floor for new openings (or to enlarge the existing ones) had a negative effect on seismic behavior (Figure 37) (Şahin-Güçhan, 2007a: 843-844). It is also known that a large part of Gediz was also destroyed by fires after earthquake (Gürpınar *et al.*, 1981: 144)

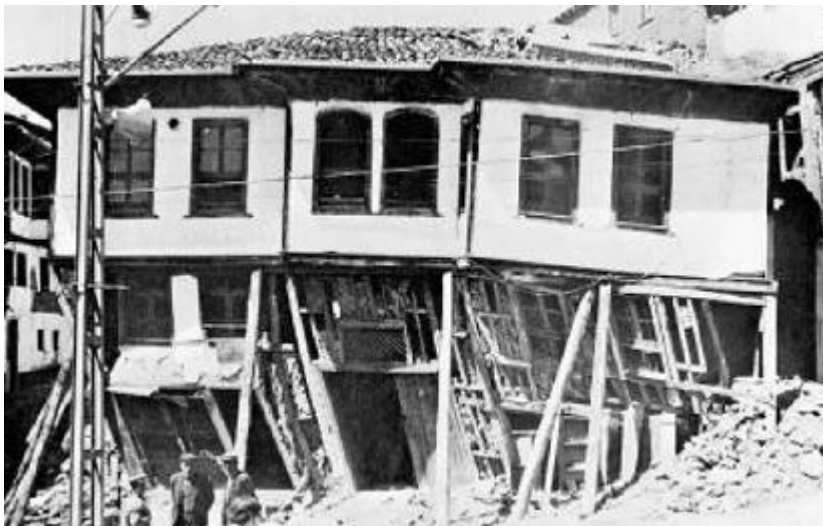
Figure 37: A timber-framed building damaged due to the weakening of the ground floor by enlargement of the openings (after Şahin-Güçhan, 2007a)

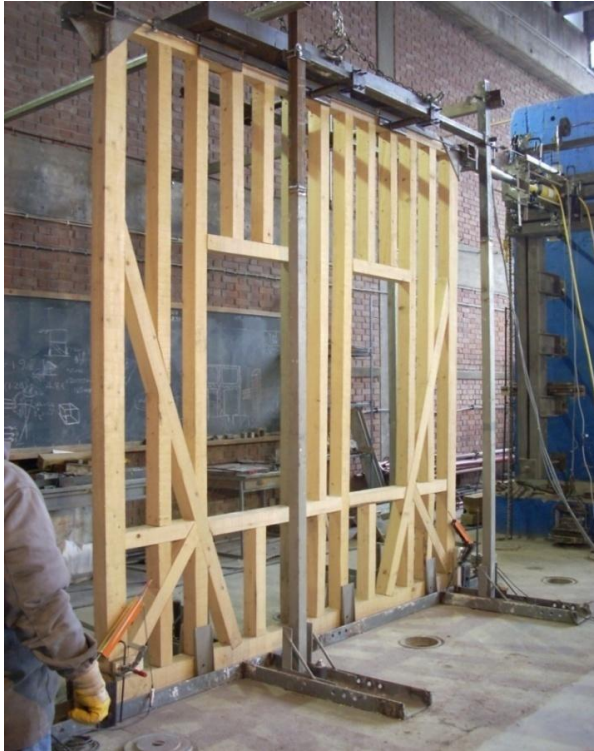
Figure 51: An overall view of the test set-up

The test set up designed for the purpose of frame experiments mentioned above, is basically composed of a foundation part, vertical masts and horizontal ones securing them to the wall (Figure 51).

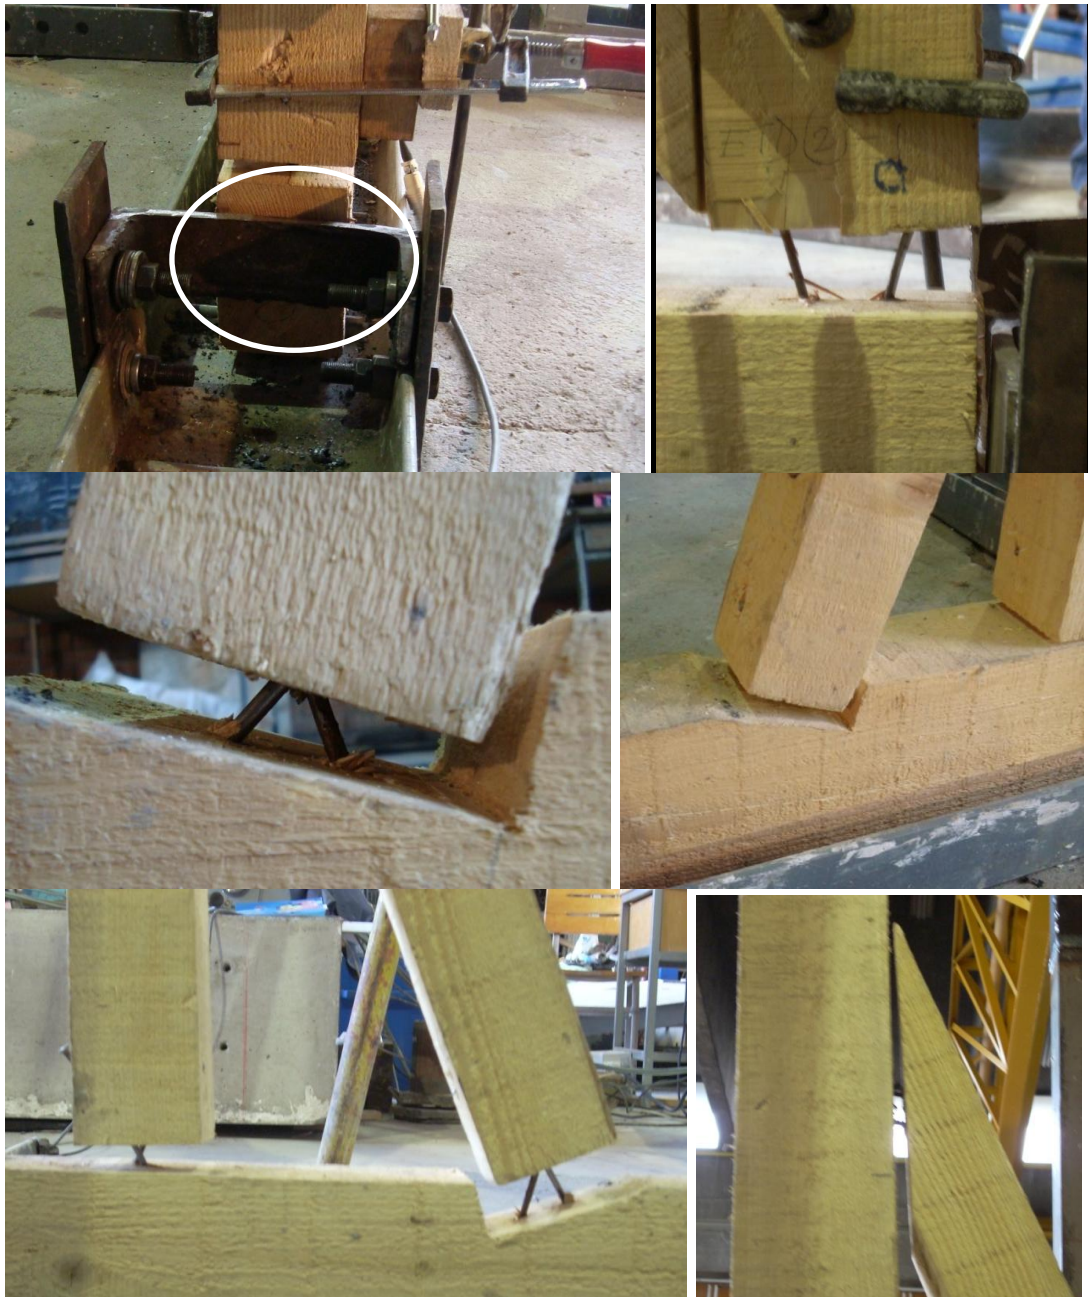
Figure 70: Several examples to joint failure in the testing of Frame#1

The failures occurred at the nailed joints in the form of dilatation are shown in Figure 70. The inclined views of the frame at the end of the test can be seen in Figure 71.

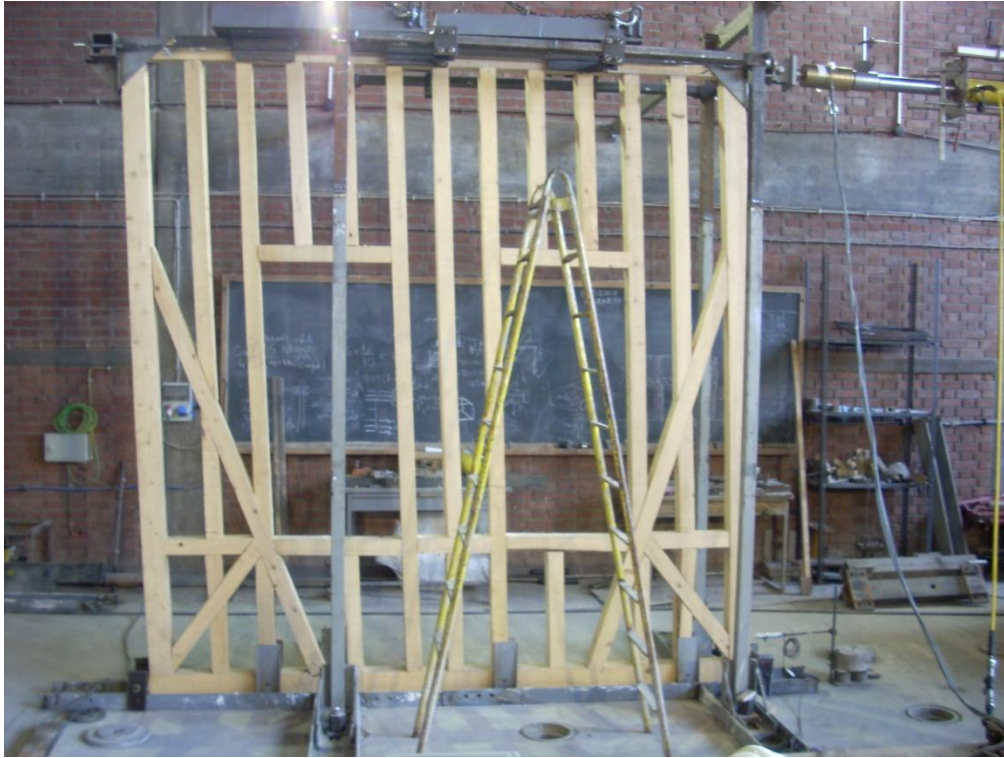
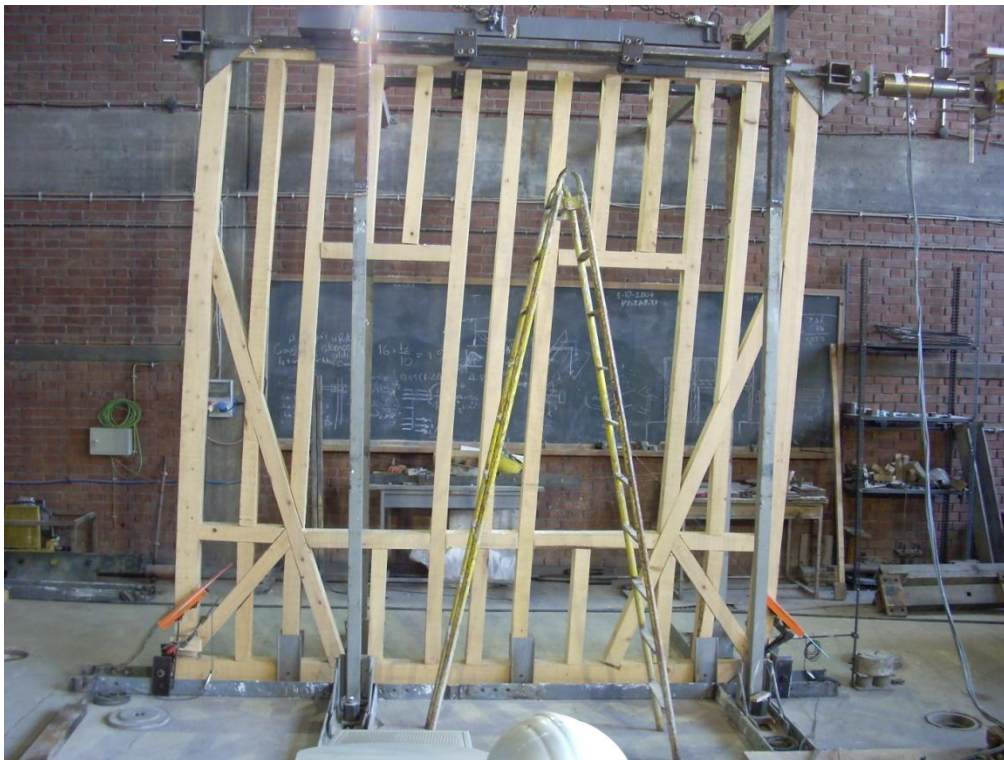
Figure 71: Two figures taken during the testing of Frame#1

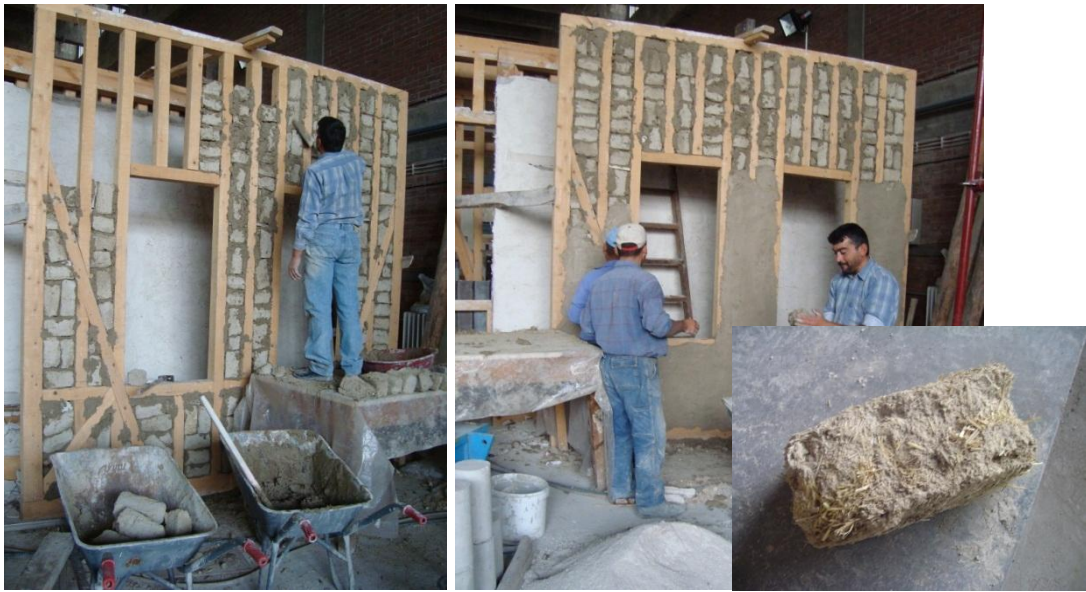
Figure 72: Infilling and plastering processes

In this test, the first frame was tested with infill. Before testing the frame, the failed connections were repaired using the same type and number of nails. The infill was carried out by 9-11.5 cm x 9-11.5 cm x 20-21 cm adobe blocks, prepared by local construction workers (Figure 72). Mortar and plaster were prepared according to traditional methods.

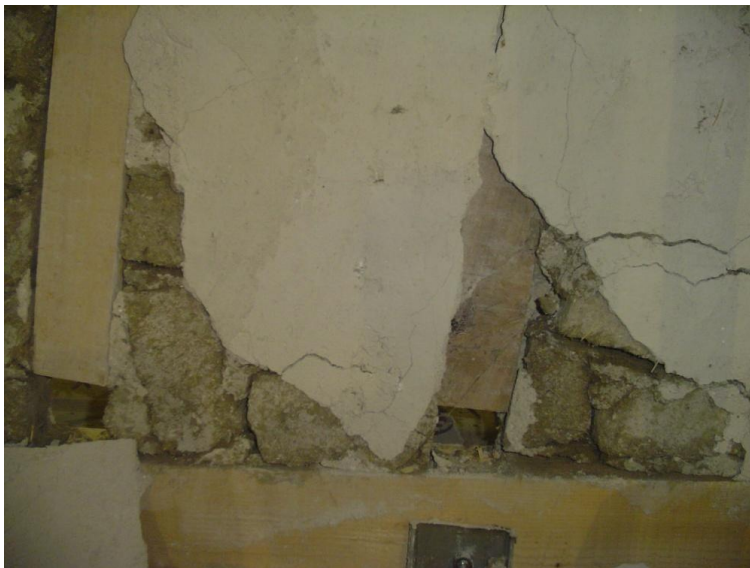
Figure 75: Connection failures

A typical failure at the nailed connections in the form of dilatation is shown in Figure 75.

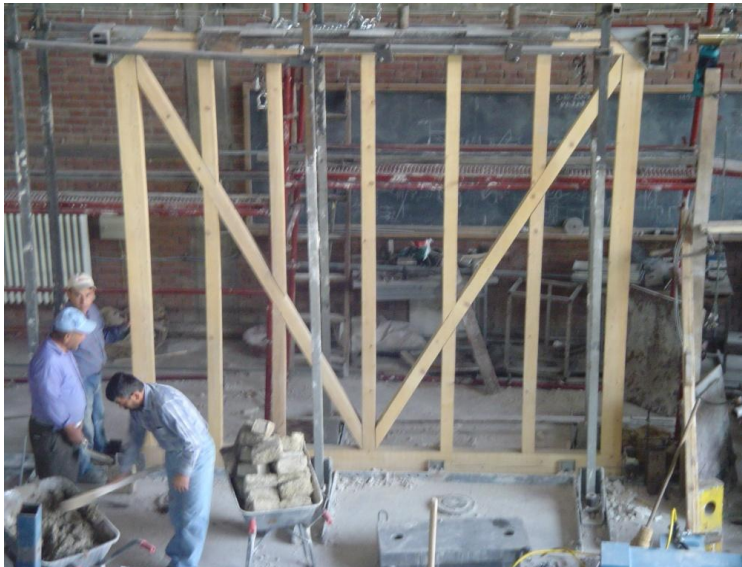
Figure 82: Frame#2 after repairing all connections

In this test, the Frame#2 was tested with adobe infill. Before testing the frame, the failed connections were repaired using the same type and number of nails (Figure 82). The infill was carried out by 9-11.5 cm x 9-11.5 cm x 20-21 cm adobe blocks, prepared by local construction workers (Figure 72). Mortar and plaster were prepared according to traditional methods.

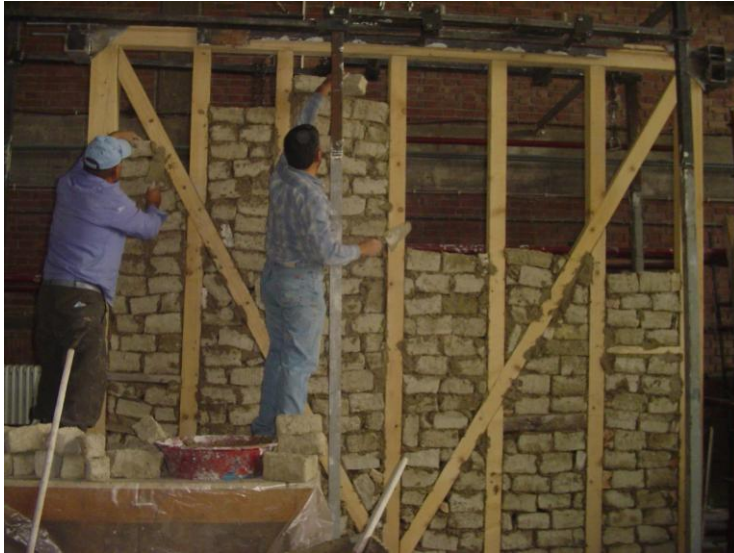
Figure 83: Adobe infilling

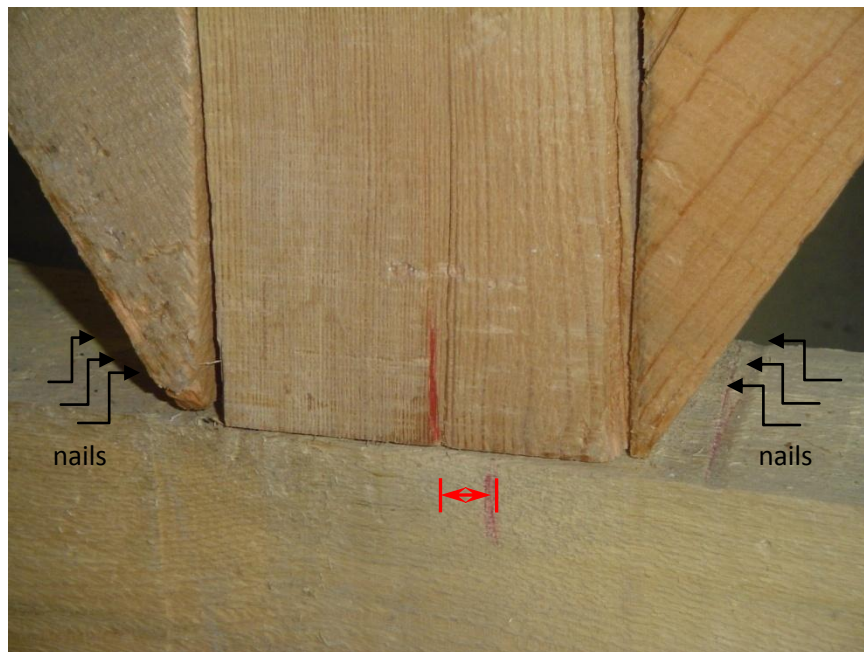
Figure 93: Displacement occurred at the middlemost upright element during Test#3

The failures occurred at the nailed joints in the form of joint dilatation and nail distortion as well as complete detachment of the timber elements from each other (Figure 93-Figure 94).

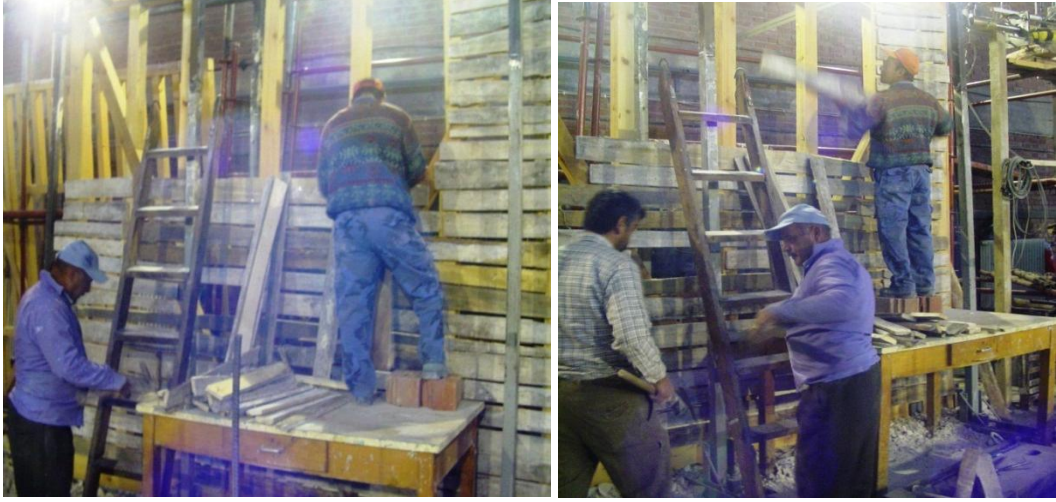
Figure 95: Nailing of laths

the frame in such a way that a gap of several centimeters is left between them, and then the surface is plastered. Plaster was prepared according to traditional methods (Figure 95-Figure 96).

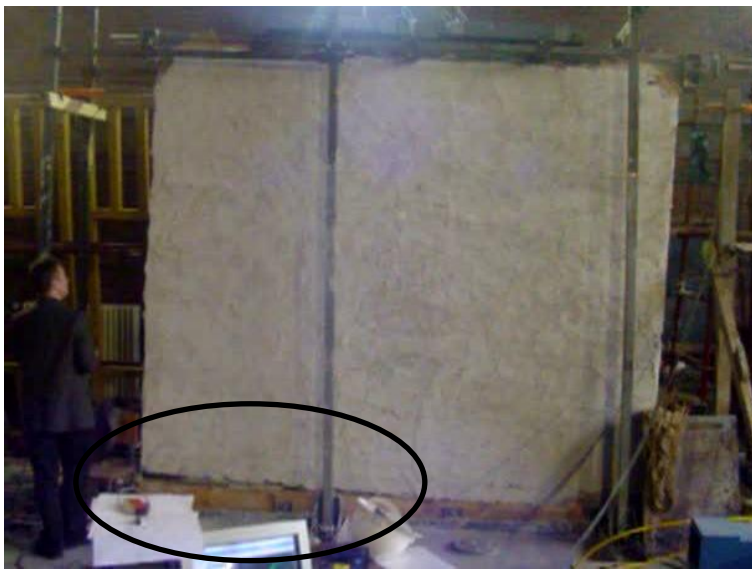
Figure 99: Dilatation at the frame bottom

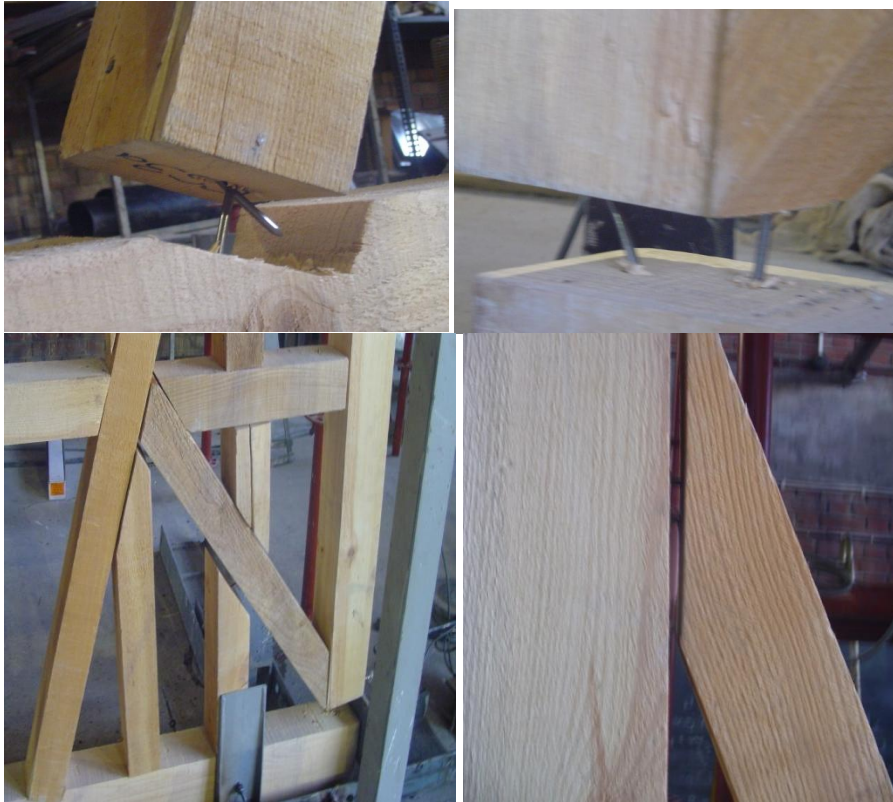
Figure 105: Details of dislocated connections observed during the testing of Frame#4

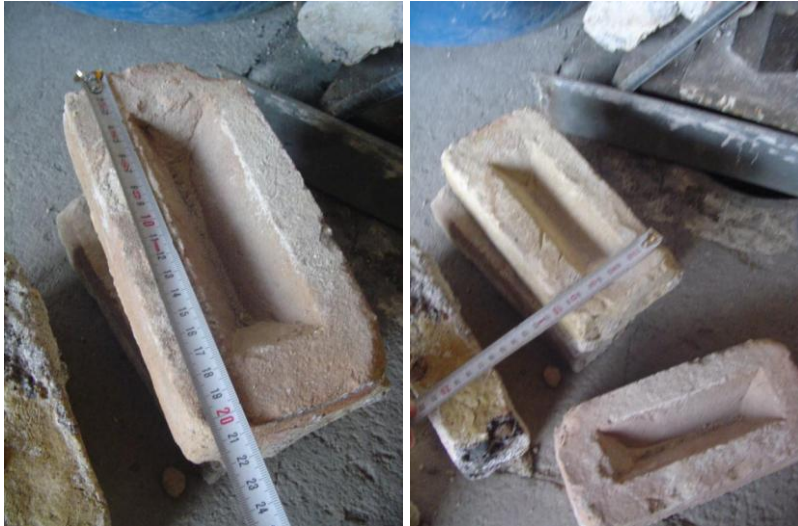
Figure 106: Solid bricks used for infill

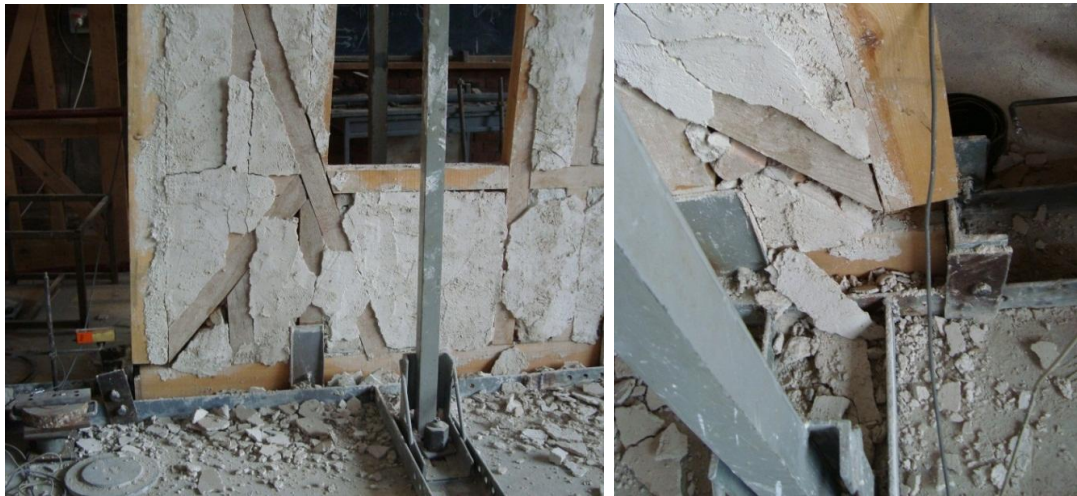
Figure 112: Examples to connection failure

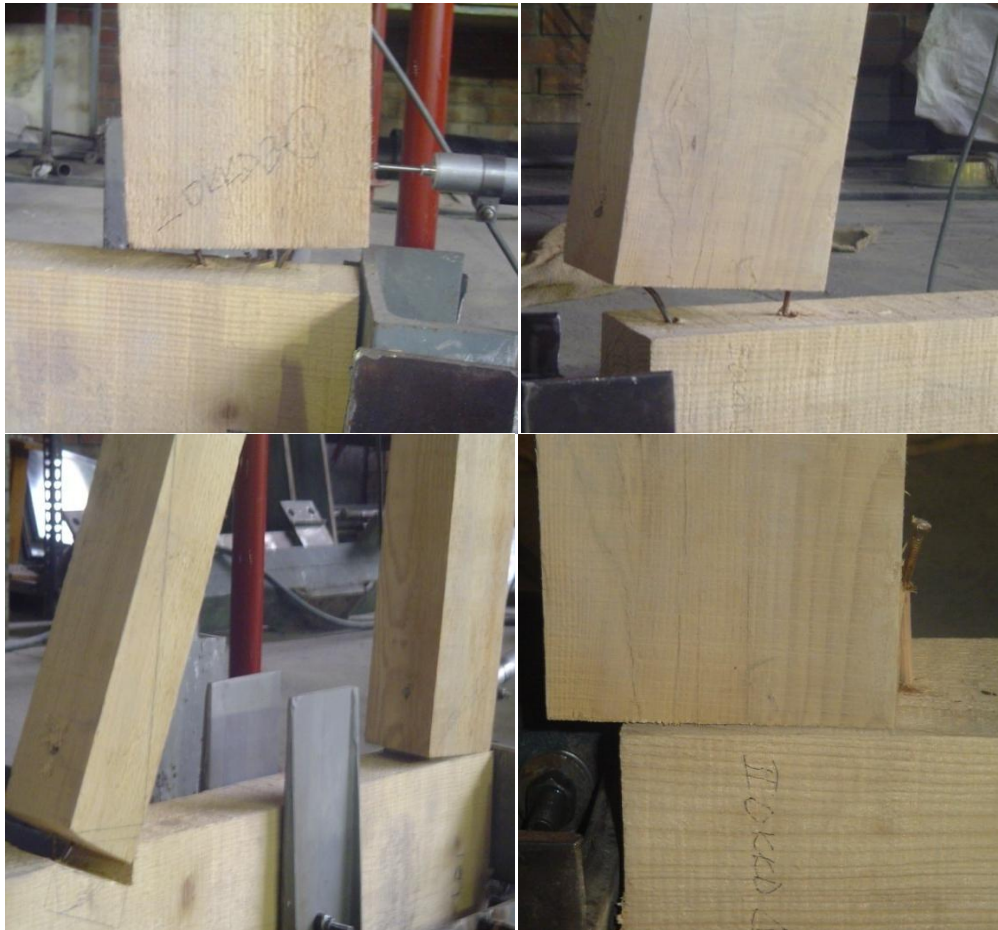
Figure 118: Examples to joint dilatation

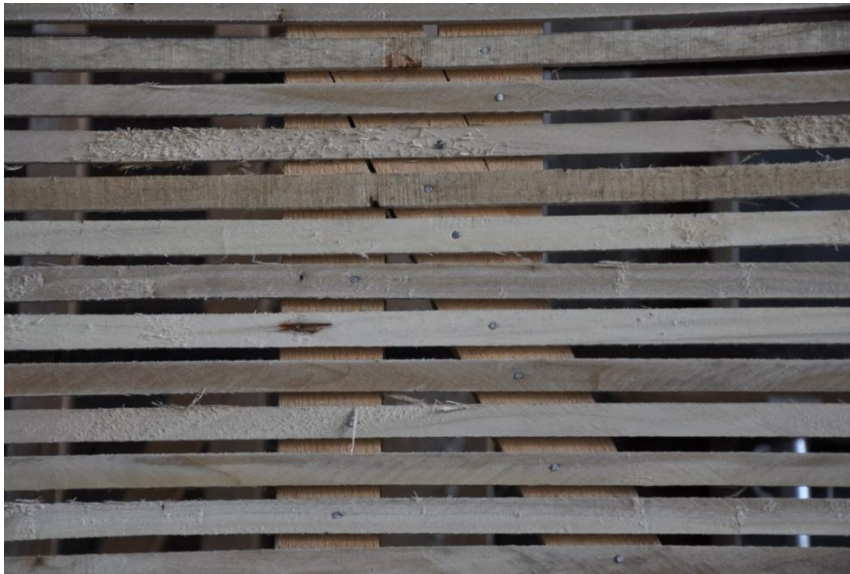
Figure 119: *Bağdadi* covering

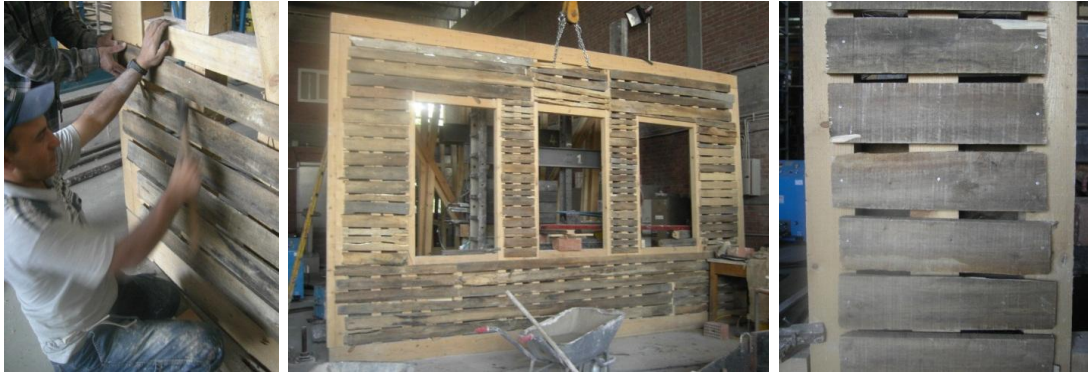
Figure 127: Nailing of laths

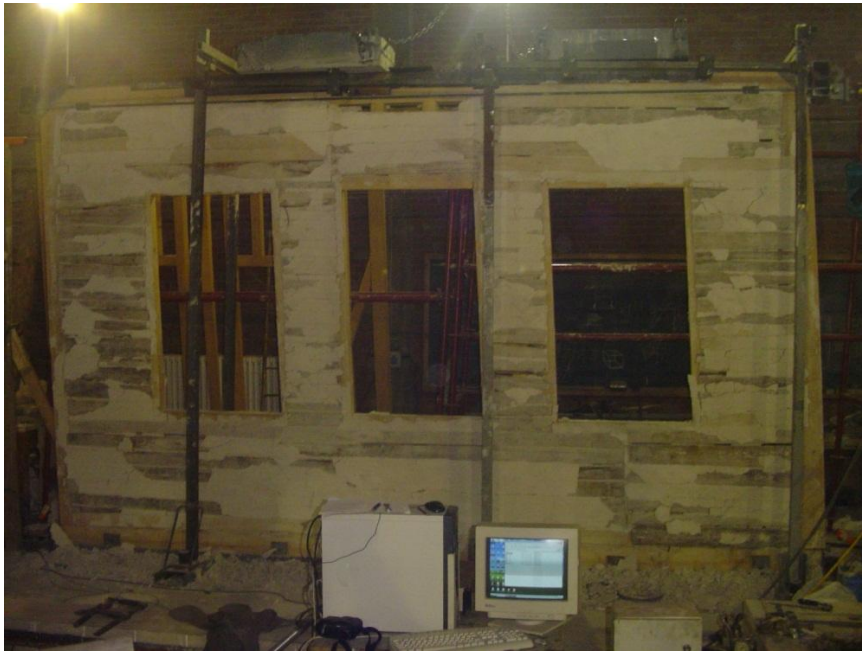
Figure 131: Frame#6 with infill after the test

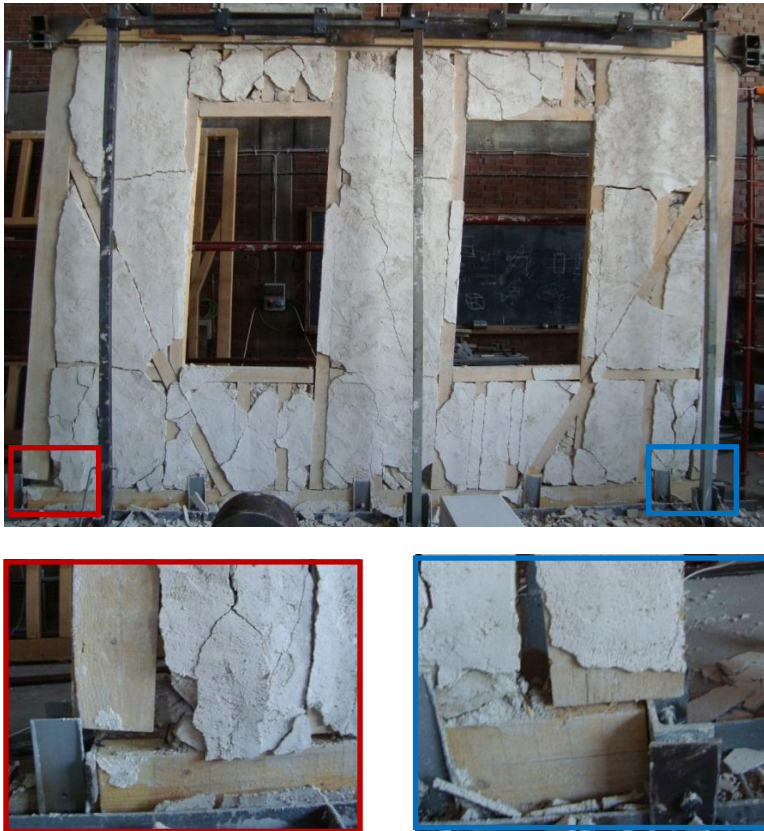
Figure 143: Frame#7 with infill after the test

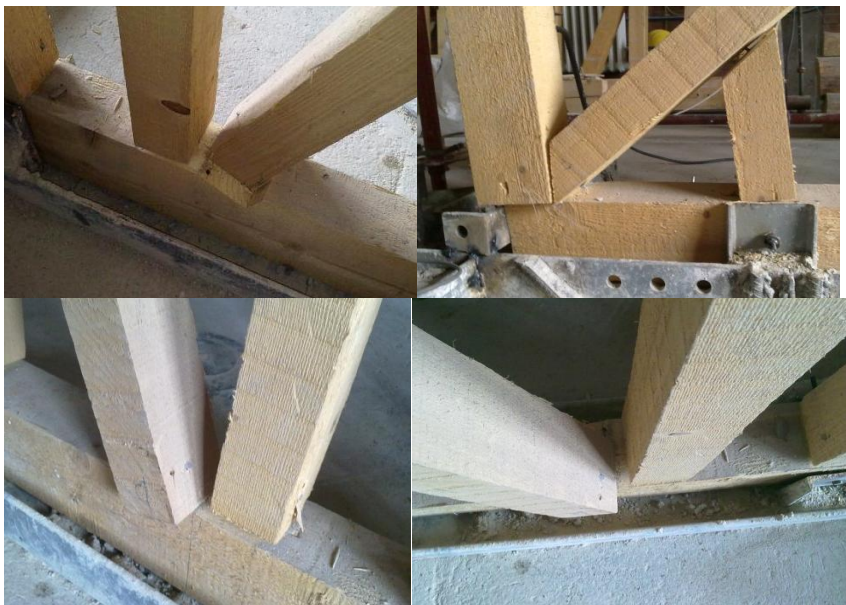
Figure 150: Examples to out-of-plane displacements occurred at the connections after the testing of Frame#8

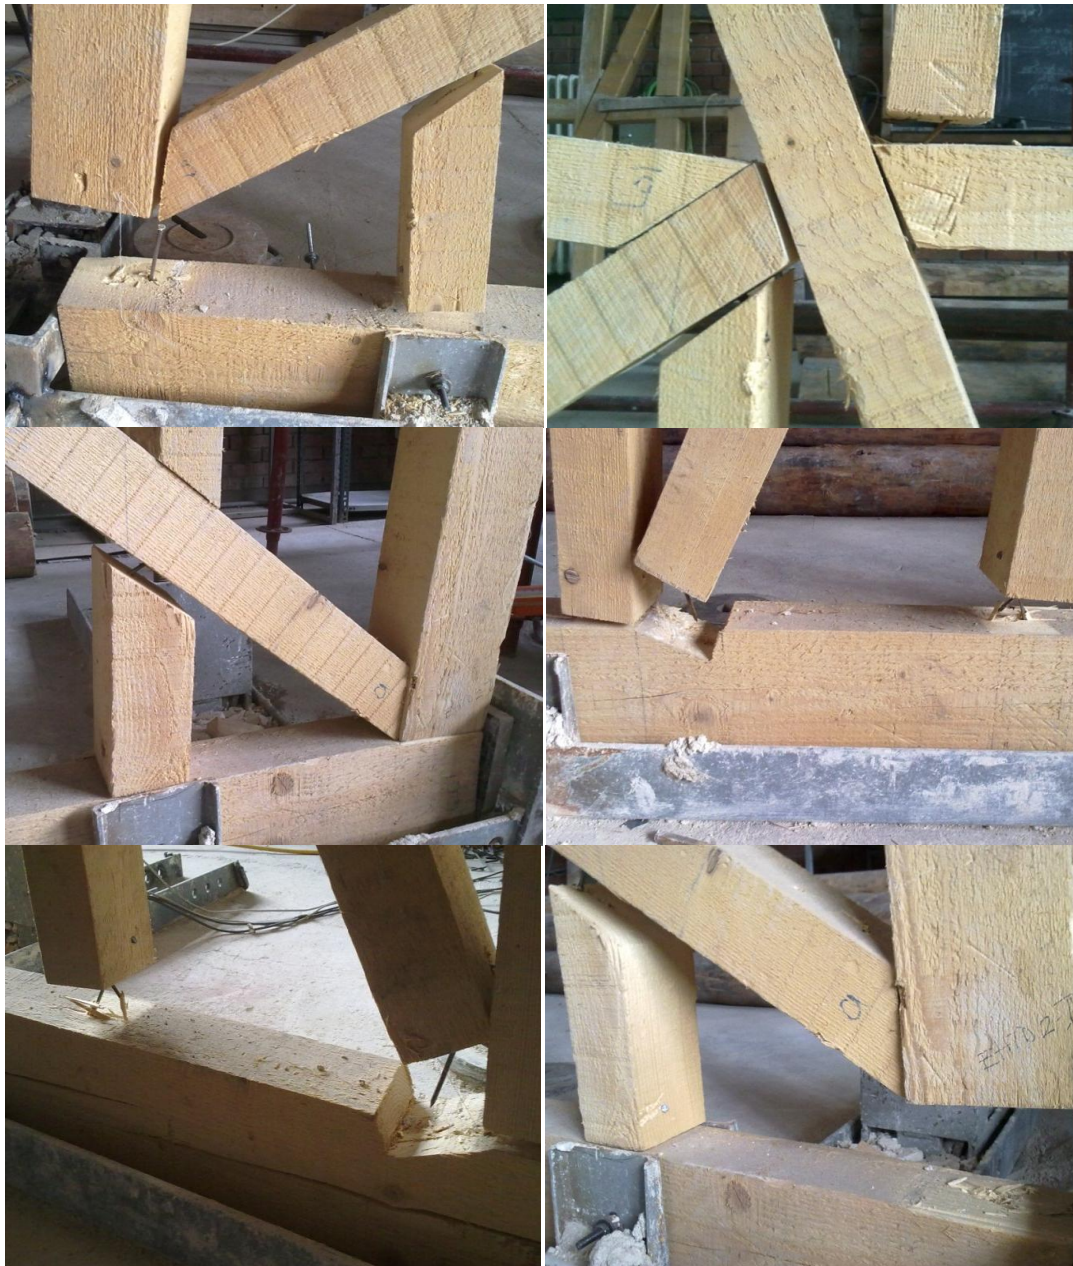
Figure 151: Examples to connection dilatations observed during the testing of Frame#8

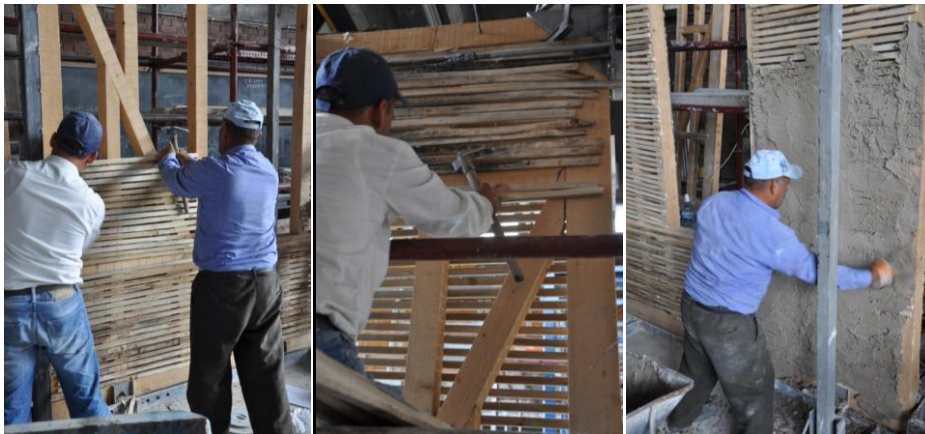
Figure 153: *Bağdadi* covering and plastering

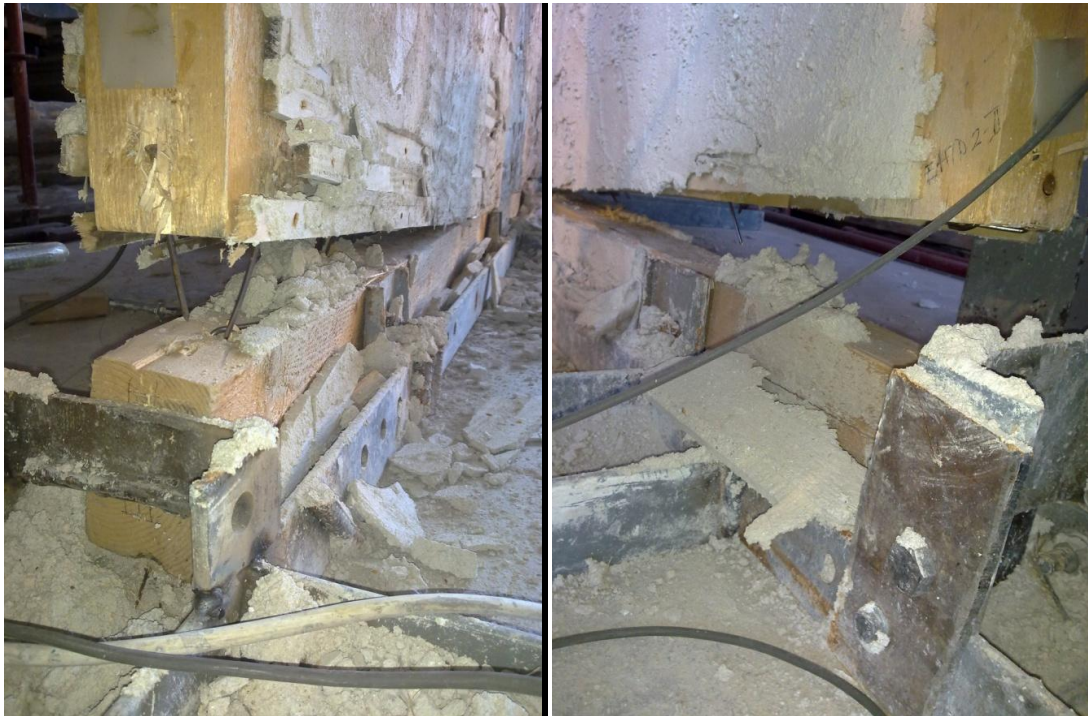
Figure 156: Examples to connection failures observed during the testing of Frame#8 with *bağdadi* covering

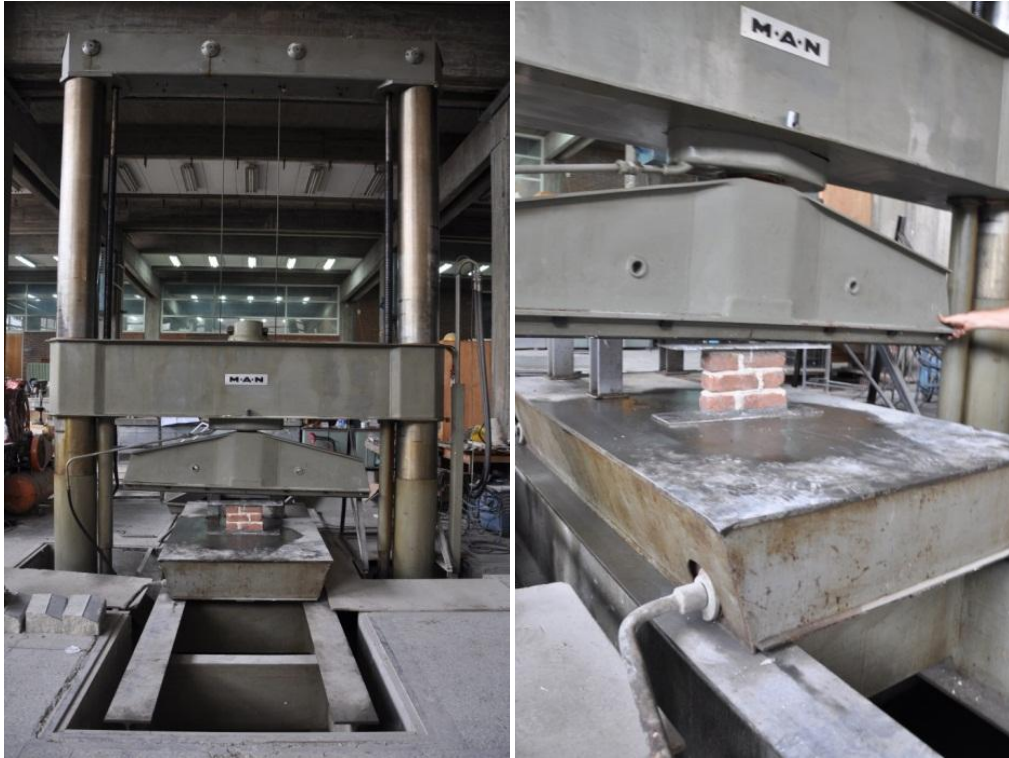
Figure 182: The equipment where compression tests were achieved

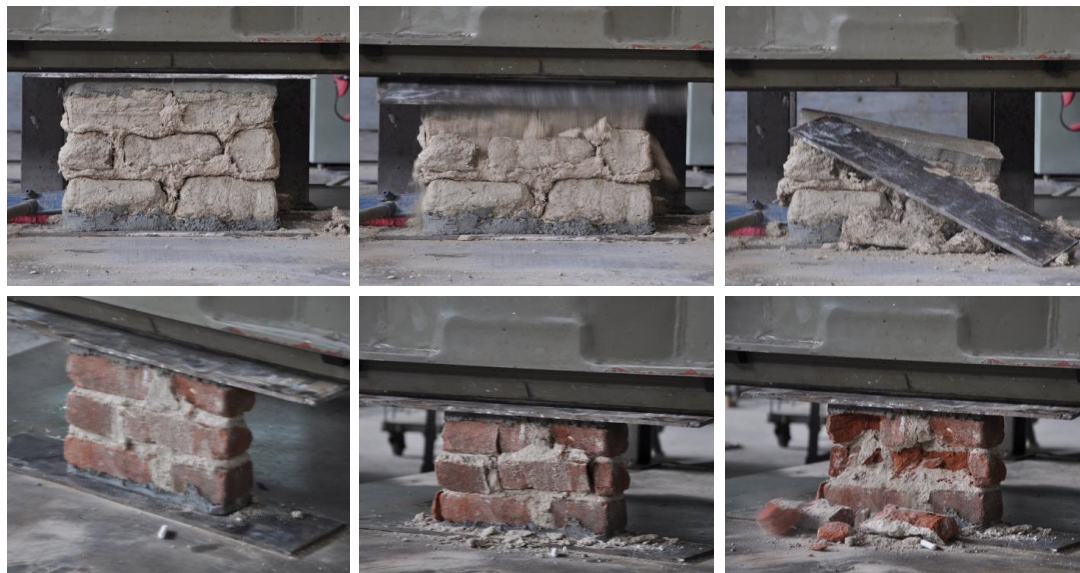
Figure 183: Two examples to the failures of adobe and brick masonry samples under compression

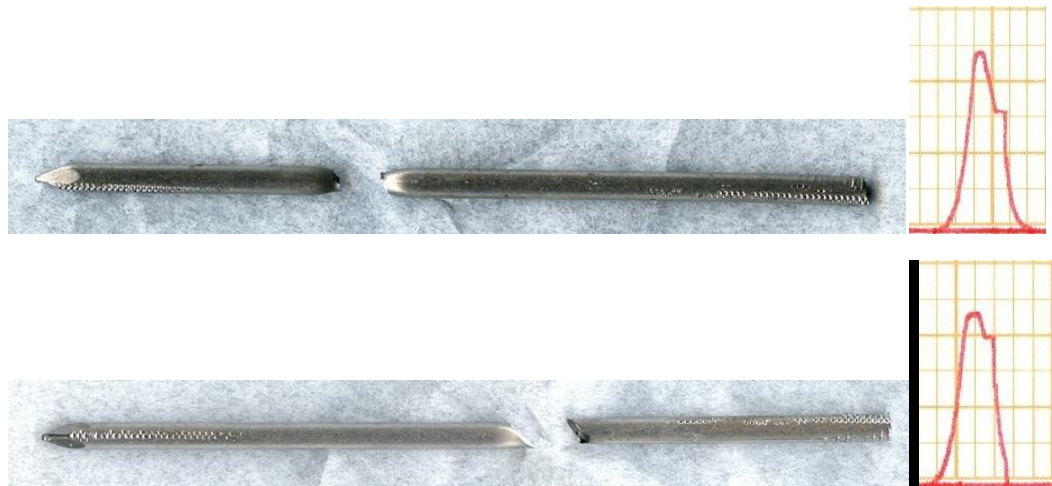
Figure 184: Nails after tension test

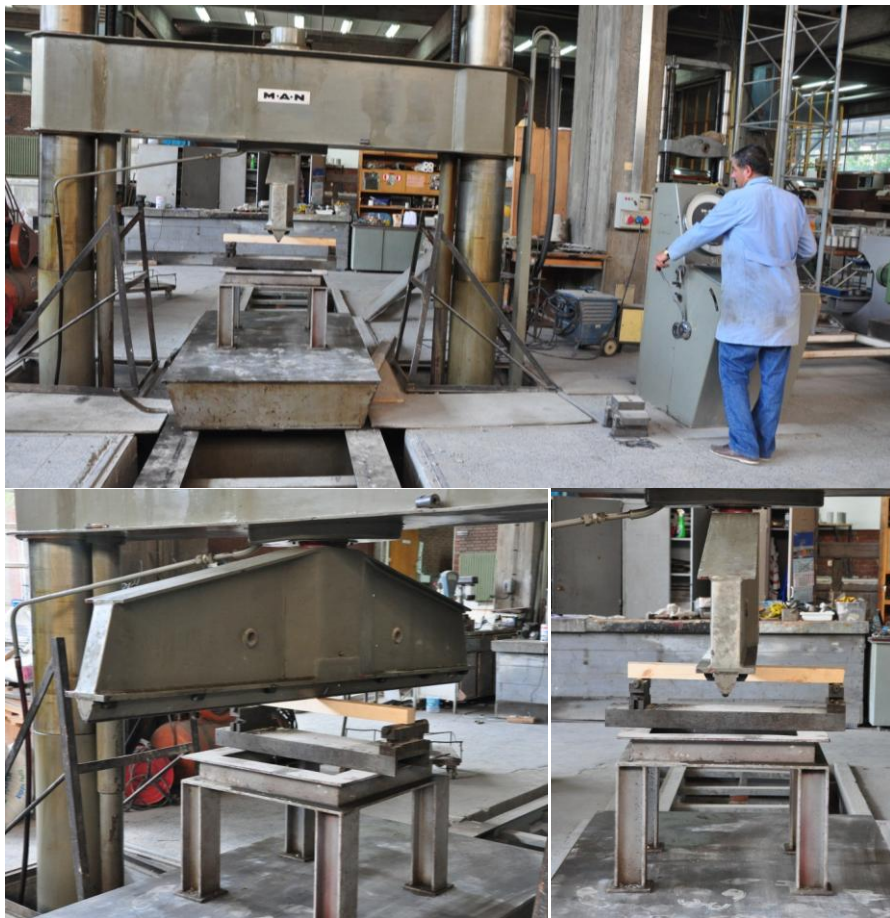
Figure 194: Overall view of the instrument, where bending tests were carried out

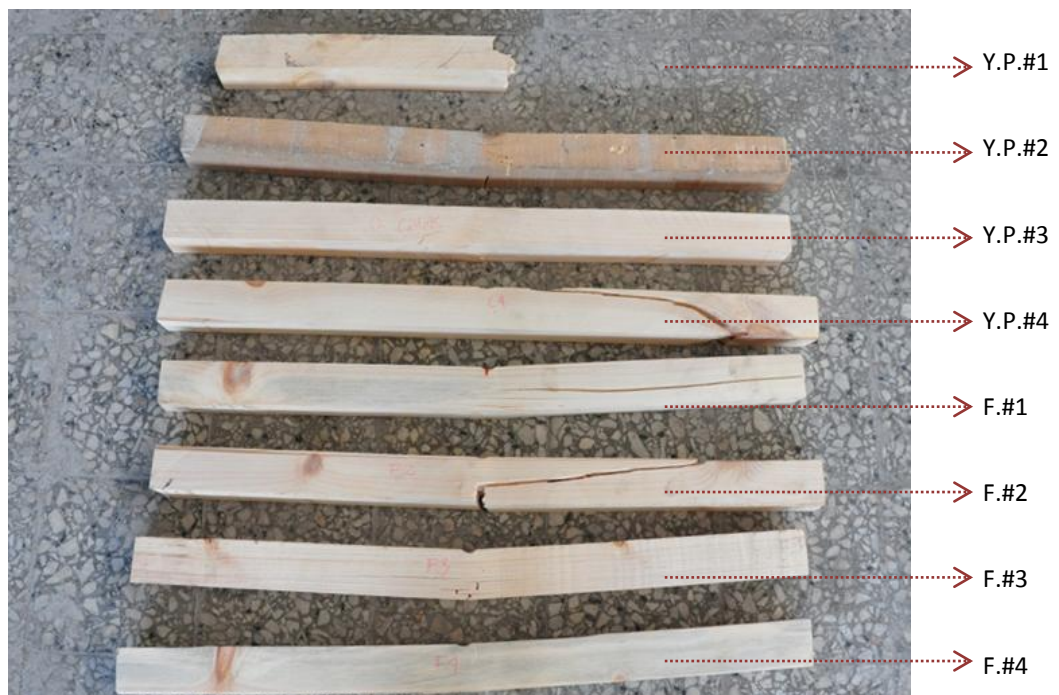
Figure 198: Specimens after testing

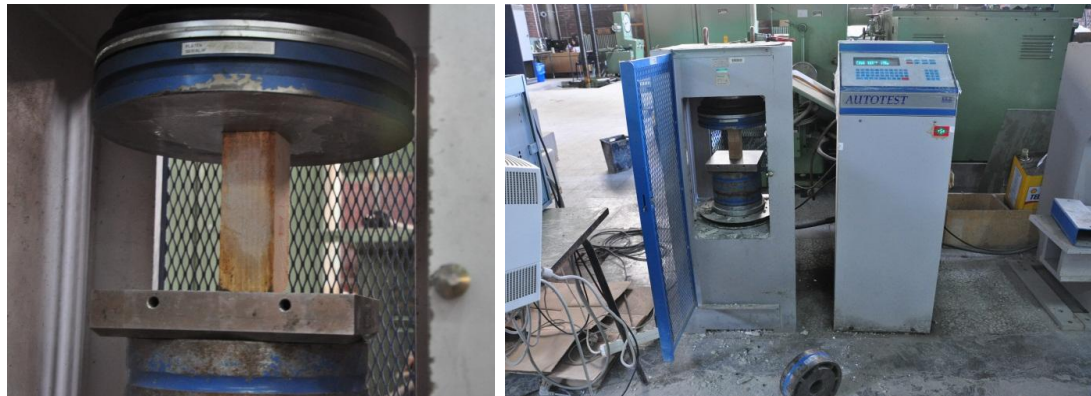
Figure 200: Views of the instrument, where compression tests were carried out
