INTEGRATION OF THE ROMAN REMAINS IN ULUS ANKARA WITHIN THE CURRENT  
URBAN CONTEXT

A THESIS SUBMITTED TO  
THE GRADUATE SCHOOL OF NATURAL AND APPLIED SCIENCES  
OF  
MIDDLE EAST TECHNICAL UNIVERSITY

IN PARTIAL FULFILLMENT OF THE REQUIREMENTS  
FOR  
THE DEGREE OF MASTER OF SCIENCE IN RESTORATION  
IN  
ARCHITECTURE

FEBRUARY 2012

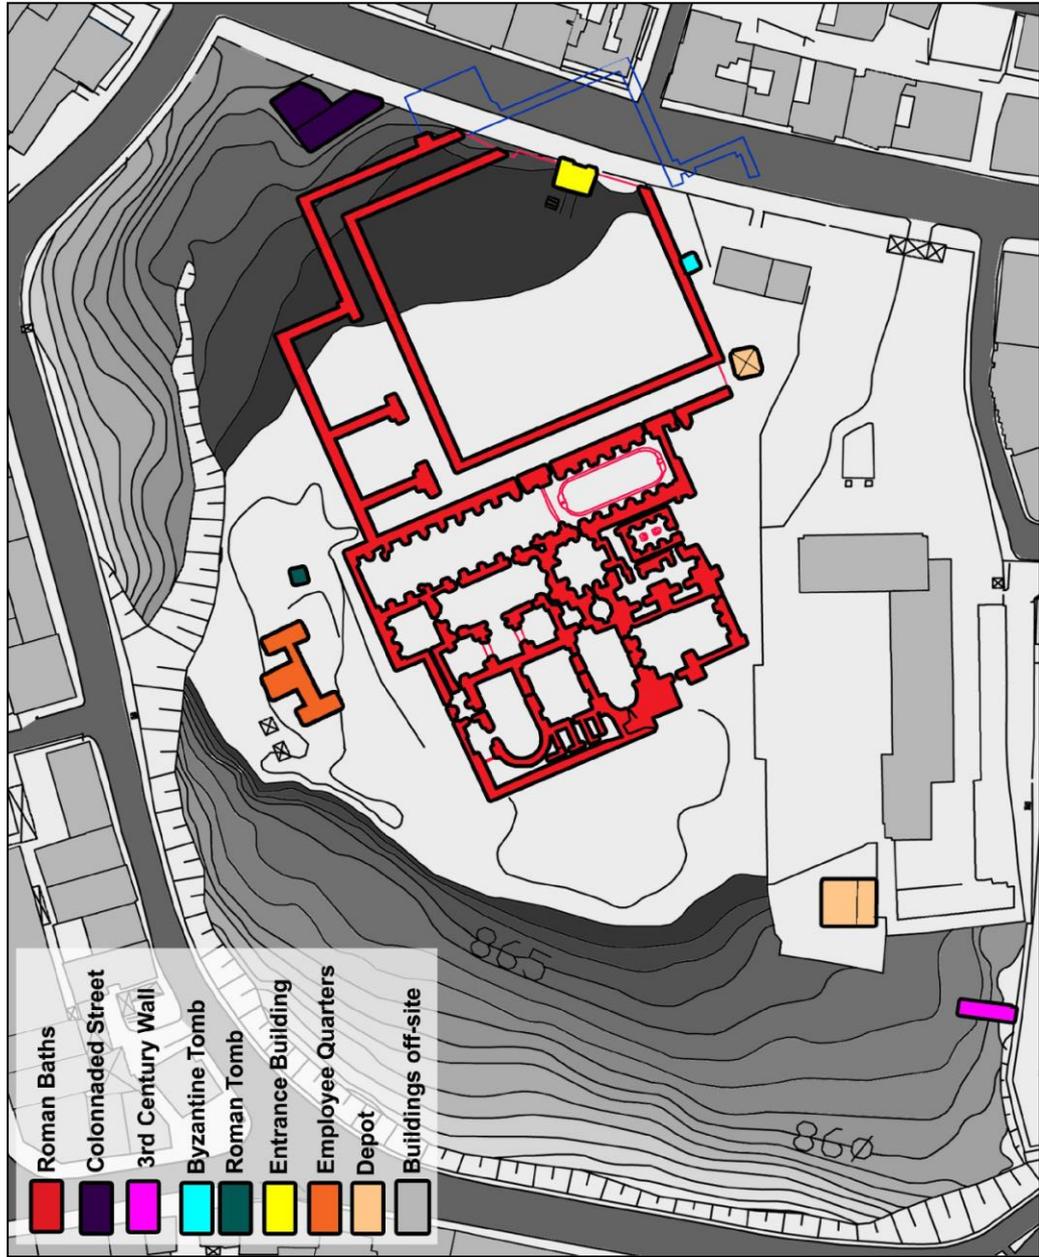
Figure 23: Components of the Roman Baths open Air Museum

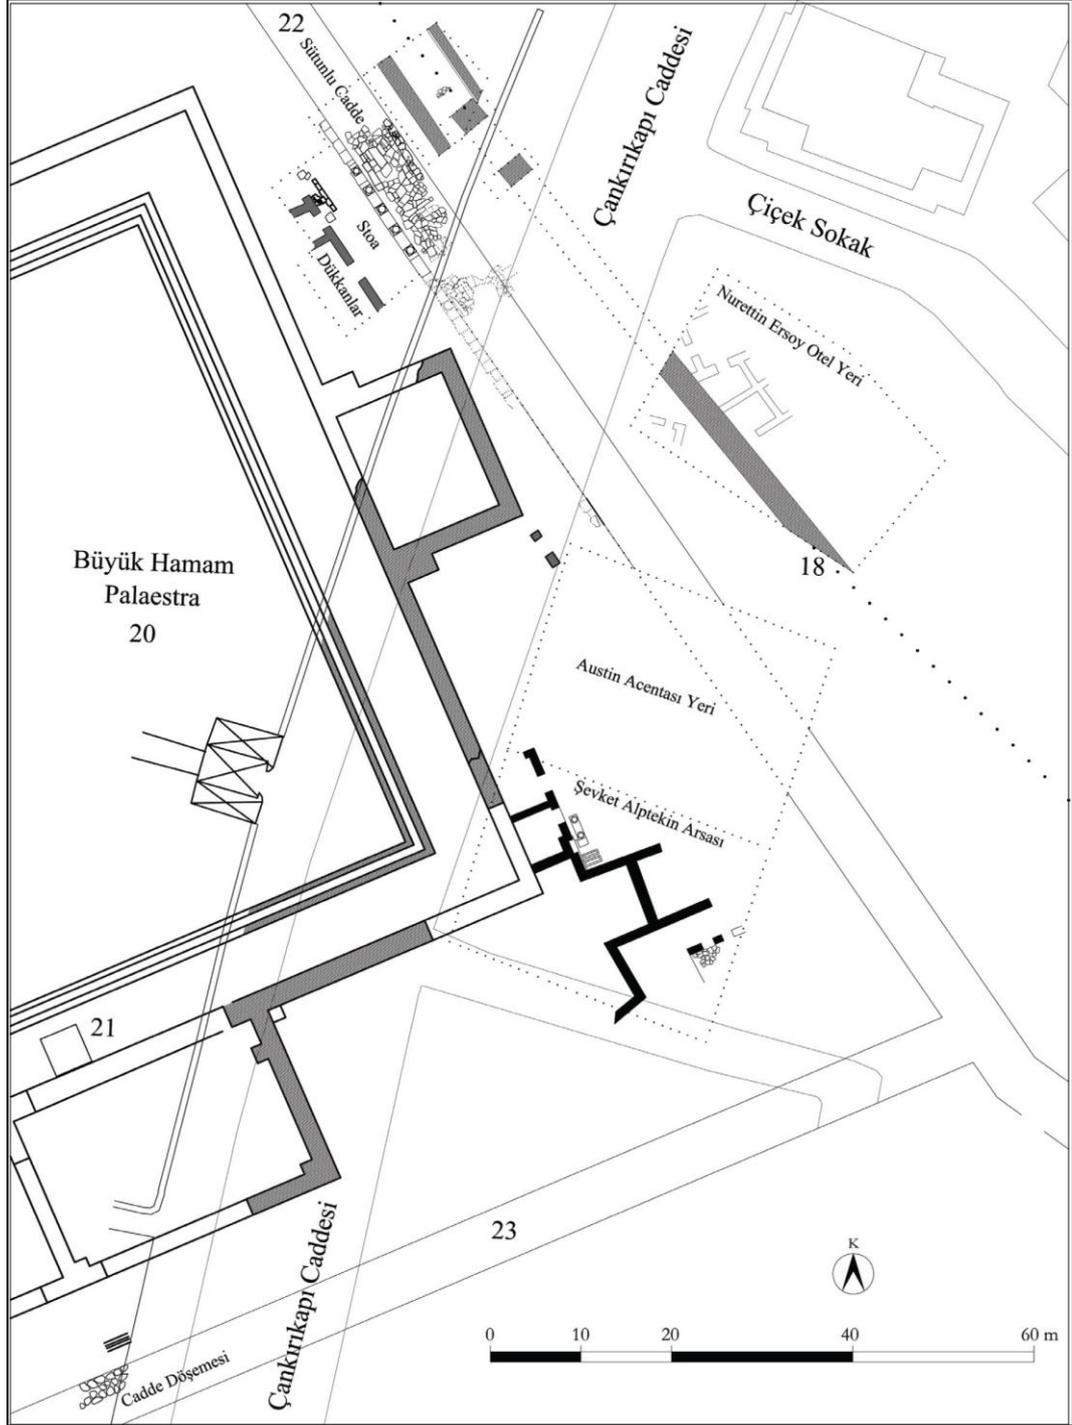
**Figure 26:** Plan of the southeast corner of the palaestra, under Çankırı Street (Kadioğlu; Görkay, 2007)

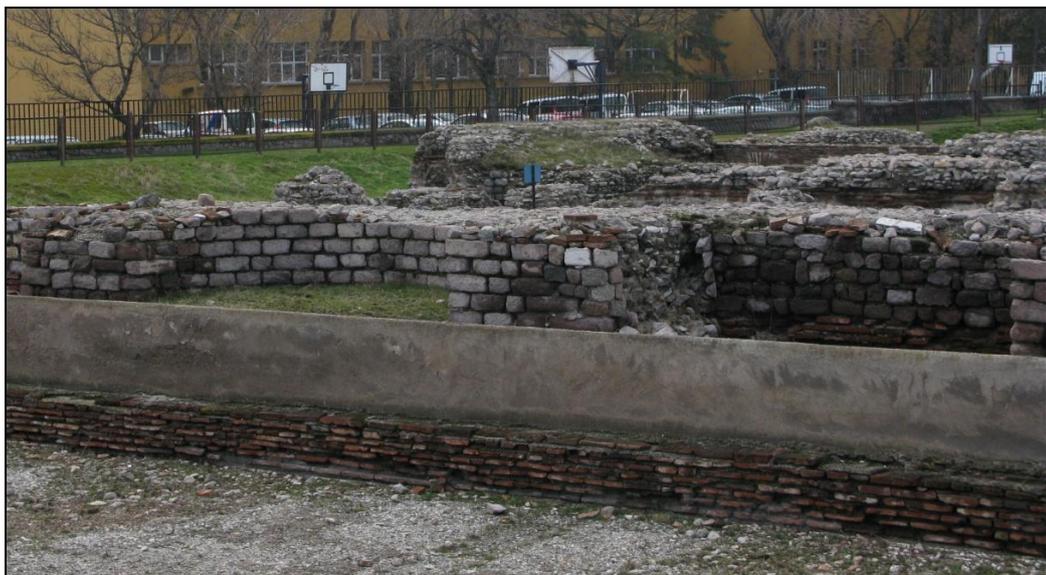
**Figure 28:** The visual decay forms visible in the site (author February, 2011)

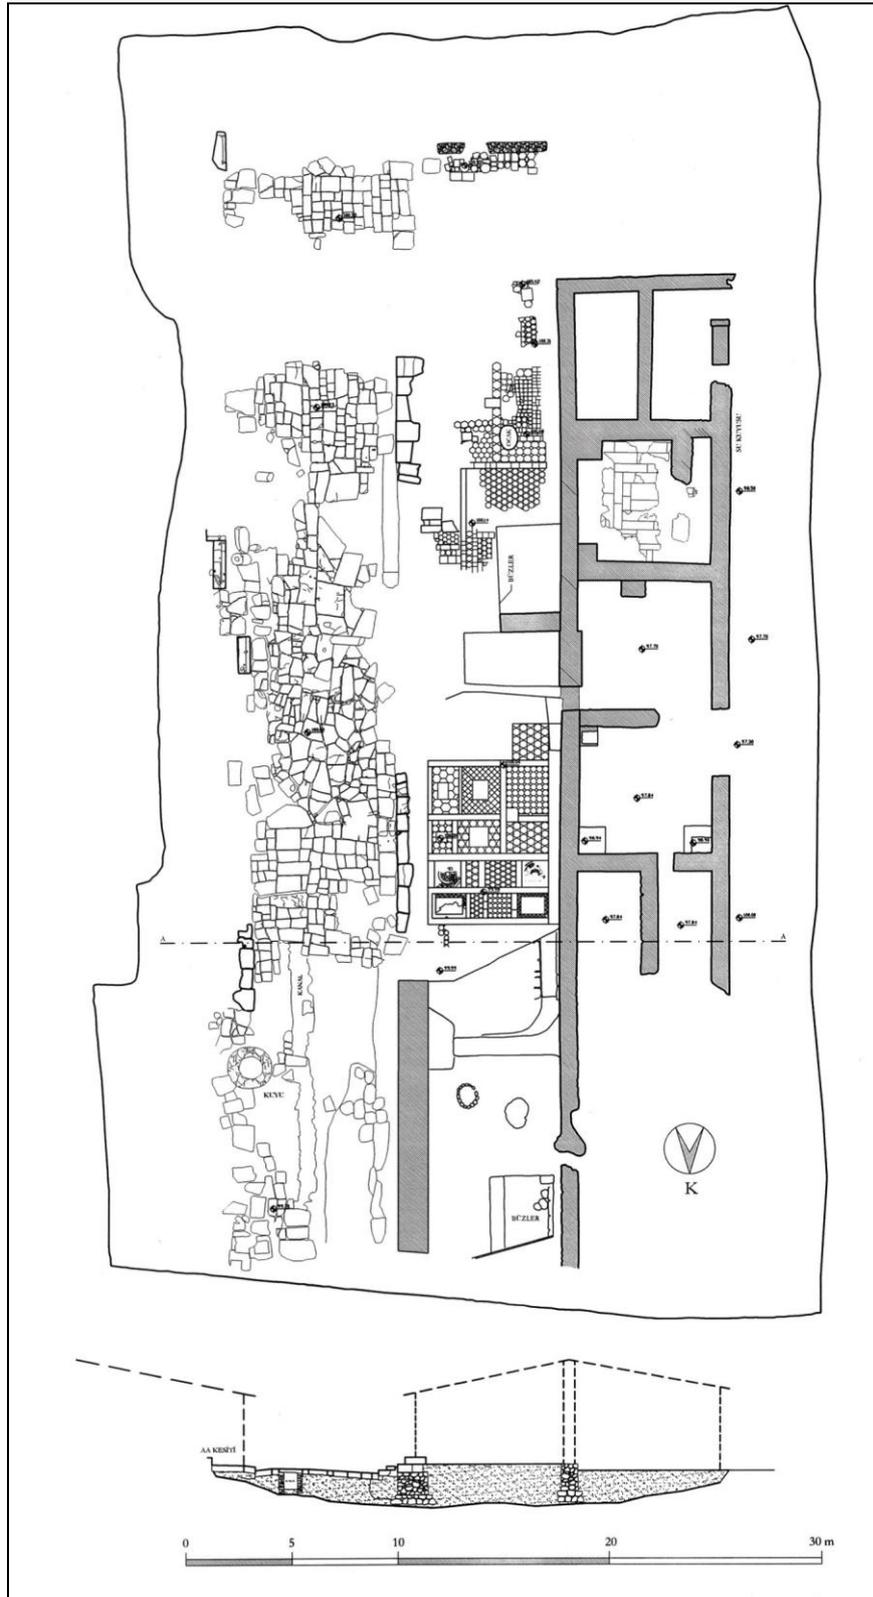
**Figure 37:** Measured drawings of the remains of Cardo Maximus (Kadıoğlu, Görkay, 2007)

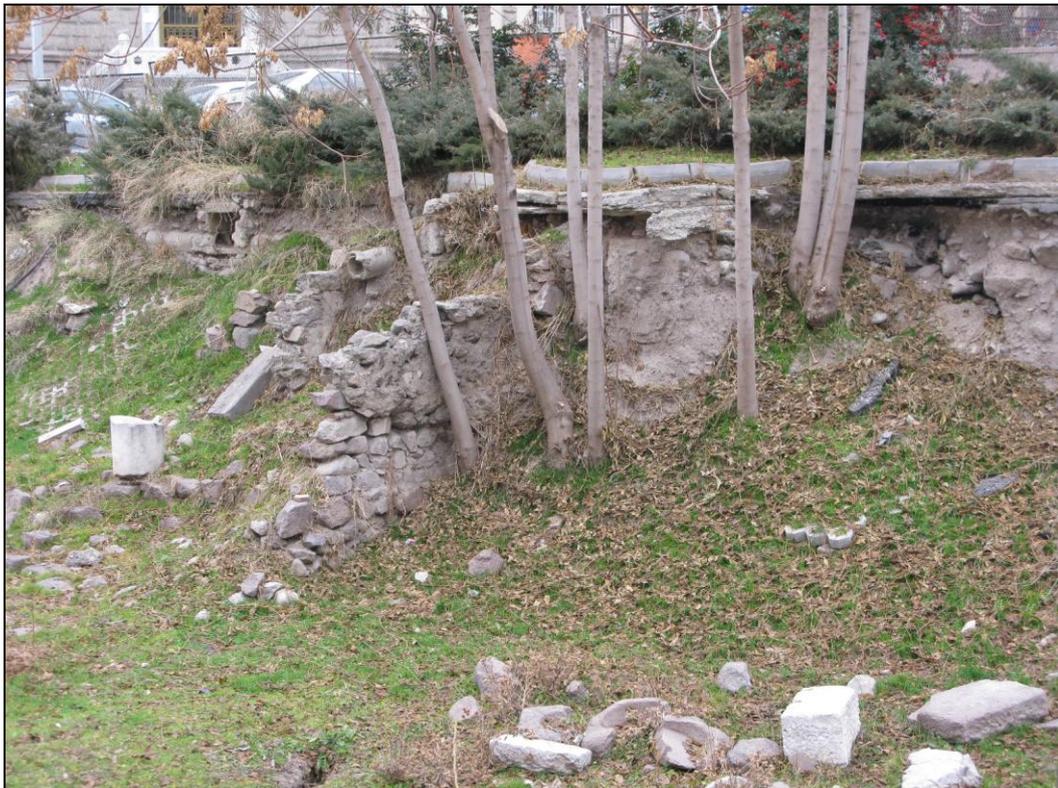
**Figure 38:** The wall remains and the biological growth on the site (author December, 2011)

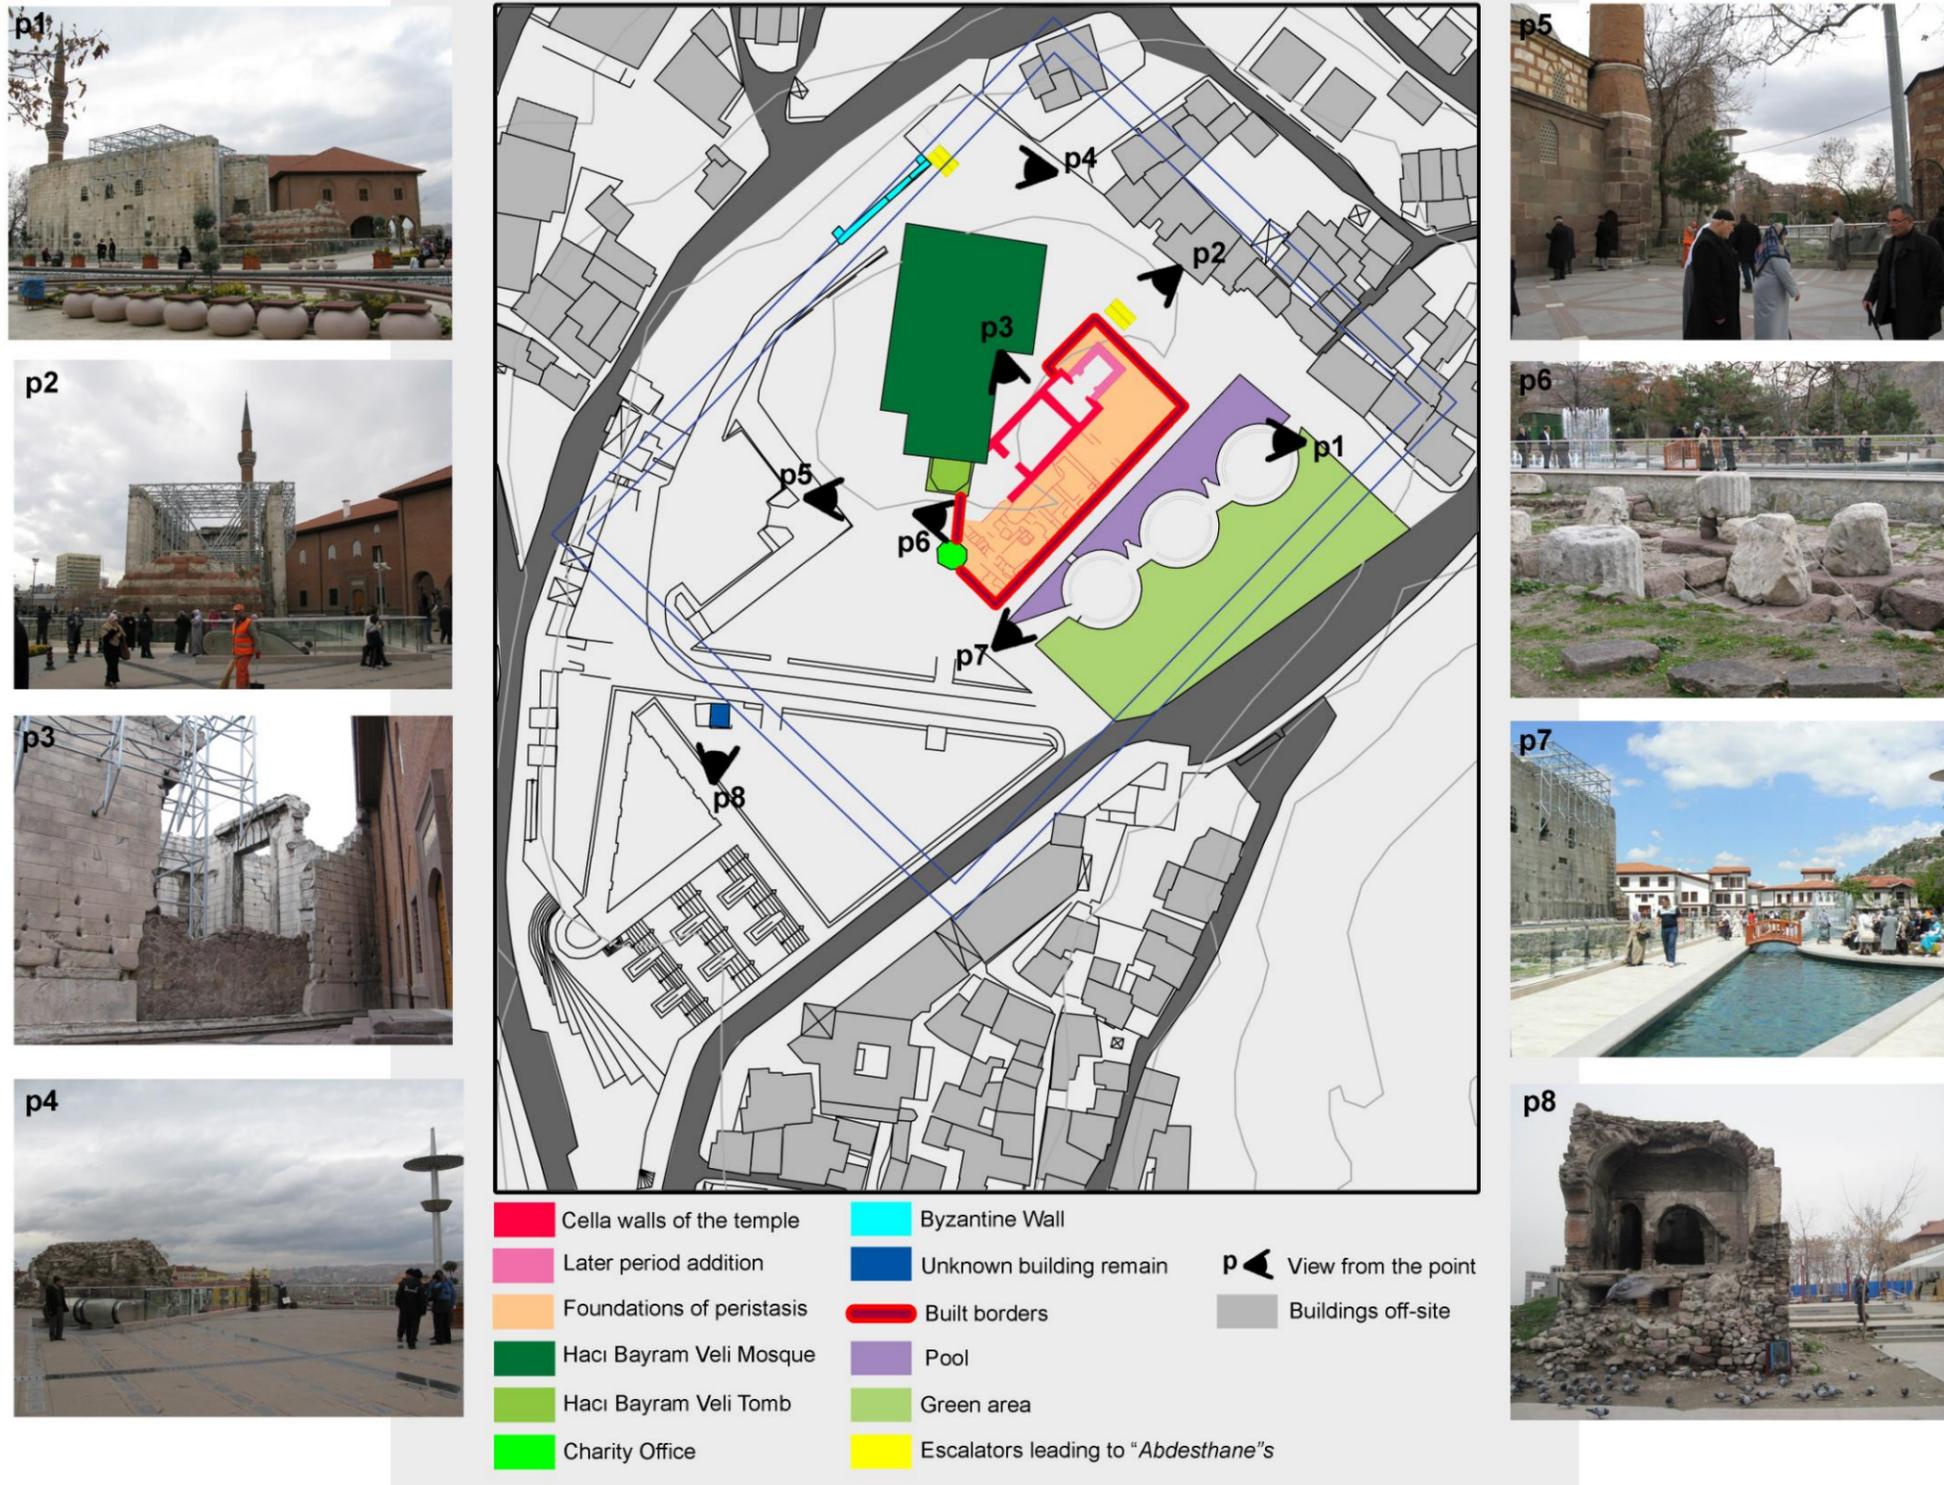
Figure 51: Components of Roma and Augustus Temple and Hacı Bayram Square

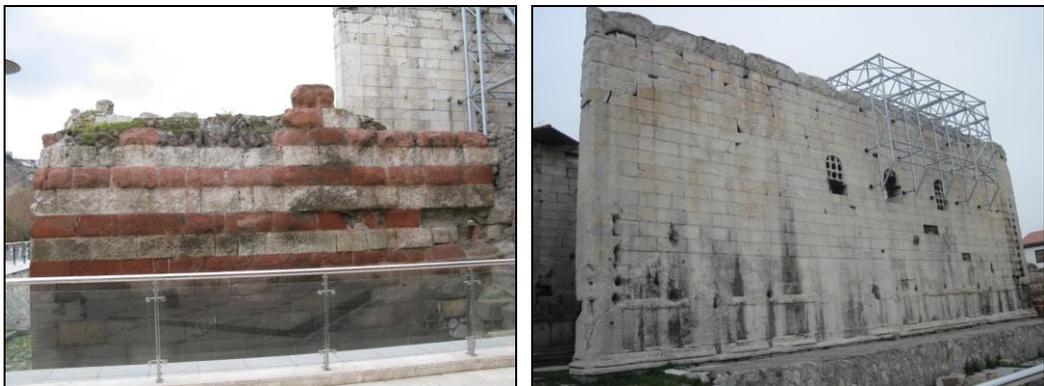
**Figure 52:** Decay forms on the northeast end of the edifice (left) and on the southeast wall of the cella (right) (author January, 2011)

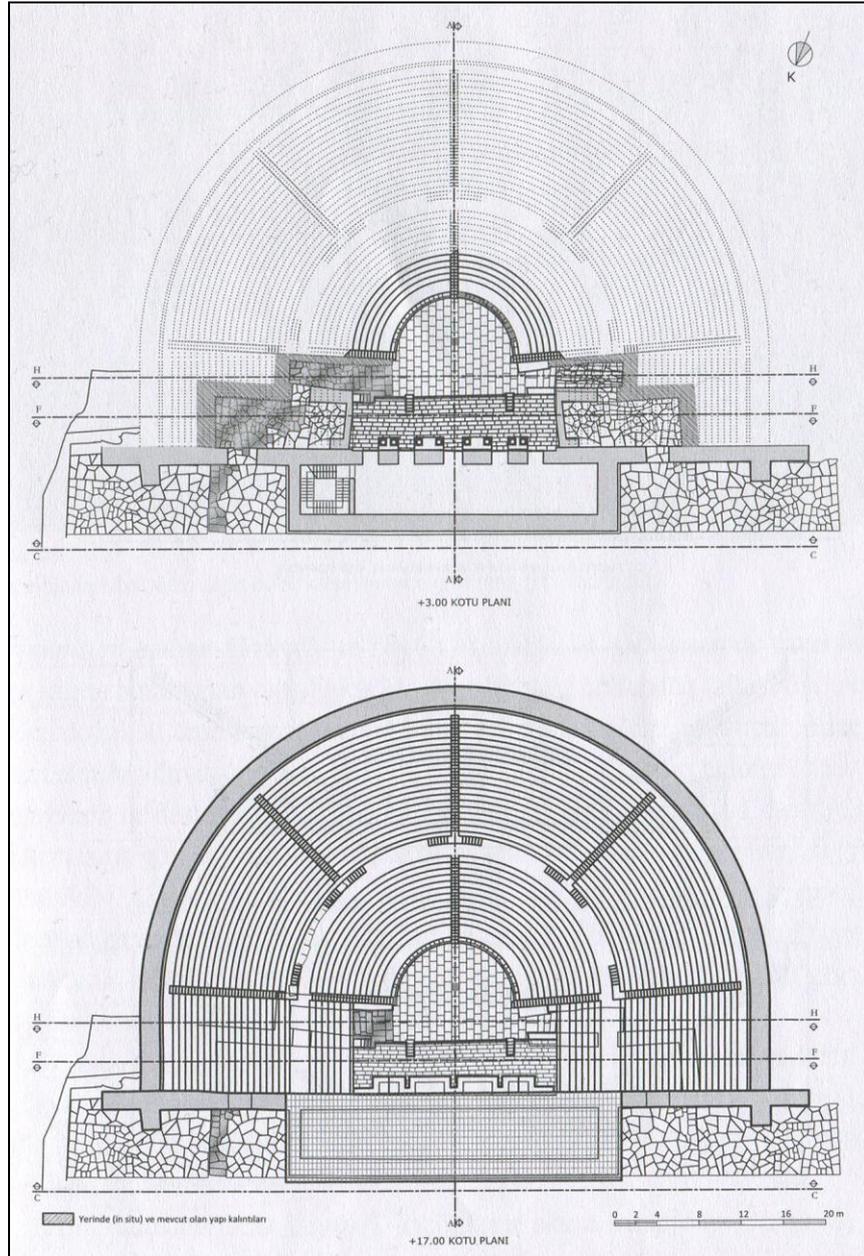
**Figure 59:** Restitution drawings of Roman Theatre (Kadioğlu; Görkay & Mitchell, 2011: 119).

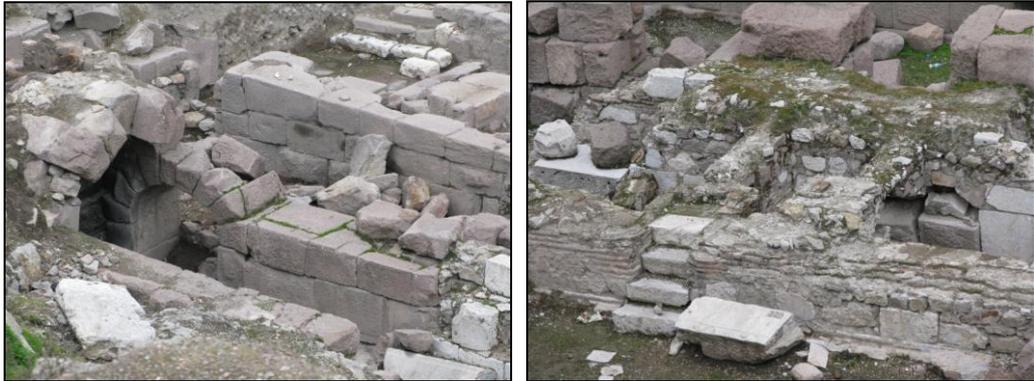
**Figure 60:** State of preservation of Roman theatre (author December, 2011)

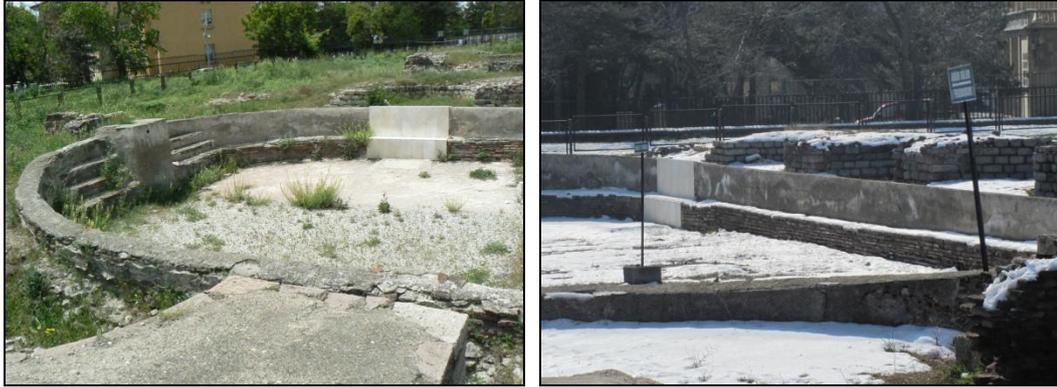
**Figure 62:** The visible deteriorations on the walls of the baths building and the former conservation interventions with cement. (author, 2011)

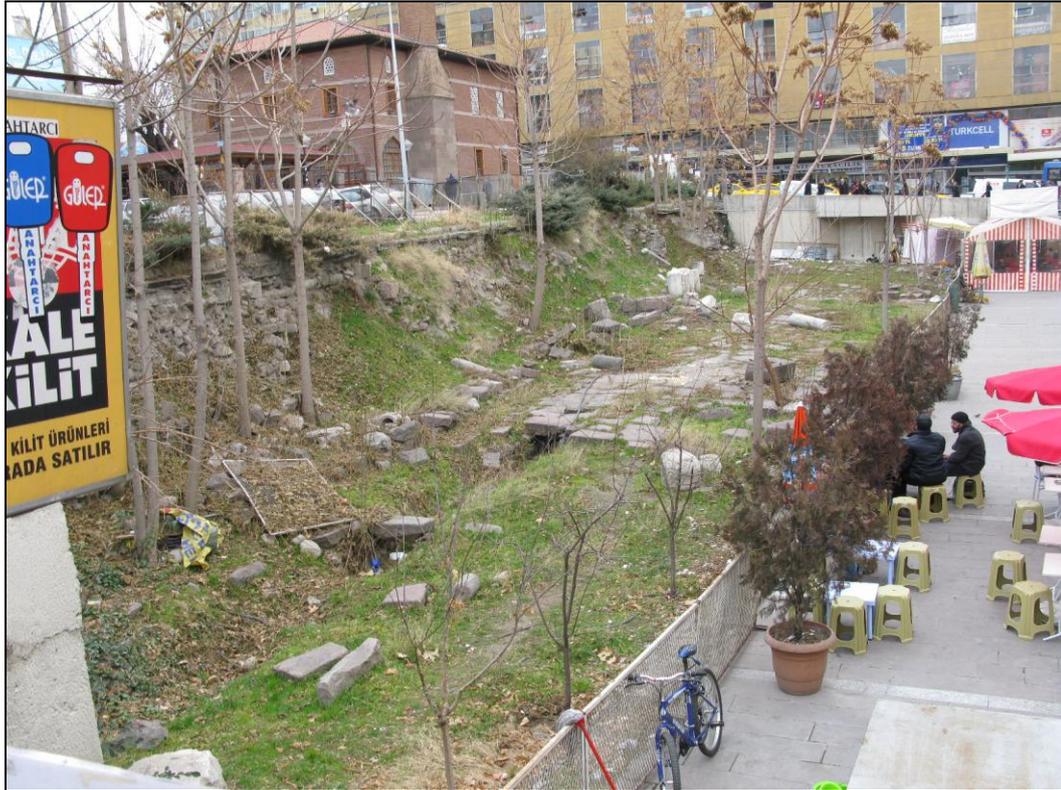
**Figure 65:** Cardo Maximus with the deterioration factors it faces (author December, 2011)

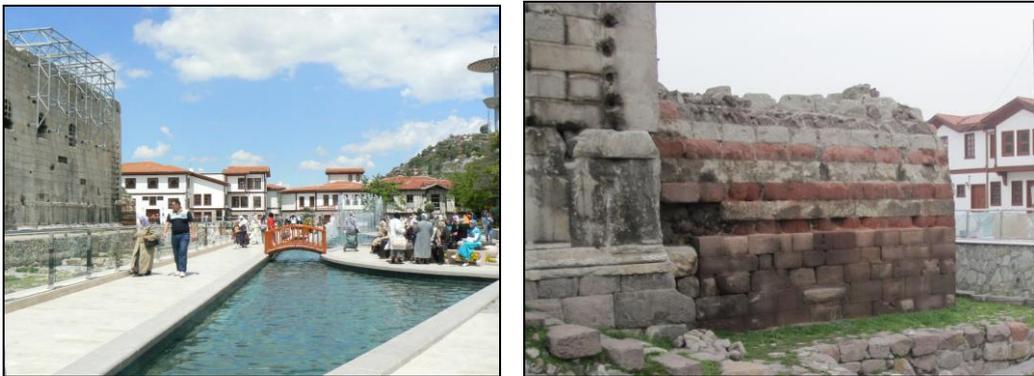
**Figure 68:** The pool next to the temple (left) (author May, 2011), Rising damp on the northern part of the temple (right) (author January, 2011)

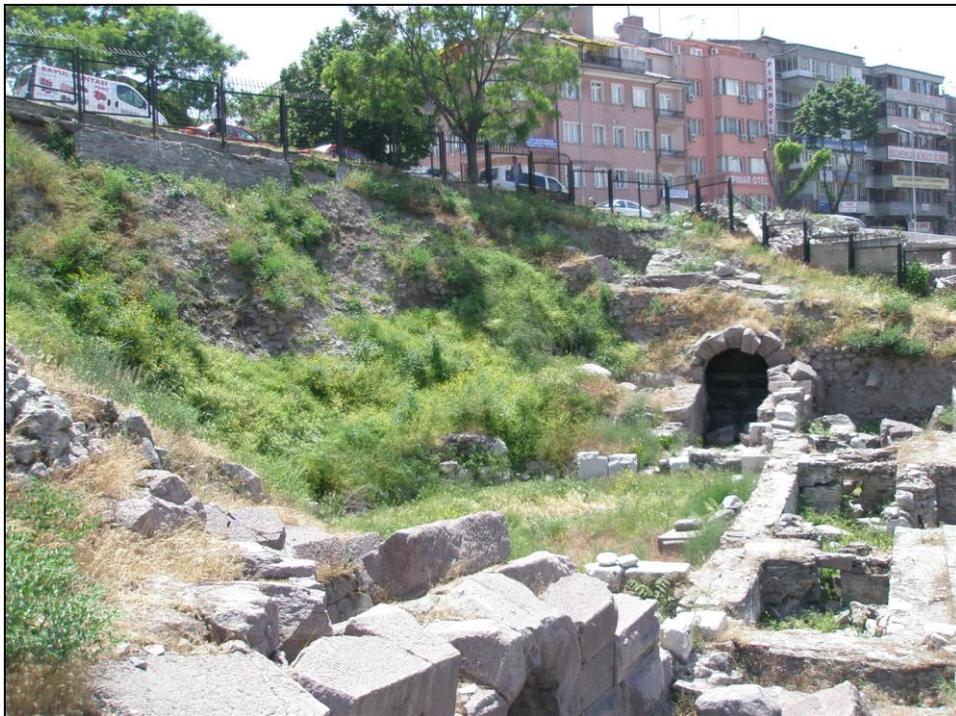
**Figure 70:** The biological growth and the uncontrolled slope on the southern edge of the archaeological site (author May, 2010)
