STRUCTURAL MODELLING, ANALYSIS, EVALUATION AND STRENGTHENING  
OF PERGE SOUTHERN GATE HELLENISTIC TOWERS

A THESIS SUBMITTED TO  
THE GRADUATE SCHOOL OF NATURAL AND APPLIED SCIENCES  
OF  
MIDDLE EAST TECHNICAL UNIVERSITY

IN PARTIAL FULFILLMENT OF THE REQUIREMENTS  
FOR  
THE DEGREE OF THE MASTER OF SCIENCE  
IN  
RESTORATION IN ARCHITECTURE

FEBRUARY 2012

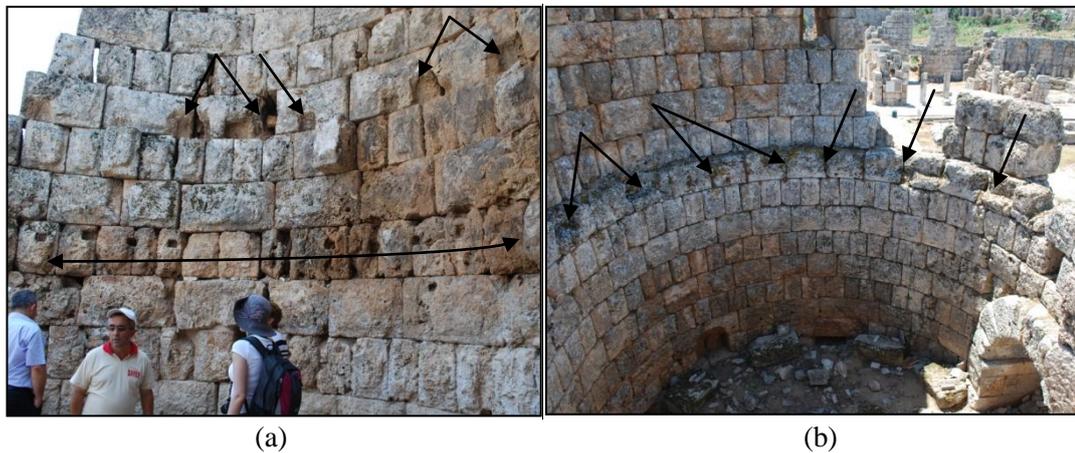
**Figure 2.11** a) Square Holes on the 11<sup>th</sup> & 16<sup>th</sup> Stone Courses of the Eastern View b) Square Sockets carved at the 16<sup>th</sup> Stone Courses of the Eastern Tower

In both towers ~5 cm deep square holes were found in the 11<sup>th</sup> course of the Eastern Tower and the 16<sup>th</sup> course of the Western Tower. The holes follow a systematic order, being located ~50 cm away from each other. The same pattern can be found in the lower courses of both towers, although featuring smaller square holes, laid in a denser pattern, and are thought to have been part of an internal timber bearing system for the towers.

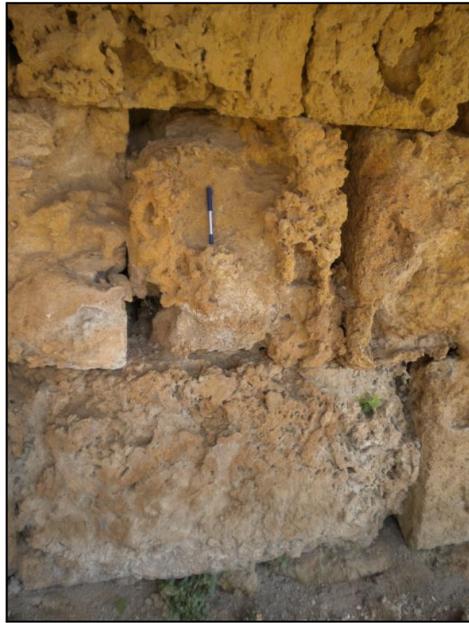
**Figure 2.16** Surface Decay at Lower Levels of the Inner Surface of Tower Walls due to Continuous Wetting Drying Cycles (Topal, 2011).

Schmit Hammer testing carried out at site by Topal (2011) revealed that the ratio of strength values between the lower and higher levels of towers was nearly 2:3. This decay, related to water exposure, is seen mostly on the surface of the wall stone elements. Therefore, this cannot be deduced as the sole cause of structural decay. However, it is known that the lower surfaces of the wall may be subjected to a high concentration of stress during lateral loading; and consequently it can be assumed that the structural vulnerability is based on a combination of both material decay and stress distribution due to the load-bearing system.

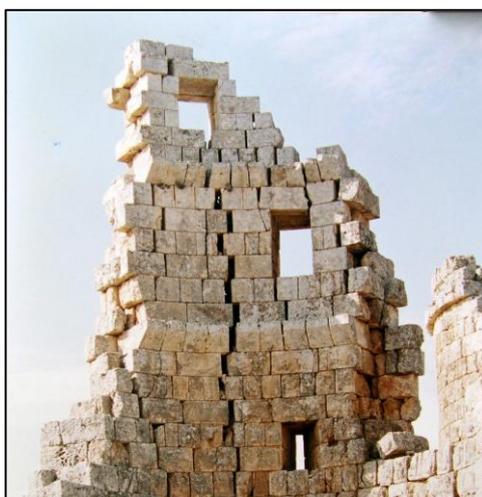
**Figure 2.17** A Vertical Crack at the Eastern Tower Following a Pattern in which Non-Successful Vertical Staggering at Stones exists. Photo by SAYKA (2002)

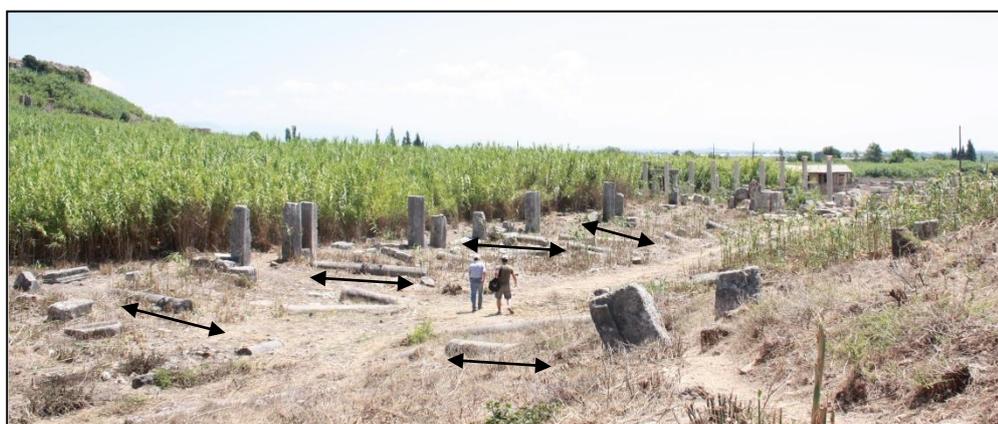
**Figure 2.18** Overturned Columns in North-South Direction at the East-West Colonnaded Street, 16.07.2010

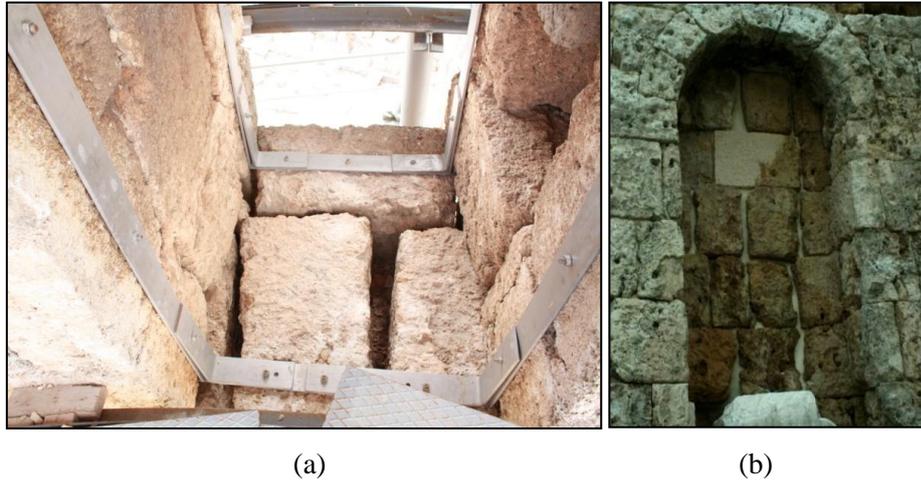
**Figure 2.22** (a) Steel Support Frame Anchored to the Inner Side of 2<sup>nd</sup> Floor Window of the Eastern Tower. (b) Consolidated Part of Courtyard Wall with Filling and Injection (SAYKA, 2009).
