A STUDY ON VALUES, PROBLEMS AND POTENTIALS OF THE
TRADITIONAL DWELLINGS IN KARABAĞLAR-MUĞLA

A THESIS SUBMITTED TO
THE GRADUATE SCHOOL OF NATURAL AND APPLIED SCIENCES
OF
MIDDLE EAST TECHNICAL UNIVERSITY

FEBRUARY 2012

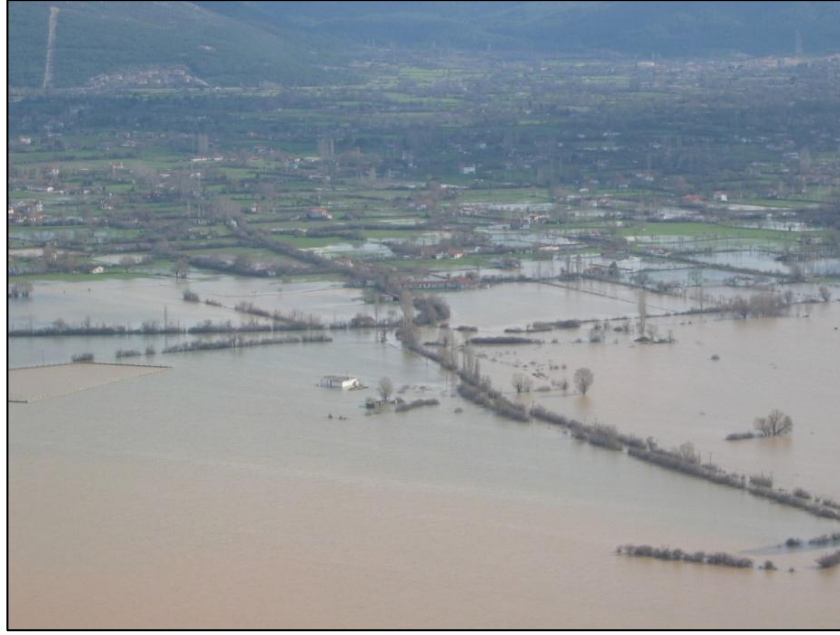
Figure 5 Photograph of the Overflowing and ponding areas-1

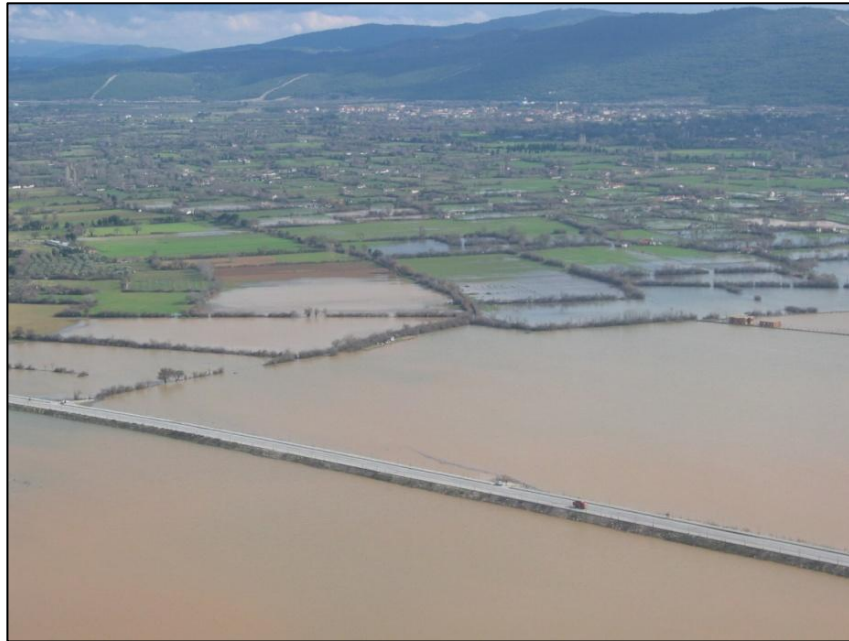
Figure 6 Photograph of the Overflowing and ponding areas⁴-2

⁴ The photographs that were taken in February 2009 from the hill adjacent to the north side of Karabağlar shows the ponding and the overflowing areas and the lot boundaries marked by the traditional boundary elements, *kesiks*.

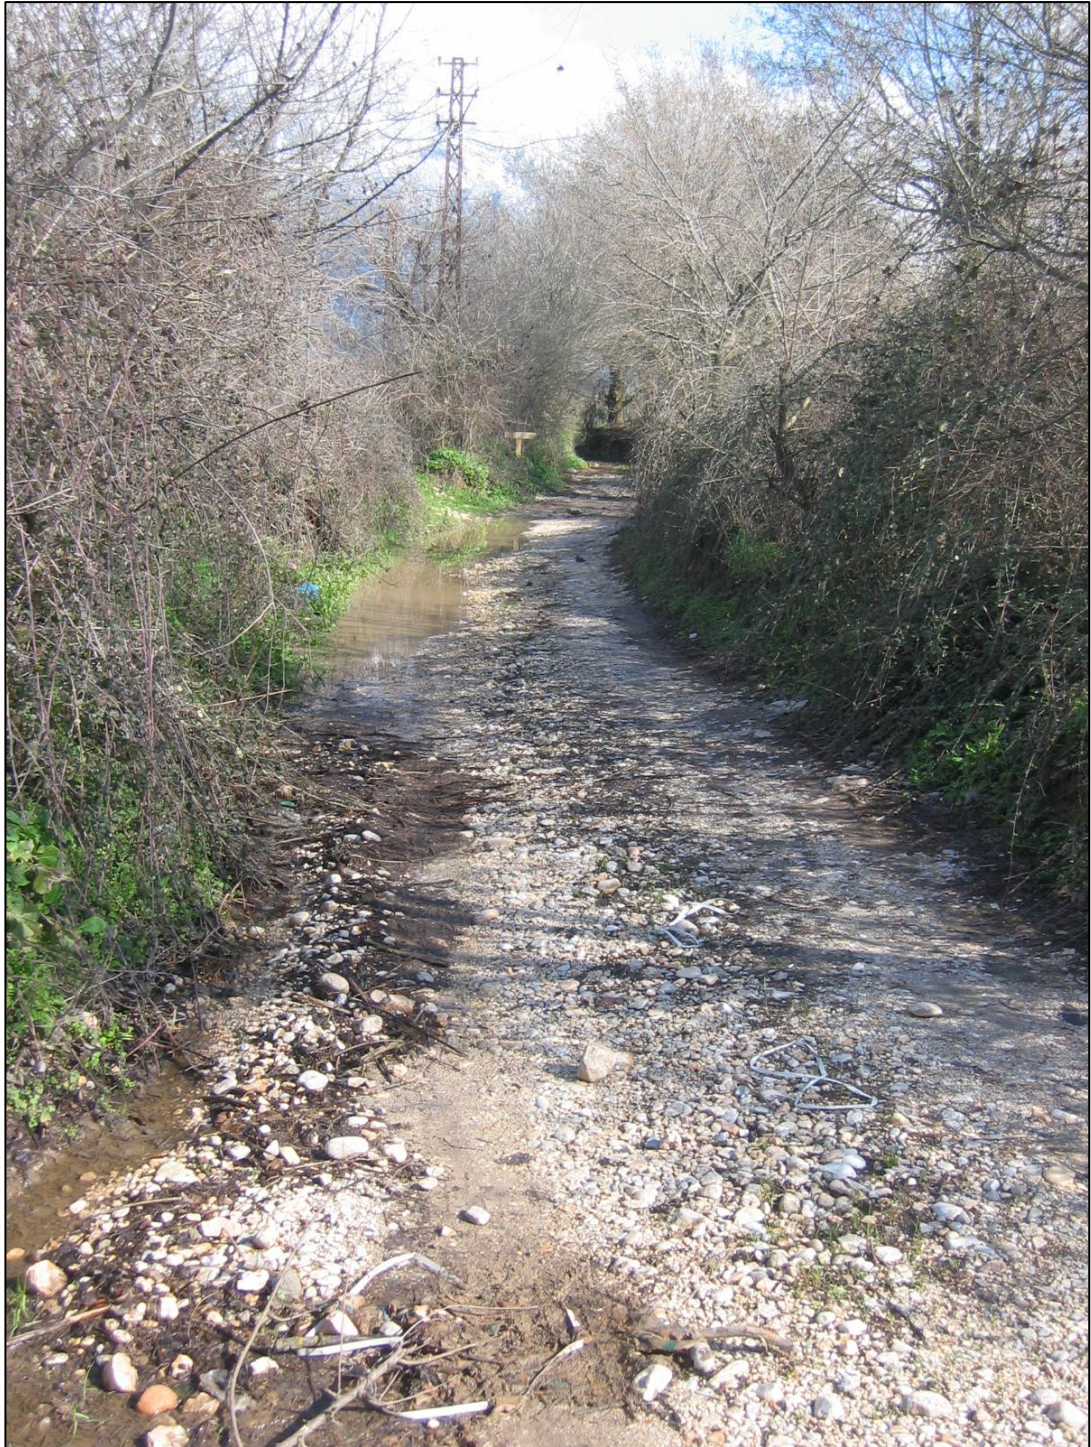
Figure 8 Photograph of an *irim* and the *kesiks* on the sides

The man-made boundaries made of earth and plants that separate the lots from other lots and the lots from the *irims* are called as the *kesiks*. (See Figure 10) Their heights are approximately a man's height and they have fruit plantations on intersections and corners which are called as the *kabalıks*. According to the survey (2002) of Dokuz Eylül University, the *kesiks* need annual maintenance in the springs. Traditionally near the *kesiks*, a canal of approximately 50cm wide and 50 cm deep is dug. The *kesiks* are repaired with the earth gathered from the canals. These canals which surround the *yurts* by the *kesiks* are called as the *şarampols* and they help the *yurts* to discharge their extra water to the *irims* through the springs. And by the help of the *irims'* network the winter rainwater is led to the *düdens*.

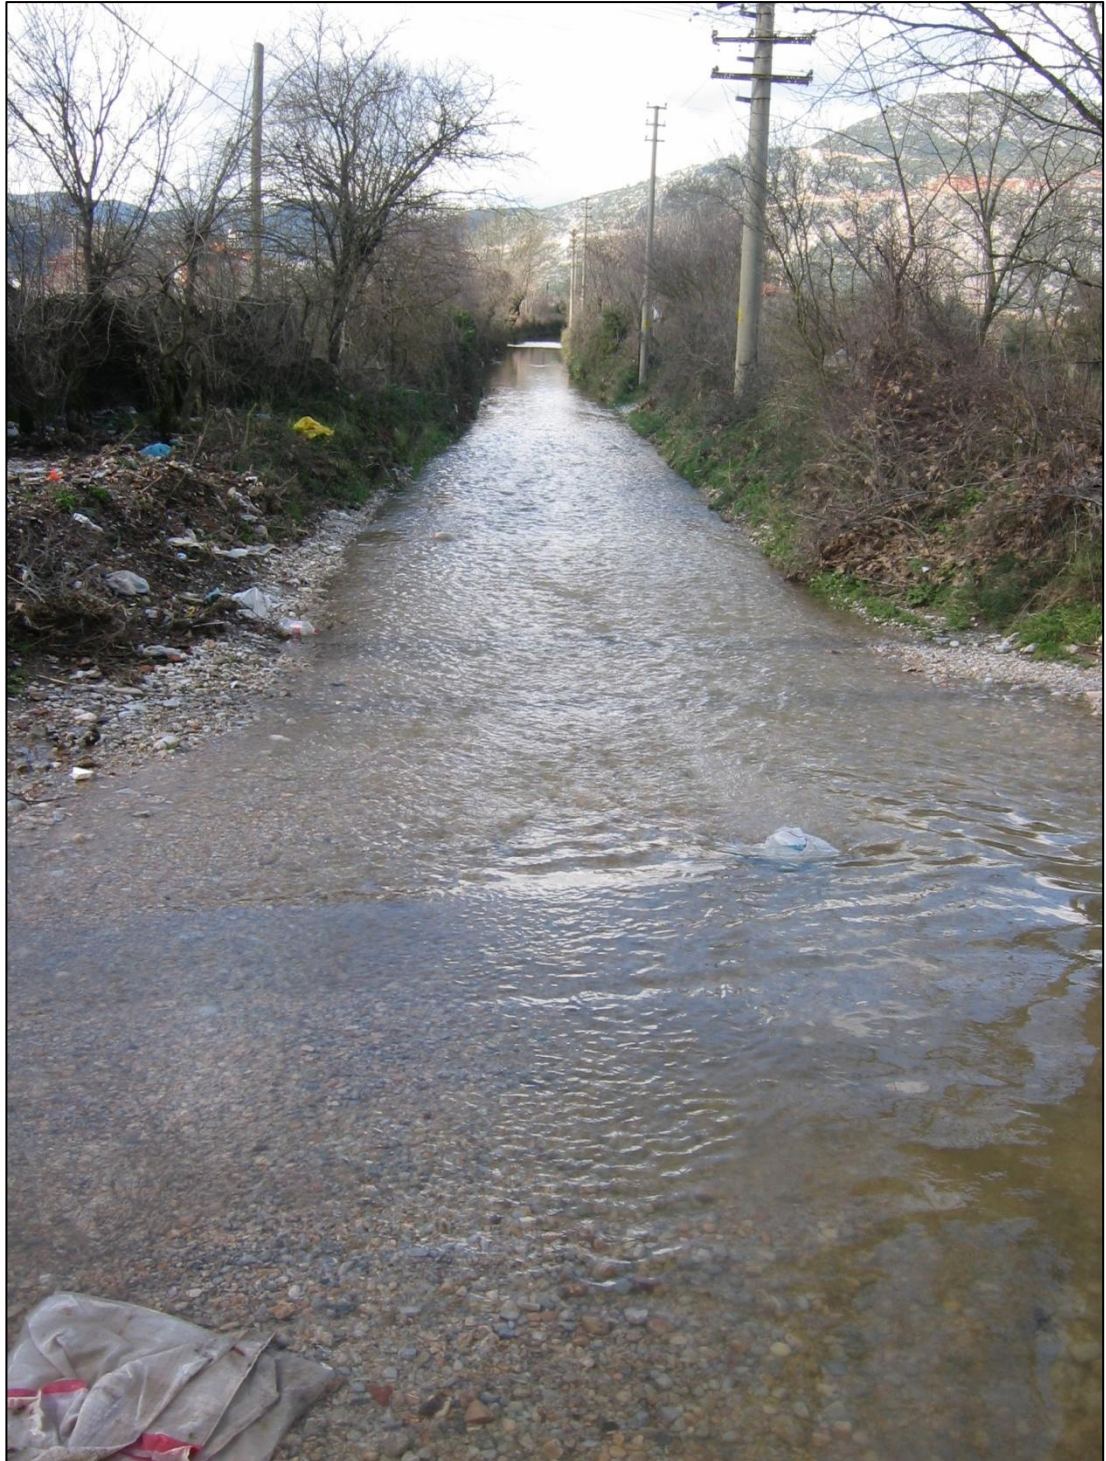
Figure 9 *İrim*s as drainage systems⁶

⁶ In Karabağlar *irims* also work as the drainage system in winters (the photograph was taken in February 2009)

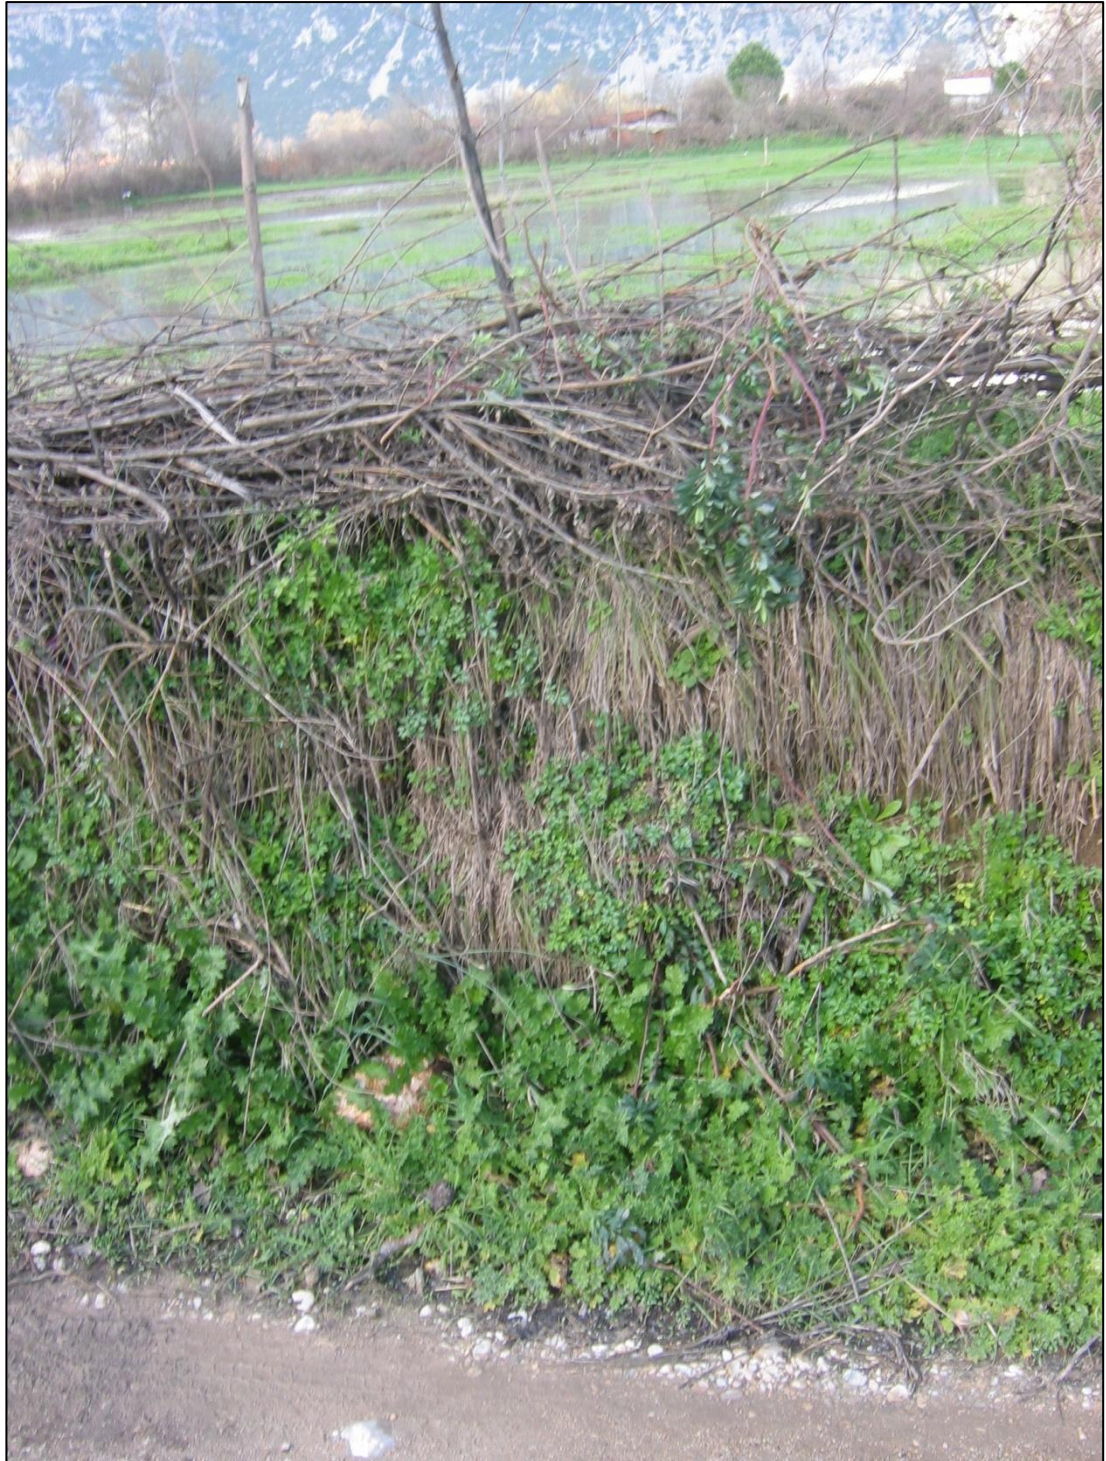
Figure 10 Photograph of a *kesik* (man-made boundary element of earth and plantation)

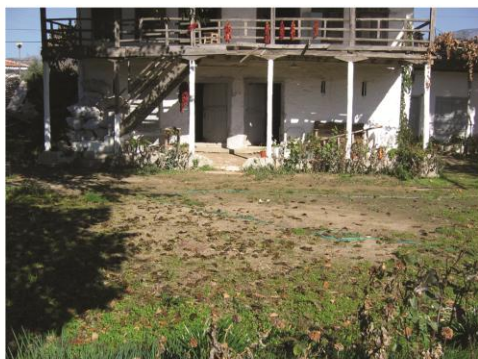
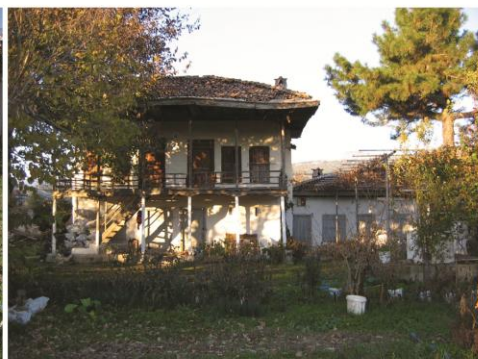
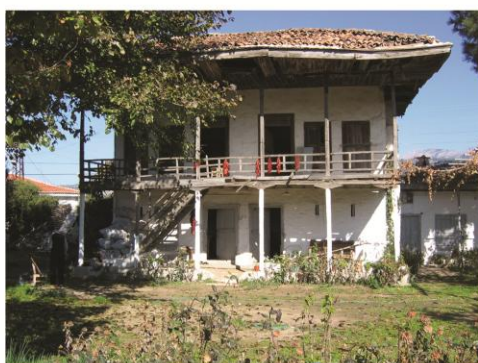
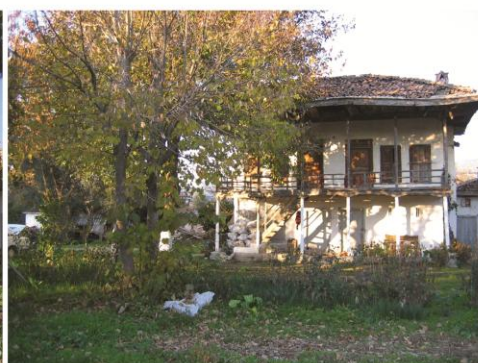
Figure 21 South Facade photographs of Block A in the *yurt* of Köseoğlu Family

On the south façade; there can be seen the simple decorated timber posts on both floors; small windows and the undecorated entrance doors of the ground floor and the simple decorated entrance doors and the vertical, larger windows with shutters of the first floor. The balustrades of the upper *sofa* are regarded as altered as the traces of the original balustrade design can be read on the bases. The severe timber deterioration especially on the open-*sofas*, on the eaves and the roof is clearly observed on this façade. (See Figure 21 for photographs)

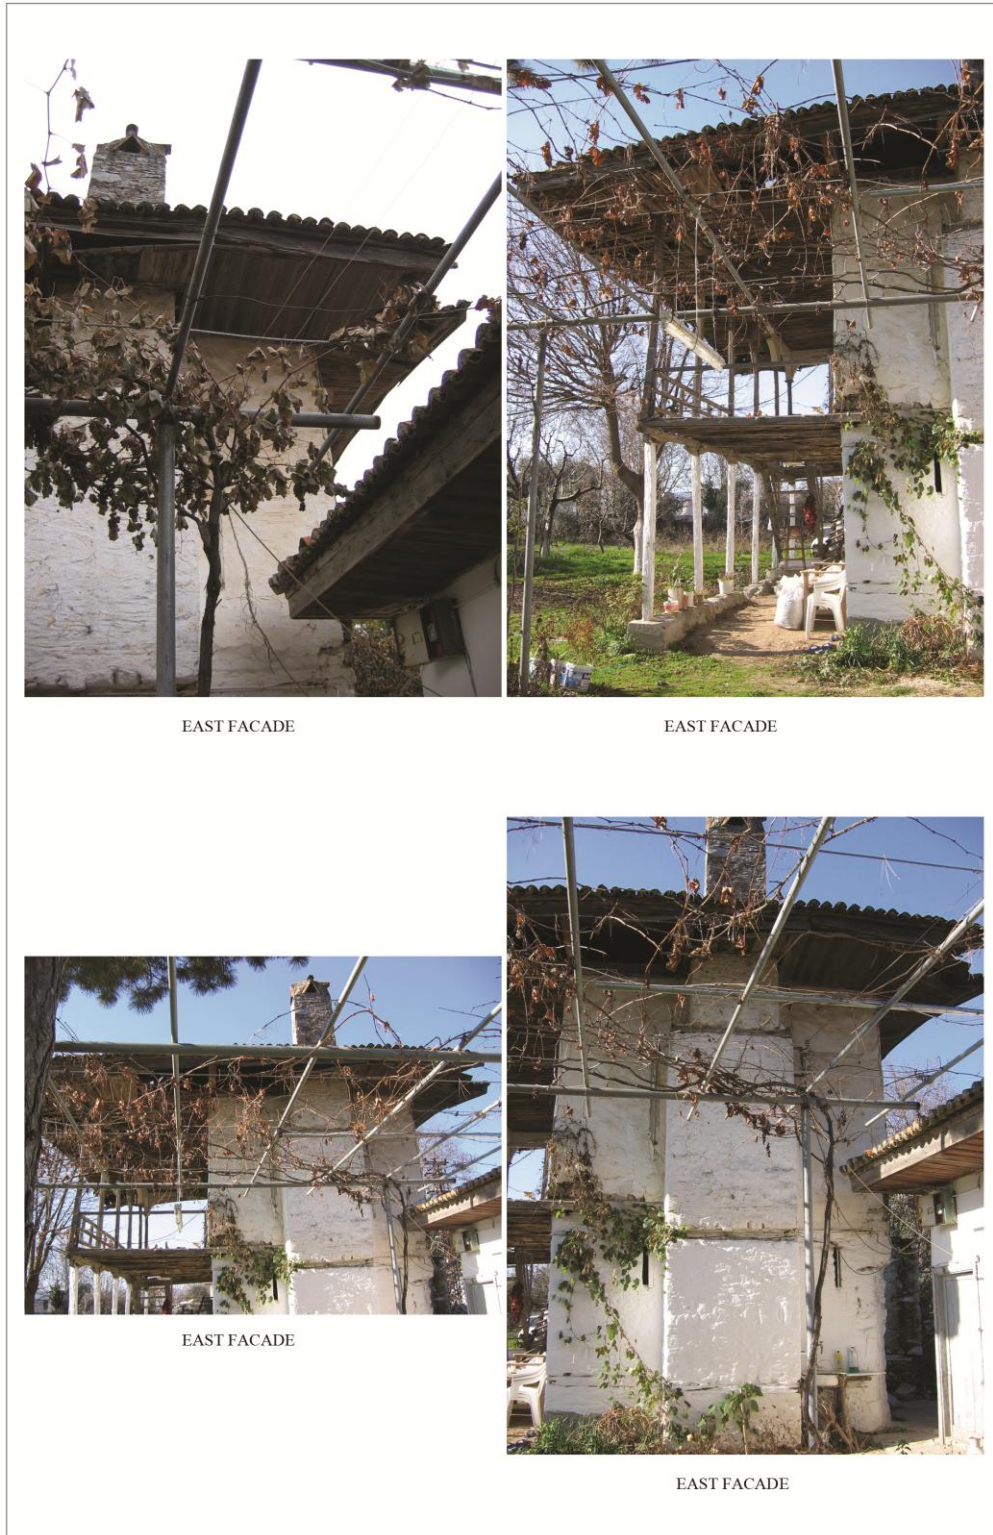
KÖSEOĞLU FAMILY YURT /Photographs/BLOCK A/EAST FACADE

Figure 22 East Facade photographs of Block A in the *yurt* of Köseoğlu Family

The chimneys with the special finishing details¹⁶ on the tops are used as the vertical exposed façade elements on both east and west facades; which is a very common pattern in traditional buildings in Karabağlar. (See Figure 22 and Figure 23 for photographs)

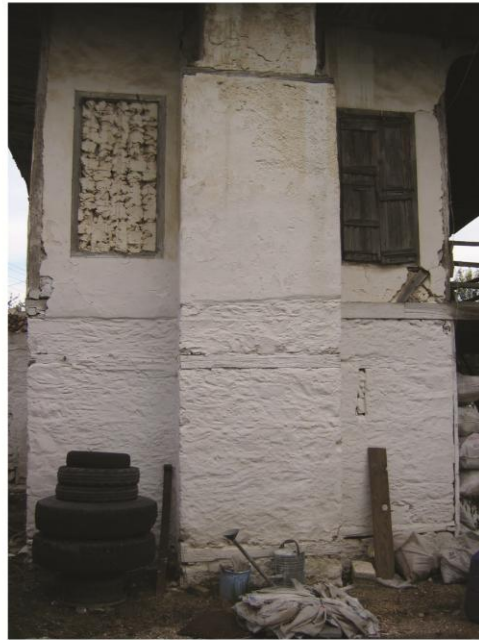
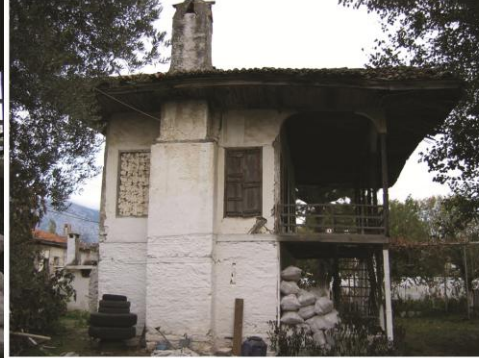
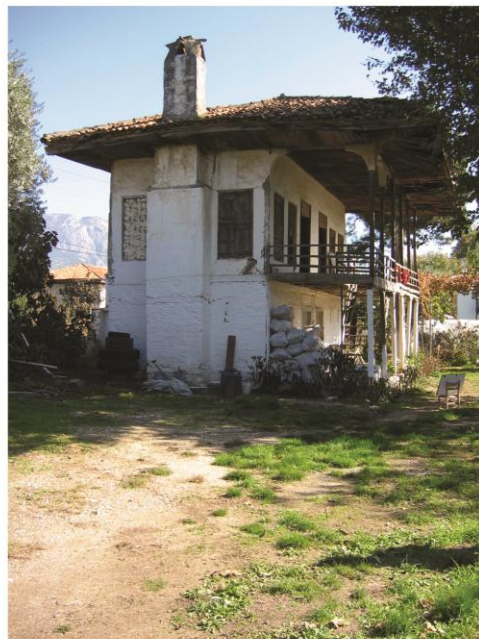
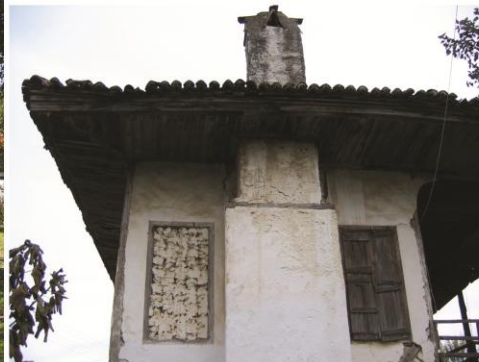
Figure 23 West Facade photographs of Block A in the *yurt* of Köseoğlu Family

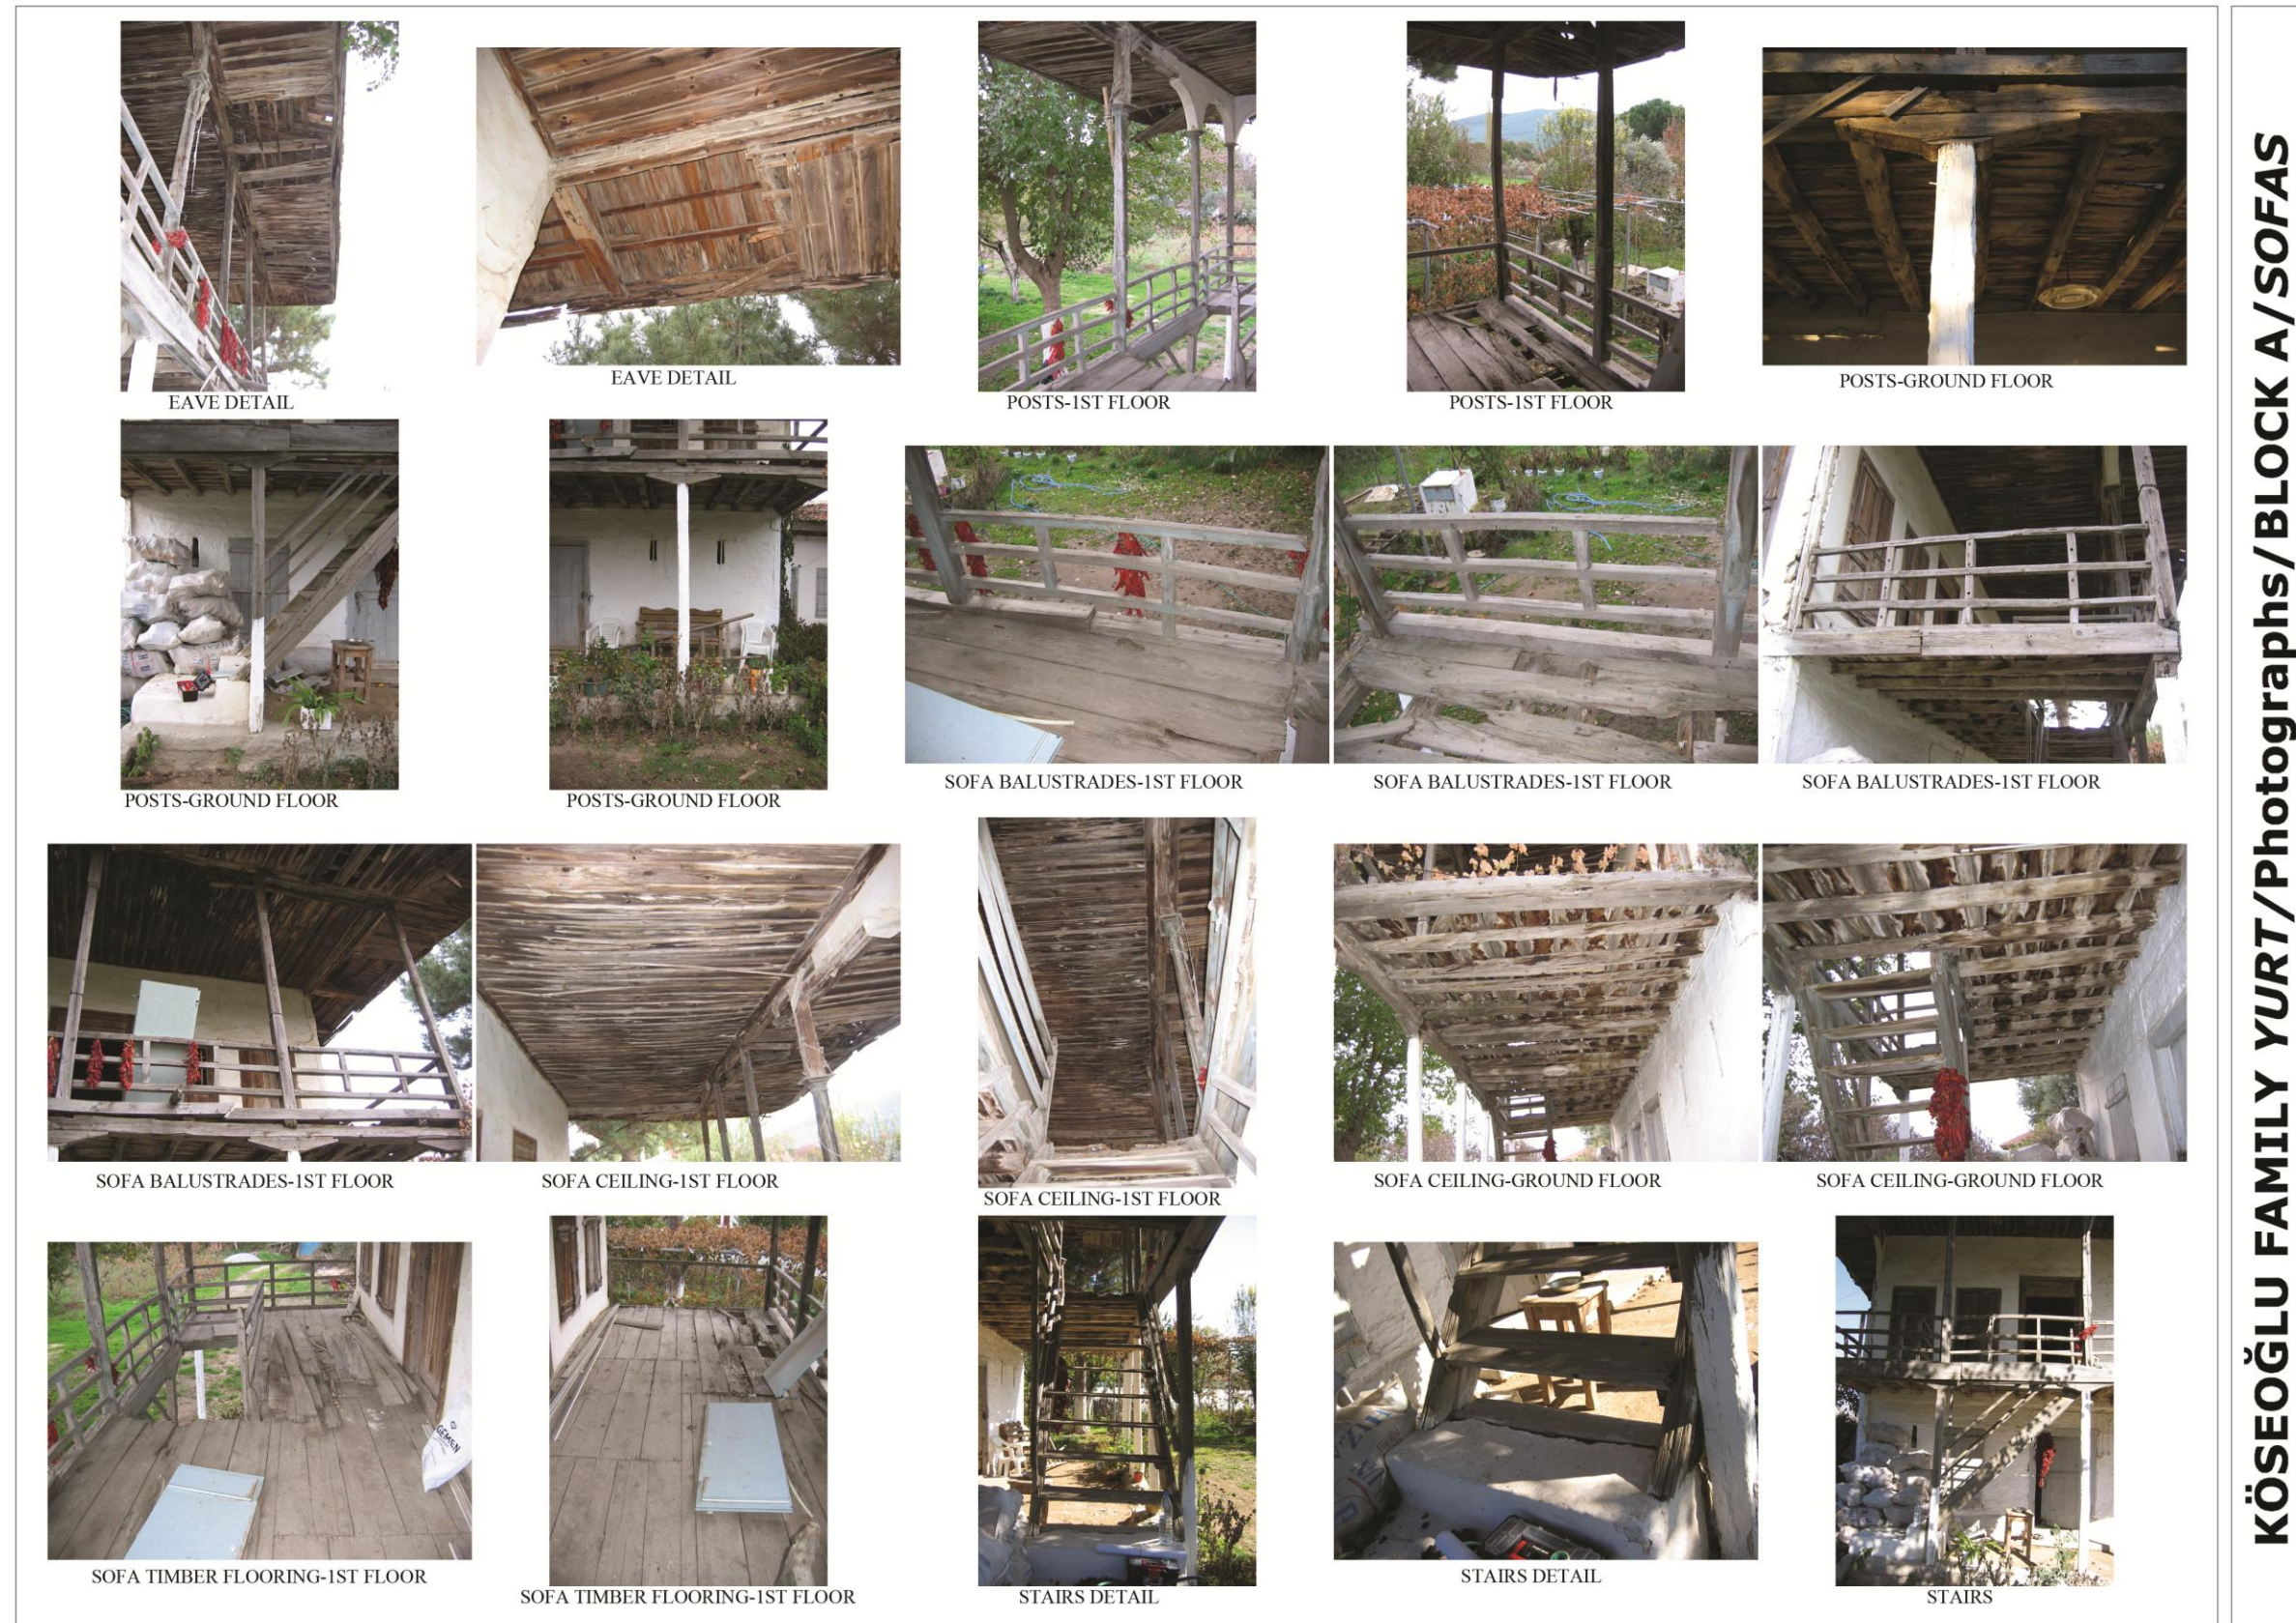
Figure 25 Sofa photographs of Block A in the *yurt* of Köseoğlu Family

Sofa 1 is the semi-open space that gives entrance to the space A and space B on its north wall. The floor covering is earth. The ceiling is simple wooden beams and the wooden flooring on top of them. On its west-south part, there placed the staircase. Six wooden posts are situated in order to carry the upper *sofa*. On the north-east side of the *sofa* there is the space A and on the north-west side there located the space B. (See Figure 25 for photographs)

Sofa 2 is the semi-open space of the upper floor that gives entrance to the space C and space D on its north wall. The floor covering is wooden which is subjected to material loss and severe decay especially on its south-east part. The ceiling is a simple wooden ceiling with laths without decorations. On its south-west part, there placed the staircase. Six wooden posts are situated in order to carry the roof. On the north-east side of the sofa 2; there is the space C and on the north-west side there located the space D. (See Figure 25 for photographs)

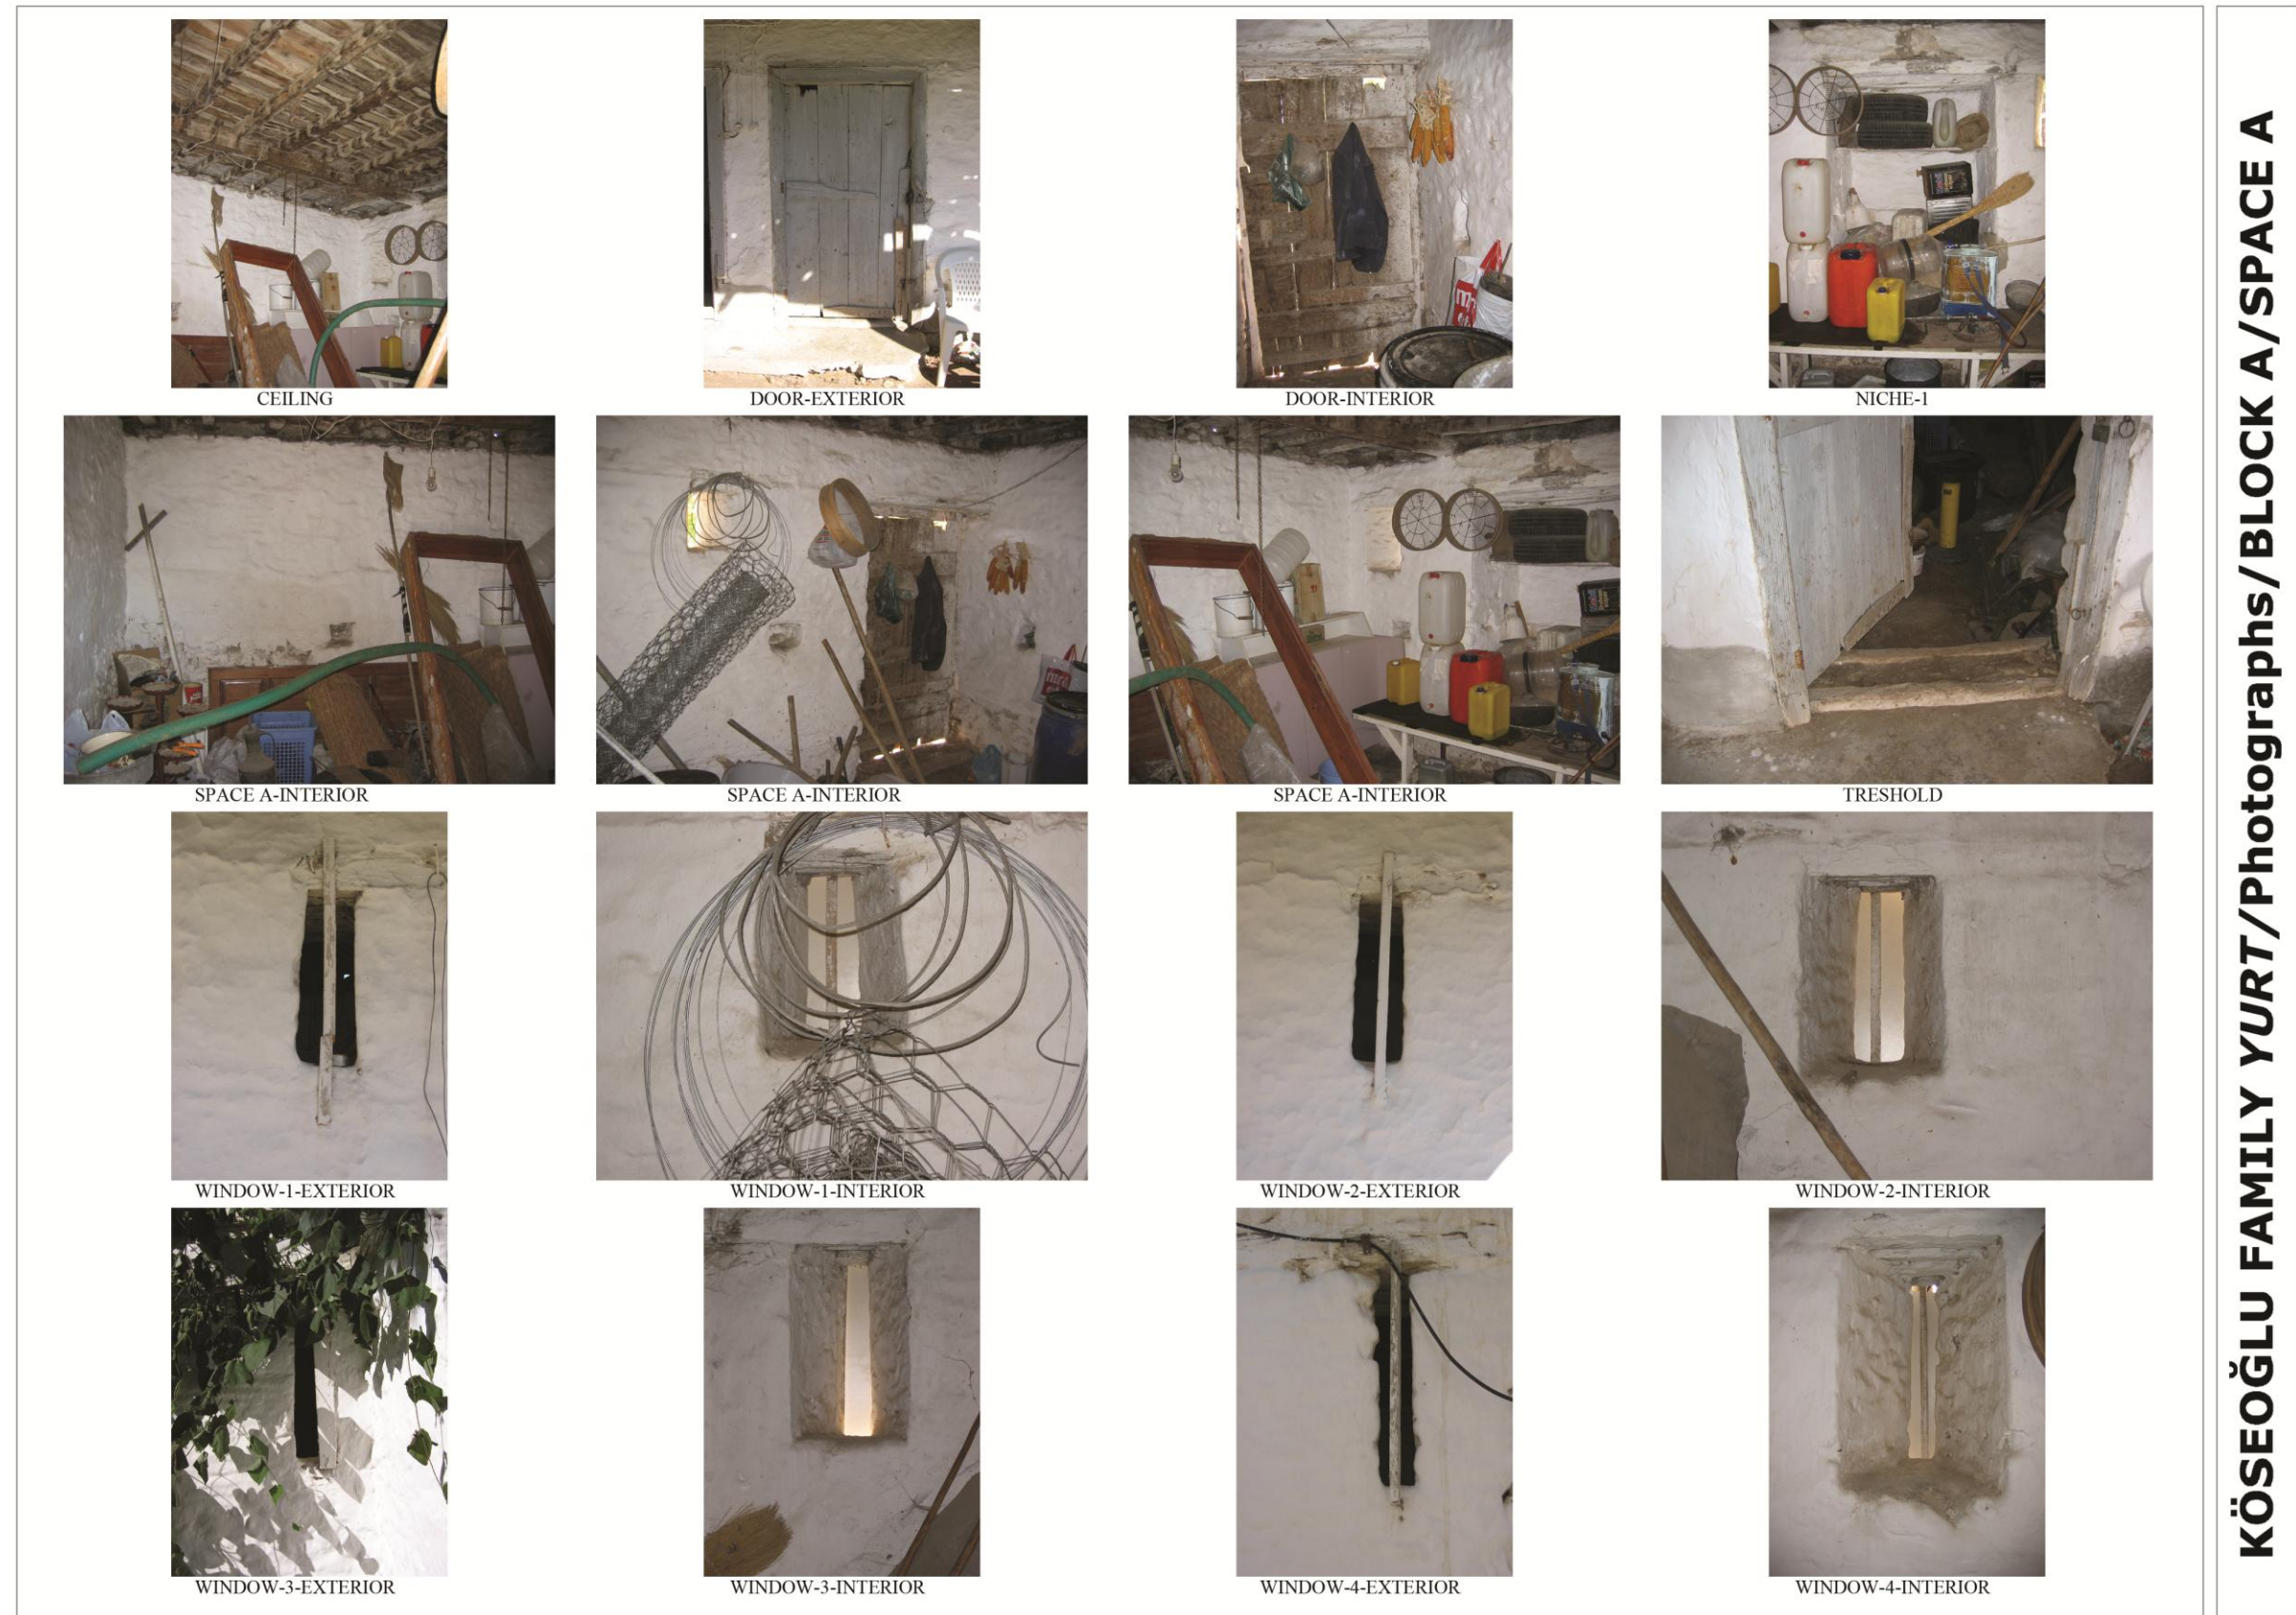
Figure 26 The photographs of Space A in Block A in the *yurt* of Köseoğlu Family

Space A is a service space which seems to have been originally a storage space for the corps of agriculture and/or animal husbandry. Today this space still works as a storage space, which is entered through a simple wooden door with a wooden-stone work threshold from the *sofa 1*. The floor covering is earth. The ceiling is simple wooden beams and the wooden flooring on top of them. The walls are white-washed and stone construction. At about 40-50 cm above the surface level, there are seen wooden horizontal elements in order to reinforce the stone walls. On its south wall, from west to east, there are the entrance door (A-D1), a small niche (A-N1) and two small windows (A-W1 & A-W2). On its east wall, from south to north, there are a small window (A-W3), a big niche (A-N2), a small niche (A-N3) and a small window (A-W4) again. On its both north and west walls there are two small niches (A-N4, A-N5, and A-N6 & A-N7). Near the south wall the floor is getting low for about 7 cm making a trace on the floor. (See Figure 26 for photographs)

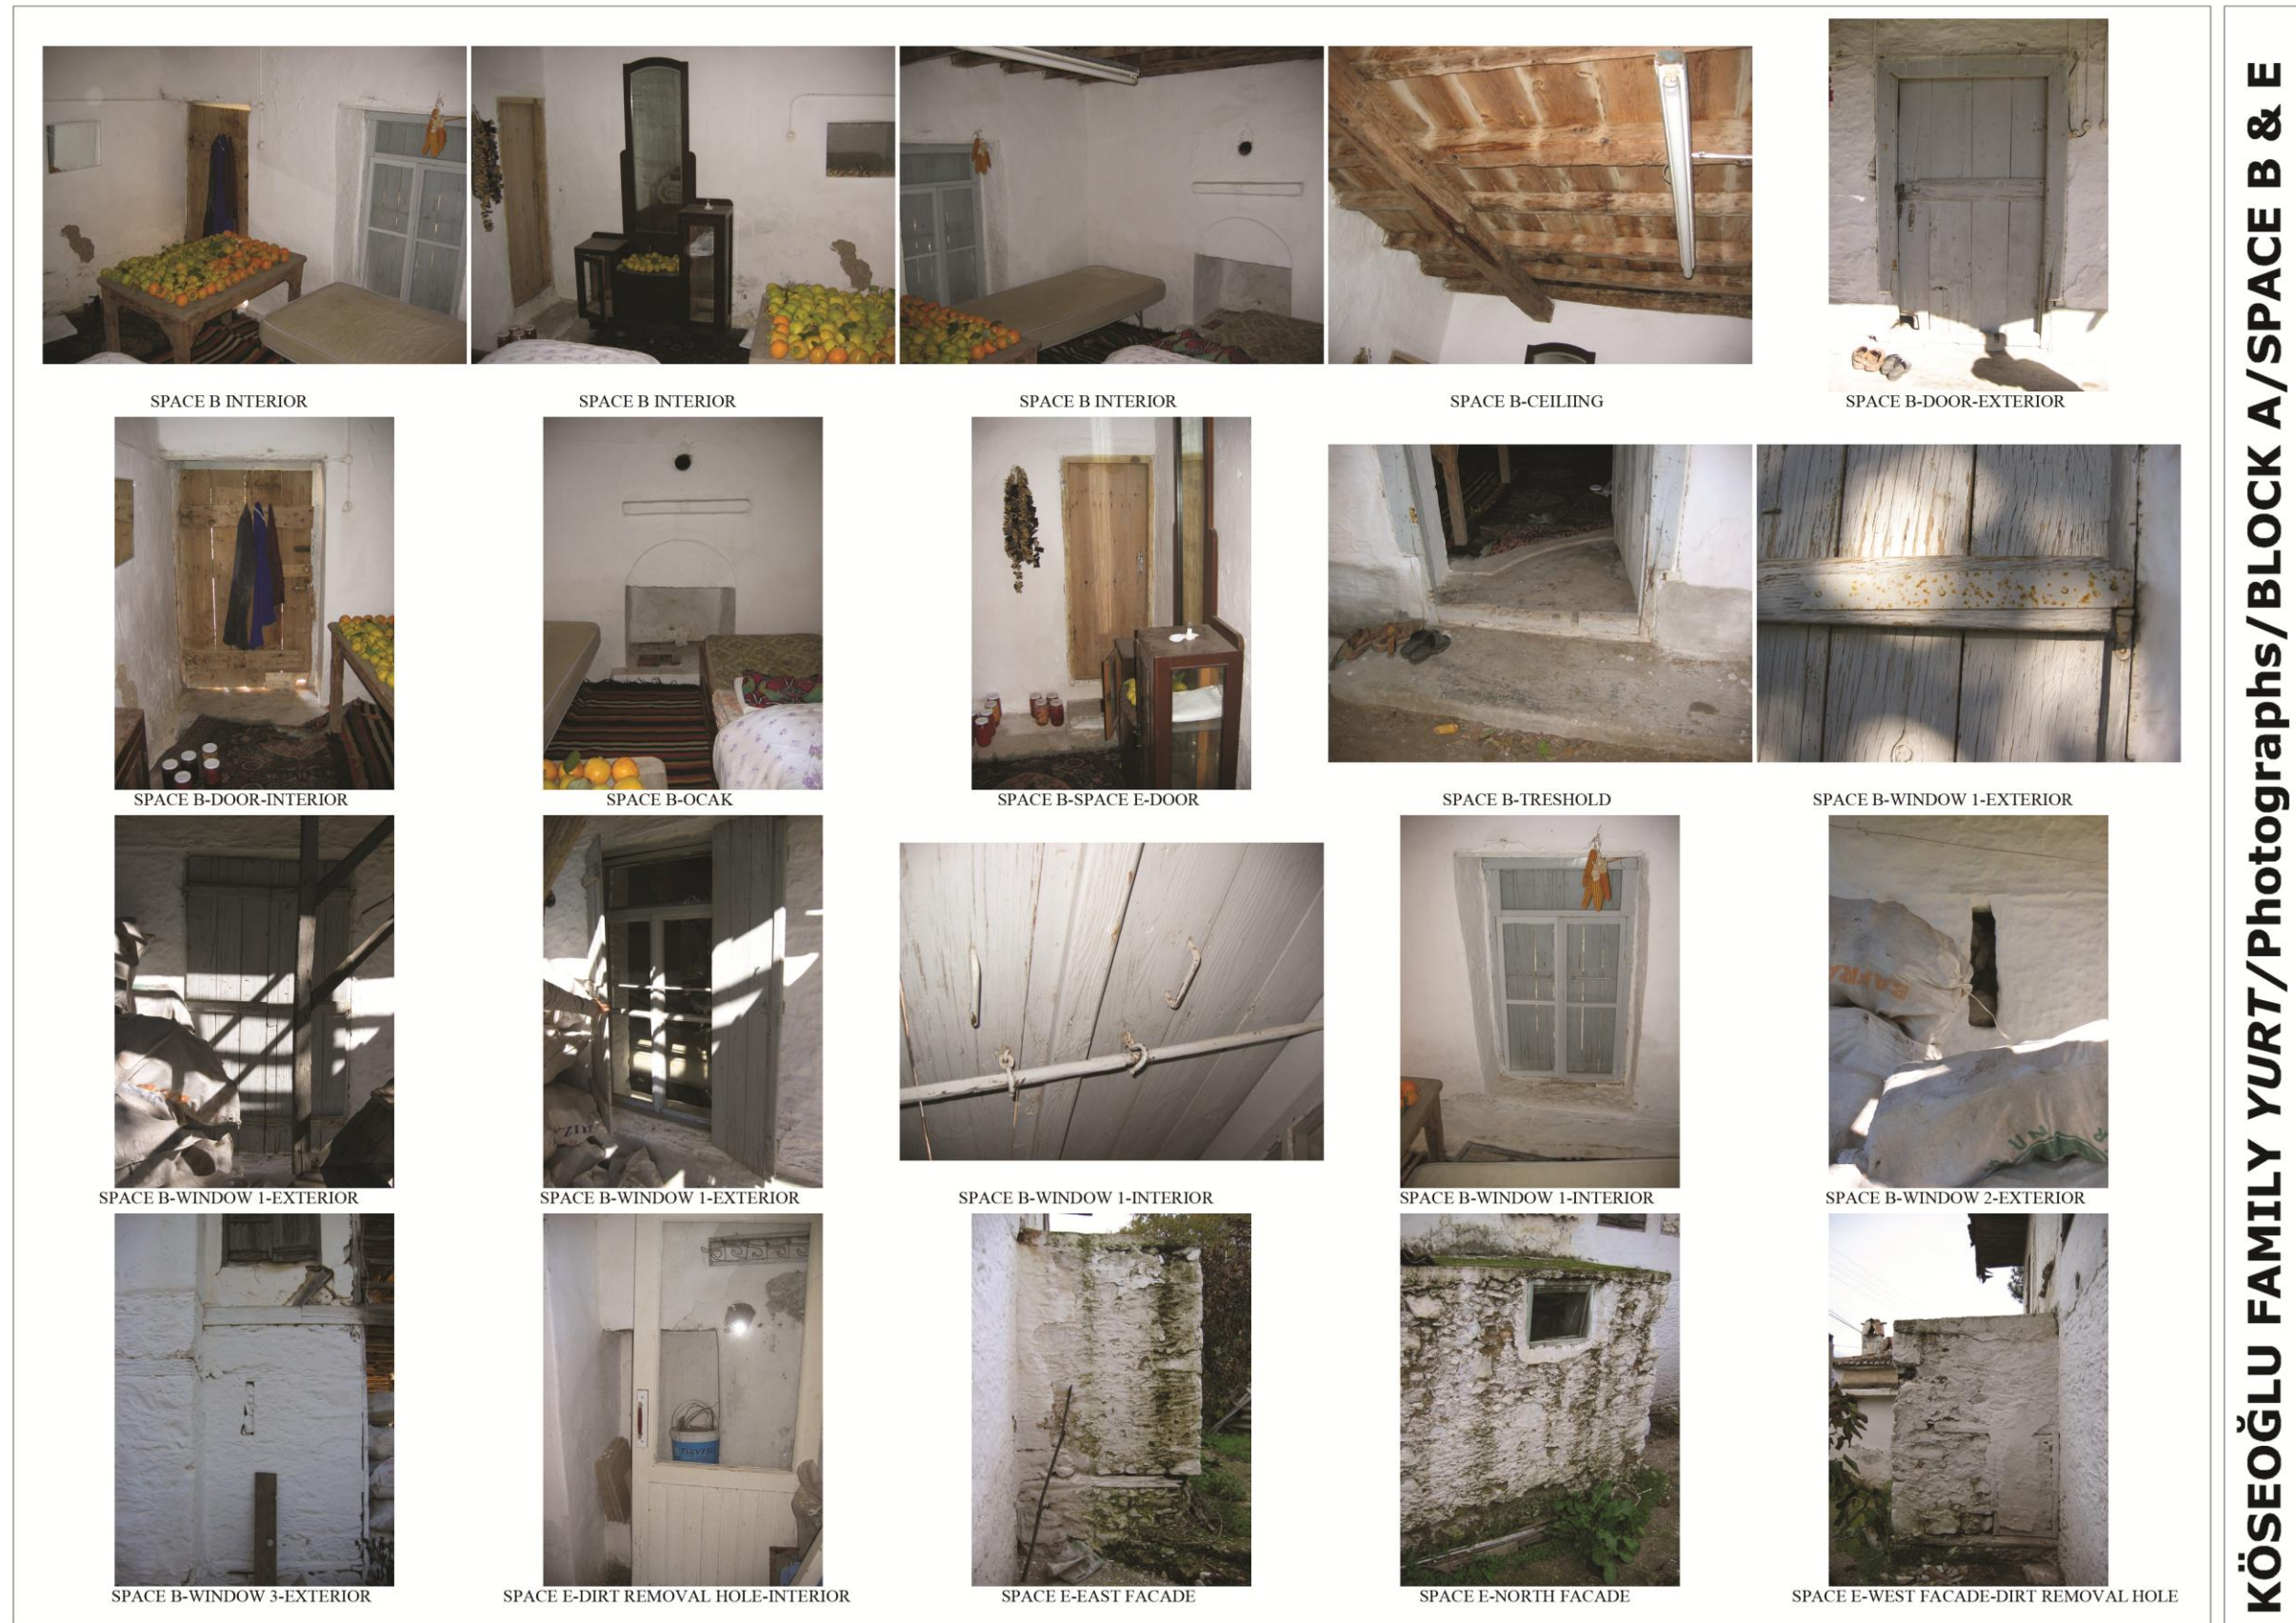
KÖSEOĞLU FAMILY YURT/Photographs/BLOCK A/SPACE B & E

Figure 27 The photographs of Space B and E in Block A in the *yurt* of Köseoğlu Family

them. The walls are plastered and white-washed but it can be read from the exteriors as being a stone wall construction with horizontal wooden elements for reinforcement. On its west wall, from south to north, there is a small closed window (B-W3) which is readable from the outside with the traces and an *ocak* (B-O1) which seems to be a later addition because of its inadequate design that is not refined as the *ocaks* of the *living units* on the upper floor. On its south wall, from west to east there is a small closed window (B-W2) which can be read from *sofa*¹; a larger window (B-W1), which seems to be later addition and the entrance door (B-D1). The window (B-W1) in the middle is considered as a later addition because of its different detailing that differs from the original windows and the design that uses glass whereas the original window designs are either small simple vertical openings without casements for the service spaces or the bigger vertical windows with casements, shutters and the balustrades without the glassed wings, the examples of which will be discussed in the traditional *living units* on the upper floor. There is no architectural element on the east wall. On the north wall there is a door (B-D2) which is thought to be a later addition as well that opens to space E. Because, space E was originally a waste accumulation space of the toilet and the *gusülhane*¹⁵ above it which is demolished today. Space E is thought to be accessed from the outside in order to be cleaned by a small opening which is observed today like a closed window very near the ground level on the west façade of Space E. Recently the toilet and bath section on the upper floor is demolished. This space is restituted from the traces on the north façade; the closed passages which are camouflaged as the shutters of a cupboard in space C and D and from the comparative study of traditional dwellings in Karabağlar, utilizing the same plan scheme particularly the traditional house in the lot of Gazezoğlu Family which will be presented later. (See Figure 27 for photographs of space B and E)
