A STUDY ON VALUES, PROBLEMS AND POTENTIALS OF THE
TRADITIONAL DWELLINGS IN KARABAĞLAR-MUĞLA

A THESIS SUBMITTED TO
THE GRADUATE SCHOOL OF NATURAL AND APPLIED SCIENCES
OF
MIDDLE EAST TECHNICAL UNIVERSITY

FEBRUARY 2012

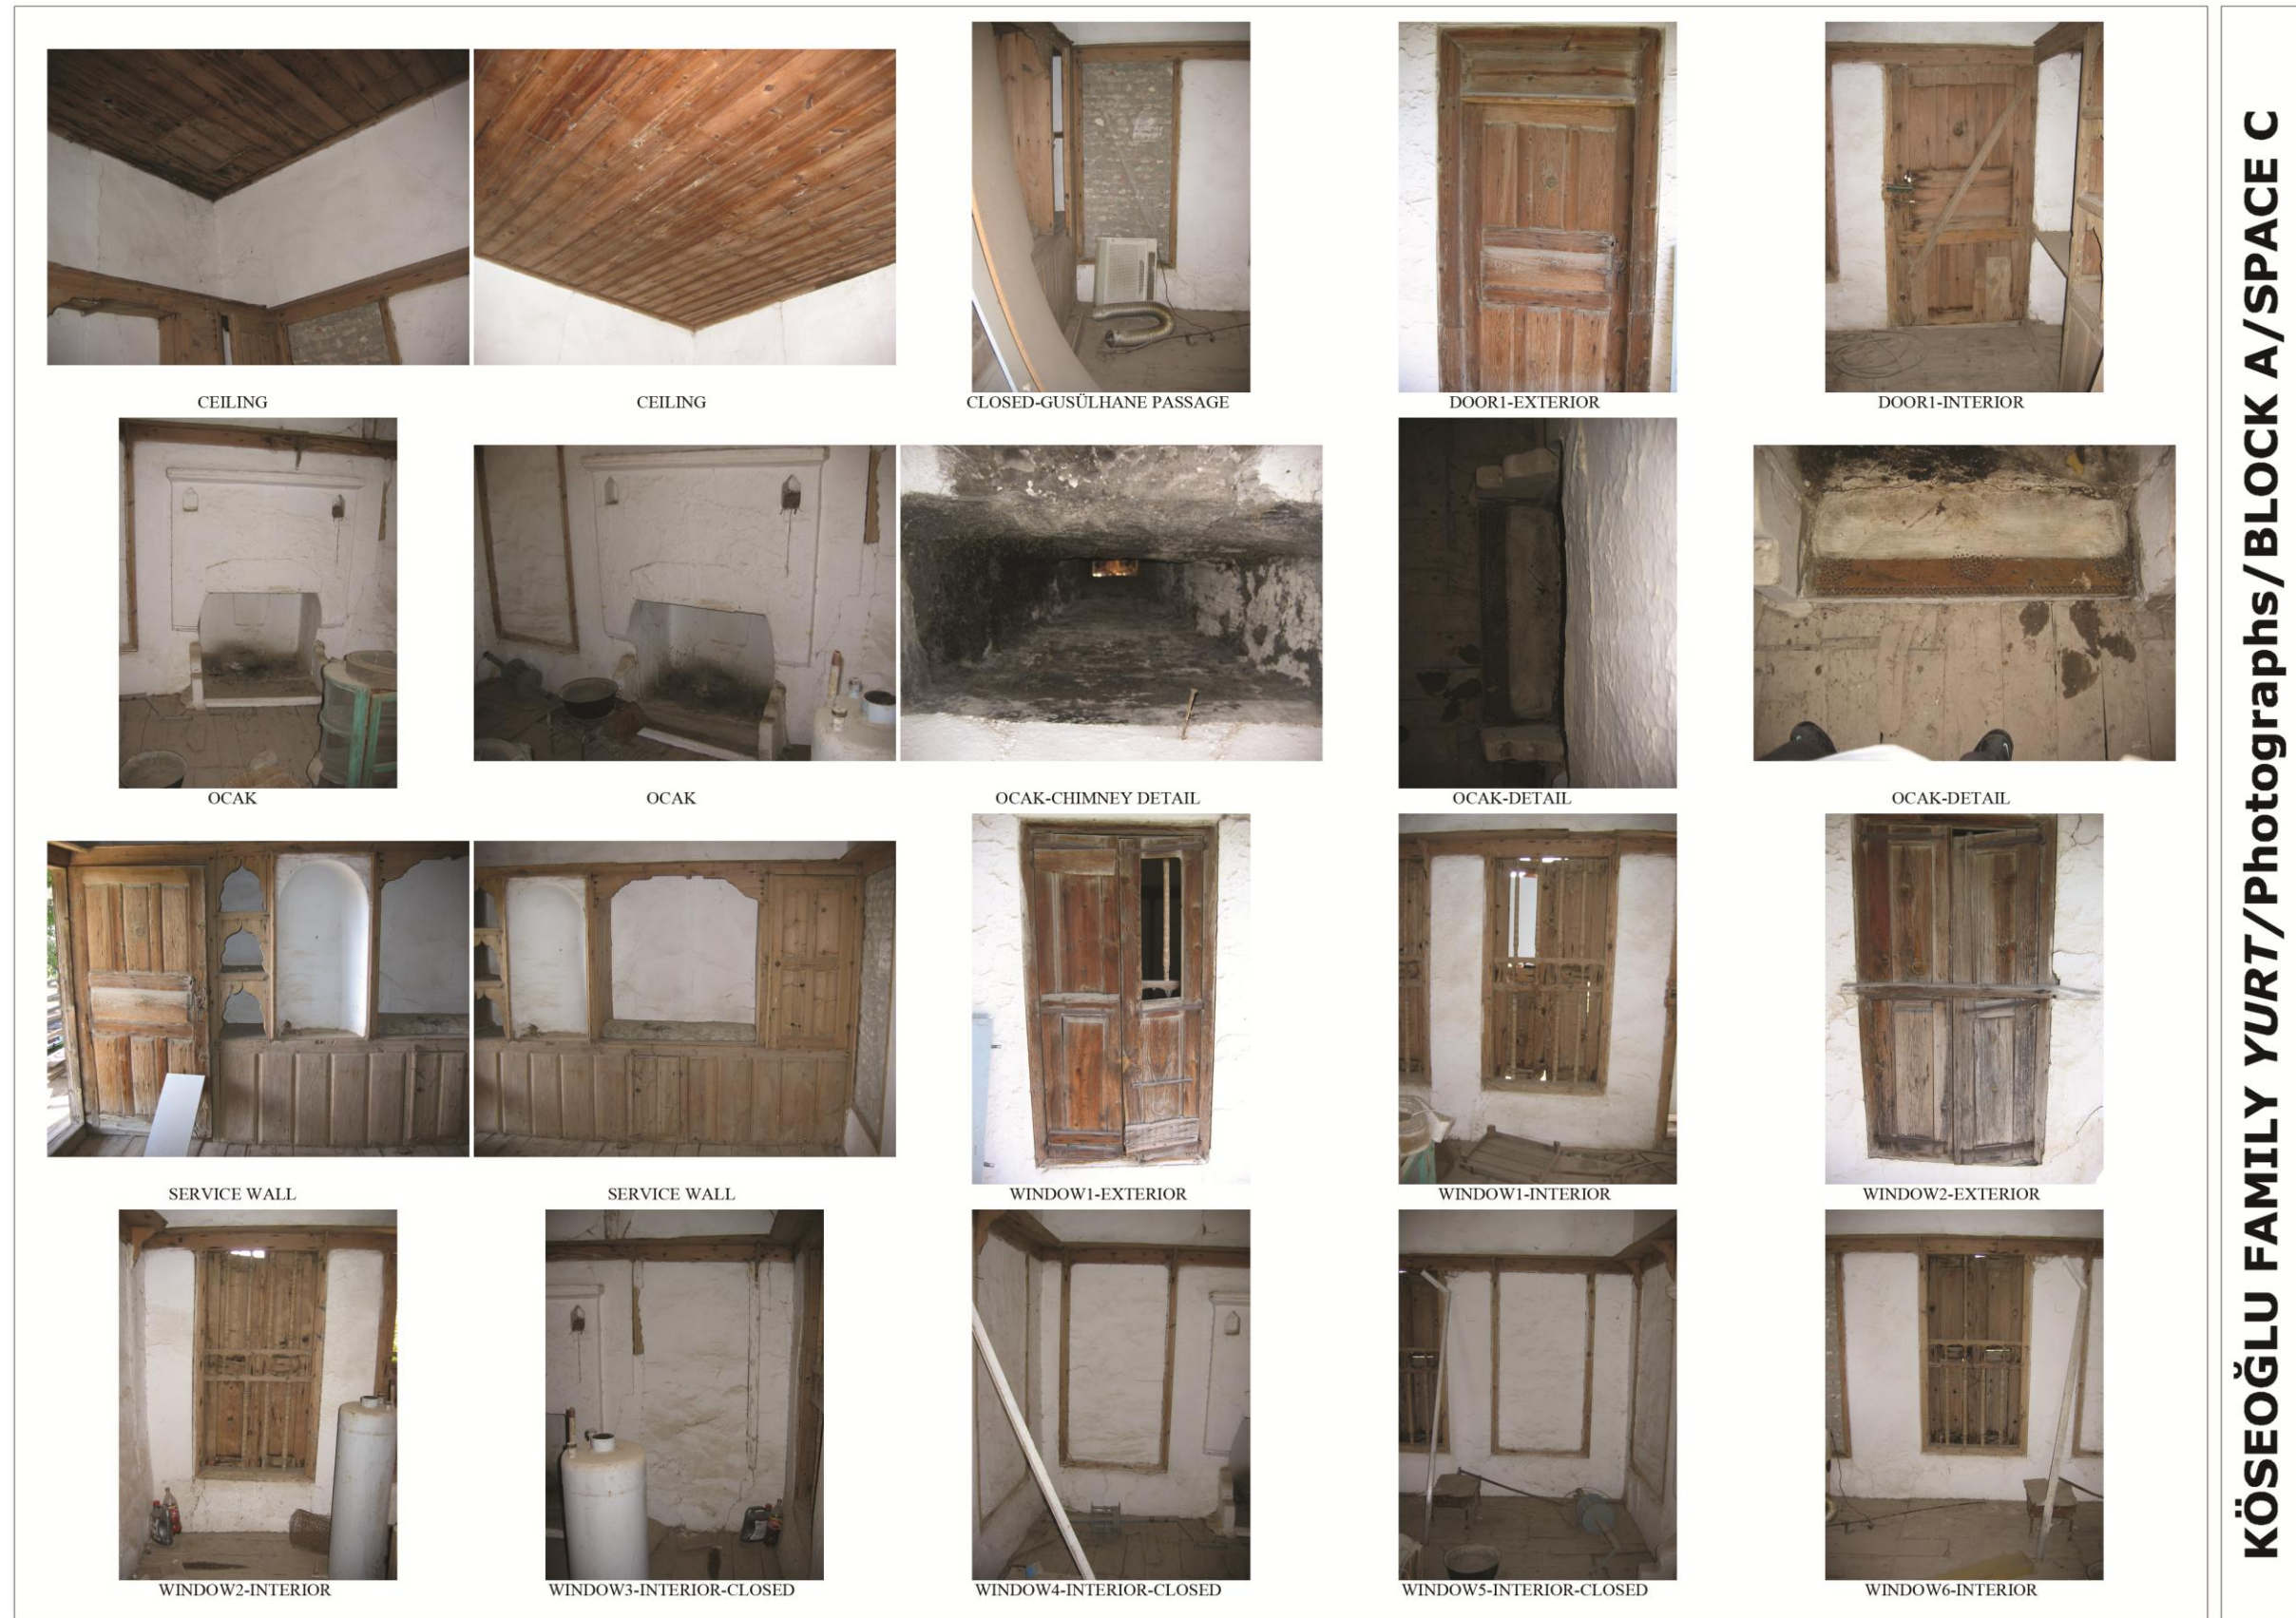
Figure 28 The photographs of Space C in Block A in the *yurt* of Köseoğlu Family

The square planned *living units* on Köseoğlu example (namely space C and D) are entered from the corners. (See Figure 28 and Figure 29 for photographs of space C and D) On one side of the room, which is not facing the outside, there situated a simple decorated service wall. These architectural elements are the storage units of the *evs* as they contain a niche for the lighting elements, niches and cupboards to store the bedding equipment and the clothes and in most cases there located a hidden passage, which is camouflaged as one of the wings of the cupboards, leading to a small, traditional body washing space, named as the *gusülhane*. In Köseoğlu example these hidden passages are separated from the service wall and are located on the north walls of the living units which lead to a demolished-yet can be restituted toilet/*gusülhane* space. The opened door wings of the entrance can be attached to the service walls with a special detail as to be seen as a complete inner elevation. It is significant that the outer facades of the entrance doors are decorated whereas the inner facades show rough

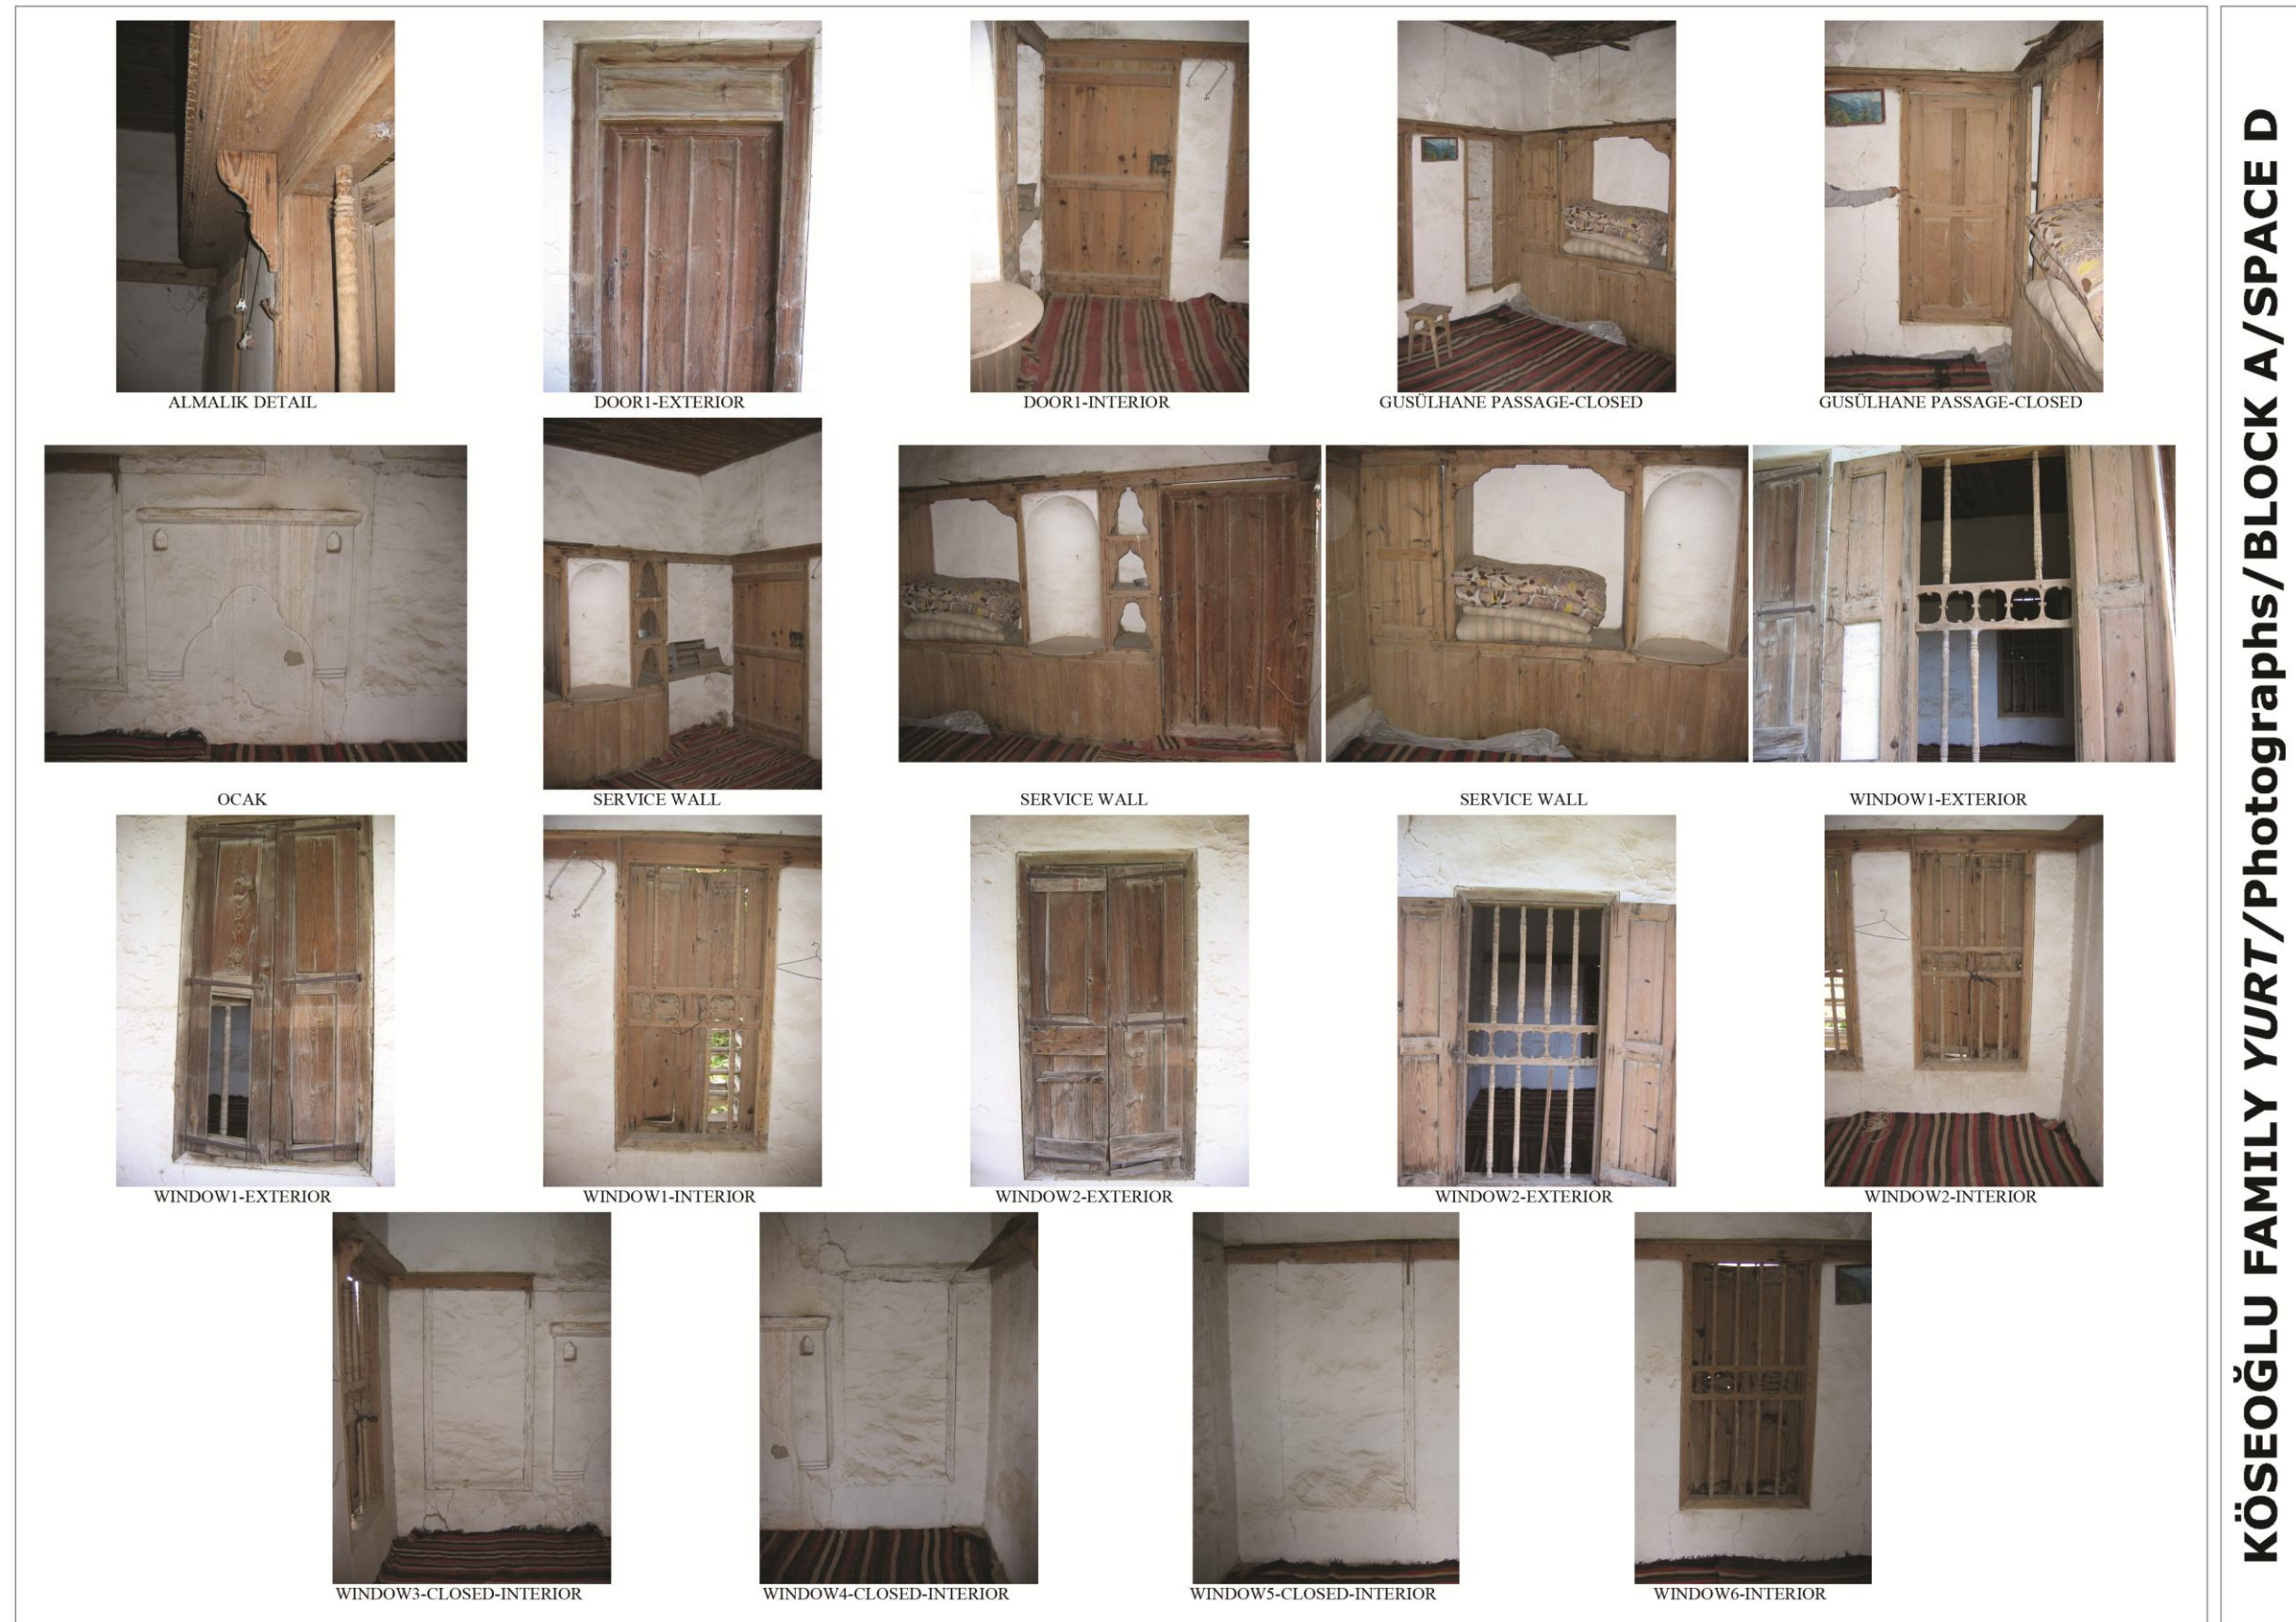
Figure 29 The photographs of Space D in Block A in the *yurt* of Köseoğlu Family

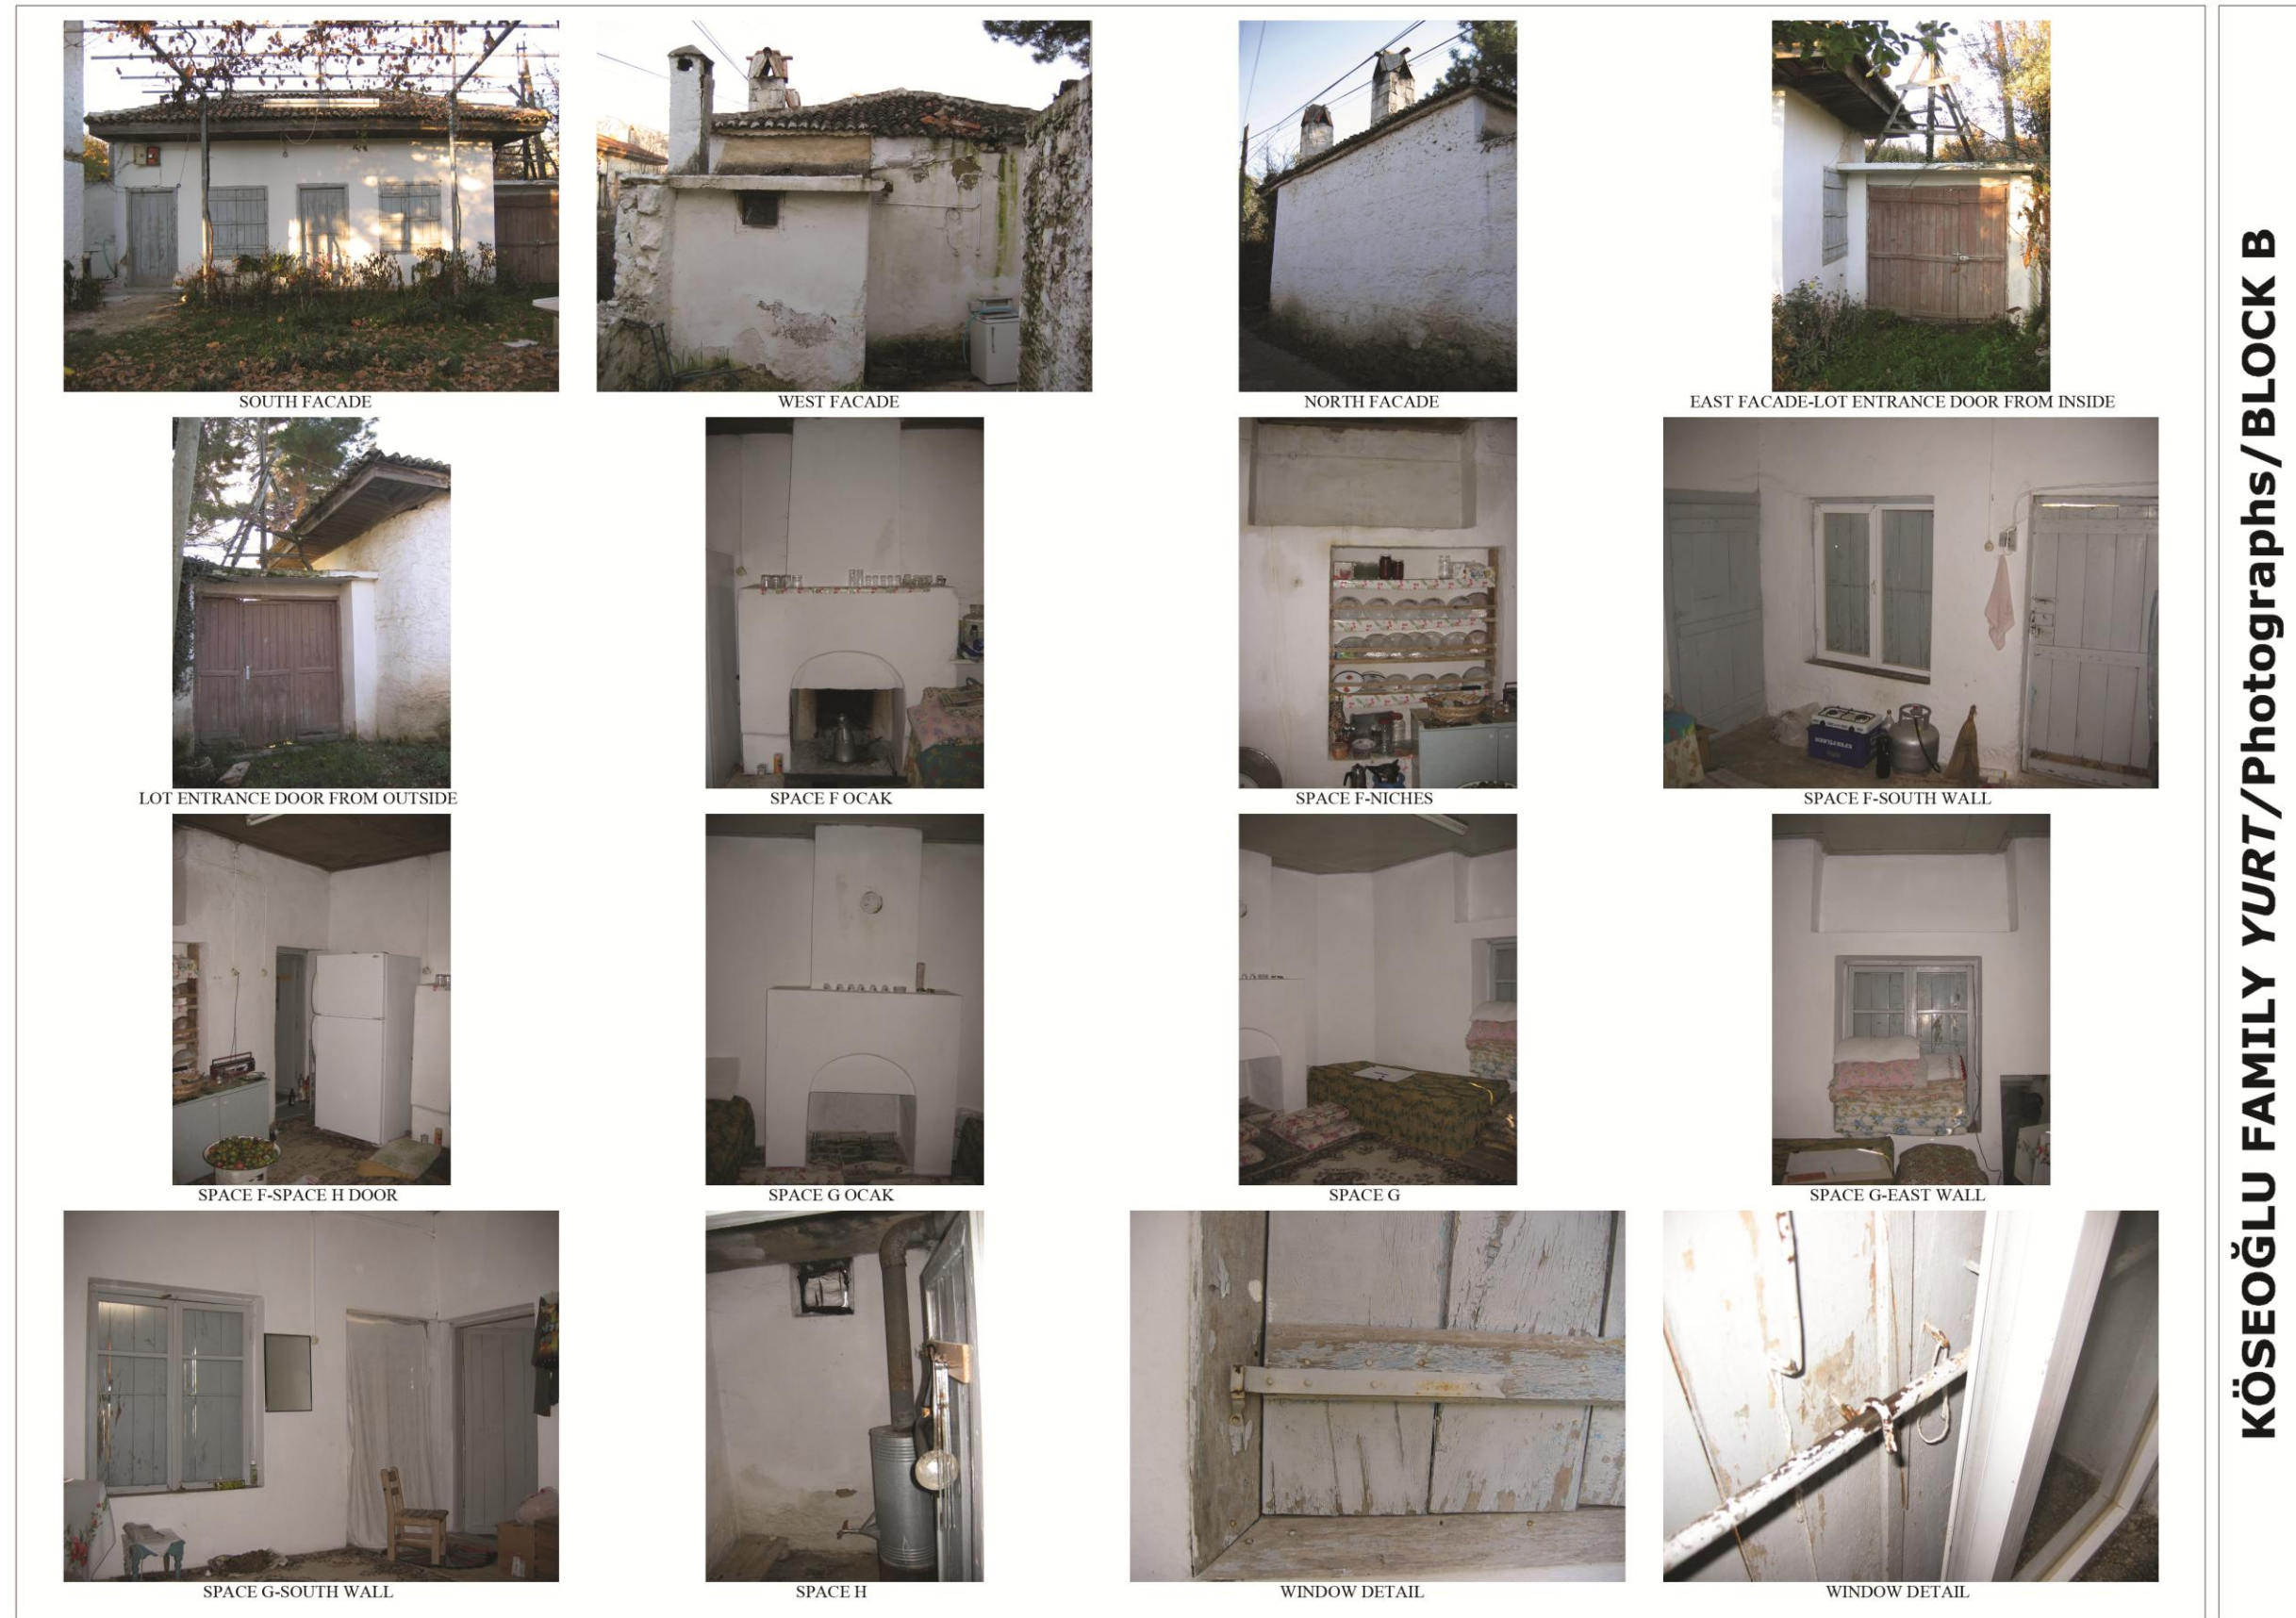
Figure 30 The photographs of Block B in the *yurt* of Köseoğlu Family

The one-storey block B seems to be the service building of block A. It consists of space F, space G and space H. (See Figure 15 for the plan, Figure 19 for the sections, Figure 20 for the facades and Figure 30 for photographs)

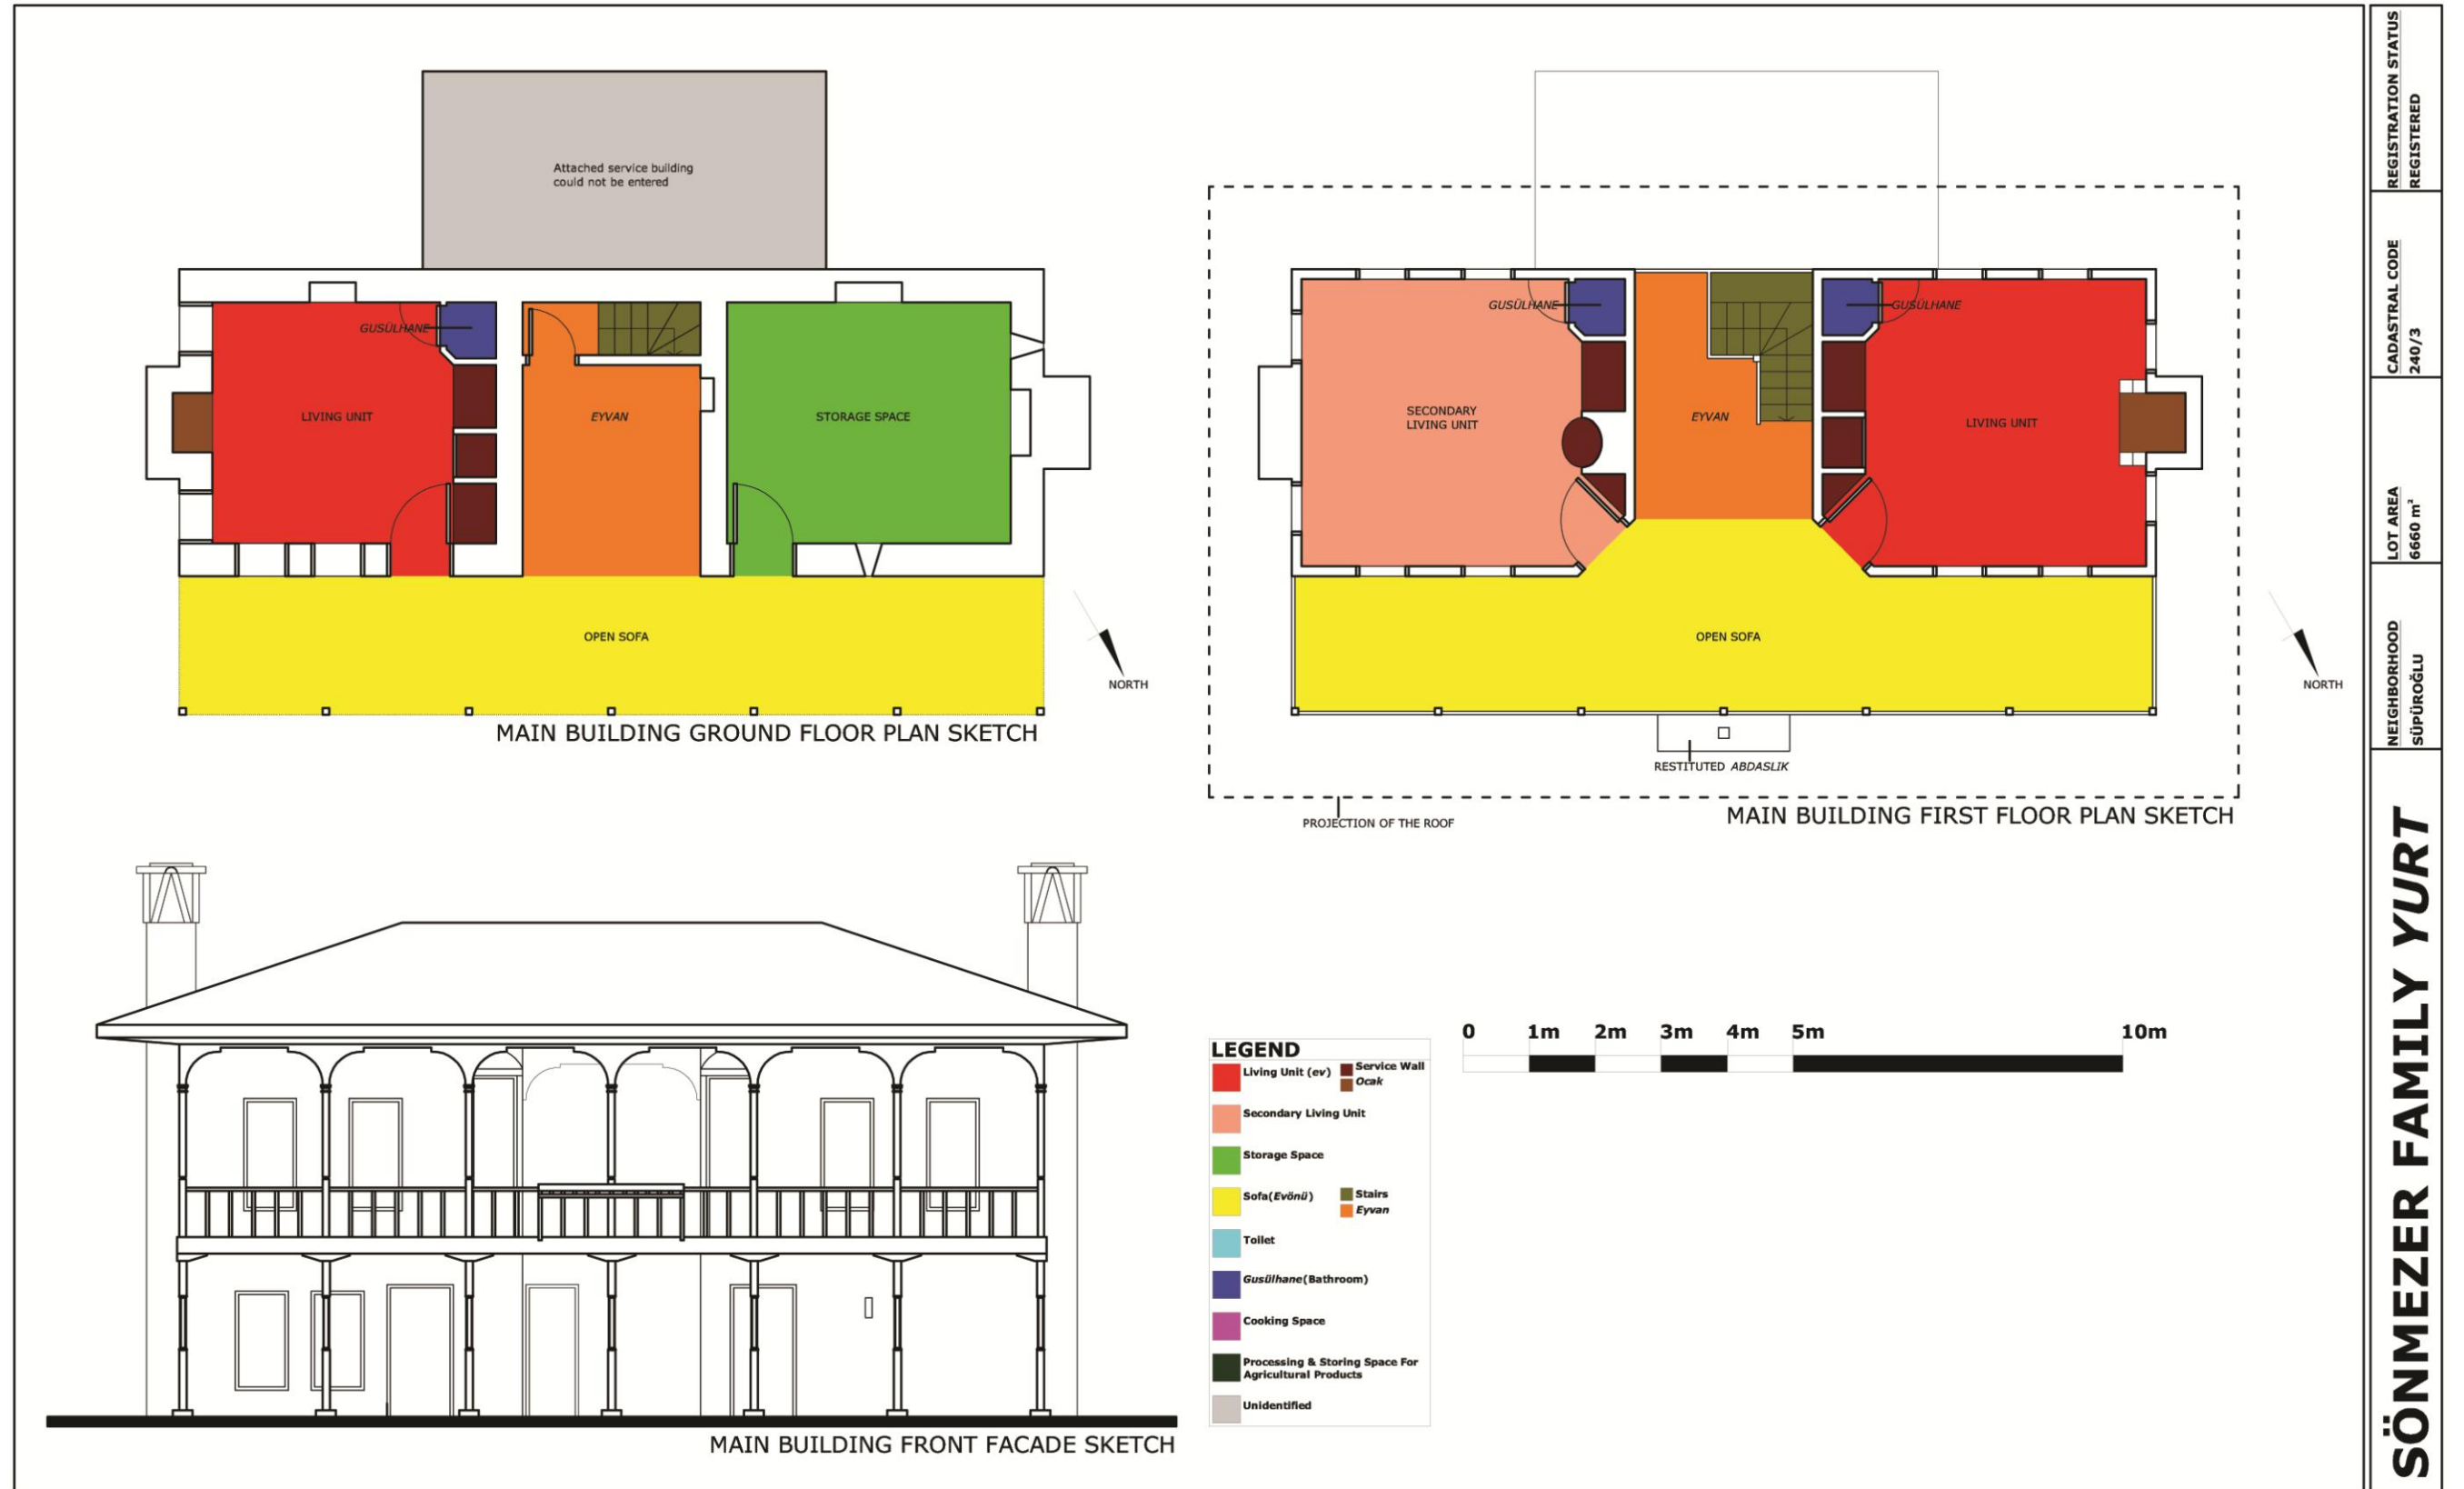
Figure 32 Plan and front façade sketches of the main building in the *yurt* of Sönmezer Family

without an *ocak* at the east. In some examples like this building, there can be observed some spaces, resembling to the *living units* in terms of their location in the building, the dimensions and the geometry of the room and the detailing; but lacking one or more characteristic elements of the *living units* such as the *ocaks* and/or the service walls. In this study those spaces are termed as the *secondary living units*. The *living units* of this building include the *gusülhane* sections hidden in their service walls. The building's plan organization as the utilization of an *eyvan* is said to be the only unique example in all Karabağlar. (See Figure 32 for plan and façade sketches and Figure 33 for photographs)

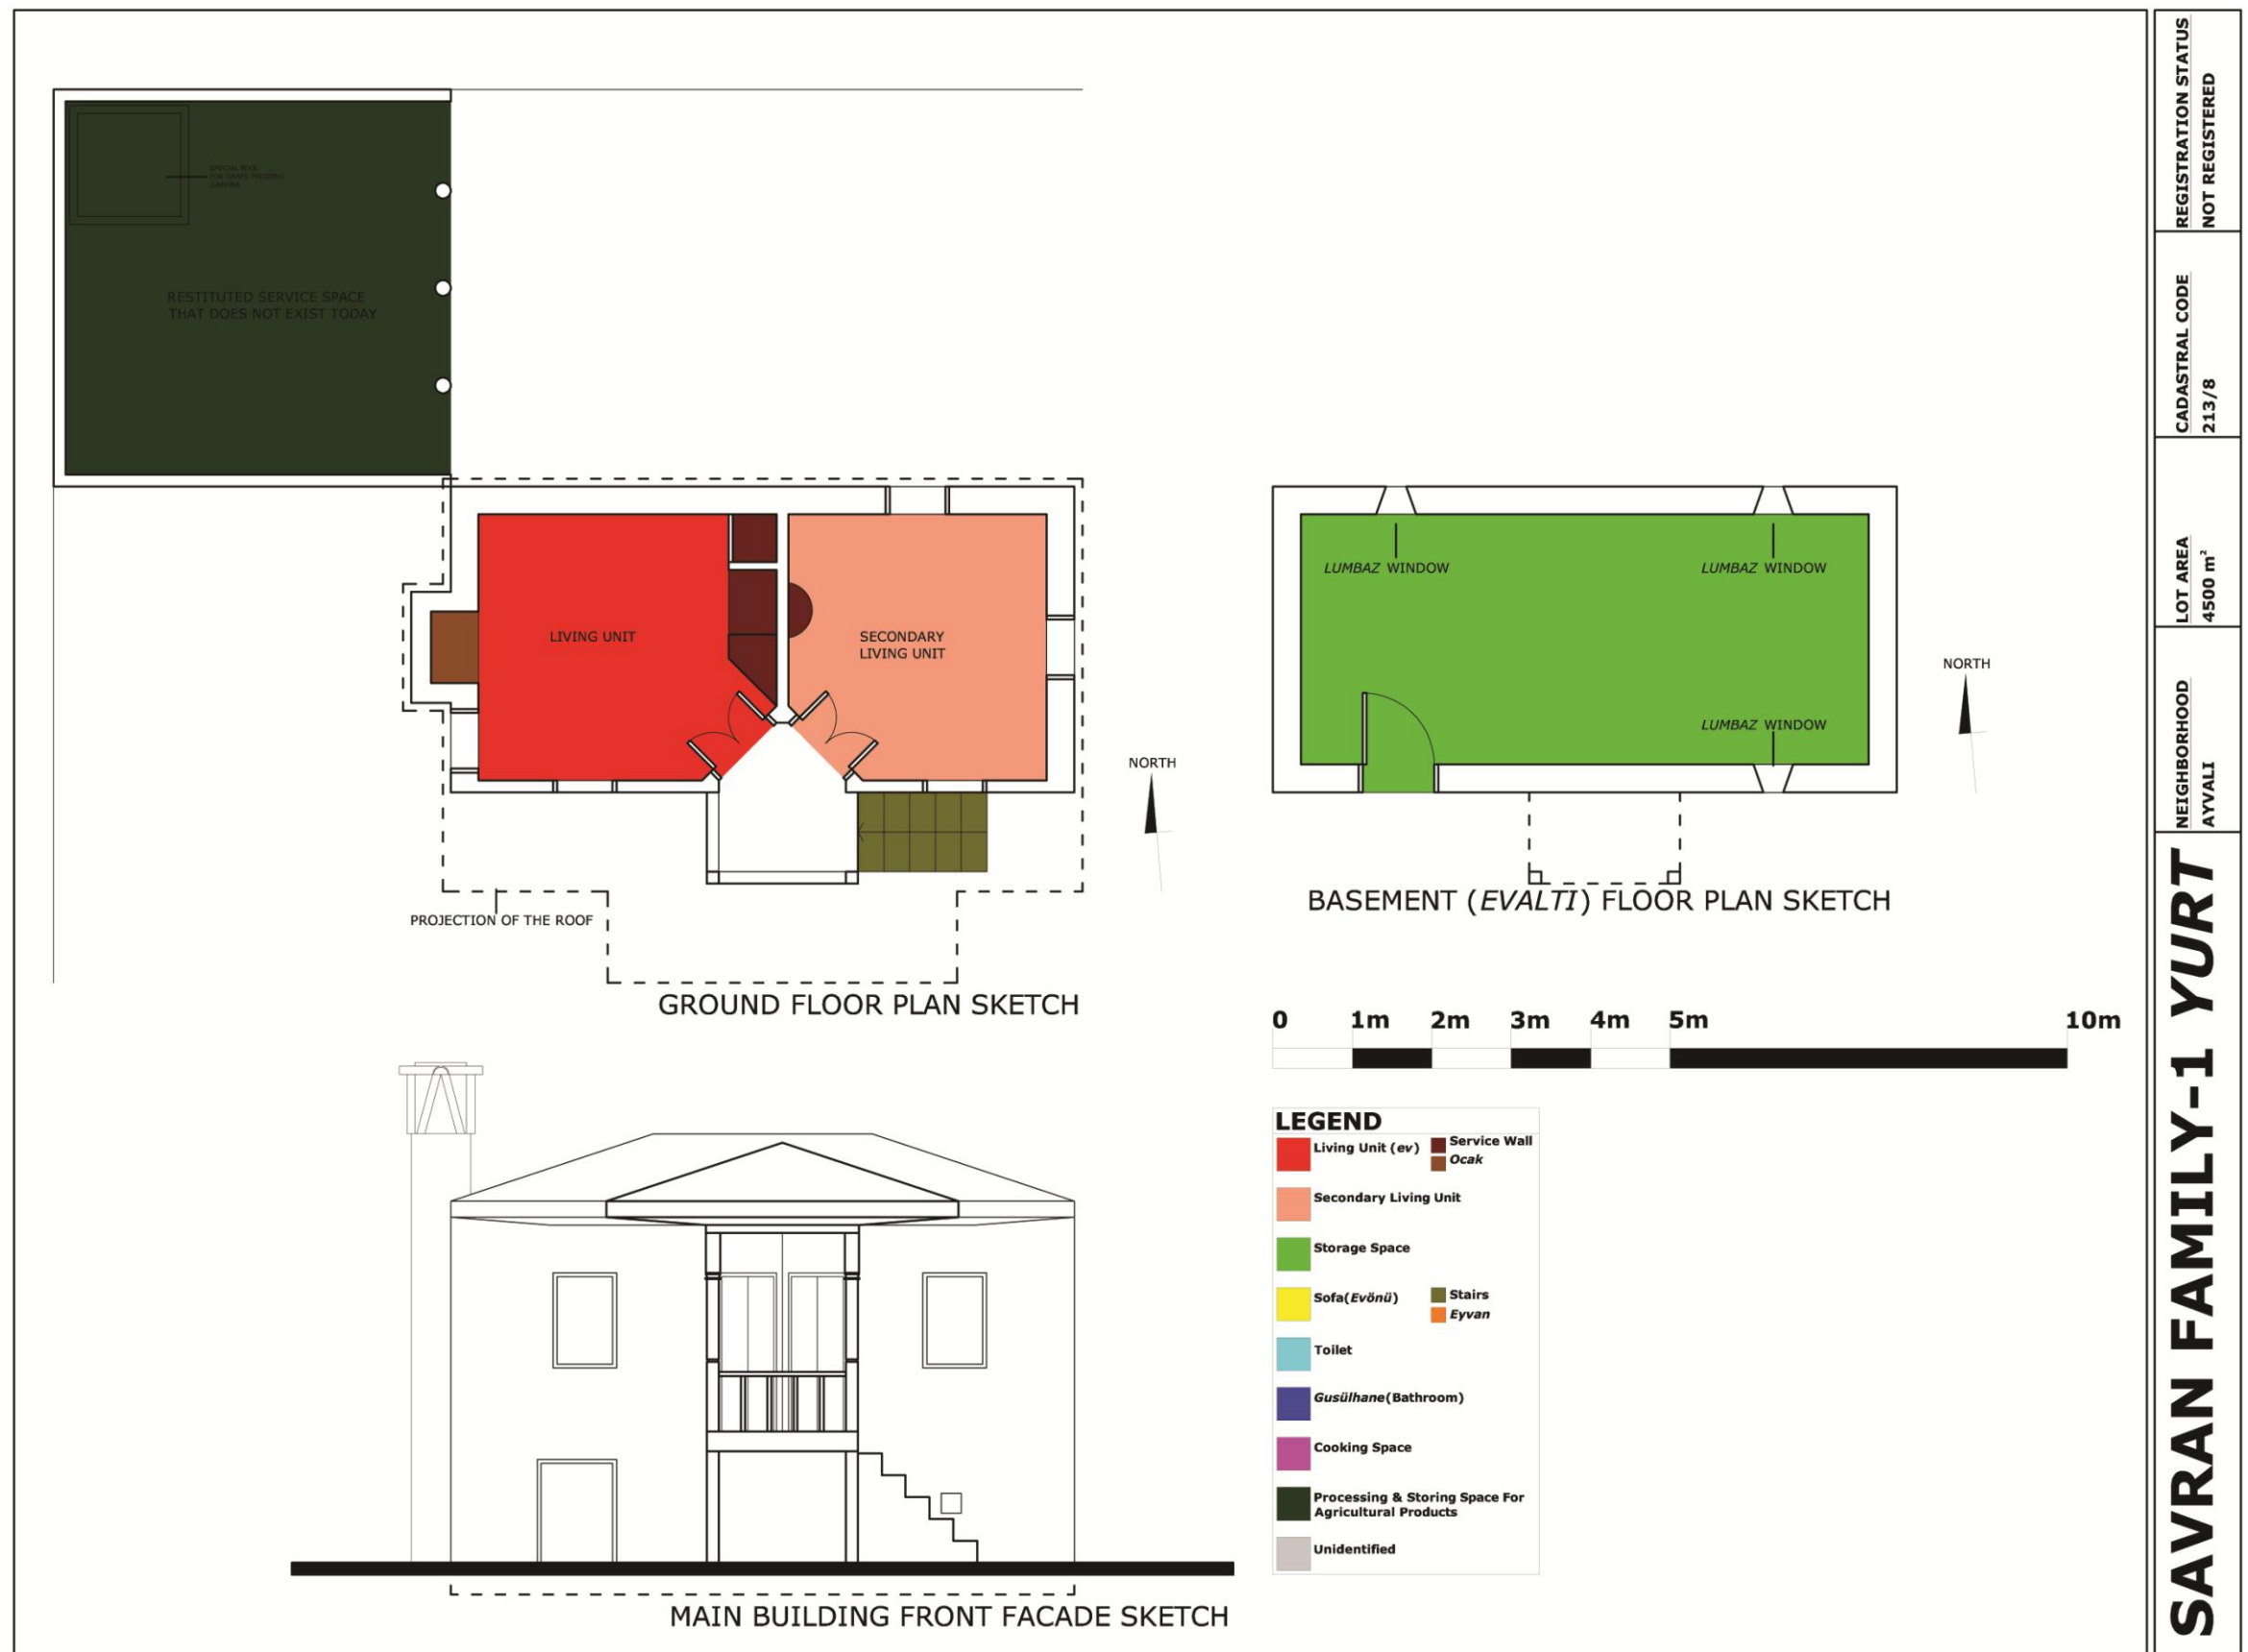
Figure 35 Plan and front facade sketches of the traditional building in the *yurt* of Savran-1 Family

The main building has one regular *living unit* at the west and one *secondary living unit* without an *ocak* at the east on its ground floor which was raised from the lot level by a 1,8 m ceiling height basement which is called as the *evaltı* section. This low-ceiling *evaltı* space acts as the mantel base in winters in order to preserve the living floor from water and humidity and in the summers acts as a

cool and humid storage space for the fruits and the vegetables. In this section, there seen special small conical windows, which were called as the *lumbaz*. In addition to their function as the windows of the basements; these *lumbaz* windows which are located at 60-70 cm above the floor of the basements are said to be helping the water flow through the building in winters. In the interviews with the owner; it is stated that the annual repairs in the springs were crucial for the maintenance of this *evaltı* section and were held every year as the first act as the immigration to the yurt begins in the springs. (See Figure 35 for plan and façade sketches and Figure 36 for photographs)

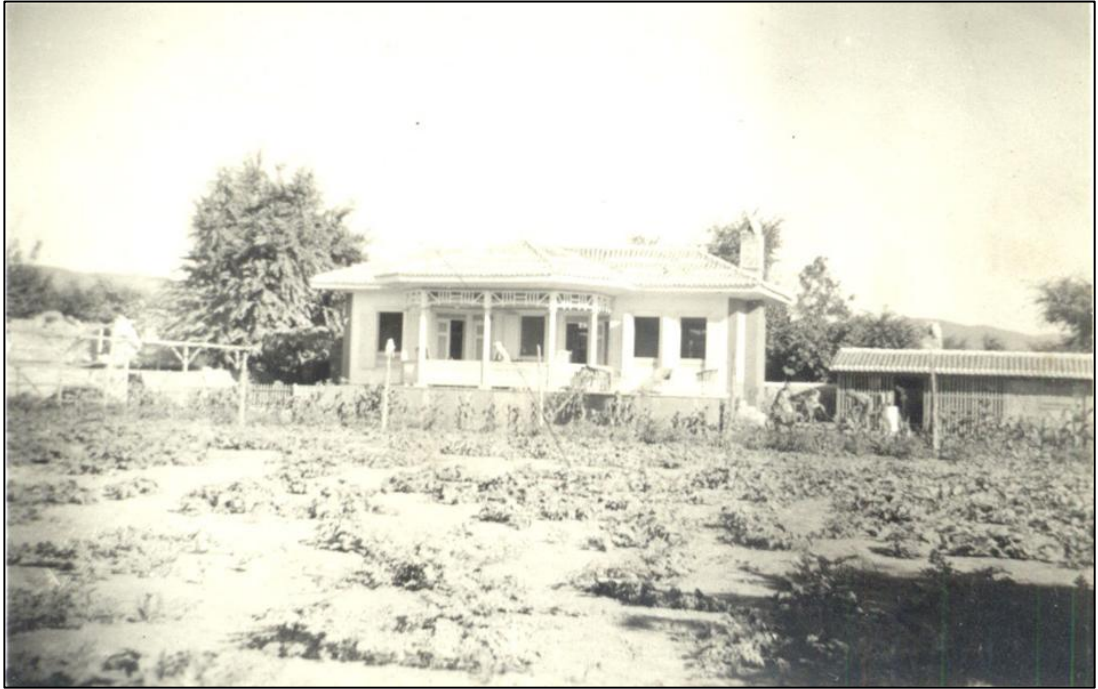
Figure 37 An old photograph¹⁷ of the *yurt* of Dişcigil Family (Source: Dişcigil Family photo archive)

¹⁷ The photograph shows Block A in the center and the *şışeli mutfak* which is in ruins today at the right side.

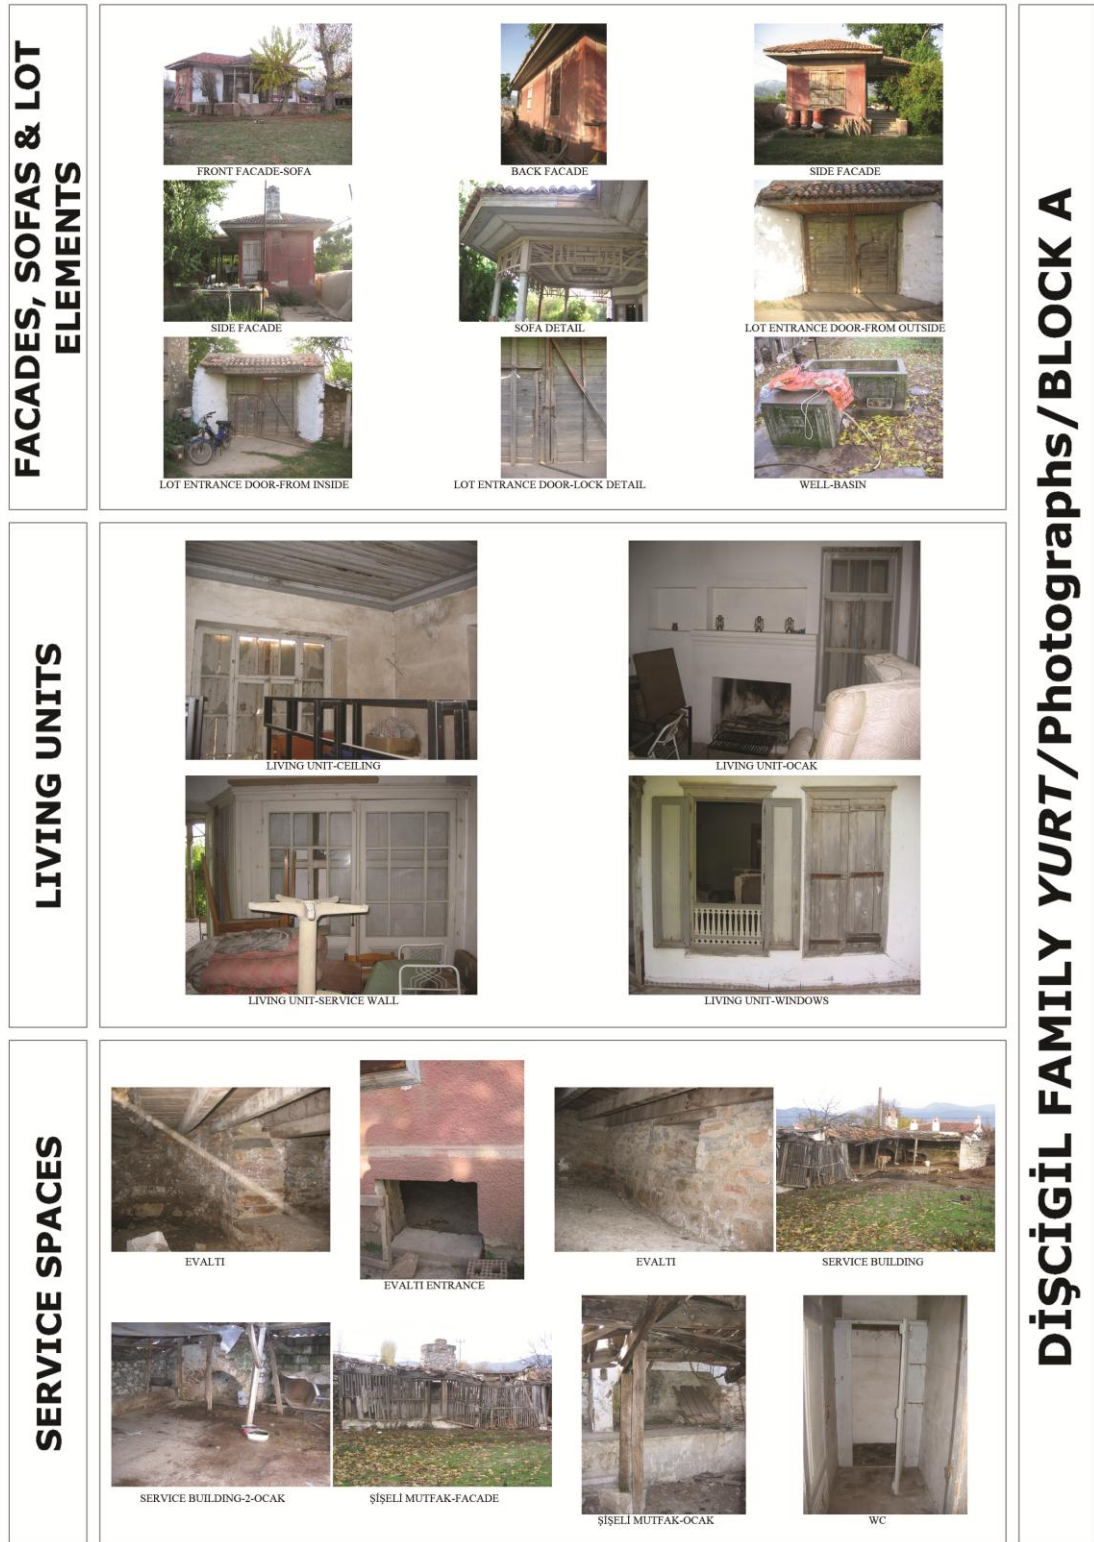
Figure 41 Photographs of Block A in the *yurt* of Dişçigil Family

Ground floor of the block A consists of a *living unit* at the north-east; a small *secondary living unit* without an *ocak* in the middle; a small narrow space near it, which was built as a toilet but said to have been never used; a bigger *secondary living unit* without an *ocak* at the south-west and finally a large open sofa at the south-east. The building is raised by a 0.8m ceiling basement (*evaltı* section). This section consists of three rooms. (See Figure 39 for plan and façade sketches and Figure 41 for photographs)
