A STUDY ON VALUES, PROBLEMS AND POTENTIALS OF THE
TRADITIONAL DWELLINGS IN KARABAĞLAR-MUĞLA

A THESIS SUBMITTED TO
THE GRADUATE SCHOOL OF NATURAL AND APPLIED SCIENCES
OF
MIDDLE EAST TECHNICAL UNIVERSITY

FEBRUARY 2012

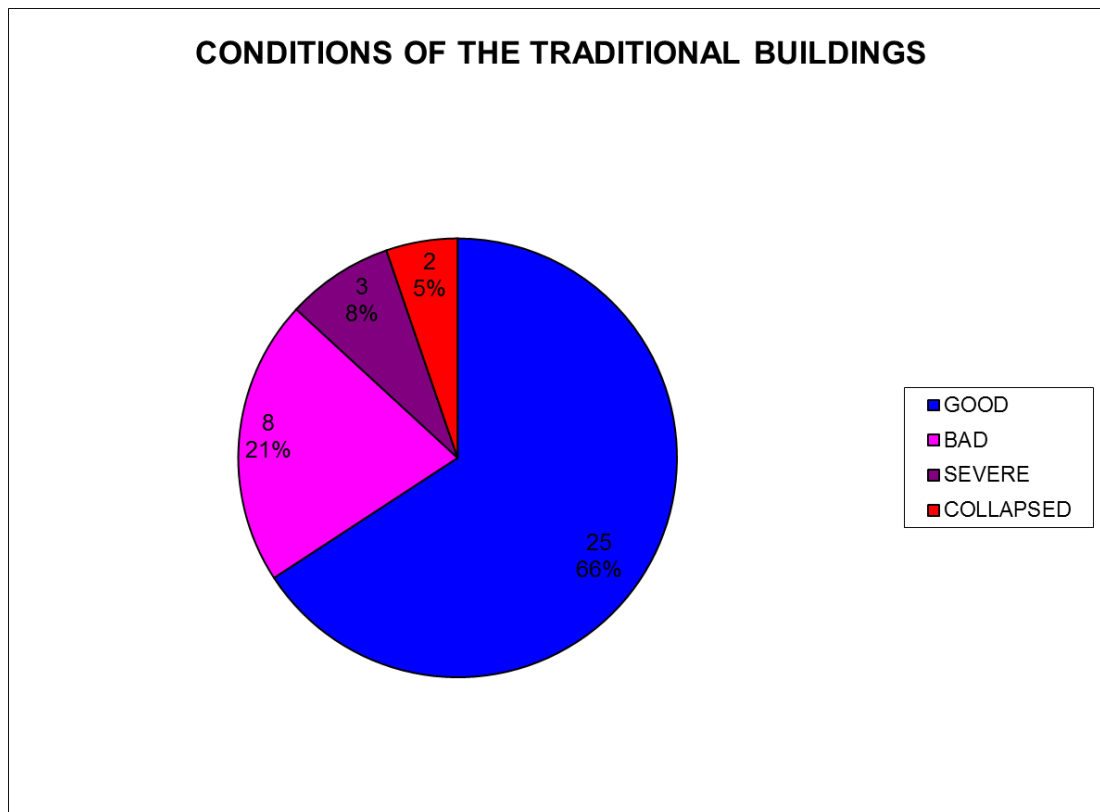
Figure 68 Conditions of the traditional buildings on the lots

- Good: is for the building with no structure or material problem which may need only regular simple repair.
- Bad: is for the building with structure and/or material problems which needs restoration project.
- Severe: is for the building which is about to collapse and needs immediate intervention.
- Collapsed: is for the building which is in ruins or excavated away.

In the subset of 38 lots that contain traditional buildings in them; according to the survey attendants 25 of these 38 (66%) lots (yurts) contain good conditioned buildings; 8 of 38 (21%) lots (yurts) contain bad conditioned traditional buildings; 3 of 38 lots (yurts) contain severe conditioned buildings and in 2 lots (yurts) the traditional buildings were collapsed. These results are also a relatively positive factor for the conservation level of Karabağlar in lot scale. (See Figure 68)

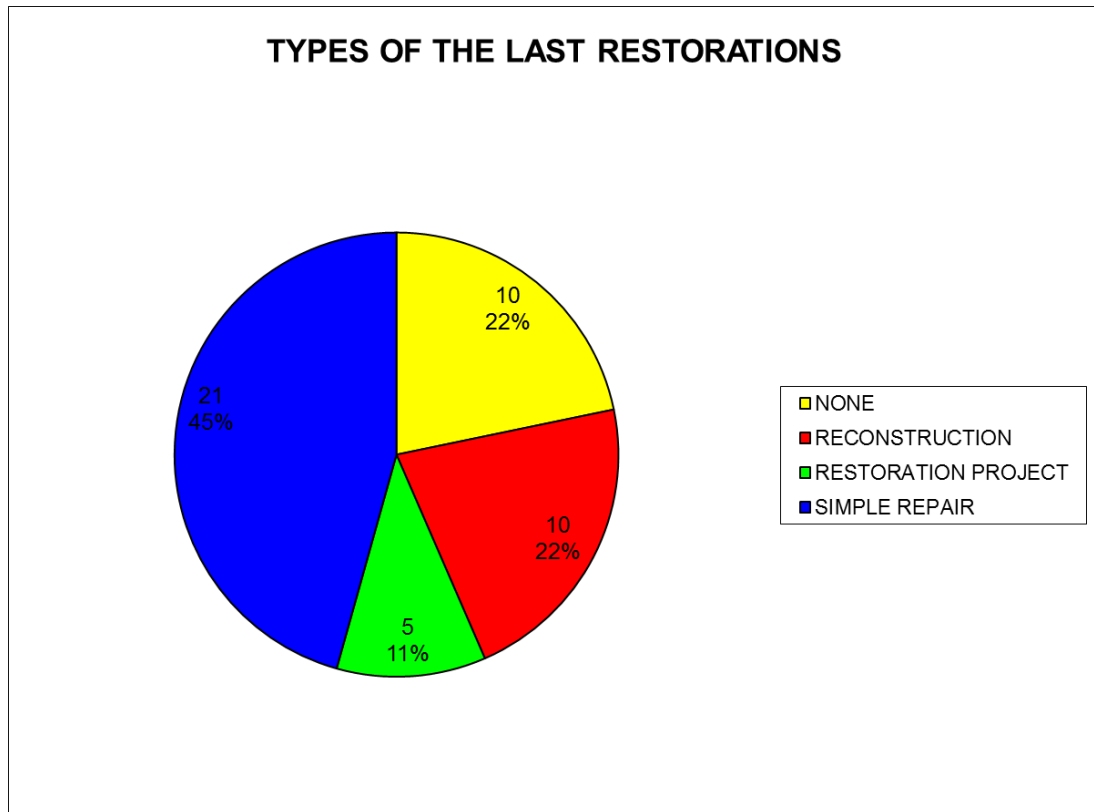
Figure 69 Types of the last restorations

- Simple repair: is for the partial repairs which do not need a restoration project e.g. roof tiles' repairs, plaster and paint repairs.
- Restoration project: is for the extensive repairs and interventions that may interfere to the structure and/or the material of the traditional building according to an approved set of architectural project.

According to the survey attendants in 21 lots the traditional buildings were subjected to the simple repairs. In 5 lots the traditional buildings had the restoration projects. In 10 lots the traditional buildings had no intervention in the known past and as mentioned before in 10 lots the traditional buildings were reconstructed which seems to be a problematic attitude that may lead to a general tendency of misconservation throughout Karabağlar. And moreover this may show the conservation awareness is not on a desired level. At this section it may also be emphasized that in the interviews the survey attendants seem not to have a clear definition of the terms *simple repair*, *restoration project* and *reconstruction* in their minds. In some cases the term *restoration project* is confused with the term *reconstruction* and the term *simple repair* is confused with *restoration projects*. (See Figure 69)

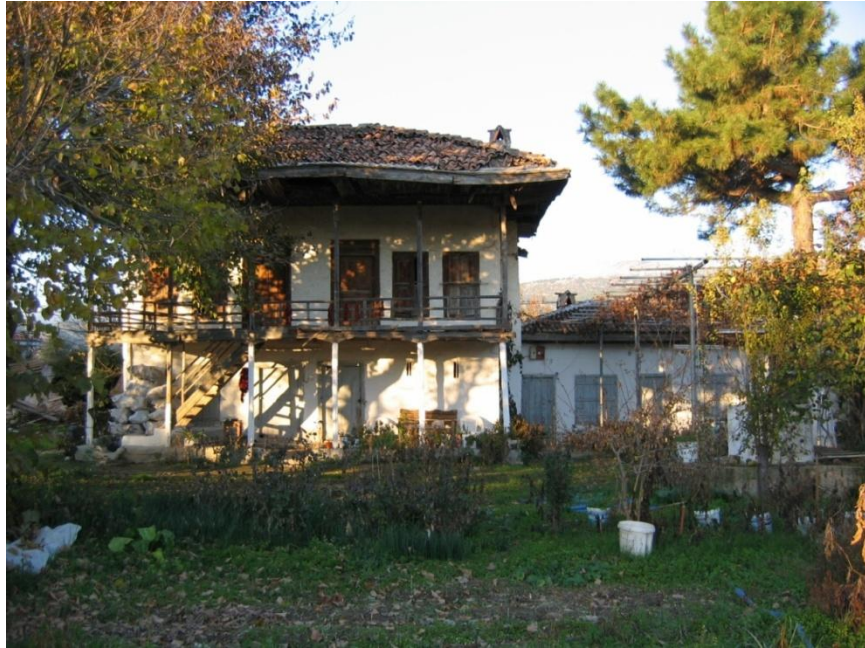
Figure 72 *Hayat* of the *yurt* of Köseoğlu Family

Spatial arrangement of the open and the semi-open spaces around the buildings, in which the daily life went on, is called as the *hayat* which is a term generally refers to the courtyards of the traditional dwellings in the old city center of Muğla. In some interviews this term is also used for the semi-open spaces of the traditional buildings like the open-sofas. The open spaces around the buildings are generally defined and shaded with the *çardaks* and large trees. (See Figure 72)

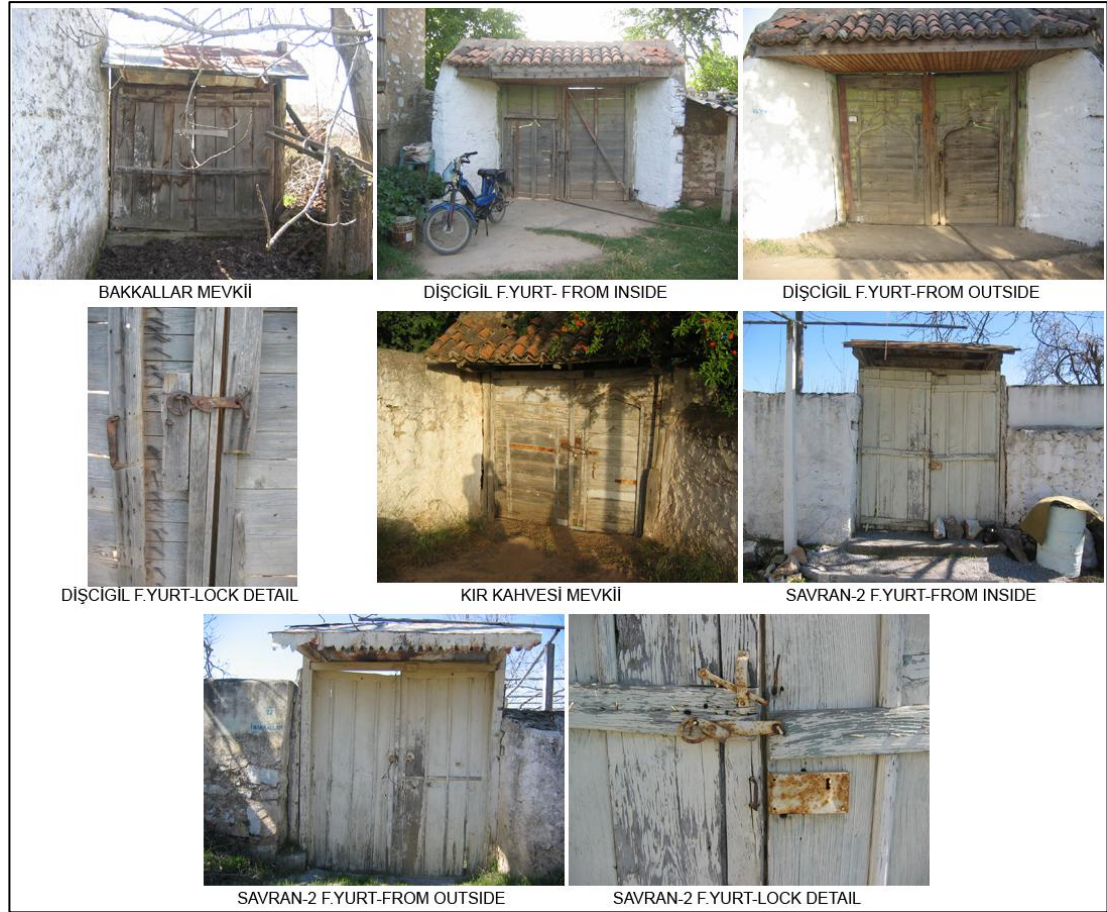
Figure 73 Photographs of the lot entrance doors from the studied *yurts*

Entrance Doors of the lots are generally wooden double doors with the protective eaves with tiles that go through both inside and outside of the lot. In some examples *kuzuluks*, which are the smaller door leaves on the bigger leaves, are seen on one side of the door.

The outside facades of the entrance doors are more decorated whereas the inner facades are more modest and roughly detailed. A special locking detail of metal work is generally utilized on the entrances. (See Figure 73)

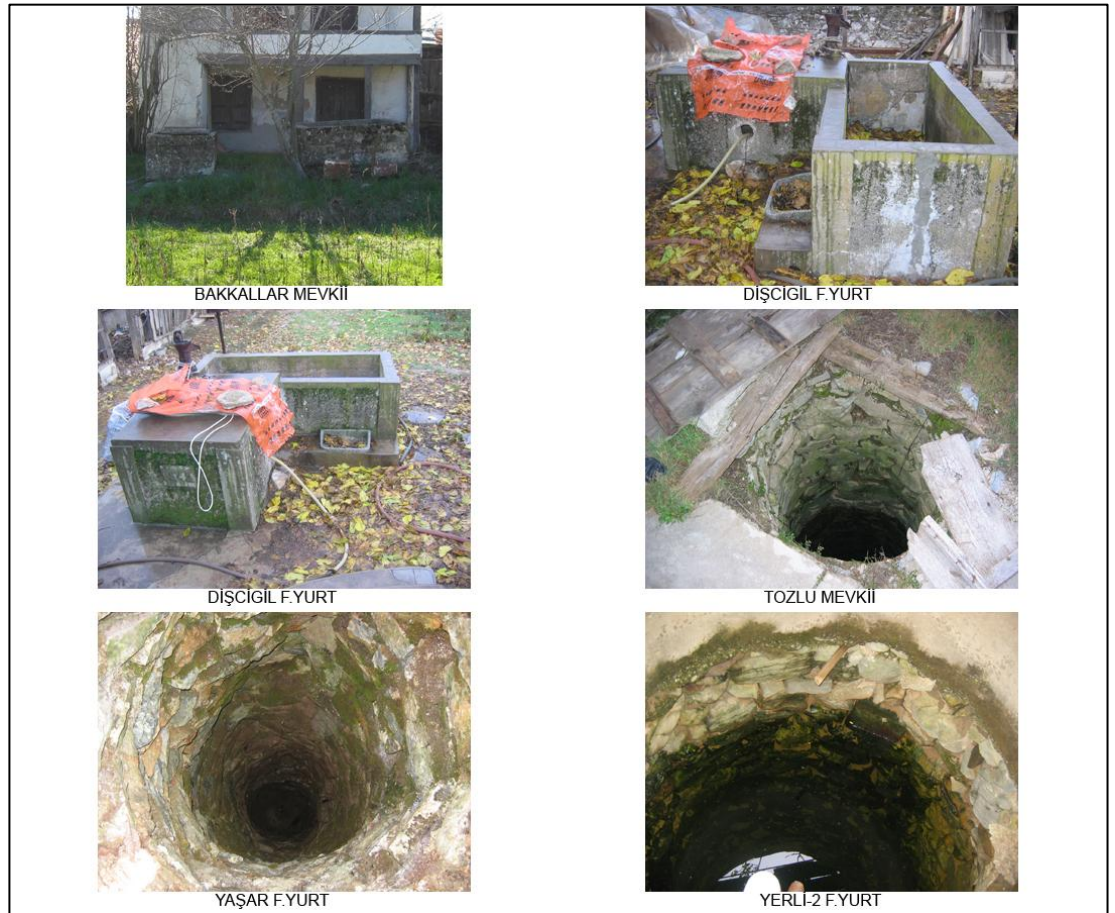
Figure 74 Photographs of the wells and basins from the studied *yurts*

The basins near these wells are used for the collection of water for daily use. In the interviews with the yurt owners, there mentioned a

special kind of basin which is called as the *şarpına* for grape pressing, however no distinctive example was situated in the site survey. (See Figure 74)

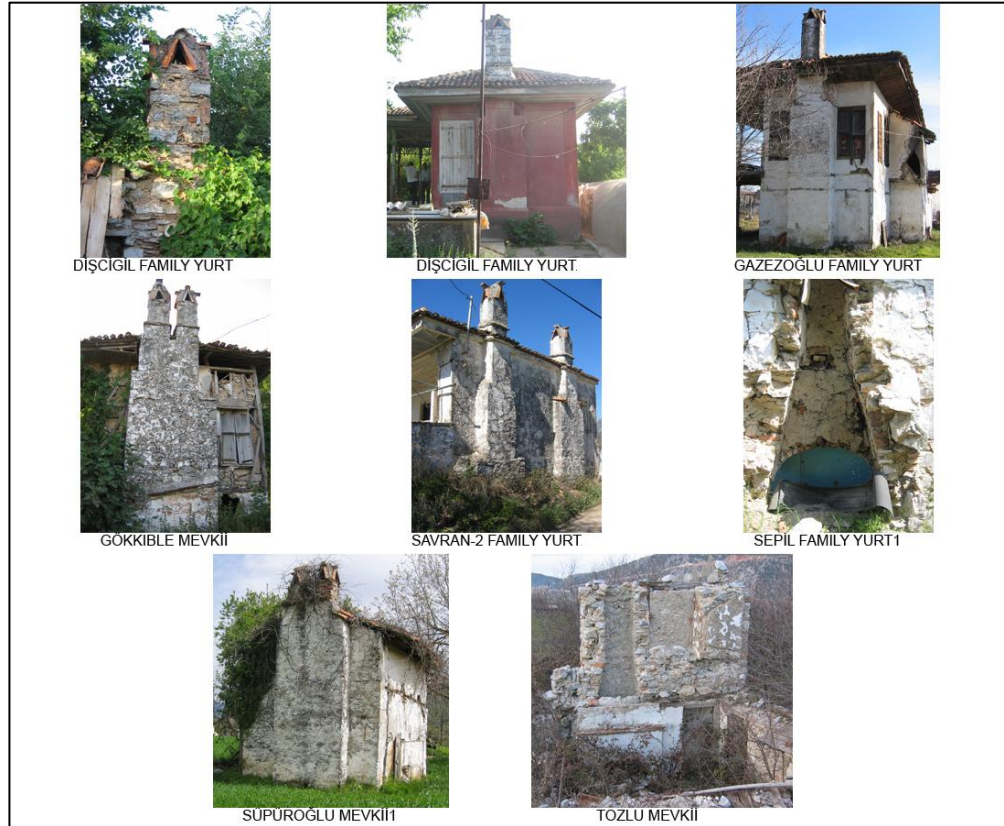
Figure 75 Photographs of the chimneys from the studied *yurts*

Chimneys have been designed as the exposed, vertical facade elements that are located at the side façades of the buildings. (See Figure 75) They are constructed of rough Stone, brick pieces and mud mortar. And on the top they finish with a special detail with tiles and mud mortar which is called as the *Muğla chimney*. (See Figure 76) On the facades, two chimneys may be constructed attached to each other.

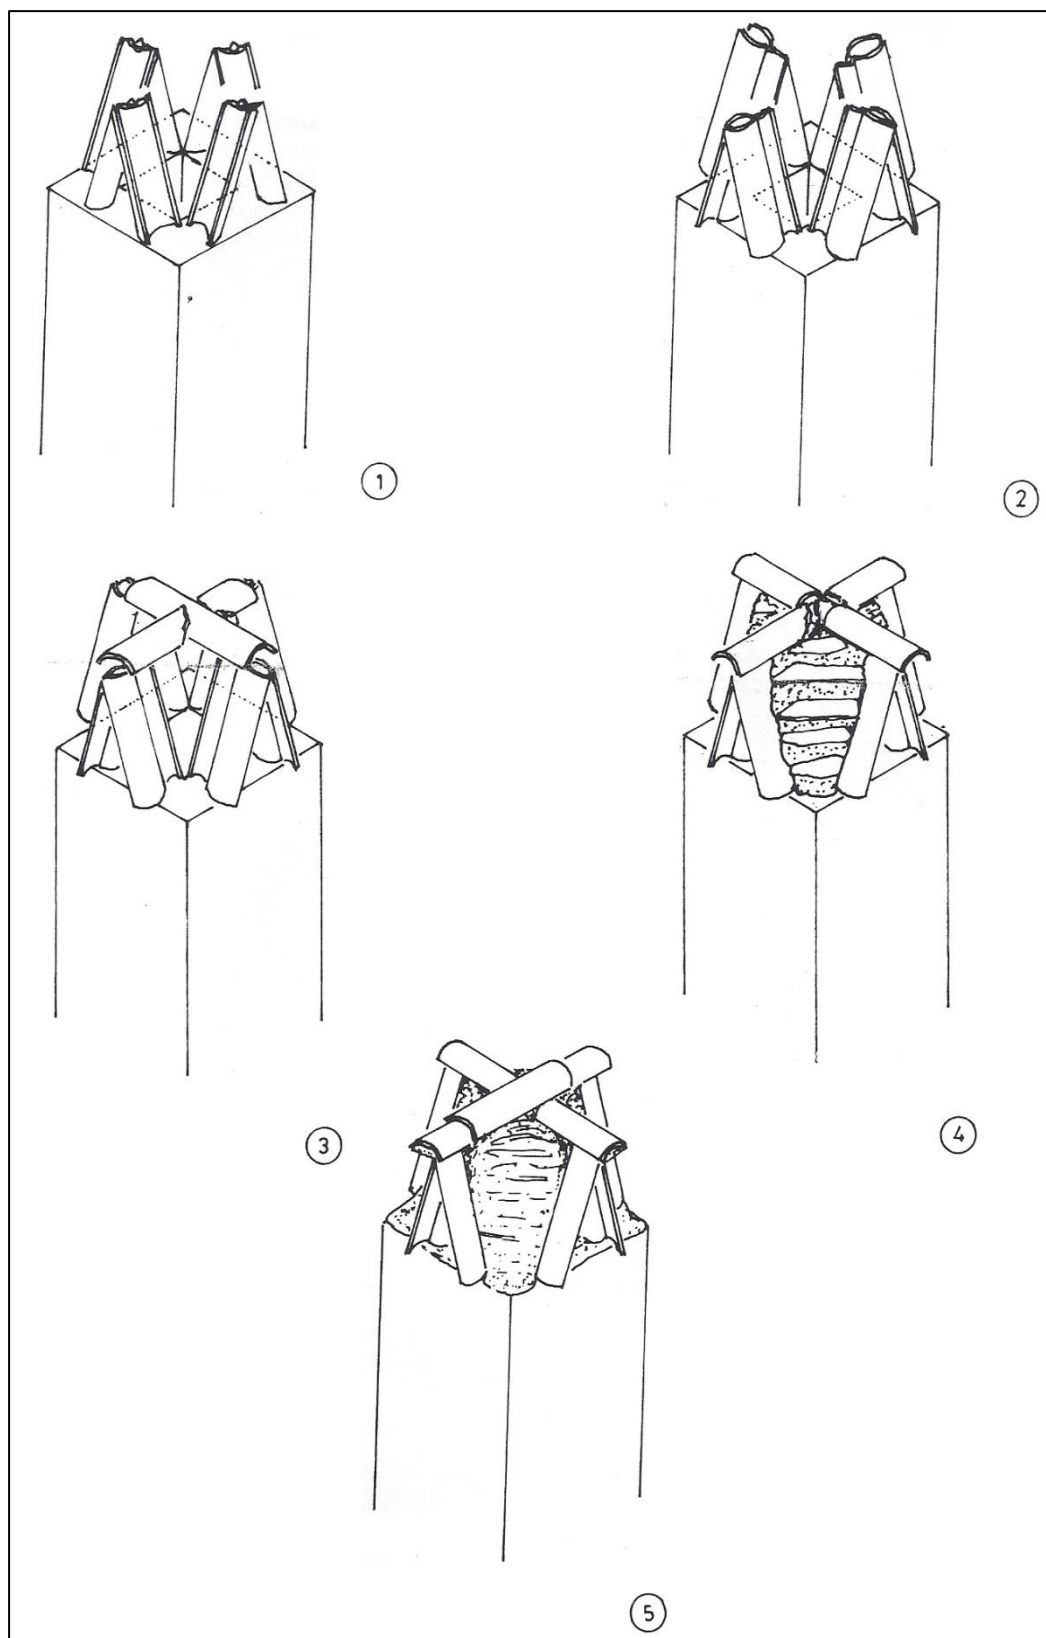
Figure 76 Construction Detail of the *Muğla chimney* (Source: ALADAĞ E., 1991. *Muğla Evi*)

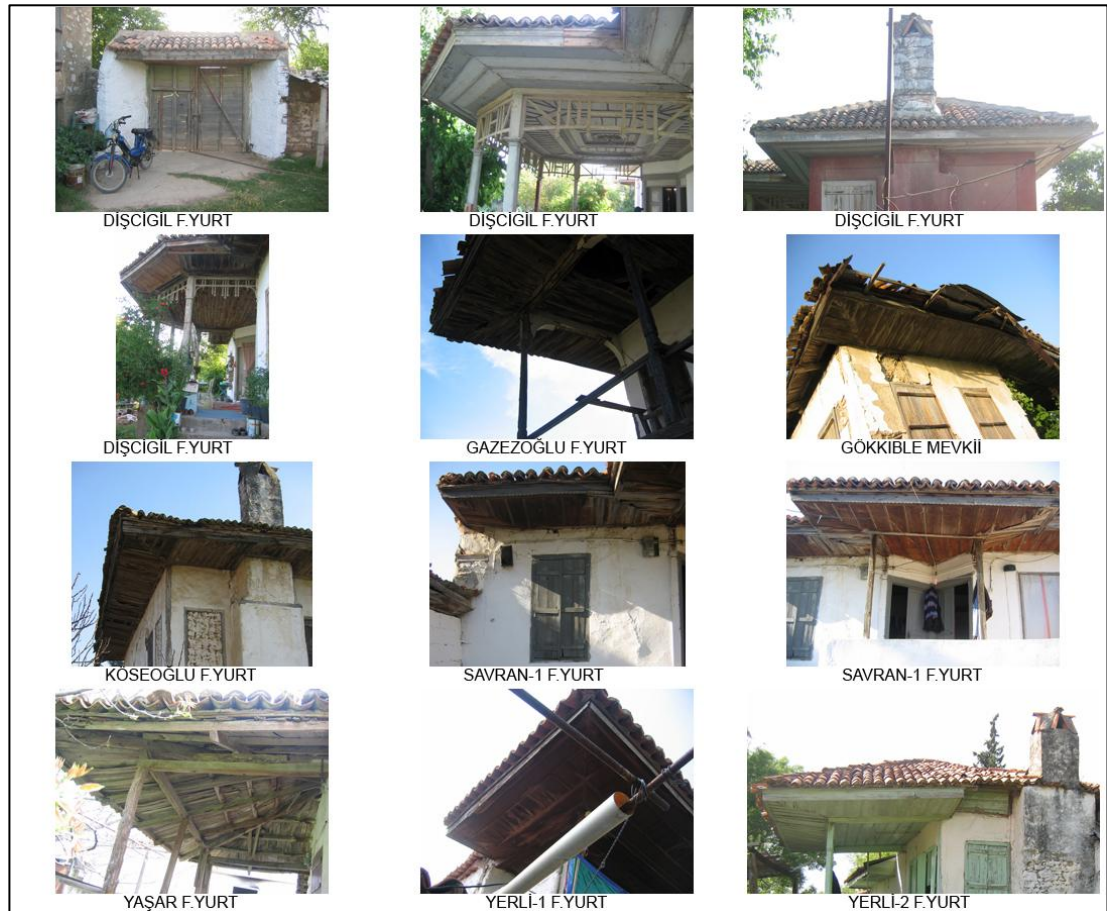
Figure 77 Photographs of the wide timber eaves from the studied yurts

Generally; only the front façades of the traditional buildings, from which they have their entrances, are protected with wide timber eaves. (See Figure 77) The side and the back facades are finished with a special detail, which is called as the *gumile* eave. (See Figure 78) In the site survey; very few examples are recorded that utilizes wide timber eaves on all facades.

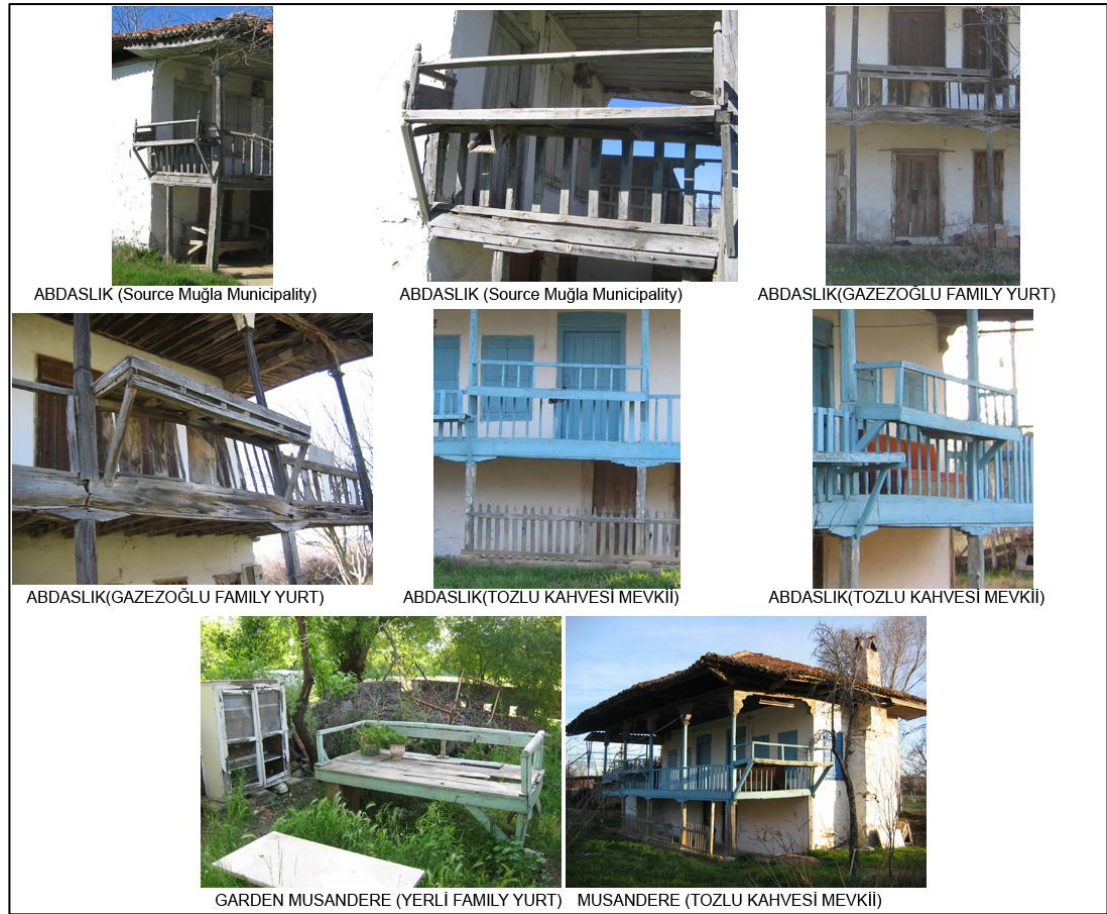
Figure 79 Photographs of the *abdaslıks* and *musandere*s from the studied *yurts*

Abdaslıks and *musanderes* are small wooden cantilever projections attached to the *sofas*. *Abdaslıks* have been used as the lavatories for daily cleaning and they have been designed with a special dirty water outlet detail. Whereas *musanderes* are like cantilever seats which are generally built on the short sides of the *sofas* for sitting and resting on. In some examples *musanderes* are seen as the detached garden seats. (See Figure 79)

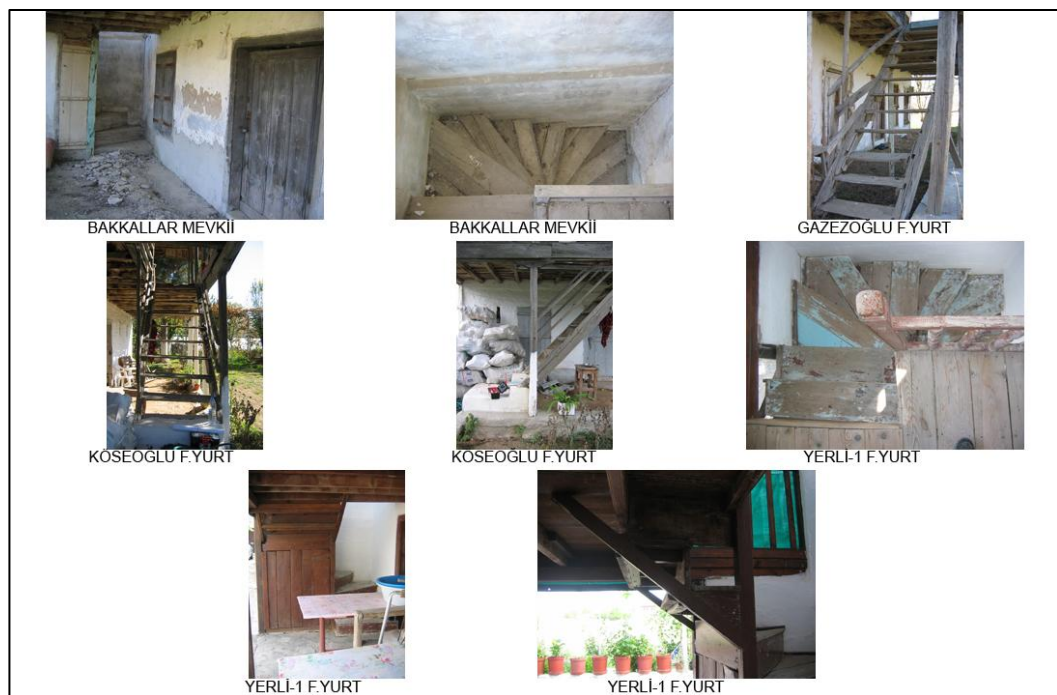
Figure 80 Photographs of the stairs from the studied *yurts*

The stairs are made of timber; whereas in some examples there are a couple of stone starter stairs at the bottom parts which may be a precaution in order to preserve the wooden stairs from water and humidity. (See Figure 80)

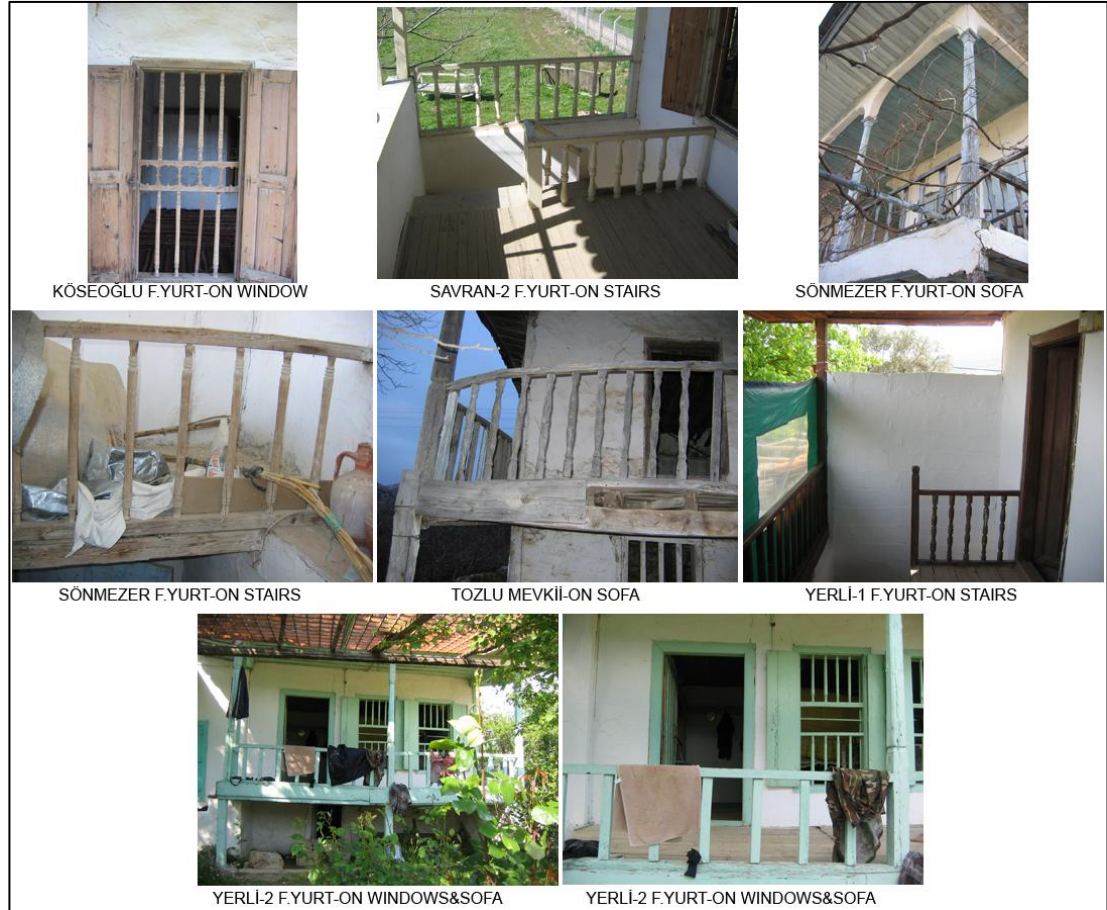
Figure 81 Photographs of the balustrades from the studied *yurts*

Balustrades are designed as both rough-detailed and ornamented. They are used as stairs and sofa railings as well as the window balustrades in the original *living unit* windows which are vertical rectangle simple openings with two shutter wings on the outside and without the glazed inner casements. (See Figure 81)

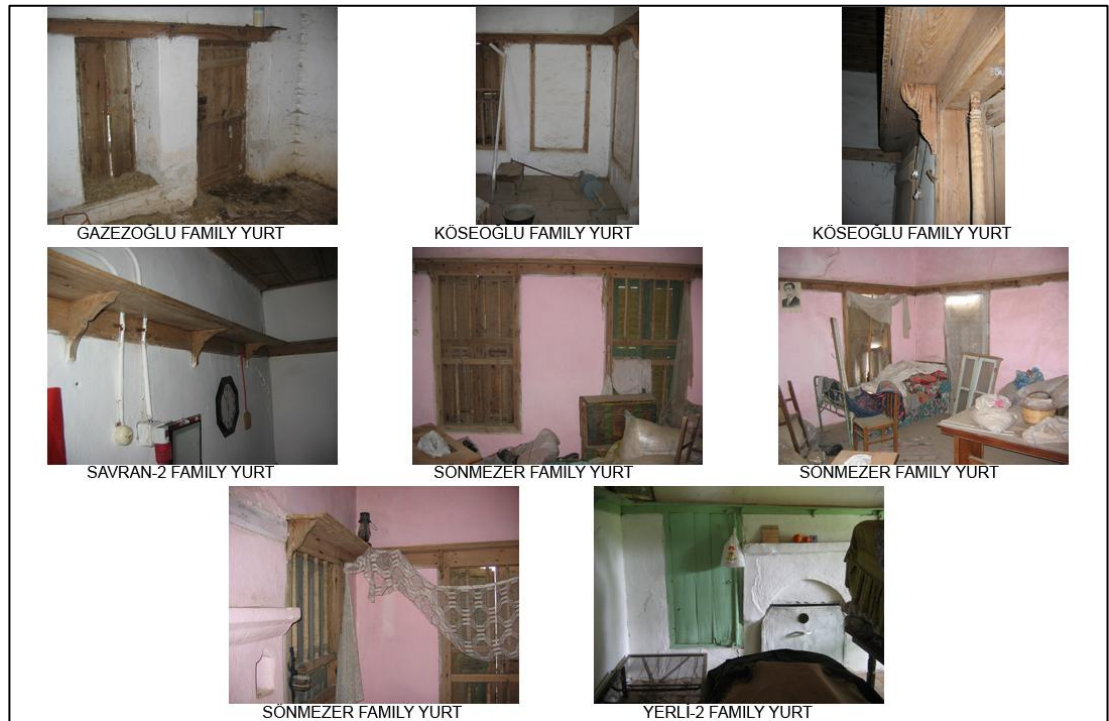
Figure 82 Photographs of the *almalıks* from the studied *yurts*

Almalıks are the strips of continuous shelves that go on all the walls of the *living units (evs)* except for the service walls. They are one of the main characteristic elements of the living units. They are used for the exhibition of the ornamental objects and for the storage of the small tools and gadgets. At few examples it is mentioned that this shelf is also used for the storage of the fruits and the dried vegetables. *Almalıks* seem to have been designed in a level relation to the entrance door, windows and the service wall of the living unit. They are carried by small, usually modestly-ornamented buttresses. (See Figure 82)

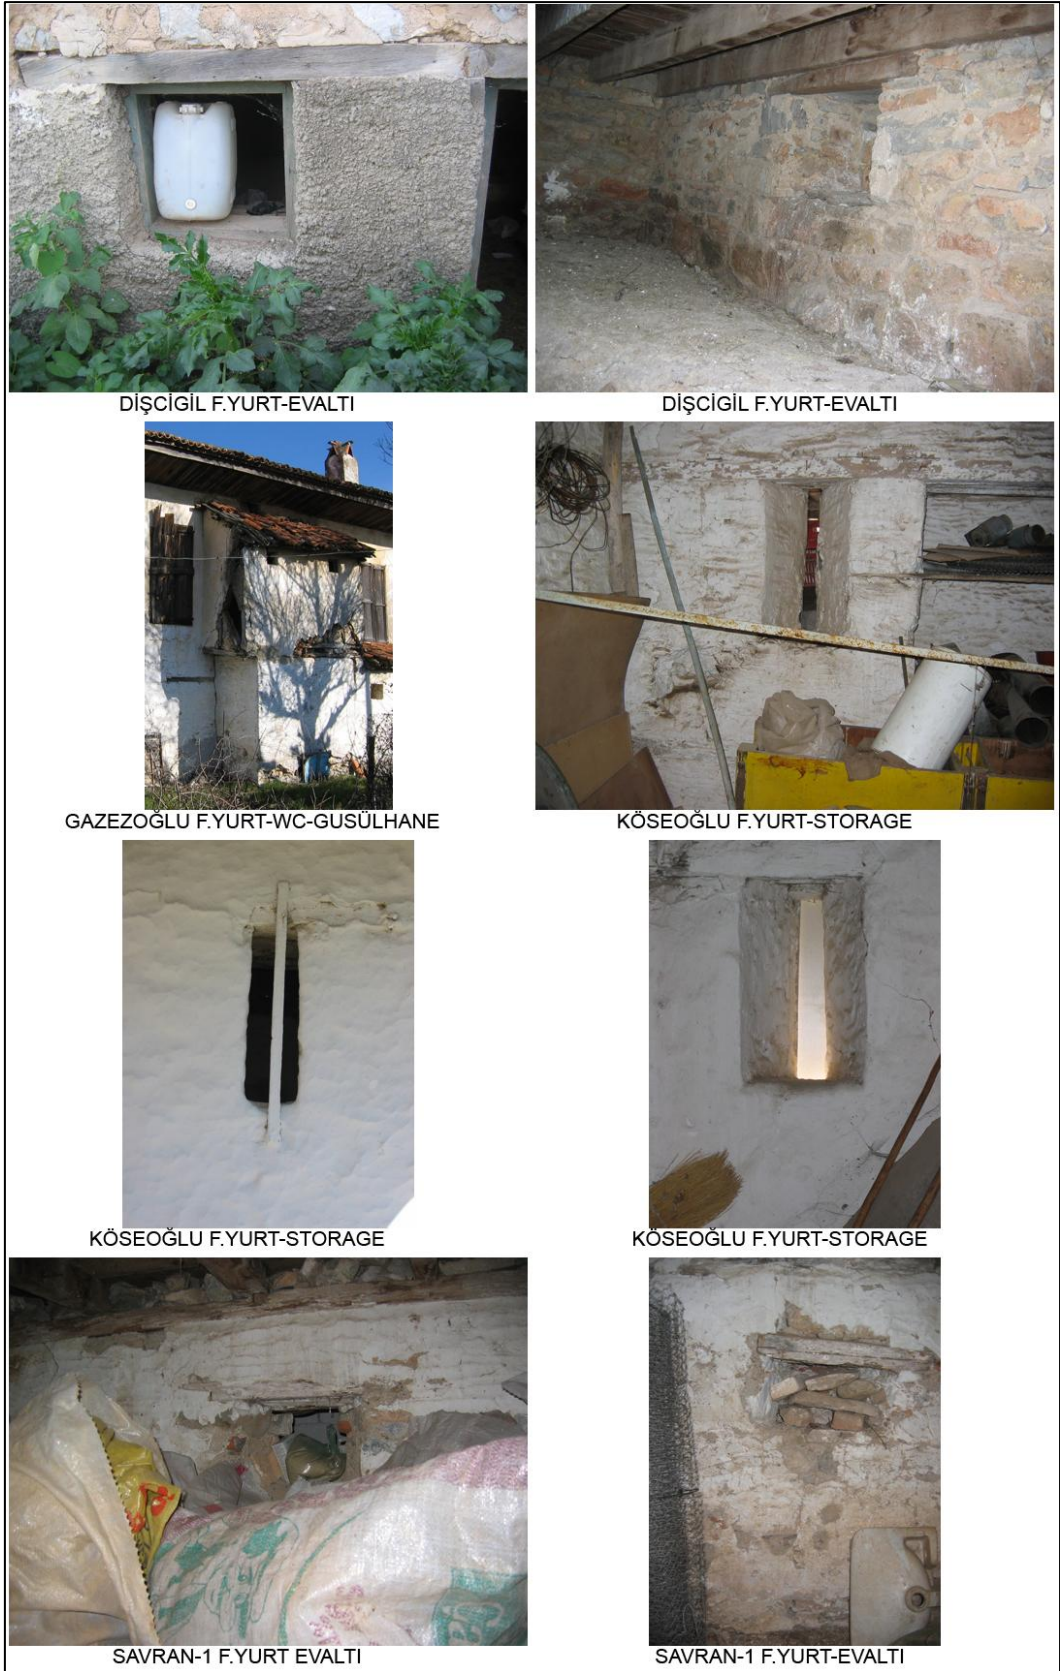
Figure 84 Photographs of the service space windows from the studied yurts

- The windows of the service spaces are simple, small rectangle or square openings (See Figure 83 and Figure 84)
- The windows of the *living units* are distinctively larger openings with modest decorations. (See Figure 85 and Figure 86)

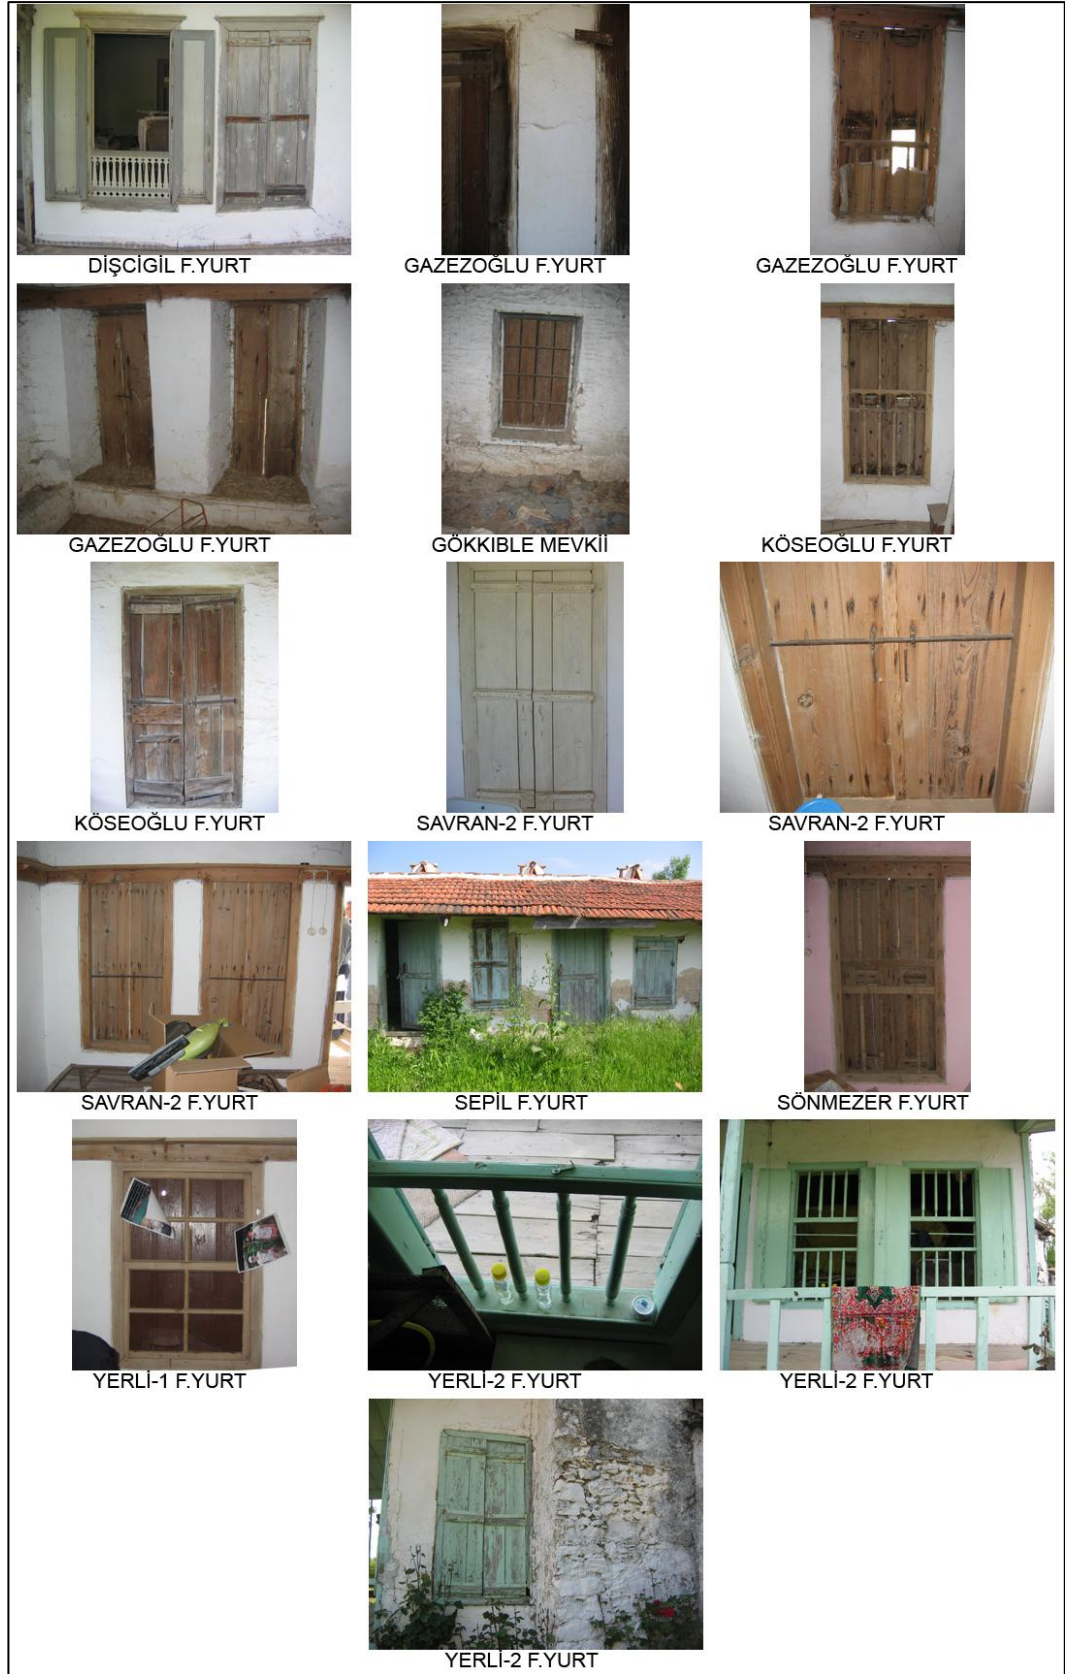
Figure 86 Photographs of the *living unit* windows from the studied yurts

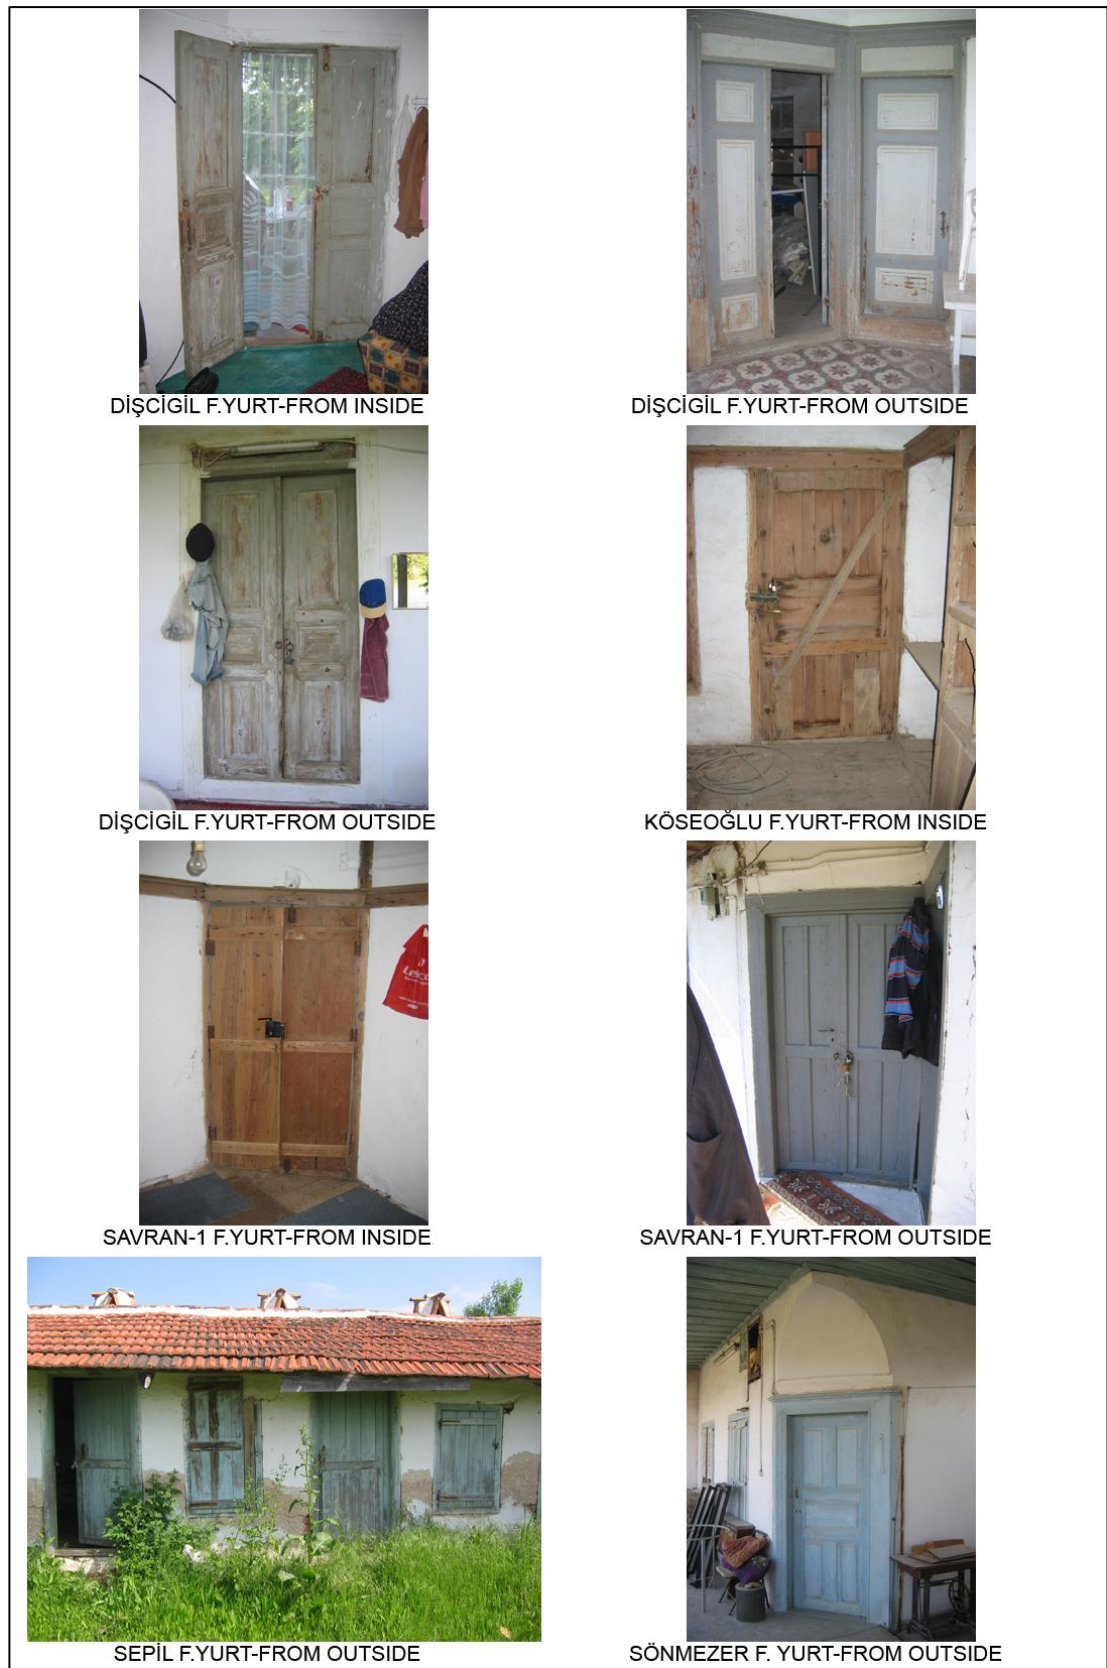
Figure 87 Photographs of the *living unit* doors from the studied *yurts*

The *living unit* entrances are designed as single or double-winged doors. They are mostly located at the corners of the rooms. In some examples; the opened door wings of these entrances are designed to be attached to the service walls of the *living units* with a special detail as to be seen as a complete inner elevation. It is interesting that the outer facades of the entrance doors are decorated whereas the inner facades show simply the raw wooden parts of their construction. This attitude establishes a sense of economy in detailing and material with a facadist approach. (See Figure 87)

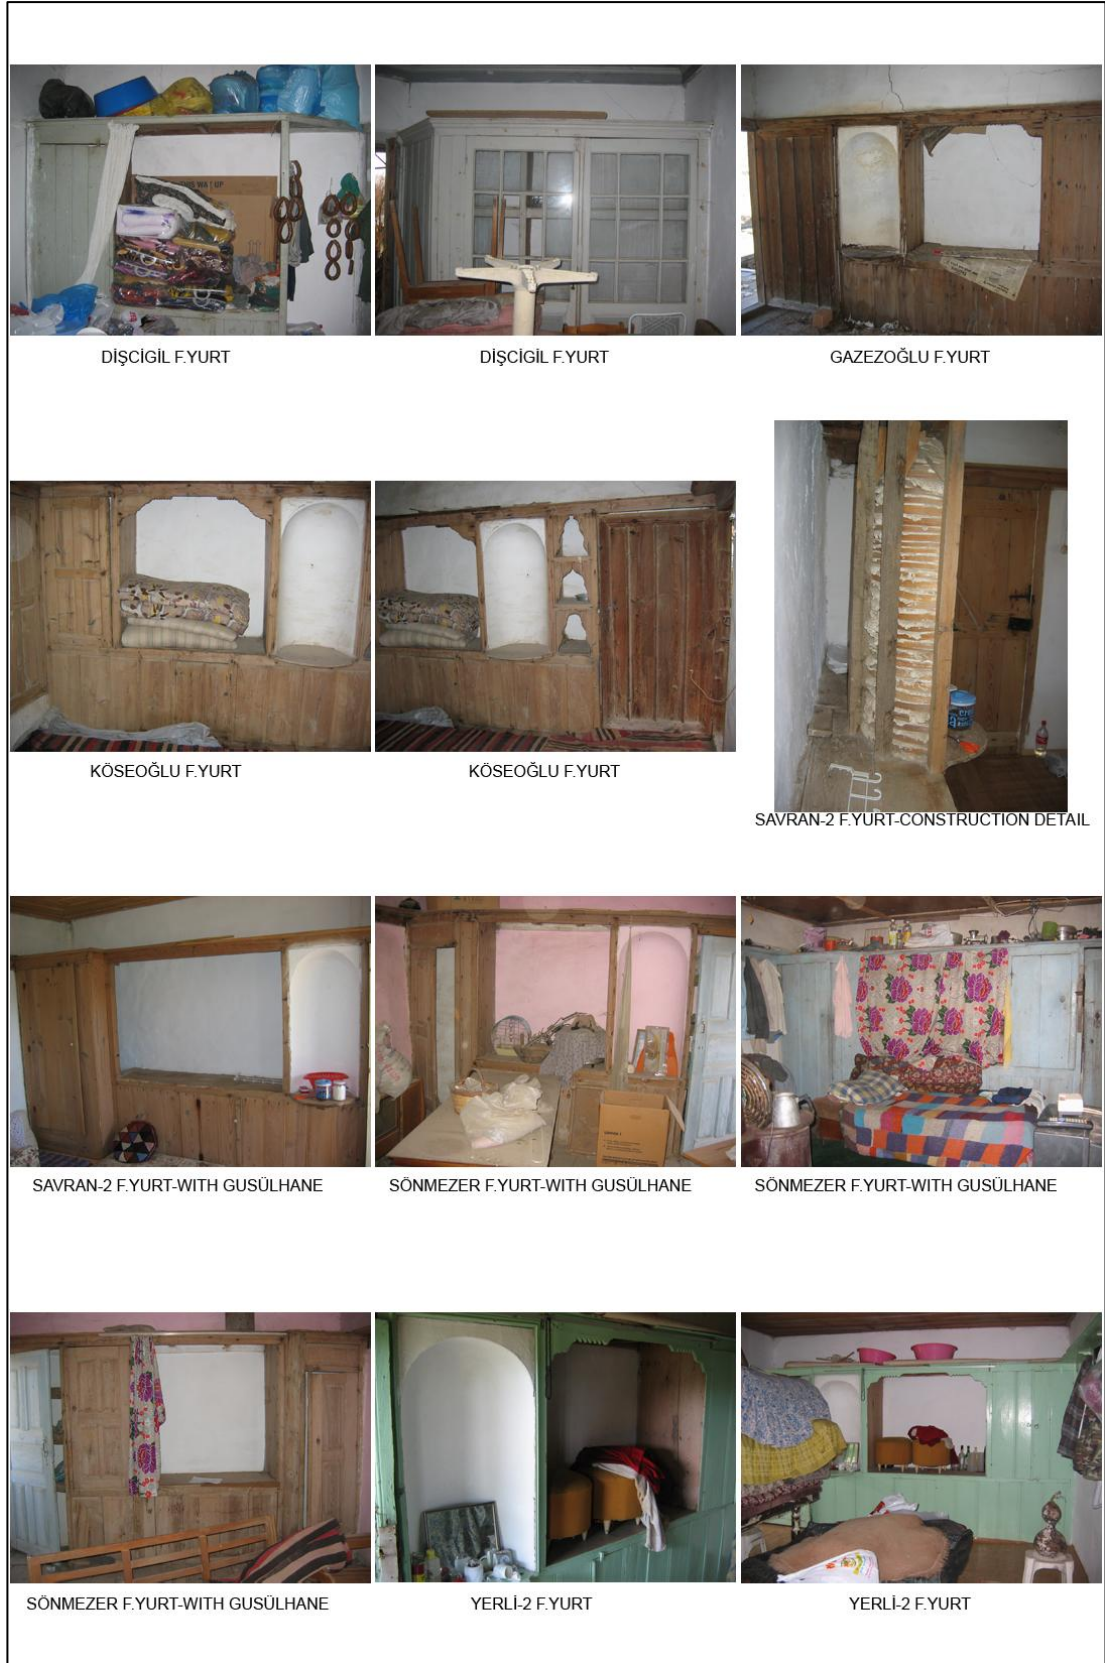
Figure 90 Photographs of the service walls of the *living units* from the studied *yurts*

Service walls are the characteristic elements of the living units (*evs*). They are located through the walls that are not facing the outside. As they serve to the multi-functional living units; they act like the storage walls for a variety of items. These service elements, which are generally 210-215 cm. in height, are the integrated designs of niches, cupboards and shelves. The largest niches which were used for the mattresses, pillows and the blankets are called as the *döşeklik* niches. The special curved planned niches which were used for the placement of the lighting equipment are called as the *çiçeklik* niches. In addition to those; the underneath cupboards were used to store woods that were to be burnt in the *ocaks* for the cooler days and the place above these service elements are used for the storage of dried vegetables and the fruits like the melons. In most of the examples the *gusülhanes* which are the spaces for body cleaning are hidden in these service elements as their entrances are camouflaged as if they were the cupboard wings of the service walls. In some cases the opened door wings of the entrances of the living units can be attached to these service walls as to be seen as a complete inner elevation. The spaces behind these attached doors were used for the clothes and the shoes. (See Figure 89 and Figure 90) The decoration, detailing and the level of the *almaliks* of the living units are mostly the same as the upper finishing details of the service walls which shows the service walls, the entrance doors and the *almaliks* were being designed and constructed together in those examples. (See photos and the drawings)

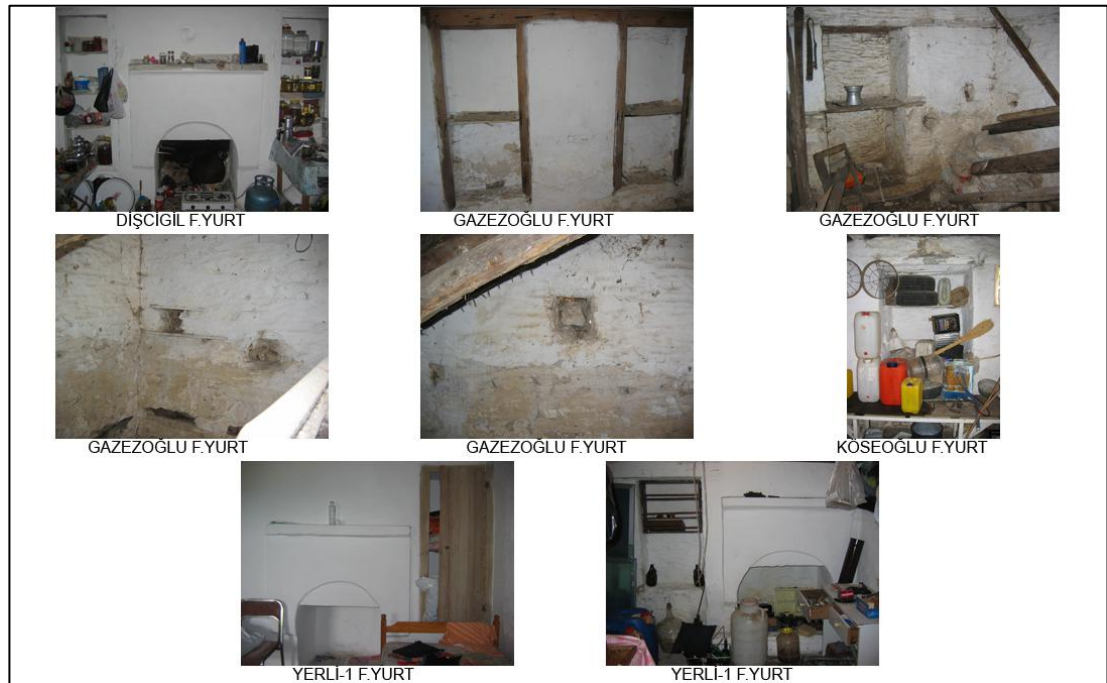
Figure 91 Photographs of the niches of the buildings in the studied *yurts*

Niches can be classified as the niches in the service spaces and the niches in the living units. The niches in service spaces are exemplified as the 15*15cm to 20*20cm sized small niches and the bigger ones with shelves which generally occupy the space under the exposed chimneys of the *ocaks* of the upper living units. The niches in the living units (*evs*) are generally timber framed and in few examples they have been designed as the shuttered cupboards. For some framed niches in the living units the restitution study may show that the niche would be an alteration of an original window. (See Figure 91)

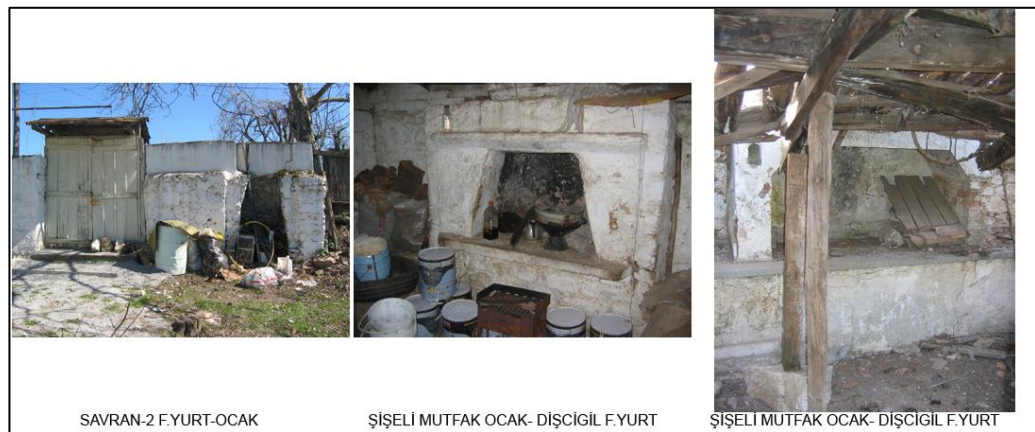
Figure 92 Photographs of the service space *ocaks* of the buildings in the studied *yurts*

Ocaks can be studied in two distinguished types as the *ocaks* of the semi open cooking service spaces and the *ocaks* of the living units. The service space *ocaks* are generally bigger in size and they have been designed elevated from the ground level on top of a counter. (See Figure 92) The *ocaks* of the living units are smaller and very near to the floor level of the rooms. (See Figure 93) Most of the studied *ocaks* are not very decorated. But in few examples of many-unit buildings, one *living unit* can be distinguished from the others by its more decorated *ocak*. *Ocaks* may have small niches which are called as the *kibritliks* and projection shelves on the top which are called as the *ocak başı* for the kindling and the matches. *Ocaks* are generally constructed of rubble stone, brick pieces and mud mortar; moreover in some examples they are constructed of only bricks and mud mortar. In more recent examples like the *worker houses*, the *ocaks* are flat-arched elements of bricks and mud mortar.
