A STUDY ON VALUES, PROBLEMS AND POTENTIALS OF THE
TRADITIONAL DWELLINGS IN KARABAĞLAR-MUĞLA

A THESIS SUBMITTED TO
THE GRADUATE SCHOOL OF NATURAL AND APPLIED SCIENCES
OF
MIDDLE EAST TECHNICAL UNIVERSITY

FEBRUARY 2012

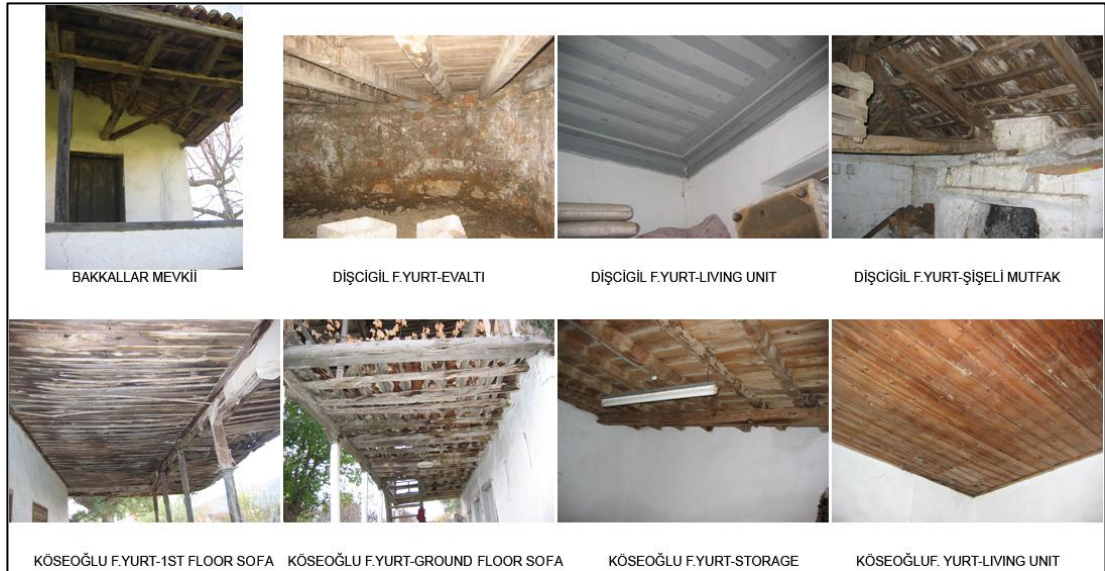
Figure 94 Photographs of the ceilings in the buildings of the studied yurts

The ceilings of the service spaces are generally left as the exposed structural timber beams and the wooden floorings on top of them. When the service spaces are just under the roofs; the ceilings compose of the exposed roof structures and the special thin sheets of roof covering timbers which are locally called as the *bedevre* timbers.

The structural elements are generally hidden behind a simple ceiling with timber laths in the living units. No ceiling with a special ornamentation is documented during the site survey. (See Figure 94)

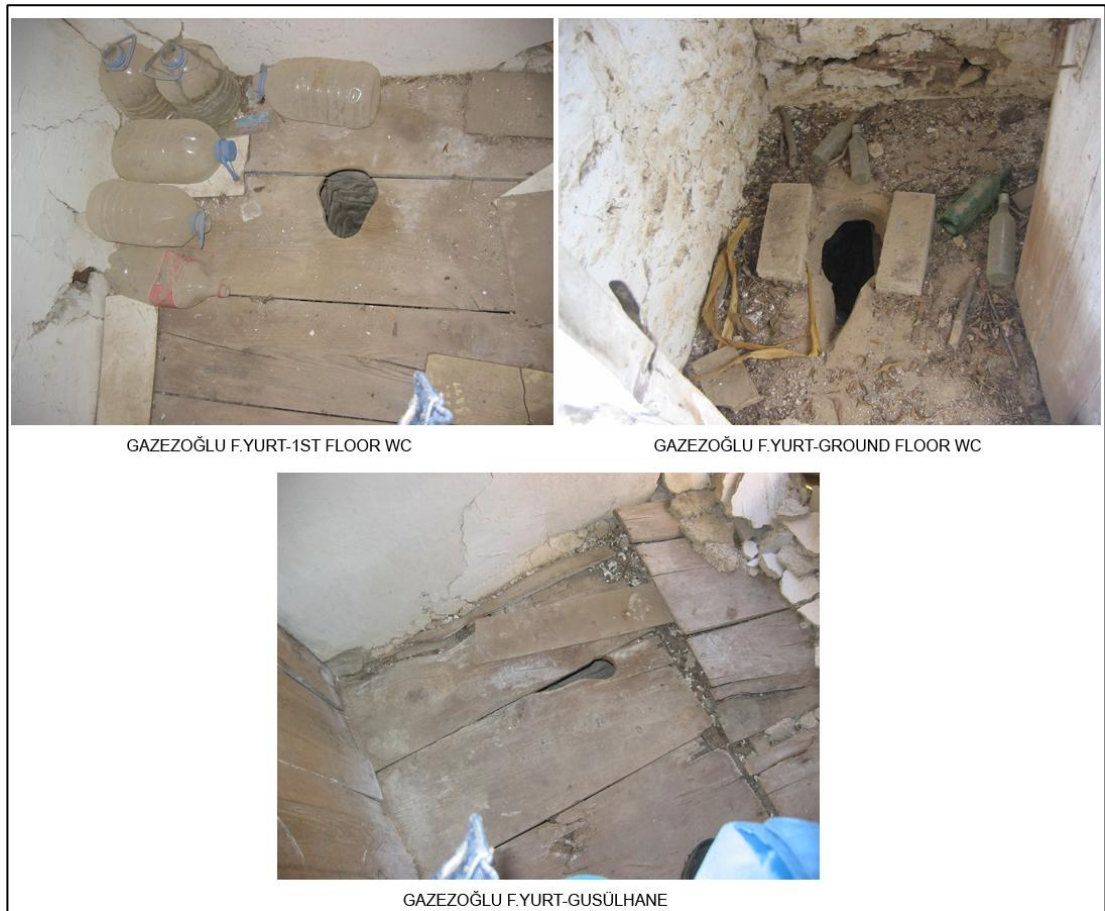
Figure 95 Photographs of the toilet-*gusülhane* outlets in the building of Gazezoğlu Family *yurt*

During the site survey; the traditional toilet detailing was only observed in the lot of the Gazezoğlu family. The toilet detailing in the first floor seems to be simply a small hole on the wooden floor. This hole opens to a closed dirt accumulation space in the ground floor which has a small opening on the building's back façade for the cleaning of the dirt collected in this space. (See Figure 95)

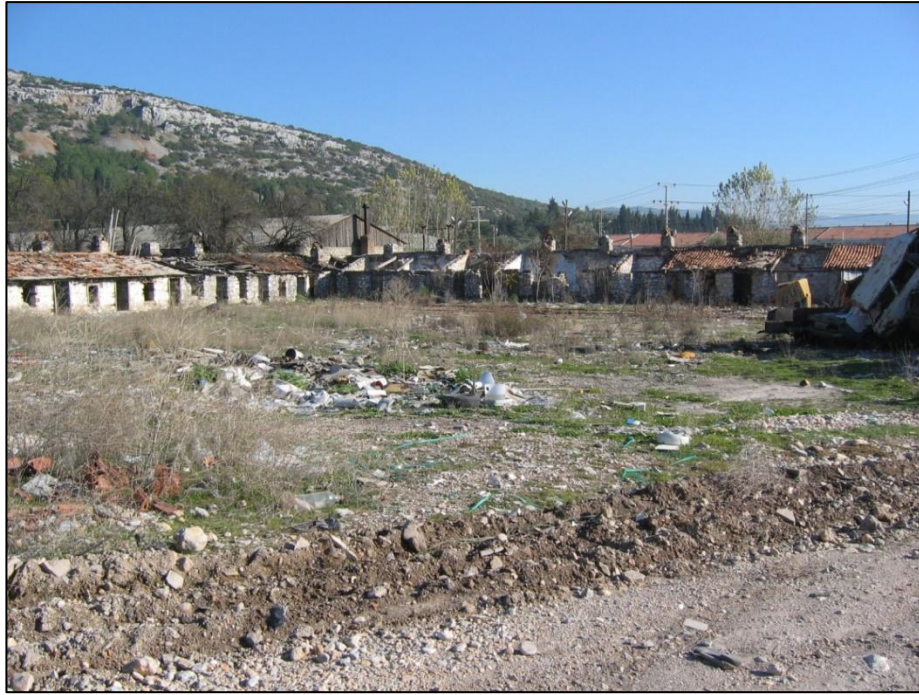
Figure 99 Photograph of the *worker houses* on the west side of the Hamursuz Hill-1

(A7) refers to the one-storey buildings with seven closed spaces which are called as the *worker houses*. These buildings are said to have been constructed in 1950s for the accommodation of the workers of the tobacco fields. As the number of the closed spaces changes in some examples; the code may change to (A6) or (A8). This type of buildings can be both seen as single constructions within a lot or in clusters forming courtyards between them. The photographs in Figure 99 and Figure 100 show a cluster of traditional *worker houses* on the west side of the Hamursuz Hill near the north-west entrance of Karabağlar approaching from the city center.
