**UPGRADING THE OLD: THE ADAPTATION OF TRADITIONAL
RESIDENTIAL BUILDINGS TO THE CONTEMPORARY LIFE**

**A THESIS SUBMITTED TO
THE GRADUATE SCHOOL OF NATURAL AND APPLIED SCIENCES
OF
MIDDLE EAST TECHNICAL UNIVERSITY**

**IN PARTIAL FULFILLMENT OF THE REQUIREMENTS
FOR
THE DEGREE OF MASTER OF SCIENCE
IN
ARCHITECTURE
IN
RESTORATION**

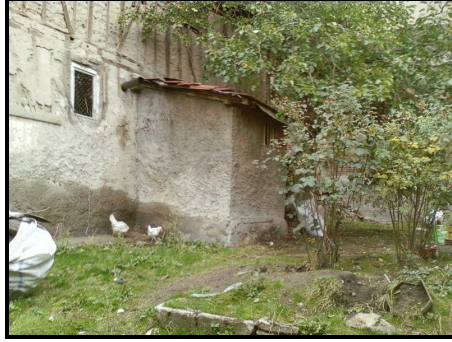
Figure 1.10

An Example to a Wet Space Addition from Yağcılar Street No. 1

All traditional buildings lack sanitary service spaces, where the existing ones are quick fixes, done unconsciously for short periods of time as conversion of living spaces (Figure 1.11 & Figure 1.12 & Figure 1.13) or additions to the buildings (Figure 1.10). These alterations harm the residential buildings not only architecturally and aesthetically but structurally in more ways than imagined.

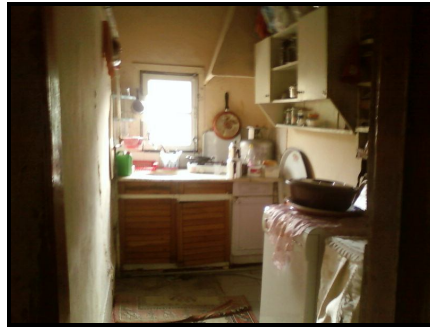
Figure 1.11

An Example of a Converted Kitchen from a Living Space from Eskicioğlu Street No.10a

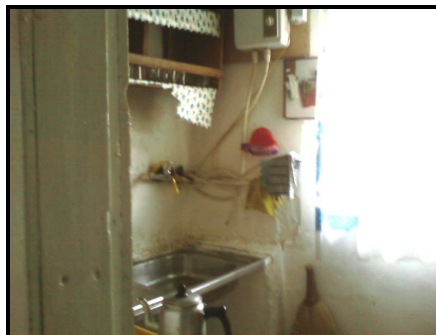
Figure 1.12

An Example of a Converted Kitchen from a Living Space from Eskicioğlu Street No. 10

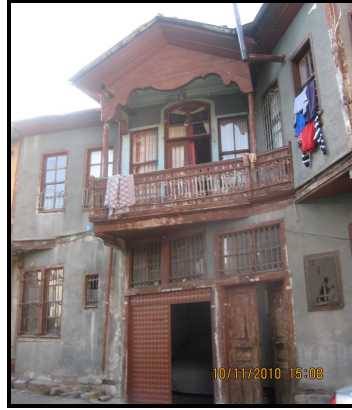
Figure 1.14

An Example of a Projection from Eskicioğlu Street No. 7

The projections of the residential buildings of İstiklal District show variety. The projections can be seen as closed or semi open-spaces like balconies. They might be located on the middle of the facade, one side or two sides of the upper floors or sometimes a floor might be projected itself. The most common ones, however, are the projections which are seen on the middle of the facade organization in the upper floors. The supported structural elements of the projections also vary, where they are generally used as decorative elements of the facade. In previous studies it is also mentioned that “*Ankara Projections*” constructed by overlapping timber beams, are not very common but can be seen within the district (Şahin et al., 1988).

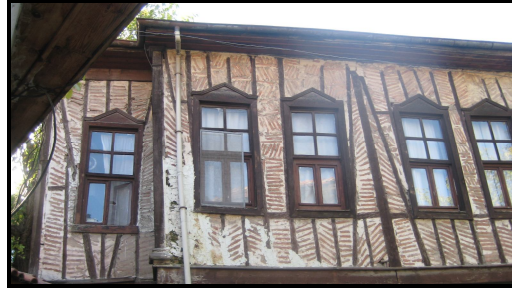
Figure 1.15
Examples of the Windows with Pediments from Eskici Street No. 4

The windows are generally seen as sash type windows which are considered as the original elements of the residential buildings or they are either single casement windows or double casement windows. The windows are the main decorative elements of İstiklal Districts' traditional residential buildings. The arched windows can be seen as well as windows with triangular decorative pediments which can be seen in the several of the traditional residential buildings within the district.

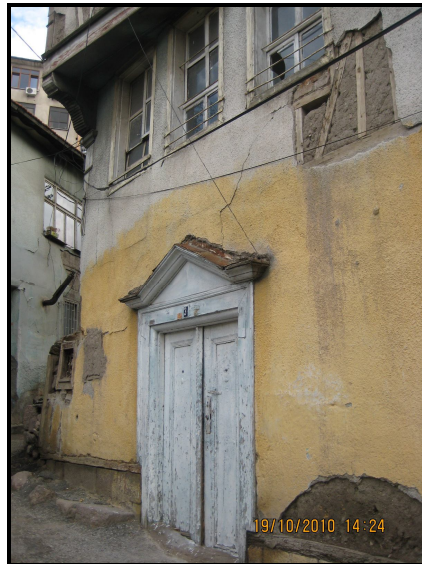
Figure 1.16
An Example of the Doors with Triangular Pediments from Kalas Street No. 3

The door properties change according to their function as either providing an entrance to the courtyard or being the main door of the residential building as providing entrance to the “*taşlık*”. The doors of the courtyards are timber without any major work on the timber. The doors of the facade organization however are generally paneled timber doors either having single or double wings and some having upper windows and pediments as decorations.

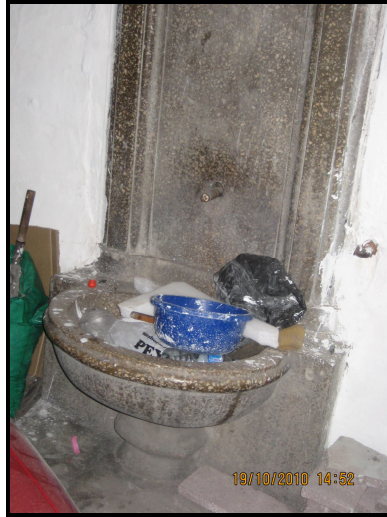
Figure 1.17
An Example of a Traditional Fountain from Eskicioğlu Street No. 7

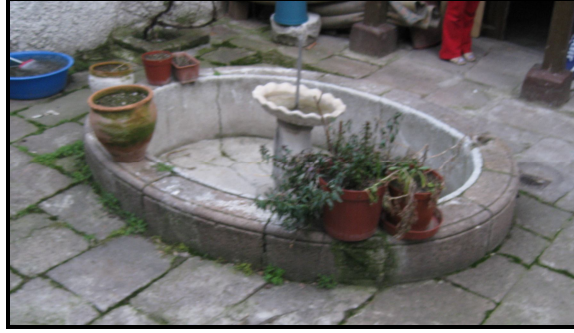
Figure 1.18

An Example of a Traditional Fountain from Birlik Street No. 3

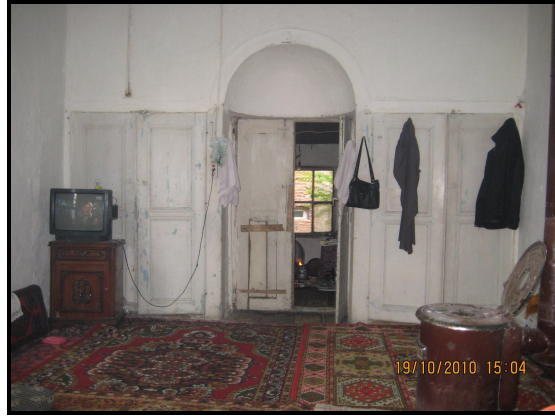
Figure 1.19

An Example of a Traditional Cupboard from Yağcılar Street No.1

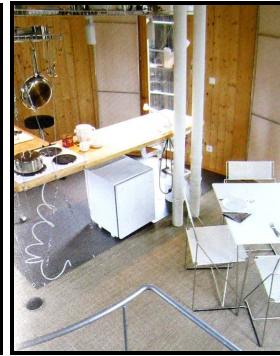
Figure 2.3

The next example (Figures 2.1 & 2.2 & 2.3) is an example for the historic buildings which are introduced to a completely new function. The structure was originally built as a store grain in Lukasod, Germany⁹. Recently, it has been converted into a residence by Eberhard Stauss. Steel tie rods were used to control the expansion of the wood (as it swells in damp) which is the original construction material of the building. The interiors were introduced to modern service units. New materials and techniques were applied during the adaptation process (Thiebaut, 2007, p.108).

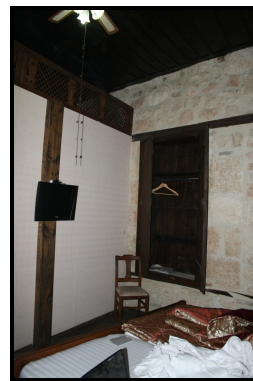
Figure 2.9

The example (Figure 2.8 & Figure 2.9) shows a room of a traditional dwelling in Tarsus, İel, which is converted into a hotel room and as can be seen, the bathroom is inserted into the space with the help of the division panels (Figure 2.9). The materials used are both compatible and distinguishable from the original materials: timber reflecting the past and plastic panels representing the contemporary.

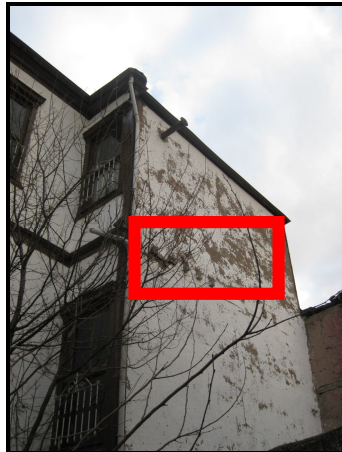
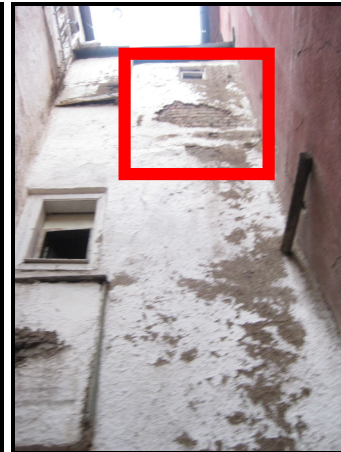
The structural system of Birlik Street No: 3 is timber frame built on a stone masonry at the basement level. As an infill material, brick is used (Figure 3.9 & 3.10). The part of the building which beholds the current service spaces might be a later addition, since this part is constructed with brick masonry and the floor materials of this part of the building even in upper floors are stone. The structural system is in good condition in terms of materials and stability. The original

structural system and materials are conserved. The building can carry loads of newly inserted technical equipments; however on upper floors this process needs more attention and consolidation must be done prior to any intervention if necessary. In fact, this should be decided after a proper assessment of the structural system and material condition of the building by experts (Table 3.5).

Figure 3.9 & Figure 3.10
Birlik Street No. 3, the Structural System

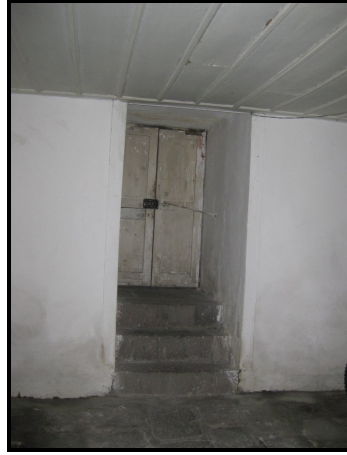
Figure 3.11 **Birlik Street No. 3, the Second Entrance Opening to “Taşlık”**

As mentioned previously, the building has three floors and a *cihannüma*. The basement floor has a different entrance which opens to “taşlık”. The “taşlık” has access to three rooms on sides; two rooms on the right, one room and the staircase on the left (Figure 3.12). At the back of the left side, there is an access to an extension part of the building where that space consists of one room and an access to the private and the smallest courtyard, which probably has served as the courtyard of the service spaces (Figure 3.12). In this courtyard, there is the original toilet. The “taşlık” also directly opens to the rear and the biggest courtyard. This courtyard has soil part for gardening and an original fountain in the middle. There is one small mass addition (Figure 3.4) at the courtyard which is adherent to one side of the traditional building at the basement floor (Table 3.2).

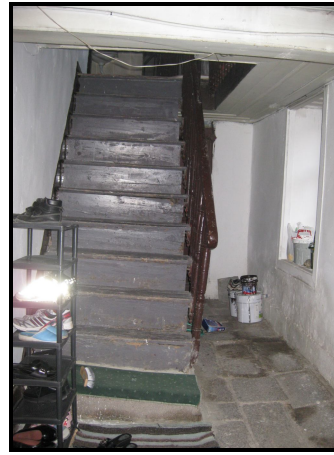
Figure 3.12 **Birlik Street No. 3, the Stairway in the Basement Leading up from the “Taşlık”**

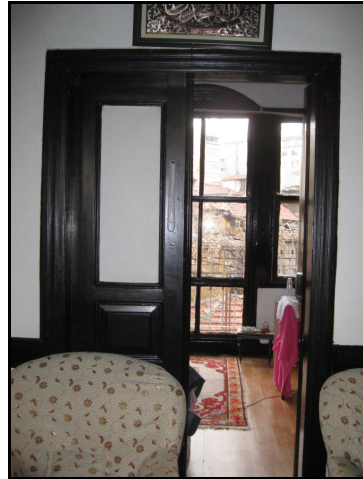
Figure 3.15

Birlik Street No. 3, the Room Projected Over the Main Entrance

The first floor is exactly like the ground floor, except there is a fourth room which is the partially projected space over the main entrance area (Figure 3.15). Therefore the first floor has four bedrooms, three on the front facing the street and one at the right back, facing the rear courtyard. Also the service spaces (kitchen, bathroom and the toilet) of this floor are exactly above the ground floor’s service spaces. The *cihannüma* is accessible from this floor through a staircase. The *cihannüma* consist of one room which opens to the balcony facing the rear courtyard (Table 3.4).

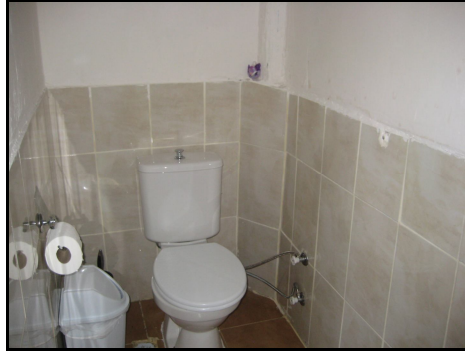
The Current W.C. in the Ground Floor (Space No. A-G7): This space, although the original function is unknown, might have been built as a part of the current kitchen. Today it is converted into a W.C. with European type closet and a ceramic sink (Figure 3.22). The size of the W.C. is about 1.03×3.18 meters. The space is extended horizontally by a space addition from the current kitchen where a partition wall has been added to provide space for the European type closet and sink at the same time. The floor is covered with ceramic tiles and the walls are covered with ceramic tiles up to approximately 1.30 meters (Figure 3.22). There is a new window addition, which faces the smallest and the private courtyard (Table 3.13).

Figure 3.22
Birlik Street No. 3, the W.C. in the Ground Floor

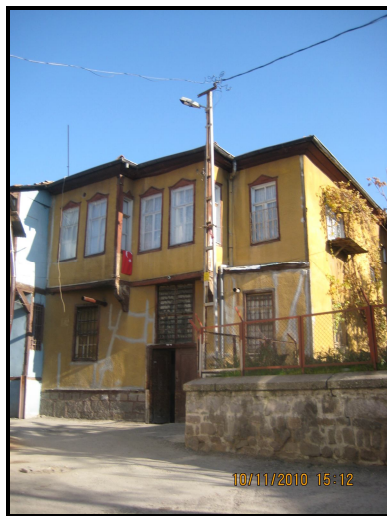
The building has many similar characteristics with the rest of the tissue. Hence, it is a good representative of the traditional residential buildings in İstiklal District in terms of mass, plan, facade and architectural properties. It has two floors. It has projections on the upper floor. Its wooden framed windows with pediments can also be seen on some other dwellings within the district (Figure 3.39). The building has many interior architectural elements such as traditional cupboards and one probable “*güsülhane*”. The spaces inside are wide and bright in terms of natural lighting.

Figure 3.36
Eskicioğlu Street No.8

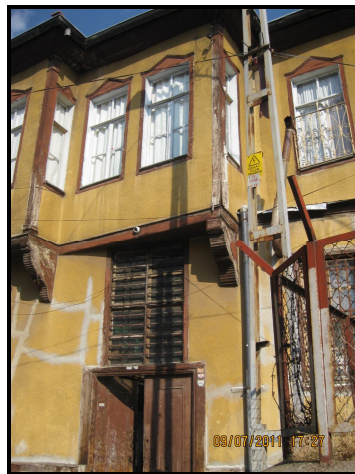
Figure 3.39

Eskicioğlu Street No.8, the Windows with Pediments

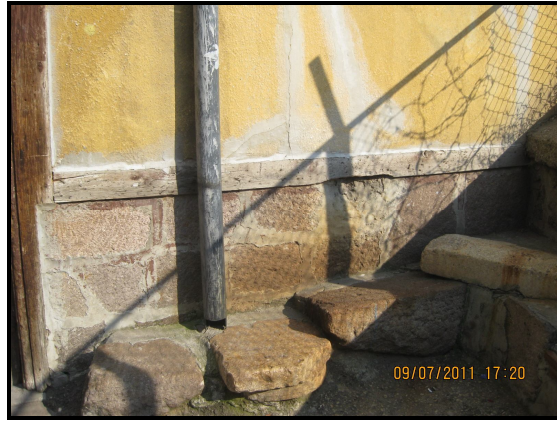
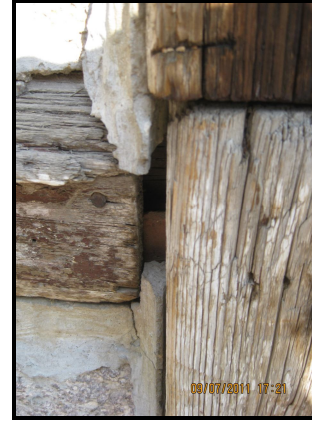
The structural system of Eskicioğlu Street No: 8 is mud brick masonry at the ground floor on a stone masonry subbasement level; the first floor is constructed with timber frame with mud brick infill (Figure 3.40 & 3.41). The original structural system and materials are conserved. However the load of the division walls and the service space additions per unit inside the building harms the structural system. The building is overloaded so it might be risky to insert new technical equipments without careful analyses and consolidation however this can be decided only after proper structural system and material analyses (Table 3.20).

**Figure 3.40 & Figure 3.41
Eskicioğlu Street No.8, the Structural System**

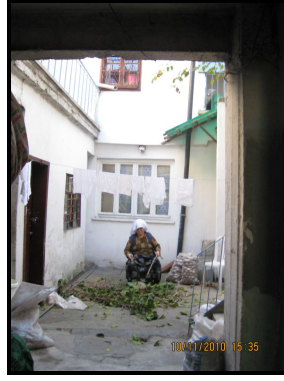
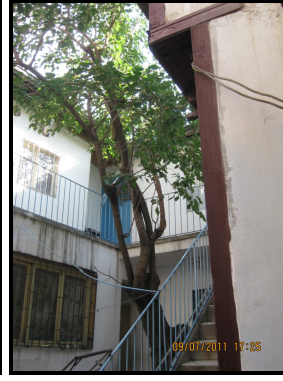
The lot of the building is quite large. The building is placed on the street side of the lot. There is a very large courtyard at the rear, which unfortunately has lost its function due to massive new building additions within the courtyard (Figure 3.39 & 3.40). Due to these new additions the originality and the boundaries of the courtyard cannot be perceived. Also these arbitrarily built new building additions not only prevent the use of the courtyard but also cause unsanitary conditions as the infrastructure for one building is now used by three buildings (Table 3.17) .

**Figure 3.42 & Figure 3.43
Eskicioğlu Street No.8, the Courtyard**

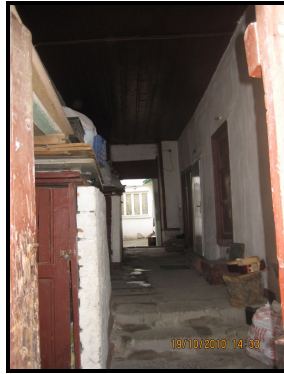
Figure 3.44 & Figure 3.45
Eskicioğlu Street No.8, the “Taşlık”

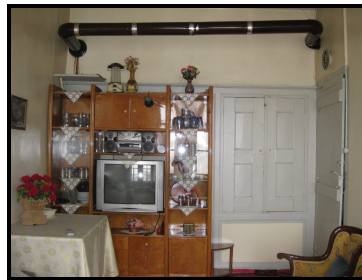
Figure 3.46
Eskicioğlu Street No.8, the Living room

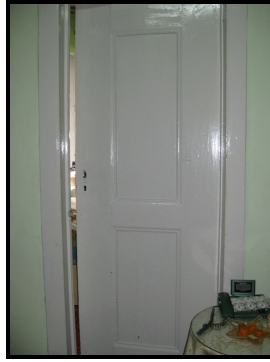
mentioned the dampness problem in the “taşlık” due to service space conversions at the first floor and the rising damp on the street facade especially in the stone sections as the biggest problem of this building in 1995 (Şahin, 1995). The architectural elements such as doors, windows, traditional cupboards are painted with white oil paint (Figure 3.49 & Figure 3.50). The technical equipments such as electric cables and pipes are hidden better than the other examples within the district (Figure 3.50). The electricity supply is equipped over the walls and timber ceilings.

Figure 3.49 Eskicioğlu Street No.8, an Original Door Painted with Oil Paint

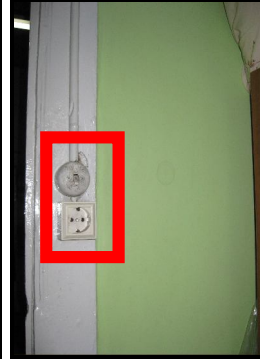
Figure 3.50 Eskicioğlu Street No.8, the Technical Equipments (Electric plug, light switch and electric cable)

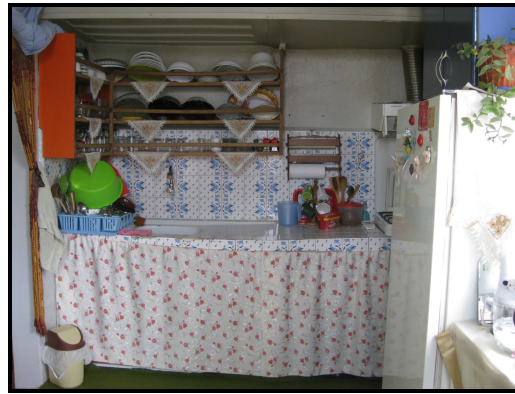
The Current Kitchen of Eskicioğlu Street No: 8 (Space NO. B-G5): The kitchen which is converted from a traditional room by the conversion of a traditional cupboard as a kitchen stall is in the first floor and faces the street (Figure 3.51). The size of the room is adequate and meets the requirements of

Figure 3.51
Eskicioğlu Street No.8, the Kitchen
The Kitchen Stall Converted from a Traditional Cupboard

The kitchen is spatially adequate however due to the current usage scheme and extra furniture, the usage becomes difficult. The kitchen is converted from a traditional cupboard as the kitchen stall (Figure 3.51 & Figure 3.57 & Figure 3.58). The refrigerator, the freezer, the oven are placed around the room. The current usage scheme must be changed within the kitchen so the technical equipments can be used without limitations. The original finishing materials of the traditional cupboards are replaced with ceramic tiles and plaster covered with oil paint. There is a later window addition which faces another lot (Figure 3.53).

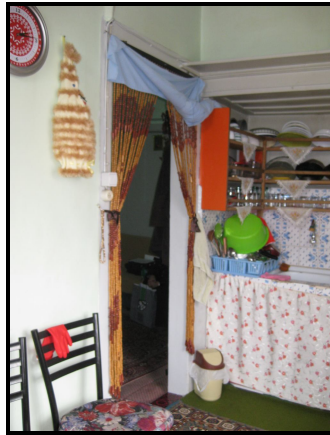
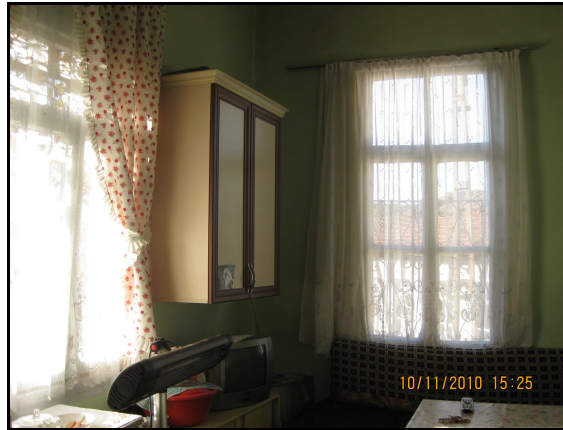
today and also serves as a living and dining room. The size of the kitchen is about 2.54×5.32 meters. There is a new window addition on the right side of the room which faces another lot (Figure 3.53). All the technical equipments are provided except the dish washer. The cupboard of this room is converted into the kitchen stall where there is the sink, the oven and the ventilation hood. The floor is timber and today covered with plastic-based covers, where carpets are placed above. The kitchen is not used as a wet space (Table 3.26).

Figure 3.52 & Figure 3.53
Eskicioğlu Street No.8, the Kitchen
The Door and the Windows

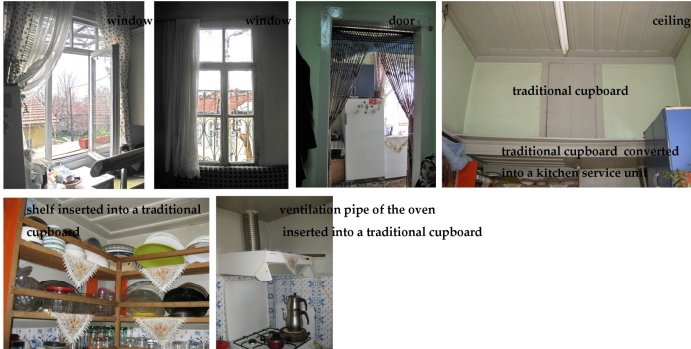
shelf inserted into a traditional cupboard ventilation pipe of the oven inserted into a traditional cupboard

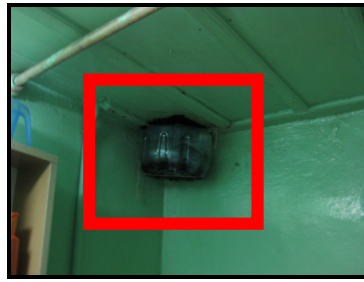
The space is in the first floor. With an addition of a partition wall, a part of the room unified with the traditional cupboard space is used as the current bathroom. The bathroom is placed into the cupboard which might also be “güsülhane” but due to major alteration, it can no longer be perceived. The size of the bathroom is 1.83×1.92 meters. There is a European type closet, a ceramic sink and a water heater within the space (Figure 3.54). There is no shower cabin; instead a part of the space is used as the showering area and this area is divided with a curtain. The walls are covered with ceramic tiles up to about 1.30 meters (Figure 3.55), the rest is oil painted with green. The ventilation of the space is inadequate. The inefficiency of this ventilation and the dampness that occurred is visible (Figure 3.55). Also the ceiling is low as it is converted from a cupboard and the lighting is inadequate since there are no windows. The size of the space is partially adequate and can meet two of the requirements of a modern bathroom of today such as the sink and the closet. The new materials are not compatible with the original (Tablo 3.27).

Figure 3.55 & Figure 3.56
Eskicioğlu Street No.8, the Bathroom
Dampness Problem and New Material Application
Cement Based Plaster and Ceramic Tiles
(These are not suitable for original materials)

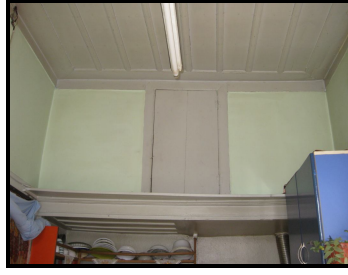
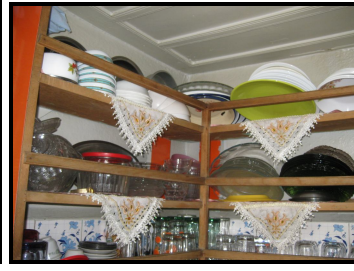
Figure 3.57 & Figure 3.58

Eskicioğlu Street No.8, the Kitchen

**The Loss of Traditional Architectural Elements: The Traditional Cupboard
The Ceramic Tiles and Oil Paint Application**

transitions are either provided by division walls or conversions of architectural elements which harm the originality of the spaces (Figure 3.57 & Figure 3.58). There are extra service space installations within this traditional residential building for each household so the extra technical load and infrastructure harm the original structural system and materials. The finishing materials of these service spaces especially for the bathroom are cement-based plasters and ceramic tiles. These new materials are not suitable for a traditional building and harm the original material (Figure 3.55 & Figure 3.56 - Figure 3.61). Due to conversions of traditional architectural elements; the authentic properties of these are lost (Figure 3.57 & Figure 3.60).

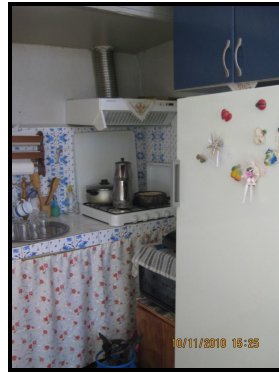
Figure 3.59

Eskicioğlu Street No.8, the Kitchen

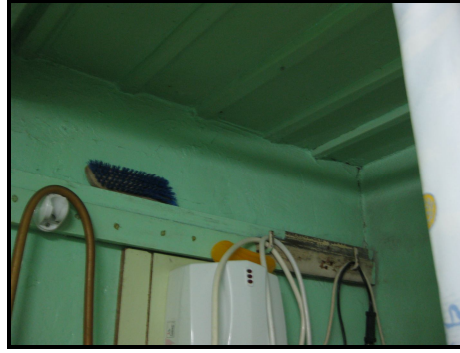
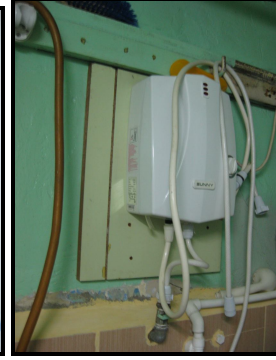
Figure 3.60 & Figure 3.61
Eskicioğlu Street No.8, the Bathroom
The Use of New Materials over Original Materials
The Water Heater

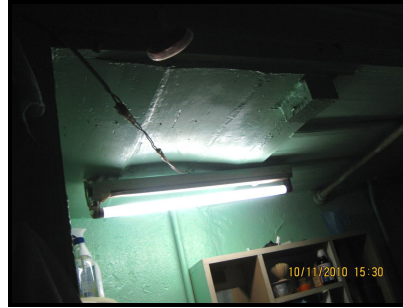
Figure 3.62
Eskicioğlu Street No.8, the Bathroom
The Lighting within the Space

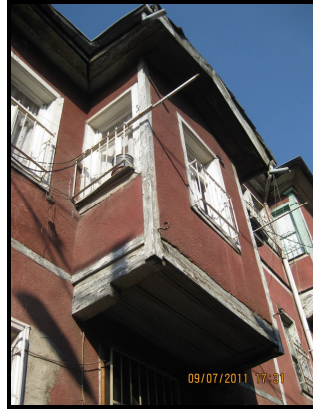
Figure 3.64

Kargı Street No.29, the Projection and the “Sofa”

The building is located at one of the most densely used streets of today's İstiklal District: Kargı Street where it intersects with Eskicioğlu and Birlik Streets (Figure 3.66 & Figure 3.67). This part of the district is overused which is the core of the district. The building is close to Anafartalar Street, a commercial axe of Ulus. The building has 2 floors. It covers the whole lot. Therefore, there is no courtyard. The facade organization with a projection shows similarities with the surrounding tissue. Although the plan organization and the architectural elements are like the earlier examples of the traditional residential buildings within the district, this building is smaller in size and the spaces are narrow (Figure 3.64 & 3.65) (Table 3.28).

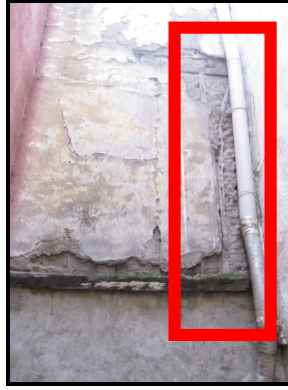
Figure 3.68
Kargı Street No.29, the Structural System

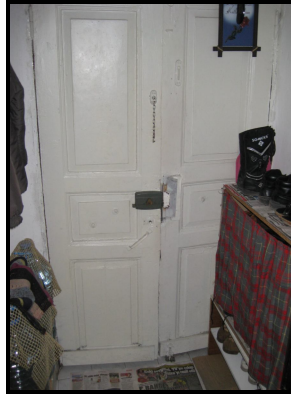
Figure 3.69
Kargı Street No.29, the Entrance to “Taşlık”

The entrance opens to the “taşlık” area in the ground floor which today serves as the entrance hall (Figure 3.69). On the left side, there is the current living room and the right side is the kitchen. At one side of the “taşlık”, the bathroom is located with a division wall where the space consists of the sink and the water heater for the bathroom. The toilet has entrance from the bathroom and it is placed in the space under the stairs (Figure 3.80 to 3.86) (Table 3.29).

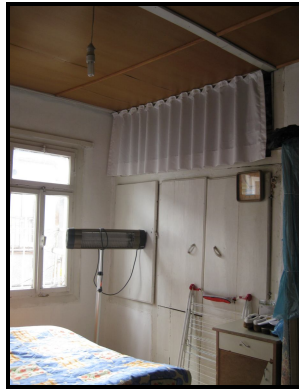
Figure 3.70 Kargı Street No.29, the Parents' Bedroom

The first floor has the narrow “sofa” which is used as a living room and the circulation area for the two rooms: one for the parents and one for the children. The parents’ bedroom is on the left side of the “sofa” where the children’s bedroom is on the right side, exactly above the kitchen (Figure 3.70 & Figure 3.71). The children’s bedroom is spatially inadequate and it can hardly meet one of today’s requirements (Figure 3.71) (Table 3.30).

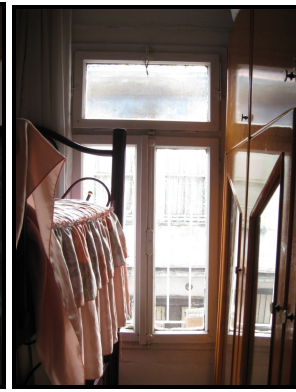
Figure 3.71 Kargı Street No.29, the Children's Bedroom

the typical modern furniture as massive fabricated furniture makes spaces even narrower (Figure 3.65 & Figure 3.71) (Table 3.32). Special designs must be offered which are prepared according to the building's spaces. The architectural elements are used efficiently such as the niches and traditional cupboards where these either continue their function or serve for a new purpose (the niche converted into a computer desk) (Figure 3.72 & 3.73).

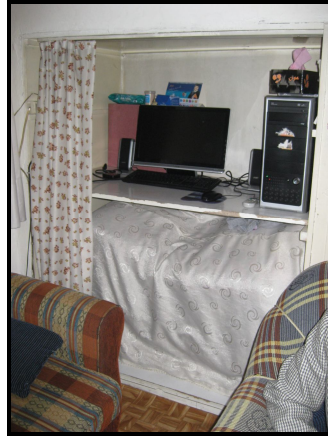
**Figure 3.72 Kargı Street No.29,
the Niche in the Living Room Used as a Working Desk**

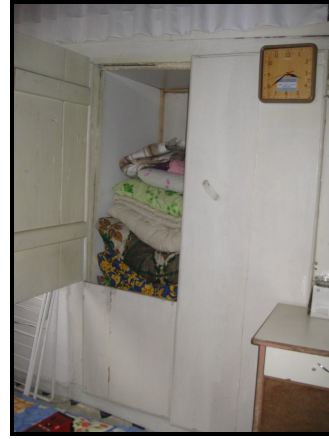
**Figure 3.73 Kargı Street No.29,
the “Yüklük” in the Bedroom Continuing its Original Function**

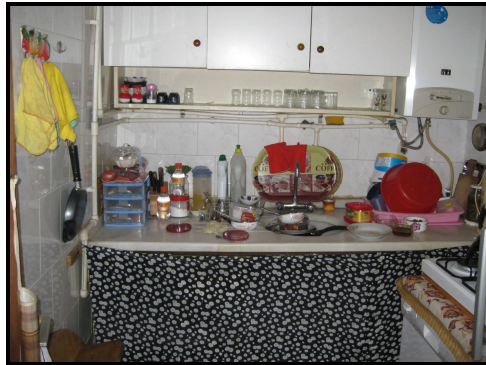
Figure 3.74 Kargı Street No.29, the Kitchen

The Current Kitchen in Kargı Street No: 29 (Space NO. C-G3): The current kitchen (Figure 3.74) is located at the ground floor, in the “taşlık” area, on the right side of the entrance. The level of the kitchen is about 24 cm below the entrance level, where there is one step at the entrance (Figure 3.75). The size of the kitchen is about 1.93×2.17 meters. All the kitchen equipments of today's requirements are met within the building however these equipments leave a very limited space to work (Figure 3.76). Also due to lack of a proper infrastructure system for the technical equipments such as electronic cables and water pipes etc., the walls are covered with these and harm the perception of the spaces (Figures 3.74 & 3.76 & 3.77 & 3.78 & 3.79). The kitchen interior walls' might probably have been demolished from the ceiling for about 1 meters and replaced with glass and plastic materials to provide light into the kitchen (Figure 3.77). The windows at the kitchen might be new additions or altered from the original (Figures 3.77 & 3.79) (Table 3.37).

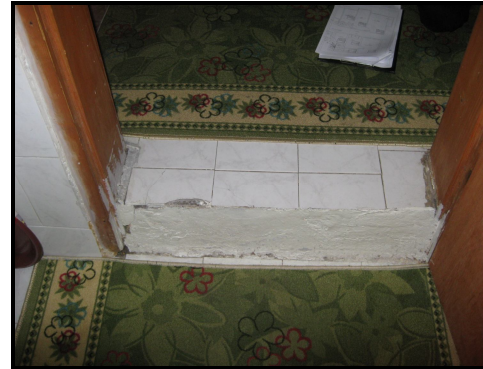
Figure 3.75 Kargı Street No.29, the Kitchen

The Step at the Entrance of the Kitchen

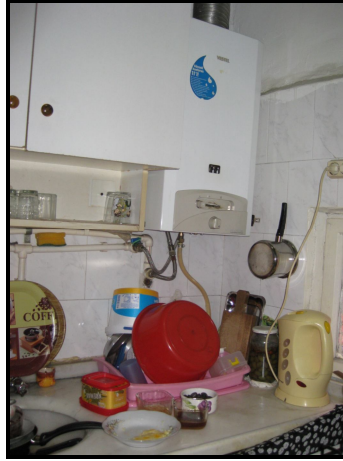
Figure 3.76 Kargı Street No.29, the Kitchen, the Kitchen Stall

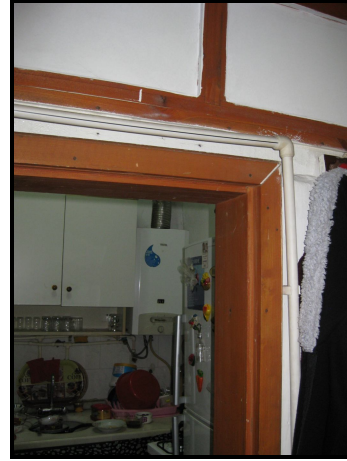
Figure 3.77 Kargı Street No.29, the Kitchen, the Door and the Panels

demolished to the door length and to the upper parts glass windows and plastic panels are added (Figure 3.77). The lighting is inadequate even with the two windows as later additions. The original finishing materials are replaced with ceramic tiles on the wall of the kitchen stall and to the rest of the walls cement based plaster is applied. A water heater is added with the pipes and the cables visible through the walls. The ventilation is inadequate and the application is poor where the ventilation pipe is connected through the glass window which is a later addition.

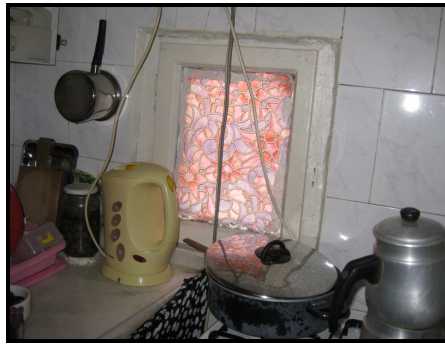
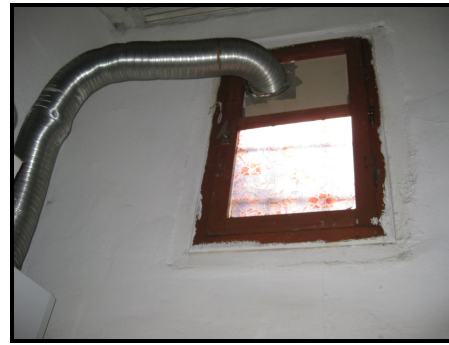
**Figure 3.79 & Figure 3.78
Kargı Street No.29, the Kitchen,
The Windows**

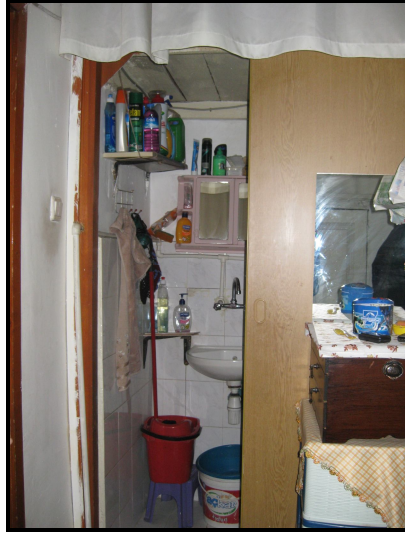
Figure 3.80 Kargı Street No.29, the Entrance to the Bathroom from “Taşlık”

The Current Bathroom and W.C. in Kargı Street No: 29 (Space NO. C-G4 / C-G4a): The current bathroom & W.C. is located at the ground floor, in the “taşlık” area, exactly straight before the entrance (Figure 3.80). This space is formed by a division wall in the taşlık area. The divided space consists of two parts where the space under the stairs is converted into a W.C. with an alaturca toilet. A part of the taşlık now serves as the bathroom with a heater and a sink (Figures 3.80, 3.81, 3.82, 3.84, and 3.85). There is no shower cabin where the space is used as a bathroom itself (Figure 3.84 & Figure 3.87).

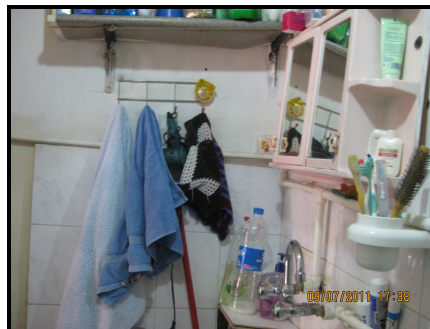
Figure 3.83

Kargı Street No: 29, the Bathroom

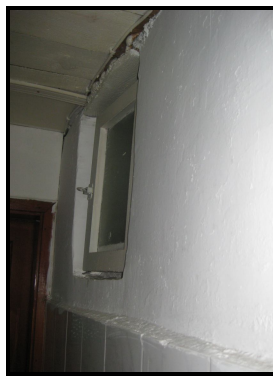
Figure 3.86

**Kargı Street No: 29, the Bathroom
The Window of the Bathroom**

The size of the bathroom is 90 cm \times 1.98 meters where this space has the water heater and the sink. The space under the stairs for the toilet is 89 \times 178 meters. These spaces may be suitable for installation of the service spaces as they are in the “taşlık” area where the traditional material is stone, which is a suitable material for service space installations. However the spaces are spatially inadequate and they can hardly meet today’s basic requirements as a bathroom and W.C. The space can only be entered with plastic slippers to avoid the wet ground (Figure 3.82 & Figure 3.85). The window of the bathroom is not original and it is a new addition after the conversion of the “taşlık” area into the bathroom. The ventilation shaft in the middle of the building might be a later addition or the original might have been altered (Figure 3.86) (Table 3.38).

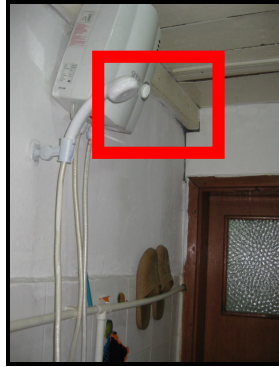
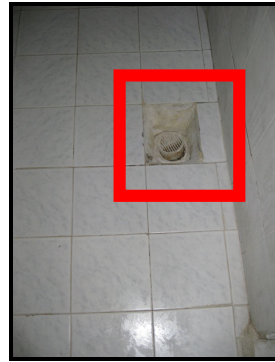
Figure 3.87 & Figure 3.88

**Kargı Street No: 29, the Bathroom
The Water Heater and the Water Drainage**

As an assessment of the service spaces, it can be said that the location of the bathroom is not proper for the modern usage scheme since it is directly straight from the main entrance. The spatial adequacies of the service spaces are inefficient. Today's requirements are met in terms of technical equipments however these are not properly installed as the technical infrastructure is visible throughout the building (Figures 3.74, 3.76, 3.77, 3.78, 3.79). The installations are done without respect to the originality of the traditional residential building. The service space conversions are done as if to a new construction. The finishing materials of the service spaces harm the traditional materials since the materials used are not compatible with the traditional. These "new" materials are installed right over the traditional ones where the traditional materials can no longer breathe. The dampness problem occurs which will cause decay of the structure and materials of the traditional residential building in long terms (Figures 3.88 & 3.89).

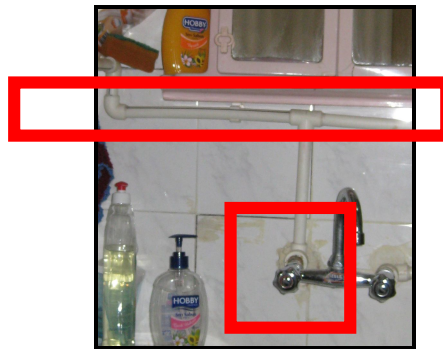
Figure 3.89

**Kargı Street No: 29, the Bathroom
The Water Pipes**

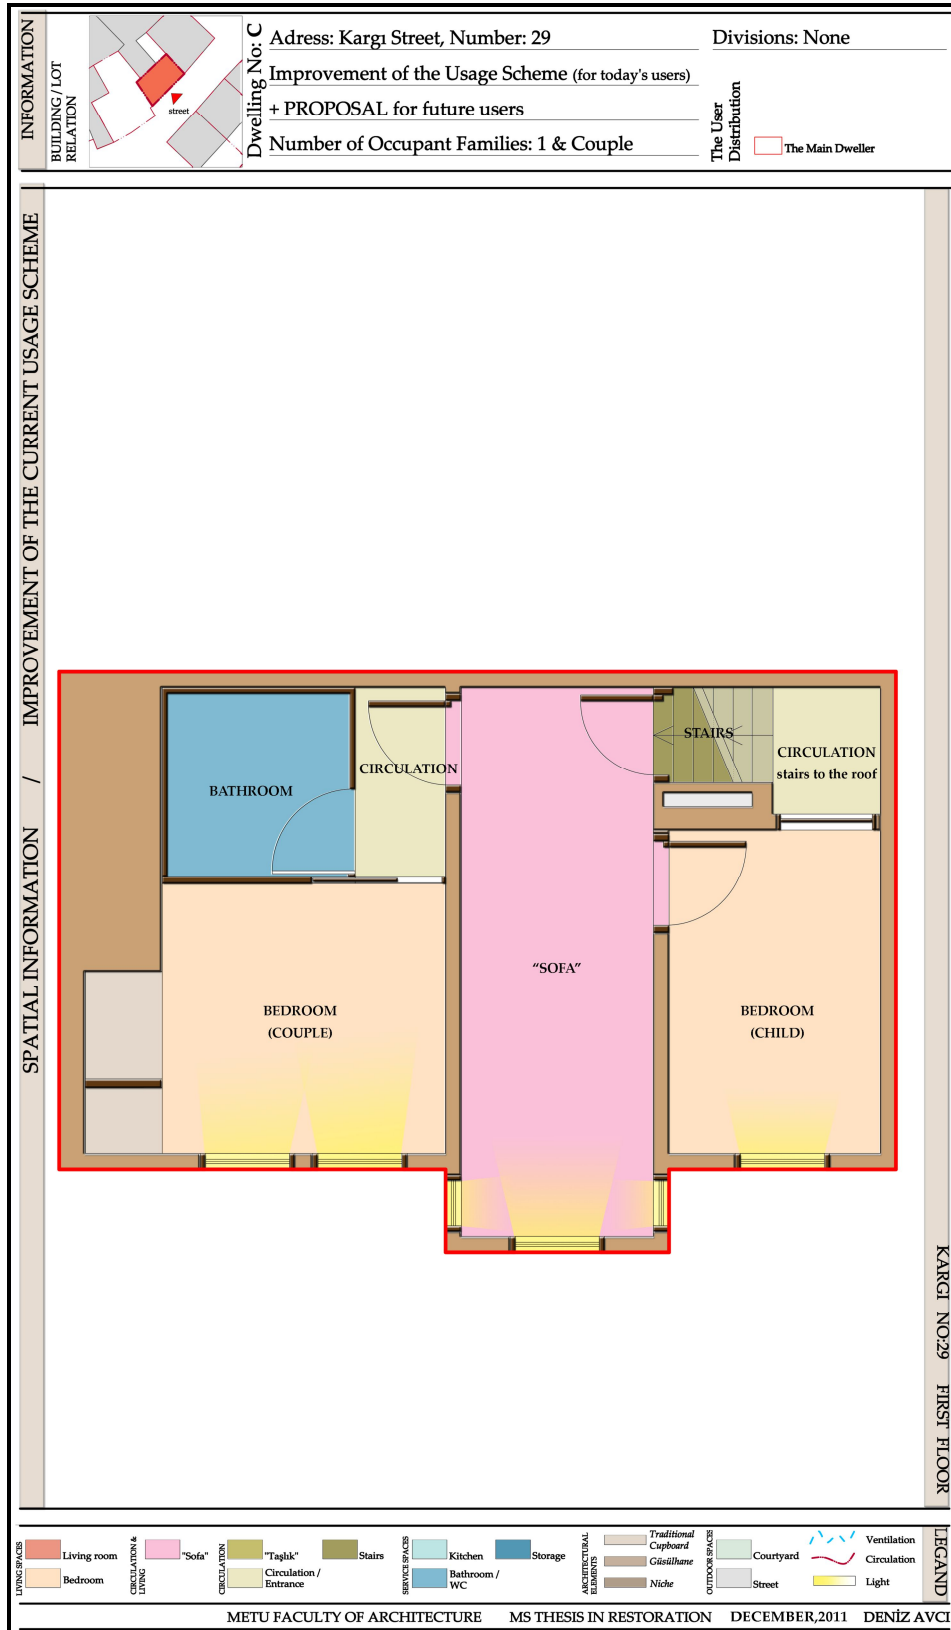
TABLE 4.18 KARGI STREET NO: 29

PROPOSAL FOR THE CURRENT AND THE FUTURE USERS / FIRST FLOOR

Due to spatial qualities and characteristics of the building there are few alternative functioning of the spaces. As the living areas are few, the choices are limited for the kitchen and the bathroom purposes. Therefore this proposal is both the improvement of the current usage scheme and it also is the proposal for the future users. The proposals for the future users are based on user definition defined by the author based on the size of the chosen traditional residential building as the case and its suitability of offering alternative living conditions for different family types. Kargı Street No: 9 offers living conditions for a Nuclear Family: A small family of parents and one small child or it can be used by a couple.
