DEFINING GENERAL CONSERVATION PRINCIPLES FOR
PRIMARY SCHOOLS OF RUM MINORITY IN ISTANBUL

A THESIS SUBMITTED TO
THE GRADUATE SCHOOL OF NATURAL AND APPLIED SCIENCES
OF
MIDDLE EAST TECHNICAL UNIVERSITY

JUNE 2012

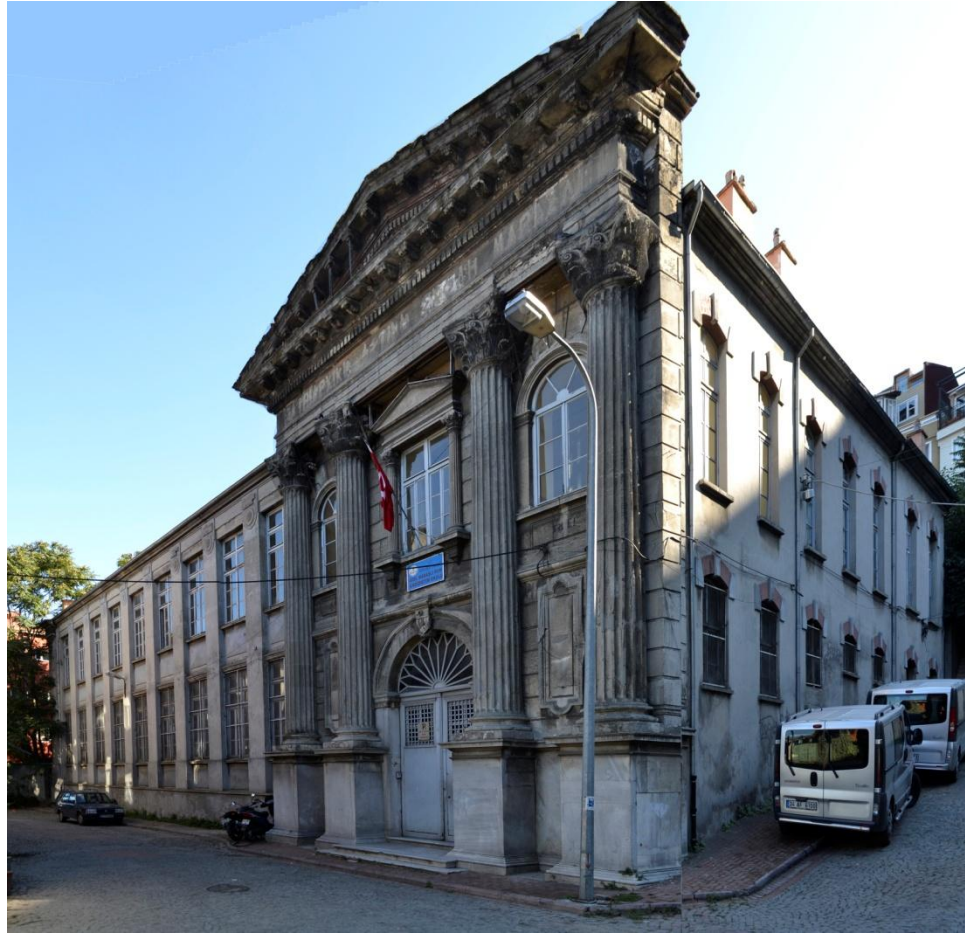
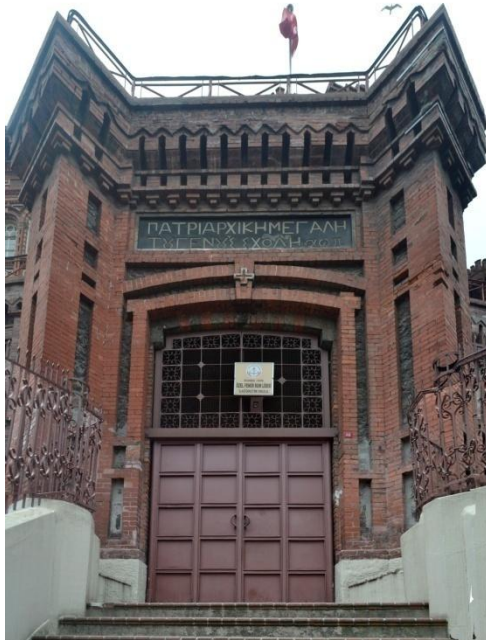
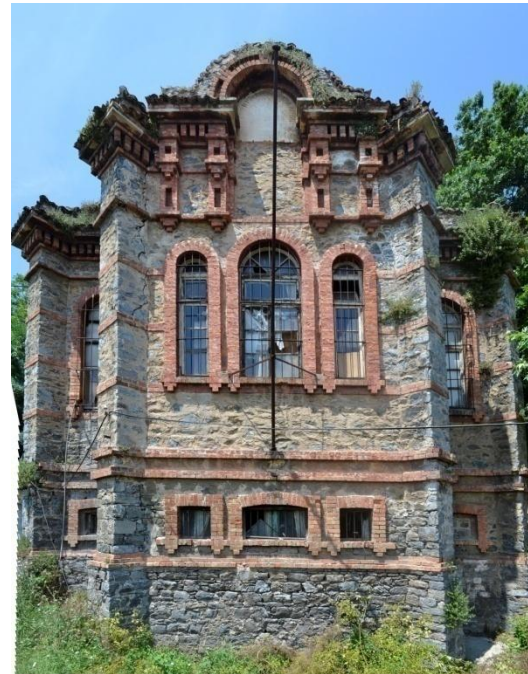
Figure 4: a) Maraşlı R.İ.O. building has a front facade which is a rich example in terms of featuring Neo-Classic elements. b) Entrance door to the courtyard of Fener R.İ.O.L. c) Front facade of Yeniköy R.İ.O. These buildings are built in Eclectic style, and features examples of Byzantine Architecture and construction techniques. (Author, June 2011).

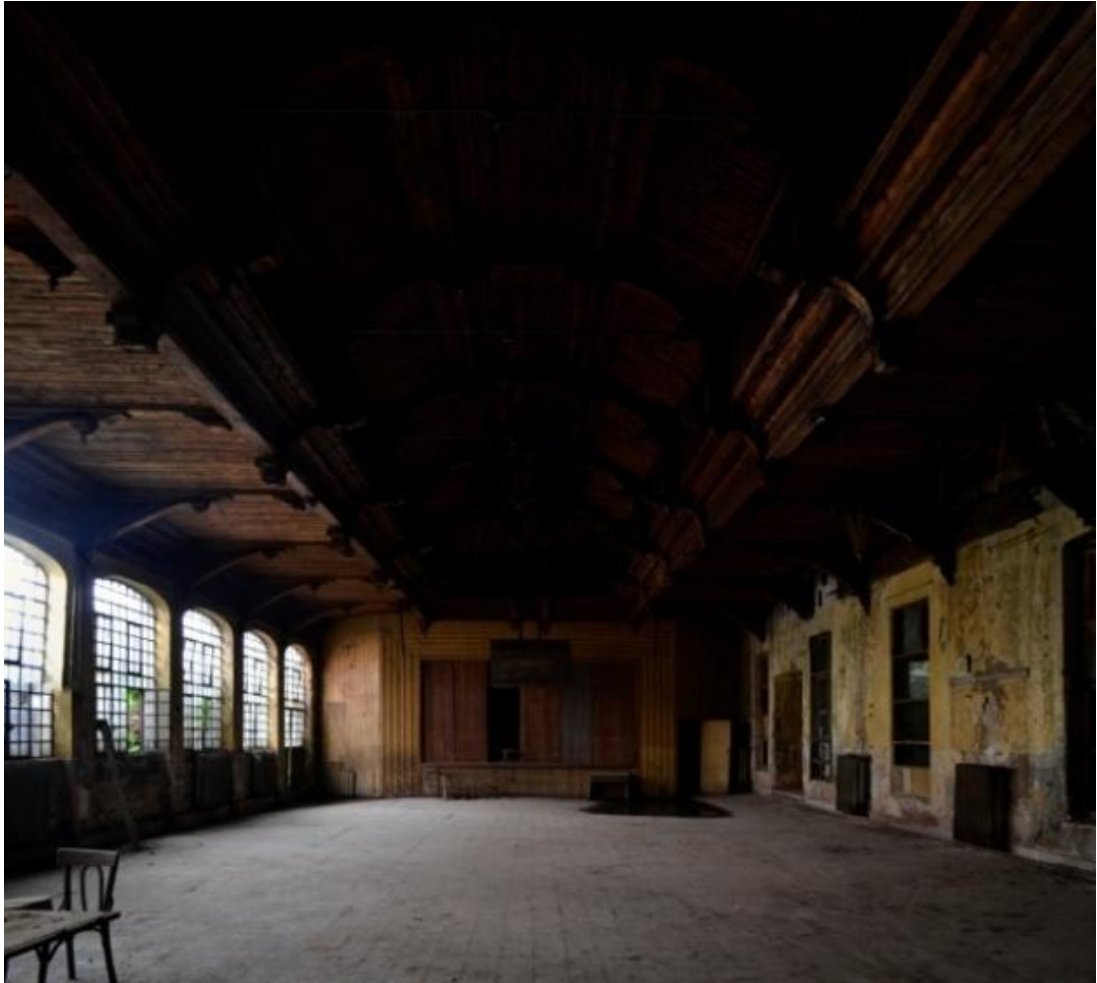
Figure 12: Hall of ceremonies / gymnastic saloon of Merkez R.İ.O.L. Highly detailed timber framed construction of roofing is a rare example that the school building features (Author, June 2011).

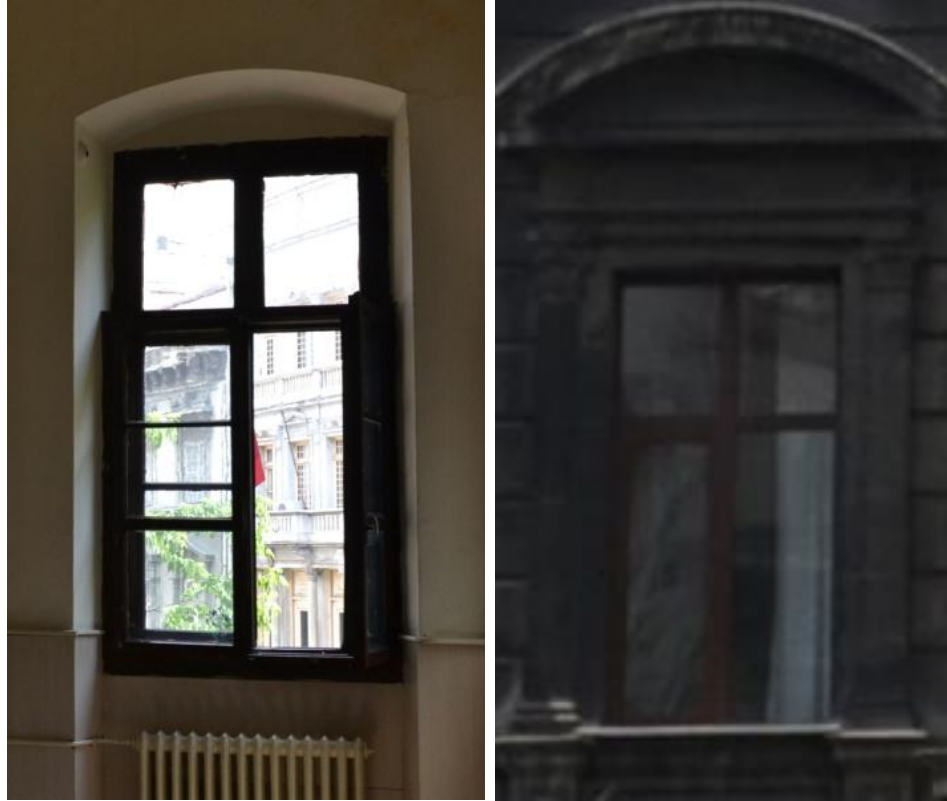
Figure 15: a) Interior view of a window opening, Zapyon R.İ.O.L. It is seen that the opening is spanned with a segmental arch. b) Exterior view of the window opening, Zapyon R.İ.O.L. From outside the opening is perceived to be spanned with a lintel (Author, June 2011).

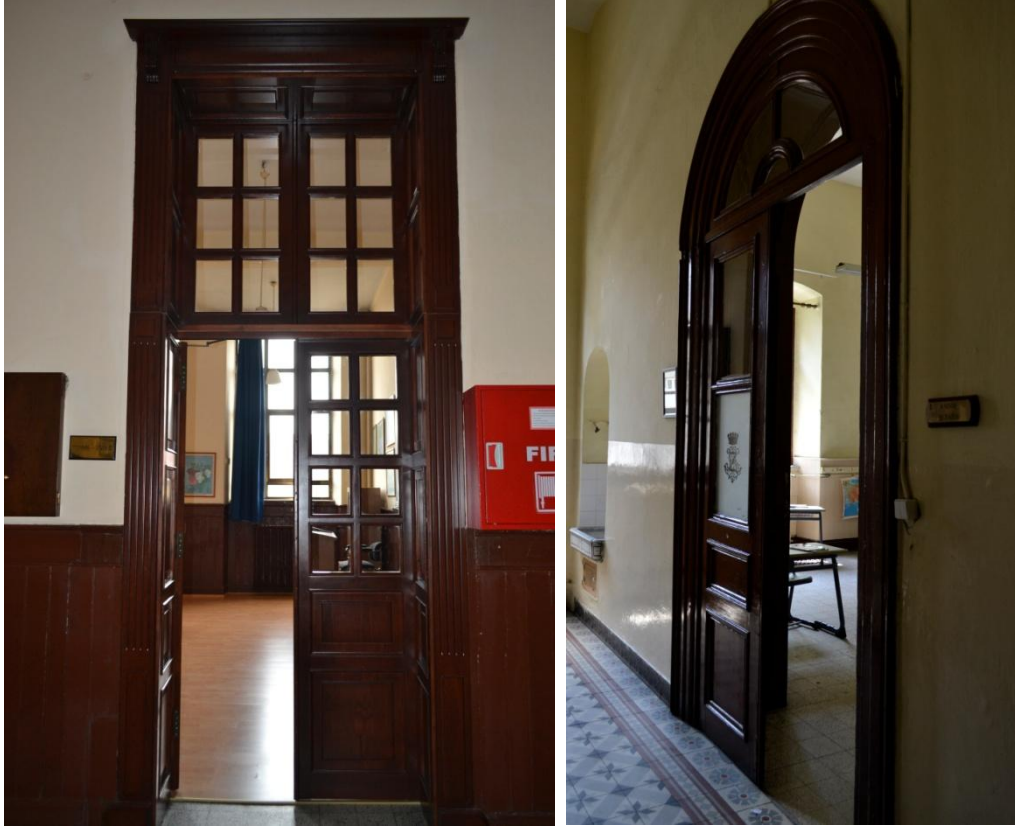
Figure 16: a) Door opening of a classroom in Zoğrafyon R.L.İ.O., which is spanned with lintel. b) Door opening of a classroom in Zapyon R.İ.O.L., which is spanned with a central arch. (Author, June 2011).

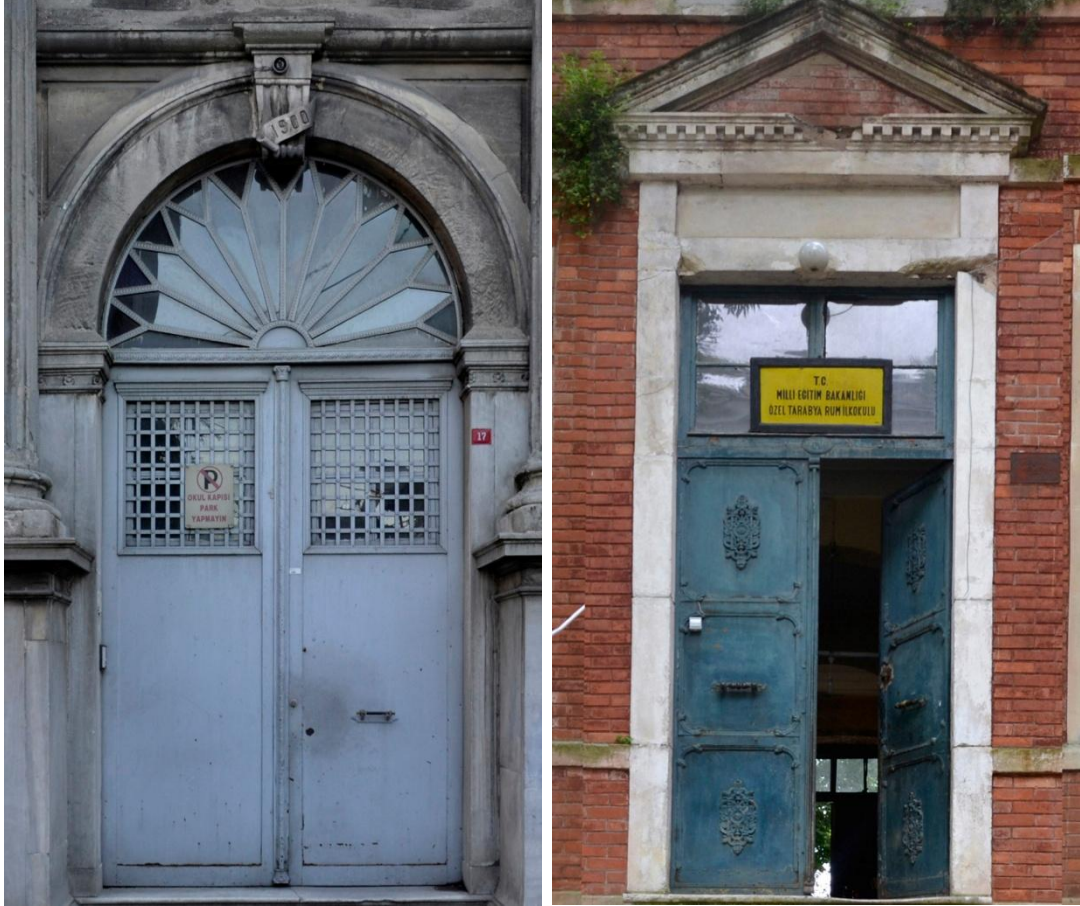
Figure 17: a) Entrance door of Maraşlı R.İ.O.; spanned with arch, different than interior doors which are spanned with lintel. b) Entrance door of Tarabya R.İ.O.; made of metal, different than timber framed interior doors.

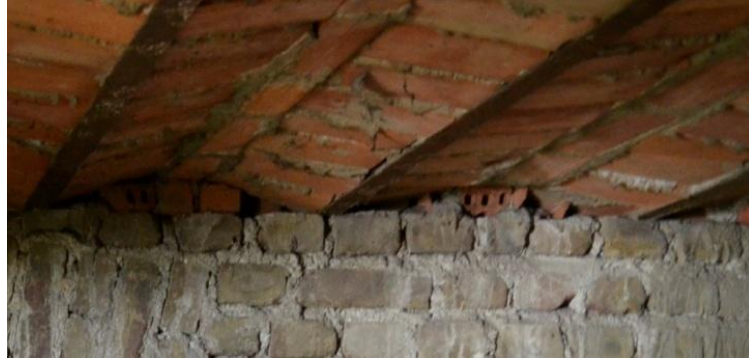
Figure 19: Detail view of brick arch floor, Tarabya R.İ.O. (Author, June 2011).

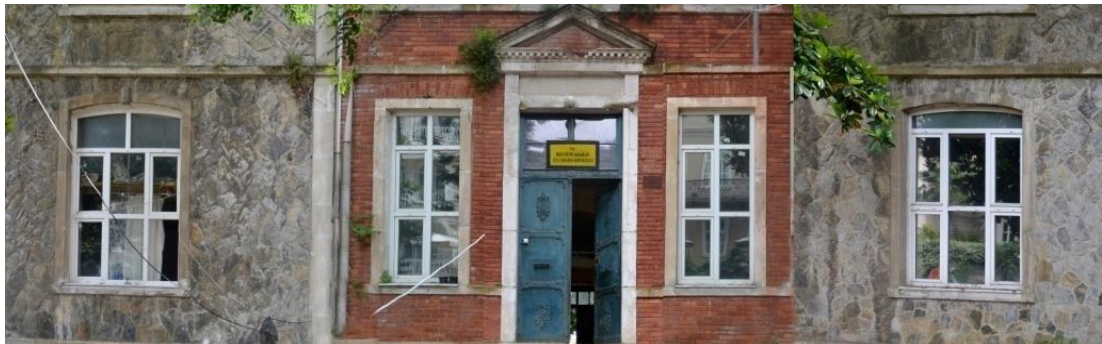
Figure 20: View of front facade, Tarabya R.İ.O., featuring exposed stone masonry on side parts and exposed brick masonry on middle part of the school building.(Author, June 2011).

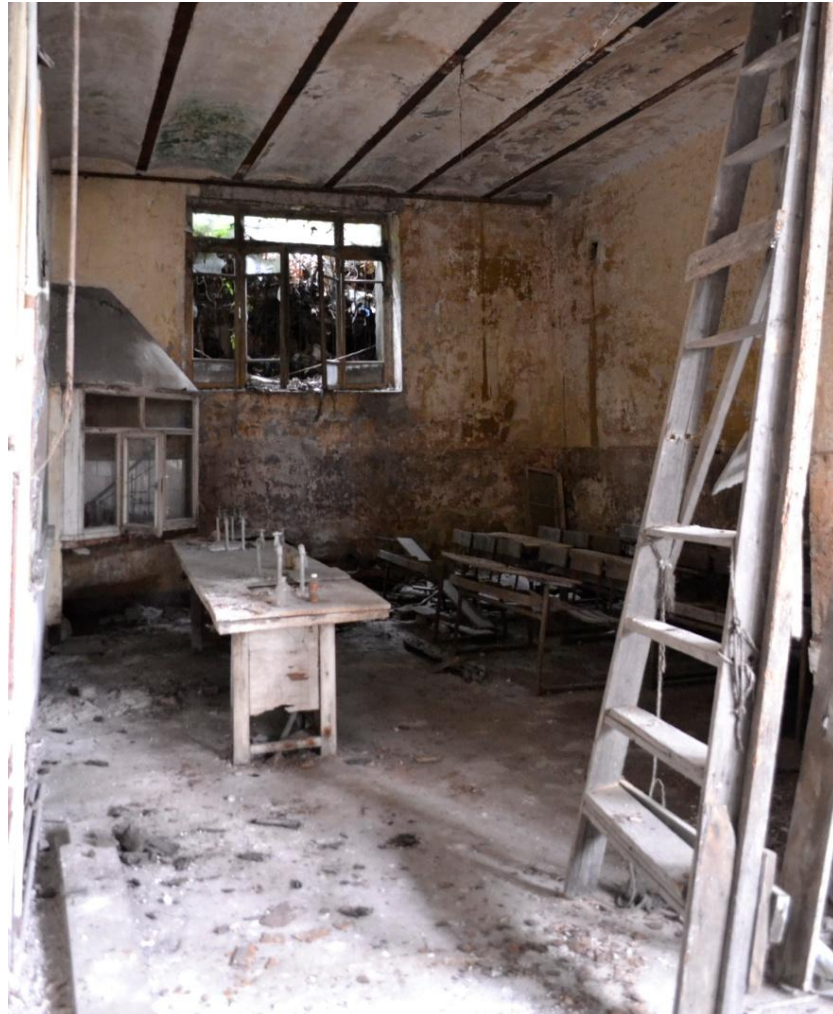
Figure 21: View of a laboratory space, Merkez R.İ.O.L. The broken window frames causes more deterioration inside.

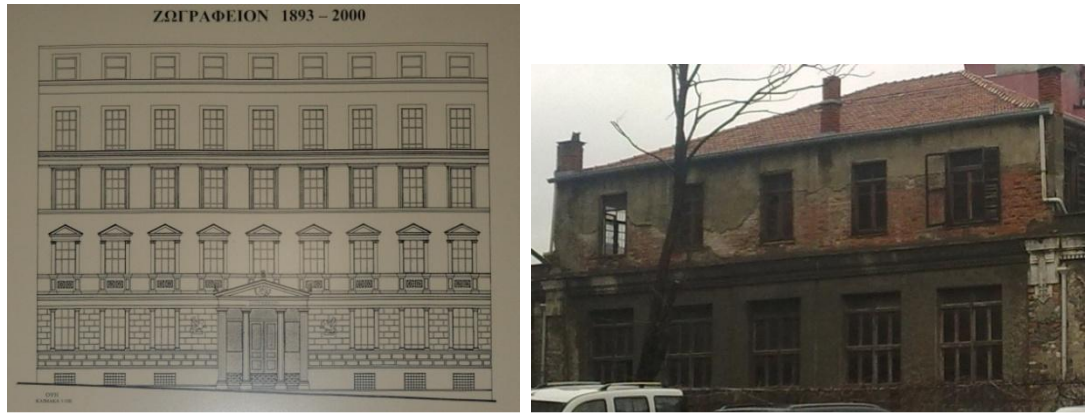
Figure 22: a) Additional floors; Zoğrafyon R.L.İ.O. There are two additional floors on originally three storey high building (Measured drawings, School Panel in Zoğrafyon R.L.i.O., 2000) b) Additional third floor; Merkez R.İ.O.L. Original building height is two storey high (Author, June 2011).

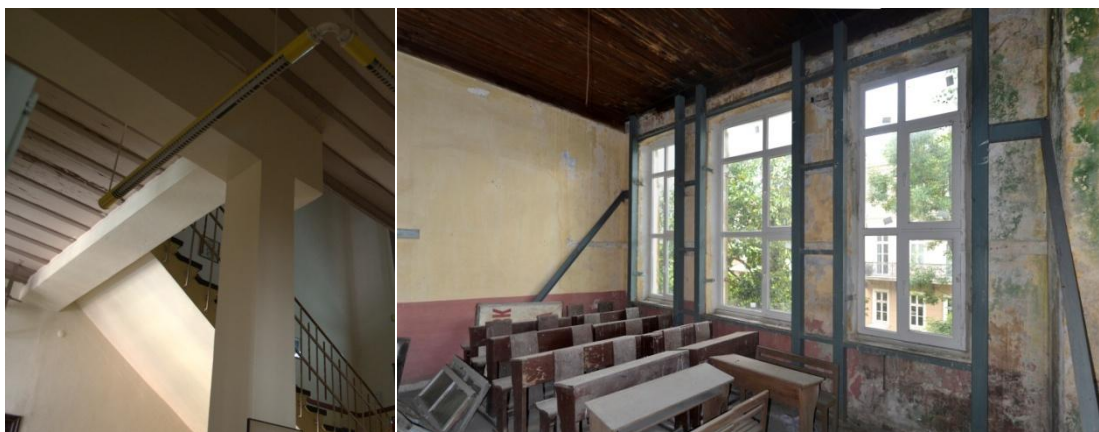
Figure 23: Images of additional reinforced concrete beams on; a) stair well of Kadıköy R.İ.O., and b) consolidated main wall of Tarabya R.İ.O. (Author, June 2011)

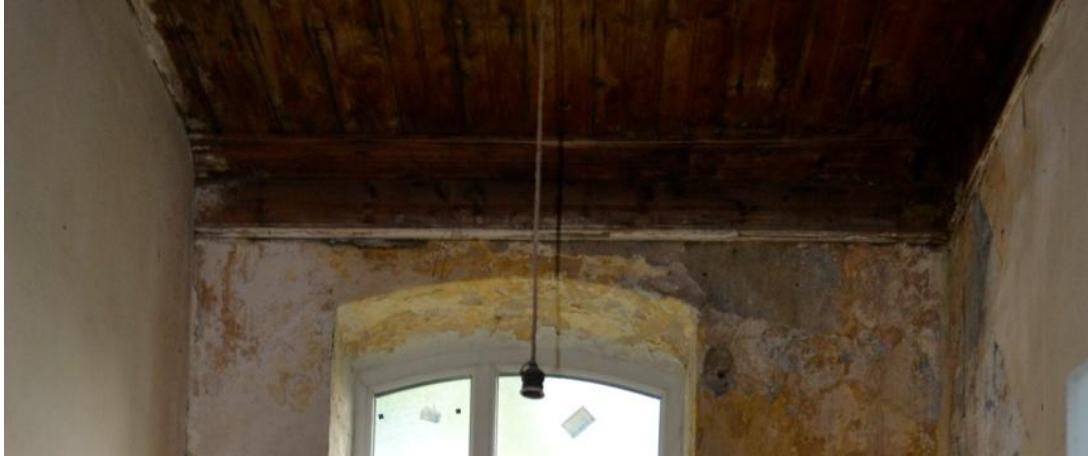
Figure 25: Additional partition wall on left, Tarabya R.İ.O. Wooden works on meeting point of ceiling and wall does not continue on left side, where additional wall meets ceiling. (Author, June 2011).

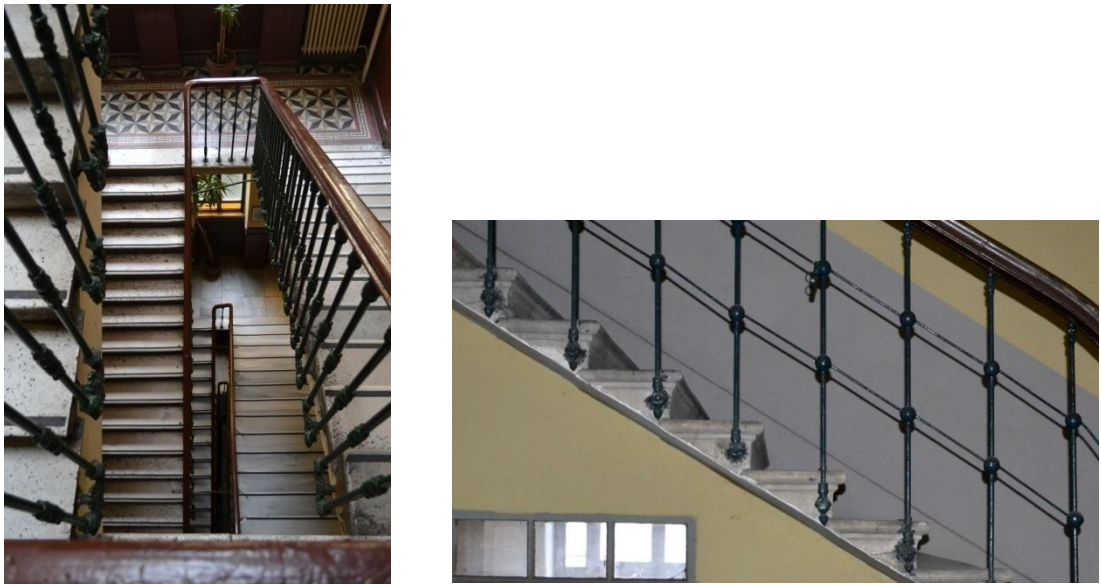
Figure 26: Detail views, a) View from stairs of Zoğrafyon R.L.İ.O. **b)** View from stairs Maraşlı R.İ.O. High level of workmanship at these exemplary architectural elements indicates high technical level of these schools' constructions (Author, June 2011).

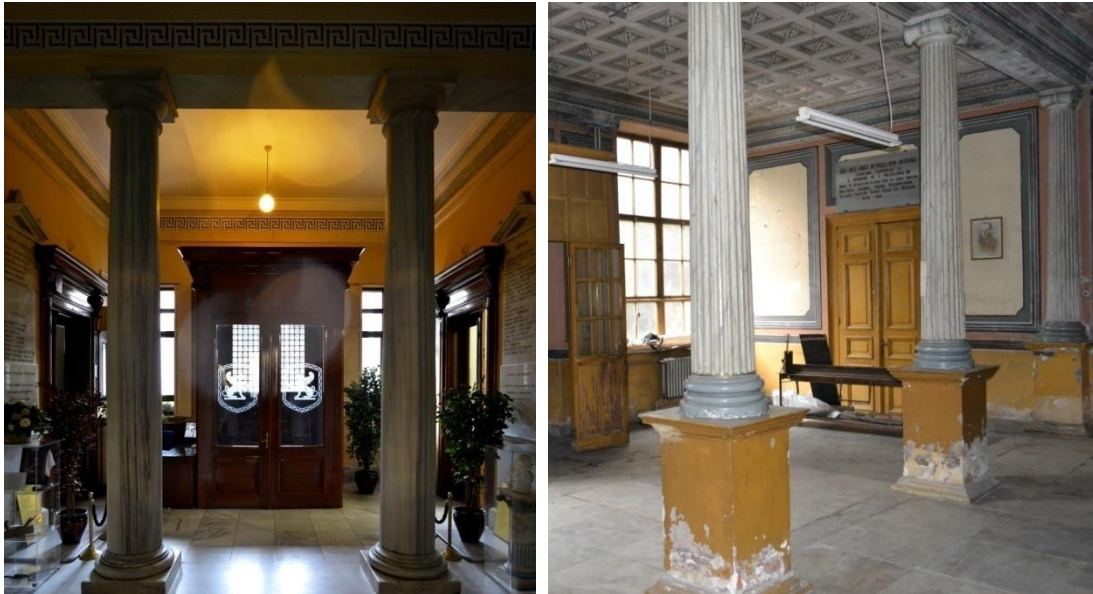
Figure 28: Buildings bearing “continuity in use value” are in a much more better condition than the ones which do not have the value. **a)** Entrance space of Zoğrafyon R.L.İ.O. **b)** Entrance space of Merkez R.İ.O.L. (Author, June 2011).

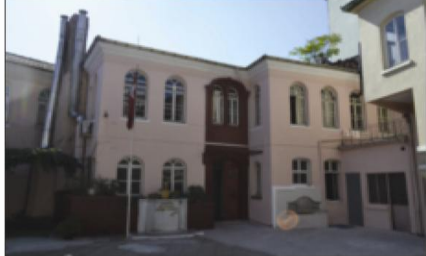
<p>From courtyard, school building is perceived as two storey high and the facade has an assymetrical organisation. On cortyard facade of the building, it is seen that entrance part is distinguished from rest of the facade with brick cover on the wall and differentiating window opening ratios.</p>	<p>North and north-east facades</p>
<p>North-West facade has a cascaded surface, and factures both arched and rectangular framed window openings. There are cornices at floor levels. The buidling is perceived as three storey high from the street level, due to the commercial spaces under the school.</p>

General Characteristics of the School Building	
<p>The school building is two storey high, and its structural system is stone masonry. It is located in the complex of Ay Todorı Greek Orthodox Church . There is one entrance door to the building from courtyard facade. The street floor under the school building are used as shops and cafes serving Imrahor Hamamı Sokađı. Facade organisations of courtyard side and street side are not similar to each other.</p>

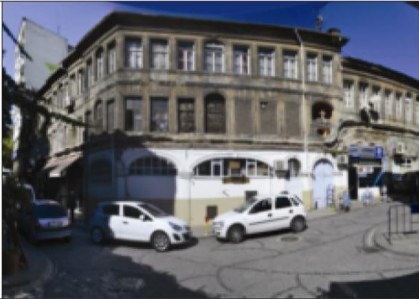
<p>North-west facade, viewed from Imrahor Hamamı Sokak</p>
Structural System and Material	
<p>Structural system of the building is stone masonry.</p>

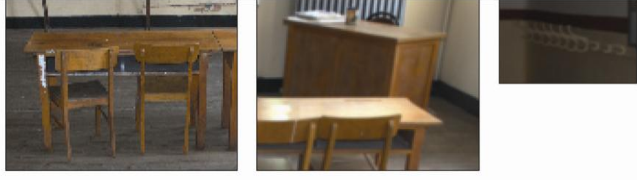
Building Form and Plan Scheme	
<p>Building Form : L shaped.</p> <p>Number of Storey : Basement floor + ground floor + first floor + second floor</p>	
<p>Ground floor of the school building houses two course units, two social units, toilets and a storage under stairs. Corridor of the floor is L shaped. On southern side of the floor, social spaces cafeteria and teachers' lounge are located while on right, art room and classroom are located. The classroom has a richly decorated ceiling and wall coverings, because it was used as a cocktail room before. A wall separates the corridor leading to entrances of mentioned course units and corridor leading to wcs, which includes "askılıklar" and "lavabolar".</p>

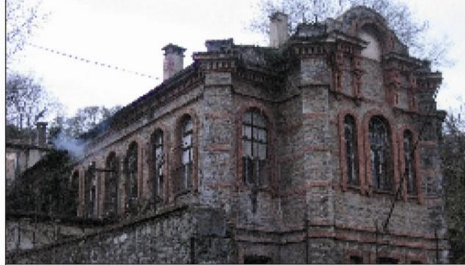
<p>It is observed that the main walls are constructed with stone and brick. Decorational elements used on facades are completely made of brick.</p>	<p>View of East and South facades.</p>
<p>There are two entrance doors to the building, both providing entrance to different levels of the school building. Both entrance doors are on North facade, and the one leading to first floor is reached through a stair in front of it. There are add</p>

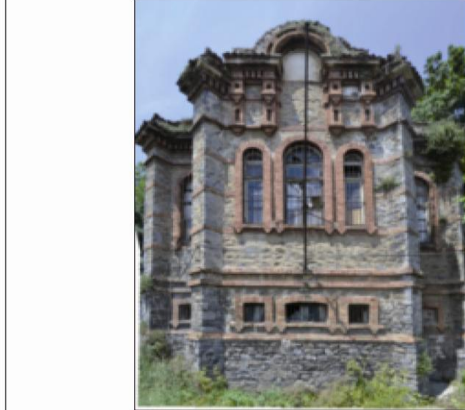
<p>Front facade of the school building has an axial organisation. Middle part with three window openings on each floor is projected. There is not an entrance door to the building on front facade. On axial center of the facade, on roof level, there is a description panel, which is covered with a central arch as seen on window openings. All window casings are made of brick.</p>	<p>East Facade</p>
<p>Front facade of the building has highly detailed brick ornamentalions. Similar brick work is also seen on another studied building; Fener Rum İlköğretim Okulu ve Lisesi, architect of which is also Konstantinos Dimadis.</p>

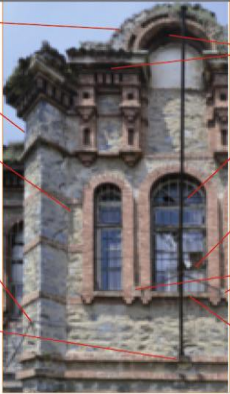
<p>Dampness on brick and marbles on the facade</p> <p>Rusting on pig iron grills</p> <p>Broken window frames and glasses, sign of vandalism</p> <p>Cement addition on facade for additional grills</p> <p>Material loss on timber casings</p>

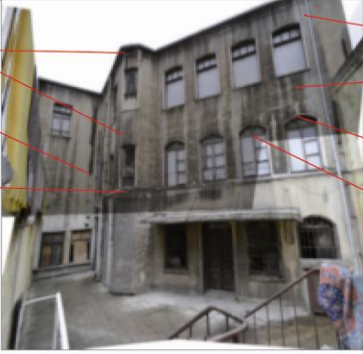
<p>Ground floor ceilings are partially collapsed. There is a structural deformation at the entrance ceiling, which is consolidated with timber trusses.</p> <p>There are surface deterioration on all walls in nearly every space in the building. All wooden and timber framed architectural elements, including window frames, doors, partition elements and cupboards are in a bad condition.</p>

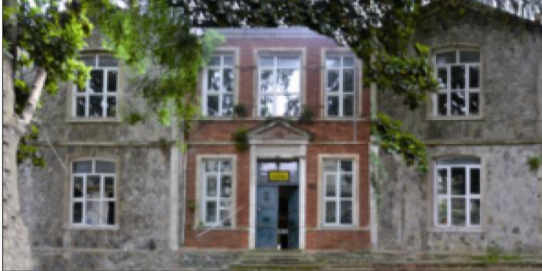
General Characteristics of the School Building	
<p>Structural system of Tarabya Rum İlköğretim Okulu is brick and stone masonry. The school building is two storey high. There are two entrance doors to building of the school from north facade and from south facade. Because the lot of the school is sloppiyi both entrance doors are reached through stairs the one on south facade being more stepped.</p> <p>North facade of the building is arranged symmetrically and composed of three parts horizontally. While side parts have equal features, entrance part is differentiated from side parts in many ways. Material used on main walls of entrance part is timber while side parts' main walls are made of stone. Window openings are different with respect to their forms, opening ratios and sizes. It is seen that entrance part windows are narrower than the ones on side parts. Entrance door has a triangular pediment upon it, at the same level with the cornice between two floors. The pediment has the same width with the entrance door.</p> <p>South facade is organised same way with north facade, with some differences. There are openings for storage spaces under ground level, as a result of sloped courtyard of the school. In addition, there is a triangular pediment upon entrance door at the same level with the one on north facade, but as wide as whole entrance part.</p>

<p>North facade</p>

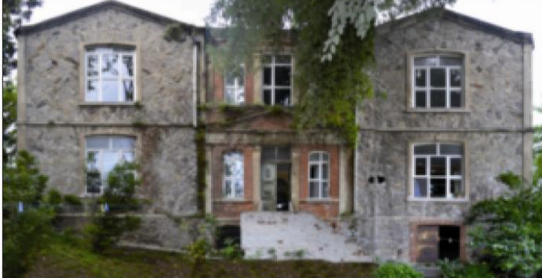
<p>South facade</p>

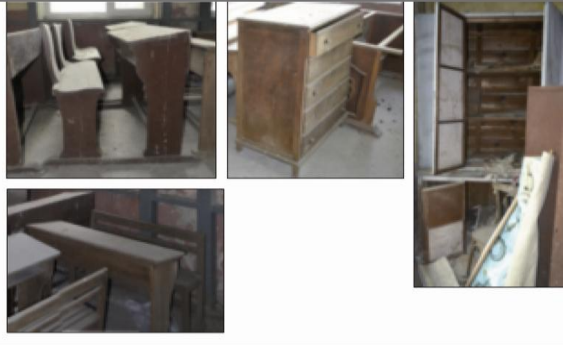
Building Form and Plan Scheme	
<p>Plan Scheme : L shaped.</p>	
<p>Number of Storey : Basement floor + ground floor + first floor + second floor</p>	
<p>Ground floor consists of hall of ceremonies and service spaces. Hall of ceremonies is also used as cafeteria, and kitchen is located right next to entrance space. Inside original building, there is no toilet space. The corridor linked to the additional building on western side of the floor heads to the toilet space.</p>

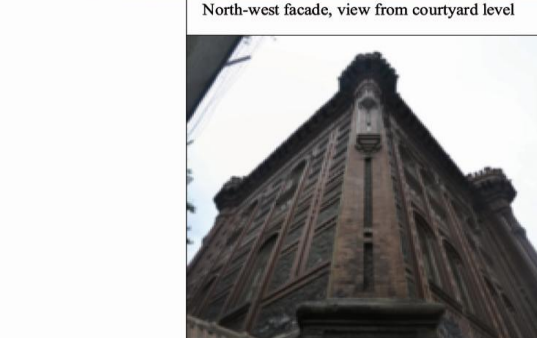
<p data-bbox="1050 934 1369 949">North-west facade, view from courtyard level</p>

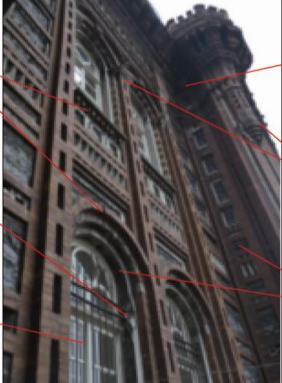
<p>Birds & biological growth on narrow spots of facade</p> <p>Detachments of stones on ornamentalations</p> <p>Staining on stone facade materials</p>
<p>Building is in a moderate condition</p>		
Alteration		
<p>No alteration is seen on the building.</p>		
<p>NOTES:</p> <p>All images are belong to Author.</p> <p>Measured drawings from Dilek Şaman's thesis are used as basis of plans.</p>

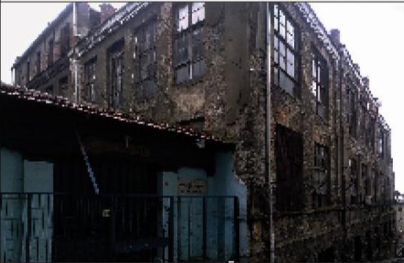
<p>South-west facade of the building has three parts. On middle part there are window openings of gymnastic saloon and above it, window openings of additional third floor are seen. On this side of the school building, there are no openings on side parts. There is no facade organisation on this side, because the school building was adjacent to the next lot on this side. Window openings of third floor are different than the ones on other facades in terms of opening ratio and size. They do not have casings, too. On gymnastic saloon's facade, there are segmental arched window openings.</p>	<p>View of north-east and north-west facades including courtyard entrance door</p>

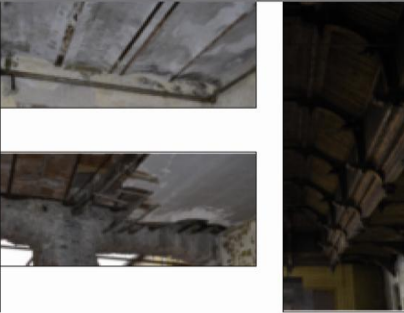
<p>South-west facade</p>	
Structural System and Material	
<p>On all floors except for additional third floor and gymnastic saloon, main walls and interior walls are mix of stone and brick masonry. Gymnastic saloon's main walls are brick masonry and its roof structure is timber framed. Additional third floor of the school building has brick main walls. Thickness of main walls are 60 centimeters on ground floor and</p>

<p>Floor slabs are brick arch floor on all levels. Roofing structure of both main building and gymnastic saloon are timber framed. Gymnastic saloon ceiling and roof structure is a very rare and important example.</p>

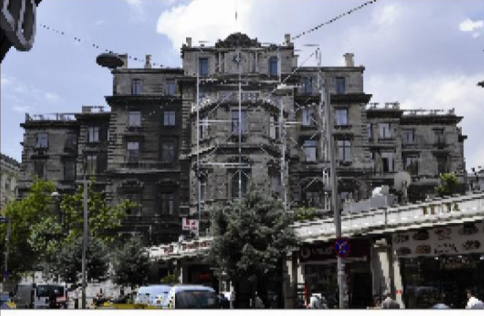
<p>North-east facade, seen from Siraselviler Caddesi</p>

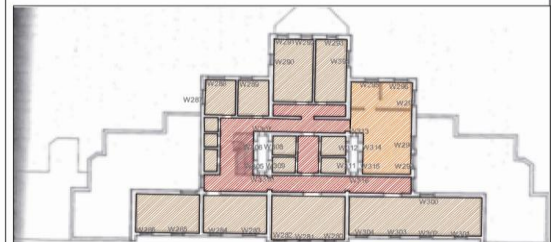
Fourth Floor Plan

Fourth floor of the school building is composed of upper floor of housing for principal, thirteen storage rooms and two terraces.

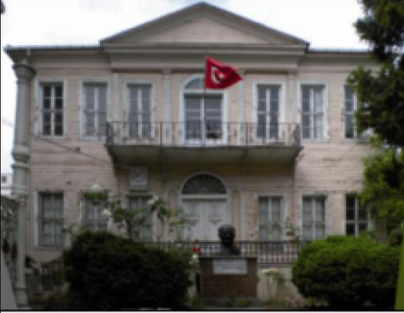
<p data-bbox="991 555 1396 577">South facade, facing İstanbul Caddesi</p>

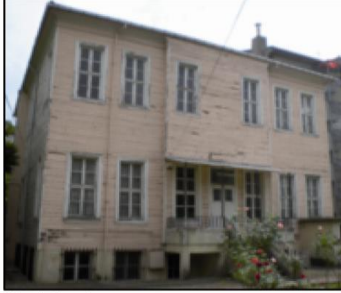
<p data-bbox="1054 887 1396 909">North facade</p>

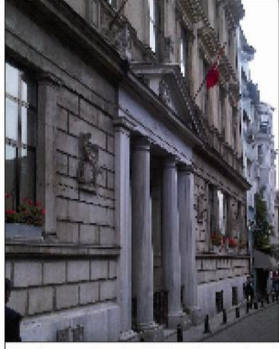
GENERAL CHARACTERISTICS OF BUILDING	
<p>The school building is five storey high, and its structural system is stone masonry. It is located in Turnacıbaşı Street. There are three entrance doors of the building , one from Turnacıbaşı Street and two opening to the rear courtyard. The first is located on the center of front facade and the other two on the courtyard are linked to ground and basement floors with stairs.</p> <p>Ground floor is higher than street level, causing the main entrance door being above street level and reached through five steps in front of it. Because of the mentioned level difference between ground floor and street, window openings of basement floor are visible from the street.</p> <p>Symmetrically arranged front facade has a triangular pediment above the door on entrance part, with four columns carrying it. The columns at two ends of the column order intersects with wall surface. On architrave, there are letters mentioning name of the school, Zoğrafyon in Greek.</p> <p>Plastering on ground floor is shaped like cut stones. This use differentiates the floor from upper floors. Platerings of window casings on first floor are shaped as triangular pediments and two columns under them, at two sides of windows.</p> <p>Although the building is five storey high, it is perceived as three storey high from narrow Turnacıbaşı Sokak. Large cornice at the upper level of third floor hides two additional upper floors.</p> <p>North-east facade of the building faces the rear courtyard and has no ornamentations such as the ones on South-West facade. It has an asymmetrical facade organisation. There are cornices on each floor level. Window casings are simple compared to the ones on front facade. Floor heights decrease at the additional third and fourth floors and can be easily perceived on this facade.</p>

<p style="text-align: center;">South-west facade, facing Turnacıbaşı Street.</p>

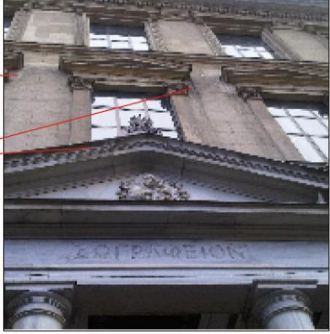
<p>The school building is physically in a good condition. It has no structural problems and facades are in a good condition with slight deteriorations.</p>			
Alteration

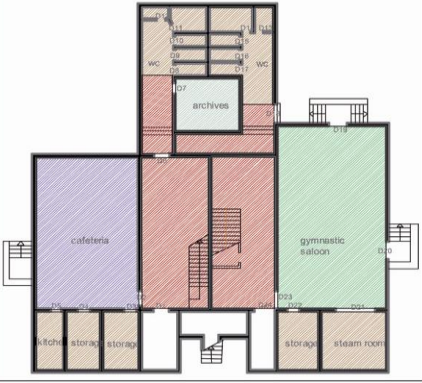
<p>Basement Floor Plan</p> <p>0 5 10m</p> <p>N</p>

Building Form and Plan Scheme	
Building Form	: L shaped.
Number of Storey	: Basement floor + ground floor + first floor
<p>Basement floor of Kadıköy Rum İlköğretim Okulu building is composed of cafeteria, gymnastic saloon, archives and service units like kitchen for cafeteria, storage rooms and wc. The additional one storey building is on eastern side of the school building and houses archives and toilet spaces. Large spaces like gymnastic saloon and cafeteria are located at north and south sides of the floor while service units are located at western side of the floor. The floor is divided into two by the wall among stairs and there is no link among northern and southern parts on the floor.</p>

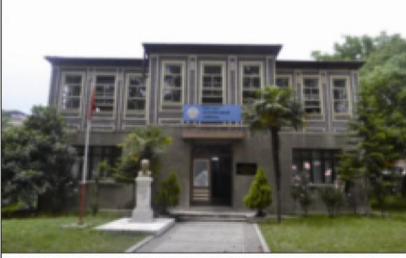
<p>South-East facade(entrance facade)</p>

General Characteristics of the School Building	
<p>Two storey high school building is stone masonry on ground floor and timber framed on first floor. There is one entrance door to the school on the center of front facade and two more entrance doors from courtyard are opening to toilet spaces on north-west facade of the building. All windows are rectangularly framed.</p> <p>Facade organization of front facade is symmetrical. The facade is organised in horizontally three parts. Entrance part is projected. In front of entrance door, there are steps made of marble. First floor windows have wooden casings. Upper parts of original ground floor timber window casings are seen on bottom part of first floor facade cover. There are wooden ornamentations on first floor, among window openings.</p> <p>Structural and material changes made on ground floor also led to changes of window opening ratios on this floor. It is understood that original window openings on ground floor had same order with first floor's, considering remaining top parts of timber ornamentation elements on first floor facade.</p> <p>South-west and north-east facades are nearly identical except for missing window openings of library space on first floor. Facades are organised assymmetrically. Chimneys are exposed on middle of the facades.</p> <p>North-west facade is covered with additional toilet mass on ground floor, in the middle. There are only two window openings on the first floor facade, one on each side.</p>

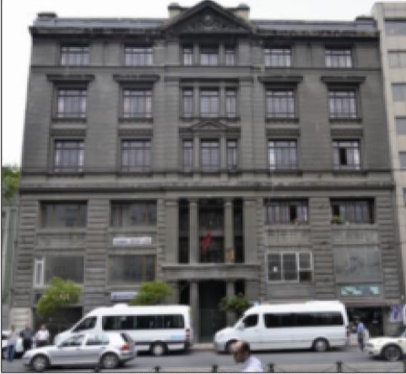
<p>South-East facade facing Kemeraltı Caddesi</p>

General Characteristics of the School Building	
<p>The building is stone masonry and six storey high. It houses both educational and commercial uses. While ground, first and mezzanine floors are in commercial use, upper floors are used as school. This mix-use also reflects itself on highly decorated front facade of the building.</p> <p>The front facade is symmetrically arranged, One and only entrance door of the building is on middle part of the facade. Window openings on commercially used ground floor and first two floors are wide and have an opening ratio of approximately 3:2. On facade, commercial and school parts are separated from each other with a cornice.</p> <p>There is use of architectural elements from classic Greek architecture. There is a triangular pediment, with detailed baroque style decorations on the roof floor, in the middle of the facade. Under the pediment, the middle part of the facade is composed of colonnades, friezes and lintels among them and another, smaller pediment on a window opening of second floor. The whole facade is plastered and the plastering is cut-stone shaped.</p> <p>South-west Facade is symmetrically arranged. It is seen that window openings of hall of ceremonies have more than twice the width of the windows on upper floors.</p> <p>Roof level windows were additional and their dimensions or number in a row is not in accordance with the lower level windows.</p> <p>Facade surface is plastered with cement-based plastering material.</p>

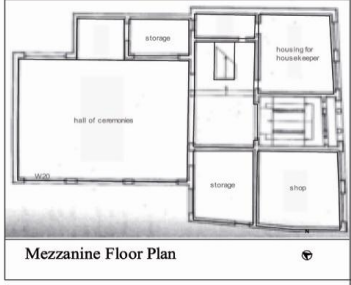
<p>Mezzanine Floor Plan</p>
Alteration

Physical Condition		
<p>Hall of ceremonies is the most richly decorated space and also the space that houses most of the deterioration problems in the school building .</p> <p>There are detachments of reinforced concrete ceiling on eastern corner. This problem is very important because the ceiling of the hall bears all upper floors' spaces. There are detachments on plasterings, especially underneath of gallery balcony on southern side of the hall.</p> <p>The stage and storage/backstage right next to it are in a severe condition with their structurally damaged ceilings and walls. Surface deterioration is seen on plastering works on southern and northern wall surfaces.</p> <p>It is understood from addition of basketball hoops on gallery level that the hall was turned into a mix of hall of ceremonies and gymnastic saloon.</p>

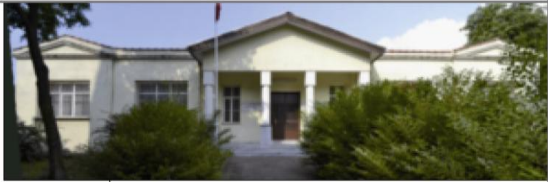
<p>East facade is arranged symmetrically and is organised in five parts. On entrance part, a triangular pediment and four columns under it are projected from the rest of the facade, creating an entrance in neo-classical style for the school. Side ending parts of the facade also have pediments on roof level in accordance with entrance part, but they are not projected.</p>	<p>East facade, facing Çekmece Caddesi</p>

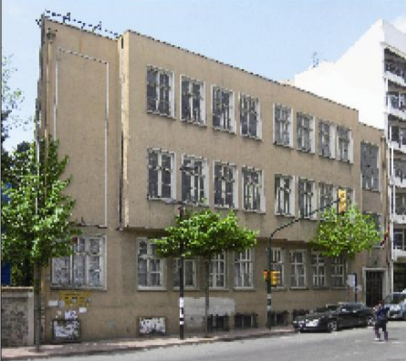
<p>East facade, facing Abide-i Hürriyet Caddesi</p>

General Characteristics of the School Building	
<p>The school building is three storey high, and its structural system is reinforced concrete. It was constructed in style. There are two entrance doors to the building on ground floor and one on basement floor. Throughout the facades of the building, there is no ornamentation.</p> <p>The front facade of the building is arranged asymmetrically. Entrance door is on northern side of the facade, being on street level although ground floor level is one meter high than street level. This makes the door's frame level being lower than the floor window openings on the facade. Middle part of first and second floor is projected on the facade. While there are stair well's windows on northern side of the projected part, on southern part there is no opening. There are cement based window casings on the facade. Basement floor's window openings are visible from the street and have metal grills and covers.</p> <p>Due to the building's L shaped plan scheme, there are two parts of the south facade. Front one has no openings since the building is adjacent to next building lot on this side. The back part of the facade has window openings on all floors, including basement floor. South facade has window openings and frames identical to east facade's, without window casings.</p> <p>West facade has window openings and frames identical to east facades', without window casings. Due to level difference between the street level and courtyard, the building is perceived four storey high from courtyard.</p>
