**IMPACT OF LAND USE CHANGES ON THE AUTHENTIC CHARACTERISTICS
OF HISTORICAL BUILDINGS
IN BURSA HISTORICAL CITY CENTRE**

**A THESIS SUBMITTED TO
THE GRADUATE SCHOOL OF NATURAL AND APPLIED SCIENCES
OF
MIDDLE EAST TECHNICAL UNIVERSITY**

**IN PARTIAL FULFILLMENT OF THE REQUIREMENTS
FOR
THE DEGREE OF DOCTOR OF PHILOSOPHY
IN
CITY AND REGIONAL PLANNING**

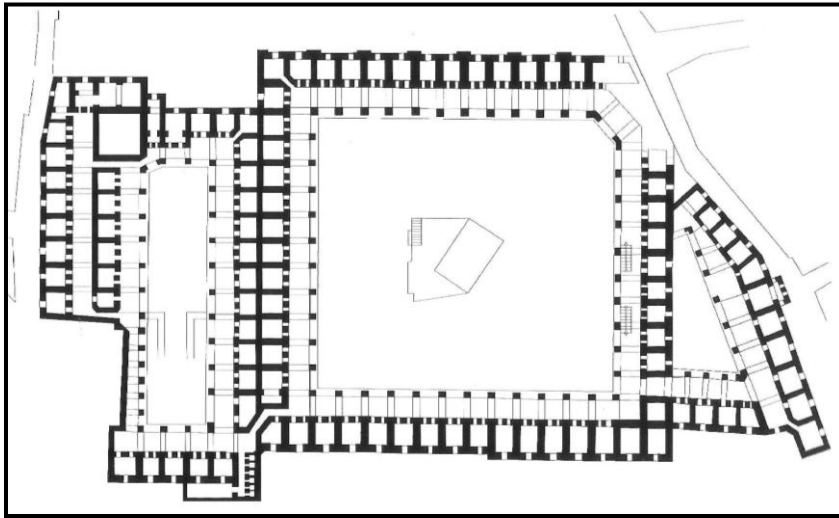
Figure 2.7. Büyük Valide Hanı in İstanbul (Kuban 2007, 396)

The typology of urban *hans* - a structure surrounding an inner court used for accommodation and storage - did not change throughout the Ottoman period (Kuban 2007, 393) (Figure 2.7). The plan of the *Emir Han* is the first example used for centuries by the Ottomans. This *han* meets all the conditions required by urban commercial *hans* (Mortan ve Küçükerman 2010, 119).

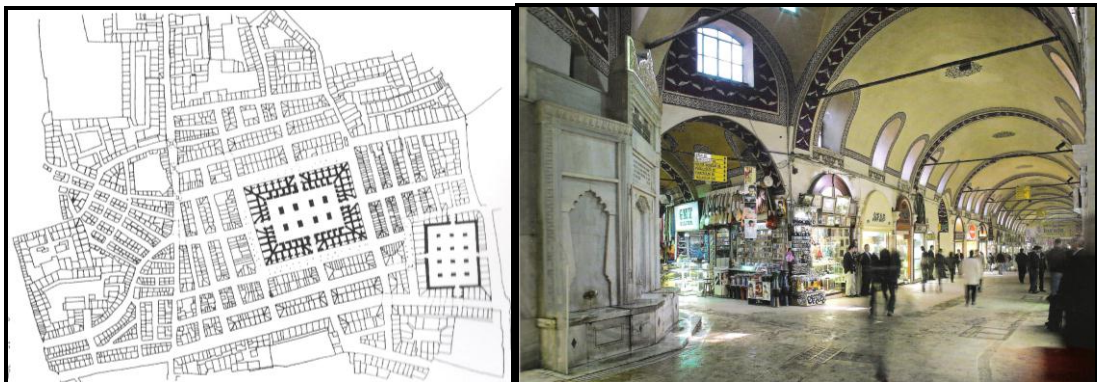
Figure 2.8. Covered Bazaar in İstanbul (Kuban 2007, 397)

The information about covered bazaars dates back to the Ottoman cities of the middle ages (Cezar 1985, 99). A long street or a number of shorter streets are covered to establish a covered bazaar (Cezar 1985, 101). Özdeş defines three types of covered bazaars. The first is a bazaar composed of a single street and surrounded by shops (Ali Paşa Bazaar in Edirne, the Covered Bazaar in Niğde and Bursa). The second type is a bazaar with two rows of shops on two streets intersecting (the Sipahi Bazaar in Bursa, the Mısır Bazaar in Istanbul). The third is a bazaar formed by several covered streets and the shops around (Covered Bazaar of Kayseri) (Özdeş 1953, 139).

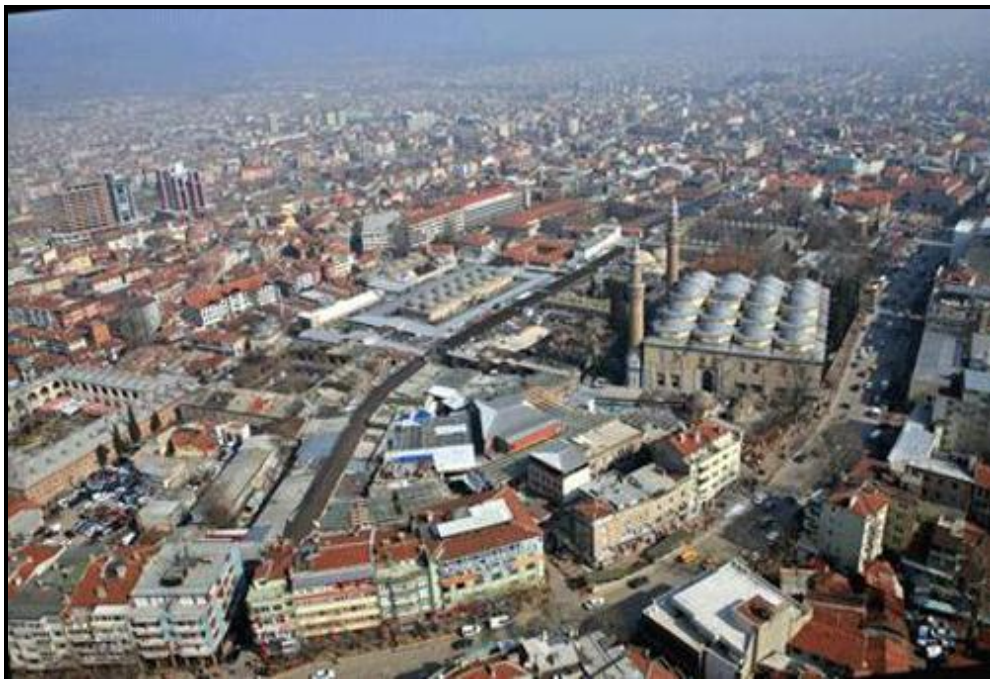
Figure 3.2 Bursa Historical City Centre (<http://www.mimdap.org/?p=35436>, last accessed, 04.01.2011).

When we evaluate Bursa City in terms of urban identity, it is in the nature of a commercial centre on the Silk Road, a thermal baths town, industrial city and manufacturing centre. Historical commercial centre of the city includes important structures representing these important features of the city. The *hans* located in the historical trade centre have an important share in the identity of Bursa City (Figure 3.2).

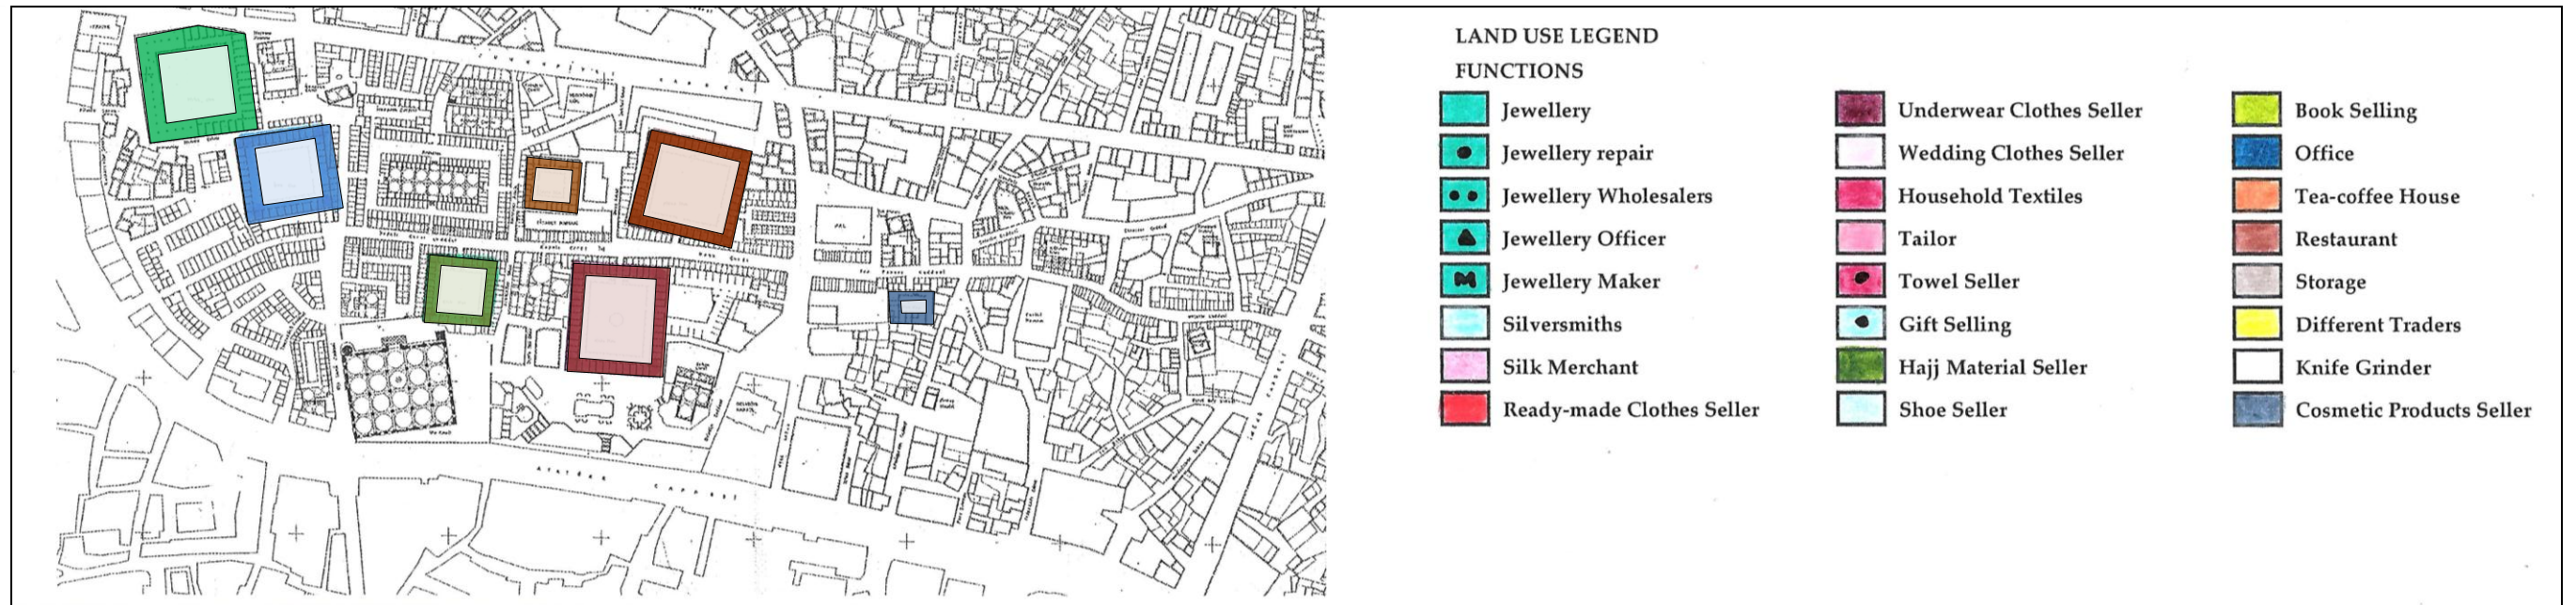
Figure 3.4. Hans in Study Area

EMİR HAN		İPEK HAN		FİDAN HAN		KOZA HAN		TUZ HAN		GEYVE HAN		PİRİNÇ HAN	
Cons. Date	IV. Century		V. Century		V. Century		V. Century		V. Century		V. Century		VI. Century	
Original Use	Covered Bazaar		Trade & Accommodation		accommodation		Trade & Accommodation		Trade		Trade		Silk Manufacture & Accommodation	
Land Use														
Main Function in 2010	Ground Floor	Upper Floor	Ground Floor	Upper Floor	Ground Floor	Upper Floor	Ground Floor	Upper Floor	Ground Floor	Upper Floor	Ground Floor	Upper Floor	Ground Floor	Upper Floor
	Jewellery	Hac Material & Jewellery	Home Textile	Storage	Home Textile & Wedding Dress Seller	Storage	Different Trades	Silk Manufacturer	Ready-made Clothes Seller	Storage	Home Textile	Storage	Tea-coffee House	Storage

In the second stage, all *Hans* in study area (*Koza Han, Emir Han, Eski İpek Han, Fidan Han, Geyve Han, Piriñç Han* and *Tuz Han*) were analysed in order to determine whether there is a relation between the function in the historical building and the deterioration of the authentic characteristics of the building (Figure 3.4). Another *han* in the study area, *Kütahya Han* was not included in the study as the restoration works have been completed recently and it still has not been brought into use.

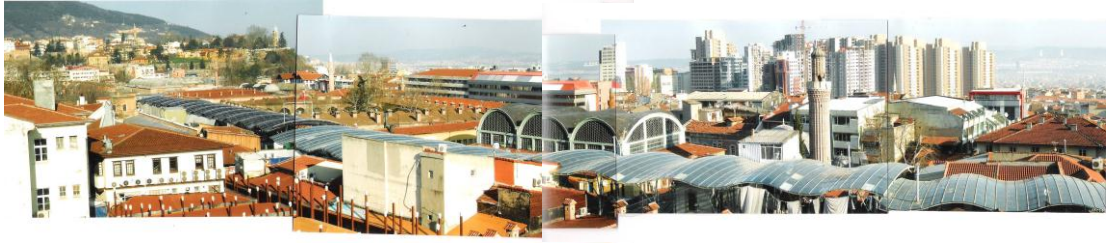
Figure 4.4. Uzun Çarşı in 2010

Spatial change in the Historical City Centre in the 2000’s is the covering of Uzun Çarşı (Figure 4.4). As a reflection of changing consumption habits, owners of the shops in the Historical City Centre demanded application of the spatial insight of the shopping malls in their space. These demands of the shop owners and the customers were taken into account in the improvement works and Uzun Çarşı area was covered on top. Facades of the two-floor shops were renovated during the creation of top cover (Vural 2007, 305).

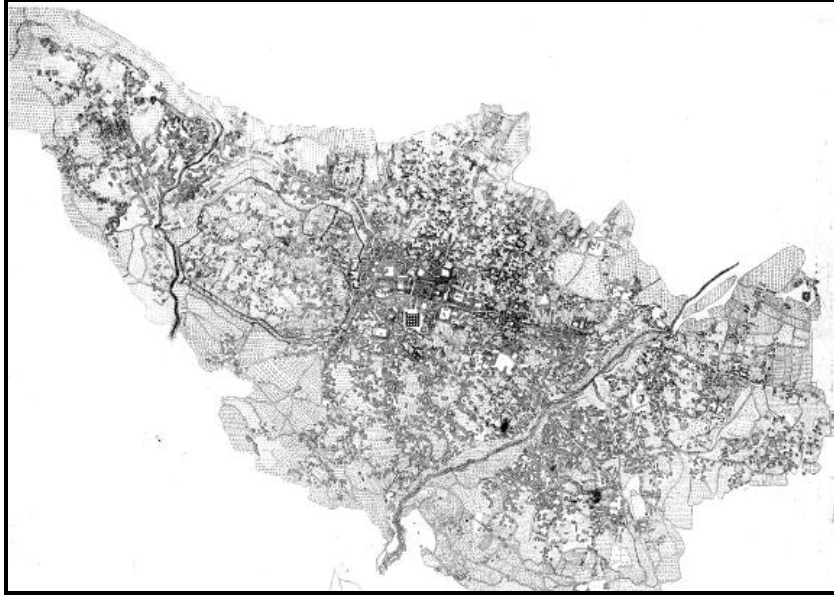
Figure 4.7. Suphi Bey Map (*Osmangazi Municipality Archive*)

In the re-construction period of Bursa after 1855 earthquake, first cadastral plan of the city was drawn by Suphi Bey in 1857 (Kaplanoğlu 2008, 45). This plan is called “1862 Suphi Bey Map” in various resources as it was printed in 1862 (Figure 4.7).

1862 year map gives general information on spatial organization of the city in the second half of the 19th century. It can be seen on this map that the historical trade centre contained mainly religious buildings in addition to *hans*, baths and bazaars. It can also be seen that transportation network of the city was dominated by blind alleys. Long and wide streets cannot be observed in that period. Existence of building and street names on the map makes it easier to determine the locations of the *hans* and the bazaars. Interventions done in the later periods can also be detected.

⁶⁵ Suphi Bey Map is a document revealing the condition of the city before Reorganization Reforms were implemented in the city.

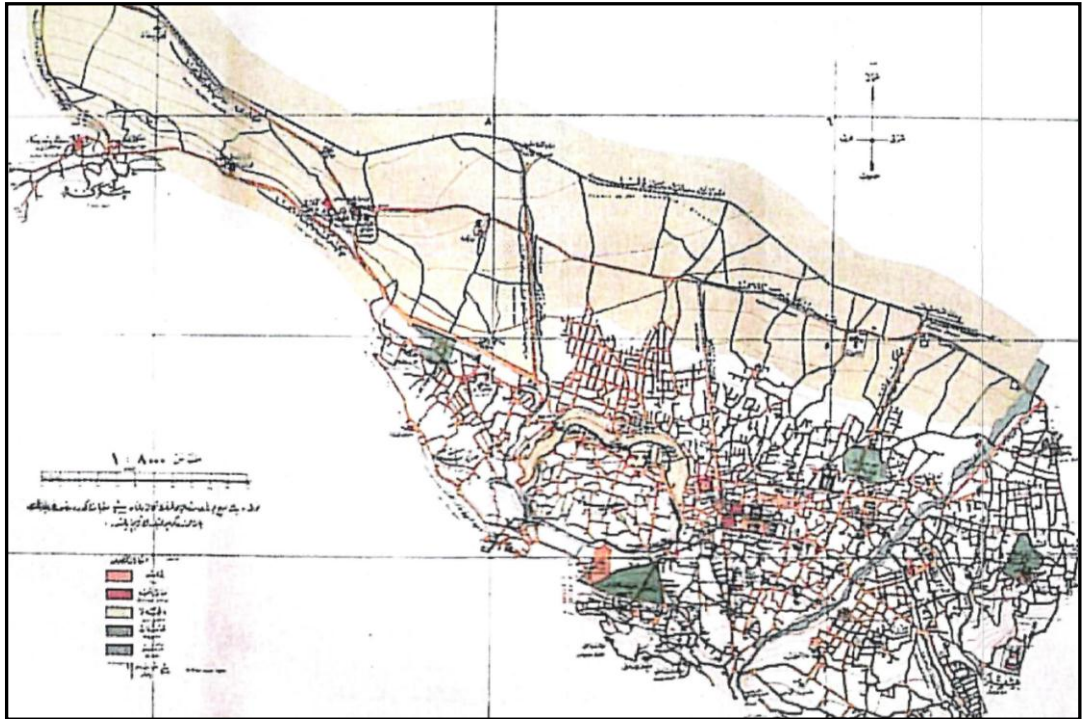
Figure 4.10. Lörcher Plan (Kaplanoğlu 2008, 78)

administrative buildings were built after 1925, Atatürk Monument and Tayyare Culture Centre were built in 1931 and Community Centre was built in 1940 in line with the decisions of this plan (Akkılıç 2001, 80). The implemented section of this plan the city is the fortress entrance of Atatürk Street (Batkan 1996, 249; Vardar 2008, 84). With Lörcher Plan, an administrative centre articulated to the commercial centre was created. Atatürk Street was the main axis of the city, as it is today, and strengthened the central location of the Hanlar Area (Bağbancı 2007, 97).

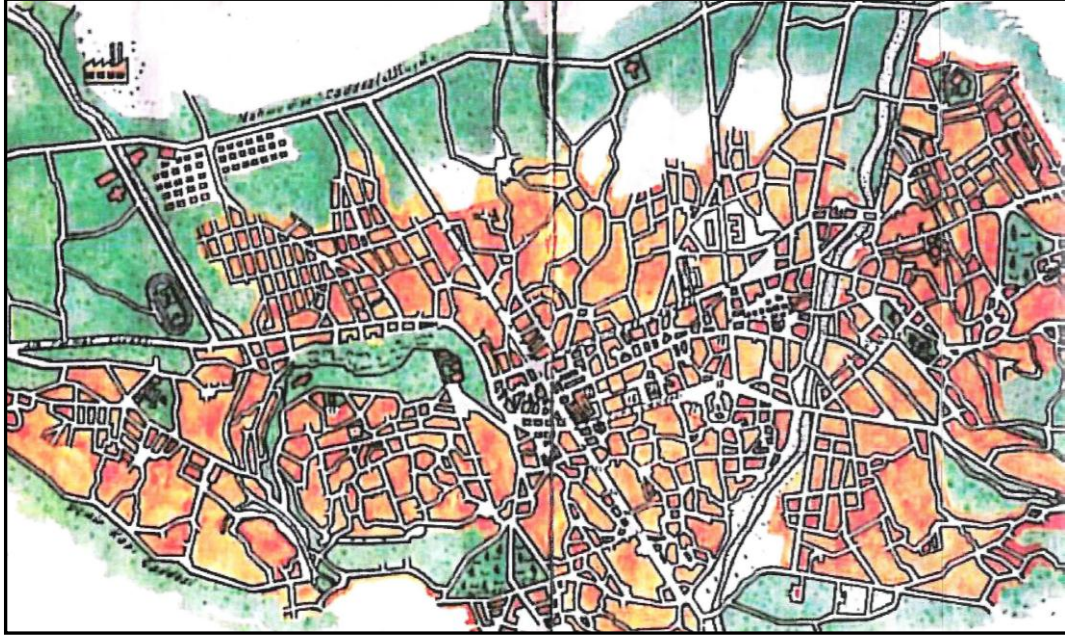
Figure 4.11. 1940 Prost Plan (Kaplanoğlu 2008, 80)

Batkan 1996, 249; Kaplanoğlu 2008, 79). Opening barren parts of Bursa Plain for settlement, regeneration of old housing zones are the important decisions of the Prost Plan. Development of Çekirge as a thermal and tourism centre, establishment of an industrial zone on Gemlik Road on the south of the railway are also foreseen in this plan (Batkan 1996, 249).

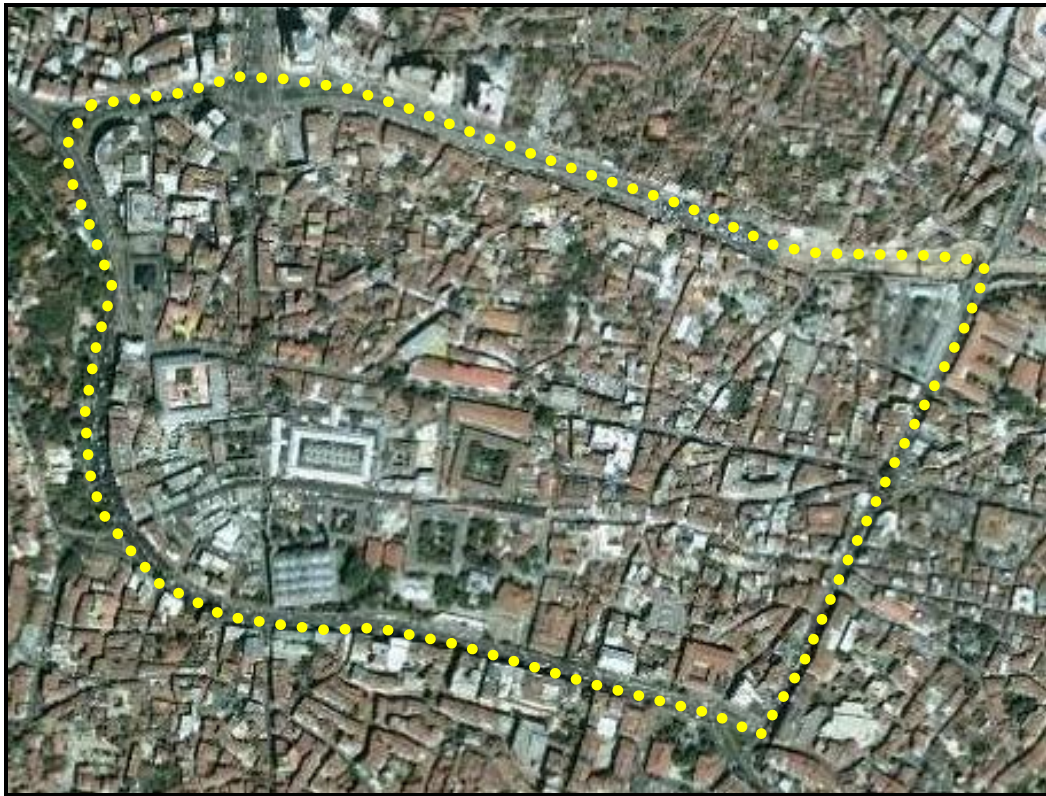
Figure 4.14. Boundary of Bursa Historical City Centre Conservation and Development plan (*google earth image*)

With this planning activity⁷³ carried by Middle East Technical University, it was aimed to enhance the integrity of the city centre and living standards by conserving the historical values of the city centre. Bursa Historical Centre Conservation-Development Plan covers an area of 46.3 acres including Reyhan Neighbourhood on the north, Kayhan Neighbourhood on the east and Hanlar District (Figure 4.13). Roads surrounding the project area are Cemal Nadir Street on the west, Atatürk Street on the south, Haşim İşcan Street on the north and Gökdere natural threshold on the east (Bursa Historical City Centre Conservation and Development Plan Report).

Hanlar District is a developed trade centre of the city with Ottoman city characteristics; Kayhan is a neighbourhood compatible with this centre and Reyhan is a neighbourhood with historical settlement pattern but with a semi-rural town view despite its proximity to the centre. The project area covers historical centre of Bursa and its close vicinity (Figure 4.14). Macro planning policy of the plan was conservation of historical environment and optimization of central function development, due to high amount of historical inputs in this region and its current city centre function (Bursa Historical City Centre Conservation and Development Plan Report).

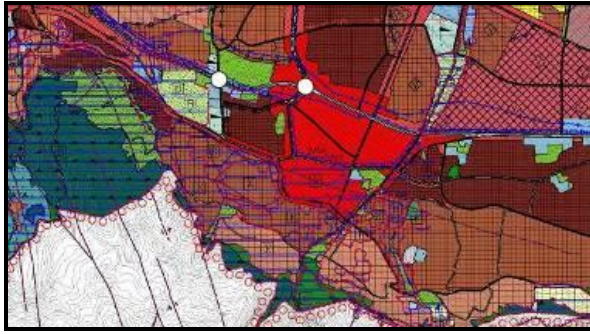
Figure 4.18. 1/25.000 Scale Central Planning Area Master Plan (*Bursa Metropolitan Municipality archive*)

1/25.000 scale Master Plans were prepared for the areas determined in 1/100.000 scale plan by Bursa Metropolitan Municipality, in line with Article 7/b of Metropolitan Municipality Law numbered 5216 and 1/25.000 scale Central Planning Area Master Plan covering the area came into force with the decision of Bursa Metropolitan Municipality dated 16.03.2006 and numbered 177, and this plan was revised and approved in accordance with Bursa Metropolitan Municipality Council decision dated 12.06.2008 and numbered 416 (Figure 4. 18).

The Historical City Centre was determined as “**CBD (Central Business District)**” in 1/25.000 scale Central Planning Area Master Plan. In Article 7.3.1 of the Plan Notes of central business districts, it is mentioned that:

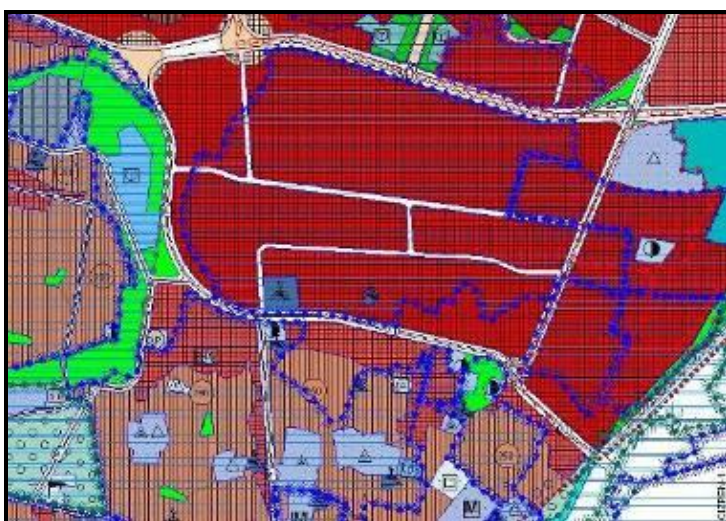
Figure 4.19. 1/5000 scale Osmangazi Municipality Master Plan (*OsmangaziMunicipality archive*)

1/5000 scale Osmangazi Municipality Master Plan was prepared by Bursa Metropolitan Municipality in line with Article 7/b of Metropolitan Municipality Law and in accordance with 1/25.000 scale Central Planning Area Master Plan decisions and the plan was approved with decision of Bursa Metropolitan Municipality Council dated 17.04.2008 and numbered 291 and came into force (Figure 4.19).

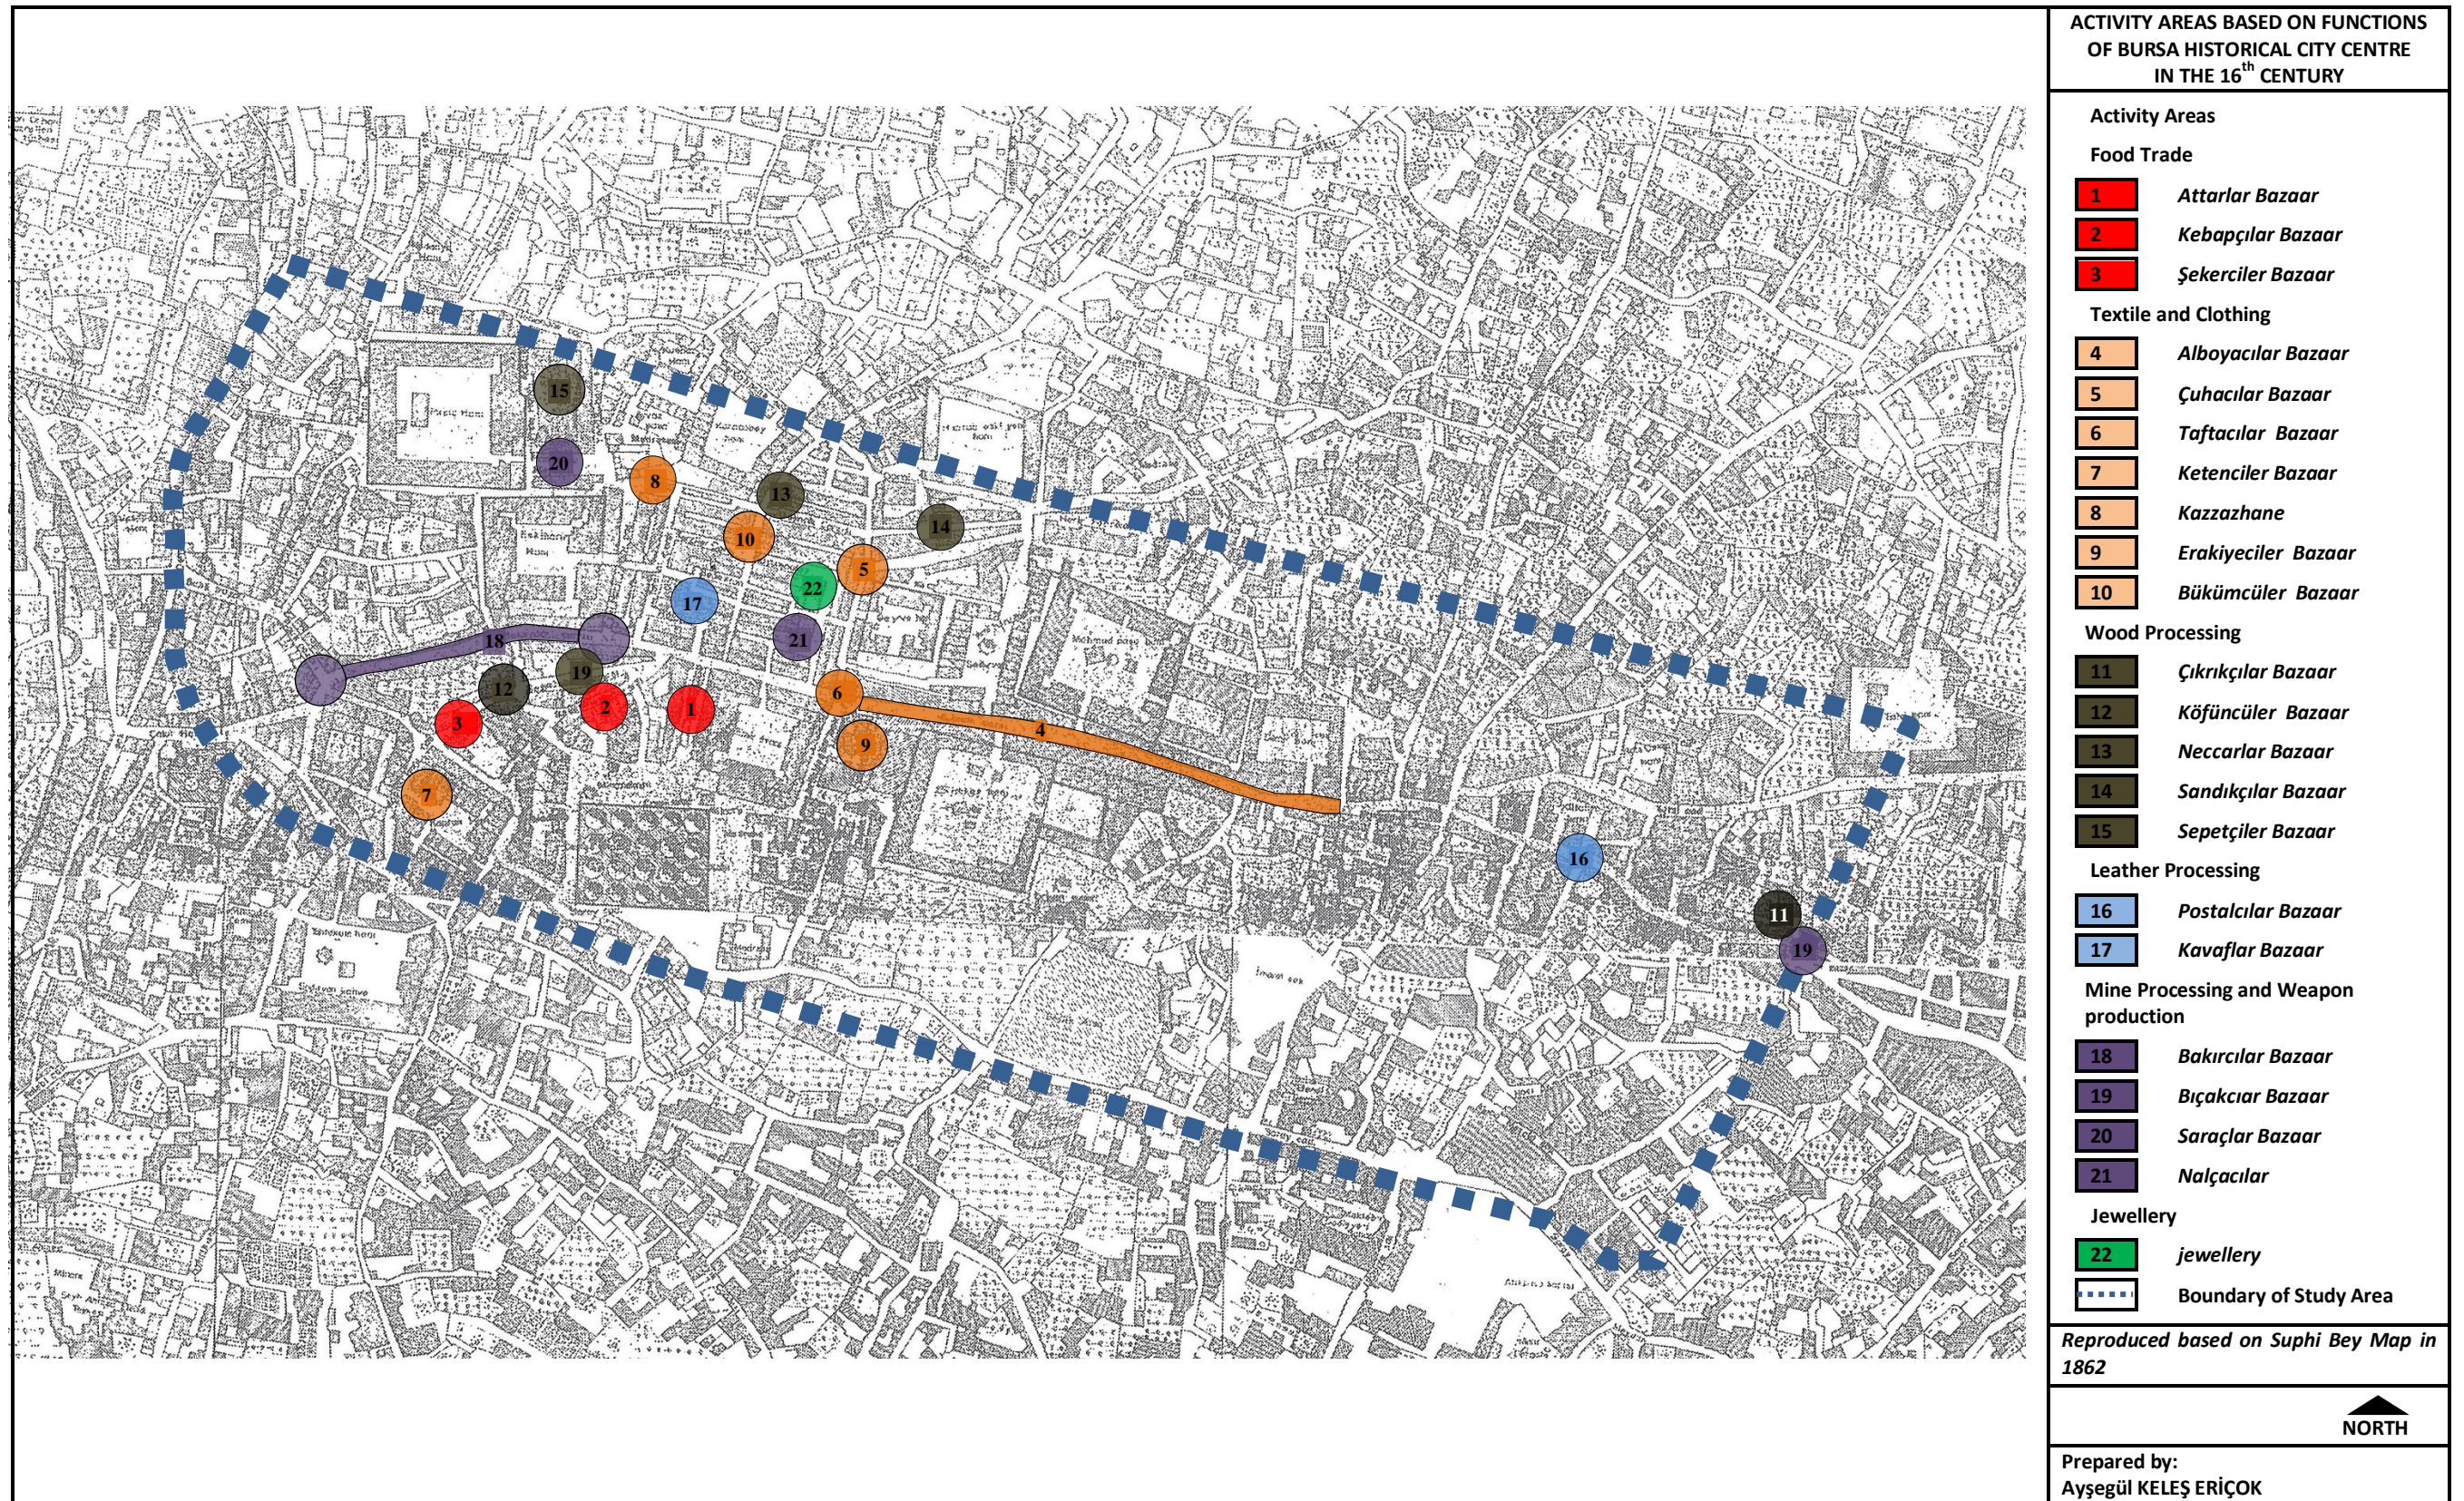
Figure 5.1. Activity Areas Based on Functions of Bursa Historical City Centre in the 16th Century

Bazaars active in the food trade market are; Attarlar (attars) bazaar, Kebapçılar (kebab sellers) bazaar and Şekerciler (candy sellers) bazaar. These bazaars are located closed to each other on the north of Ulu Cami (Figure 5.1).

These are Alboyacılar bazaar, Çuhaacılar bazaar, Taftacılar bazaar, Ketenciler bazaar, Kazzazhane, Erakiyeciler bazaar, Bükümcüler bazaar, Kebeciler bazaar. These bazaars are

located in groups close to each other in different parts of the historical city centre. Some of them are located on Uzun Çarşı axis, some other are on the north of Bedesten and the rest is located on the west of Ulu Cami.

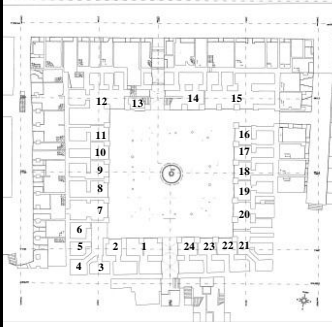
Covered Riwaq and removing the main wall</p> <p>+ Function of Shop</p>

- **Wedding dress seller:** the wedding dress seller in the *han* opened an entrance on the main wall and included the space behind the wall to the store.
- **Storage:** one of the 2 storage places in the han did not do any interventions to the structure, while the other one opened an entrance on the main wall to include the space behind the wall
- **Tea-coffee house:** The tea house in the *han* did not do any interventions to the building but

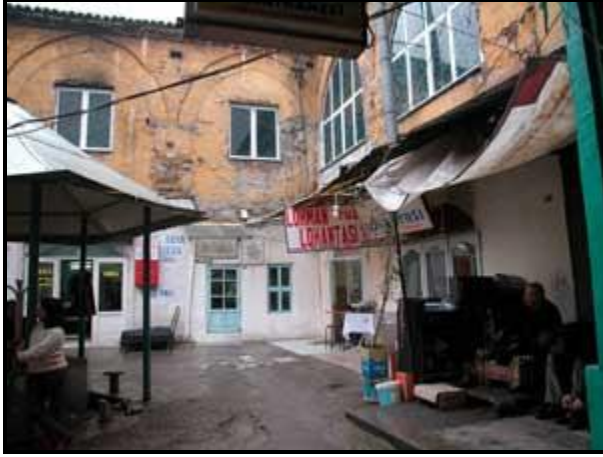
Figure 5.17. Tuz Han before restoration (www.Osmangazi-bld.gov.tr).

floor and some additions⁹³ were constructed for rooms (Ayverdi 1989-II, 356). It was stated that Tonak Han was used mostly by meatball restaurants (Tonak 2003, 64). Tuz Han was used as a warehouse before its restoration by Ormangazi Municipality⁹⁴ (Figure 5.17).

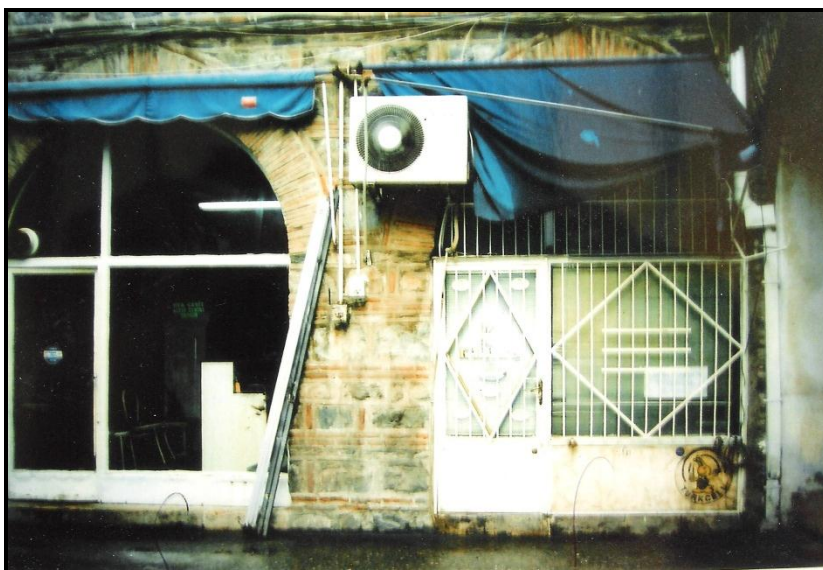
Figure 5.24. Jewellery shop removing the main wall in the ground floor of Emir Han (*Bursa Council for the Conservation of Cultural and Natural Assets Archive*)

It was seen that the uses in this group were mainly uses requiring storages such as home textile and shoe stores and broad window shops such as the jewellery shops. The most common form of intervention by these types of uses is closing the *riwaqs* located on the ground floor. Other forms of intervention are removing the main walls of the *han* to connect spaces with each other, and building mezzanines and basement floors for the shops (Figure 5.24- Figure 5.25).

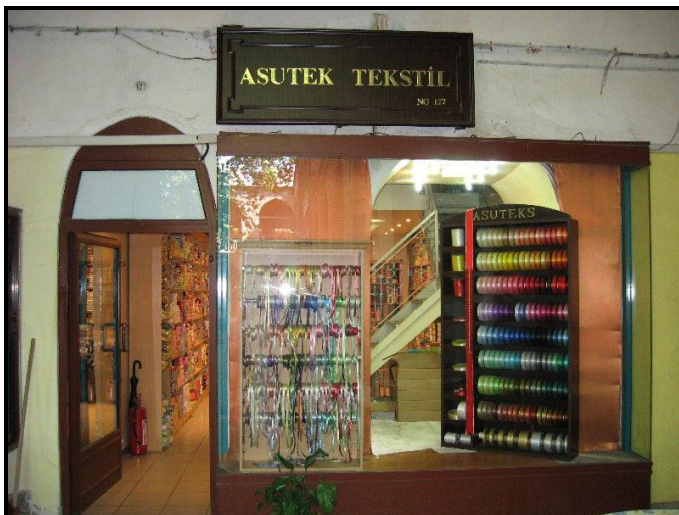
Figure 5.25. Shops having a mezzanine in Koza Han (<http://www.kozahan.org/altkat/asuteks/index.html>, last accessed, 21.03.2011)

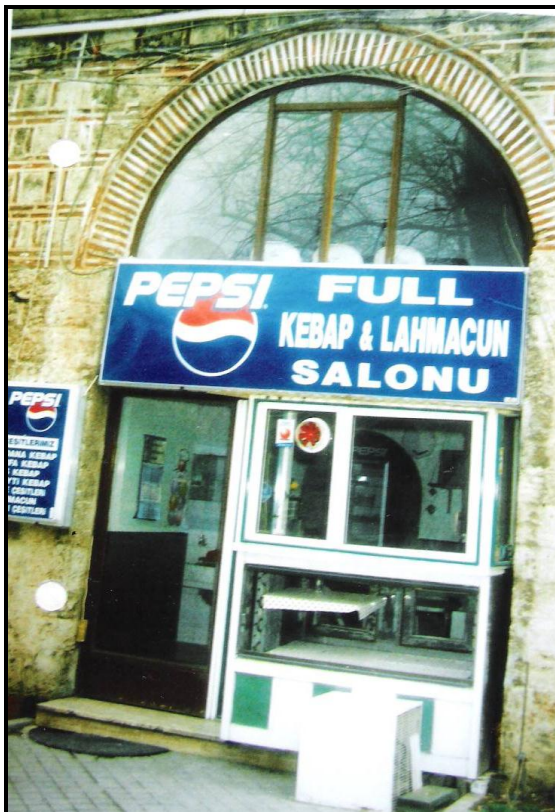
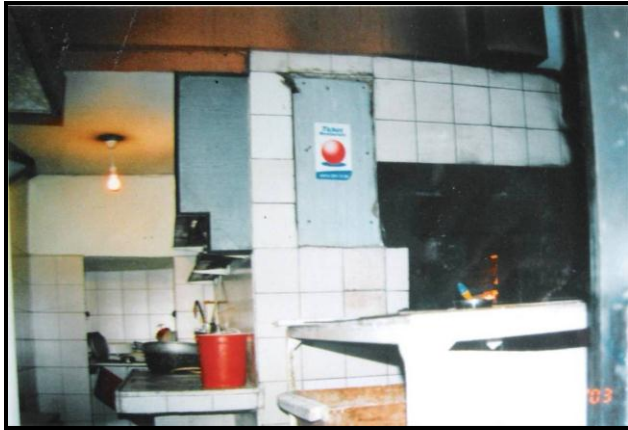
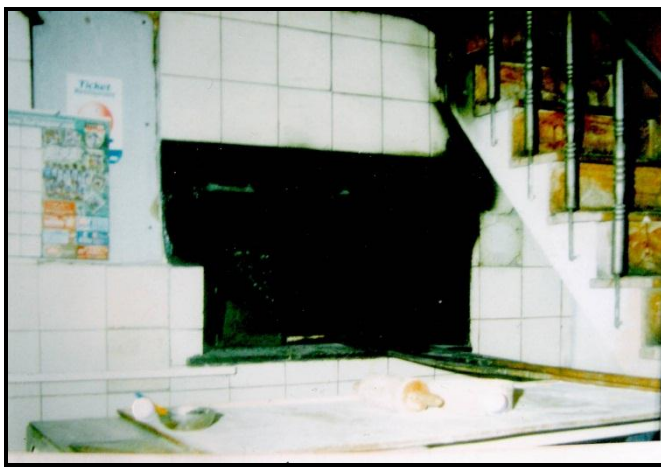
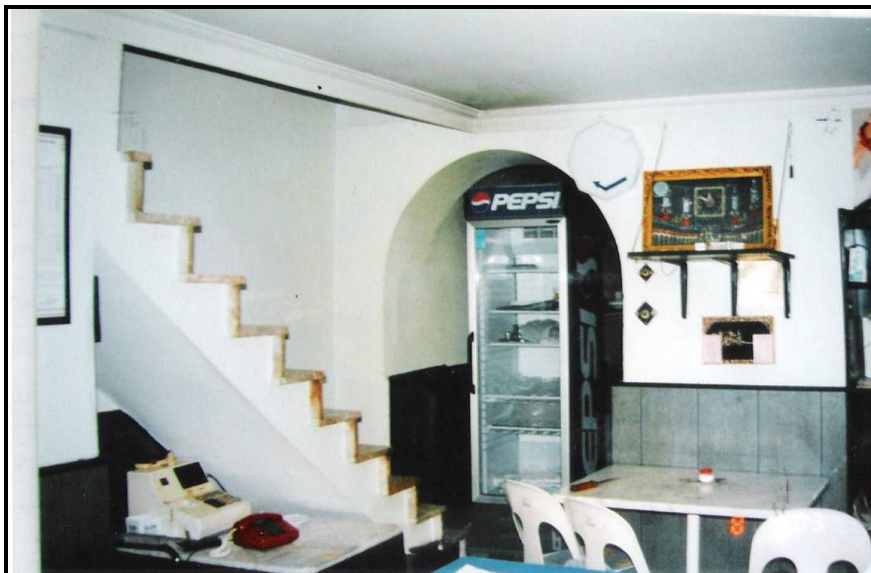
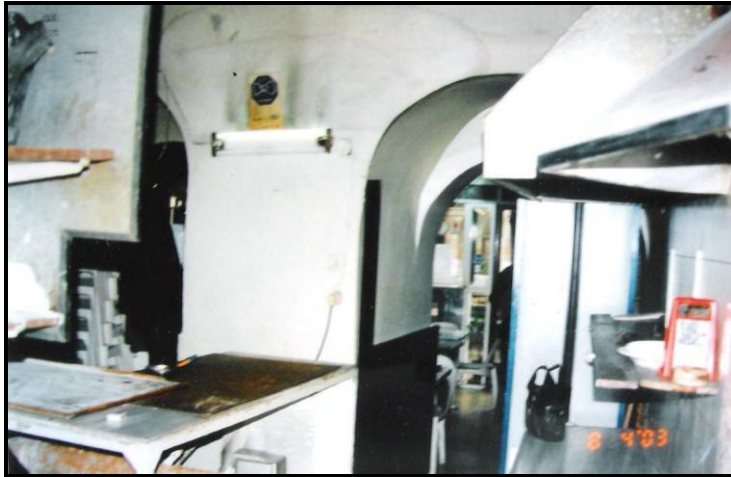
Figure 5.26. Restaurant in the ground floor of Koza Han (*Bursa Council for the Conservation of Cultural and Natural Assets Archive*)

It was identified that the uses in this group were eating and drinking places with their own kitchen, and jewellery manufacturing shops. Besides, there are furniture shops that decrease the perceptibility of the buildings although they do not adverse effect to the building. In the *hans* that were not originally places to eat and drink (Uysal 2004, 68) today there are used such as tea and coffee houses and restaurants. Today, a limited number of this type of use can be in the *hans* in a planned manner, however, the increase in the number of these uses and the consequent tables, chairs and shades block the open space, namely the courtyard of the building and reduce its perceptibility. In particular, the addition of ovens and counters in uses such as restaurants causes damage to the original characteristics of the building (Figure 5.26).

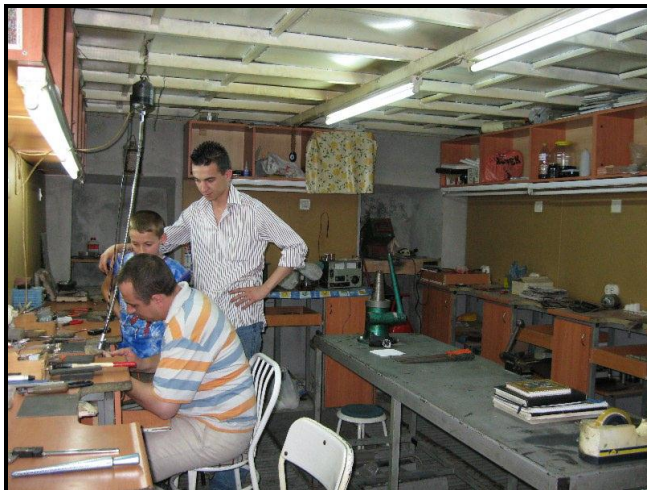
Figure 5.27. Jewellery maker in Ground Floor of Koza Han
(<http://www.kozahan.org/altkat/metistaki/index.html>, last accessed, 21.03.2012)

Moreover, although the need of space of jewellery manufacturing shops is compatible for the buildings, they are a threat due their use of industrial bottled gases. In this reason jewellery manufacturing shops are incompatible for the historical buildings (Figure 5.27).

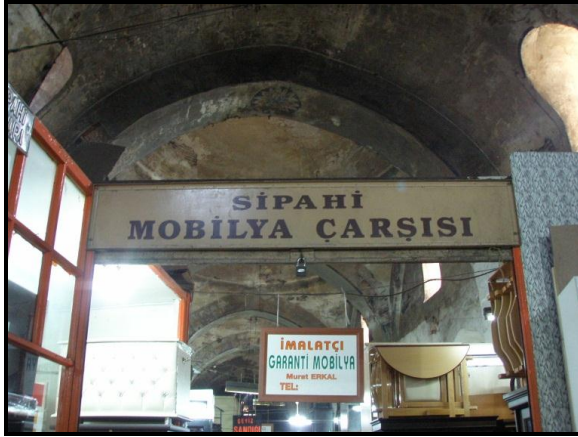
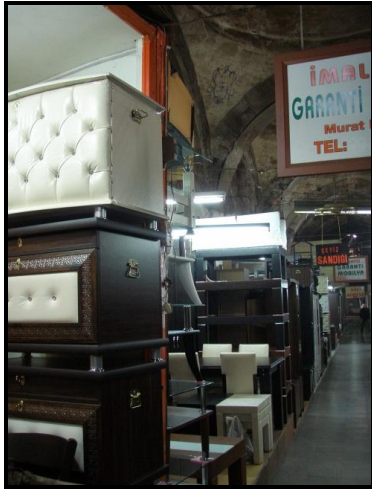
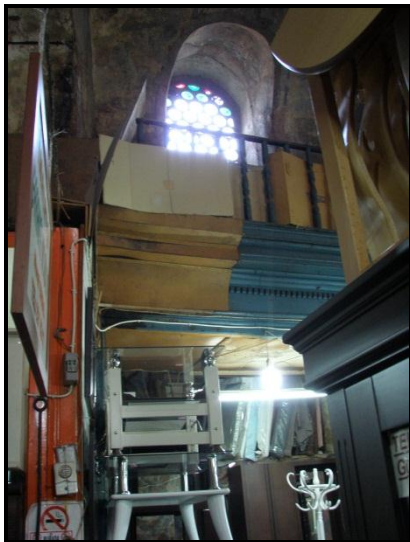
Figure 5.28. Furniture shop in the Sipahi Bazaar (*Personal Archieve*)

The analyses conducted show that another type of use whose need of space is incompatible for the historic buildings is furniture shops. The İvazpaşa Bazaar that has been related to woodworking and a place for furniture trade since the time it was first established is not perceptible today (Figure 5.28).

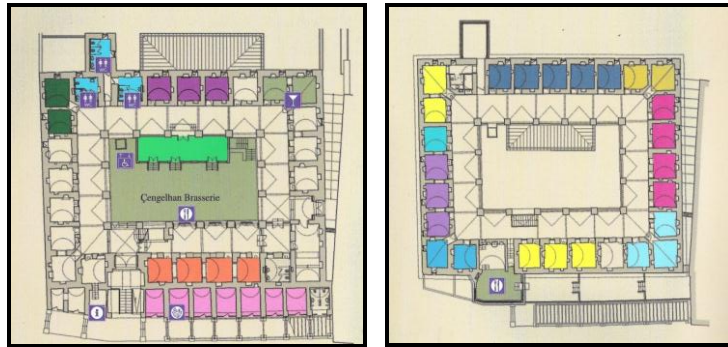
Figure 5.29. Çengel Han floor plans (Ankara Council for the Conservation of Cultural and Natural Assets archive)

Hans are currently used as museums, cultural centres and hotels in addition to commercial uses. A typical Ottoman urban *han* established in the 16th century for accommodation and trade, Çengel Han in Ankara Historical City Centre is now used as a museum. The historic monument document dating 1972 shows that the *han* was used as office space, and coffee, leather, mohair and cotton storage (Ankara Council for the Conservation of Cultural and Natural Assets archive). According to the examination conducted in the *han* in 1992, most of the spaces on the ground floor were used as storage for sheep skin and tannery (Ankara Council for the Conservation of Cultural and Natural Assets archive). The proposal of the General Directorate for Foundations for using the *han* as a museum and a tourist bazaar was found to be appropriate and approved by the Cultural and Natural Heritage Preservation Board in accordance with Decision No 7965 dated 07.6.2002. Then, the use of the *han* as a museum became definite and a project for adapting the *han* for this use was prepared⁹⁶. As the original function of the *han* was accommodation and the *han* was structured accordingly, there are no large spaces compatible for exhibition and small portable works were intended to be exhibited. Composed of small, adjacent spaces, the building was organized in sections for exhibition for better circulation. As a result, the closed spaces are used as permanent exhibition space, office, warehouse, toilets and salesroom and the *riwaqs* as permanent exhibition space and circulation space (Figure 5.29). On the other hand, the Mahmut Paşa Bedesten, established in the 15th century and located in the historic city center of Ankara, was used as a distribution center for mohair fabrics. Between 1938 and 1968, the Bedesten was restored to be used as the Museum of Anatolian Civilizations. However, only five shops were kept in their original state and the main walls between the rest of the shops were removed in order to obtain a large exhibition corridor in the building surrounded by an *arasta* composed of 102 opposite small shops (Ankara Council for the Conservation of Cultural and Natural Assets archive).

Ground floor

Upper floor

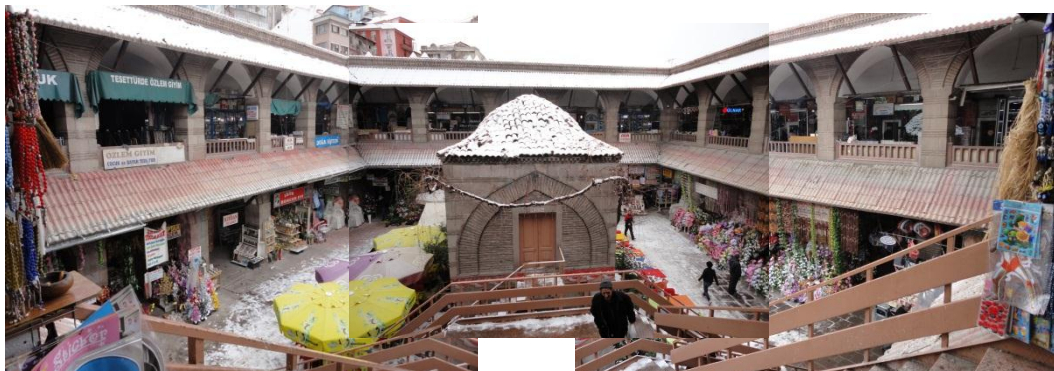
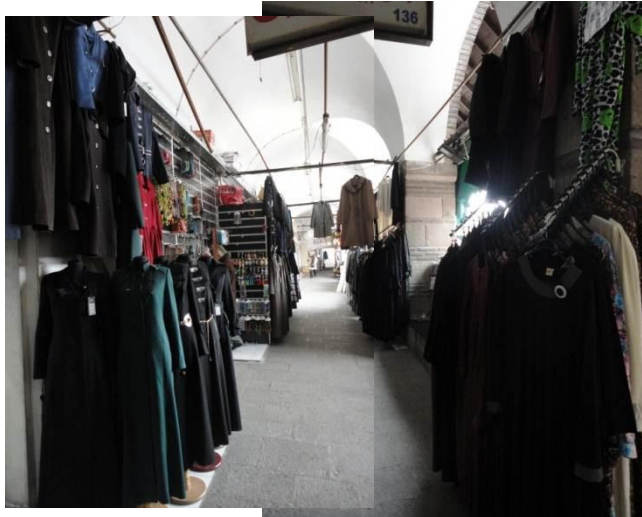
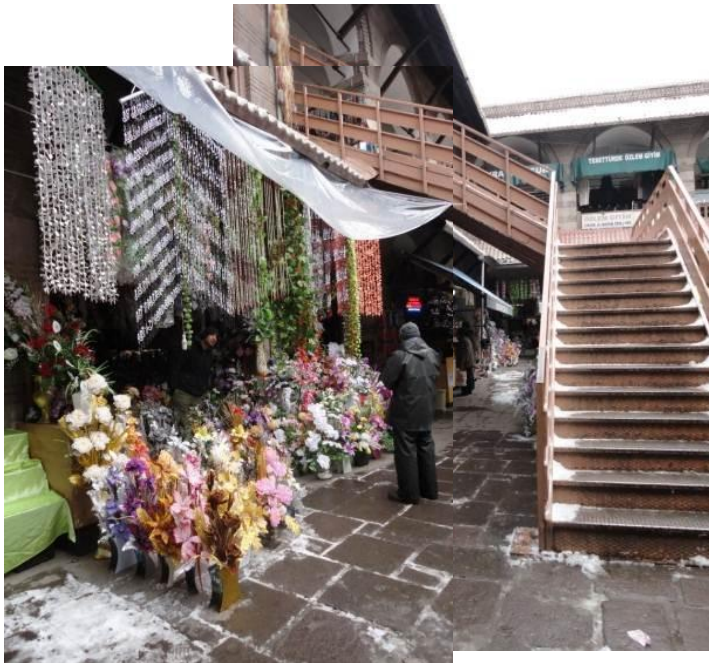
Figure 5.30. Suluhan in 2011 (*Personal Archieve*)

Established in accordance with the classical scheme of Ottoman *han* in the 17th century, Suluhan (Mahmut Paşa Han) used to be the centre for coffee and silk trade in the 18th century. During that period, herbalists were located in and around the *han* (Tuncer 2001). The decaying Suluhan was used as a small market for vegetables and fruits until the 1950s. In the 1980s, as a result of the restoration works carried out by the General Directorate for Foundations, the *han* gained its original appearance⁹⁷. Today, the *han* mainly hosts uses such as shops selling jewellery and material for jewellery, florists, coppersmiths, electrical equipment shop, and ready-made clothing shops. However, as the closed space of the shops in the *han* is not sufficient, the goods are displayed in front of the shops, and thus, it prevents the authentic characteristics of the *han* to be perceived (Figure 5.30).

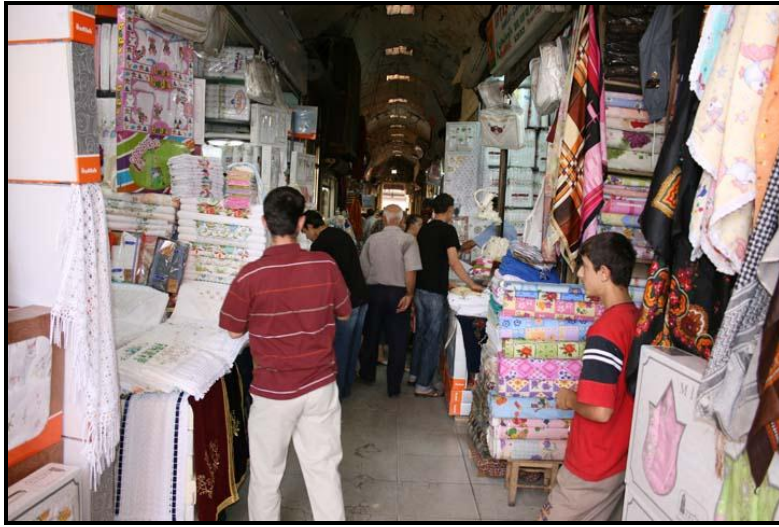
Figure 6.1. Kemikli bedesten in Gaziantep

Home textile use requiring small spaces but high product load impacts the common space use of the building and causes imperceptibility of the cultural assets (Figure 6.1). Streets occupied by jewellery stores and variety shops in Gaziantep Kemikli covered bazaar, Kahramanmaraş Kavaflar and Bezirgan bazaars (Akar 2009, 47).

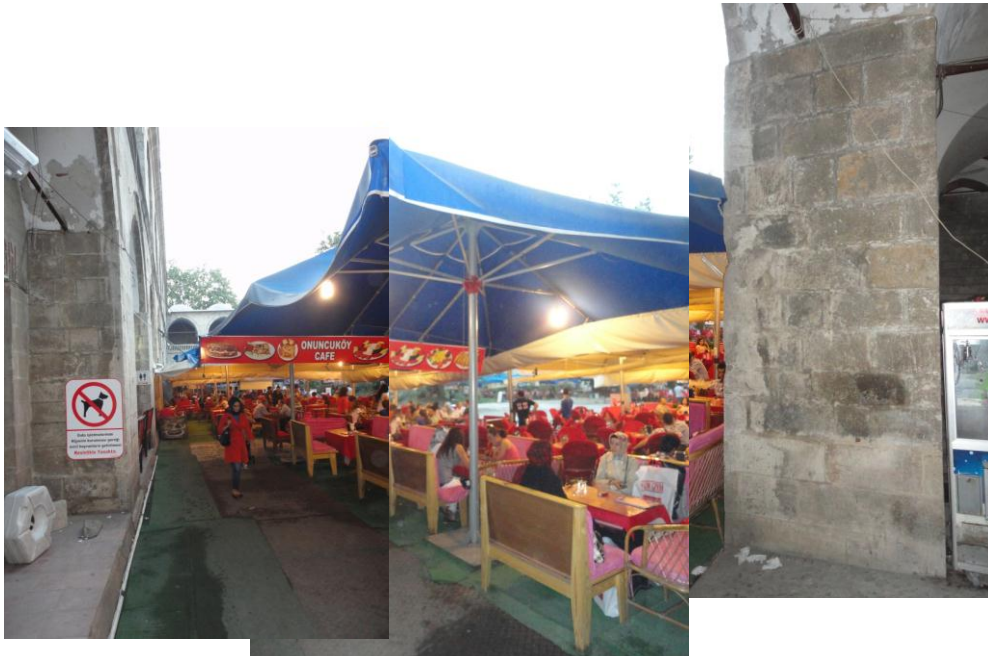
Accordingly, it is determined that tables, chairs and shades in the courtyard of the *hans*, where tea/coffee houses are in significant numbers, decrease the perceptibility of the *hans*. Moreover, elements such as window arrangements, signboards and panels lead to imperceptibility of the buildings (Figure 6.2).

Figure 6.2. Courtyard of Pirinç Han in 2012 (Personal Archive)

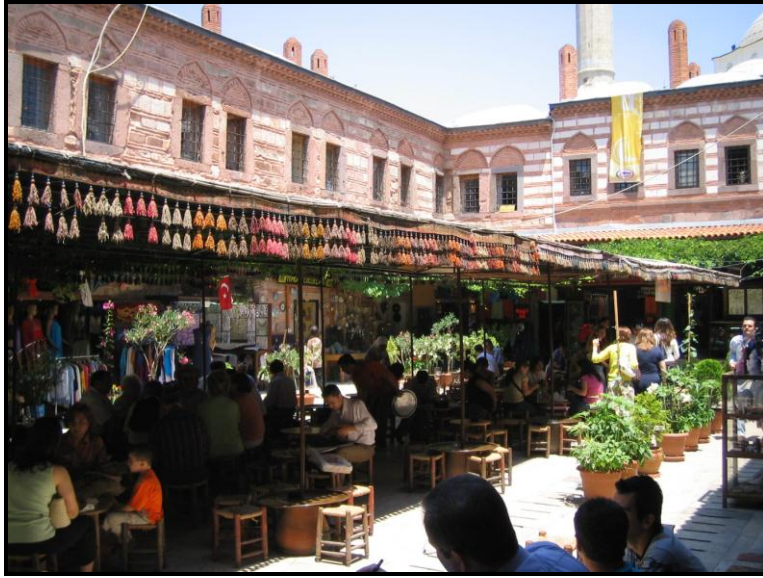
Some buildings including Kızlarağası Han (Figure 6.3) in İzmir Kemeraltı have been transformed into modern touristic bazaars or office structures with important interventions. Historical buildings have undergone interventions such as the addition of galleries in their inner space or closure of courtyards to have additional space which have damaged their authentic characteristics (Kayın 2002, 31⁹⁸).

Figure 6.3. Kızlağası Han in İzmir (<http://www.izmirkulturturizm.gov.tr/belge/1-87480/kizlaraqasi-hani.html>, last accessed 24.12.2011)
