ASSESSMENT OF NONLINEAR STATIC (PUSHOVER) ANALYSIS  
PROCEDURES USING FIELD EXPERIENCE

A THESIS SUBMITTED TO  
THE GRADUATE SCHOOL OF NATURAL AND APPLIED SCIENCES  
OF  
MIDDLE EAST TECHNICAL UNIVERSITY

NOVEMBER 2013

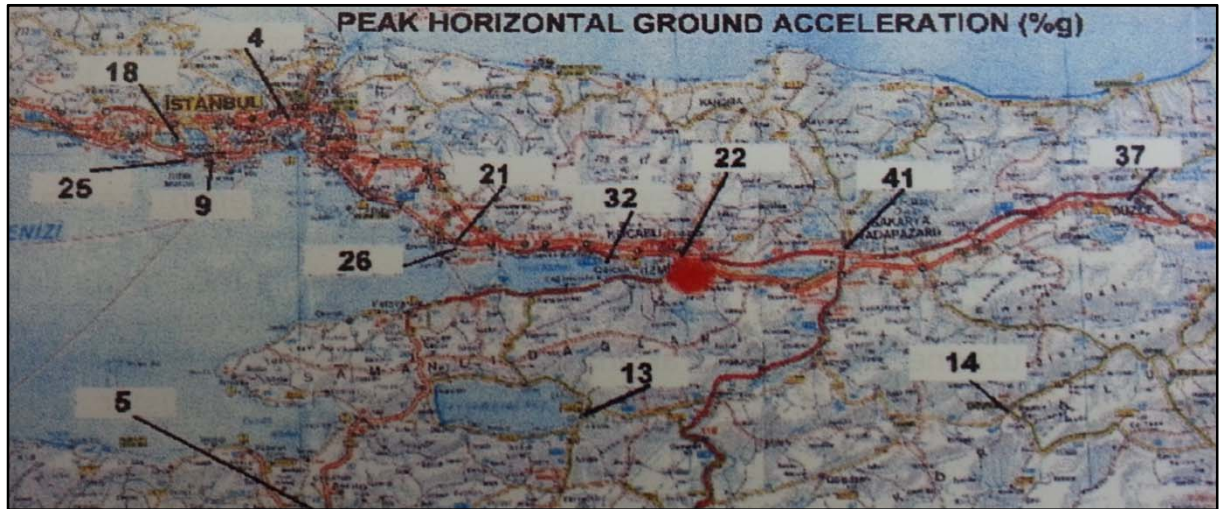
**Figure 3.1** Map of northwestern Turkey, affected by 1999 Marmara Earthquake  
(adopted from GDDA, 2000)

The northwestern region of Turkey was strongly shaken by the Marmara Earthquake on August 17<sup>th</sup>, 1999. The 7.4 magnitude earthquake occurred on the western part of the 1200 km long North Anatolian Fault (NAF) that lies through the whole north Anatolia. A segment of approximately 140 km of the NAF ruptured between İzmit Bay (Gölcük) and Melen (Eften) Lake (Düzce) (Bakır et al. 2002, Sezen et al. 2003). The map of the affected region is given in Figure 3.1 where the peak ground acceleration values measured are shown as percentage of acceleration of gravity.

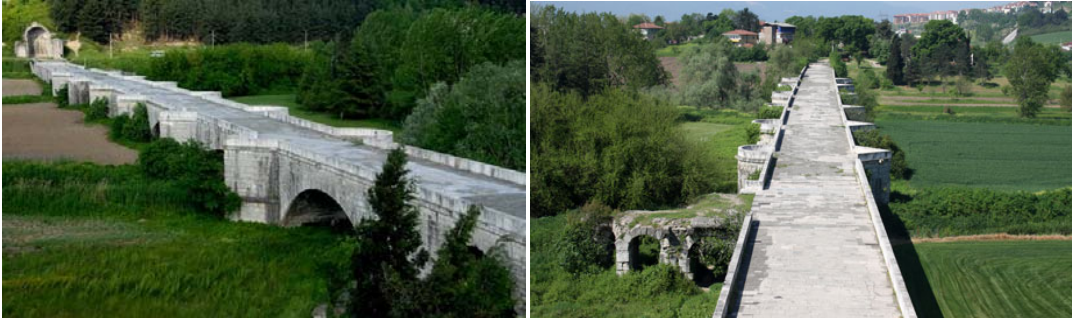
**Figure 3.5** Justinianus Bridge (Beşköprü)

The site condition of Adapazarı has been created by the Sakarya and Çark rivers and their tributaries depositing the alluvium materials. The current situation of "Justinianus Bridge (Beşköprü)" is an interesting sign of the geotechnical evolution of the basin, when the current river stream is considered. The 430 meter long Justinianus Bridge was built spanning Çark Stream, which flows from Sapanca

Lake to Sakarya River, at about 553-561 AD. Since then, the stream bed has been displaced by natural tectonic effects; however, the Bridge itself is deeply embedded in the ground today, and the geometry of the piers indicates that when the bridge was built, the stream flowed in the opposite direction. The Justinianus Bridge (Beşköprü) is shown in Figure 3.5.

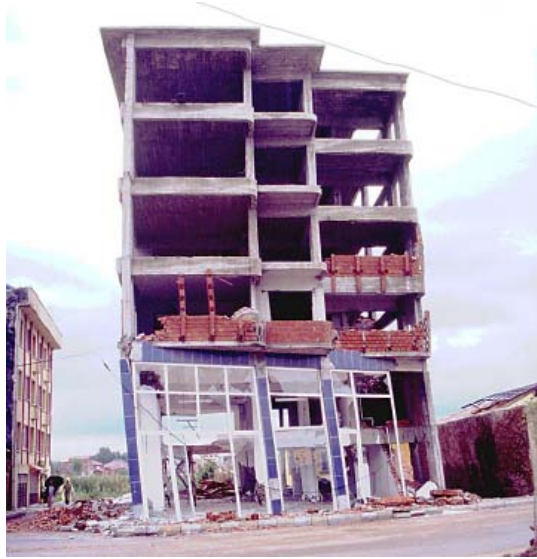
**Figure 3.8** Failure due to the soft story irregularity (photo courtesy of METU-DMC)

The building inventory of downtown Adapazarı consisted of mid-rise buildings with three or more stories. The majority of these buildings were four to six story RC buildings. The ground stories of the buildings were commonly used for commercial businesses. For this purpose these commercial stories were built higher than the upper stories. Moreover, the infill (partition) walls that increase the lateral strength and stiffness were usually less than the upper stories. These common building traditions lead to the occurrence of weak and soft stories. The building shown in Figure 3.8 which was under construction during the earthquake, experienced severe damage due to high lateral drift demands that caused the soft story mechanism.

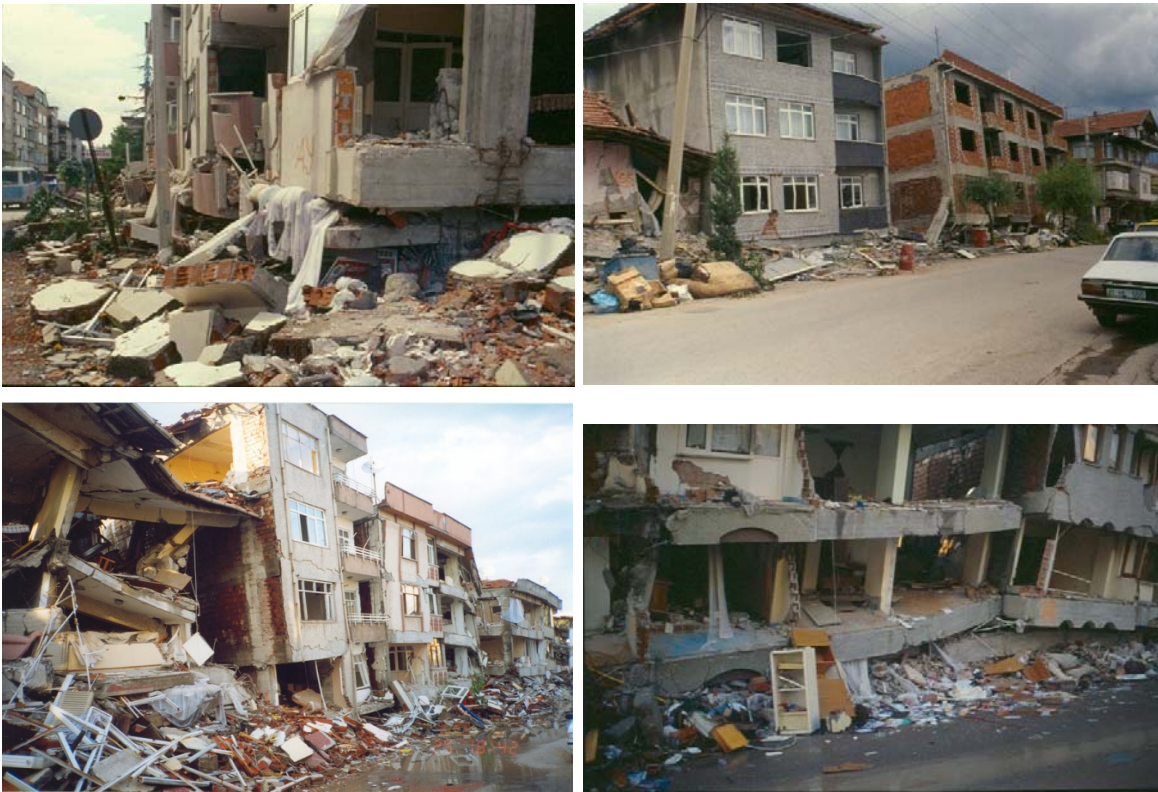
**Figure 3.9** Ground floor destruction due to high ductility demands (photos courtesy of METU-DMC)

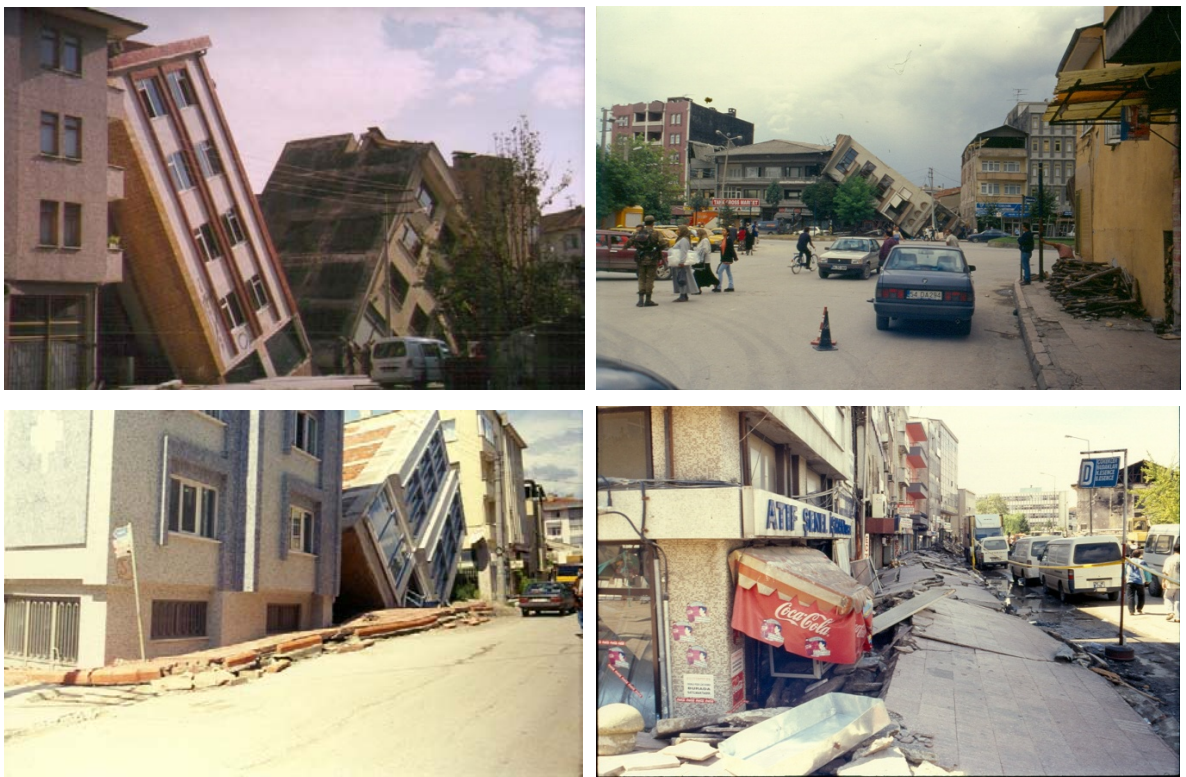
**Figure 3.10** Tilting and/or settlement of the buildings (photos courtesy of METU-DMC)

During the Marmara Earthquake, approximately 22 percent of the buildings located in central districts were severely damaged or completely collapsed. Additionally, about 14–15 percent of these buildings experienced moderate damage within the limits of economic repair. Most of the buildings that experienced moderate structural damage had simultaneously foundation displacements (settlement and/or tilting). The significantly damaged or collapsed buildings, however, rarely experienced such foundation bearing failures (Bakır et al. 2002). The buildings shown in Figure 3.10 were tilted and/or settled during the earthquake in consequence of the loss of soil bearing capacity.

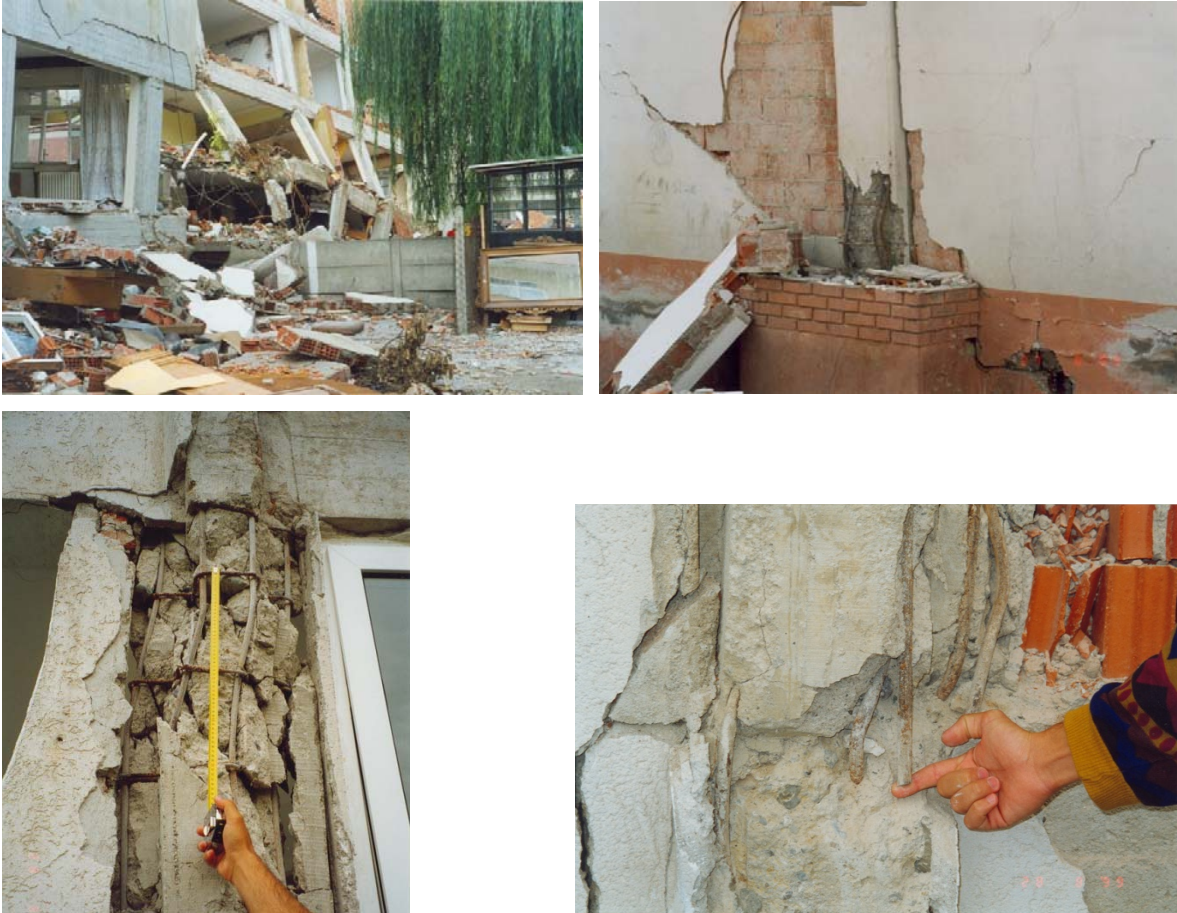
**Figure 3.11** Nonductile detailing (photos courtesy of METU-DMC)

reconnaissance report (Sezen et al. 2000). The examples are shown in Figure 3.11. As shown in Figure 3.11, the spacing of the transverse reinforcement is approximately 250 mm in the region close to column ends.

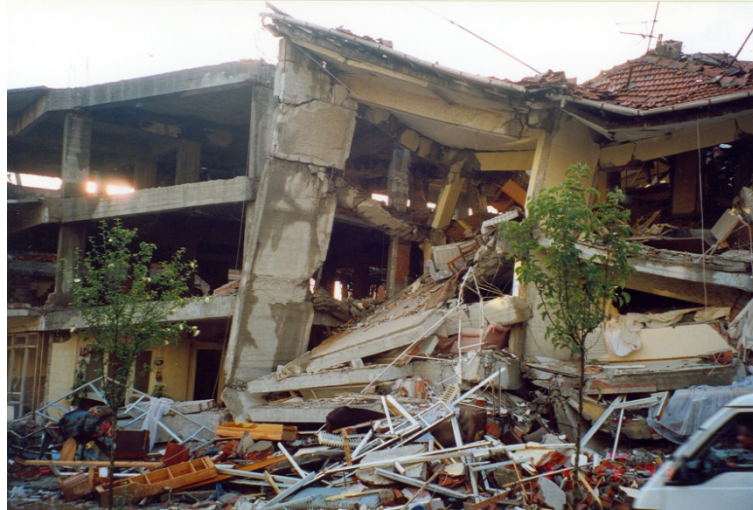
**Figure 3.12** Anchorage problems at beam-column connections (photo courtesy of METU-DMC)

Another reason for the structural damage was the poor construction quality observed (e.g. material strength, workmanship), especially for the residential buildings. According to the investigations on damaged buildings, an average value of concrete strength was found to be 15 MPa, although the specified values were 20 MPa in design documents (Yakut et al. 2005). The building shown in Figure 3.12 has strong columns; however, due to the lack of anchorage reinforcement of beams to the columns, beam mechanisms occurred.

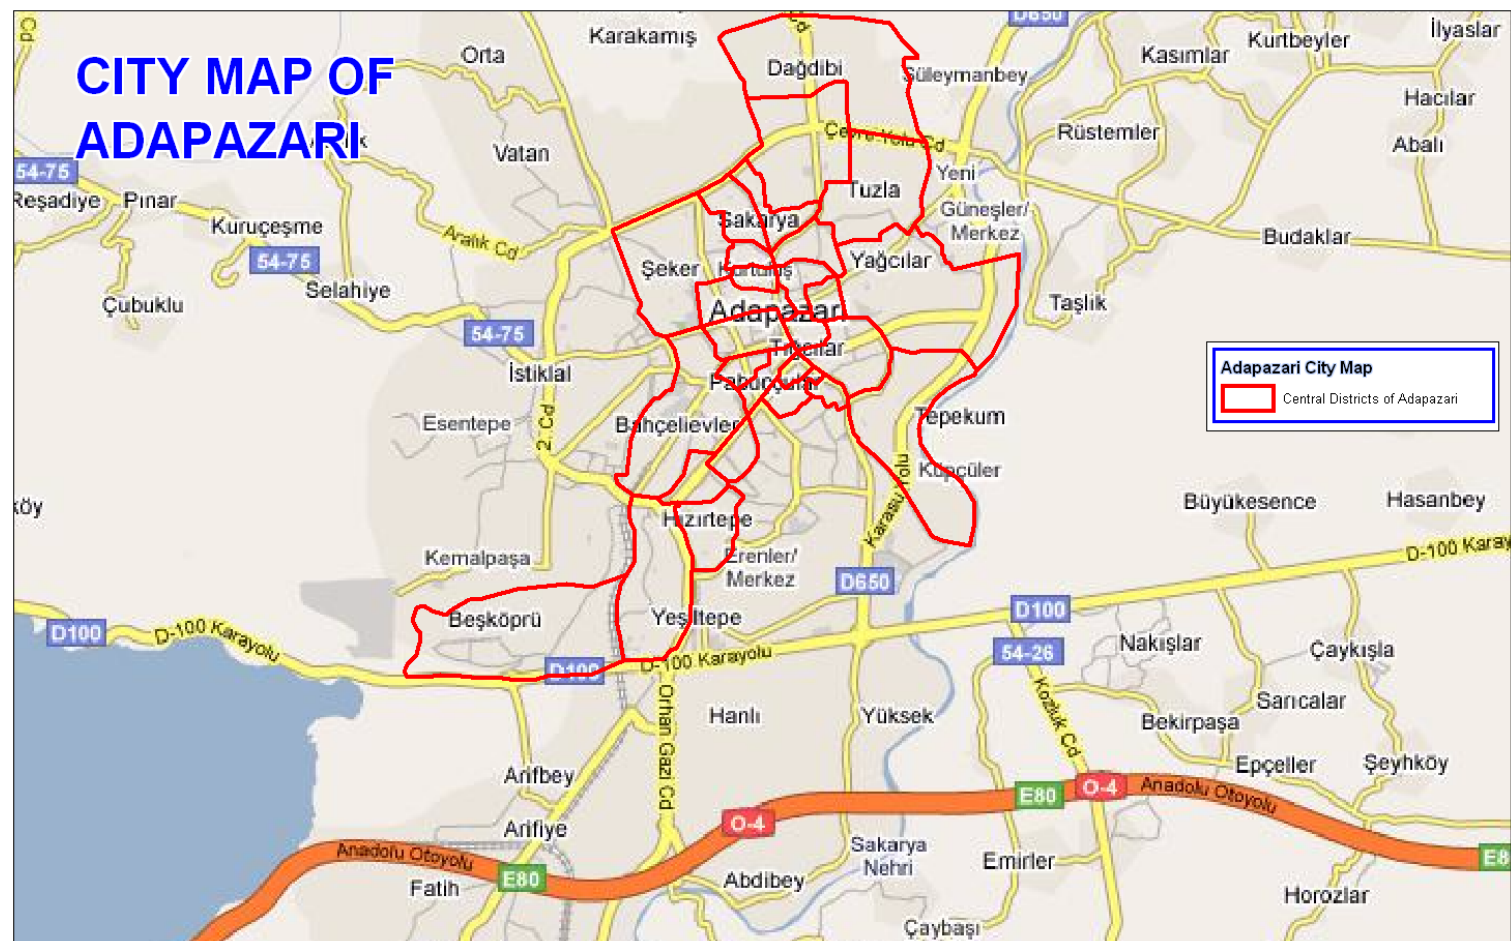
**Figure B.1** Adapazarı City Map. The borders of the 26 central districts of Adapazarı are shown in red.

Some of the maps obtained from the Adapazari survey using GIS tools which is discussed in Section 4.3 are shown in the following figures. The locations of the buildings selected for this dissertation are also shown on the maps.
