INVESTIGATION OF MATERIAL PROPERTIES FOR THE TURKISH  
MASONRY BUILDINGS

A THESIS SUBMITTED TO  
THE GRADUATE SCHOOL OF NATURAL AND APPLIED SCIENCES  
OF  
MIDDLE EAST TECHNICAL UNIVERSITY

IN PARTIAL FULFILLMENT OF THE REQUIREMENTS  
FOR  
THE DEGREE OF MASTER OF SCIENCE  
IN  
CIVIL ENGINEERING

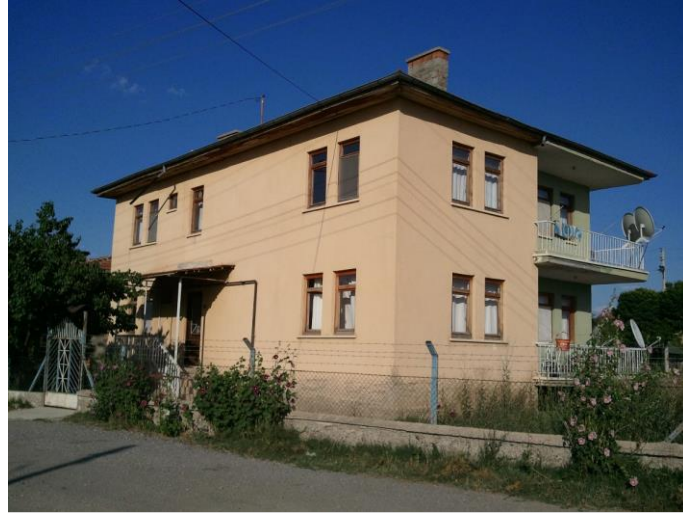
Figure 2.2 Building 1 Information

Building 1 was located in Çubuk/Ankara. It was a two story structure constructed with hollow clay bricks. The slab of the building was made of reinforced concrete and it had no RC beams or columns. The picture and floor plan of Building 1 is shown in Figure 2.2. Table 2.2 summarizes brief information about the building.

a) Appearance of the building

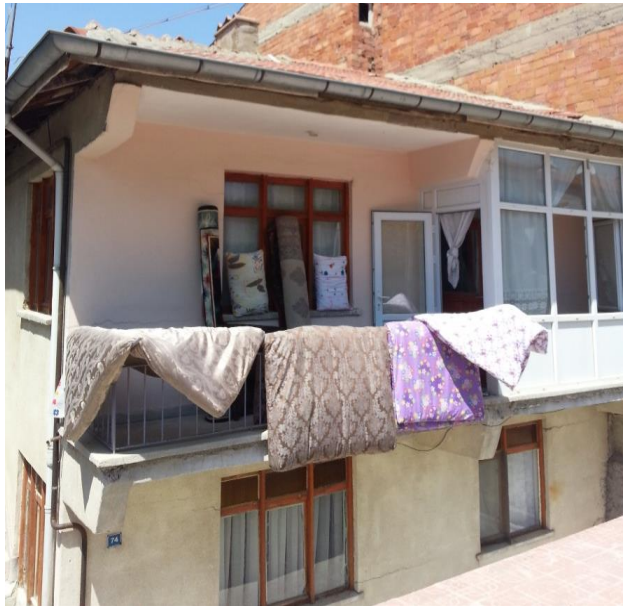
Figure 2.3 Building 2 information

Building 2 was located in Gölbaşı/Ankara. It was a two story structure constructed with hollow clay bricks. The slab of the building was made of reinforced concrete and it had no RC beams or columns. The picture and floor plan of Building 2 is shown in Figure 2.3. Table 2.3 summarizes brief information about the building.

a) Appearance of the building

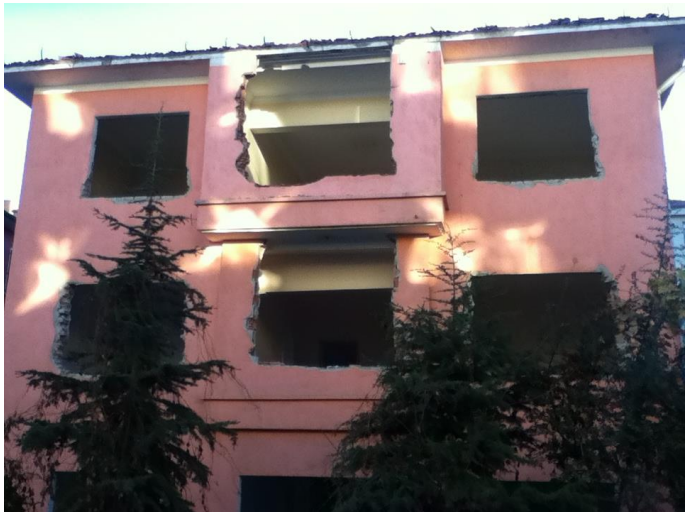
Figure 2.4 Building 3 information

Building 3 was located in Aydınlikevler/Ankara. It was a three story structure constructed with solid clay bricks. The slab of the building was made of reinforced concrete and it had no RC beams or columns. The picture and floor plan of Building 3 is shown in Figure 2.4. Table 2.4 summarizes brief information about the building.

a) Appearance of the building

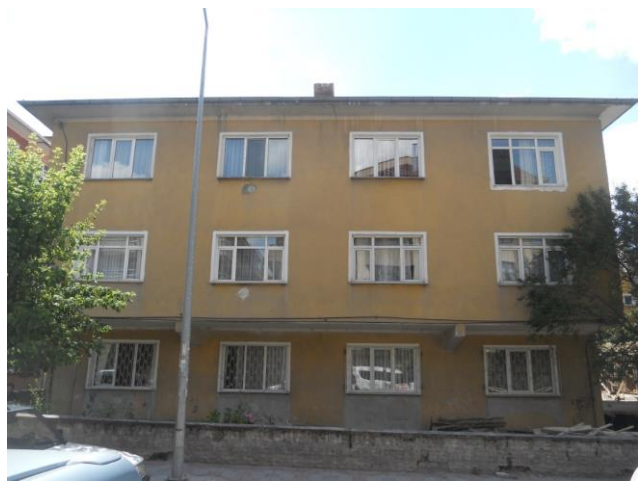
Figure 2.5 Building 4 information

Building 4 was located in Aydınlikevler/Ankara. It was a three story structure constructed with solid clay bricks. The slab of the building was made of reinforced concrete and it had no RC beams or columns. The picture and floor plan of Building 4 is shown in Figure 2.5. Table 2.5 summarizes brief information about the building.

a) Appearance of the building

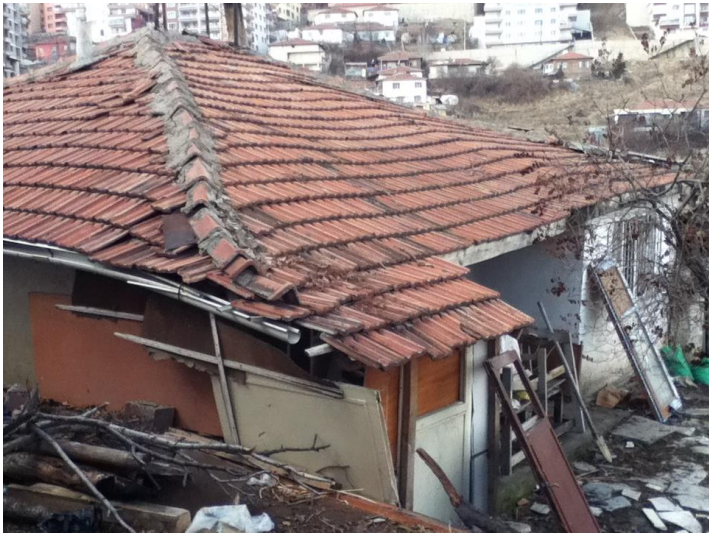
Figure 2.6 Building 5 information

Building 5 was located in Mamak/Ankara. It was a one story structure constructed with cellular concrete blocks and adobe. The slab of the building was made of reinforced concrete and it had no RC beams or columns. The picture and floor plan of Building 5 is shown in Figure 2.6. Table 2.6 summarizes brief information about the building.

a) Appearance of the building

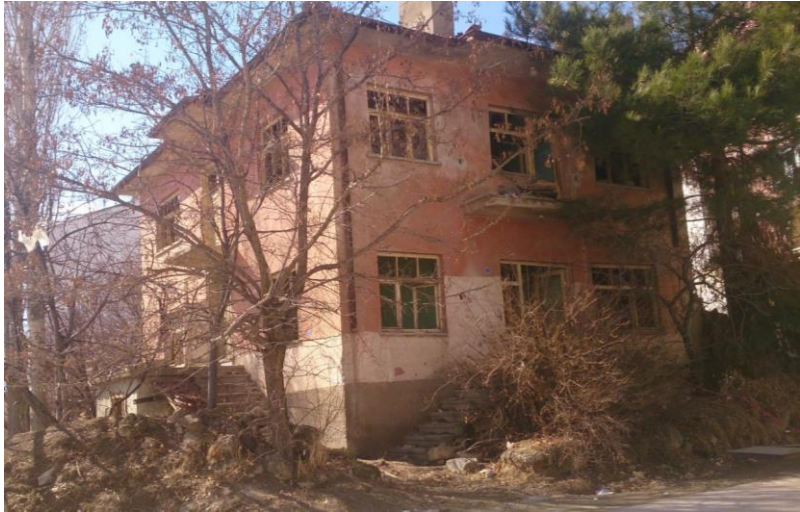
Figure 2.7 Building 6 information

Building 6 was located in Merkez/Kırşehir. It was a two story structure constructed with solid concrete brick. The slab of the building was made of reinforced concrete and it had no RC beams or columns. The picture and floor plan of Building 6 is shown in Figure 2.7. Table 2.7 summarizes brief information about the building.

a) Appearance of the building

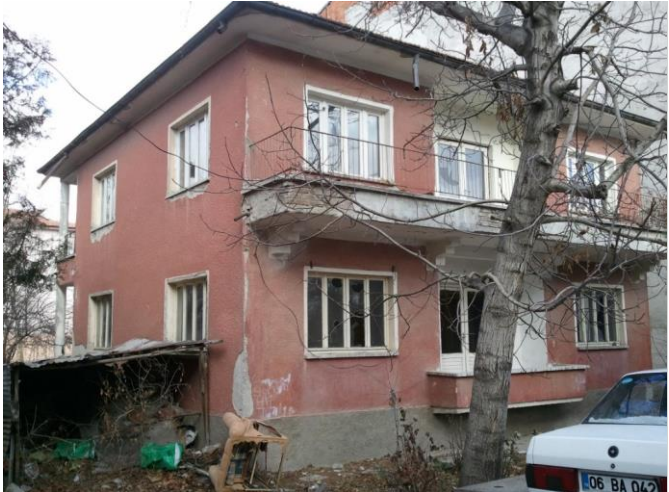
Figure 2.8 Building 7 information

Building 7 was located in Çubuk/Ankara. It was a two story structure constructed with solid concrete bricks. The slab of the building was made of reinforced concrete and it had no RC beams or columns. The picture and floor plan of Building 7 is shown in Figure 2.8. Table 2.8 summarizes brief information about the building.

a) Appearance of the building

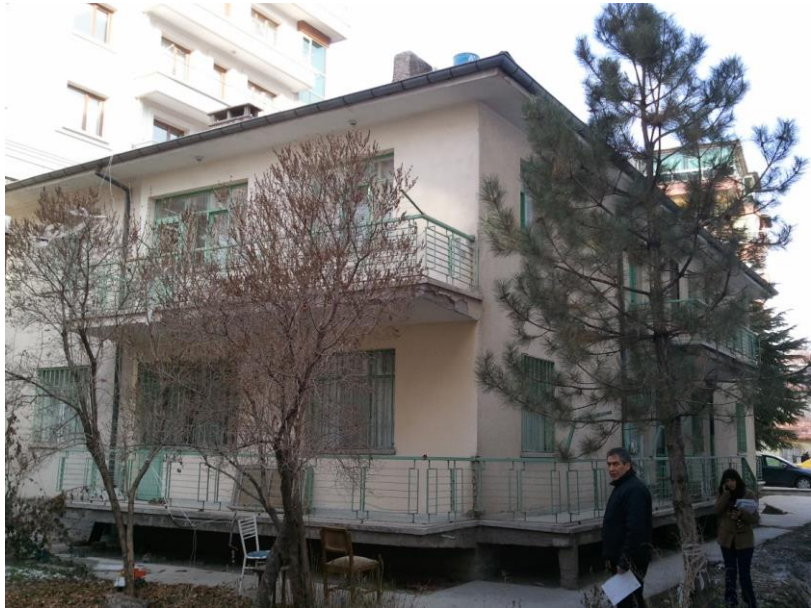
Figure 2.9 Building 8 information

Building 8 was located in Çubuk/Ankara. It was a two story structure constructed with hollow concrete bricks. The slab of the building was made of reinforced concrete and it had no RC beams or columns. The picture and floor plan of Building 8 is shown in Figure 2.9. Table 2.9 summarizes brief information about the building.

a) Appearance of the building

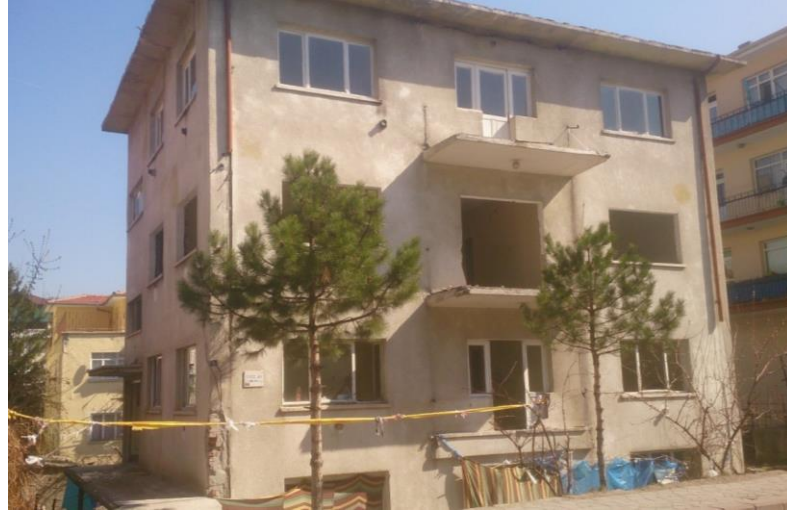
Figure 2.10 Building 9 information

Building 9 was located in Aydınlikevler/Ankara. It was a three story structure constructed with hollow concrete bricks. The slab of the building was made of reinforced concrete and it had no RC beams or columns. The picture and floor plan of Building 9 is shown in Figure 2.10. Table 2.10 summarizes brief information about the building.

a) Appearance of the building

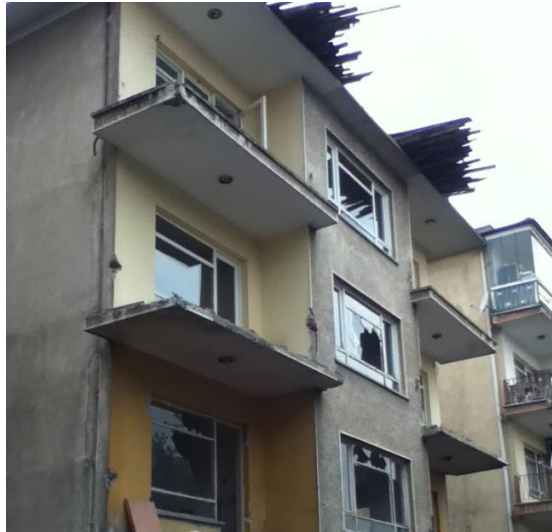
Figure 2.11 Building 10 information

Building 10 was located in Bahçelievler/Ankara. It was a three story structure constructed with hollow concrete bricks. The slab of the building was made of reinforced concrete and it had no RC beams or columns. The picture and floor plan of Building 10 is shown in Figure 2.11. Table 2.11 summarizes brief information about the building.

a) Appearance of the building

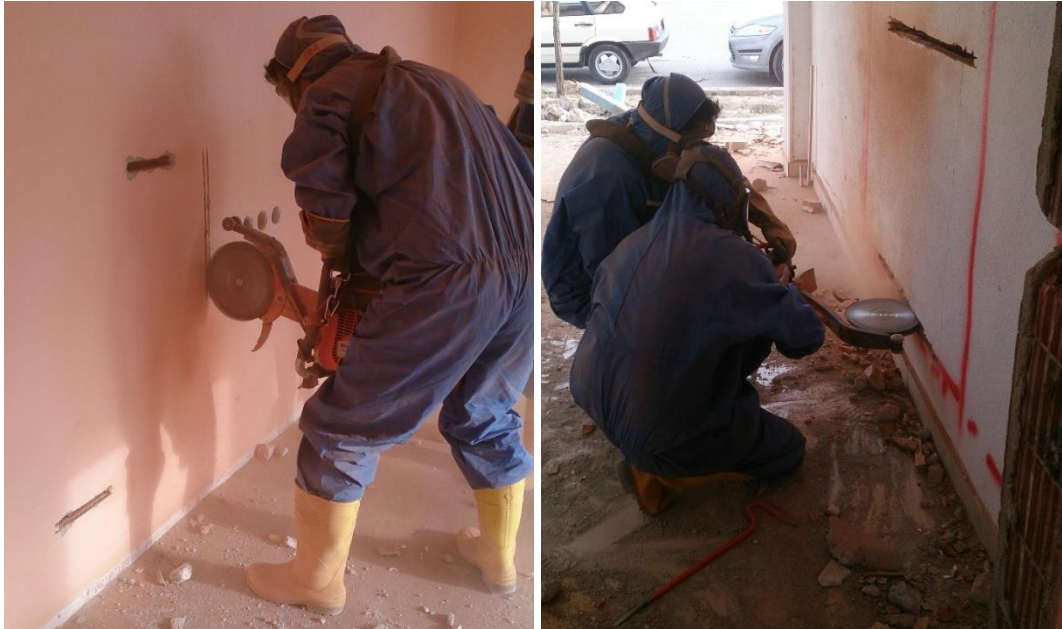
Figure 3.1 Examples from specimen removal process

The marked walls at aforementioned positions in each building were photographed and then cut using a saw with the brand Husqvarna K760. The removal process was carefully performed by spraying water. It was assured that the specimens maintained their integrity and did not get damaged. In order to minimize the damage to specimen removed from existing masonry walls, the process was followed exactly as recommended in ASTM C1532/1532M-12. Firstly, the bottom part was cut and

shimmed to take up the weight of the specimen. Then, the top of the specimen was cut and finally the sides were cut. Pictures showing the whole process of obtaining wall specimens are given in Figure 3.1.

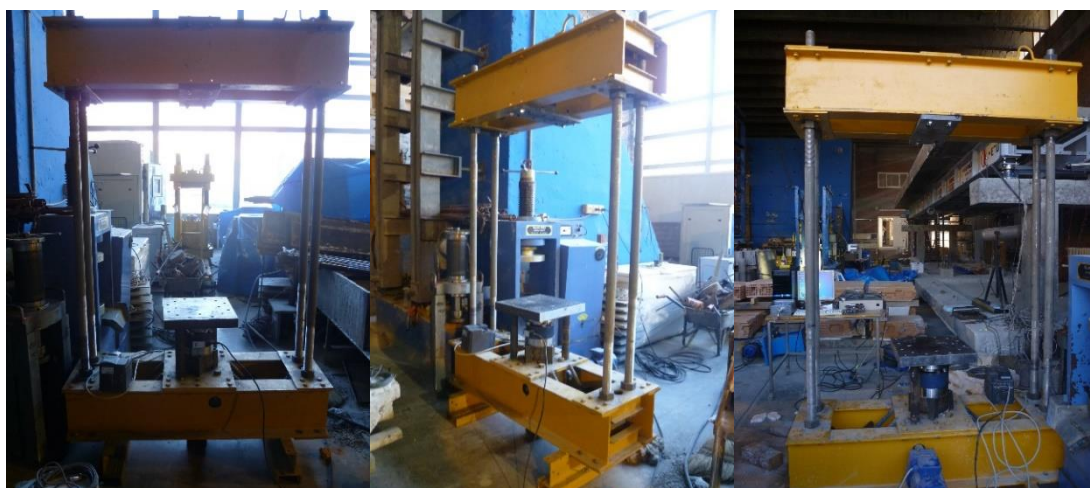
Figure 3.2 Displacement based test machine

The tests were conducted using a displacement controlled test machine (Figure 3.2) at METU, Department of Civil Engineering, Structural Mechanics Laboratory. Use of this machine allows obtaining the softening branch on the load-deformation graph after the specimen reached its capacity. This curve was successfully obtained in all the diagonal tension experiments, while for the compression tests it could not be obtained due to the observed brittle failure mode.

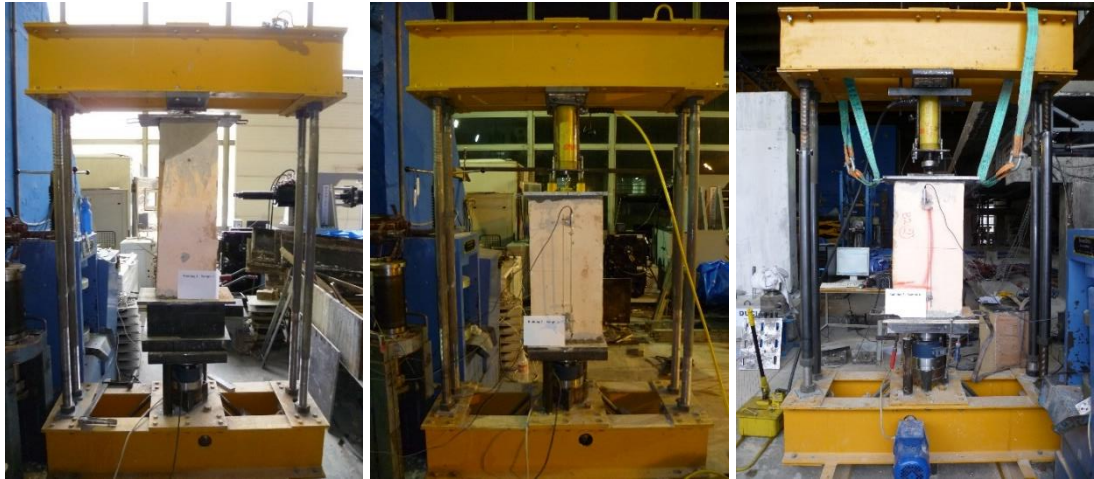
Figure 3.3 Axial compression test setup

Steel rods of 6 mm thickness were inserted into the previously drilled holes by applying epoxy. After the curing of epoxy, LVDTs were placed such that displacements were measured between the ends of the steel rods. Afterwards the instruments including the LVDTs and the load cell were connected to the computer and their calibrations were conducted. Due to the safety reasons, the necessary equipment was tied to the test machine assuring that they would fall down upon sudden failure. Specimen dimensions were measured and after being photographed, specimens were ready for testing. Pictures showing the axial compression test setup (Figure 3.3) are given below.

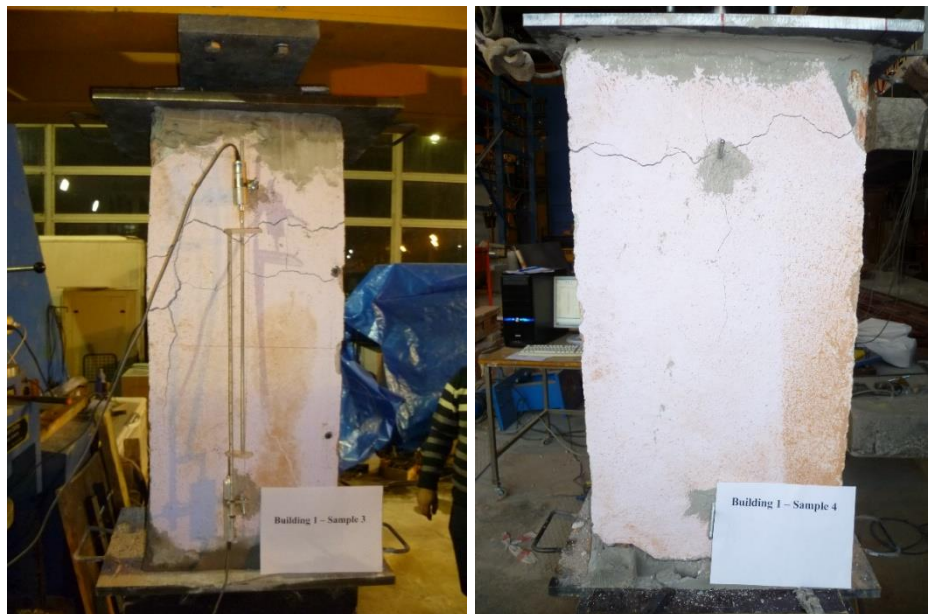
Figure 3.4 Building 1 compression test results along the axis parallel to the load bearing direction of the wall

a) Geometric properties and axial compression test result of Specimen 1

b) Geometric properties and axial compression test result of Specimen 2

c) Specimen 1 and Specimen 2 at the end of the test

The data that was obtained through the calculations were displayed as stress -strain graphs and the important values were shown on it. The experiment results obtained from axial compression tests were given below with the geometric properties of each specimen. Test results including the dimensions of the specimens, measured stress-strain response, and the pictures of the failed specimens are presented in Figures 3.4 to 3.20 for specimens extracted from buildings 1 to 10, respectively.

Three types of irregularities were observed on the stress vs. strain curves of some specimens. First type of irregularity was the decrease in the strain while the stress was increasing after linearly elastic part of the curve (for example see Figure 3.13). The main reason for this type of irregularity is the out of plane bending that occurred due to the inhomogeneous section of the masonry wall units that are composed of unequal plaster thickness on both sides. Despite the fact that the geometric centroidal axis of the specimen was perfectly aligned with the center of loading head, the inhomogeneity led to out of plane bending of the specimen. The second type of irregularity observed, was the increase in the strain under constant or decreasing stresses (for example see Figure 3.6). A mechanical glitch in the test setup caused the electromotor to halt under low rates of loading. Increasing the speed of the loading enabled to continue the experiment, however this caused the second type of irregularity on the stress vs. strain curves. Finally, third type of irregularity was the incomplete stress vs. strain curves as shown in Figure 3.10. This was caused because the LVDT's were taken out before the specimen reached its capacity to prevent them from taking any damage.

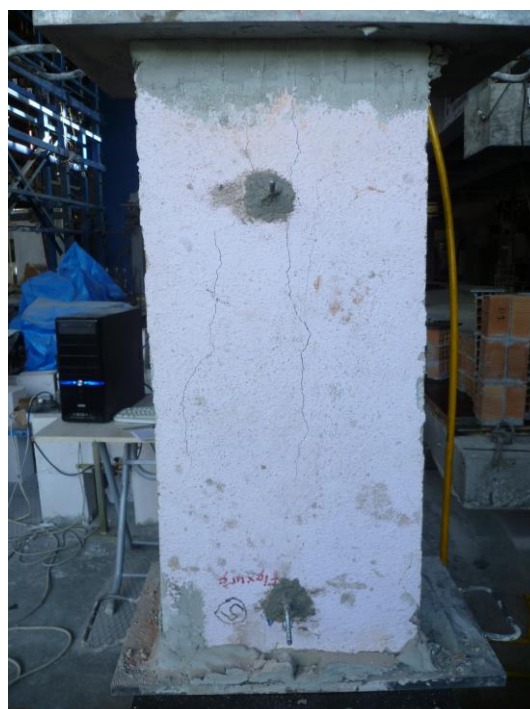
Figure 3.5 Building 1 compression test results along the axis parallel to the load bearing direction of the wall

a) Geometric properties and axial compression test result of Specimen 2\*

b) Specimen 2\* at the end of the test

\* The test for the second specimen of Building 1 compression test along the axis parallel to the load bearing direction of the wall was repeated with another specimen since the failure was caused by a pipe installed in the second specimen.

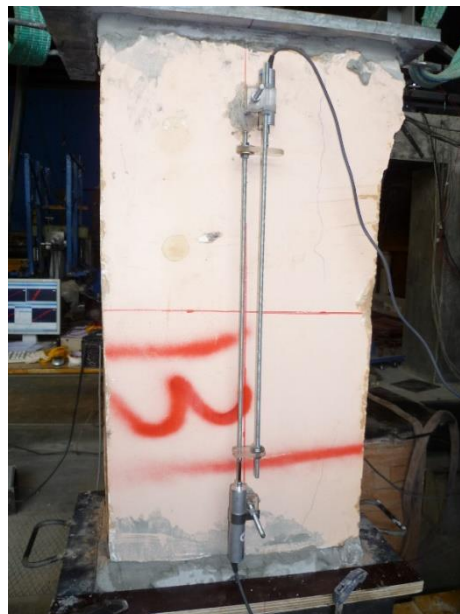
Figure 3.8 Building 2 compression test results along the axis perpendicular to the load bearing direction of the wall

c) Specimen 3 at the end of the test

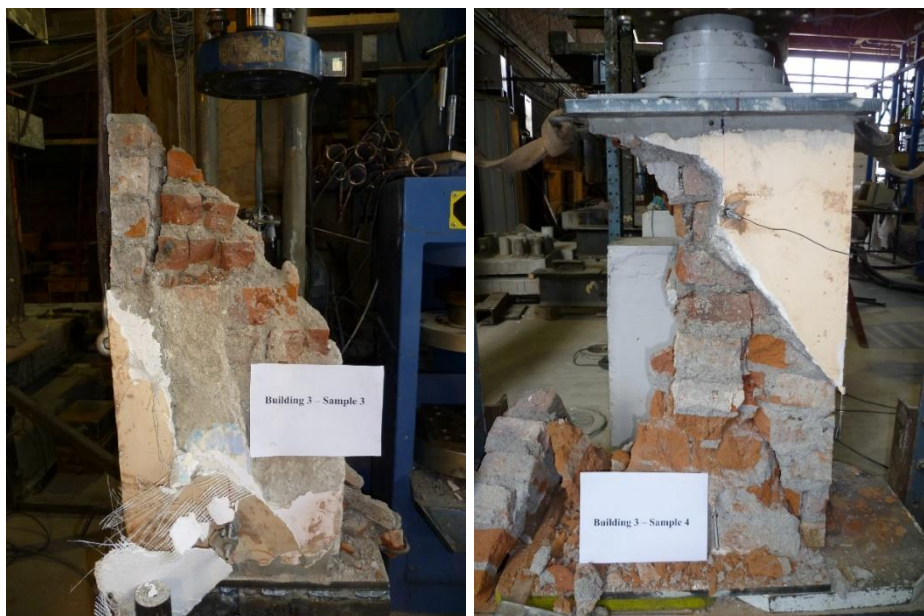
Figure 3.9 Building 3 compression test results along the axis parallel to the load bearing direction of the wall

c) Specimen 1 and Specimen 2 at the end of the test

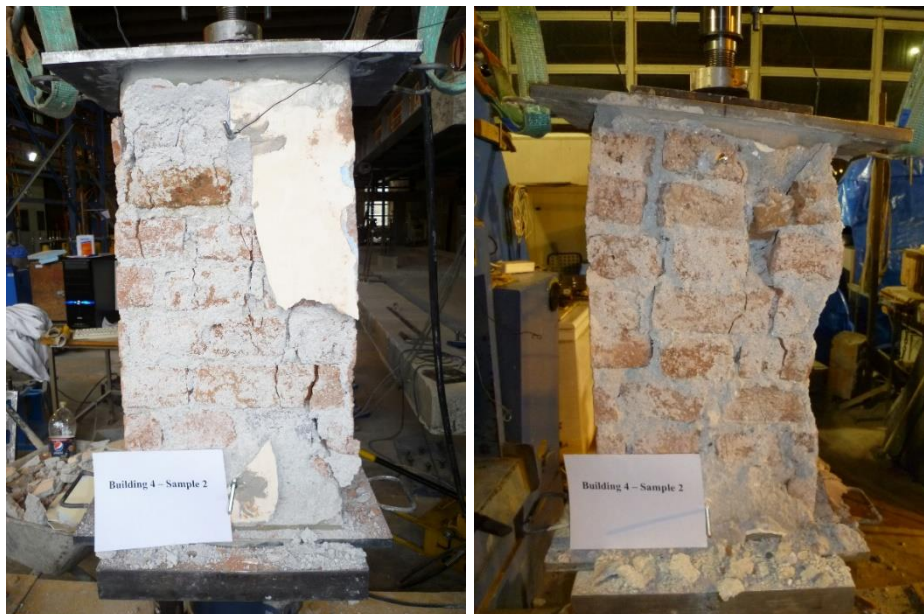
Figure 3.11 Building 4 compression test results along the axis parallel to the load bearing direction of the wall

c) Specimen 1 and Specimen 2 at the end of the test

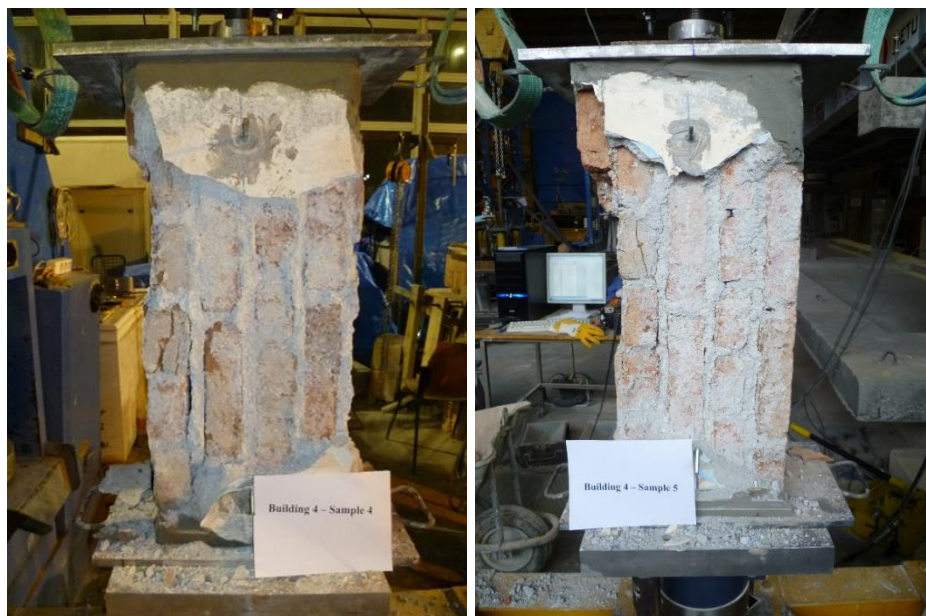
Figure 3.12 Building 4 compression test results along the axis perpendicular to the load bearing direction of the wall

c) Specimen 3 and Specimen 4 at the end of the test

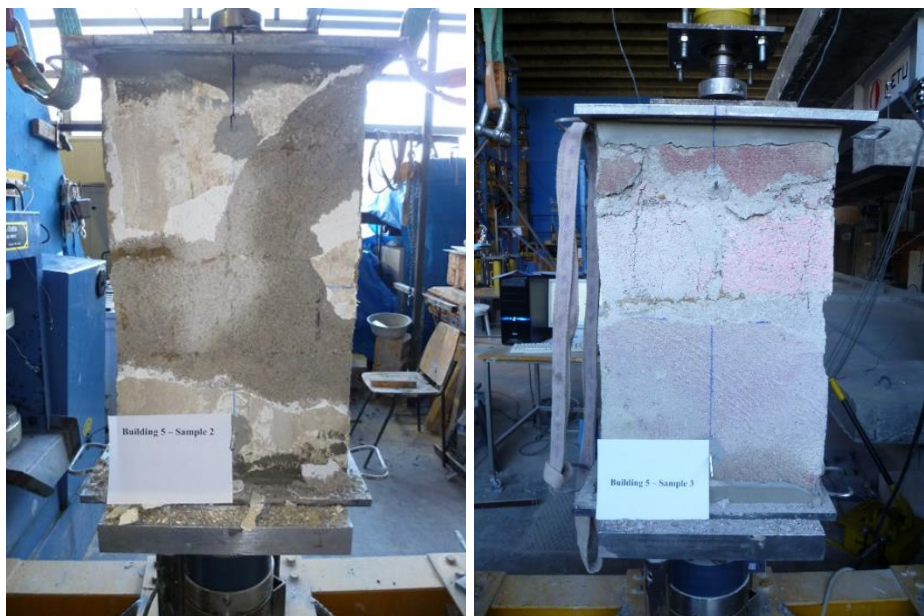
Figure 3.13 Building 5 compression test results along the axis parallel to the load bearing direction of the wall (Cellular concrete block)

c) Specimen 1 and Specimen 2 at the end of the test

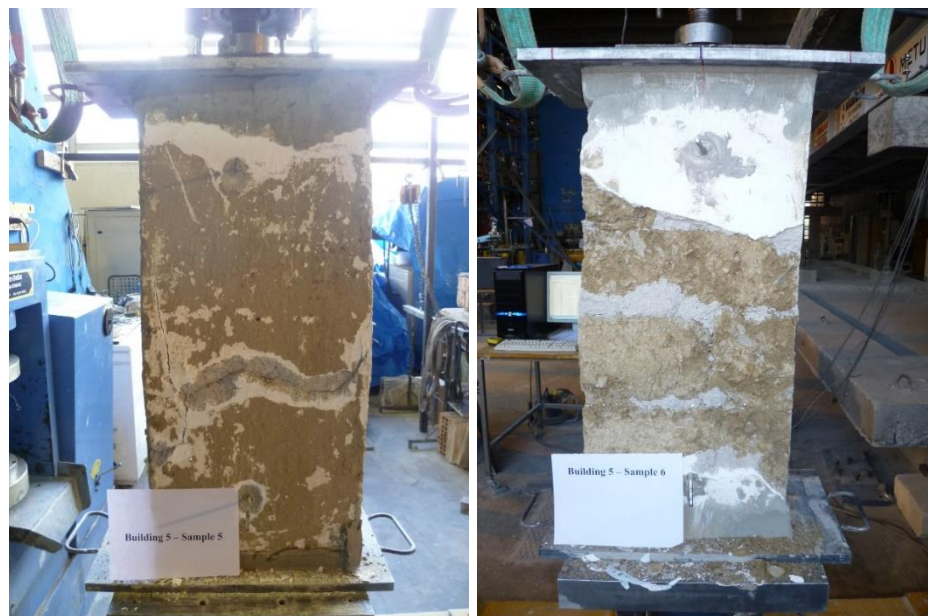
Figure 3.14 Building 5 compression test results along the axis parallel to the load bearing direction of the wall (Adobe)

c) Specimen 3 and Specimen 4 at the end of the test

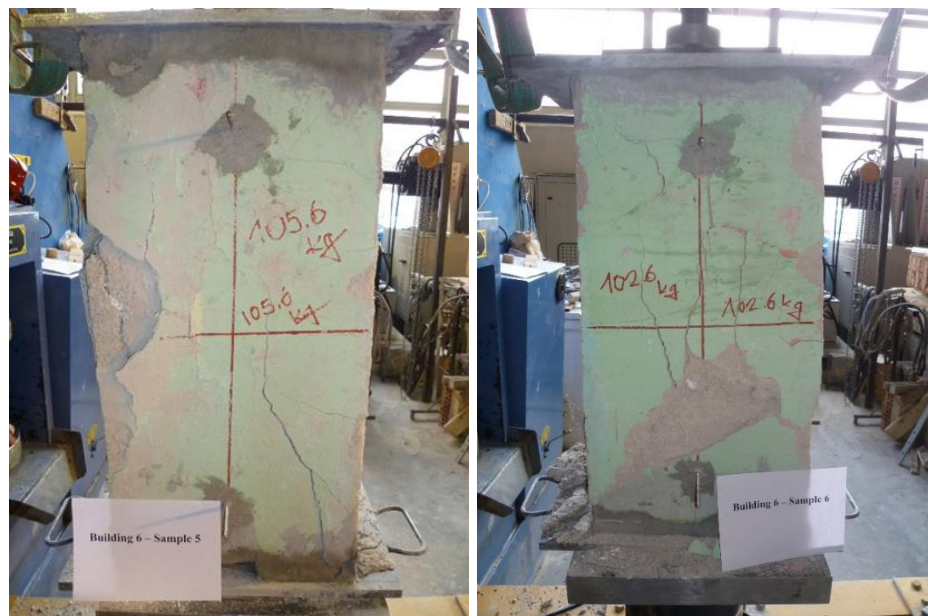
Figure 3.16 Building 6 compression test results along the axis perpendicular to the load bearing direction of the wall

c) Specimen 3 and Specimen 4 at the end of the test

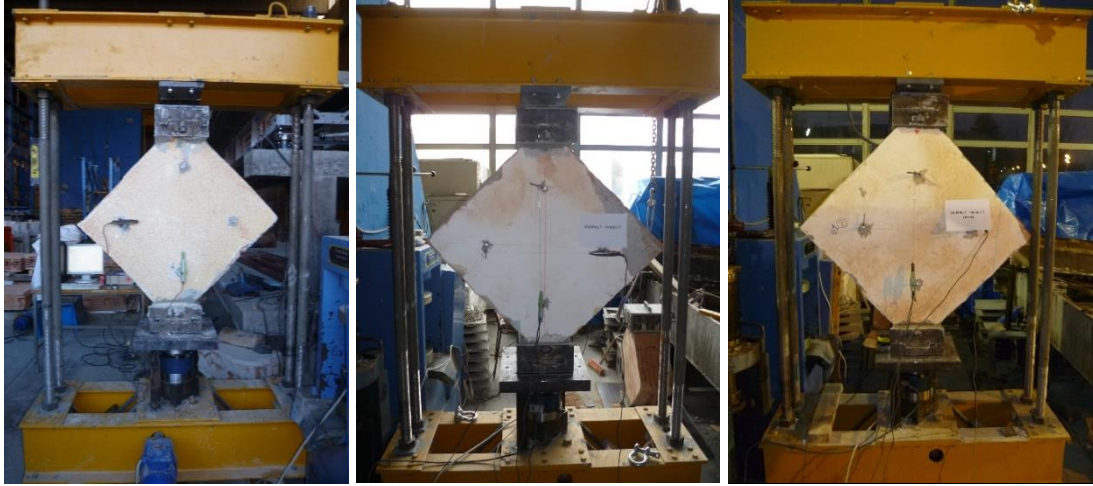
Figure 3.23 Diagonal tension test setup

In order to achieve sufficient force transfer between the specimen and the loading shoes, a gypsum-cement based mortar was used. After waiting approximately half a day for the cap to dry, the specimens were placed in the test machine. Then the centroidal axis of the specimen was aligned with the center of trust of the machine and a spherical headed support was placed on the top of the upper loading shoe.

failure. Specimen dimensions were measured and after being photographed, specimens were ready for testing. Pictures showing the diagonal tension test setup are given in Figure 3.22.

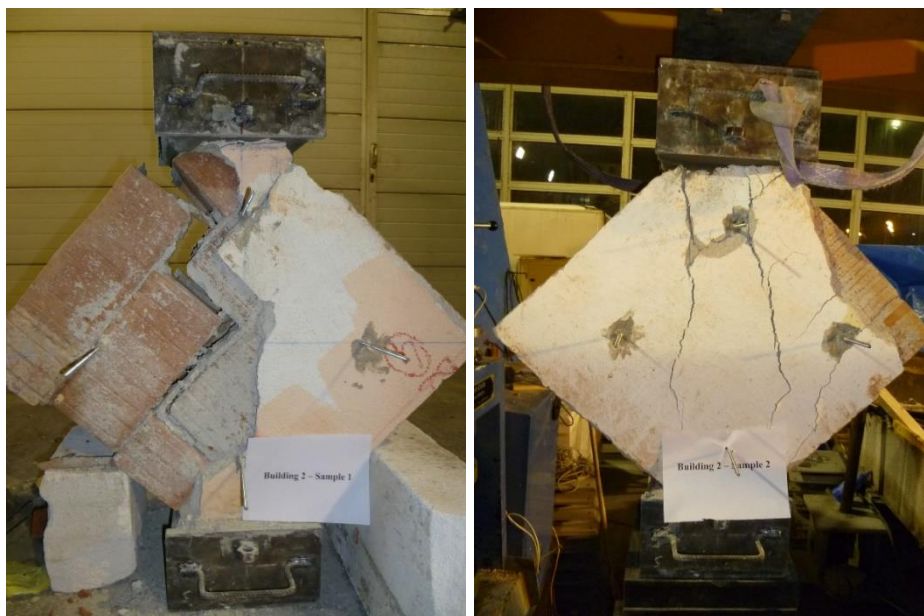
Figure 3.25 Building 2 diagonal tension test results

c) Specimen 1 and Specimen 2 at the end of the test

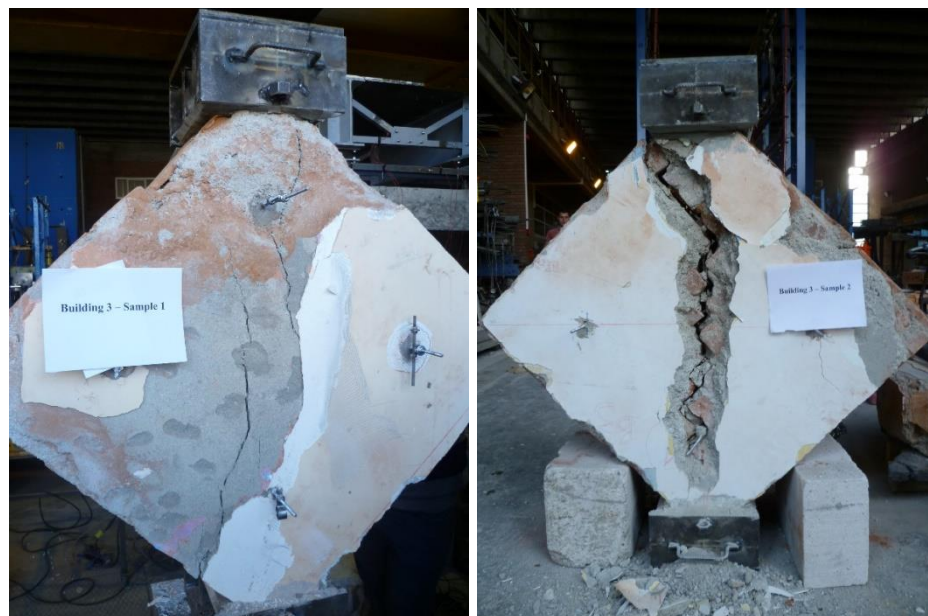
Figure 3.26 Building 3 diagonal tension test results

c) Specimen 1 and Specimen 2 at the end of the test

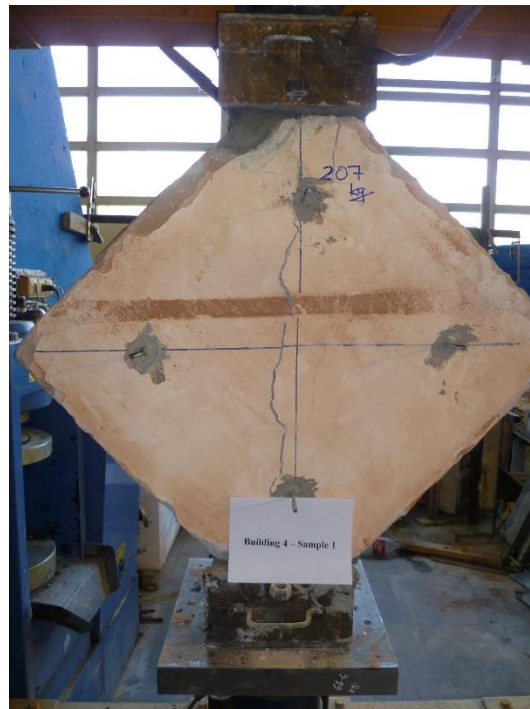
Figure 3.27 Building 4 diagonal tension test result

b) Specimen 1 at the end of the test

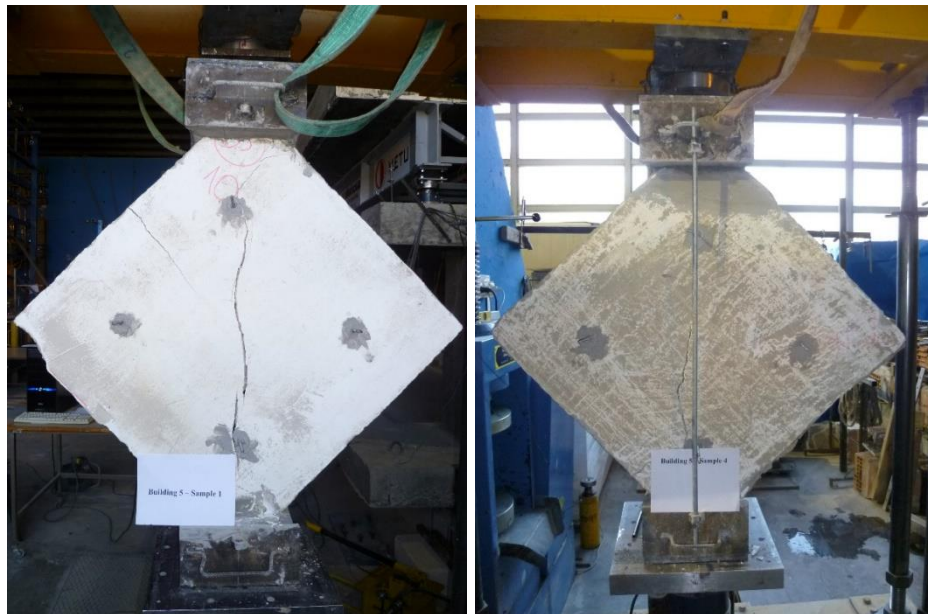
Figure 3.28 Building 5 diagonal tension test results

c) Specimen 1 and Specimen 2 at the end of the test

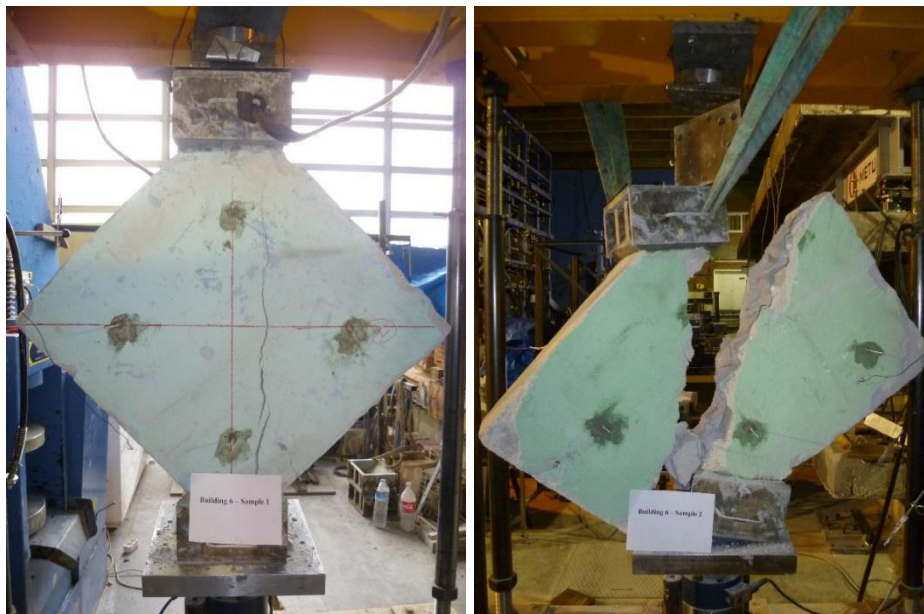
Figure 3.29 Building 6 diagonal tension test results

c) Specimen 1 and Specimen 2 at the end of the test

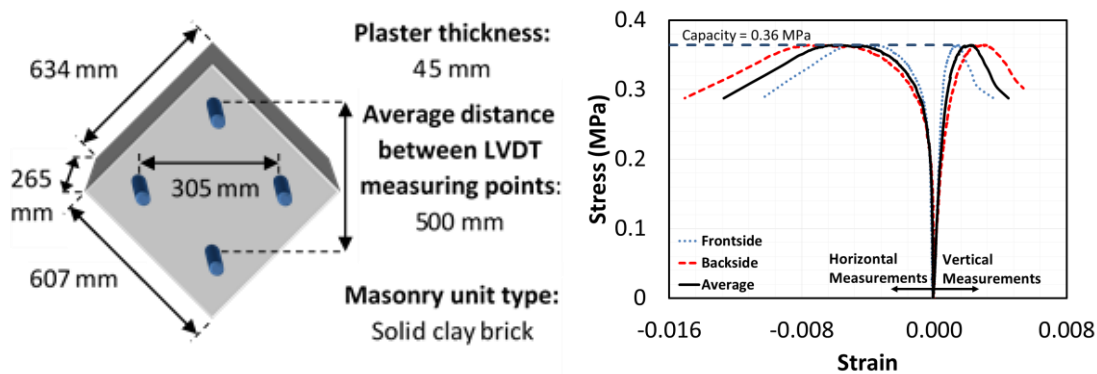
Figure 3.30 Building 7 diagonal tension test result

a) Geometric properties and diagonal tension test result of Specimen 1

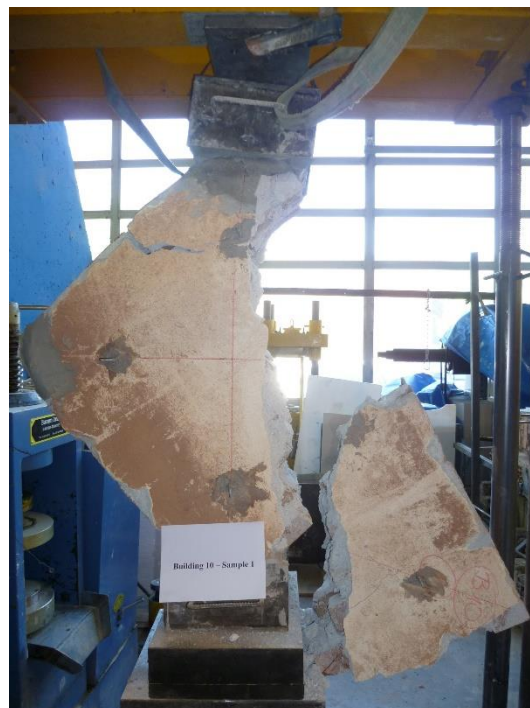
Figure 3.33 Building 10 diagonal tension test result

b) Specimen 1 at the end of the test

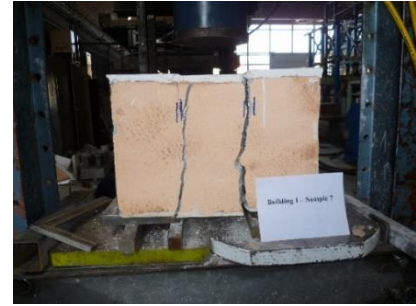
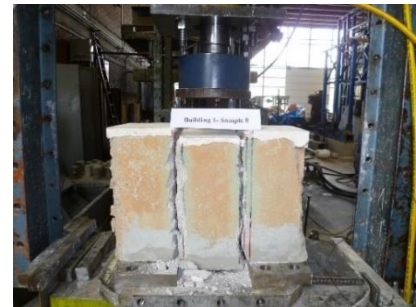
Figure 3.36 Building 1 triplet test results

a) Geometric properties and triplet test result of Specimen 1

b) Geometric properties and triplet test result of Specimen 2

After the experiments were finished, specimens were photographed and the load-deformation data were extracted. In order to calculate the shear strength of the masonry wall, the following procedure was used: Each compressive load data was multiplied with the gravitational acceleration and divided by the cross-sectional area of the specimen under shearing stresses. The maximum calculated stress value is taken as the shear strength. The experiment results obtained from sliding shear tests are given in Figures 3.35 to 3.43 for specimens extracted from buildings 1 to 10, respectively.

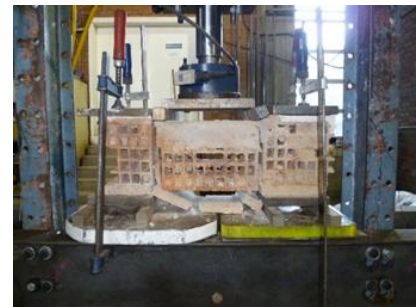
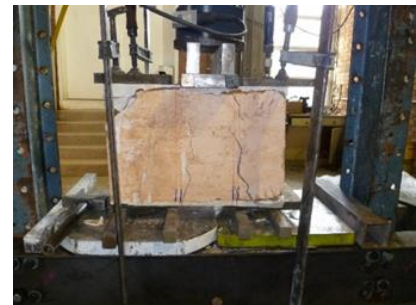
Figure 3.37 Building 2 triplet test results

a) Geometric properties and triplet test result of Specimen 1

b) Geometric properties and triplet test result of Specimen 2

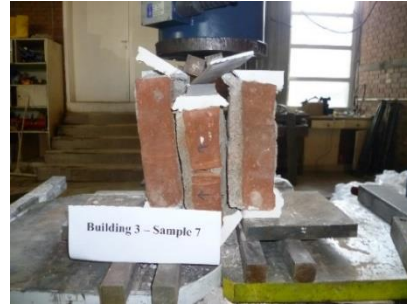
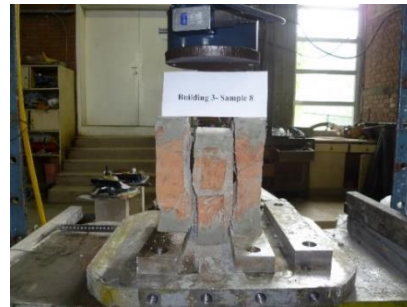
Figure 3.38 Building 3 triplet test results

a) Geometric properties and triplet test result of Specimen 1

b) Geometric properties and triplet test result of Specimen 2

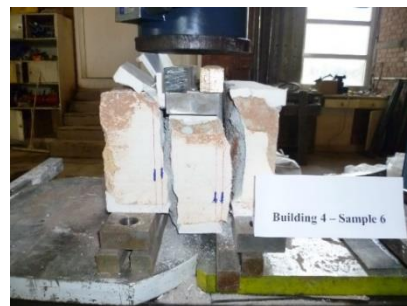
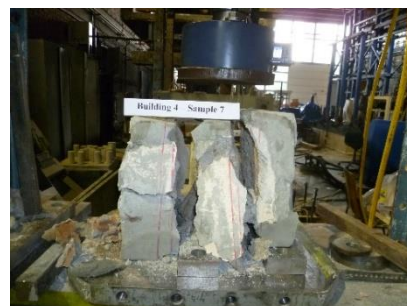
Figure 3.39 Building 4 triplet test results

a) Geometric properties and triplet test result of Specimen 1

b) Geometric properties and triplet test result of Specimen 2
