GENERATION OF AN EARLY WARNING SYSTEM FOR LANDSLIDE AND
SLOPE INSTABILITY BY OPTICAL FIBER TECHNOLOGY

A THESIS SUBMITTED TO
THE GRADUATE SCHOOL OF NATURAL AND APPLIED SCIENCES
OF
MIDDLE EAST TECHNICAL UNIVERSITY

AUGUST 2015

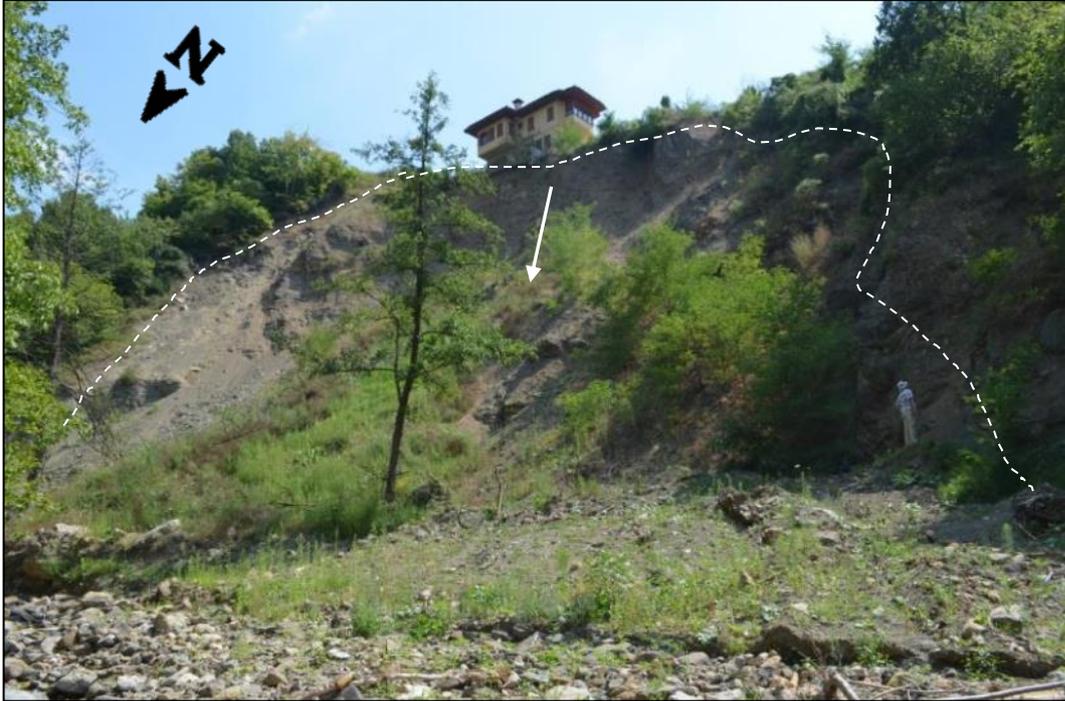
Figure 3: General geometry of the landslide and the house affected

Apart from the economic importance of Kocaeli, the study area was selected due to its critical location in terms of landslide risk. In 2010, a landslide occurred and the region was announced as a hazard prone area by the AFAD in 19.02.2013 because the landslide was threatening a house that was located in its crown area (Figure 3).

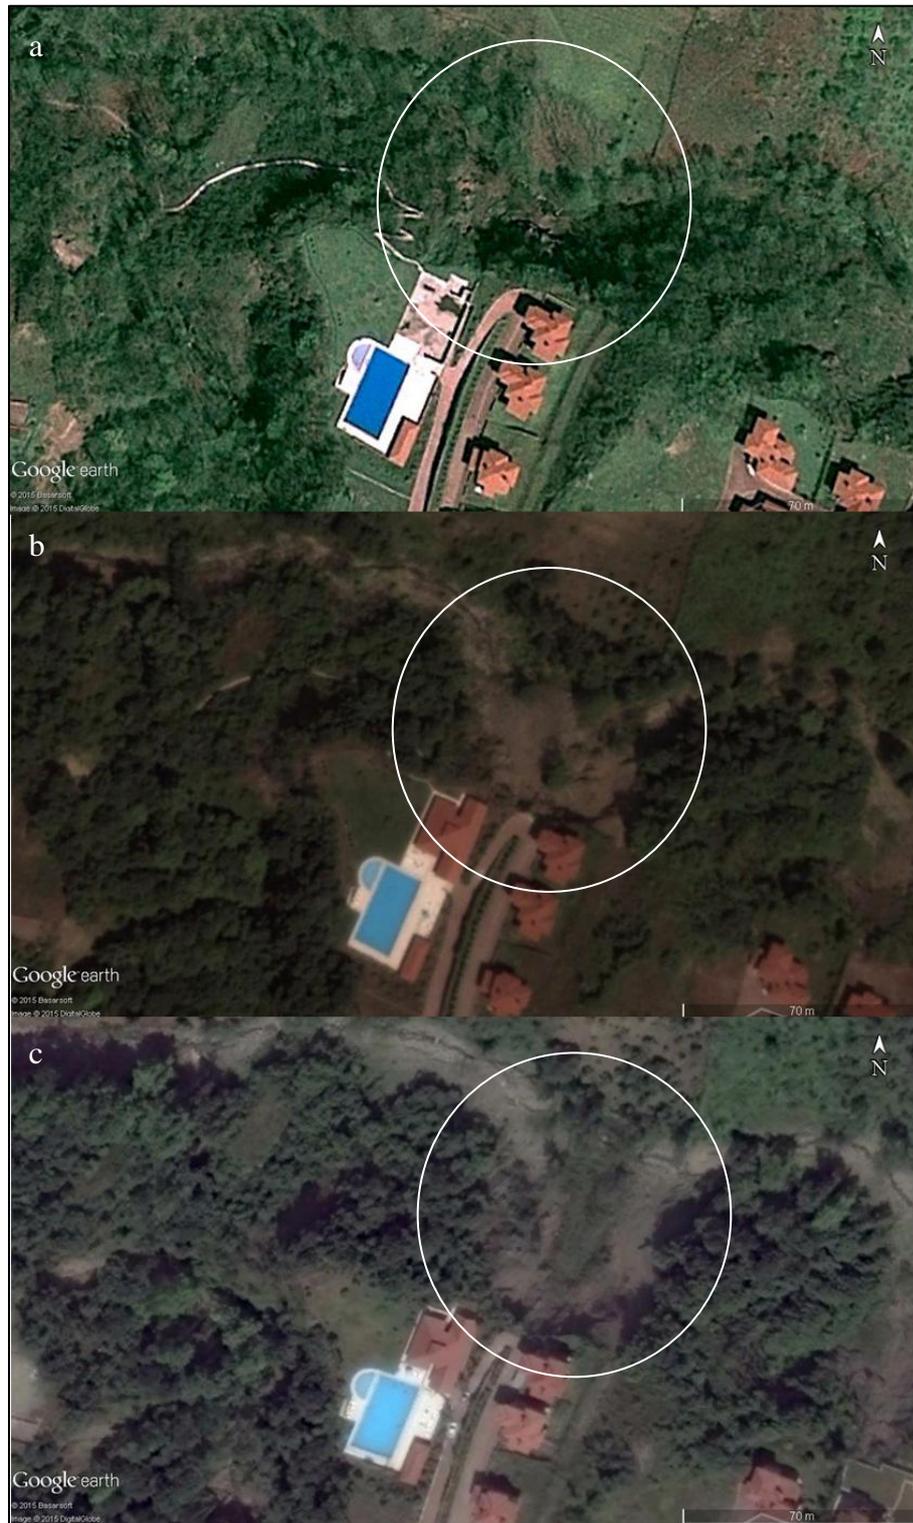
Figure 4: Appearance of the study area dated on a) 11.04.2009 (before), b) 05.08.2011 (after), c) 07.05.2015 (after).

Figure 4a through 4c give Google Earth images of the study area before and after the landslide as well as the house affected for the years 2009, 2011, and 2015, respectively. Field observations and measurements showed that the mass movement located at the study area has a width of 120 m and height of 40 m.

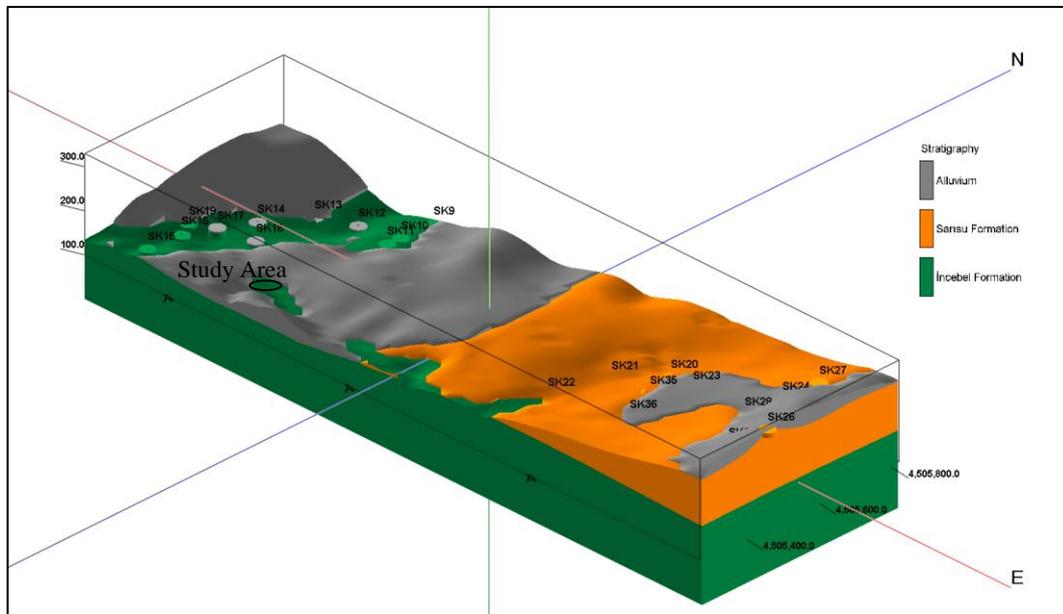
Figure 10: Three-dimensional stratigraphic model of the study area

The study area is located within a valley that lies within the stream bed of the Sarılık Stream. A three-dimensional stratigraphic model of the region prepared by the Rockworks v.16 (Rockware, 2013) is given in Figure 10.

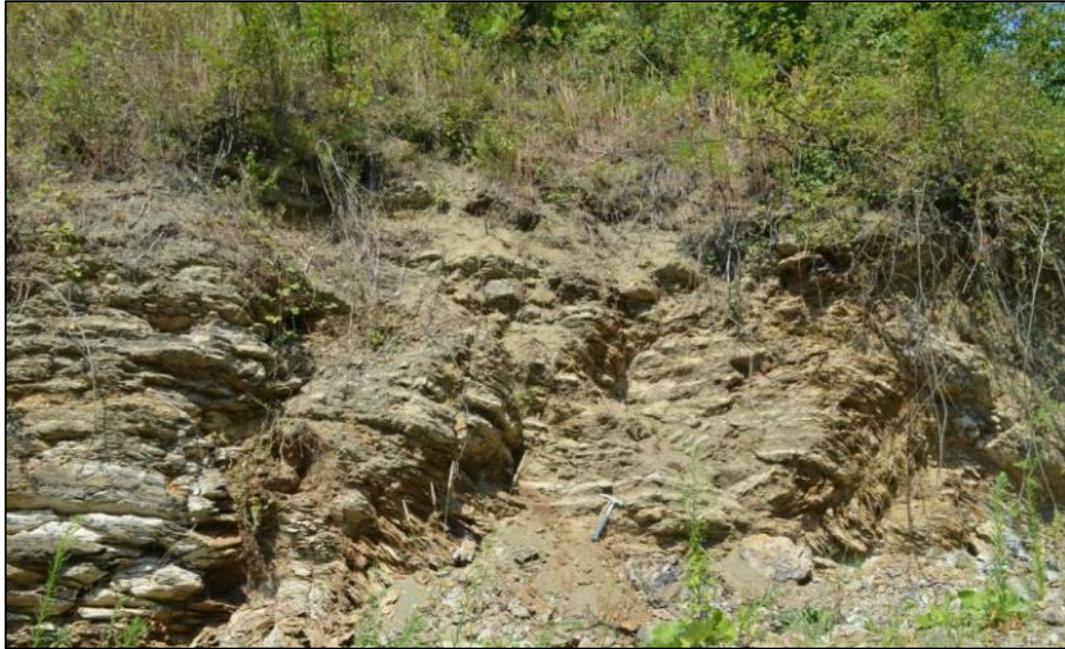
Figure 12: Folded structures and small scale non-persistent scattered discontinuities present in the study area

The sandstone marl alternation sequence contains scattered and non-persistent discontinuity sets. Small scale folds are observed in the field. As explained in Section 2.2, the study area is located within a tectonically active region, or in other words, in a shear zone. Figure 12 shows a view of the folded and sheared structures

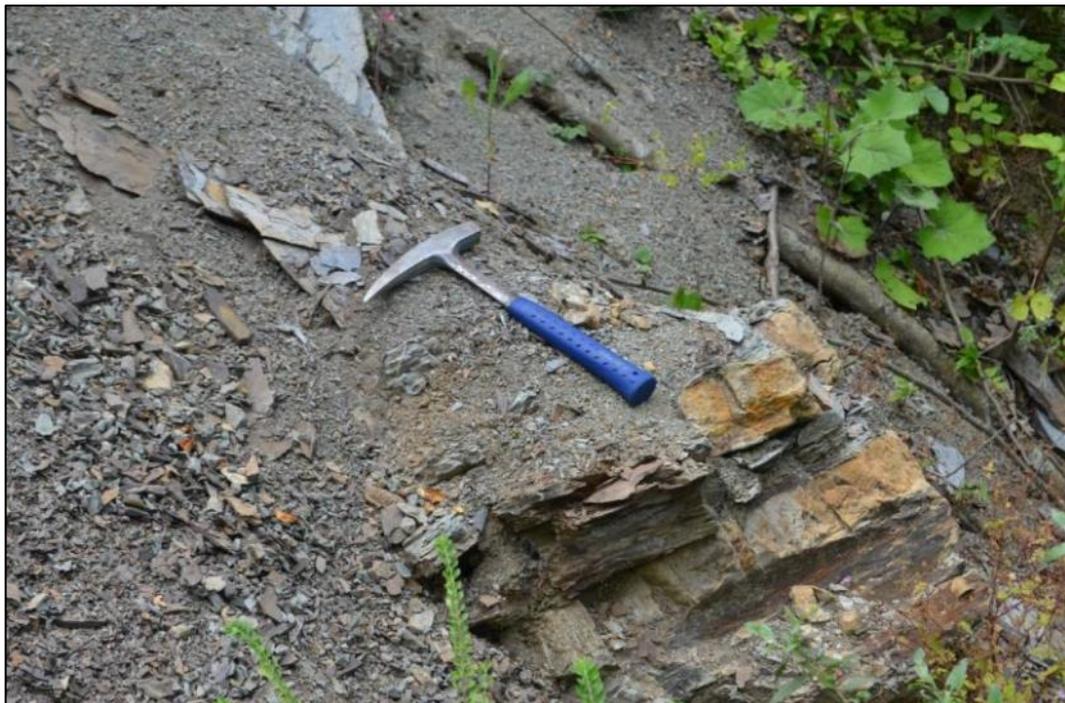
Figure 13: Disintegrated lithology and firm blocks of Incebel Formation

A sequence made up of sandstone and siltstone alternation occurs within the boundaries of the landslide. The sequence is generally tectonically deformed and disintegrated although in several locations of the landslide it outcrops as detached blocks (Figure 13). The sandstone has a yellowish brown color while the siltstone is greenish grey. They possess weak to very weak strength and are moderately to highly weathered (ISRM, 1981). The siltstone is weaker and more weathered than the sandstone layers. Scattered discontinuity sets are present in the area. Discontinuity surfaces are slickensided with clay infilling and possess small persistence according to ISRM (1981).

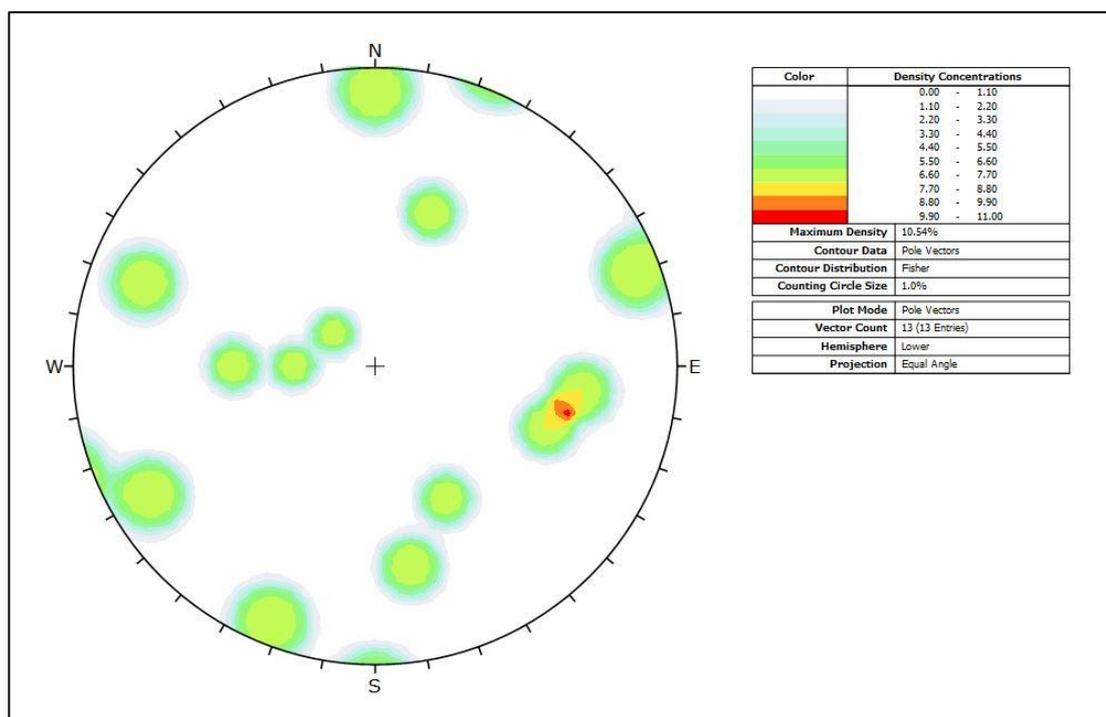
Figure 14: Pole plot of scattered discontinuities in the landslide area

DIPS v.6 (Rocscience Inc., 2012) to understand whether there is any identifiable structural pattern of the pole concentration or not (Figure 14). The obtained scattered plot of discontinuities implies that discontinuities present in the region do not represent any identifiable structural pattern. Therefore, a circular type of slope failure is likely in the region (Hoek and Bray, 1981).

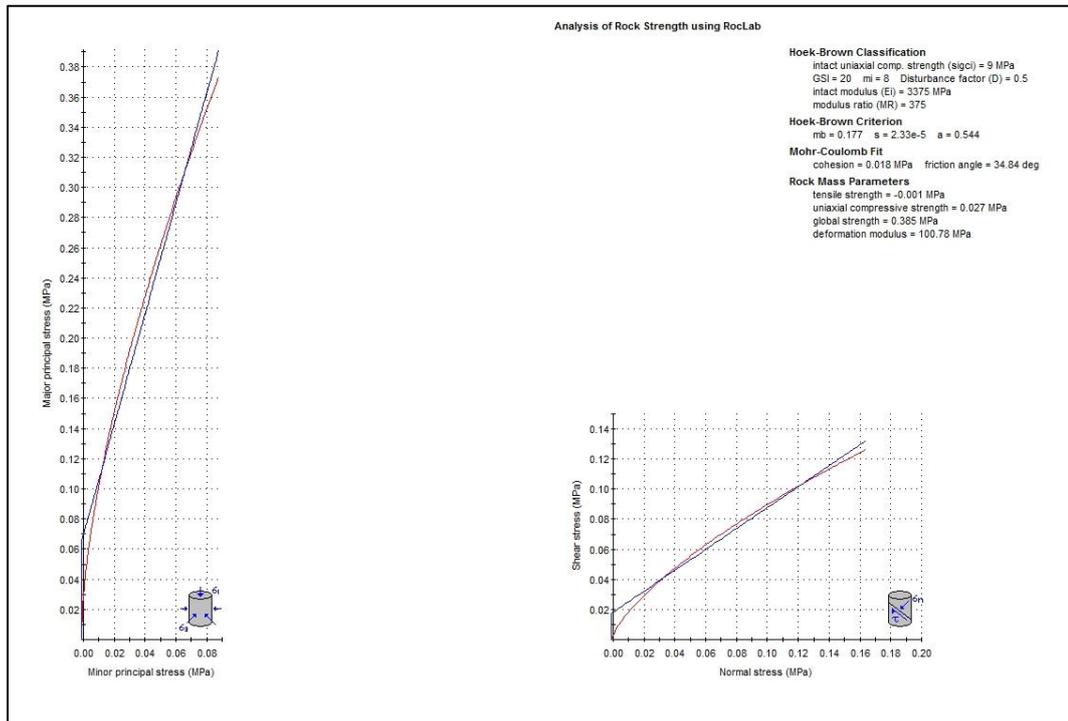
Figure 16: Analysis of rock strength from RocLab software.

Rock Mass Parameters		Hoek Brown Classification	
sigt	-0.001 MPa	sigci	9 MPa
sigc	0.027 MPa	GSI	20
sigcm	0.410 MPa	mi	9
E_{rm}	100.78 MPa	D	0.5
Failure Envelope Range		MR	375
Application	Slopes	Hoek Brown Criterion	
Mohr-Coulomb Fit		mb	0.199
c	0.022 MPa	s	2.33e-5
ϕ	33.88°	a	0.544

GSI system applied by using field study observations and measurements was resulted with a cohesion (c) value of 22 kPa and internal friction angle (ϕ) value of 34 degrees. Figure 16 shows the rock strength analysis results of the GSI system from RocLab software.

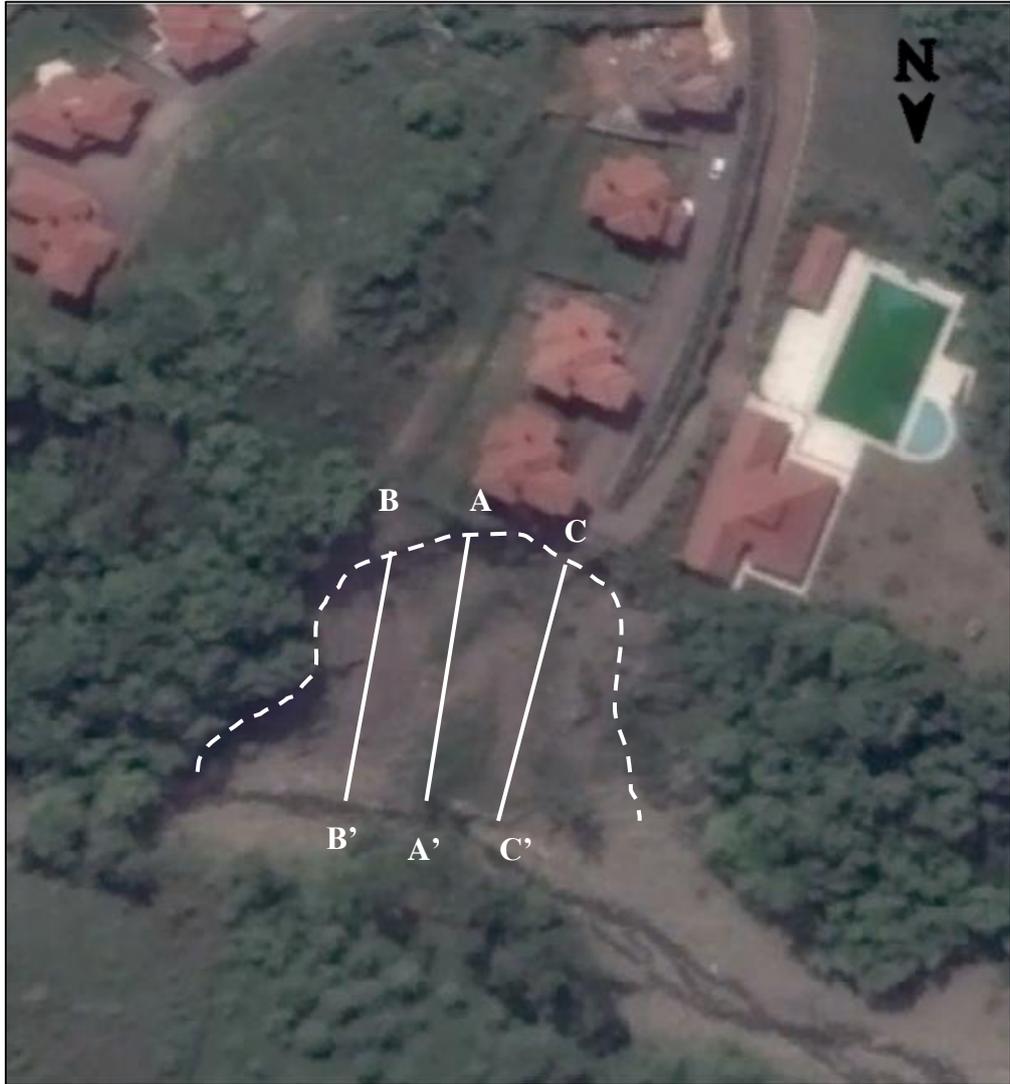
Figure 19: Locations and orientations of the cross sections of landslide.

From the digital elevation model three cross sections (AA', BB', CC') were created along the landslide that were parallel to the slope movement direction and the cohesion-internal friction angle pairs at the time of failure (i.e., satisfying a factor of safety value of 1.0) were computed. Figure 19 gives the location and orientation of the cross sections of the landslide.

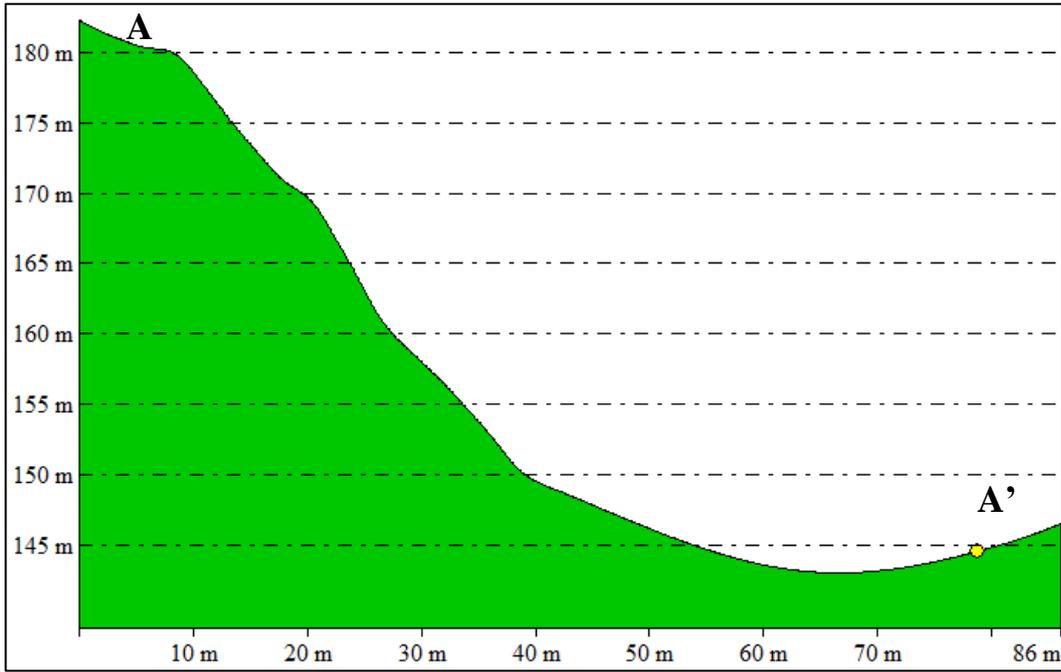
Figure 20: Profile along AA'

Figure 20, Figure 21 and Figure 22 shows the profiles obtained by cross sections AA', BB' and CC', respectively.

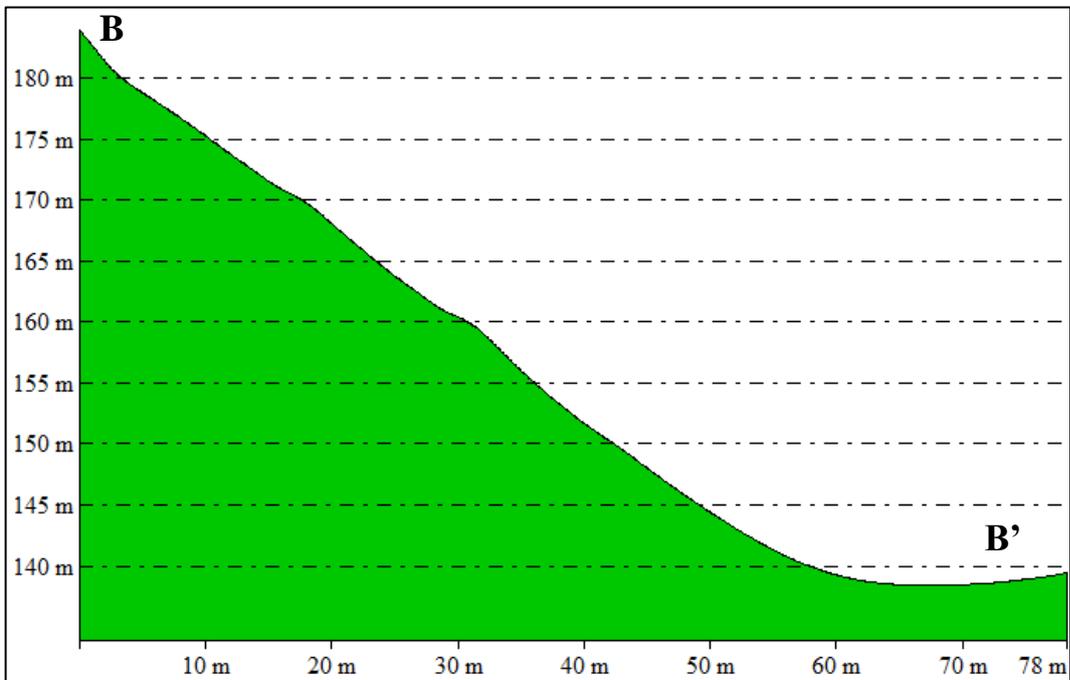
Figure 21: Profile along BB'

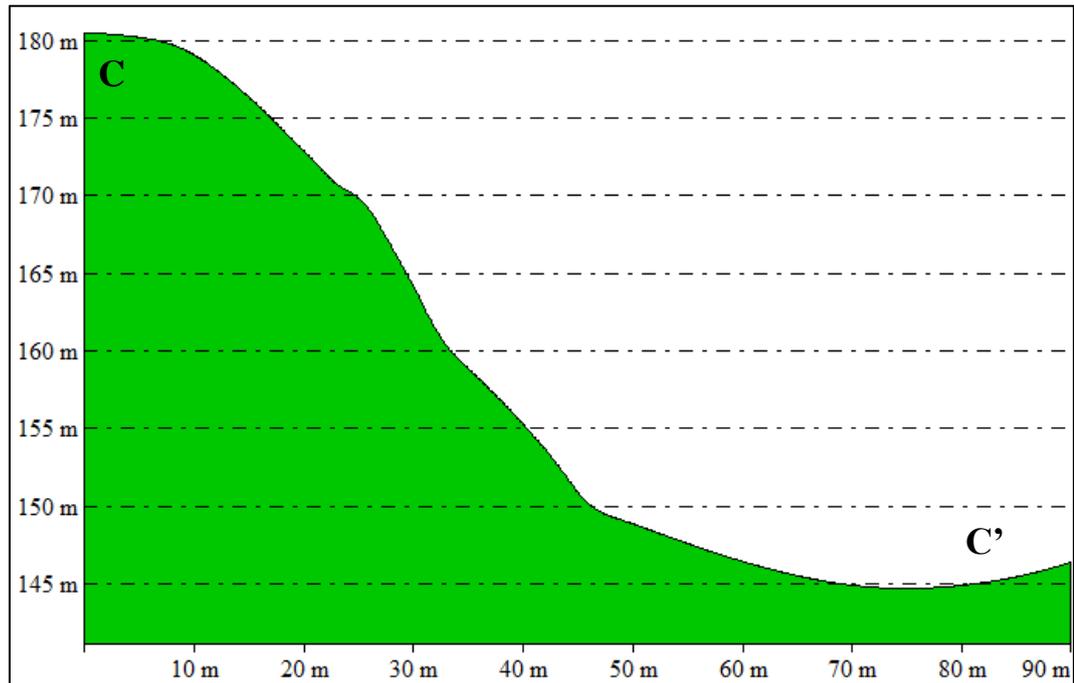
Figure 22: Profile along CC'

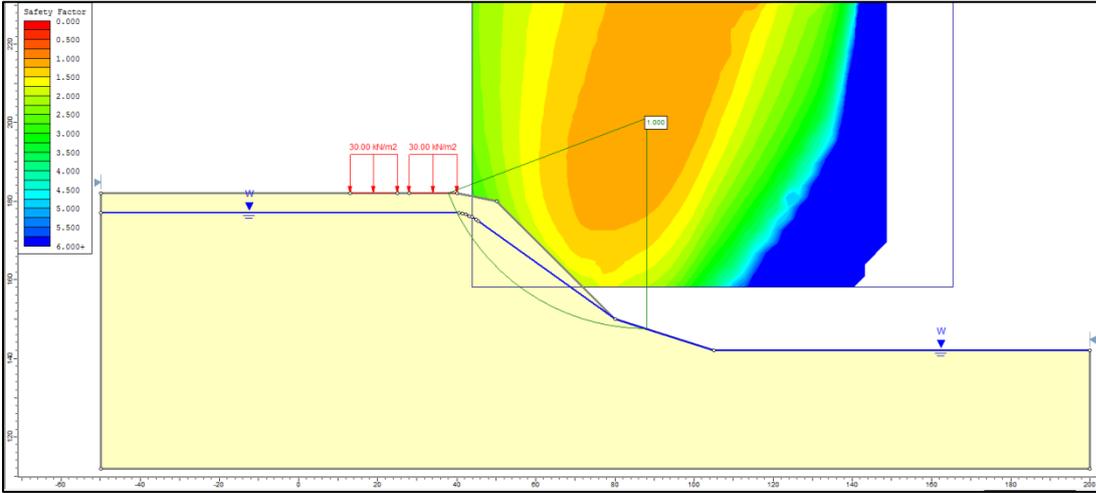
Figure 23: c' - ϕ' pair satisfying FS=1.0 for the profile AA'

Once the cross sections were created, the back analysis was performed through limit equilibrium solution by the Morgenstern-Price method using the Slide v.6 software (Rocscience Inc., 2010). A fully saturated mass (representing heavy rainfall and flooding conditions) together with a 30 kPa of surcharge to represent the surcharge of the houses that are located in and behind the crown area (two-storey residential buildings). Figure 23, Figure 24 and Figure 25 represent the back calculated results of the limit equilibrium analyses of the cross-sections AA', BB' and CC'.

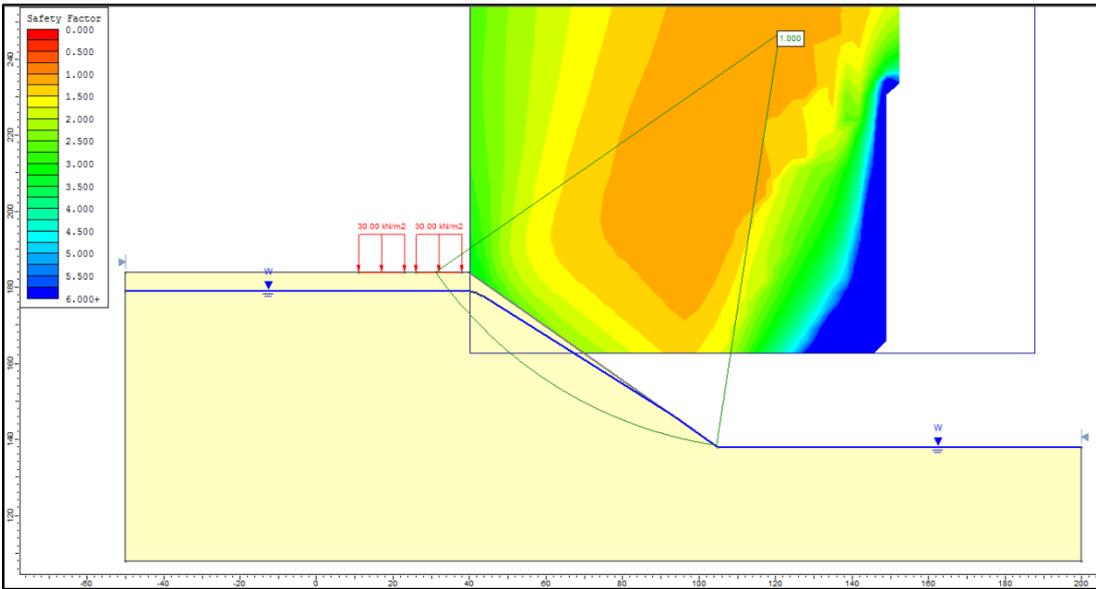
Figure 24: c' - ϕ' pair satisfying FS=1.0 for the profile BB'

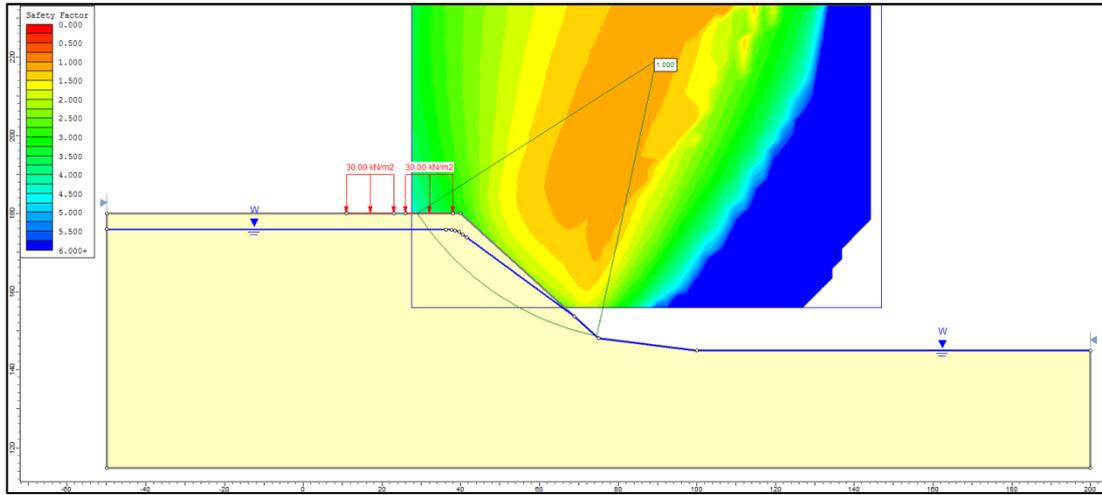
Figure 25: c' - ϕ' pair satisfying FS=1.0 for the profile CC'

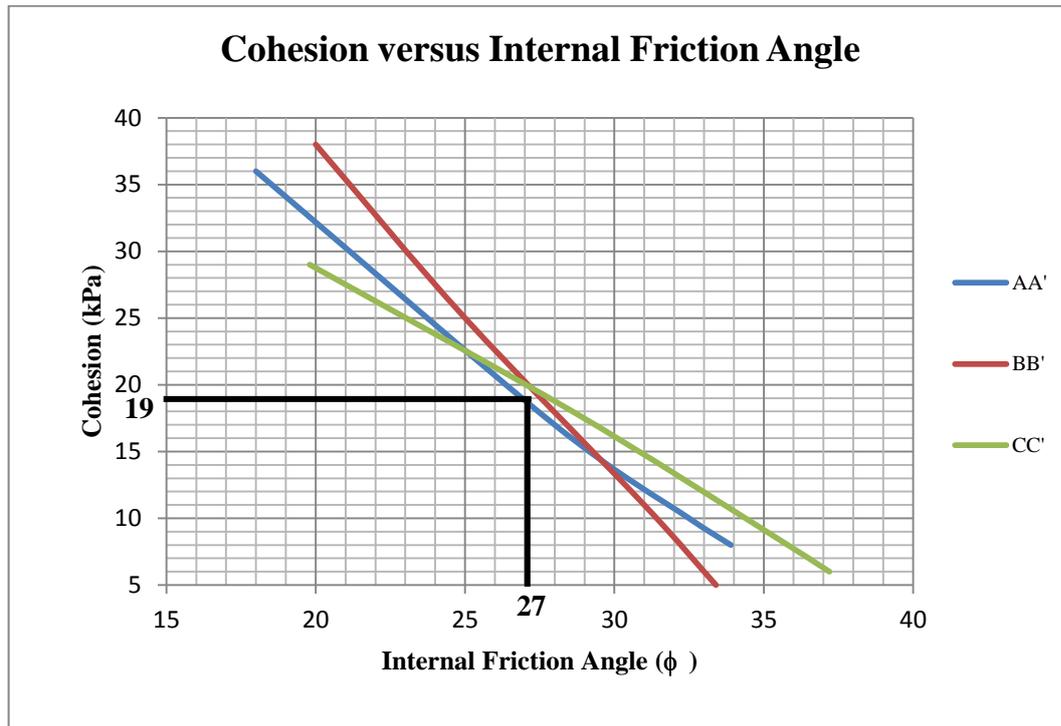
Figure 26: c' - ϕ' pairs obtained by back analysis

AA'		BB'		CC'	
c' (kPa)	ϕ' (°)	c' (kPa)	ϕ' (°)	c' (kPa)	ϕ' (°)
36	18.0	38	20.0	29	19.80
17	28.0	25	25.0	18	28.60
10	32.5	11	31.0	9	35.10
8	33.9	5	33.4	6	37.20

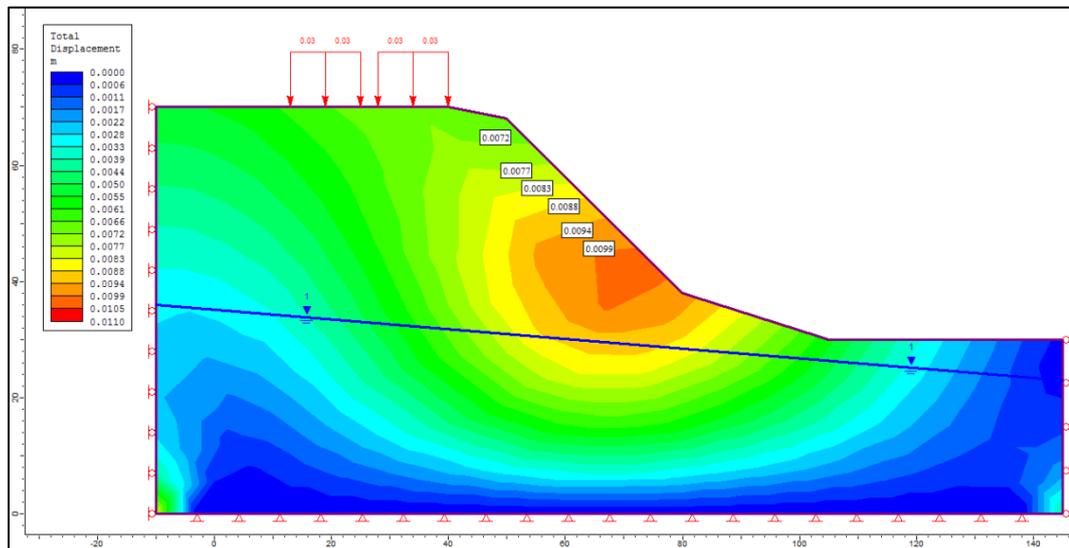
Figure 27: Displacement contours of the landslide for present situation

In order to understand the effect of groundwater in the landslide area, sensitivity analyses were performed with different scenario levels of groundwater. Figure 27 shows the deformation contours obtained by the finite element solution for the present case groundwater situation. Figure 28 displays the deformation contours for a partly saturated groundwater condition can be possible during a heavy rainfall precipitation. Lastly, Figure 29 gives the deformation contours for fully saturated condition that can be represented the worst case scenerio.

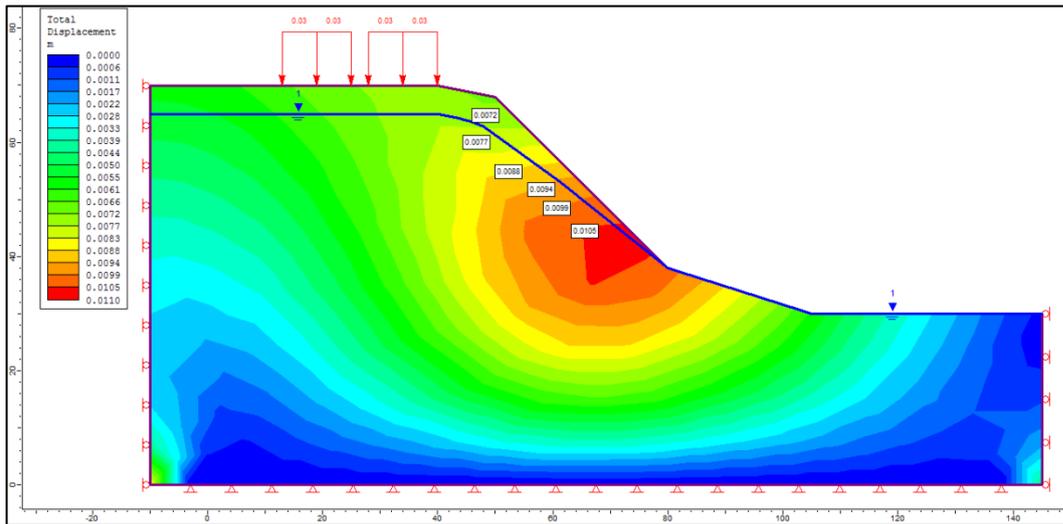
Figure 28: Displacement contours of the landslide for partially saturated condition

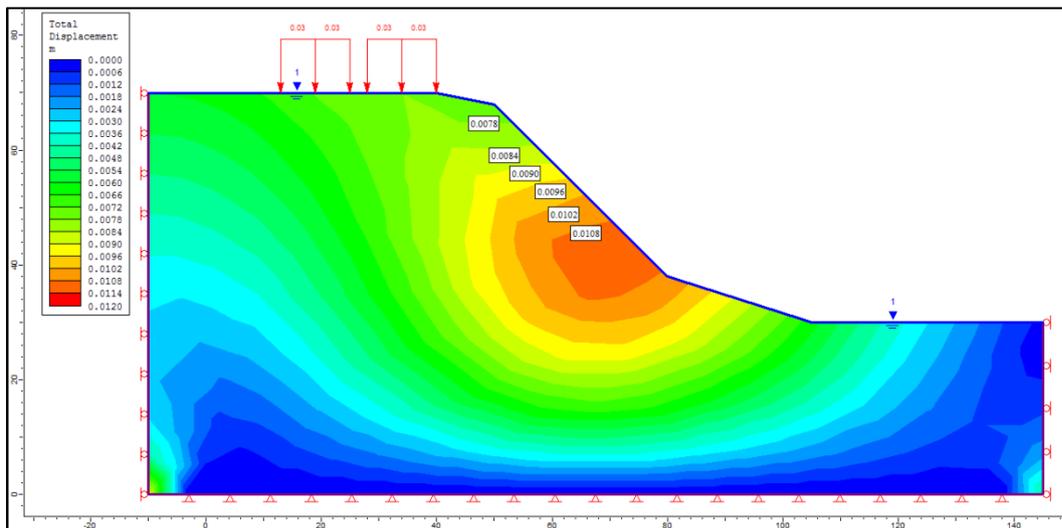
Figure 29: Displacement contours of the landslide for the worst case scenario

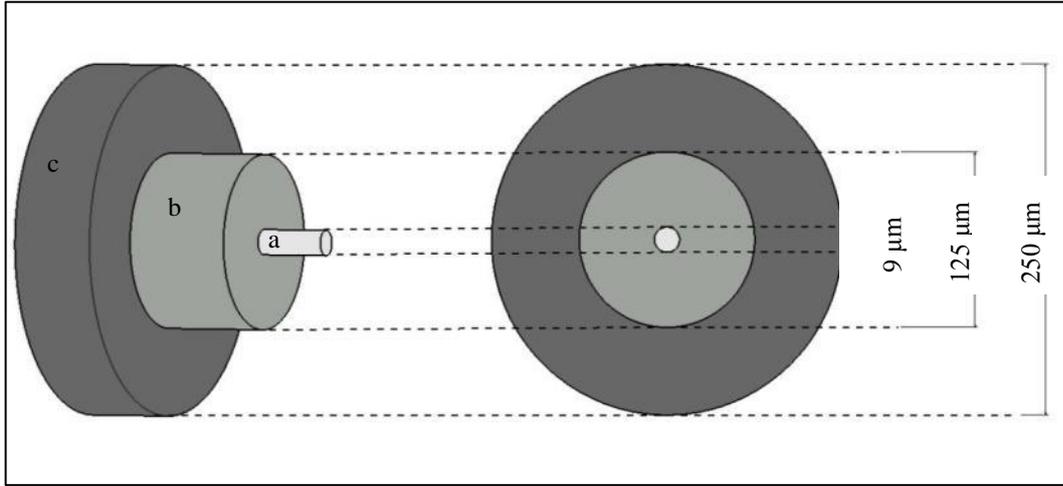
Figure 30: Basic structure of fiber cable; a) core, b) cladding, c) coating (Modified from Hayes, 2006).

An optical fiber is a transmission medium that conducts the light from cable's one end to another in order to transfer it along a long distance. Optical fibers are thin cables composed of core and cladding, and their material is generally plastic or glass (silica). Fiber optic cables are made up of two main parts as core and cladding that covers the core. In addition to these two layers, a coating is coiled to protect the core and the cladding. Figure 30 shows the basic structure of an optical fiber cable.

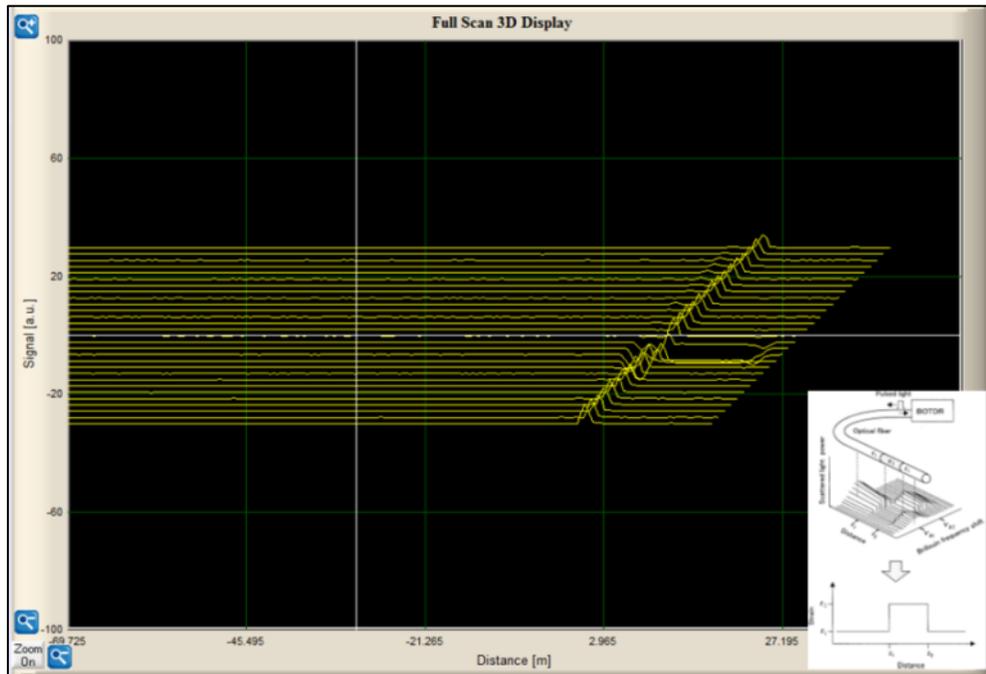
Figure 32: Measurement procedure of BOTDA taken from one of the experiments. The figure at the right hand corner is taken from Ohno et al. (2001)

Brillouin Optical Time Domain Analyzer (BOTDA) requires two laser beams having opposite directions in a fiber cable layout. One of them is the light launched to the cable and the other is the backscattered light. When the frequency difference between these two laser beams equals the Brillouin frequency of the fiber, a peak forms on the result graph (Xiaofei et al., 2011). The working principle of the Brillouin based time domain analysis can be seen in Figure 32.

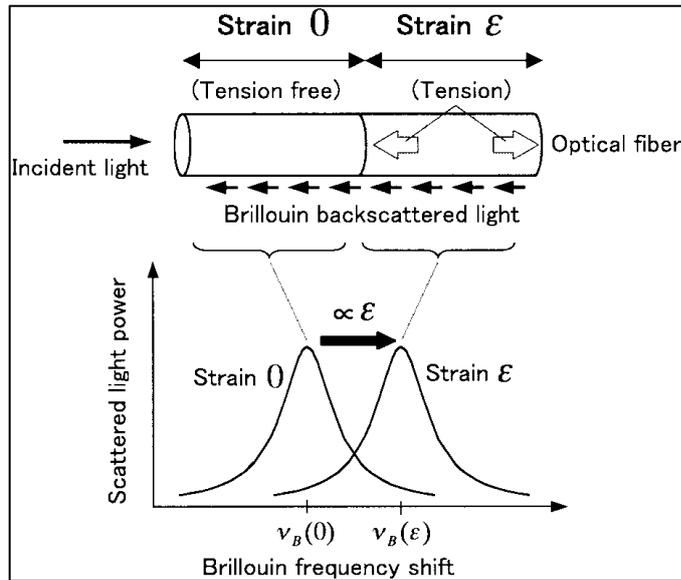
Figure 33: Brillouin frequency shift due to strain (Ohno et al., 2001)

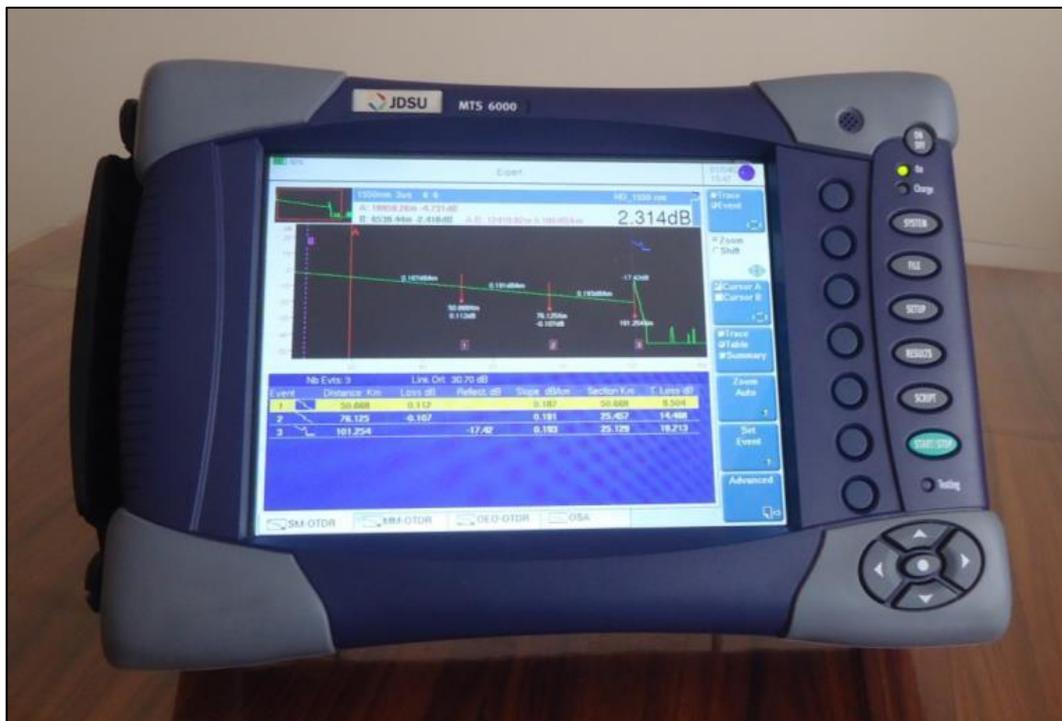
Figure 34: Optical Time Domain Reflectometer (OTDR)

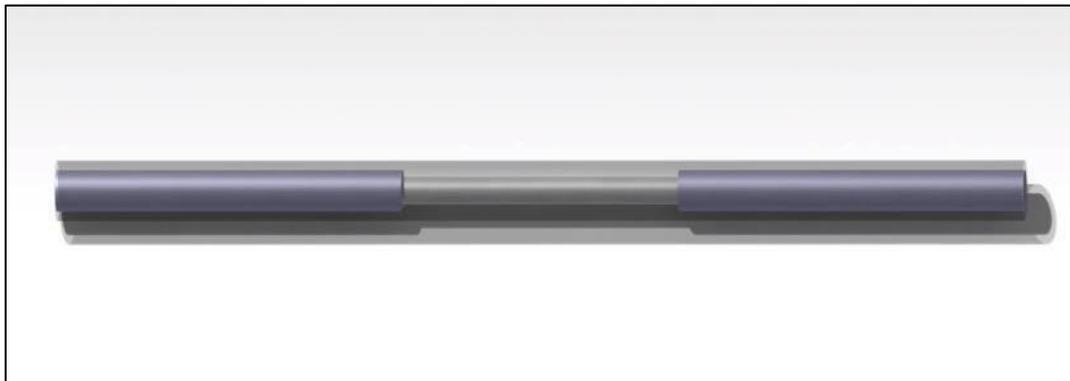
Figure 35: Basic structure of the heterocore

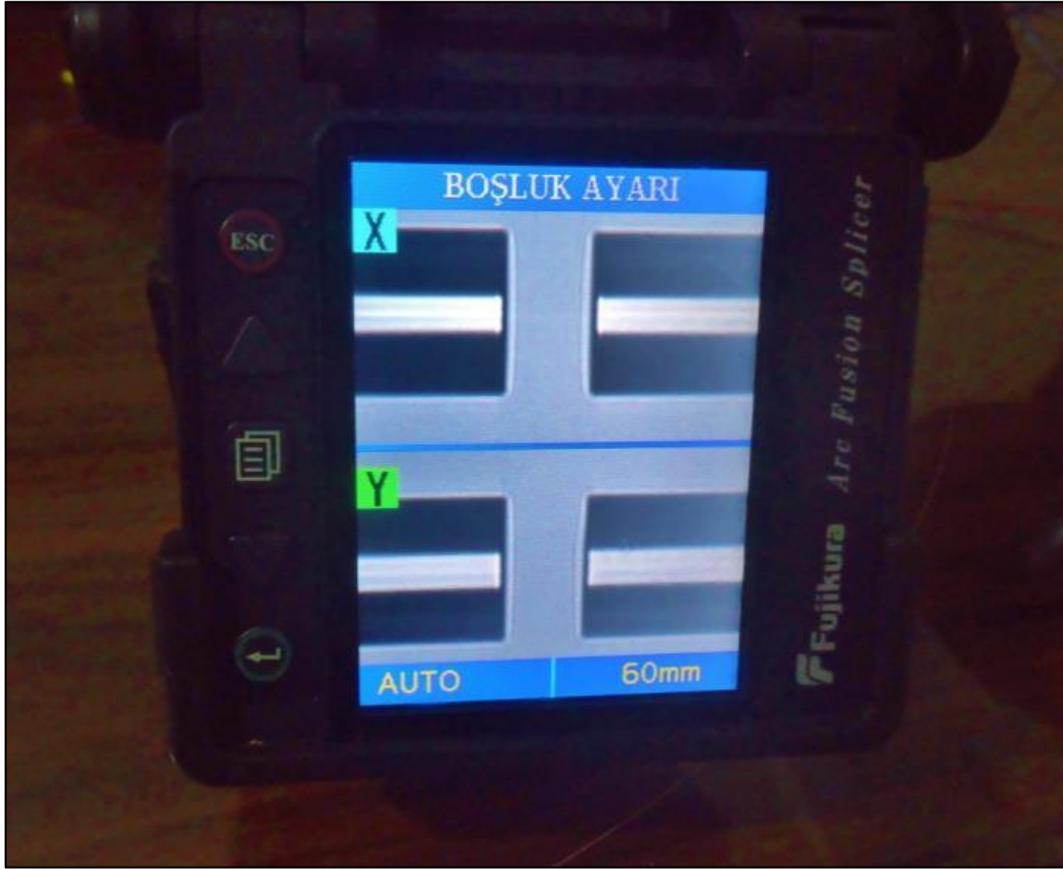
Figure 36: The utilized fusion splicer (Fujikura FSM 60S) to fuse two cables without signal loss

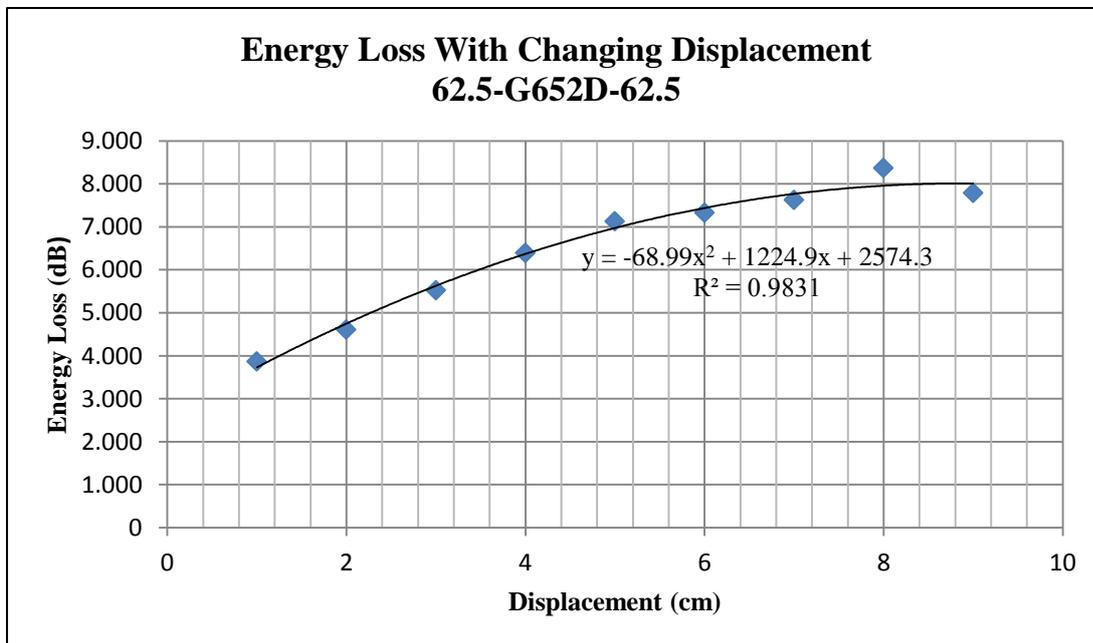
Figure 38: Energy loss and displacement relation for the cable pair of 62.5 and G652D

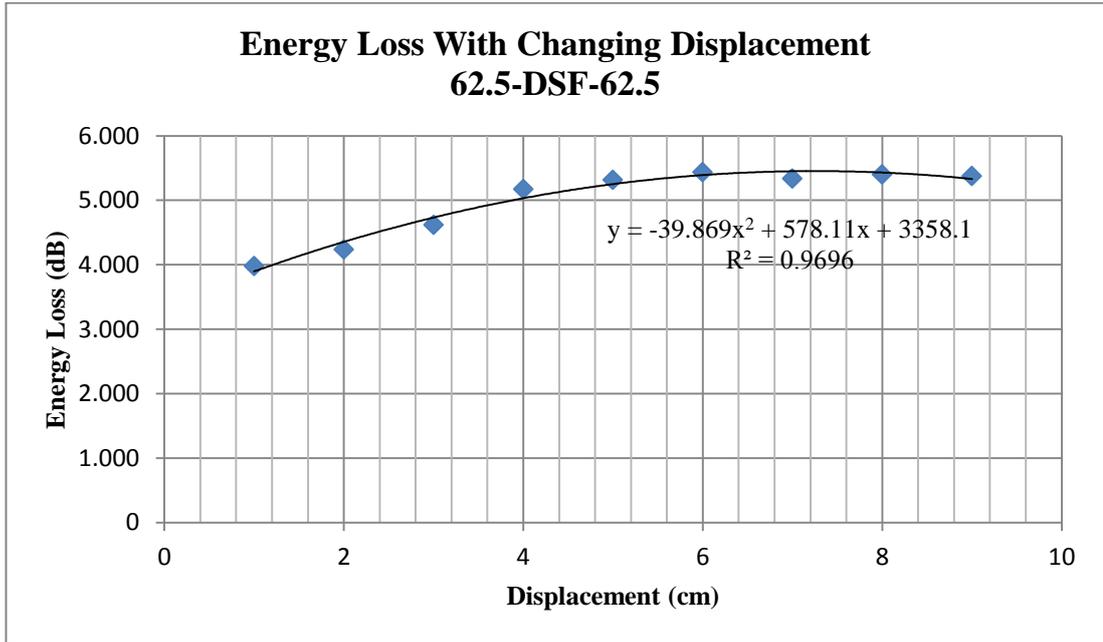
Figure 39: Energy loss and displacement relation for the cable pair of 62.5 and DSF

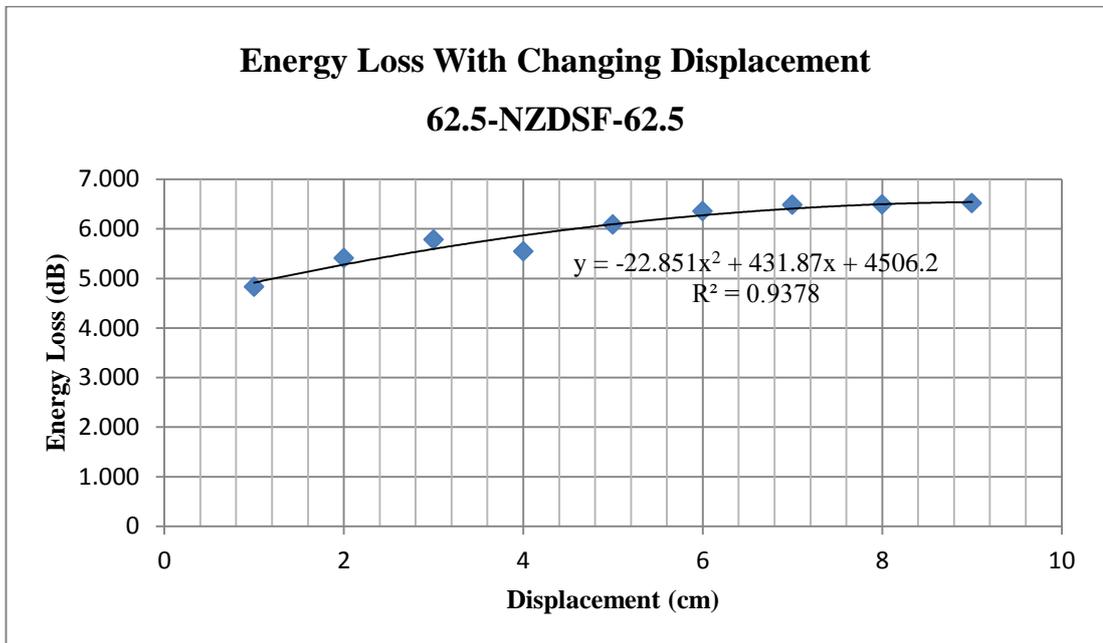
Figure 40: Energy loss and displacement relation for the cable pair of 62.5 and NZDSF

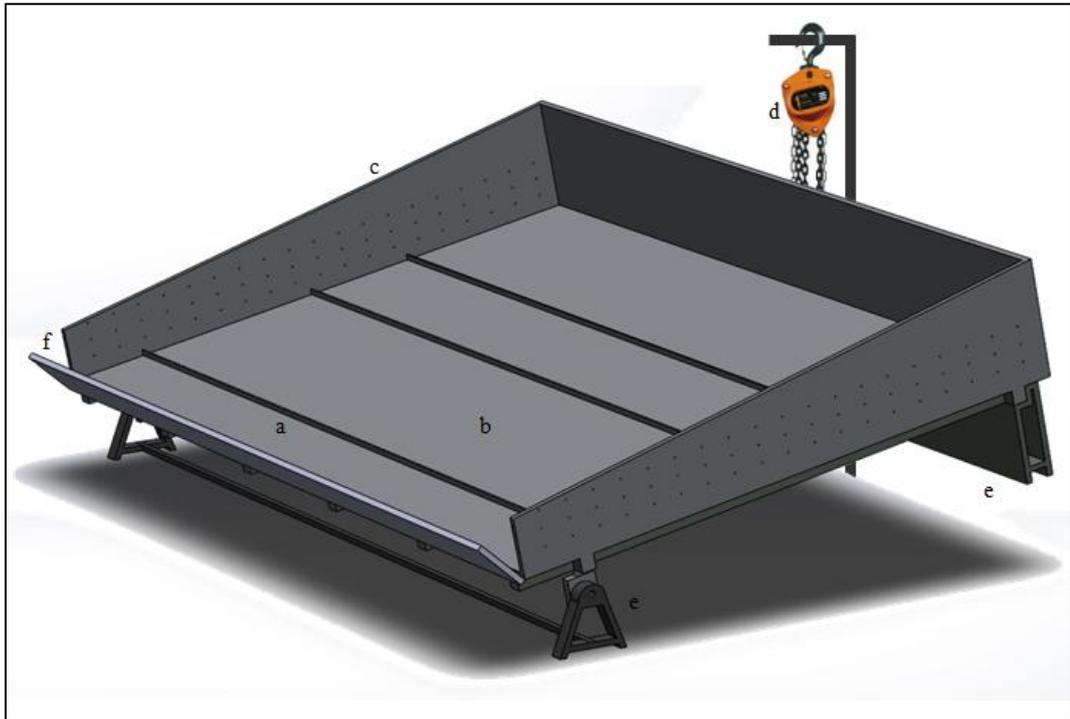
Figure 41: Representative sketch of laboratory experimental set-up. a) soil barrier having a height of 20 mm, b) soil-model interface, c) optical fiber cable holes, d) chain hoist to lift the model up and down in a controlled fashion, e) model feet for balancing, f) stopper to control mass movement

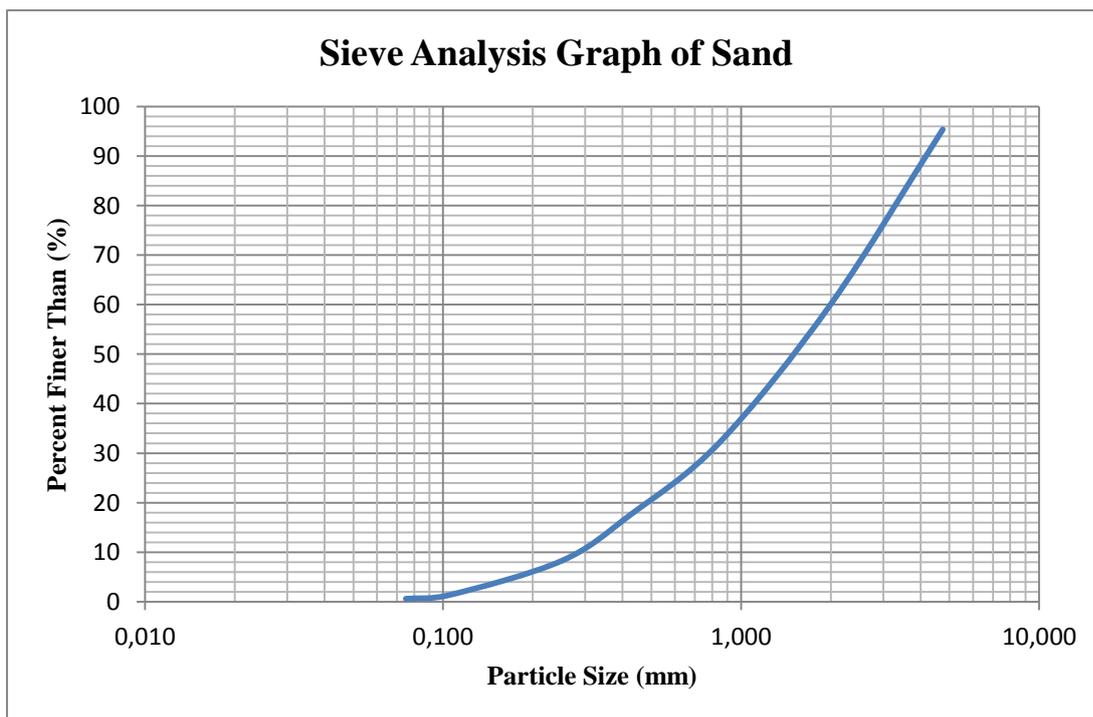
Figure 42: Sieve analysis result for the sand used
