GENERATION OF AN EARLY WARNING SYSTEM FOR LANDSLIDE AND
SLOPE INSTABILITY BY OPTICAL FIBER TECHNOLOGY

A THESIS SUBMITTED TO
THE GRADUATE SCHOOL OF NATURAL AND APPLIED SCIENCES
OF
MIDDLE EAST TECHNICAL UNIVERSITY

AUGUST 2015

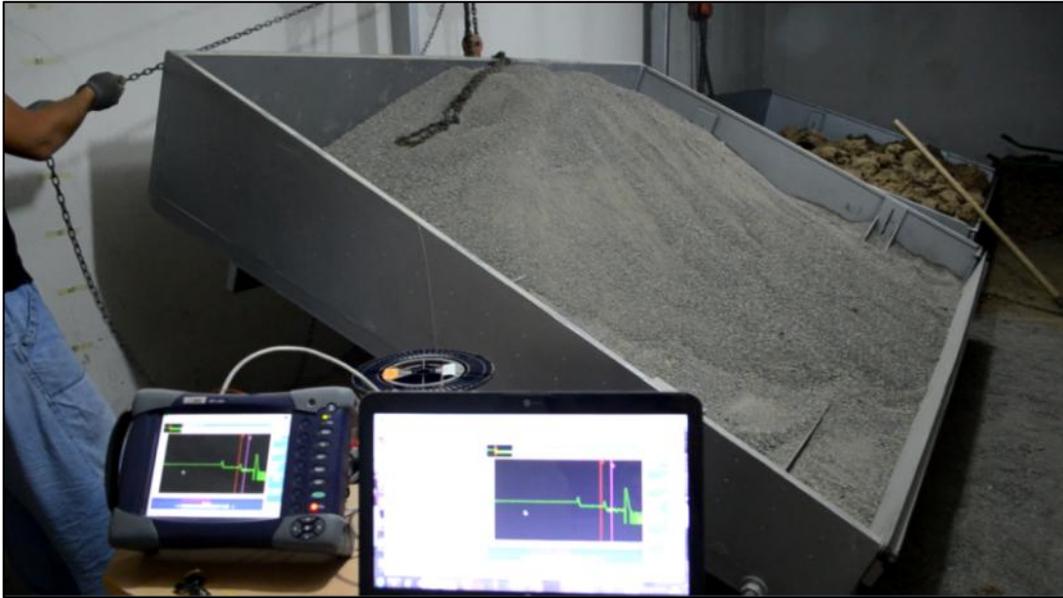
Figure 43: OTDR system measurement in landslide simulator before a movement based on inclination

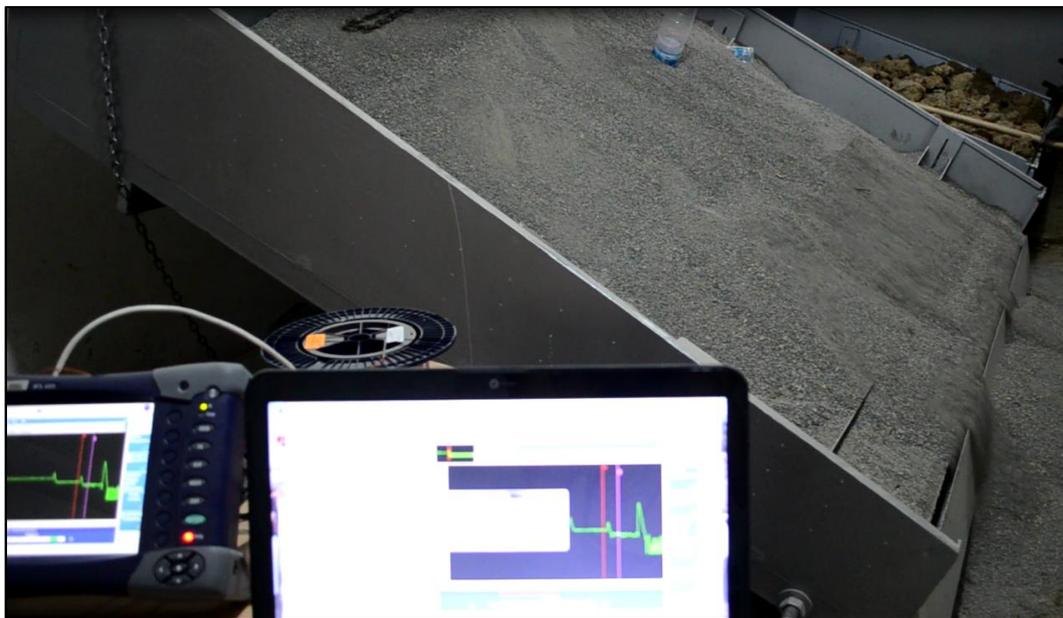
Figure 44: OTDR system measurement in landslide simulator after a small movement based on inclination

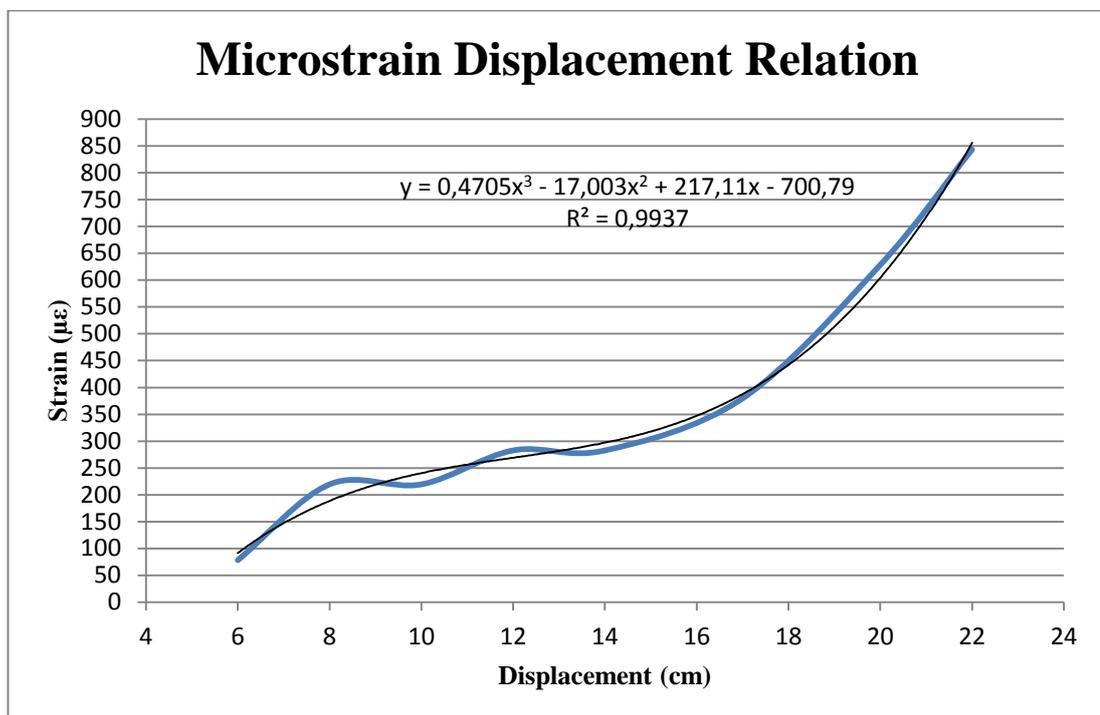
Figure 45: Strain changing with respect to displacement

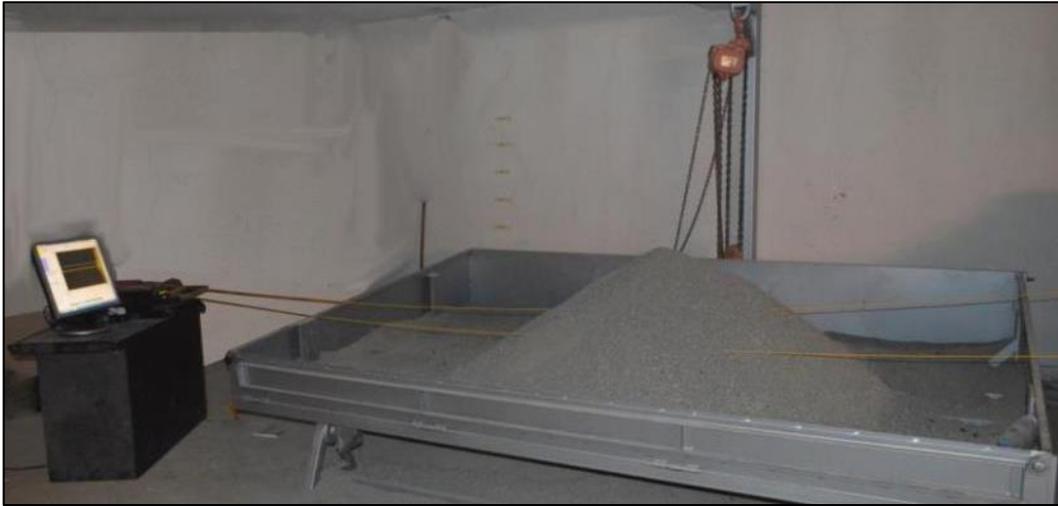
Figure 46: Initial state of the BOTDA system on the laboratory simulator before sliding

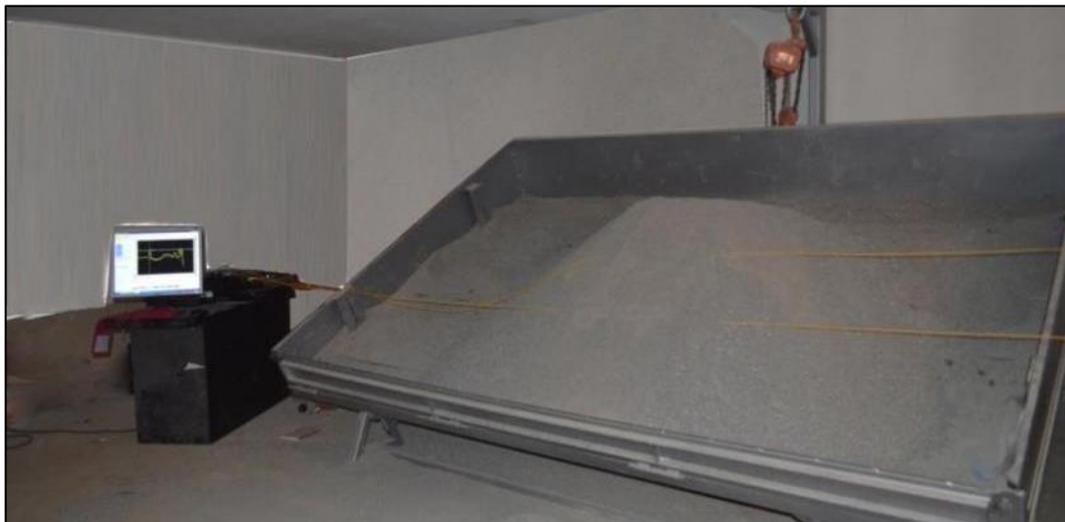
Figure 47: Appearance of the BOTDA system after given inclination after sliding

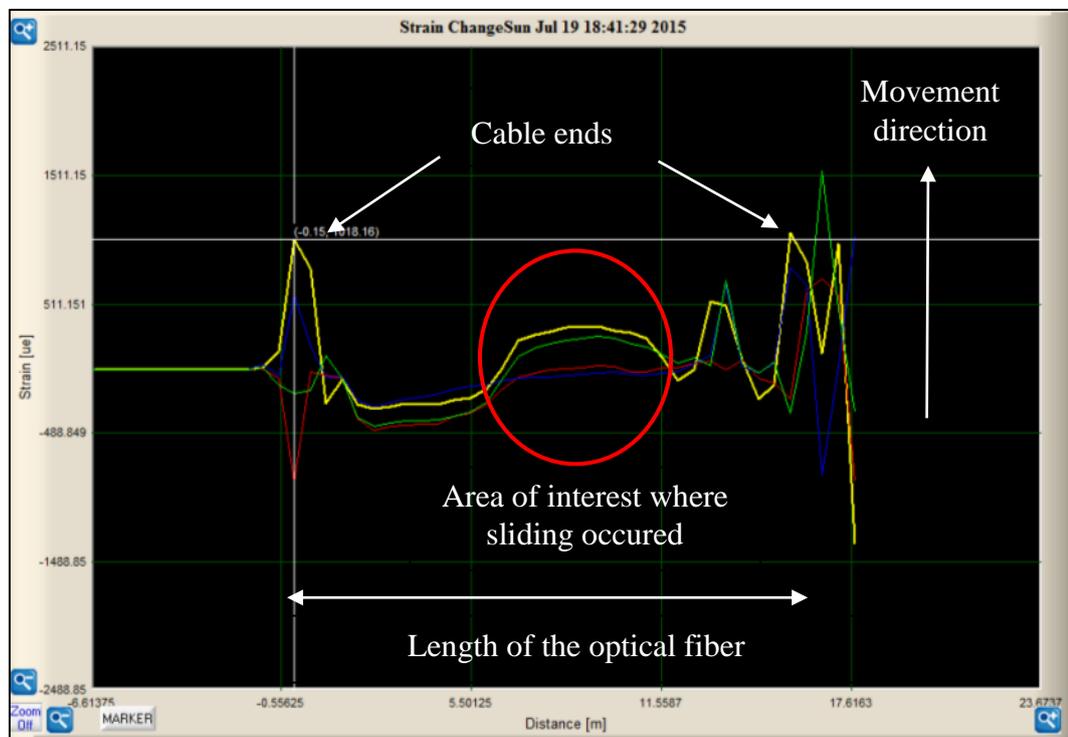
Figure 48: Microstrains formed due to changing inclination of the landslide simulator (red line represents the measurement taken at 10° inclination, green represents 20° and yellow represents 30° inclination).

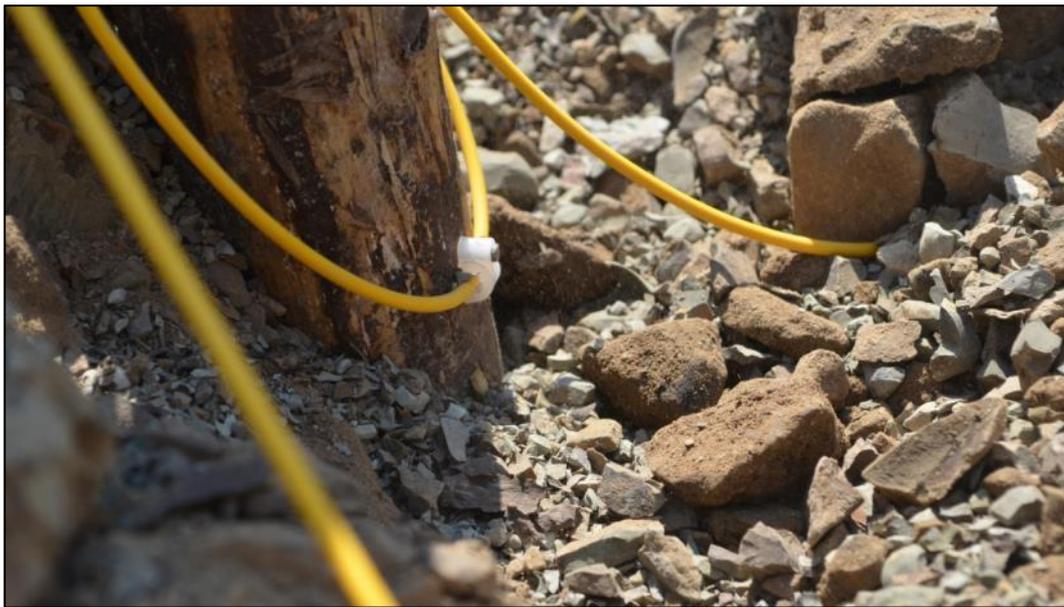
Figure 49: Close up view showing fixing of the cable on a wooden pole

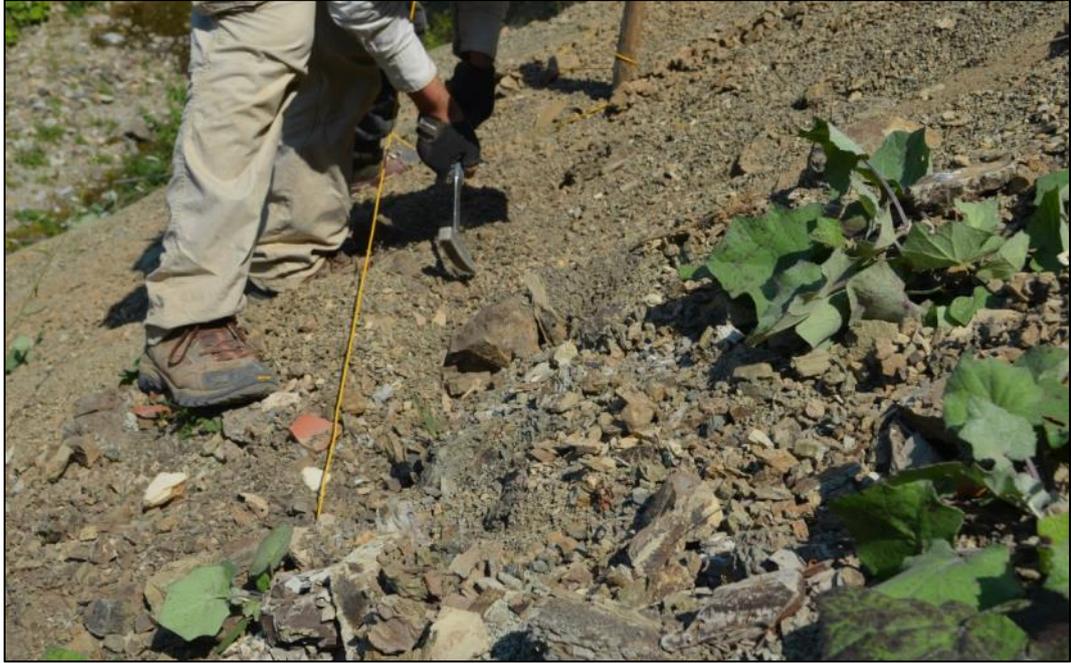
Figure 50: A view of opening stage of guidance channels

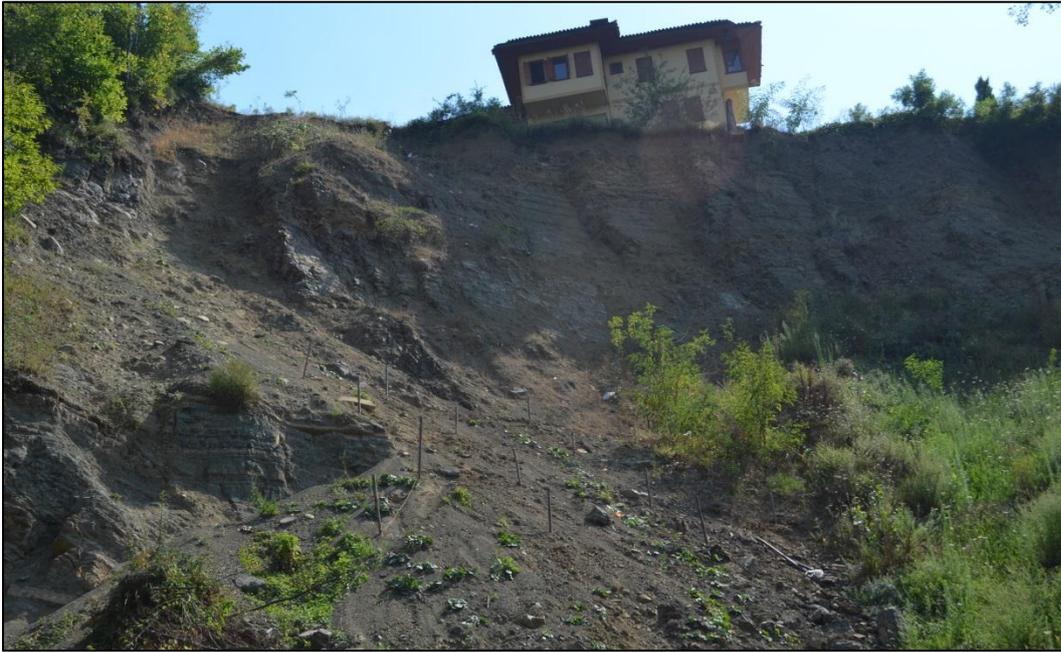
Figure 51: Layout of the deployed fiber cables and fixing points (from toe to scarp)

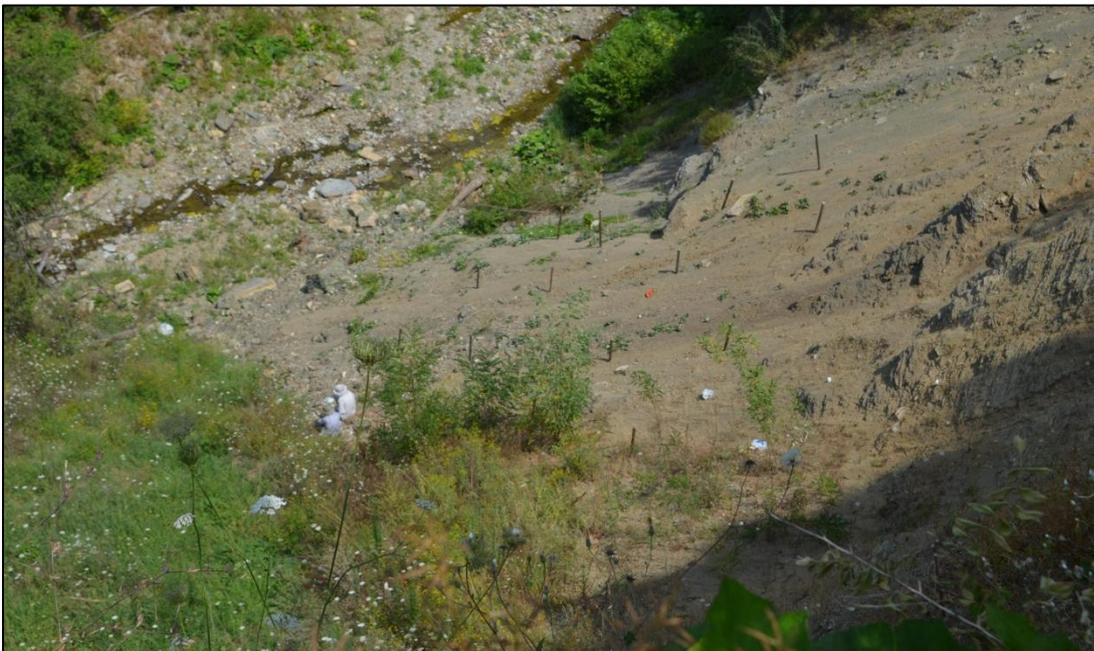
Figure 52: Layout of the deployed fiber cables and fixing points (from scarp to toe)

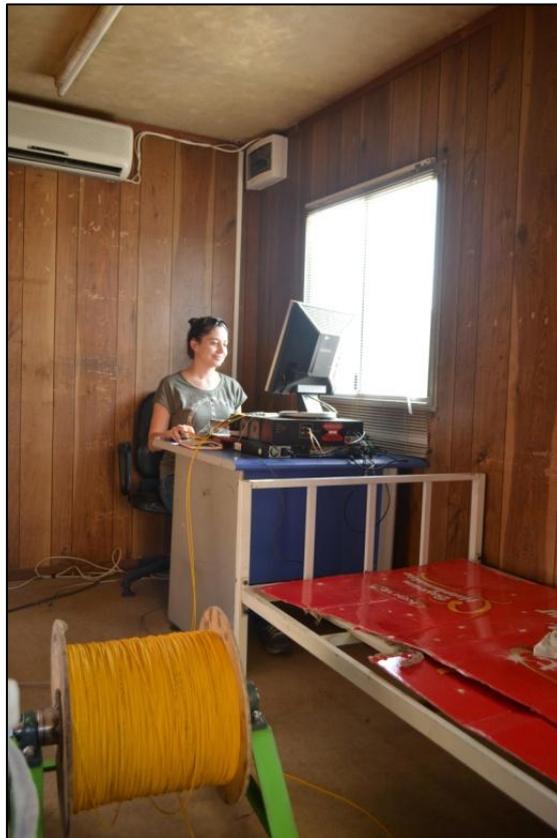
Figure 53: The monitoring unit of the field set up in the container

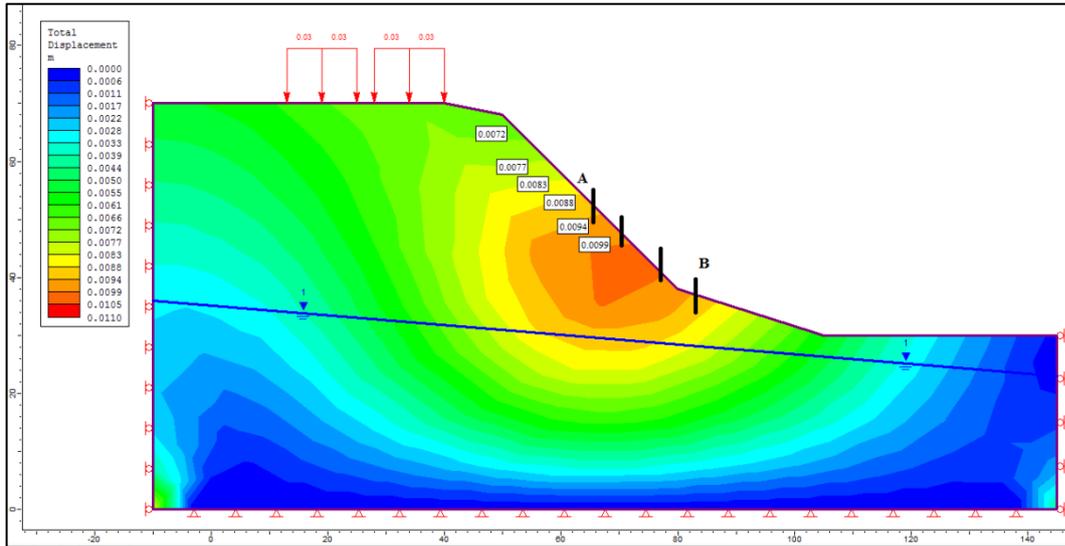
Figure 54: Landslide geometry shown together with deformation contours and cable fixing points

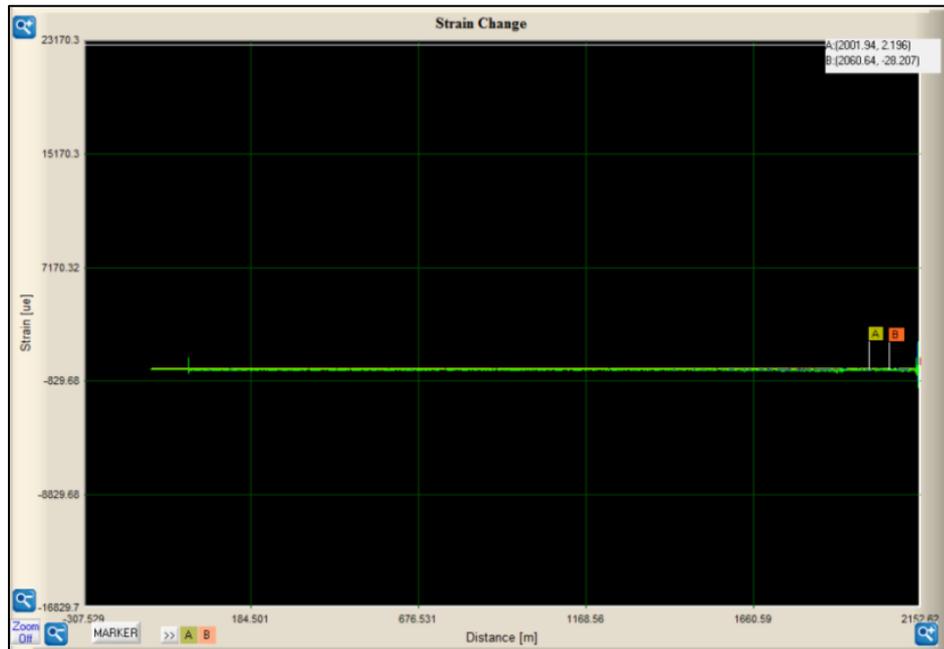
Figure 55: Baseline measurement of the whole cable

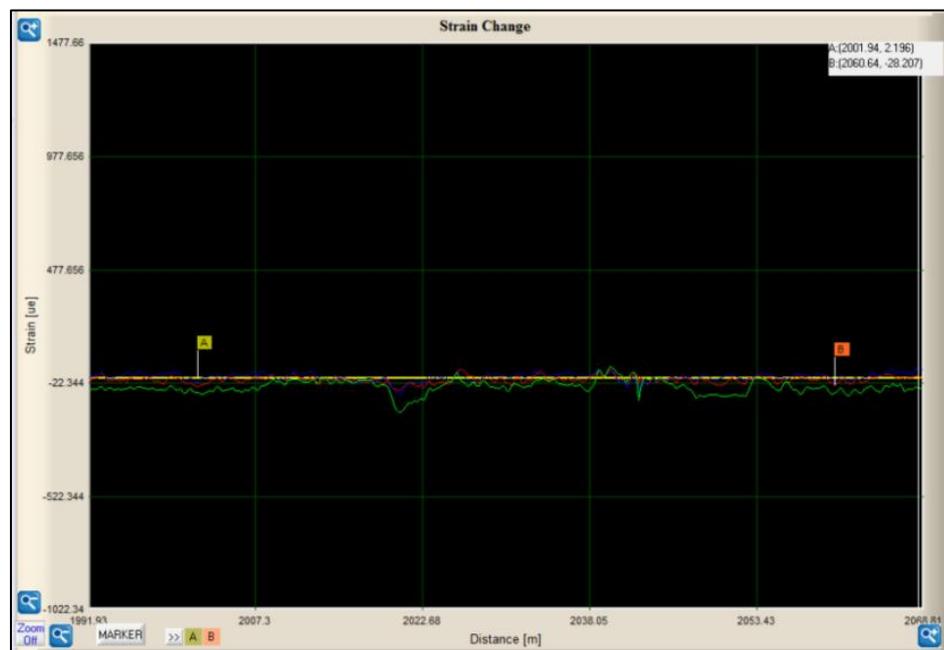
Figure 56: A close up view of the related portion of the cable along with the representative daily measurements taken during three days
