STRUCTURAL ANALYSIS, EVALUATION AND STRENGTHENING OF THE  
TEMPLE OF AUGUSTUS IN ANKARA

A THESIS SUBMITTED TO  
THE GRADUATE SCHOOL OF NATURAL AND APPLIED SCIENCES  
OF  
MIDDLE EAST TECHNICAL UNIVERSITY

FEBRUARY 2016

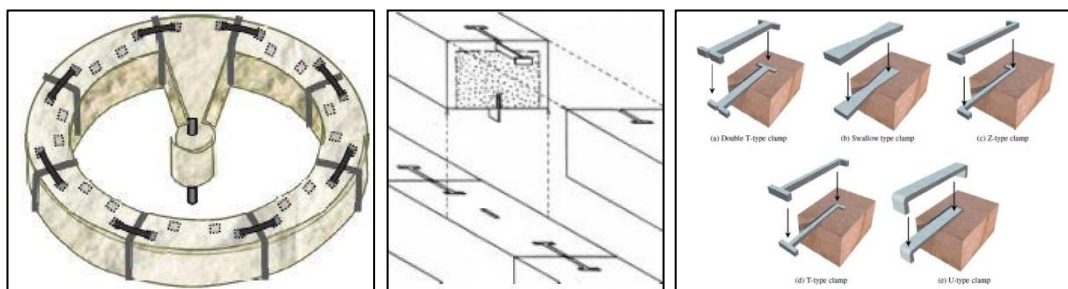
**Figure 1.7:** Various types of dowels and clamps, used in various types of structures. From *Seismic Performance of Historical and Monumental Structures*, H. Sezen and A. Dogangun, 2012

Traditionally, dowels were used to provide stability in the vertical direction while clamps were employed in the horizontal direction (Figure 1.7). Before the usage of iron; these connectors were made of wood, bronze and lead. However, most frequent material of choice was iron, which is, despite being stronger than other materials, prone to corrosion. Corroded iron expands, which causes serious damage in the masonry units. In order to prevent iron from corroding, molten lead was poured in the area surrounding the iron connector, in order to serve as a barrier

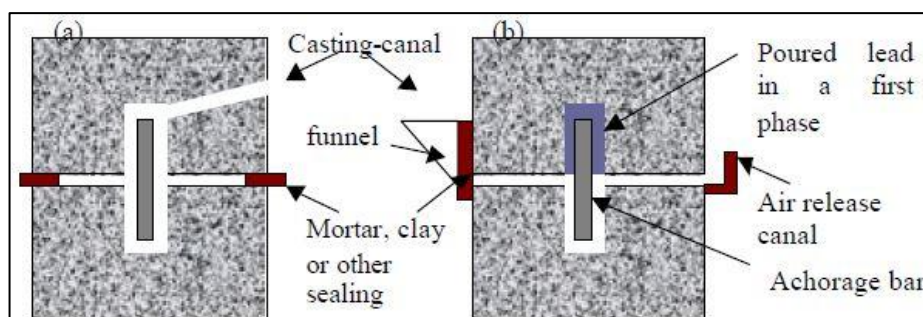
**Figure 1.8:** Different methods employed in the joint realization. From *Metal anchors in lead, fundamental approach and alternatives*, Schueremans et al, 2003

In general there were two different methods employed in the execution of joints. In the first one (Figure 1.8, (a)) a canal to cast the molten lead is drilled in the upper stone, the upper stone is laid upon the lower stone with the dowel in between, then the lead is poured from the canal. In the second method (Figure 1.8, (b)), the upper stone is placed upon the lower one after the dowel is placed into the hole with lead encasing, a gap between the two stones and a canal for the air to leave is provided, and then with the help of a funnel, molten lead is poured in between the stones (Schueremans et al, 2003).

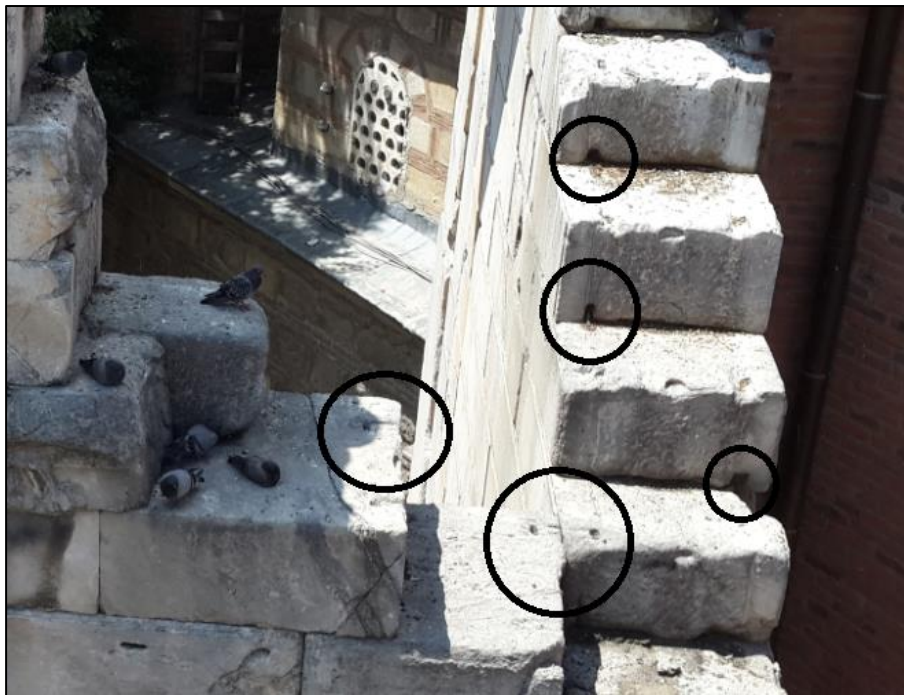
**Figure 1.9:** Marks showing the application of Opus Revinctum on the temple

Despite these problems encountered in the production of these type of connections, a proof of the durability and integrity provided by the use of iron clamps can be observed in the number of such historical structures survived to this day, including Parthenon in Athens (447-432 BC), Colosseum in Rome (70-80 BC), Hagia Sophia in Istanbul (573 AD), and many surviving mosques and their minarets from the Ottoman period. Moreover, the frequency of the application of such connectors can be observed in the ruins of Greek and Roman settlements dating back to the period, around the Aegean Sea. The picture given in Figure 1.9 was taken by the author at the Temple of Augustus, showing the marks of Opus Revinctum on the temple blocks at a cracked section.

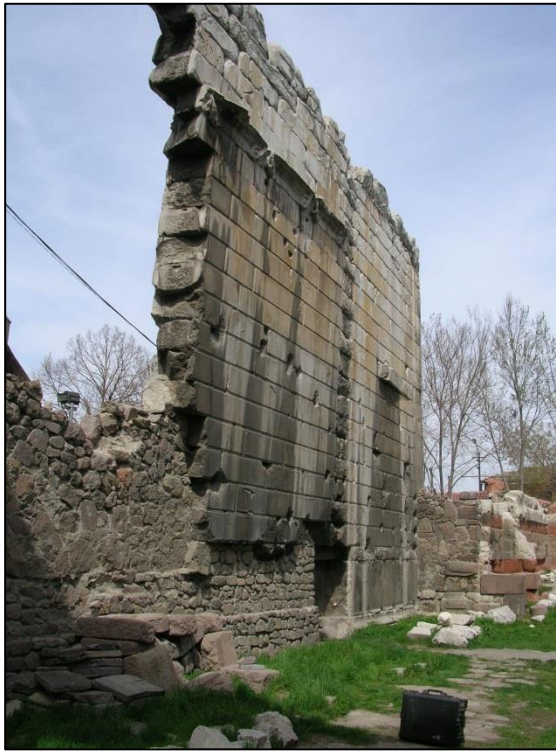
**Figure 1.10:** A pre-intervention system view of the northern isolated wall, showing the extension of the rubble wall beneath it.

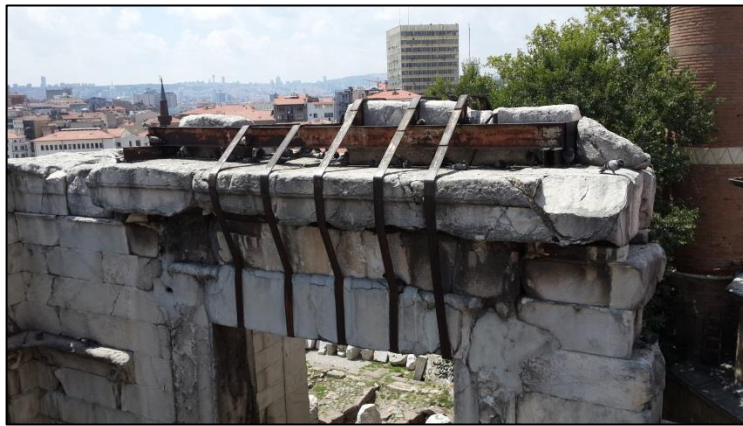
**Figure 1.12:** Door lintel in a deteriorated state. Intervener and the date of intervention are unknown.

replaced with a rubble wall similar to what was mentioned above in some parts; and in other parts blocks of local material (andesite) were used to support the structure. Fortunately, the southeastern wall is connected to the gate section and instability is not a visible risk. The ornate lintel of the gate section is also in a deteriorated state, where an earlier attempt to intervene with metal strips, is visible. Its balance is prone to be disturbed by a slight external effect, and this may lead to its loss with a collapse (Figure 1.12).

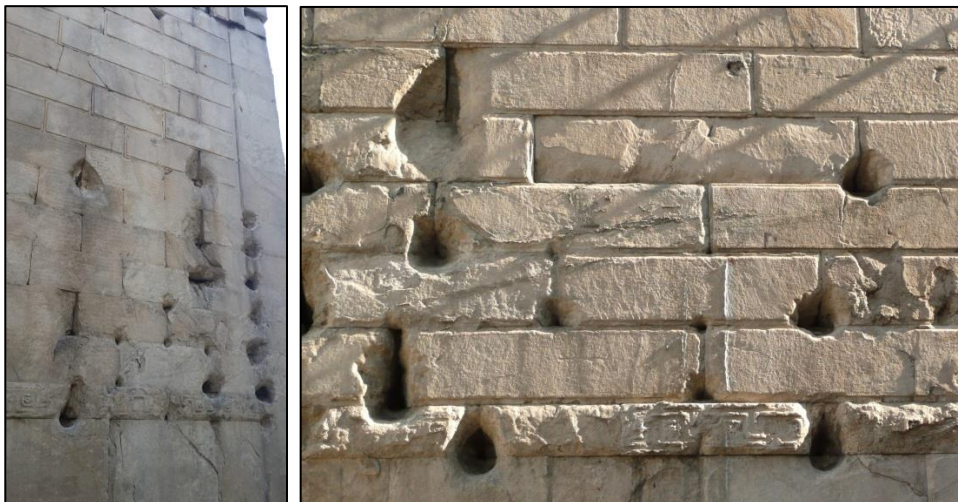
**Figure 1.13:** Drilled holes on the walls

In addition to the aforementioned local defects, all around the structure there are holes on the walls, especially at the intersections of masonry blocks, caused by uncertain reasons. They may have been drilled by treasure hunters in pursuit of iron clamps or the encapsulating lead. Another cause may be the expansion of iron connectors as a result of corrosion (Figure 1.13). Furthermore, as a result of two thousand years of exposition to adverse effects of the atmosphere, all round material degradation can be observed on the blocks.

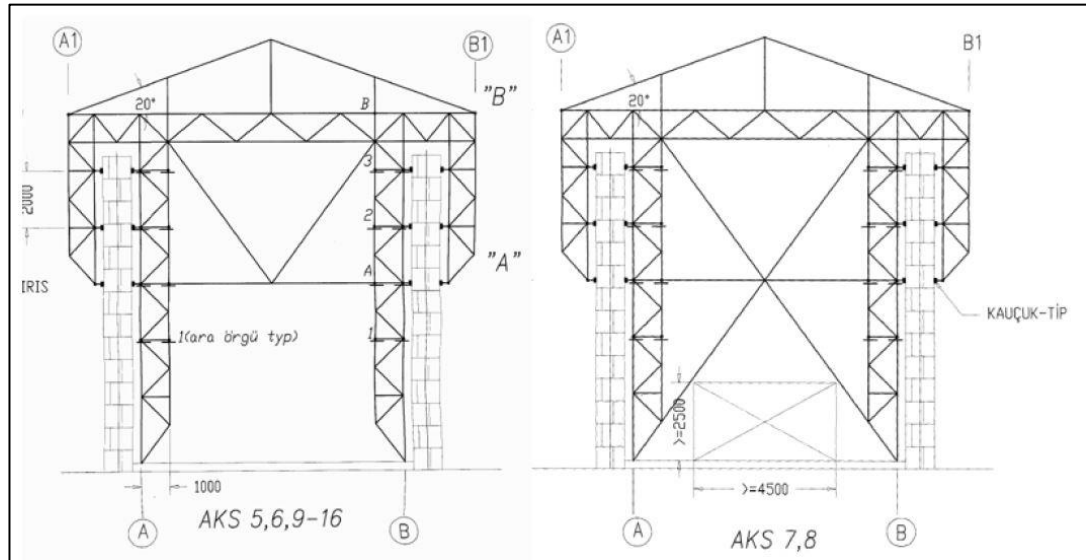
**Figure 1.14:** Emergency intervention system, viewed from different axes.

foundation blocks were selected as 50cm x 50cm cross-sectioned blocks extending from one lateral wall to the other. A view of the system from different axes is provided in Figure 1.14.

This system also features rubber pads at the protruding ends of the truss, originally designed not to get in contact with the walls themselves. Unfortunately, while the design was progressing with academic support from Middle East Technical University, the construction was started without the final consent of the supporting professors, leading to a number of problems uncalled for in the original design. The rubber pads, designed not to be in contact with the walls, were built contacting them, affecting the walls' behavior. Contrary to the academic advice, Portland cement was used in the foundation blocks, which may lead to material degradation of the temple walls surrounding and beneath it. Moreover, the roof of the system seen in the Figure 1.14 was not built, leading the further exposition of the temple and the inscriptions outdoor conditions such as acid rains and snow.

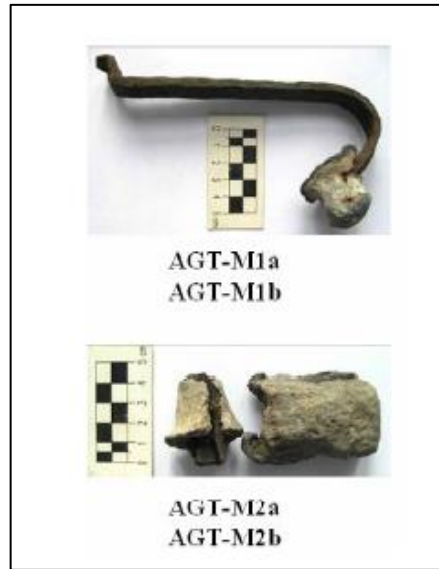
**Figure 1.15:** Iron connector samples from the Temple of Augustus. From *Augustus Tapınađı 2008 Yılı Arkeometrik alıřmaları*, Y. K. Kadiođlu & A.A. Akyol, 2008.

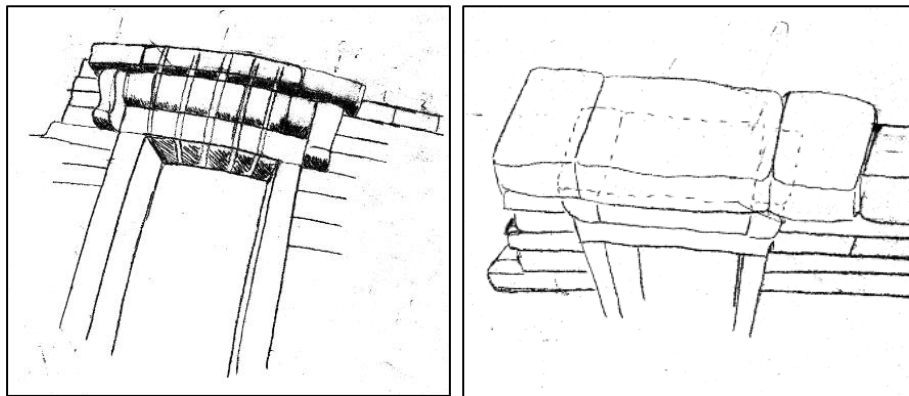
**Figure 1.16:** Discretization of the ornamented gate lintel

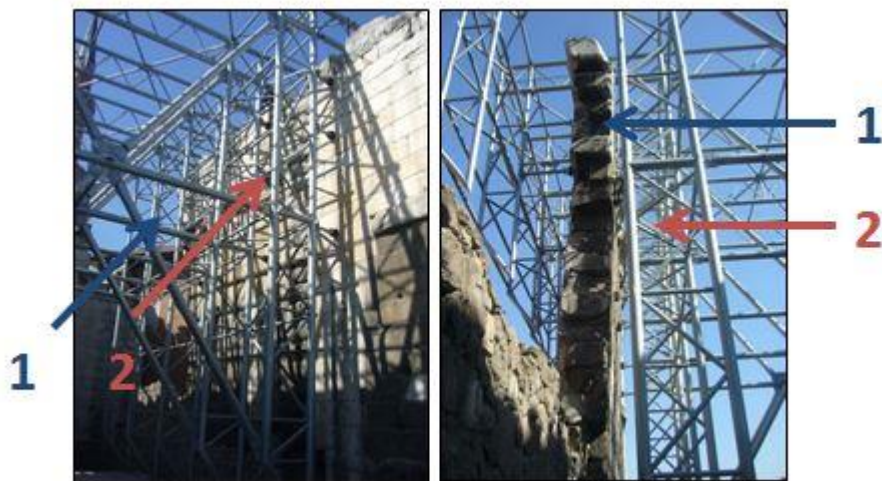
**Figure 2.1:** Tiltmeter locations

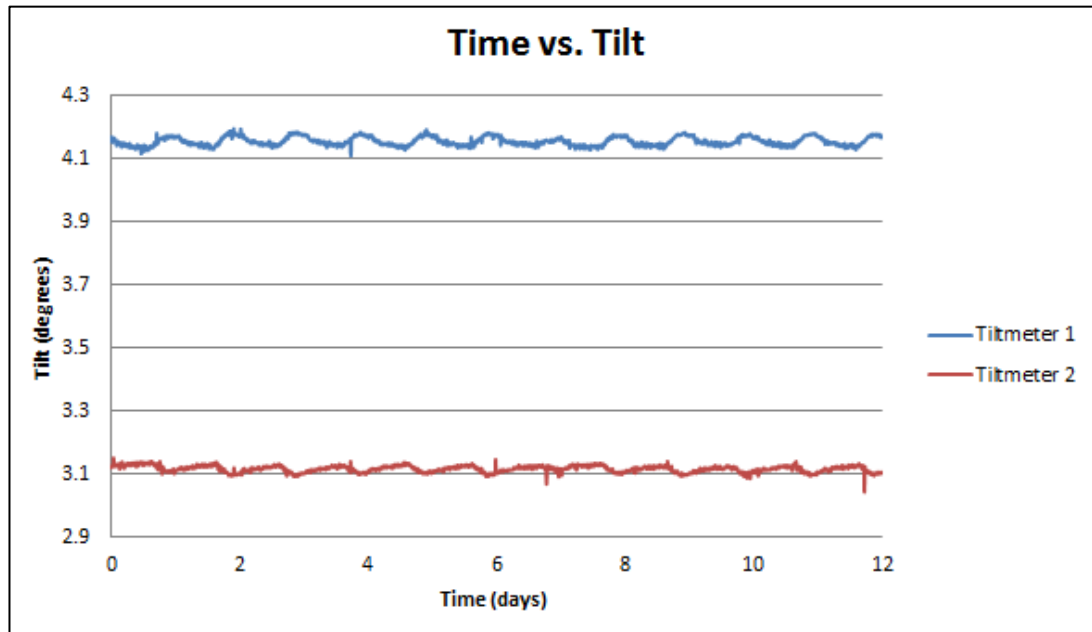
**Figure 2.2:** Time vs. Tilt graph between 29.07.2010 - 10.08.2010

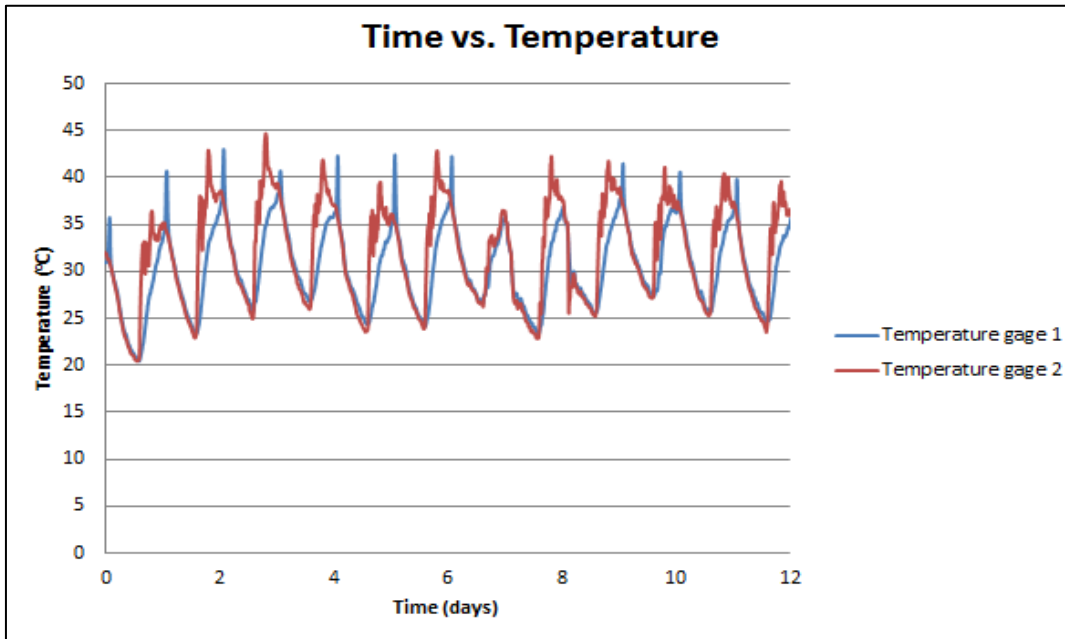
**Figure 2.3:** Time vs. Temperature graph between 29.07.2010 - 10.08.2010

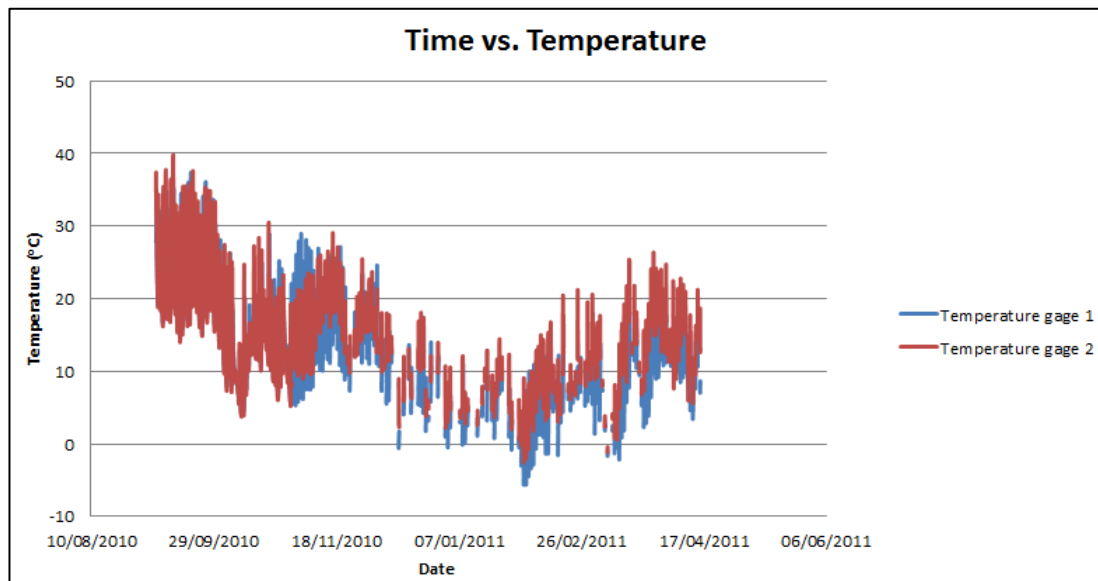
**Figure 2.5:** Time vs. Temperature graph between 05.09.2010 - 15.04.2011

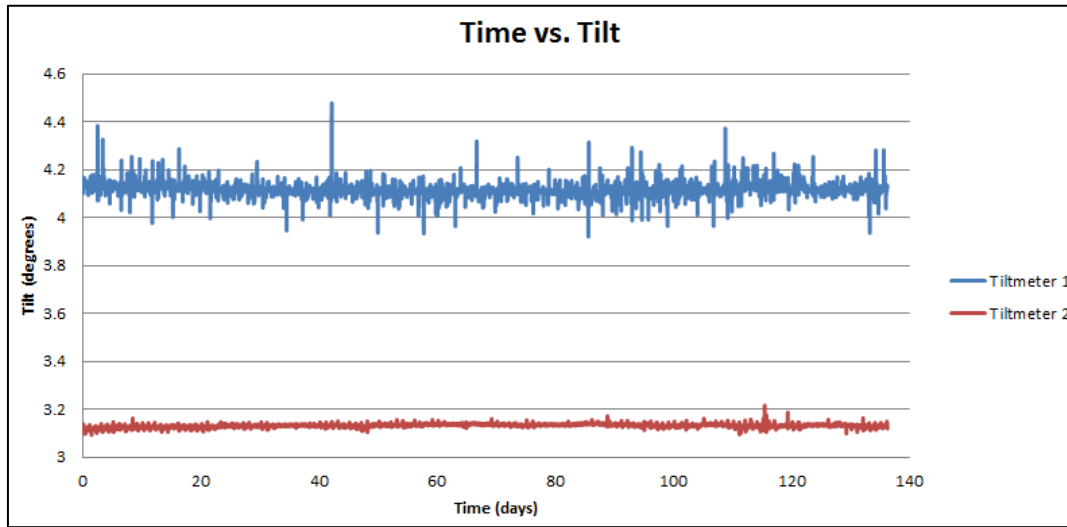
**Figure 2.6:** Time vs. Tilt graph between 16.10.2012 - 01.03.2012

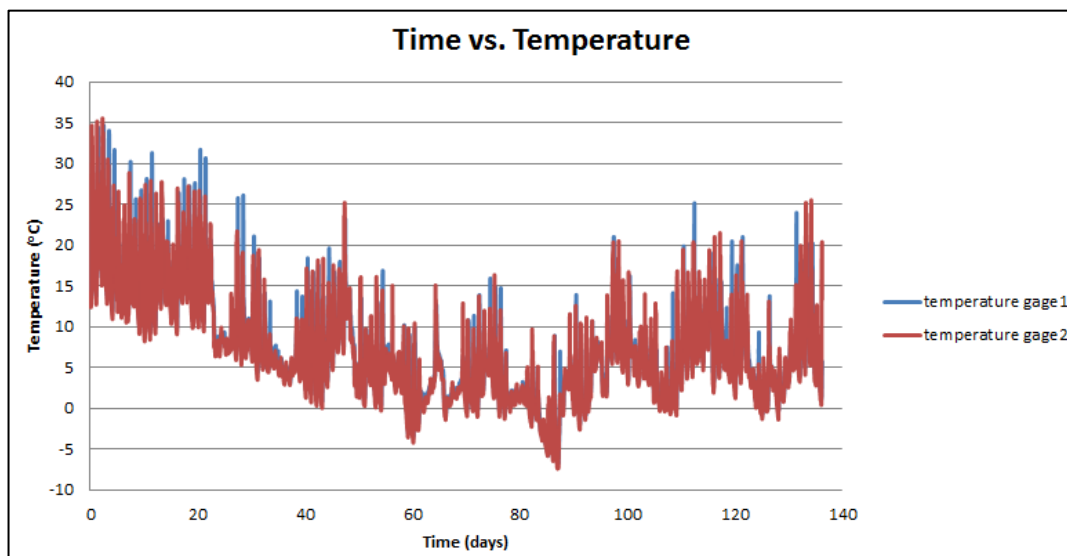
**Figure 2.7:** Time vs. Temperature graph between 16.10.2012 - 01.03.2013

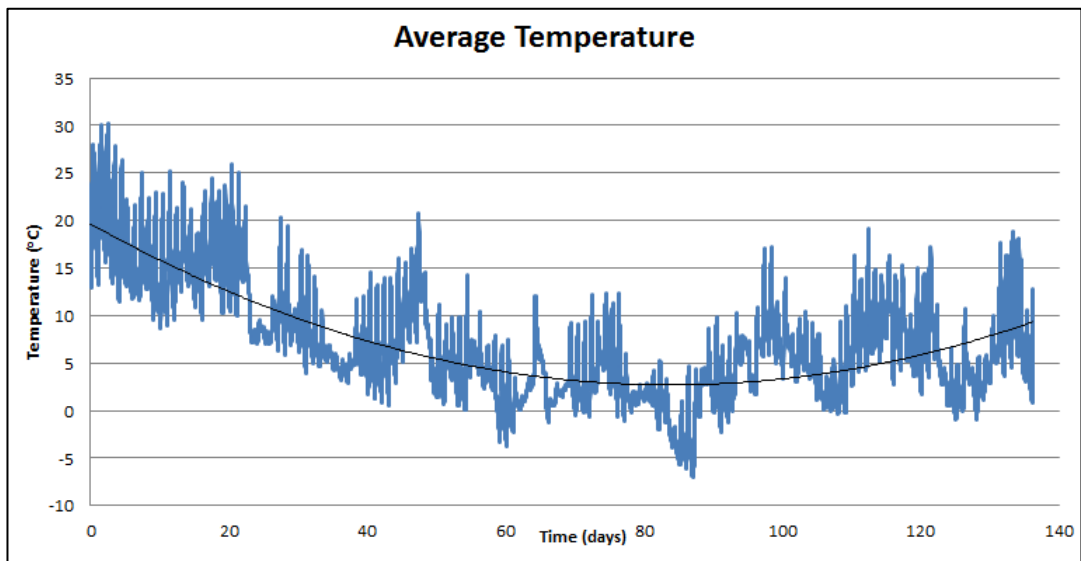
**Figure 2.8:** Average temperature with a polynomial trend line in this time interval

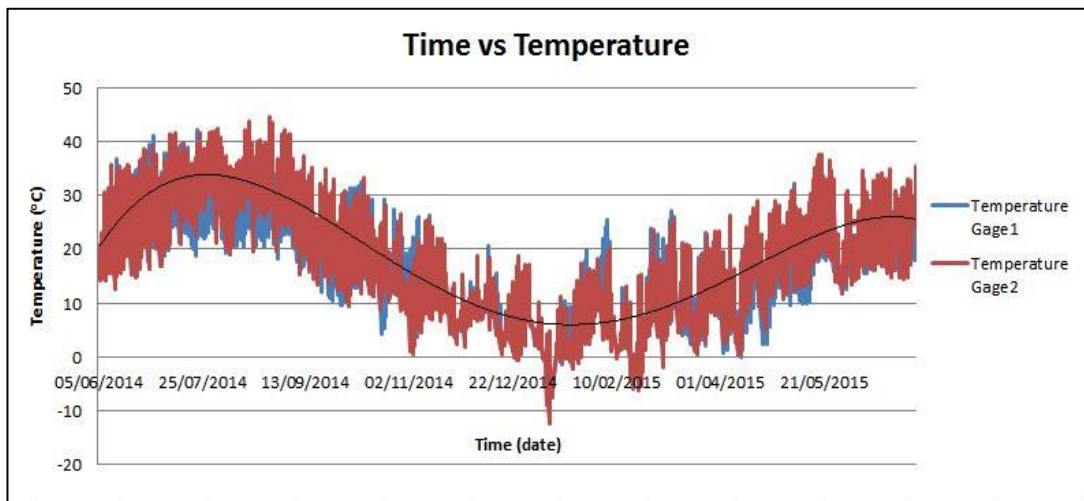
**Figure 2.11:** Time vs Temperature for the time period between June 6<sup>th</sup>, 2014 – July 7<sup>th</sup>, 2015, making a full yearly cycle.

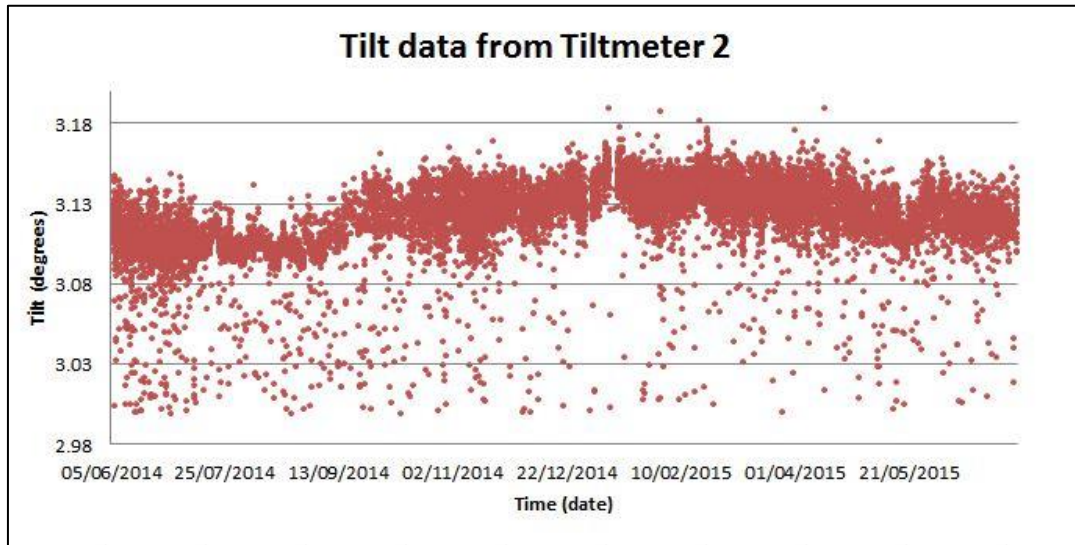
**Figure 2.13:** Tilt data obtained from tilt meter 2 between dates June 6<sup>th</sup>, 2014 – July 7<sup>th</sup>, 2015

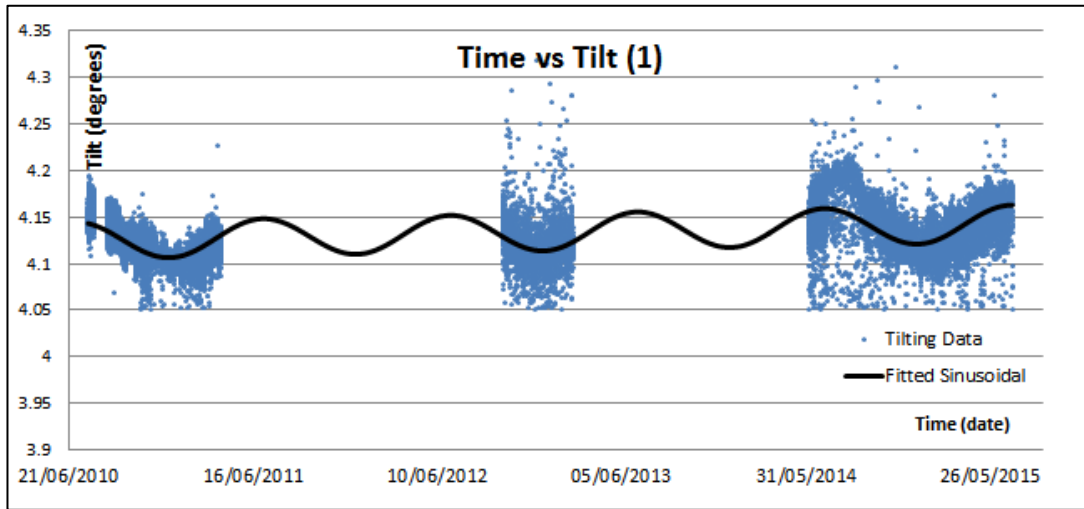
**Figure 2.14:** All tilting data collected from tiltmeter 1 with a fitted sinus curve. Curve's equation is  $y=10*(10^{-6})*(t)+4.125+0.02*\sin(2*\pi/365*((t)-250))$  where  $t$  stands for elapsed number of days

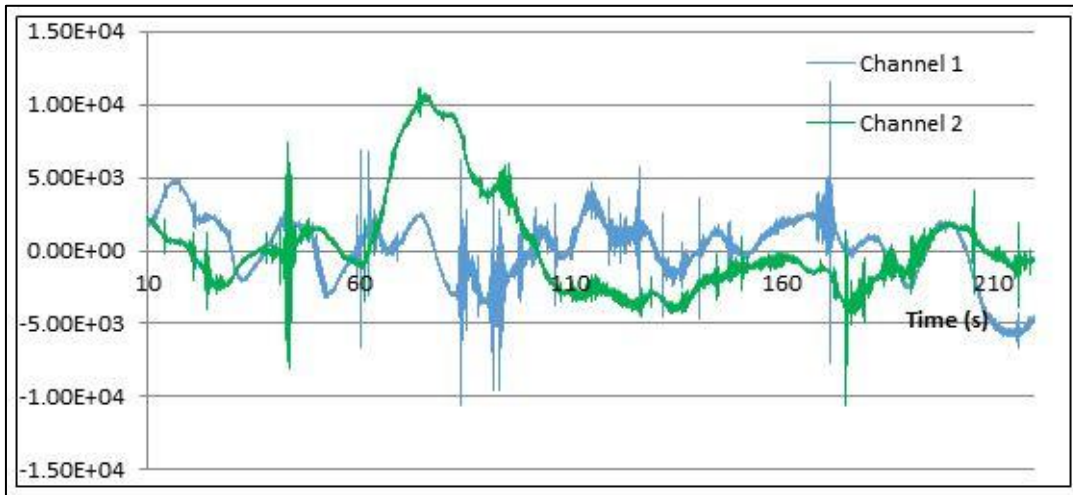
**Figure 2.21:** 3.5 minute measurement taken at the top of the wall with two accelerometers. It contains more than 550000 data points.

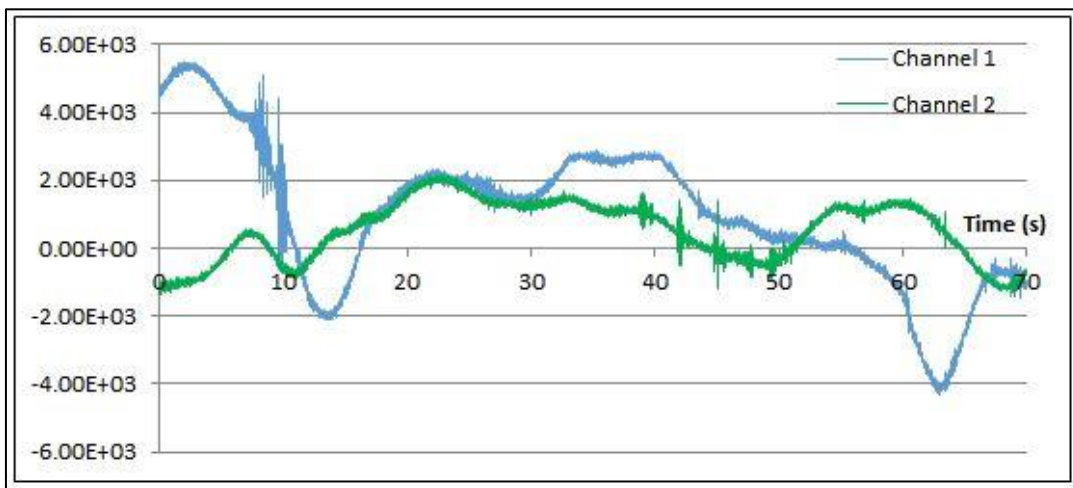
**Figure 2.22:** Second ambient vibration measurement recorded at the top of the Northern isolated wall.

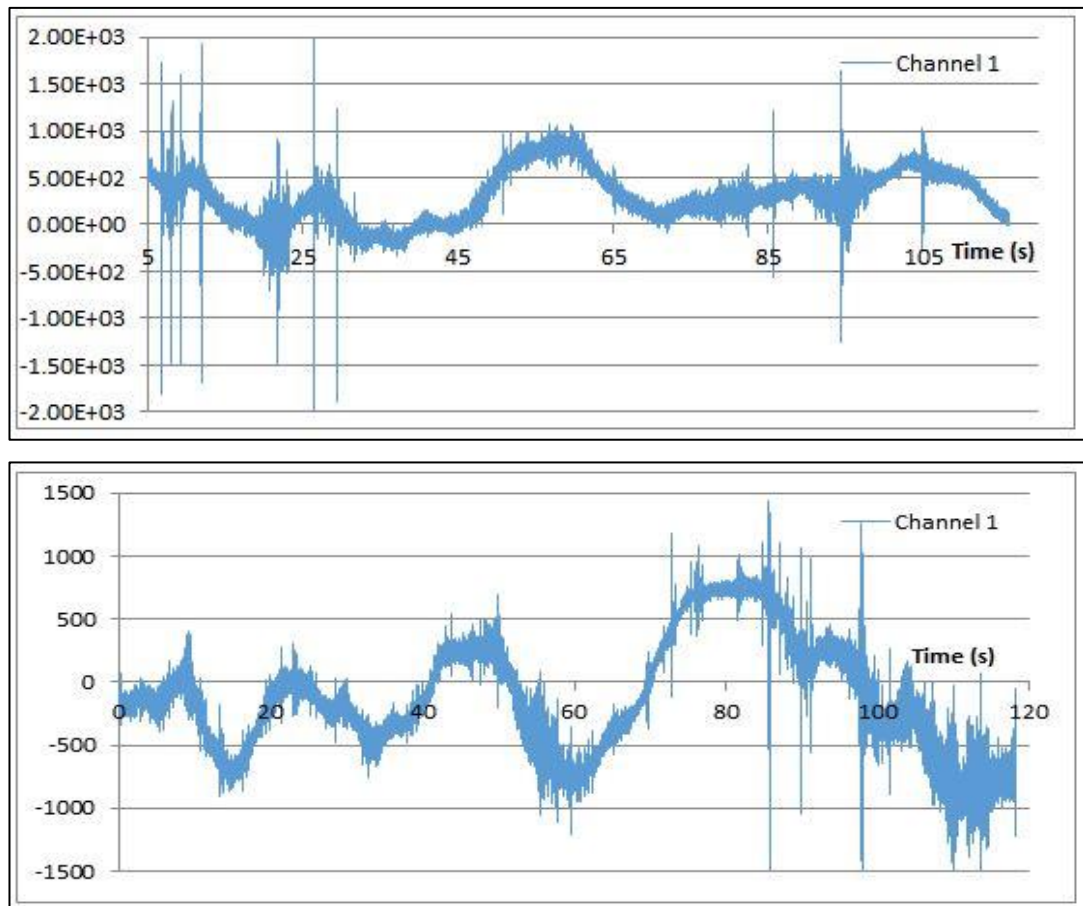
**Figure 2.23:** Measurement taken from the northern wall mid-height (top).  
Measurement record of the southeastern wall (bottom)

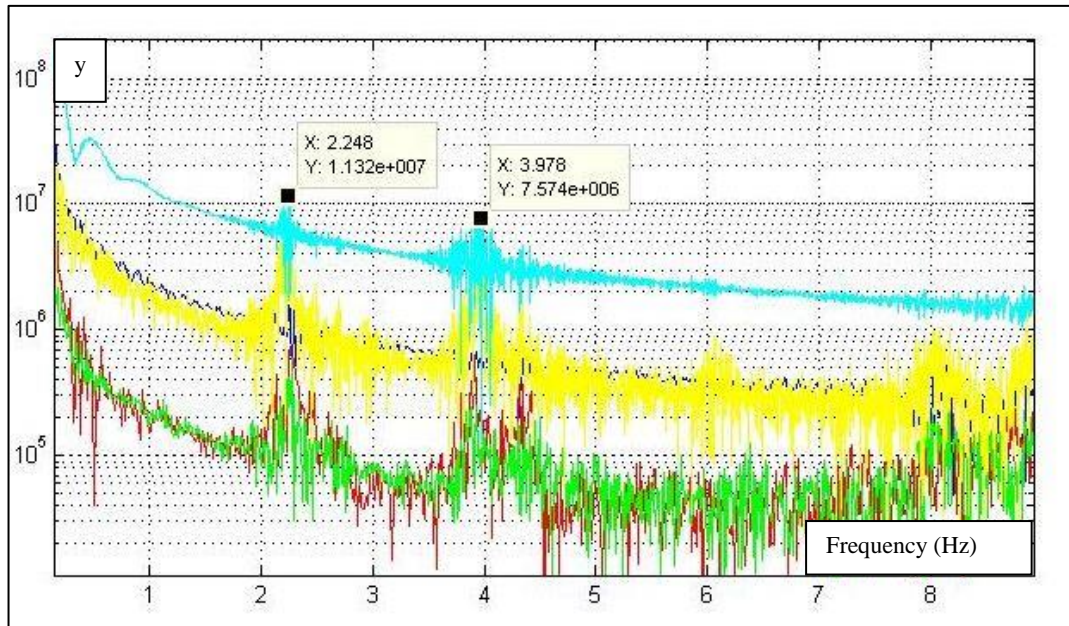
**Figure 2.24:** FFT results for the measurements from the northern isolated wall.

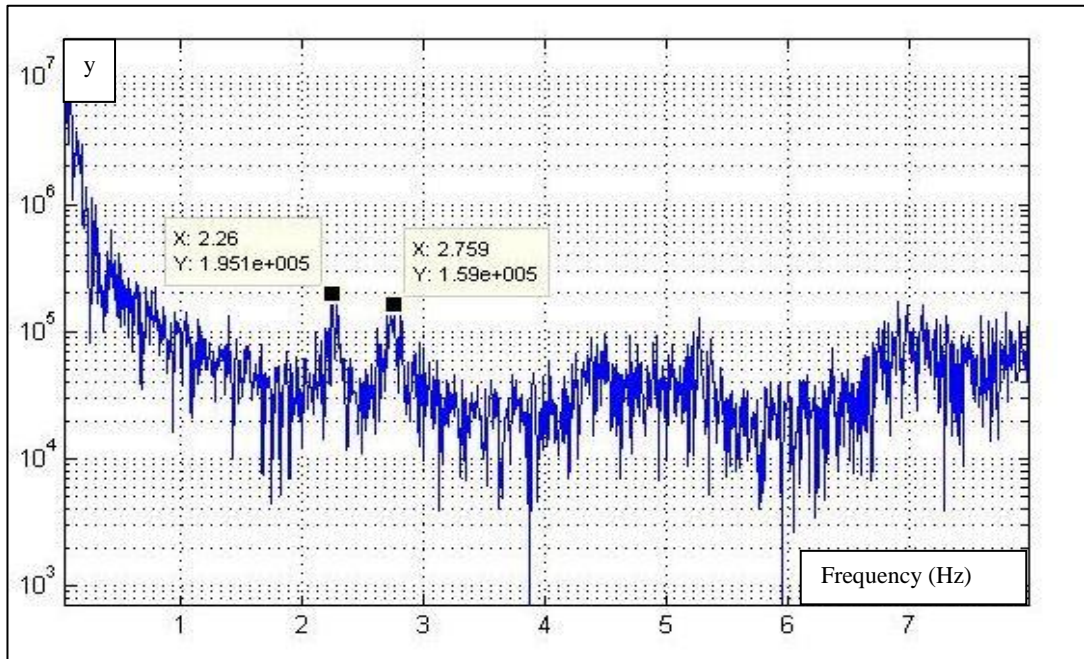
**Figure 2.25:** Southeastern wall measurement data converted with FFT to frequency domain.

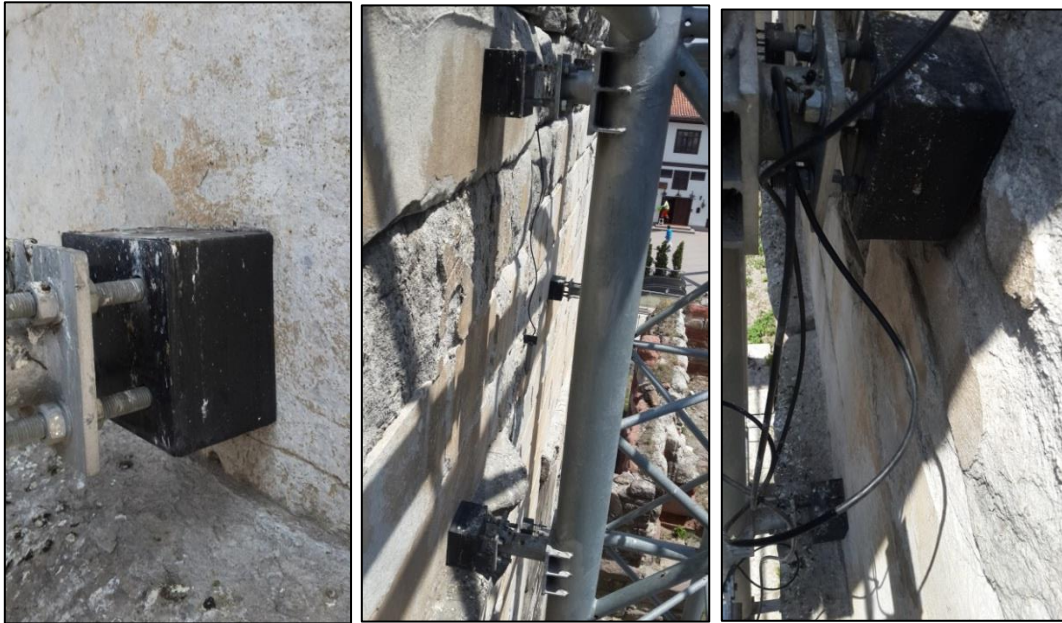
**Figure 2.26:** Rubber pads in contact with wall surface

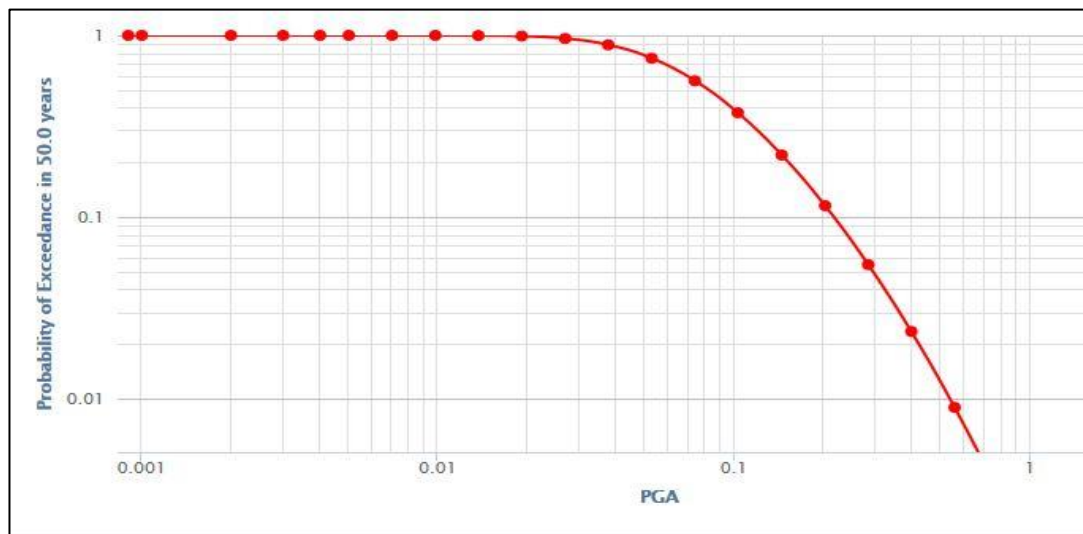
**Figure 3.1:** PGA Hazard Curve for Ulus area in Ankara (obtained from EFEHR Website <http://www.efehr.org:8080/jetspeed/portal>)

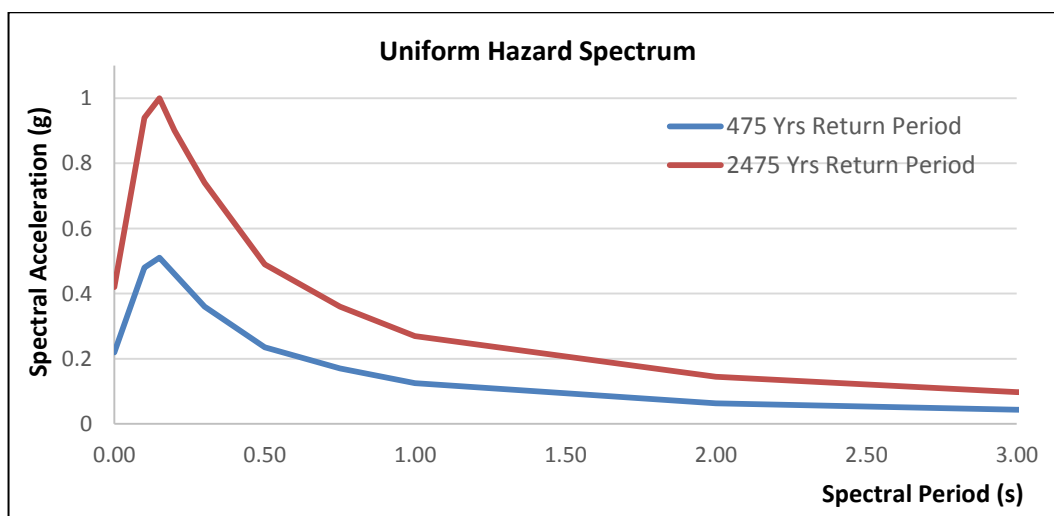
**Figure 3.2:** Uniform Hazard Spectra for 475 and 2475 return periods

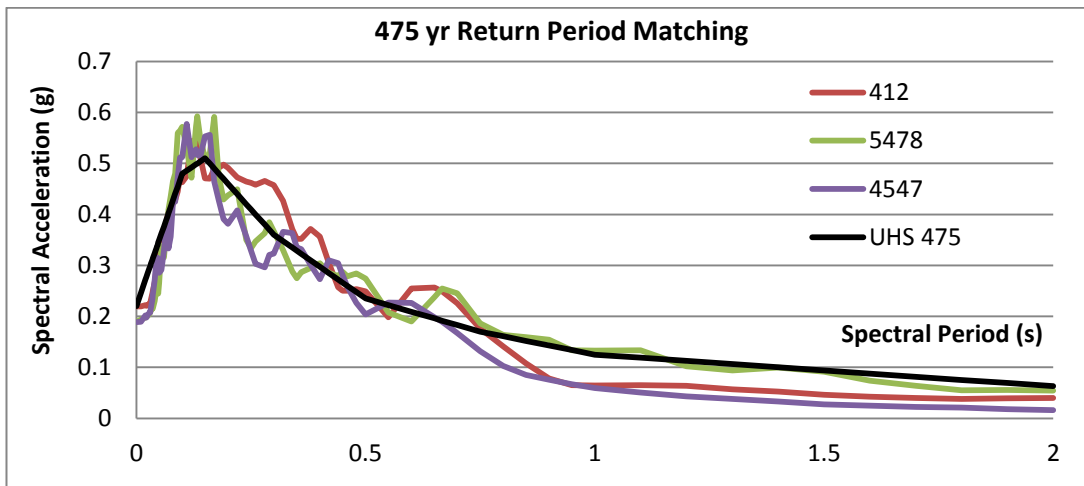
**Figure 3.3:** Matching results for 475 years return period spectrum and the selected ground motions

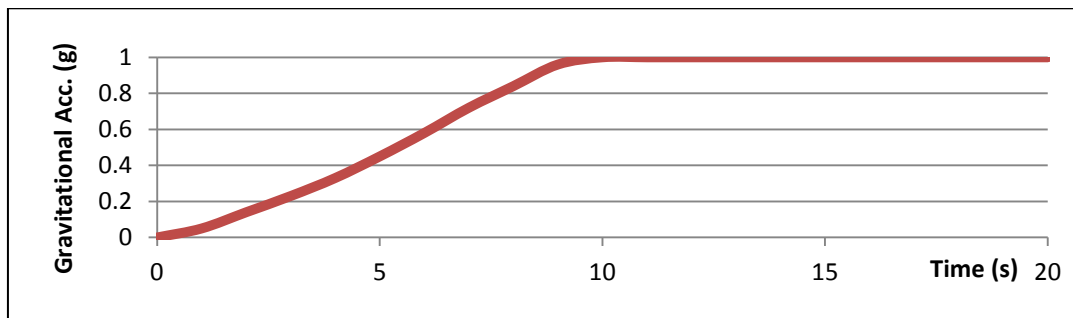
**Figure 3.12:** Time (s) vs Gravitation Acceleration (g) curve applied to the models at the first step

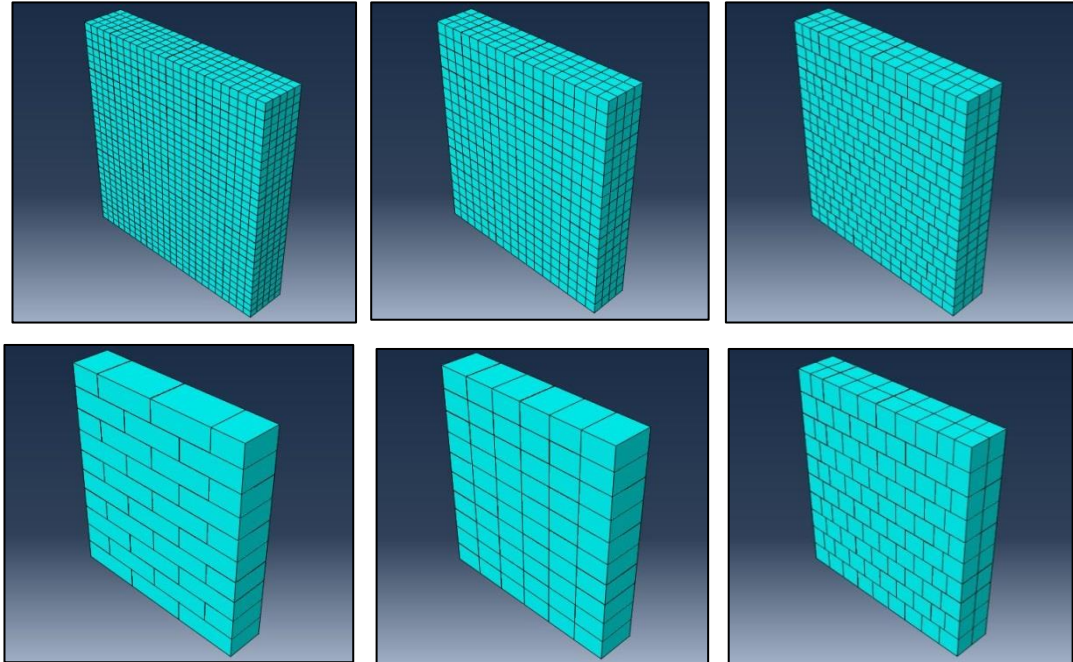
**Figure 3.13:** Various mesh densities applied on the wall, specimens with 0.2m, 0.25m 0.3m, 0.5m, 0.75m and 1.5m densities are displayed here in clockwise direction sequence

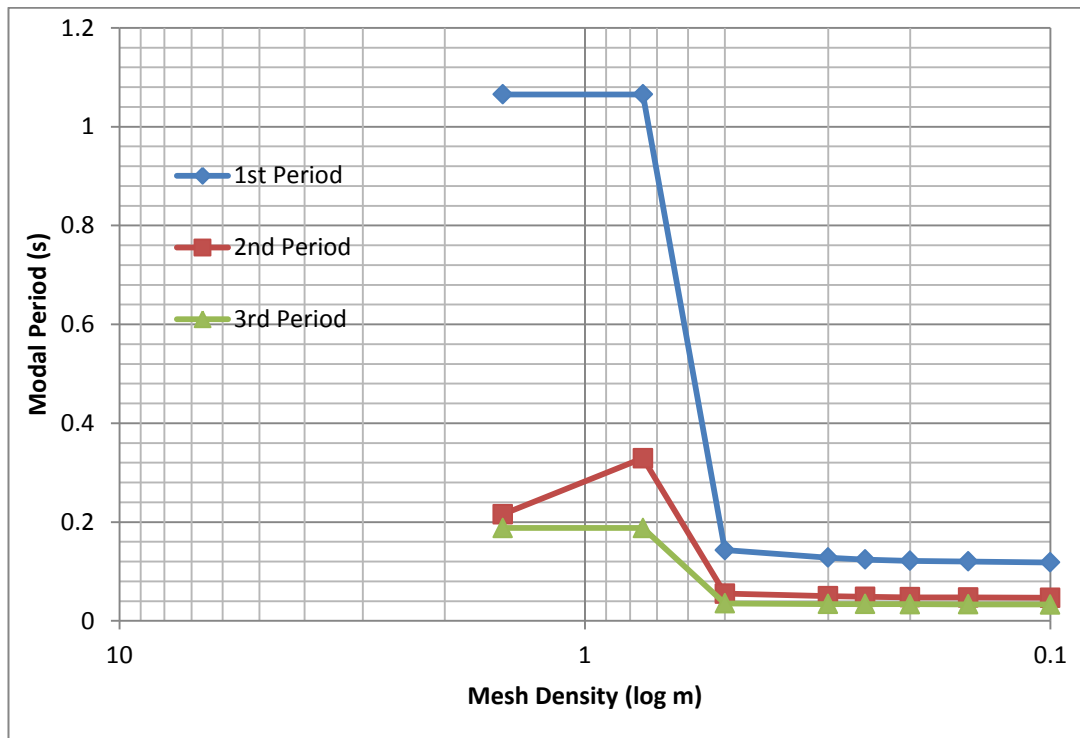
**Figure 3.15 :** Results of modal convergence analysis. Convergence start can be observed at 0.5m mesh density.

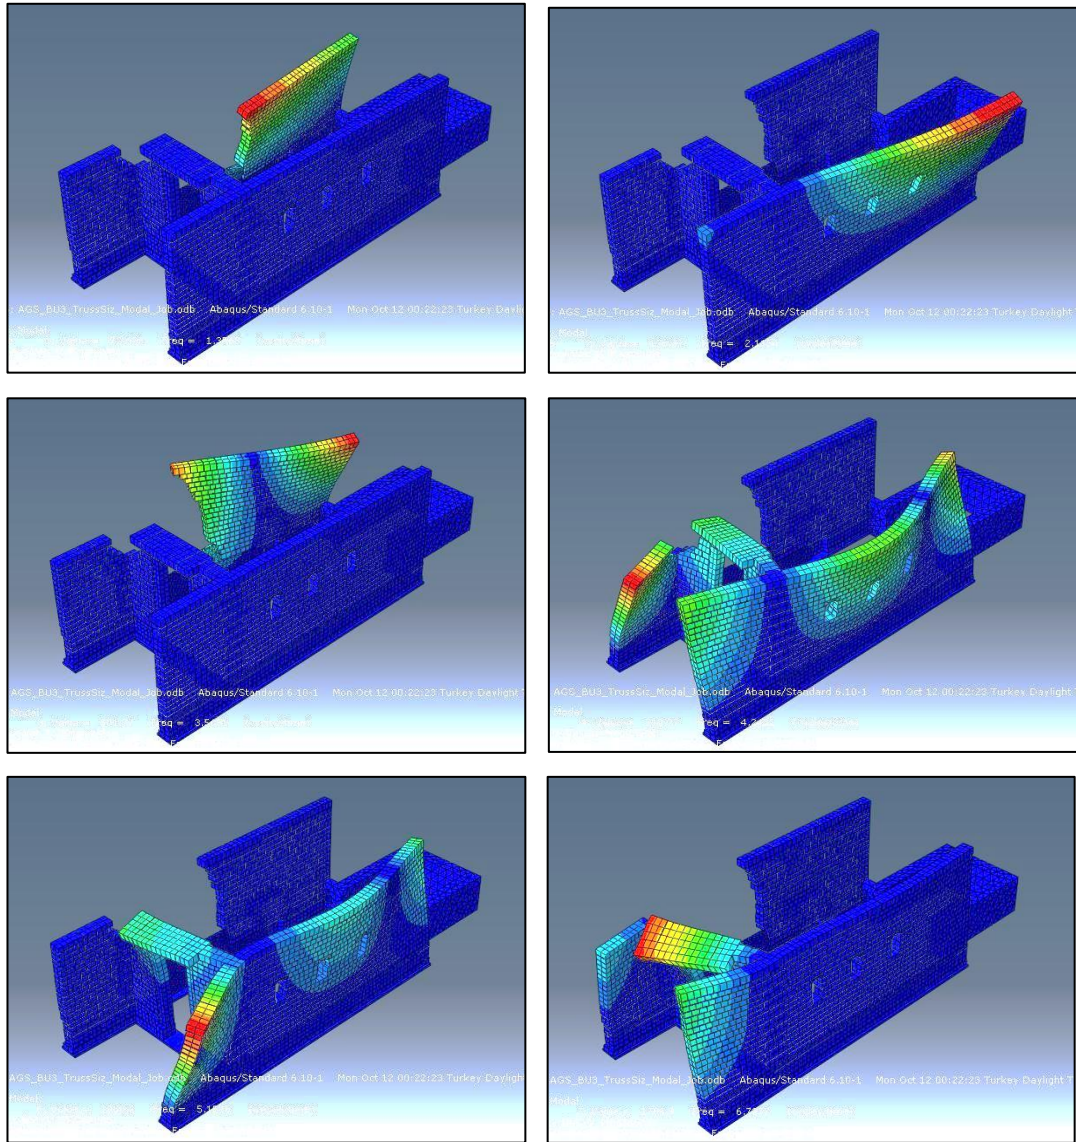
**Figure 3.16:** Mode shapes of the calibrated discrete element model. First mode is on the first row on the left, second mode on the right, third mode on the second row on the left and so on.

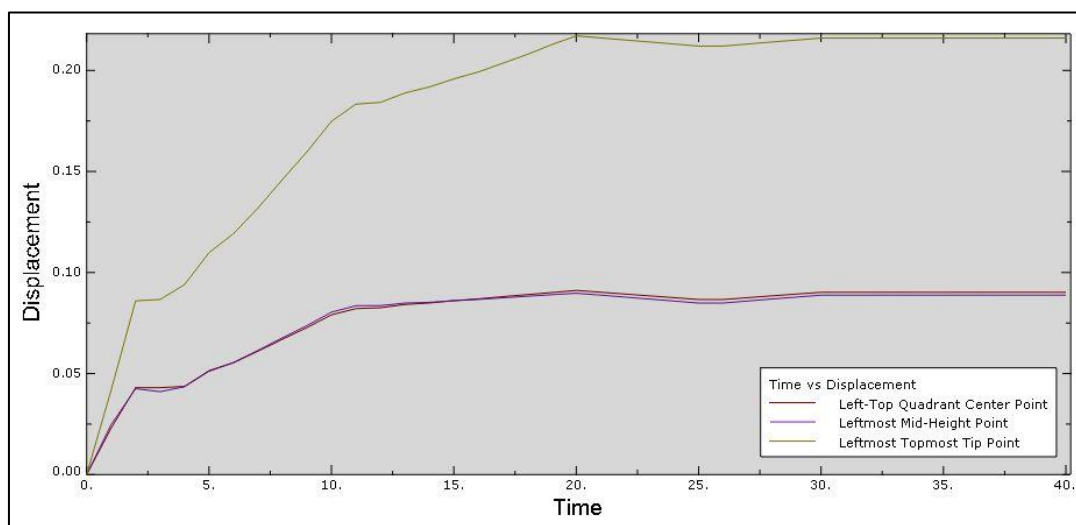
**Figure 3.17:** Time vs. Displacement graph of elements on the northern isolated wall’s tilted end. Displacement of “Left-Top Quadrant Center Point” is from the element whose displacement amount was the main target.

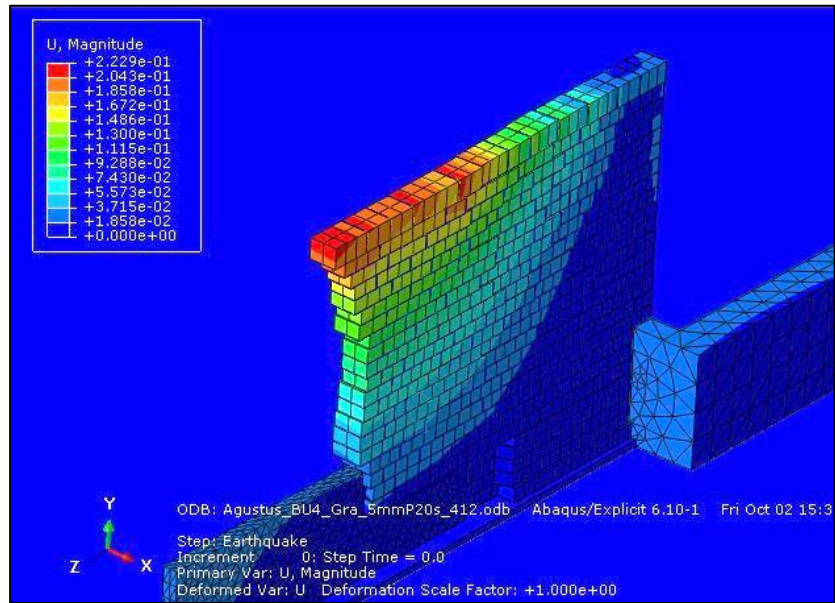
**Figure 3.18:** Northern isolated wall showing 22.29 cm displacement. Unique behavior of the actual wall where it resembles a folding paper leaf is mimicked accurately.

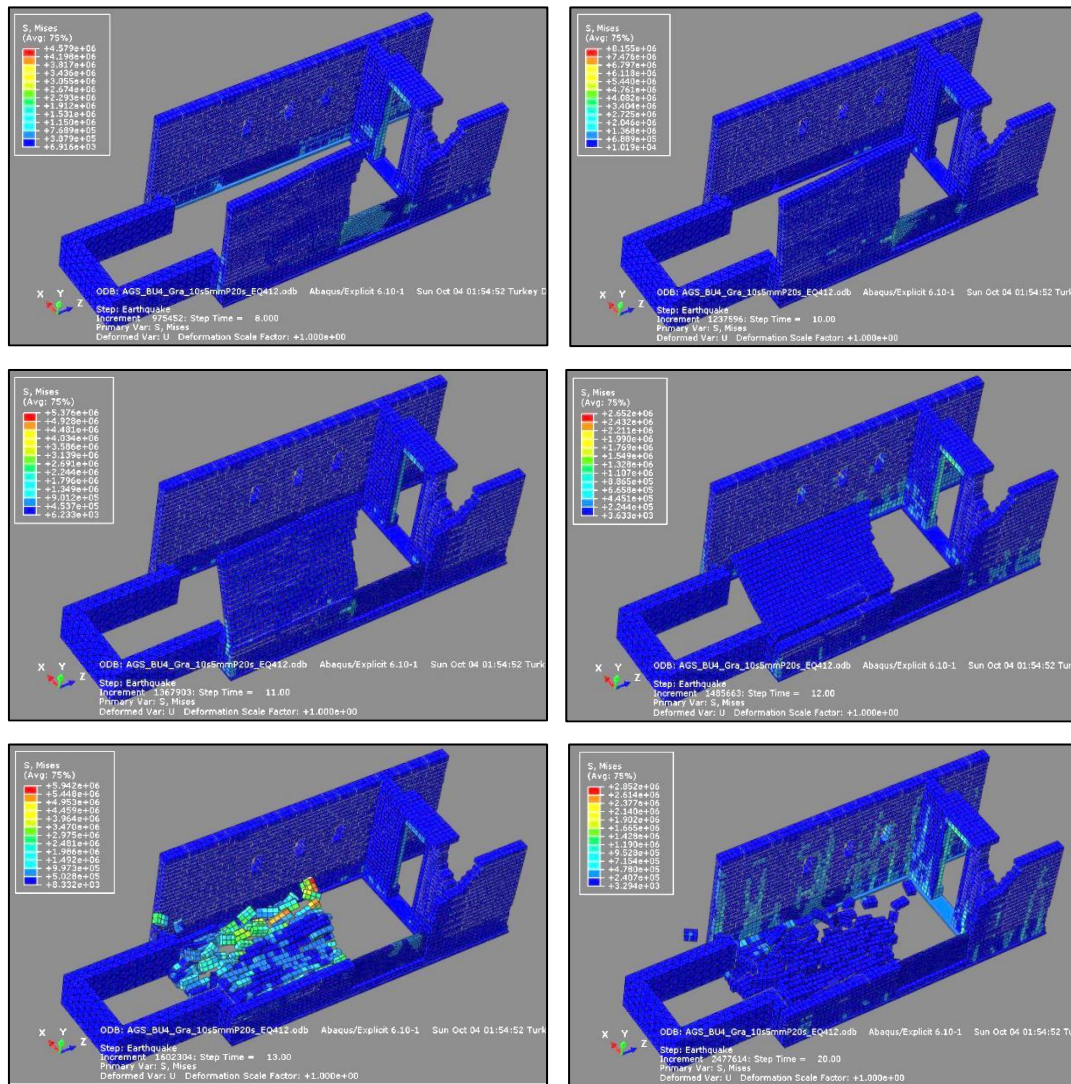
**Figure 3.19:** Collapse of the northern isolated wall as induced by EQ No 412
