STRUCTURAL ANALYSIS, EVALUATION AND STRENGTHENING OF THE  
TEMPLE OF AUGUSTUS IN ANKARA

A THESIS SUBMITTED TO  
THE GRADUATE SCHOOL OF NATURAL AND APPLIED SCIENCES  
OF  
MIDDLE EAST TECHNICAL UNIVERSITY

FEBRUARY 2016

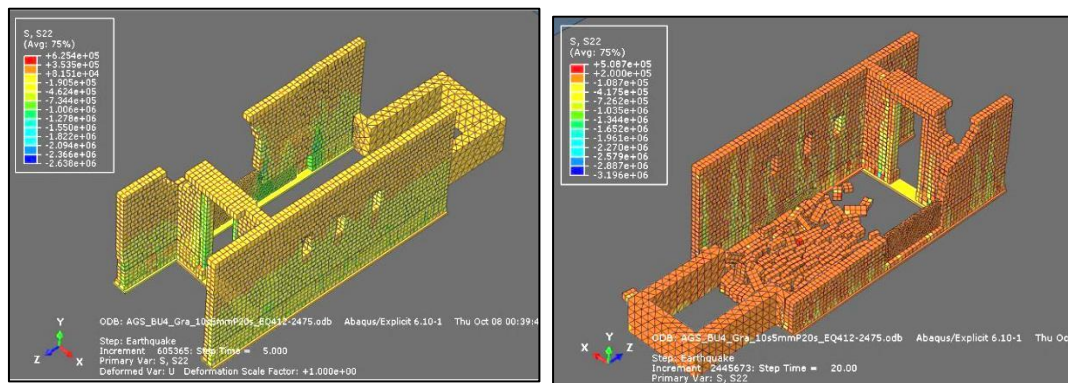
**Figure 3.23:** Vertical stress distributions observed on the model, (left) prior to north wall overturn, the 5th second into the analysis, and (right) at the end of the earthquake excitation.

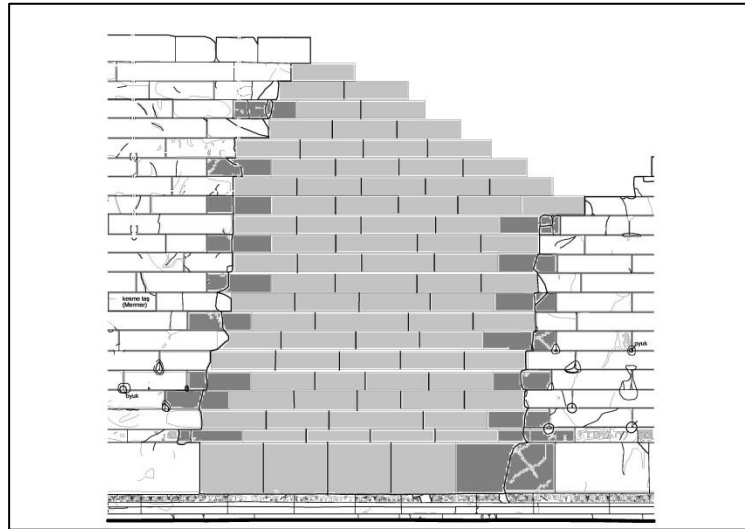
**Figure 4.1:** Reconstruction of the destroyed section of the northwestern wall. Original stones are colorless; those that are patched up are in dark grey and new stones in light grey

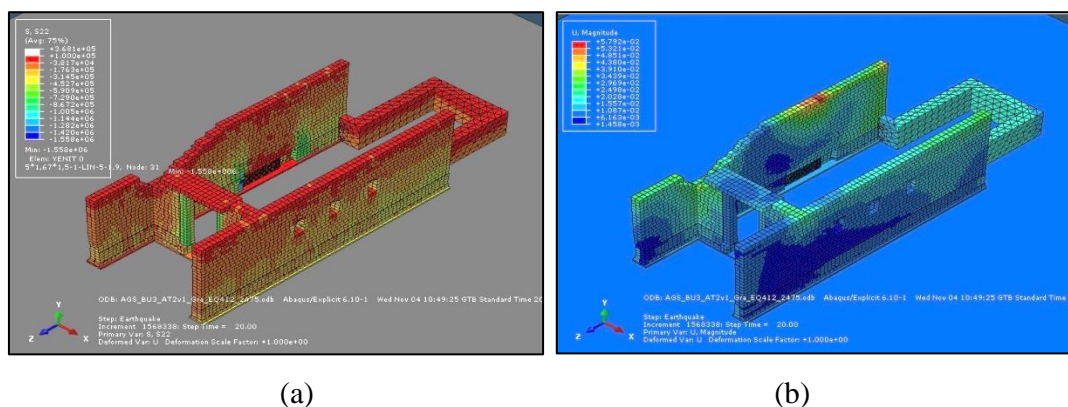
**Figure 4.2:** Analysis results with earthquake no 412-2475, stress distributons (a) and displacements (b).

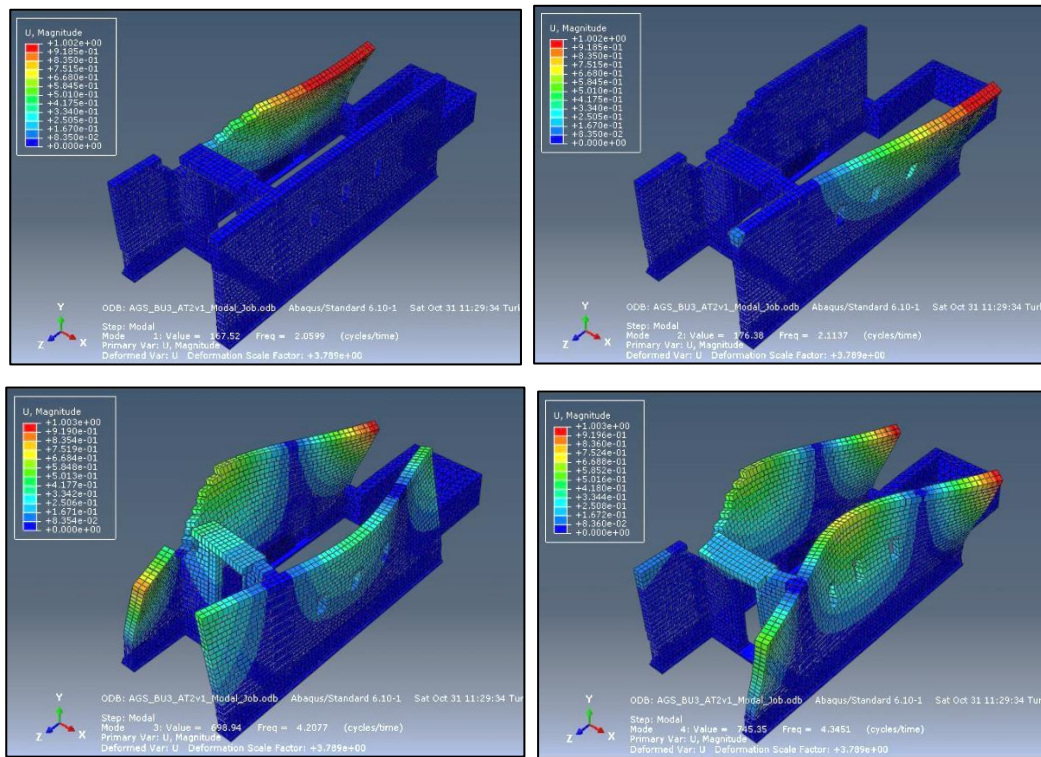
**Figure 4.3:** Mode shapes and modal periods of the model without stone block replacements. Period values are 0.485s, 0.473s, 0.237s and 0.230s.

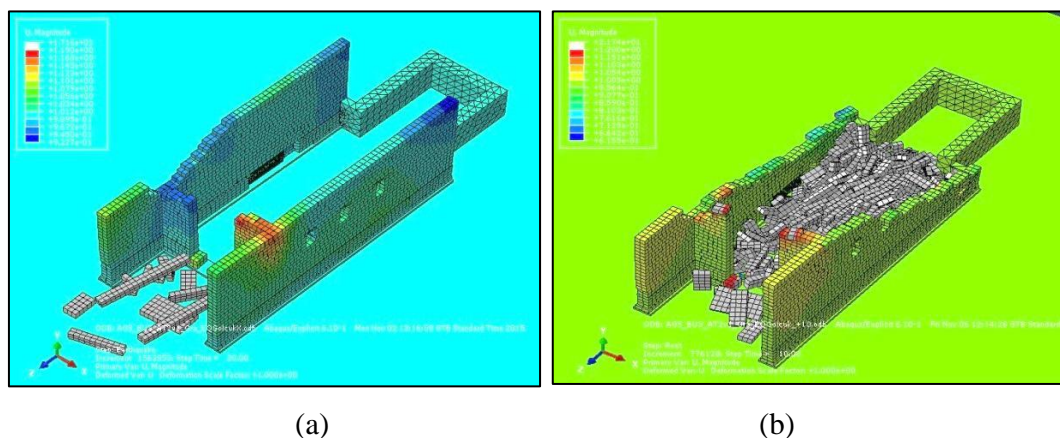
**Figure 4.4:** Application of Izmit 1999 earthquake record. Lateral walls maintain integrity (a) and collapse almost completely (b).

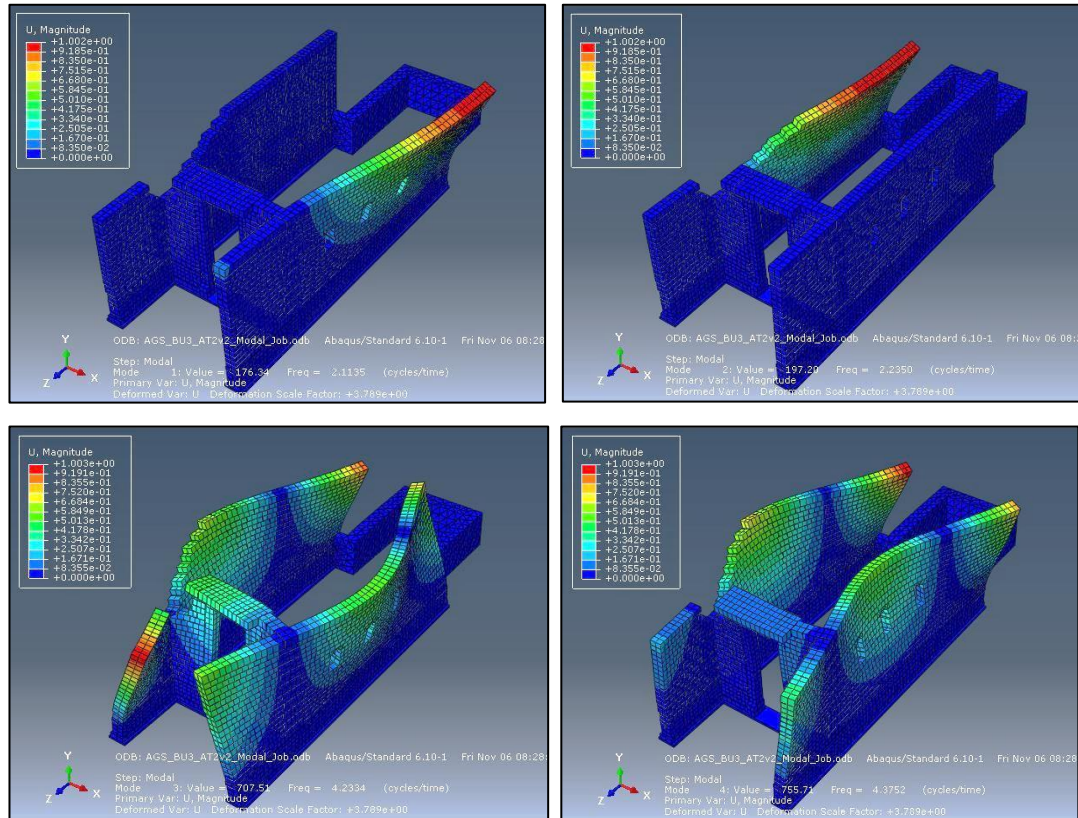
**Figure 4.5:** Mode shapes and modal periods of the model with stone block replacements. Period values are 0.473s, 0.447s, 0.236s and 0.228s.

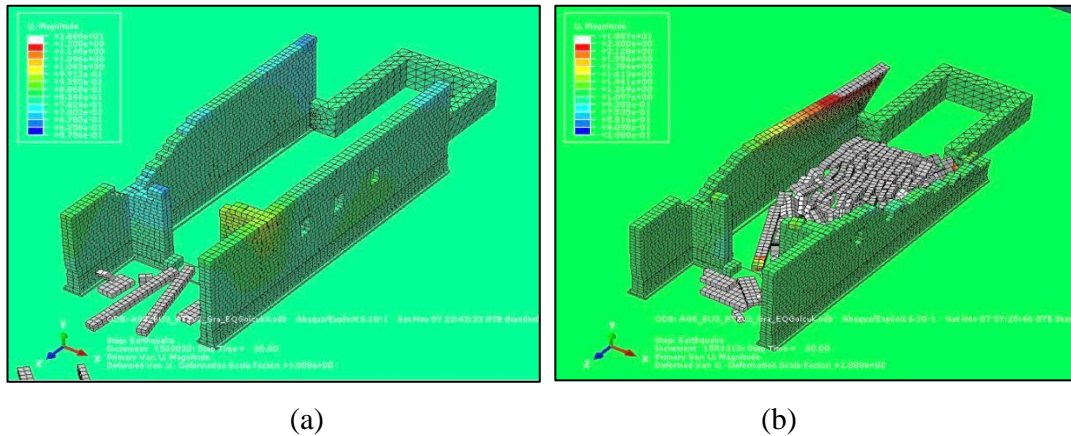
**Figure 4.7:** Performance check and collapse mechanism observed under Izmit 1999 earthquake excitation. Lateral walls maintain integrity (a) and collapse in sequence, northwestern wall after northeastern wall (b).

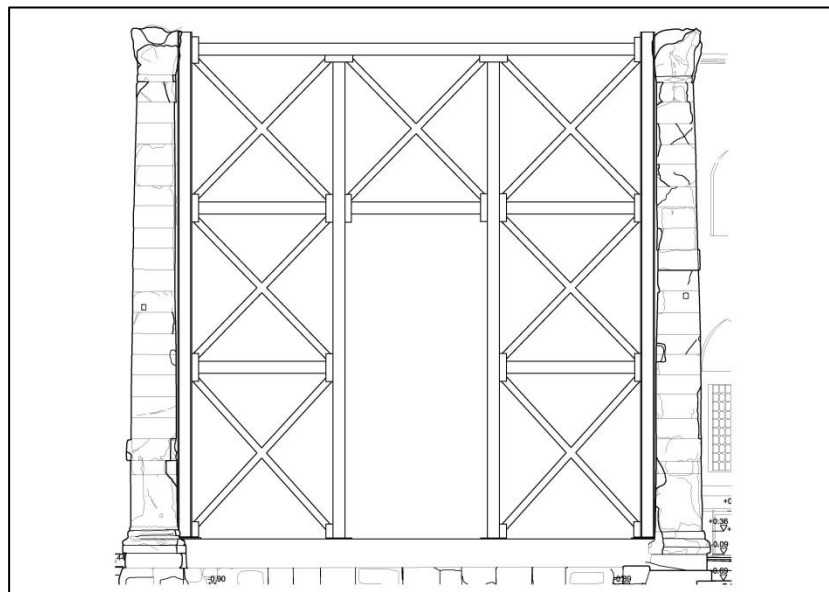
**Figure 4.8:** Visualization of the proposed truss system, opisthodomos axis.

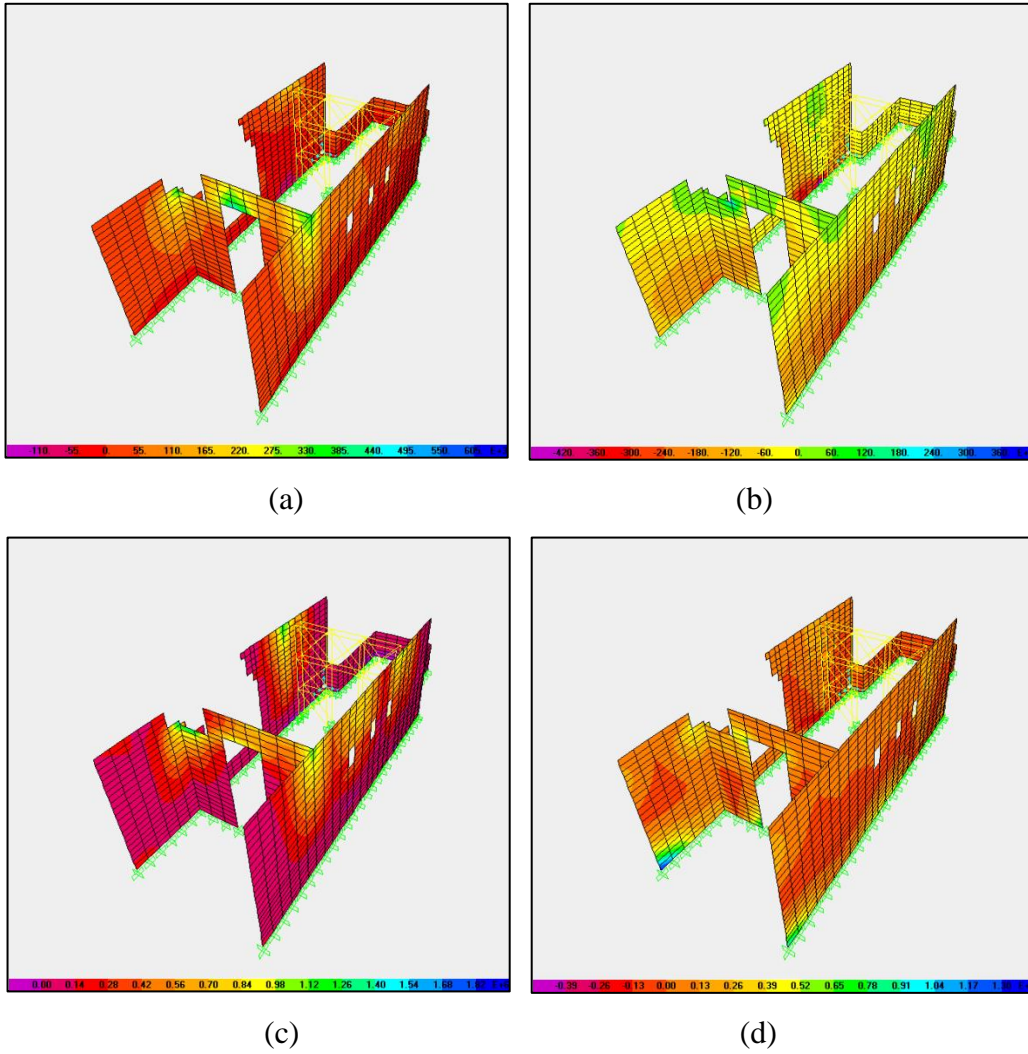
**Figure 4.9:** Response spectrum analysis results, with longitudinal direction application results S11 (a) and S22 (b) in top row, and transverse direction application results S11 (c) and S22 (d) in bottom row. Units in Pa.

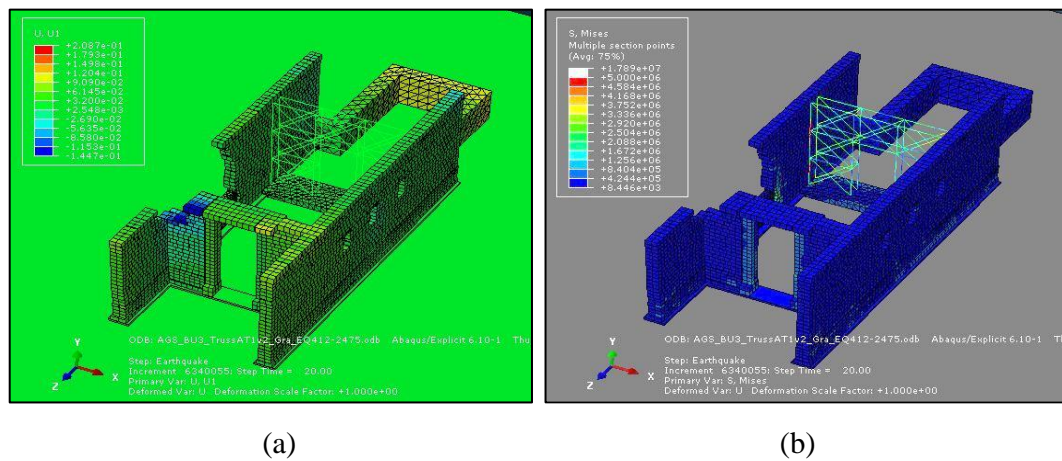
**Figure 4.15:** Earthquake no 412-2475 excitation results: Displacements (a) and stress distributions (b).

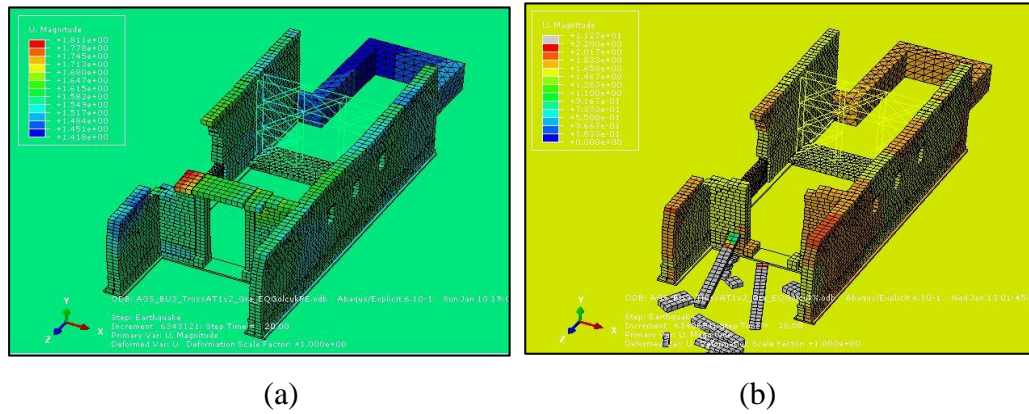
**Figure 4.16:** Performance check results with Izmit 1999 earthquake excitation. The ornamented gate lintel resists collapse (a) and collapsed ornamented lintel, local dislocations at top layers (b).

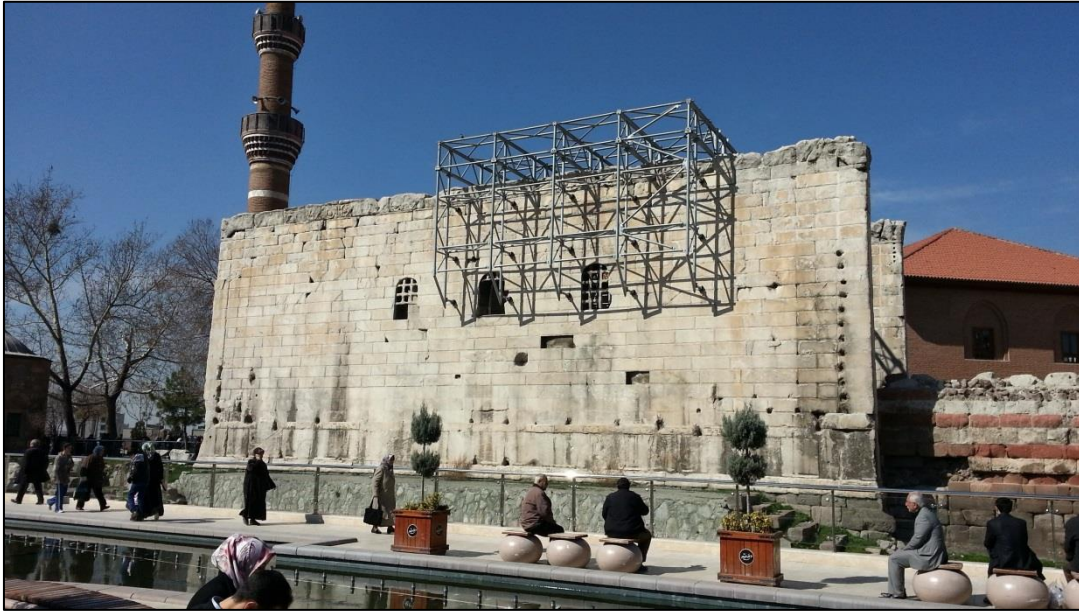
**Figure A.2:** General view from the eastern vantage point, holes are visible all around the wall

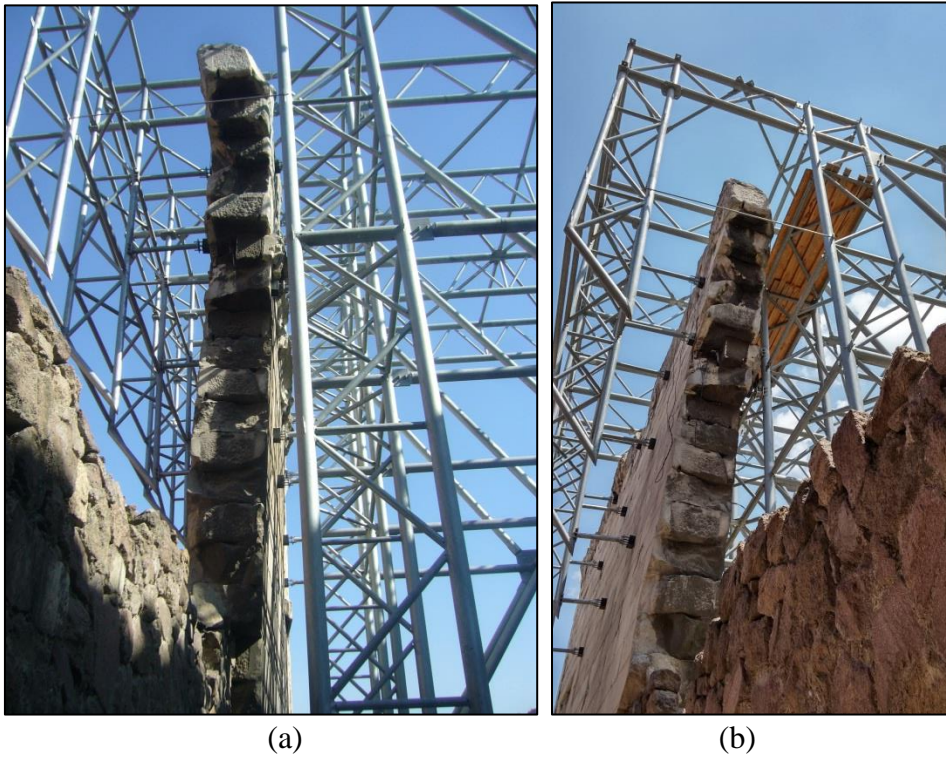
**Figure A.6:** Northern isolated wall, seen from inside (a) and outside (b) the temple

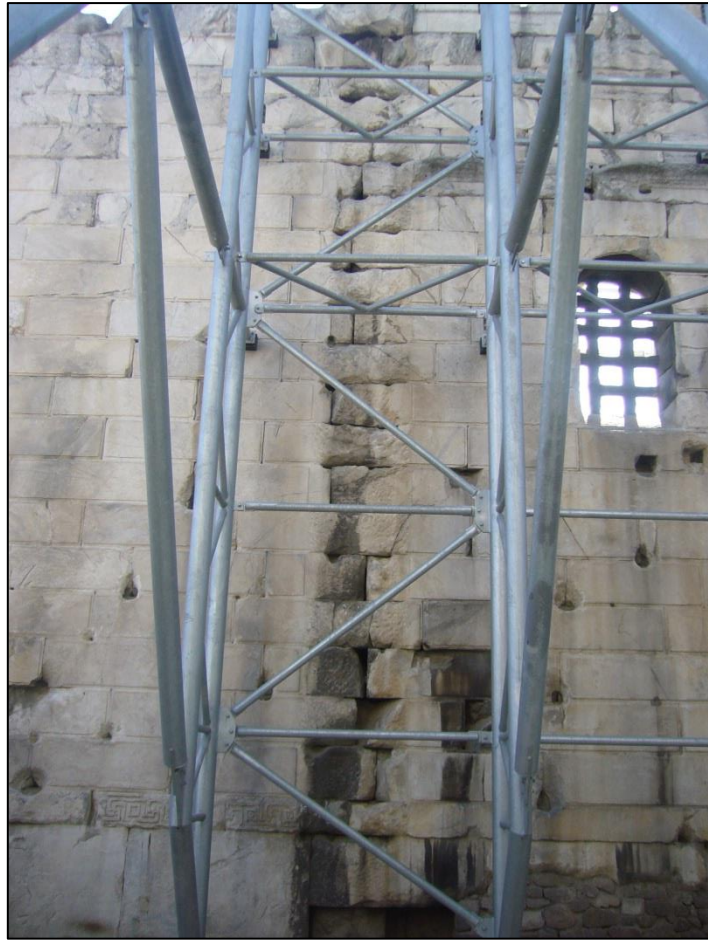
**Figure A.8:** Location of the removed opisthodomos wall, where the deformations left from the removal operation are visible

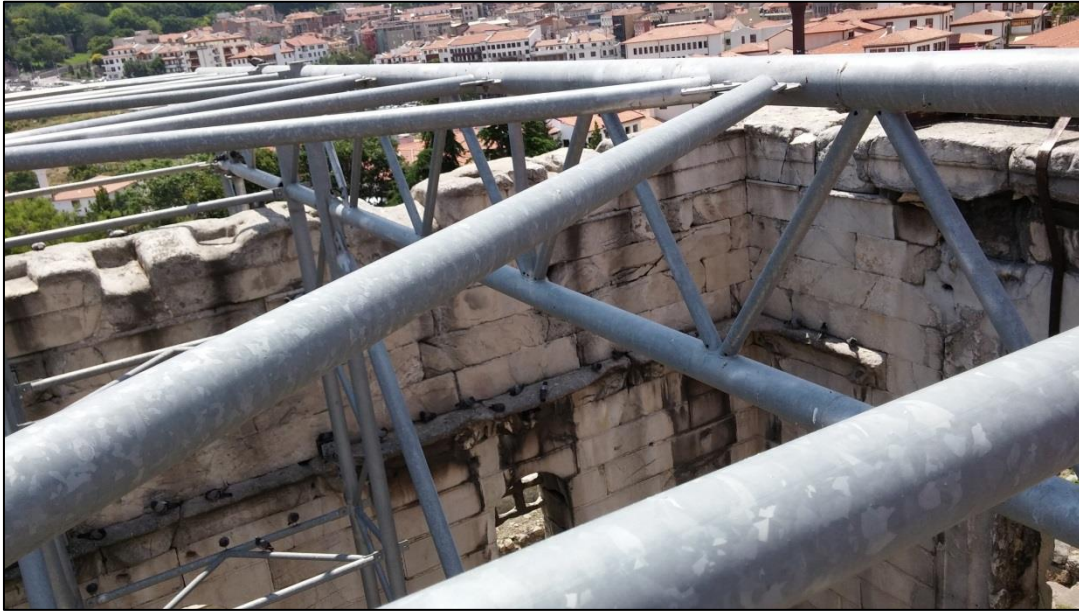
**Figure A.9:** Temple from atop the northern isolated wall, looking at the intersection of the southeastern wall and the gate section. The slots where most probably the ancient wooden beams were placed are visible.
