A STUDY ON THE BUILDING TECHNIQUES AND MATERIALS IN THE
LATE ANTIQUE AND BYZANTINE FORTIFICATIONS IN ANATOLIA:
ANCYRA AND NICAEA

A THESIS SUBMITTED TO
THE GRADUATE SCHOOL OF NATURAL AND APPLIED SCIENCES
OF
MIDDLE EAST TECHNICAL UNIVERSITY

DECEMBER 2016

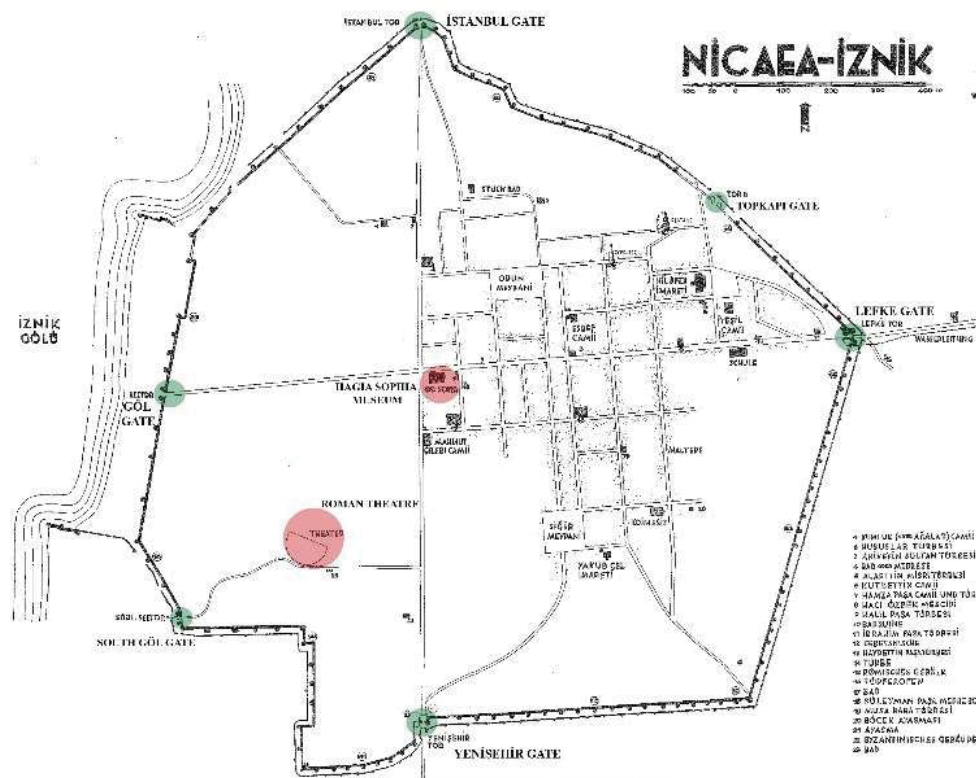
Figure 2-2: Plan of Nicaea (Iznik) (after Schneider, 1938)

As can be seen in similar fortifications from the Byzantine period, this fortification wall has the ground plan of an irregular polygon, and it is one of the best preserved Byzantine structures in Anatolia (Figure 2-2, plan) (Schneider, 1938). This irregular plan, observed in some Byzantine fortifications, can be attributed to the fact that they were built along the contours of the hills without any attempts to alter or destroy the topography of their site (Foss, 1996b).

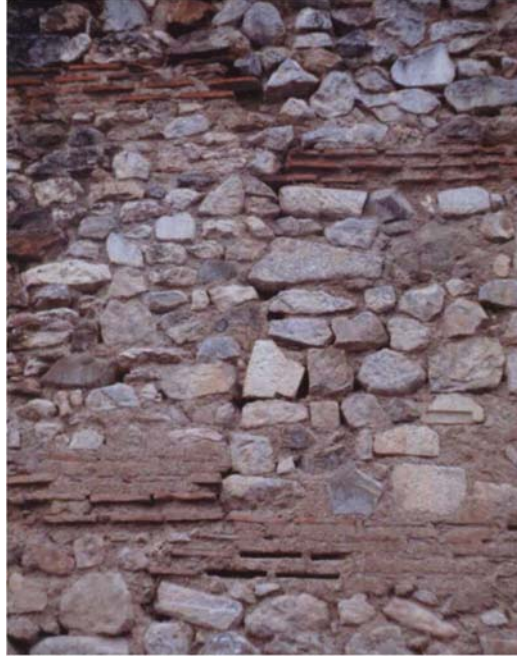
Figure 2-6: The southern facade of Iznik walls, traces of deformation (Adatepe and Arel, 2006)

Earthquakes have been important factors in the historical damage that has occurred to the fortifications of Iznik. The fourth century earthquakes, in 358, 362 and 368 AD were devastating events. However, it seems that the earthquakes of 358 and 362 were less destructive since the walls were still an effective defence during the revolt of Procopius, a relative of Emperor Julian, in 365 AD. The earthquake of 368 AD is thought to have caused significant damage to the walls, though there is no documentary evidence to support this. Adatepe and Erel (2006) reach the conclusion from their studies of seventeen different earthquakes which affected Iznik between 2100 BC and 1900 AD that there are no traces of any massive earthquake in the Roman, Byzantine, Seljuk and Ottoman periods in Iznik. The study on dating of the deformation observed on the southern walls surrounding Iznik could not be realized because the precise date of the earthquake and the subsequent repair of the walls could not be determined (Figure 2-6). Taking into account all the evaluations, the city plan, which has not changed since the foundation of the city, the still surviving work of ancient times prove

clearly that there was no widespread devastation from any of the earthquakes appearing in the historic periods (Adatepe and Erel, 2006).

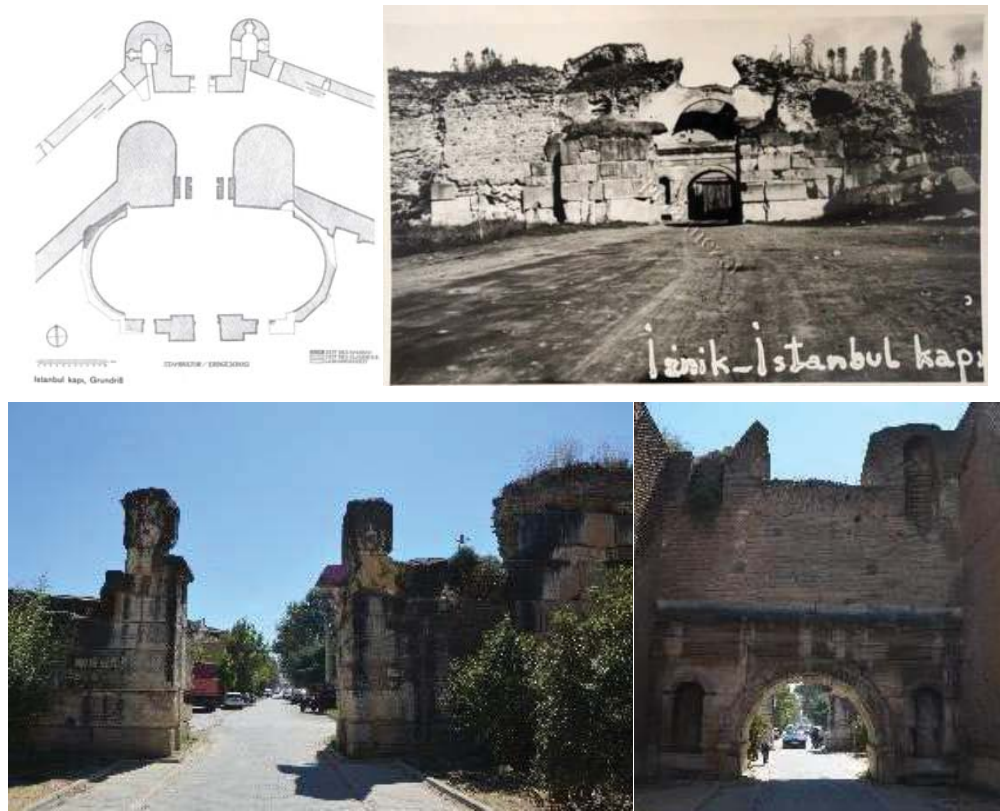
Istanbul Gate: The Istanbul Gate, one of the two gates that most interested travellers, is at the end of the road connecting the city to Istanbul and it is situated in the north. One of the reasons why it was built so magnificently could be that it was the entrance generally used by people arriving from Istanbul (Figure 2-14). Travellers remarked both on the presence of carefully chosen spolia, and that there were reliefs (Ermiş, 2014). Peyssonel, who visited both Izmit and Iznik in 1745, stated that there were these reliefs, but the figures on them were damaged.⁴⁰ In the part of the first stage of the gate from the inner to the outer, there are carvings of masks brought from the theatre (Figure 2-13).

Figure 2-13:a: The plan of Istanbul gate (above left) (Schneider and Karnapp,1938), b: Istanbul gate from inside (above right) (courtesy of Kadir Balı), c: The first stage of Istanbul gate with theatrical mask (below left), d: The second stage of Istanbul gate (below, centre), e: The third stage of Istanbul gate (below right), (c,d,e: author, September 2015).

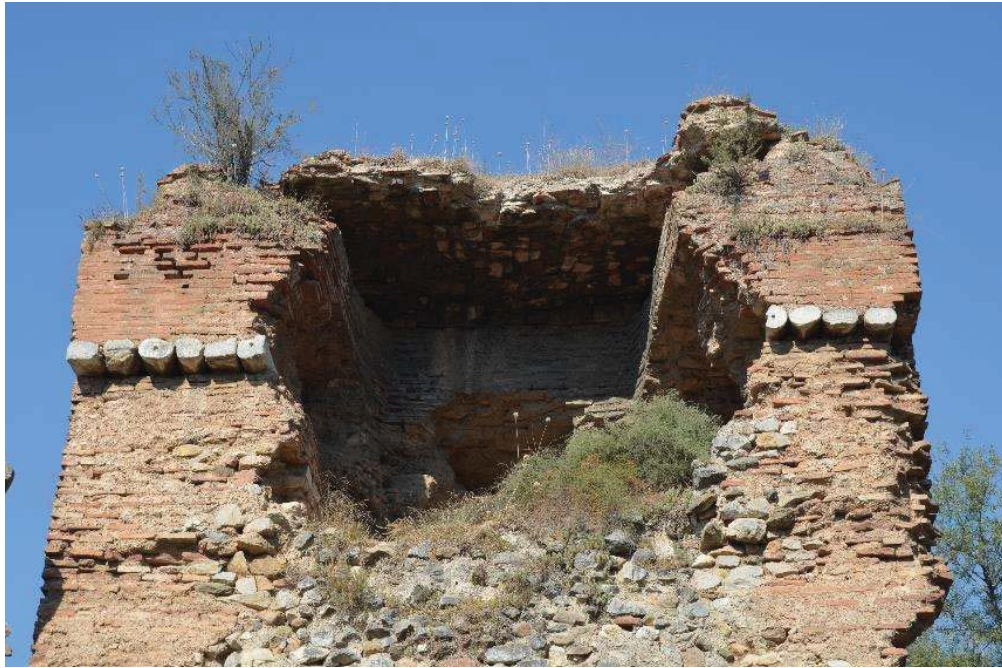
Figure 2-17: Spolia in the upper chambers of Tower 66 (author, September 2015)

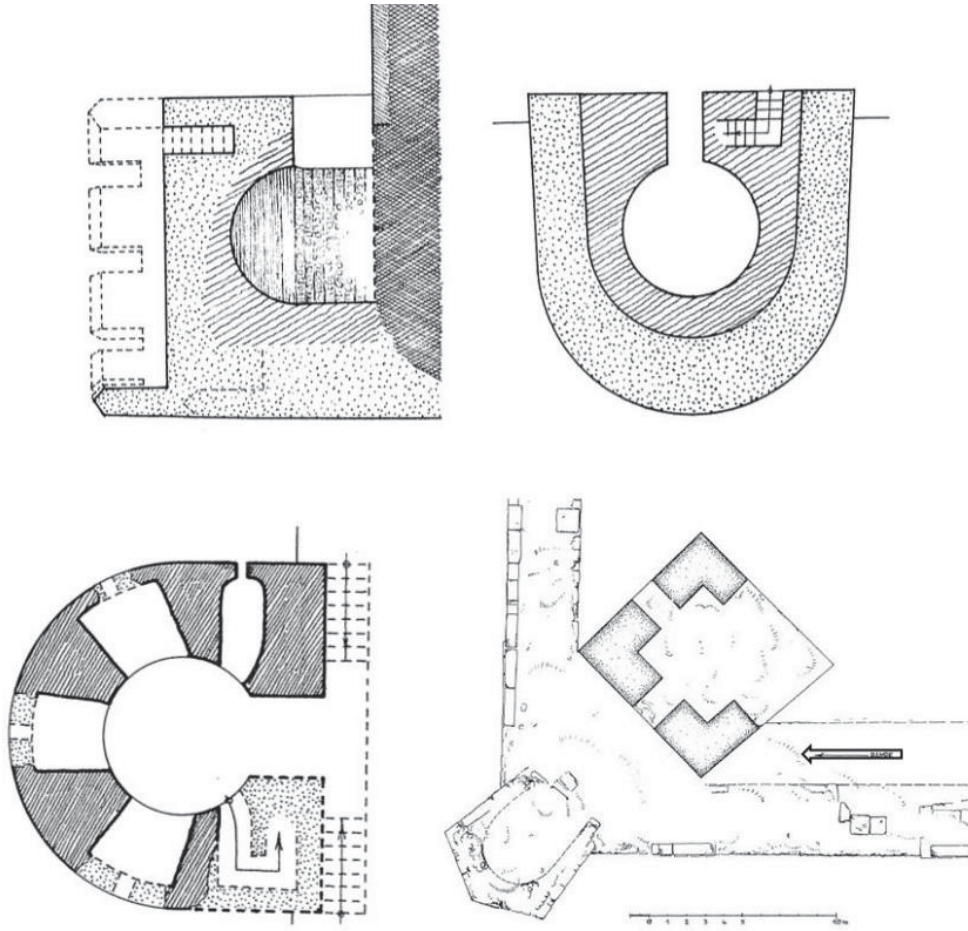
Although we did not have any opportunity to take aerial images of the towers; the descriptions of Foss (2003) for the upper parts of the towers can be observed occasionally from ground level. Foss, states that although many of the original upper parts disappeared during subsequent reconstructions, they had windowless chambers with for storage that were accessible through the pavements of the top parts of the fortification, adding that there are flat roofs on the highest points to accommodate catapults and similar defence weapons (Foss, 2003) (Figure: 2-18).

Figure 2-18: Chamber without upper windows (above) and chamber with upper windows (below) (Schneider and Karnapp, 1938)

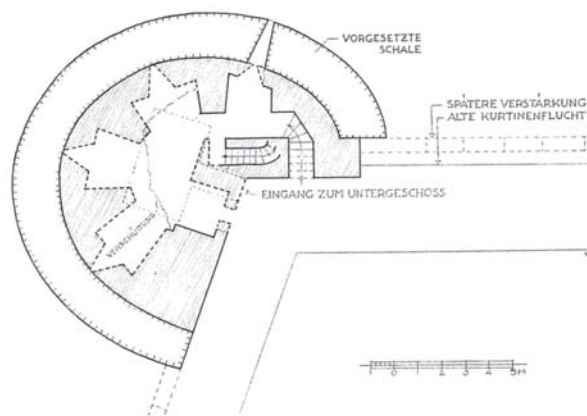
even-numbered ones are the towers that were added during the period of Michael III (842-867) and the most evident difference is the spolia used in the foundation. The towers that are later additions share another characteristic in having embrasures⁴⁵ and/or loopholes. One of the interventions in this wall, known to be significant, belongs to the period of Theodore II Lascaris (1254-1258). Foss states that T7, T9, and T16 were reconstructed during this period and says that T15 is most probably a reconstruction belonging to the same period.⁴⁶ When compared with the other towers, the T20, has the greatest diameter stands at the end of this section of wall. It is located approximately in the midpoint between the Yenişehir and the Lefke Gate. One of the reasons of its large dimensions could be due to the added covering of masonry facing added in the intervention during the period of the Emperor John III Vatatzes (1222-1254) (Figure 2-19).

Figure 2-19: The plan of Tower 20 (Schneider and Karnapp, 1938)

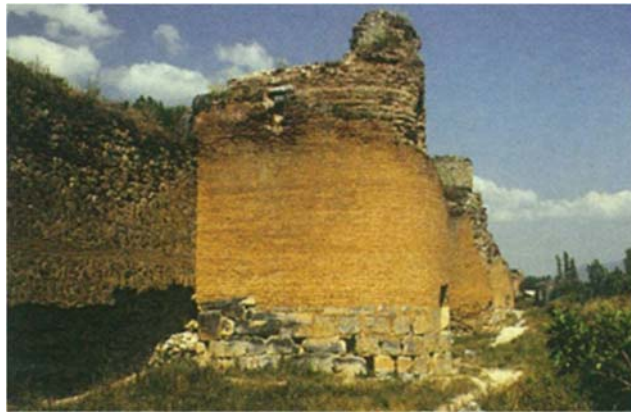
T9: Part of the 9th tower comprises work done under Michael III (842-867) and it is, in fact, a part of the first significant change occurring in efforts to reinforce the defence system (Foss, 2003). Because of the infrequency of the towers facing the south and located on the eastern wing of the Yenişehir Gate, in particular, the new towers were added in between and the strength of the defences improved. While the observed

interventions were generally repair and maintenance, floor additions, increasing the height, etc., here new towers were added to improve the strength of this area. It is almost impossible to distinguish the newly added towers from the older ones even today since they were built in a very similar way to the originals. The features such as semi-circular plan, brick facing, same height and width and bases constructed generally with spolia are observed in both the new and the old towers. T9 is different from the other towers because the amount of the spolia used in its base is more abundant than in the others (Figure 2-20).

Figure 2-20: Tower 9 (Foss, 2003: 253, fig. 9)

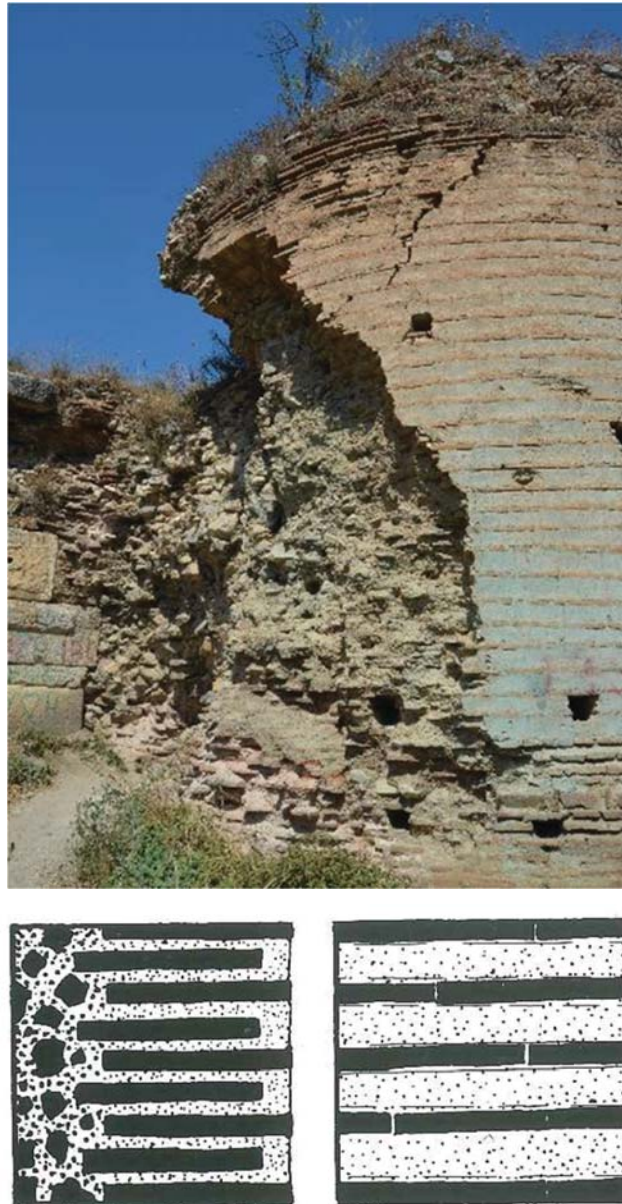
T37: The ‘recessed brick’ technique observed in this tower points to the period when the construction technique of the towers changed.⁴⁷ The fortifications suffered severe

damage in the earthquake in 1065, and this technique is more frequently seen on the eastern side (Figure 2-23) (Map 9).⁴⁸

Figure 2-23: Tower 37, with repairs (on left) using wide bands of mortar, made after the earthquake of 1065, original third century masonry on right (author, September 2015); Diagram of the recessed brick technique-wall section and elevation detail (Ousterhout, 1999: 174)

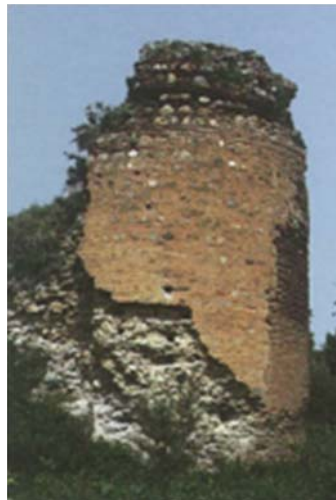
T50: The originally third century structure gave way to this thirteenth century renovated tower. Each of the towers that were located at a distance of 70-80 m away from each other were tightly connected to the main body of the fortification in the first phase. In fact, the brick rows in the towers continue towards the inner parts of the main building. However, as it can be seen in this example, the most frequently observed problem encountered by the builders of the subsequently added towers was their lack of integrity with the main building (Figure 2-24). For this matter, Foss (2003) notes that the design of the towers changed depending on the ground level rise over time and the new towers were not in organic connection in integrity with the fortifications themselves. Although these non-integrated towers negatively affect the connection with the fortifications, in reality this constituted a safety feature since if the tower was undermined and weakened, its potential collapse would not affect the main structure of the fortifications. Storage rooms without windows that would be expected to appear on the upper parts of the tower and flat roofs to locate the defence equipment have disappeared in many towers.

Figure 2-24: Tower 50, original third century construction (Foss, 2003: 251, fig. 4)

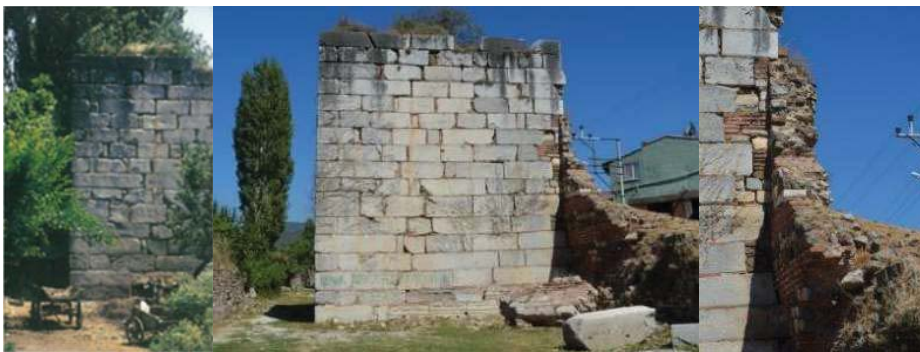
T71: This tower is known to have been renewed during the Arab attacks in 727. However, there is no information about its original state. Together with this attack, the fortifications underwent major changes for the first time. These fortifications were completely rebuilt using spolia marble material removed from demolished or abandoned buildings; indicating that they belong to different periods (Figure 2-26).

Figure 2-26: Tower 71, built after the Arab attacks of 727, left (Foss, 2003) centre and right (author, September 2015)

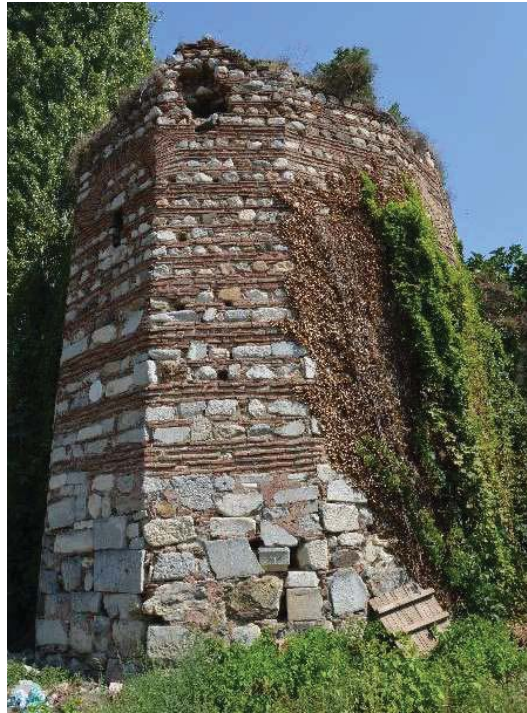
The repairs that Andronicus II carried out using fine brickwork on the lake shore side of the walls can still be seen. The use of alternating courses of brick and stonework is a technique that is mostly seen in the walls between two towers; however, it is seen in some of the towers on the lakeside, as well. In this tower, construction technique is with alternating courses of brick and stone including spolia (Figure 2-28).

Figure 2-28: Tower 88 (author, September 2015)

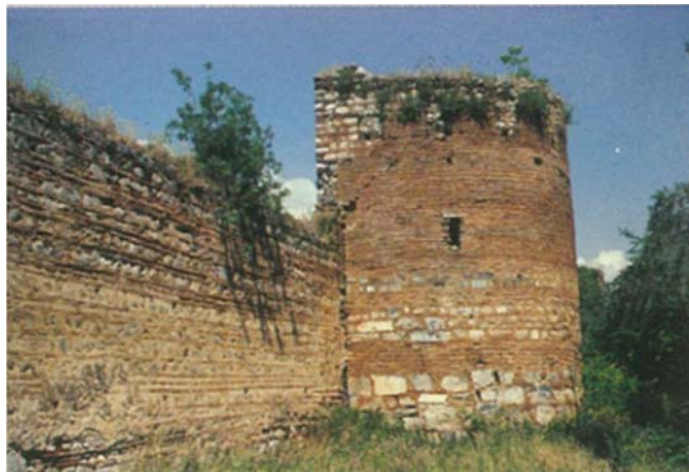
T97: This tower shows the interventions the walls underwent layer by layer. Foss (2003) dates the coexistence of spolia and brick in the lower part to the ninth century and the brick work above these to the early thirteenth century (Figure 2-29). He assumes that the loophole on the facade is original and this interval belongs to the period of John III Vatatzes (1205).

Figure 2-29: Tower 97 (Foss, 2003)

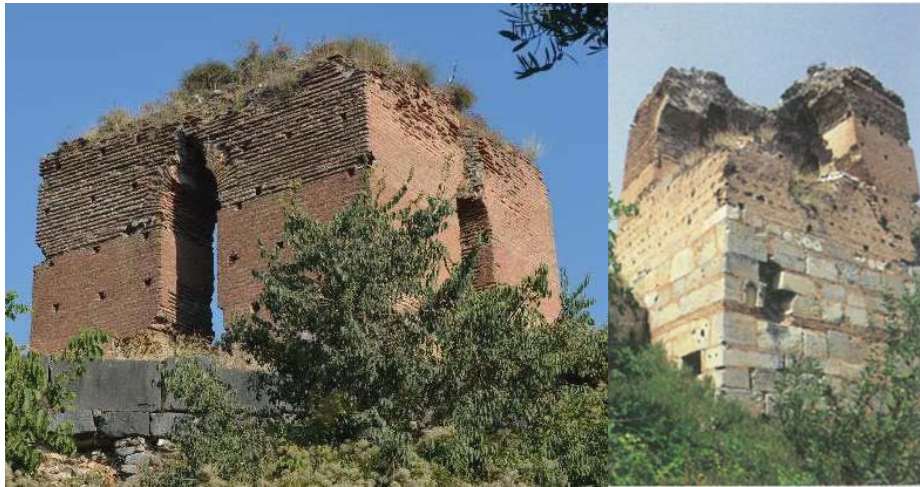
T106: This tower was built during the strengthening of the fortifications under Theodore I Lascaris (1204-1222), and both the brick and spolia blocks are dominant in its construction. The top part is entirely made of plain brick and shows regular beam holes. The cloisonné technique⁵¹ was used in the lower part. There are two or three rows of brick banding courses approximately in the middle of the spolia section in the lower part that was built higher than the foundations with ordinary blocks of spolia (Figure 2-30).

Figure 2-30: Tower 106, inner view, showing the large defense chamber at top (left: author, September 2015); (right: Foss, 2003)

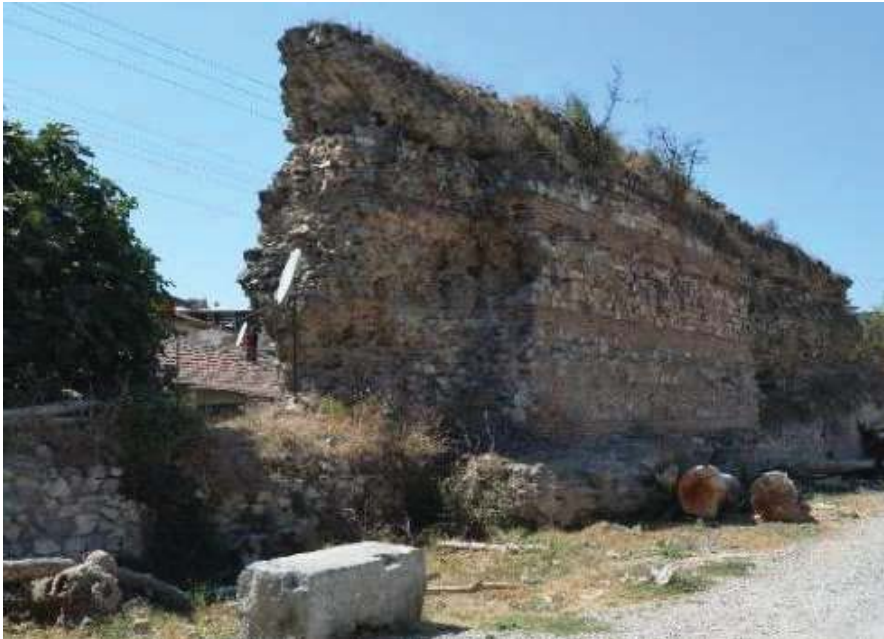
When the features of the curtain wall between two towers are examined, they contain bands of brick and stone and constructed with the alternating rows of brickwork and masonry. It is seen in a section of the wall that the walls are generally 4-metres wide. Even though both of the stone and brick rows are visible on the outer surfaces, only the brick rows, which are flat and generally rectangular, go through the entire thickness. Where the facing is stone, the interior is usually a mixture of mortar and rubble stone (Figure 2-33) (Tables 3-A, 3-B).

Figure 2-33: Section of the wall (author, September 2015)

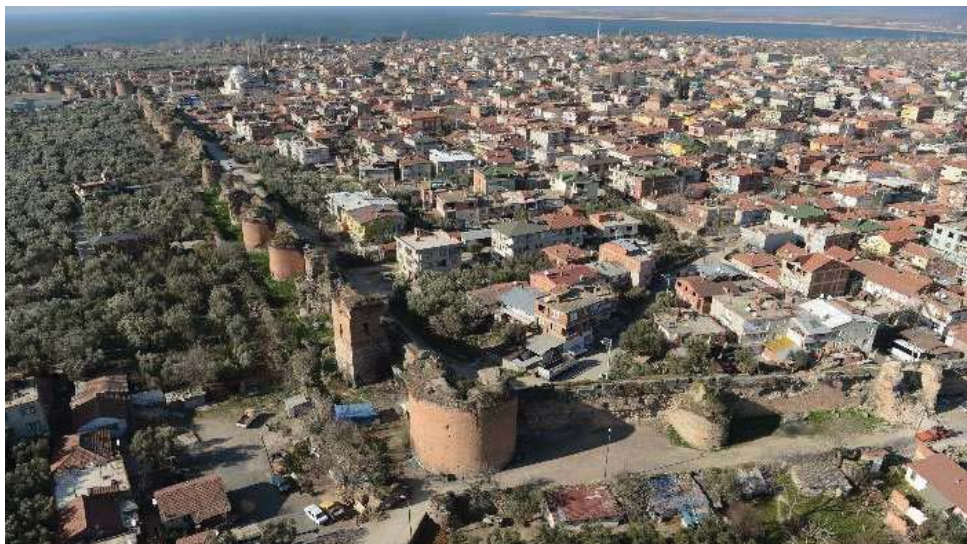
Figure 2-40: Aerial view of Iznik fortifications from southeast, (courtesy of Kadir Balı)

W (18-20): Foss and Winfield (1986) conclude that the recessed brick technique, seen on top of the wall in between T18 and T20, may provide information about the reconstruction of this wall in the eleventh century, but this information is possibly unreliable (Figure 2-40).

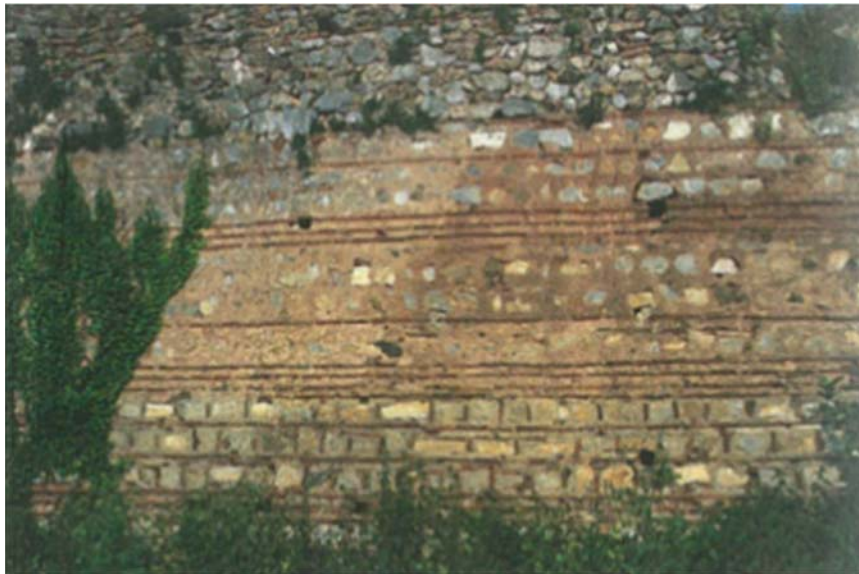
W (89-90): Foss (2003) describes this stone masonry technique, dated by him to the late twelfth century, consisting of a well finished facing employing alternating bands of brick and stonework with brick predominantly used in the repair work (Figure 2-42). He notes that the Byzantine Emperor Manuel Comnenus (1143-1181) set up a castle network of fortresses called Neokastra around Pergamum and had the parts of the fortification on the lake side repaired and he attributes this construction technique to that period.

Figure 2-42: Wall between T88 and T89, with the elaborate brickwork of the late twelfth century (Foss, 2003, fig. 14)

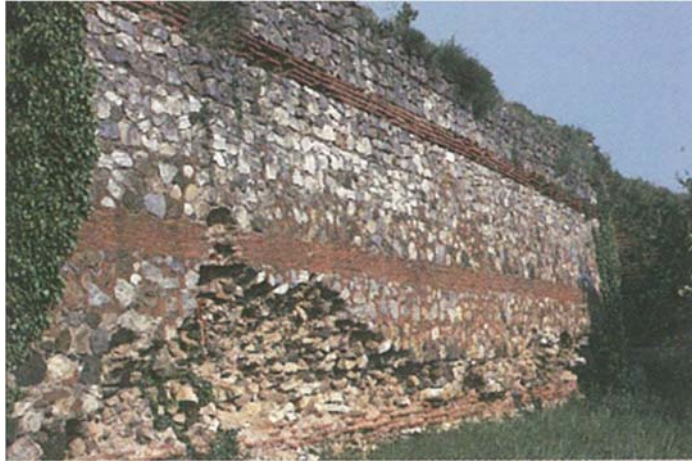
Figure 2-43: Wall of the third century, between T90 and T91 (Foss, 2003, fig. 19)

W (90-91): Foss (2003: 250) defines this wall as in the following; “the walls derived their strength from a massive core of mortared rubble, interrupted at regular wide intervals by bands of flat square Roman bricks, laid four deep, that ran through their entire width.” (Figure 2-43).

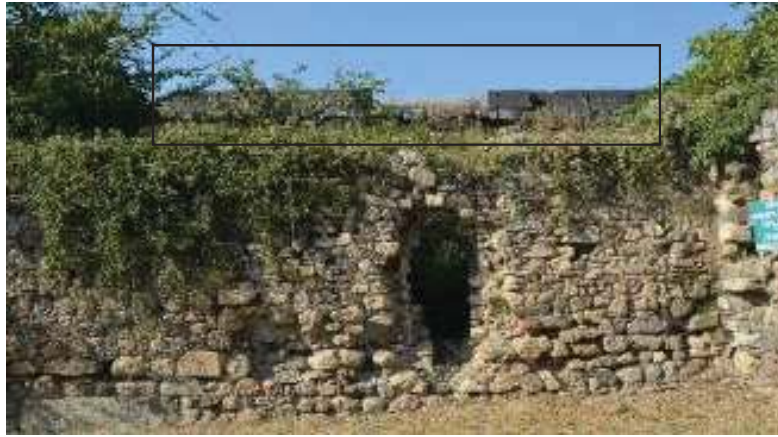
Figure 2-45: Wall with the traces of added balustrade of Leo III (author, September 2015)

W (107-108): The most significant feature the walls and the towers share in common is the use of a dense mortar filled with rubble stones in the inner parts and an outer surface consisting of rubble stone and brick. The period when many of the stone blocks were gathered and brought from the theatre was under Leo III (717-741) (Figure 2-45). These blocks, which we know had been previously used, not only raised the height of the top level of the fortifications, but also enabled a walkway to be constructed along the top of the wall. Foss (1996b) argues that this reinforcing work occurring under Leo III (717-741) and other additional reinforcing work, increased both the military significance of Iznik and the political power of the region of which it was the capital city.

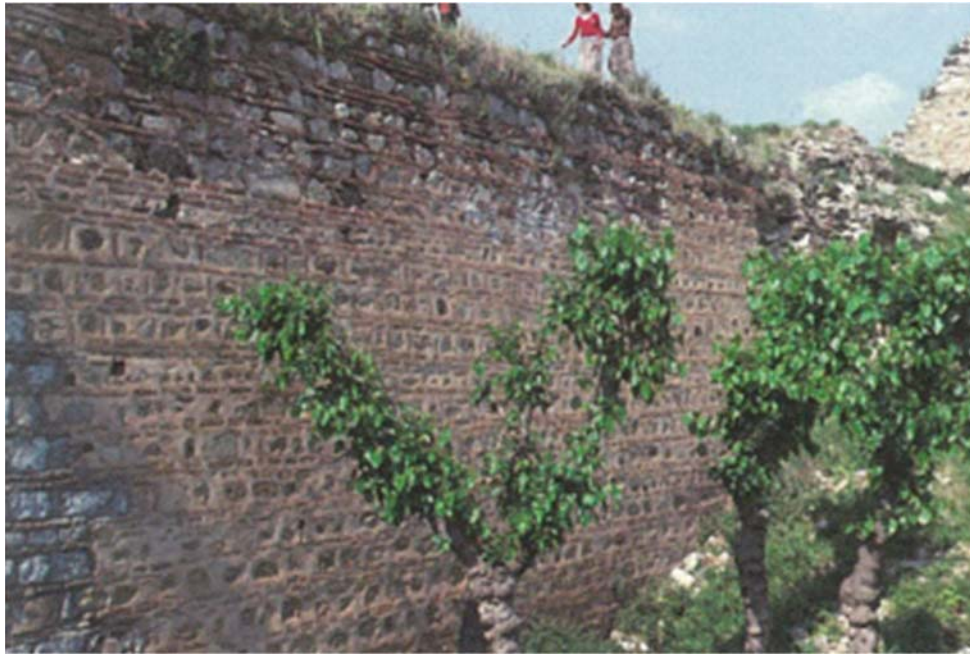
Figure 2-46: Wall of Theodore Lascaris (1204-1222) between T111 and T112, with decorative brickwork and extensive use of mortar on the outer surface of the wall (Foss, 2003, fig. 18)

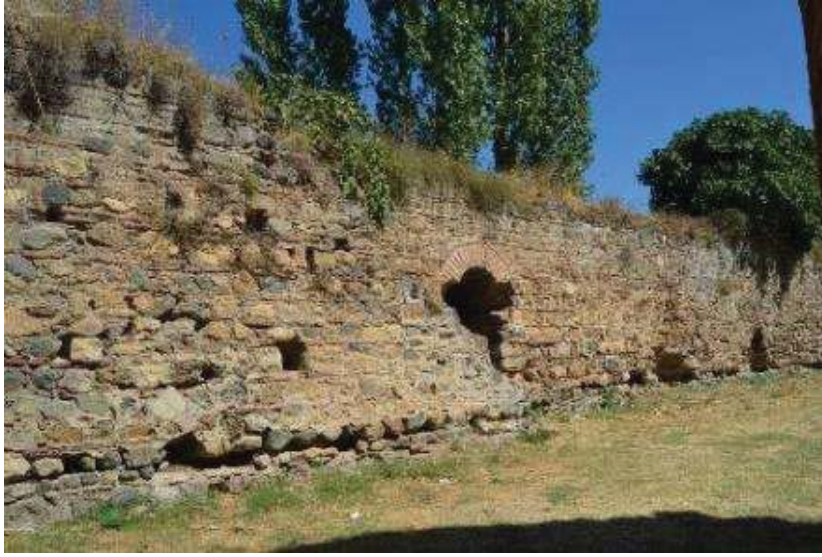
Figure 2-47: Outer wall (circuit) (author, September 2015)

The construction of the outer circuit is dated about thousand years later than that of the inner circuit. It was part of the work done under Emperor John III Vatatzes, in approximately the mid-thirteenth century, and comprises one of the most important alterations in the fortifications. It underwent some further interventions later on. The most significant differences that distinguish them from the inner circuit are; lower height and narrower width, different proportion of the quantities of brick rows/stone rows, the use of rubble stone through the fortifications and the lack of spolia (Figure 2-47).

As mentioned above, examination of the construction technique indicates that the proportions of stone-brick rows are different from the inner walls; the use of a single row of brick followed by a stone row can be seen, marking a difference from the main fortification. There is an unelaborated and less detailed use of materials (Table 4).

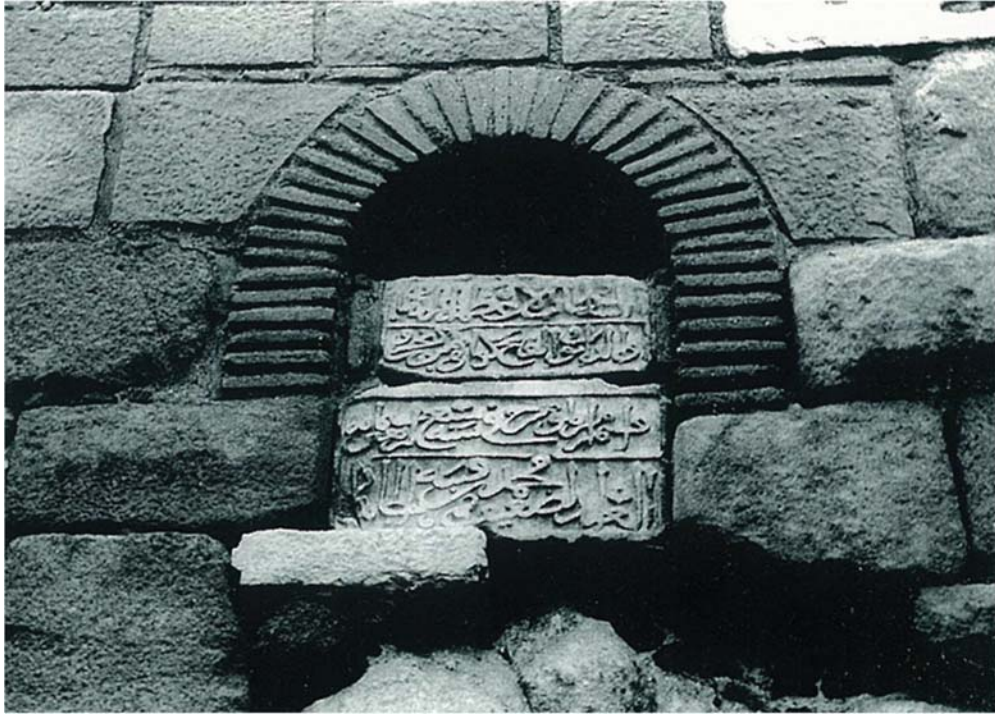
Figure 3-8: Inscription containing Seljuk period interventions (Serin, 1998: Pl. VI-b)

The Seljuk ruler Alparslan defeated the Byzantine army in the Battle of Manzikert between 1071 and 1074, and conquered Ankara. However, the city was recaptured in 1101 during the Crusades and continued to serve as a citadel on the eastern border of the Byzantine Empire for a period (İdil, 1997). İdil states that Kılıçarslan conquered the city in 1169 and united the Anatolian Seljuk State. Later on, the city was reorganized in the reign of Alaeddin Keykubat (1219-1237) during the golden age of the Seljuks. He adds that Keyhusrev ordered repairs to the citadel in 1250 (İdil, 1997) (Figure 3-8).

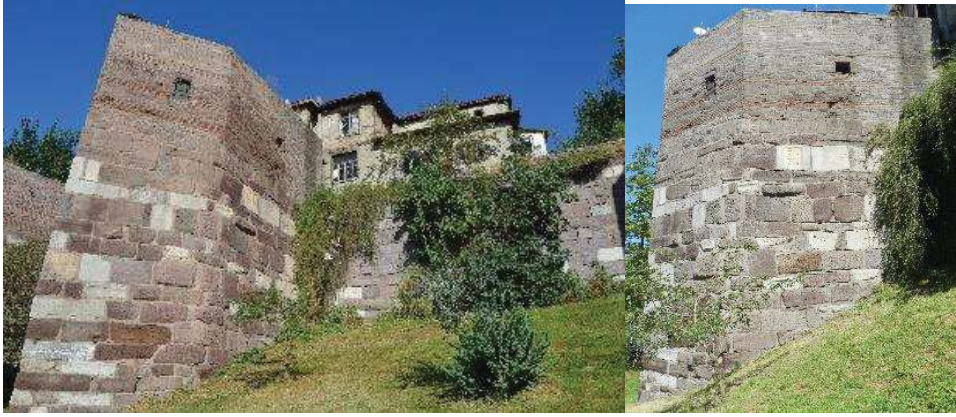
Figure 3-9: West facade of the inner fortifications (author, September 2015; 2016)

Foss (1977) who states that Ankara is still dominated by medieval pentagonal towers located on the hill over the city centre, emphasizes that the fortification walls, which he considers as the most splendid examples of the Byzantine buildings in the city, might be an outcome of the reorganization in the Byzantine army in the seventh century. The author describes the walls as following: there are two parts of the fortification walls; the outer circuit composed of square towers at 40m intervals and the inner circuit, which watches saliently over the city like the prow of a ship. The inner circuit covers an area of 350mx150m and when the outer circuit is added, the total enclosed area is significant. Large blocks removed from ancient monumental buildings were used in the lower part of the inner circuit up until the level of 8 to 10 m. The upper parts were built with brick (Figure 3-9). The core of the wall consists of mortared rubble. The towers of the outer circuit were built in a similar, but less organized, manner.

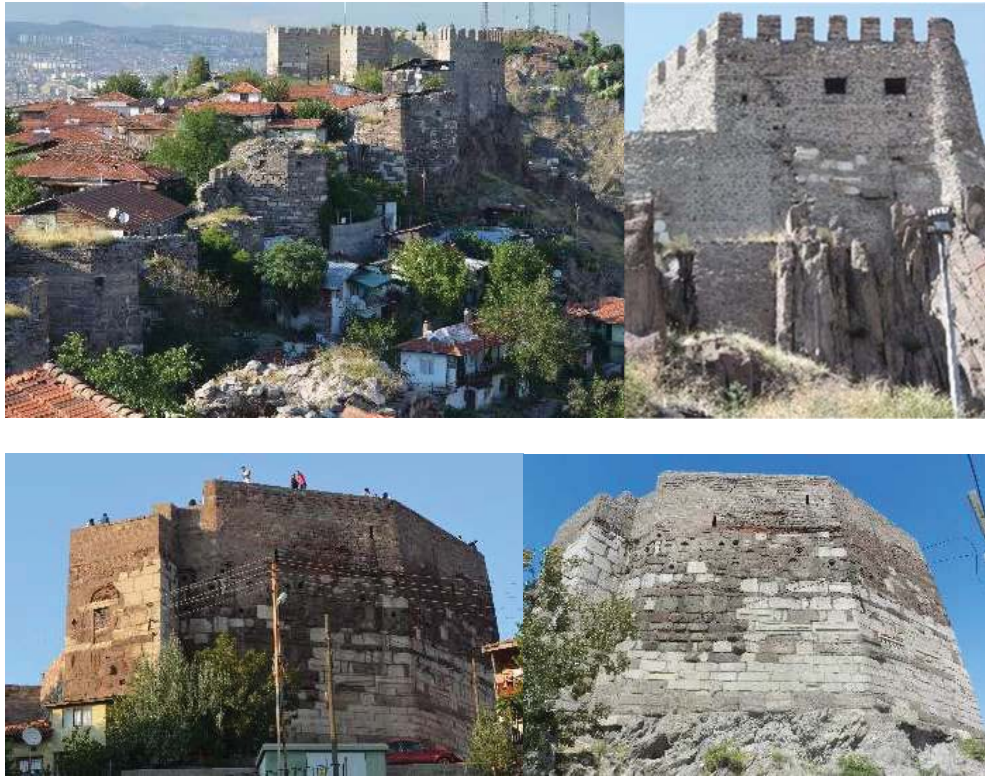
Figure 3-10: Akkale (above) and Şarkkale (below) as seen in 2015-2016 (author)

The main access is from the south and interiors of both lines of walls are accessible. In addition, strong bastions were added to the south-eastern corner and to the highest point of the hill in the northeast in order to dominate the city from the east and the west. The bastions mentioned by the author are Akkale and Şarkkale, which are still standing but have undergone numerous alterations (Figure 3-10) (Map 16).

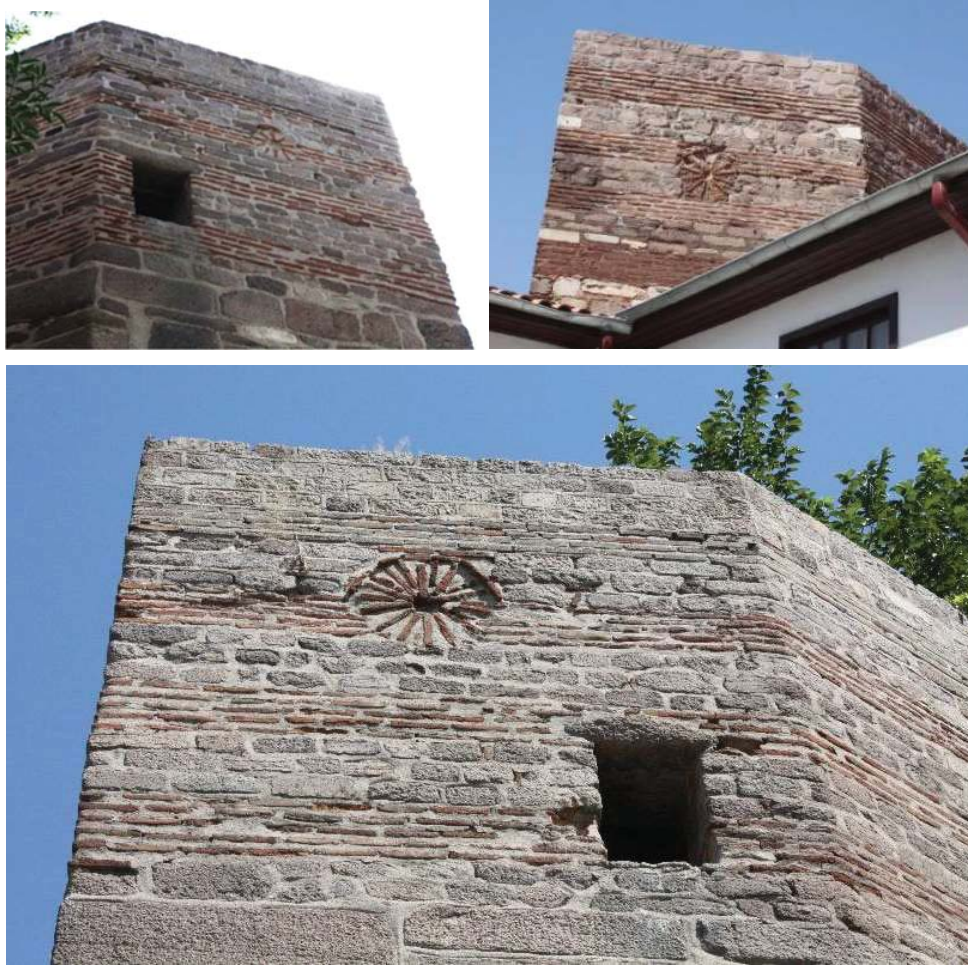
Figure 3-17: Alternating rows of brick and rubble stone with brick decoration typically of the Byzantine period (author, September 2016).

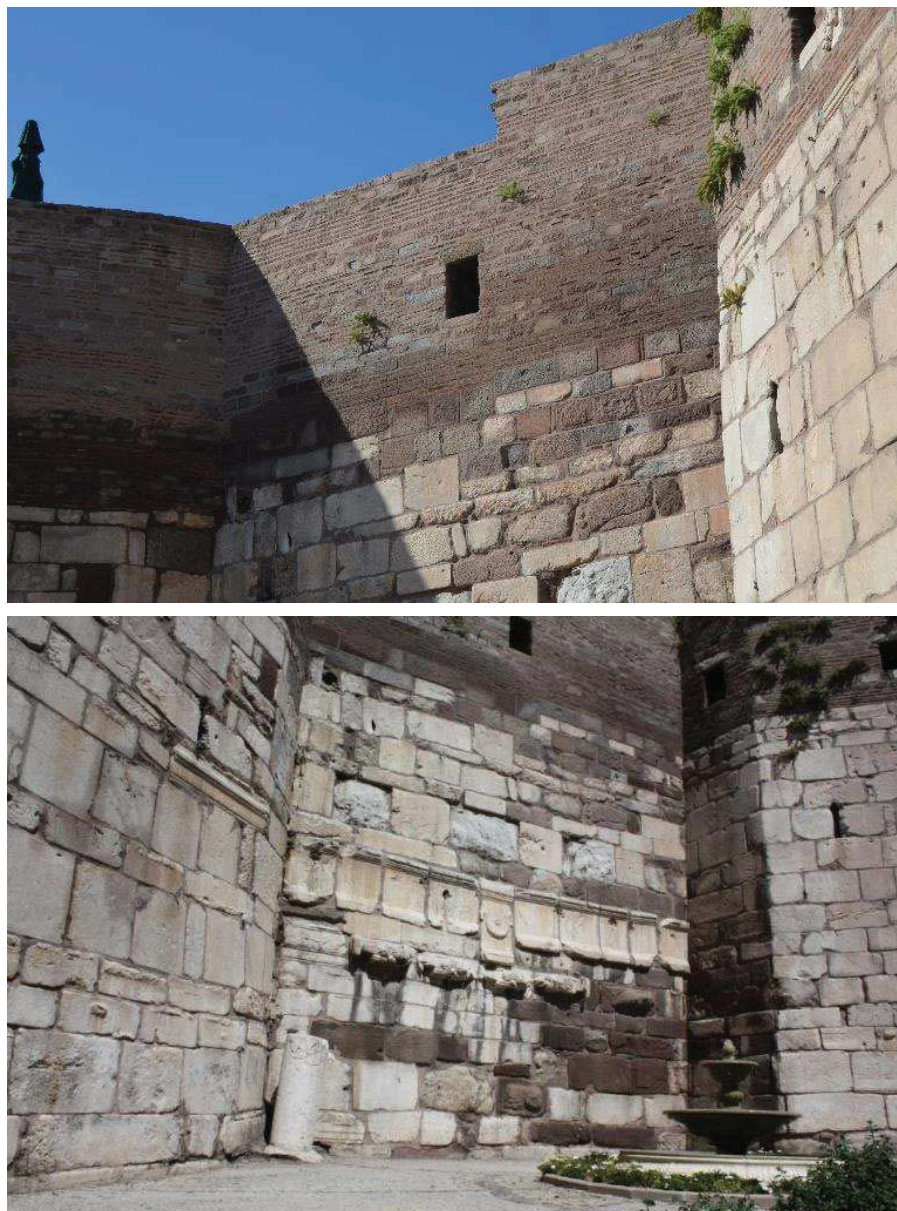
Figure 3-18: Ankara Citadel, Inner Circuit, extensive use of spolia (September 2015-16, author)

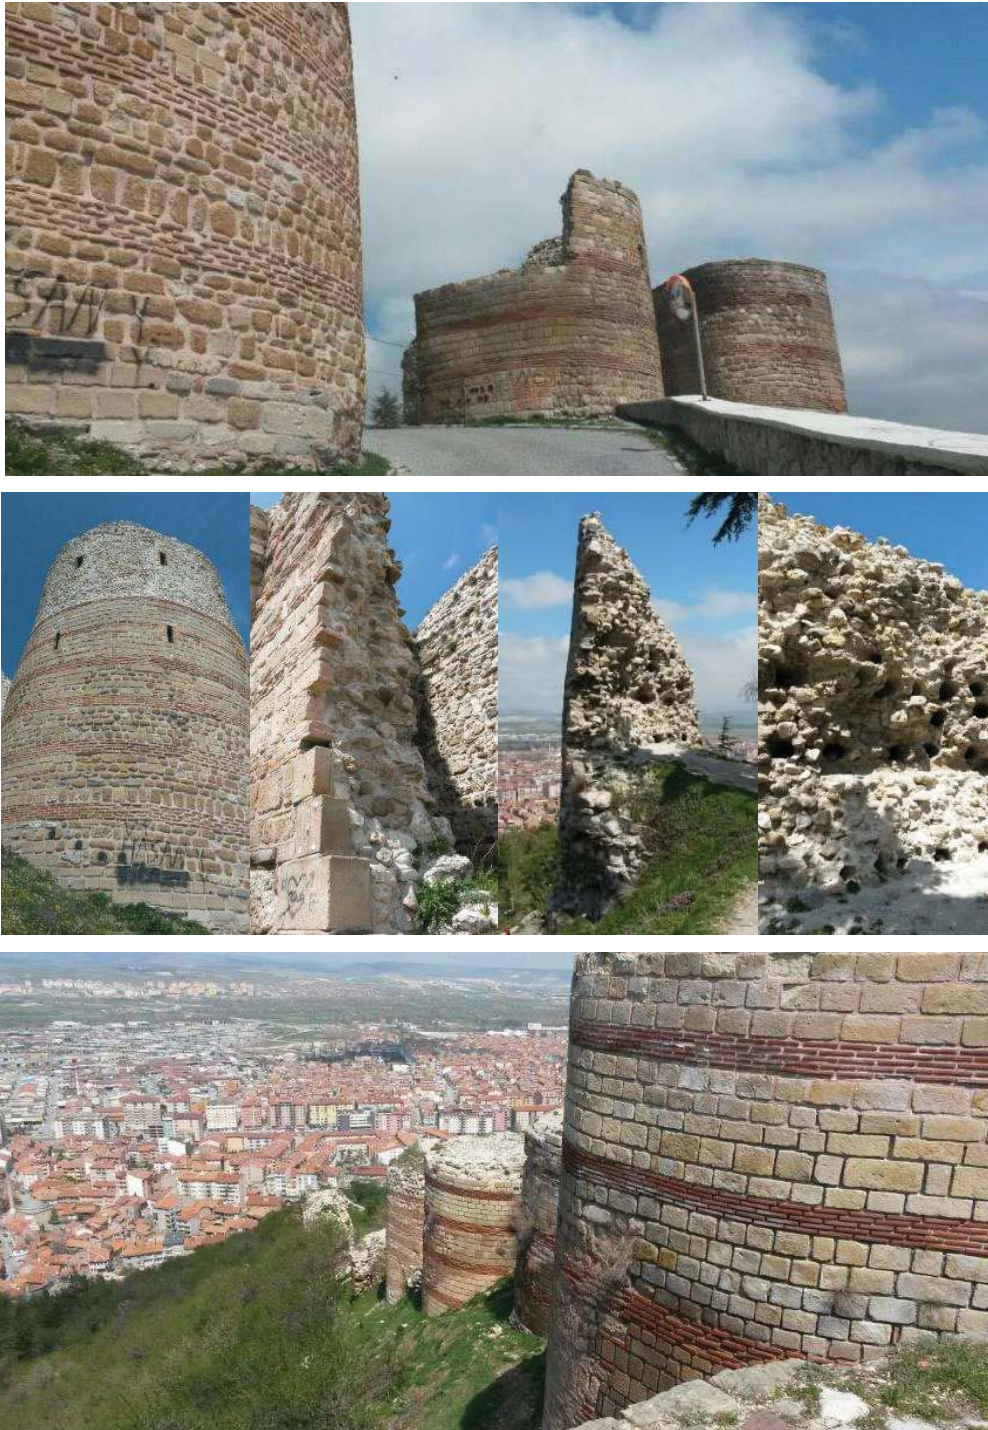
Figure 4-8:Details from the walls and towers of fortifications of Kütahya (courtesy of Nehir Akgün, 2015)

The methodology of the study on the surviving fortifications in Kütahya is similar to the one followed for the Iznik fortifications because in both places the walls and towers of the fortifications are constructed using different techniques. The technique used for the walls is a rubble stone core faced with the cut stone or rubble stone masonry. Apart from the cases where both the types of stonework are used, the use of rubble stone or cut stone in conjunction with courses of brickwork is seen as well. The main technique used on the towers is alternating courses of brick and stone where courses of cut stone or rubble stone stand in between bands formed by four or five courses of brick layers adjacent to each other.¹¹⁵ When the construction technique, materials, and spolia are taken into consideration, a picture is formed of a typical Byzantine fortification (Figure 4-8).

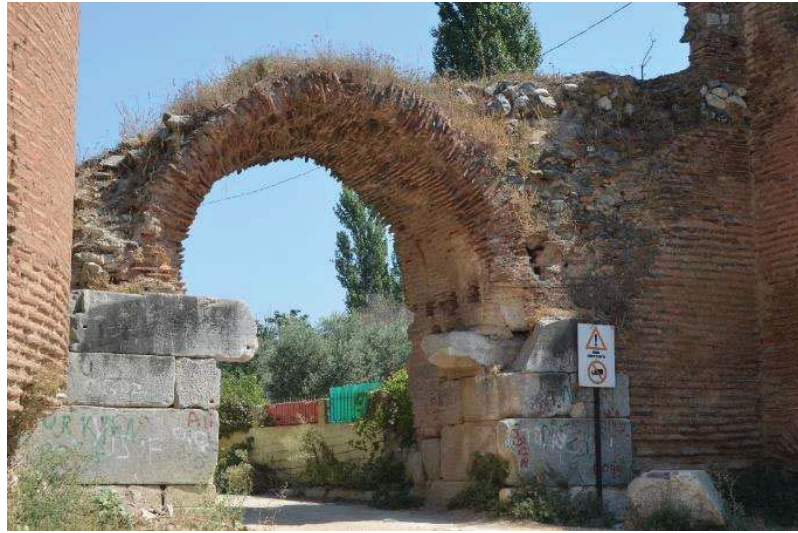
Figure 4-11:South Göl Gate of Iznik fortifications (author, September 2015)

Together with the cloisonné technique, there are variable amount of courses of brickwork that do not follow any strict order. There are not well-ordered brick rows as in the examples of other studied cities, but the use of 3 rows of brick is observed along with the cloisonné technique. There are two types of towers; towers with circular plans and those with quadrilateral plans. Foss (1996a: 37) when describing the South Gate located at this part of the fortification, states that there are limestone blocks that are not laid with mortar on both sides of the gate and the stones located at the corners bear traces as if they were removed with clamps. The opening, with a height of approximately 2.5 m, is spanned by a brick arch similar to the example of the South Göl Gate in Iznik (Figure 4-11).

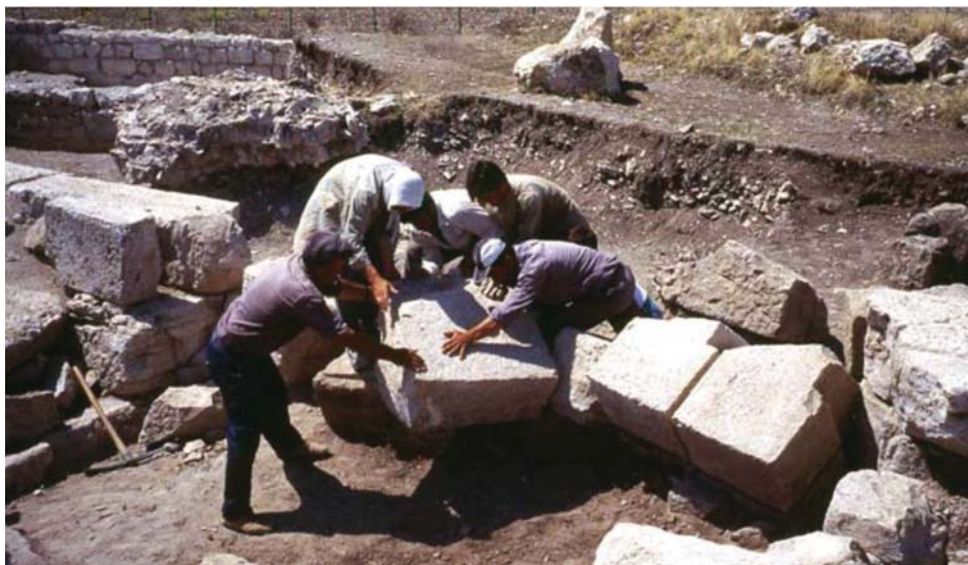
Figure 4-14: Interlocking lintel blocks fallen from above the gateway in the Lower City Walls (Lightfoot and Lightfoot, 2007: 11)

The stones, which were supposed to belong to the lower city walls, that Lightfoot and Lightfoot (2007: 113) mentions are dated to a period between the fifth century to the beginning of the ninth century (Figure 4-14). Lightfoot and Lightfoot (2007) state that the remains located in Hisarköy, a settlement nearby Amorium, are not as flamboyant as those in many other Roman cities in Anatolia. They explain this by the fact that Amorium was a very big settlement established after the Roman period. It was even suggested that the city was the third biggest city following Constantinople and Thessaloniki. Excavations at Amorium, a city that survived until the end of the eleventh century, aided in understanding the character of a Byzantine city. There are samples dated to the period from the sixth century to the eleventh century among the marble and limestone belonging to the Byzantine period church of the city located outside the fortifications (Figure 4-15). Lightfoot and Lightfoot (2007: 24-5) list the important events taking place in the history of Amorium as following: Amorium was annexed to the Asia, the new Roman province, in 133 BCE. The fortifications of Amorium were built in ca. 480, during the reign of emperor Zeno (474-491).¹¹⁸In addition to the Arab invasions, affecting cities such as Ankara, Istanbul, Iznik and Izmit, started in 641 and the first Arab assault in Amorium took place in 644. Although it is known whether all the cities were exposed to these invasions, as Lightfoot and Lightfoot (2007: 59) mentions, there are scholars who have suggested that Amorium’s recovery took some time and the imperial authorities did not commence the reconstruction works immediately afterwards, as in Ankara and that in fact Amorium did not recover fully after the Arab invasions.
