A STUDY ON THE BUILDING TECHNIQUES AND MATERIALS IN THE
LATE ANTIQUE AND BYZANTINE FORTIFICATIONS IN ANATOLIA:
ANCYRA AND NICAEA

A THESIS SUBMITTED TO
THE GRADUATE SCHOOL OF NATURAL AND APPLIED SCIENCES
OF
MIDDLE EAST TECHNICAL UNIVERSITY

DECEMBER 2016

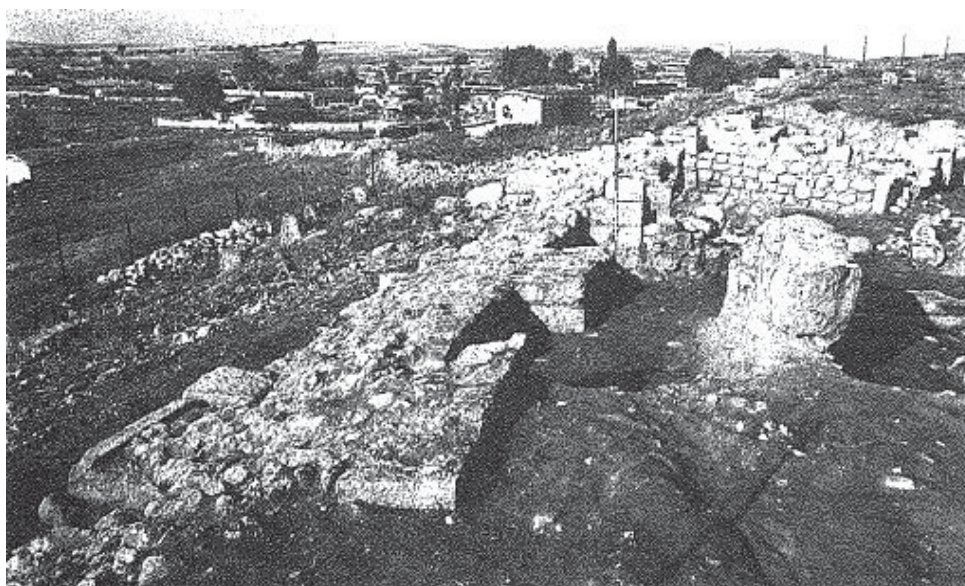
Figure 4-16: General view of the building (Lightfoot, 1994: 19, fig. 5)

The fortifications of Amorium comprise two (lines of) walls set on two different levels (Figure 4-13/19). It is not known when the lower city was surrounded with fortification walls. Lightfoot (1994: 19-20), who emphasises that the building complex located in

the southern part of the lower city is a significant structure, although its function is as yet unknown, associates part of this building, made of rectangular blocks of masonry with the upper parts of the walls surrounding the lower city. However, there are courses of brickwork above the courses of stonework in the walls of this building, which is thought to be significant, although its function is unknown (Figure 4-16). With little of the walls remaining intact and no mention of the technique of alternating courses of brickwork in the sources, clear information on the use and type of the brickwork could not be obtained (Figure 4-17). However, both courses of stone and brick could be seen in the remains of wall located in the lower enclosure (Figure 4-18). Lightfoot (1994: 19-20) on the basis of similarities between the fortification walls and the structure under discussion in terms of construction technique and material, and on the basis of the chronology of the ceramics found in the structure, states that it was built in the same period as the fortifications in the late fifth century. With future advances in research, it may be possible to gather detailed information on the technique of the upper parts of the fortifications. Little remains of the fortifications of Amorium, which are dated to the Late Roman period in the light of the excavations conducted. The lower city walls, only a very small part of which are observable in terms of height and length, are known to have surrounded the entire city (Figure 4-19). However, since the fortification wall is not intact, this is impossible to confirm.

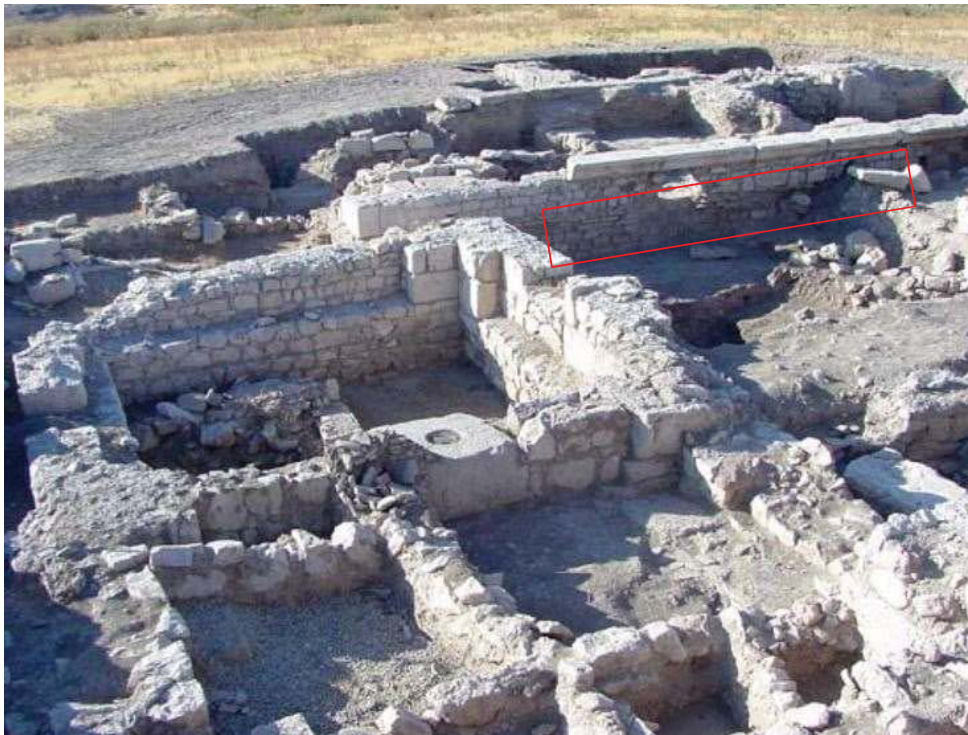
Figure 4-17: Mid-Byzantine defensive wall around the Upper City (Lightfoot, 1994: 24, fig. 8)

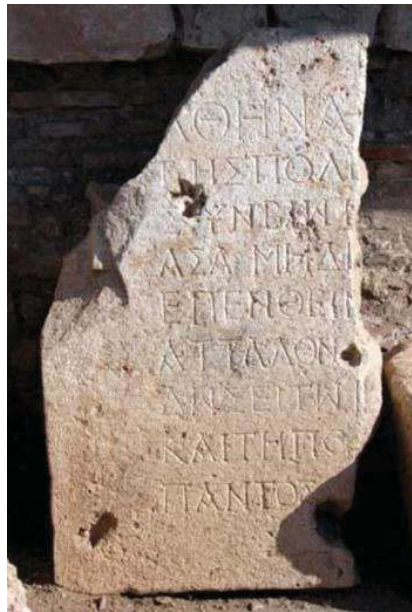
Figure 4-20: Fragment of an inscribed block from a monumental tomb from the first half of the third century AD (Lightfoot and Lightfoot, 2007: 38)

The use of spolia is a general characteristic of Byzantine period fortifications. The part that was built with spolia of the upper city walls is similar to the Citadel of Ankara and it was therefore thought reasonable to date the wall built with spolia to the seventh century.¹¹⁹ It was stated that the inscriptions located on the fortifications dated to the Byzantine period had been gravestones before being reused in the walls, and a large inscription unearthed in the foundation of the walls could be dated to the first half of the third century (Figure 4-20).¹²⁰

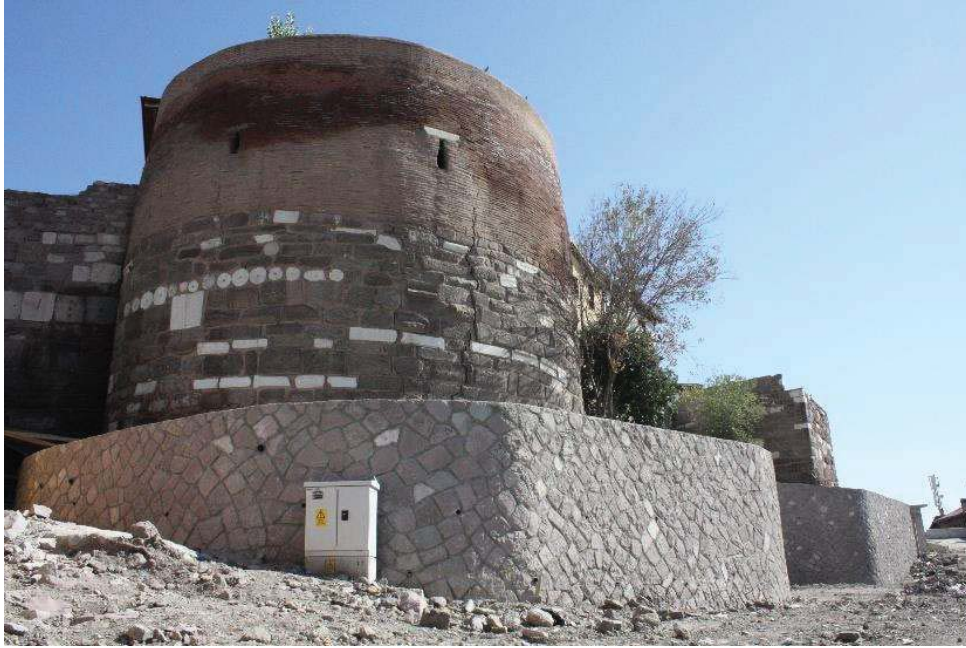
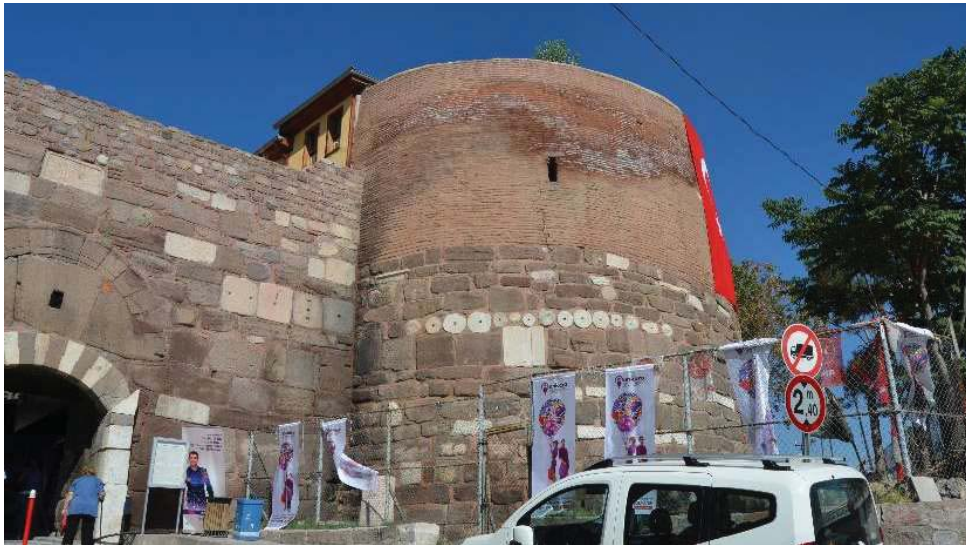
Figure 5-1: The Citadel of Ankara, Hisarkapı before and after the addition of external wall in 2016 (author, September 2016-2015)

Finally, existing information on the fortifications which are difficult to date currently, can become unrecognizable and even lost because of modern interventions. Moreover, these interventions negatively influence the setting of the fortifications and legibility of the forms and topographic itinerary of the walls (Figure 5-1) (Map 17). On the other hand, excessive use of mortar pointing on wall surfaces (covering the edges of the stones), a practice which is dated to the Byzantine period by Foss (2003), is a common restoration application in Turkey (in past and at present). Therefore, the possibility that this application was made in a recent period cannot be ruled out (Figure 5-2). However, repairs which are made with concerns about using materials and techniques compatible with the original ensure the proper transfer of these urban cultural properties to future generations (Figure 5-3).

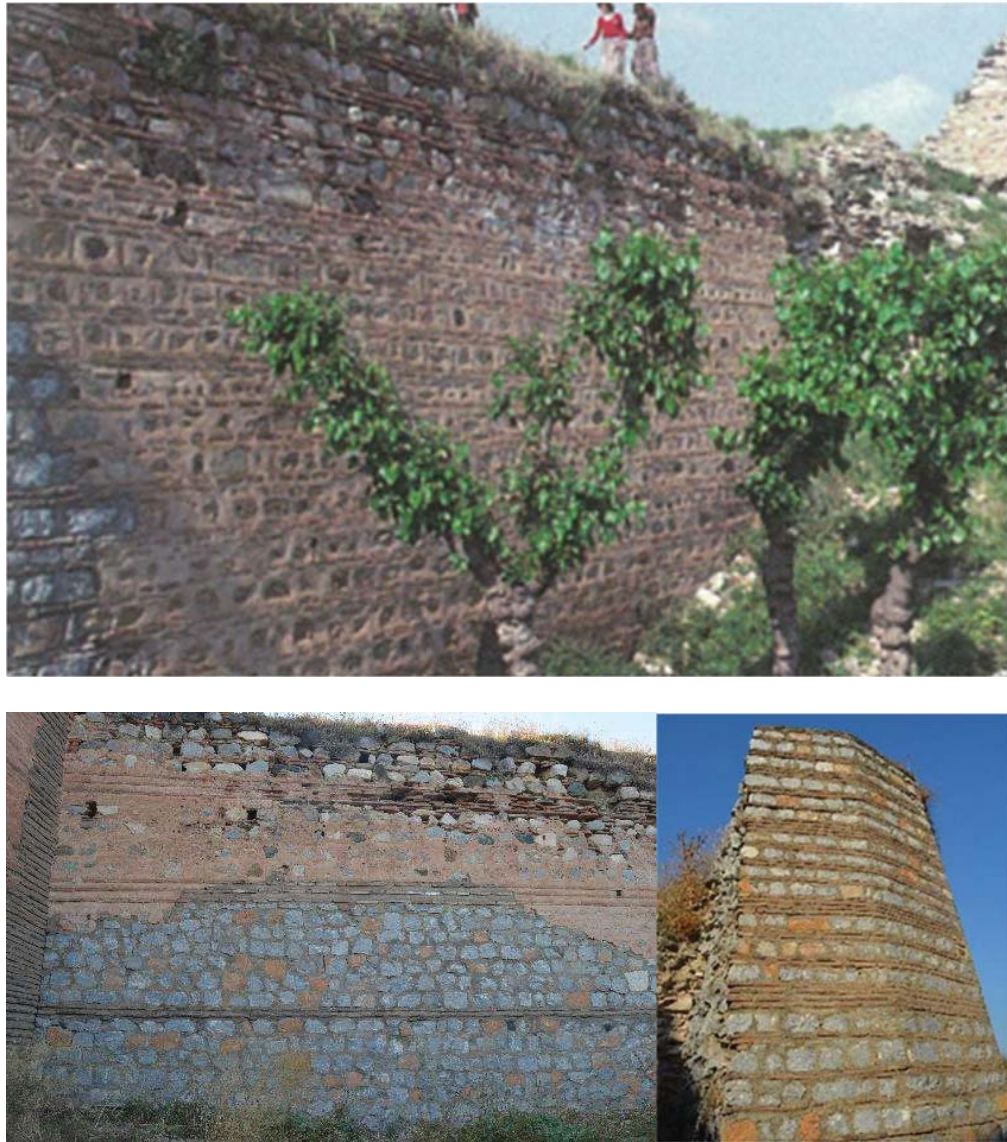
Figure 5-2: Iznik fortification wall with decorative brickwork and extensive use of mortar (above) (Foss, 2003: 259, fig. 18), Restoration application of covering the stone with mortar at the bottom of the wall (below left), use of same application on the surface of a tower (below right) (author, September 2015)

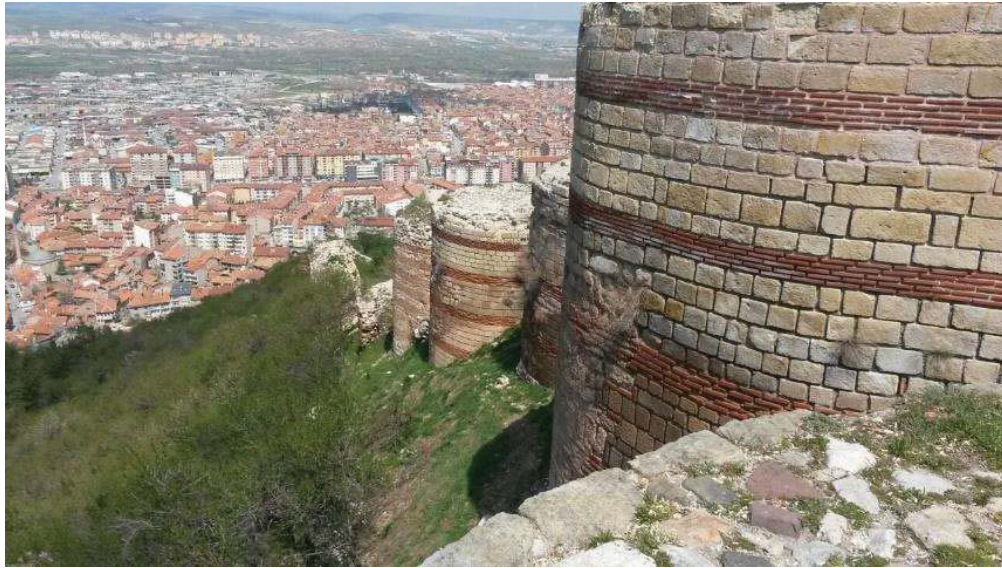
Figure 5-3: Modern repair on the fortifications of Kütahya (courtesy of Nehir Akgün, 2015)

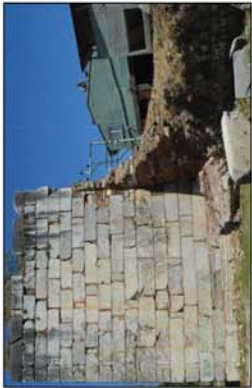
stone masonry

Table 2: Tower classification according to construction techniques and materials

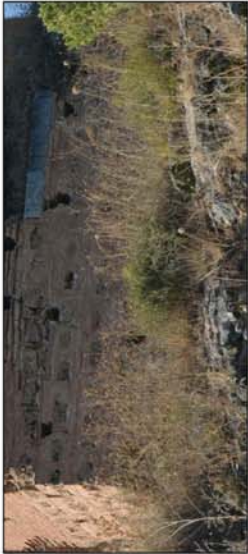
cloisonné

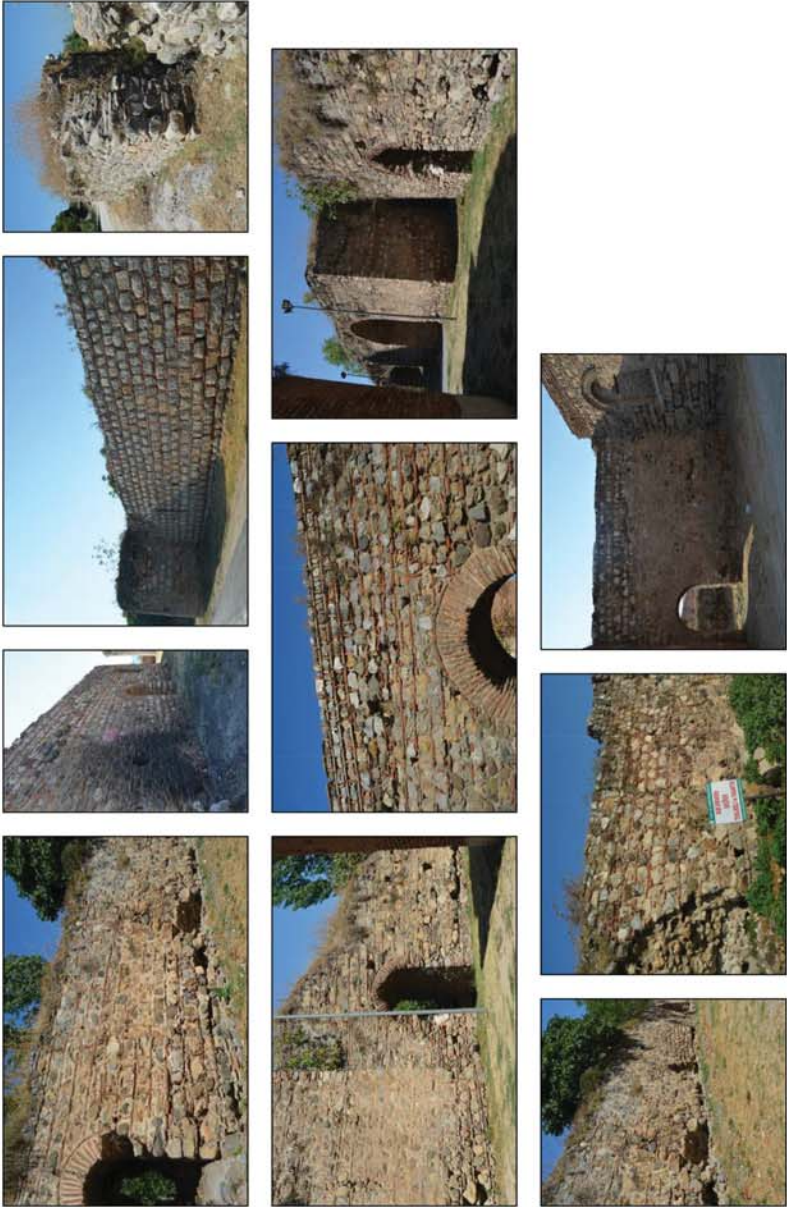
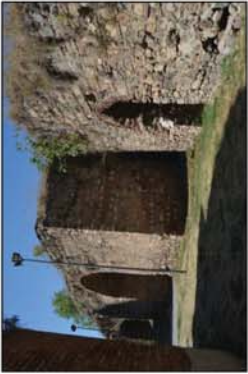
Table 4: Outer wall with cloisonné technique

OUTER WALL - CLOISONNE TECHNIQUE				PHOTO			
TYPE	ELEVATION	SECTION					
walls

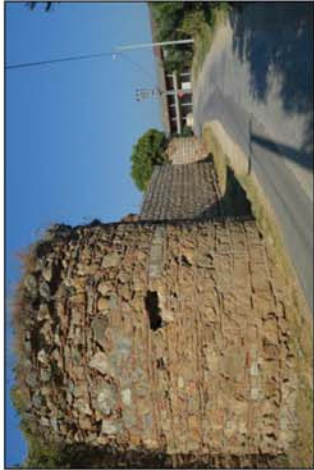
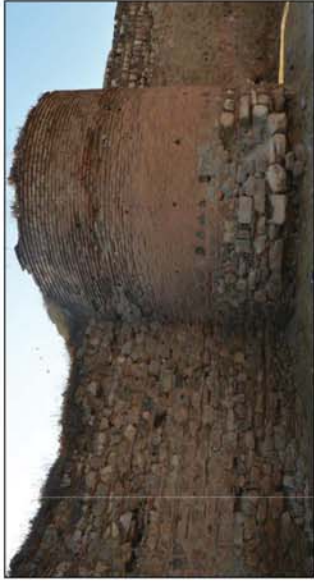
towers

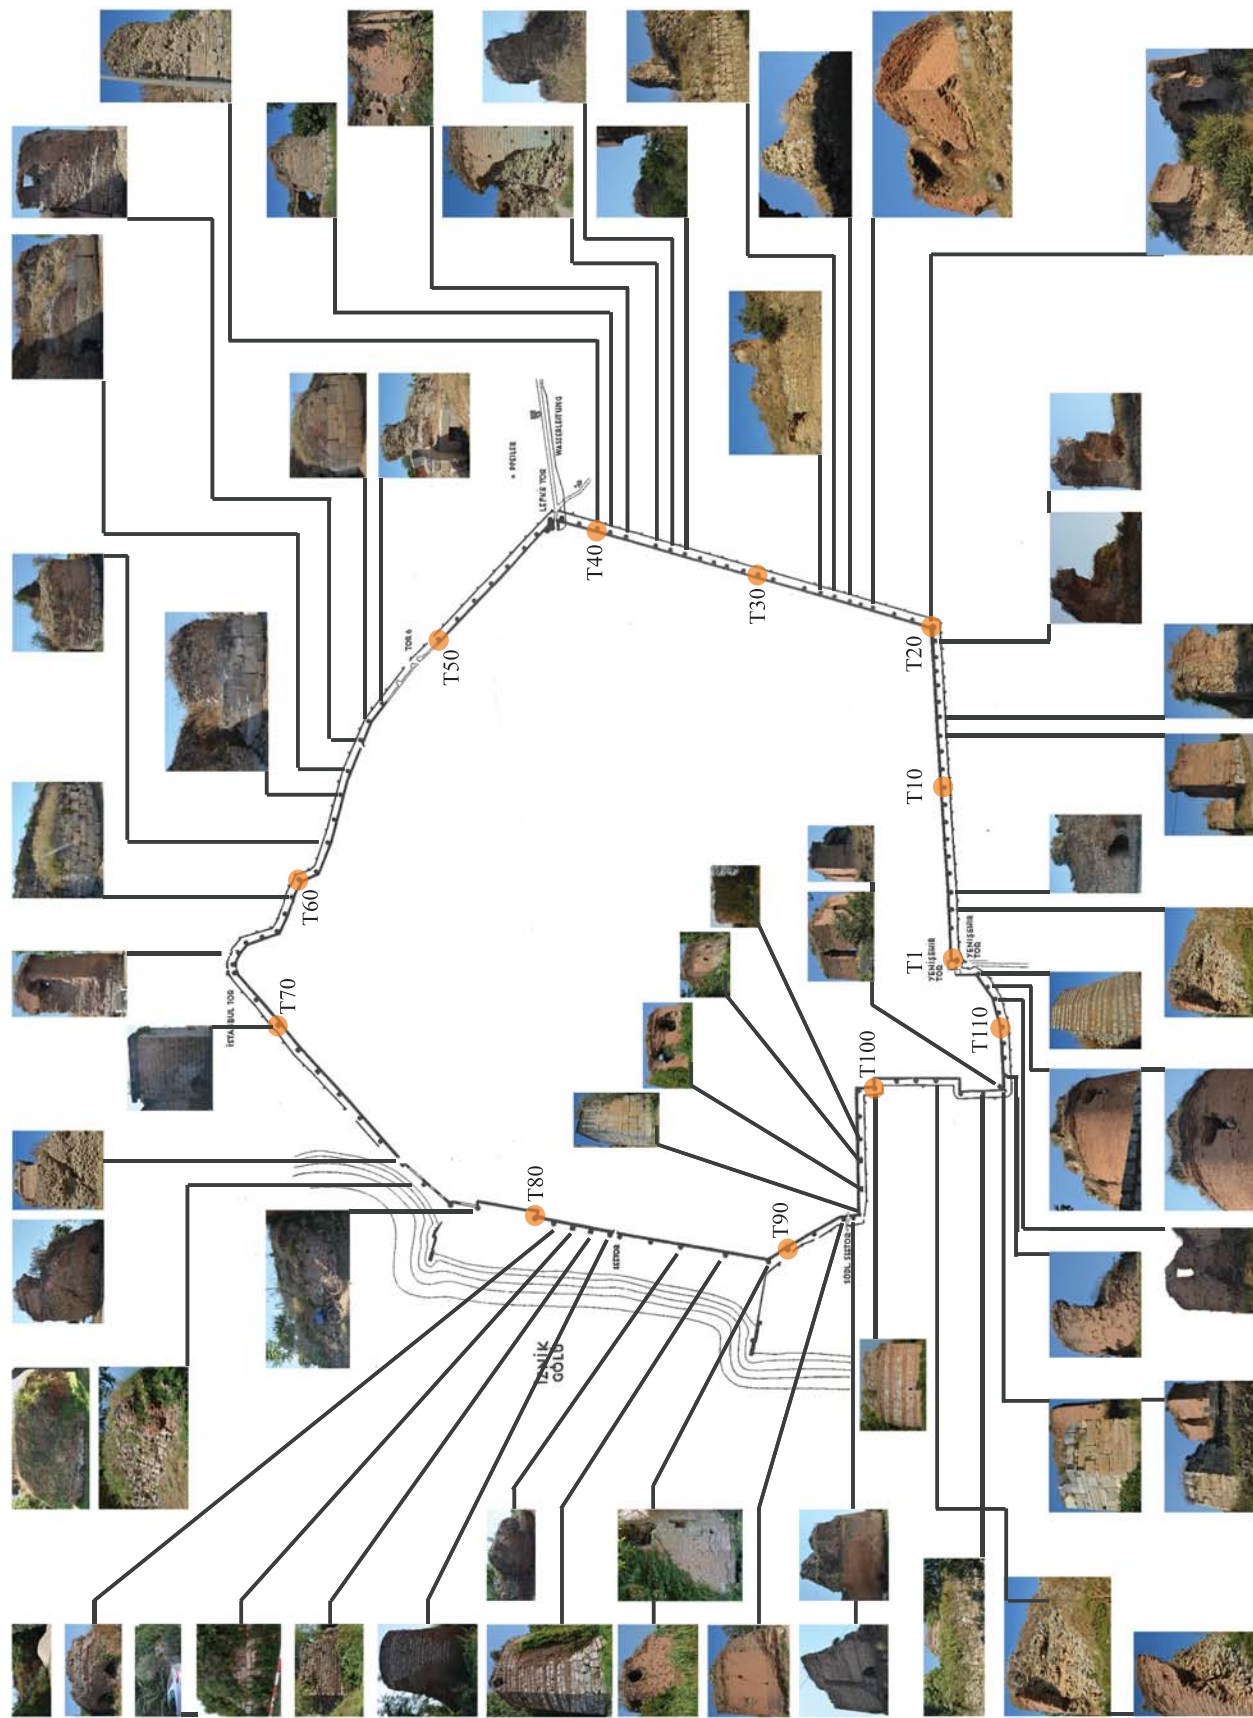
Map 1: Walls of Iznik fortifications 187
