CAUSES AND EFFECTS OF URBAN TRANSFORMATION PROCESSES ON
THE CULTURAL HERITAGE IN HACI BAYRAM AREA, ULUS

A THESIS SUBMITTED TO
THE GRADUATE SCHOOL OF NATURAL AND APPLIED SCIENCES
OF
MIDDLE EAST TECHNICAL UNIVERSITY

IN PARTIAL FULFILLMENT OF THE REQUIREMENTS
FOR
THE DEGREE OF MASTER OF SCIENCE
IN
CONSERVATION OF CULTURAL HERITAGE
DEPARTMENT OF ARCHITECTURE

OCTOBER 2015

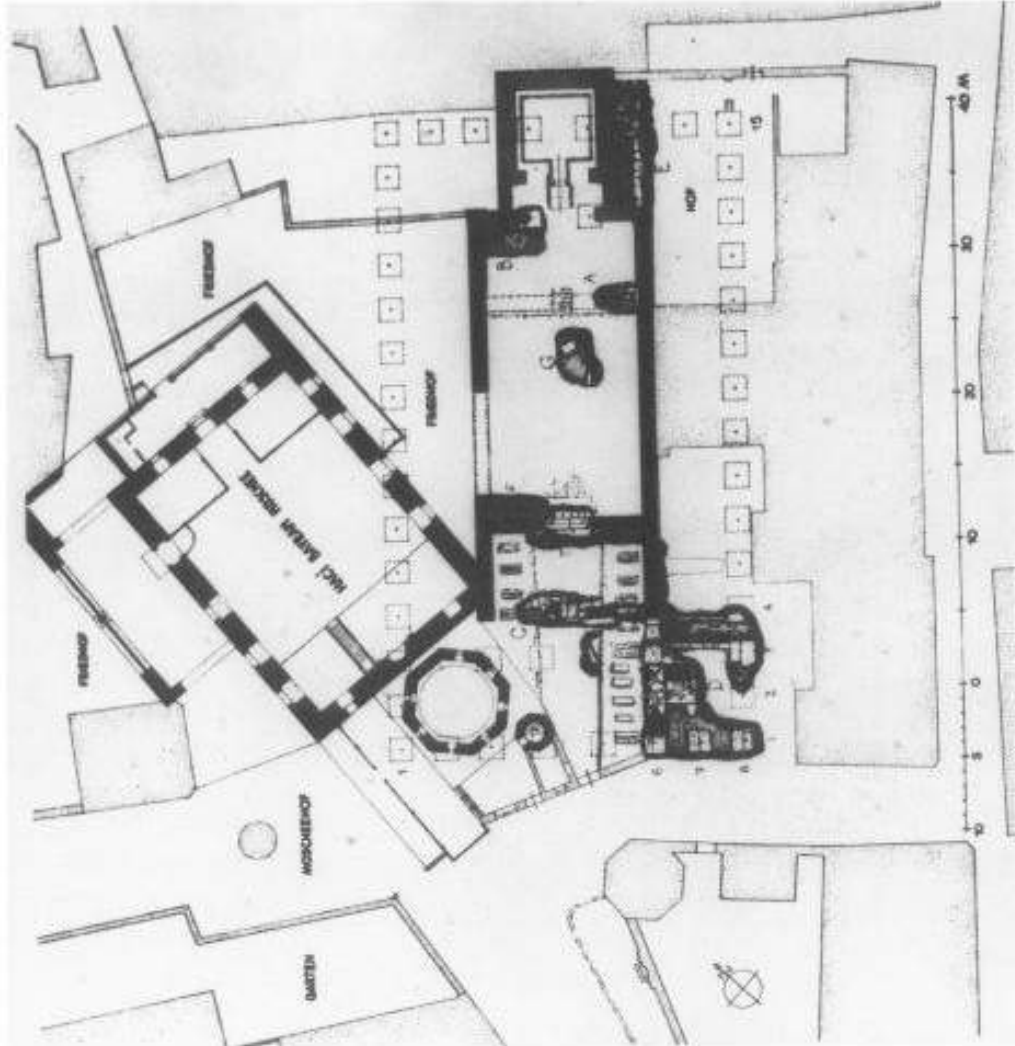
Figure 3.2: Temple of Augustus, Ankara, and Hacı Bayram mosque, plan after the German excavations in 1926. (Güven, 1998)

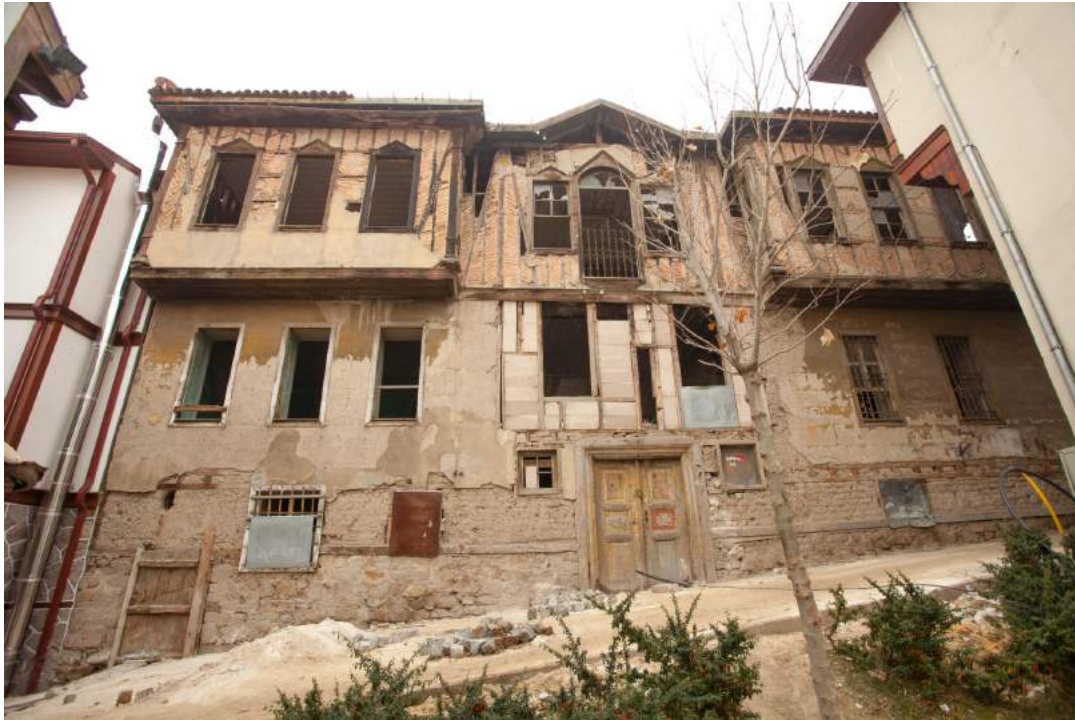
Figure 3.10: Block:19995, Lot:7; Traditional Technique, Timber Frame (RTT in Figure 3.8)

The combination of these two parameters are defined in 4 building categories and presented in Figure 3.8. The six main categories divided into sub groups. In the buildings constructed with traditional technique; RTT, RTM, RsTM, RsTT and ETP in Figure: 3.8 are observed as the examples can be seen from Figure 3.10 and 3.11.

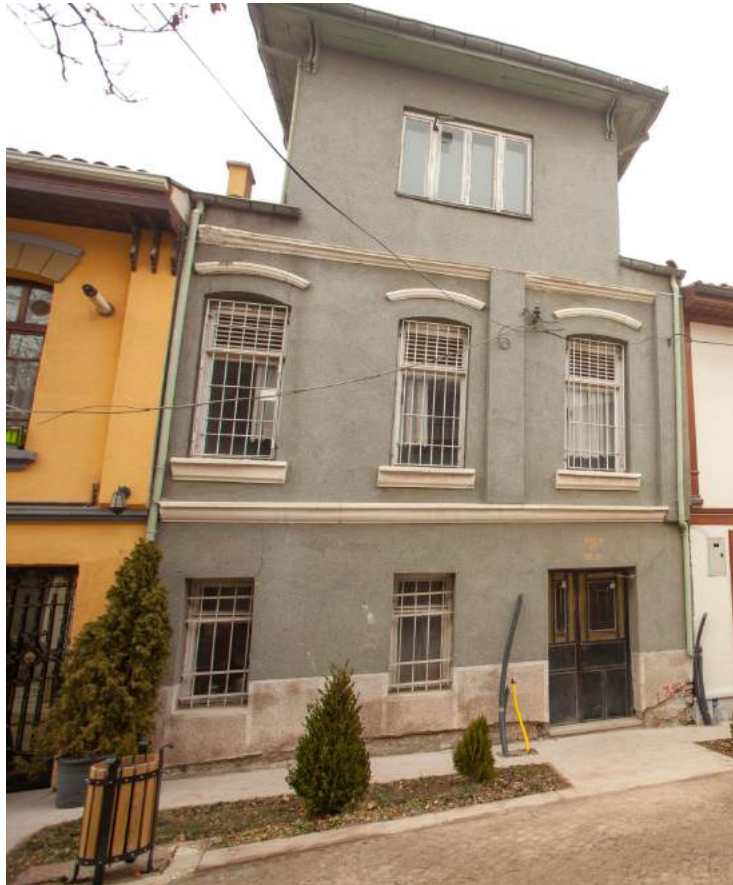
Figure 3.11: Block:19955, Lot:3; Traditional Technique, Masonry (RTM in Figure 3.8)

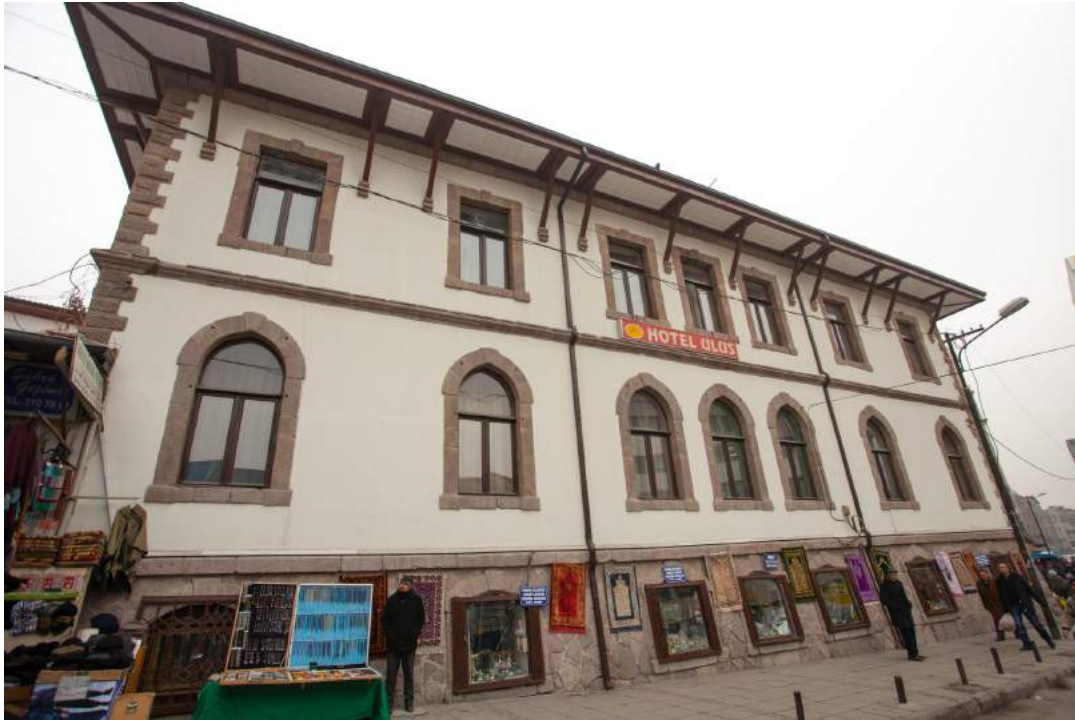
Figure 3.12: Building Block:19977, Lot:1; Early Republican Period, Masonry

In apartments and Republican period groups masonry and concrete buildings are seen (Figure 3.12 and 3.13).

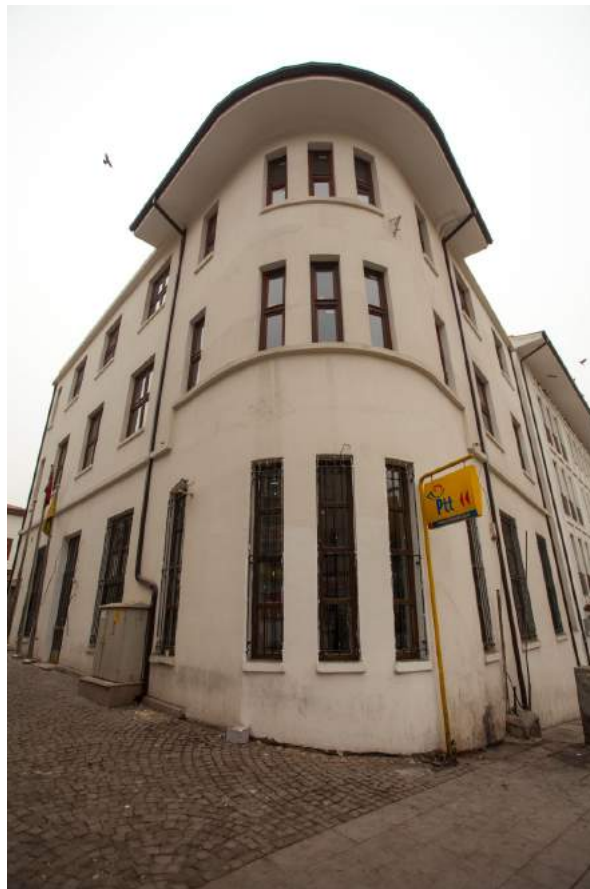
Figure 3.13: Building Block:19975, Lot:1; Apartment, Concrete

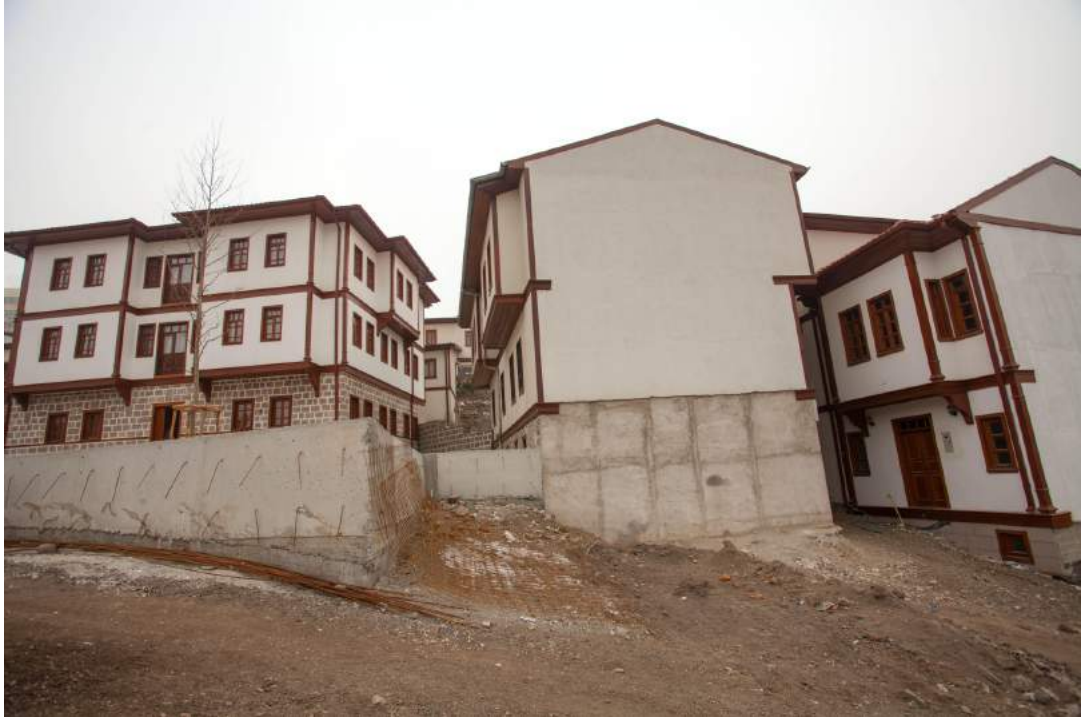
Figure 3.14: Building Block:19971, Lot:4, 1; Building Block:19970, Lot:8; Pseudo Traditional Surfacing Building (RNP in Figure 3.8)

In the CNP sub-group in Figure 3.8, concrete is used as a material and the buildings were constructed by the new techniques, however, their facades seem like traditional buildings (Figure 3.14).

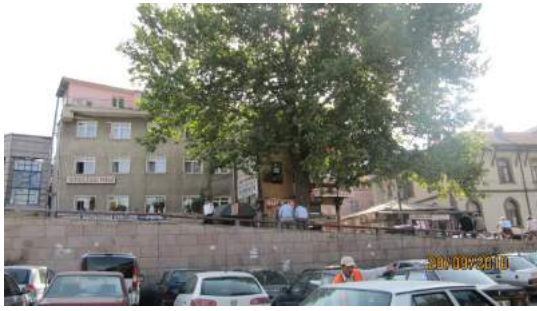
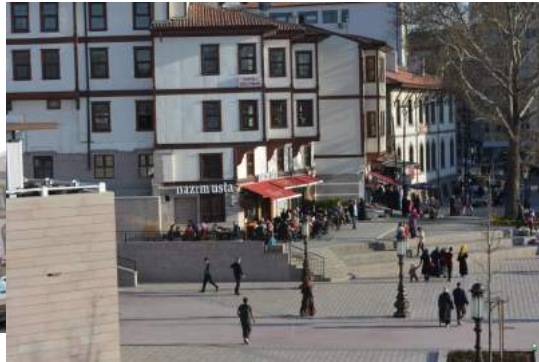
(a) Building Block:19982, Lot:1; Before Rehabilitated as Pseudo Facade

(b) Building Block:19982, Lot:1; After Rehabilitated as Pseudo Facade)

Figure 3.15: Example of CNR Sub-group in Figure: 3.8

In the buildings, whose original functions are commercial, two of the three subgroups are seen as CNR (Figure: 3.15) and CNC (Figure: 3.16) and the other one is CNP in Figure: 3.8.

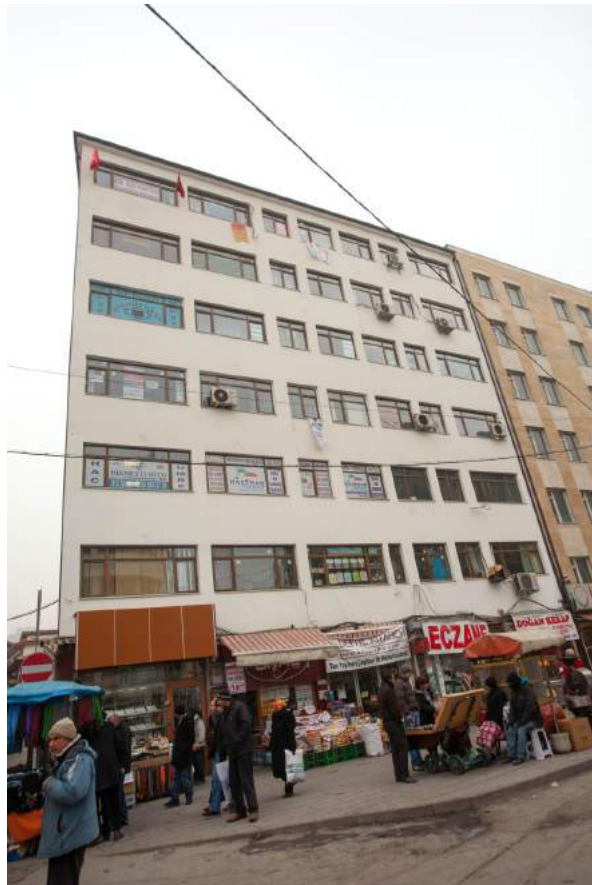
Figure 3.16: Block:19976, Lot:23; New, Concrete (CNC in Figure 3.8)

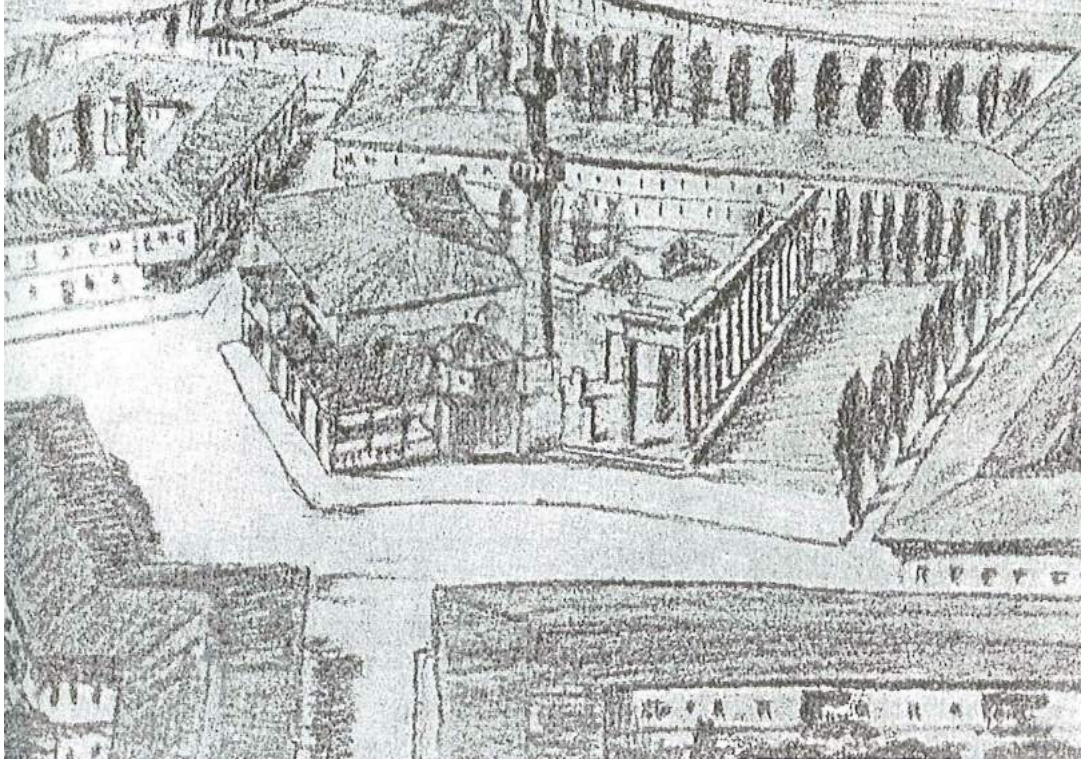
Figure 3.29: Drawings of Hacı Bayram Veli Mosque and The Temple of Augustus by Lörcher (Cengizkan, 2004)

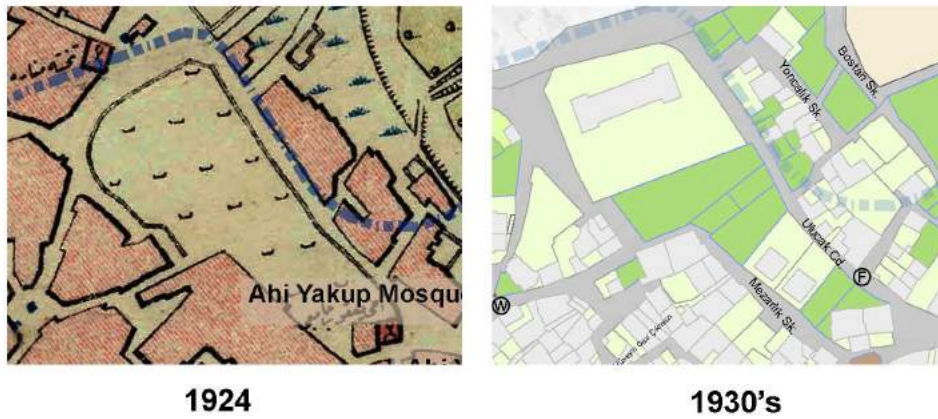
Figure 3.41: Change in Cemetery Block between 1924 and 1930's

Three lots were demonstrated as cemetery in 1930's. On the other hand, the larger cemetery block shown in 1924 transformed and divided into the gardens, school and courtyard of the school in 1930s. According to Cengizkan, in Lörcher Plan it is proposed that all cemetery area would be transferred to outer space of the city (Cengizkan, 2004). This change which is shown in Figure 3.41 can be read as the outcome of the Lörcher Plan.

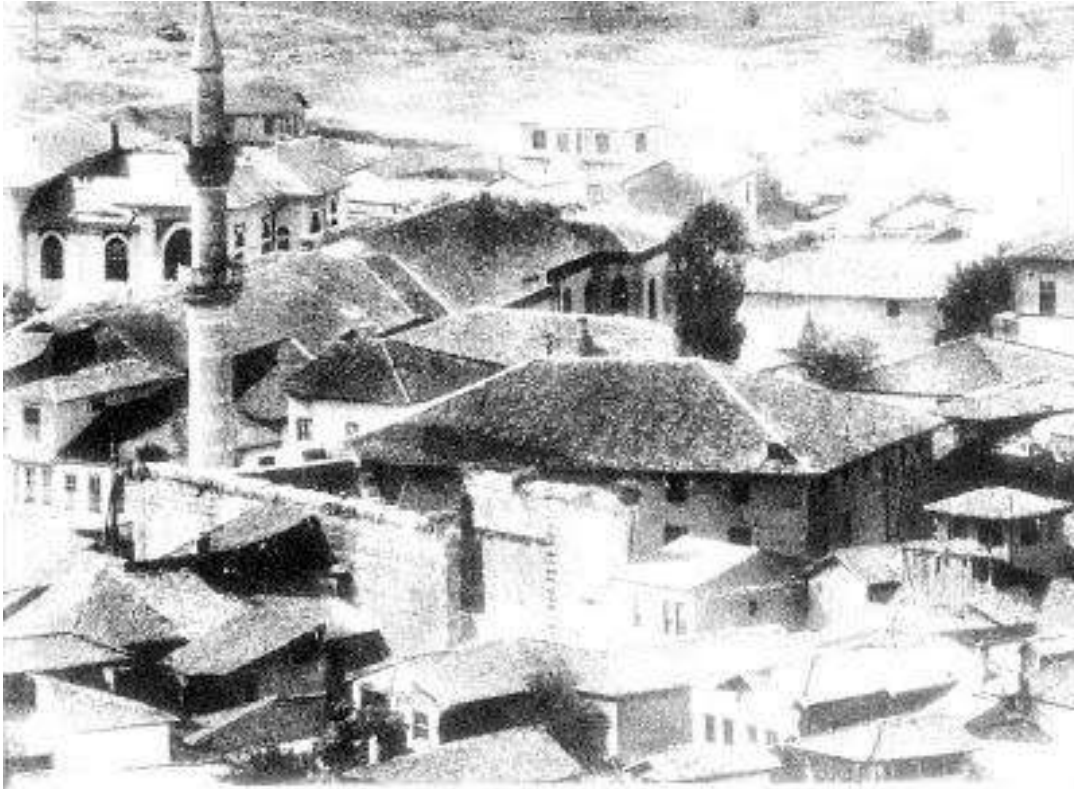
Figure 3.50: The situation of demolished residential tissue around Hacı Bayram Veli Mosque in the end of 19th Century (Tunçer, 2000)

As it can be seen from the Figure 3.49 38 buildings were demolished from 1930's to 1948 in the surrounding lots of Hacı Bayram Veli Mosque. The demolished buildings were mostly residential houses in 1930's cadastral map (Figure 3.50). Furthermore, Madrasah buildings in the lot including Ismail Pasha Turbe at southern of Hacı Bayram Mosque were also demolished (Figure 3.49). In place of demolished urban fabric at the north-eastern and north-western part of Hacı Bayram Veli Mosque, the new street was formed which is defined by the newly planted trees. Therefore, it should be stated that this change resulted in lost of traditional urban pattern within the adjacent neighboring lots to Hacı Bayram Veli Mosque and the Temple of Augustus during this period.

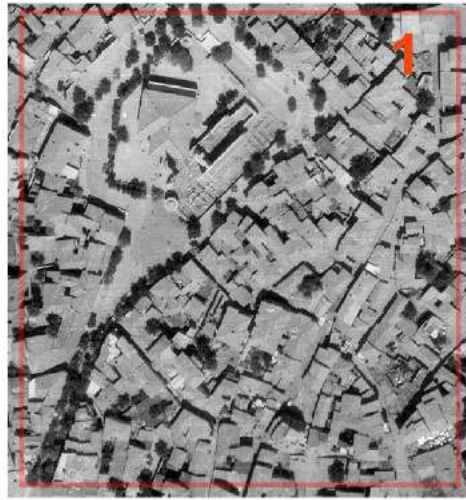
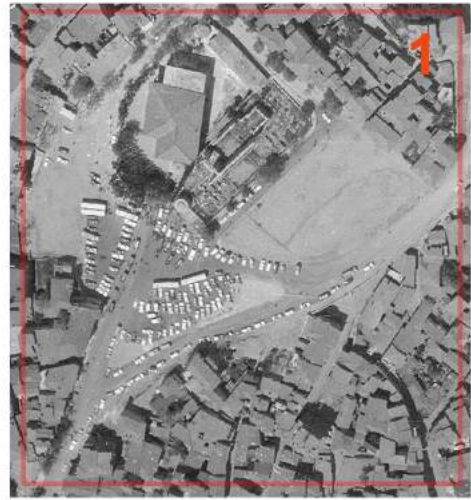
Figure 3.63: Change in Urban Pattern in the surroundings of the Hacı Bayram Veli Mosque and the Temple of Augustus

The other important change, additions of Hacı Bayram Veli Mosque, can be seen in Figure 3.63 that two new buildings were constructed at the northern part of the mosque.

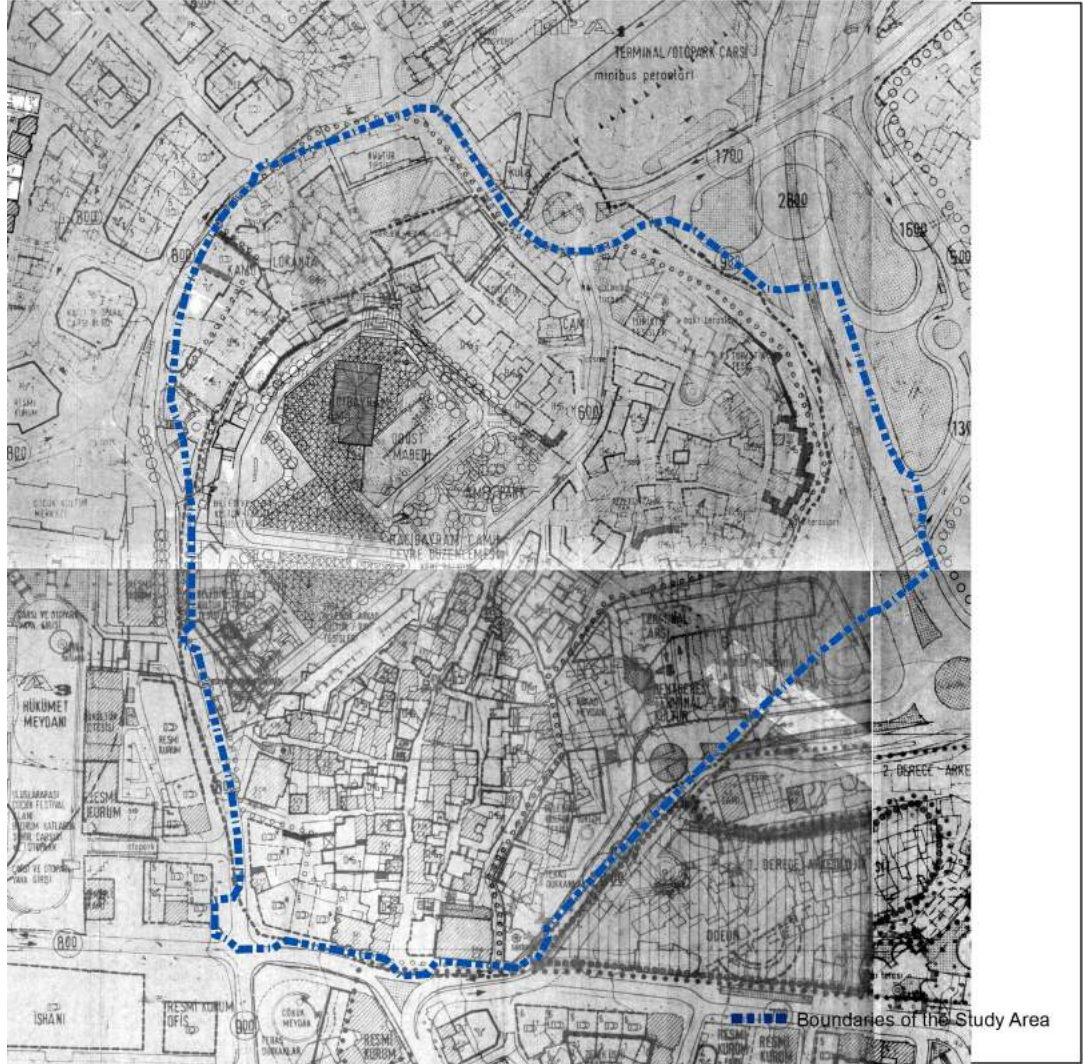
Figure 3.70: The Study Area in Bademli Plan, City and Regional Planning Department Archive, METU

The majority of the study area is proposed within the boundaries of 'conservation program area'⁹ in Bademli Plan,1990 (Figure: 3.70). The buildings in these lots, which were changed by the impacts of Yücel-Uybadin Plan, shown in blue color in Figure 3.66, are not within the boundaries of conservation program area. These buildings were defined as 'contented building' and 'new buildings' in the legend ¹⁰. Furthermore, the new block on the Kevgirli Street at southern-east is remained out of

As the boundaries seen from the Figure 3.70 by the dashed lines, 'public project area' is defined in the study area. In the legend, It is indicated for the public project areas

The new proposal can be shown in Figure 3.70 around the Hacı Bayram Mosque and the Temple of Augustus in Bademli Plan. The new formation of open spaces with rigid geometric order are defined by the new larger scale buildings (Figure 3.71). According to these proposals in 1/1000 plan as a public project area, AKTVKBK approved the Hacı Bayram Mosque and the Temple of Augustus Environmental Design Project in 1/500 scale by the decision numbered 1219 on May 1 , 1990 (Figure 3.72). By this project the surroundings of Hacı Bayram Veli Mosque would have the square inspired by certain geometry that defined by the buildings with arcades used as small shops mostly are the book stores(Figure 3.73).

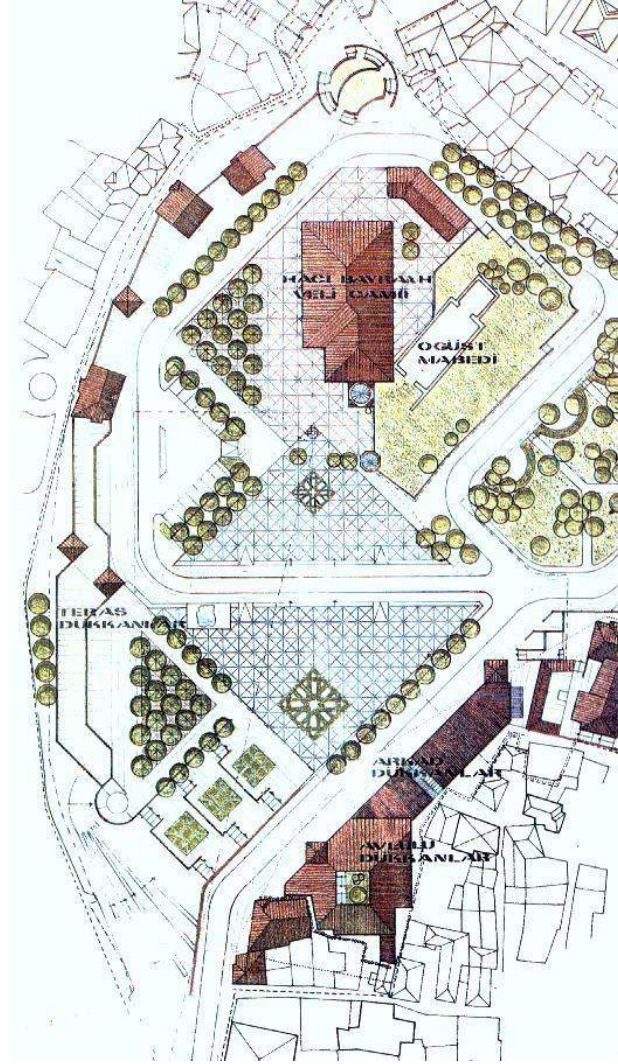
Figure 3.72: Hacı Bayram Project Environmental Design Project in Bademli Plan (Architects: Celal Abdi Güzer and Ufuk Yeğenoğlu), The Chamber of City Planners Archive

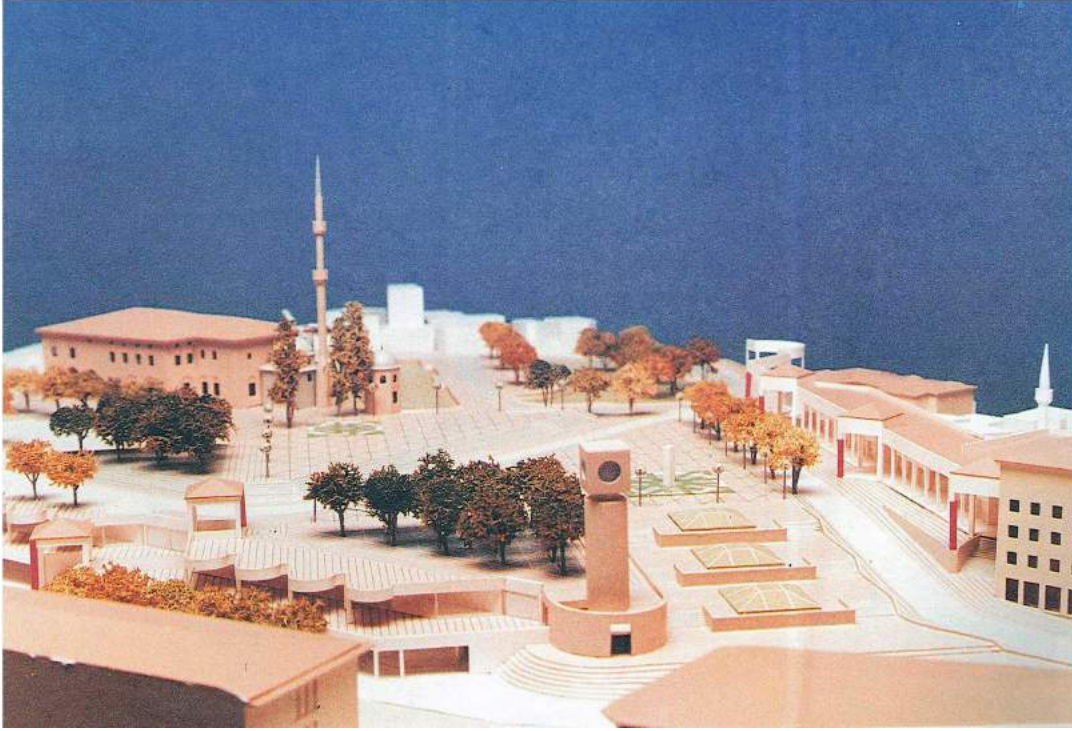
Figure 3.73: Hacı Bayram Project Urban Design Project in Bademli Plan, Chamber of City Planners Archive

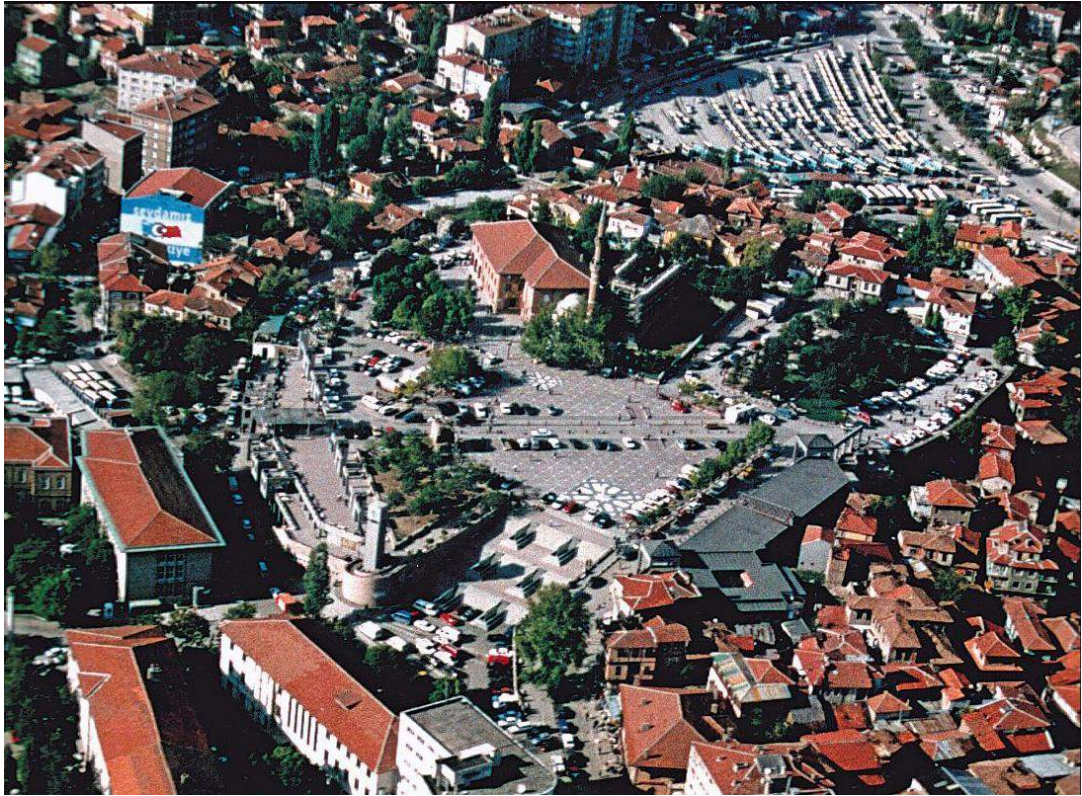
Figure 3.76: Hacı Bayram Square implemented according to the Decisions of Bademli Plan, The Chamber of City Planners Archive

While concerning the open and built-up areas in 1994, It can be observed that Hacı Bayram Square is enlarged and defined by the larger buildings which are not compatible with the dominant building pattern in the study area (Figure: 3.76).

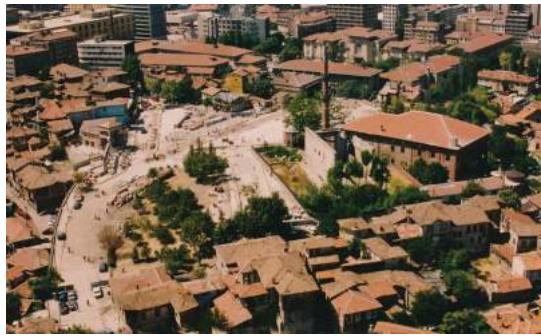
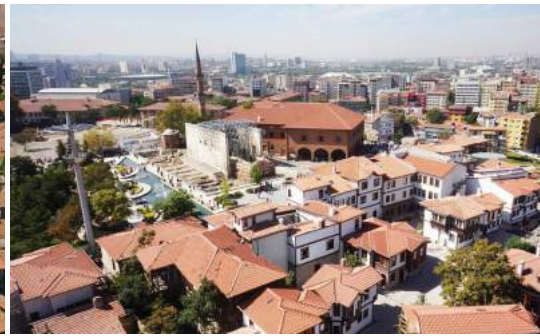
(a) Before the Pool Arrangements, (www.melihgokcek.com)

(b) After the Pool Arrangements, (www.melihgokcek.com)

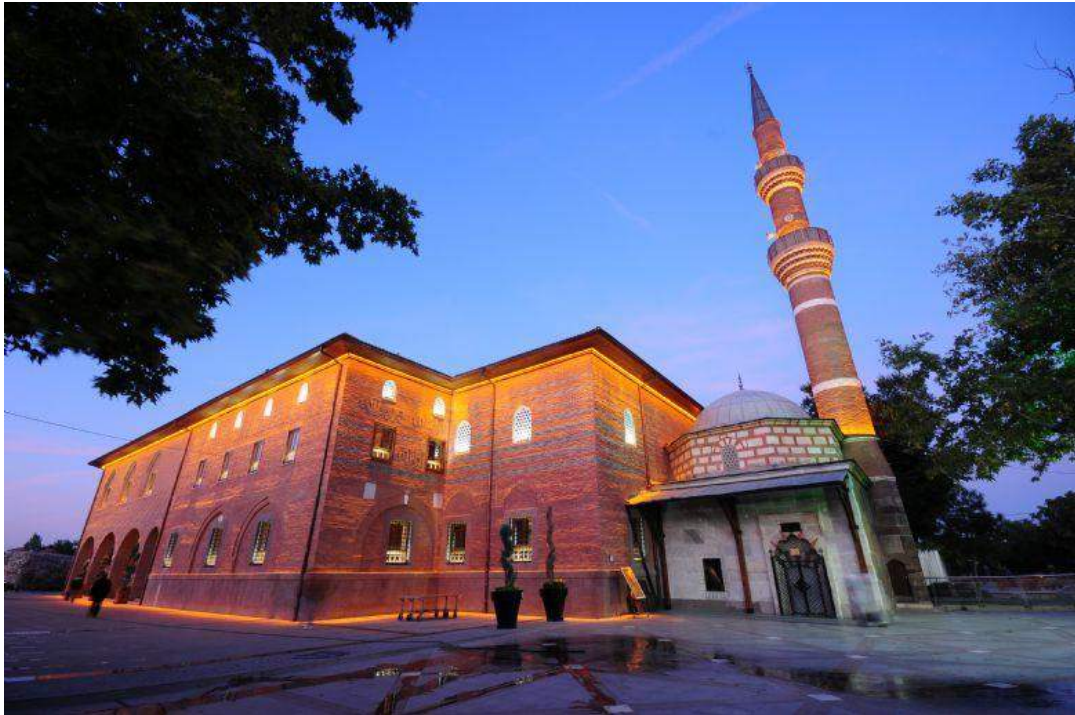
Figure 3.85: Hacı Bayram Mosque After the Restoration Project (www.melihgokcek.com)

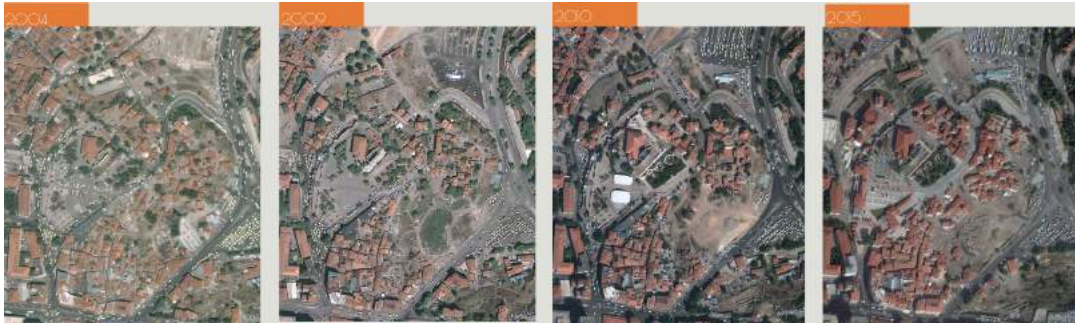
Figure 3.89: Google Earth Images in 2004,2009,2010,2014

When compared the Google Earth images of the area between 2004 and 2015, it can be seen that the urban fabric on the eastern part of the area was conserved more or less during Bademli Plan (Figure: 3.89). In 2005, Bademli Plan was canceled and only one year between 2007 and 2008 Hassa Plan remained valid. After its cancellation, the implementation in urban fabric in the area were conducted lot by lot not depending on a valid Conservation Master Plan but through the decisions of conservation councils. Similar to urban design project mentioned below, the interventions has been conducted according to the Conservation Principles and Terms of Use During to Transaction Period (*Geçiş Dönemi Koruma Esasları ve Kullanım Şartları*) by the consent of the council.

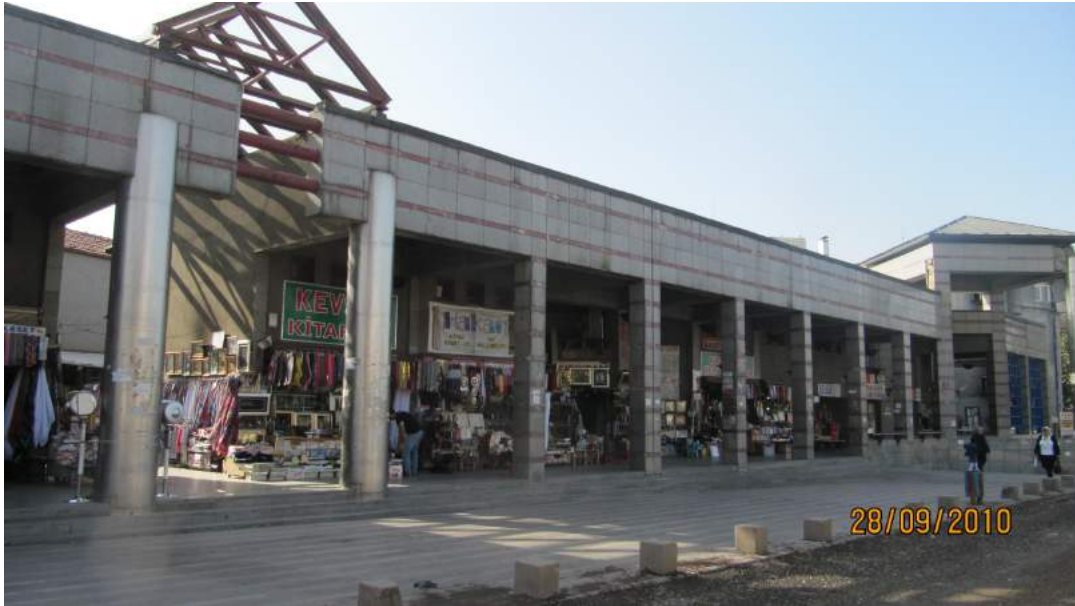
Figure 3.95: Bazaar Building on Hükümet St. Constructed According to the Bademli Plan, Conservation Council Archive

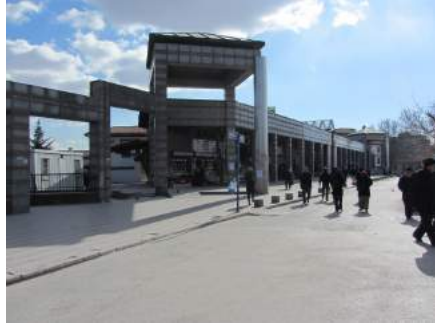
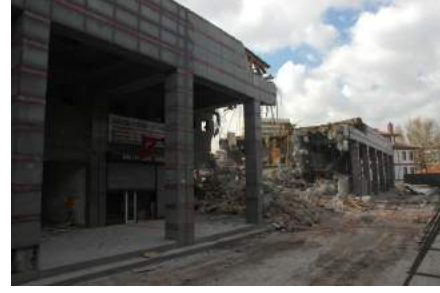
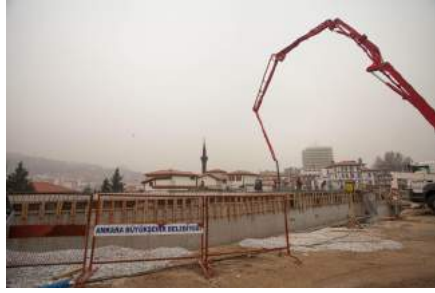
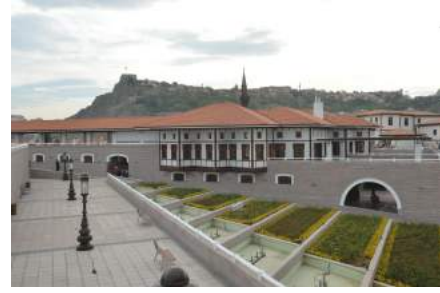
Figure 3.96: Demolishing the old Bazaar Buildings and Constructing new Arasta Buildings, (1,2: Conservation Council Archive, 4: www.ankara.bel.tr)

by the commercial activities which mostly have book stores, and the shops selling pilgrim materials Figure: 3.96).

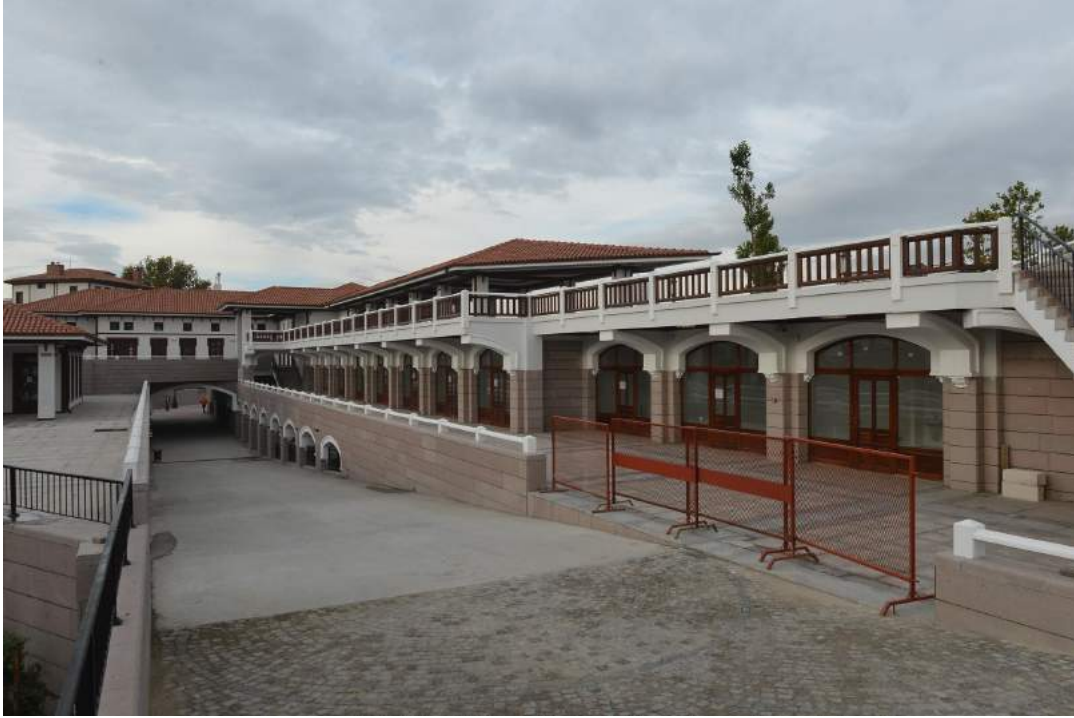
Figure 3.97: The New Bazaar Building 'Arasta' on Hacı Bayram Street, www.ankara.bel.tr

As shown in Figure 3.98 the shops in new bazaar consists of two blocks spreading to 17000 m2 construction site. The four storey block on the Hükümet street was built on 2000 m2 area with the total closed area 6500 m2 and consists of 44 shops. The other block of three storeys on Hacı Bayram Street built on 2500 m2 area with 6000 m2 closed area and consists of 42 shops (Figure:3.97).

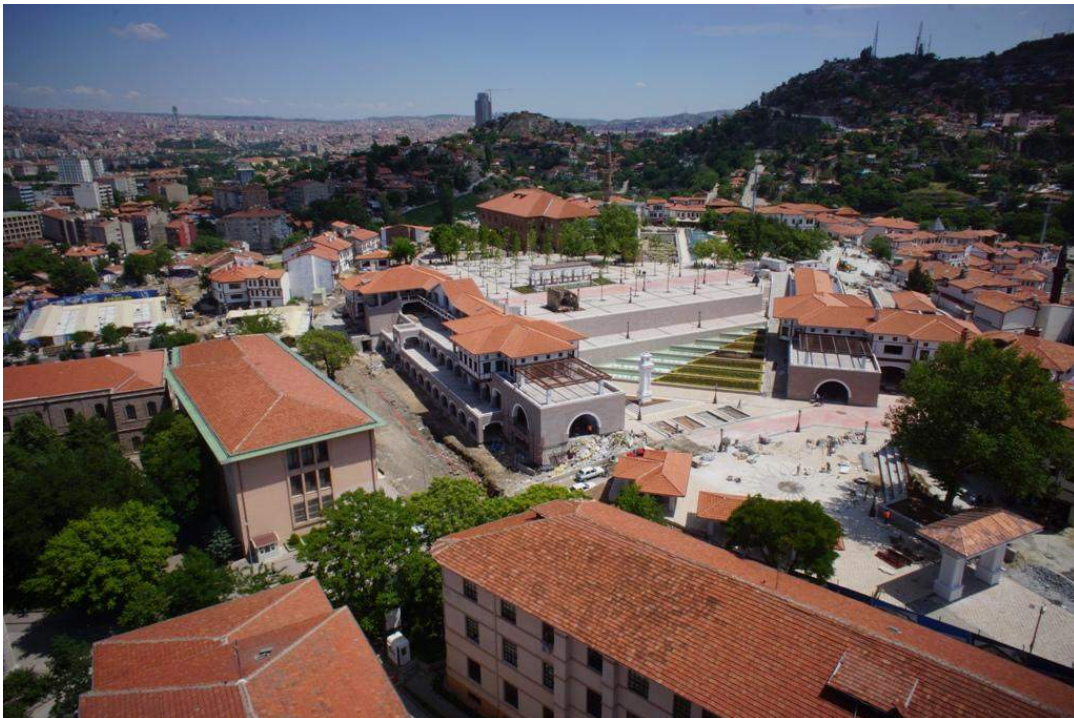
Figure 3.98: The Hacı Bayram Square After the Recent Implementations, Project Designed by Öner Tokcan, www.ankara.bel.tr

Within the context of this project, the square was enlarged and planted. The area in which funeral prayer performed was renewed and decorated by historic colonnade¹⁸ (Figure:3.98).

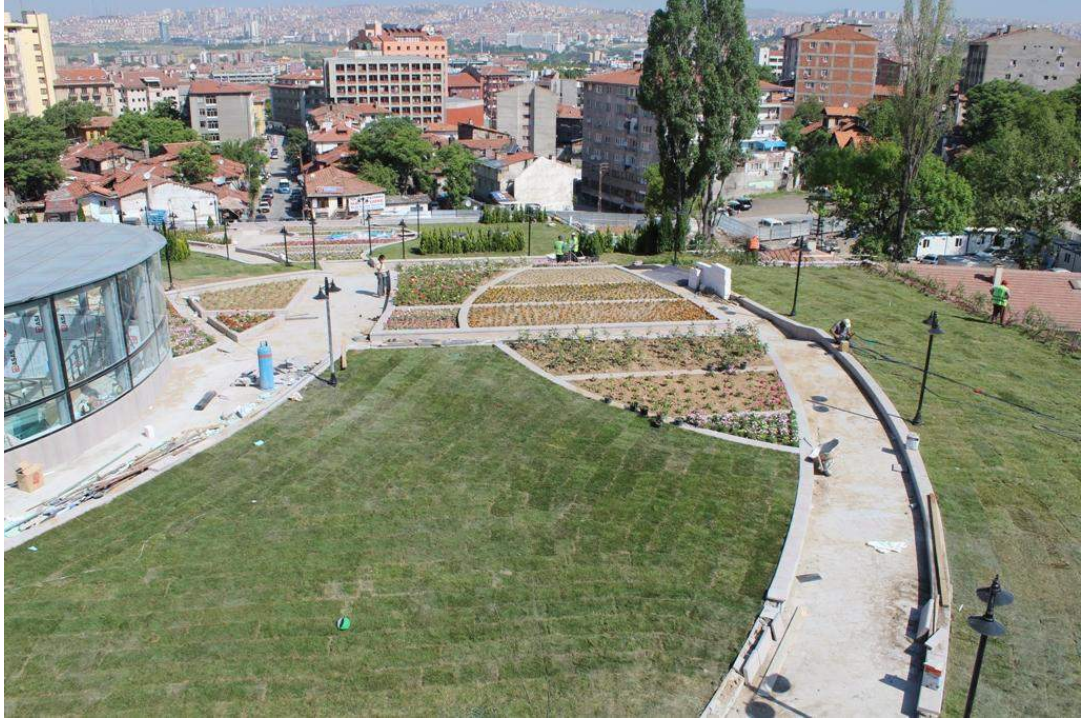
Figure 3.99: Underground Multi Storey Car-Park Project in Hac1 Bayram Area, www.ankara.bel.tr

In the scope of the Hacı Bayram Urban Design Project, Underground Multi Storey Car Park Project was approved by the decision of YAKTVKBM numbered 153 on 16 May, 2012. The implementation of this project was achieved by demolishing

the reconstructed building on Building Block: 19990, Lot: 1 and reconstructing this building again on the Acropolis of Roman Ankara. Furthermore, the top of the multi-story car park was covered by a park with the landscape arrangements on the northern part of the Hac1 Bayram Mosque and huge garage floors were hidden underneath (Figure:3.99).
