UNDERSTANDING THE LAHORE MUSEUM  
FOR THE DEFINITION OF A CONSERVATION PROCESS

A THESIS SUBMITTED TO  
THE GRADUATE SCHOOL OF NATURAL AND APPLIED SCIENCES  
OF  
THE MIDDLE EAST TECHNICAL UNIVERSITY

USMAN SAMI

JULY 2017

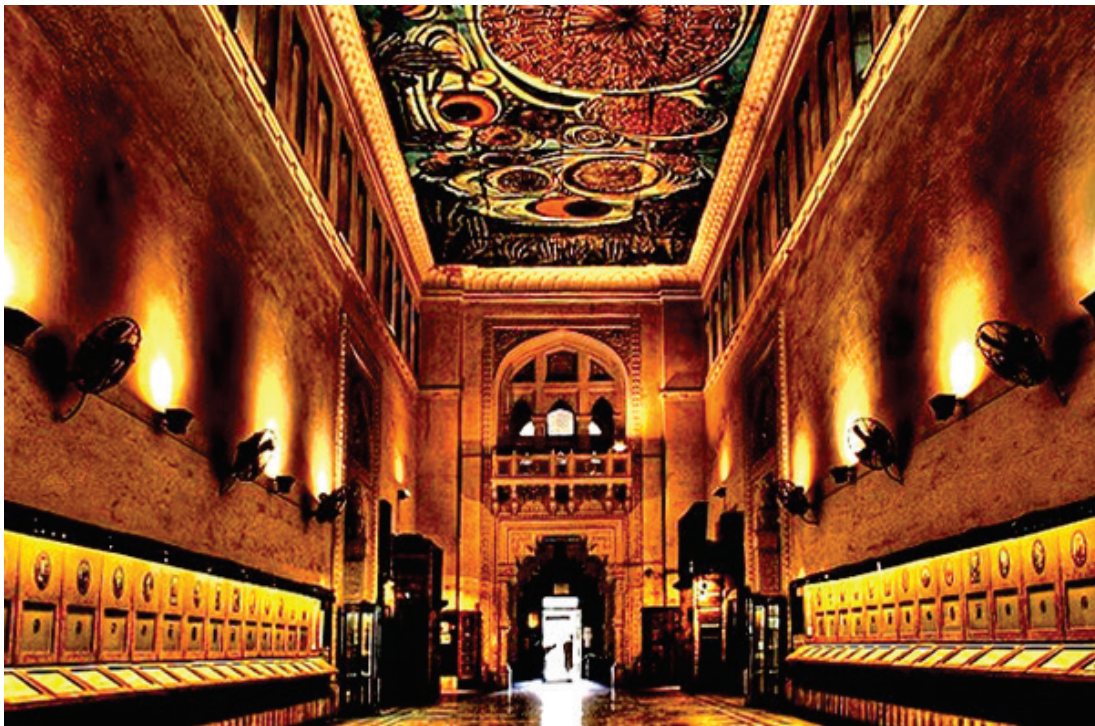
Figure 1.3: Central Gallery – Facing north (2009)  
Photo: Ali Raza.

The construction and ornamentation of the Lahore Museum building was thus envisioned as a laboratory for providing hands-on training to the students of the school in the craft traditions of the Punjab and thereby ensuring their longevity (Figure 1.3).

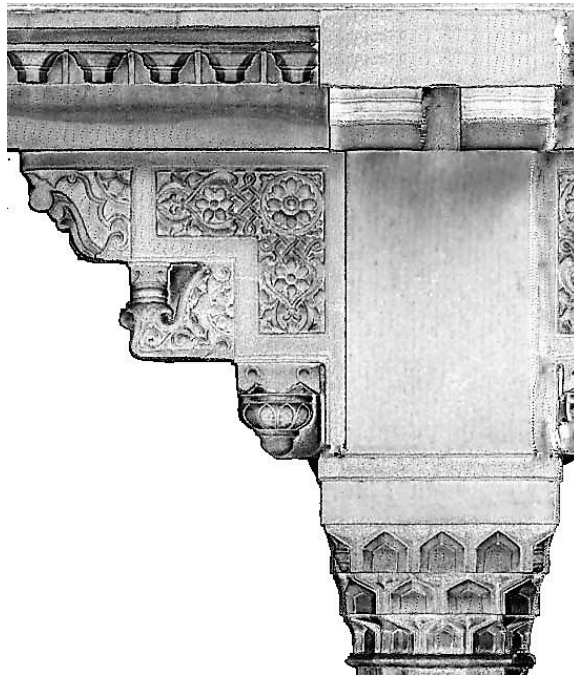
The Leica ScanStation P20 offered a monochrome texturing option. This device function, colors the laser scans in greyscale using the luminance values picked up by the laser, from the surface being scanned, creating a texture map providing the largest possible amount of detail without being affected by lighting conditions (Figure 1.4).

Figure 1.4: Marble bracket on column capital – Entrance Portico – Laser scan (2015)  
Textured in monochrome using luminance values picked up by the laser.

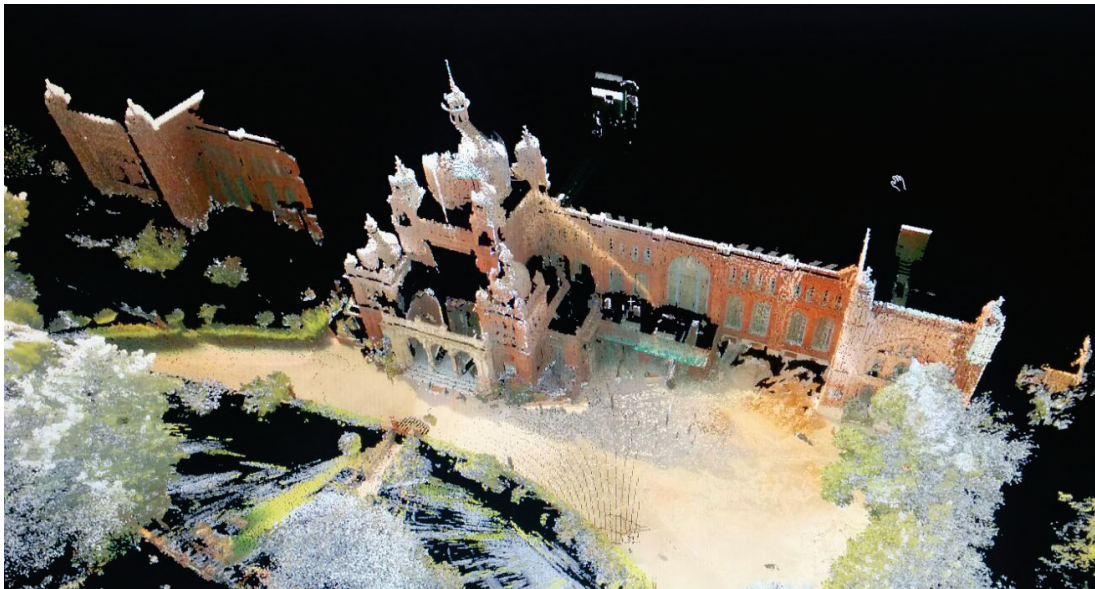
Figure 1.5: Lahore Museum Exterior – Photo-textured laser scan (2015)

The laser scanner was also fitted with an external DSLR camera for higher resolution photo-texturing than what its internal camera provides (Figure 1.5). This color data was not processed due to the large amount of time required to carry out the calibration. Every laser scan had a set of five corresponding photographs, each one of which had to be manually aligned to the scan by selecting at least three but preferably more than five corresponding points between the scan and photograph. This process would be required for the production of a walkthrough animation and not for the production of drawings. The color photo-texturing of the scans has been left to be carried out at a later period.

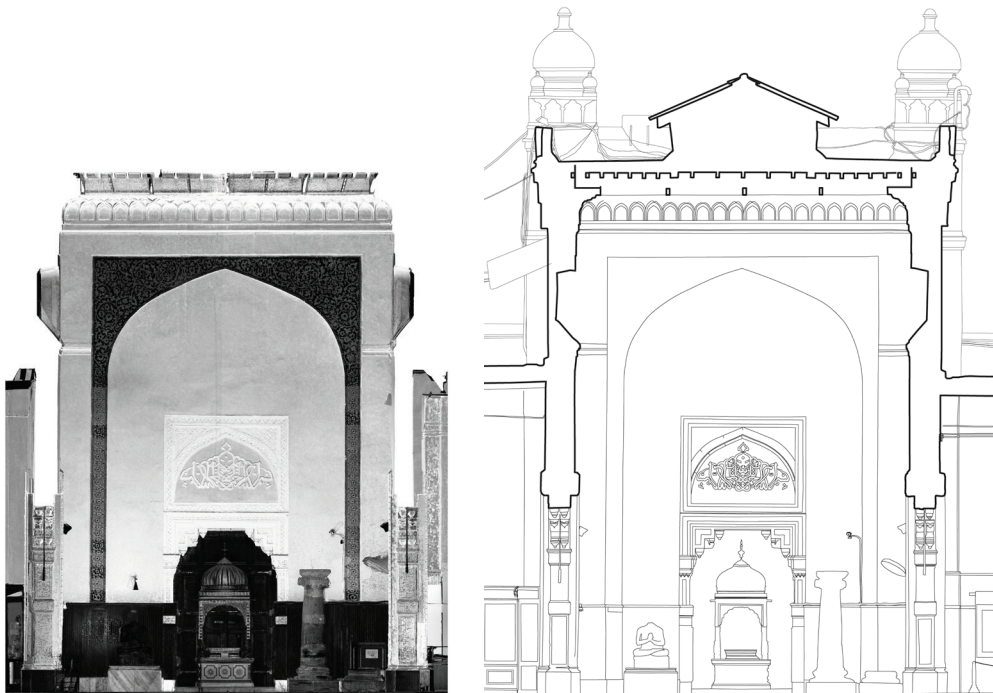
Figure 1.9: Sample drawing prepared from laser scan – ortho-photo (2016)  
Background Image from Laser scan (left), Sectional Drawing, with internal architectural details (right)

For each section, an ortho-photo was generated from the same section plane, which was extended to include the parts of the point-cloud visible behind the section plane (Figure 1.8, down). The objects and surfaces, visible behind the section plane were drawn in the elevational layers (with reduced line thickness) to represent objects in the background (Figure 1.9).

Drawings prepared using this process are abstractions, as are any other architectural drawings, therefore the selection of surfaces and objects drawn in the measured drawings were those that provided the most relevant information for those particular drawings. Laser scans are embedded with excessive data which is impossible to be encapsulated in a single drawing, therefore the measured drawings of sections and elevations are accompanied with translucent overlays of the laser scans used for the preparation of the drawings. These scans add extra depth to the information carried by the measured drawings.

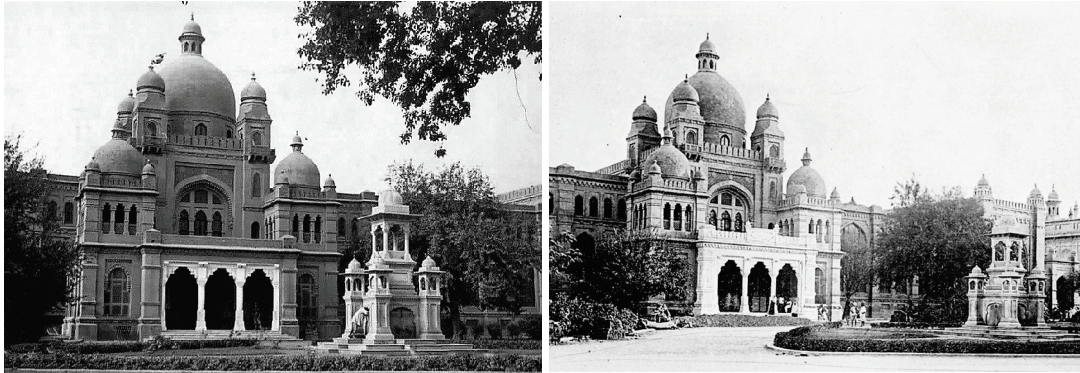
Figure 2.20: Entrance Portico – Before and After (1907 ; 1908)  
Colonnade has been replaced with marble structure (left), Application of marble revetments to the exterior surfaces of the Entrance Portico (right)  
Source: National College of Arts Archives

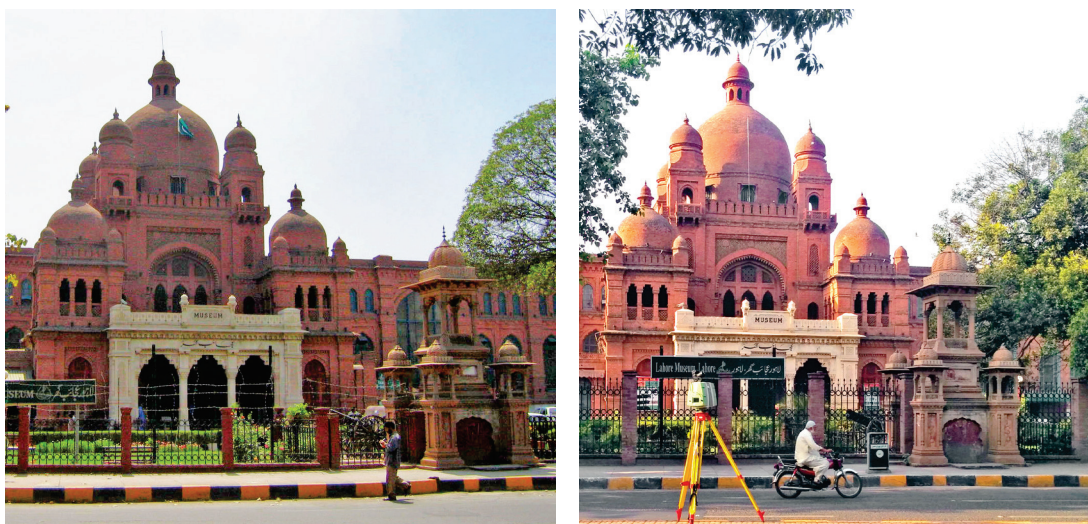
There is an ornamental drinking fountain<sup>41</sup> at the northern end of the lot, directly opposite to the Entrance Portico. The fountain was constructed in the middle of an island as can be seen in Figure 2.20, but due to successive road expansions, the lot boundary has moved southward and now passes through its center. The northern end of the fountain's sandstone platform is now buried under the sidewalk. (Figure 3.4).

Figure 3.4: Lahore Museum – Northern Fence & Drinking Fountain (2006 ; 2015)  
1.2 m high fence, with barbed wire (left), Fence raised to 2.3 m (right)

<sup>41</sup> The fountain is out of order. The stonework is also deteriorating and some of the finials have fallen off.

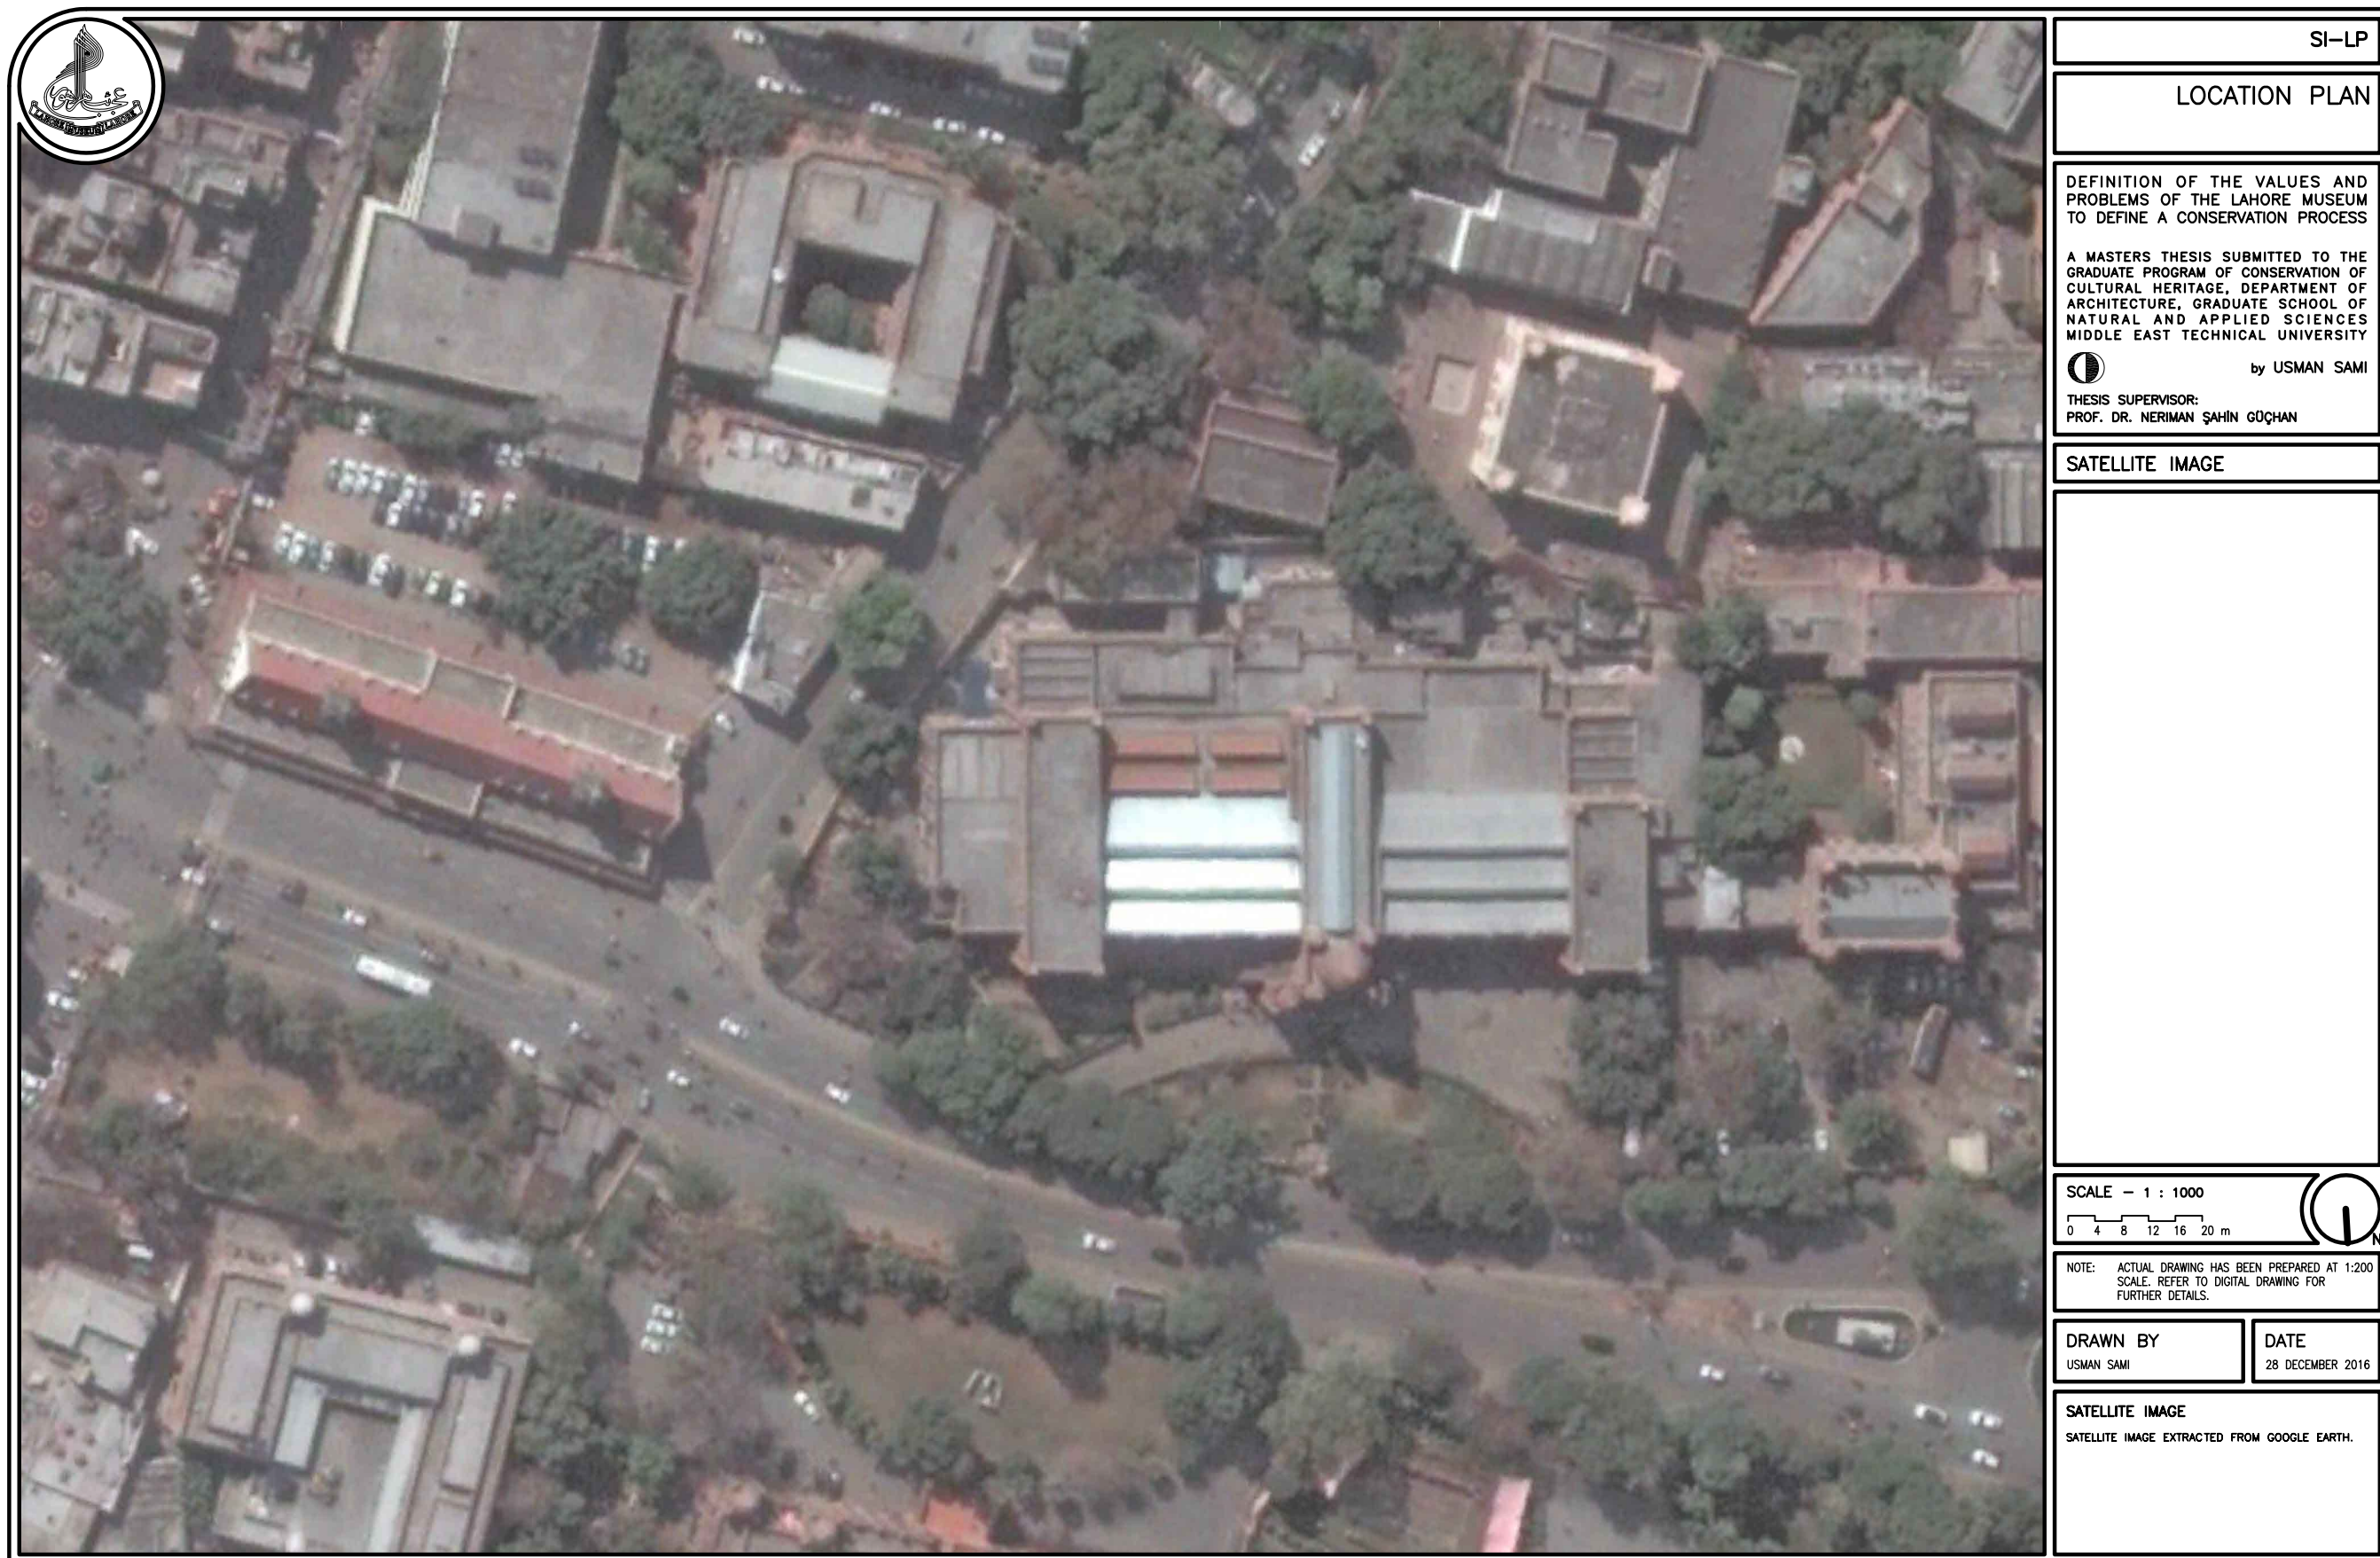
Figure 3.5: SI-PL-LP – Satellite Image – Location Plan (2016)

The Museum and the NCA, sit on the north of a city block bounded by the Mall Road towards the north, Library Road towards the east and Prof. Ashfaq Ali Khan Road (formerly known as Bank Road) towards the west (Figure 3.5 & Figure 3.6).

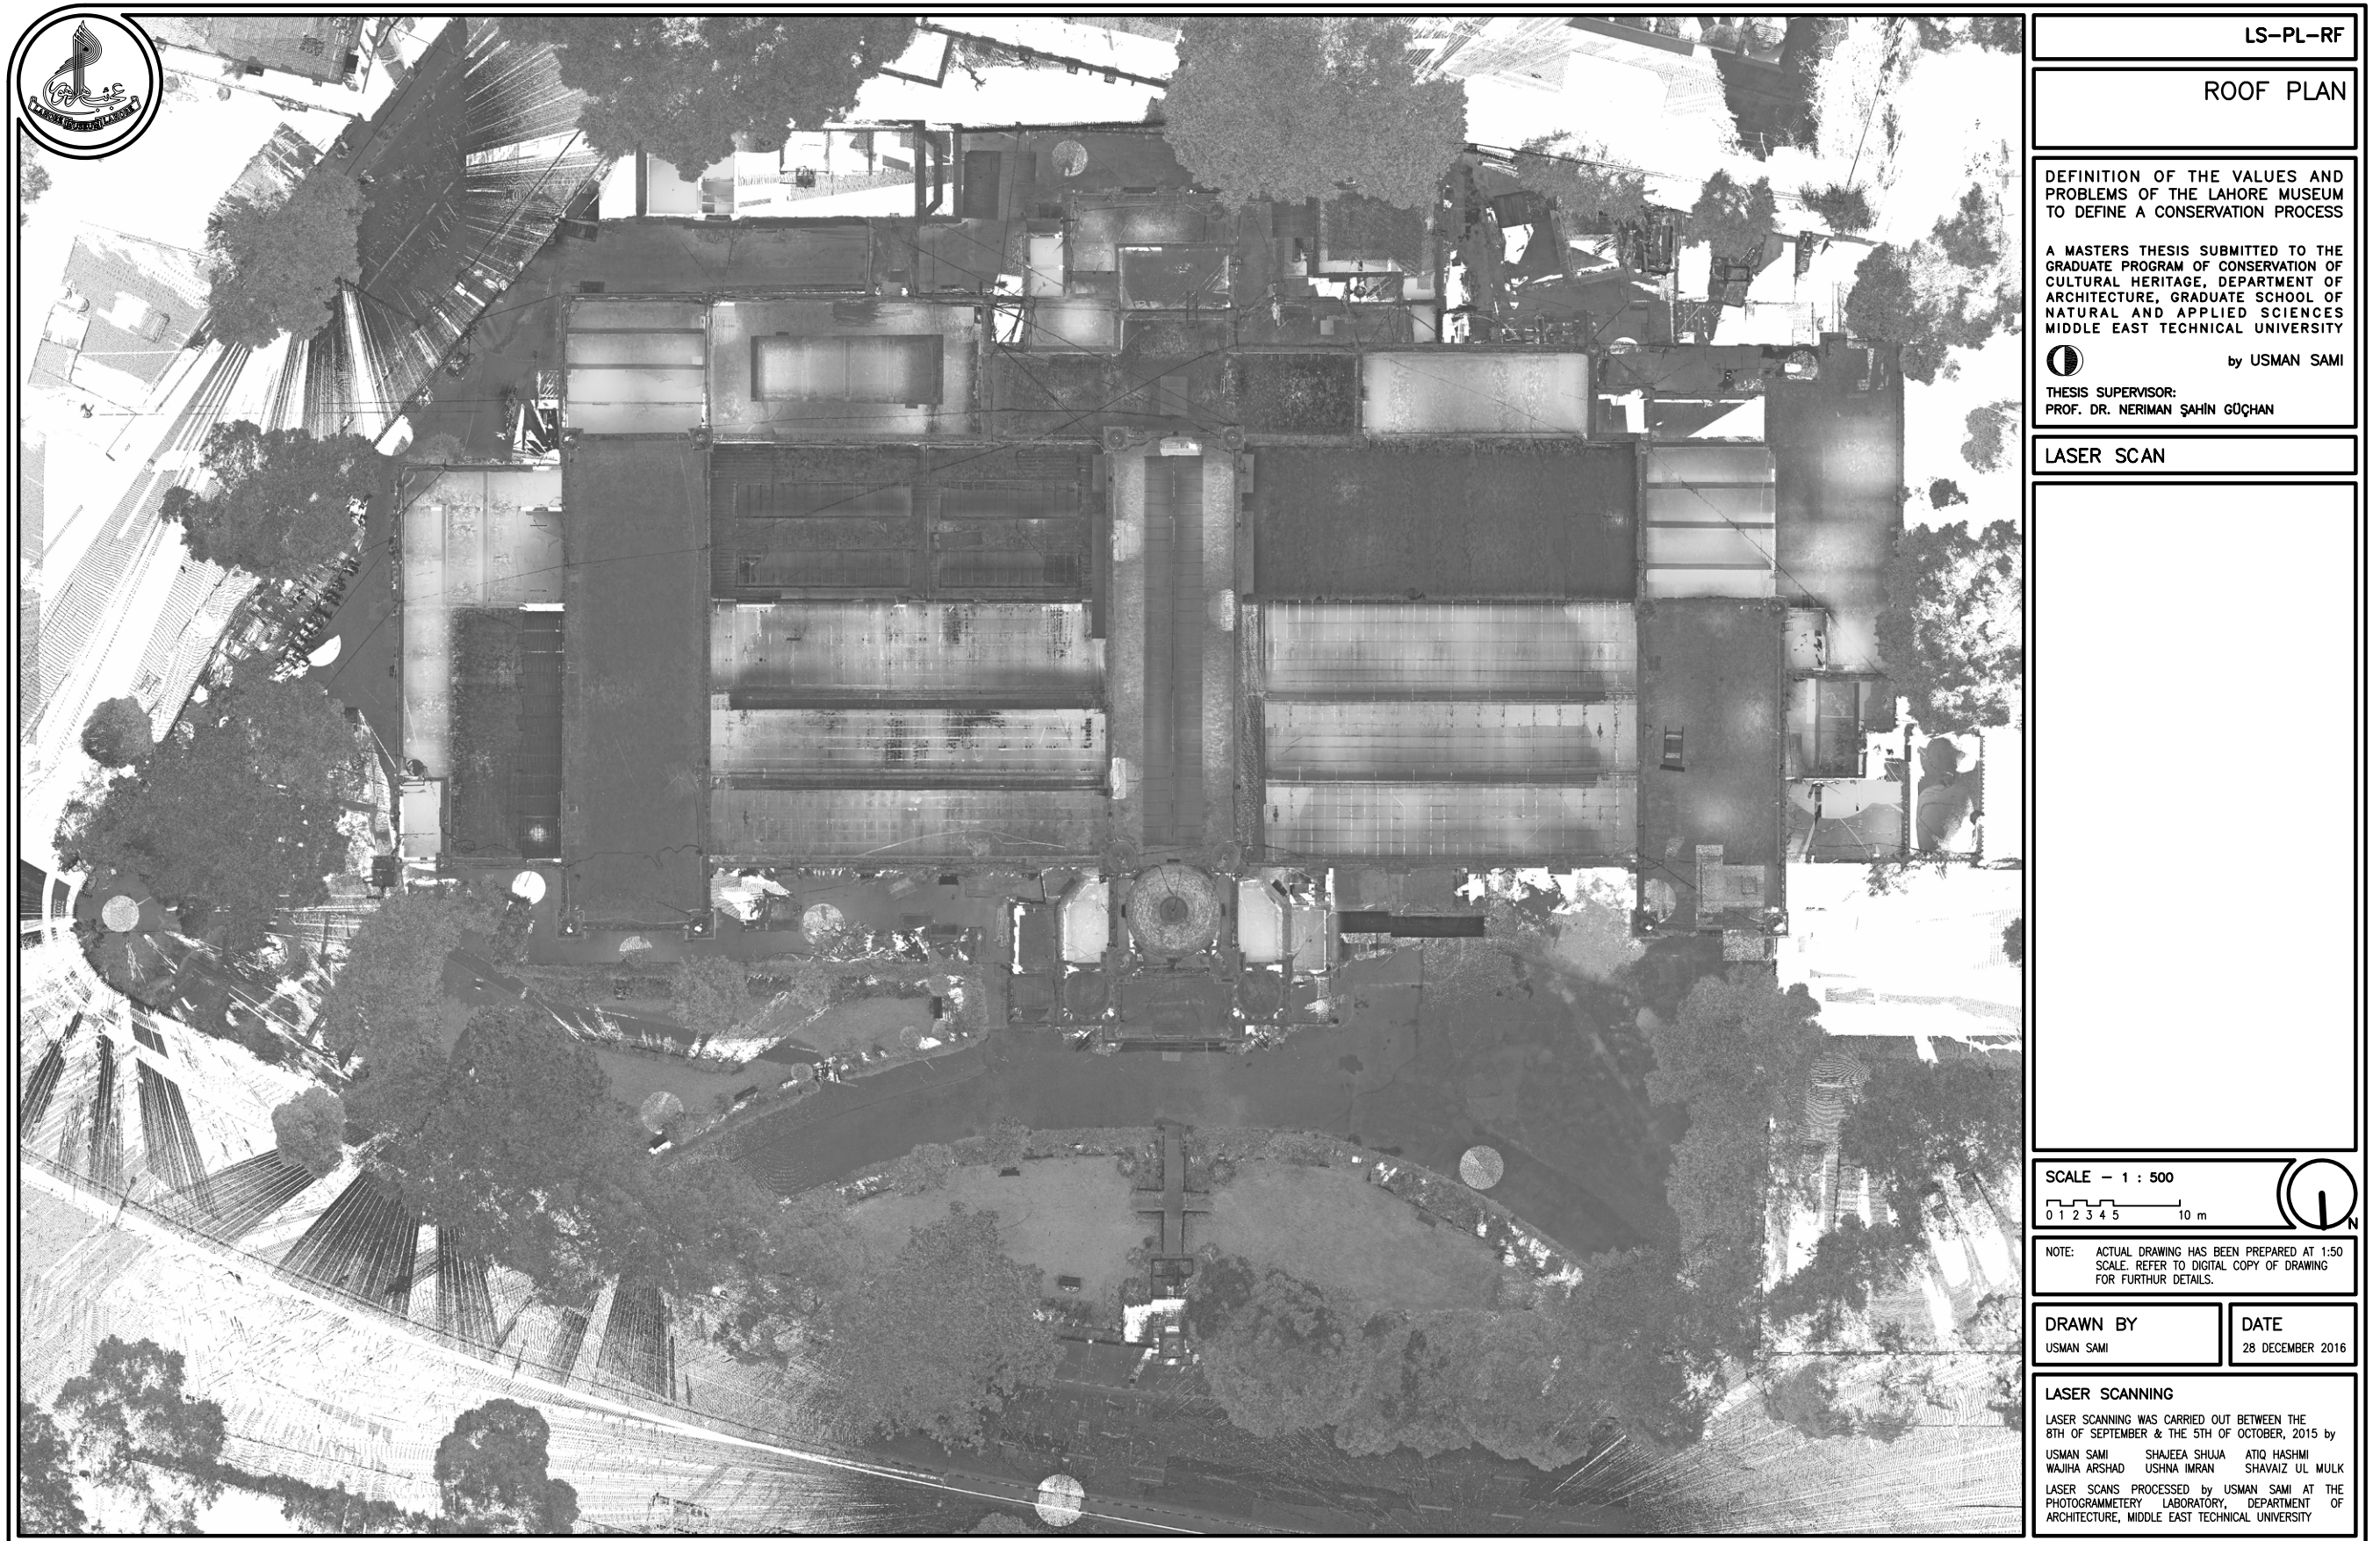
Figure 3.11: LS-PL-RF – Laser Scan – Roof Plan (2016)

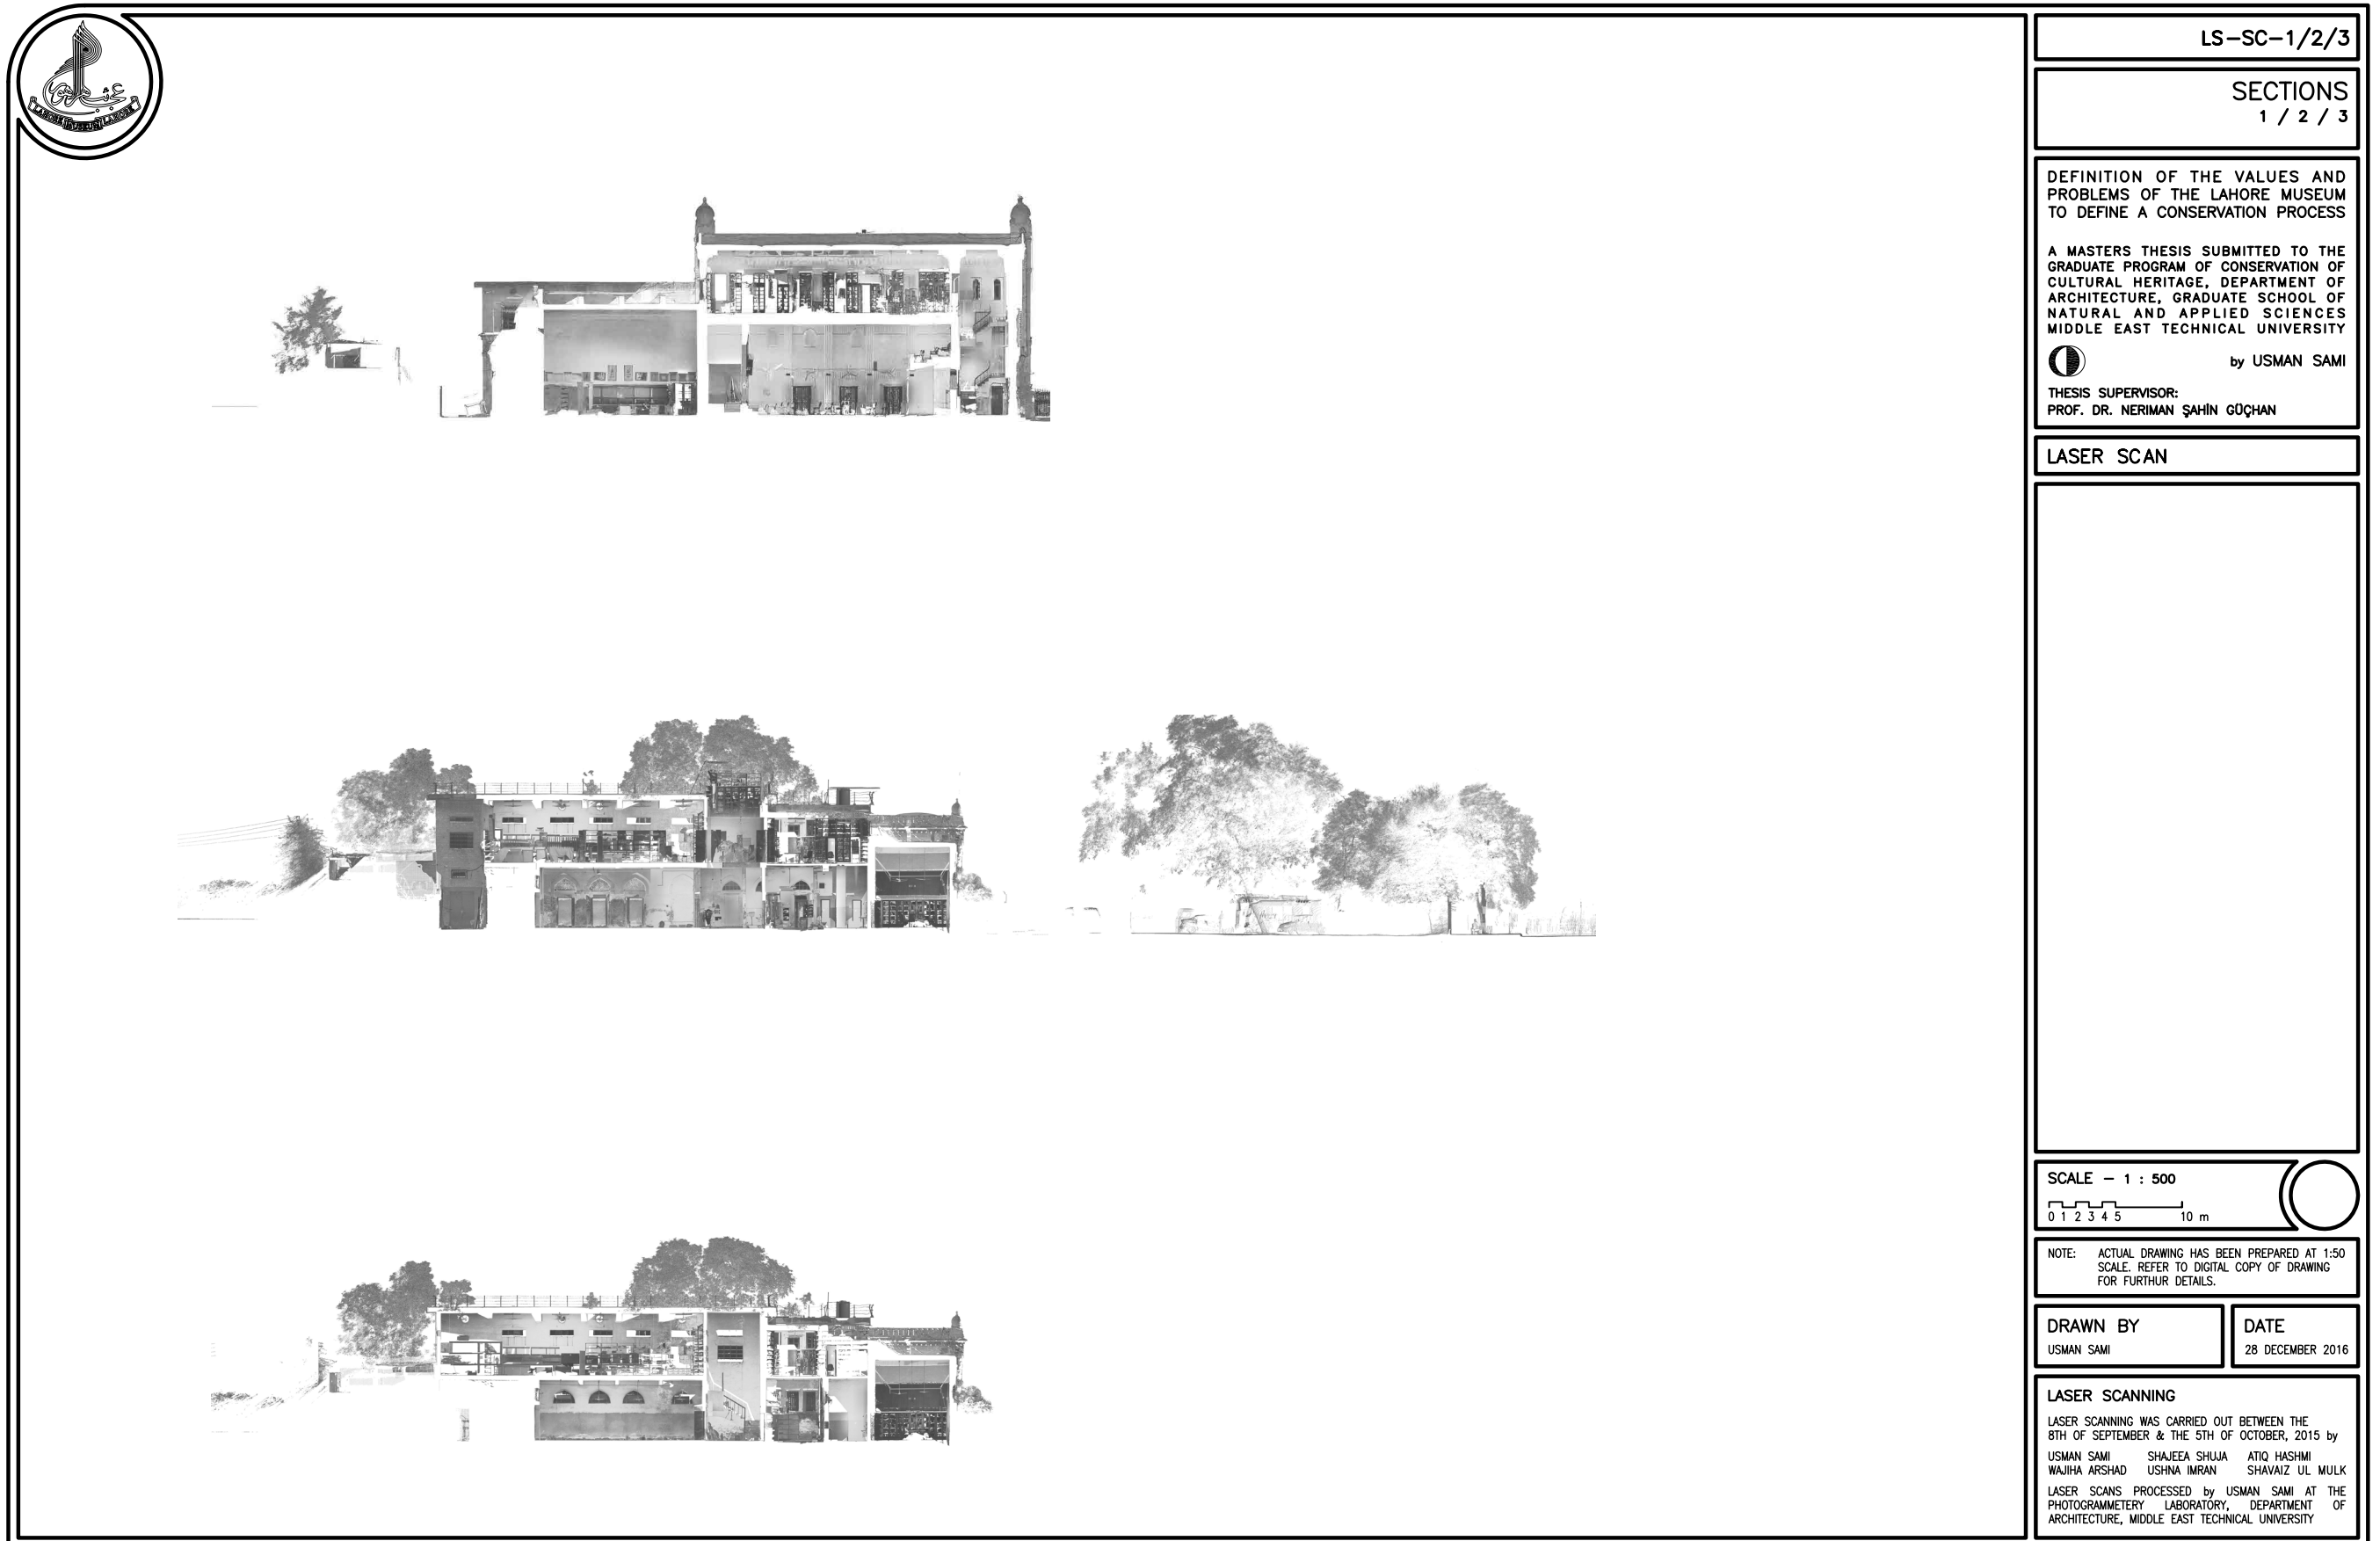
Figure 3.15: LS-SE-1/2/3 – Laser Scan – Sections – 1 / 2 / 3 (2016)

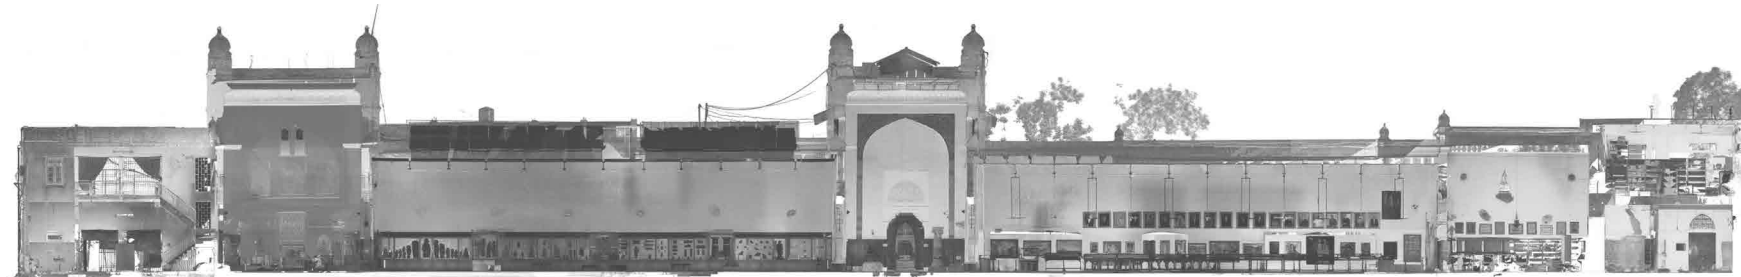
LS-SC-5/6/7

SECTIONS  
5 / 6 / 7

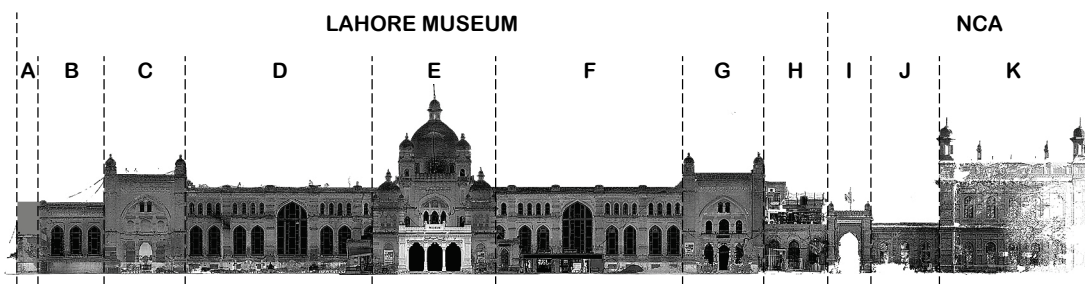
Figure 3.21: Lahore Museum and NCA – Northern Façade (2016)  
 Orthographic projection from laser scan and photogrammetric point-clouds (NCA).  
 A: Laboratory, B/C/D/F: Galleries, E: Frontispiece, G: Auditorium and Library, H: Conference Room,  
 I: NCA – Entrance Portal, J/K: NCA

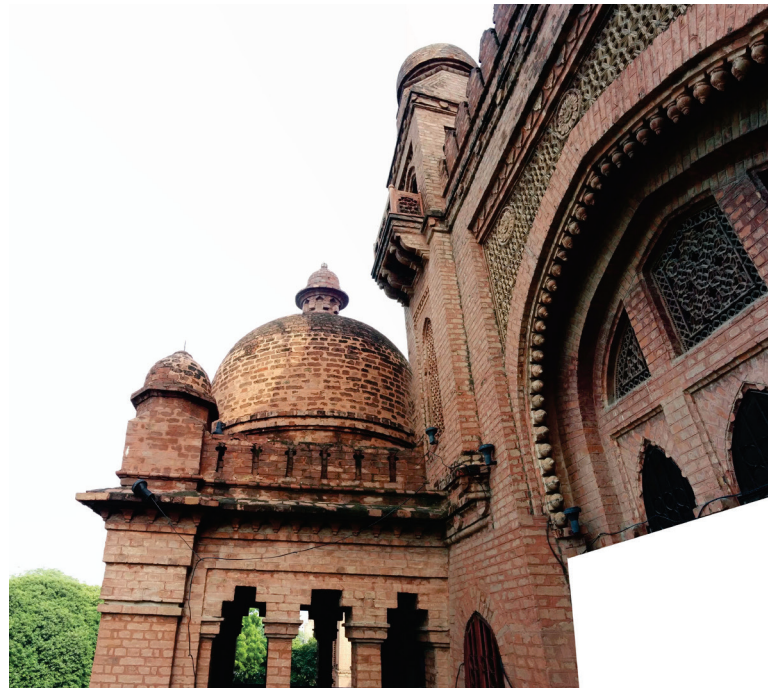
Figure 3.22: Turrets and central arch (2016)  
View from the roof of the portico.

The middle level has three triple-cross-centered arches. The central arch is 1.47 m wide and 2.15 m high. The base of the arch is 5.12 m above the plinth and the springer is 6.51 m above the plinth. The arches on the sides are placed at an interval of 91 cm from the central arch. They are 9.6 m wide and 2 m high. The base of these arches is 5.12 m above the plinth and the springer is 6.51 m above the plinth.

The central section of the top level has two triangular arches 70 cm wide and 1.7 m high with an interval of 31 cm between them. The base of these arches is 7.92 m above the plinth and the springer is 9.45 m above the plinth. Centered on top of the two windows is a horizontal diamond shaped window 67 cm wide and 34.5 cm high with its lowest point 9.55 m above the plinth.

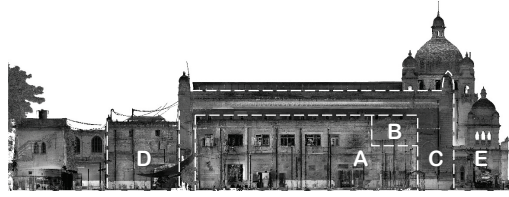
Figure 3.25: Lahore Museum— Eastern Façade (2016)  
Orthographic projection from laser scan point-clouds.  
A: Laboratory, B/C/D: Galleries, E: Frontispiece.

The *Eastern Façade* is primarily composed of the eastern faces of Blocks A, B and D. Towards the east of the elevation is the eastern face of southern end of Block D. This part of the elevation is a dead wall, with two blind four-cross-centered arches on its lower level. The southern arch shows traces of a doorway, blocked with a cement plastered masonry wall. There is a small 2 m by 3 m chamber, constructed in front of the northern arch. The upper level of the wall has two rectangular openings for exhaust fans fitted with metal flaps.

Block A is a rectangular cuboid volume. On the eastern face of the block, is an unsystematic arrangement of openings punctured into the façade. The upper part of the façade has six rectangular windows towards the southern end of the wall. The first of which (from south to north) is 1.2 m wide, the next four 2.1 m wide and the last, again 1.2 m wide. This is the only systematic arrangement of openings on this façade.

The façade is dotted with traces of earlier archways blocked with brick masonry walls, through which newer openings have been punctured, later. The whole façade is also covered with arbitrarily placed fresh water and storm water drainpipes. The chaos is added to, by numerous exposed electrical cables crisscrossing the façade.

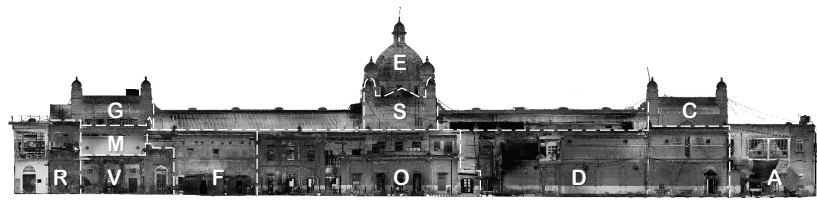
Figure 3.26: Lahore Museum– Southern Façade (2016)  
Orthographic projection from laser scan point-clouds.  
A: Laboratory, C/D/F/M/S: Galleries, E: Frontispiece, G: Auditorium and Library,  
R: Reserves Storage, V: Stores

Block V is a veranda / portico with five openings, all of which have been blocked with plastered masonry walls fitted with doors and ventilators, except for the second blocked opening from the west, which only has a ventilator. The blinded openings on the eastern and western ends are formed by three-cross-centered arches, while the three openings in the middle have flat brickwork lintels. The upper floor of Block R is constructed on top of the western archway. This wall has a horizontal slit ventilator.

The visible part of Block F is a dead wall with five two-cross-centered blind arches on the ground level. The one towards the east is much narrower than the other four. The upper part of the wall is ornamented with regularly distributed recessed panels on two levels.

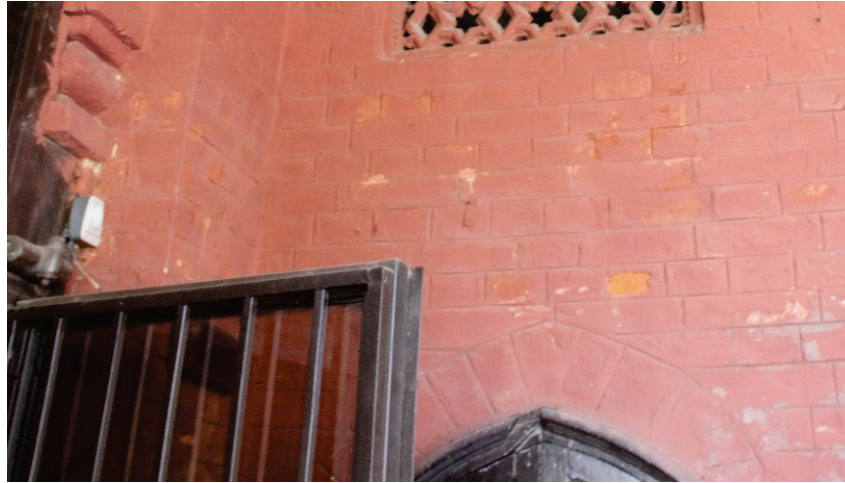
The exposed brick surfaces of the walls have been repointed in cement mortar. The re-pointing process seems to have also included the use of cement to even out the

surfaces of the bricks. Cement flakes are falling off in multiple places exposing the powdering bricks underneath (01–L2/L3 – Figure 4.12Figure 4.12).

Figure 3.29: Gnd-N/01 – Entrance Portico (2016)  
Powdering of brick and flaking of the thin surface layer of red tinted cement.

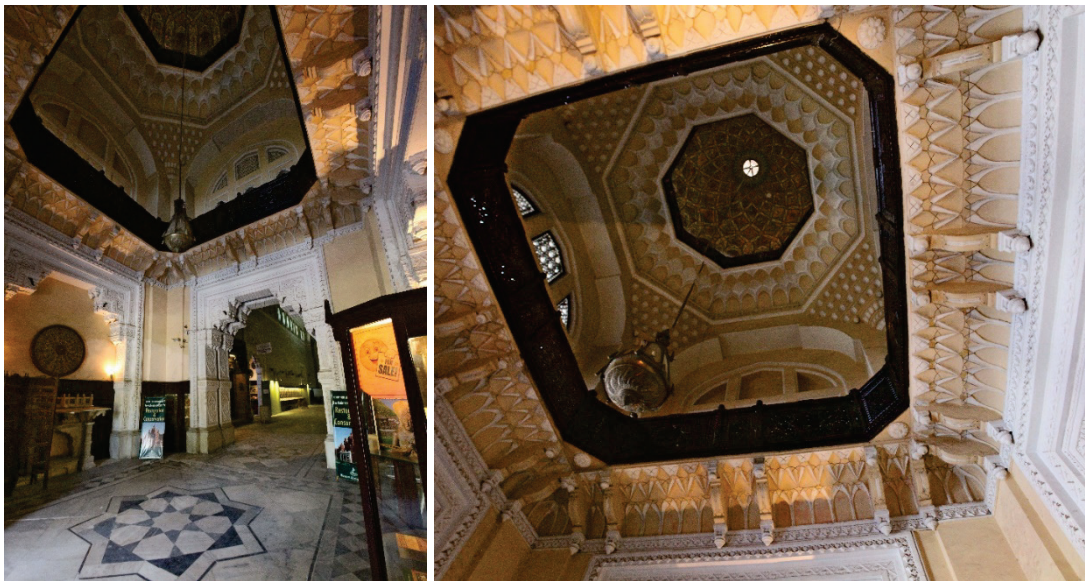
This space is entered through the door (Gnd-N/01-SW-D2) on the northern wall (Gnd-N/02-NW). This is a double-layered, large, four panel, carved wooden door. The outer four panels are made of solid wood and fold out onto the walls of the Entrance Portico. The inner four panels are glazed out of which the middle two open inwards. The door is fitted in the flat arched opening which is supported on masonry brackets. This is the main entrance to the museum. The eastern (Gnd-N/02-EW) southern (Gnd-N/02-SW) and western (Gnd-N/02-WW) walls, all have identical ornamented plasterwork doorways. These doorways have a flat lintels supported on triple-tiered brackets. The surface ornamentation is a veneer in plaster of Paris, attached to the wall by means of an underlying wooden

framing.<sup>47</sup> The masonry structure underneath mirrors the surface and can be seen from the other sides of the walls, from inside the spaces (Gnd-N/04 & 06). The eastern and western doorways are blind and have been fitted with ornamental fireplaces for their display. The southern doorway (Gnd-N/02-SW-D1) is open and leads to the space (Gnd-C/01). The lower parts of the walls, excluding the plaster of Paris doorways, have been fitted with a dado in wooden paneling.

Figure 3.30: Gnd-N/02 – Entrance Vestibule (2017)  
Looking South-East (left), Looking Up (right)

The ceiling above is cantilevered from all sides, supported on three pairs of brackets on each side, interspersed with *Qalibkari*<sup>48</sup> with a quarter-round profile. There is a truncated square opening in the middle of the ceiling, forming a balcony all around.

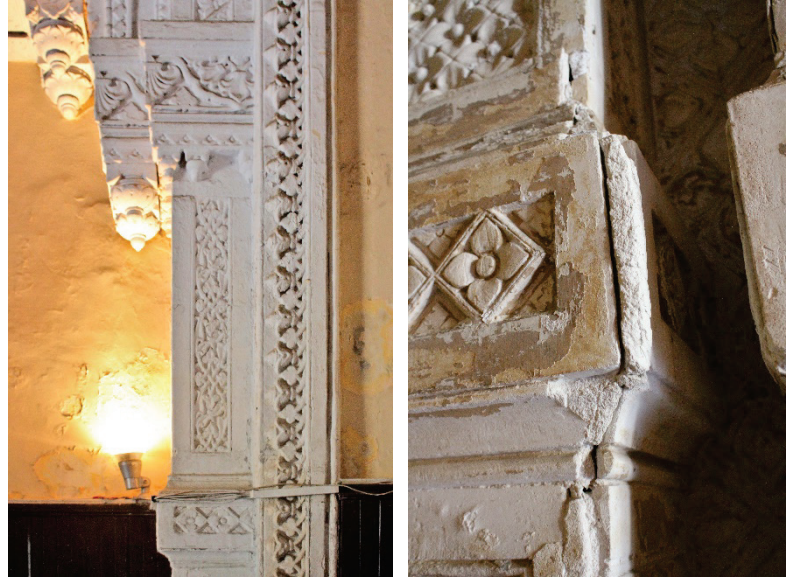
Figure 3.31: Gnd-N/02 – Entrance Vestibule – Deterioration (2016)  
Flaking paint on the Eastern Wall (Gnd-N/02-EW) (left), Flaked paint on and detachment of molded Plaster of Paris panels – (Gnd-N/02 EW) (right)

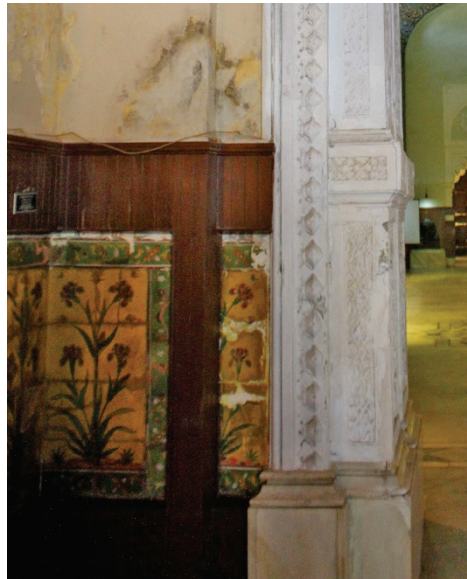
Figure 3.32: Gnd-N/02 – Entrance Vestibule – Deterioration (2016)  
Flaking of pain on the wall and efflorescence on glazed tiles – Southern Wall Gnd-N/02-EW

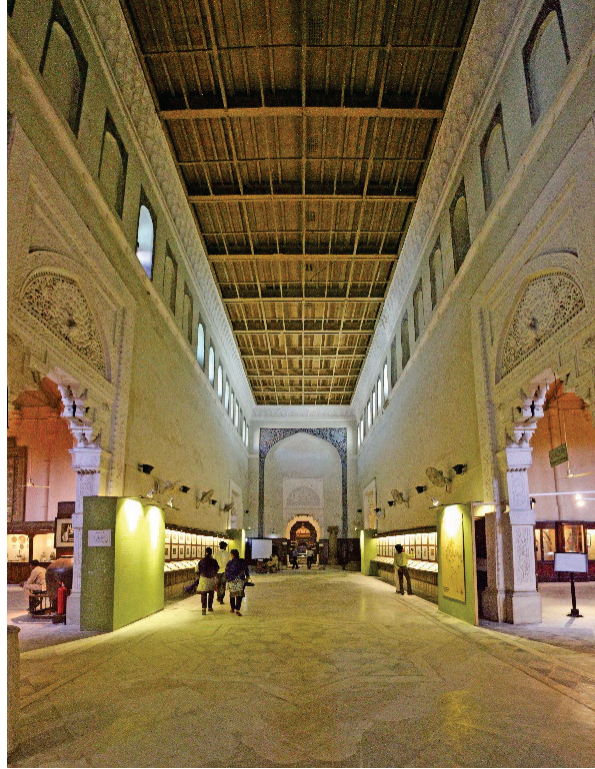
Figure 3.33: Gnd-C/01 – Miniature Painting Gallery (2017)  
Looking South

There are two large doorways (Gnd-C/01-WW-D1 & D2) on the eastern wall (Gnd-C/01-WW). Along the top of the wall, are eighteen four-cross-centered arches among which seventeen are fitted with ventilators (Gnd-C/01-WW-V1 – V10), four of which are boarded up. Starting from left to right, the first two arches are the ventilators (Gnd-C/01-WW-V1 & V2). The third arch is blind. Arches four to seven are the ventilators (Gnd-C/01-WW-V3 – V6). Arches number eight and nine have ventilators (Gnd-C/01-WW-V7 & V8) which have been blocked off with plywood painted white to match the walls. Arches number ten and eleven are blind. The twelfth arch has a ventilator (Gnd-C/01-WW-V9) which has been blocked off with plywood painted white to match the walls. Arches number, thirteen, fourteen and

fifteen are blind. Arches number sixteen also has a ventilator (Gnd-C/01-WW-V10) which has been blocked off with plywood painted white to match the walls. The remaining two arches (seventeen and eighteen) are again blind.

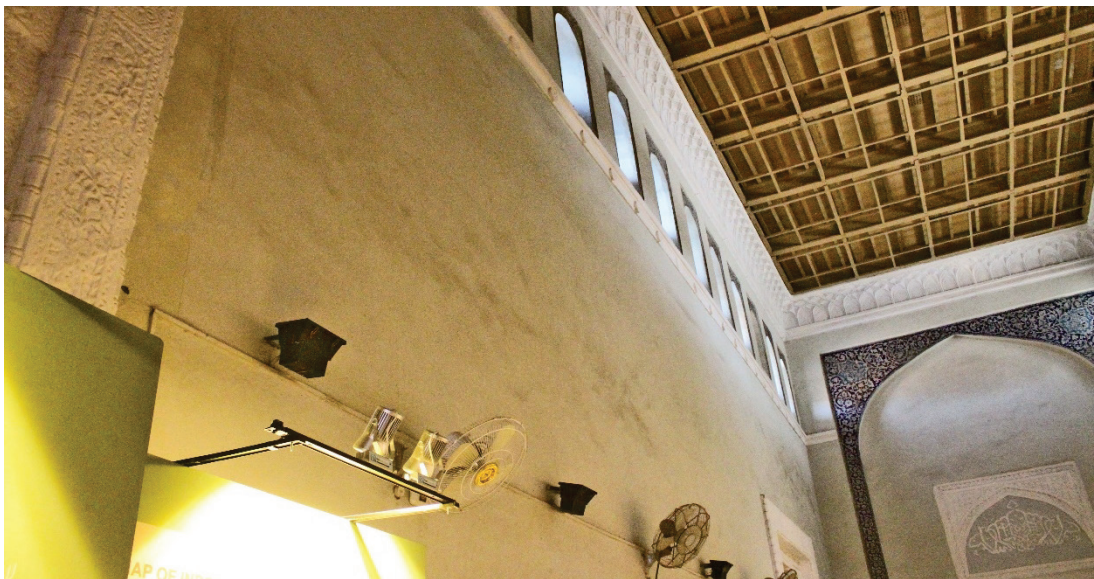
Figure 3.34: Gnd-C/01 – Miniature Painting Gallery (2017)  
Looking South-East and up

There is swelling of plaster midway up both the eastern (Gnd-C/01-EW) and western (Gnd-C/01-WW) walls (Figure 3.34), (50–P1 – Figure 4.12). The patterned marble floor was also damaged (51–L4 – Figure 4.12) in parts but has since the documentation been hastily repaired the same as in other spaces (Figure 3.56).
