UNDERSTANDING THE LAHORE MUSEUM  
FOR THE DEFINITION OF A CONSERVATION PROCESS

A THESIS SUBMITTED TO  
THE GRADUATE SCHOOL OF NATURAL AND APPLIED SCIENCES  
OF  
THE MIDDLE EAST TECHNICAL UNIVERSITY

USMAN SAMI

JULY 2017

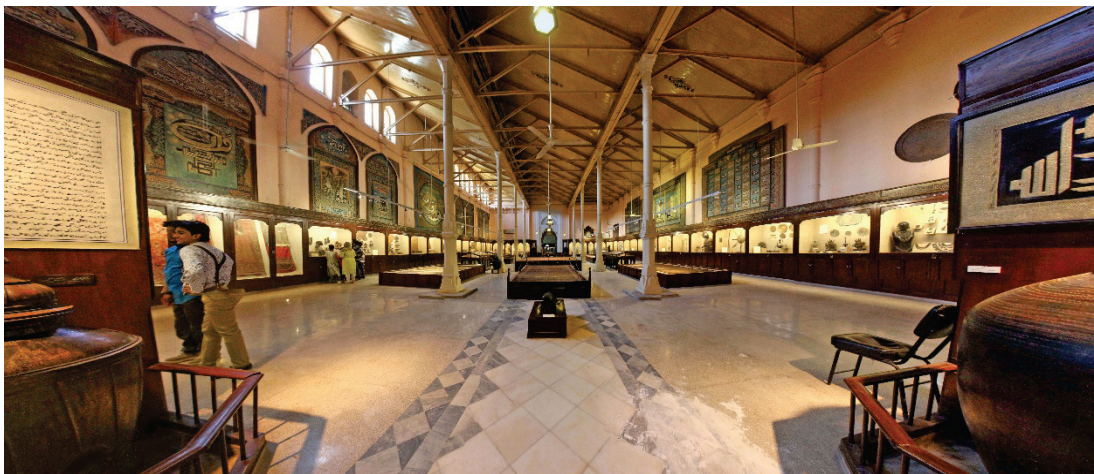
Figure 3.36: Gnd-E/01 – Islamic Arts Gallery (2017)  
Looking East

On the northern wall (Gnd-E/01-NW), there are nine four-cross-centered arched windows (Gnd-E/01-NW-W1 – W9). These windows have been covered and closed off with calligraphic paintings, fitted within the arched openings. Above these windows are sixteen ventilators (Gnd-E/01-NW-V1 – V16). On the eastern wall (Gnd-E/01-EW) there is a door (Gnd-E/01-EW-D1). There are no architectural features of import on the southern wall (Gnd-E/01-SW). This space is entered through the door (Gnd-C/01-EW-D1) on the western wall (Gnd-E/01-WW).

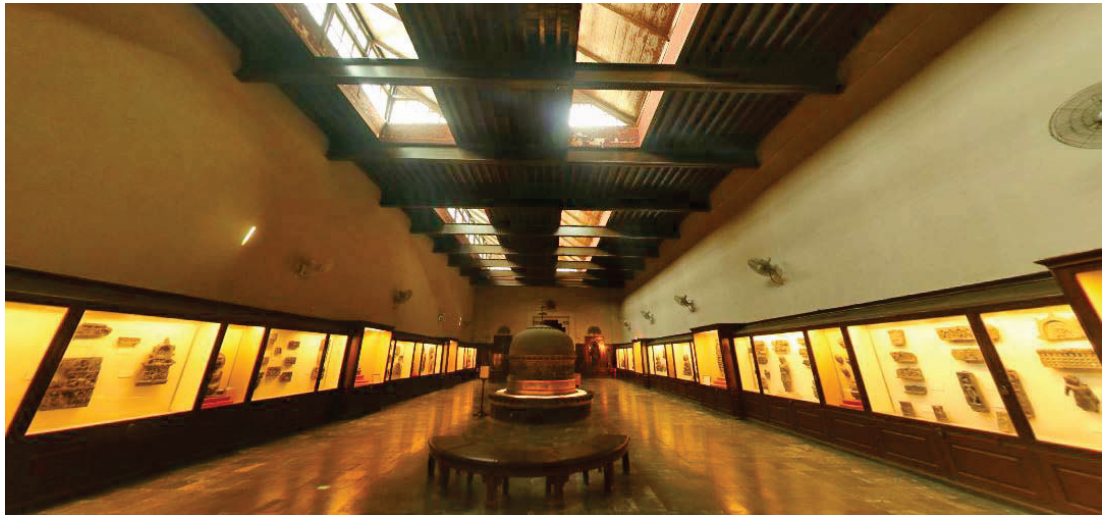
Figure 3.38: Gnd-E/02 – Gandhara Gallery (2016)  
Looking East

The roofing of the room is primarily supported on steel I-section beams running in the north-south direction. On top of these beams run wooden battens in the east-west direction, which are topped with wooden boarding. In the middle of the roof are four narrow rectangular skylights, in two rows of two each, running in the east-west direction. These skylights have pitched roofs sloping towards the south with windows on the northern, eastern and western sides. The room has a black marble floor.

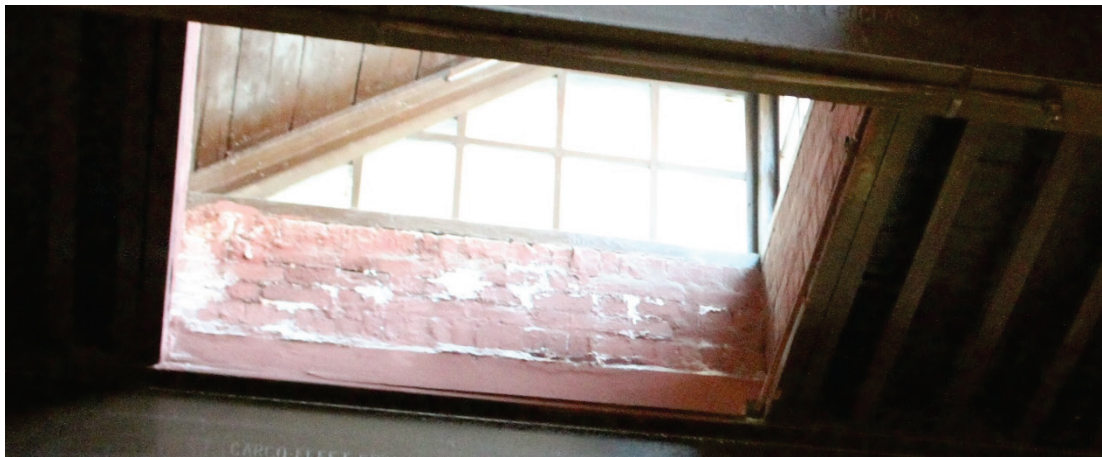
Some efflorescence can be seen along surfaces the brick masonry retaining walls of the skylights (Figure 3.39), (13–D2 – Figure 4.12).

Figure 3.39: Gnd-E/02 – Gandhara Gallery – Skylight (2016)  
Looking up and West

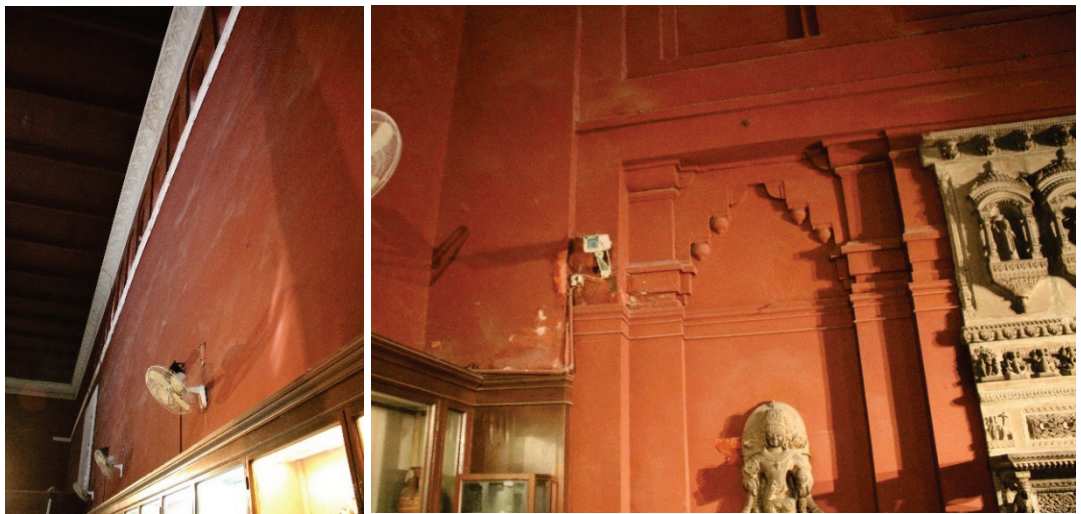
Figure 3.41: Gnd-E/03 – Hindu and Buddhist Gallery – Deterioration (2017)  
Plaster Swelling on Gnd-E/03-EW (left) and paint flaking on Gnd-E/03-SW (right)

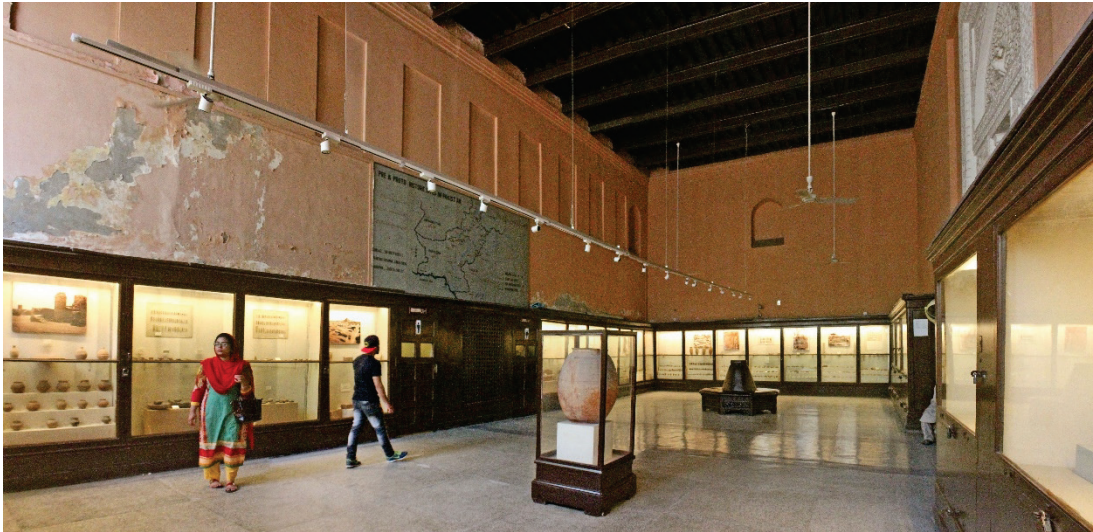
Figure 3.42: Gnd-E/04 – Prehistoric / Indus Gallery (2017)  
Looking South-East

The eastern wall (Gnd-E/04-EW) has a large patch towards the north where the paint has flaked off and the wall is damp (16-D1/P4 – Figure 4.12). Towards the south of the wall, another thin long patch for flaked paint can be seen just above the display cases (Figure 3.42). The central window in the northern wall (Gnd-E/04-NW-W2) has a structural crack passing through it (Figure 3.43), (17-S1 – Figure 4.12).

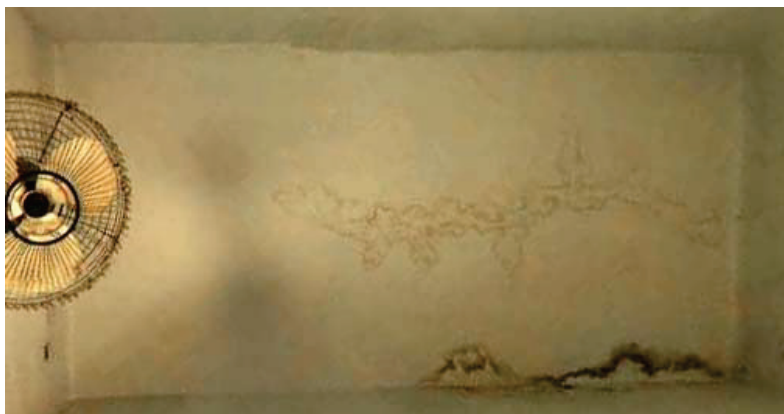
Figure 3.45: Gnd-E/05 – Vestibule outside Men's Toilets – Roof – Deterioration (2015)  
Looking Up

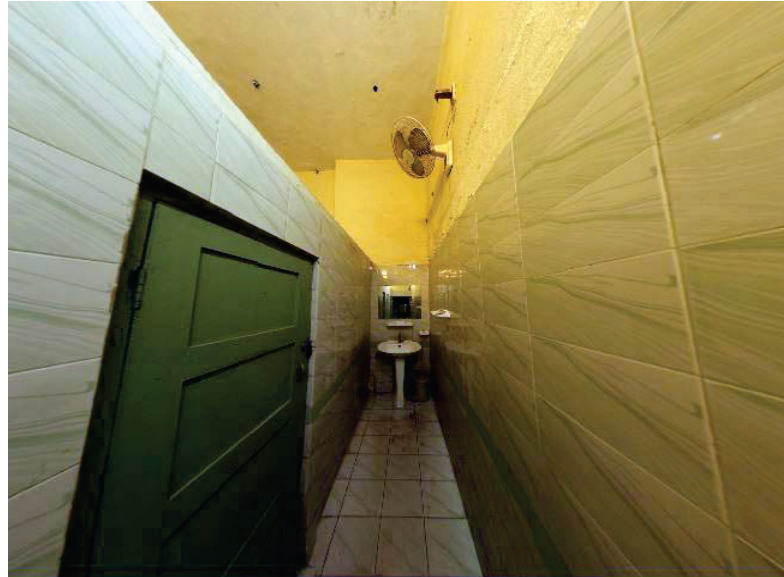
Figure 3.48: Gnd-E/08 – Ladies Toilets (2016)  
Looking South

There is flaking of paint at the upper part of the western wall (Gnd-E08-WW) (Figure 3.48), (20–P4 – Figure 4.12).

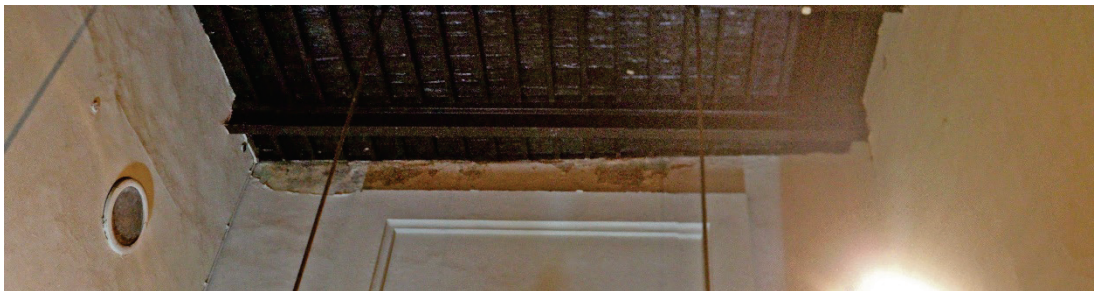
Figure 3.50: Gnd-E/17 – Jain Gallery (II) – Deterioration – South & West walls (2016)  
Looking West

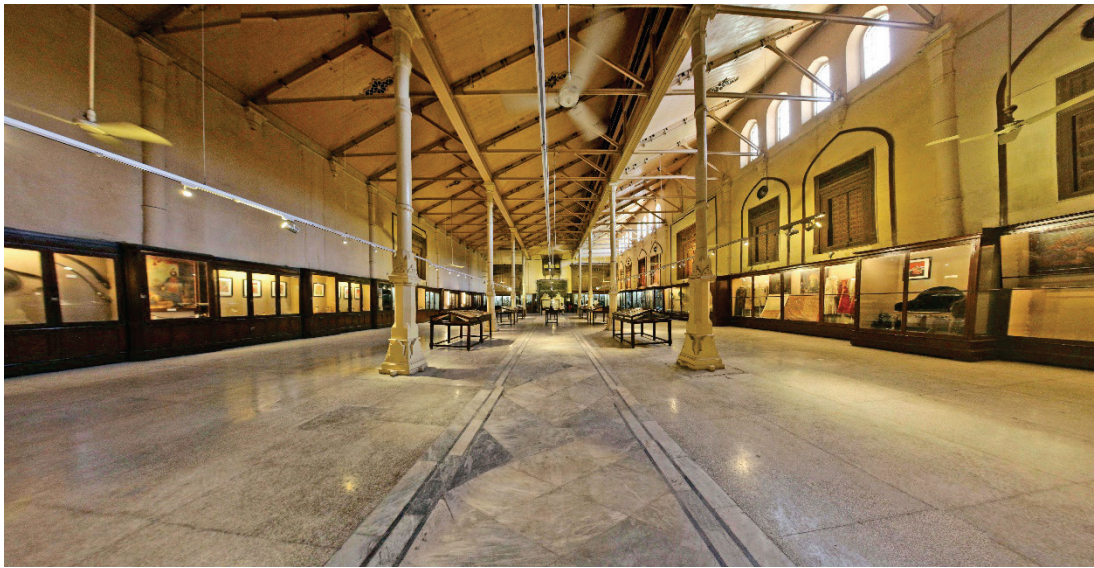
Figure 3.53: Gnd-W/01 – General Gallery (2017)  
Looking East

The roofing is a composite structural system with the supporting structure constructed with steel railway girder beams forming a saw tooth profile truss. These saw tooth trusses are supported on cast-iron columns, eight of which stand in the middle of the room in two, east-west rows of four columns each, while sixteen of them are partially embedded in the masonry walls. This arrangement of columns forms a grid of three

(north-south) by five (east-west) squares. There are fourteen trusses that run in the north-south direction. They are supported on the two double I-section beams supported by the central columns, running in the east-west direction. Each truss forms three peaks towards the north. The valleys are towards the south. The vertical surfaces face north, and are fitted with windows (which are now blocked with G. I. sheets from the exterior). The soffits are finished in wooden boarding. The whole roofing system is painted a deep off-white.

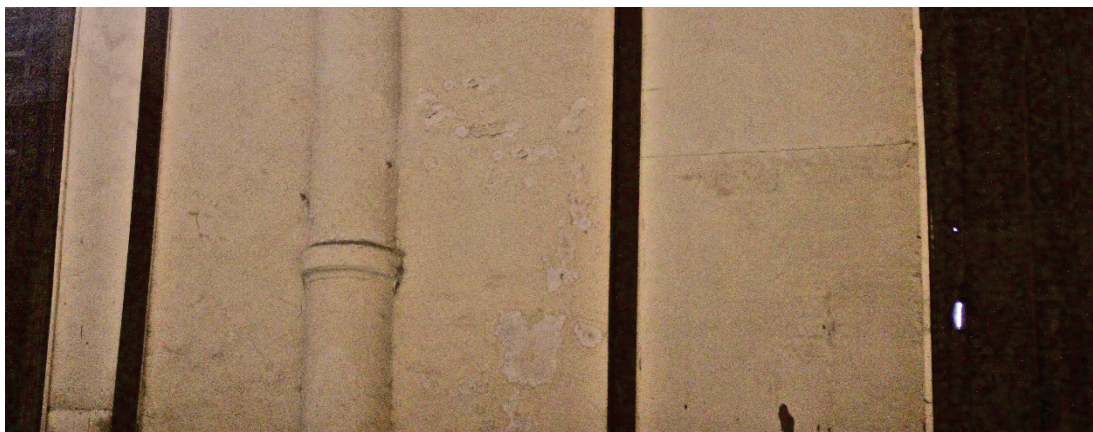
Figure 3.55: Gnd-W/01 – General Gallery – Deterioration (2016)  
Looking North

The walls embedded with cast iron columns between the windows (Gnd-W/01-NW-W5 / W6 / W7 / W8 & W9) on the north wall, have discoloration and flaking of paint at near the sill level of the window (Figure 3.55). The room flooring is also being altered currently and repaired with marble that does not match the tone of the original flooring (Figure 3.56) as can be seen in earlier repairs made to the same floor (Figure 3.53), (34–P4 – Figure 4.12).

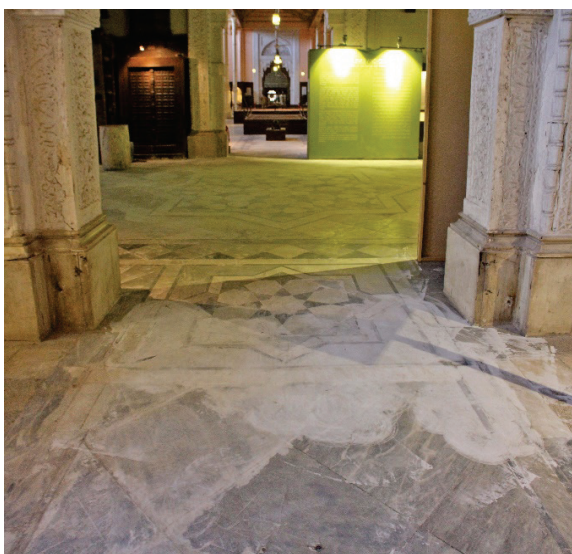
Figure 3.56: Gnd-W/01 – General Gallery (2017)  
Floor Repair

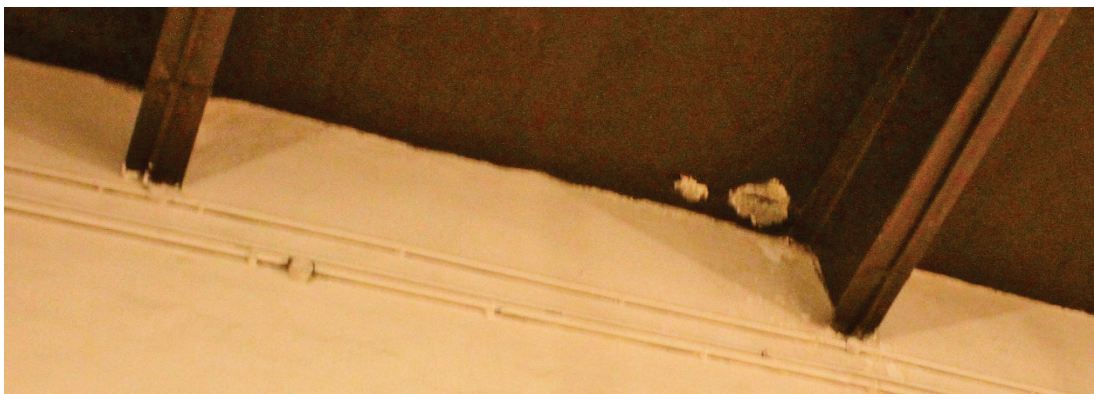
Figure 3.58: Gnd-W/02 – Contemporary Painting Gallery (2016)  
Looking up and South

There is detachment of a small chunk of concrete from the roof, exposing the steel rebars near the southern wall (Gnd-W/02-SW), (Figure 3.58), (35–L4 – Figure 4.12).

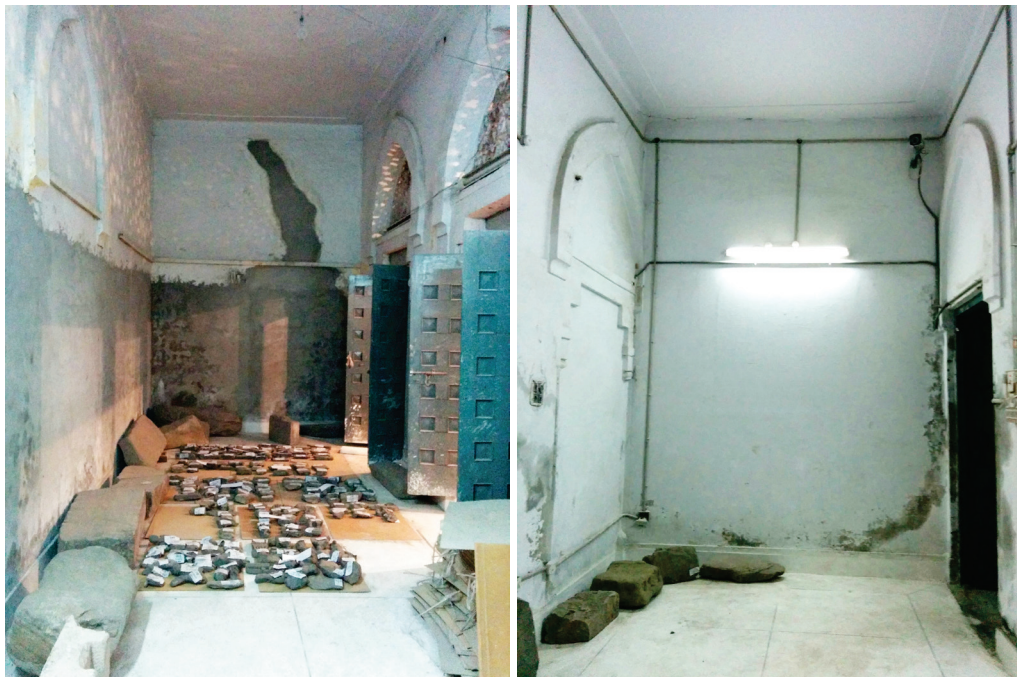
Figure 3.61: Gnd-W/04 – Museum Reserves Storage (2015)  
Looking South (left), Looking North (right)

The roof is an RCC slab, plastered and painted white. The room has white terrazzo flooring, separated by glass strips into a square grid.

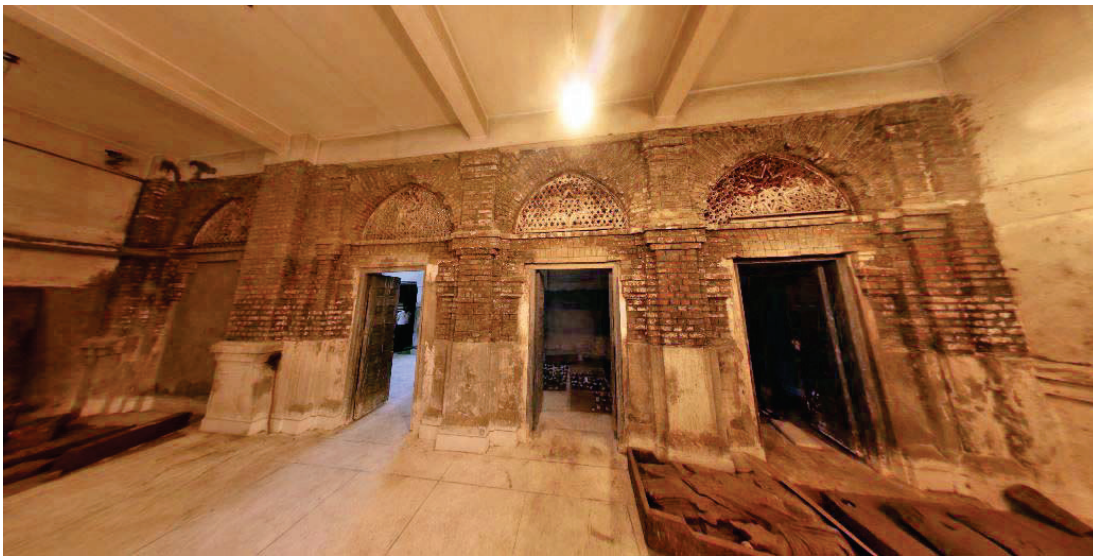
Figure 3.62: Gnd-W/05 – Museum Reserves Storage (2015)  
Looking East

The surface of the eastern wall (Gnd-W/05-EW) had been painted white. This paint has flaked off from most of the wall surface (37–P4 – Figure 4.12). The terracotta *jails* fixed inside the arches are powdering in some places (Figure 3.62). The western wall has been re-plastered (38–P3 – Figure 4.12).

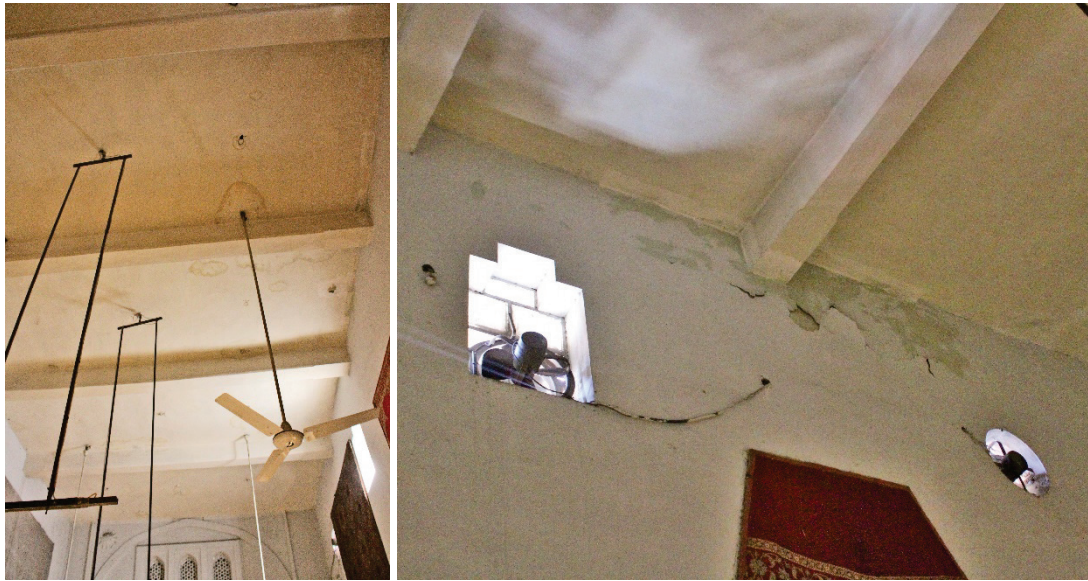
Figure 3.67: Gnd-W/08 – Swat Gallery (II) – Deterioration (2016)  
Looking up and East (left), Looking up and South (right)

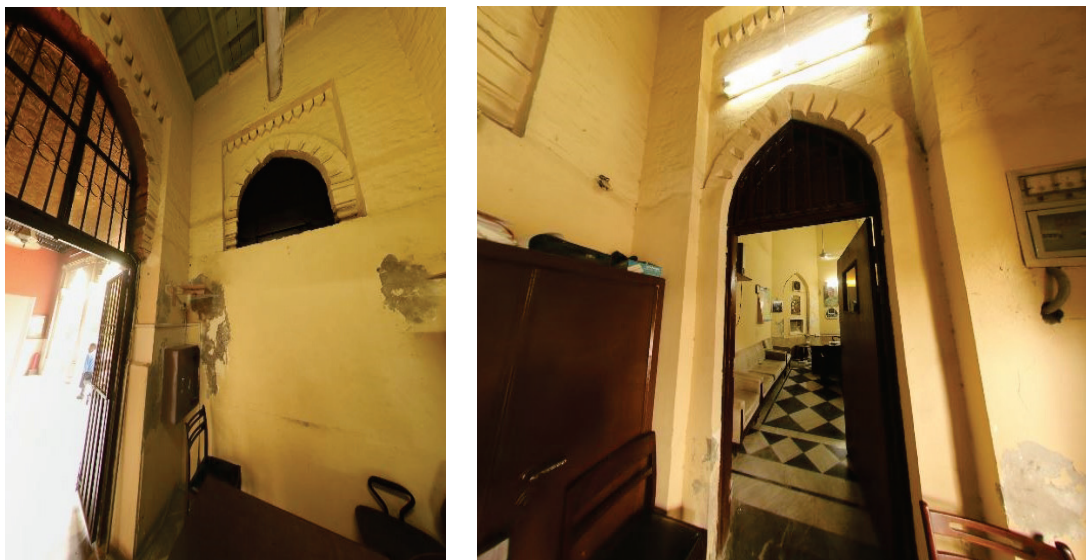
Figure 3.68: Gnd-N/03 – Security Office (2015)  
Looking North-West (left), Looking South (right)

There is flaking of paint at the lower parts of the eastern and southern walls (Figure 3.68). Paint can also be seen flaking at the mid-height of the northern wall (03-P4 – Figure 4.12).

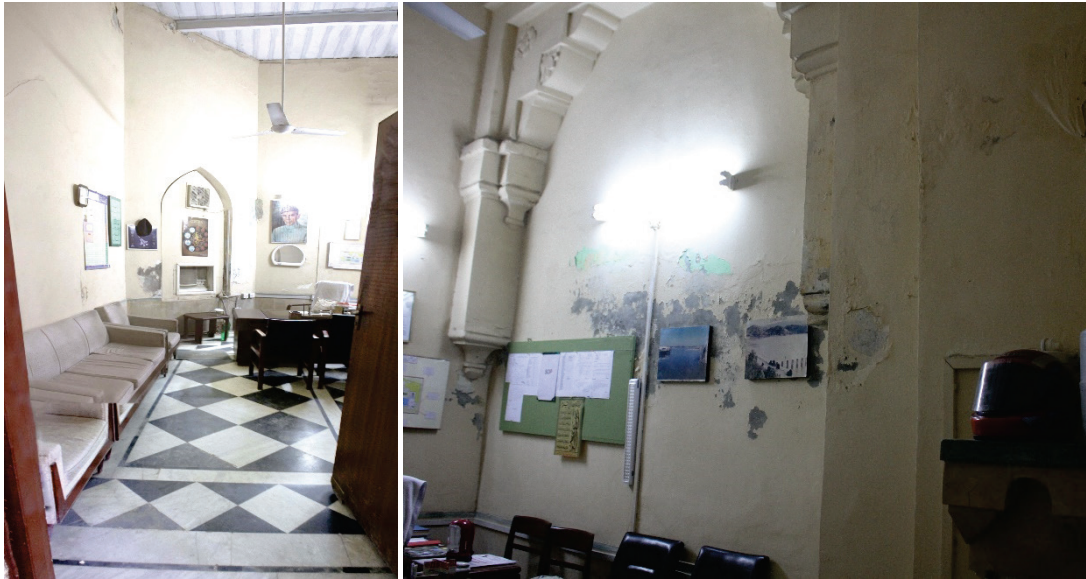
Figure 3.69: Gnd-N/04 – Chief Security Officer's Office (2015)  
Looking South (left) Looking West (right)

There is dampness in the western wall (Gnd-N/04-WW), visible from the discolored and flaking paint at the mid-height level of the wall (Figure 3.69), (04-D1/P4 –Figure 4.12).

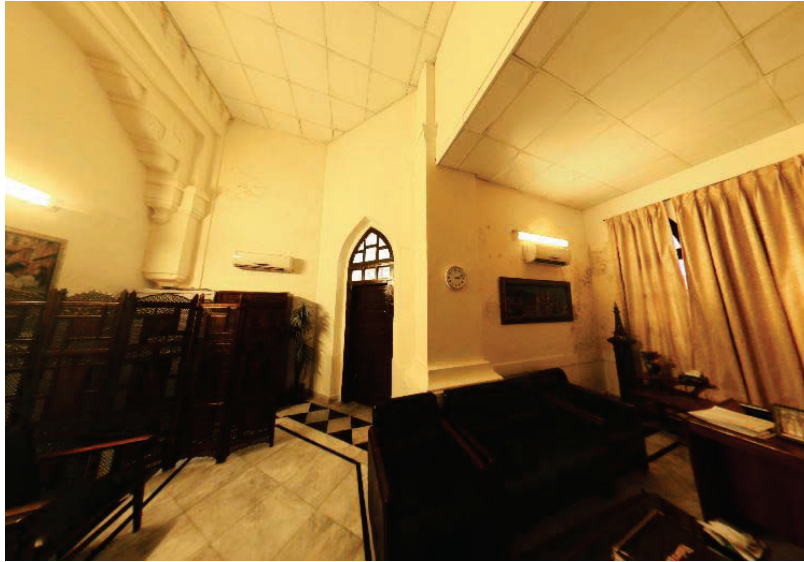
Figure 3.71: Gnd-N/06 – Public Relations Officer's Office (2015)  
Looking South

The room had recently been repainted, thus no traces of deterioration could be observed apart from discoloration of the paint, due to dampness, in the south-west corner of the western part of the space (Figure 3.71), (05–D1 – Figure 4.12).

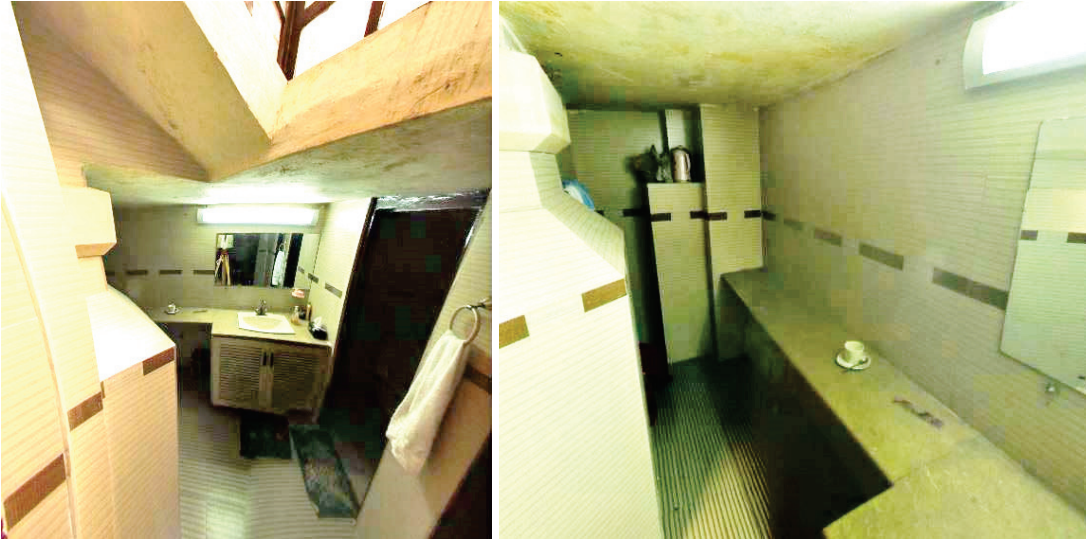
Figure 3.73: Gnd-N/07 – Kitchenette (2015)  
Looking South (left), Looking East (right)

There is leakage at the edges of the sky light as can be seen by drip marks at the edges. The soffit of the whole ceiling has discoloration and due to dampness along with some patches of flaking paint (Figure 3.73), (06–D1 – Figure 4.12).

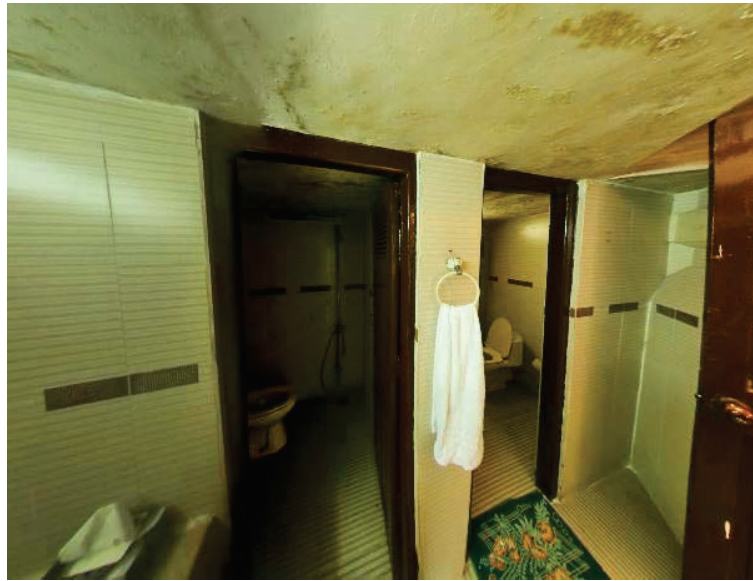
Figure 3.74: Gnd-N/08 & Gnd-N/09 – Toilet Stalls (2015)  
Looking West

The soffit of the whole ceiling has discoloration and due to dampness along with water drip marks and some patches of flaking paint (Figure 3.74), (07-D1 – Figure 4.12).

The soffit of the whole ceiling has discoloration and due to dampness along with water drip marks and some patches of flaking paint (Figure 3.74), (08-D1 – Figure 4.12).

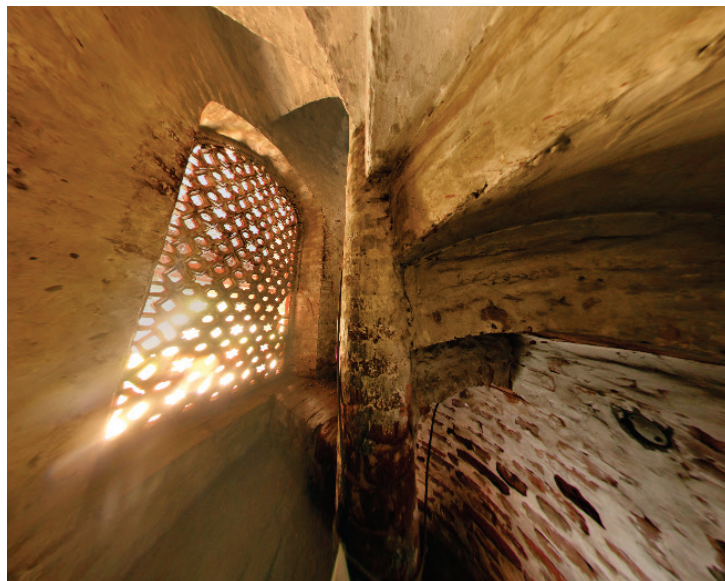
Figure 3.75: Gnd-N/11 – North-Western Stairwell (2016)  
Looking North, halfway to the first floor

The steps are supported on brickwork arches with a segmental profile, which are in turn supported between the 21.5 cm wide central column and the periphery wall. The

The white paint on the walls has flaked / powdered and fallen off (Figure 3.75), (10–P4 – Figure 4.12).

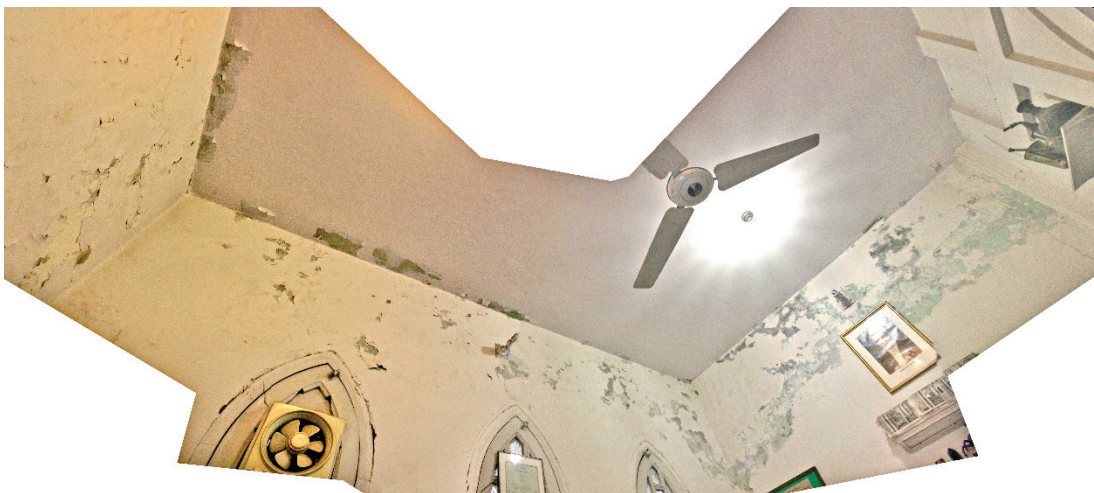
Figure 3.76: Gnd-N/12 – Curio Shop (2015)  
Looking up and East

There is paint flaking on the upper edges of the northern, eastern and southern walls and the connecting edges of the ceiling (11–P4 – Figure 4.12).

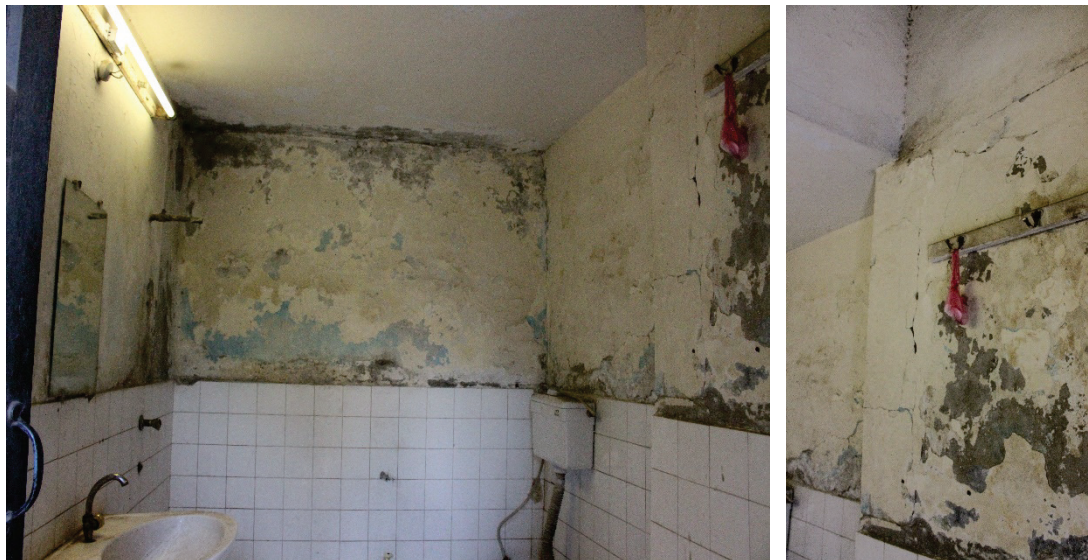
Figure 3.79: Gnd-E/10 – Toilet (2016)  
Looking West (left), Looking North and up (right)

The roof is an RCC slab that folds downward, around the middle of the room and then folds back to a horizontal at a lower height towards the western part of the room. This chamber above the western part of the room is inaccessible from any side and its purpose is unknown. The room has a white ceramic tile floor.

The paint on all the walls is flaking off (Figure 3.79). There is visible dampness on parts of the wall where the paint has completely fallen off, (21-D1/P4 – Figure 4.12).

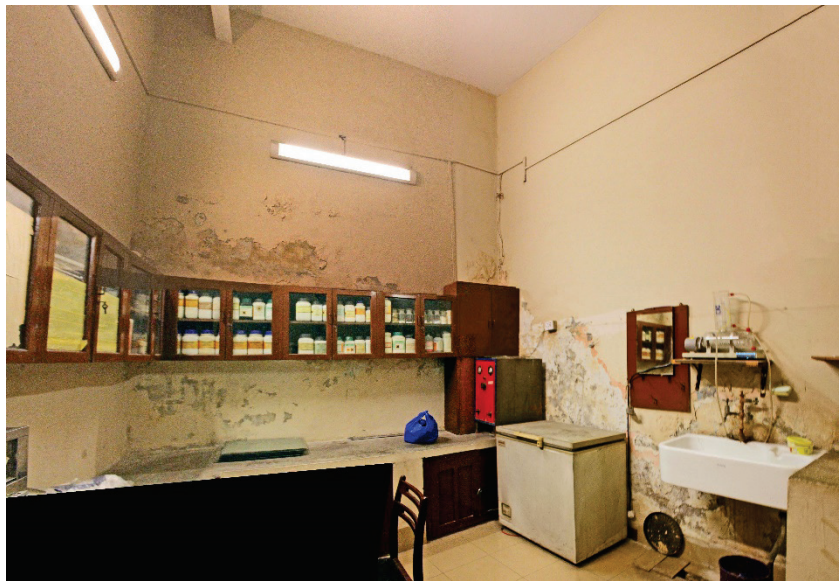
Figure 3.86: Gnd-E/16 – Conservation Laboratory (2016)  
Looking North

There is flaking of paint on the lower part of the eastern (Gnd-E/16-EW) and middle part of the northern (Gnd-E/16-NW) walls (Figure 3.86). There is visible dampness on parts of the wall where the paint has completely fallen off (25-D1/P4 – Figure 4.12).

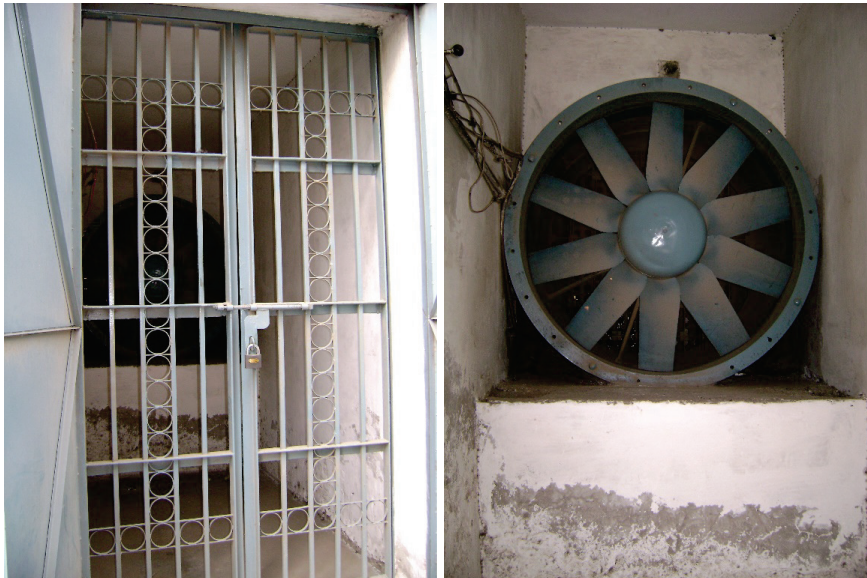
Figure 3.87: Gnd-E/20 – Ventilation Extractor (2007)  
Looking west, from the outside (left), from the inside (right)  
Photos: Fawad Raza

There is flaking of paint on the lower parts of the walls, all around the floor (Figure 3.87), (28–P4 – Figure 4.12).

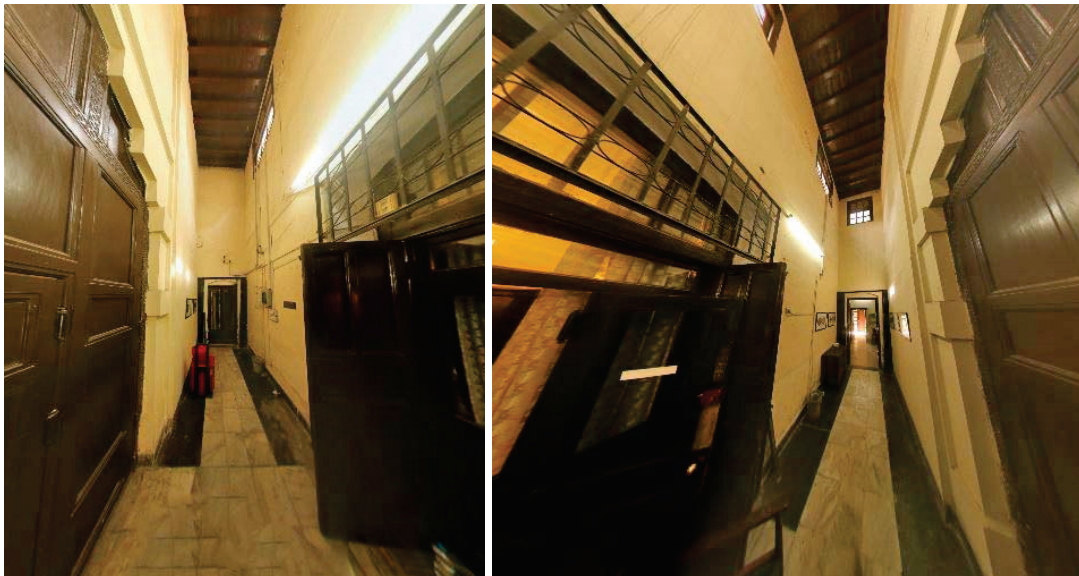
Figure 3.89: Gnd-C/03 – Corridor (2016)  
Looking East (left), Looking West (right)

There are drip marks flowing down from the ventilators, showing the lack of water tightness (Figure 3.89), (52–D1 – Figure 4.12).

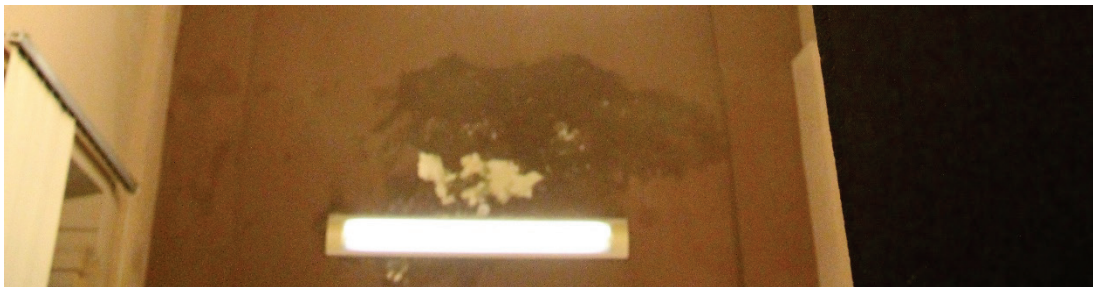
Figure 3.98: Gnd-S/10 – Office – Deterioration (2016)  
Looking East

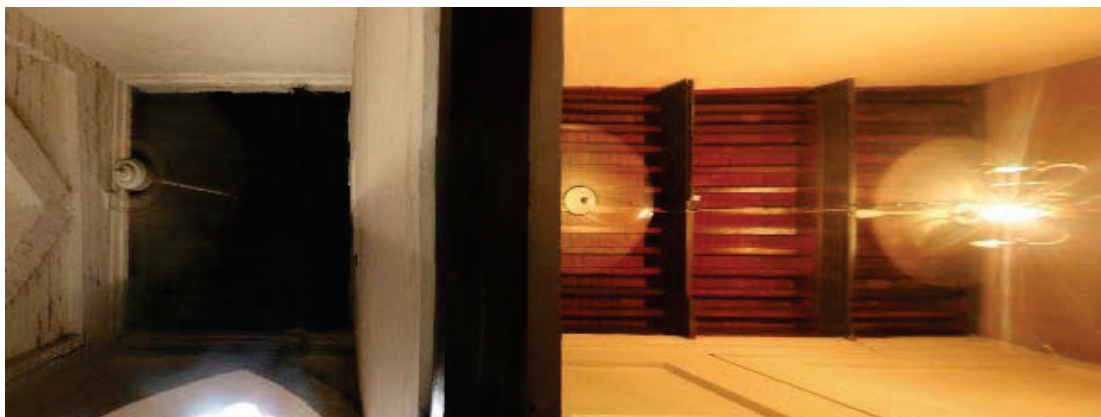
Figure 3.99: Gnd-S/09 & 10 – Veranda and Office – Ceiling (2016)  
Looking up

Traces of the southern veranda can be seen in multiple places such as this continuing roofing system, between the spaces (Gnd-S/9 & 10), divided at a later time by a partition wall (Figure 3.99).

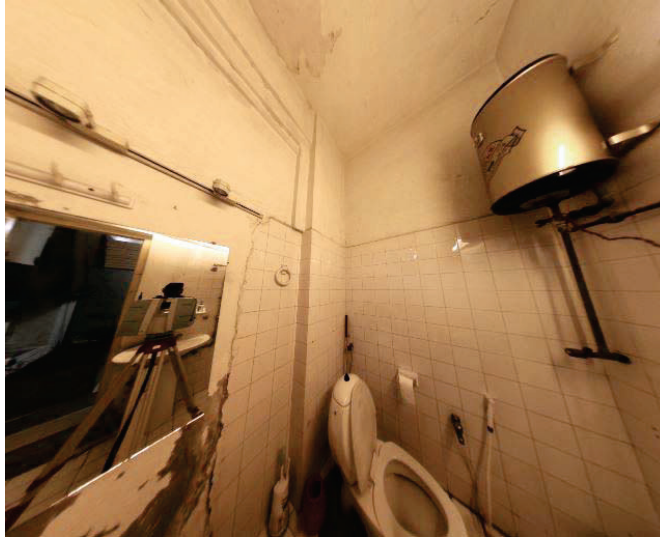
Figure 3.100: Gnd-S/12 – Toilet (2016)  
Looking North-West

There has been partial re-plastering (30-P3 – Figure 4.12) of parts of the western wall (Gnd-S/12-WW). There is also some flaking of paint on the ceiling (Figure 3.100), (31-P4 – Figure 4.12).

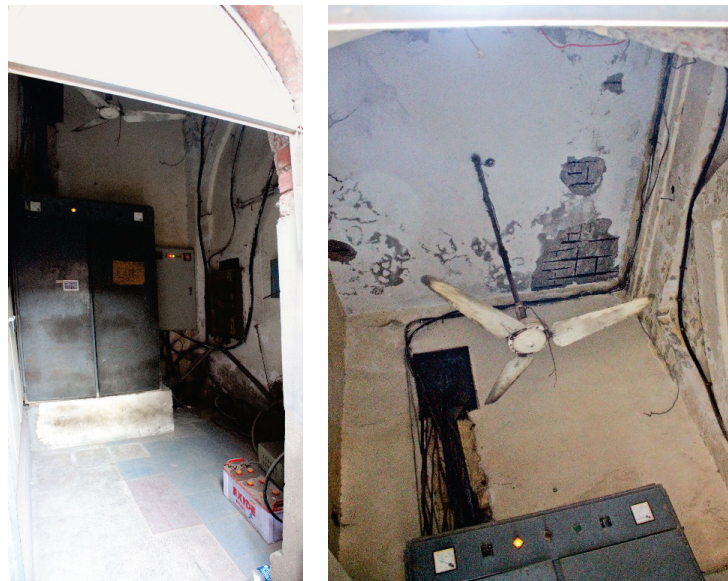
Figure 3.101: Gnd-S/13 – Electric Control Room (2016)  
Looking North (left), Looking up (right)

There is detachment of chunks of concrete from the roof in three patches exposing the steel rebars. There is also flaking of paint on other parts of the ceiling (32-L4 – Figure 4.12).

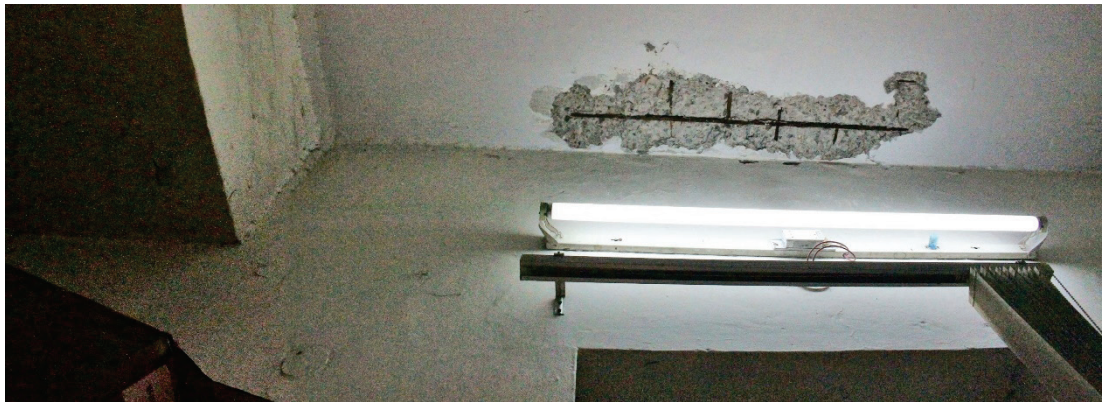
Figure 3.107: Gnd-S/19 – Office – Deterioration (2016)  
Looking South

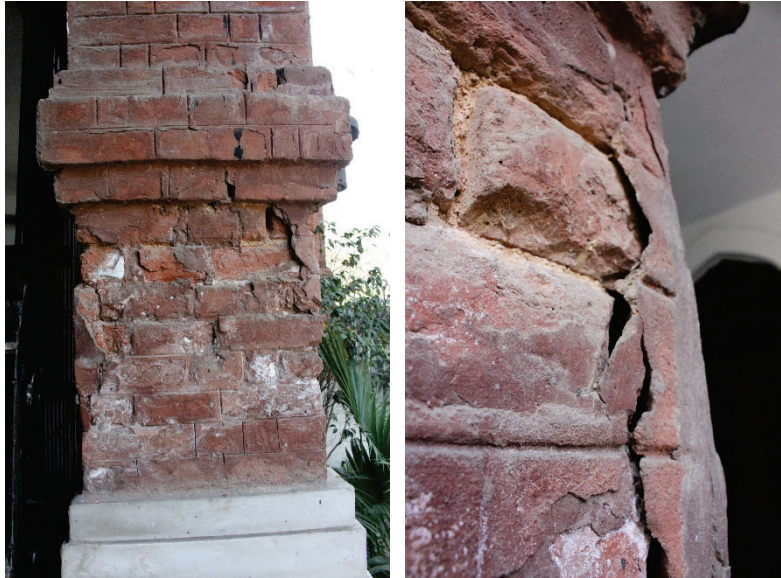
Figure 3.109: Gnd-W/09 – Auditorium & Library – Entrance Lobby (2016)  
Powdering and detachment of bricks

There is detachment (41–L2/L3 – Figure 4.12) of parts of brick units on both columns towards the north, between the openings (Gnd-W/09-NW-D1 / D2 / D3). The bricks which have partially fallen off show signs of efflorescence. The cement repointing has also detached from the brick surfaces.

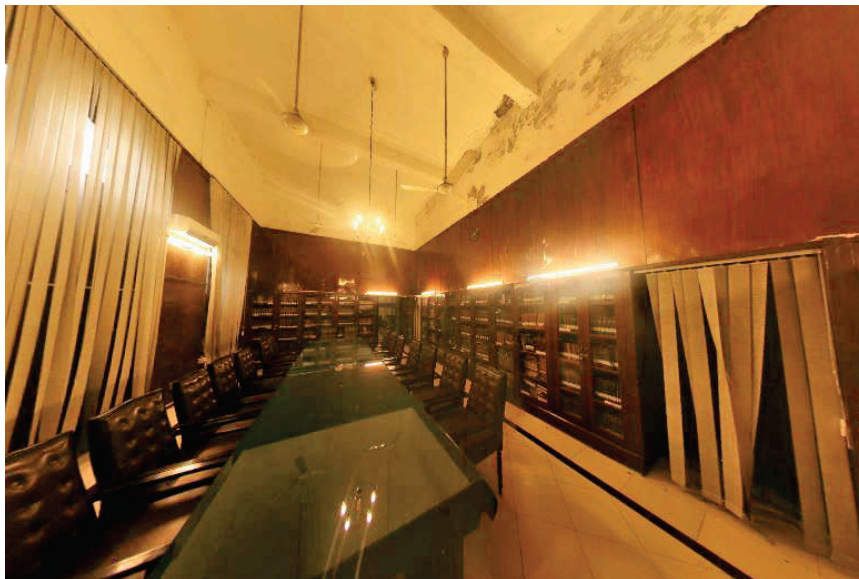
Figure 3.111: Gnd-W/11 – Library / Archives / Conference Room (2016)  
Looking East

There is flaking of paint (42-P4 – Figure 4.12) at the upper parts of the southern wall (Gnd-W/11-SW) (Figure 3.111).

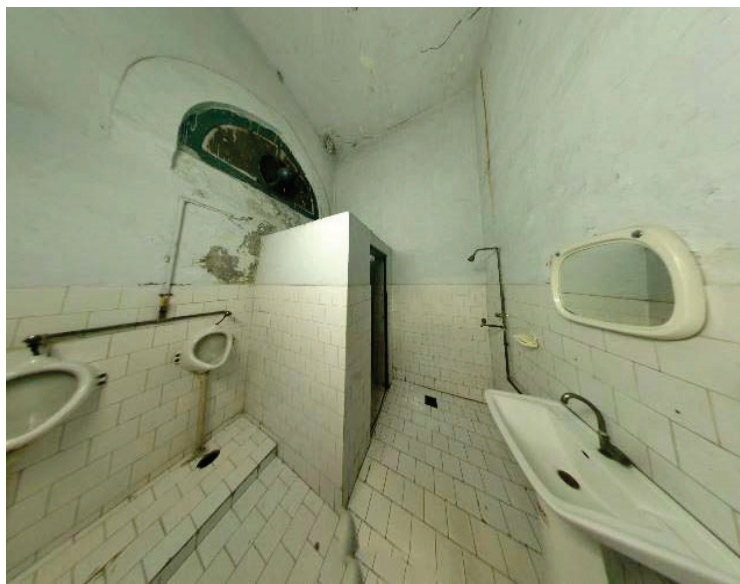
Figure 3.113: Gnd-W/14 – Men's Toilet (2016)  
Looking West

Paint is flaking (45-P4 – Figure 4.12) on the upper part of the southern wall (Gnd-W/14-SW) and some parts of the ceiling (Figure 3.113).

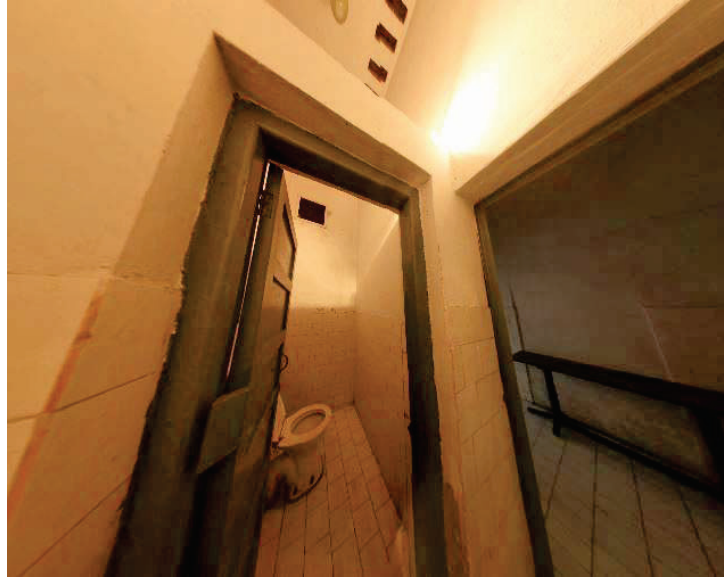
Figure 3.115: Gnd-W/16 – Ladies Toilet (2017)  
Looking South

The roof is an RCC slab with four blocked off apertures near the north wall (Gnd-W/16-NW). The room has white ceramic tile flooring.

The space has no visible signs of deterioration.

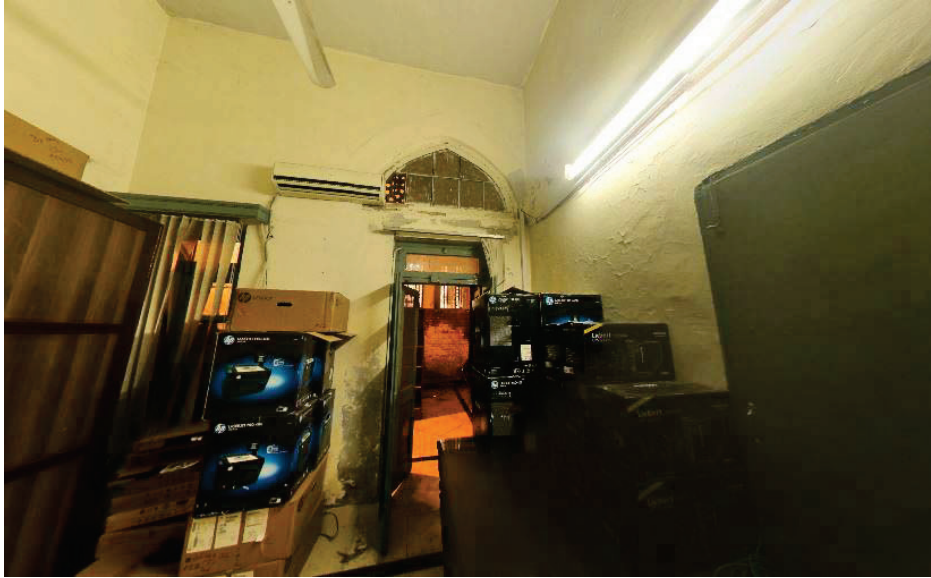
Figure 3.116: Gnd-W/17 – Store (2017)  
Looking West

There is flaking of paint (46-P4 – Figure 4.12) on both the western (Gnd-W/17-WW) (Figure 3.116) and eastern (Gnd-W/17-EW) walls (Figure 3.118).

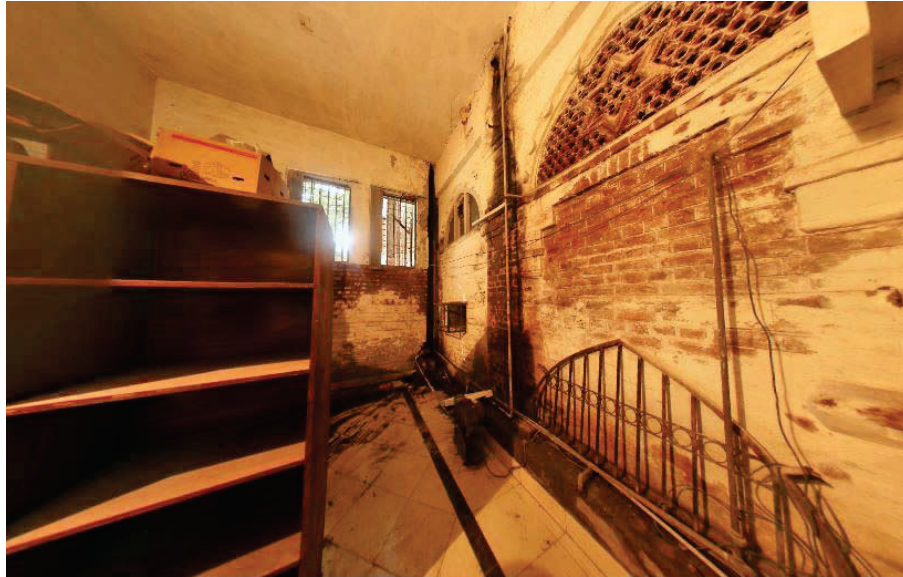
Figure 3.117: Gnd-W/18 – Store (2017)  
Looking West

The paint on the northern (Gnd-W/18-NW) and western walls (Gnd-W/18-WW) has powdered and flaked off (Figure 3.117), (47-P4 – Figure 4.12). There is a storm

drainage downpipe at the north-western corner of the room. This pipe empties onto the floor. The water from this pipe then flows over the floor into a floor drain in the corner.

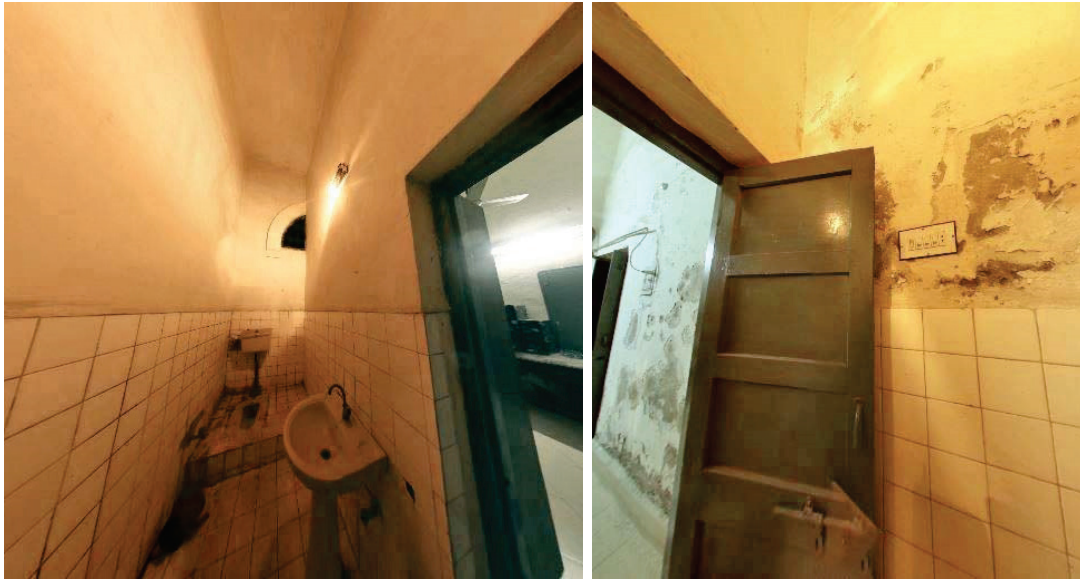
Figure 3.118: Gnd-W/19 – Toilet (2017)  
Looking West (left), Looking East (right)

The paint on the eastern (Gnd-W/19-EW) wall is powdering and flaking off (48-P4 – Figure 4.12). Some efflorescence is also visible at parts where the paint has completely fallen off (Figure 3.118).

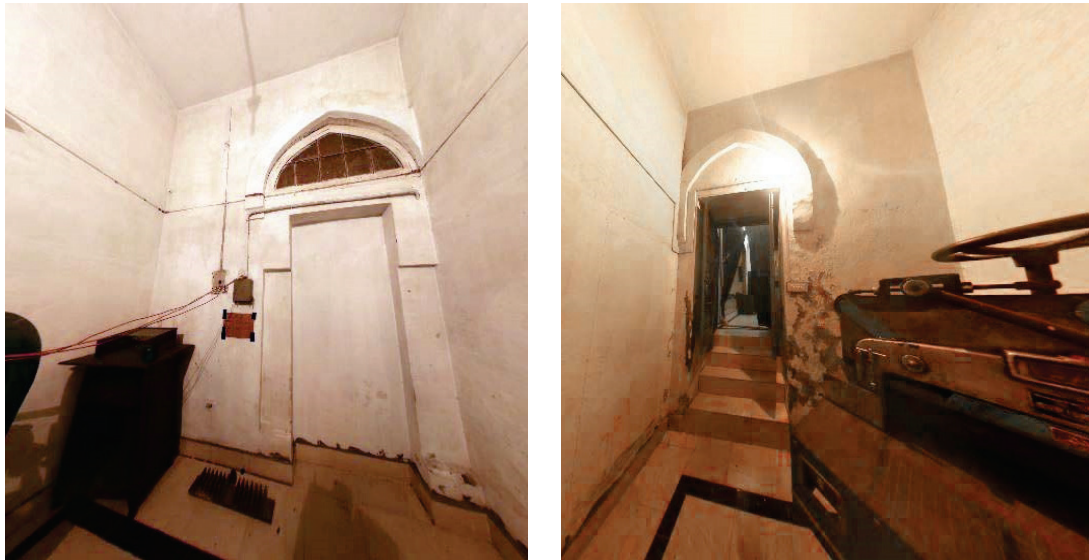
Figure 3.119: Gnd-W/20 – Backstage Area – Auditorium (2017)  
Looking West (left), Looking East (right)

The paint on the eastern (Gnd-W/20-EW) wall is powdering and flaking off (Figure 3.119), (49-P4 – Figure 4.12).
