UNDERSTANDING THE LAHORE MUSEUM  
FOR THE DEFINITION OF A CONSERVATION PROCESS

A THESIS SUBMITTED TO  
THE GRADUATE SCHOOL OF NATURAL AND APPLIED SCIENCES  
OF  
THE MIDDLE EAST TECHNICAL UNIVERSITY

USMAN SAMI

JULY 2017

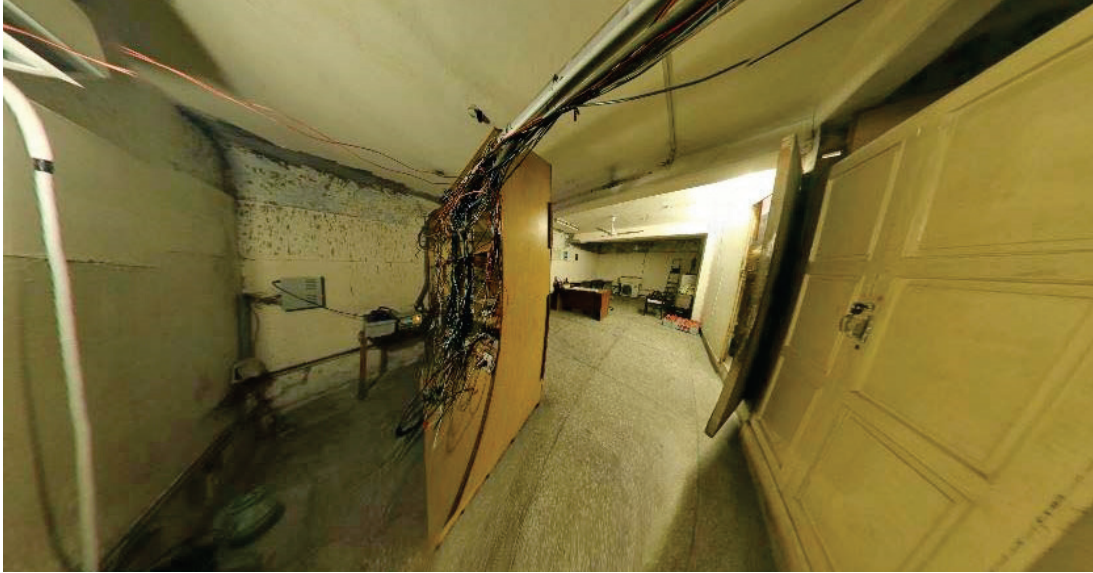
Figure 3.120: Bas-E/01 – Video Surveillance Room (2016)  
Looking North East

The roof is an RCC slab supported on two concrete beams suspended from the ceiling, running in a north-south direction. They are 34 cm wide and drop 32 cm from the soffit. The center of the first beam is 3.35 m from the western (Bas-E/01-WW) wall and the center of the second is 3.35 m from the center of the first. The room has a grey terrazzo floor.

Chunks of concrete had detached from the north-west corner of the roof (Figure 3.120). This patch has been recently re-plastered (53–L4/P3 – Figure 4.12).

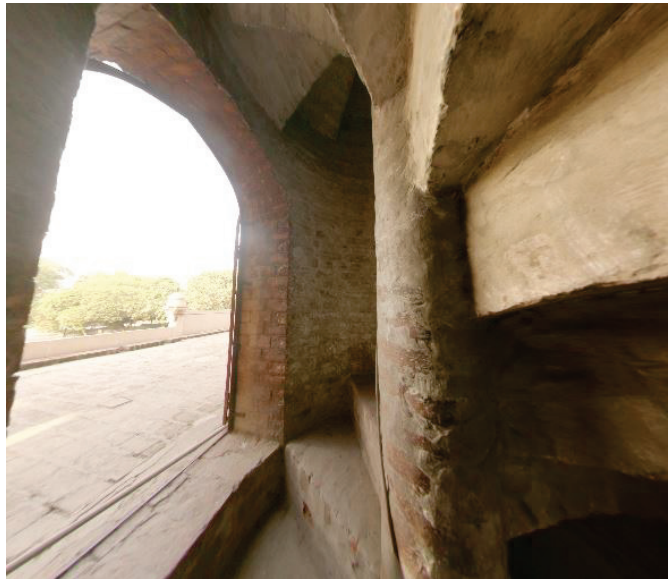
Figure 3.121: Fst-N/01 – Western Stairwell (2016)  
Looking North East – First Floor

The steps are supported on brickwork arches with a segmental profile, which in turn are supported between the 21.5 cm wide central column and the periphery wall. The steps are 6.5 cm wide towards the center of the spiral and 42.5 cm towards the periphery and are finished in exposed brickwork.

The steps and the walls of the stairwell have general wear from usage. There are no signs of any major deterioration.

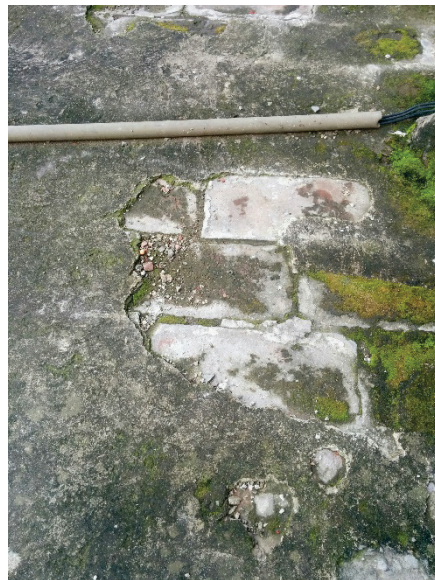
Figure 3.124: Fst-N/03 – Terrace – Floor (2016)  
Looking down

There is microbiological growth on the floor of the terrace (Figure 3.124) (54–M1 – Figure 4.13Figure 4.13).

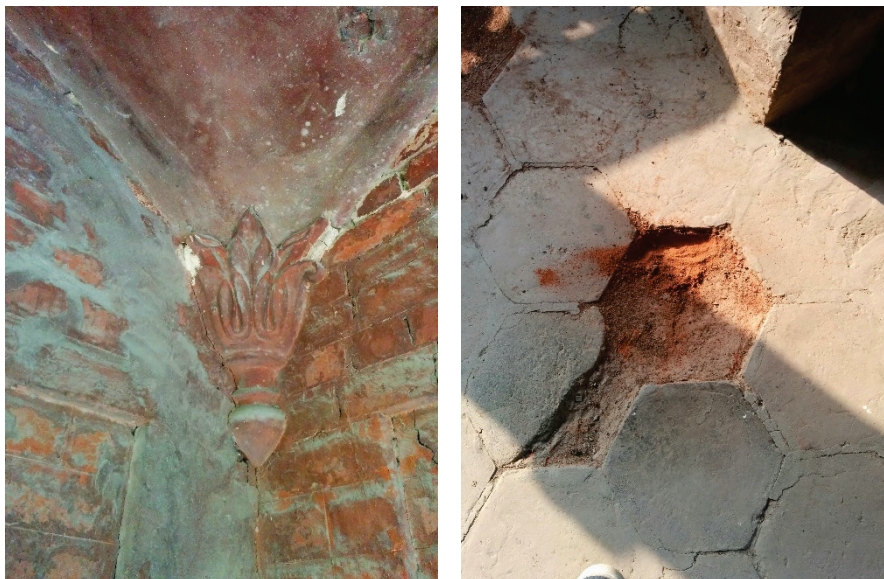
Figure 3.126: Fst-N/04 – Western Turret – Condition (2016)  
Looking up and South East (left), Looking down (right)

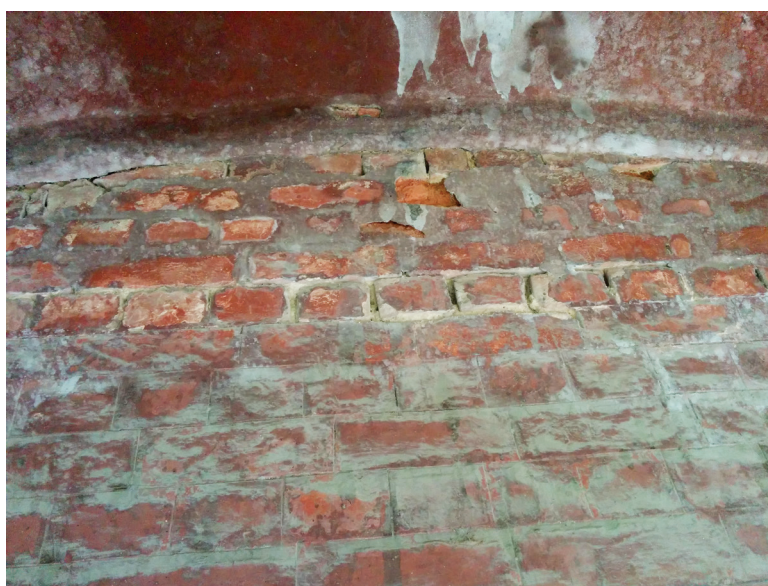
Figure 3.128: Fst-N/05 – Eastern Turret – Deterioration (2016)  
Looking up and South

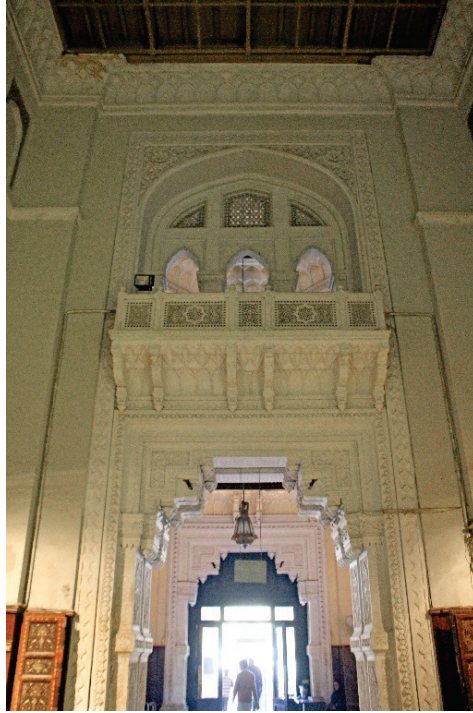
Figure 3.130: Fst-C/01 – Balcony – Miniature Gallery (2016)  
Looking North

This space is entered through the three archways (Fst-N/06-SW-D1 / D2 / D3) on the northern wall (Fst-C/01-NW). The space is bounded by *pinjra-work* balustrades on the eastern (Fst-C/01-EW), southern (Fst-C/01-SW) and western (Fst-C/01-WW) sides. The balconies has a hexagonal brick tile floor.

The *pinjra-work* (woodwork) panels are covered in multiple layers of paint which has obscured the fine detailing. One of the supporting brackets' hanging bulbs is broken detached (79-L4 – Figure 4.13).

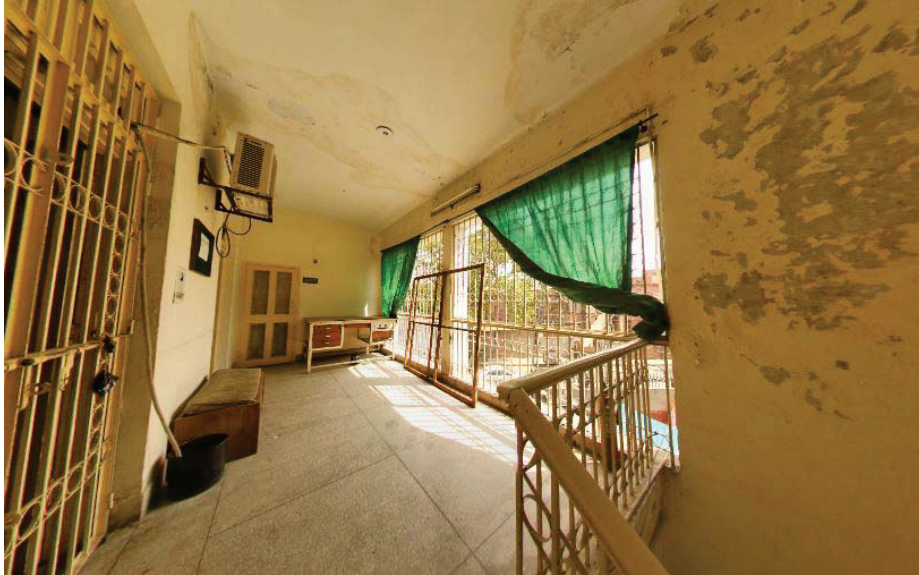
Figure 3.131: Fst-E/01 – Veranda / Stair Hall for the Conservation Laboratory (2016)  
Looking East

There are drip marks and discoloration around every electrical point on the ceiling, suggesting that the electrical conduits are not watertight (59-D1 – Figure 4.13). Paint is also flaking on southern wall (Gnd-E/01-SW) (Figure 3.131), (60-P4 – Figure 4.13).

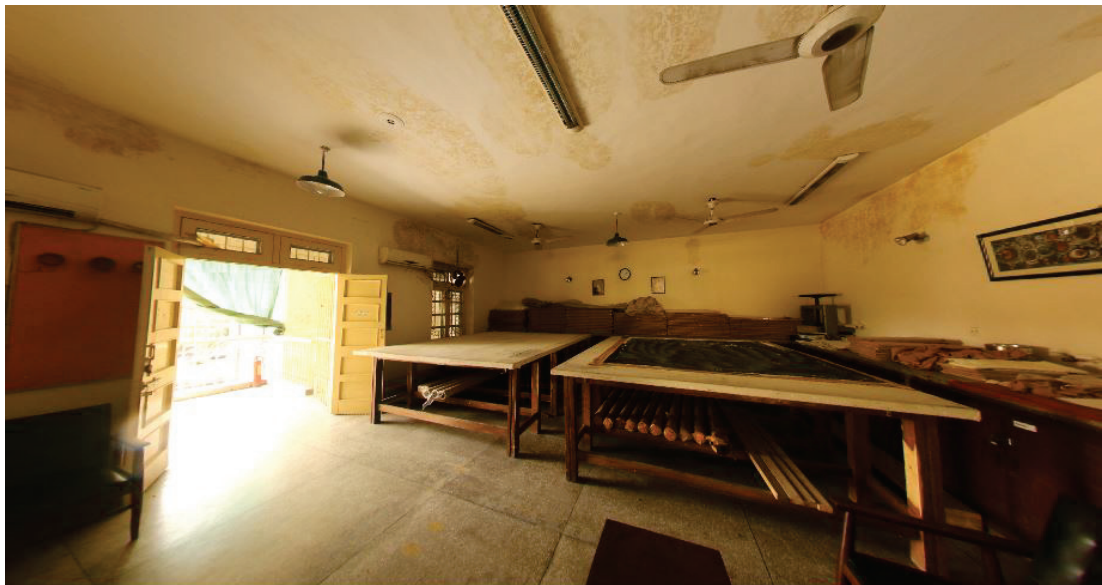
Figure 3.132: Fst-E/03 – Conservation Workshop (2016)  
Looking West

There are drip marks and discoloration around every electrical point on the ceiling, suggesting that the electrical conduits are not watertight. This discoloration continues down the surfaces of the northern (Gnd-E/03-NW) and southern (Gnd-E/03-SW) walls (Figure 3.132) (61–D1 – Figure 4.13).

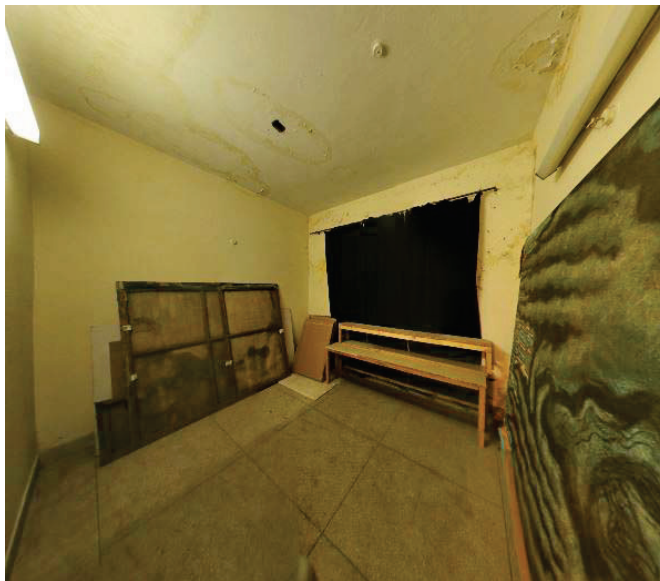
Figure 3.133: Fst-E/04 – Photography Section – Conservation Workshop (2016)  
Looking East

There are drip marks and discoloration around every electrical point on the ceiling, suggesting that the electrical conduits are not watertight (62–D1 – Figure 4.13). There is flaking of paint on the eastern wall (Gnd-E/04-EW) (Figure 3.133), (63–P4 – Figure 4.13).

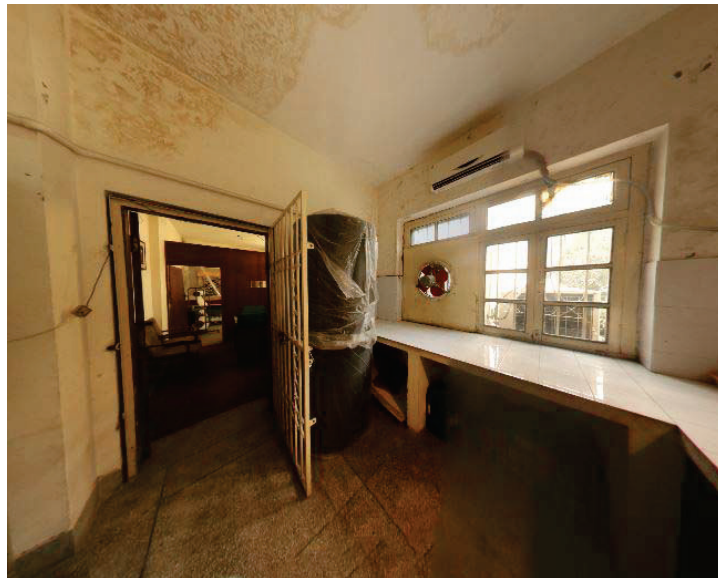
Figure 3.134: Fst-E/05 – Transitional Space – Conservation Workshop (2016)  
Looking North

There are drip marks and discoloration around every electrical point on the ceiling, suggesting that the electrical conduits are not watertight. This discoloration continues down the surfaces of the northern (Gnd-E/05-NW) and eastern (Gnd-E/05-EW) walls (Figure 3.134), (64–D1 – Figure 4.13).

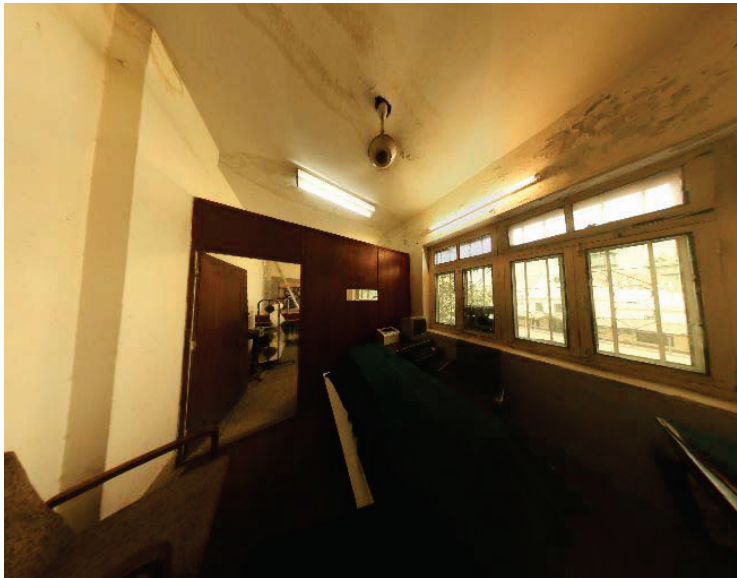
Figure 3.135: Fst-E/06 – Conservation Workshop (2016)  
Looking North

There are drip marks and discoloration around every electrical point on the ceiling, suggesting that the electrical conduits are not watertight (65–D2 – Figure 4.13). There is flaking of paint on the eastern wall (Gnd-E/06-EW) (Figure 3.135), (66–P4 – Figure 4.13).

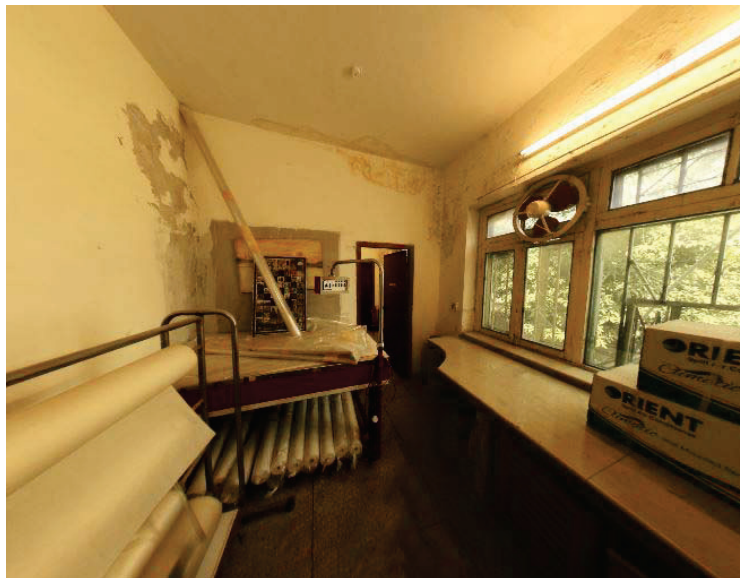
Figure 3.136: Fst-E/07– Conservation Workshop (2016)  
Looking North

continues down the surfaces of the northern (Gnd-E/07-NW) and eastern (Gnd-E/07-EW) walls (67-D1 – Figure 4.13). There is also some flaking of paint on the western wall (Gnd-E/07-WW) (Figure 3.136), (68-P4 – Figure 4.13).

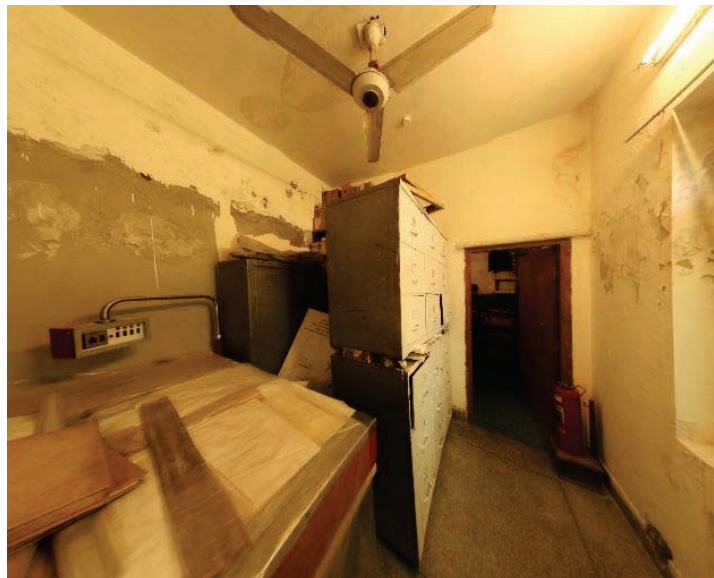
Figure 3.137: Fst-E/08 – Conservation Workshop (2016)  
Looking North

down the surfaces of the northern (Gnd-E/08-NW) wall. There is also some flaking of paint on the eastern wall (Gnd-E/08-EW), (69-P4 – Figure 4.13). The western wall (Gnd-E/08-WW) has recently been re-plastered (Figure 3.137), (70-P3 – Figure 4.13).

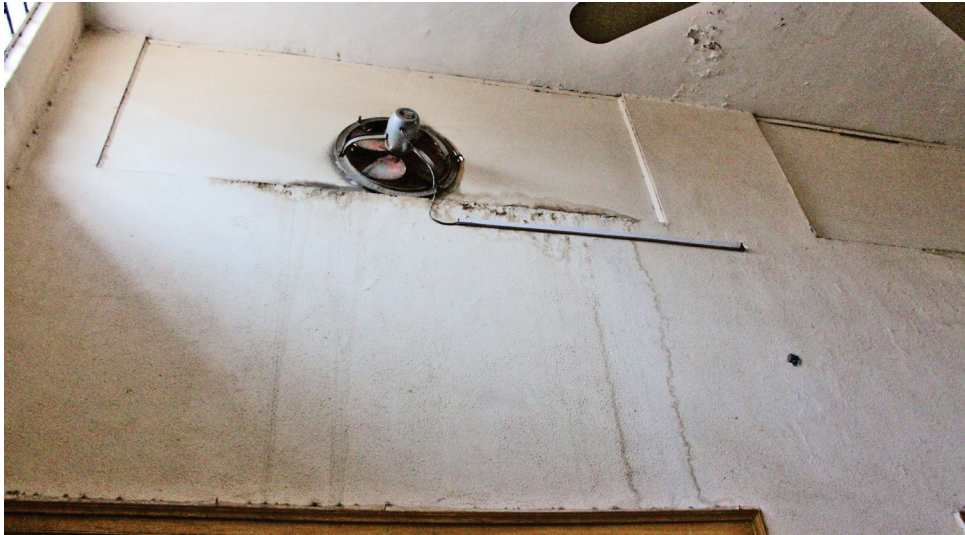
Figure 3.143: Fst-E/13 – Freedom Movement Gallery – Leakage (2016)  
Looking up and North

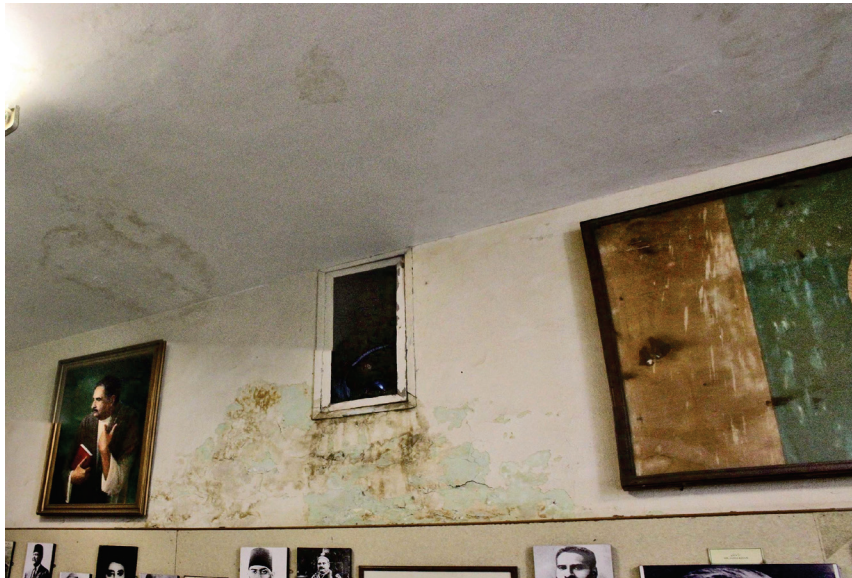
Figure 3.146: Fst-E/15 – Freedom Movement Gallery – Deterioration (2016)  
Looking up and East

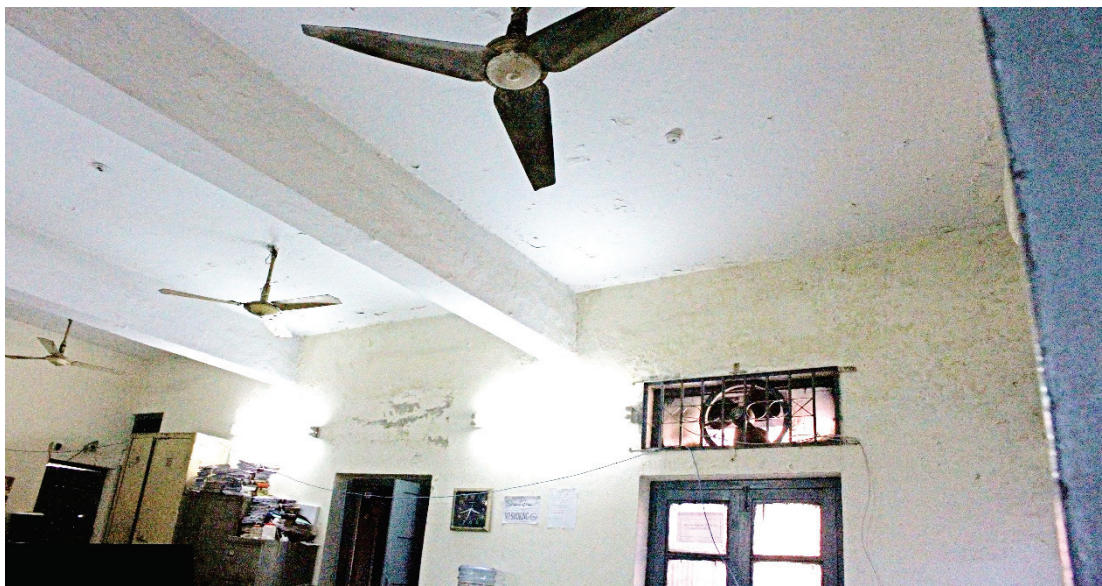
Figure 3.147: Fst-S/01 – Office – Clerical Staff (2016)  
Looking North

There is discoloration of paint due to dampness at the top of the walls on the north-east corner of the room. There is also some flaking of paint on the northern wall (Gnd-S/01-SW) (Figure 3.147), (74-D1/P4 – Figure 4.13).

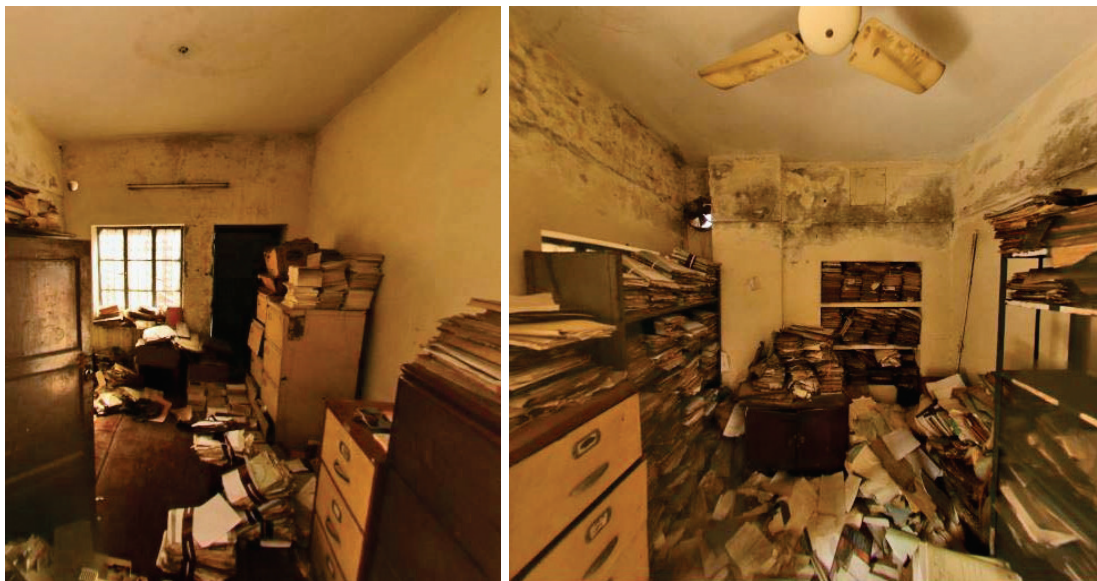
Figure 3.148: Fst-S/04 – Record Room (2016)  
Looking east (left), Looking West (right)

There is powdering and flaking of paint all around the top of the walls on the eastern (Gnd-S/04-EW), southern (Gnd-S/04-SW) and western (Gnd-S/04-WW) walls. (Figure 3.148), (75–P4 – Figure 4.13).

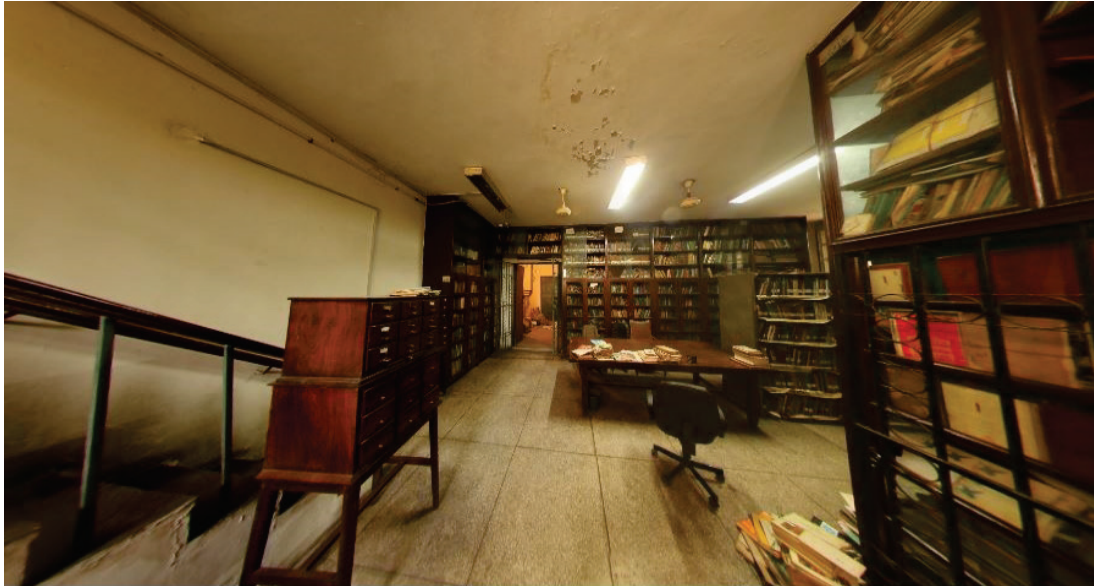
Figure 3.152: Fst-W/04 – Library Store (2016)  
Looking South

There are drip marks and discoloration around the electrical points on the ceiling, suggesting that the electrical conduits are not watertight. There is also some flaking of paint (Figure 3.152) (76–D1 – Figure 4.13).

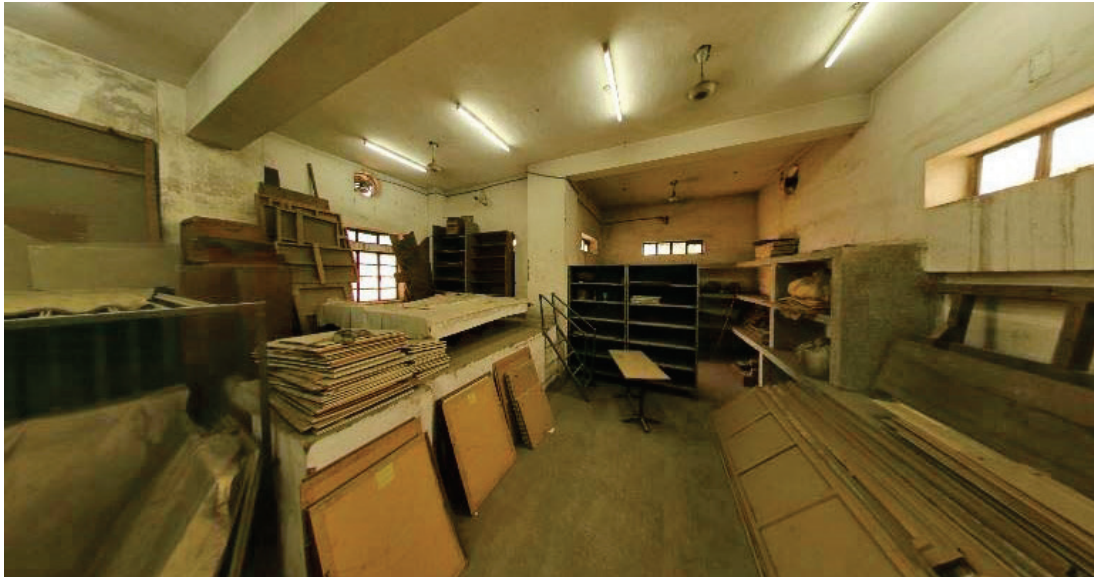
Figure 3.154: Fst-W/07 – Reserves' Storage (2016)  
Looking South

There are drip marks flowing from under the ventilators (Fst-W/07-WW-V1 – V4) on the western wall. The ventilators are not watertight (77-D1 – Figure 4.13). There is also swelling of plaster on the eastern wall (Fst-W/07-EW) (Figure 3.155) on the surface of which there is also powdering and flaking of paint (Figure 3.154), (77-P1 – Figure 4.13).

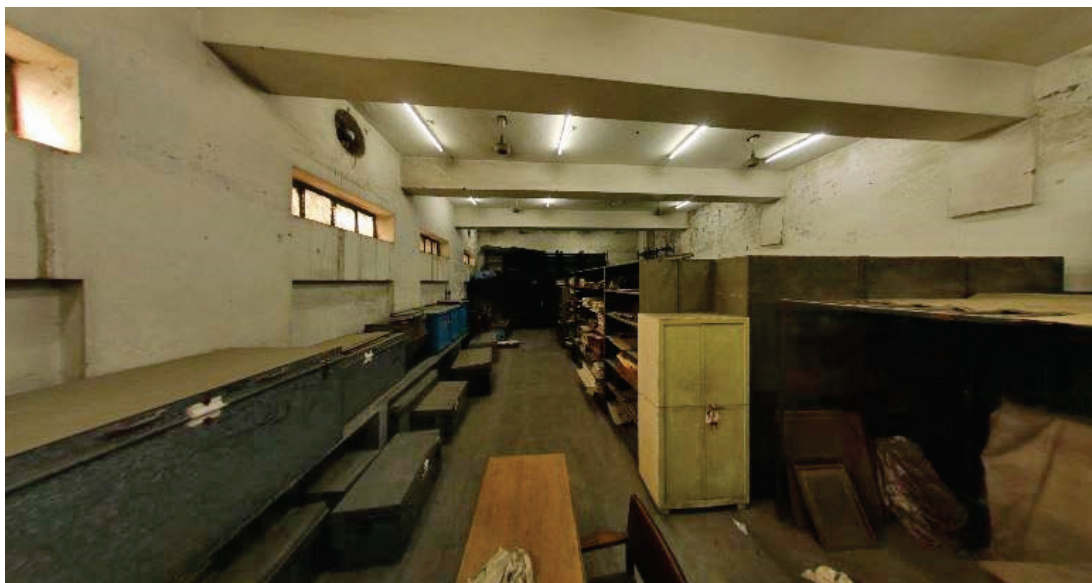
Figure 3.155: Fst-W/07 – Reserves' Storage (2016)  
Looking North

The roof is an RCC slab supported on four concrete beams suspended from the ceiling, running in the east-west direction. They are 50 cm wide and drop 61 cm from the soffit. The center of the first beam is 3.1 m from the northern wall (Fst-W/07-NW). The center of the second is 3.1 m from the center of the first, the center of the third is 2.6 m from the center of the second and the center of the fourth is 3.4 m from the center of the third beam. The room has a grey terrazzo floor.

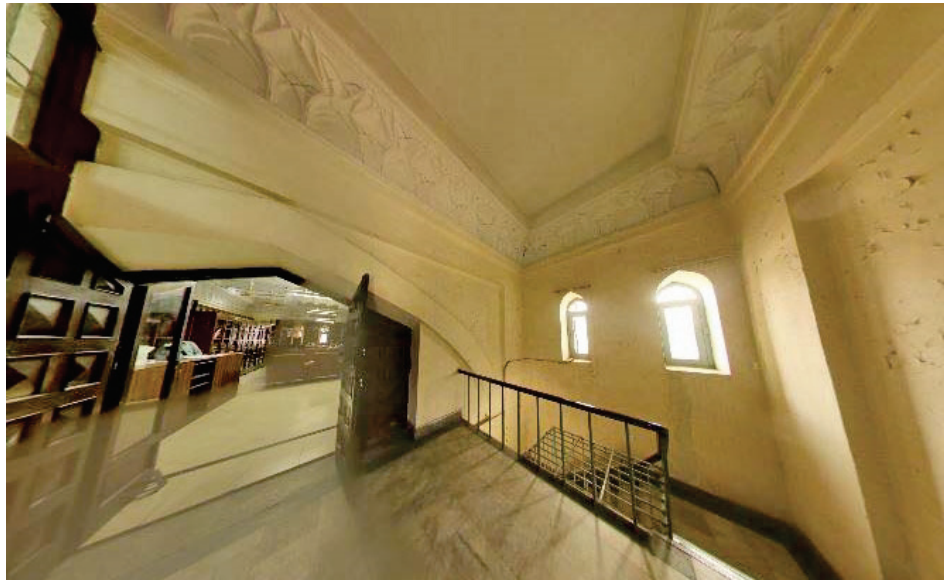
Figure 3.156: Snd-W/01 – Stair Hall – Auditorium / Library – Second Floor (2016)  
Looking West

There is flaking of paint on the northern wall (Snd-W/01-NW) (Figure 3.156) (80–P4 – Figure 4.13).

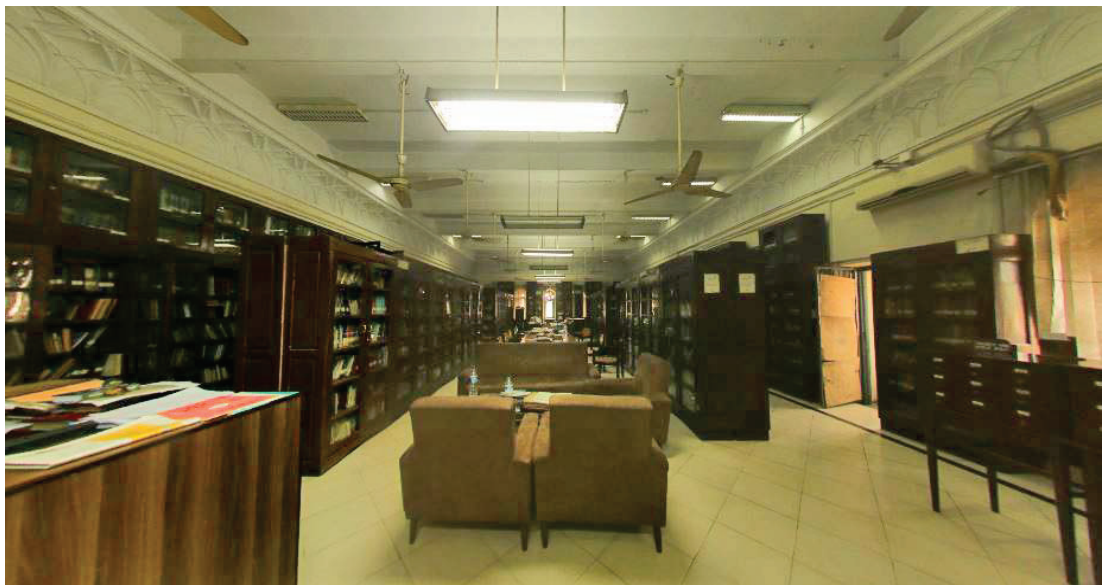
Figure 3.159: Snd-W/03 – Museum Library (2016)  
Looking South

The roof is an RCC slab supported on steel I-section beams running in an east-west direction. The space has an off-white porcelain tile floor.

Two of the arched window openings on the western wall (Snd-W/03-WW) have been expanded into rectangular openings destroying the original brickwork detailing and fitted with doors (Snd-W/03-WW-D1 & D2) (Figure 3.159).

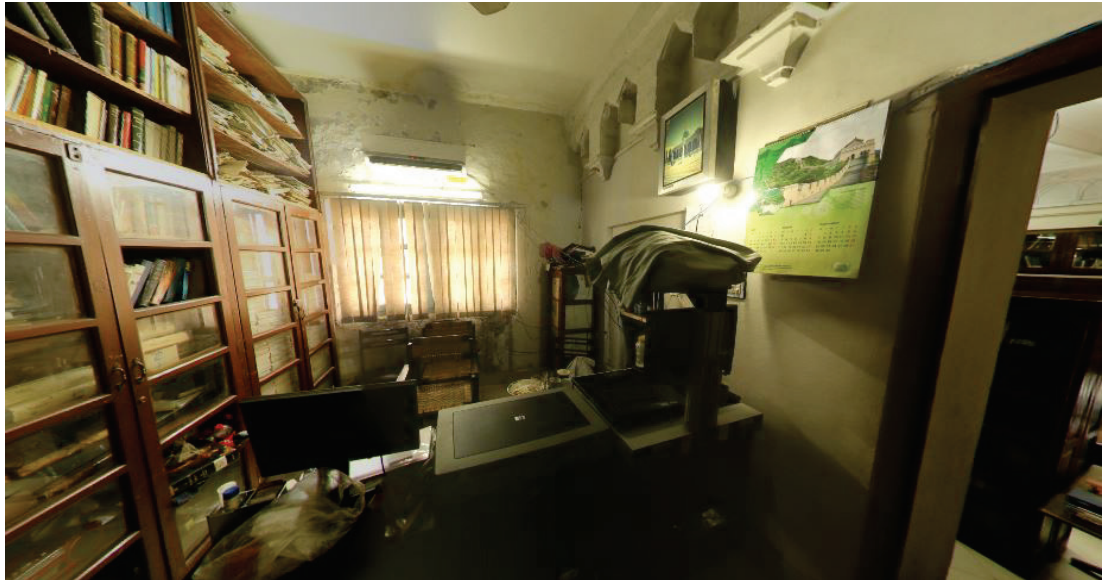
Figure 3.160: Snd-W/05 – Digitizing Room (2016)  
Looking North

There is flaking of paint on the northern wall (Snd-W/05-NW) (Figure 3.160), (81-P4 – Figure 4.13).

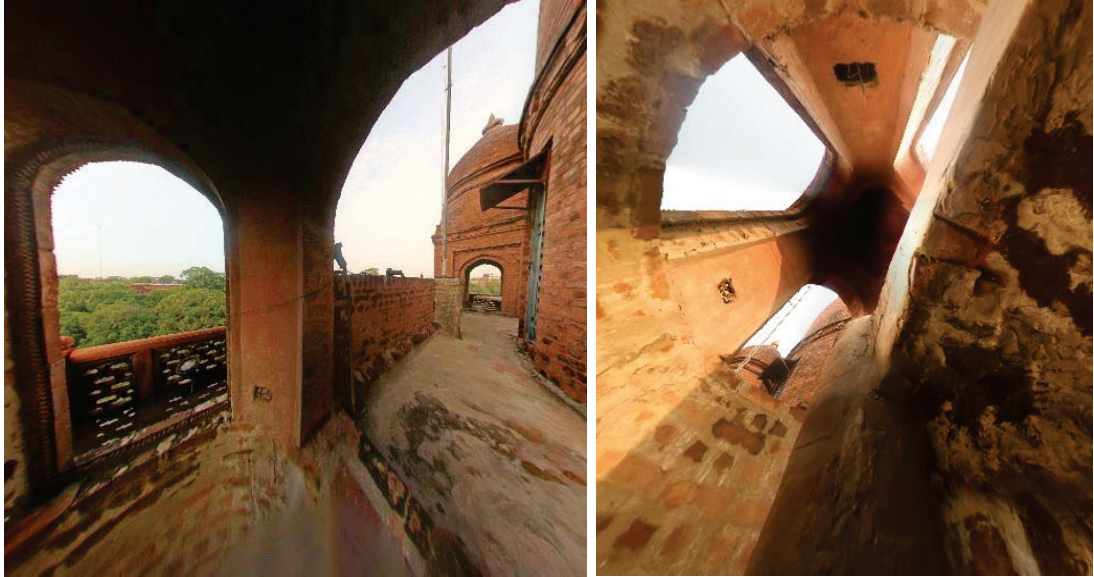
Figure 3.161: Thd-N/01 – North-Western Canopy (2016)  
Looking North-East (left), Looking up (right)

This canopy was repaired and partly reconstructed in the year 1993 after it was damaged in an earthquake. It was re-plastered after the original lime plaster was removed and electrical points / conduits were installed (Executive Engineer, 1980, p. 2). The undersides of the last few steps have lost their pointing (Figure 3.161), (82-L3 – Figure 4.13).

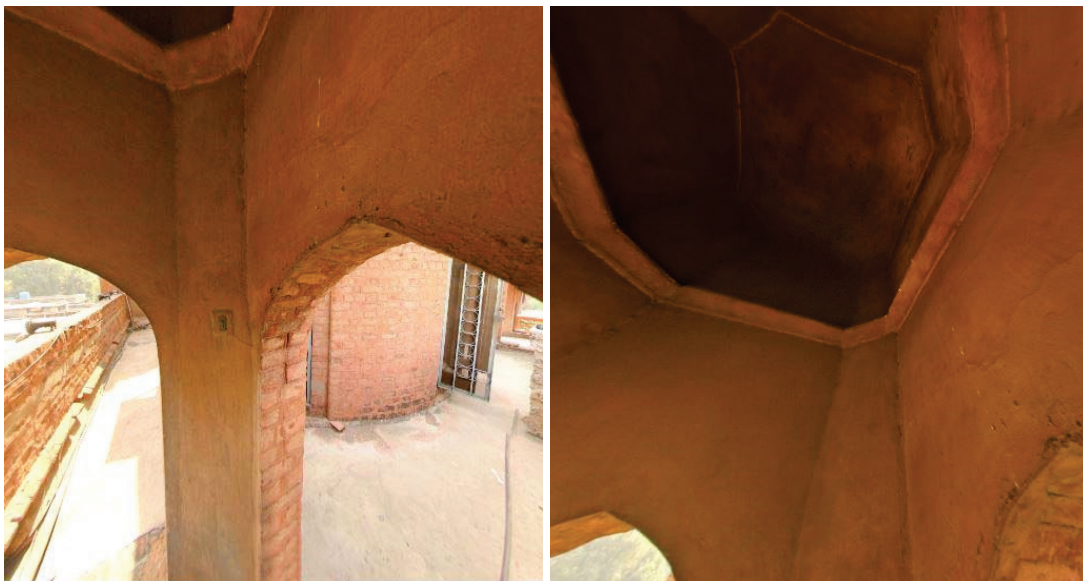
Figure 3.163: Thd-N/02 – North-Eastern Canopy (2016)  
Looking South-West (left), Looking up (right)

This canopy was repaired and partly reconstructed in the year 1993 after it was damaged in an earthquake. It was re-plastered after the original lime plaster was removed and electrical points / conduits were installed (Executive Engineer, 1980, p. 2). The space has no visible signs of deterioration.

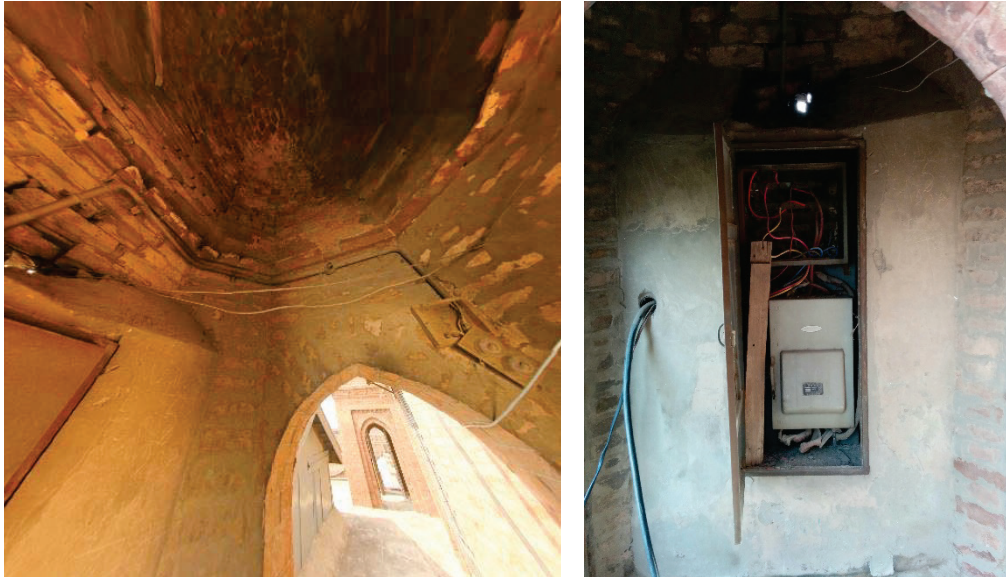
Figure 3.164: Thd-N/03 – South-Eastern Canopy (2016)  
Looking up and West (left), Looking South (right)

The south wall (Thd-N/03-SW) has been blocked with cement masonry above which the keystone of the original arch has been punctured to create a passage for electric cables (Figure 3.164), (82–L2 – Figure 4.13). The inner dome has lost all of its lime plaster save a few detached pieces around its springer course. The lower parts of the interior have been repointed using cement mortar (84–P3 – Figure 4.13).

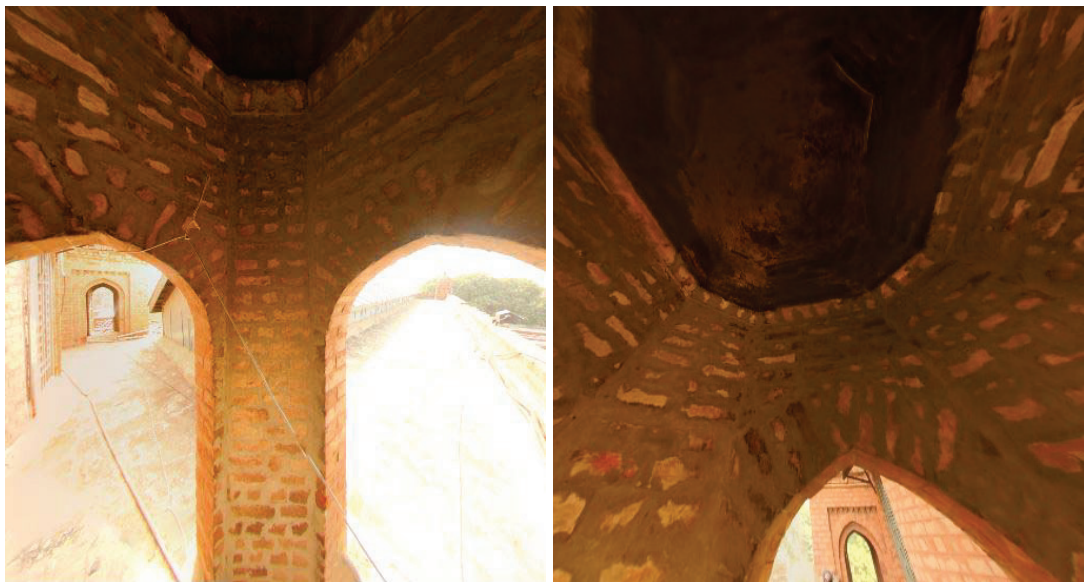
Figure 3.165: Thd-N/04 – South-Western Canopy (2016)  
Looking up and East (left), Looking up (right)

This is the south-western Canopy on the third level of the Frontispiece. It was built in the year 1893. The space is 1.28 m wide by 1.28 m deep. The floor is at +12.65 m, above the plinth and the soffit of the center of the inner double-domed canopy is at a height of +16.4 m, above the plinth. The whole composition is finished in exposed brickwork with the soffit of the inner dome being the only surface rendered in lime plaster.

This space can be entered through the four-cross-centered arched opening (Thd-N/04-NW-D1) on the northern wall (Thd-N/04-NW). This space can also be entered through the four-cross-centered arched opening (Thd-N/04-EW-D1) on the eastern wall (Thd-N/04-EW). On the southern wall (Thd-N/04-SW) there is a four-cross-centered arched opening (Thd-N/03-WW-D1) leading towards the roof of the Miniature Gallery (Gnd-C/01) towards the south. On the western wall (Thd-N/04-WW) there is a four-cross-centered arched opening (Thd-N/04-WW-D1) that leads onto a small balcony with a terracotta jali balustrade supported on brackets.

The roof is most probably a double-dome, constructed in brick masonry with the cavity in between being inaccessible. The lower dome, visible from inside the canopy has a

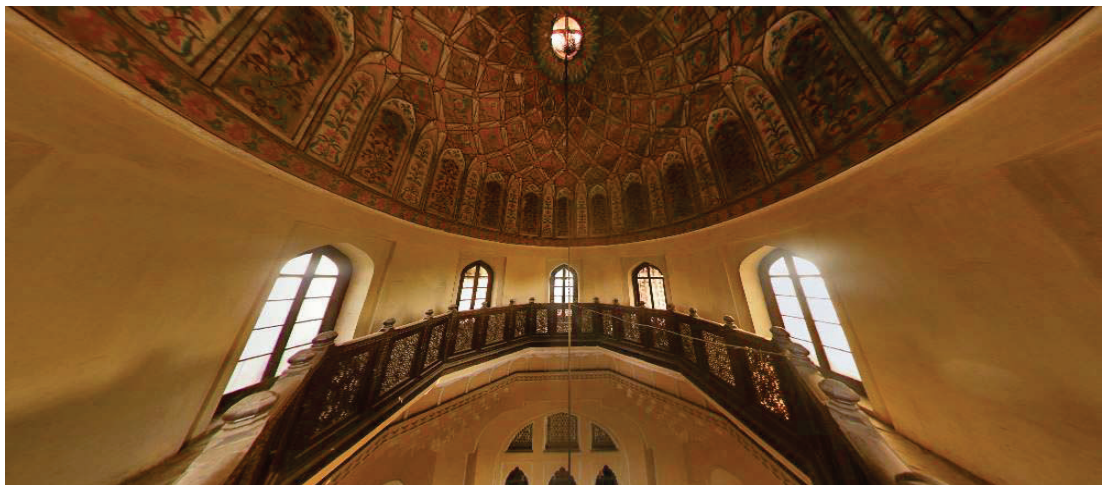
Figure 3.166: Thd-N/05 – Dome (2016)  
Looking South

The dome is constructed in brick masonry visible from the exterior. The drum transitions into a two-cross-centered profile with its first center 16.89 m above the plinth at the center of the dome. The second center is +13.9 m, above the plinth and flush with the inner surface of the drum wall. The balcony has a hexagonal brick tile floor.

The space has no visible signs of deterioration.

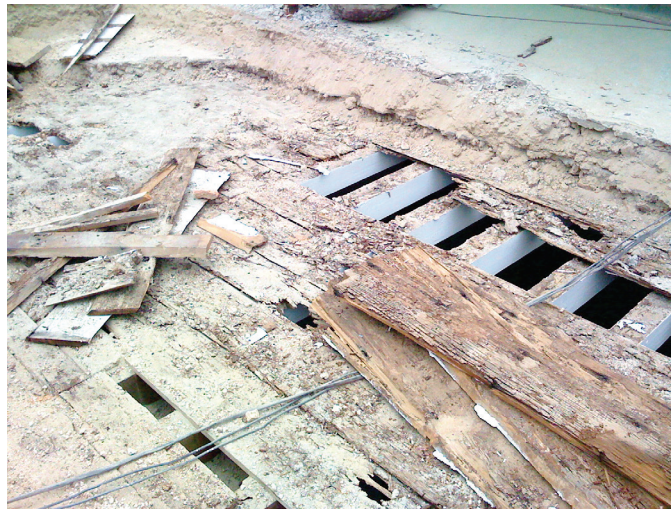
Figure 3.168: Central Police Office (2009)

can be made based on the roofing details of the Central Police Office.<sup>58</sup> The construction details of the Central Police Office's roof were observed, when it was opened for replacement of damaged wooden planks. These planks were covered with a layer of lime concrete. Compacted earth was layered on top of this, which was covered on top with brick tiles. By the time this observation was made, the brick tile covering of the roof had been grouted with cement mortar. The original grouting would have been in lime.

The roofing system was exposed when repairs were carried out for the replacement of roofing boards.

It is plausible that this is roughly the same detailing used in the museum's flat wooden roofs, as the recent repairs of the saw-tooth truss roof of the Islamic Gallery (Gnd-E/01) also revealed a layer of lime concrete, laid over wooden planks and battens, using brick tiles to level the cavities between the battens.

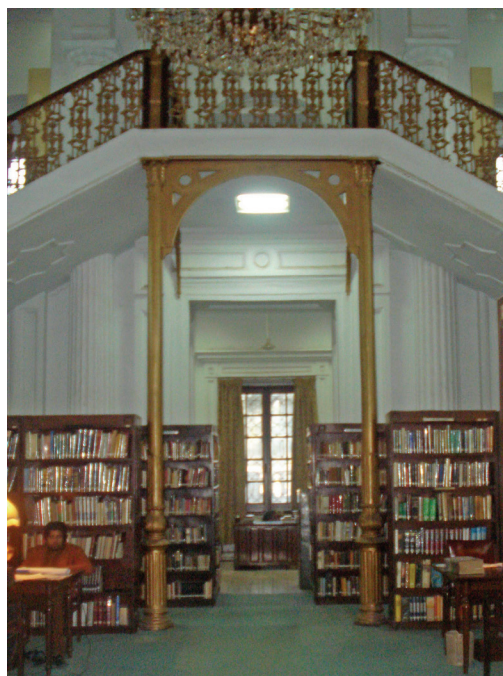
Figure 4.2: Montgomery Hall, Lahore – Raised Platform (2007)

The Lecture Hall (Gnd-W/10) used to have a “wooden gallery, entrance to which [was] by a winding staircase in the entrance hall” (Department of Education, 1911, p. 166). This means that the present-day concrete staircase leading up to the mezzanine gallery and the concrete slab interfloor is most probably in the same configuration as its wooden predecessor. There are no written descriptions or images of what the wooden structure looked like, though there are wooden staircases and raised platforms that still exist from the same time period, such as the raised platform (Figure 4.2) accessed by two staircases, at the Montgomery Hall (built in 1866).

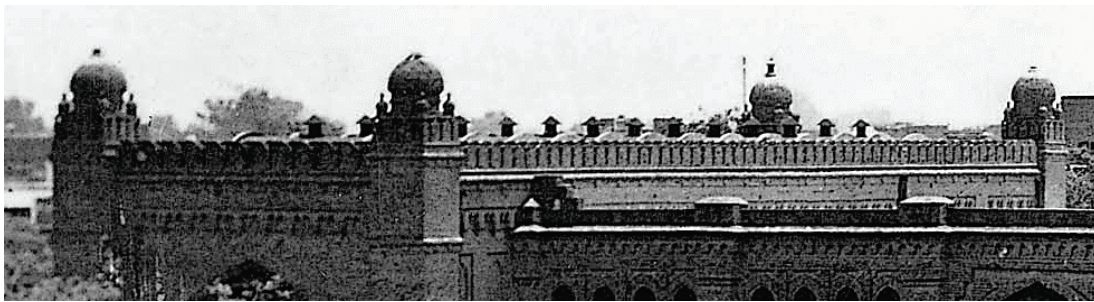
Figure 4.3: Gnd-E/03 – Jack-arched roof – Hindu and Buddhist Gallery (1938)  
In 1965 this roof was modified by replacing the jack-arch vaults with an RCC slab.  
Source: NCA Archives
