UNDERSTANDING THE LAHORE MUSEUM  
FOR THE DEFINITION OF A CONSERVATION PROCESS

A THESIS SUBMITTED TO  
THE GRADUATE SCHOOL OF NATURAL AND APPLIED SCIENCES  
OF  
THE MIDDLE EAST TECHNICAL UNIVERSITY

USMAN SAMI

JULY 2017

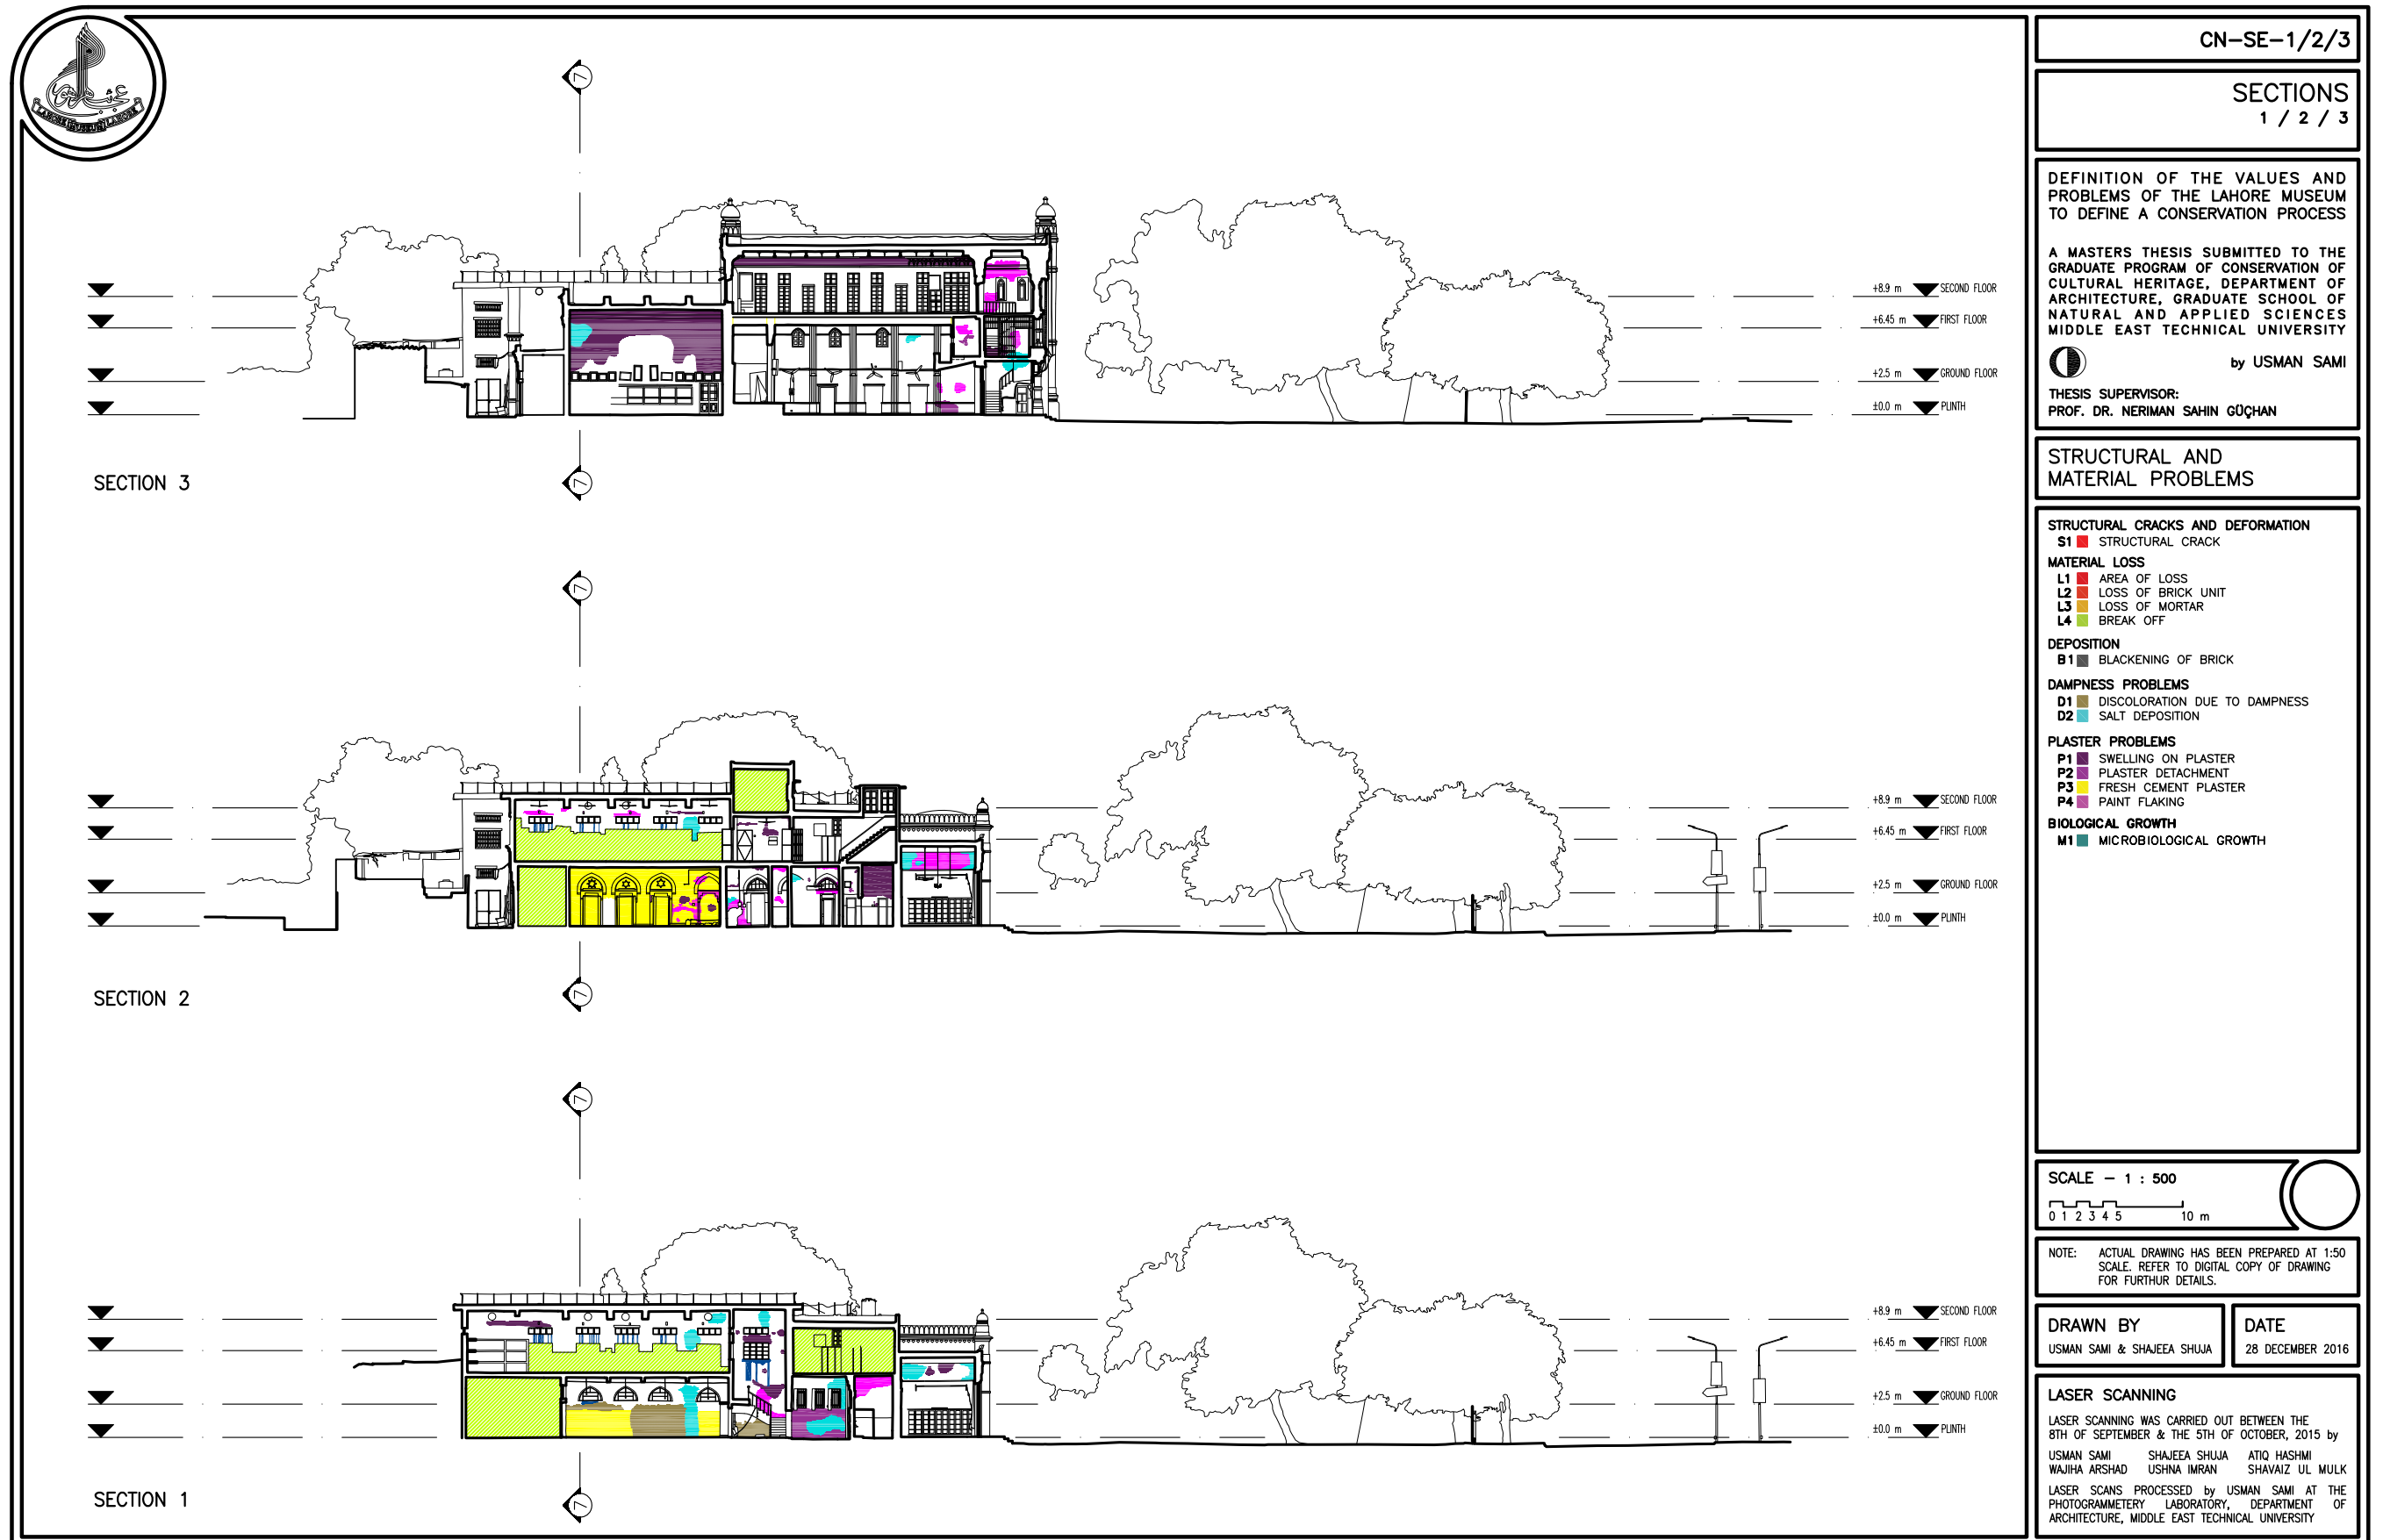
Figure 4.17: CN-SE-1/2/3 – Structural and Material Problems – Sections – 1 / 2 / 3 (2016)

The building suffers from a host of material deterioration problems. This includes Dampness Problems, causing Discoloration (D1) and in some cases, Salt Deposition (D2). There is also Blackening of Brick (B1) on the building exterior. The plastering in the building has multiple recurring problems such as the Swelling of Plaster (P1) and Plaster Detachment (P2). Some areas where the plaster had detached, have been freshly Re-plastered with cement (P3). Flaking of Paint (P4) has been observed in some areas. Microbiological Growth (M1) has also been observed on some parts of the roof (Figure 4.12, Figure 4.13, Figure 4.14, Figure 4.15, Figure 4.16, Figure 4.17 & Figure 4.18).

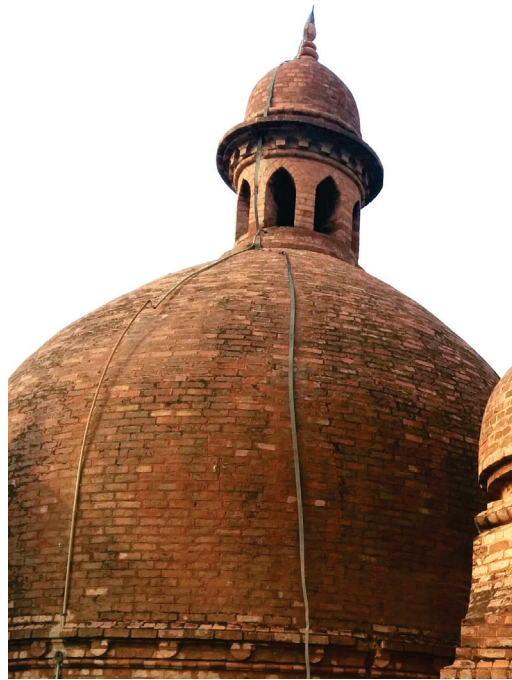
Figure 4.19: Main Dome – South Face (2016)

There are two visible structural cracks on the exterior of the building. One passing through the central arched window in Block B on the north elevation and the other on the southern side of the main central dome (Figure 3.43 & Figure 4.19).

This crack through the arch in the space (Gnd-E/04), is visible on both sides of the wall. This crack has been expanding since it appeared in the year 2014, when the roof was opened for repairs. The earth-fill and roof boards were removed without the use of scaffolding to keep the slender north wall stable. Additionally, a crane for the hoisting of repair materials was placed on top of the wall. This extreme shift in loading patterns has caused out-of-plane behavior in the wall. The crack has been opening up at a greater rate towards the top of the wall (Figure 3.43), and the parapet can now be seen to be tilting towards the east. This may also indicate differential settlement.

A faint trace of the grouted up vertical structural crack can be seen near the middle of the image.

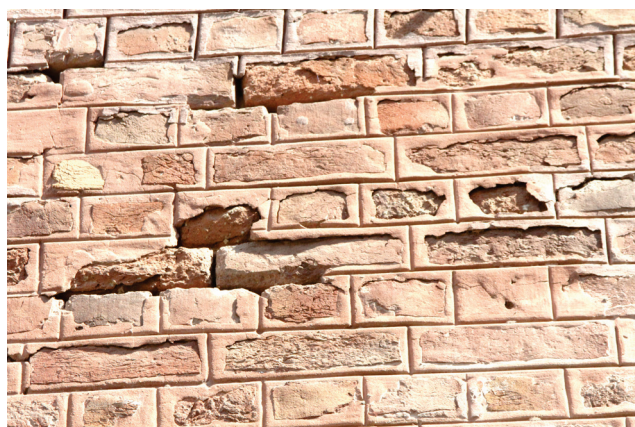
Figure 4.21: Fst-W/01 – Exterior Wall – Powdering of Brick / Detachment of Pointng (2017)

Multiple repair, maintenance and addition schemes, coupled with constant re-pointing in red colored cement mortar, has made it almost impossible to differentiate the brick types. The continuous reintroduction of salts carried by cement have caused powdering of the edges of bricks which are pointed with successively thicker layers of mortar in an unending cycle (Figure 4.21).

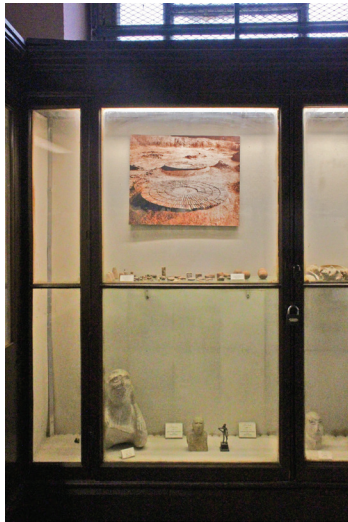
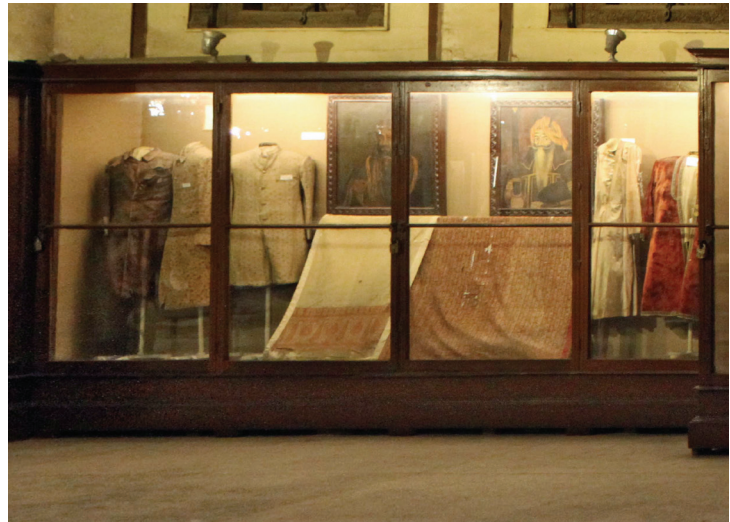
Figure 4.22: Display Cases (2017)  
Indus Gallery (Gnd-E/04) (left), General Gallery (Gnd-W/01) (right)

The presentation of objects is also arbitrary. The display cases are either jam-packed with objects or are disproportionately empty (Figure 4.22). Particularly, large architectural wood work pieces, which are permanently attached to the walls, all over the museum, have no relation to their surrounding exhibits. These objects are either bolted higher up on the walls or affixed into the existing or additionally erected masonry (Figure 4.23). In addition to this, there are also no temperature or humidity controls in the display cases, even for organic objects.

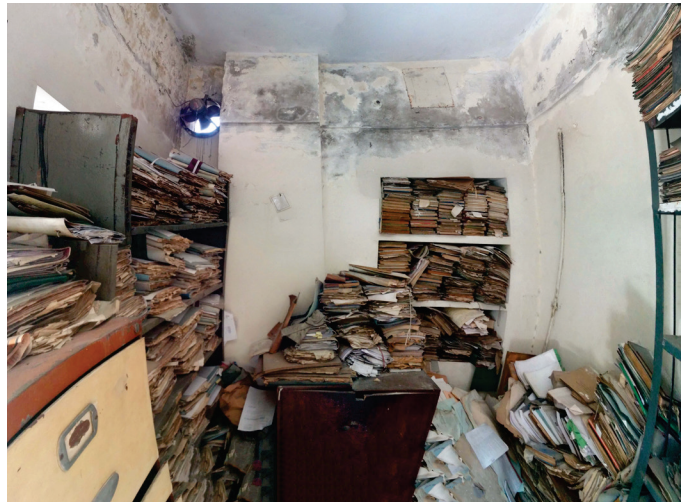
Figure 4.32: Fst-S/04 – Record Room (2016)

The record keeping practices of the museum have deteriorated over time. Any files or documents, other than running paperwork, is deposited in the Record Room, on top of paperwork that has previously been discarded, lying partly in heaped piles on the record room floor (Figure 4.32). There is no listing available for these records.

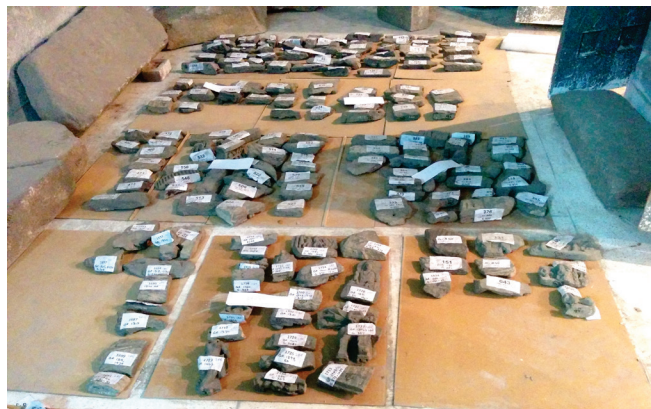
Figure 4.33: Gnd-W/04 – Reserves Storage (2016)

The situation regarding storage of objects fares no better. The heavier objects (mostly from the Gandhara Collection), are stored on the floor of the ground floor Reserves Store. Their item numbers are handwritten on pieces of paper which are pasted onto the objects with glue (Figure 4.33). The smaller objects kept in the Reserves Storage on the first floor fare no better. The room has dampness problems due to leaking ventilators. The smaller objects are kept on shelves, unprotected, and are covered in thick layers of dust (Figure 4.34).
