INVESTIGATION ON DETERIORATION MECHANISMS OF THE BASALTS
USED IN THE DİYARBAKIR CITY WALLS

A THESIS SUBMITTED TO
THE GRADUATE SCHOOL OF NATURAL AND APPLIED SCIENCES
OF
MIDDLE EAST TECHNICAL UNIVERSITY

IN PARTIAL FULFILLMENT OF THE REQUIREMENTS
FOR
THE DEGREE OF DOCTOR OF PHILOSOPHY
IN
GEOLOGICAL ENGINEERING

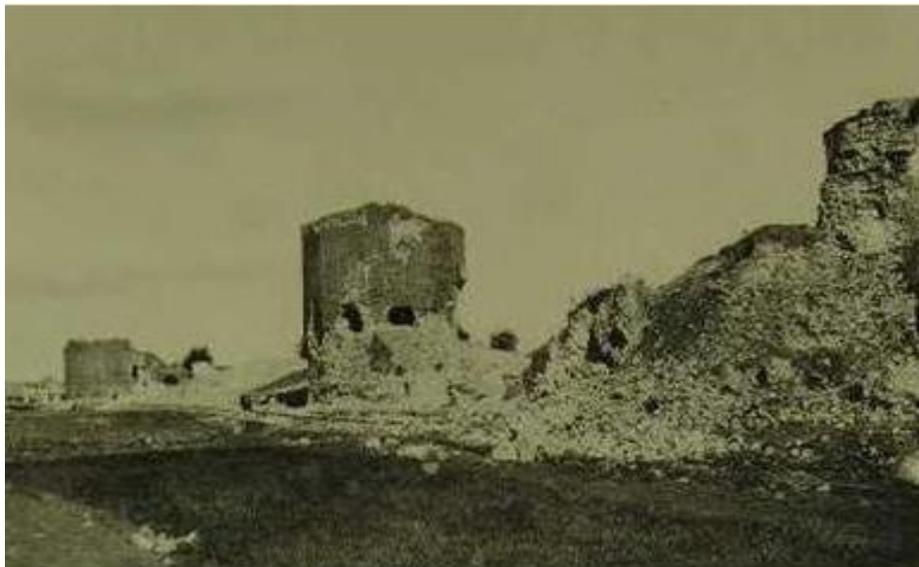
Figure 1.5 Ruins of demolished walls (northern section of the DCW; Tower 4 and vicinity) (Gabriel, 1940, 2014)

Since the proclamation of the republic in 1923 until recently, the destruction and demolition of the DCW have continued without respite. Between 1930 and 1932, for example, considerable parts of the walls located in the Dağ Gate section were systematically dynamited (Gabriel, 1933), demolishing three towers and some 200 meters of the northern section of the DCW (Figure 1.5).

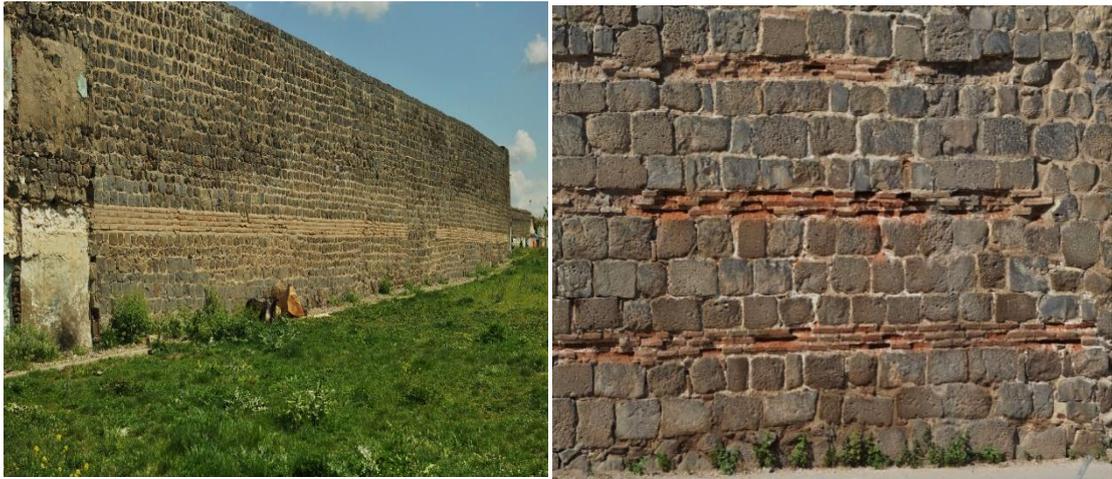
Figure 1.9 Opus listatum (east section of the DCW)

The erected masonry walls were commonly faced with *opus incertum*, *opus quadratum*, and *opus listatum*. In order to fill their cores, *opus caementicium* was most commonly used. *Opus caementicium*, is a mixture of irregular basalt and brick fragments with mortar and is found in many sections of the DCW (Figure 1.8). In order to create a friction with mortar, the interior faces of the basalt blocks were intentionally left undressed.

Brick, as another construction material, was used in different sections of the city walls. It was the primary construction material for the domes, vaults and arches of the towers. (Figures 1.9 and 1.15).

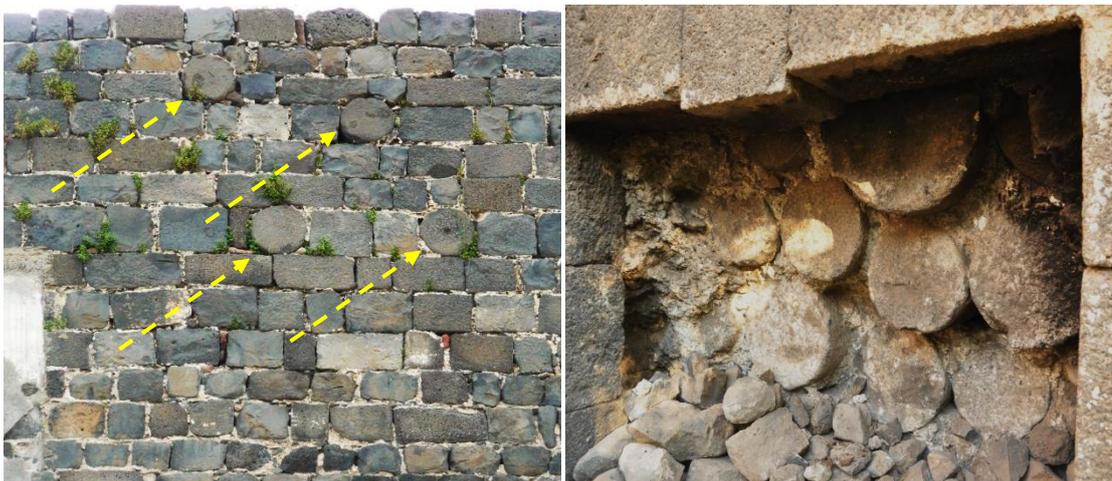
Figure 1.10 Cylindrical basalt applications (south and north section of the DCW)

In some sections, cylindrical or squared basalt blocks were placed perpendicularly to the face of the walls and towers. These embedded columns were probably intended to increase the strength of the walls (Figure 1.10).

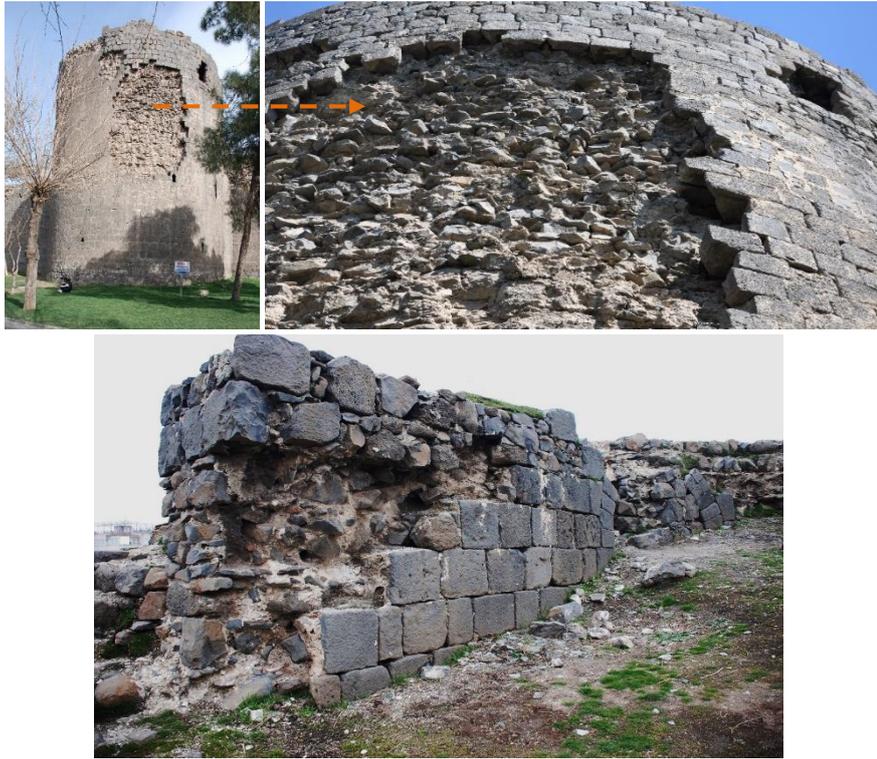
Figure 1.11 A Tower façade and wall section

Preparing the foundation is the initial step in wall and tower construction. Although there is no specific evidence of the precise form of the foundations of the DCW, they lie on the basalt bedrock. In order to form the internal and external faces of the masonry, two parallel walls were constructed, and the spaces between them were filled with rubble and mortar (Figures 1.8 and 1.11).

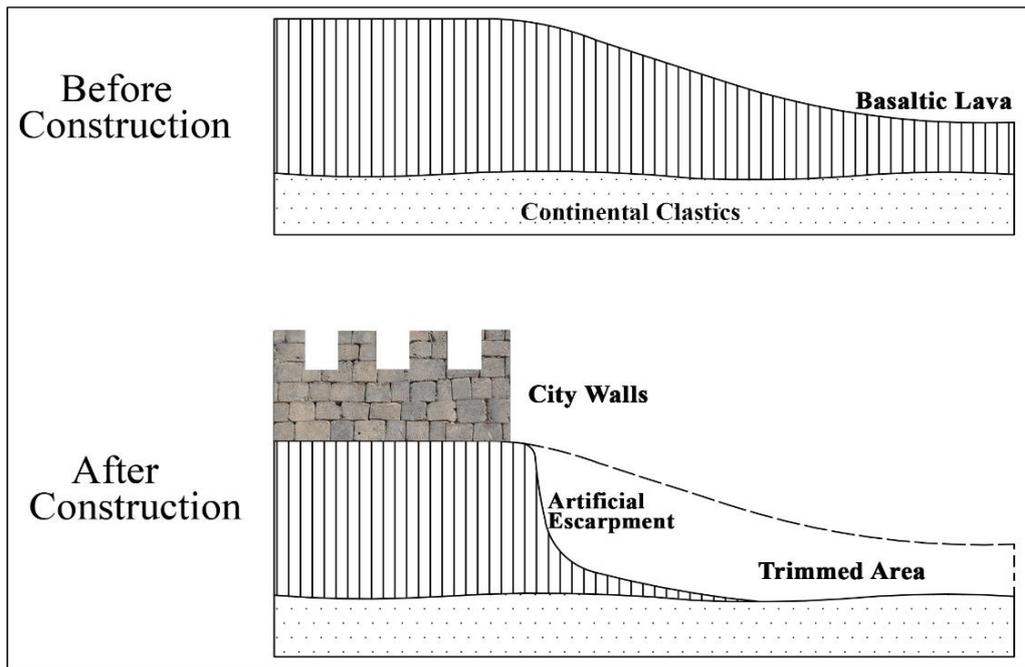
Figure 1.13 The estimated extraction of basalt (Modified from Toprak, 2012)

As Figure 1.13 illustrates, removing basalt blocks from the face of the natural cliffs not only reduced the cost of transportation and the duration of the construction, but also enhanced the defensive function of the walls by creating artificially steepened slopes (Toprak, 2012).

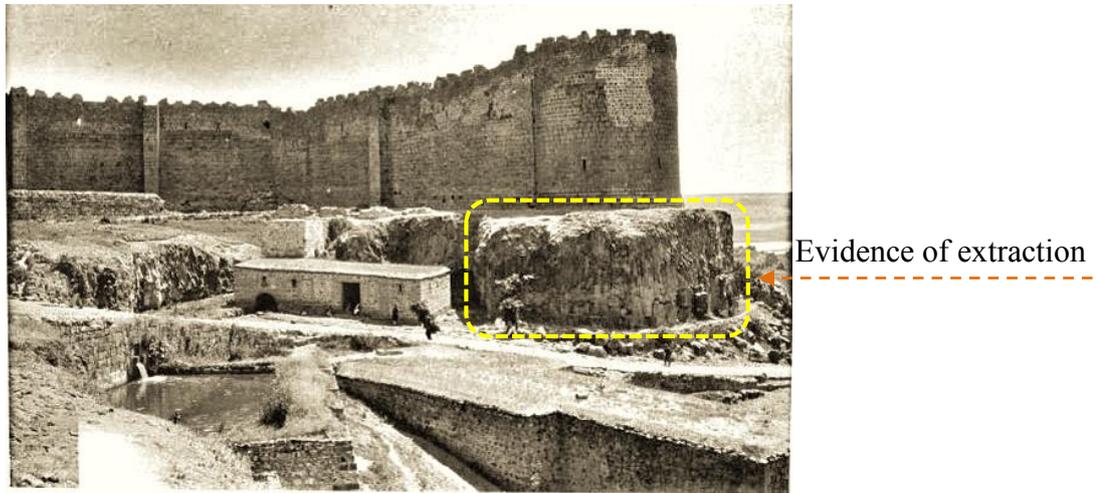
Figure 1.14 Traces of steepening extraction by the Keçi Tower (NUGBA, 2014)

Although the evidence of hillside extraction still can be traced to some extent, most of the ancient quarries have been destroyed or covered with debris. A 1909 photograph, credited to an English traveler, Gertrude Bell, shows visible evidences of the extraction (Bell, 1924; NUGBA, 2014). In it, traces of some 10 m of extraction on the south section of the DCW can be seen (Figure 1.14).

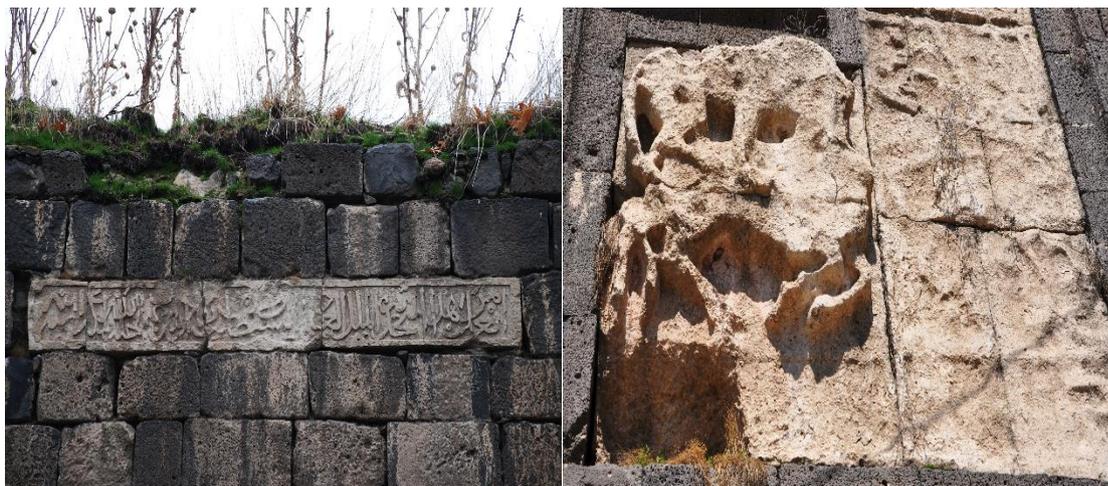
Figure 1.16 Limestone applications in the form of inscription and relief

Limestone was also used in the DCW, particularly, in some of the inscriptions and decorative elements (Figure 1.16). Limestone was not used as a principal construction material for the different historical structures in the study area. It was mostly used for decorative purposes; especially on the façades of some structures to produce an aesthetic contrast with the basalt (Figure 1.17a). Limestone, however, was not available on site. It is assumed that the limestone used in the DCW and other structures within them probably derived from quarries at some distance both to the north and south of the city.

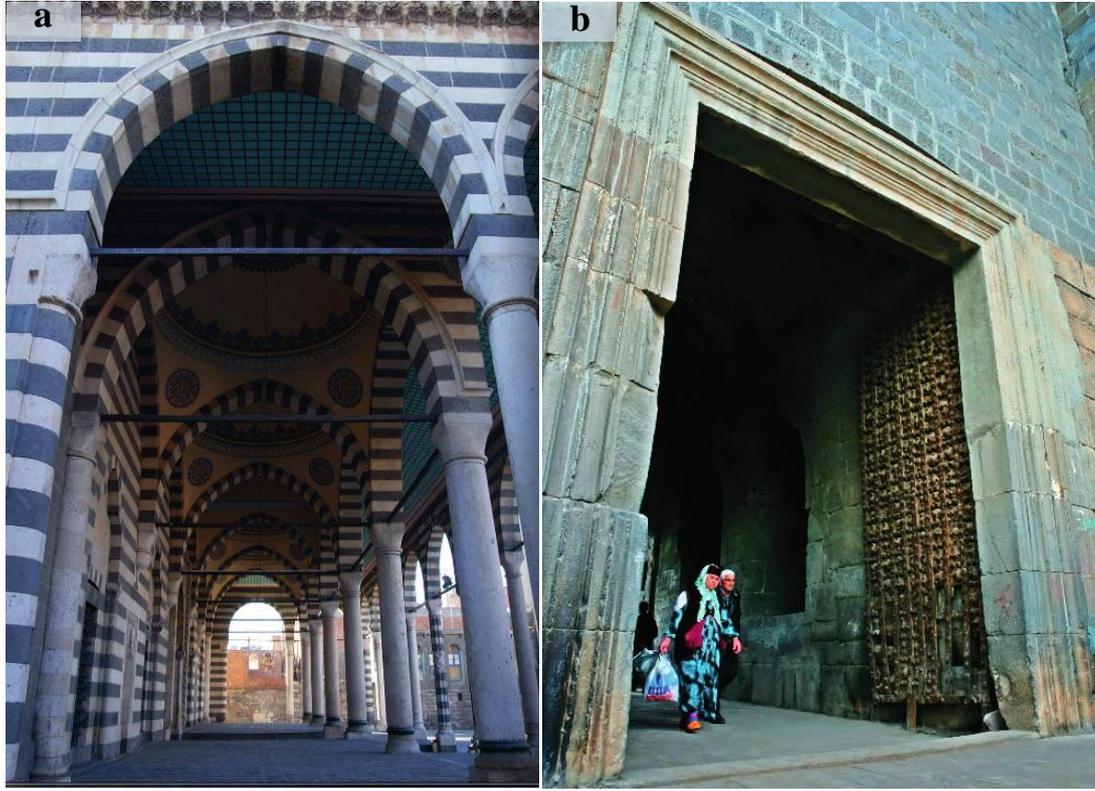
Figure 1.17 Limestone and metal applications (a) Alternation of limestone and basalt at Behram Pasha Mosque; (b) A metal door at Mardin Gate (Governorship of Diyarbakır, 2016)

Finally, metal was also employed in the City Walls, only used in the doors of some principal gates and as clamps to hold stone blocks (Halifeoğlu, 2012). Particularly, the doors of the Mardin and Urfa Gate were cast in metal (Figure 1.17b).

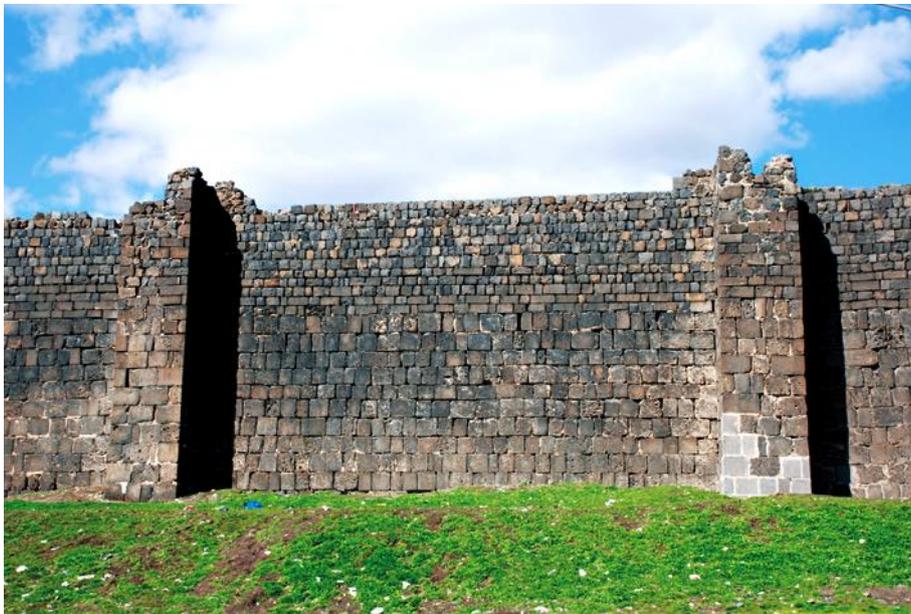
Figure 1.24 Butresses at the south section of the DCW

The projecting towers were shaped in different forms. The citadel's 18 towers are circular, triangular, square or polygonal in form. The 82 towers on the enceinte are mostly circular, polygonal or square. The towers have 2, 3 or 4 stories with staircases and domes or vaults (Güçhan et al., 2005; Dalkılıç and Nabikoğlu, 2012; Halifeoğlu, 2012; Gabriel, 2014). Of the towers on the DCW, the Melikşah, Ulu Beden, Yedi Kardeş, Nur and Keçi Towers are the most significant ones regarding their decoration, inscription, plan, size or construction techniques (Figure 1.23). These towers have attracted the attention of various researchers, including historians, archaeologists, architects, art historians and engineers. However, considering the scope of this dissertation, the towers' remarkable features will not be discussed here. In addition to the towers, more than 120 buttresses (Tuncer, 2012b) were constructed against the exterior walls to provide them with additional support (Figure 1.24).

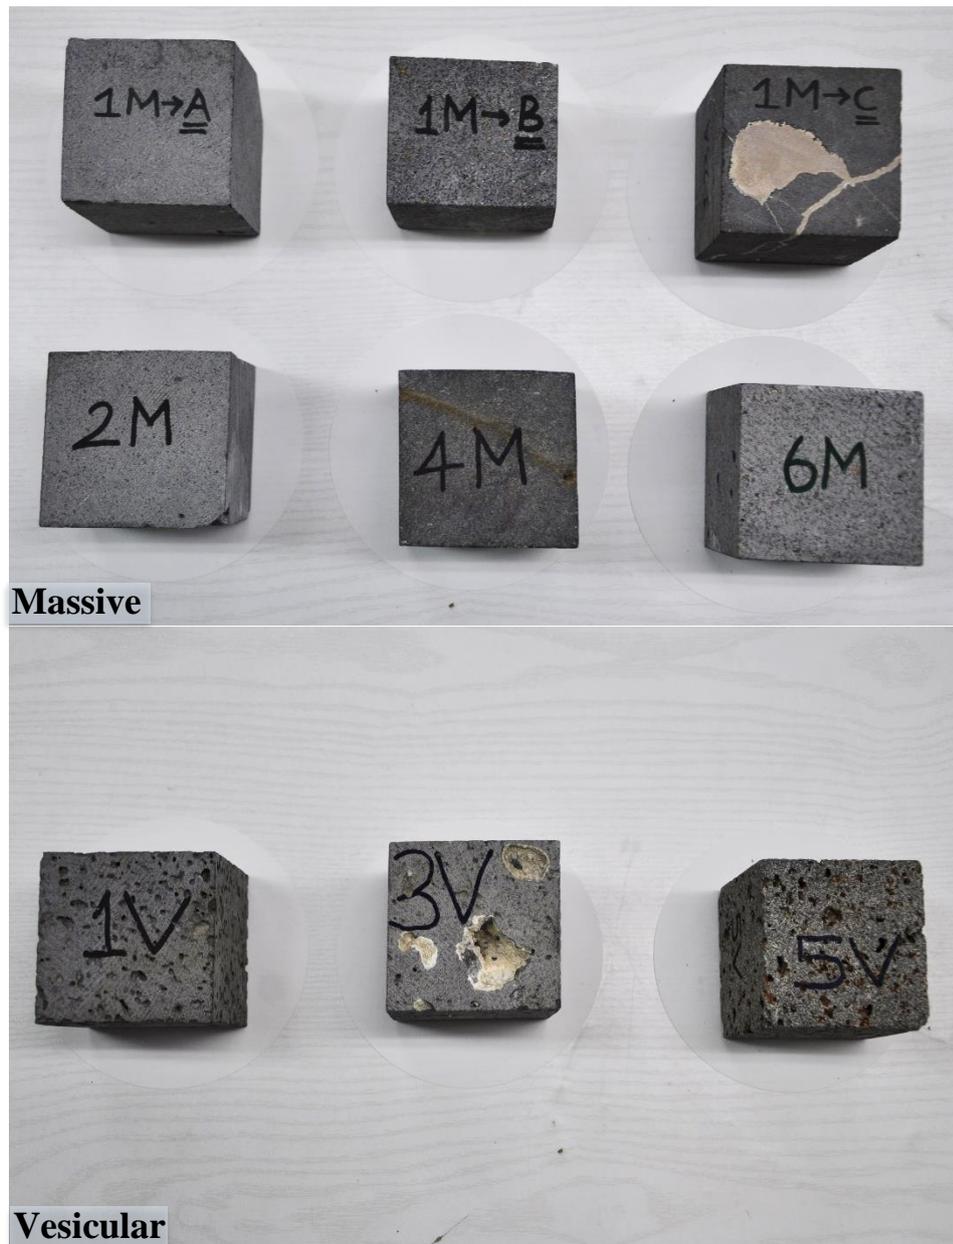
Figure 1.28 The massive and vesicular basalt samples used in the experimental studies

For the accelerated weathering and proposed experiments, several field surveys were performed in the study area to determine sampling spots. Based on the types of the basalts, six representative locations were chosen for sampling. They are listed in Table 1.4, and shown in Figure 1.27. Fresh basalt blocks were taken from the outcrops along the City Walls and from quarries in the vicinity of the site. Oriented samples were extracted from the surface, using jackhammers. The oriented block samples were collected and cut into slabs in accordance with the ASTM D5121–15 standard and ISRM suggestion (ISRM, 1981; ASTM, 2017a). A description of each sample site and the blocks were recorded, including information pertaining to the location, alignment, texture, color, secondary minerals and other observable features. For the sample preparation stage, the oriented (normal to the flow direction) block samples were cut with 7 centimeters sides and 30 centimeters height parallel sets. Those parallel sets were then cut into 7 centimeters (and some into 6 centimeters) cubic samples for the laboratory studies (Figure 1.28). A total of 390 massive and vesicular fresh cubic basalt samples were prepared, packed, and then transferred from Diyarbakır to the Engineering Geology Laboratory of Geological Engineering Department of METU for the laboratory studies. Here, the cubic samples were sorted as massive and vesicular, and were defined by their provenances and textures (e.g., 1M-10: the first character is the sampling location; the second is the texture of the sample, whether massive or vesicular, and the number is the specific sample number for that sample location).

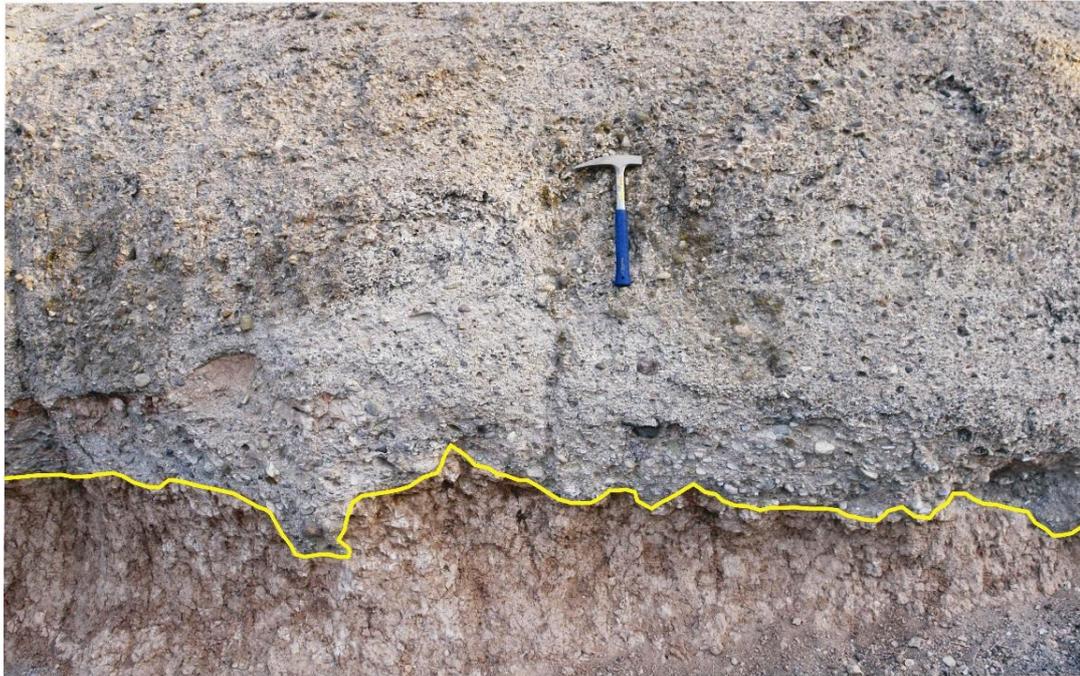
Figure 2.4 Contact relation of the Yeniköy formation and the Gölpınar formation at the north of the study area (the contact is indicated by yellow line)

The bottom contact of the formation is not observed in the study area; however, the top contact is clearly observed in the north part of the study area near the village of Şilbe (Yolaltı) (Dursun, 2008). Here, the formation is overlain unconformably by Gölpınar formation on an erosional surface (Figure 2.4). However, in the study area, the formation is overlaid by the Karacadağ volcanics (Figure 2.5).

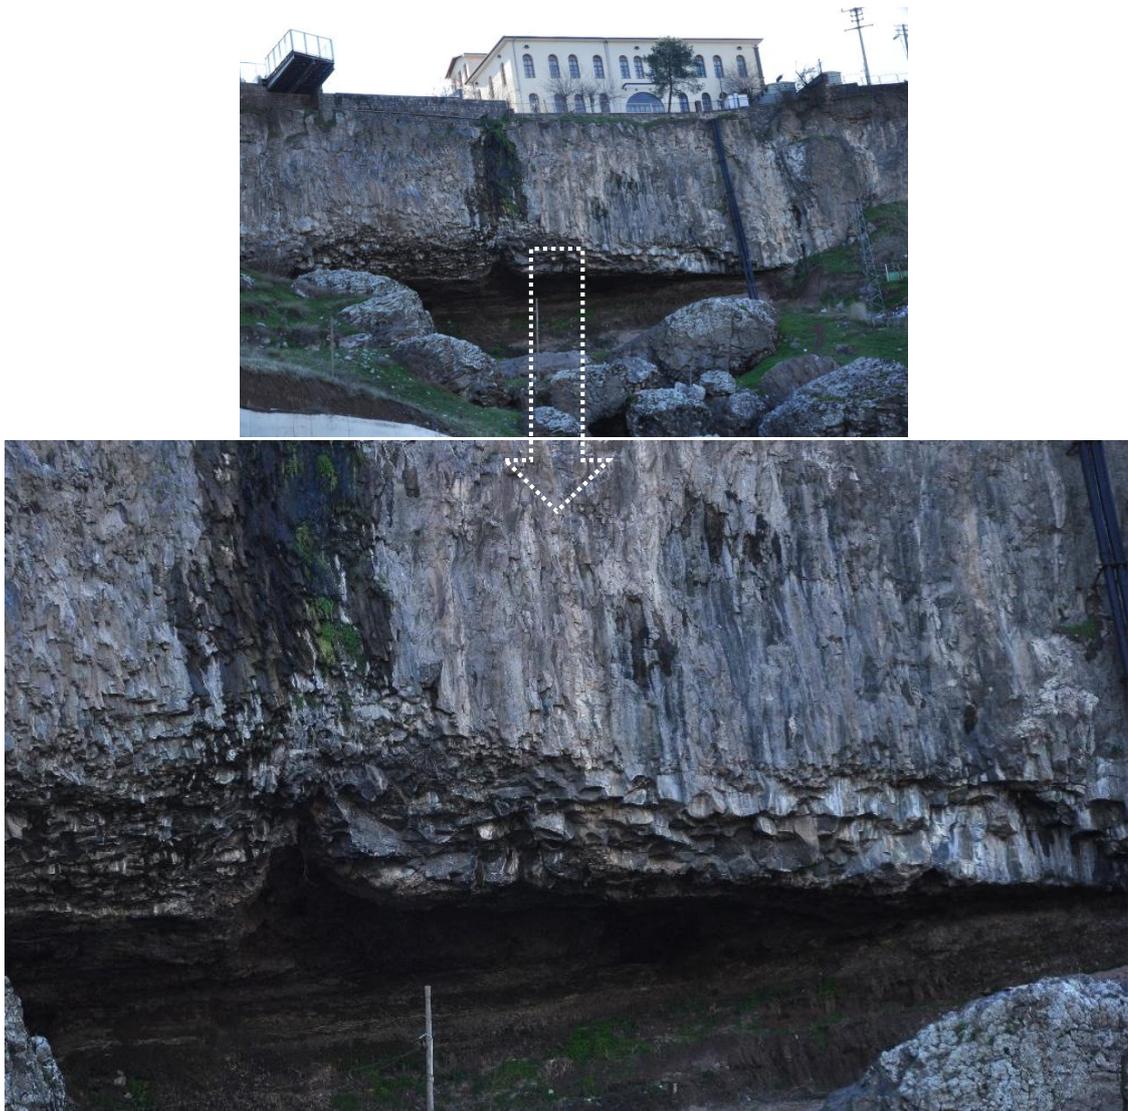
Figure 2.9 A cliff of columnar basalt at the northeastern section of the DCW

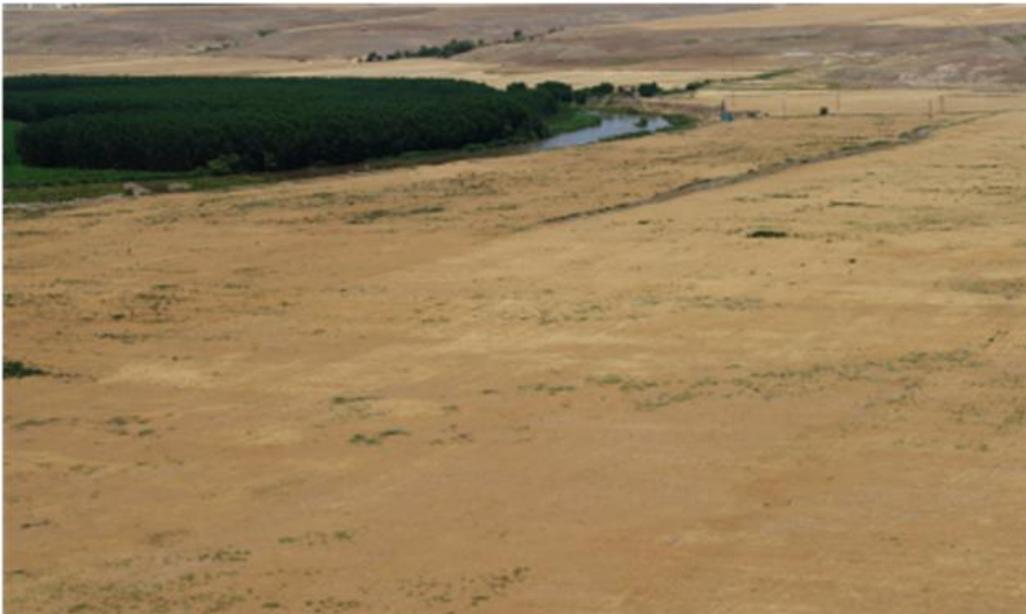
The alluvium deposited along the banks of the Tigris River is classified as the old alluvium (Figure 2.10). The unit consists of five terraces, and they were formed as a result of the deepening of the Tigris Valley. The thickness of the terrace deposits attains an elevation of more than 50 meters (Kuzucuoğlu and Karadoğan, 2015). This unit contains more sand and silt sized materials than the recent alluvium.

Figure 2.10 A view of the old alluvium from the Kırklardağı Mt.

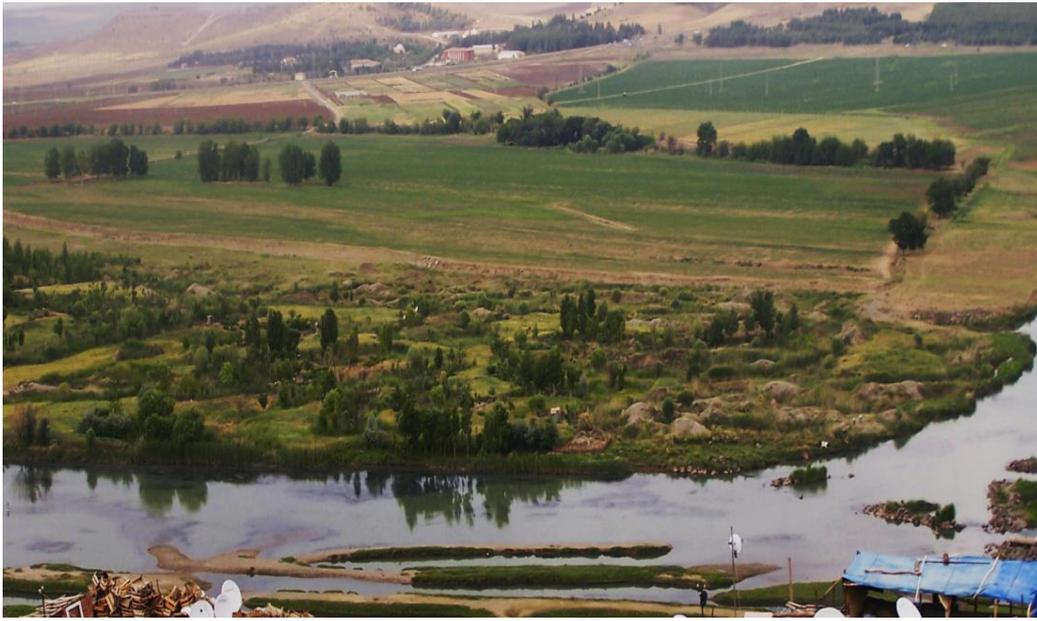
The recent alluvium is also deposited in the study area. The recent alluvium was formed along the Tigris River and is composed of unconsolidated gravel, sand, silt and clay. The recent alluvium can be seen in the east and south of the DCW (Figure 2.11). The unit is mostly derived from the older rocks exposing in the north of the region (Bağırsakçı et al., 1995).

Figure 2.11 A general view of the recent alluvium depositions at the Tigris River

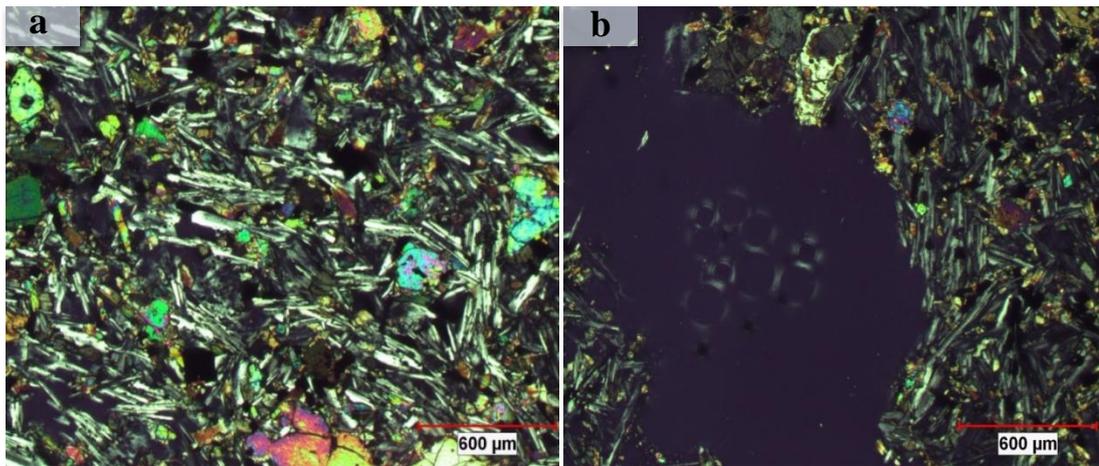
Figure 3.1 Photomicrograph illustrating overall mineralogical and textural features of the fresh (a) massive and (b) vesicular basalt samples

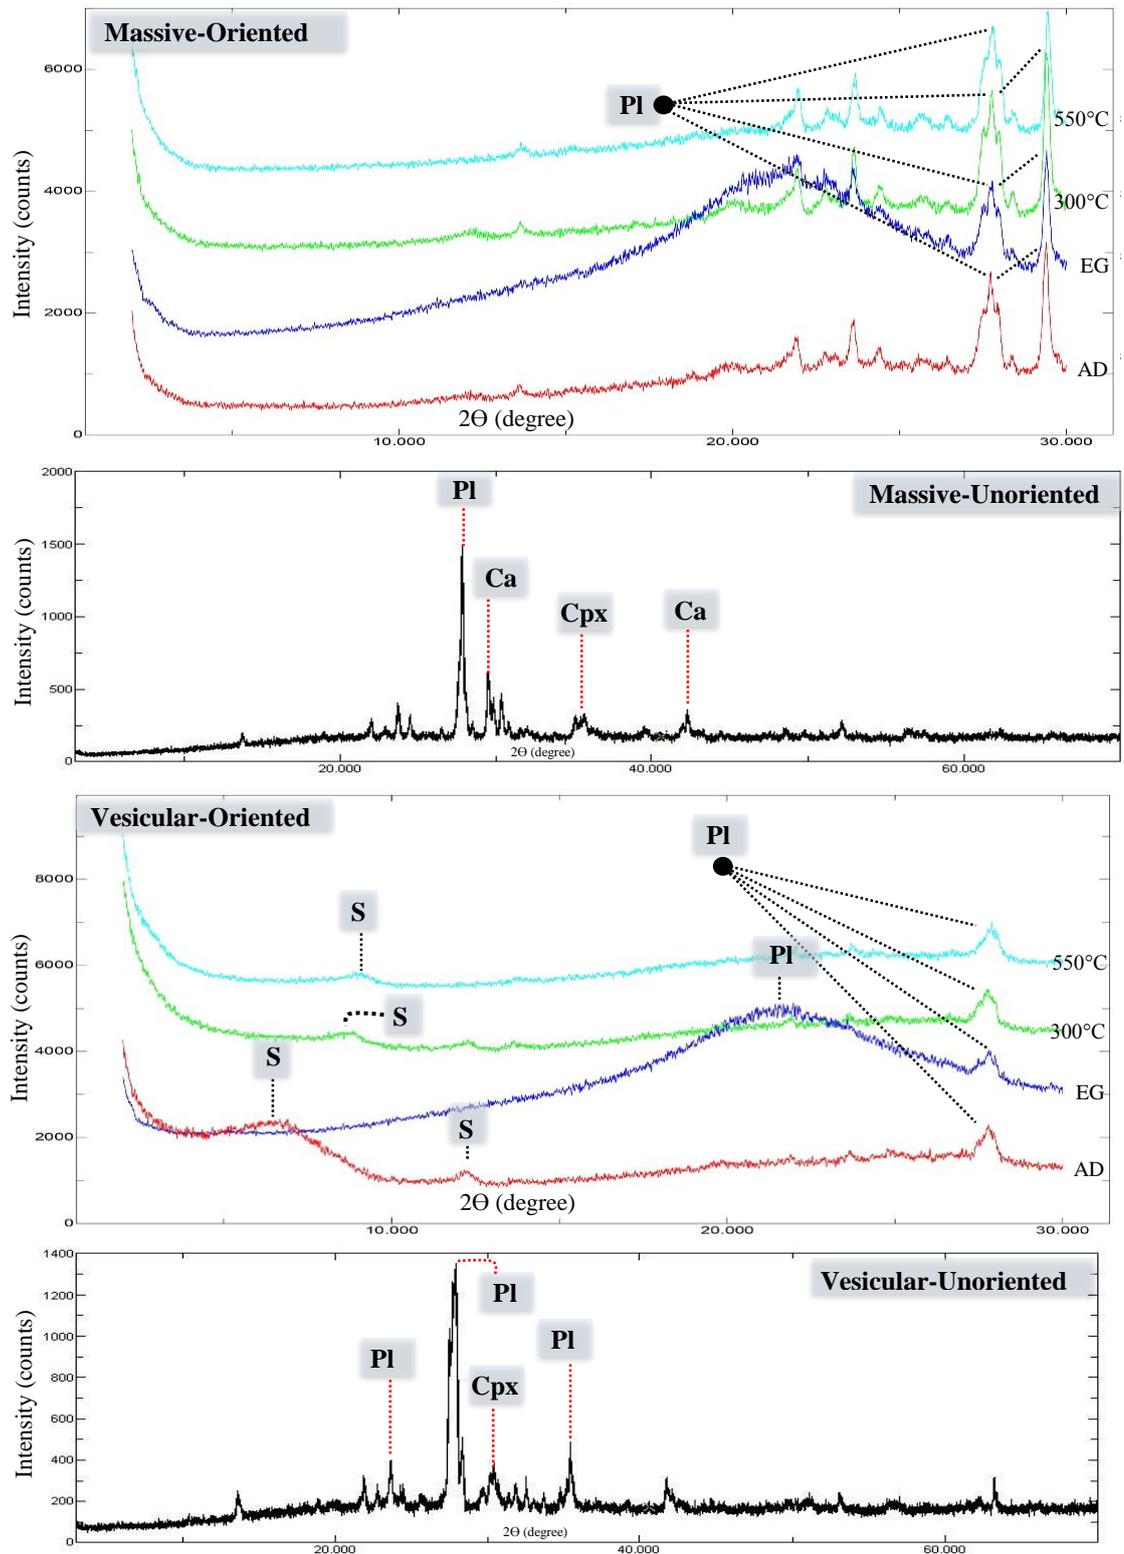
Figure 3.4 X-ray diffraction patterns of the massive and vesicular basalt samples (Pl: Plagioclase, Ca: Calcite; Cpx: Clinopyroxene; S: Smectite)

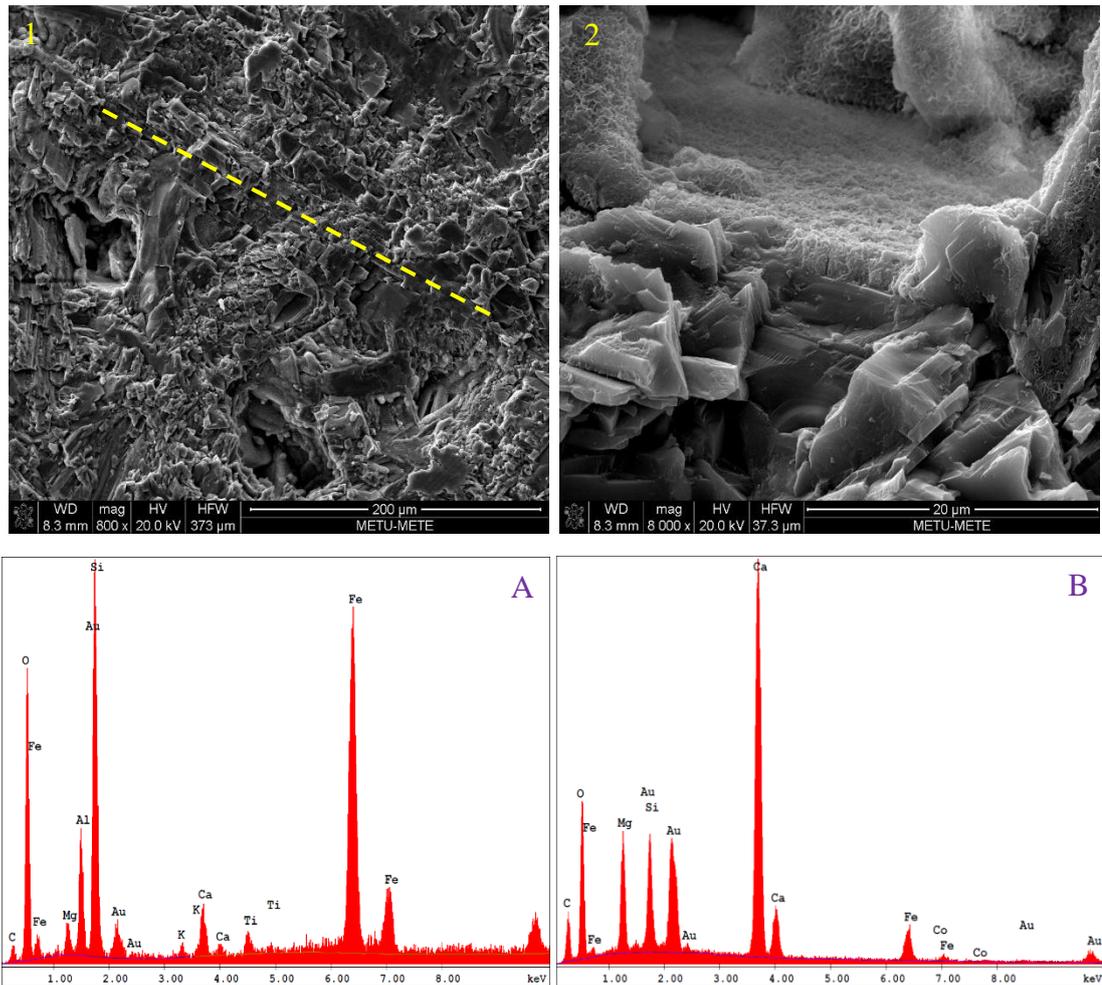
Figure 3.5 SEM micrographs and EDX analyses of a fresh massive basalt (1: microfracture pattern; 2: calcite deposition; A: EDX analyses of the overall surface; B: EDX analyses of the calcite deposition section) (microfracture pattern is indicated by yellowish dashed line)

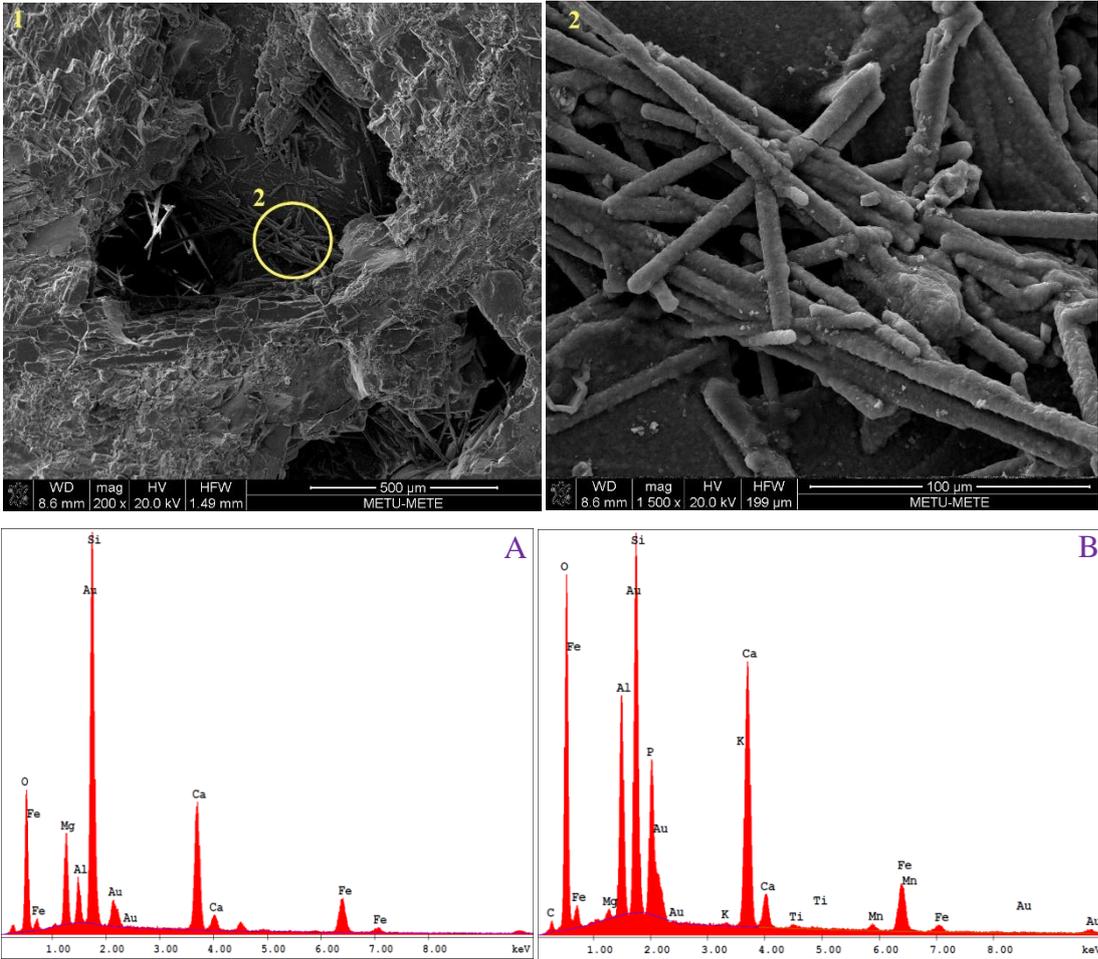
Figure 3.6 SEM micrographs and EDX analyses of a fresh vesicular basalt (1: overall morphology; 2: needle-like textures; A: EDX analyses of the overall surface; B: EDX analyses of the needle-like structure)

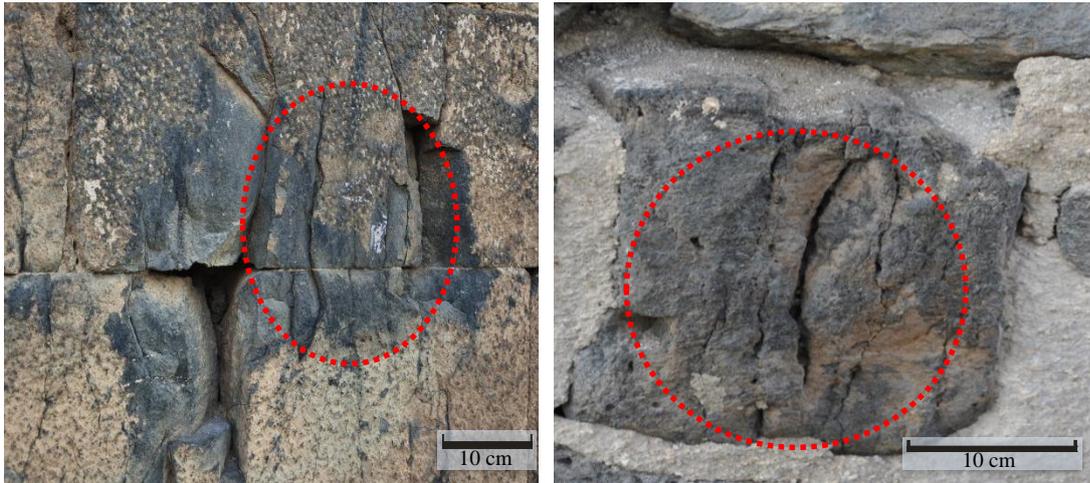
Figure 5.1 Vertical cracks and fractures on sections of the DCW (cracks and fractures are indicated by the dashed circles)

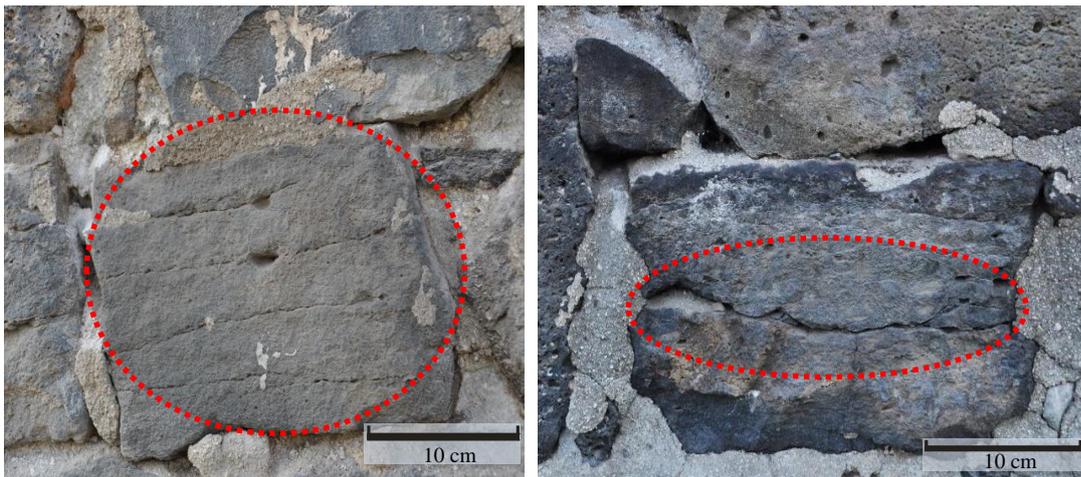
Figure 5.2 Horizontal cracks and fractures on sections of the DCW (cracks and fractures are indicated by the dashed circles)

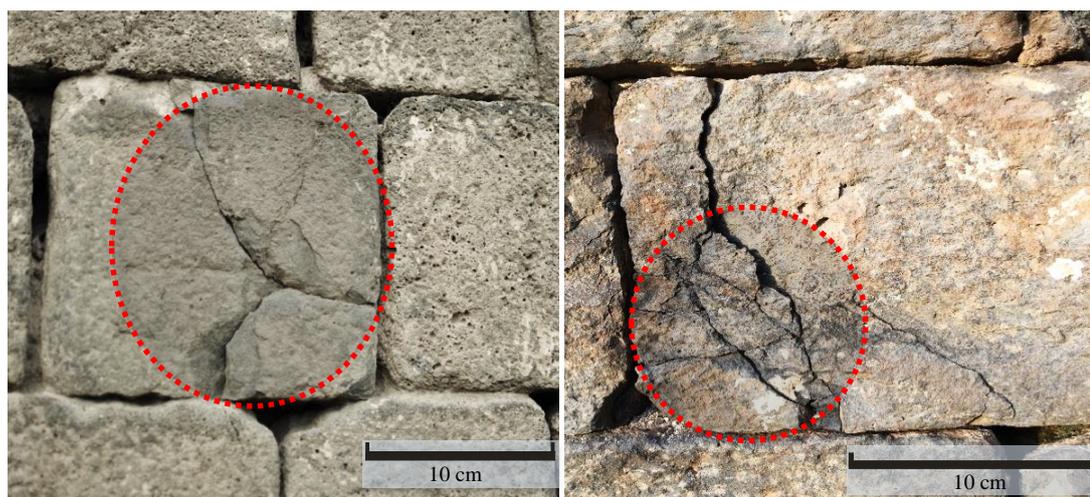
Figure 5.3 Crack networks on basalt blocks of the DCW (crack networks are indicated by dashed circles)

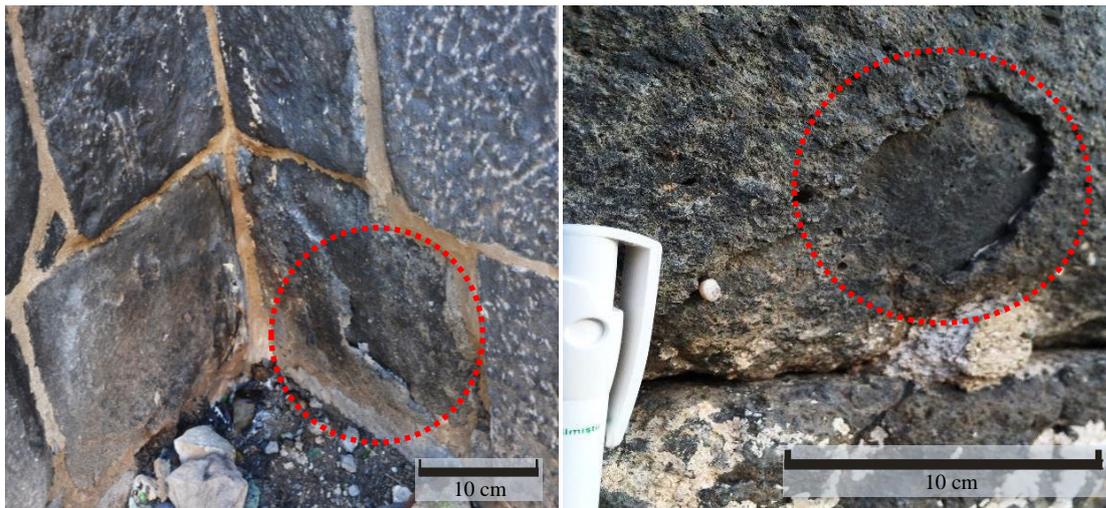
Figure 5.4 Blistering patterns at the lower parts of the walls (blistering patterns are indicated by dashed circles)

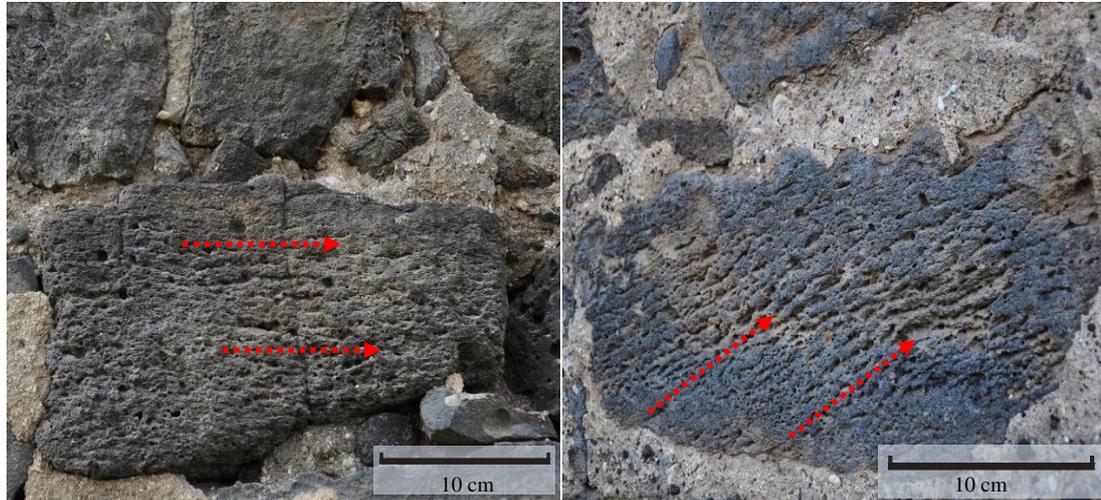
Figure 5.5 Delamination of basalt along the flow directions (flow directions are indicated by dashed arrows)

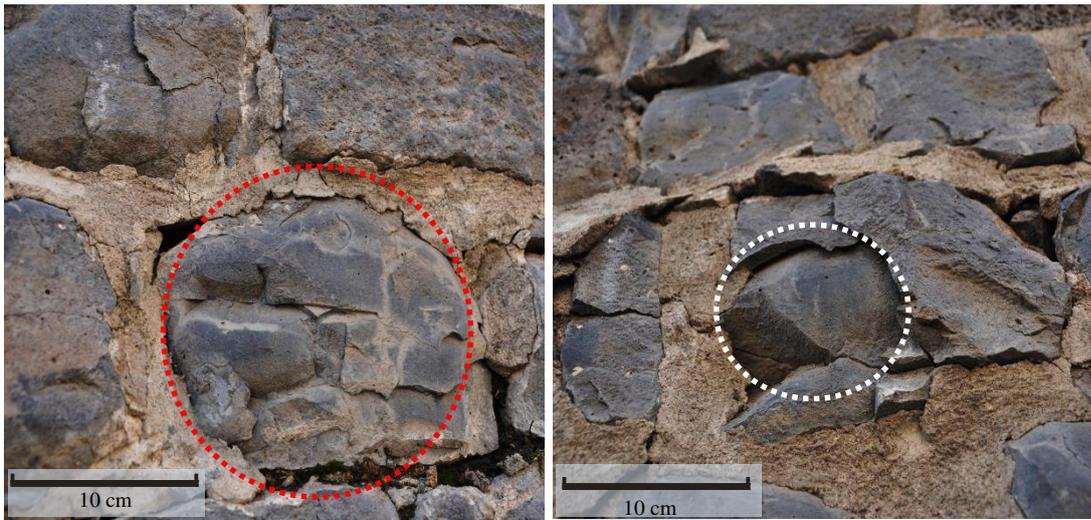
Figure 5.6 Crumbling and spheroidal weathering forms on the DCW (crumbling is indicated by reddish dashed circle, and spheroidal weathering is indicated by whitish dashed circle)

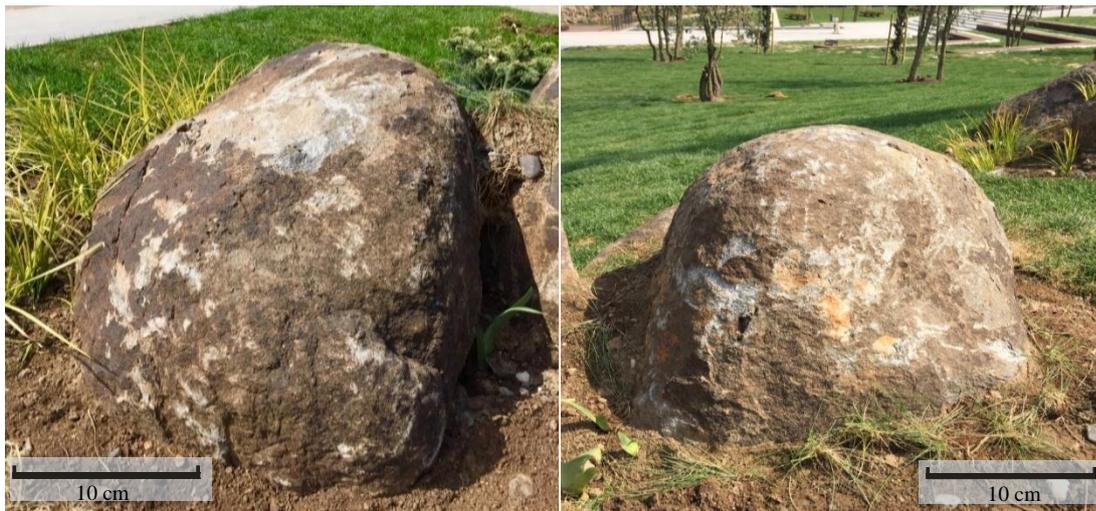
Ollier (1971) lists the causes of spheroidal weathering: unloading, temperature change, frost, salt, absorption of water, micro cracks and the chemical decay of minerals. This type of weathering occurs not only on the dressed basalt used in the DCW, it is also common on basalt blocks spread over road alignments and on single stone blocks (Figure 5.7).

Figure 5.7 Spheroidal weathering on basalt blocks (north section of the study area)

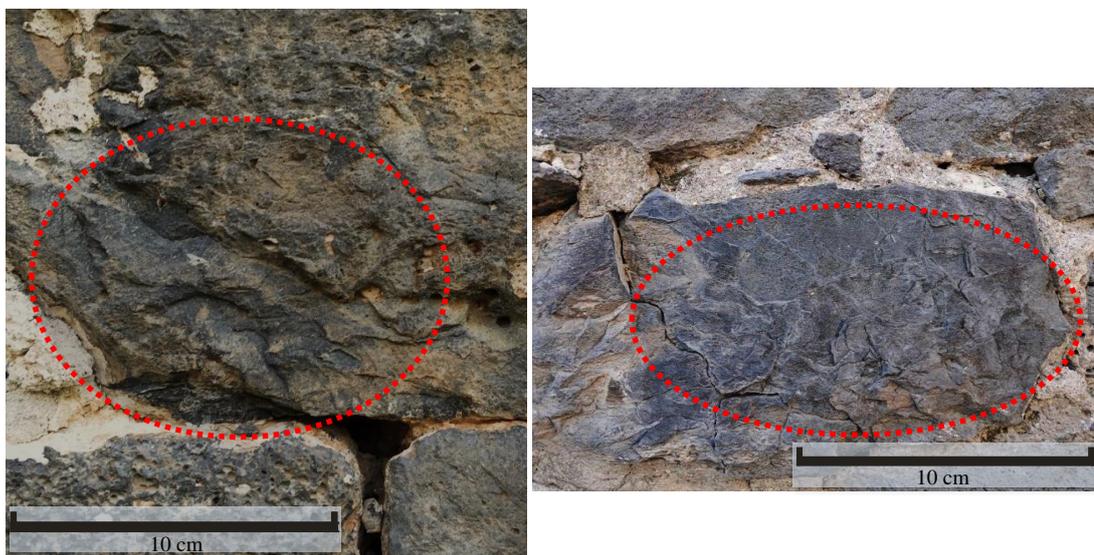
Figure 5.8 Splintering on the DCW (splintering is indicated by dashed circles)

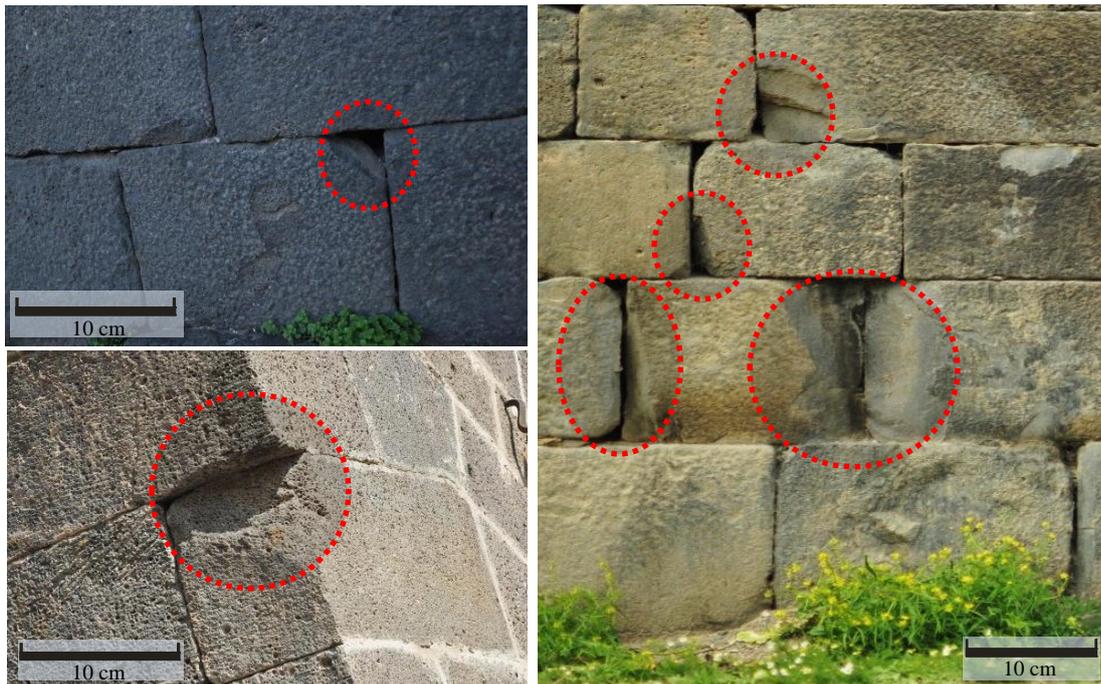
Figure 5.9 Chipping on sections of the DCW (chipping is indicated by dashed circles)

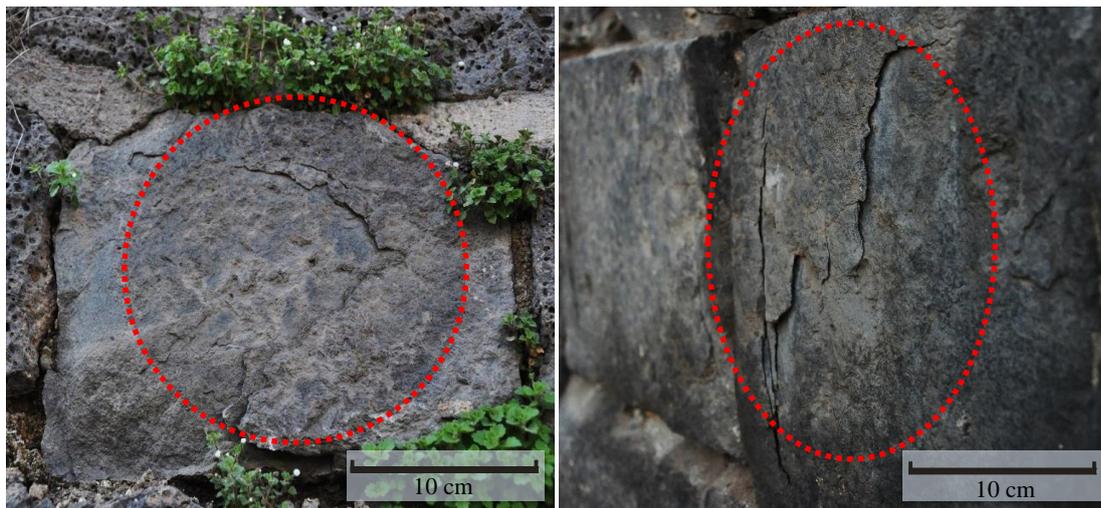
Figure 5.10 Flaking on sections of the DCW (flaking is indicated by dashed circles)
