INVESTIGATION ON DETERIORATION MECHANISMS OF THE BASALTS
USED IN THE DİYARBAKIR CITY WALLS

A THESIS SUBMITTED TO
THE GRADUATE SCHOOL OF NATURAL AND APPLIED SCIENCES
OF
MIDDLE EAST TECHNICAL UNIVERSITY

IN PARTIAL FULFILLMENT OF THE REQUIREMENTS
FOR
THE DEGREE OF DOCTOR OF PHILOSOPHY
IN
GEOLOGICAL ENGINEERING

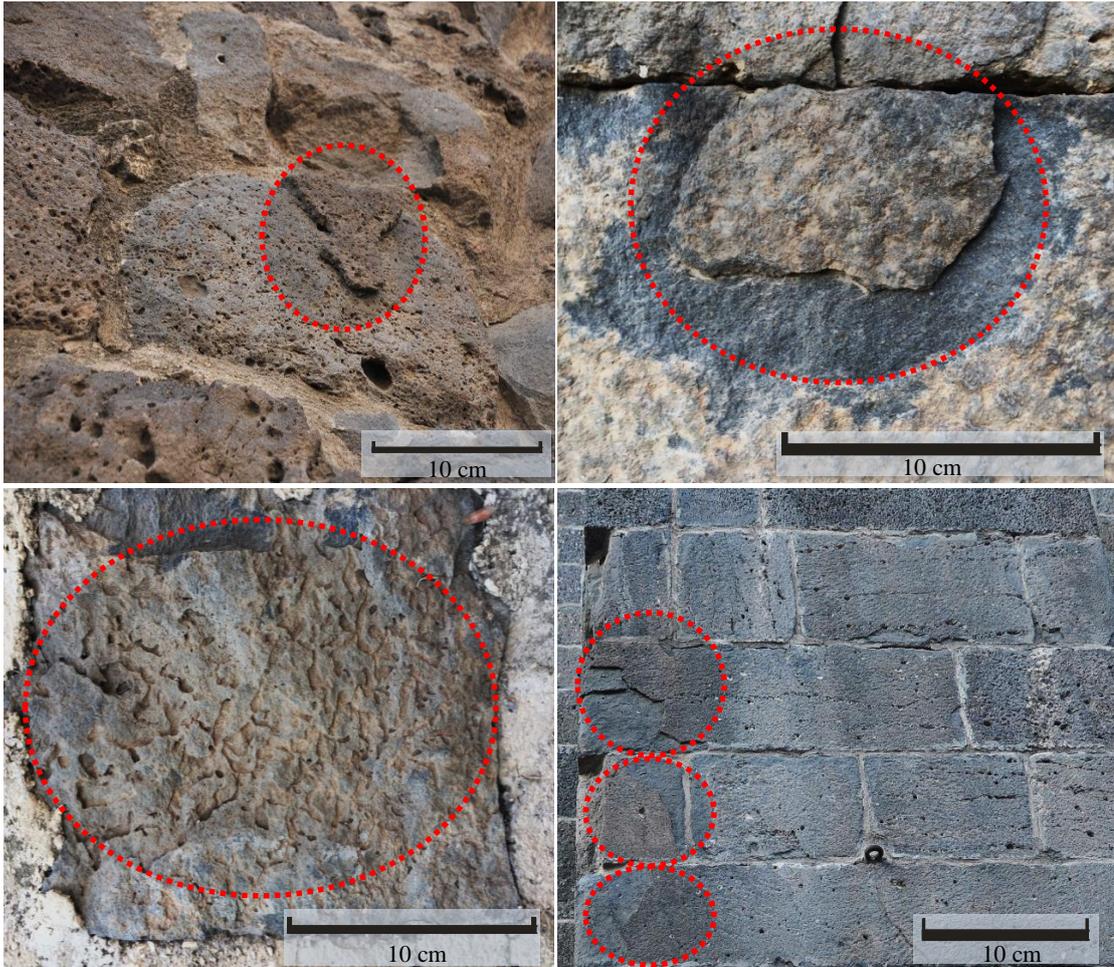
Figure 5.11 Scaling on sections of the DCW (scaling is indicated by dashed circles)

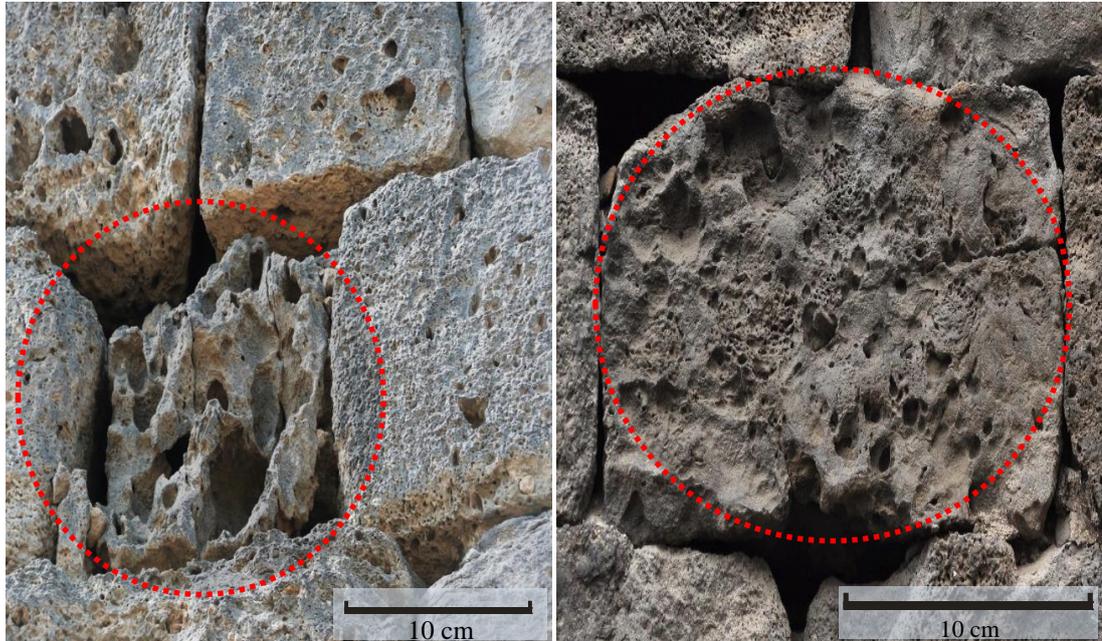
Figure 5.12 Alveolization on sections of the DCW (alveolization is indicated by dashed circles)

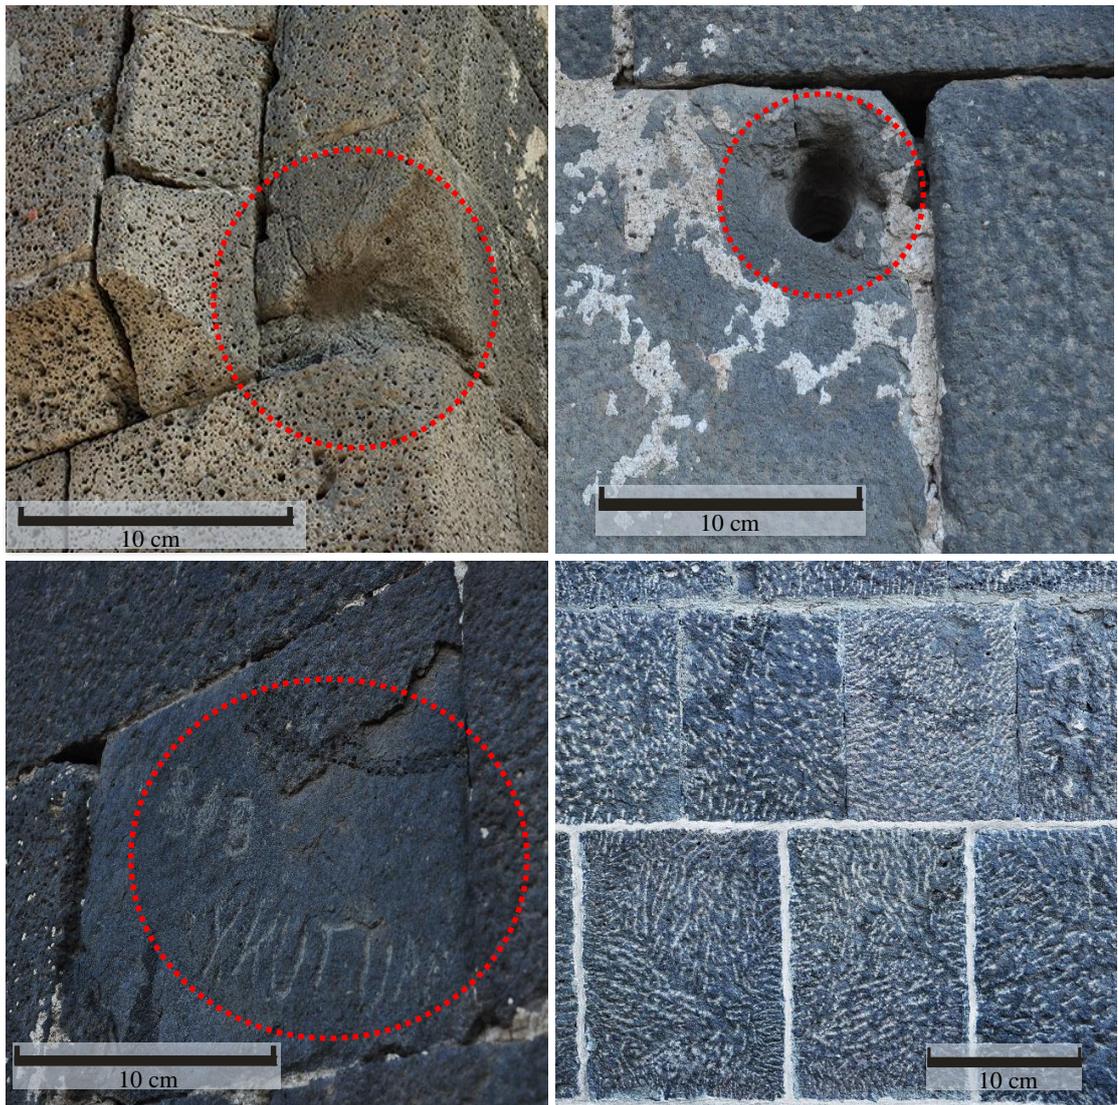
Figure 5.15 Mechanical damages on sections of the DCW (clockwise from top left: impact damage; cavity; scratch/engrave; keying) (damages are indicated by dashed circles)

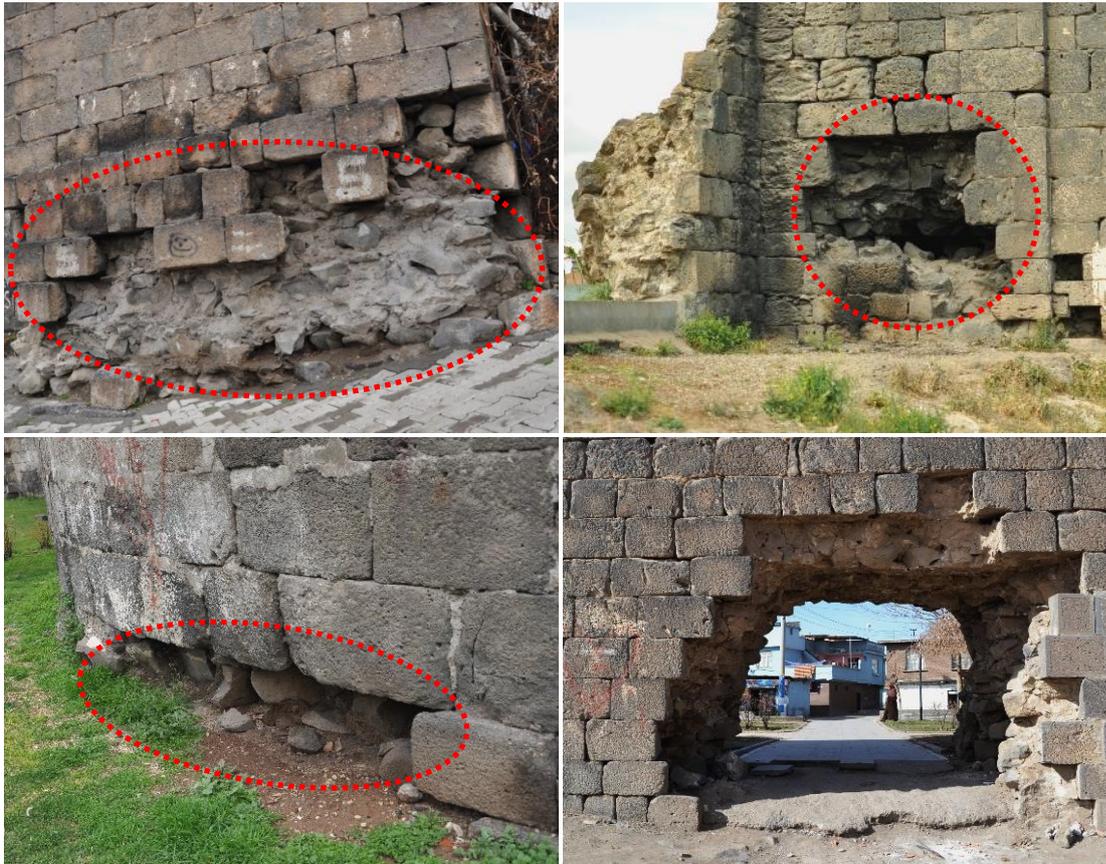
Figure 5.16. Dismantled stone blocks and a breach in the DCW (dismantled sections are indicated by dashed circles)

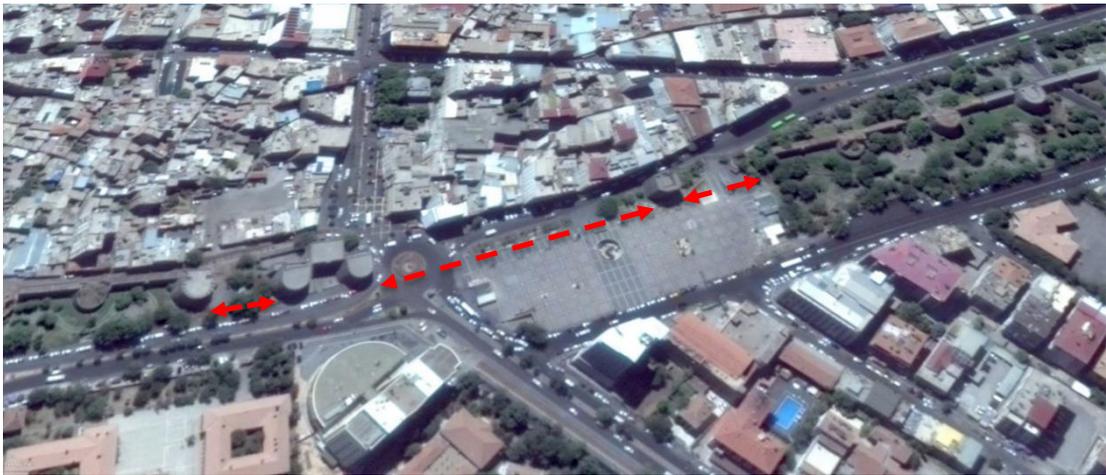
Missing parts are another forms of damage to the DCW. The missing parts are not small-scale gaps or holes, they are also in large-scale forms such as demolishing entire wall sections and towers. Currently, a total of *ca.* 650 meters of the DCW are missing. Although some damage occurred due to natural events, most of them are due to human interventions. For instance, different sections of the walls have been breached, and large stone blocks, especially at the base of the walls, have been dismantled (Figures 5.16 and 5.17). Loss of stone material is observed on the iconic reliefs as well. As Figure 5.18 shows, the missing parts of the lion reliefs on the Ulu Beden Tower are mostly the loss of heads, legs or tails.

Figure 5.17 Demolished segments of the north section of the DCW (demolished parts are indicated by reddish dashed lines)

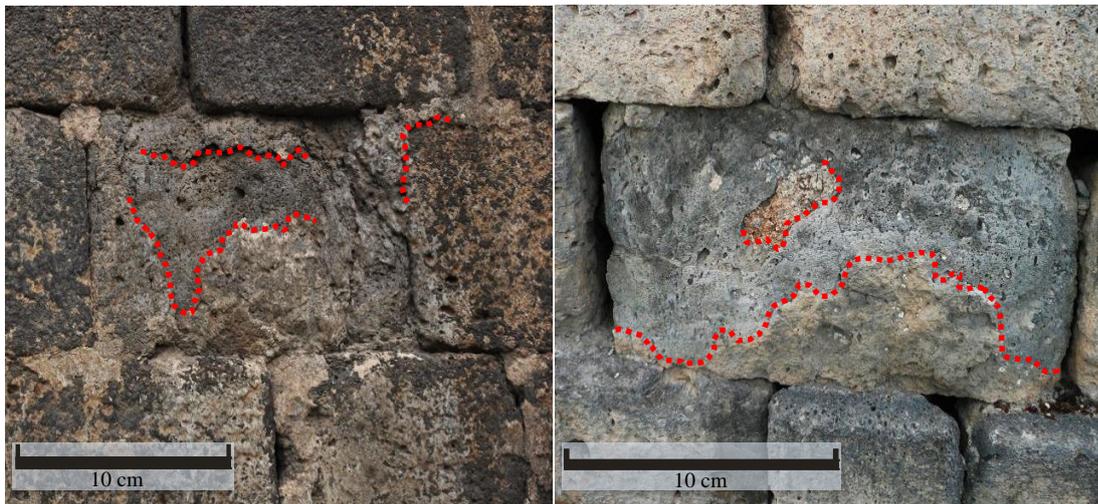
Figure 5.19 Crust formations on the DCW (the crust layers are roughly indicated by reddish dashed lines)

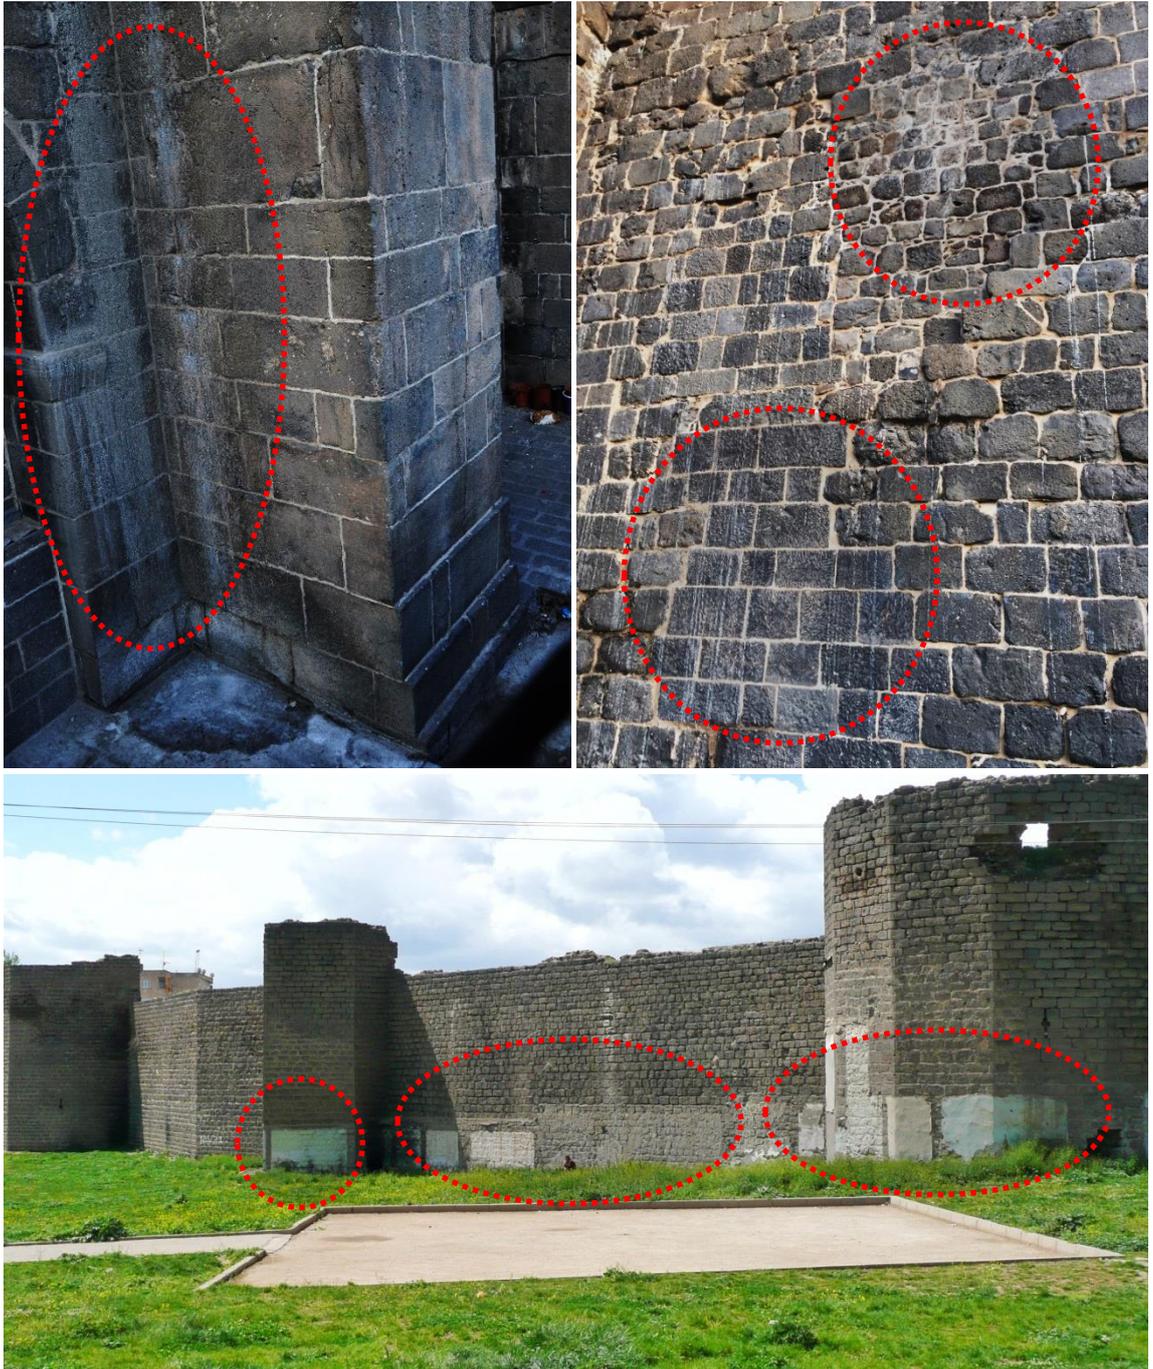
Deposit is another common weathering form found on various sections of the DCW. Deposits refer to the accumulation of exogenic material on the stone surface. Deposits vary in thickness, color, morphology and origin. Deposits can be splashes of mortar or paint, bird droppings, black soot or dust. The remains of conservation materials or housing are also categorized as deposits through the present study (Figures 5.20 and 5.22).

Figure 5.20 Deposits on the sections of the DCW (deposits are indicated by dashed circles)

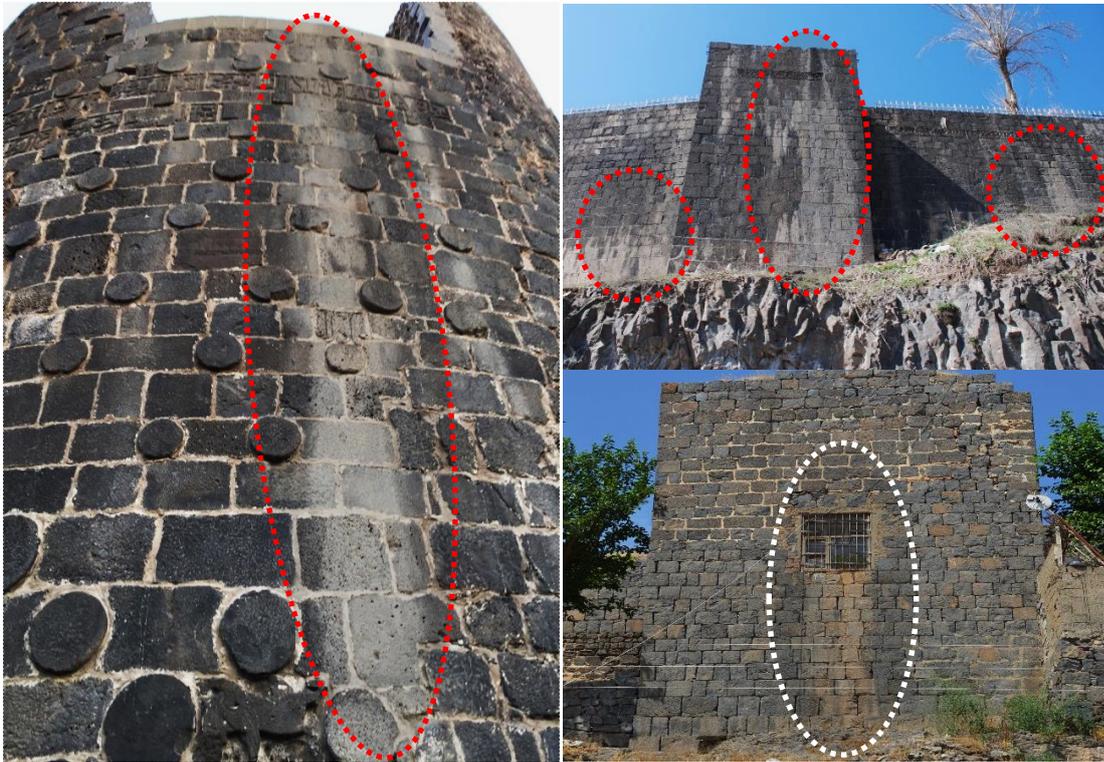
Figure 5.21 Bleaching and staining on sections of the DCW (bleaching is indicated by reddish dashed circles and staining is indicated by whitish dashed circle)

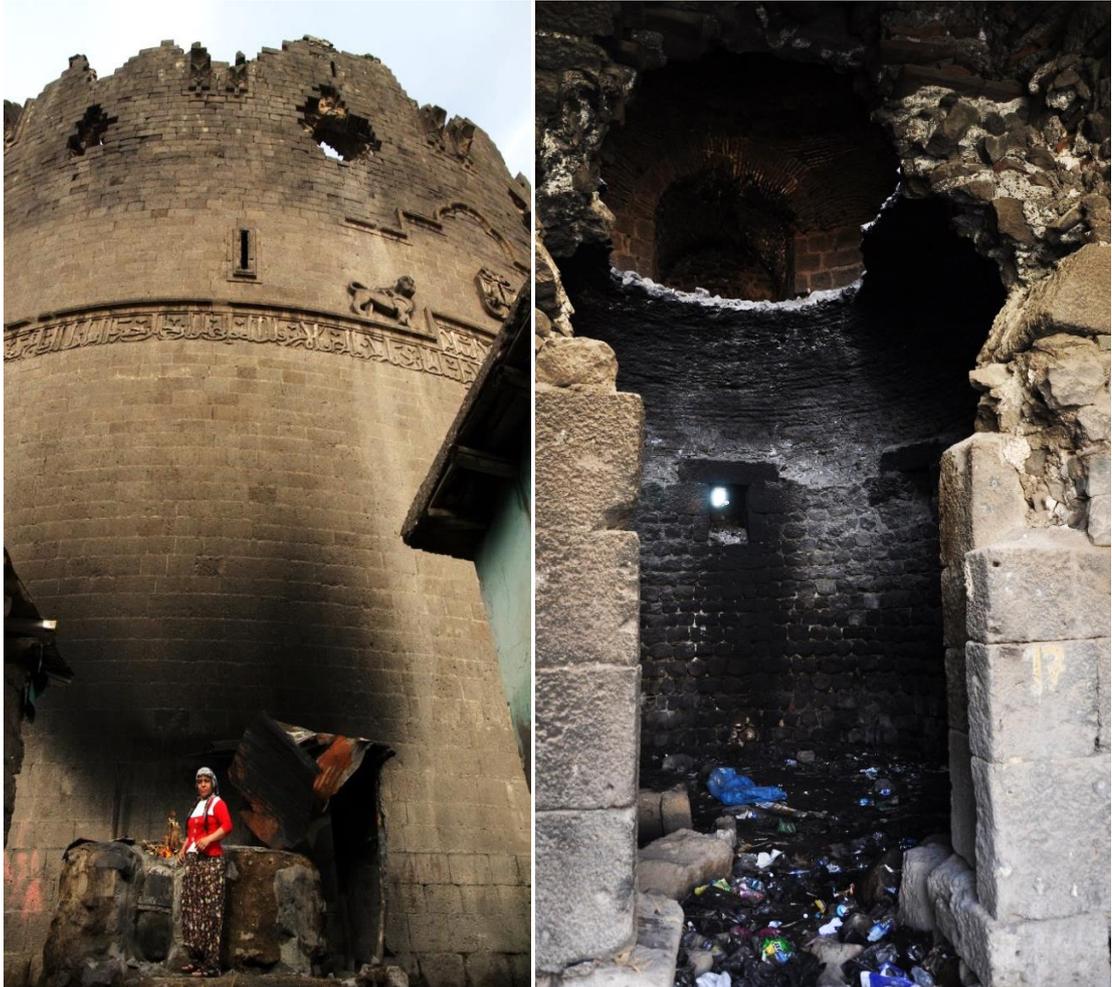
Some abandoned portions of the DCW, especially the inner sides of some towers, are used for shelter by the homeless. Here, the walls are discolored due to unconscious human-induced activities (Figure 5.22).

Firing activities may induce stress and differentiations in the surface temperature of the stone material. Hence, fires may modify the physical properties of stone, and finally, such damages may increase the susceptibility of stone to deterioration (Steiger et al., 2011).

Figure 5.22 Discoloration of the stone surface due to human-induced activities (left: A tandoor located just under the Yedi Kardeş Tower; right: Inside part of an abandoned tower) (left image credit: Aşılı, 2010)

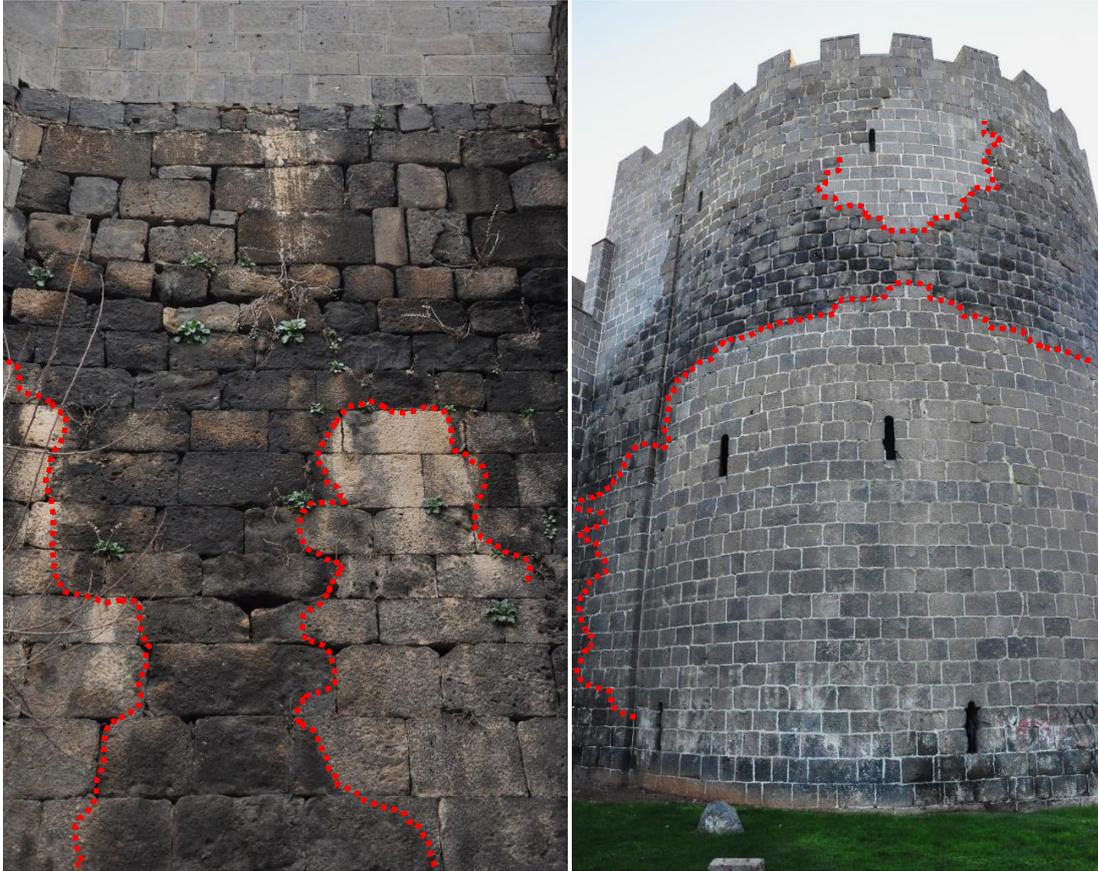
Figure 5.23 Moist areas on sections of the DCW (the moist area boundaries are roughly indicated by reddish dashed lines)

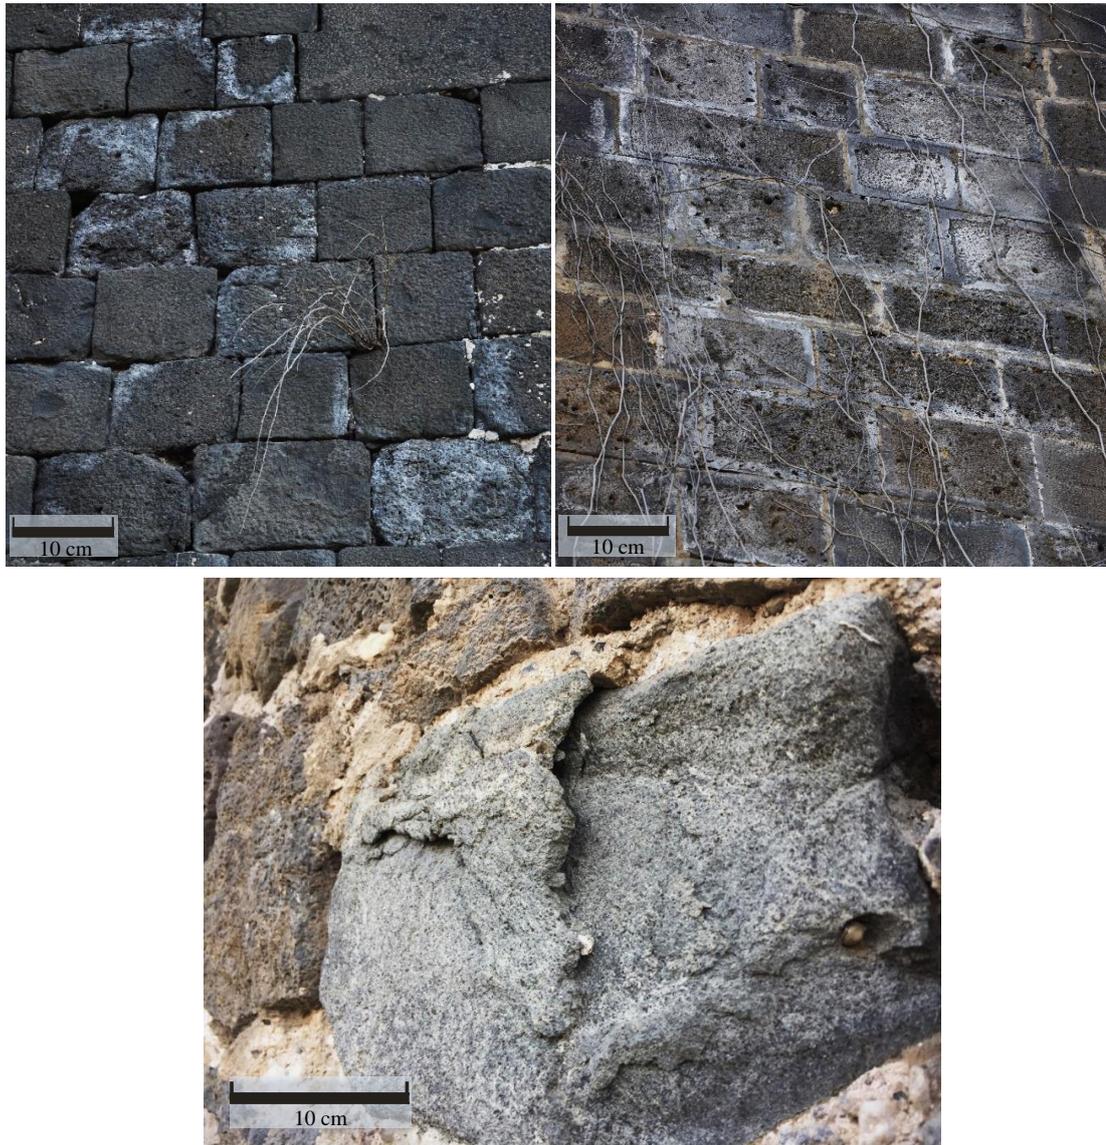
Figure 5.24 Efflorescence patterns on the DCW (the whitish patterns on the stone surface are considered as efflorescence)

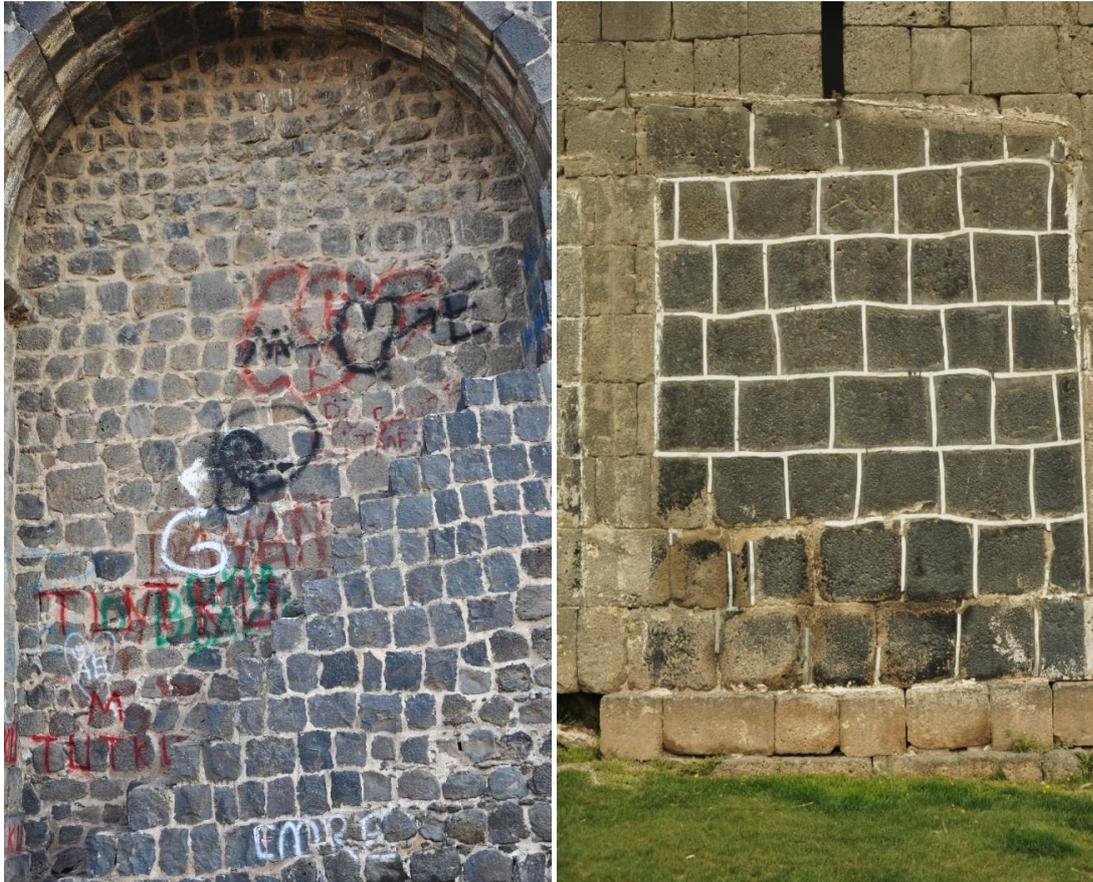
Graffiti is another form of discoloration and deposits found on many sections of the DCW (Figure 5.25). Graffiti can be writing, scratching, cutting or engraving. It can also be paint, ink or similar materials applied to the stone surface (ICOMOS-ISCS, 2008).

Figure 5.25 Paintings on the DCW

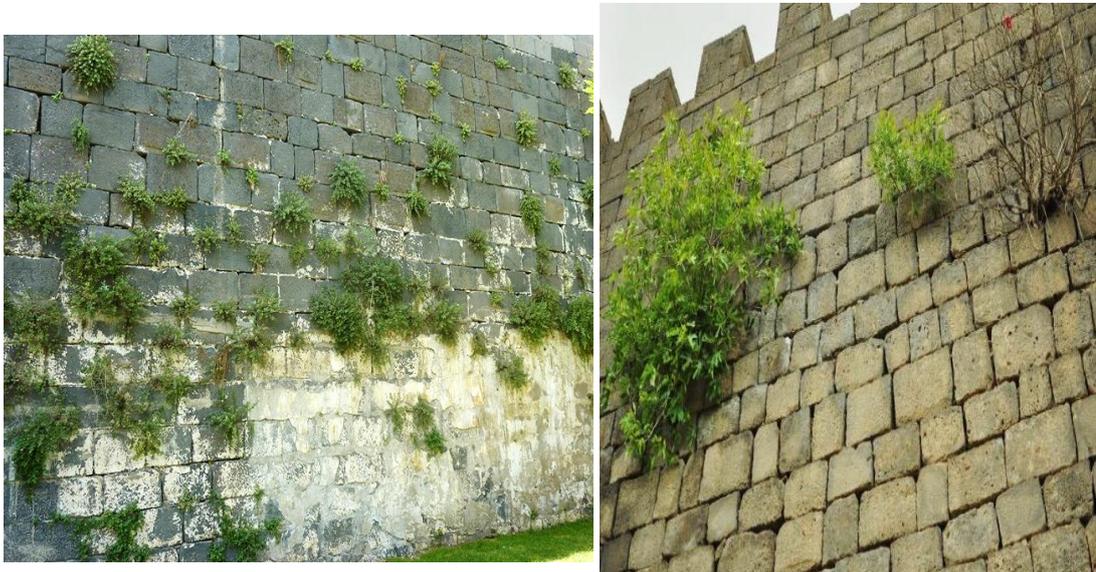
The biological colonization on the DCW is commonly in the form of plants (Figure 5.26) and lichens (Figure 5.27), but alga and moss development are also found on some specific sections of the DCW. The higher plants frequently grow through the open joints, cracks and the missing parts on the walls and towers.

Figure 5.26 Plants growing on sections of the DCW

The growth of higher plants is a deterioration problem that is frequently observed on sections of the DCW. Plants grow mostly in moist cracks, open joints and in the missing parts of the walls and towers. Their roots penetrate the walls, increase the amount of substrate and damage the material. Therefore, it is essential to seal or properly repair the open joints, cracks and missing parts to prevent further growth.

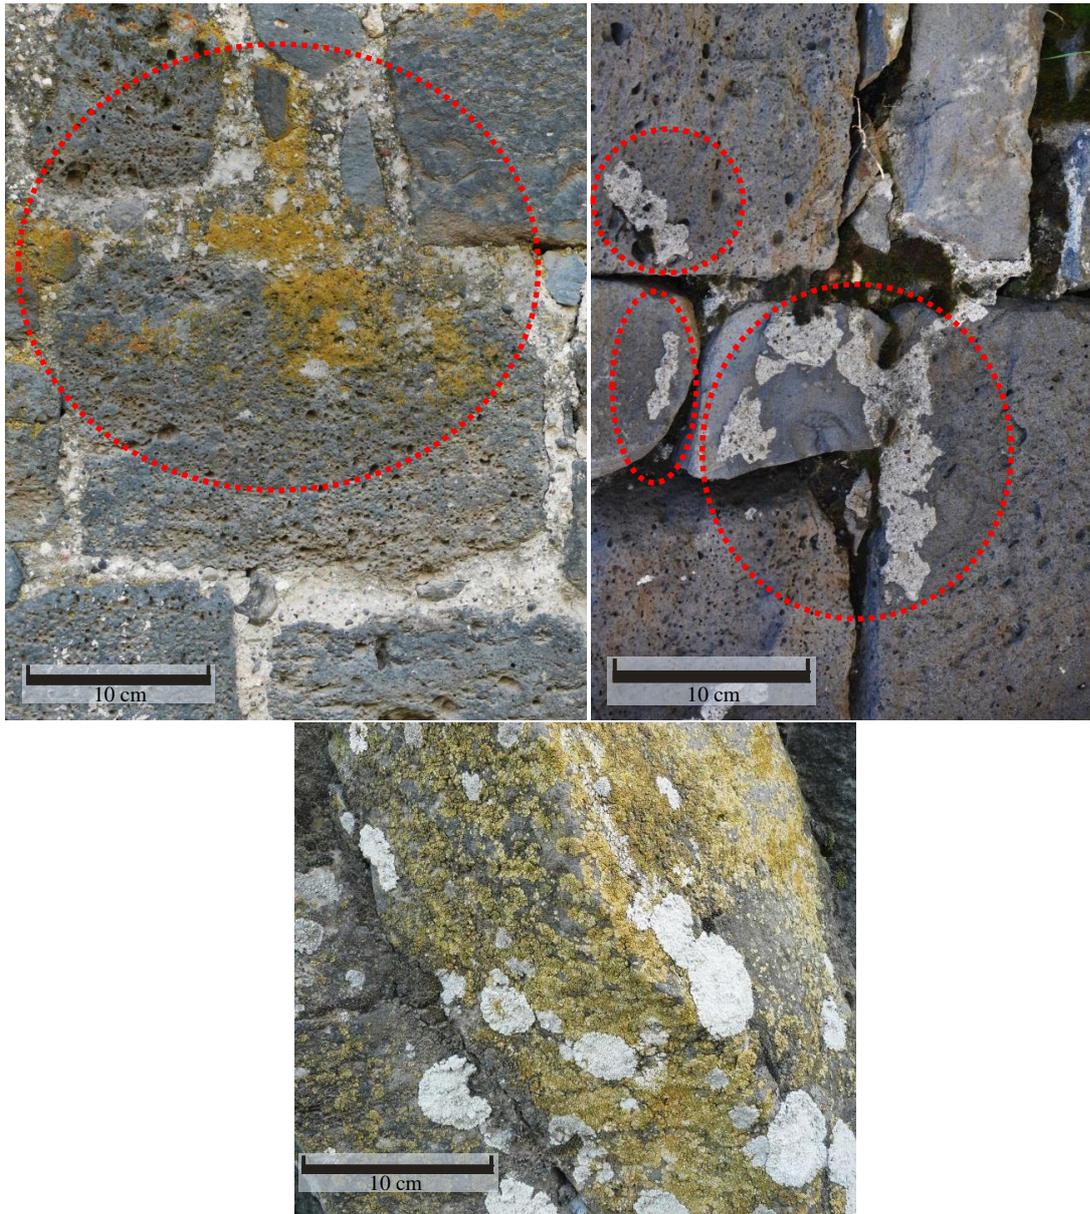
Figure 5.27 Lichens on sections of the DCW (lichens are indicated by dashed circles)

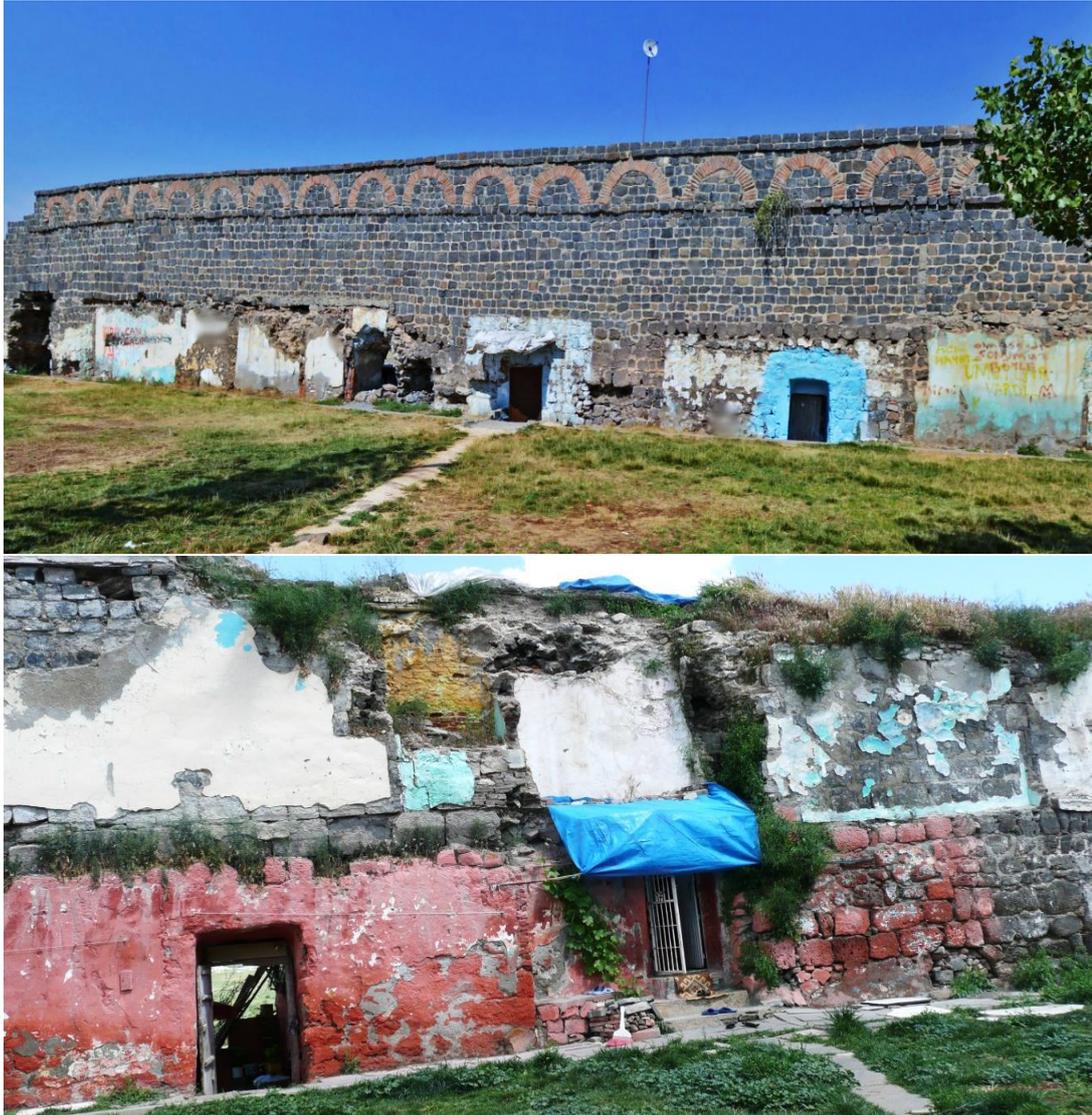
In addition to the above-mentioned weathering forms, the DCW are significantly affected from the damages caused by human activities. Those activities can be classified as environmental pollution, illegal housing, painting, vibrations caused by traffic, fires, the dismantling of stone blocks and so forth (Figure 5.28).

Figure 5.28 Paint and illegal housing on the east section of the DCW (the houses no longer exist, however, traces of them can be found on the walls)

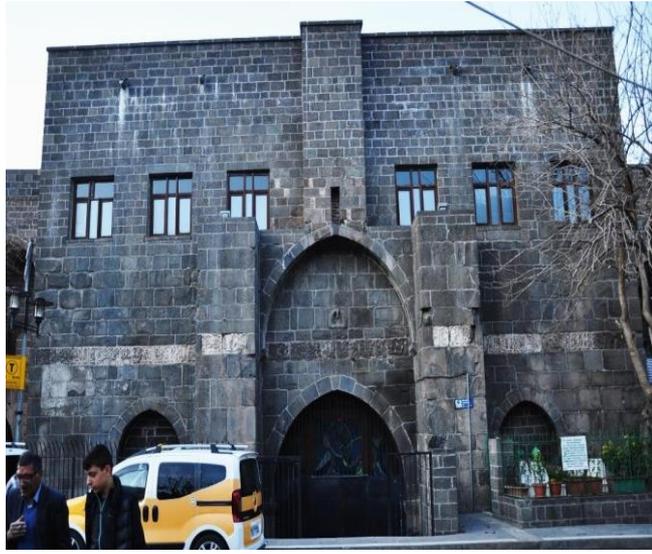
Figure 5.29 reveals the materials employed in the construction of the inner section of the Dağ Gate. The types of materials used in the structure are classified as massive and vesicular basalt, limestone and brick. As Figure 5.30 shows, the external façade of the inner side of the Dağ Gate is examined, and the common weathering patterns are compared to the relatively original condition of the stone material. The uppermost part of the façade (see the upper section of the dashed line) was recently restored and is characterized by weathering forms such as deposits and moist areas. However, the lower parts (see the lower section of the dashed line) are relatively original and characterized by common weathering forms such as scaling, material loss,

Figure 5.29 The material map of the inner section of the Dağ Gate

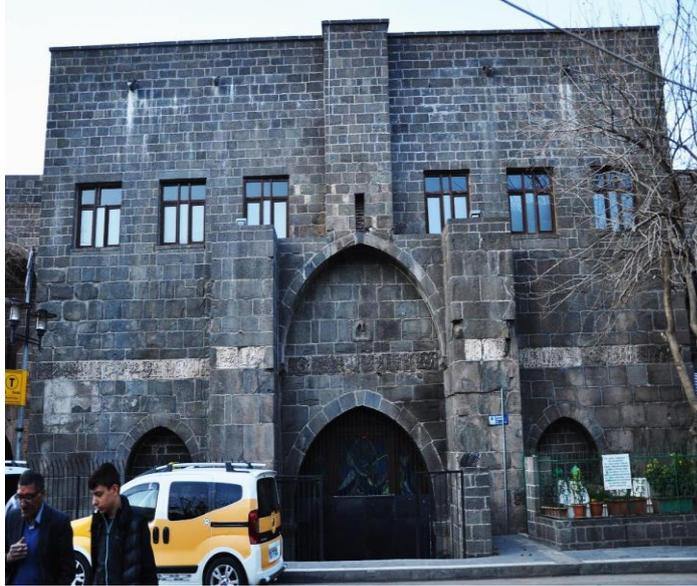
The documented weathering patterns on the first section (Figure 5.30) are classified into the categories of deposits, material loss, delamination, fragmentation, cracks and fractures, scaling, discoloration and moist areas. Here, the category of deposits includes crusts, efflorescence, splashes of mortar or paint, bird droppings, soot, dust and plaster. The cracks and fractures category includes vertical, horizontal or network cracks on the façade. Since the detachments observed on the façade developed in different forms, they were represented separately as delamination, fragmentation and scaling. The features induced by loss of stone material include erosion, mechanical damage and missing parts. Those weathering forms were represented in the material loss category. The discoloration category includes color changes in the form of bleaching or fading; and finally, the darkening of the stone surface due to dampness is represented in the category of moist areas.

discoloration, cracks and fractures, delamination and fragmentation. Like the upper part, deposits and moist areas are also found on the lower part of the façade.

Figure 5.30 The map of visual decay forms on the inner section of the Dağ Gate

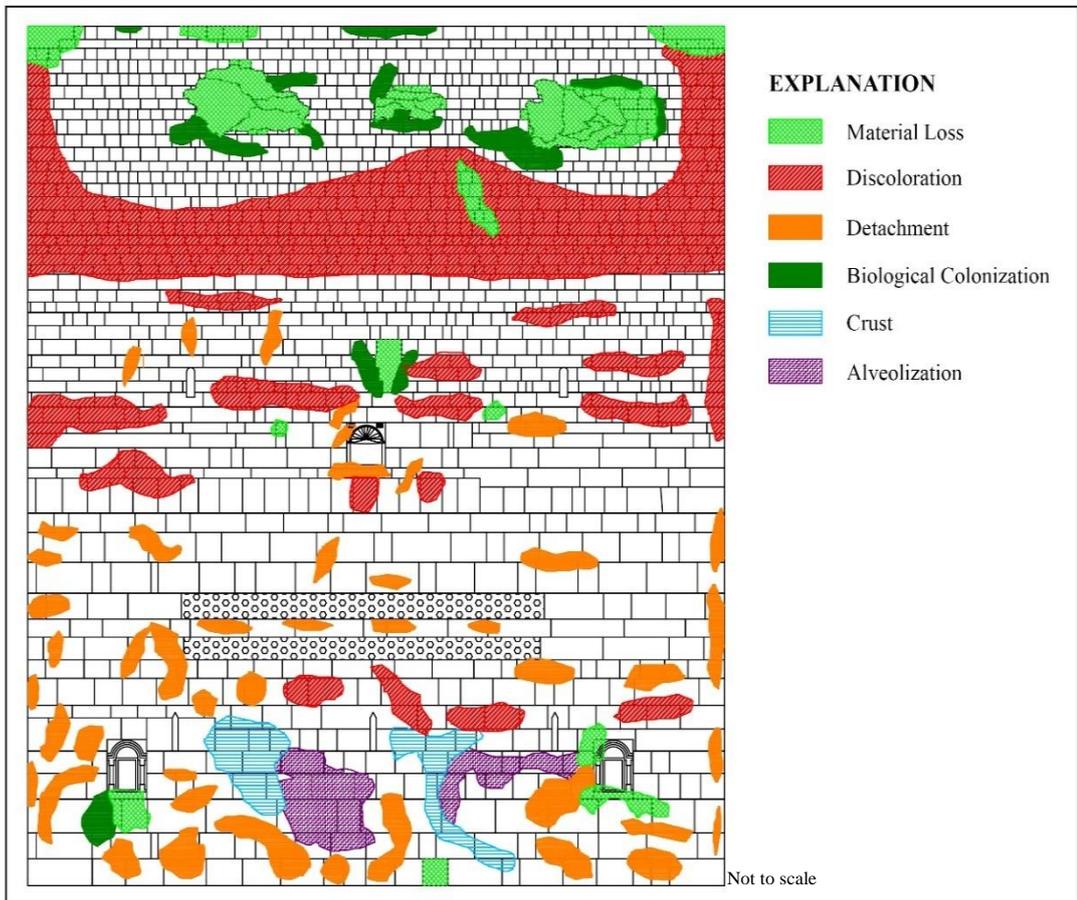
Figure 5.32 The map of visual decay forms on the tower 52

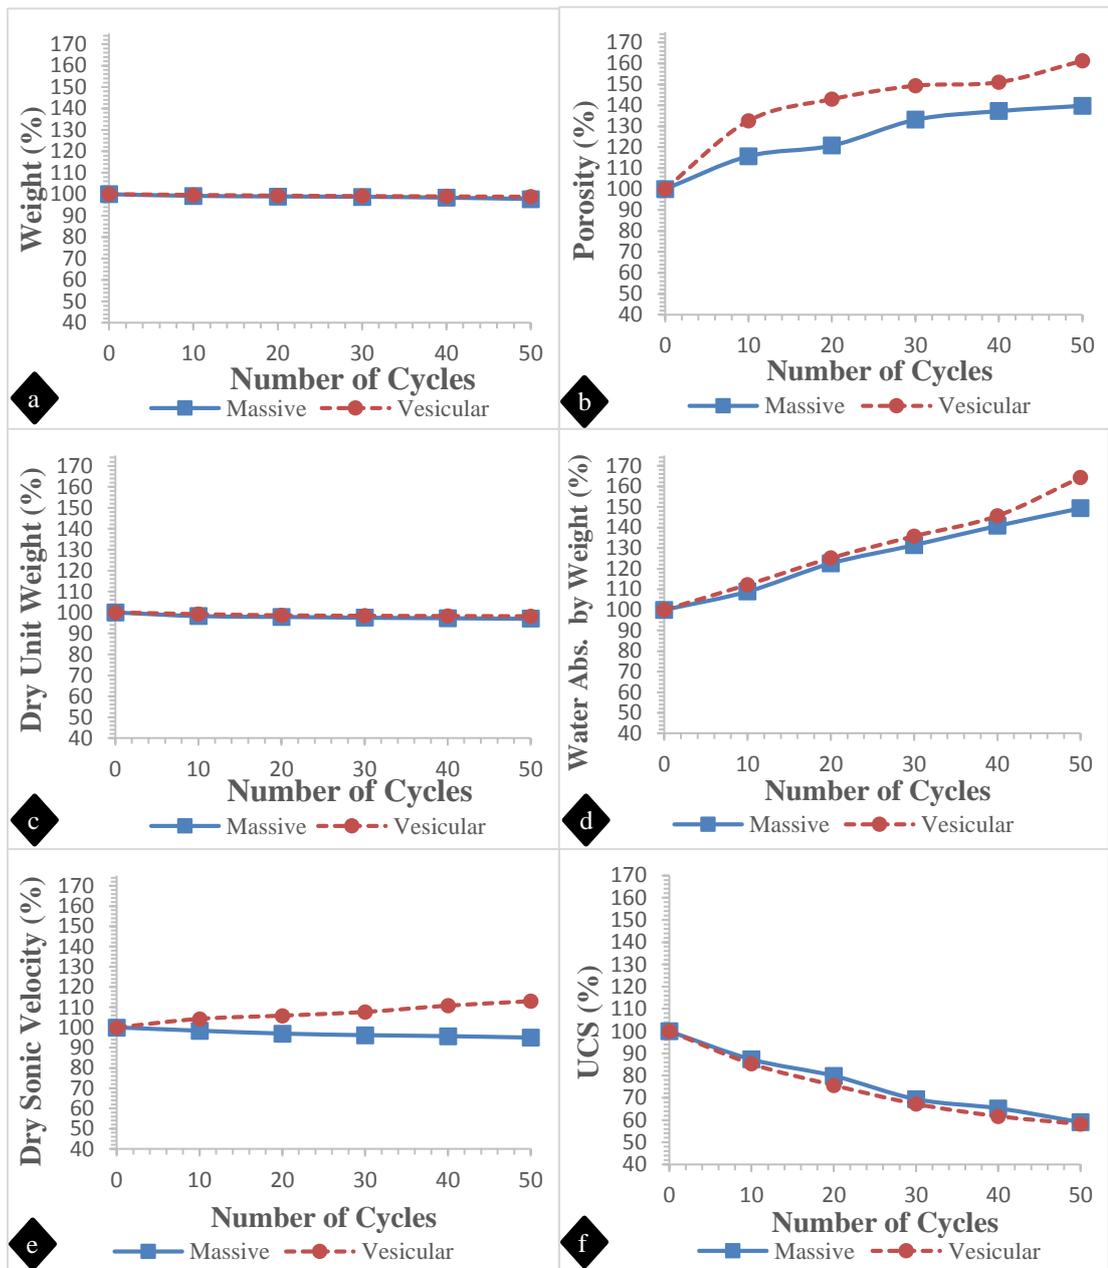
Figure 5.37 Variations in the physical and mechanical properties of the massive and vesicular basalts after the salt crystallization cycles

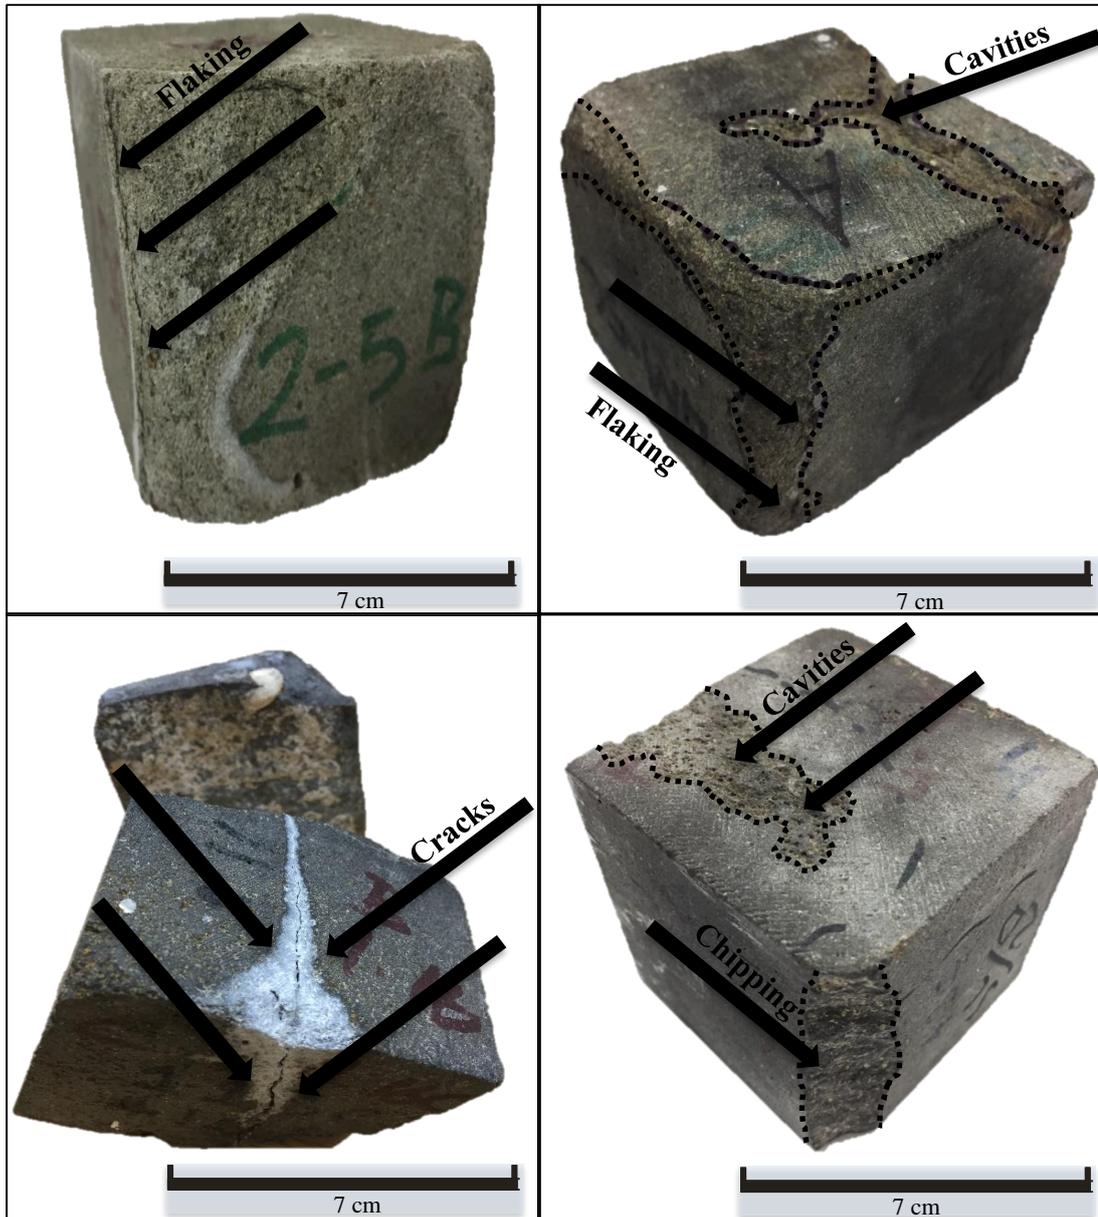
Figure 5.39 Patterns of deterioration on the massive basalt samples after the 30th cycle of the salt crystallization test

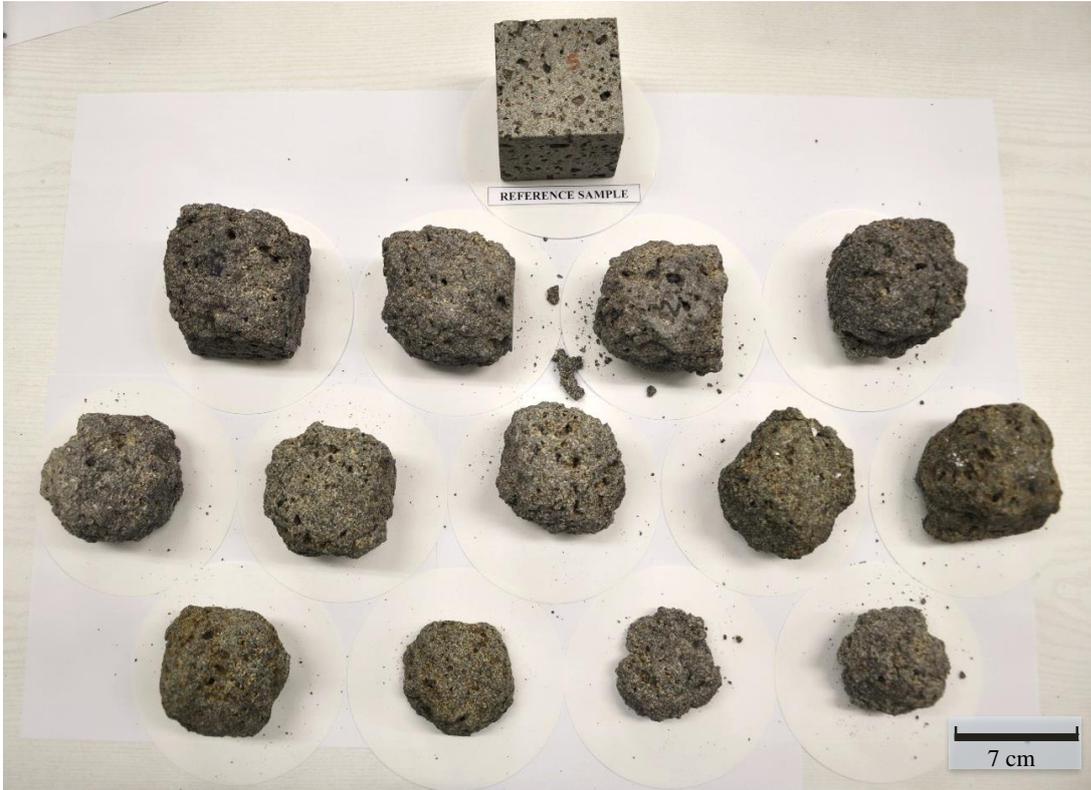
Figure 5.40 Disintegration of some of the vesicular basalt samples after 16th cycle of the salt crystallization test
