INVESTIGATION ON DETERIORATION MECHANISMS OF THE BASALTS
USED IN THE DİYARBAKIR CITY WALLS

A THESIS SUBMITTED TO
THE GRADUATE SCHOOL OF NATURAL AND APPLIED SCIENCES
OF
MIDDLE EAST TECHNICAL UNIVERSITY

IN PARTIAL FULFILLMENT OF THE REQUIREMENTS
FOR
THE DEGREE OF DOCTOR OF PHILOSOPHY
IN
GEOLOGICAL ENGINEERING

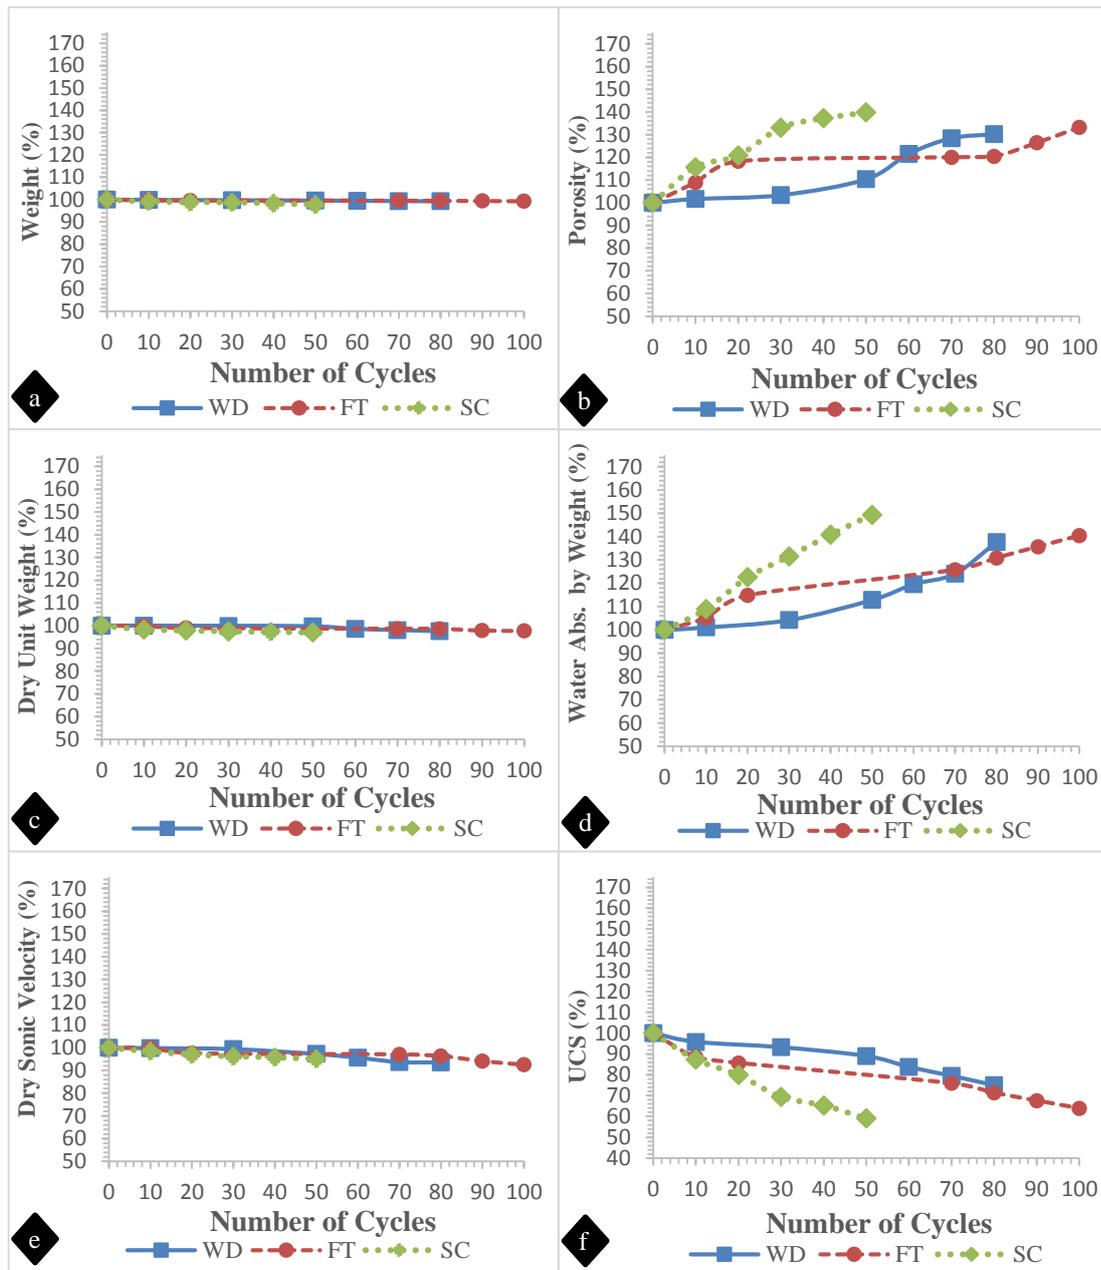
Figure 5.41 Effect of durability tests on the physico-mechanical properties of the massive basalt samples (WD: Wetting-Drying; FT: Freezing-Thawing; SC: Salt Crystallization)

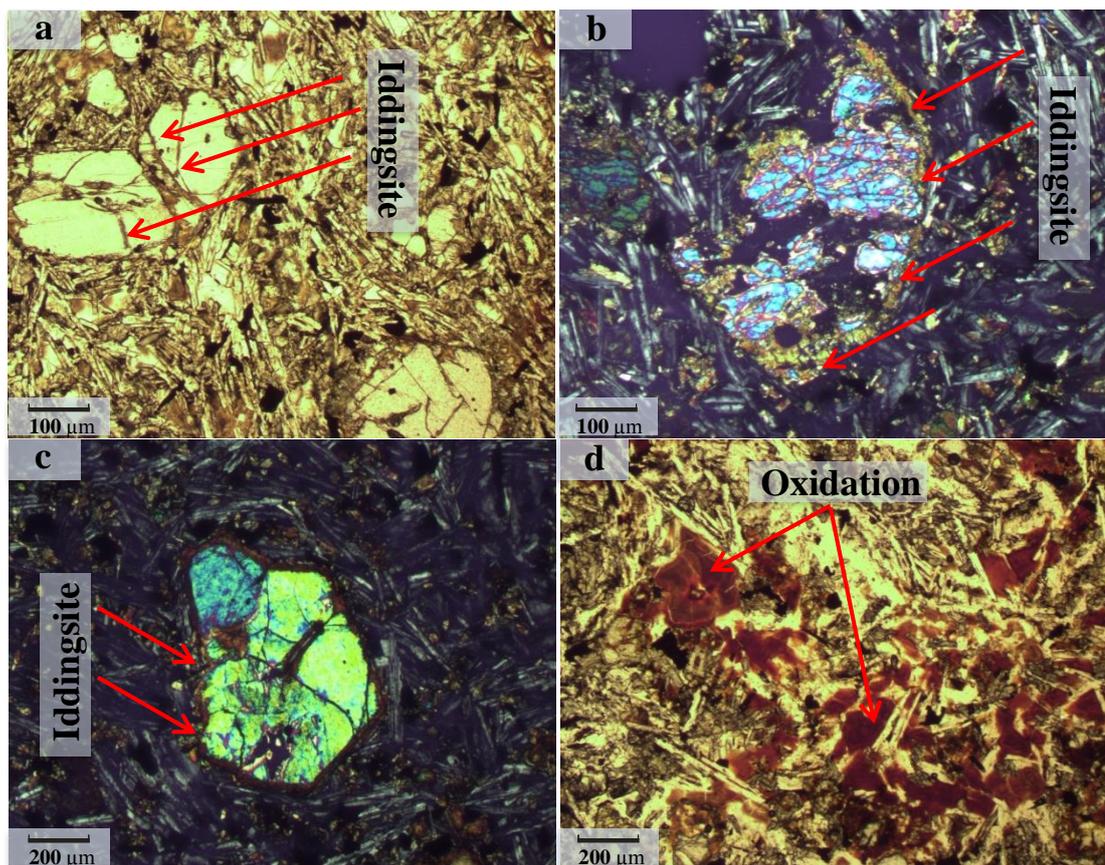
Figure 5.43 Photomicrographs of the weathered basalt samples (a,b,c: iddingsite formations through the mineral boundaries and cracks; d: oxidation)

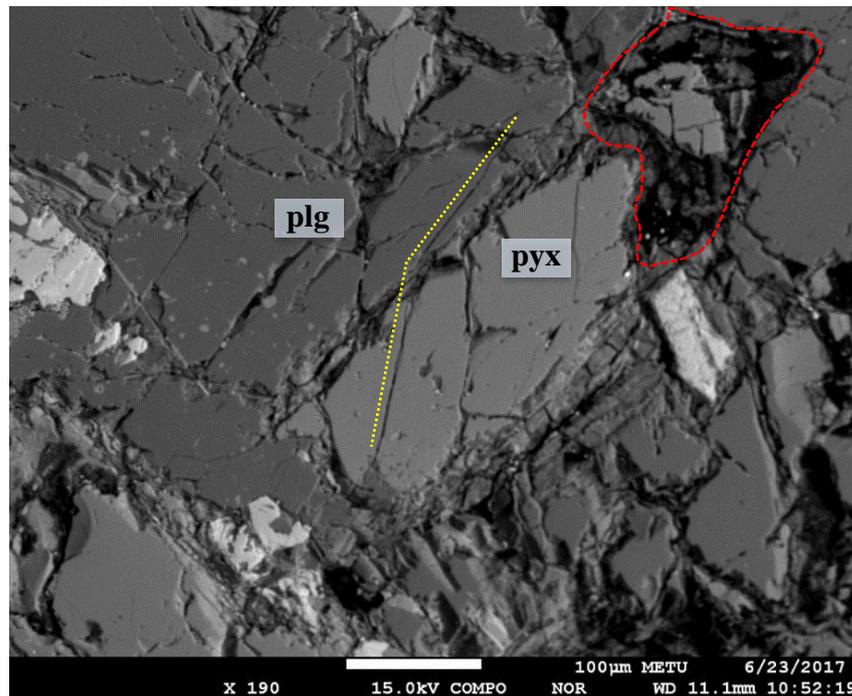
Figure 5.48 Back-scattered image showing change in crack direction and partial loss of pyroxene crystal after the wetting-drying test (the direction change is indicated by the yellow dotted lines, and the mineral remnant is indicated by the red dashed lines)

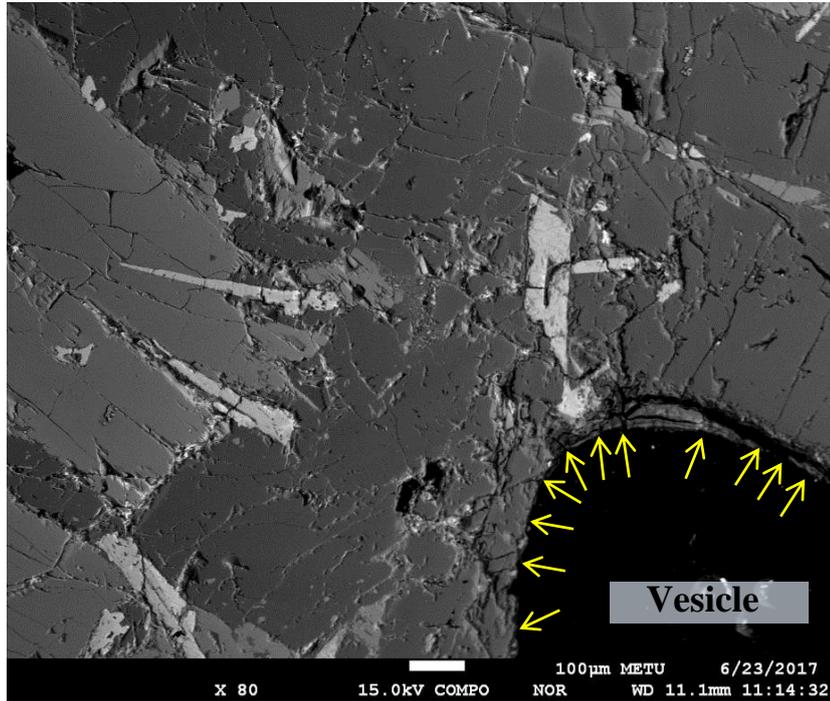
Figure 5.49 Back-scattered image displaying microfracture propagation that initiated from a vesicle after the wetting-drying test (microfractures are indicated by the yellow arrows)

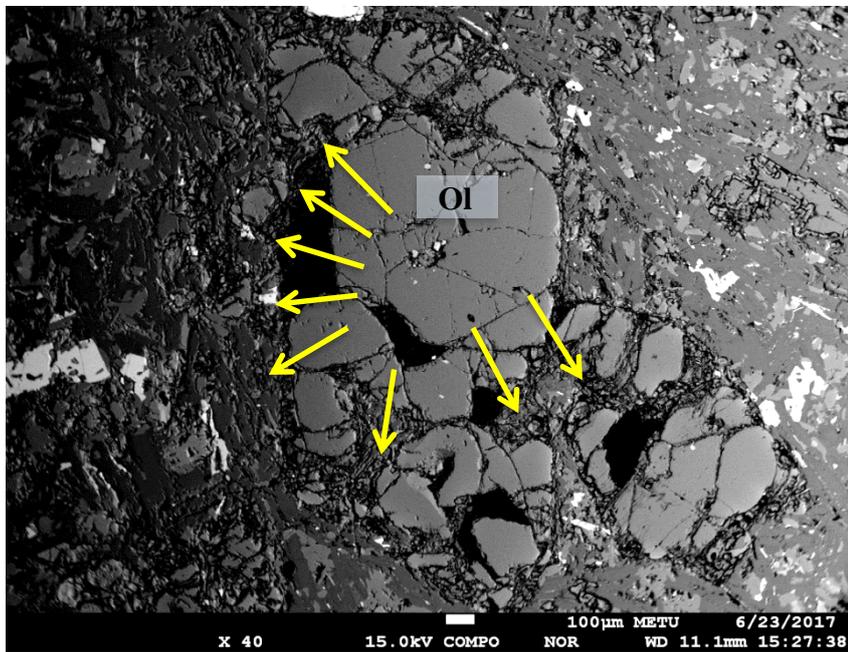
Figure 5.58 A back-scattered image displaying microfracture propagation along the rim of a naturally weathered olivine phenocryst (crack propagation is indicated by yellow arrows)

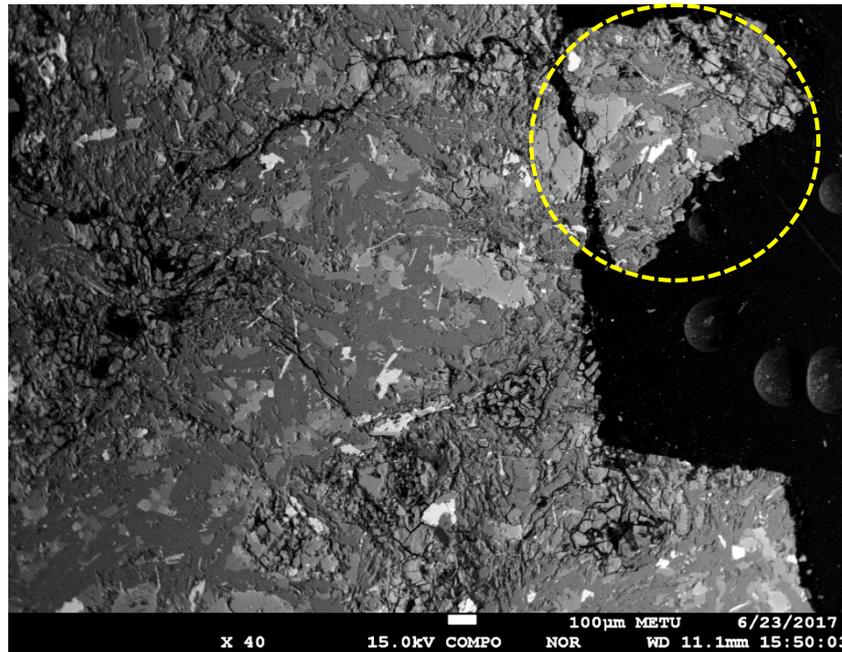
Figure 5.59 Back-scattered image of a naturally weathered basalt sample indicating a microfracture-associated detachment (the broken piece is indicated by the yellow dashed lines)

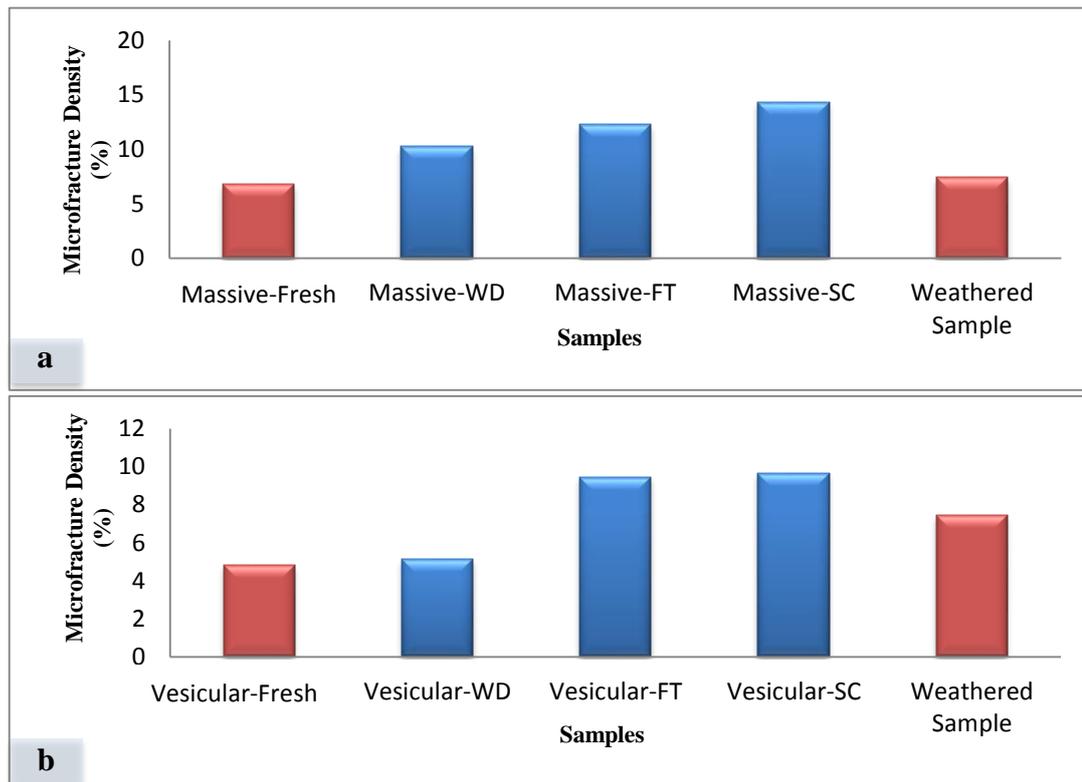
Figure 5.63 Histograms depicting the microfracture density of the examined samples (a: correlation of the massive and naturally weathered samples; b: correlation of the vesicular and naturally weathered samples; WD: Wetting-Drying; FT: Freezing-Thawing; SC: Salt Crystallization)

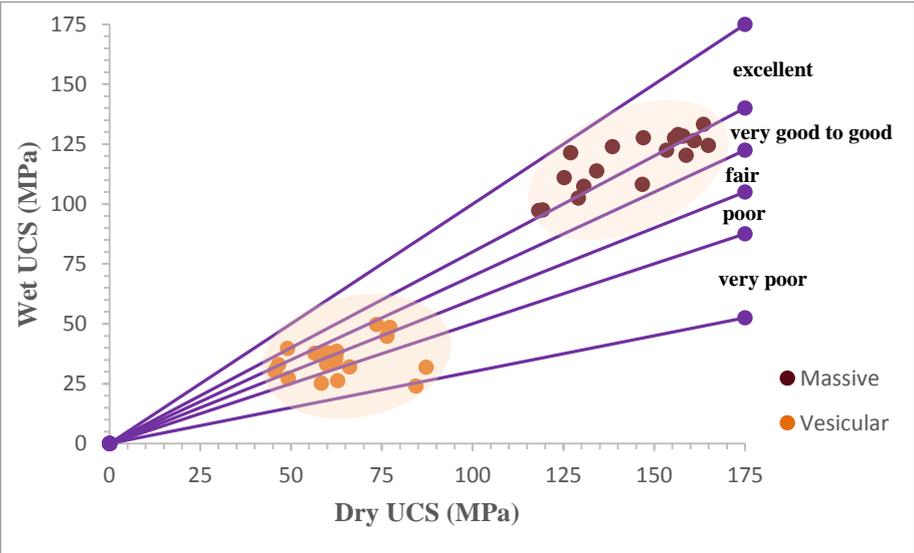
Figure 6.1 Durability assessment of the massive and vesicular basalt samples based on the wet-to-dry strength ratio proposed by Winkler (1986)

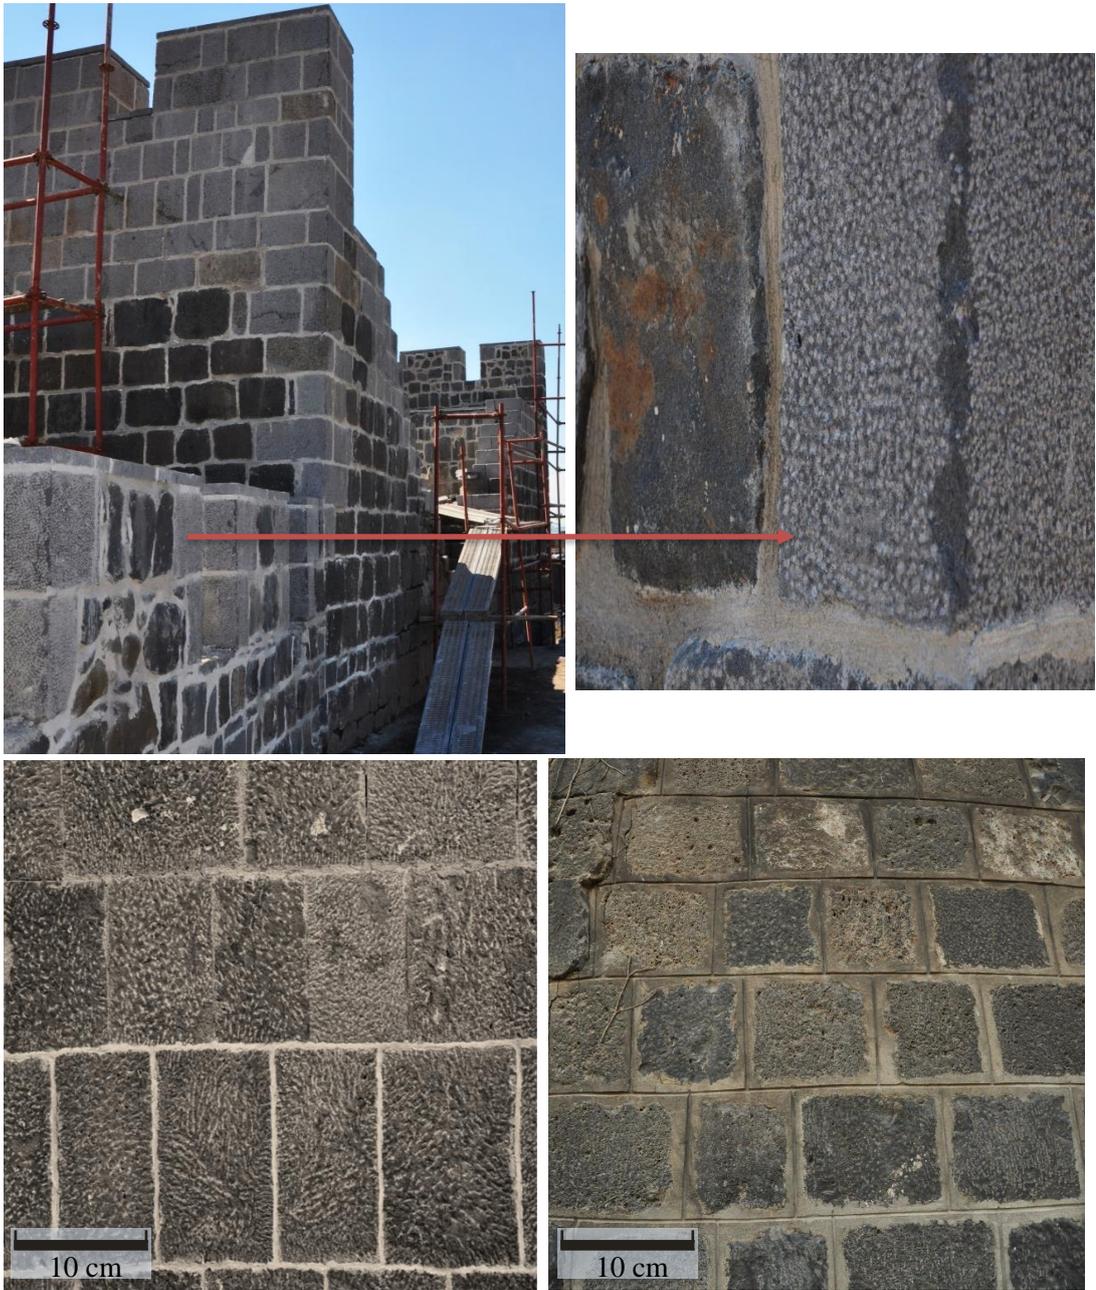
Figure 7.1 Different surface finishes on the DCW

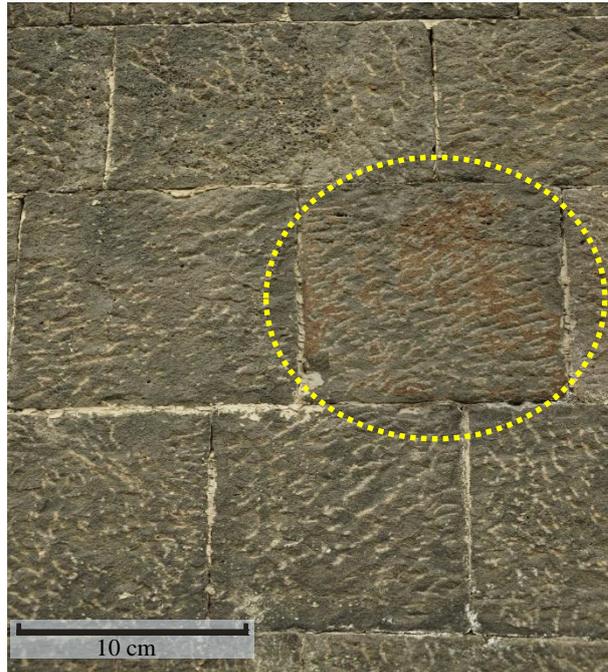
Figure 7.2 A surface finish that caused material loss and biological colonization on the surface of the basalt blocks (biological colonization is indicated by the dotted circle)
