A SURVEY ON PLAN TYPOLOGIES IN APARTMENT BLOCKS:
THE CASE OF NECATİBEY NEIGHBOURHOOD, ANKARA
(1920s-1960s)

A THESIS SUBMITTED TO THE GRADUATE SCHOOL OF NATURAL AND
APPLIED SCIENCES
OF
MIDDLE EAST TECHNICAL UNIVERSITY

SEPTEMBER 2017

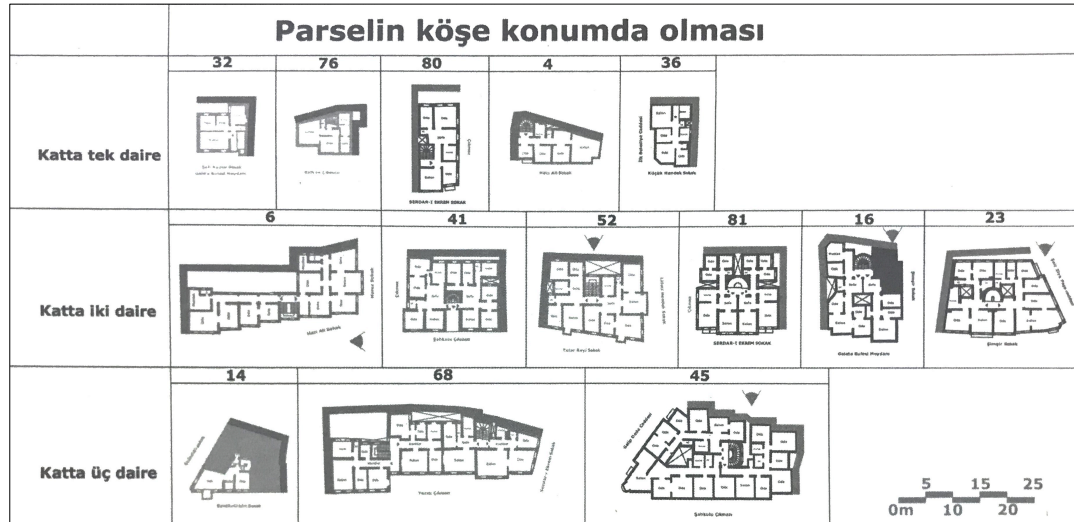
Figure 3.1 An analysis table from Öncel's study (2010, 160).

In this study, Öncel's classification system is adapted to allow for the evaluation of building shapes in the neighbourhood. Since there is no example of a building that is attached from three sides among the selected cases, the plot use characteristics are examined in three groups. The first group consists of apartment blocks that are attached to the next buildings on two opposing sides; this, of course, means they have only front and rear facades. The second group contains the blocks in corner plots; generally, these blocks have two adjacent street-facing facades. The final group of blocks are attached to the next building from one lateral side, and have three facades. There are no detached apartment blocks in the area because of the attached order.

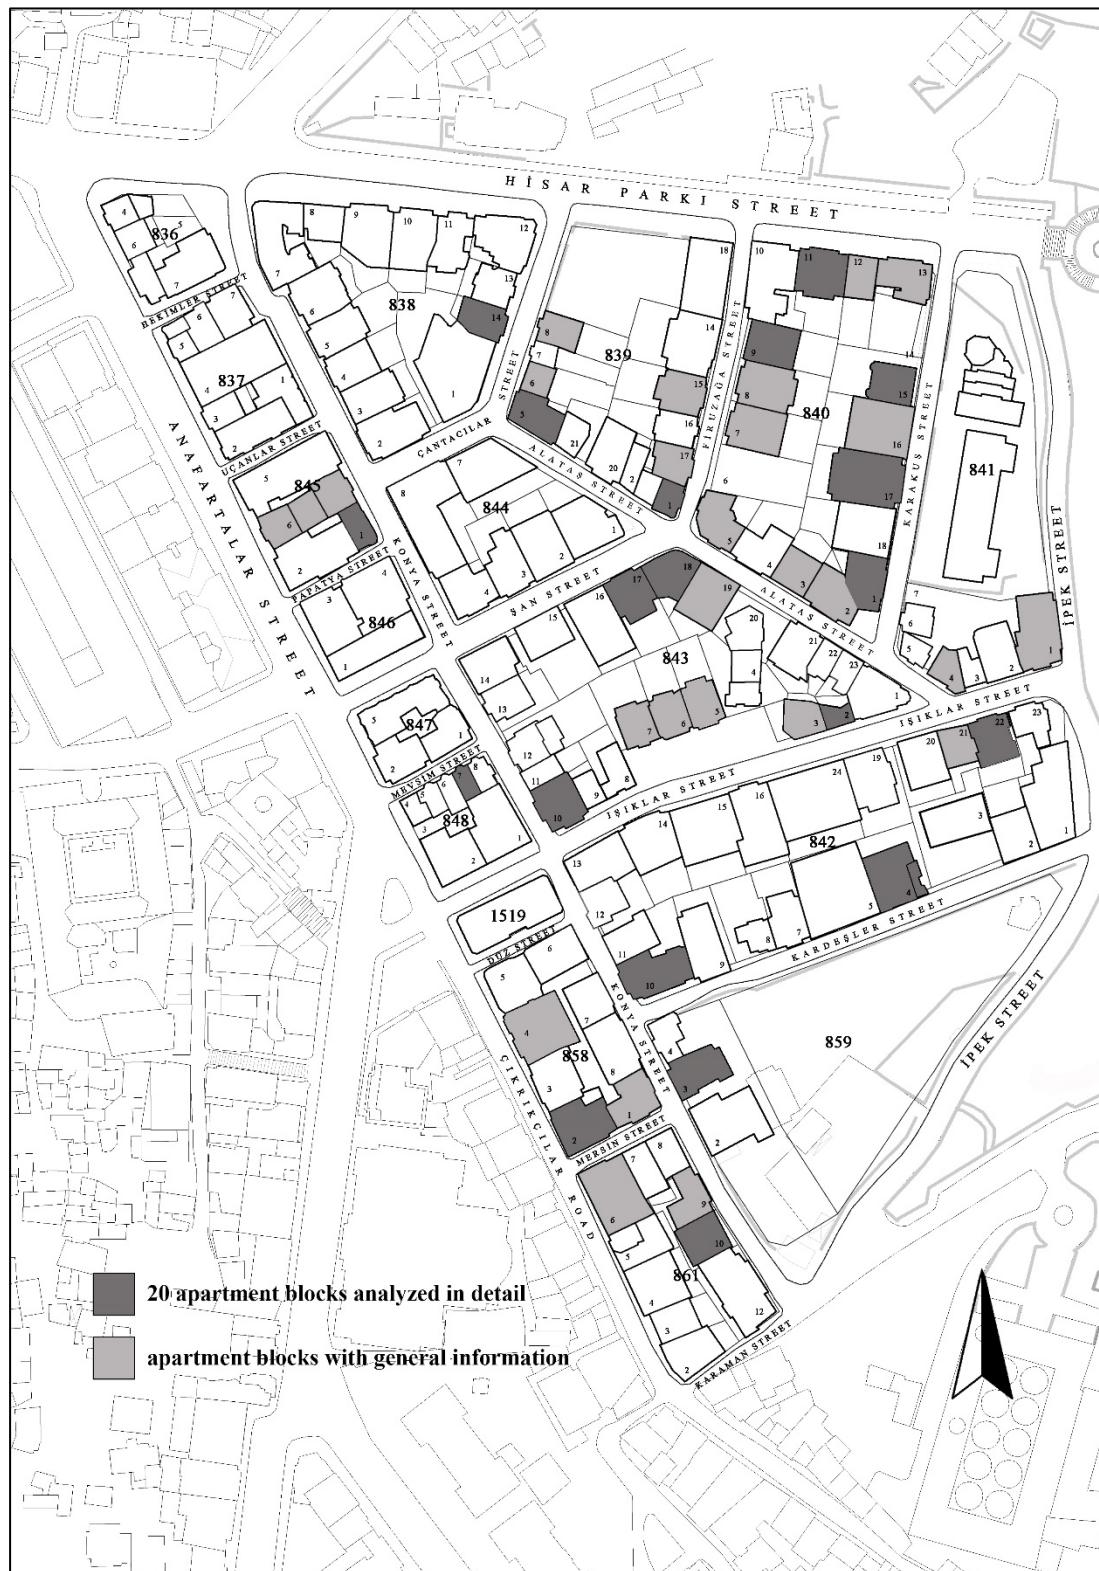
Figure 3.2 Selected apartment blocks' locations on the map.

In this part of the study, typical floor plans and facade characteristics are analysed through determined typological aspects. For practical reasons, by selecting four apartment blocks from each decades, 20 buildings are analysed in detail among examined 45 apartment blocks in the neighbourhood (Figure 3.2) (Table 3.2). There are different amount of examples from each period, due to the changes on the construction activities in the area (Table 3.1).

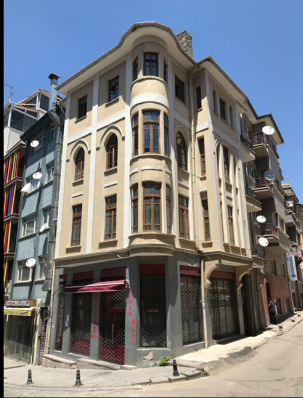
Table 3.3. General information for 839/1.

<p>Building name: Salih Çelebi Apartmanı Date: 1920s (?) Architect: Y. Müh. Adnan Canbek Cadastral: 839/1 Construction technique: Iron I beams and brick filling Number of floors: 4 Current function: Commercial Style: Historical (First National Style)</p>

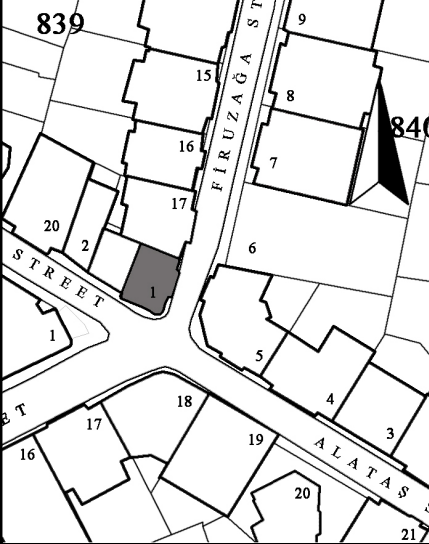
<p>TYPICAL FLOOR PLAN (Municipality Archive)</p>
<p>Salih Çelebi Apartmanı is located at the intersection of Alataş and Firuzağa Streets. Because of the location of plot, the design of the block is adapted to the corner, which has two adjacent facades facing the roads. It has a square shape with a semi-circular surface on the corner. The use of semi-circular arches, horizontal subdivisions, and the tower structure on the corner of the block indicates the characteristics of the First National Movement (Aslanoğlu 1980, 14).</p> <p>Unfortunately, the exact date of construction is not recorded in any formal documentation, however Nalbantoğlu and Nalcioğlu confirm that the building belongs to 1920-1930 period. (Nalbantoğlu 1981, 56-57; Nalcioğlu 1990, 14)</p> <p>There is one simple unit on each floor, and the block has only three units and a shop on the ground floor. Site studies show that the apartment block is in a good condition in terms of physical appearance.</p> <p>According to studies by Nalbantoğlu, the original owner of the block was a cook who had his own restaurant in the district in 1920s, and the building still belongs to his family. Today, the building is not being used for residential purposes.</p>

<ul style="list-style-type: none"> common use space (<i>hol, oda</i>) private use space (<i>oda</i>) kitchen (<i>mutfak</i>) wet area (<i>banyo, tuvalet</i>) <p>The unit consists of four rooms including living rooms and bedrooms, a bathroom, a WC, and a kitchen, which are connected with a hall in centre of the plan. Except for bathroom, all rooms can be directly accessed from the hall. The bathroom is located in one of the bedrooms. It is possible to say rooms are not arranged according to their privacy levels; rather, there is a 'free attitude' in the spatial organization. However, there is continuity between the more common spaces. Living rooms are the largest spaces and they have lots of windows compared with other spaces in the unit. The bathroom, WC, and kitchen form a service zone at the farthest part of the block. The kitchen and WC receive daylight via the light shaft.</p>

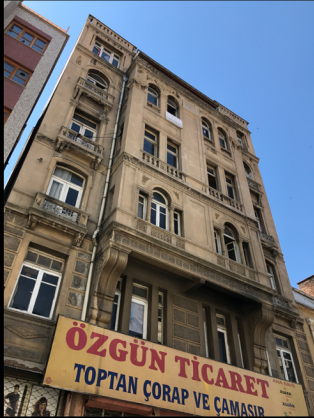
Table 3.5. General information for 842/22.

<p>Building name: Özgün Han (Current name) Date: 1920s (?) Architect: Unkown Cadastral: 842/22 Construction technique: Reinforced concrete frame (?) Number of floors: 6 Current function: Commercial Style: Historical (Neoclassical Style)</p>

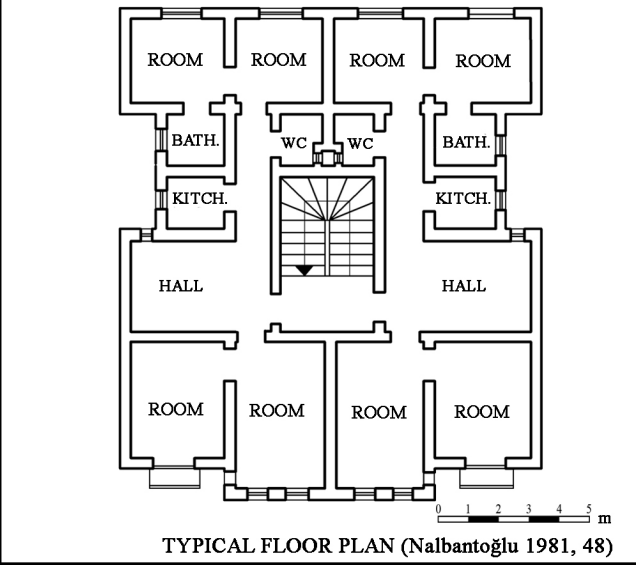
<p>TYPICAL FLOOR PLAN (Nalbantoğlu 1981, 48)</p>
<p>This building is located on Işıklar Street in the Necatibey Neighbourhood. Although there is no information about the construction date, Nalbantoğlu and Nalcioğlu confirm that the building belongs to 1920-1930 period (Nalbantoğlu 1981, 48; Nalcioğlu 1990, 96). Information from the architect and engineer regarding the building is not recorded in official documentation.</p> <p>The ornamented columns and buttresses, stone surfacing and projected middle section of the facade are characteristic of the Neo-classical style; French balconies and balusters indicate the effect of Westernization.</p> <p>According to site studies, the building requires minor repairs.</p> <p>There are two symmetrical units on each floor; the block has a shop on ground floor and ten units in total. According to Nalbantoğlu, the building originally was designed to accommodate the French living in Ankara. However, the block is named ‘Özgün Han’ and is currently being used as a commercial complex.</p> <p>Since it is not possible to obtain the original drawings, there is no available information on the original functions of the ground or top floors.</p>

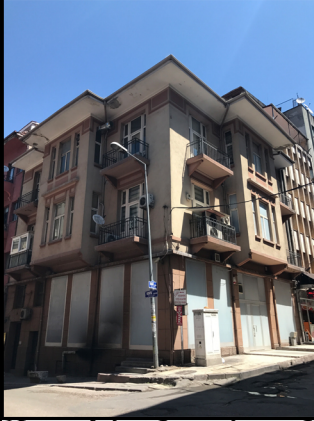
Table 3.7. General information for 843/10.

<p>Building name: A.T.T. Bankası Apartmanı Date: 1920s (?) Architect: Unknown Cadastral: 843/10 Construction technique: Reinforced Concrete Number of floors: 3 Current function: Commercial Style: Historical</p>

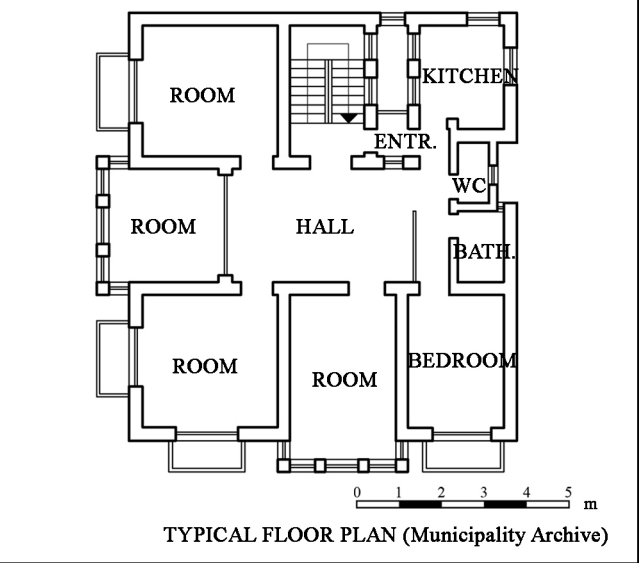
<p>TYPICAL FLOOR PLAN (Municipality Archive)</p>
<p>The A.T.T. Bankası Apartmanı is located at the intersection of Konya and Işıklar Streets. Accordingly, the block has two adjacent facades, which include cantilevered surfaces. Unfortunately there is no information available as to its construction date or the identity of the architect/engineer. Nalcıoğlu shows that the building belongs to the 1920-1930 period in her study. According to official documentation in the Municipality archive, the apartment block was designed for Adapazarı Türk Ticaret Bankası.</p> <p>Compared with coevals, the facades display a simple treatment with their rectangular and unornamented windows and balconies. It should be noted that a symmetrical design approach has been taken. The building is in a good condition in terms of physical appearance.</p> <p>Each floor has only one unit; accordingly, the building consists of two units and a shop. Today, it is being used for commercial purposes.</p>

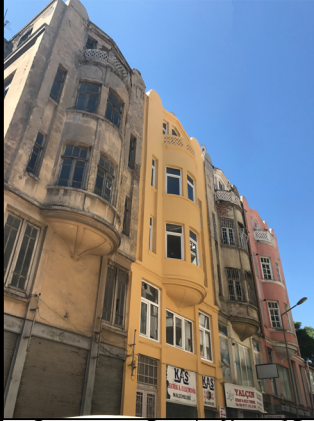
Table 3.9. General information for 848/7.

<p>Building name: Daldal Apartmanı Date: 1924 (?) Architect: Unkown Cadastral: 848/7 Construction technique: Steel construction Number of floors: 4 Current function: Commercial Style: Historical (Neoclassical Style)</p>

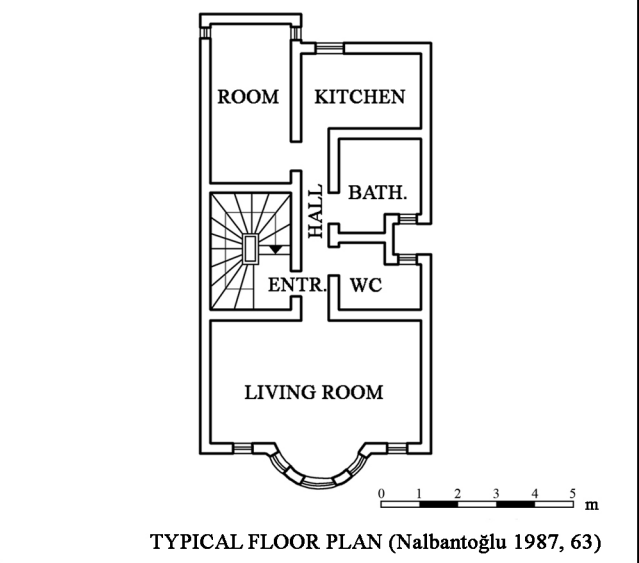
<p>TYPICAL FLOOR PLAN (Nalbantoğlu 1987, 63)</p>
<p>This building is one of four identical apartment blocks in Mevsim Street, which is connected to Anafartalar Street. Today, information regarding the architect/engineer, the construction date and the drawings are not available in the Municipality archive. According to investigations by Kefu, the building was constructed around 1924. Nalbantoğlu and Nalcıoğlu also verify the period of the buildings as being the 1920-1930s (Kefu 2001, 150) (Nalcıoğlu 1990, 14)</p> <p>The same four facades have semi-circular cantilevers, ornamented balustrades, and horizontal subdivisions. The plans show a variety of layouts depending upon the size and location of the plots; however, the spatial organization and space sizes are very similar to each other. While Daldal Apartmanı is in a good physical condition, the adjacent blocks require major repairs. Nalbantoğlu claims that, originally, the buildings were probably built to be rented to small income groups or bachelors, considering the features of the units (Nalbantoğlu 1981, 63). Today, the ground floors are used for commercial purposes, while the upper floors are used as storage for the shops.</p>

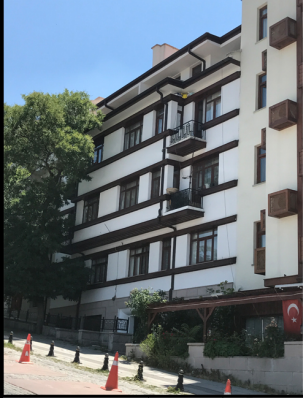
Table 3.11. General information for 840/11.

<p>Building name: Halit Kurşuncu Apartmanı Date: 1937 Architect: Fen Mesulu H. Kurtuluş Cadastral: 840/11 Construction technique: Reinforced concrete frame Number of floors: 5 Current function: Residential Style: Modern (Cubic Style)</p>

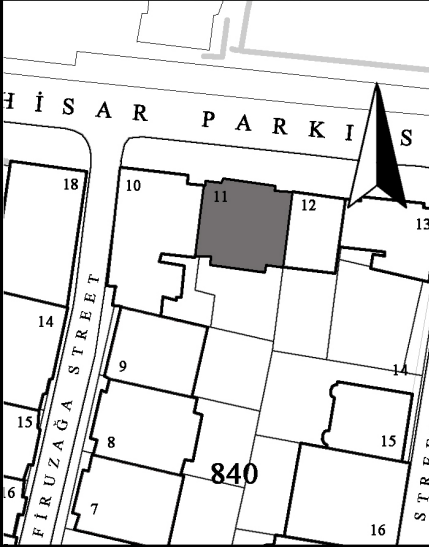
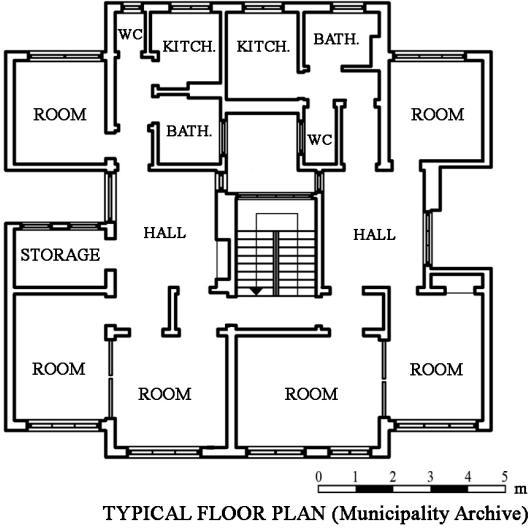
<p>TYPICAL FLOOR PLAN (Municipality Archive)</p>
<p>Halit Kurşuncu Apartmanı is located on Hisar Parkı Street, which meets the stairs of Ankara Citadel. This building is one of the few apartment blocks still used for residential purposes.</p> <p>There are two units on each floor, and the apartment block consists of eight units in total. On the basement floor there is a laundry room and coal cellars that belong to units.</p> <p>Because of attached order, the building has two facades. It may be noted that there some effort has been made to gain a symmetrical appearance to the building. On the other hand, unit plans do not resemble each other; in other words, their floor plans do not show symmetric regulation. The roadside facade has a simple appearance compared to other buildings from the 1920s and 1930s. It is observed from site surveys that Kurşuncu Apartmanı does not require any restoration or renewal.</p> <p>The shape of the block does not have curvilinear surfaces; it has an 'H'-like shape, a design which was prevalent in the 1930s and 1940s.</p>

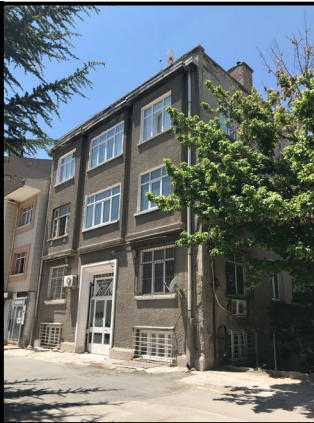
Table 3.13. General information for 840/15.

<p>Building name: Ahmet Şahin (Çamlıca) Apartmanı Date: 1932 Architect: Mimar Halim Cadastral: 840/15 Construction technique: Reinforced concrete frame Number of floors: 3 Current function: Residential Style: Modern (Cubic Style with historical features)</p>

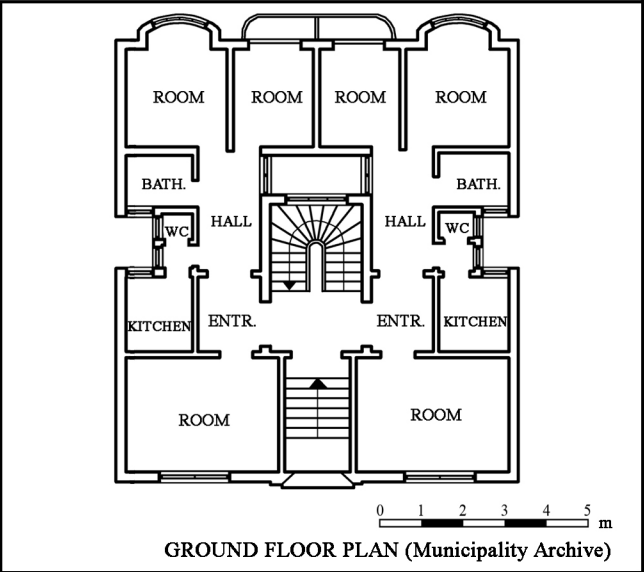
<p>GROUND FLOOR PLAN (Municipality Archive)</p>
<p>Ahmet Şahin (Çamlıca) Apartmanı is located on Karakuş Street in Necatibey Neighbourhood. While being perceived as a simple and prismatic block from the roadside, the back facade has semi-circular cantilevers and balconies. In this way, the building has a different sense of design. Considering the simple plan order and facade organization, this building is an important representative of civil architecture in the Early Republican Period (Bayraktar, Batuman & Ayhan, 2014, 17).</p> <p>In plan drawings, the block has two facades as a result of the attached order in the area. However, it has been observed that there are windows on the north facade of the building, which were probably added later. According to site studies, the building has slight material deterioration and requires minor repairs.</p> <p>There are two identical units on each floor, including the ground and basement floors; the block has eight units in total. This building is one of the few apartment blocks still being used for residential purposes in the area.</p>

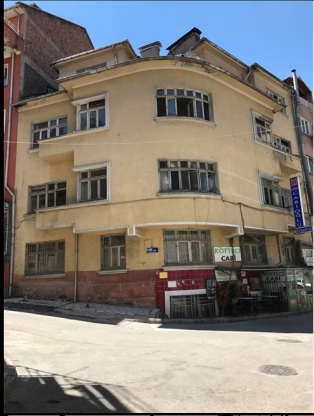
Table 3.15. General information for 843/18.

<p>Building name: İnci Apartmanı Date: 1934 Architect: Mimar Halim Cadastral: 843/18 Construction technique: Reinforced concrete frame Number of floors: 4 Current function: Commercial Style: Modern (Cubic Style)</p>

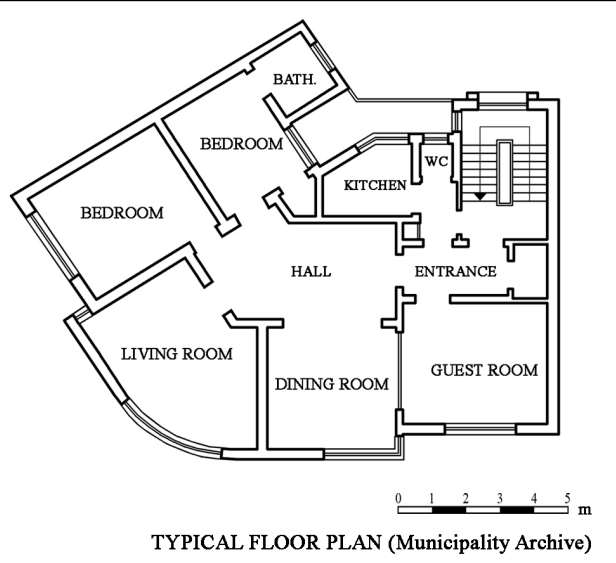
<p>TYPICAL FLOOR PLAN (Municipality Archive)</p>
<p>İnci Apartmanı is located at the intersection of Şan and Alataş Streets. The shape of the building is that of a bent rectangle, which follows the shape of the road. Apart from this, the building displays a simple and unornamented character on the facade and plan schema.</p> <p>According to the official documents in the Municipality archive, the apartment building originally belonged to the famous poet Mehmet Emin Yurdakul. It is understood from official records that the building was inherited by his daughter, Metruke Hanım.</p> <p>There is only one unit on each floor; in total, there are five units in the building. On the basement floor, there is a janitor room and top floor consisting of a small flat which has three rooms.</p> <p>The ground floor of the building is still used for commercial purposes; on the other hand, upper floors have become non-functional and have been abandoned. It is possible to observe slight material deterioration on the facades.</p>

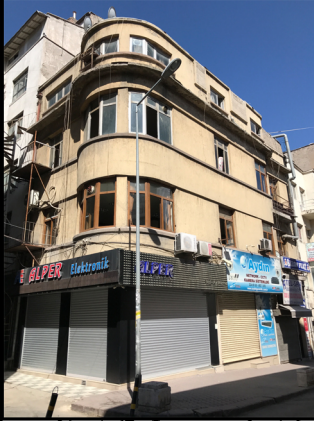
Table 3.17. General information for 845/1.

<p>Building name: Süleyman Sırrı Bey (İçöz) Apartmanı Date: 1930 Architect: Mimar Halim Cadastral: 845/1 Construction technique: Reinforced concrete frame Number of floors: 4 Current function: Commercial Style: Modern (Cubic Style)</p>

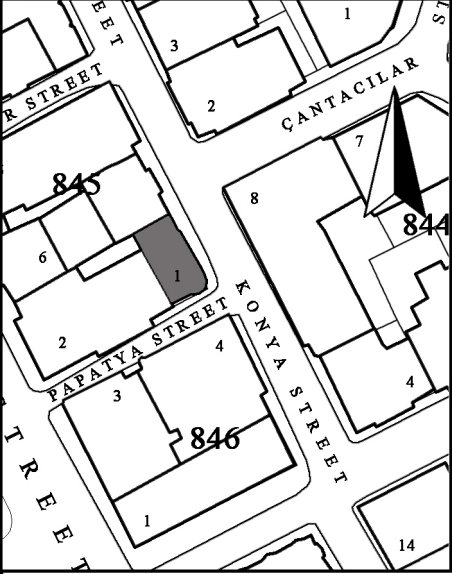
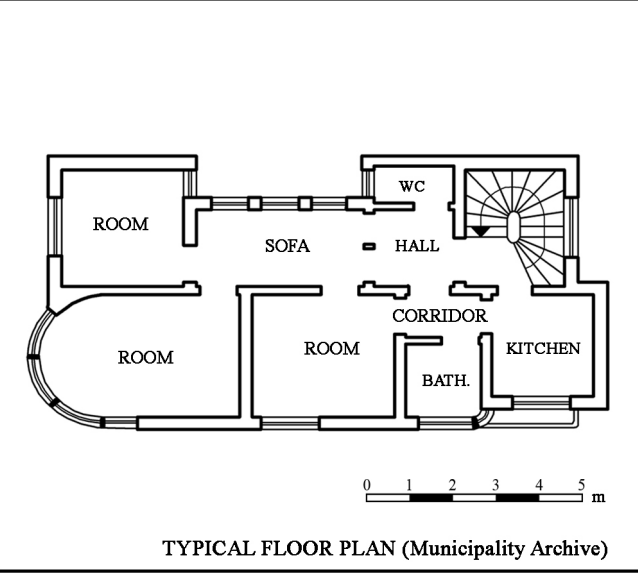
<p>TYPICAL FLOOR PLAN (Municipality Archive)</p>
<p>İçöz Apartmanı is located at the intersection of Papatya and Konya Streets. The building is one of the first apartment blocks of the Early Republican Period. It was designed for Süleyman Sırrı (İçöz) Bey, who was a member of parliament. The design of the block is specialized according to that of a corner plot, which has two adjacent facades facing the roads. The curvilinear surface at the corner and simple horizontal mouldings are the remarkable features of the facades. The building is in a good condition except for slight surface deteriorations.</p> <p>The shape of the block is rectangular with a rounded corner. The spatial organization of the plan also shows simplicity. In this way, it represents the free approach of residential buildings in the modern period (Bayraktar; Batuman & Ayhan 2014, 15).</p> <p>The block consists of four storeys, while the ground floor contains two shops, and there is one unit on each upper floor. Currently, the building has a commercial function.</p>

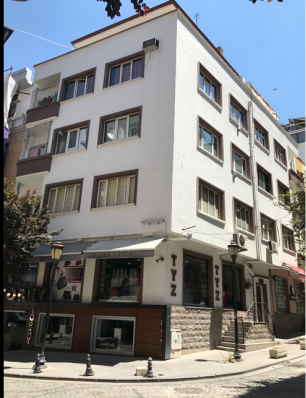
Table 3.19. General information for 839/5.

<p>Building name: Fahrettin Tiritoglu Apartmanı Date: 1947 Architect: Muhittin Binar Cadastral: 839/5 Construction technique: Reinforced concrete frame Number of floors: 5 Current function: Commercial Style: Modern (International Style)</p>

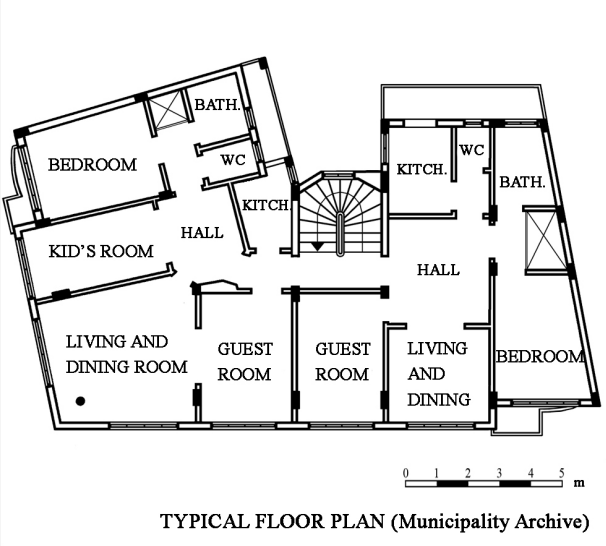
<p>TYPICAL FLOOR PLAN (Municipality Archive)</p>
<p>Tiritoglu Apartmanı is located at the intersection of Alataş and Çantacılar Streets. The function of the block has become a commercial one, similar to many other buildings in the area.</p> <p>The block consists of six storeys, while the basement and ground floors contain two shops, and there are two units on each upper floor. Except for the penthouse, there were originally six units in the building.</p> <p>The shape of floor plan of the block is formed from the merger of two trapezoidal forms. In this way, despite the attached order, the building has five facades, and with two of them facing the roads. These simple and unornamented facades represent a modern design approach; however, the shape of the balconies in the original drawings give the impression of the National style. It is no symmetrical order to the design of the building.</p> <p>The block has already been renewed, and does not require any repair or restoration.</p>

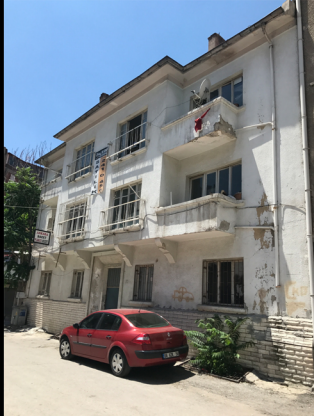
Table 3.21. General information for 840/1.

<p>Building name: Unknown Date: 1942 Architect: Mimar Hidayet Cadastral: 840/1 Construction technique: Reinforced concrete frame Number of floors: 3 Current function: Commercial Style: Modern (Cubic Style)</p>

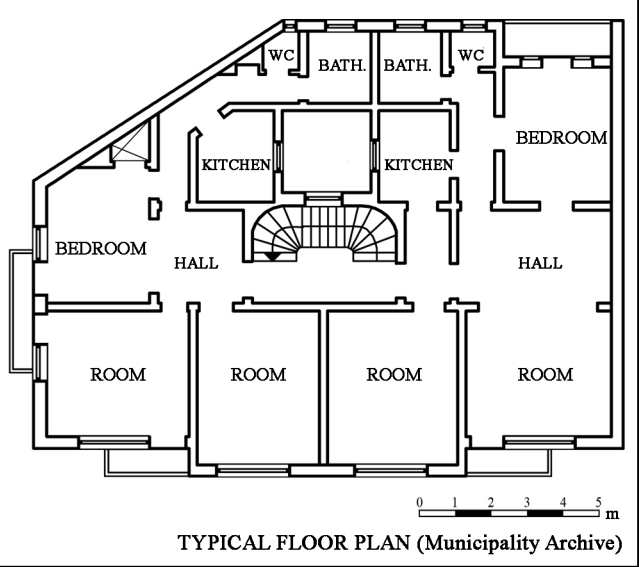
<p>This apartment block, which does not have a name in official records, is located at Karakuş Street. Examining the map of the area, it may be noticed that this is one of the twin blocks on the corner plots.</p> <p>As distinct from other apartment buildings in corner plots, the block has three facades, one of which faces the back yard. The simple and unornamented facades with large transparent surfaces are indicatives of the Cubic Style. Contrary to the facades, the irregular pentagon shape of the plan does not show a complete symmetric treatment.</p> <p>There are two similar units on each floor, and the block contains six units in total. In general, the building is in a good condition; but the plaster of the facade has deteriorated somewhat and requires simple repairs.</p> <p>Similar to the twin block, various manufacturers use the building as workshops.</p>

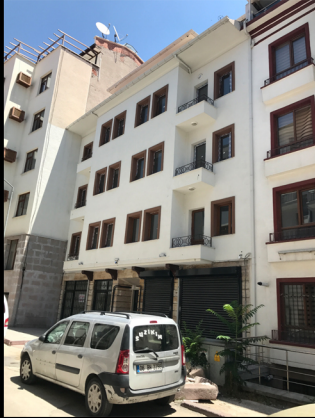
Table 3.23. General information for 840/9.

<p>Building name: Bay Recep Vahyi Oğuz Apartmanı Date: 1942 Architect: Nazım Arman Cadastral: 840/9 Construction technique: Reinforced concrete frame Number of floors: 4 Current function: Commercial Style: Modern (Cubic Style)</p>

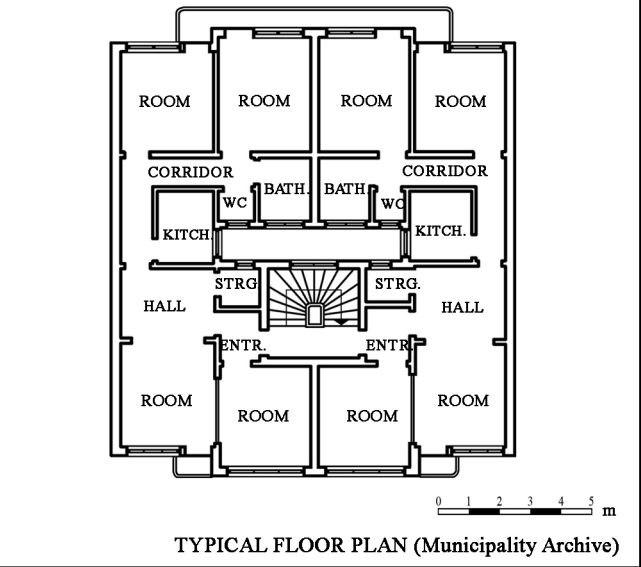
<p>TYPICAL FLOOR PLAN (Municipality Archive)</p>
<p>Bay Recep Vahyi Oğuz Apartmanı, which is known as Levent Apartmanı, is located on Firuzağa Street. Because of the attached order, the block has two facades facing the road and backyard.</p> <p>Considering the construction date of the block, simple and unornamented design of the facades is indicative of the Cubic Style.</p> <p>Originally, there are two identical units on each floor, which are symmetrically placed. The block contains two shops on the ground floor, and six units in total. The building seems to be newly restored, and is in a good physical condition. Compared with images from 2014, it can be observed that the roof floor is constructed in a different way from the original. Today, the building is used for commercial purposes.</p>

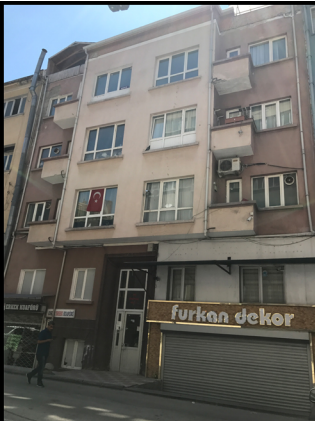
Table 3.25. General information for 843/17.

<p>Building name: Şan Apartmanı Date: 1941 Architect: Mimar Hidayet Cadastral: 843/17 Construction technique: Reinforced concrete frame Number of floors: 5 Current function: Commercial Style: Modern (Cubic Style)</p>

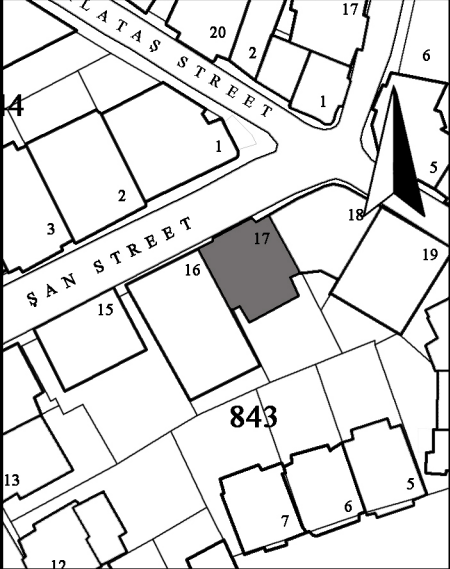
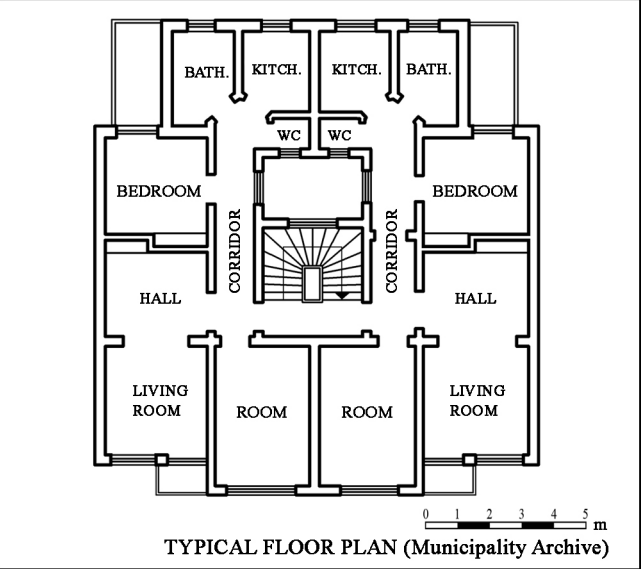
<p>TYPICAL FLOOR PLAN (Municipality Archive)</p>
<p>Şan Apartmanı is located on Şan Street. Because of the attached order, in a similar manner to most of the buildings in the area, the block has two facades facing the street and back yard.</p> <p>Both the plan schema and facades display a symmetrical characteristic. The simple and unornamented design of the facades is indicative of the Cubic style. The surfaces of the building shows a small amount of deterioration, but not to the extent that it requires overall repairs.</p> <p>The block contains two symmetrical units on each floor, and there are six units in total. In addition, there are two shops with their mezzanine floors on the ground floor.</p> <p>Today, the building is used for commercial purposes.</p>

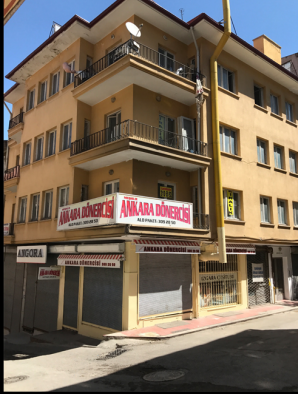
Table 3.27. General information for 842/10.

<p>Building name: Erciyes Apartmanı Date: 1953 Architect: Zeki Gökay Cadastral: 842/10 Construction technique: Reinforced concrete frame Number of floors: 4 Current function: Commercial Style: Historical (Second National Style)</p>

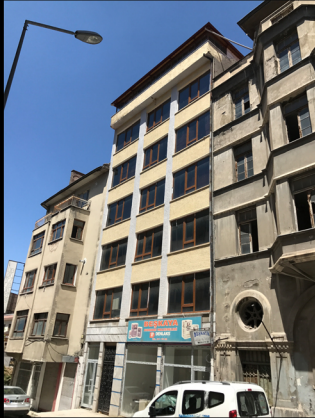
Table 3.29. General information for 843/2.

<p>Building name: Unknown Date: 1957 Architect: Unkown Cadastral: 843/2 Construction technique: Reinforced concrete frame Number of floors: 6 Current function: Commercial Style: Modern (International Style)</p>

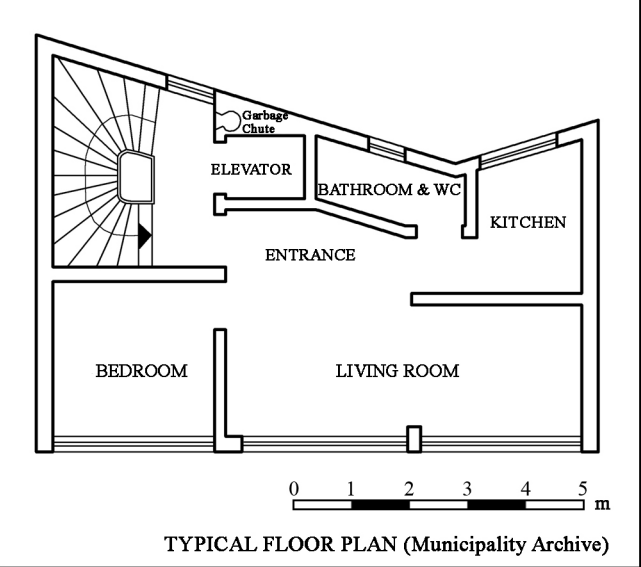
<p>TYPICAL FLOOR PLAN (Municipality Archive)</p>
<p>This small apartment building is located on Işıklar Street. It shows different characteristics in its facade than other apartment blocks in the area. Large and continuous windows on the flat surface and the absence of balconies give the impression of a commercial building; however, it actually contains one studio apartment on each floor. The block comprises a shop on the ground floor and five units in total.</p> <p>Considering its construction date, the simplicity of the facades with their large windows and plan order indicates the International Style.</p> <p>The most important feature of the building is that it contains an elevator, which is unique among the apartment blocks in the neighbourhood.</p> <p>The building is in good condition in terms of its physical appearance, and it does not require renewal or repair. Like many other buildings in the area, it is currently used for commercial purposes.</p>

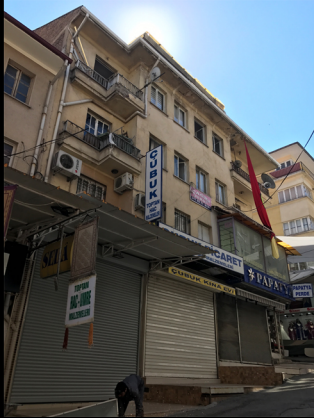
Table 3.31. General information for 858/2.

<p>Building name: Tiftik (Kınacı) Apartmanı Date: 1952 Architect: Zeki Gökay Cadastral: 858/2 Construction technique: Reinforced concrete frame Number of floors: 6 Current function: Commercial Style: Historical (Second National Style)</p>

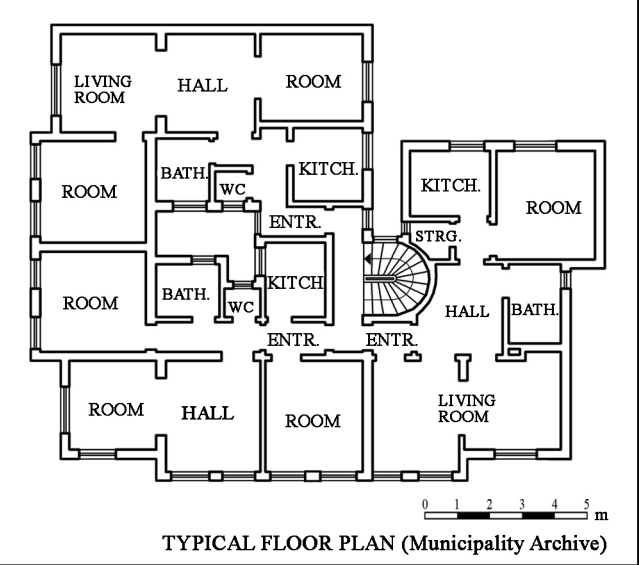
<p>TYPICAL FLOOR PLAN (Municipality Archive)</p>
<p>Tiftik Apartmanı is located at the intersection of Mevsim Street and Çıkrıkçılar Road, which is continuation of Anafartalar Street as a pedestrianised area. Because of its indented shape, the block has four facades. These facades show characteristics of the Second National Movement with large projected eaves, a symmetric design, and cantilevered surfaces. However, the plan schema does not have a completely symmetrical ordering; moreover, the additional unit behind the core destroys the perception of symmetry.</p> <p>This four-storey apartment block originally contained three shops and a laundry room on the ground floor, and three units on each upper floor (Bayraktar, Batuman & Ayhan 2014, 71). Today, all parts of the building are used for commercial purposes.</p> <p>The building has surface and material deterioration and requires restoration.</p>

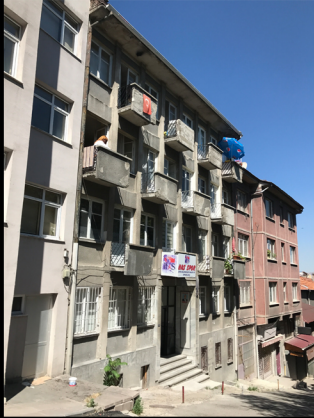
Table 3.33. General information for 861/10.

<p>Building name: Bay Mehmet Kazazoğlu Apartmanı Date: 1957 Architect: Fahri Yetman Cadastral: 861/10 Construction technique: Reinforced concrete frame Number of floors: 4 Current function: Residential Style: Modern (International Style)</p>

<p>TYPICAL FLOOR PLAN (Municipality Archive)</p>
<p>Kazazoğlu Apartmanı is located on Konya Street. It is one of the rare examples of blocks which are still used for residential purposes in the area.</p> <p>The building has two facades because of the attachment order. In contrast to the back elevation, the front facade has a simple and dynamic design with a staggered ordering of its balconies. Due to its simple design approach and distinctive facade, the building has an important place among the residential blocks of the modern period (Bayraktar, Batuman & Ayhan 2014, 121). A simple but original arrangement of the facade with modern balconies strongly indicates the International style.</p> <p>The first basement floor and four upper floors contain units, whilst the second basement floor is used as a coal cellar. The building has eight units in total, which is a high number compared to other blocks in the neighbourhood.</p> <p>The building has material deterioration and requires renewal.</p>

Photograph 4.6. Kazazoğlu Apartmanı, 861/10

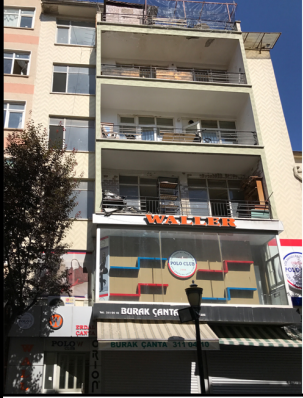
Table 3.35. General information for 838/14.

<p>Building name: Nilüfer Apartmanı Date: 1966 Architect: Hilmi Bener Cadastral: 838/14 Construction technique: Reinforced concrete frame Number of floors: 6 Current function: Commercial Style: Modern (International Style)</p>

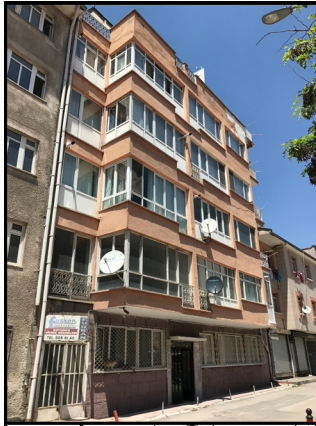
Table 3.37. General information for 840/17.

Building name: İstiklâl Apartmanı
Date: 1965
Architect: Fehmi Doğan, Mehmet Ünal
Cadastral: 840/17
Construction technique: Reinforced concrete frame
Number of floors: 5
Current function: Residential
Style: Modern (International Style)

İstiklâl Apartmanı is located on Karakuş Street, which still has residential buildings in the area. This building is also still being used for residential purposes.

The block has five storeys and it encompasses three units on each floor. This building is one of the largest and most recent apartment blocks in the neighbourhood. This shows the direct relationship between the construction date and the size of the buildings.

The building is in good condition in terms of its physical appearance, and does not require renewal or repair.

Photograph 4.9 The facade view of İstiklal Apartmanı, constructed in 1965.

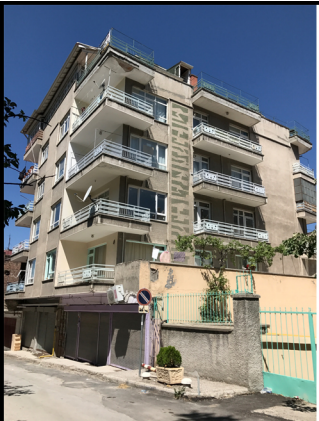
Table 3.39. General information for 842/4.

<p>Building name: Mustafa Sabuncu (Şale) Apartmanı Date: 1962 Architect: Rifat Ünal Cadastral: 842/4 Construction technique: Reinforced concrete frame Number of floors: 6 Current function: Residential Style: Modern (International Style)</p>

Photograph 4.8 Mustafa Sabuncu Apartmanı.

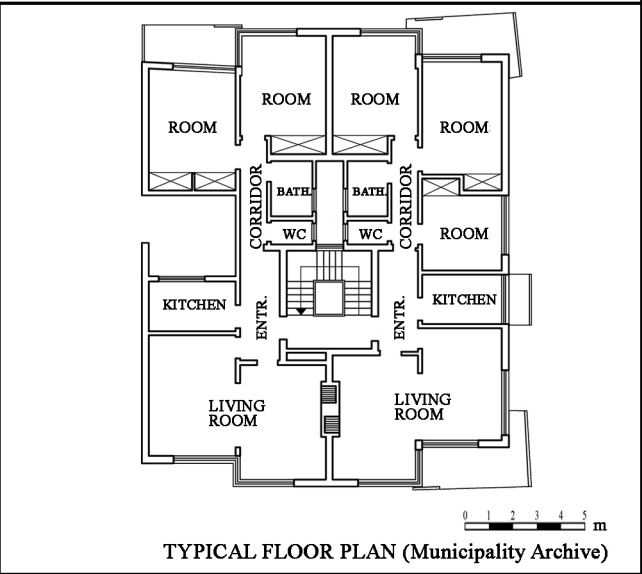
<p>TYPICAL FLOOR PLAN (Municipality Archive)</p>
<p>Mustafa Sabuncu (Şale) Apartmanı is located on Kardeşler Street, near to St. Therese Church. Due to the attached order, the block has three facades; it is attached from one side to the next building. All these facades have different designs, but it is possible to note the symmetrical design in both facades and the plan drawings. The shape of the block, and in particular the large balconies which are placed at different angles, reflect the modern architecture. Contrary to its simple and unornamented design, a coloured pattern is notable on one of the facades.</p> <p>The other distinctive feature of the building is the cold store at the basement level that exists in its original design (Bayraktar, Batuman & Ayhan, 179).</p> <p>The building consists of two shops on the ground floor, and two units on each upper floor. It has ten units in total. These units are still being used for residential purposes. The block is in good condition in terms of its physical appearance, and does not require renewal or repair.</p>

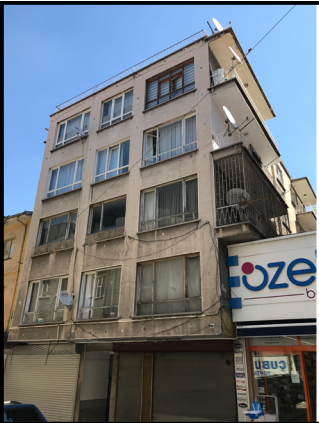
Table 3.41. General information for 859/3.

<p>Building name: Buket Apartmanı Date: 1966 Architect: Mehmet Savaş Cadastral: 859/3 Construction technique: Reinforced concrete frame Number of floors: 5 Current function: Residential Style: Modern (International Style)</p>

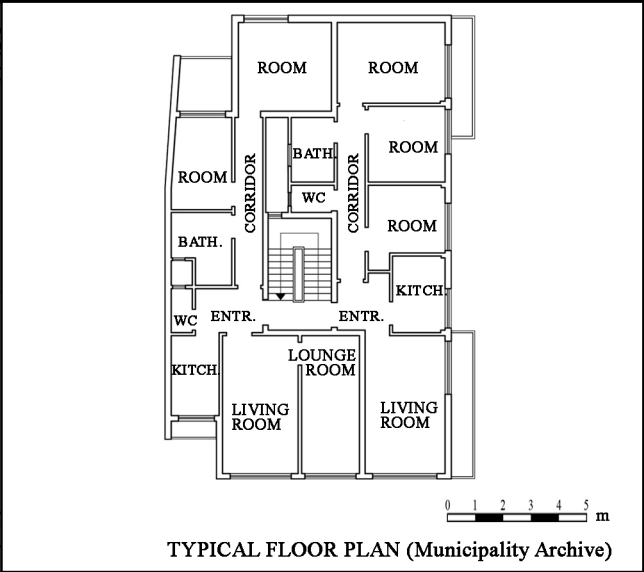
<p>TYPICAL FLOOR PLAN (Municipality Archive)</p>
<p>Buket Apartmanı is located on Konya Street which is an area of intense commercial activity. However, the building is one of the rare blocks that is still being used for residential purposes in the area.</p> <p>The shape of the block and windows on the facades are strongly indicative of the modern architecture. There is no noticeable symmetrical order on the plan schemas or facades.</p> <p>Because of the attached order, the block has three facades; it is adjacent to the next building form one side. All these facades have different designs.</p> <p>Each floor contains two units, though these units do not have the same plan ordering; the building consists of a shop on the ground floor and eight units on the upper floors.</p> <p>There is a coal cellar, a blockhouse, a refuse storage, and a janitor room on the basement floor. In addition, There is a small unit on the top floor.</p> <p>The building requires simple repairs because of slight surface deterioration.</p>

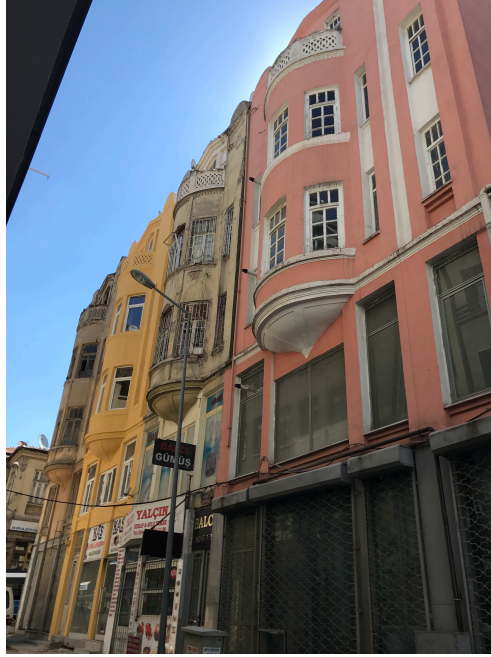
a) Plot use: Analyses show that in this period, apartment blocks completely cover the plot in general. The land occupancy ratio is greater than 1 in three-quarter of the examples that were examined in detail. The majority of buildings have projections which exceed the borders of the plots (Photograph 4.1). Only a few examples have back yard behind the block.

Photograph 4.1 The apartment blocks which were constructed in 1924, on Mevsim Street.

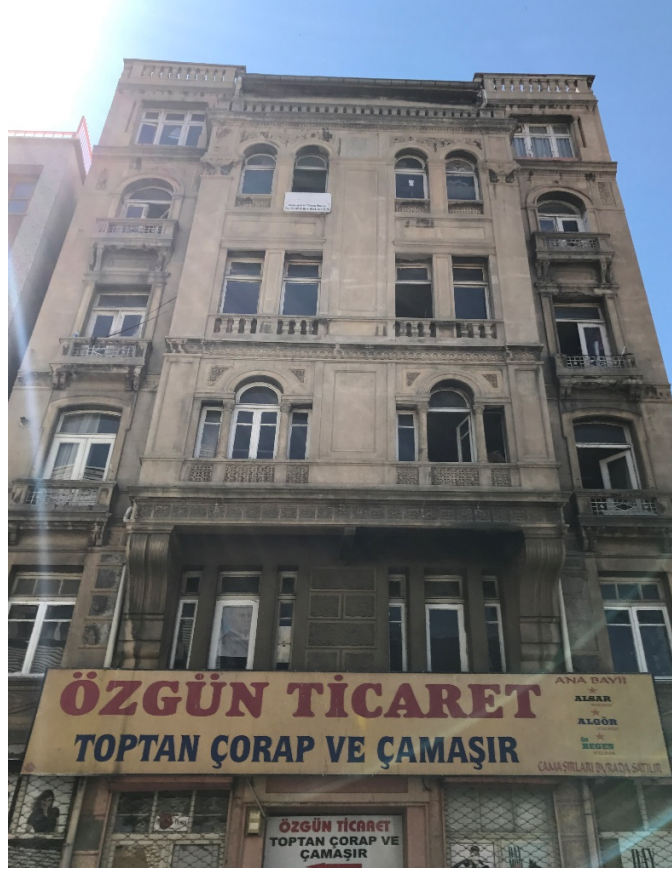
c) Open space: Except for a few cases, the balconies form approximately 1% of the floor plan in the 1920s. Usually they are organized in a symmetrical order on facades and service rooms or living rooms within the units. These balconies are commonly in semi-circular or rectangular forms (Photograph 4.2).

Photograph 4.2. The view of Özgün Han, 2017.

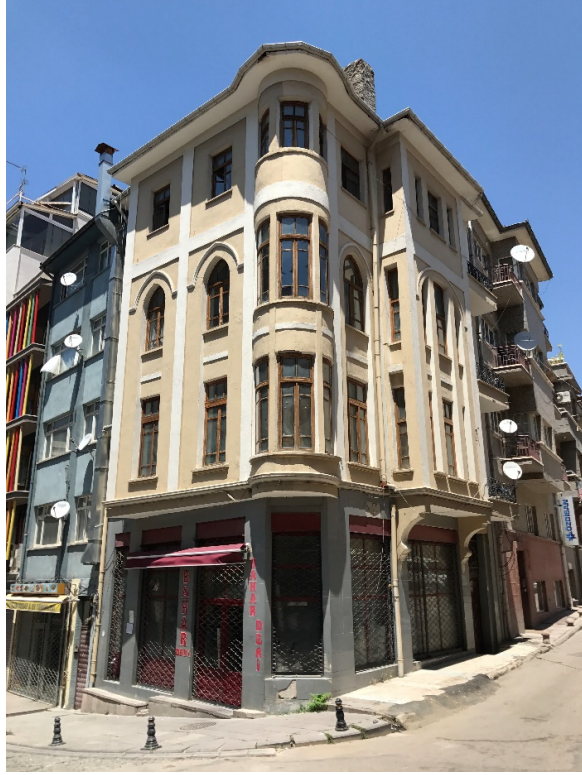
e) Architectural style: In this period, the “First National Style” is the prevalent approach in practice. Buildings have curvilinear surfaces and semi-circular projections on their front facades. Tower structures on the corner of blocks are very common features of these blocks. In addition to these, decorated mouldings,

ornamented reliefs, rosette windows, use of cut stones, and a search for symmetry on the facades are particular characteristics of this style (Nalbantoğlu 1981, 37). In addition, the facade arrangement of one of the examples indicates the Neo-classical Style. This shows the effect of foreign architects and master builders in the 1920s (Table 4.6).

Photograph 4.3. An apartment block designed with the First national Style in the 1920s, Salih Çelebi Apartmanı.

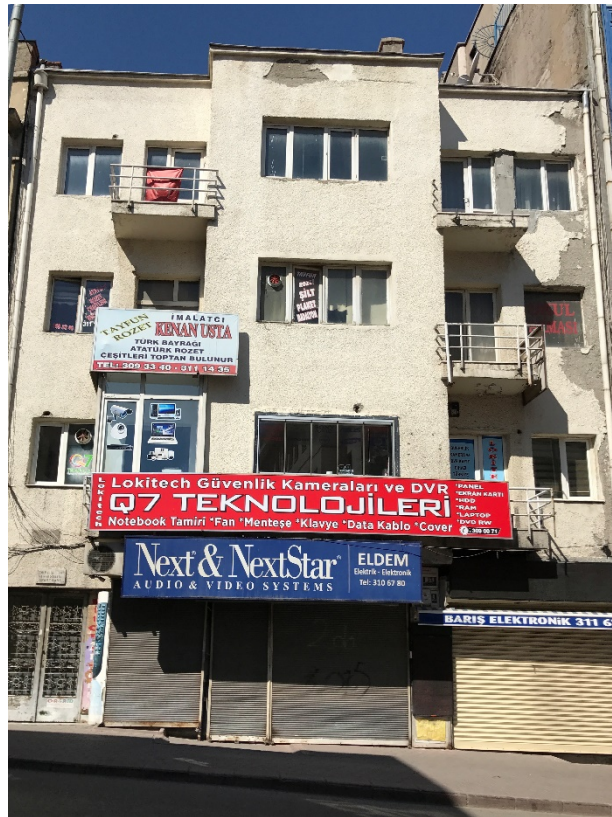
e) Architectural style: In this period, the First National Movement, which has symbolic elements of Ottoman architecture such as domes, arches, etc., started to lose its influence upon building designs. Rather, the Modern Movement that represented a new and simple architecture became dominant in the design of apartment buildings under the influence of foreign architects. The buildings commonly bear the traces of cubic architecture in the 1930s (Nalbantoğlu 1981, 87-88).

Photograph 4.4 The view of Yüzbaşıoğlu ve Kardeşleri Apartmanı, 845/6.

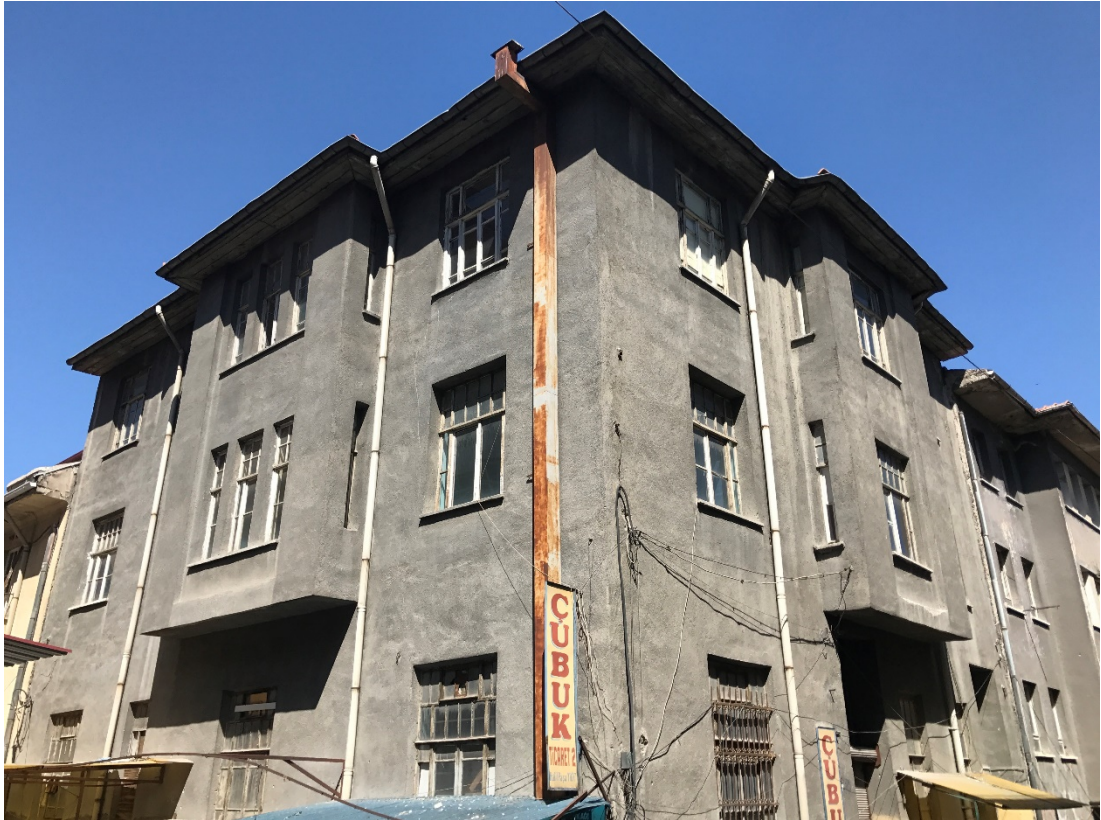
e) Architectural style: In this period, the Second National Movement became the prevalent approach, which bears the traces of national and regional elements such as projected eaves, consoled surfaces, symmetrical arrangement on facades, etc. (Photograph 4.5). Accordingly, the buildings have simple and unornamented facades compared with the First National Movement examples from the 1920, and were designed in a more traditional way than in the 1930s.

Photograph 4.5 The view of 858/1.
