A SURVEY ON PLAN TYPOLOGIES IN APARTMENT BLOCKS:
THE CASE OF NECATİBEY NEIGHBOURHOOD, ANKARA
(1920s-1960s)

A THESIS SUBMITTED TO THE GRADUATE SCHOOL OF NATURAL AND
APPLIED SCIENCES
OF
MIDDLE EAST TECHNICAL UNIVERSITY

SEPTEMBER 2017

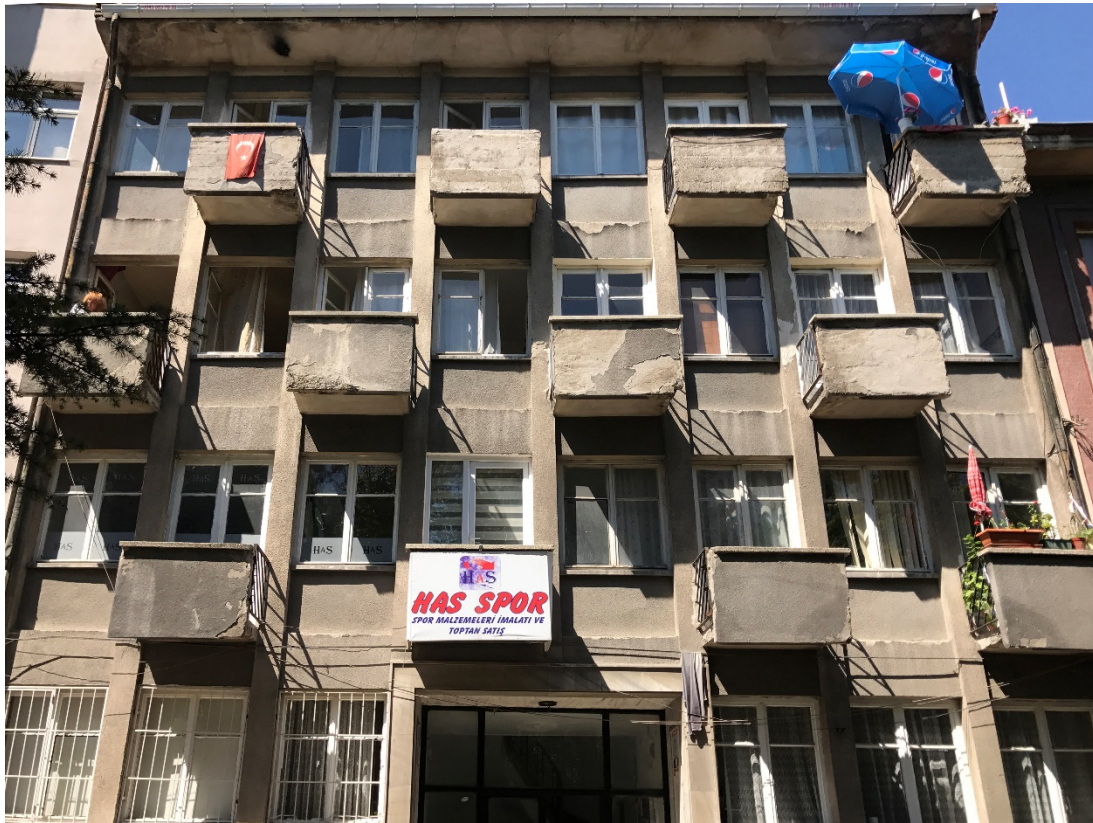
c) Open space: The average ratio of open spaces is 4%, which is same as the 1940s. All balconies have rectangular or square forms and are in the cubic style. They usually service living rooms, guest rooms, bedrooms, and kitchens. In one of the examples, open spaces are used as dynamic elements of the facade arrangement in this period (Figure 4.7).

Photograph 4.6. Kazazoğlu Apartmanı, 861/10

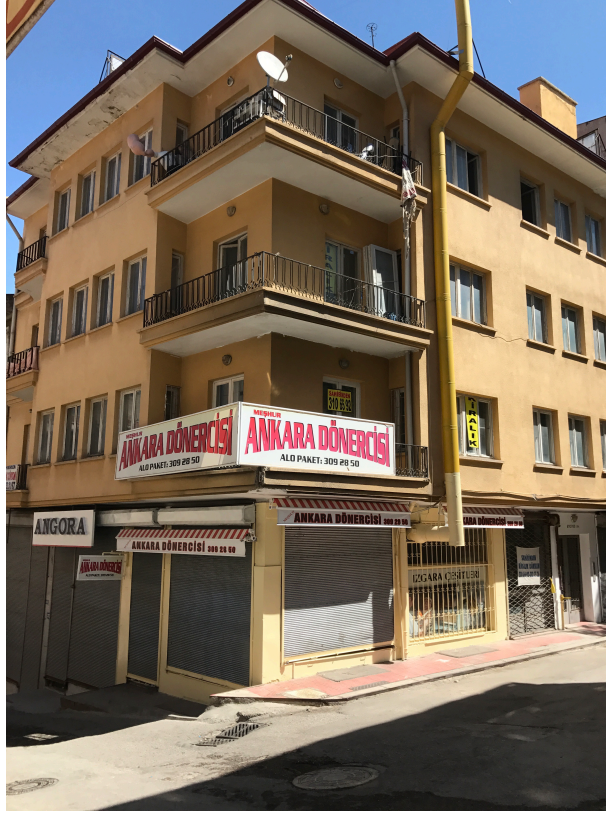
e) Architectural style: In the 1950s, the Second National Movement started to lose its influence on building style; rather, the International Style became dominant in later examples of this period. It is possible to read the associated simple design approach in both plans and facades.

Photograph 4.7. Erciyes Apartmanı, 842/10.

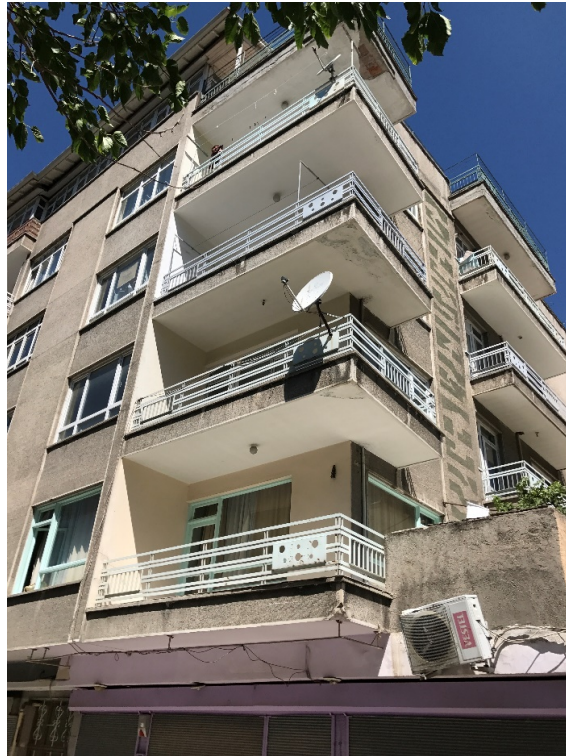
c) Open space: There is a sharp increase in the ratio of open spaces in the floor plan from the 2-4% range of previous decades to 6%. All open spaces are arranged in a simple plan and facade arrangements of buildings. They service living rooms, bedrooms and kitchens.

Photograph 4.8 Mustafa Sabuncu Apartmanı.

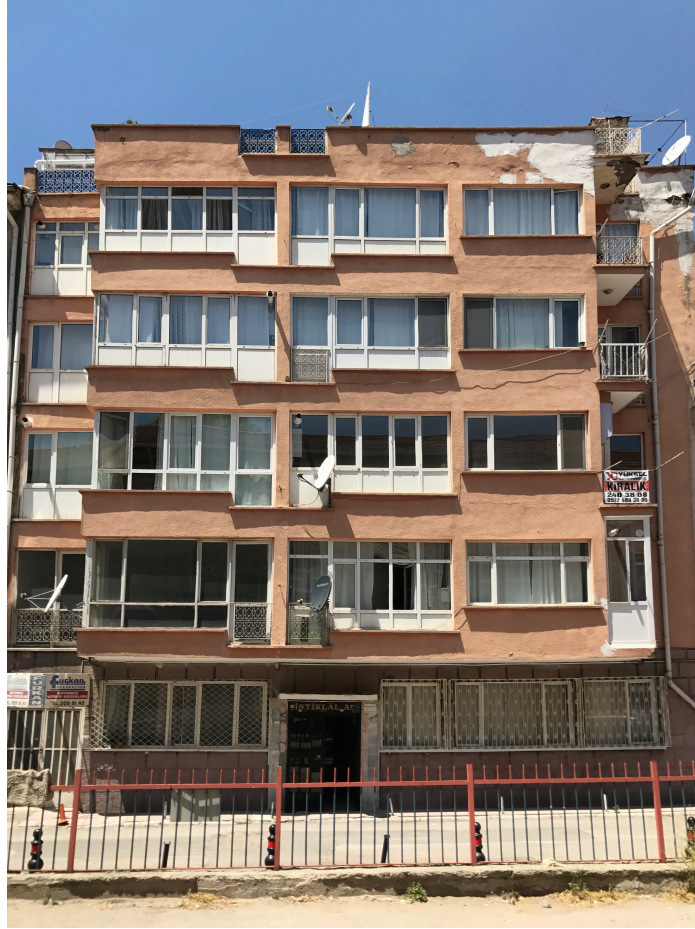
e) Architectural style: The Second National Movement completely lost its influences on the residential buildings. It is possible to observe the effects of the

International Style on all of the facades from this period. For example large-horizontal windows, large balconies, simple and unornamented facades etc.

Photograph 4.9 The facade view of İstiklal Apartmanı, constructed in 1965.

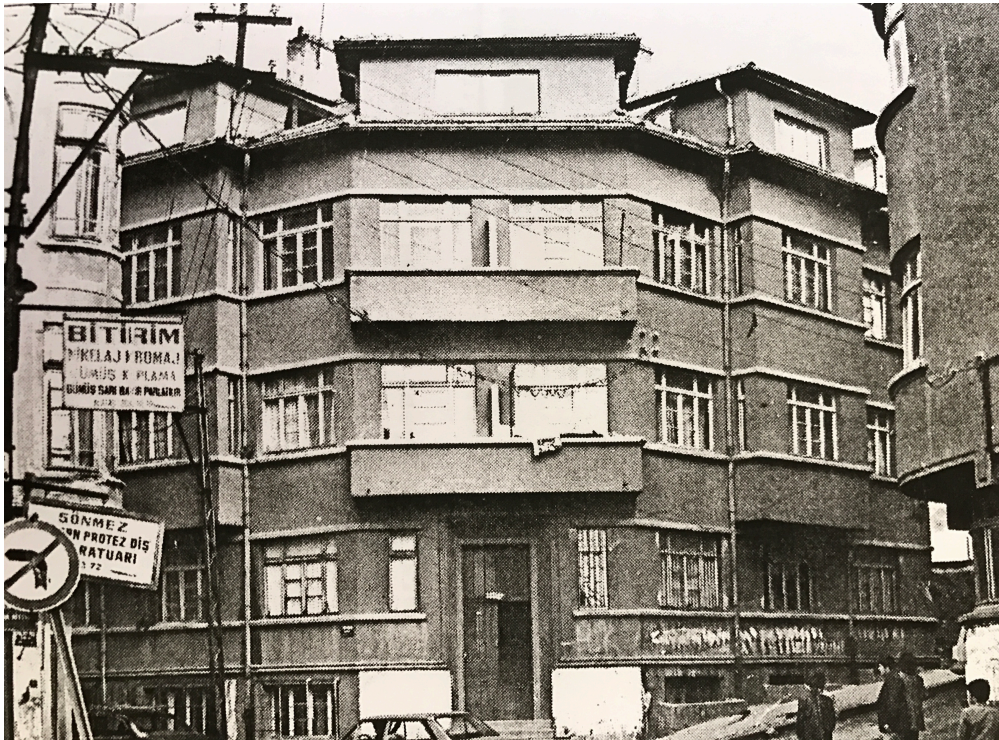
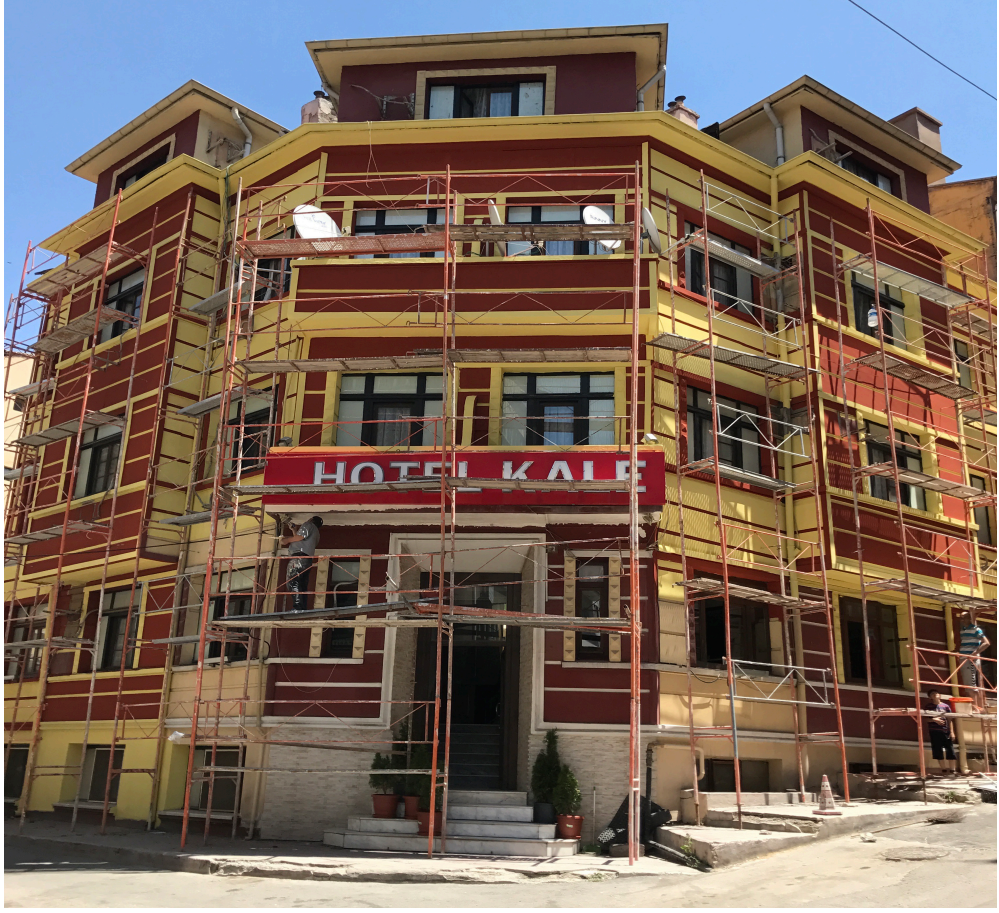
Photograph 5.1 İbrahim Atlas Apartmanı (Nalbantoğlu 1981, 99).

Photograph 5.2 İbrahim Atlas Apartmanı (Kale Otel), 2017.

It is obvious that İbrahim Atlas Apartmanı, which is currently named Kale Otel, suffers from inappropriate facade renewal compared to its original design. In addition, external components of air conditioners, satellite dishes and a huge signboard are problematic when one attempts to perceive the design of the facade. There are many other apartment blocks exposed to these same practices.

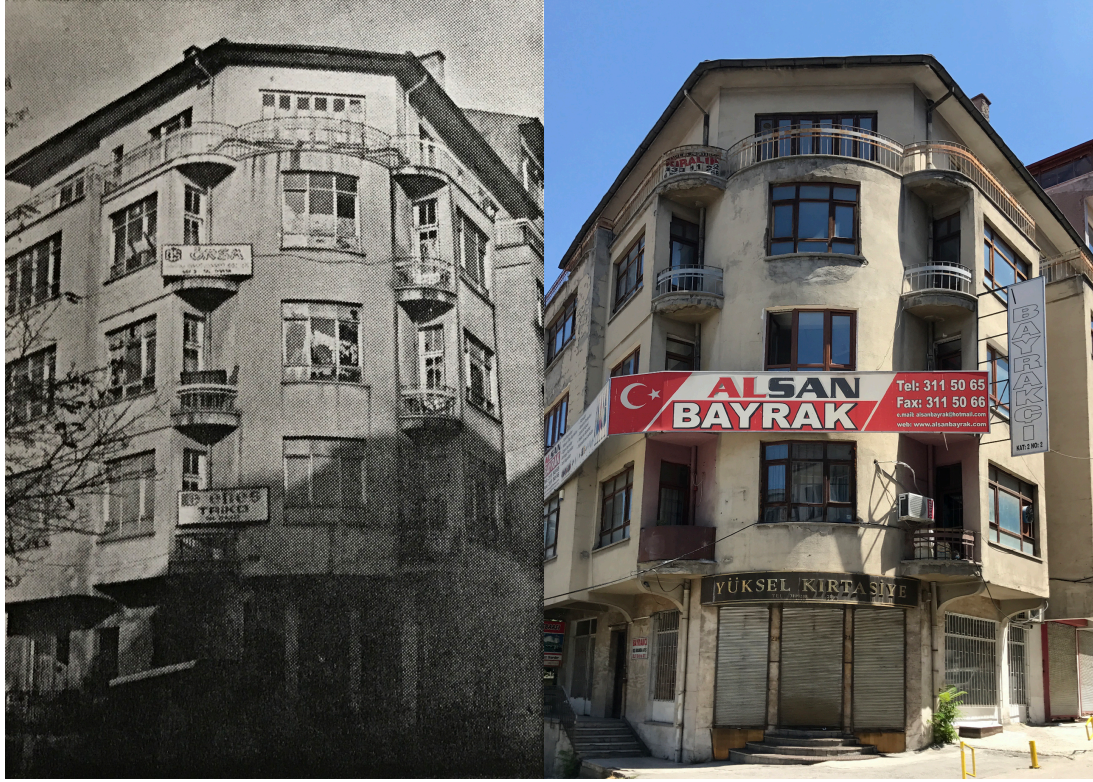
Photograph 5.3 Appearance of Ilgar Apartmanı (with advertising boards) in 1981 (Nalbantoğlu 1981, 112) and 2017.

Along with the material deterioration of the buildings, the huge number of shop signs and advertising boards, presented in various styles, disrupt the perception of the appearance of the architectural products. In addition, improper renovation of the facades has given rise to identity loss of both the buildings and the area. Architectural elements and ornamentations, which reflected the design approach of certain periods disappeared completely, or were transformed in a misleading way.

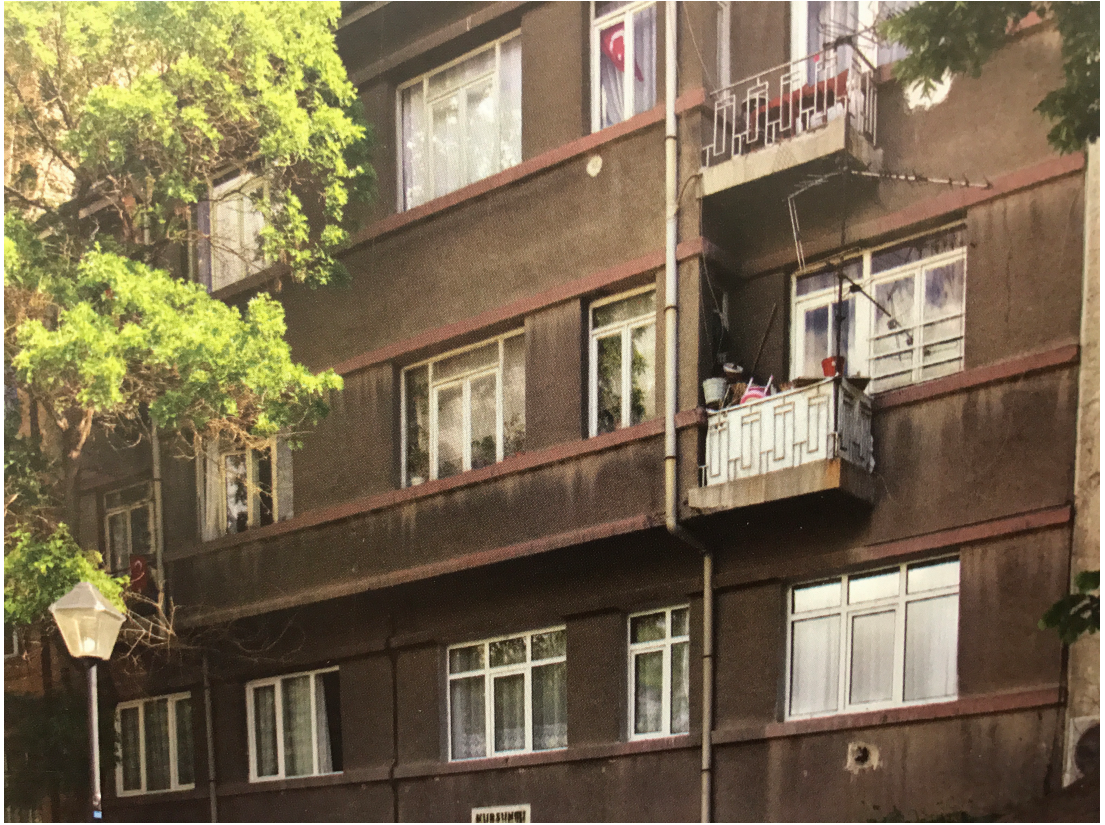
Photograph 5.4 Original facade of Halit Kurşuncu Apartmanı (Bayraktar, Batuman & Ayhan 2014, 9)

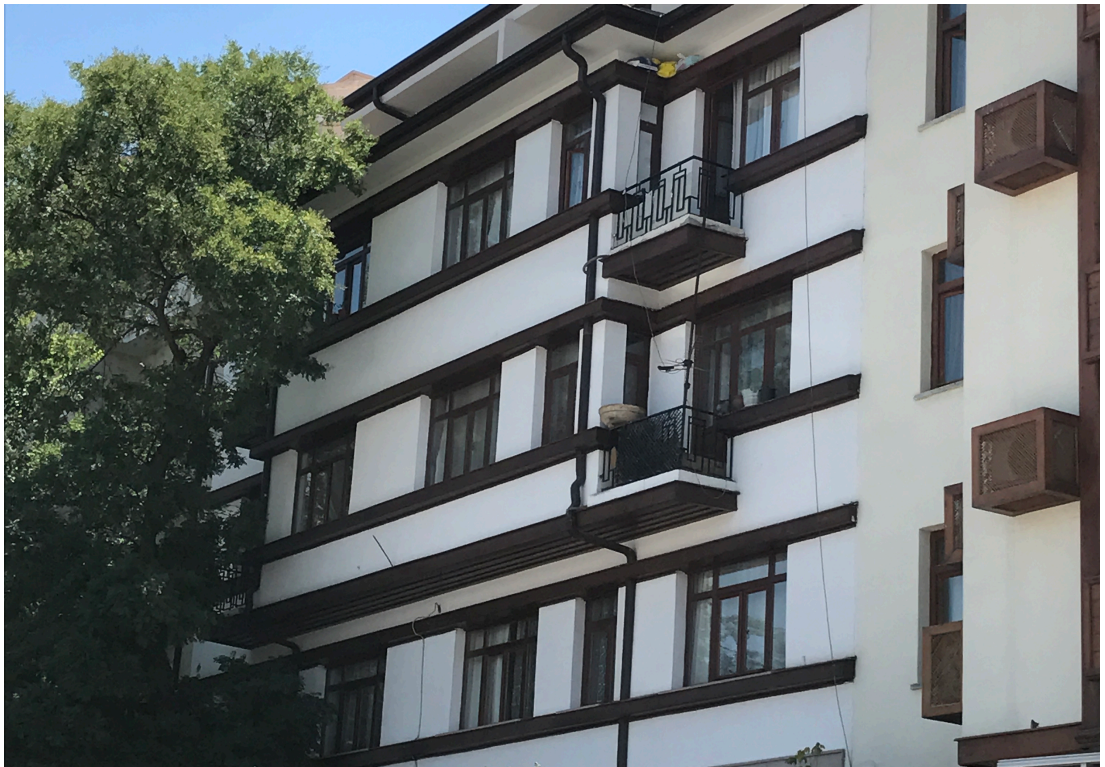
Photograph 5.5 Current appearance of Halit Kurşuncu Apartmanı, 2017.

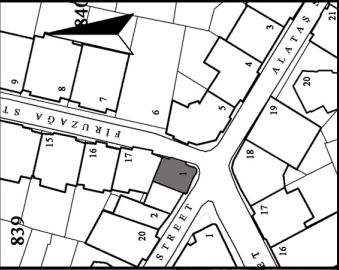
<p>Building name: Salih Çelebi Apartmanı Date: 1920s (?) Architect: Y. Müh. Adnan Canbek Cadastral: 839/1 Construction technique: Iron I beams and brick fill Number of floors: 4 Current function: Commercial Style: Historical (First National Style)</p>

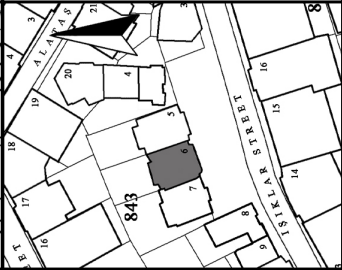
11

<p>Building name: Kardaşlar Apartmanı Date: 1934 Architect: (?) Cadastral: 843/6 Construction technique: Reinforced concrete frame Number of floors: 4 Current function: Commercial Style: Modern (Cubic Style)</p>

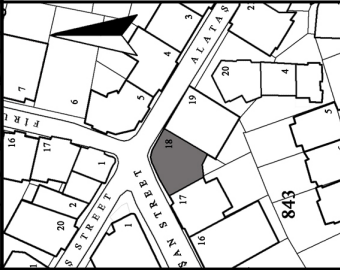
12

<p>Building name: İnci Apartmanı Date: 1934 Architect: Mimar Halim Cadastral: 843/18 Construction technique: Reinforced concrete frame Number of floors: 4 Current function: Commercial Style: Modern (Cubic Style)</p>

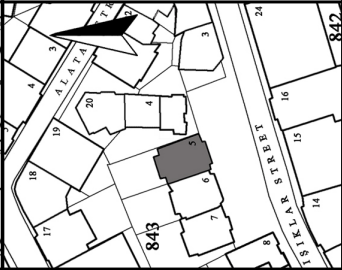
<p>17</p>

<p>Building name: Nuri Asmaz Apartmanı (?) Date: 1936 Architect: Mimar Halim Cadastral: 843/5 Construction technique: Reinforced concrete frame Number of floors: 4 Current function: Commercial Style: Modern (Cubic Style)</p>

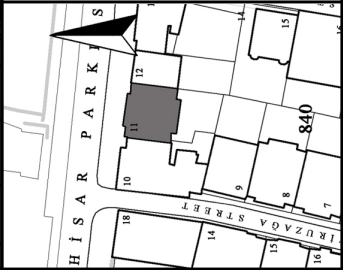
<p>18</p>

<p>Building name: Halit Kurşuncu Apartmanı Date: 1937 Architect: Fen Mesulu H. Kurtuluş Cadastral: 840/11 Construction technique: Reinforced concrete frame Number of floors: 5 Current function: Residential Style: Modern (Cubic Style)</p>

<p>TYPICAL FLOOR PLAN (Municipality Archive)</p>
<p>Halit Kurşuncu Apartmanı is located on Hisar Parkı Street, which meets the stairs of Ankara Citadel. This building is one of the few apartment blocks still used for residential purposes.</p> <p>There are two units on each floor, and the apartment block consists of eight units in total. On the basement floor there is a laundry room and coal cellars that belong to units.</p> <p>Because of attached order, the building has two facades. It may be noted that there some effort has been made to gain a symmetrical appearance to the building. On the other hand, unit plans do not resemble each other; in other words, their floor plans do not show symmetric regulation. The roadside facade has a simple appearance compared to other buildings from the 1920s and 1930s. It is observed from site surveys that Kurşuncu Apartmanı does not require any restoration or renewal.</p> <p>The shape of the block does not have curvilinear surfaces; it has an 'H'-like shape, a design which was prevalent in the 1930s and 1940s.</p>

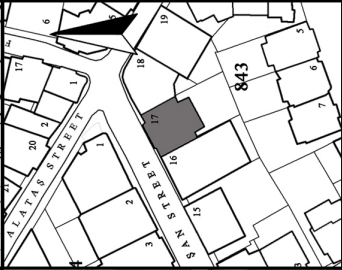
<p>23</p>

<p>Building name: İnci Apartmanı Date: 1941 Architect: Mimar Hidayet Cadastral: 843/17 Construction technique: Reinforced concrete frame Number of floors: 5 Current function: Commercial Style: Modern (Cubic Style)</p>

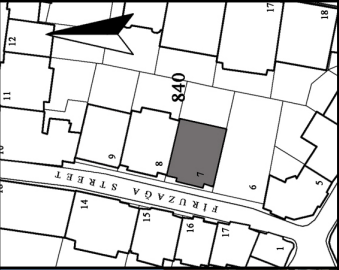
29

<p>Building name: M. Canlı Apartmanı Date: 1948 Architect: Unknown Cadastral: 840/7 Construction technique: Reinforced concrete frame Number of floors: 5 Current function: Residential Style: Modern (Cubic Style)</p>

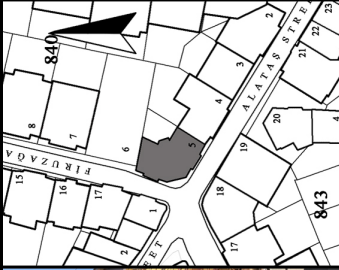
<p>31</p>

<p>Building name: İbrahim Atlas Apartmanı Date: 1949 Architect: Unknown Cadastral: 840/5 Construction technique: Reinforced concrete frame Number of floors: 4 Current function: Commercial Style: Modern (Cubic Style)</p>

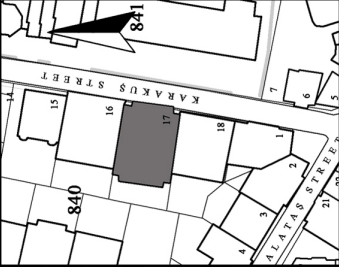
43

<p>Building name: İstiklâl Apartmanı Date: 1965 Architect: Fehmi Doğan, Mehmet Ünal Cadastral: 840/17 Construction technique: Reinforced concrete frame Number of floors: 5 Current function: Residential Style: Modern (International Style)</p>

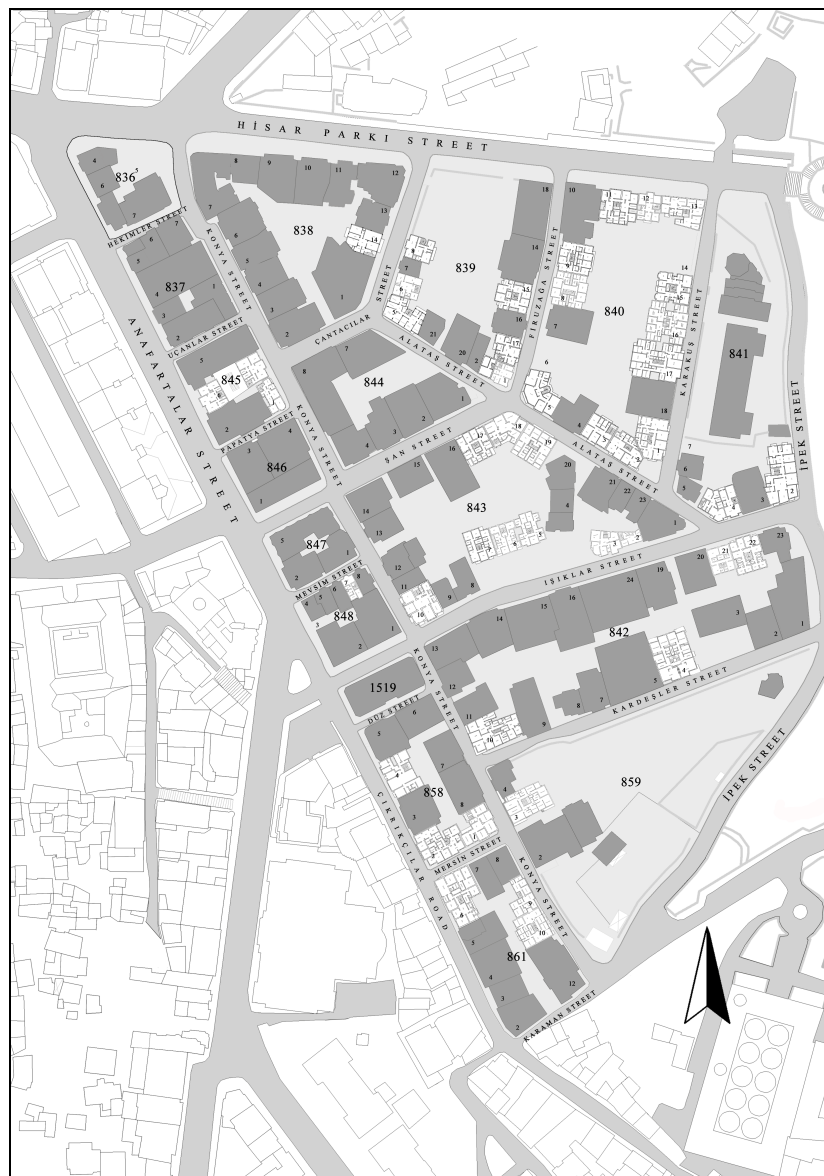
Figure F.1 The map of cadastral blocks showing apartment block plans.
